Your Ref: TP/IP/05500/2022
Our Ref : CI/TPD22005245/N

Fatal Accident Investigation Team

INSPECTION REPORT OF MOTORCYCLE FBR 4863G

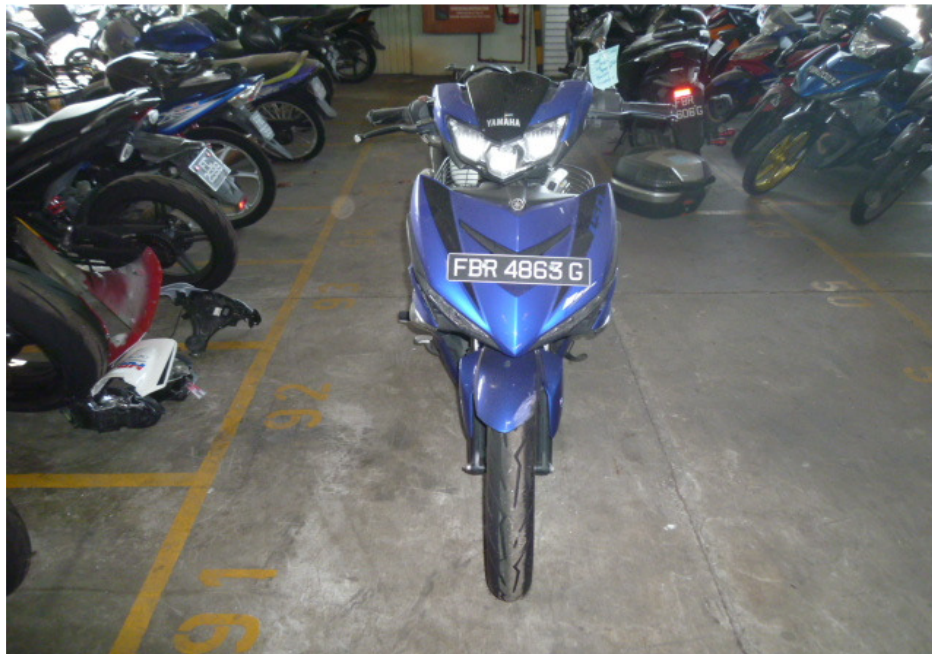
Photo 1 shows a general view of the frontal portion of the Motorcycle at the time of our inspection. The Motorcycle was observed to have sustained damages all around. The mileage of the Motorcycle could not be recorded as the ignition key was not available at the time of our inspection.

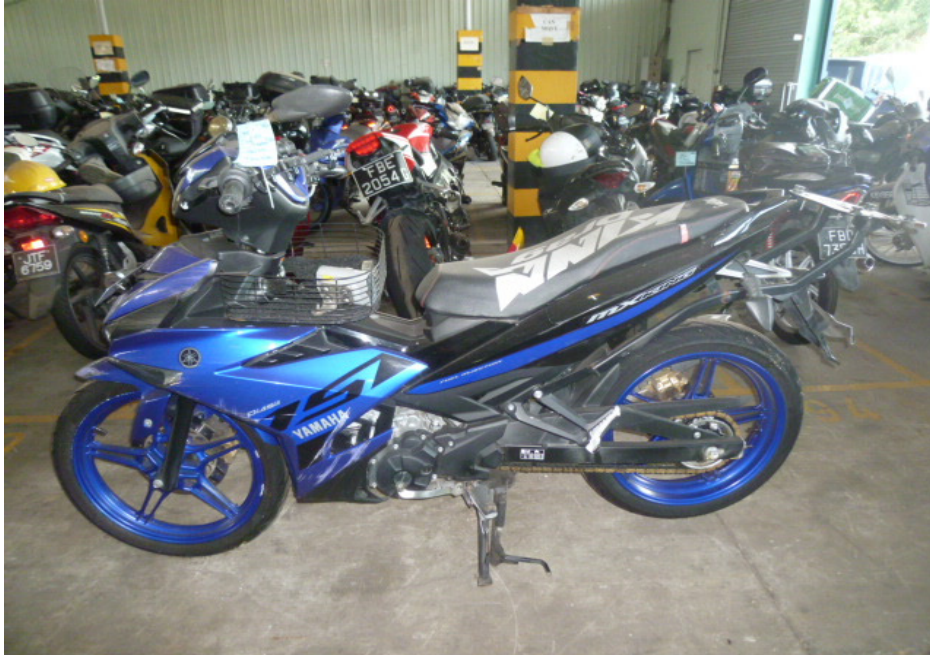
Photo 2 shows a general view of the left body of the Motorcycle at the time of our inspection. The Motorcycle was observed to have sustained damages all around.

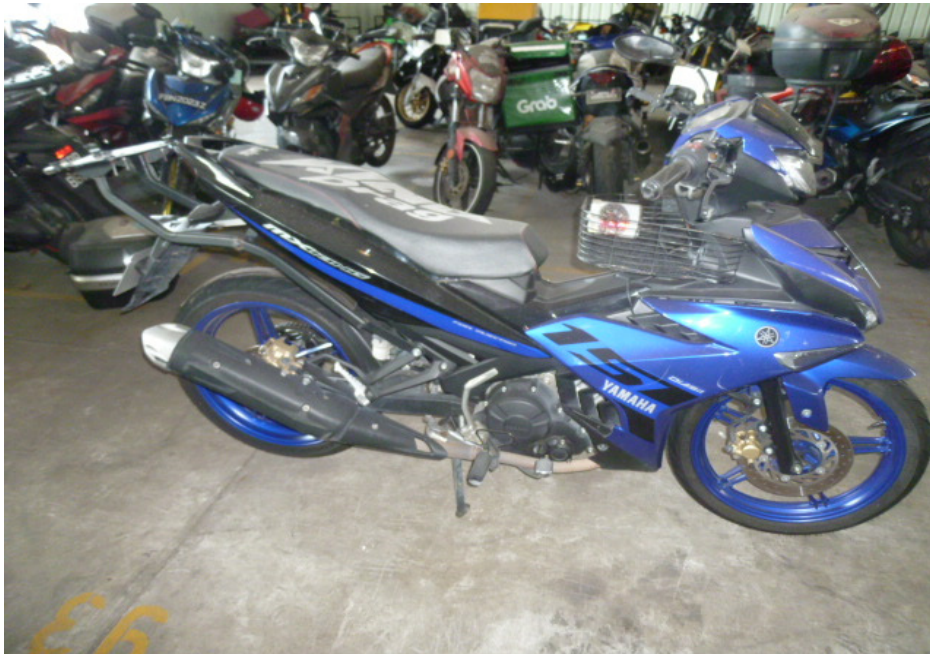
Photo 3 shows a general view of the right body of the Motorcycle at the time of our inspection. The Motorcycle was observed to have sustained damages all around.

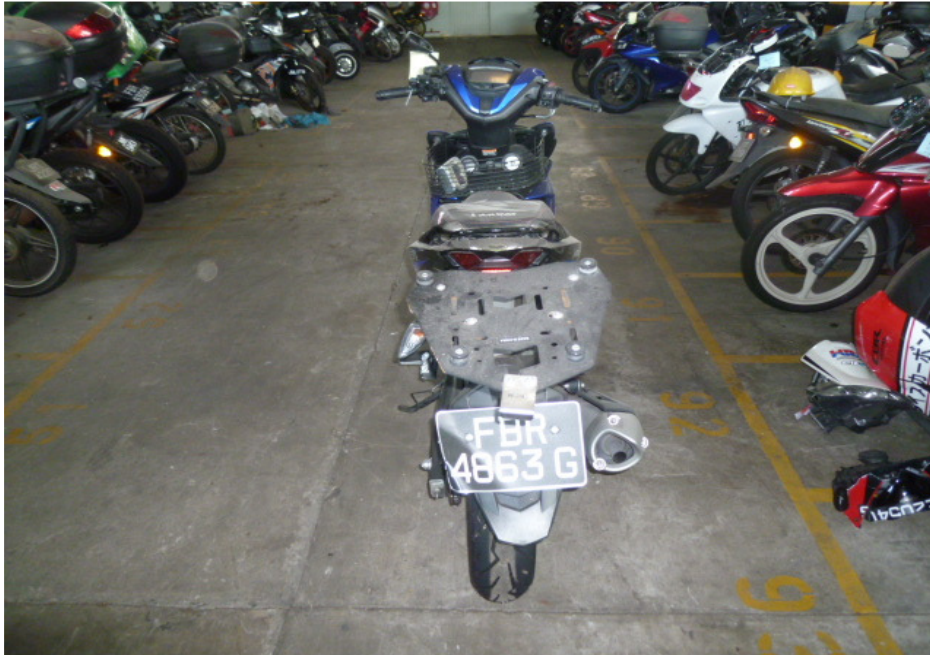
Photo 4 shows a general view of the rear portion of the Motorcycle at the time of our inspection. The Motorcycle was observed to have sustained damages all around. The body parts that were found to have been damaged include its front cowling, front mudguard, side cowlings, left side mirror, front brake lever, clutch lever, handlebar ends, gear shift pedal, rear brake pedal, front footrests, left rear side cover, left rear signal lamp and rear number plate, amongst others.

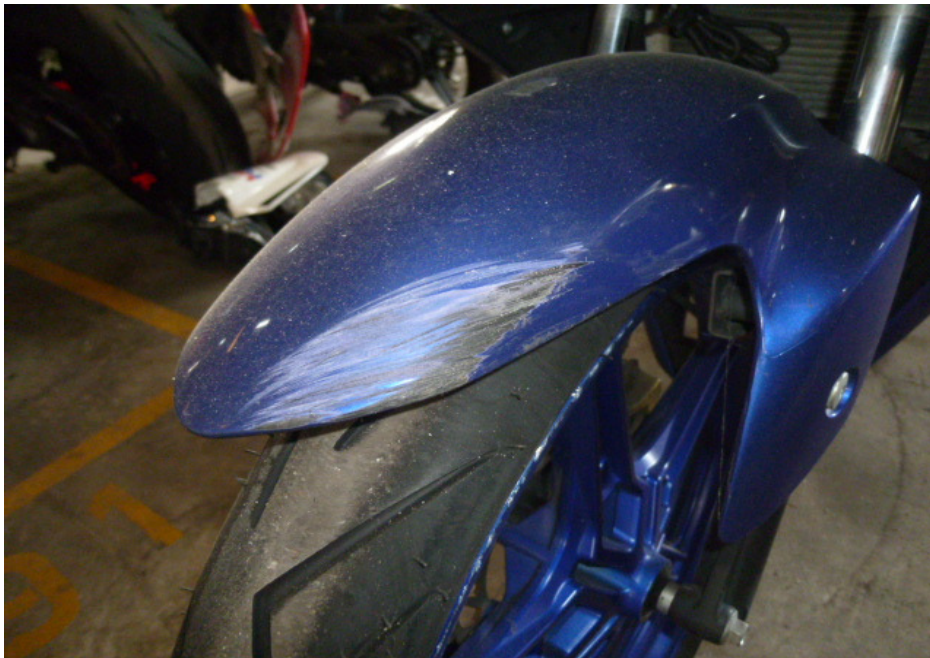
Photo 5 shows a closer view of the front mudguard which was amongst the body parts of the Motorcycle that had sustained damage as a result of the accident.

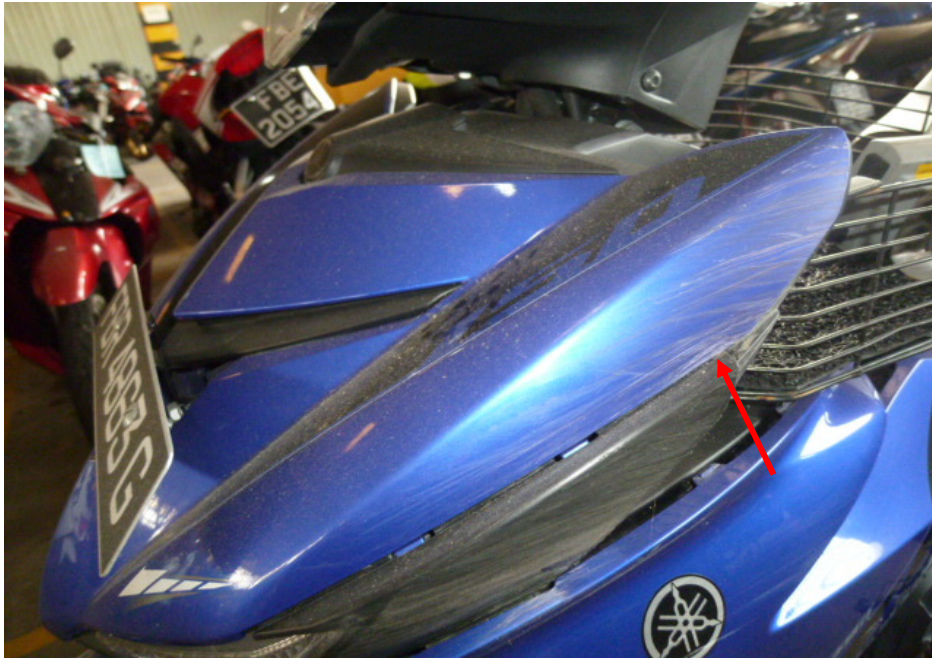
Photo 6 shows the front cowling (arrowed), which was amongst the body parts of the Motorcycle that had sustained damage as a result of the accident.

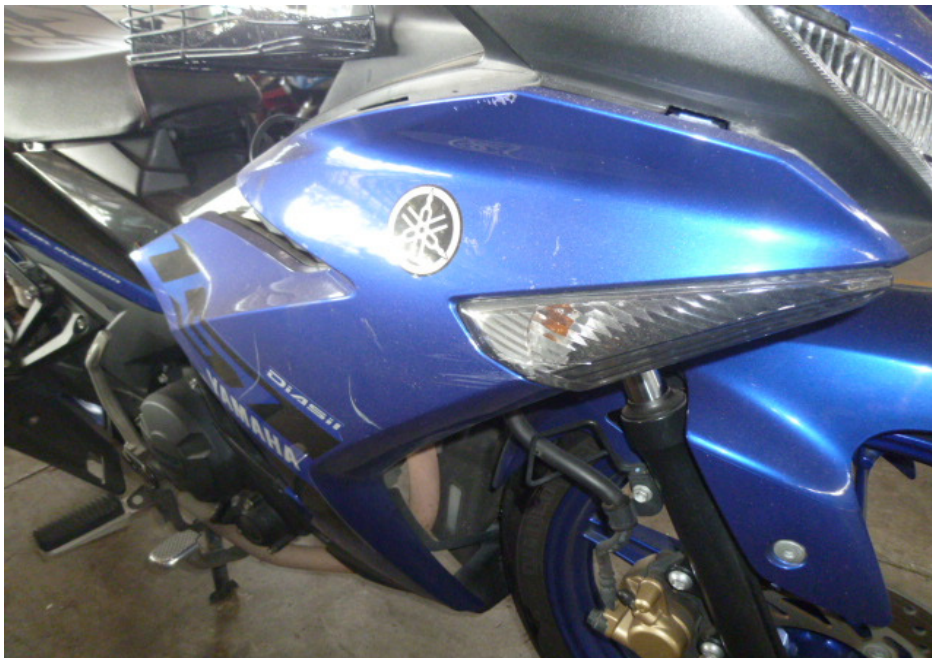
Photo 7 shows a closer view of the right cowling which was amongst the body parts of the Motorcycle that had sustained damage as a result of the accident.

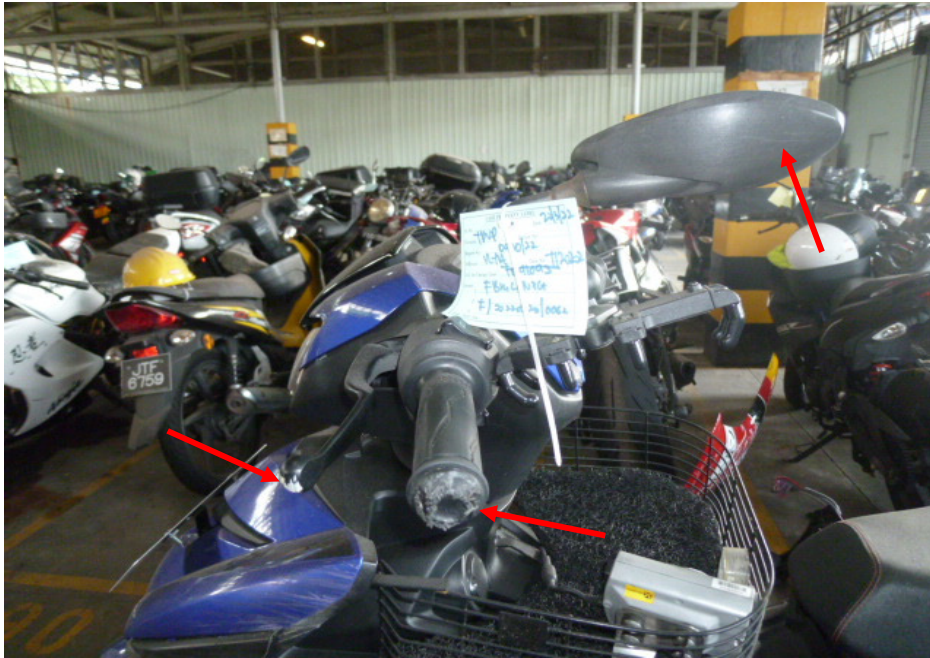
Photo 8 shows the left handlebar end, clutch lever and left side mirror (arrowed), which were amongst the body parts of the Motorcycle that had sustained damage as a result of the accident.

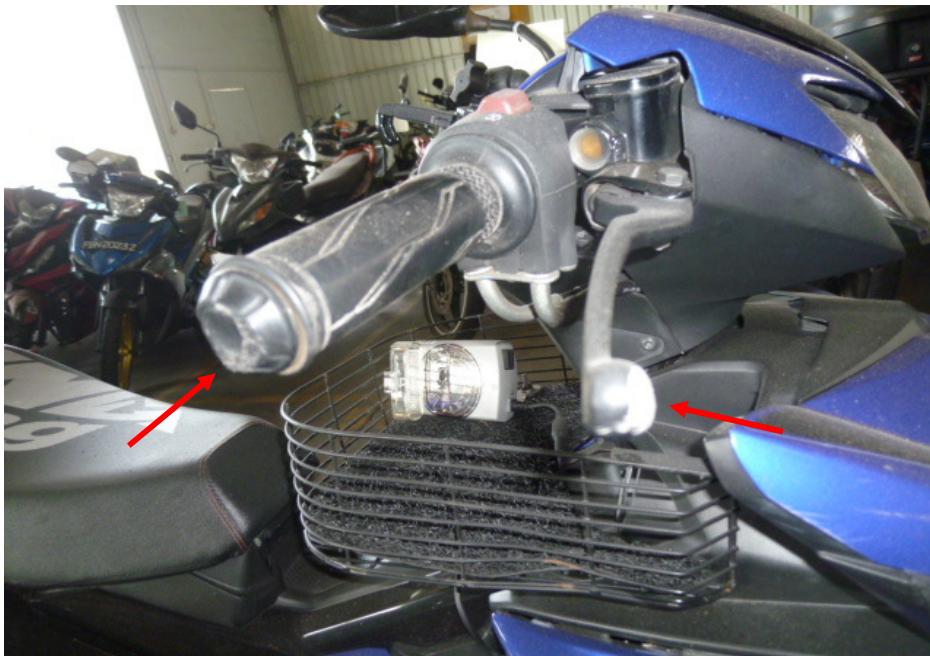
Photo 9 shows the right handlebar end and front brake lever (arrowed), which were amongst the body parts of the Motorcycle that had sustained damage as a result of the accident.

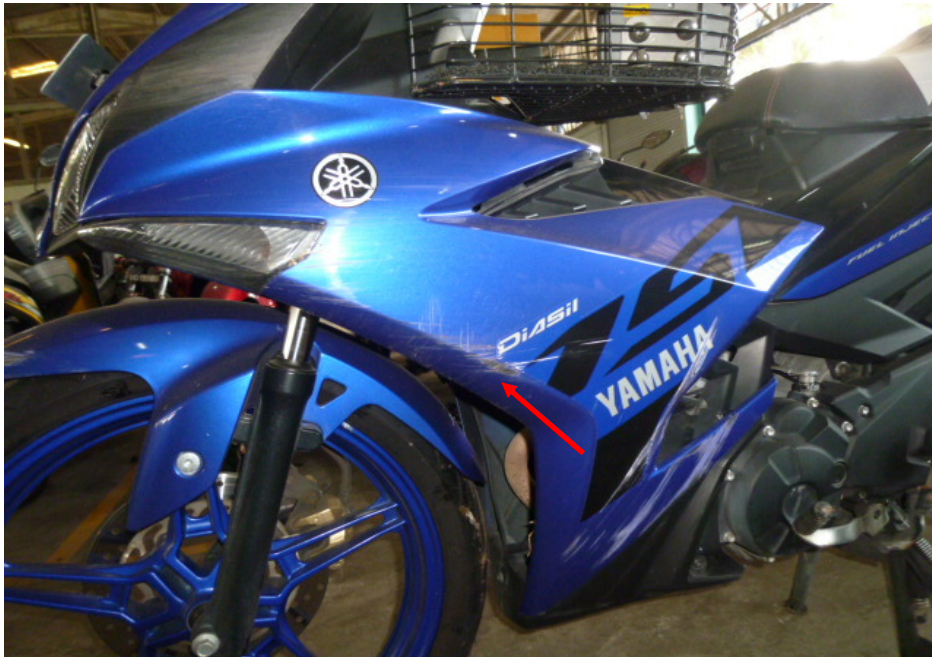
Photo 10 shows a closer view of the grazed left cowling of the Motorcycle as a result of the accident (arrowed).

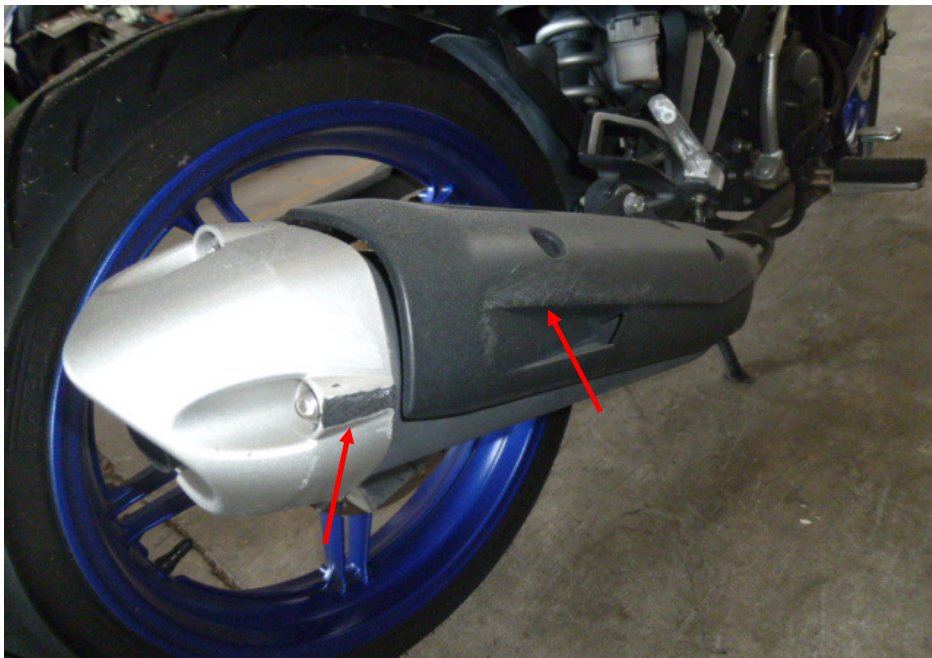
Photo 11 shows a closer view of the exhaust muffler heat shield which was amongst the body parts of the Motorcycle that had sustained damages of grazing nature as a result of the accident (arrowed).

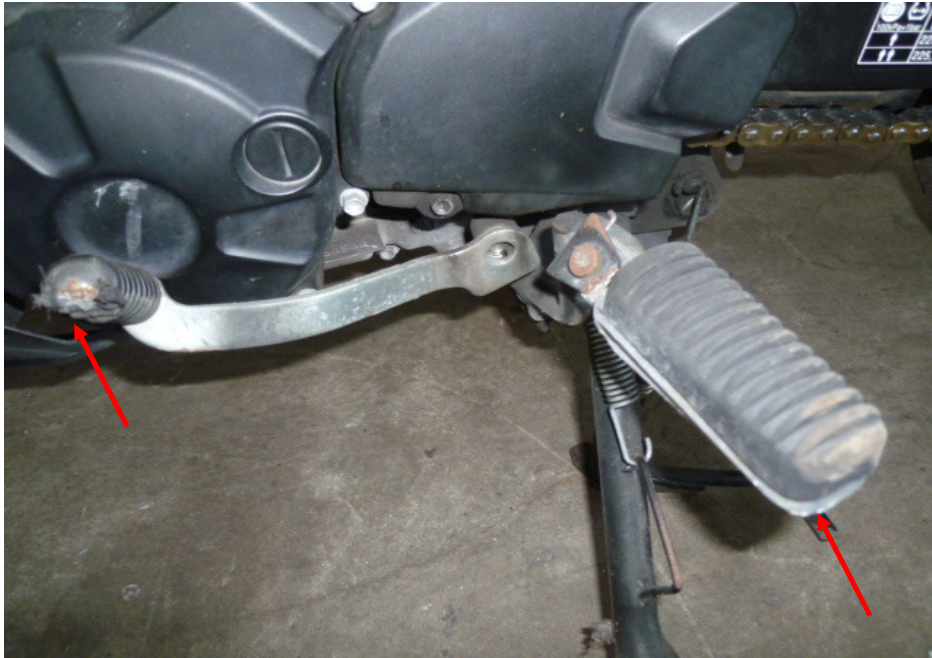
Photo 12 shows the bent gear shift pedal and left front footrest of the Motorcycle as a result of the accident (arrowed).

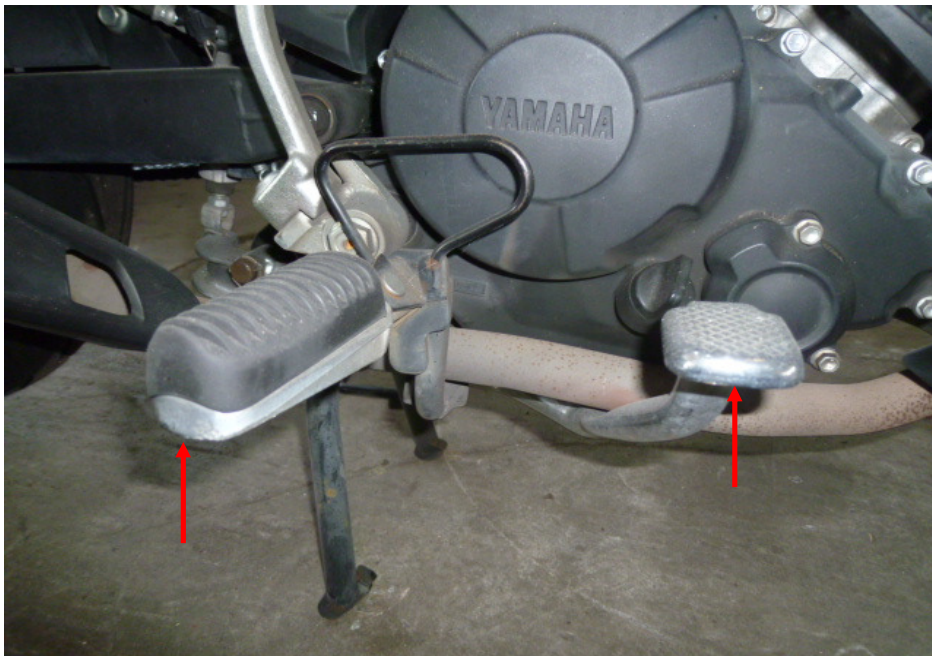
Photo 13 shows the rear brake pedal and right front footrest of the Motorcycle that had sustained damage as a result of the accident (arrowed).

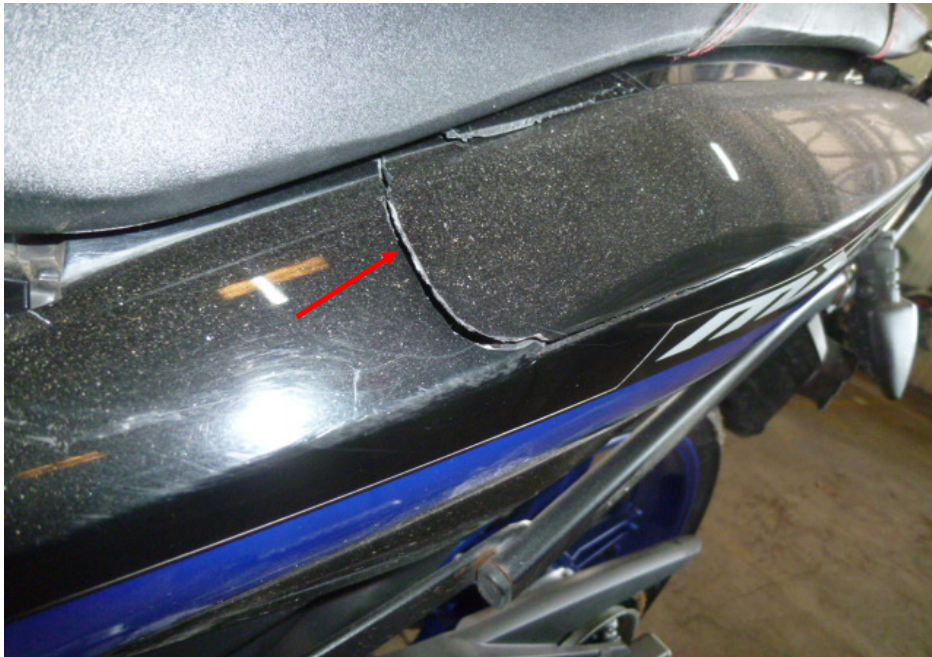
Photo 14 shows a closer view of the cracked left rear side cover of the Motorcycle as a result of the accident (arrowed).

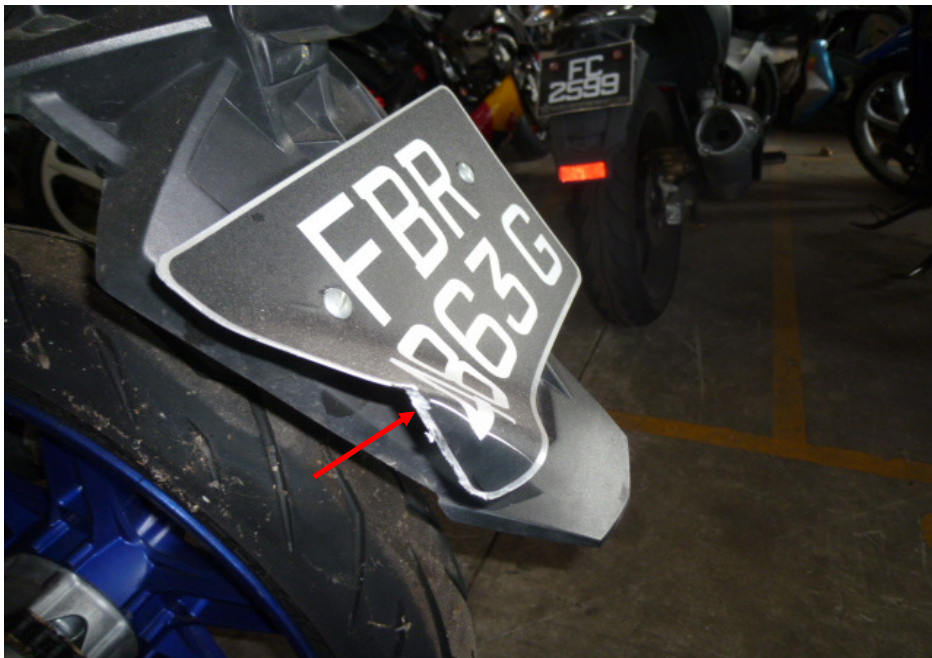
Photo 15 shows a closer view of the dented rear number plate of the Motorcycle as a result of the accident (arrowed).

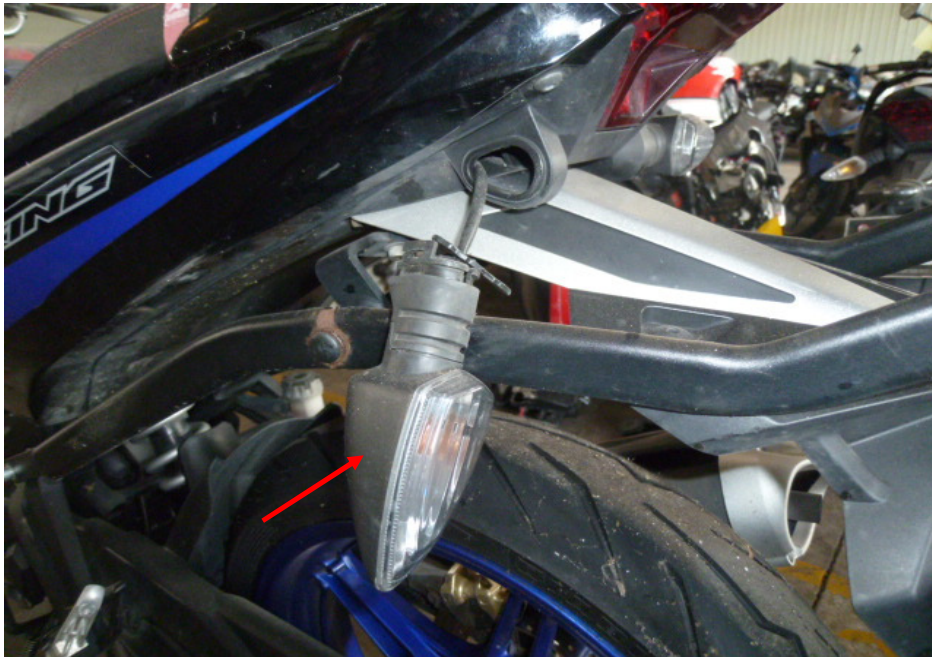
Photo 16 shows a closer view of the broken left signal lamp of the Motorcycle as a result of the accident (arrowed).

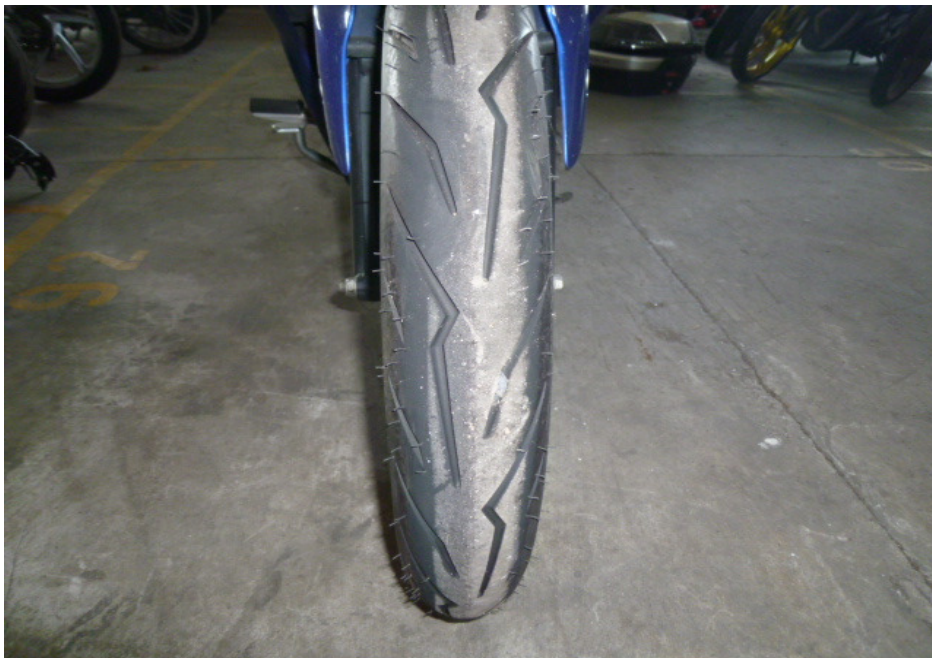
Photo 17 shows the front tyre of the Motorcycle at the time of our inspection. The front tyre was observed to be in serviceable condition with remaining tread depth of approximately 4mm. The pattern of the tread was also clearly visible. There was no tear, burst mark(s) and/or punctured hole(s) on the sidewalls as well as across the tread of the front tyre.

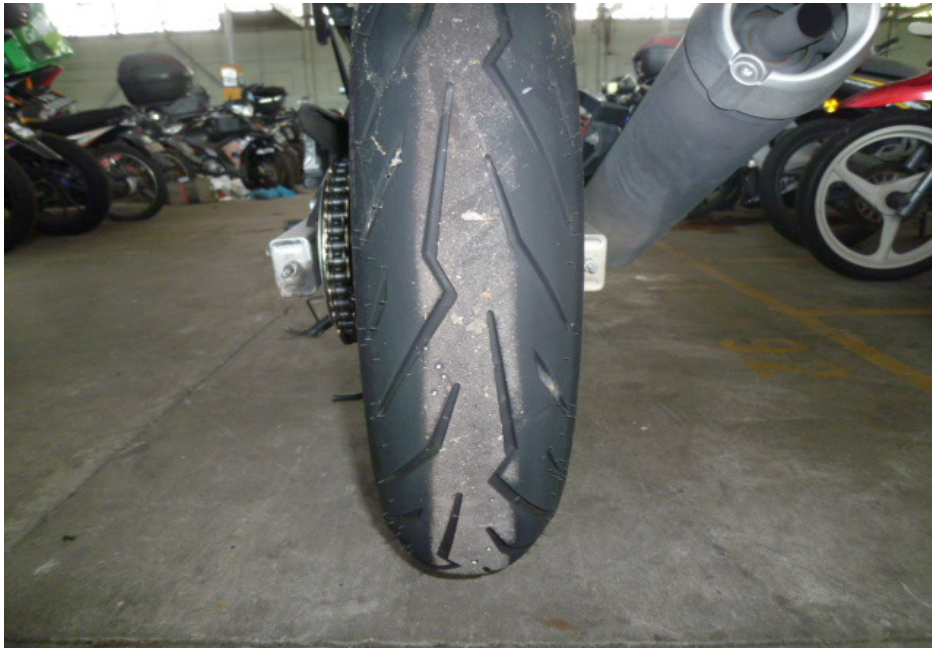
Photo 18 shows the condition of the Motorcycle's rear tyre. The rear tyre was observed to be in serviceable condition with remaining tread depth of approximately 5mm. The tyre was also observed to be sufficiently inflated for vehicular operation. We did not observe any tear, burst mark(s) and/or punctured hole(s) on the sidewalls as well as across the tread of the rear tyre.

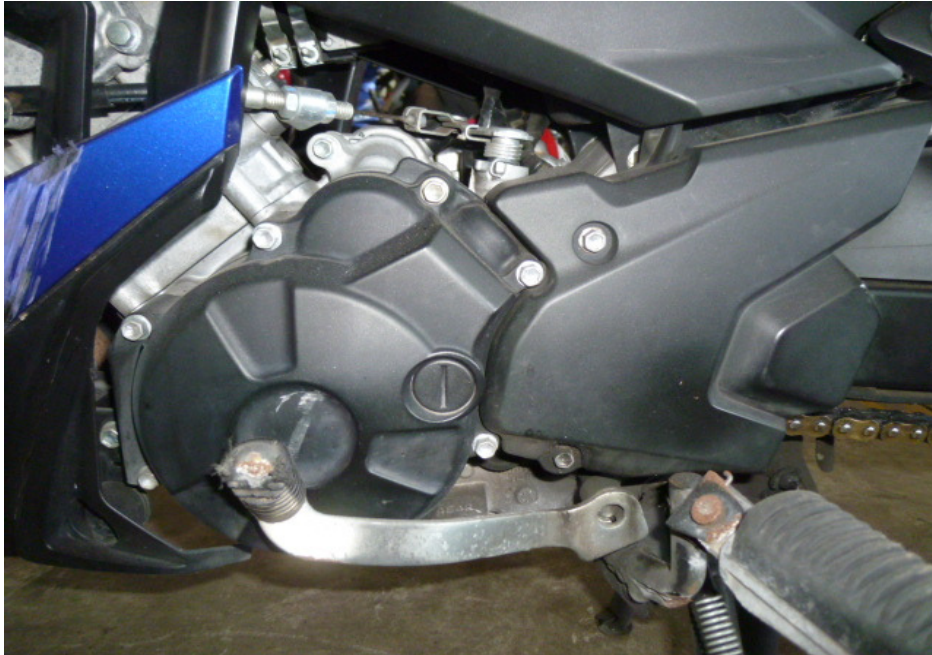
Photo 19 shows the left side of the engine of the Motorcycle at the time of our inspection. The various engine related parts and components were found to be intact with no visible damage. There was also no sign(s) or indication(s) of fluid leak observed around the left engine area of the Motorcycle.

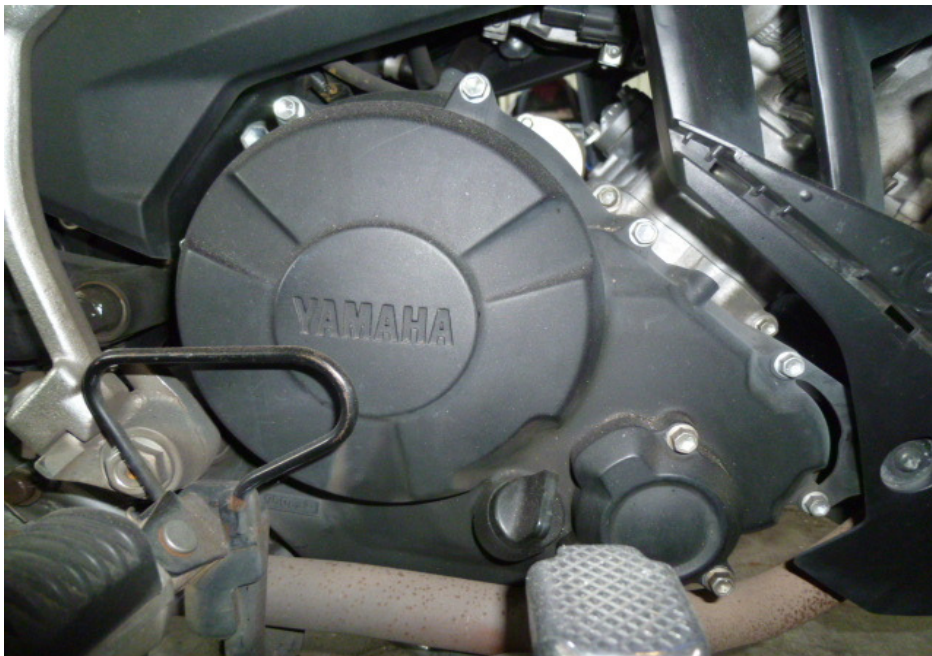
Photo 20 shows the right side of the engine of the Motorcycle at the time of our inspection. The various engine related parts and components were found to be intact with no visible damage. There was also no sign(s) or indication(s) of fluid leak observed around the right engine area of the Motorcycle.

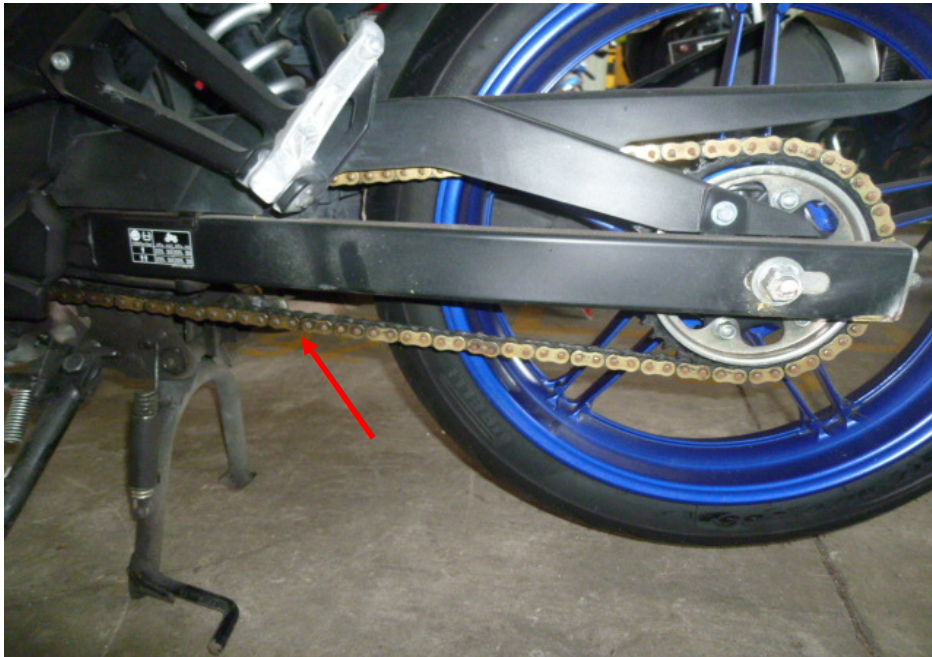
Photo 21 shows the general view of the gear train (arrowed) of the Motorcycle, which was observed to be intact with no misalignment. It was also adequately lubricated for operating purposes.

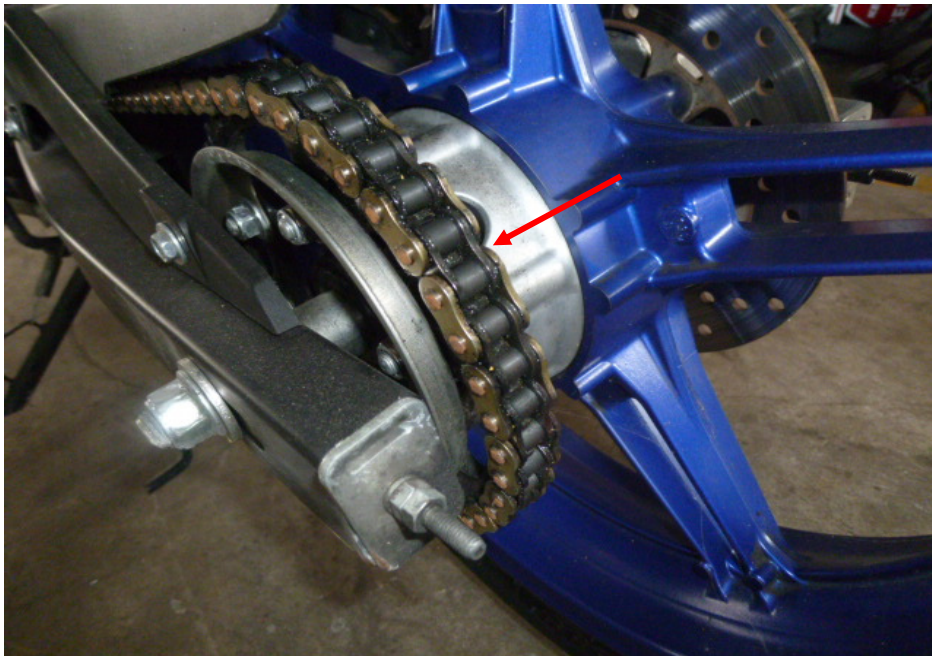
Photo 22 shows a closer view of the gear train (arrowed) of the Motorcycle, which was observed to be intact with no misalignment. It was also adequately lubricated for operating purposes.

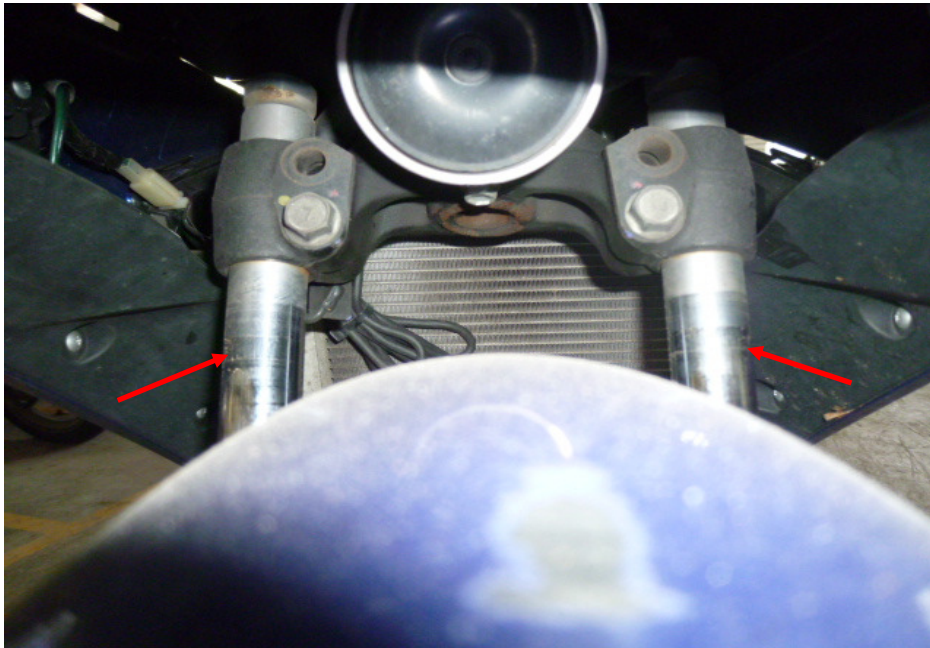
Photo 23 shows the front forks (arrowed) of the Motorcycle. The front forks and fork bracket of the Motorcycle were both found to be intact and undamaged. Turning the Motorcycle's handle bar towards the left and right did not produce any abnormal free play. The steering system of the Motorcycle was in serviceable condition at the time of our inspection.

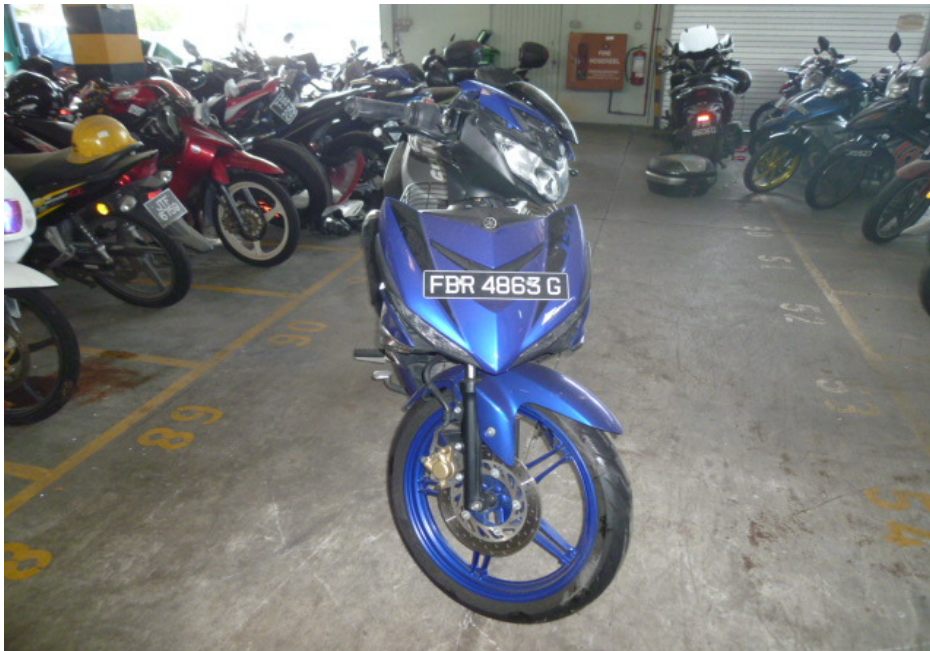
Photo 24 shows the front wheel of the Motorcycle turned towards its full left. Turning the Motorcycle's handle bar towards the left did not produce any abnormal free play and/or resistance. This would indicate that the steering system of the Motorcycle was in serviceable condition at the time of our inspection.

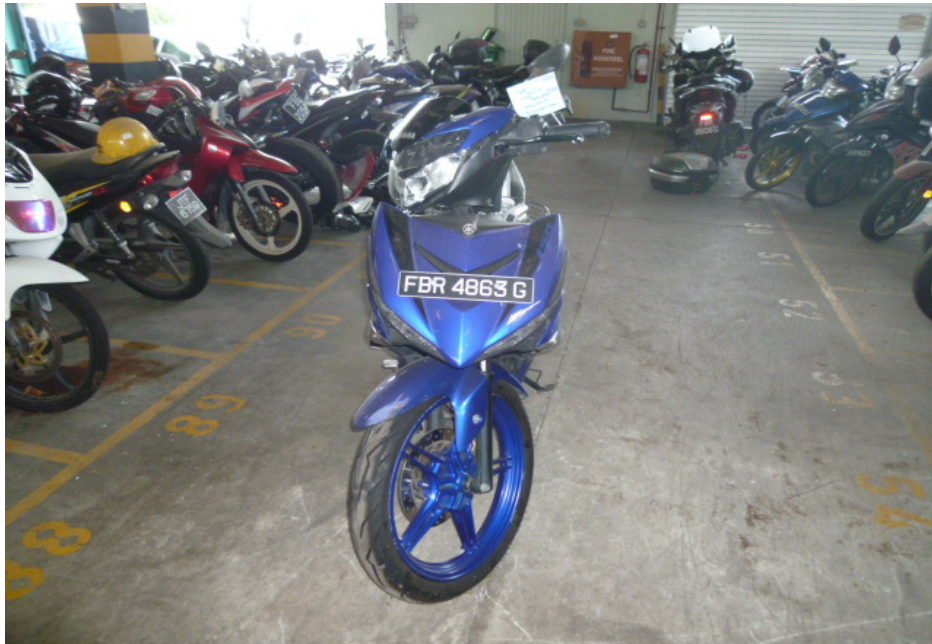
Photo 25 shows the front wheel of the Motorcycle turned towards its full right. Turning the Motorcycle's handle bar towards the right did not produce any abnormal free play and/or resistance. This would indicate that the steering system of the Motorcycle was in serviceable condition at the time of our inspection.

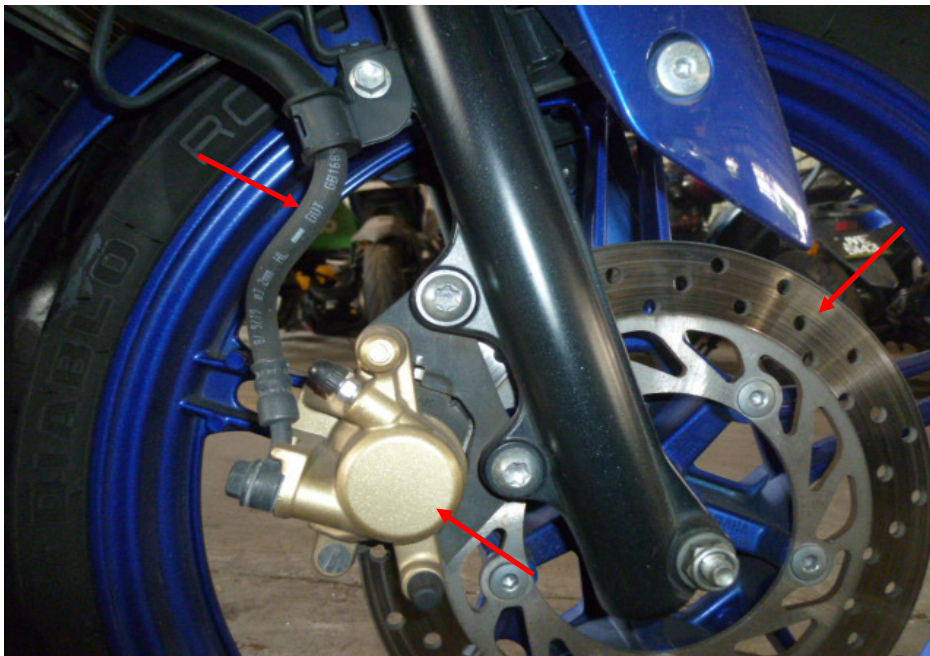
Photo 26 shows a close up view of the front brake caliper, front brake disc and front brake hose (arrowed) of the Motorcycle, which are all part of the components in the hydraulic front brake system of the Motorcycle. Our visual checks of these various components had revealed all to be intact with no visible damage. No leakage of brake fluid was also observed.

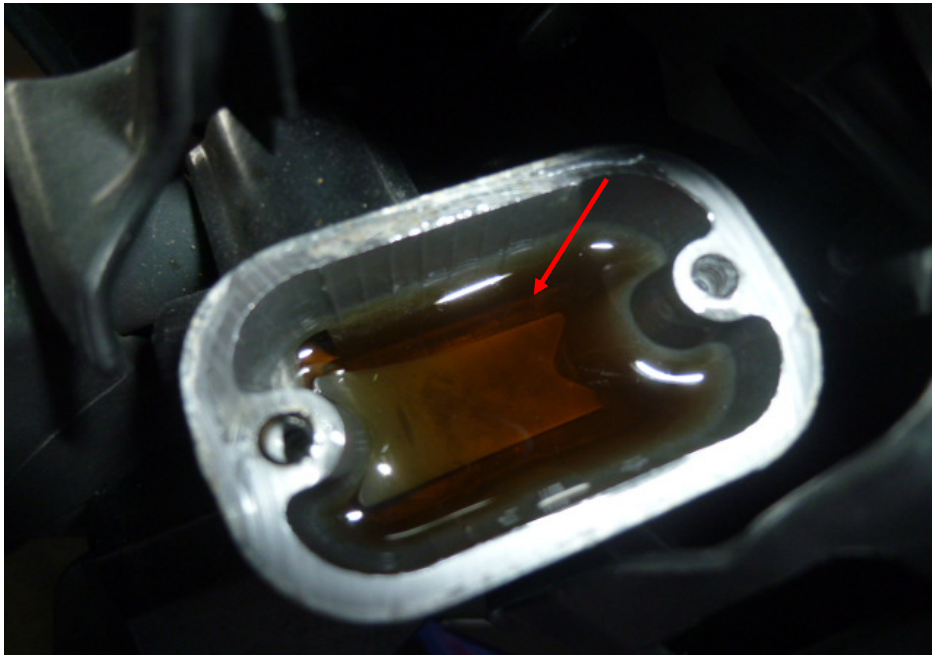
Photo 27 shows the brake fluid reservoir for the front brake of the Motorcycle. The brake fluid was observed to be of sufficient level for operating purposes. However it was found to be slightly contaminated (arrowed).

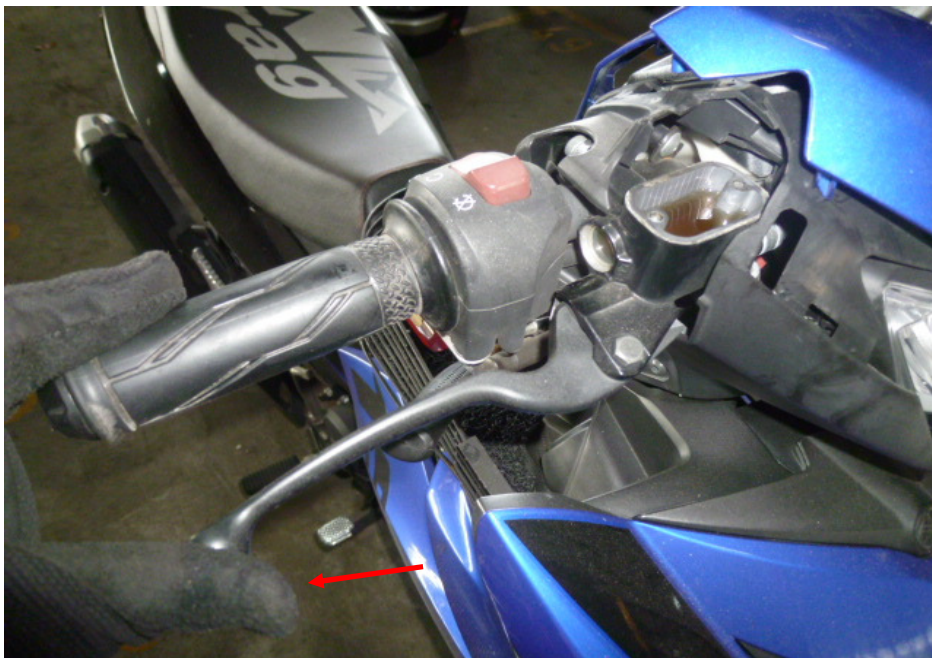
Photo 28 shows the front brake lever being depressed. There was some resistance felt (spongy like feel) upon pressing the front brake lever (arrowed). This would indicate that there is no leakage of pressure/vacuum in the brake system.

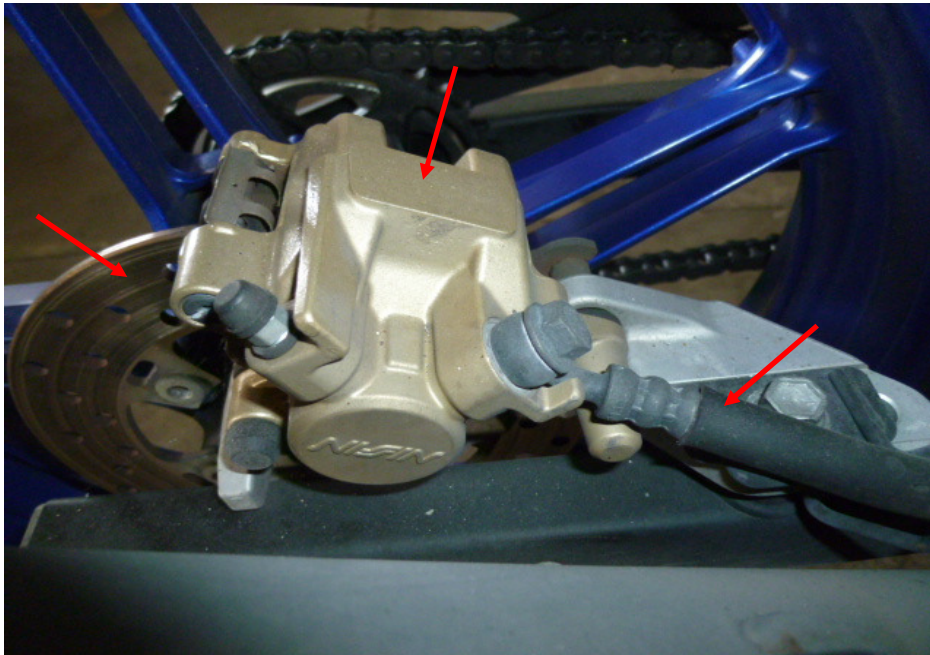
Photo 29 shows a close up view of the rear brake caliper, rear brake disc and rear brake hose (arrowed) of the Motorcycle, which are all part of the components in the hydraulic rear brake system of the Motorcycle. Our visual checks of these various components had revealed all to be intact with no visible damage. No leakage of brake fluid was also observed.

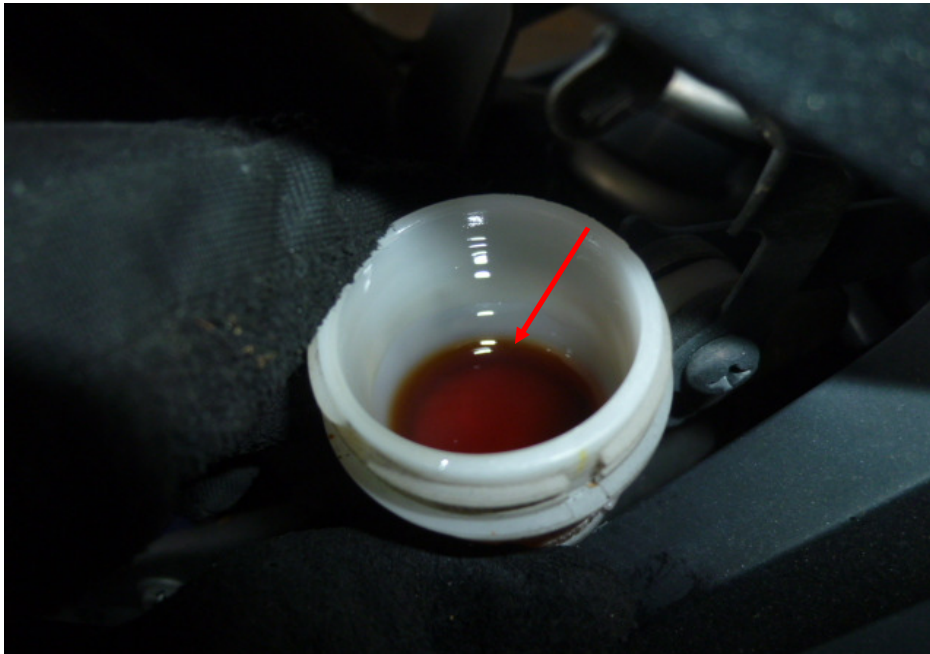
Photo 30 shows the brake fluid reservoir for the rear brake of the Motorcycle. The brake fluid was observed to be of sufficient level for operating purposes. However it was found to be slightly contaminated (arrowed).
