Your Ref: TP/IP/06752/2021
Our Ref : CI/TPD22005246/N

15 July 2022

INSPECTION REPORT OF MOTORCYCLE JNS 4103

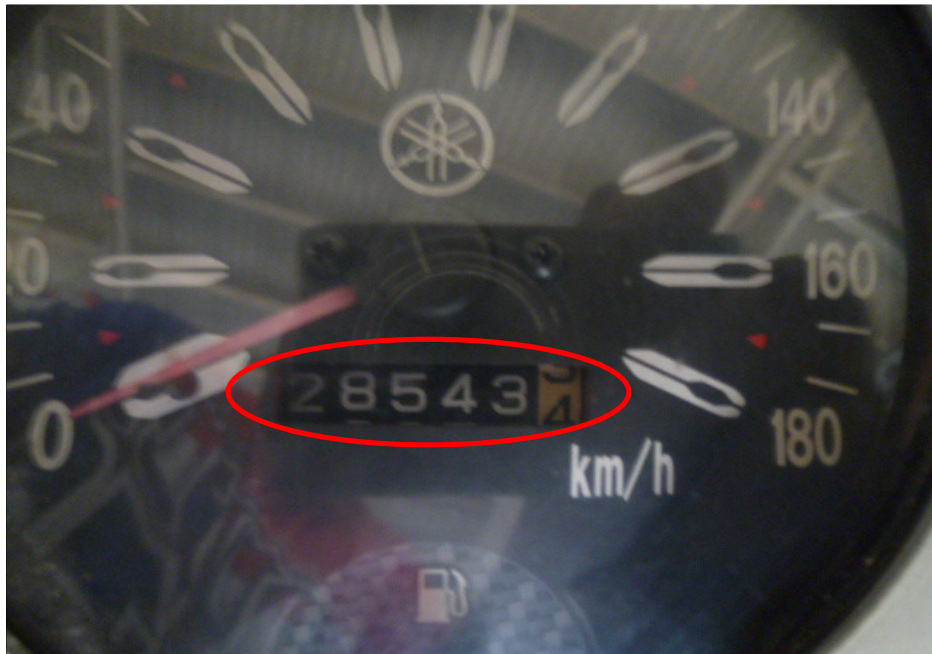
Photo 1 shows the speedometer gauge of the Motorcycle. The mileage of the Motorcycle at the time of our inspection was 28, 543km (circled).

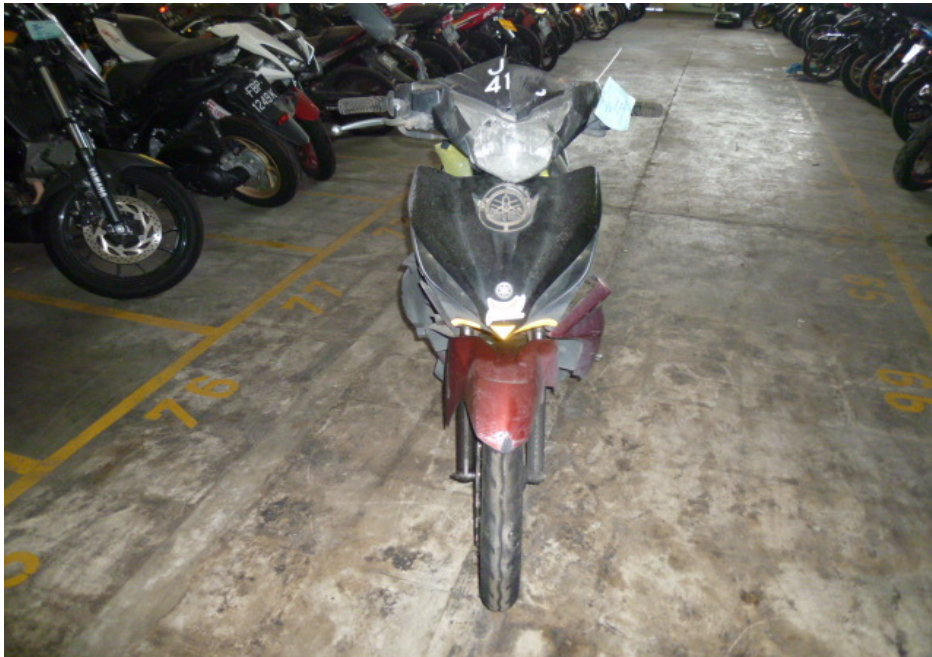
Photo 2 shows a general view of the frontal portion of the Motorcycle at the time of our inspection. The Motorcycle was observed to have sustained damages all around.

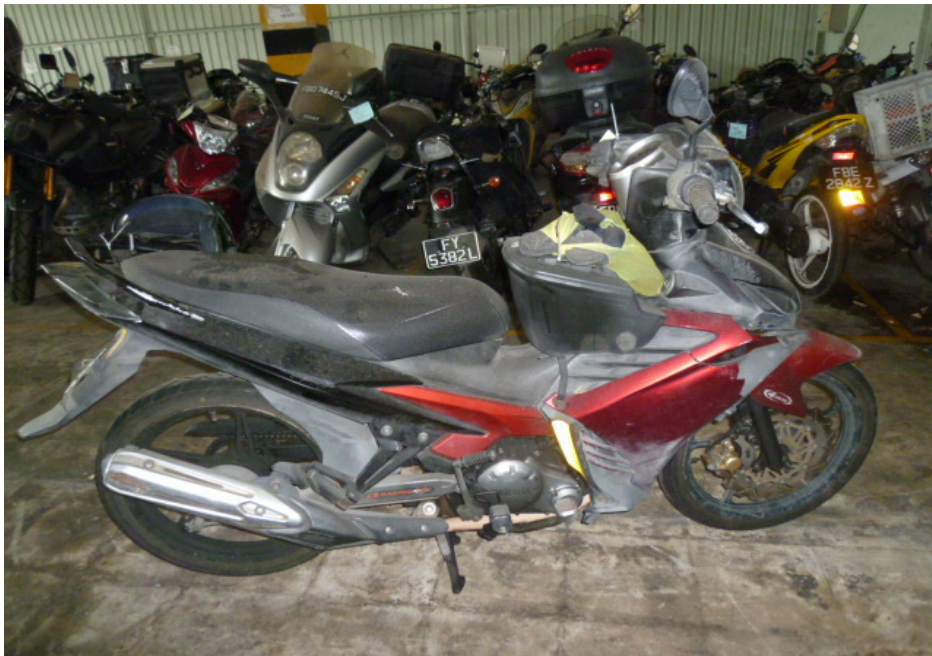
4. The mileage of the Motorcycle at the time of our inspection was 28, 543km.
5. The Motorcycle was observed to have sustained damages all around. The body parts that were found to have been damaged include it head cowl, front mudguard, rear brake pedal, side cowlings, side mirrors, rear side covers, right front footrest and exhaust muffler heat shield, amongst others.

Photo 3 shows a general view of the right body of the Motorcycle at the time of our inspection. The Motorcycle was observed to have sustained damages all around. Amongst the body parts that were found to have been damaged include its head cowl, front mudguard, rear brake pedal, side cowlings, side mirrors, rear side covers, right front footrest and exhaust muffler heat shield, amongst others.

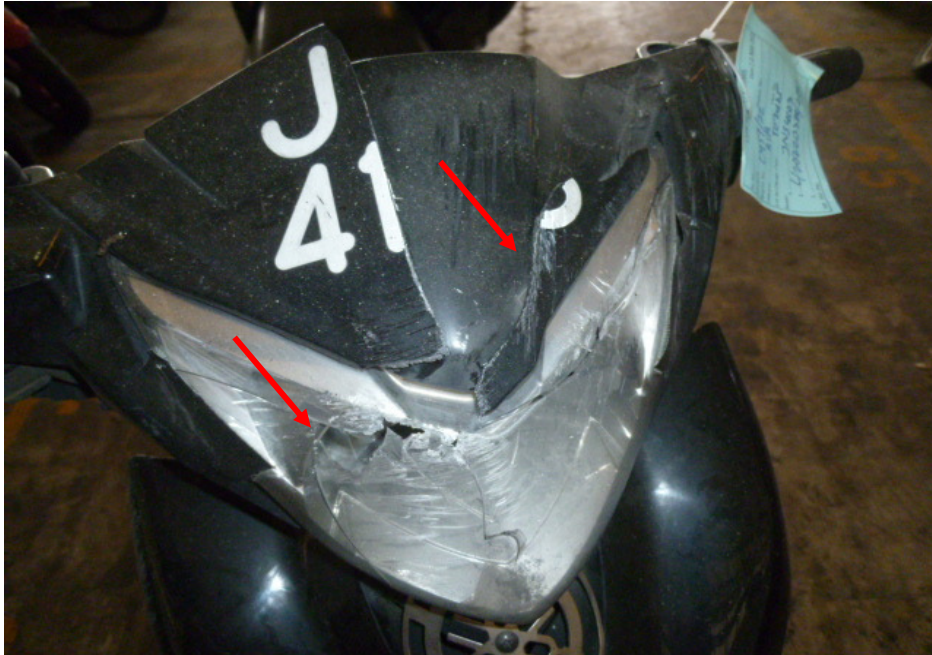
Photo 4 shows a closer view of the cracked head cowling and headlight assembly (arrowed) of the Motorcycle as a result of the accident.

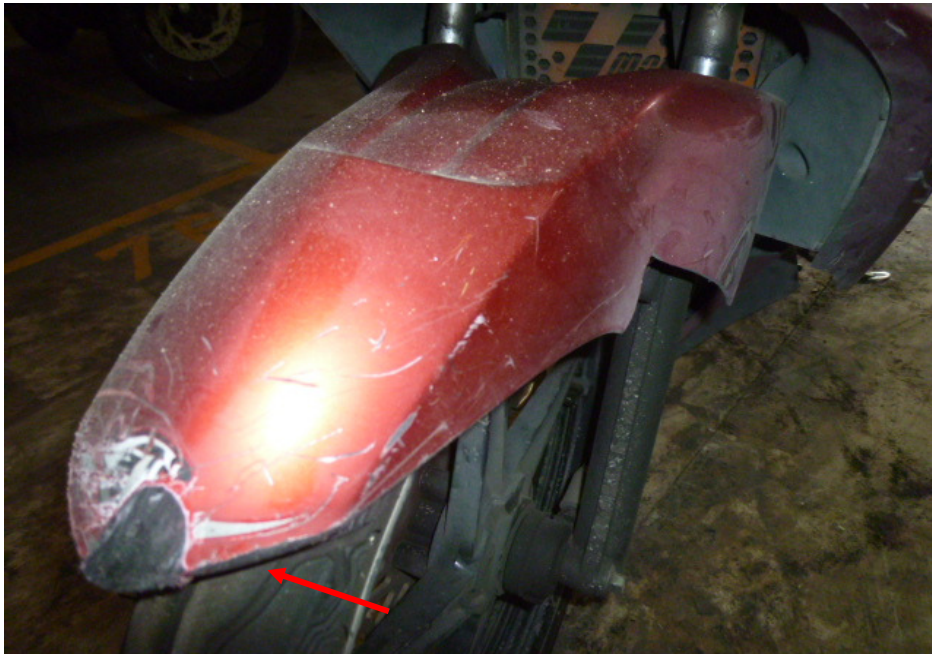
Photo 5 shows a closer view of the grazed front mudguard of the Motorcycle as a result of the accident (arrowed).

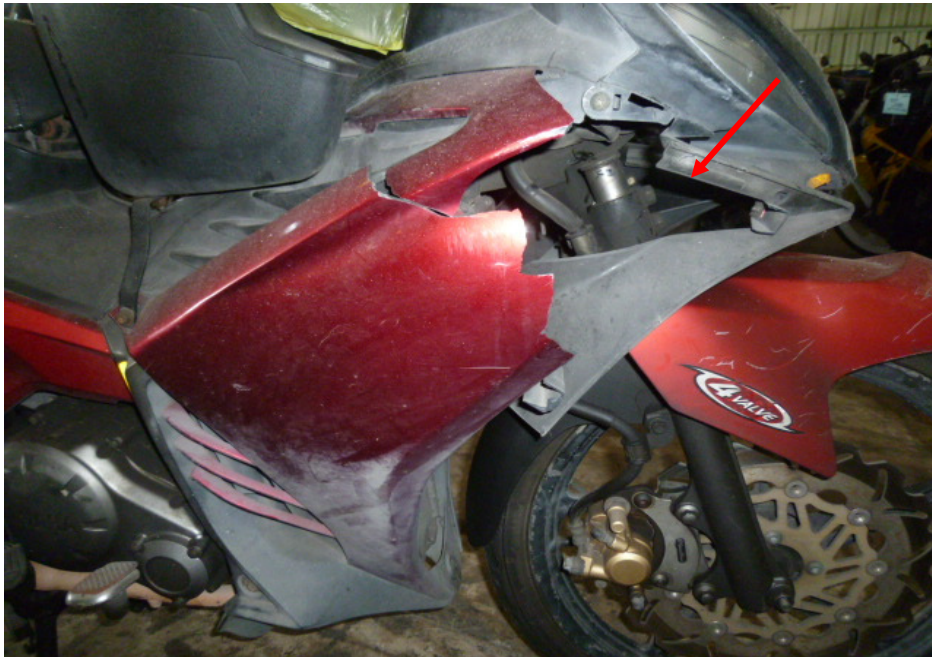
Photo 6 shows a closer view of the right cowling (arrowed) which was amongst the body parts of the Motorcycle that had sustained damage as a result of the accident.

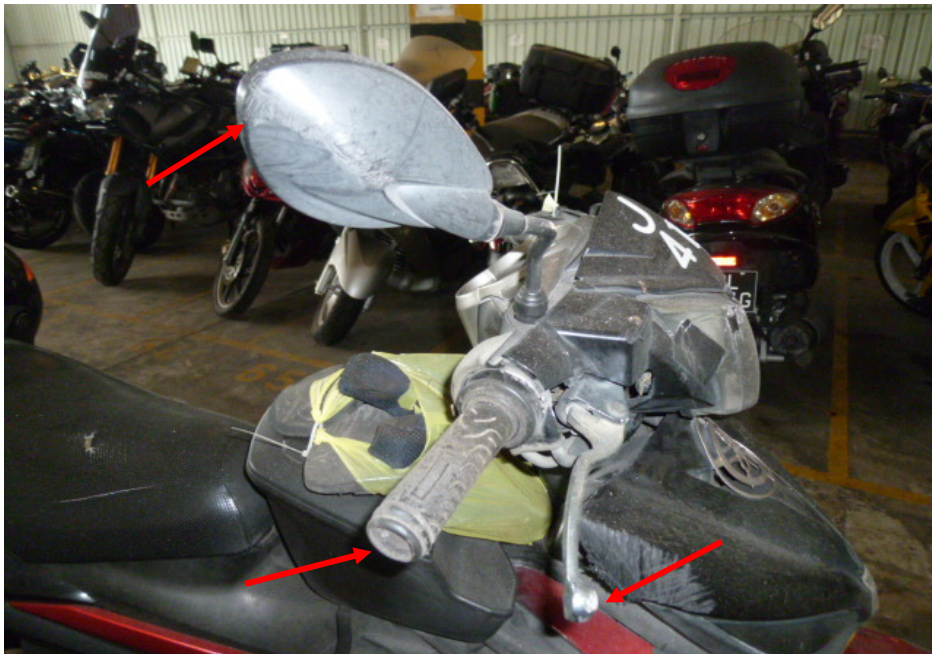
Photo 7 shows the front brake lever, right handlebar end and right side mirror (arrowed), which were amongst the body parts of the Motorcycle that had sustained damage as a result of the accident.

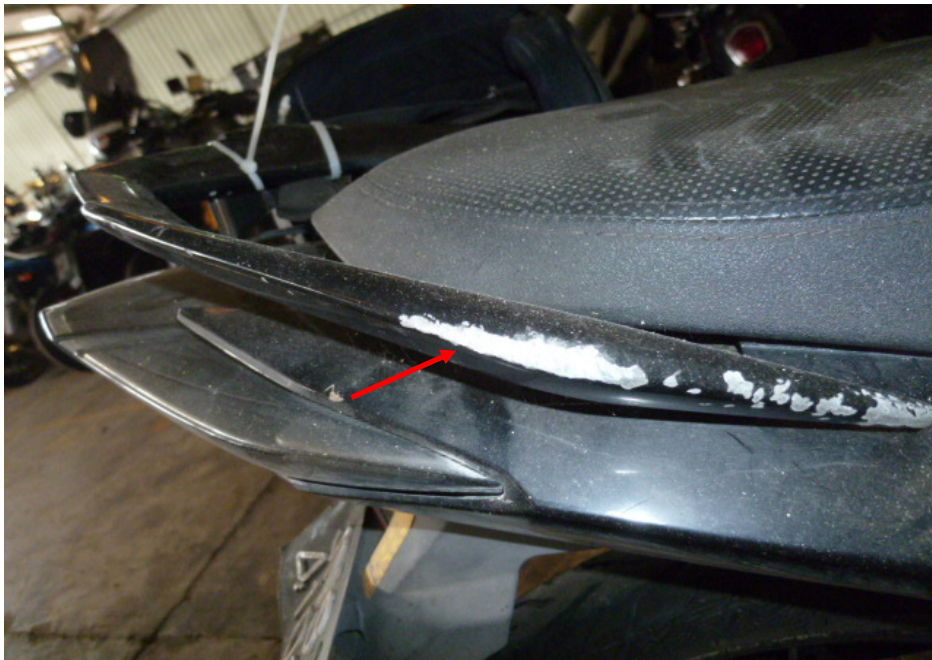
Photo 8 shows a closer view of the grazed right pillion grab rail (arrowed) of the Motorcycle as a result of the accident.

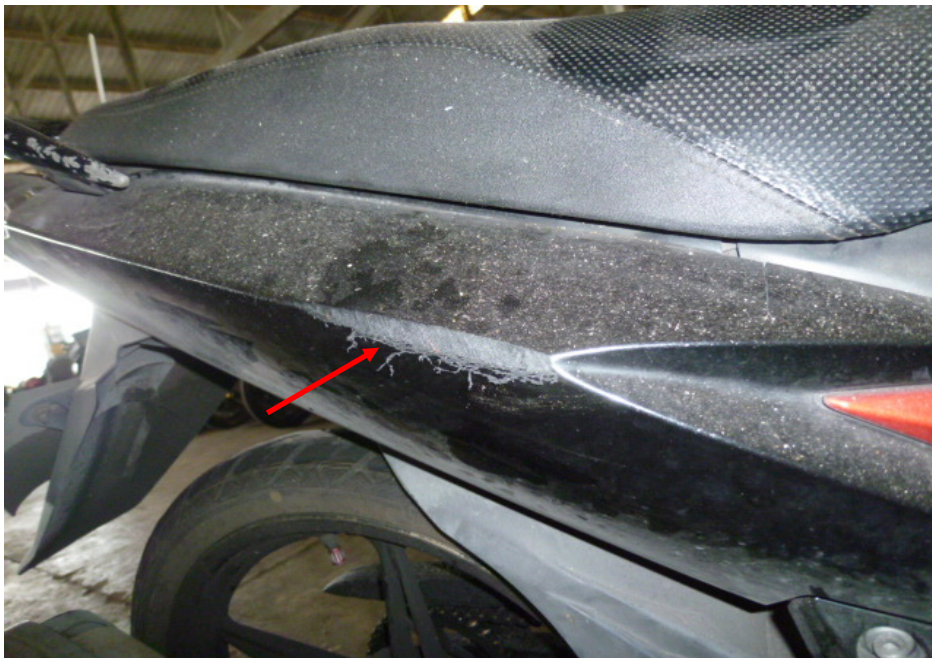
Photo 9 shows a closer view of the grazed right rear side cover (arrowed) of the Motorcycle as a result of the accident.

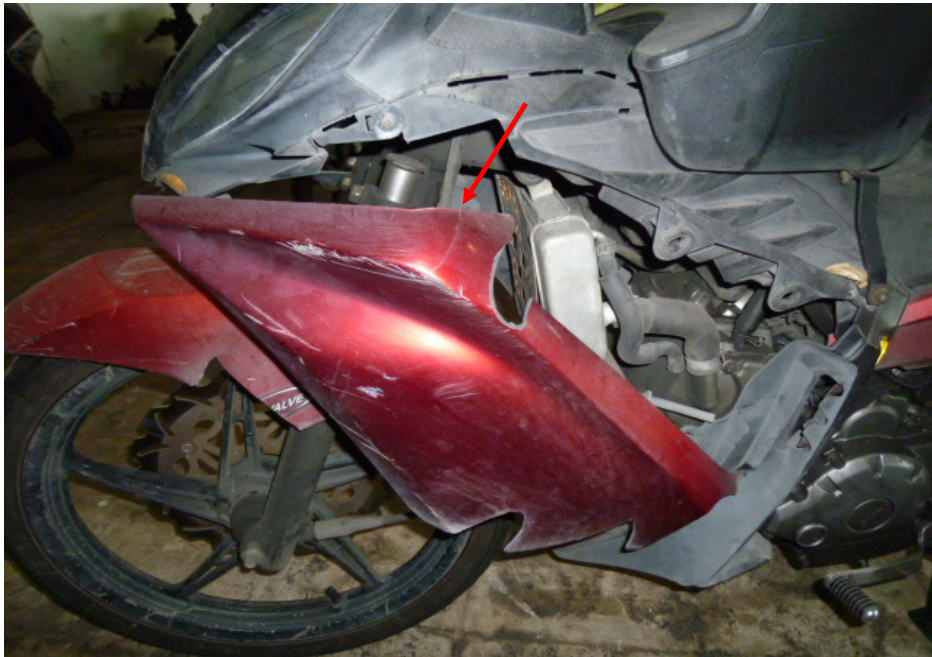
Photo 10 shows a closer view of the deformed left side cowling (arrowed) of the Motorcycle as a result of the accident.

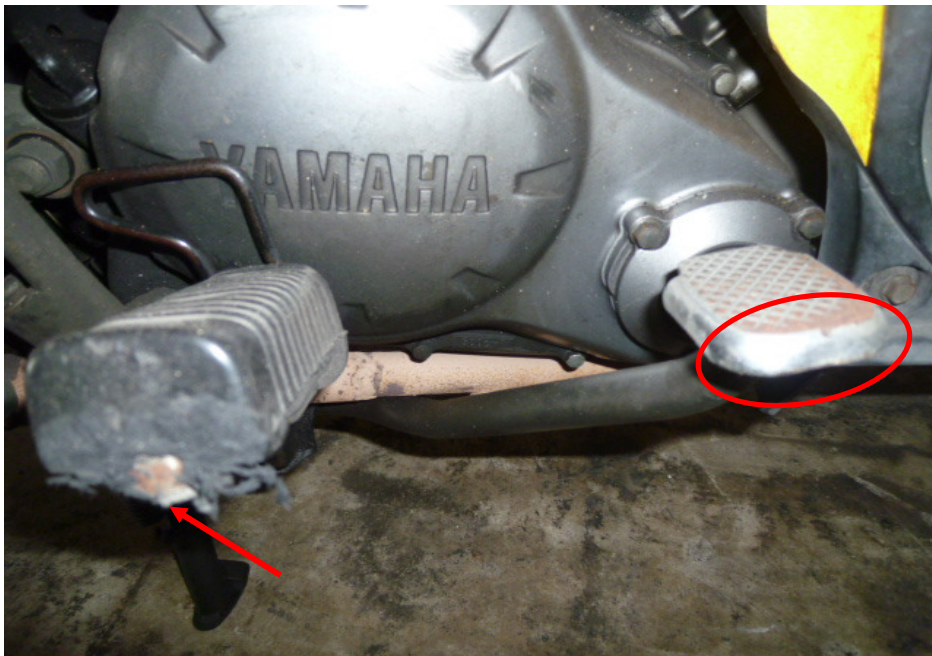
Photo 11 shows a closer view of the grazed rear brake pedal (circled) and right front footrest (arrowed) of the Motorcycle as a result of the accident.

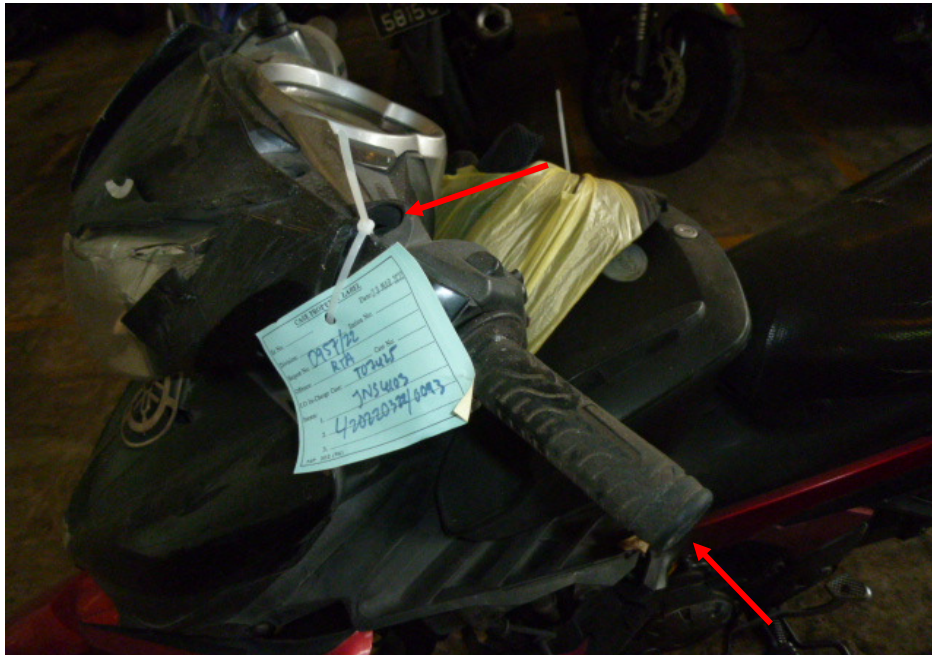
Photo 12 shows the left handlebar end and missing left side mirror (arrowed), which were amongst the body parts of the Motorcycle that had sustained damage as a result of the accident.

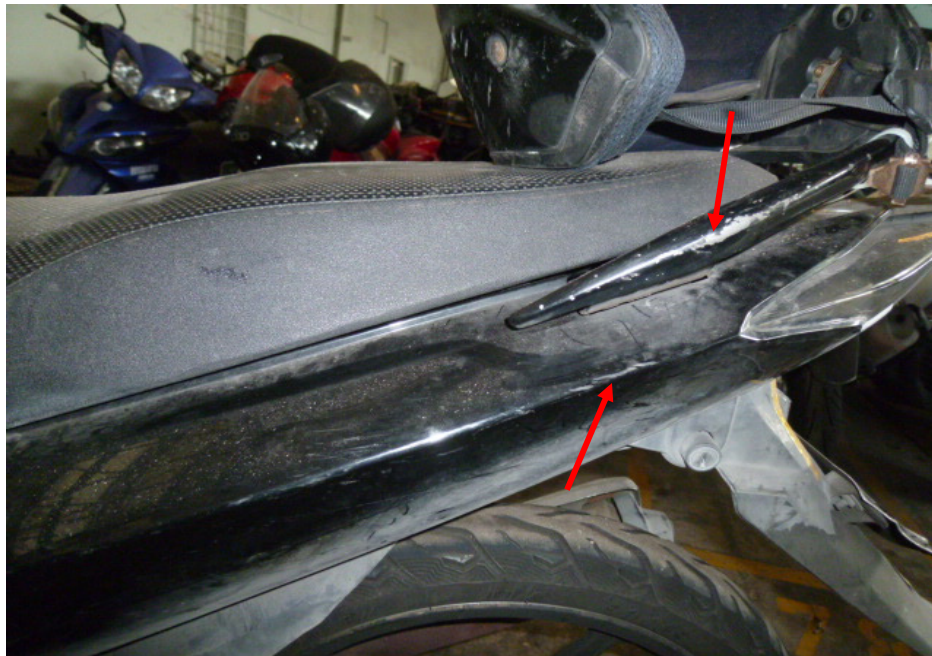
Photo 13 shows the grazed left pillion grab rail and left rear side cover (arrowed) of the Motorcycle as a result of the accident.

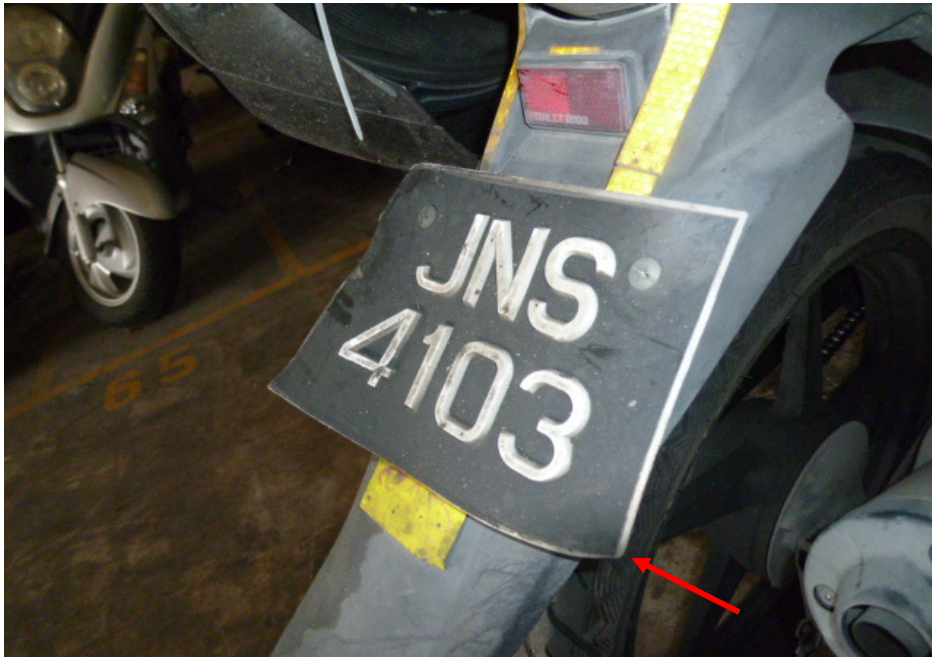
Photo 14 shows the dented rear number plate (arrowed) of the Motorcycle as a result of the accident.

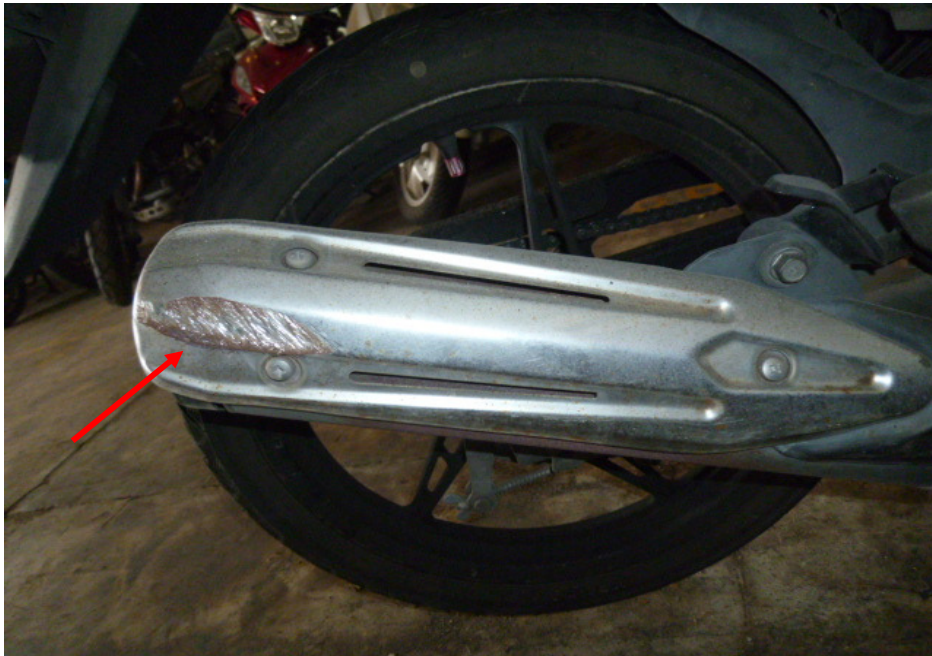
Photo 15 shows a closer view of the exhaust muffler heat shield which was amongst the body parts of the Motorcycle that had sustained damages of grazing nature as a result of the accident (arrowed).

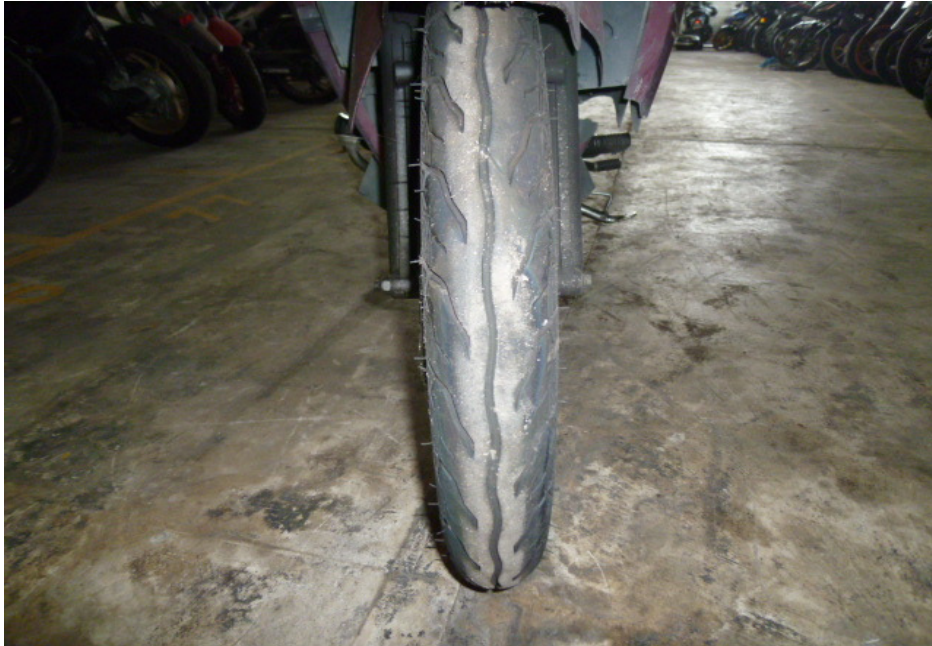
Photo 16 shows the front tyre of the Motorcycle at the time of our inspection. The front tyre was observed to be in serviceable condition with remaining tread depth of approximately 5mm. The pattern of the tread was also clearly visible. There was no tear, burst mark(s) and/or punctured hole(s) on the sidewalls as well as across the tread of the front tyre.

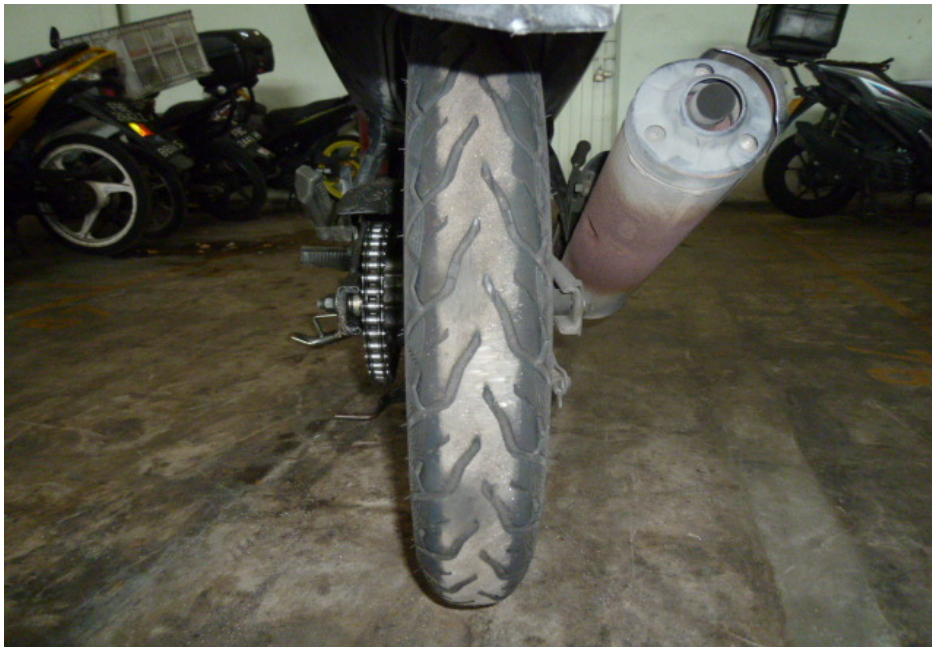
Photo 17 shows the condition of the Motorcycle's rear tyre. The rear tyre was observed to be in serviceable condition with remaining tread depth of approximately 3mm. The tyre was also observed to be sufficiently inflated for vehicular operation. We did not observe any tear, burst mark(s) and/or punctured hole(s) on the sidewalls as well as across the tread of the rear tyre.

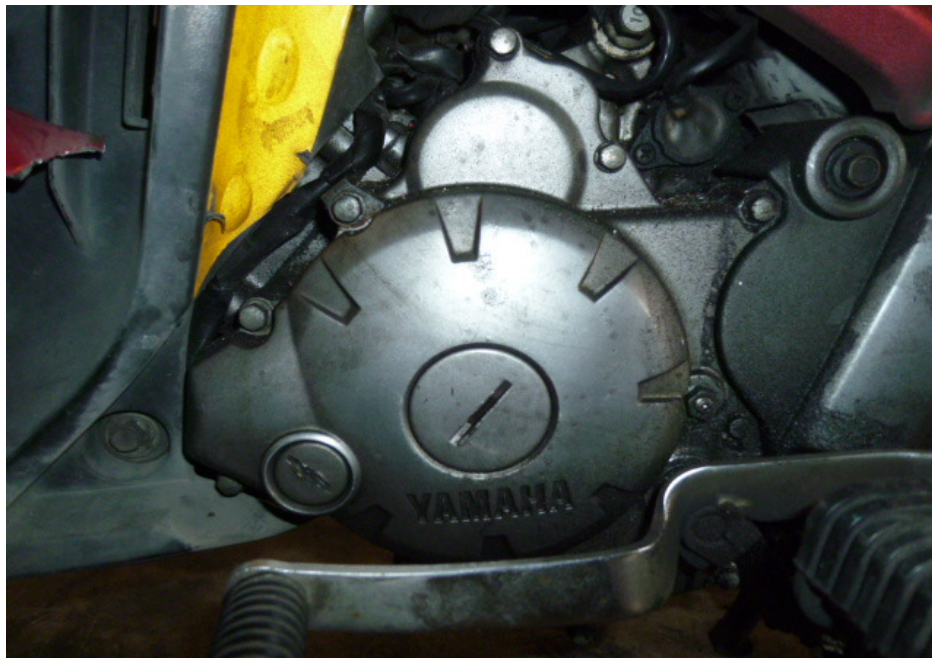
Photo 18 shows the left side of the engine of the Motorcycle at the time of our inspection. The various engine related parts and components were found to be intact with no visible damage. There was also no sign(s) or indication(s) of fluid leak observed around the left engine area of the Motorcycle.

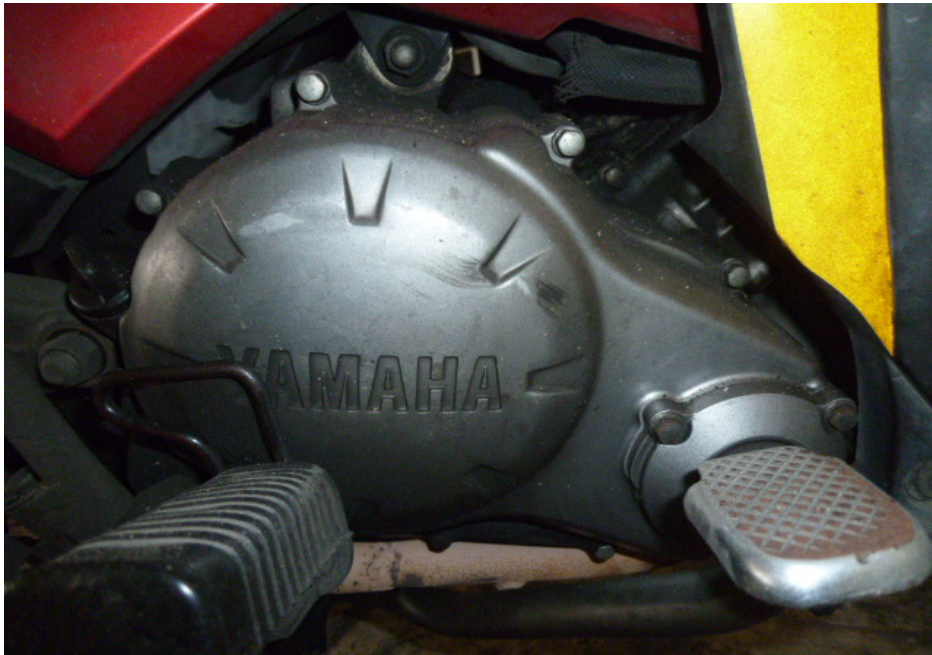
Photo 19 shows the right side of the engine of the Motorcycle at the time of our inspection. The various engine related parts and components were found to be intact with no visible damage. There was also no sign(s) or indication(s) of fluid leak observed around the right engine area of the Motorcycle.

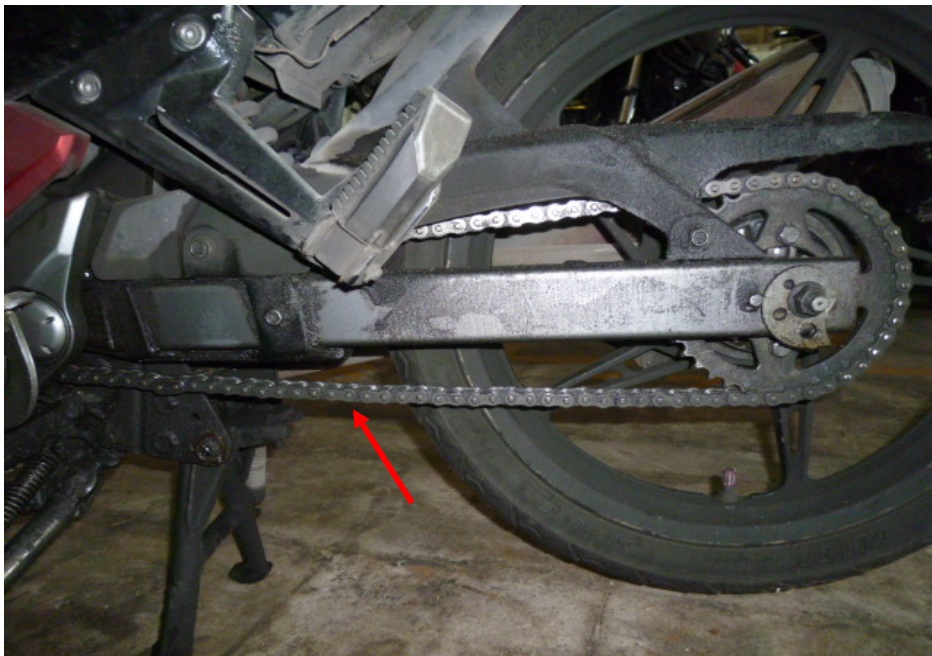
Photo 20 shows the general view of the gear train (arrowed) of the Motorcycle, which was observed to be intact with no misalignment. It was also adequately lubricated for operating purposes.

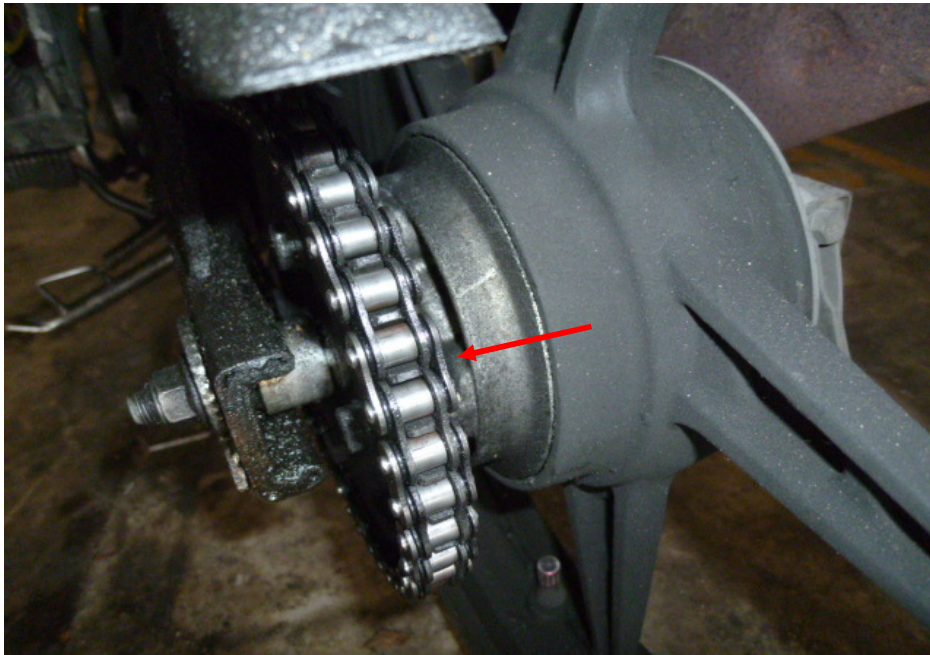
Photo 21 shows a closer view of the gear train (arrowed) of the Motorcycle, which was observed to be intact with no misalignment. It was also adequately lubricated for operating purposes.

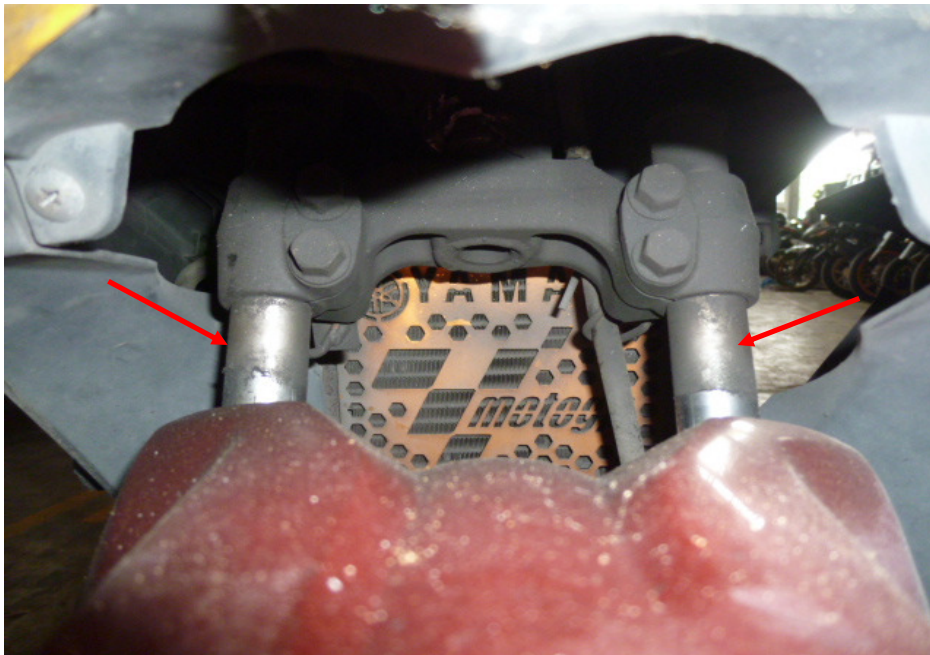
Photo 22 shows the front fork (arrowed) of the Motorcycle. The front fork and fork bracket of the Motorcycle were both found to be intact and undamaged. Turning the Motorcycle's handle bar towards the left and right did not produce any abnormal free play and/or resistance. The steering system of the Motorcycle was in serviceable condition at the time of our inspection.

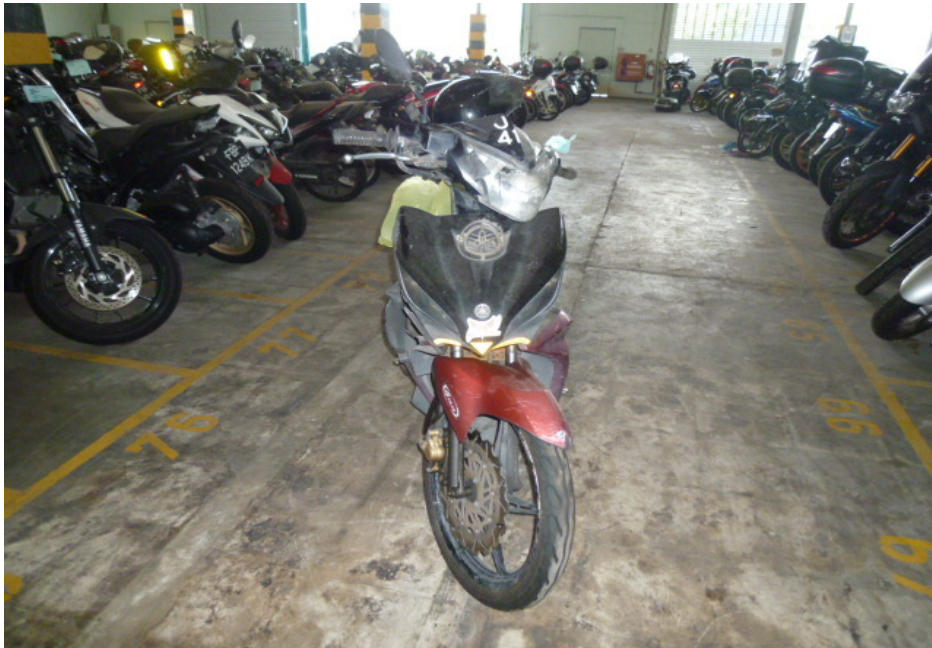
Photo 23 shows the front wheel of the Motorcycle turned towards its full left. Turning the Motorcycle's handle bar towards the left and right did not produce any abnormal free play and/or resistance. This would indicate that the steering system of the Motorcycle was in serviceable condition at the time of our inspection.

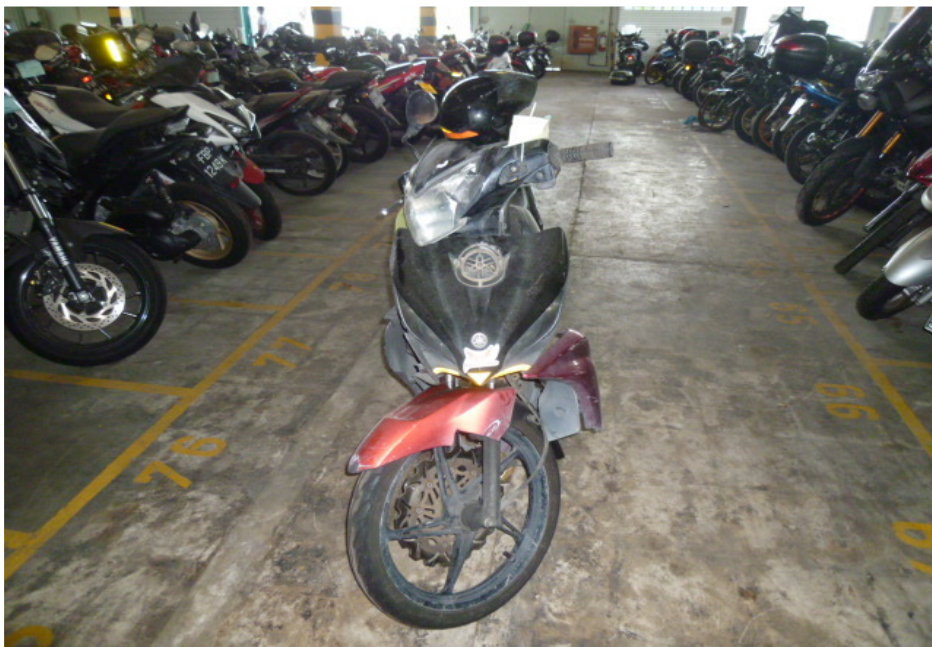
Photo 24 shows the front wheel of the Motorcycle turned towards its full right. Turning the Motorcycle's handle bar towards the left and right did not produce any abnormal free play and/or resistance. This would indicate that the steering system of the Motorcycle was in serviceable condition at the time of our inspection.

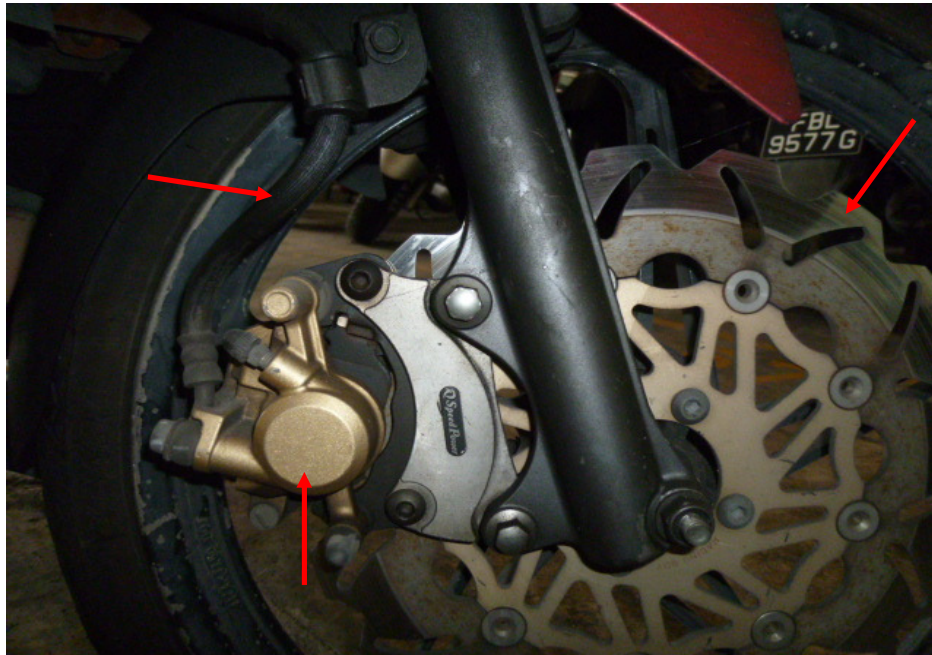
Photo 25 shows a close up view of the front brake caliper, front brake disc and front brake hose (arrowed) of the Motorcycle, which are all part of the components in the hydraulic front brake system of the Motorcycle. Our visual checks of these various components had revealed all to be intact with no visible damage. No leakage of brake fluid was also observed.

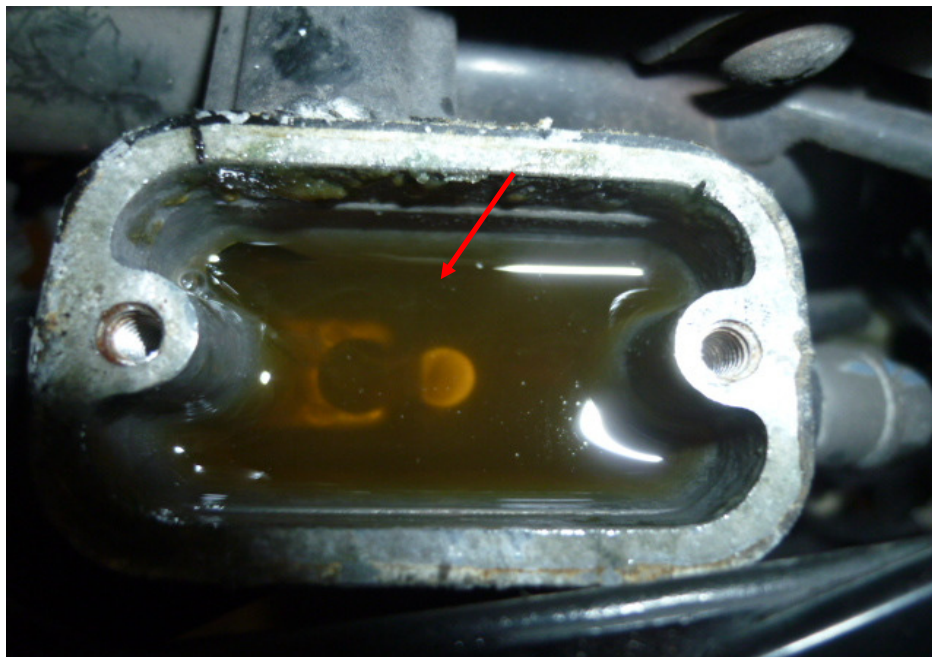
12. The brake system of the Motorcycle was of a semi-hydraulic type, where hydraulic (brake fluid) pressure controls the brake for the front wheel while the brake for the rear wheel is controlled by mechanical means (cables and springs). Our visual examination of the various components in the brake system, like the brake disc, brake caliper, drum, brake lever and brake foot pedal, revealed all to be intact and without damage. There was also no leakage of brake fluid observed along the front brake hose. This was from the respective front brake fluid reservoir to the front brake caliper of the Motorcycle. The brake fluid for the front brake was found to be of sufficient level for operating purposes. However the brake fluid was found to be slightly contaminated. There was also no visible tear or cut observed on the connecting hoses and cables.

Photo 26 shows the brake fluid reservoir for the front brake of the Motorcycle. The brake fluid was found to be of sufficient level for operating purposes. However the brake fluid was found to be slightly contaminated (arrowed).

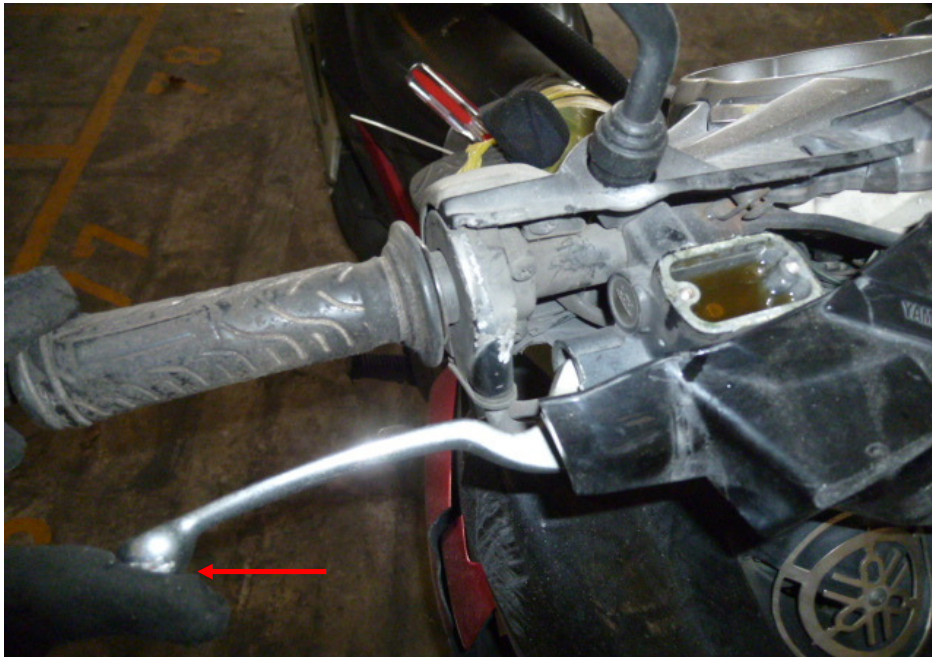
13. Static brake tests conducted on the Motorcycle had appeared to indicate that the front brake system of the Motorcycle was in serviceable condition. There was some resistance felt (spongy like feel) upon pressing the front brake lever. This would indicate that there's no leakage of pressure/vacuum in the front brake system.

Photo 27 shows the front brake lever being depressed. There was some resistance felt (spongy like feel) upon pressing the front brake lever (arrowed). This would indicate that there is no leakage of pressure/vacuum in the brake system.

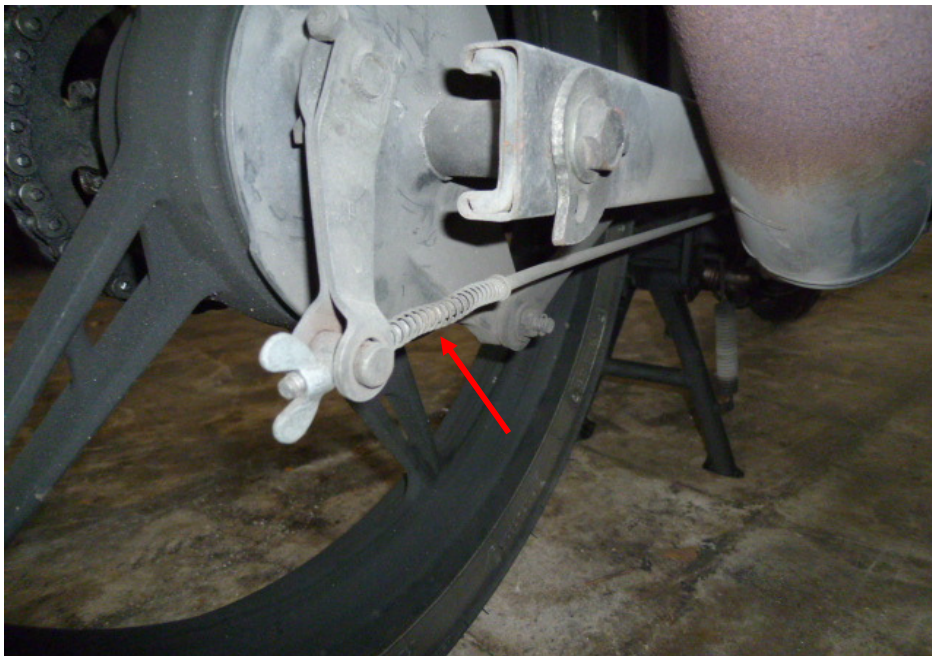
Photo 28 shows the rear wheel of the Motorcycle. The type of brake system for the rear wheel was of a mechanical type, controlled by the brake foot pedal of the Motorcycle. Our checks of the cable (arrowed), spring and drum which are all part of the components in the rear brake system of the Motorcycle reveal all to be intact and without damage.
