Your Ref: TP/IP/04897/2022
Our Ref : CI/TPD22005247/N

Fatal Accident Investigation Team

INSPECTION REPORT OF MOTORCYCLE FBB 9553C

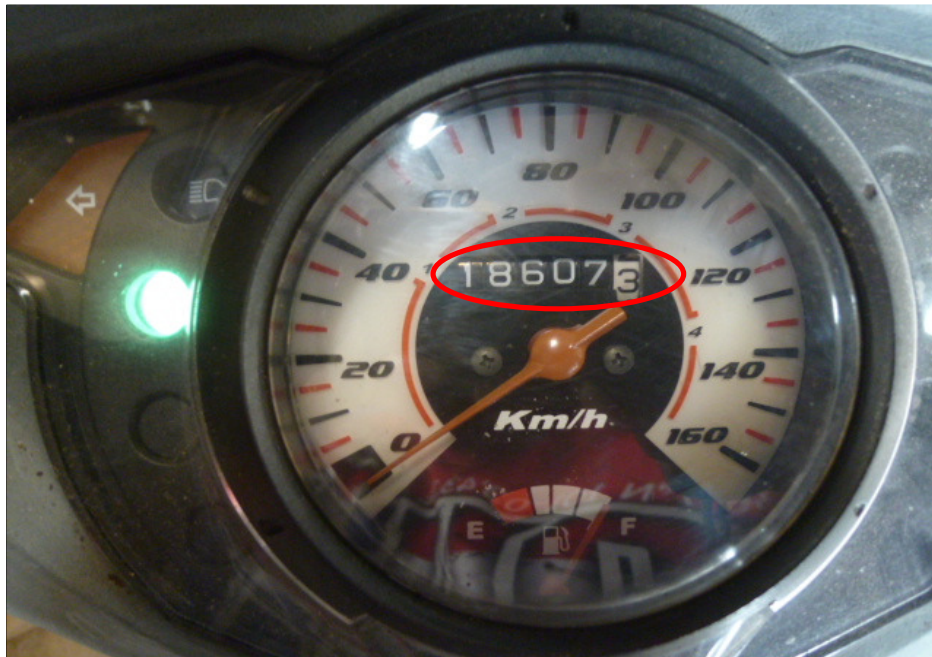
Photo 1 shows the speedometer gauge of the Motorcycle. The mileage of the Motorcycle at the time of our inspection was 18, 607km (circled).

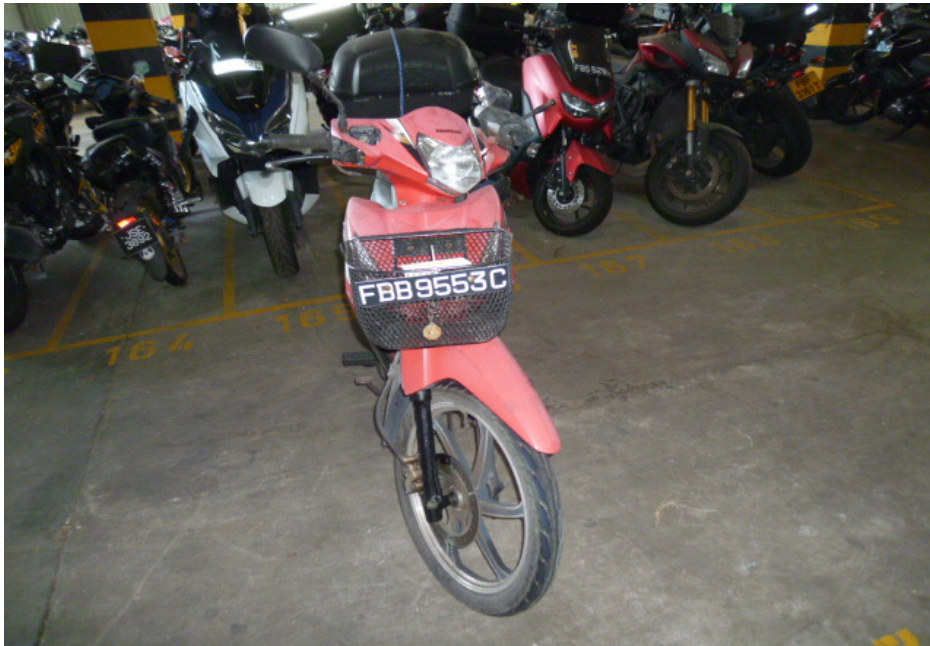
Photo 2 shows a general view of the frontal portion of the Motorcycle at the time of our inspection. The Motorcycle was observed to have sustained damages all around.

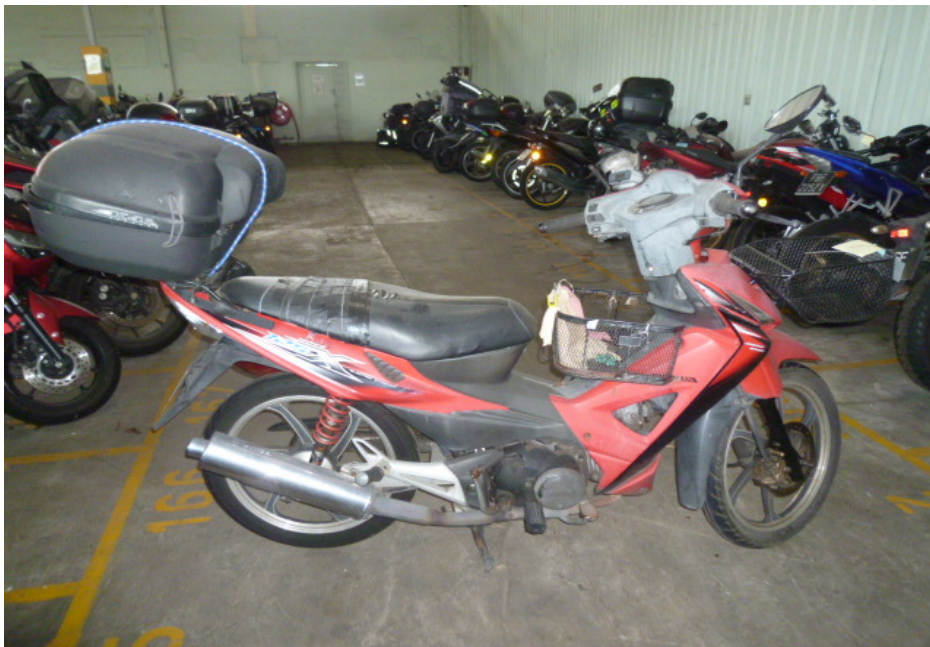
Photo 3 shows a general view of the right body of the Motorcycle at the time of our inspection. The Motorcycle was observed to have sustained damages all around. The body parts that were found to have been damaged include its front cowlings, side cowlings, side mirrors, handlebar ends, front brake lever, gear shift pedal, left front footrest and rear side covers, amongst others.

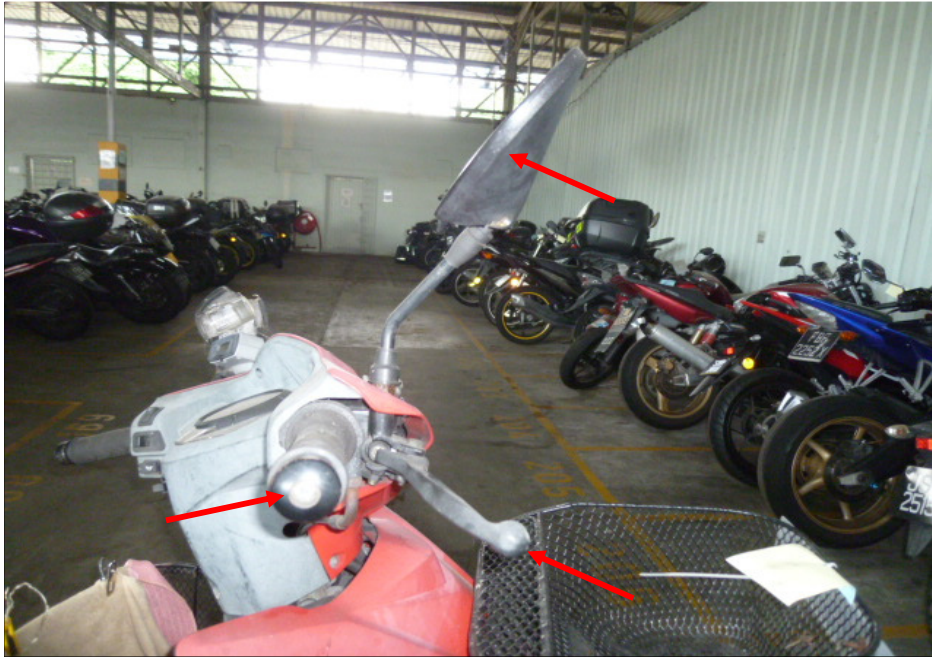
Photo 4 shows the right handlebar end, front brake lever and right side mirror (arrowed), which were amongst the body parts of the Motorcycle that had sustained damage as a result of the accident.

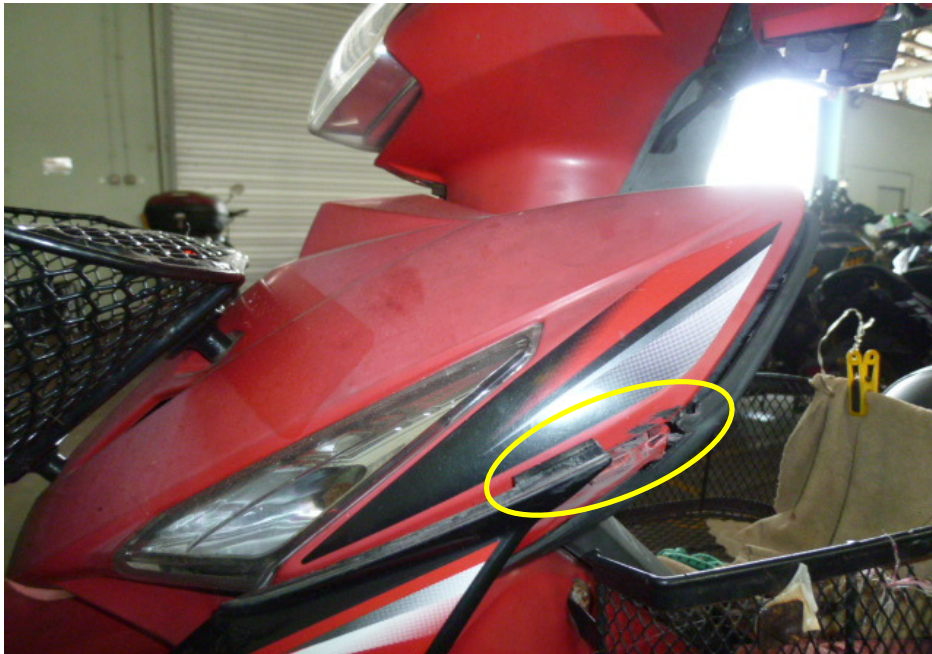
Photo 5 shows a closer view of the front cowling (circled) which was amongst the body parts of the Motorcycle that had sustained damage as a result of the accident.

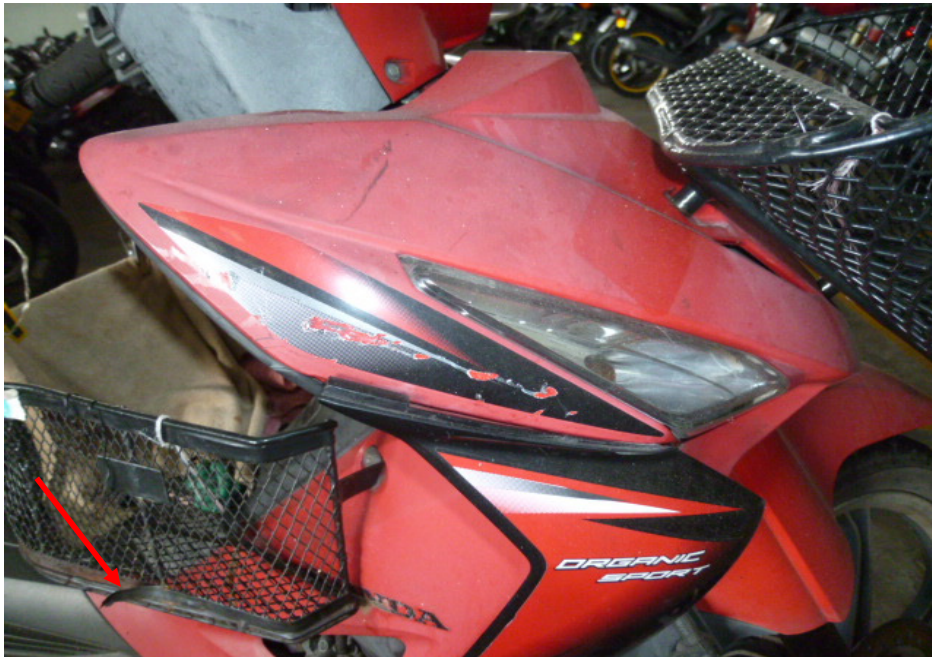
Photo 6 shows a closer view of the basket (arrowed) which was amongst the body parts of the Motorcycle that had sustained damage as a result of the accident.

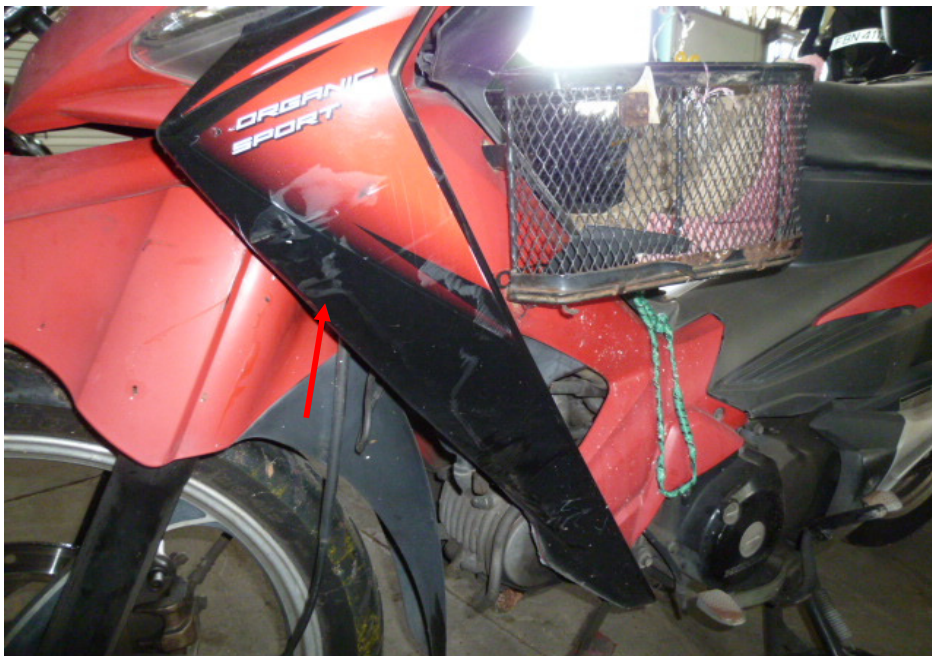
Photo 7 shows the left cowling (arrowed), which were amongst the body parts of the Motorcycle that had sustained damage as a result of the accident.

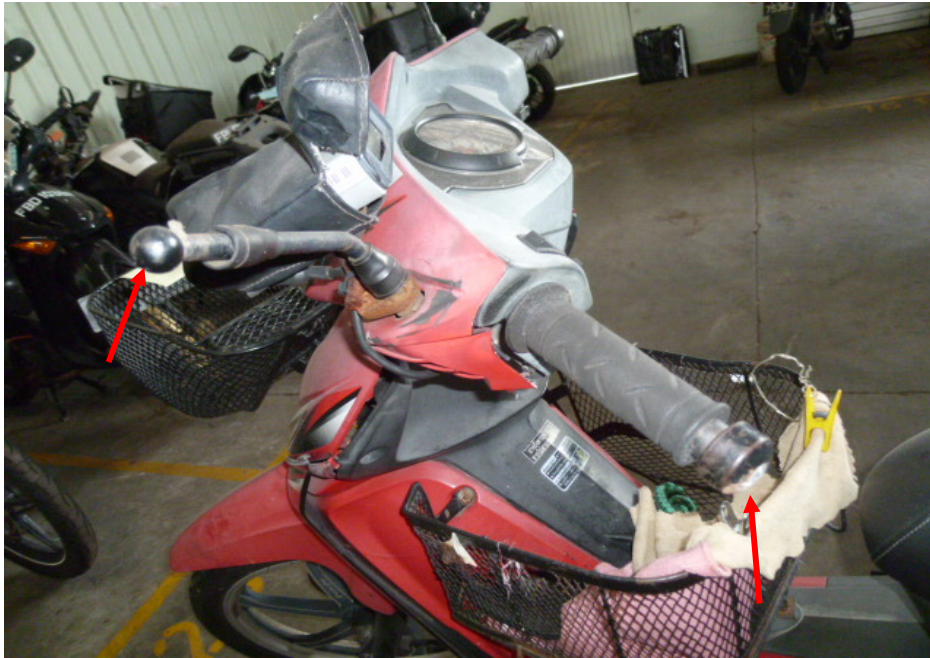
Photo 8 shows the left handlebar end and left side mirror (arrowed), which were amongst the body parts of the Motorcycle that had sustained damage as a result of the accident.

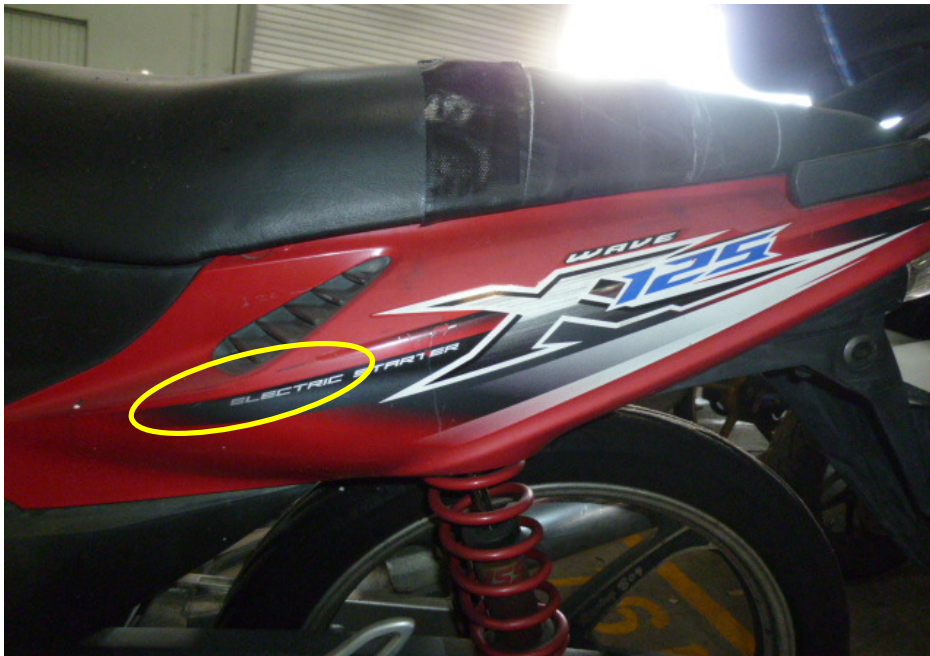
Photo 9 shows a closer view of the left rear side cover which was amongst the body parts of the Motorcycle that had sustained damages of grazing nature as a result of the accident (circled).

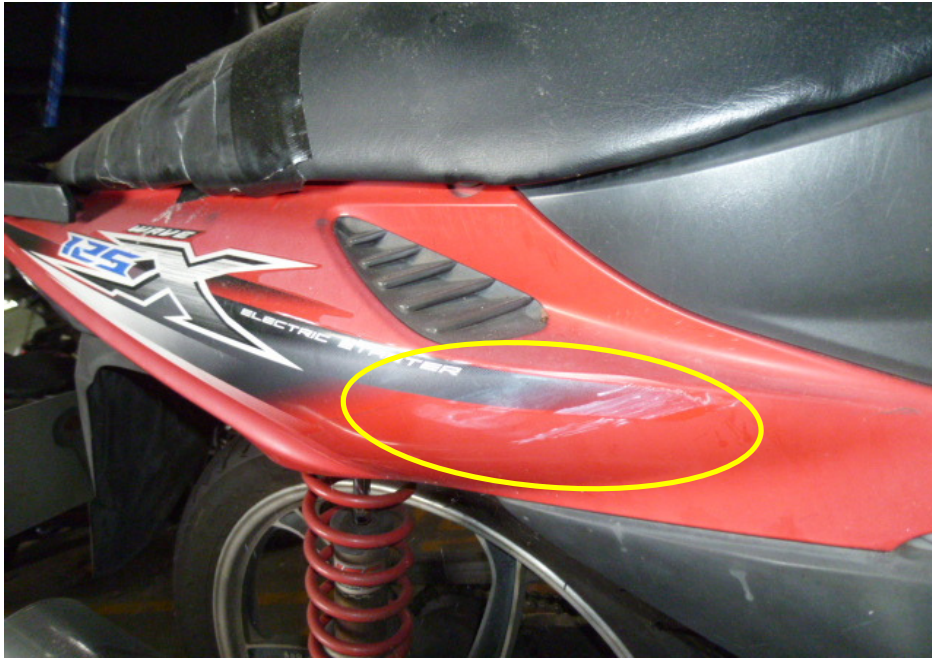
Photo 10 shows a closer view of the right rear side cover which was amongst the body parts of the Motorcycle that had sustained damages of grazing nature as a result of the accident (circled).

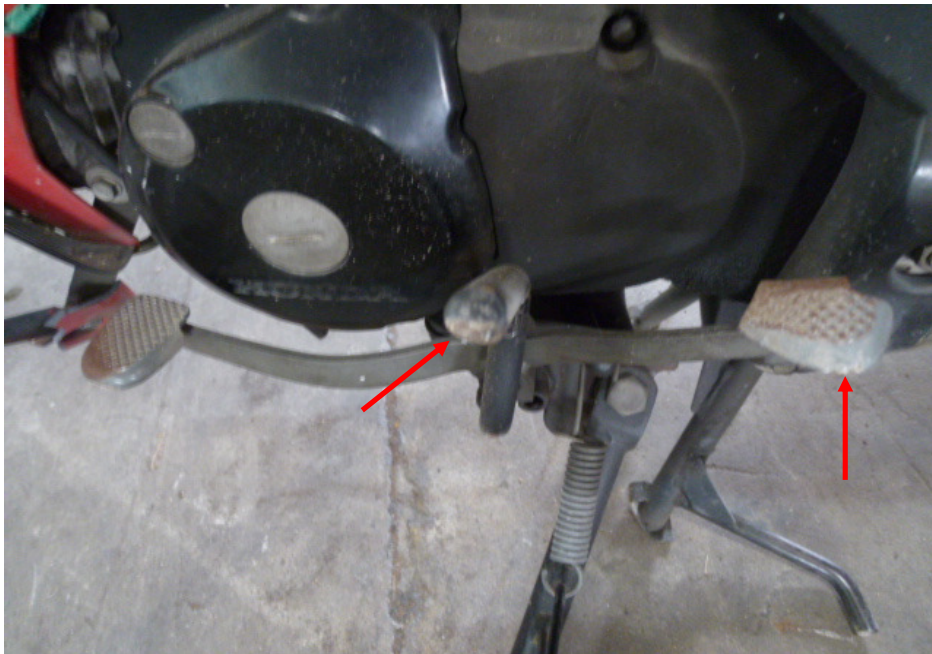
Photo 11 shows the grazed gear shift pedal and bent left front footrest of the Motorcycle as a result of the accident (arrowed).

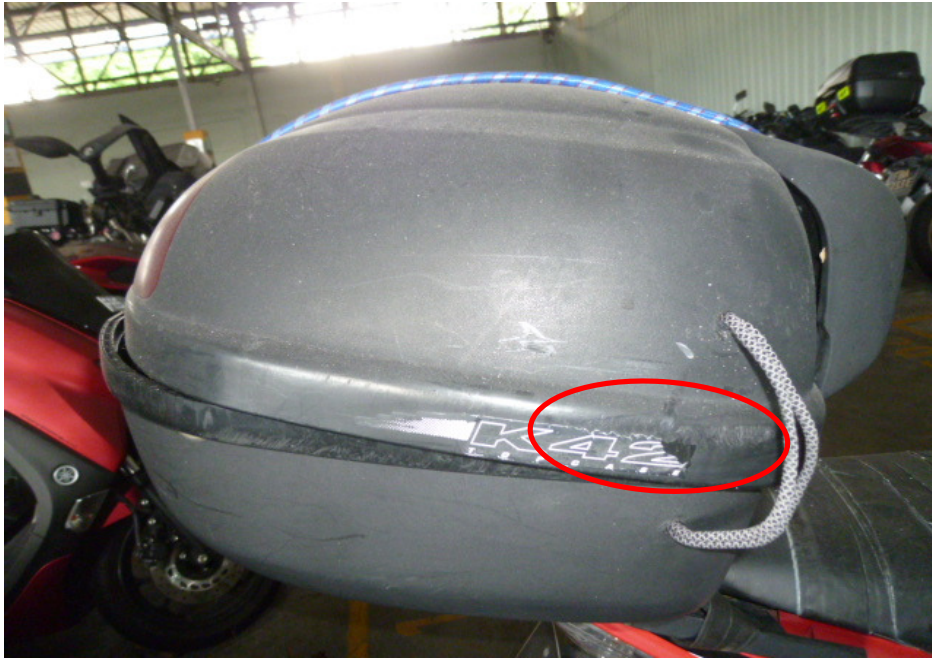
Photo 12 shows the top box of the Motorcycle that had sustained damage as a result of the accident (circled).

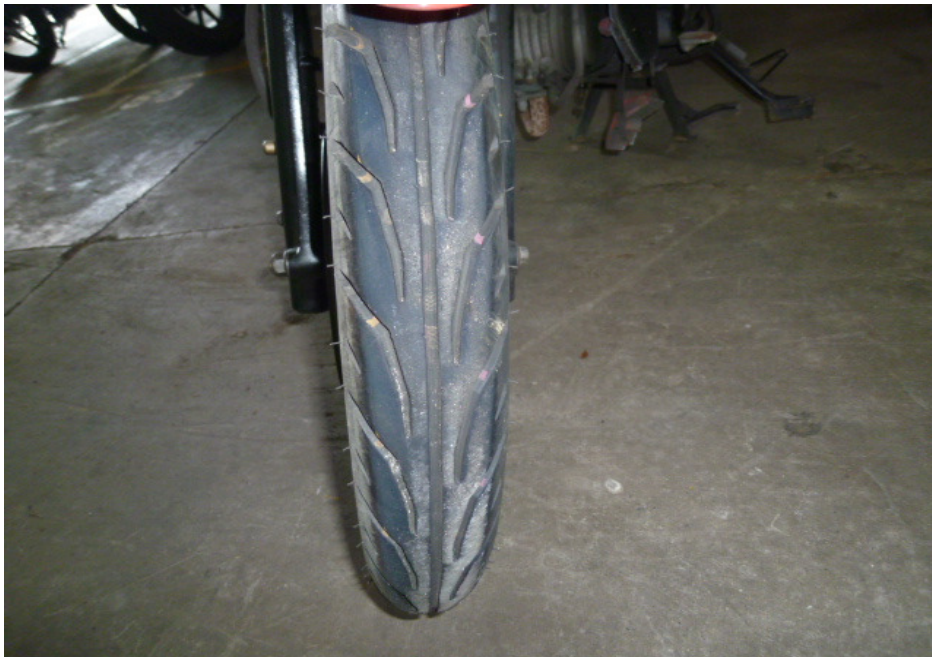
Photo 13 shows the front tyre of the Motorcycle at the time of our inspection. The front tyre was observed to be in serviceable condition with remaining tread depth of approximately 5mm. The pattern of the tread was also clearly visible. There was no tear, burst mark(s) and/or punctured hole(s) on the sidewalls as well as across the tread of the front tyre.

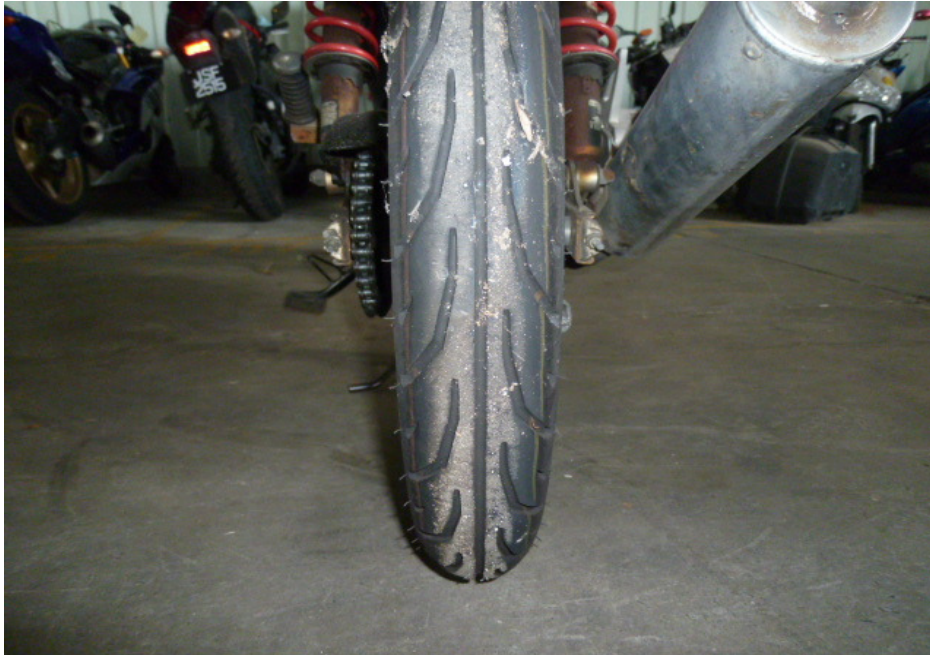
Photo 14 shows the condition of the Motorcycle's rear tyre. The rear tyre was observed to be in serviceable condition with remaining tread depth of approximately 4mm. The tyre was also observed to be sufficiently inflated for vehicular operation. We did not observe any tear, burst mark(s) and/or punctured hole(s) on the sidewalls as well as across the tread of the rear tyre.

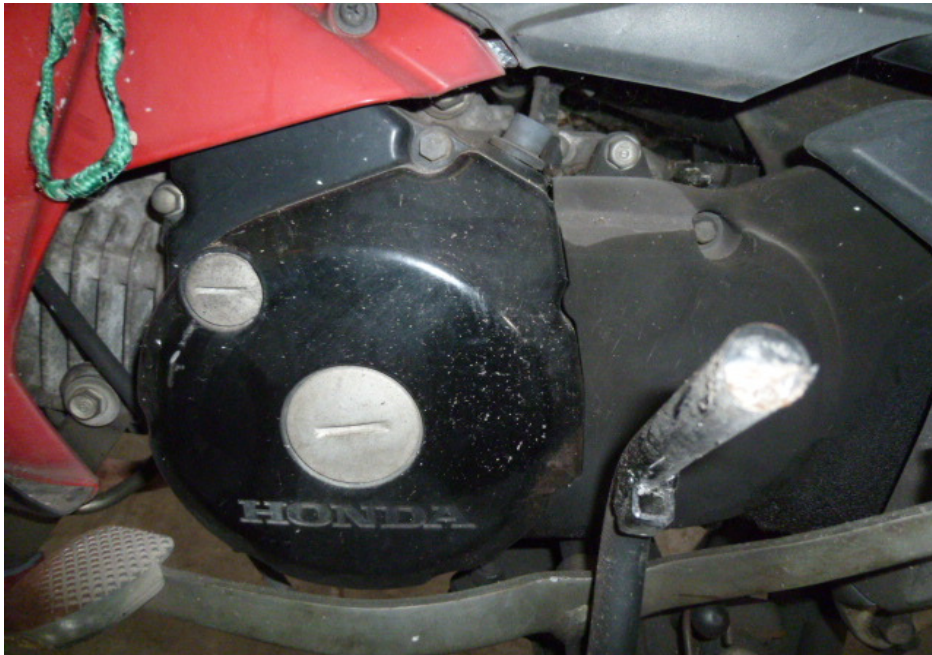
Photo 15 shows the left side of the engine of the Motorcycle at the time of our inspection. The various engine related parts and components were found to be intact with no visible damage. There was also no sign(s) or indication(s) of fluid leak observed around the left engine area of the Motorcycle.

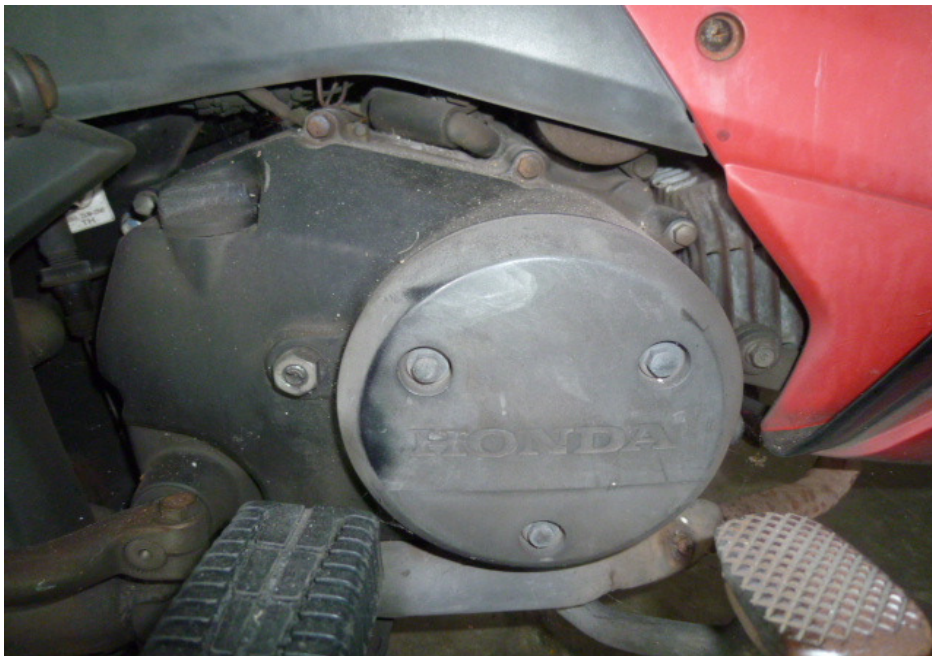
Photo 16 shows the right side of the engine of the Motorcycle at the time of our inspection. The various engine related parts and components were found to be intact with no visible damage. There was also no sign(s) or indication(s) of fluid leak observed around the right engine area of the Motorcycle.

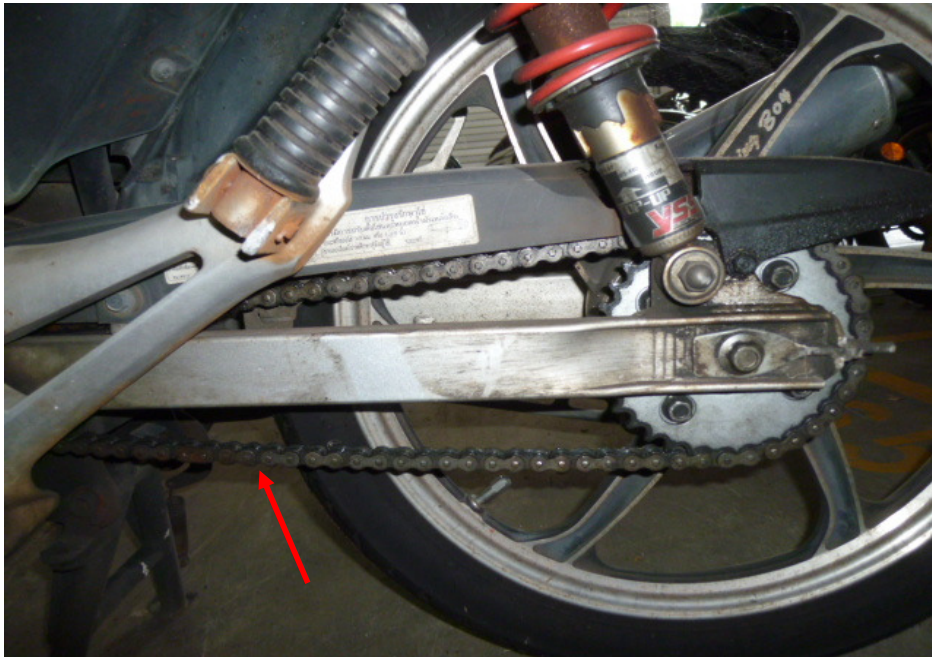
Photo 17 shows the general view of the gear train (arrowed) of the Motorcycle, which was observed to be intact with no misalignment. It was also adequately lubricated for operating purposes.

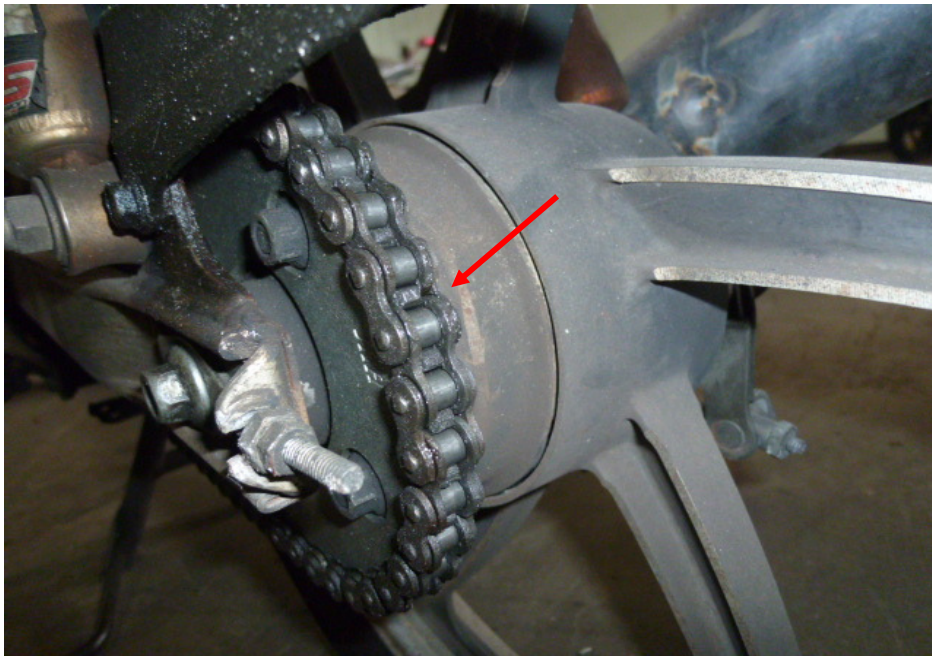
Photo 18 shows a closer view of the gear train (arrowed) of the Motorcycle, which was observed to be intact with no misalignment. It was also adequately lubricated for operating purposes.

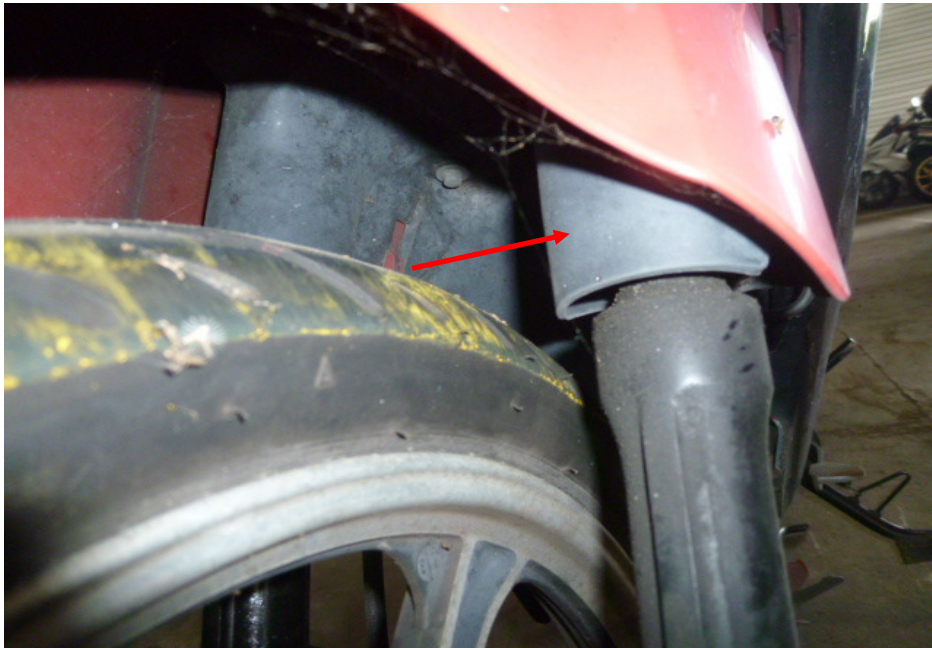
Photo 19 shows the left front fork (arrowed) of the Motorcycle. The left front fork and fork bracket of the Motorcycle were both found to be intact and undamaged. Turning the Motorcycle's handle bar towards the left and right did not produce any abnormal free play. The steering system of the Motorcycle was in serviceable condition at the time of our inspection.

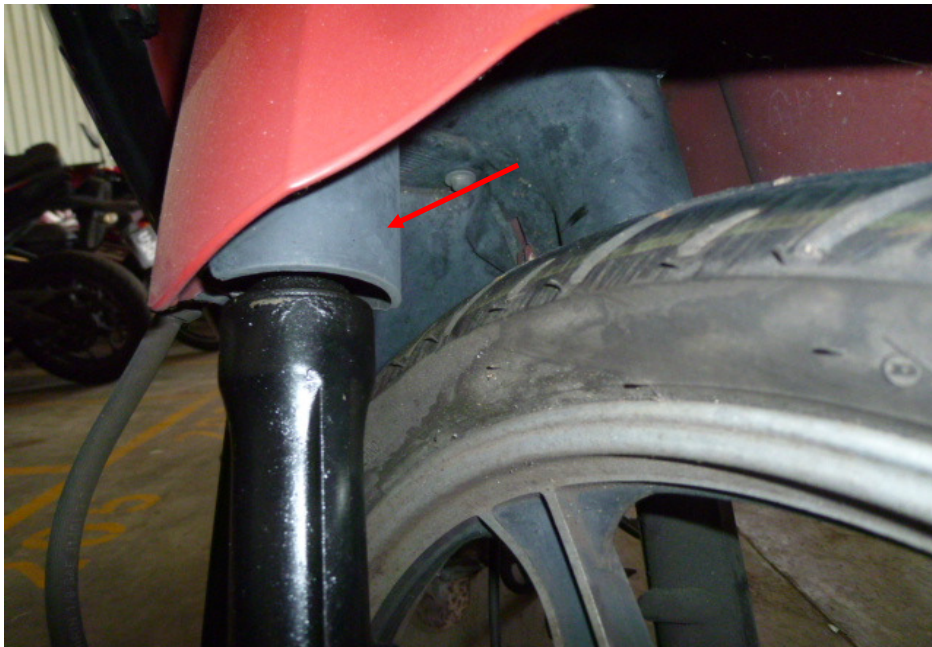
Photo 20 shows the right front fork (arrowed) of the Motorcycle. The right front fork and fork bracket of the Motorcycle were both found to be intact and undamaged. Turning the Motorcycle's handle bar towards the left and right did not produce any abnormal free play. The steering system of the Motorcycle was in serviceable condition at the time of our inspection.

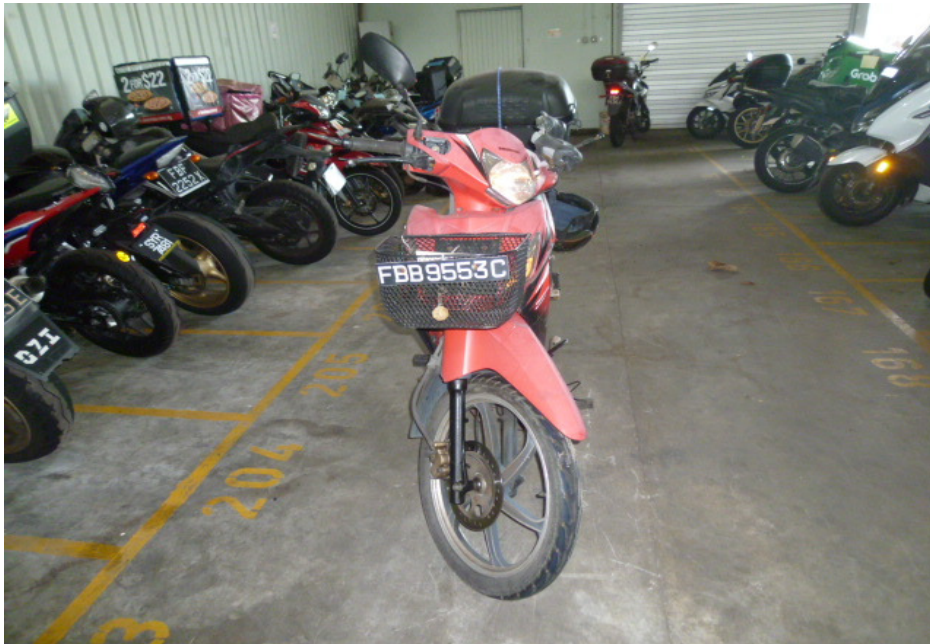
Photo 21 shows the front wheel of the Motorcycle turned towards its full left. Turning the Motorcycle's handle bar towards the left did not produce any abnormal free play and/or resistance. This would indicate that the steering system of the Motorcycle was in serviceable condition at the time of our inspection.

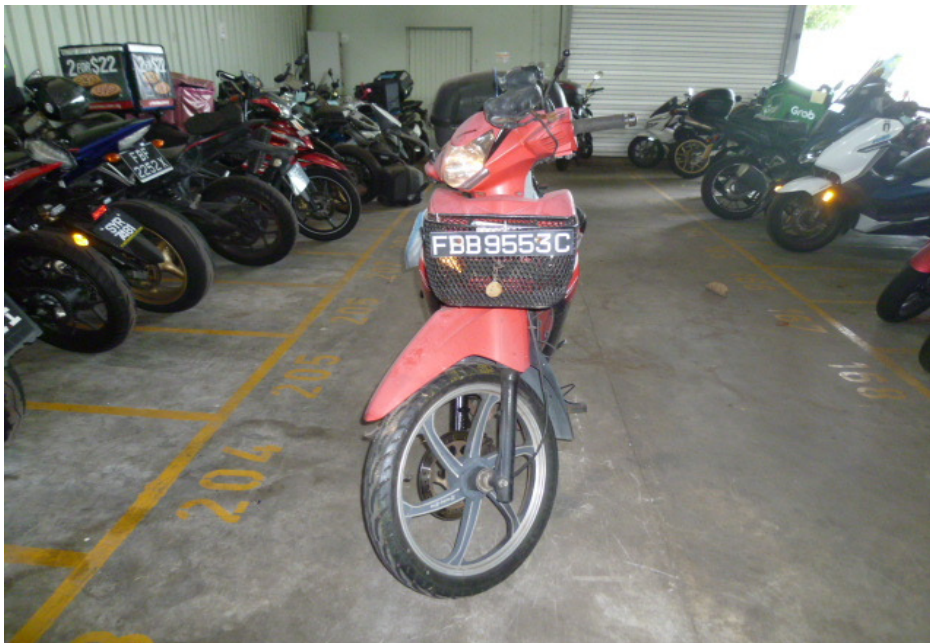
Photo 22 shows the front wheel of the Motorcycle turned towards its full right. Turning the Motorcycle's handle bar towards the right did not produce any abnormal free play and/or resistance. This would indicate that the steering system of the Motorcycle was in serviceable condition at the time of our inspection.

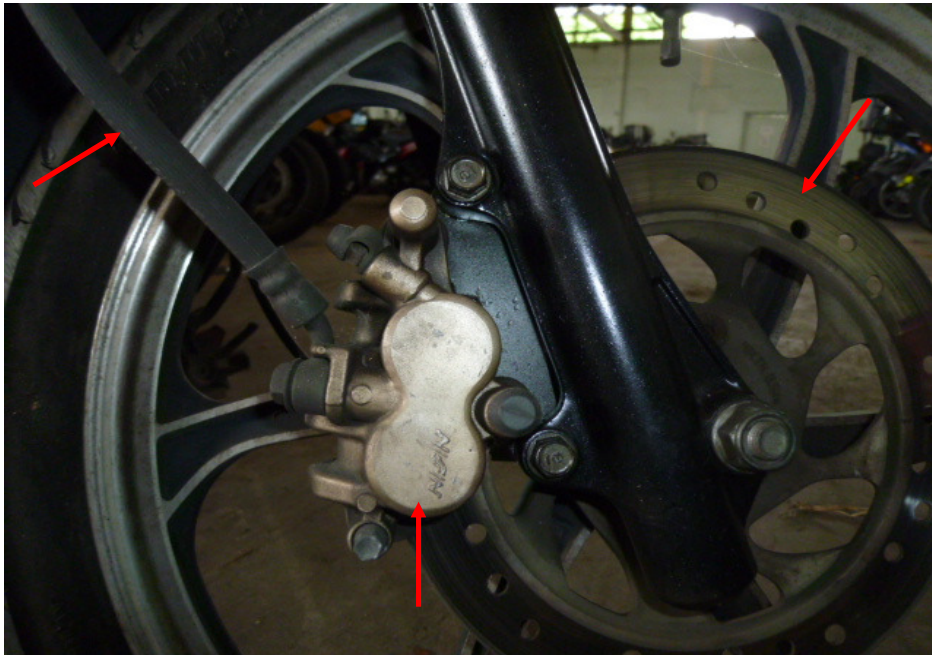
Photo 23 shows a close up view of the front brake caliper, front brake disc and front brake hose (arrowed) of the Motorcycle, which are all part of the components in the hydraulic front brake system of the Motorcycle. Our visual checks of these various components had revealed all to be intact with no visible damage. No leakage of brake fluid was also observed.

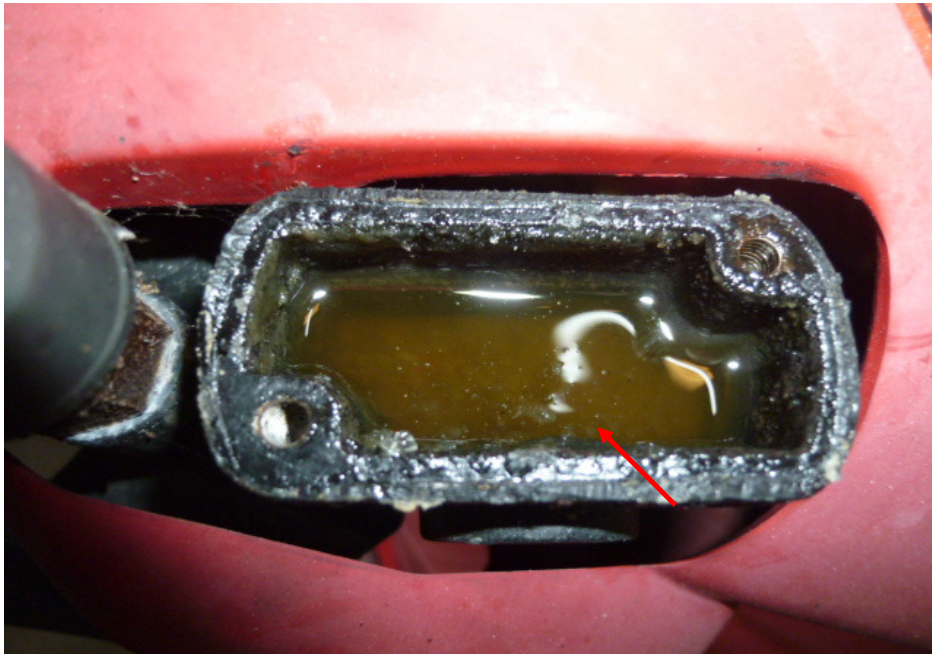
Photo 24 shows a close up view of the brake fluid reservoir for the front brake of the Motorcycle. The front brake fluid was observed to be of sufficient level for operational purposes. However it was found to be slightly contaminated (arrowed).

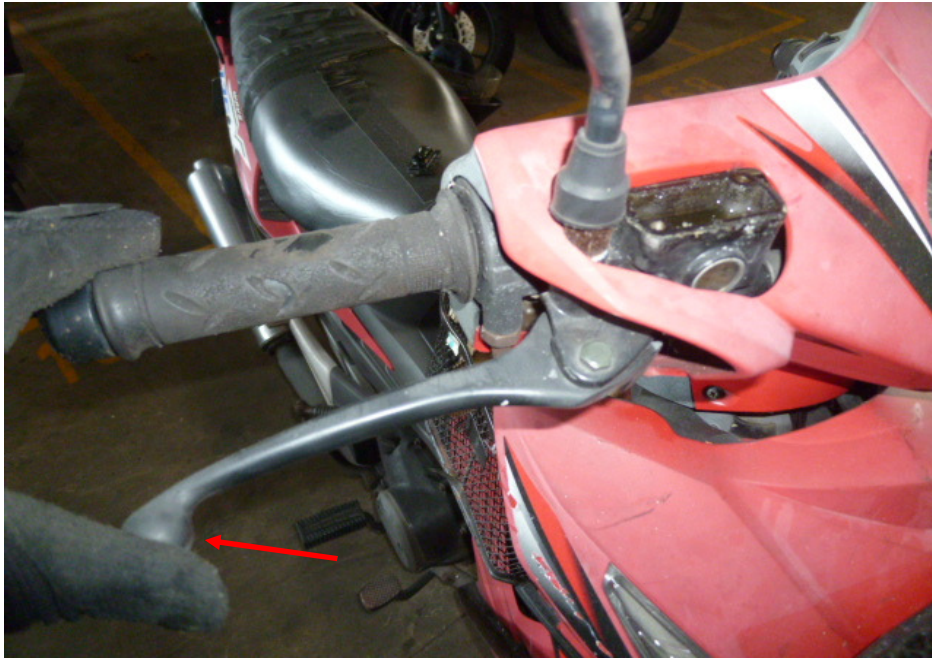
Photo 25 shows the front brake lever being depressed. There was some resistance felt (spongy like feel) upon pressing the front brake lever (arrowed). This would indicate that there is no leakage of pressure/vacuum in the brake system.

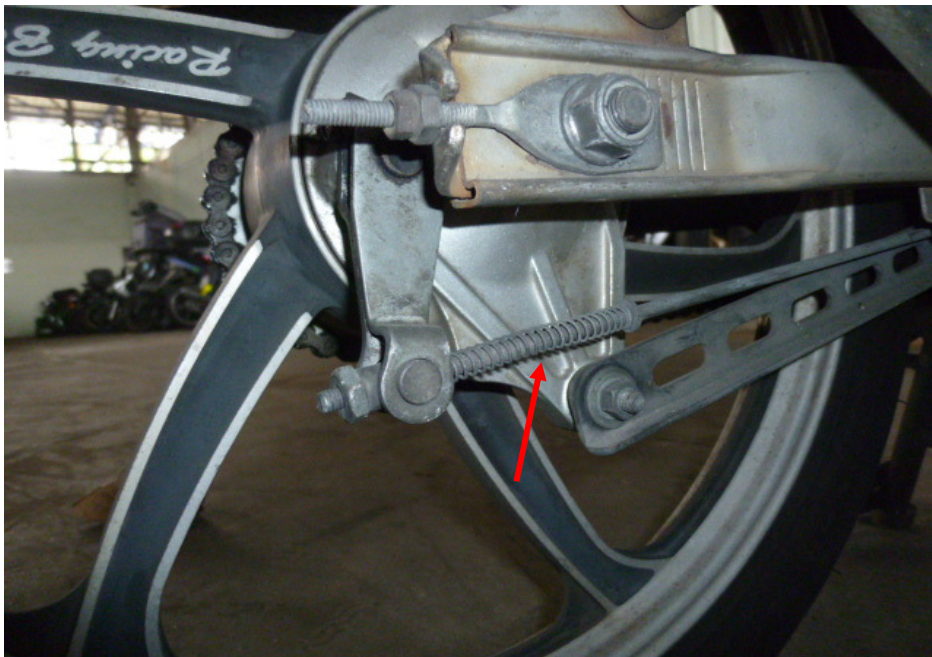
Photo 26 shows the rear wheel of the Motorcycle. The type of brake system for the rear wheel was of a mechanical type, controlled by the brake foot pedal of the Motorcycle. Our checks of the cable (arrowed), spring and drum which are all part of the components in the rear brake system of the Motorcycle reveal all to be intact and without damage.
