Your Ref: TP/IP/59995/2021
Our Ref : CI/TPD22005248/N

Fatal Accident Investigation Team

**INSPECTION REPORT OF BICYCLE (BRONZE) - TRAFFIC POLICE POUND
REPORT NO. 4373/21**

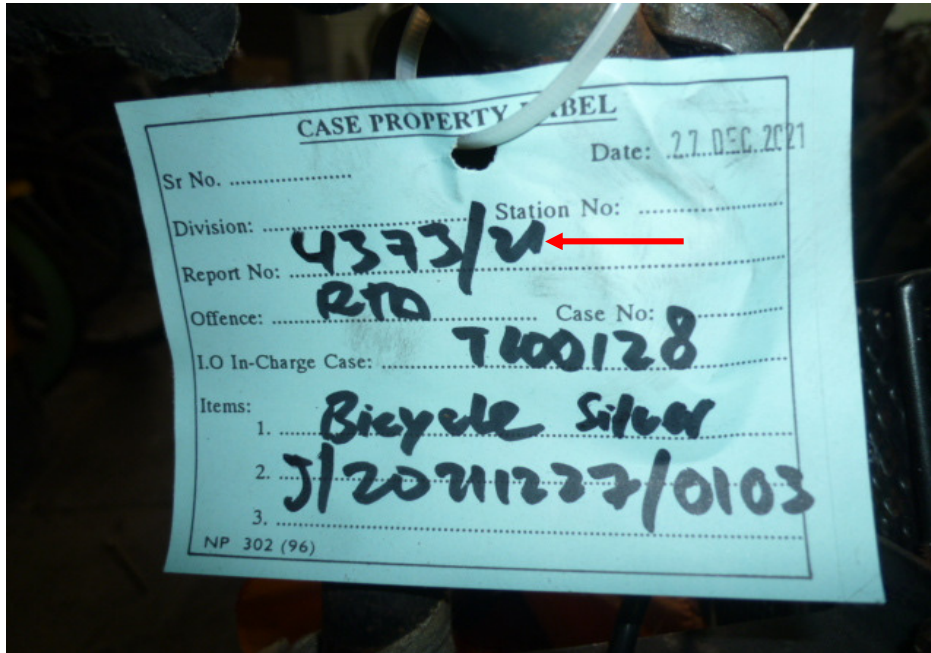
Photo 1 shows the identification of the Bicycle with reference to Traffic Police Pound Report No. 4373/21 (arrowed).

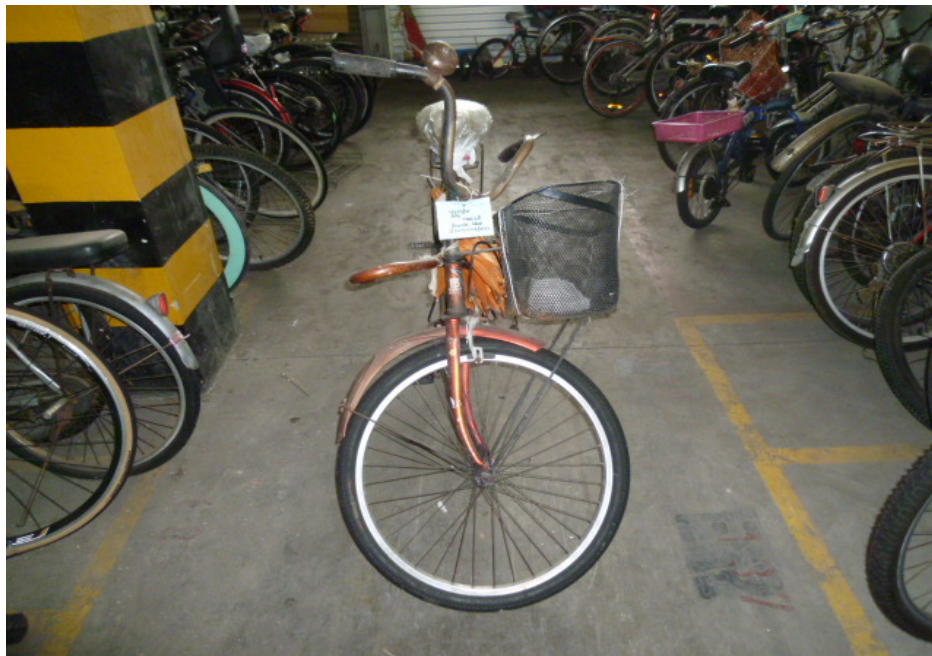
Photo 2 shows the frontal portion of the Bicycle at the time of our inspection. The Bicycle had sustained damages all around.

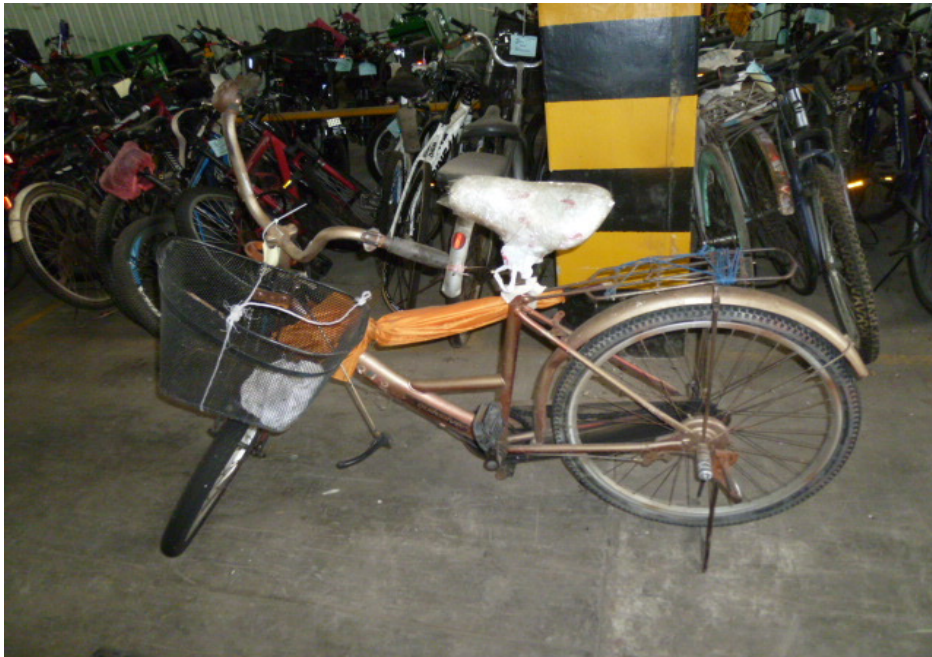
Photo 3 shows the left body of the Bicycle at the time of our inspection. The Bicycle had sustained damages all around.

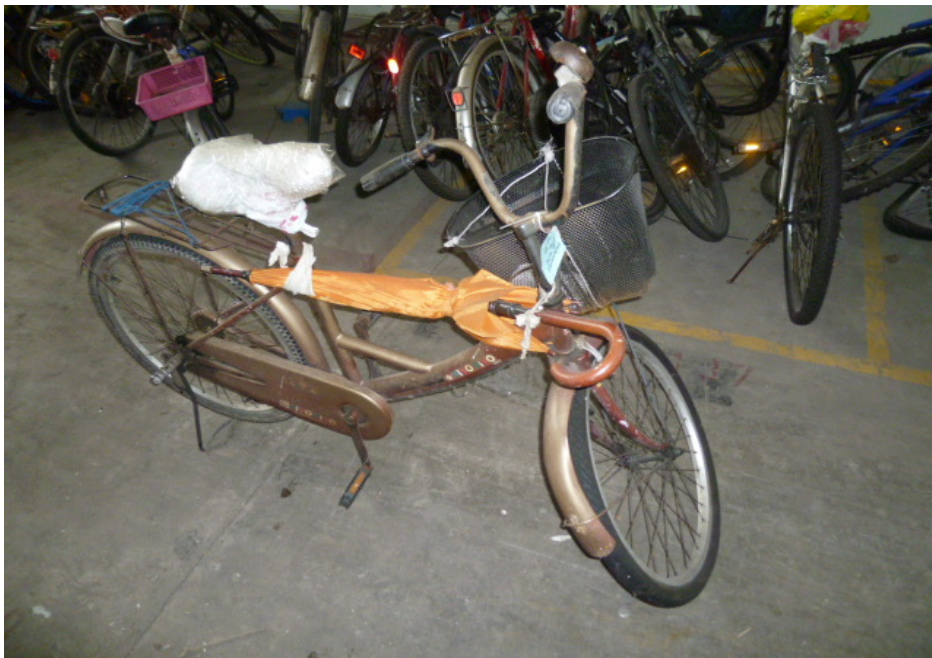
Photo 4 shows the right body of the Bicycle at the time of our inspection. The Bicycle had sustained damages all around. The body parts that were found to have been damaged include its handlebar, right handlebar grip, front basket, front fork assembly, front mudguard, left pedal, left pillion foot peg, braking components and rack, amongst others as a result of the accident.

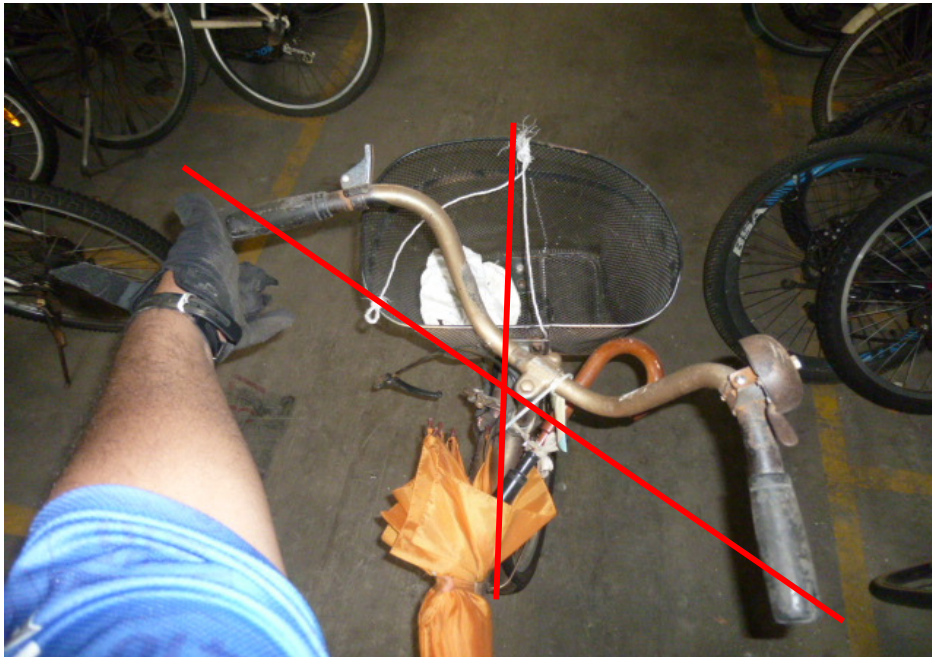
Photo 5 shows the frontal portion of the Bicycle (top view) at the time of our inspection. A misalignment of the handlebar & front tyre was observed.

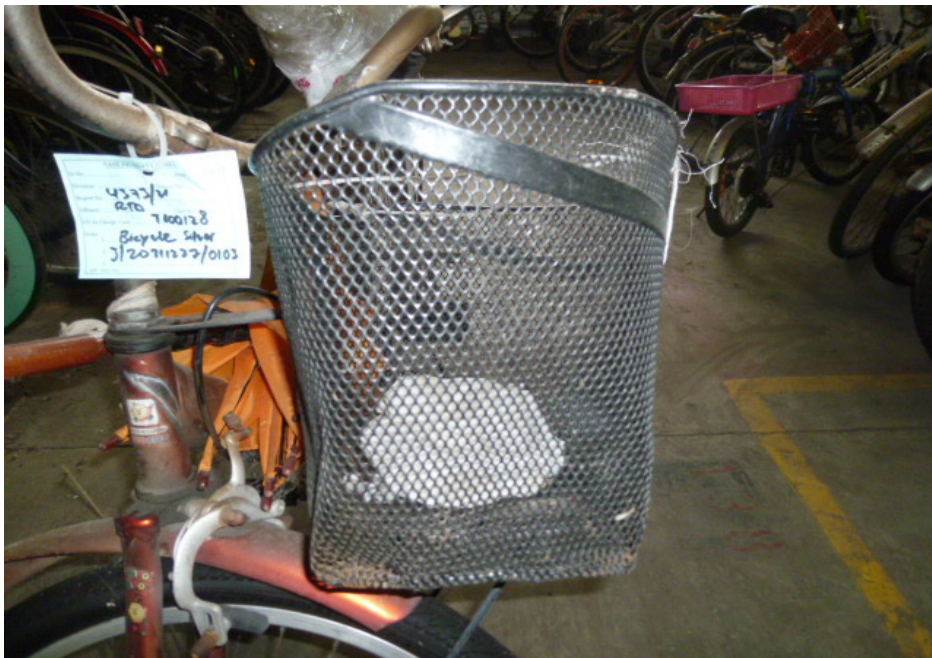
Photo 6 shows the damaged front basket of the Bicycle at the time of our inspection.

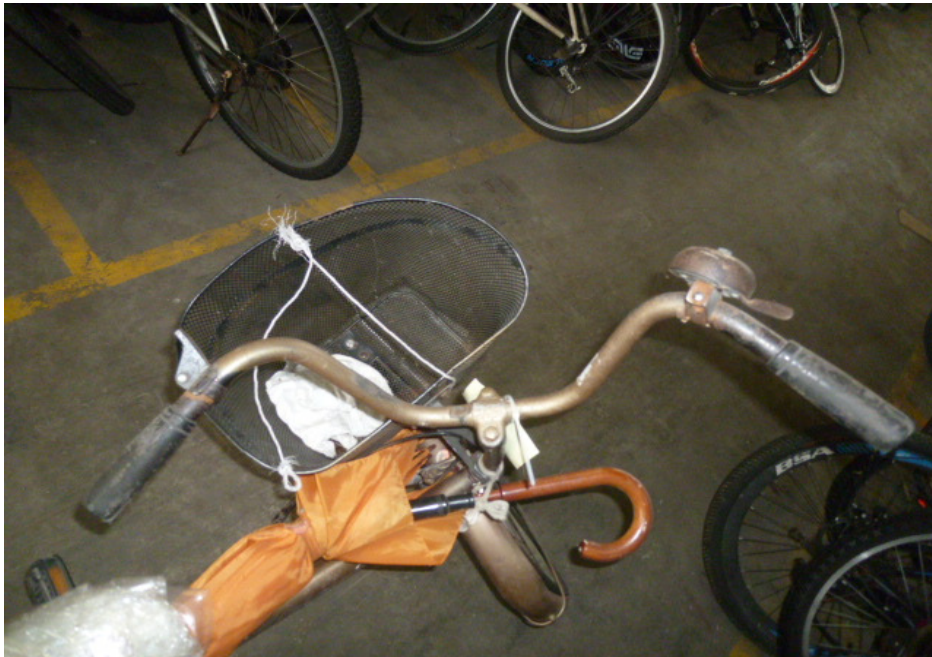
Photo 7 shows the deformed handlebar of the Bicycle at the time of our inspection.

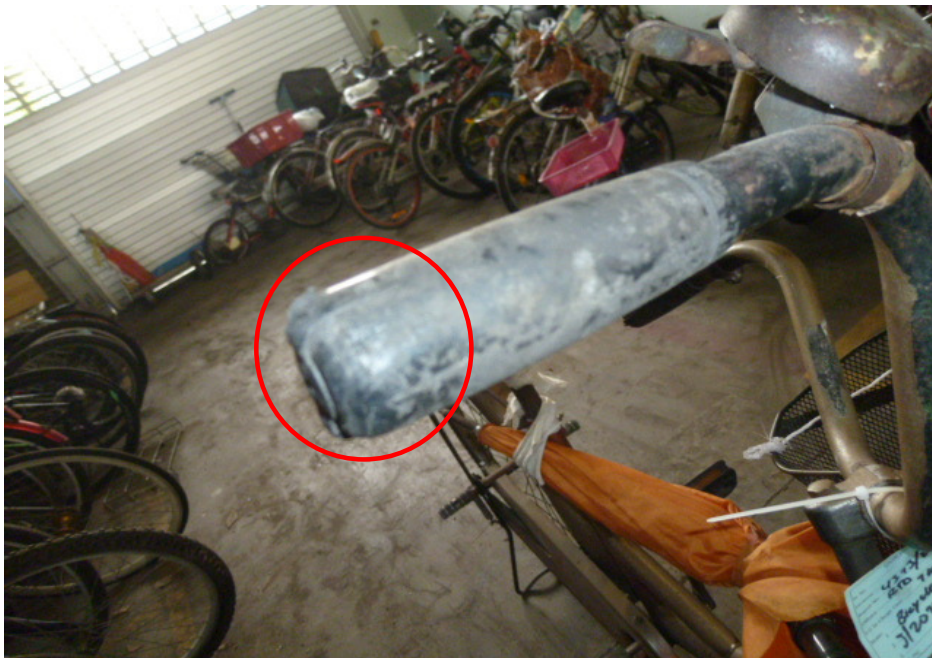
Photo 8 shows the damaged right handlebar grip of the Bicycle at the time of our inspection (circled).

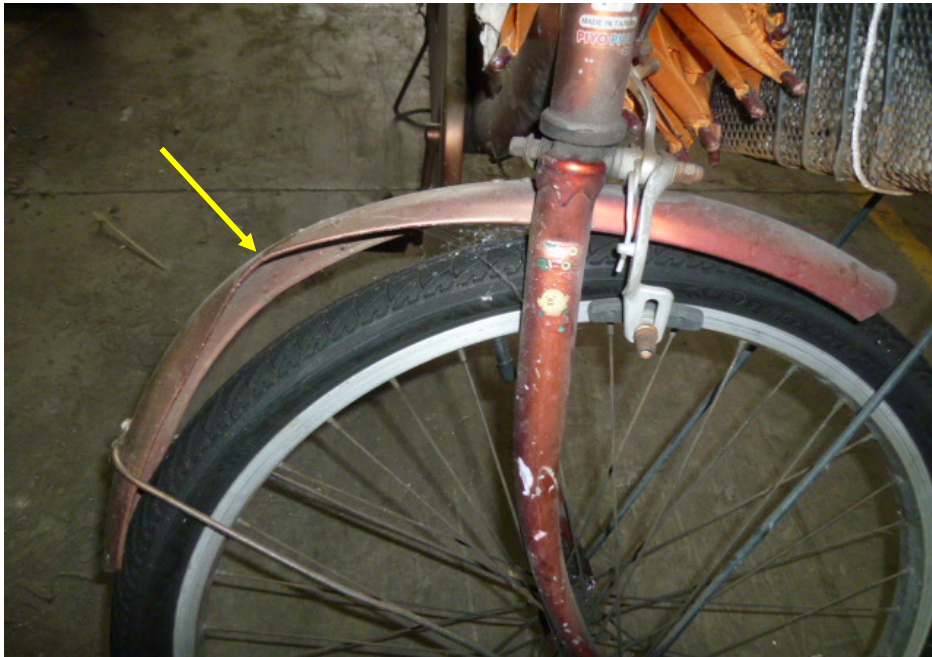
Photo 9 shows a close-up view of the deformed front mudguard of the Bicycle due to the accident (arrowed).

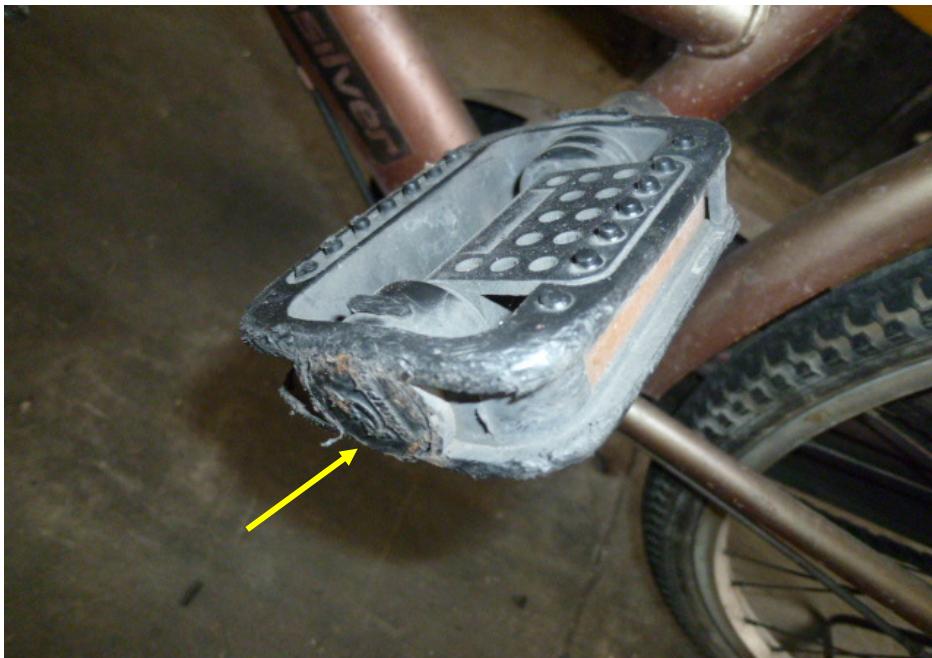
Photo 10 shows the left pedal of the Bicycle which had sustained damages of grazing nature as a result of the accident (arrowed).

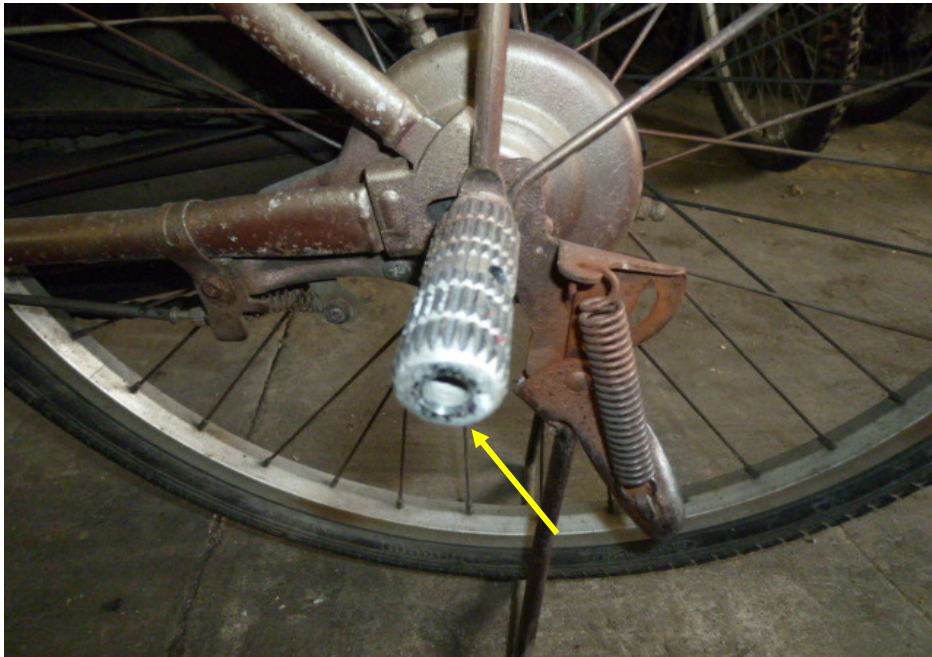
Photo 11 shows a close-up view of the left pillion foot peg of the Bicycle which had sustained damages of grazing nature as a result of the accident (arrowed).

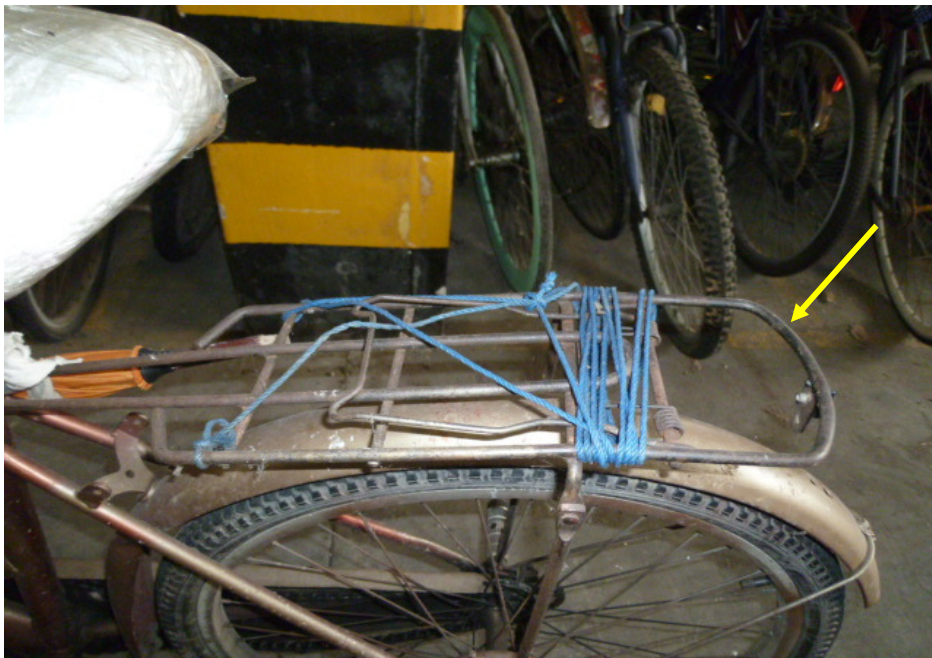
Photo 12 shows the deformed rack of the Bicycle as a result of the accident (arrowed).

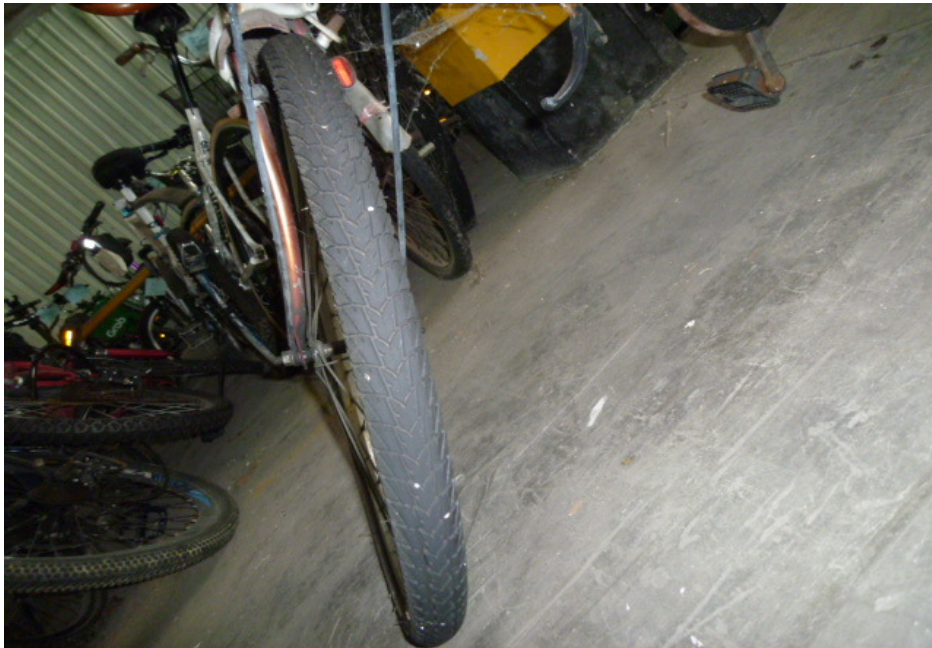
Photo 13 shows the front tyre of the Bicycle. The front tyre was observed to be in serviceable condition with remaining tread depth of approximately 3mm. There was no tear, burst mark(s) and/or punctured hole(s) on the sidewalls as well as across the tread of the front tyre. The front tyre was also observed to be sufficiently inflated for vehicular operation.

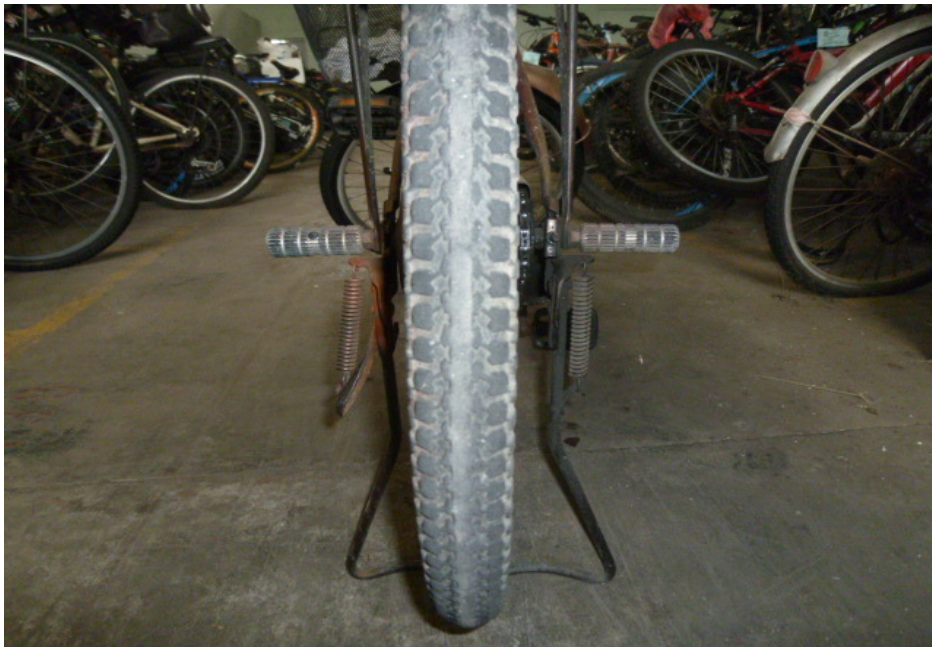
Photo 14 shows the rear tyre of the Bicycle. The rear tyre was observed to be in serviceable condition with remaining tread depth of approximately 3mm. The pattern of the tread was clearly visible. There was no tear, burst mark(s) and/or punctured hole(s) on the sidewalls as well as across the tread of the rear tyre. The rear tyre was also observed to be sufficiently inflated for vehicular operation.

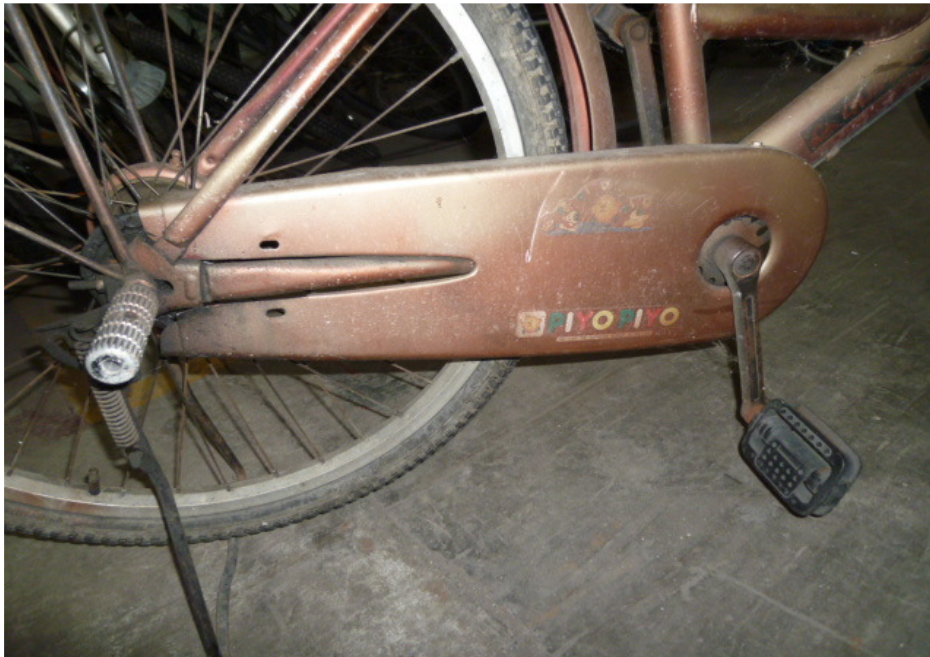
Photo 15 shows the general view of the gear train of the Bicycle, which was observed to be intact with no misalignment. It was also adequately lubricated for operating purposes.

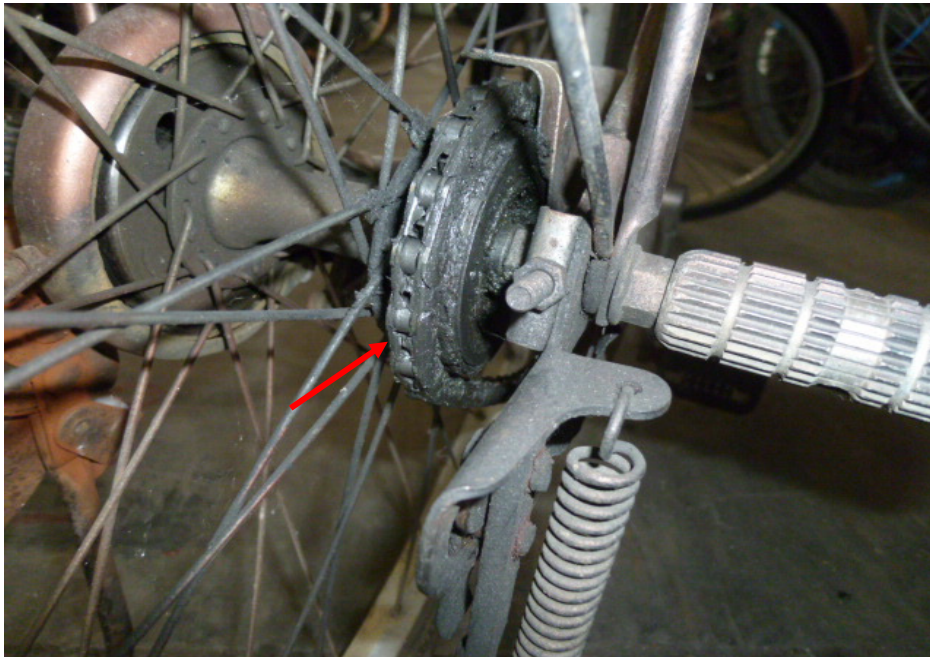
Photo 16 shows a closer view of the gear train of the Bicycle, which was observed to be intact with no misalignment (arrowed). It was also adequately lubricated for operating purposes.

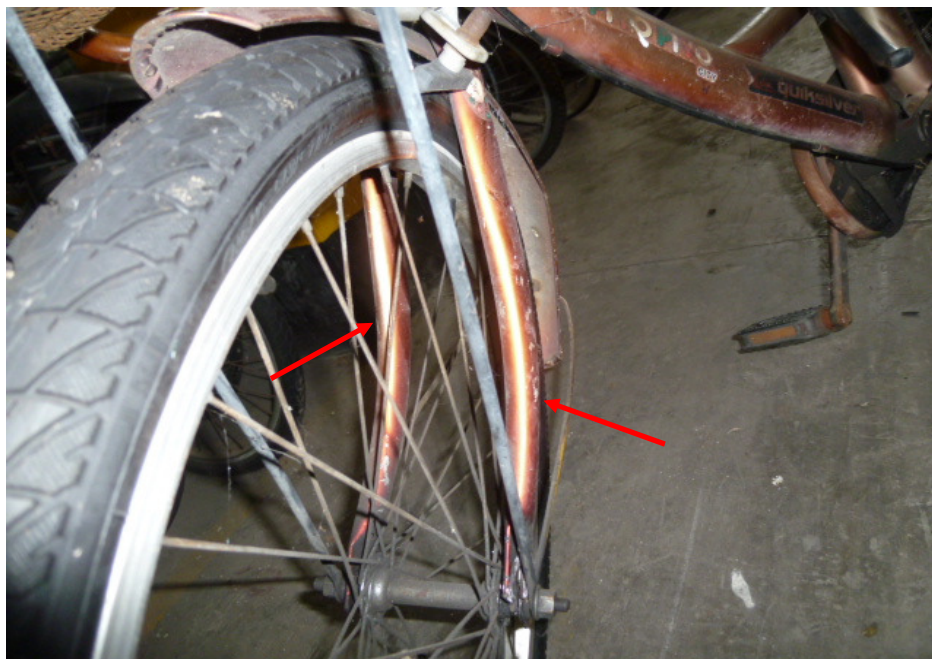
8. For this case, we were not able to conduct any test(s) on the steering system of the Bicycle due to the damages on its front fork assembly. The front forks were found to be bent as a result of the accident, hence causing the whole steering system to be out of alignment and rendering the Bicycle immobile for any static or operational tests.

Photo 17 shows the front fork assembly of the Bicycle. The front forks of the Bicycle were found to be bent as a result of the accident (arrowed), hence causing the whole steering system to be out of alignment and rendering the Bicycle immobile for any static or operational tests.

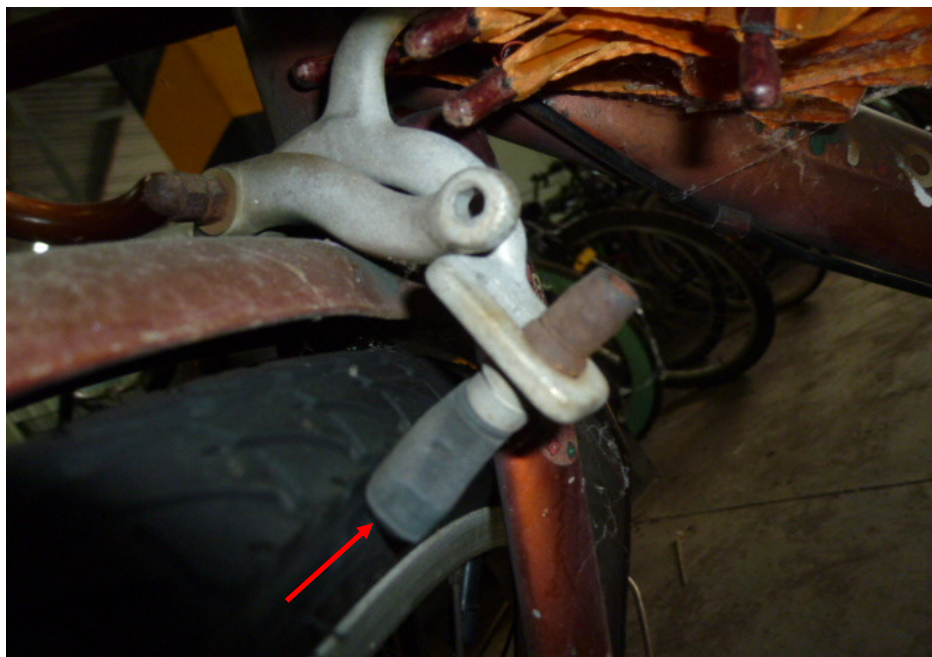
10. A static brake test could not be conducted on the front brake of the Bicycle due to the misaligned front brake clamp assembly as well as the missing right hand brake lever.

Photo 18 shows the front brake clamp assembly of the Bicycle which was intact however it was observed to be misaligned (arrowed).

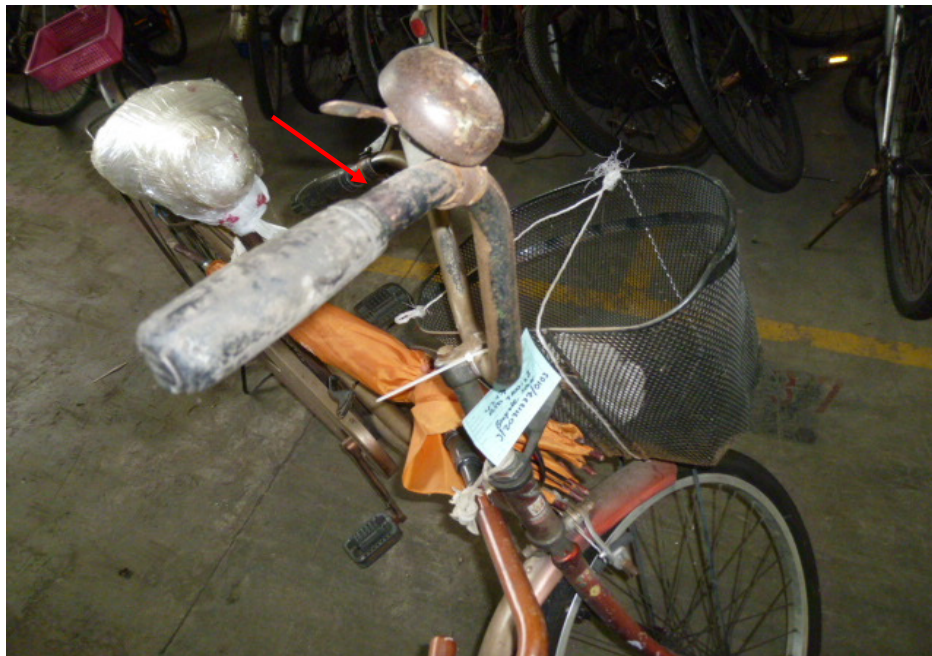
Photo 19 shows the right handlebar of the Bicycle. The right hand brake lever was observed to be missing as a result of the accident (arrowed). Hence a static brake test could not be conducted on the Bicycle's front braking system.

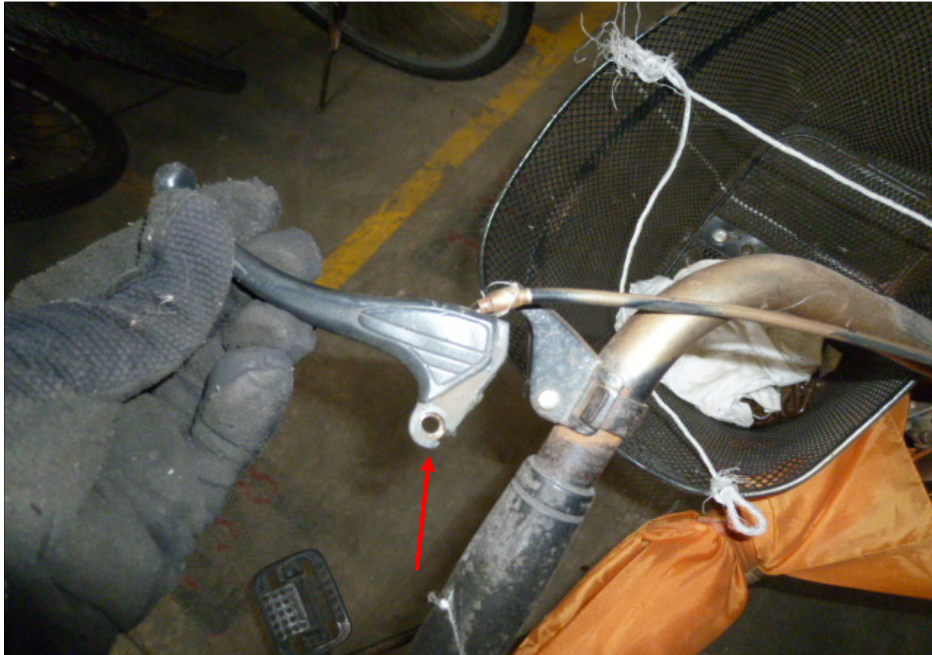
11. A static brake test could not be conducted on the rear brake of the Bicycle due to the broken left hand brake lever.

Photo 20 shows the left hand brake lever which was found to be broken due to the accident (arrowed). Hence a static brake test could not be conducted on the Bicycle's rear braking system.

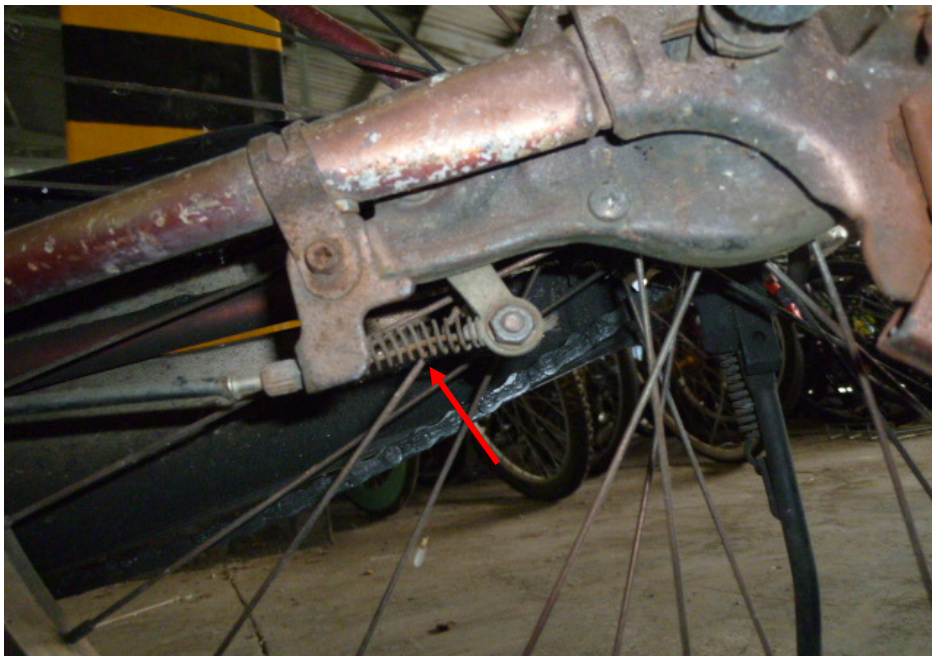
Photo 21 shows the rear wheel of the Bicycle. The type of brake system for the rear wheel was of a mechanical type, controlled by the left hand brake lever of the Bicycle. Our checks of the cable (arrowed), spring and drum which are all part of the components in the rear brake system of the Bicycle reveal all to be intact and without damage.
