Your Ref: TP/IP/02433/2022  
Our Ref : CI/TPD22005249/N

6 July 2022

**Fatal Accident Investigation Team**

**MECHANICAL INSPECTION REPORT OF MOTORCYCLE JSB 5465**

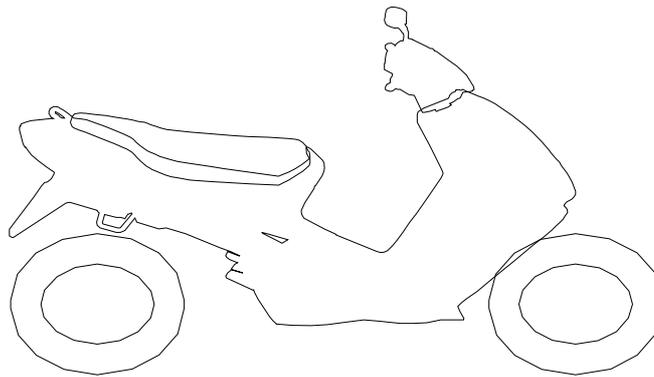
7. The tyre brand, tyre size and remaining tread depth of the 2 tyres of the Motorcycle were recorded as follows:-

Pirelli 80/90 R17 (6mm)

Michelin 70/90 R17 (3mm)

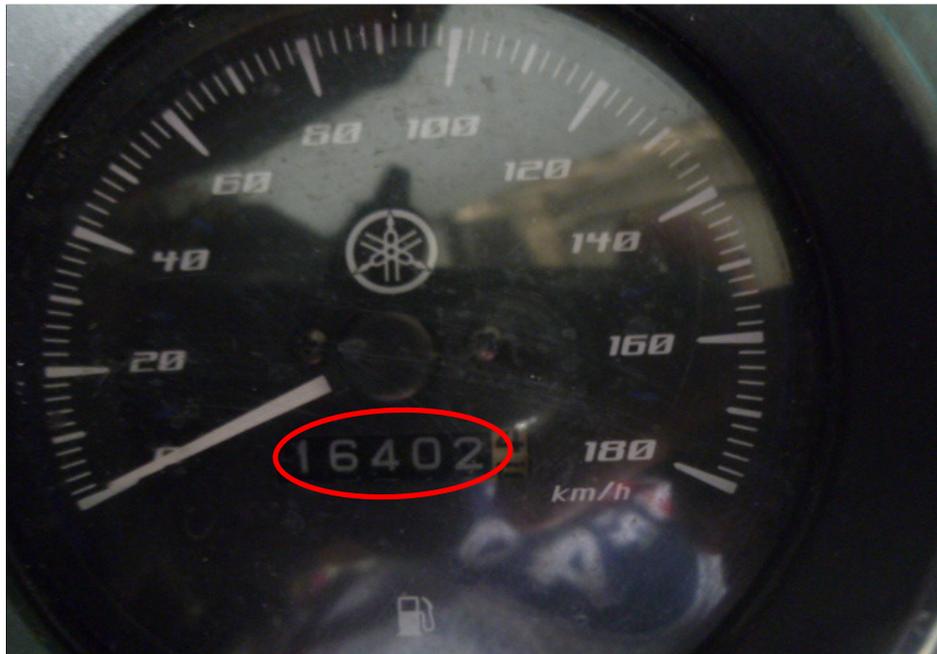
**Photo 1** shows the speedometer gauge of the Motorcycle where the mileage recorded at the time of our inspection was 16, 402km (circled).

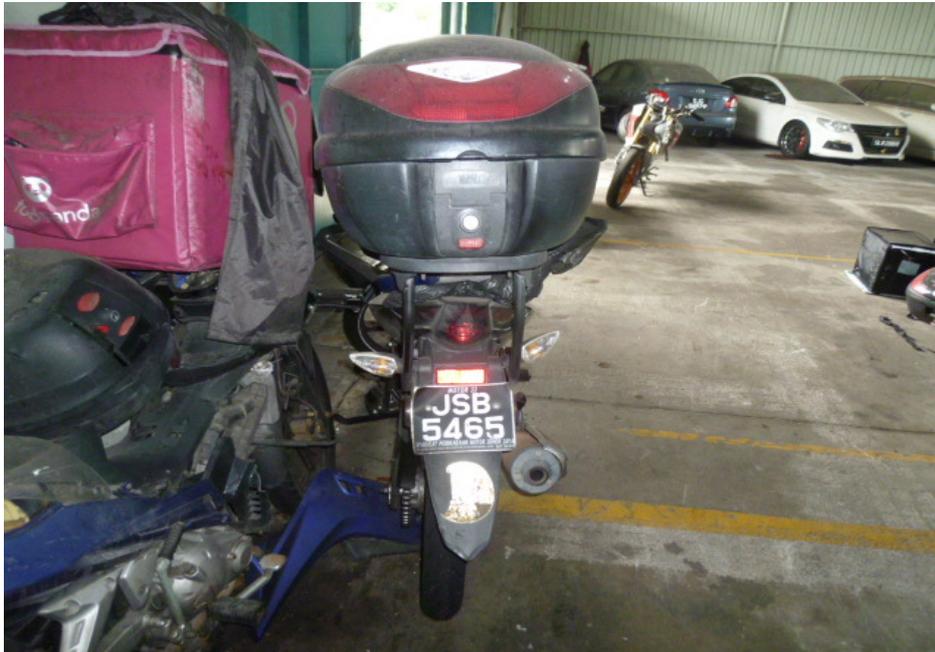
**Photo 2** shows a general view of the rear portion of the Motorcycle at the time of our inspection. The Motorcycle had sustained damages all around.

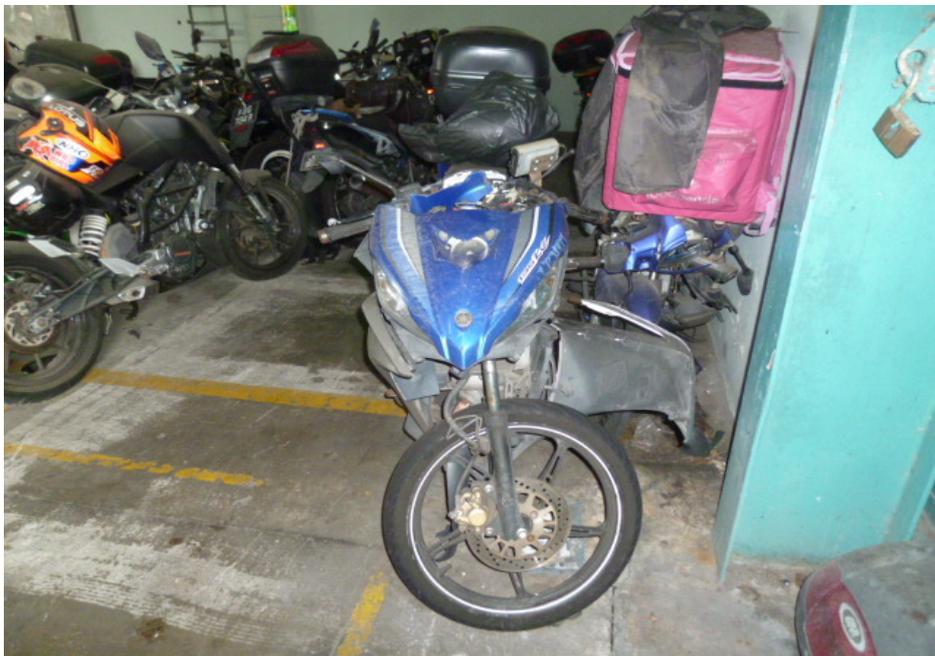
**Photo 3** shows a general view of the frontal portion of the Motorcycle at the time of our inspection. The Motorcycle had sustained damages all around.

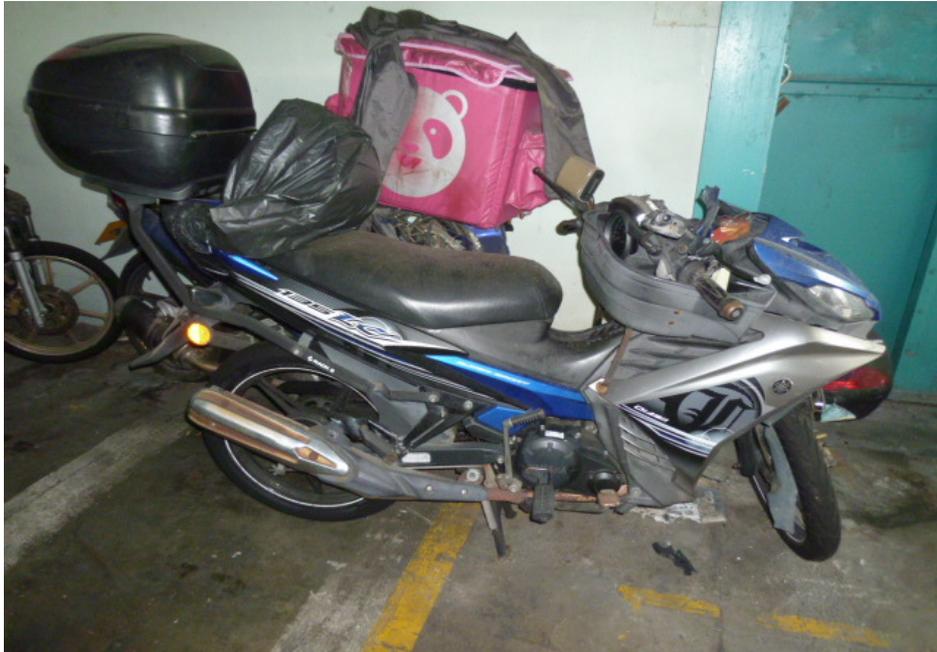
**Photo 4** shows a general view of the right body of the Motorcycle at the time of our inspection. The Motorcycle had sustained damages all around. Body parts that were found to have been damaged include its headlight assembly, front cowlings, steering stem, handlebar ends, side mirrors, front brake lever, side cowlings, right rear side cover, rear brake pedal, right front footrest, top box and left rear signal lamp, amongst others.

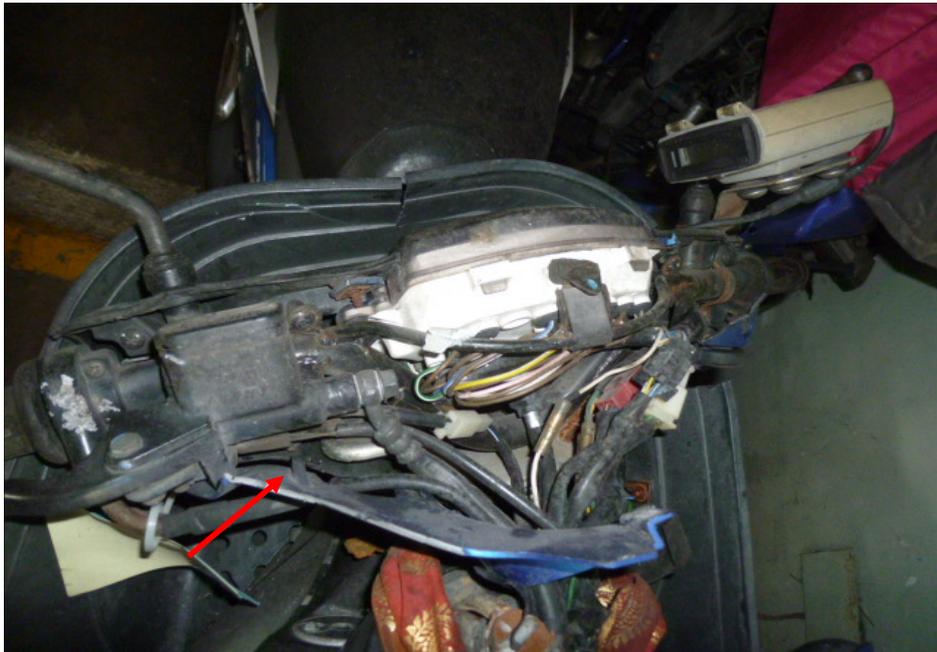
**Photo 5** shows a closer view of the missing headlight assembly of the Motorcycle as a result of the accident (arrowed).

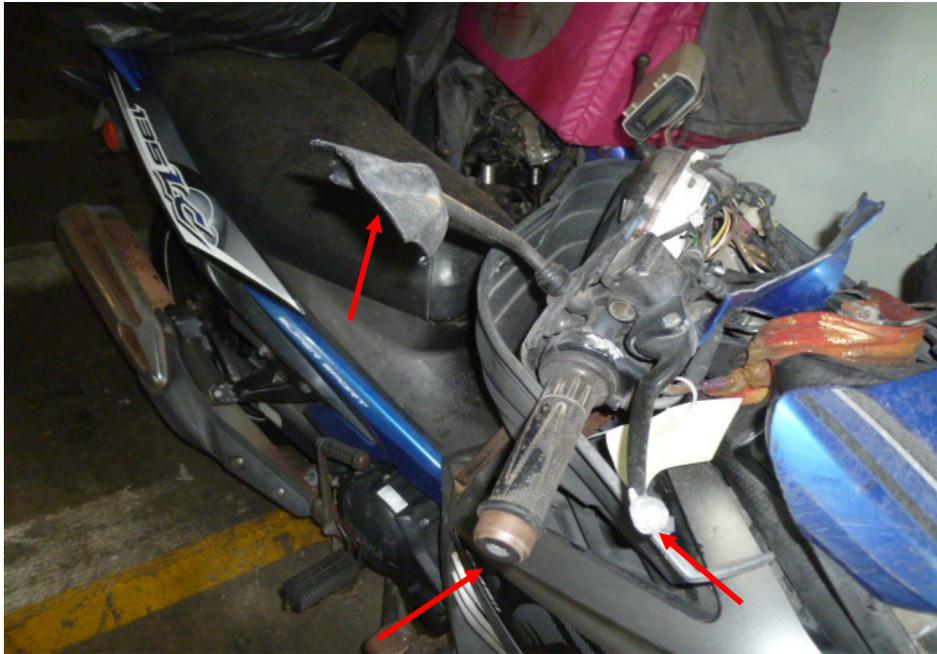
**Photo 6** shows a closer view of the front brake lever, right side mirror and right handlebar end of the Motorcycle (arrowed). These parts were amongst the body parts of the Motorcycle which were damaged as a result of the accident.

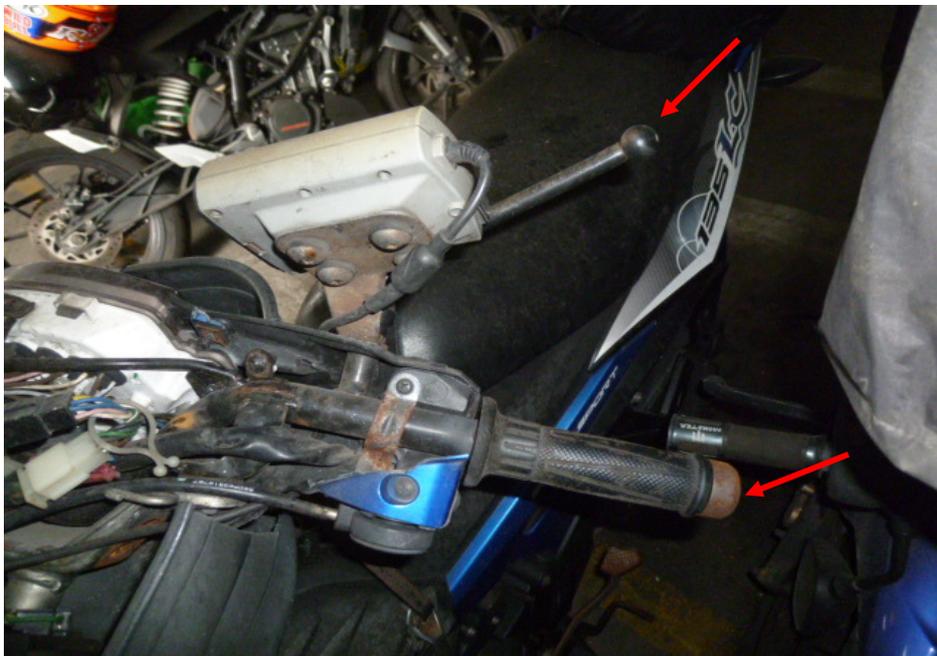
**Photo 7** shows a closer view of the left side mirror and left handlebar end of the Motorcycle (arrowed). These parts were amongst the body parts of the Motorcycle which were damaged as a result of the accident.

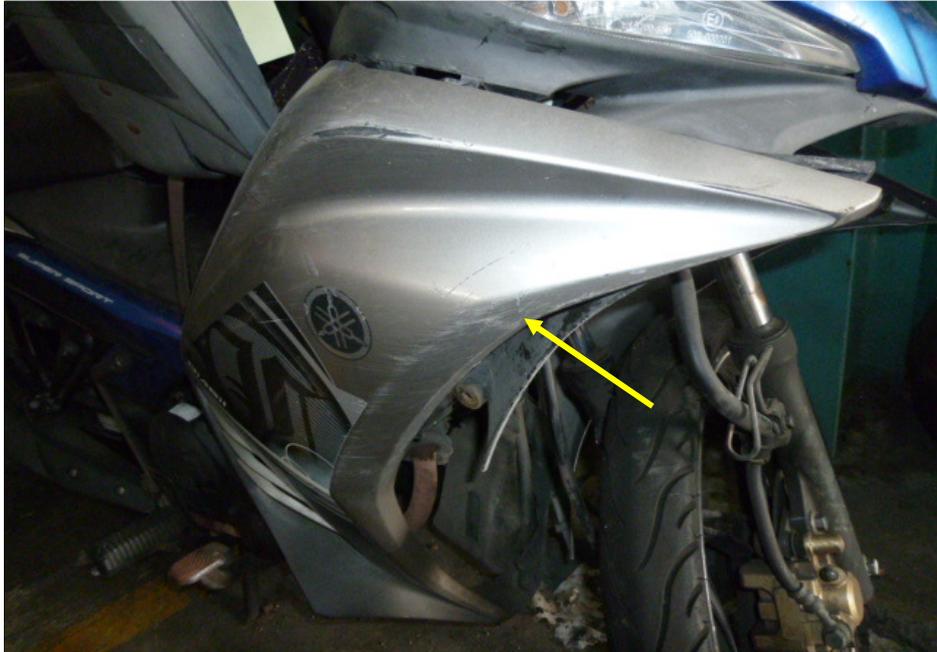
**Photo 8** shows a closer view of the right cowling which was amongst the body parts at the front body of the Motorcycle that had sustained damages as a result of the accident (arrowed).

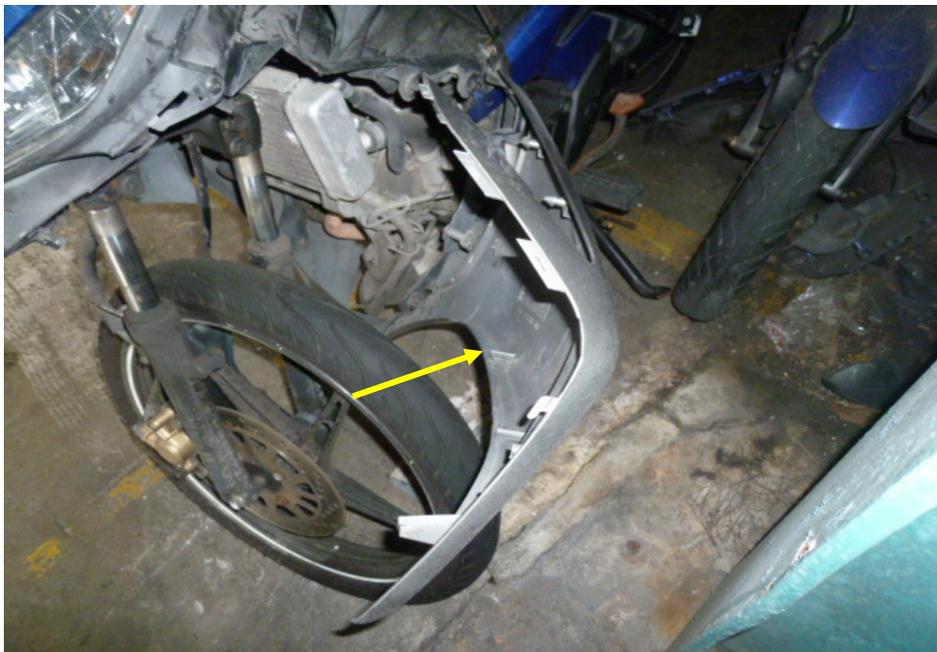
**Photo 9** shows a closer view of the cracked left cowling which was amongst the body parts at the front body of the Motorcycle that had sustained damages as a result of the accident (arrowed).

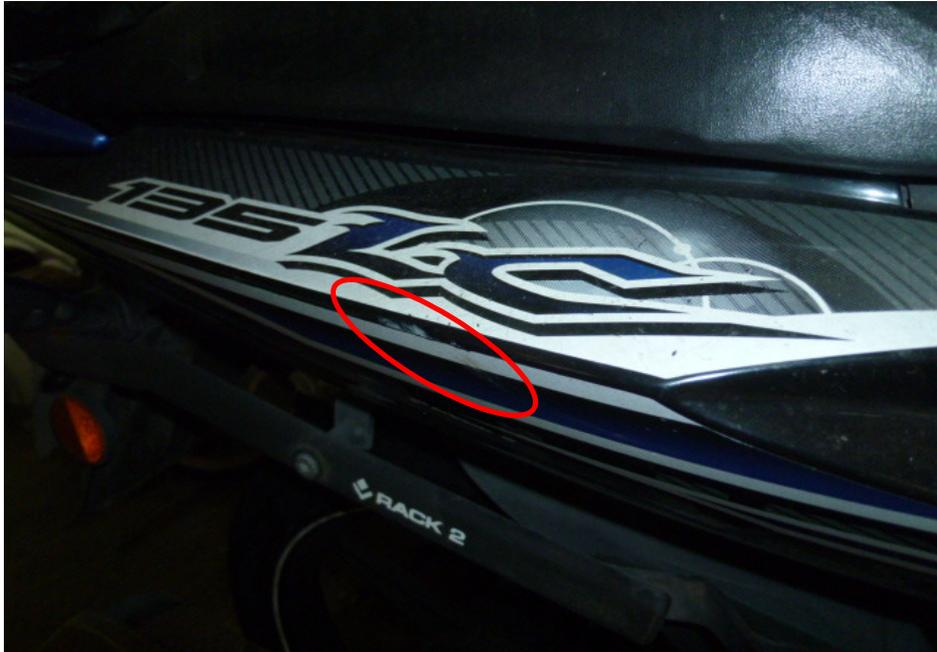
**Photo 10** shows a closer view of the right rear side cover which was amongst the body parts of the Motorcycle that had sustained damages of grazing nature as a result of the accident (circled).

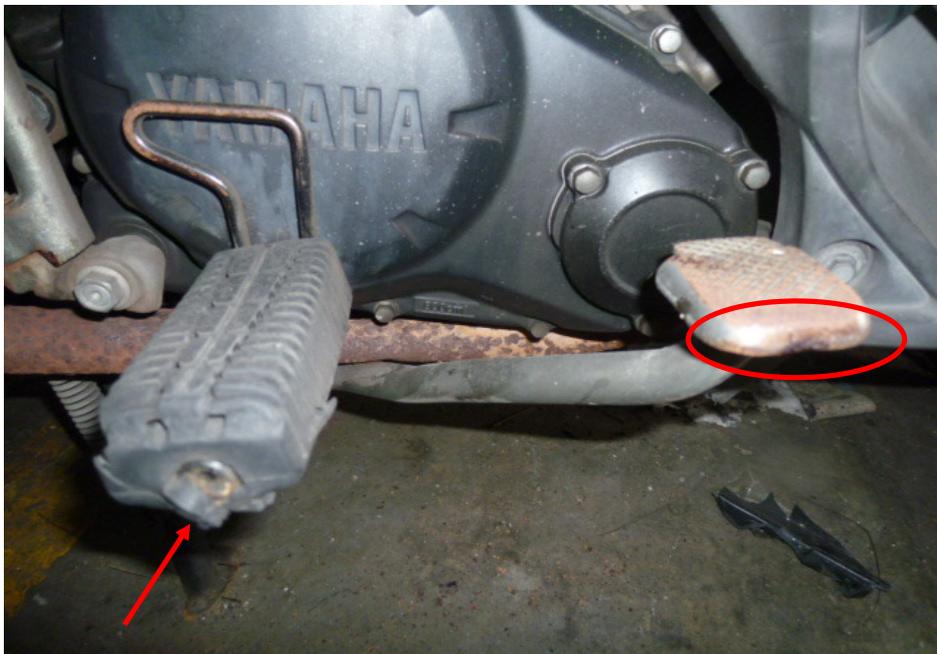
**Photo 11** shows a closer view of the rear brake pedal (circled) and right front footrest (arrowed) which were amongst the body parts of the Motorcycle that had sustained damage as a result of the accident.

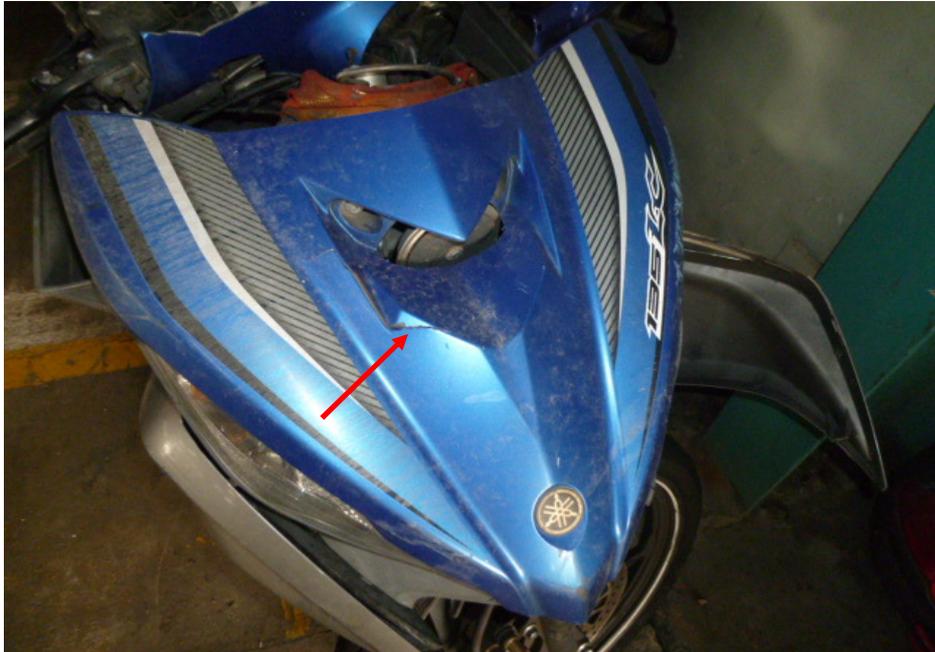
**Photo 12** shows the cracked front cowling of the Motorcycle at the time of our inspection (arrowed).

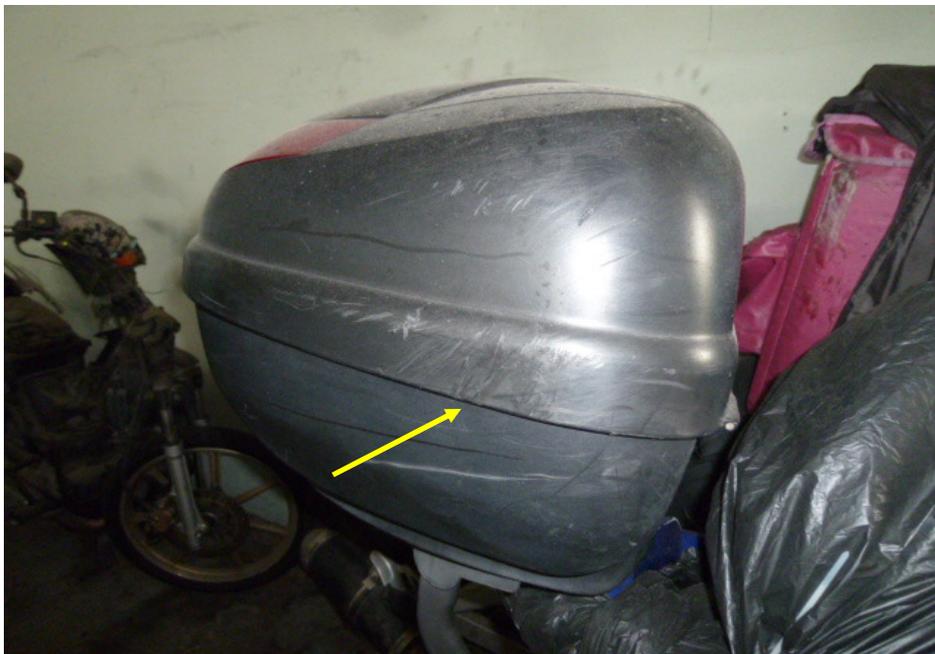
**Photo 13** shows a closer view of the top box which was amongst the body parts of the Motorcycle that had sustained damages of grazing nature as a result of the accident (arrowed).

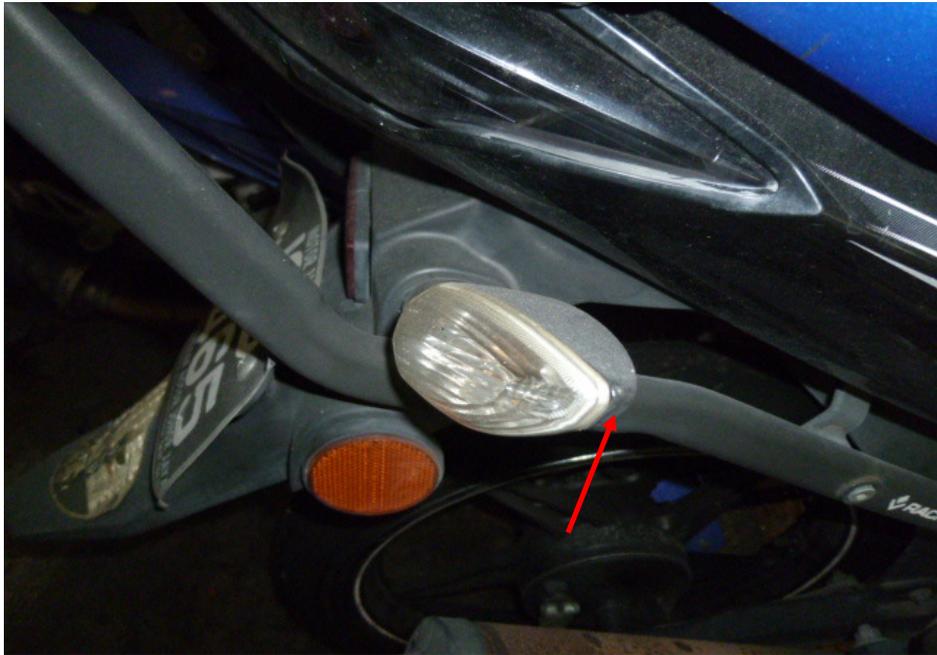
**Photo 14** shows a closer view of the deformed left rear signal lamp of the Motorcycle as a result of the accident (arrowed).

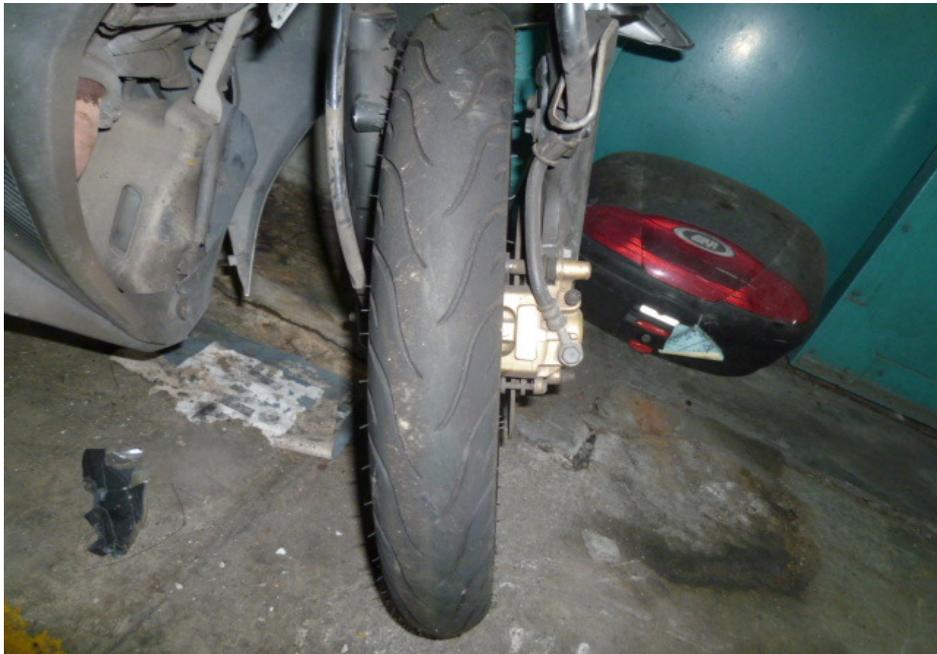
**Photo 15** shows the front tyre of the Motorcycle at the time of our inspection. The front tyre was observed to be in serviceable condition with remaining tread depth of approximately 3mm. The pattern of the tread was also clearly visible. There was no tear, burst mark(s) and/or punctured hole(s) on the sidewalls as well as across the tread of the front tyre.

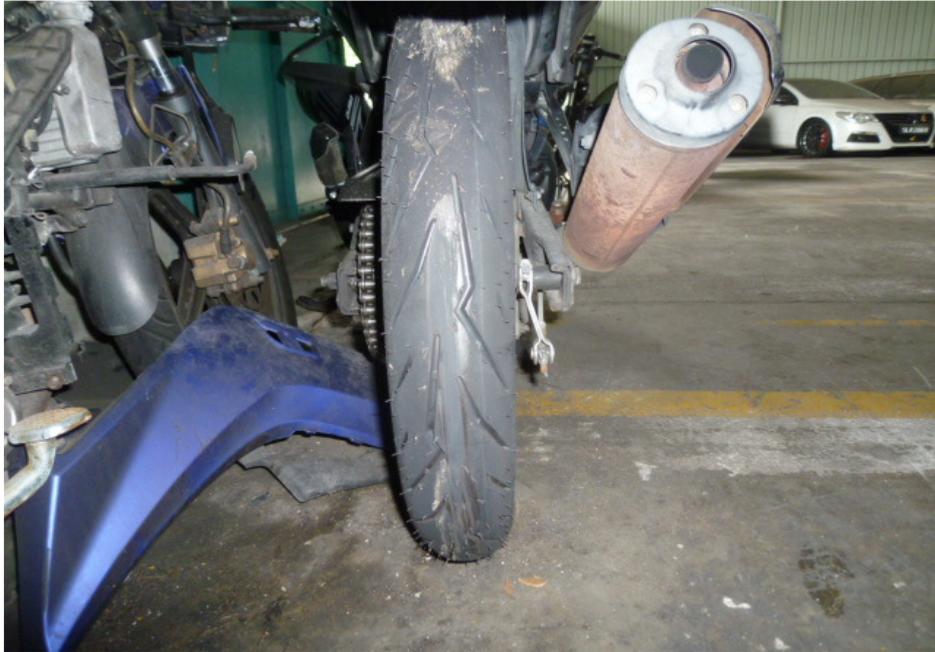
**Photo 16** shows the condition of the Motorcycle's rear tyre. The rear tyre was observed to be in serviceable condition with remaining tread depth of approximately 6mm. The tyre was also observed to be sufficiently inflated for vehicular operation. We did not observe any tear, burst mark(s) and/or punctured hole(s) on the sidewalls as well as across the tread of the rear tyre.

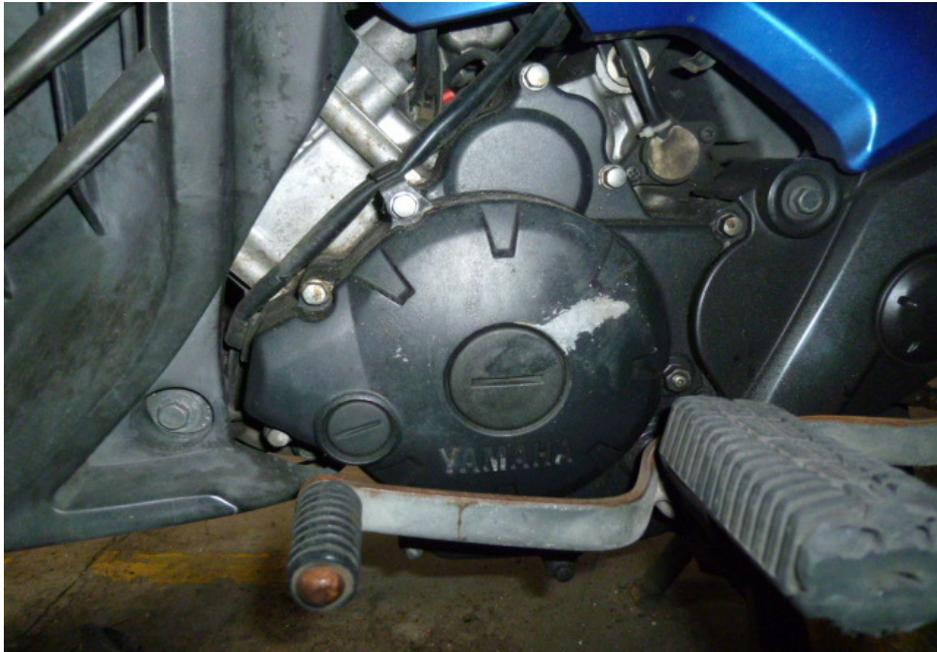
**Photo 17** shows the left side of the engine of the Motorcycle at the time of our inspection. The various engine related parts and components were found to be intact with no visible damage. There was also no sign(s) or indication(s) of fluid leak observed around the left engine area of the Motorcycle.

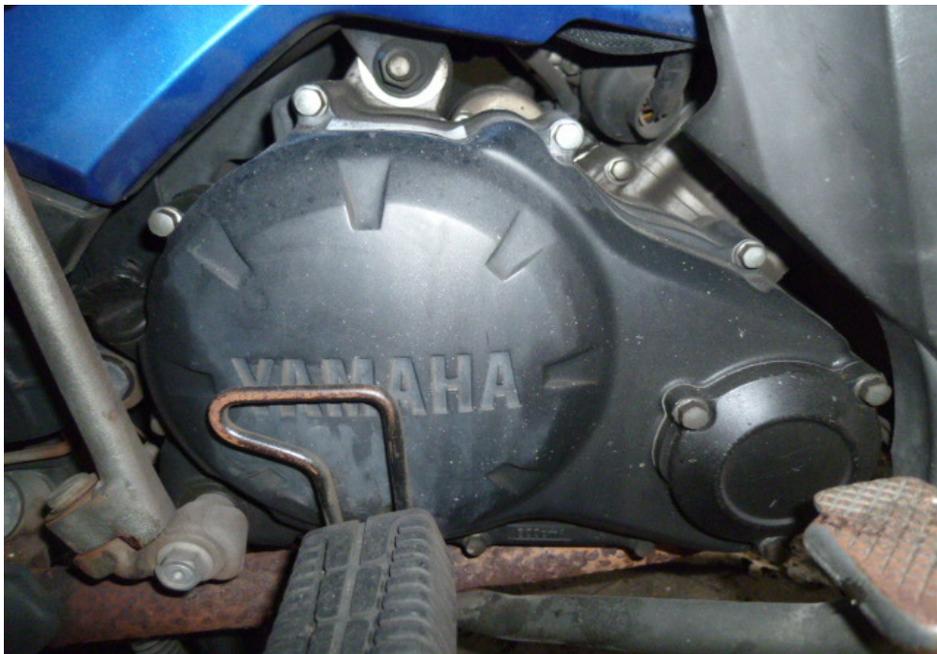
**Photo 18** shows the right side of the engine of the Motorcycle at the time of our inspection. The various engine related parts and components were found to be intact with no visible damage. There was also no sign(s) or indication(s) of fluid leak observed around the right engine area of the Motorcycle.

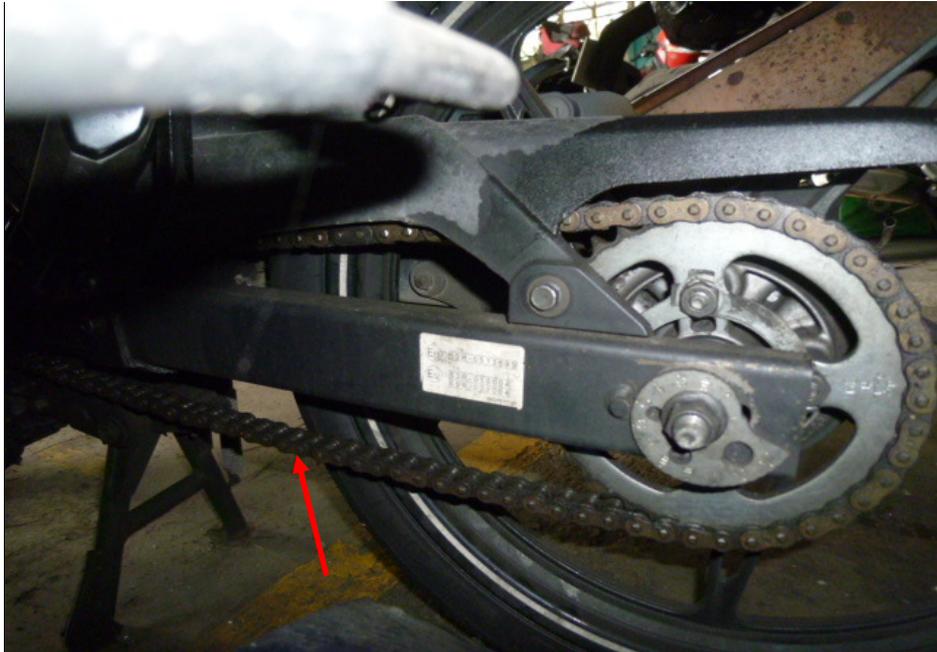
**Photo 19** shows the gear train (arrowed) of the Motorcycle, which was observed to be intact with no misalignment. It was also adequately lubricated for operating purposes. The gear train rotates the rear wheel of the Motorcycle.

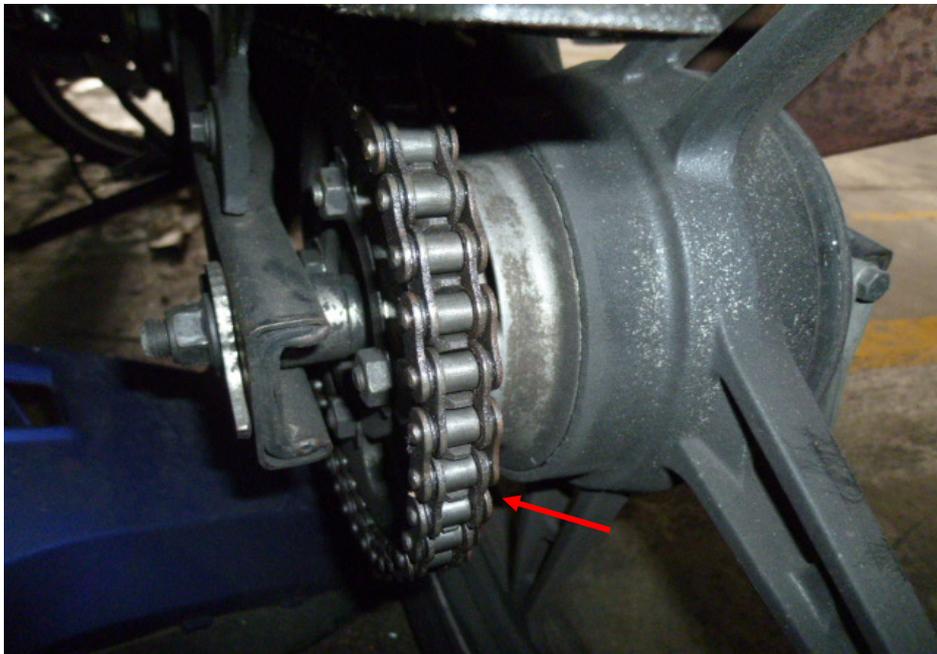
**Photo 20** shows the closer view of the gear train (arrowed) of the Motorcycle, which was observed to be intact with no misalignment. It was also adequately lubricated for operating purposes.

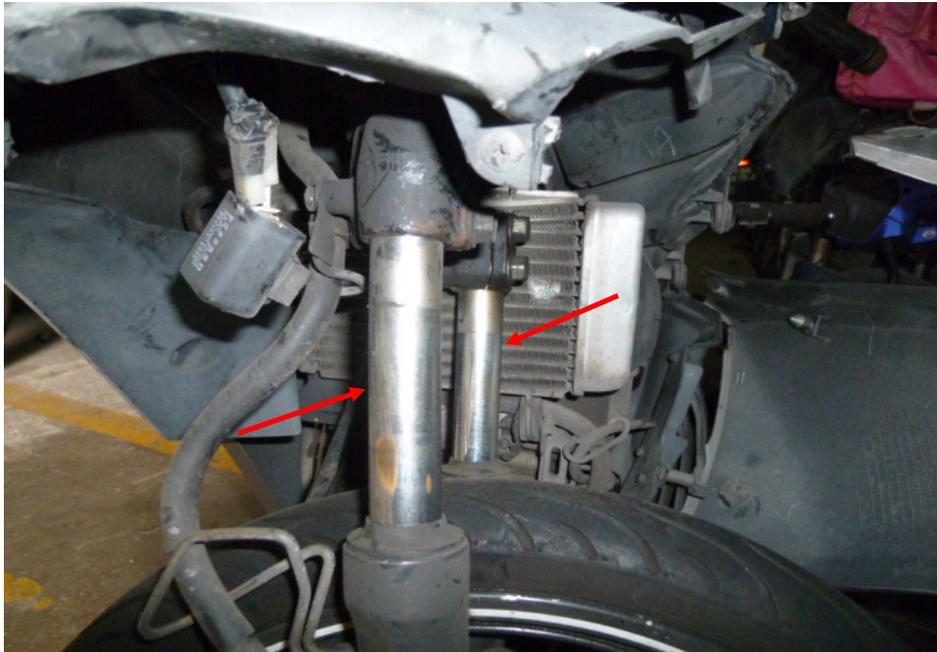
11. For this case, we were not able to conduct any test(s) on the steering system of the Motorcycle due to the damage to its front forks and steering stem. The front forks were observed to be bent inwards and the steering stem was observed to be broken as a result of the accident.

**Photo 21** shows a closer view of the front forks of the Motorcycle. The front forks were observed to be bent inwards (arrowed) as a result of the accident. We were hence not able to conduct any tests on the steering system of the Motorcycle.

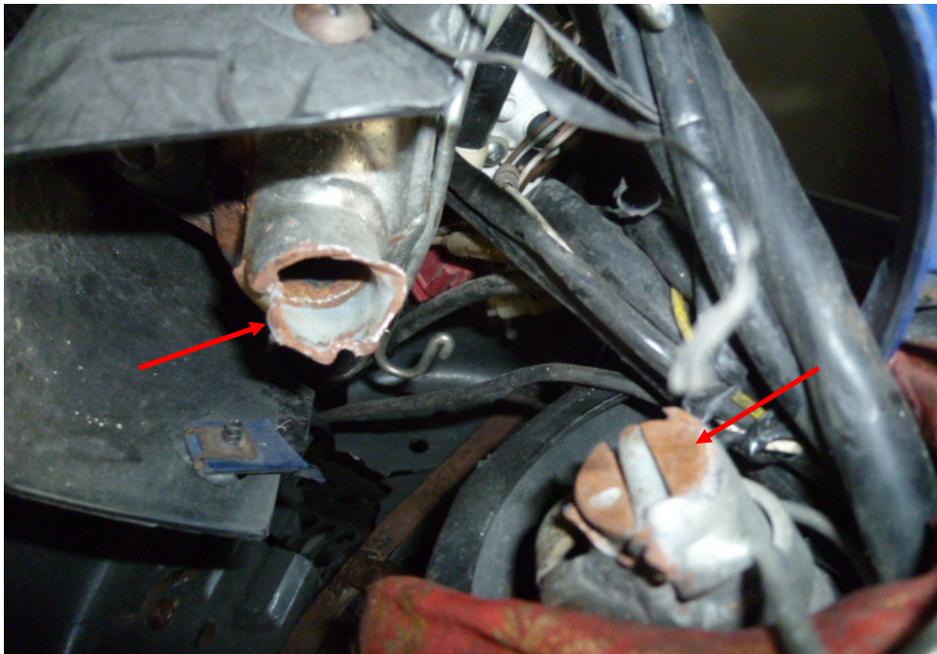
**Photo 22** shows a close up view of the steering stem of the Motorcycle. The steering stem (arrowed) was observed to be broken as a result of the accident. We were hence not able to conduct any tests on the steering system of the Motorcycle.

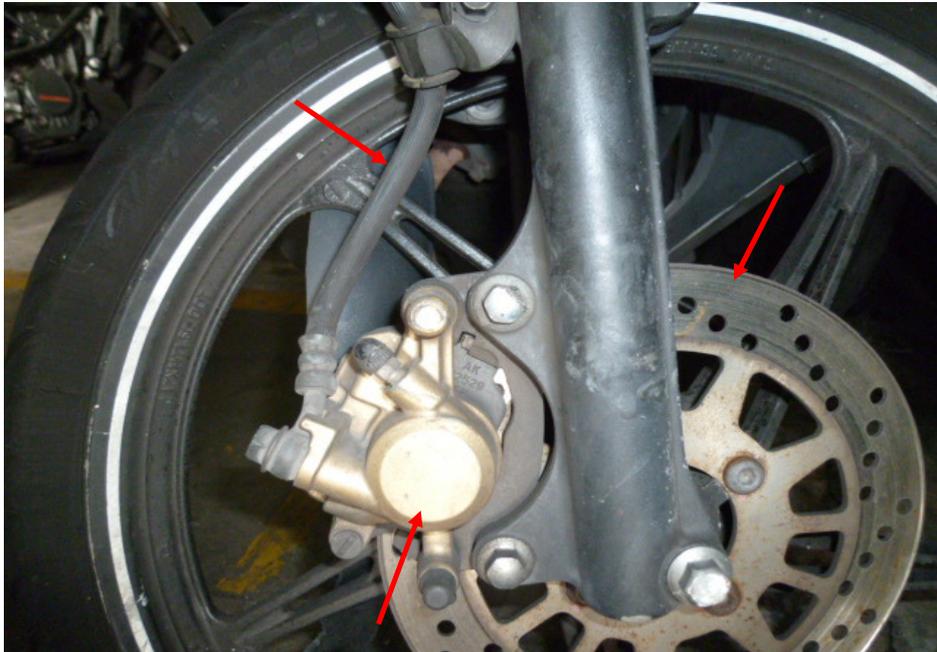
**Photo 23** shows a close up view of the front brake caliper, front brake disc and front brake hose (arrowed) of the Motorcycle, which are all part of the components in the hydraulic front brake system of the Motorcycle. Our visual checks of these various components had revealed all to be intact with no visible damage. No leakage of brake fluid was also observed.

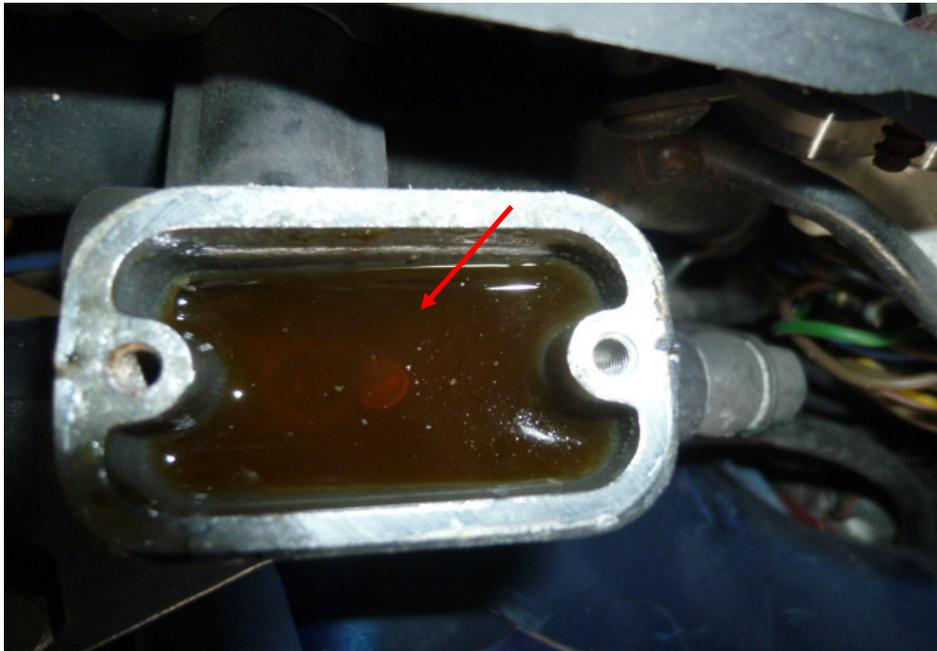
**Photo 24** shows the brake fluid reservoir for the front brake of the Motorcycle. The brake fluid was observed to be of sufficient level for operating purposes. However it was found to be slightly contaminated (arrowed).

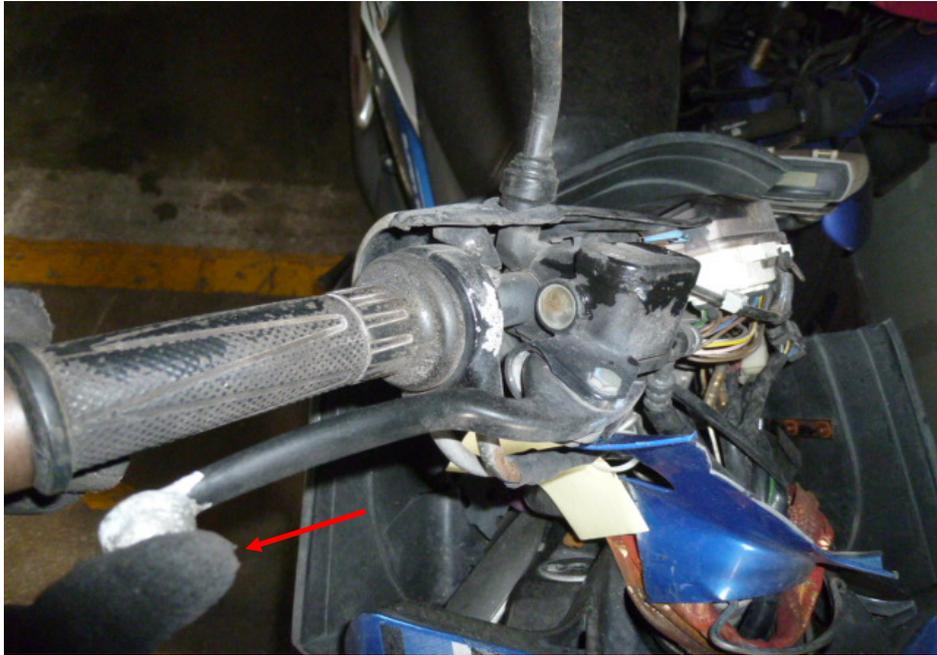
13. Static brake tests conducted on the Motorcycle had appeared to indicate that the brake system of the Motorcycle was in serviceable condition. There was some resistance felt (spongy like feel) upon pressing the front brake lever. This would indicate that there's no leakage of pressure/vacuum in the front brake system.

**Photo 25** shows the front brake lever being depressed. There was some resistance felt (spongy like feel) upon pressing the front brake lever (arrowed). This would indicate that there is no leakage of pressure/vacuum in the brake system.

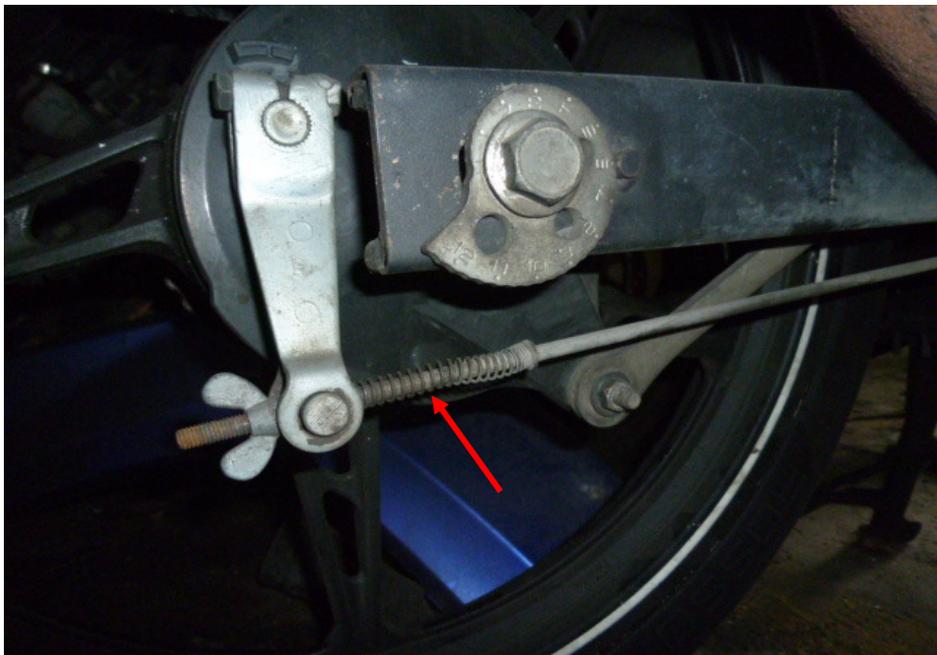
**Photo 26** shows the rear wheel of the Motorcycle. The type of brake system for the rear wheel was of a mechanical type, controlled by the brake foot pedal of the Motorcycle. Our checks of the cable (arrowed), spring and drum which are all part of the components in the rear brake system of the Motorcycle reveal all to be intact and without damage.
