Your Ref: TP/IP/07067/2021  
Our Ref : CI/TPD22005250/N

**Fatal Accident Investigation Team**

**INSPECTION REPORT OF MOTORCYCLE FBQ 4093J**

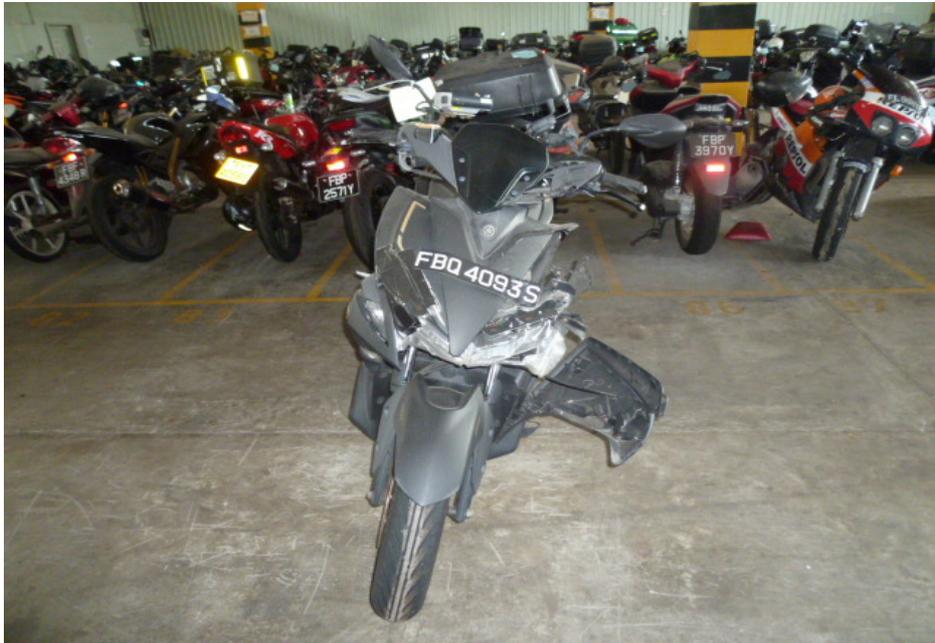
**Photo 1** shows a general view of the frontal portion of the Motorcycle at the time of our inspection. The Motorcycle was observed to have sustained damages all around. The mileage of the Motorcycle could not be recorded at the time of our inspection due to a flat battery in the smart key remote transponder. The body parts that were found to have been damaged include its head cowl, front brake lever, right handlebar end, side mirrors, side cowlings, side lower cowlings, left pillion foot peg, main stand, rear side covers and exhaust muffler heat shield, amongst others.

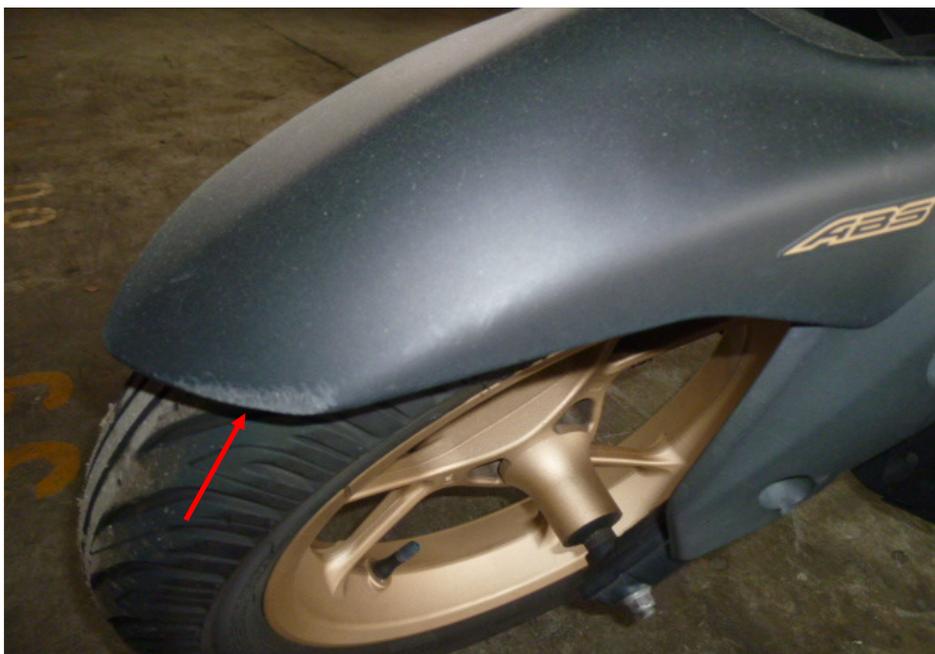
**Photo 2** shows a close-up view of the grazed front mudguard of the Motorcycle as a result of the accident (arrowed).

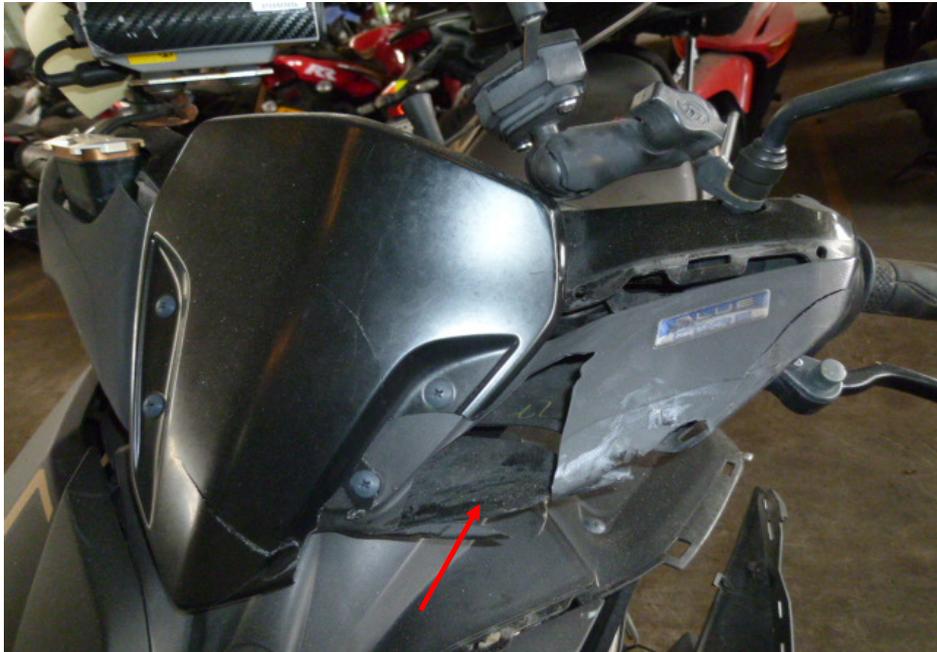
**Photo 3** shows a close-up view of the cracked head cowl of the Motorcycle at the time of our inspection (arrowed).

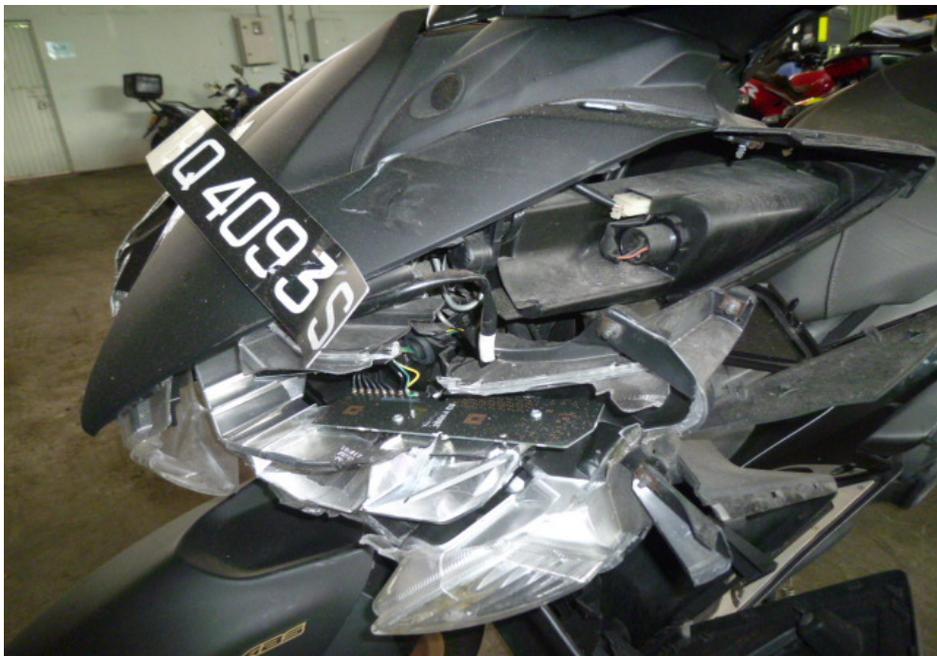
**Photo 4** shows a general view of the front cowl of the Motorcycle at the time of our inspection. The Motorcycle was observed to have sustained damages all around. The body parts that were found to have been damaged include its front brake lever, right handlebar end, side cowlings, side lower cowlings, pillion footpegs, side stand, rear side covers and exhaust muffler, amongst others as a result of the accident.

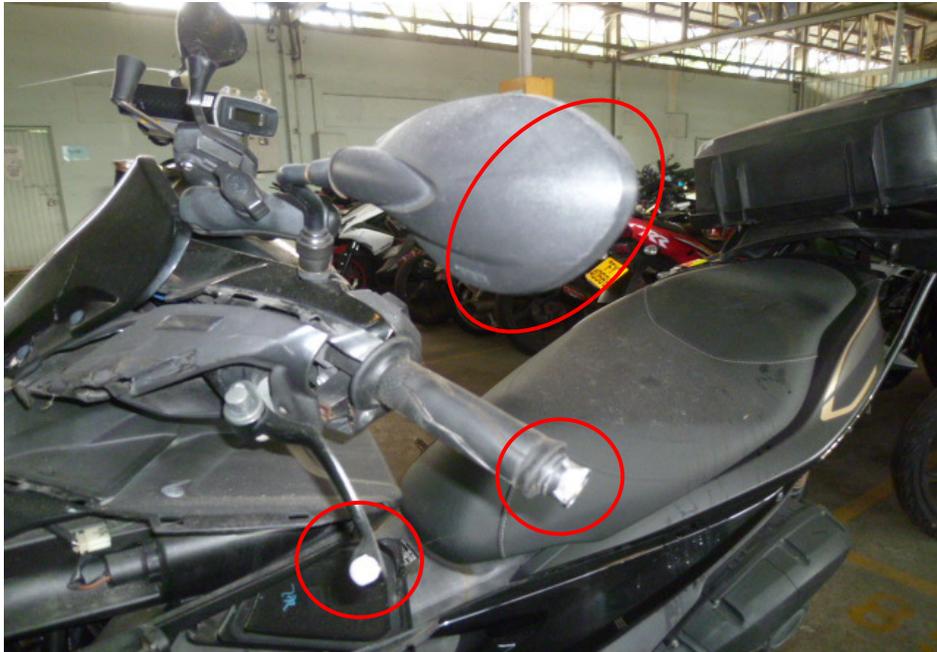
**Photo 5** shows a closer view of the left handlebar end, left side mirror and rear brake lever of the Motorcycle which were observed to be damaged due to the accident (circled).

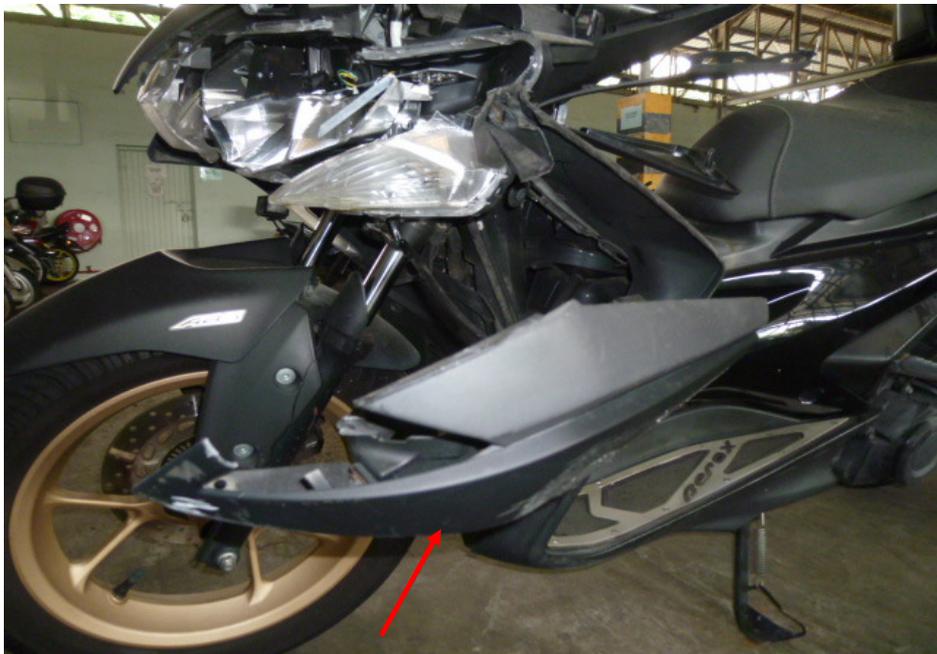
**Photo 6** shows a close-up view of the cracked left side cowling of the Motorcycle at the time of our inspection (arrowed).

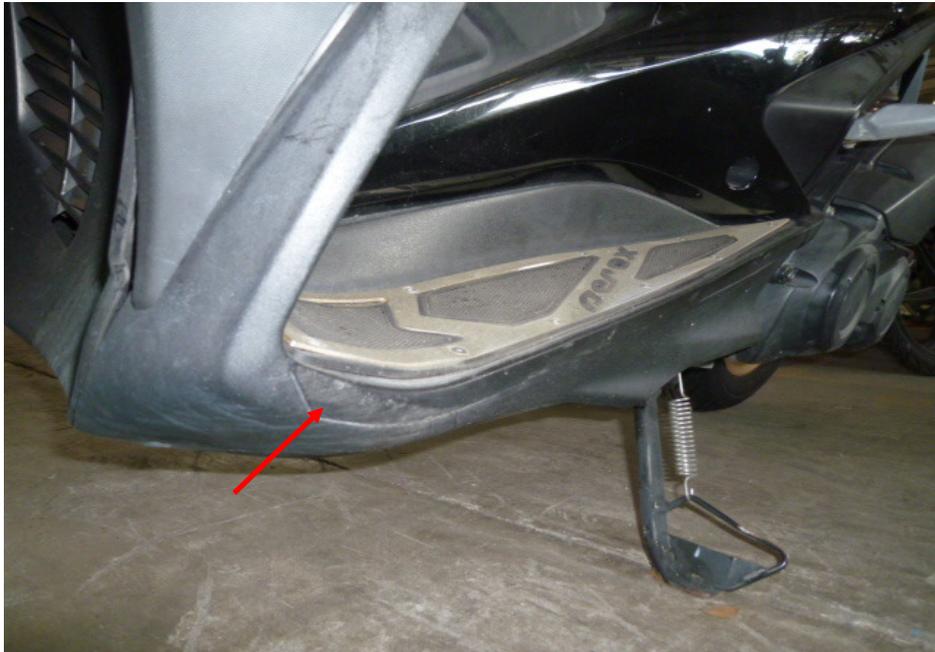
**Photo 7** shows a close-up view of the grazed left lower side cowling of the Motorcycle as a result of the accident (arrowed).

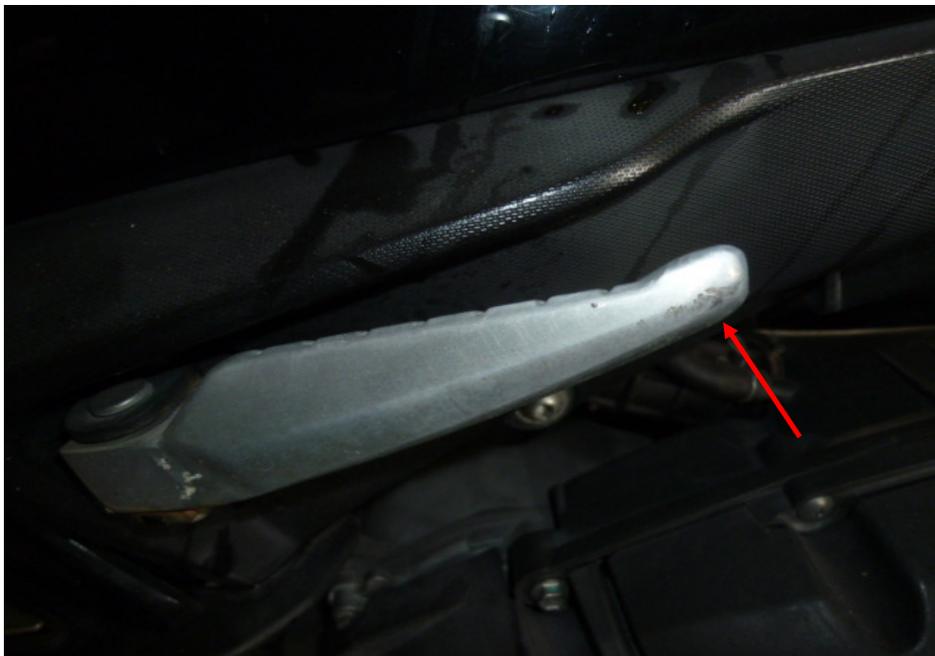
**Photo 8** shows a closer view of the grazed left pillion foot peg (arrowed) of the Motorcycle as a result of the accident.

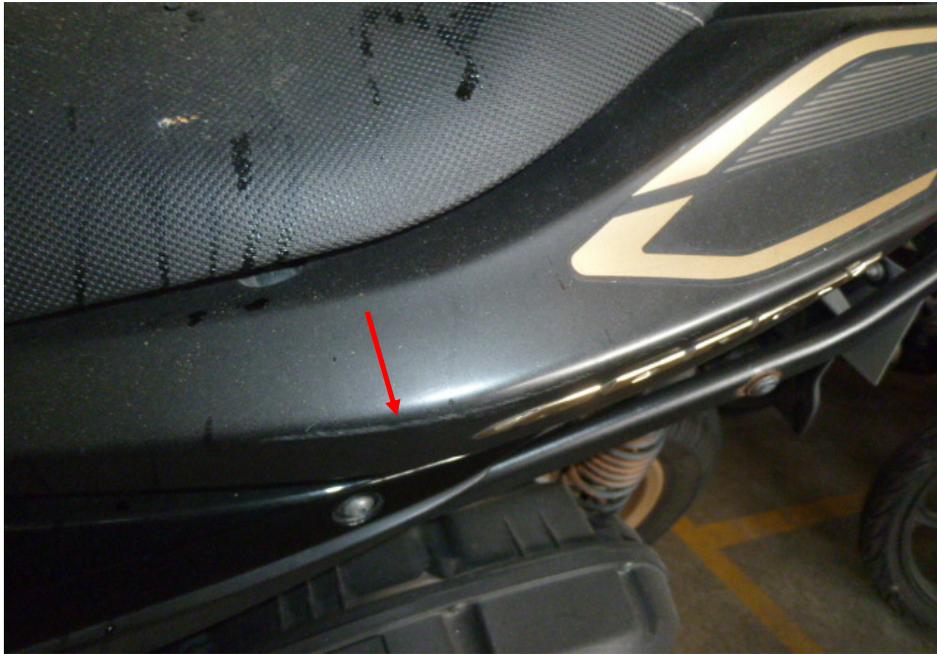
**Photo 9** shows a closer view of the grazed left rear side cover of the Motorcycle as a result of the accident (arrowed).

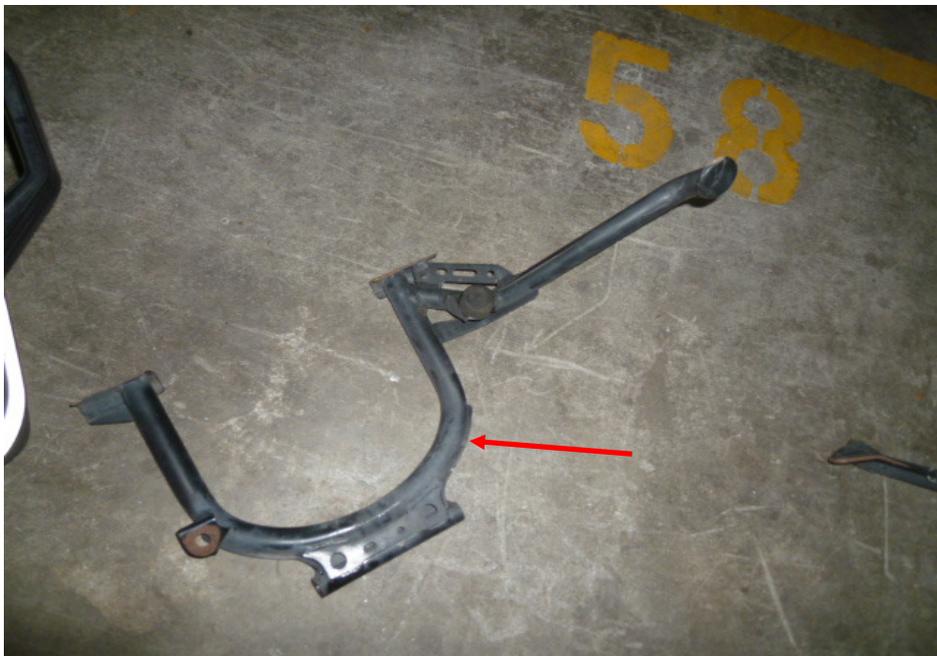
**Photo 10** shows a closer view of the broken main stand of the Motorcycle as a result of the accident (arrowed).

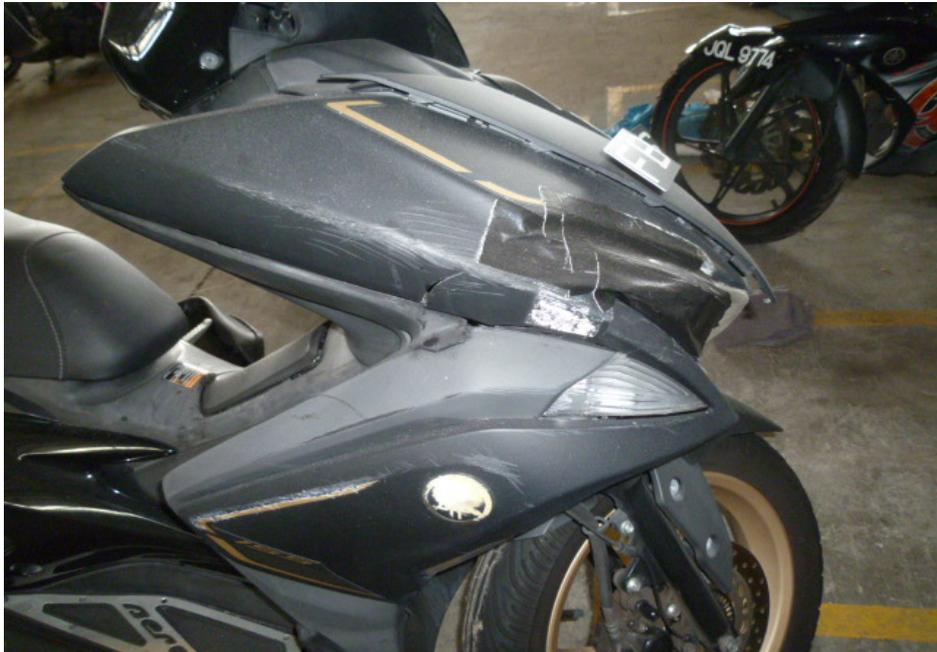
**Photo 11** shows the cracked right side cowling of the Motorcycle as a result of the accident.

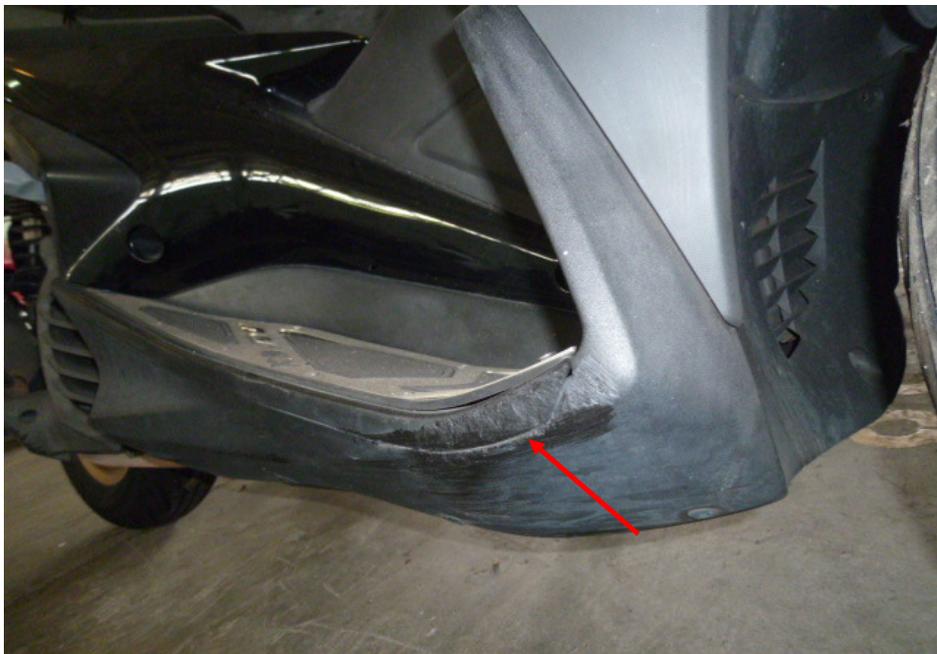
**Photo 12** shows a close-up view of the grazed right lower side cowling of the Motorcycle as a result of the accident.

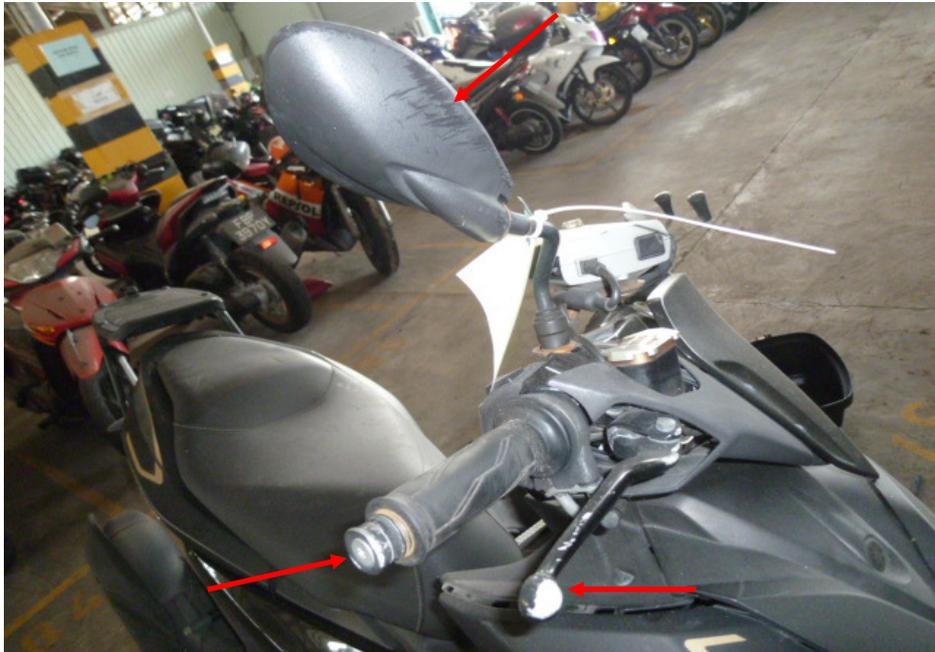
**Photo 13** shows a closer view of the right handlebar end, right side mirror and front brake lever of the Motorcycle which were observed to be damaged due to the accident (arrowed).

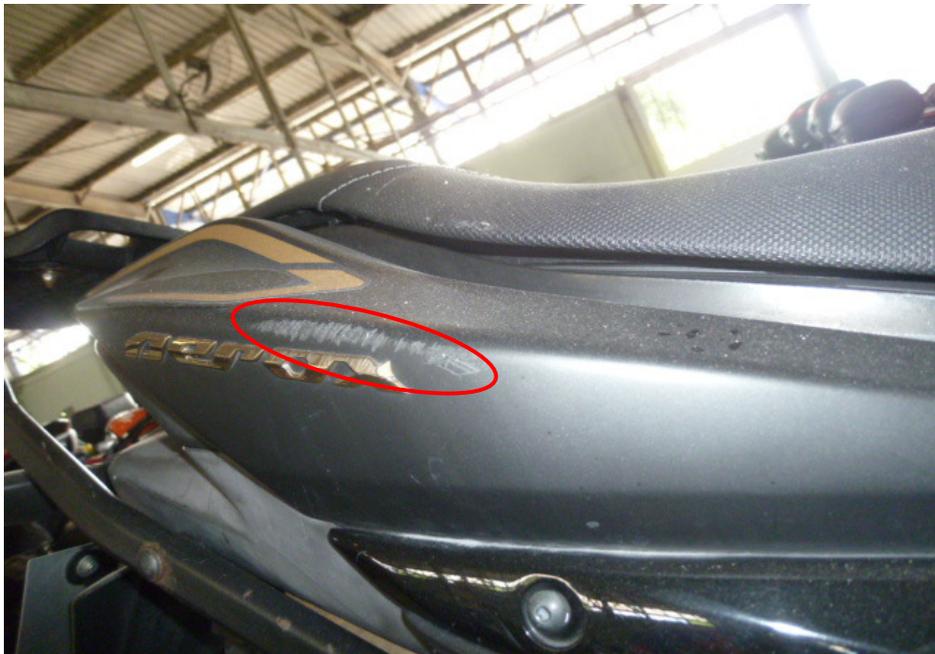
**Photo 14** shows a closer view of the grazed right rear side cover (circled) of the Motorcycle as a result of the accident.

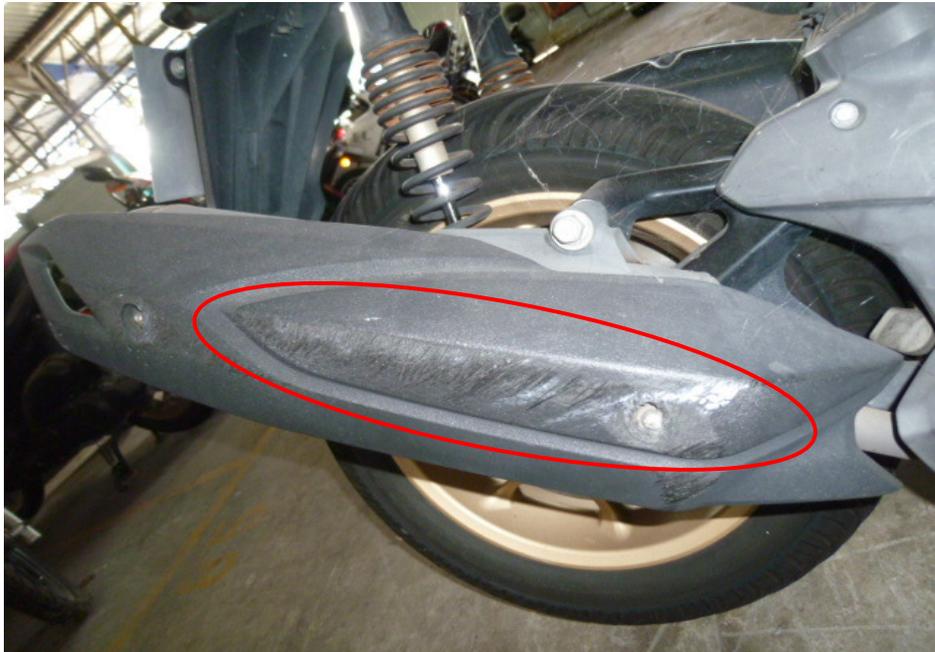
**Photo 15** shows a closer view of the grazed exhaust muffler heat shield of the Motorcycle as a result of the accident (circled).

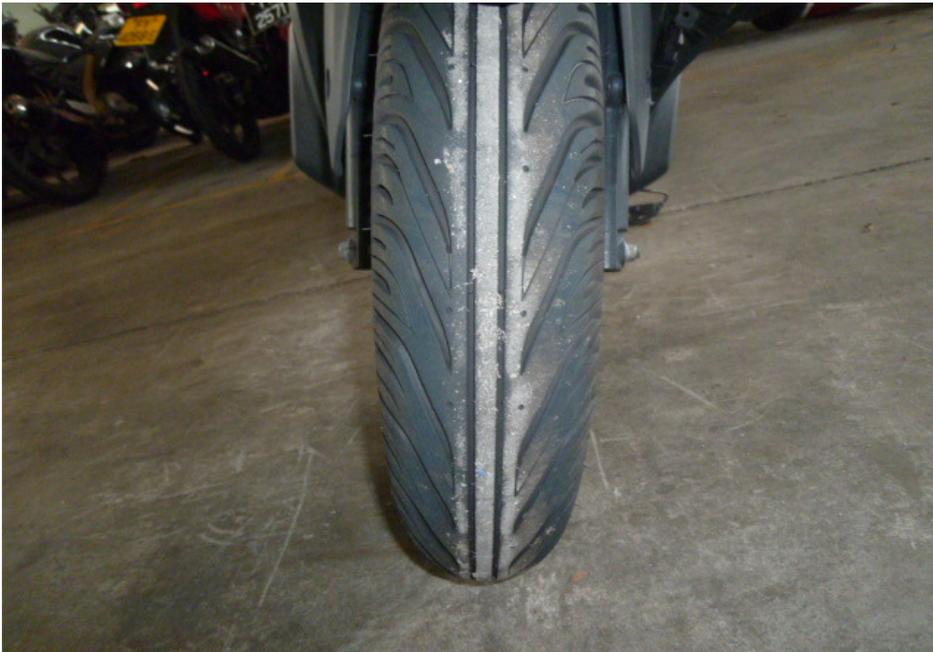
**Photo 16** shows the condition of the Motorcycle's front tyre. The front tyre was observed to be in serviceable condition with remaining tread depth of approximately 5mm. There was no tear, burst mark(s) and/or punctured hole(s) on the sidewalls as well as across the tread of the front tyre.

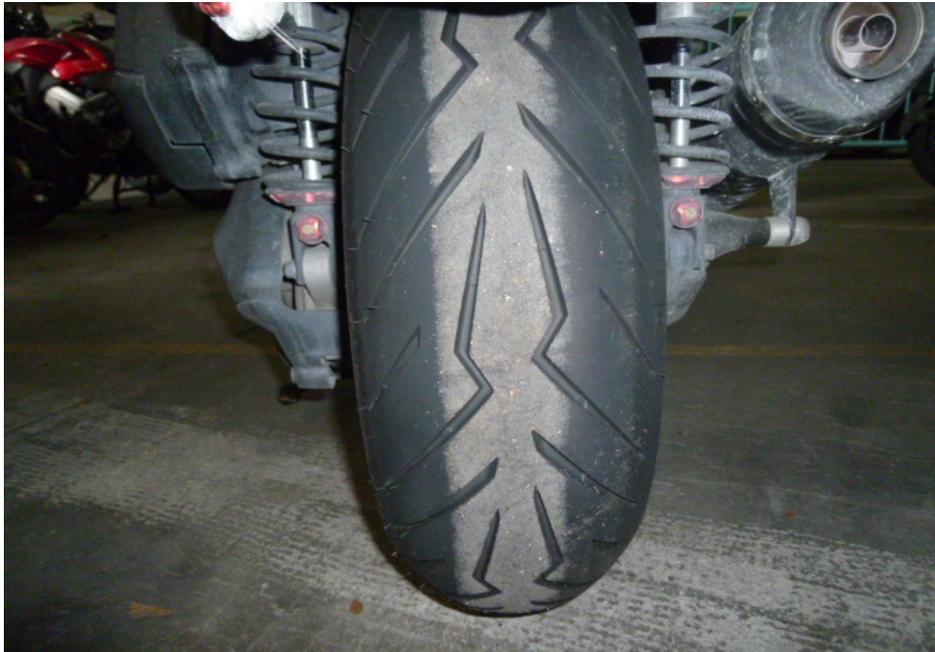
**Photo 17** shows the condition of the Motorcycle's rear tyre. The rear tyre was observed to be in serviceable condition with remaining tread depth of approximately 8mm. The tyre was also observed to be sufficiently inflated for vehicular operation. We did not observe any tear, burst mark(s) and/or punctured hole(s) on the sidewalls as well as across the tread of the rear tyre.

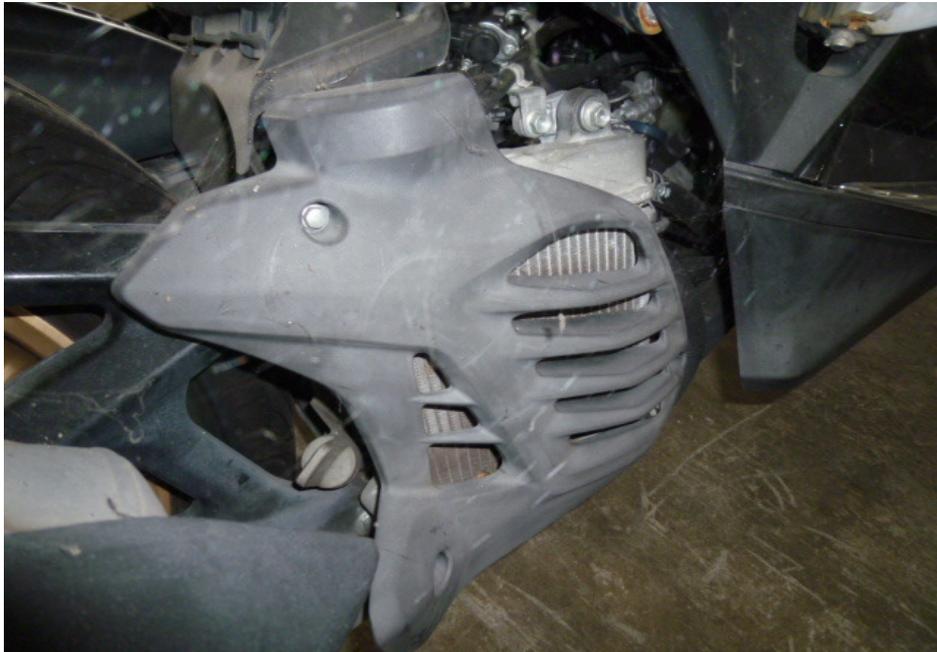
**Photo 18** shows the right side of the engine of the Motorcycle at the time of our inspection. The various engine related parts and components were found to be intact with no visible damage. There was also no sign(s) or indication(s) of fluid leak observed around the right engine area of the Motorcycle.

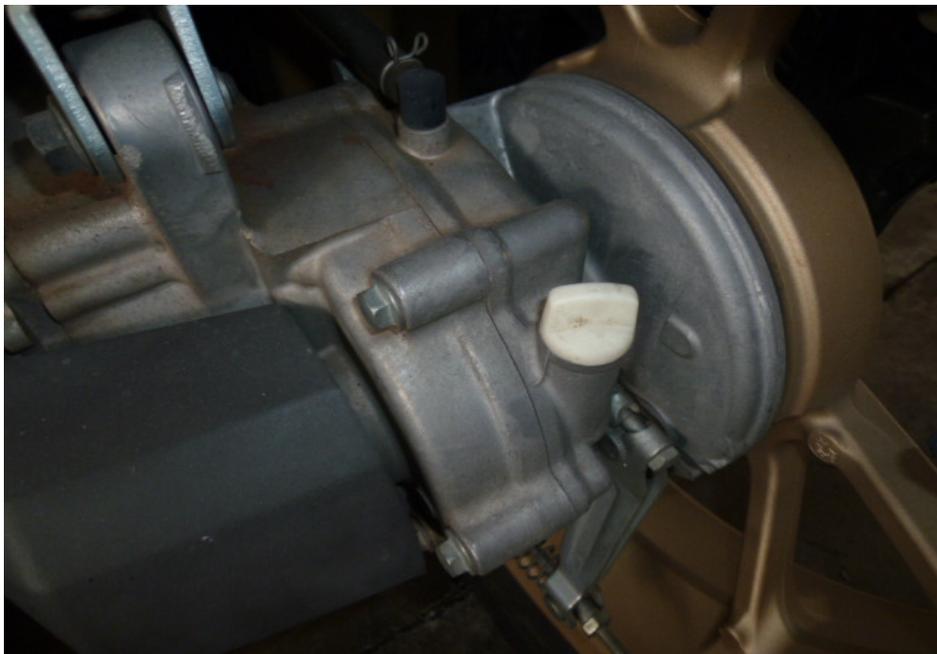
**Photo 19** shows the left side of the engine of the Motorcycle at the time of our inspection. The various engine related parts and components were found to be intact with no visible damage. There was also no sign(s) or indication(s) of fluid leak observed around the left engine area of the Motorcycle.

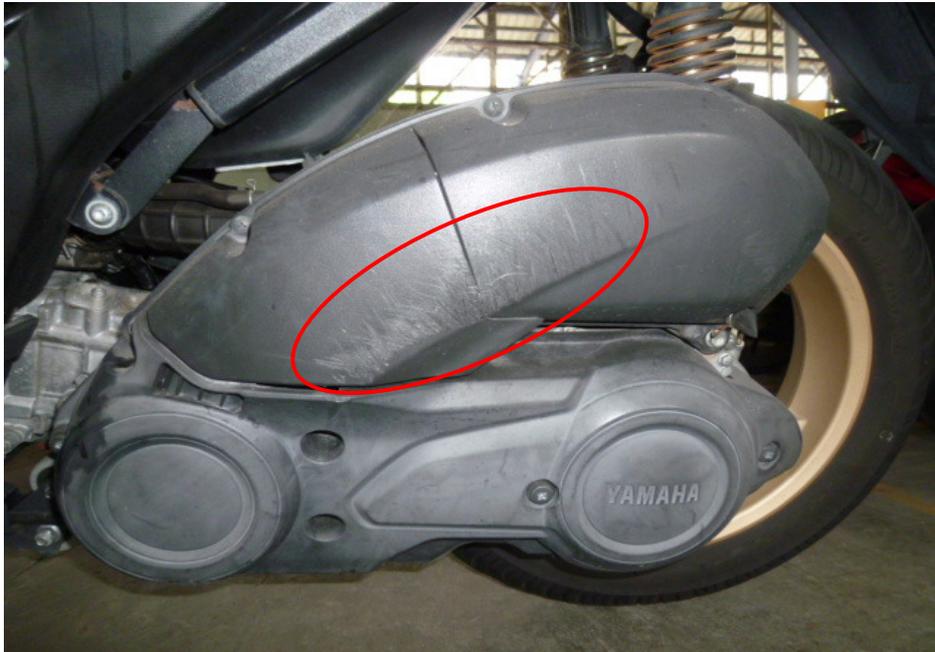
**Photo 20** shows the drive train of the Motorcycle which was found to be intact without any misalignment. However the drive train cover had sustained damages of grazing nature as a result of the accident (circled). Upon examination of the Motorcycle's engine area, we had observed that the various engine related parts and components were intact with no visible damage. There was also no sign(s) or indication(s) of fluid leak observed around the engine area of the Motorcycle.

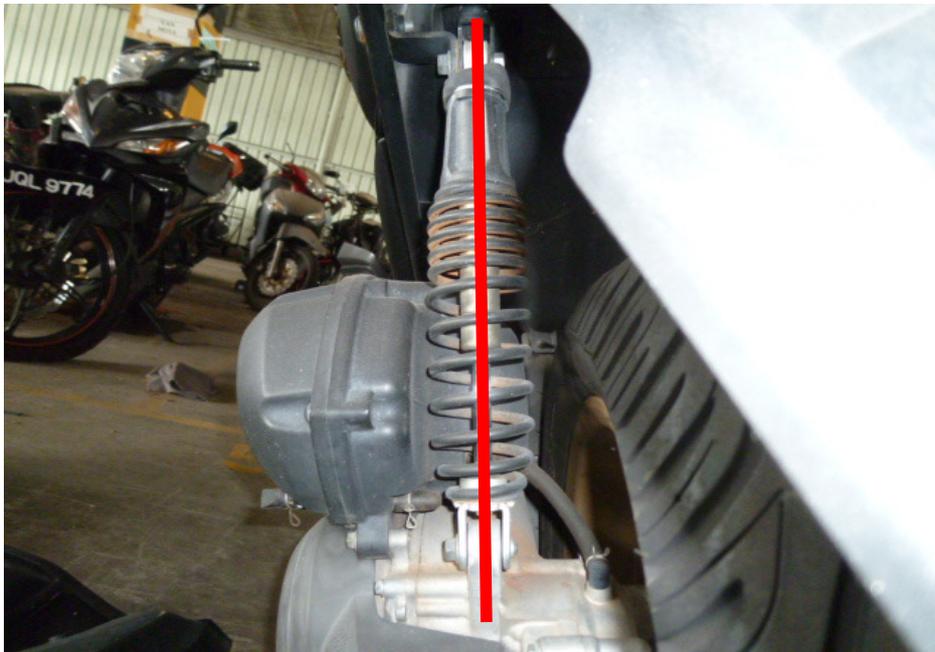
**Photo 21** shows the left shock absorber of the Motorcycle which was found to be intact without any misalignment.

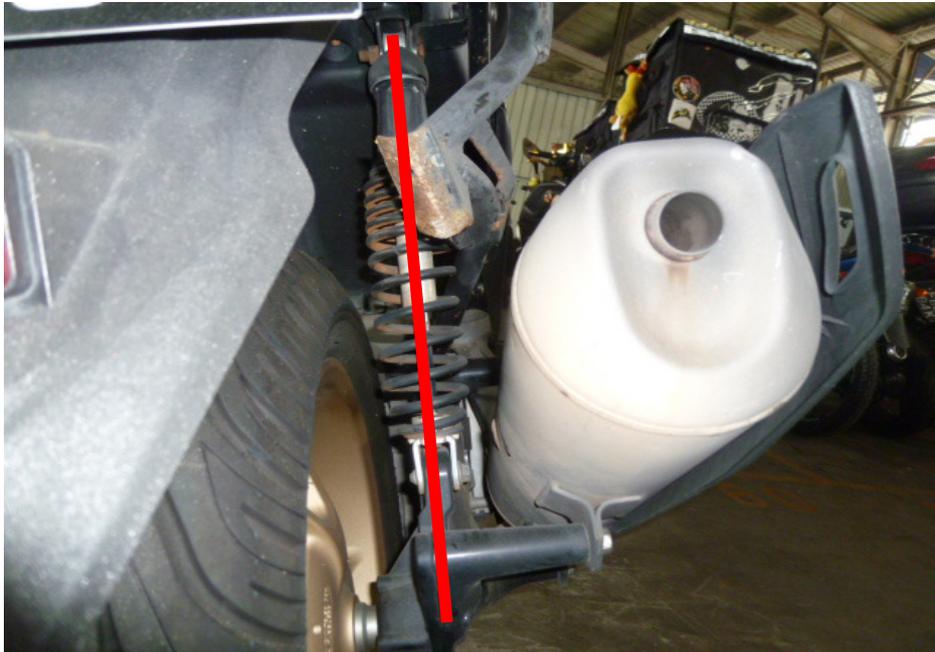
**Photo 22** shows the right shock absorber of the Motorcycle which was found to be intact without any misalignment.

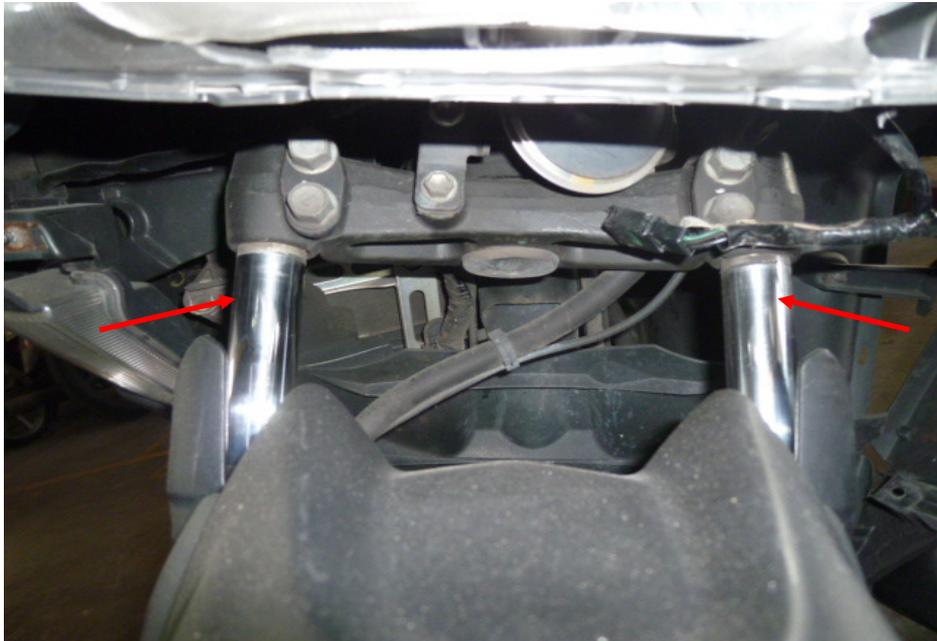
**Photo 23** shows the front forks (arrowed) of the Motorcycle. The front forks and fork brackets of the Motorcycle were both found to be intact and undamaged. Turning the Motorcycle's handle bar towards the left and right did not produce any abnormal free play and/or resistance. The steering system of the Motorcycle was in serviceable condition at the time of our inspection.

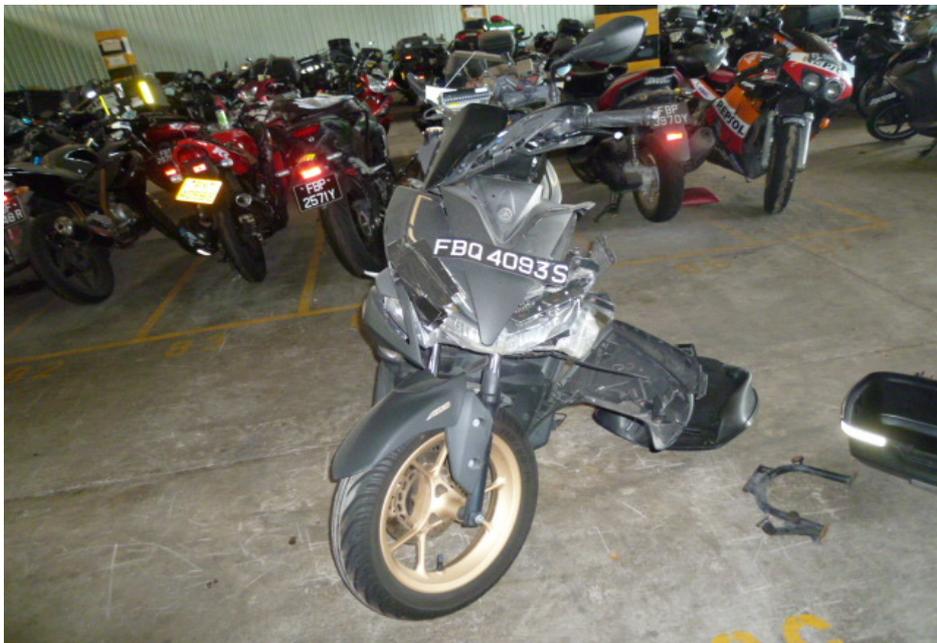
**Photo 24** shows the front wheel of the Motorcycle turned towards its full right. Turning the Motorcycle's handle bar towards the left and right did not produce any abnormal free play and/or resistance. This would indicate that the steering system of the Motorcycle was in serviceable condition at the time of our inspection.

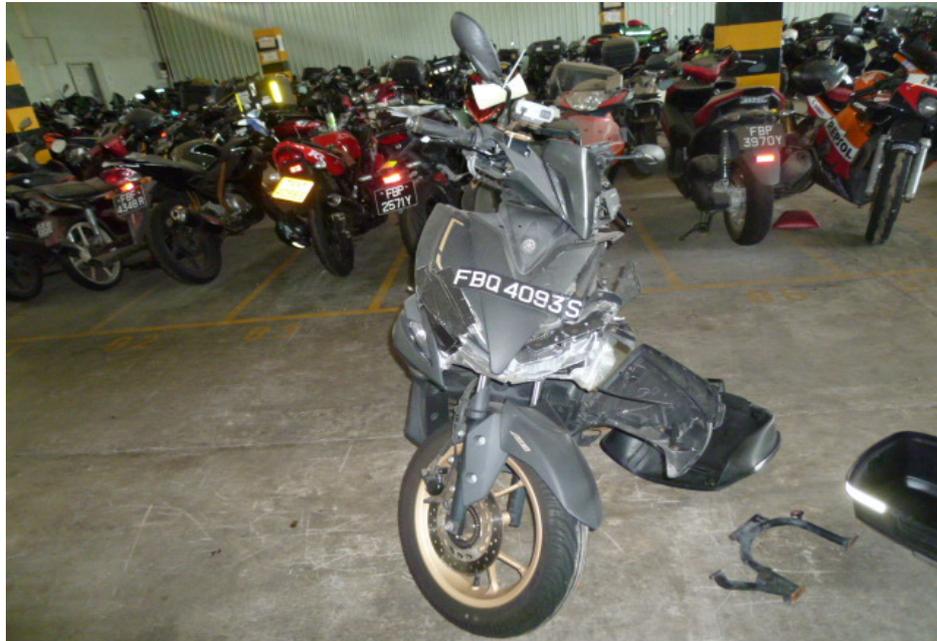
**Photo 25** shows the front wheel of the Motorcycle turned towards its full left. Turning the Motorcycle's handle bar towards the left and right did not produce any abnormal free play and/or resistance. This would indicate that the steering system of the Motorcycle was in serviceable condition at the time of our inspection.

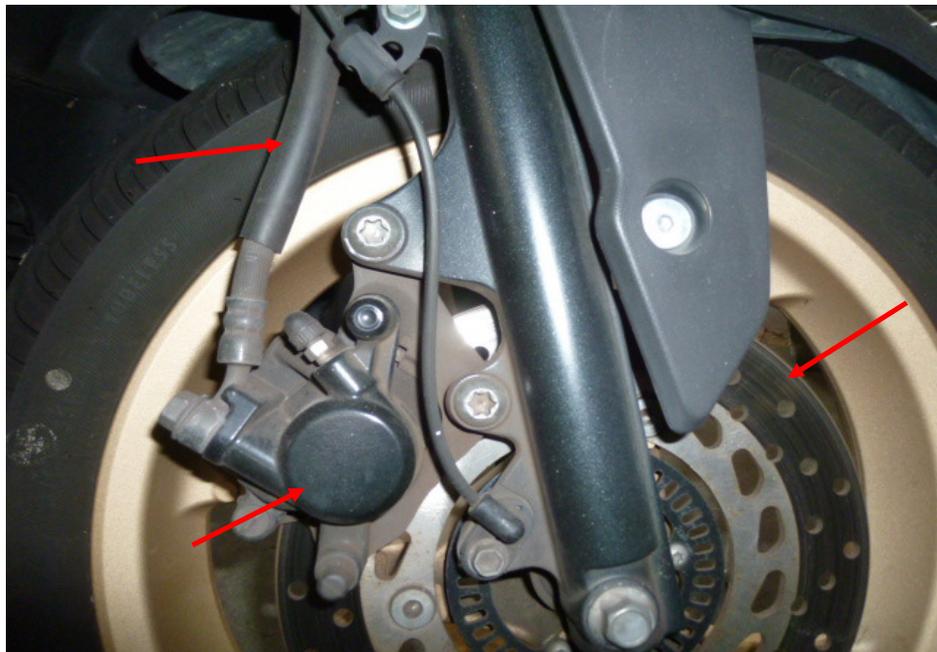
**Photo 26** shows a close up view of the front brake caliper, front brake disc and front brake hose (arrowed) of the Motorcycle, which are all part of the components in the hydraulic front brake system of the Motorcycle. Our visual checks of these various components had revealed all to be intact with no visible damage. No leakage of brake fluid was also observed.

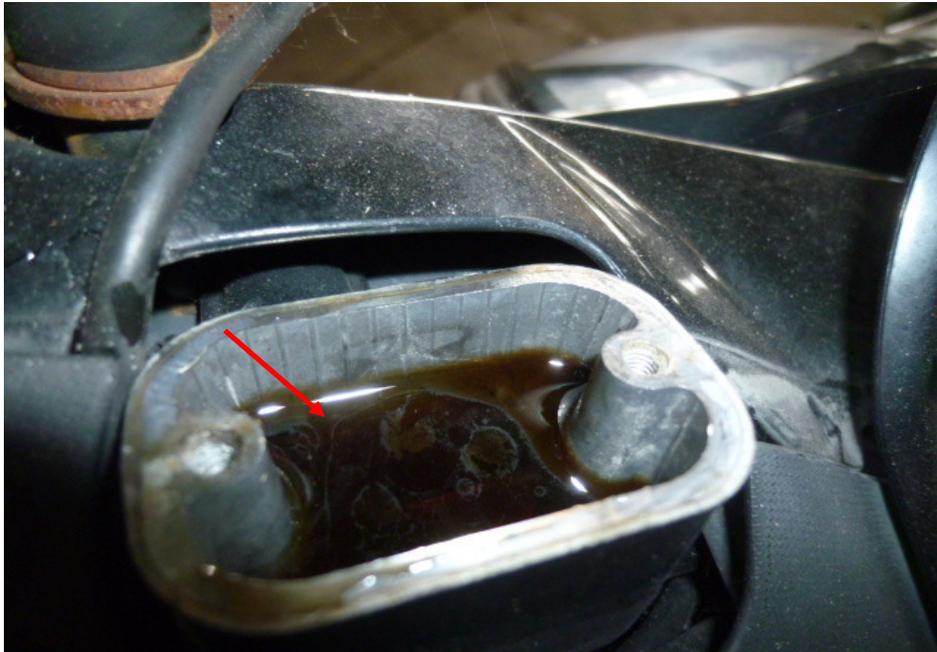
**Photo 27** shows the brake fluid reservoir for the front brake of the Motorcycle. The brake fluid was observed to be of sufficient level for operational purposes. However it was found to be slightly contaminated (arrowed).

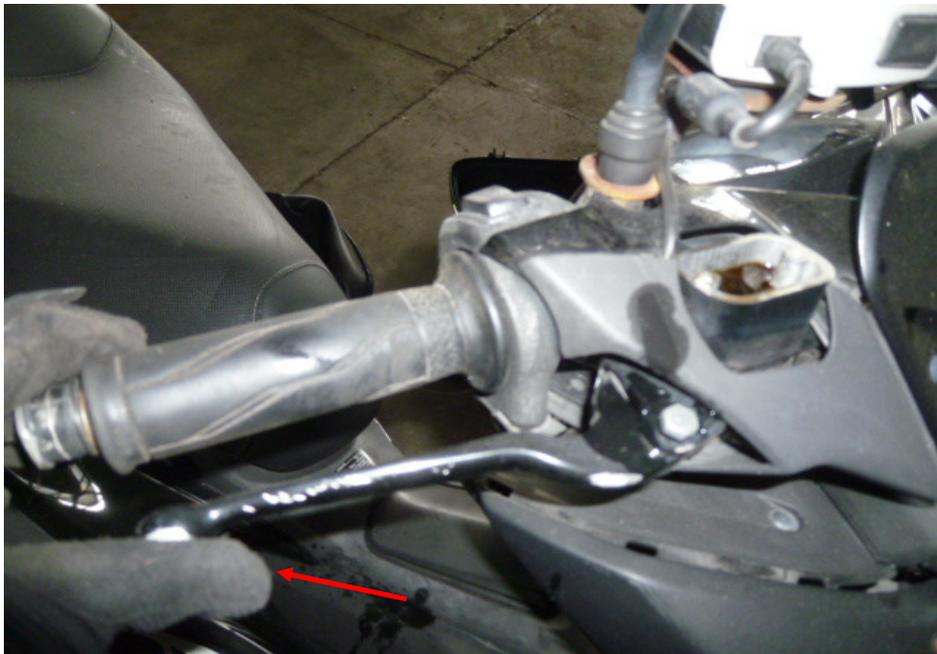
**Photo 28** shows the front brake lever being depressed. There was some resistance felt (spongy like feel) upon pressing the front brake lever (arrowed). This would indicate that there is no leakage of pressure/vacuum in the brake system.

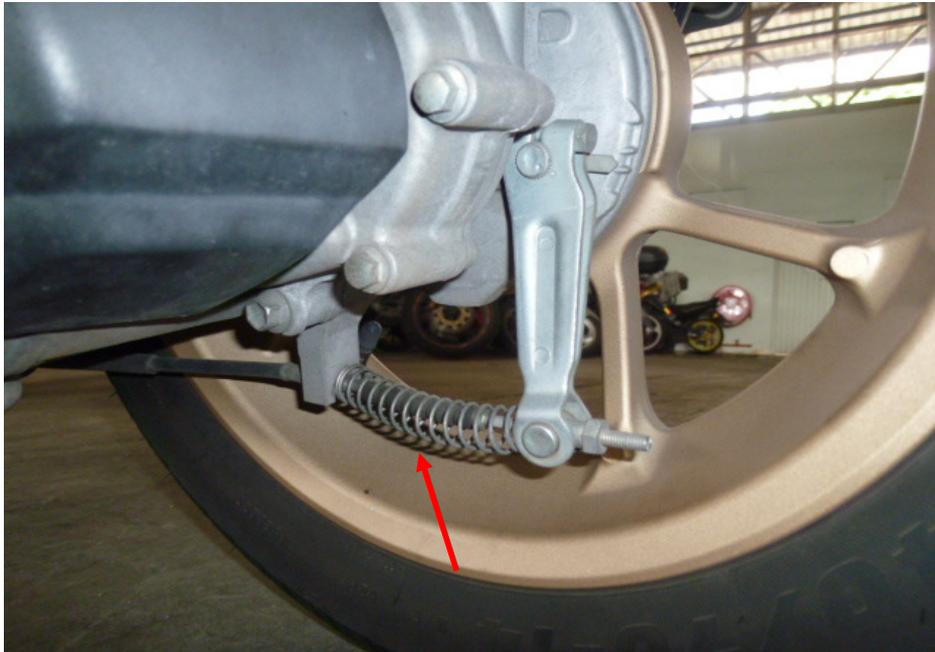
**Photo 29** shows the rear wheel of the Motorcycle. The type of brake system for the rear wheel was of a mechanical type, controlled by the brake foot pedal of the Motorcycle. Our checks of the cable (arrowed), spring and drum which are all part of the components in the rear brake system of the Motorcycle reveal all to be intact and without damage.
