Your Ref: TP/IP/08101/2022  
Our Ref : CI/TPD22005252/N

**Fatal Accident Investigation Team**

**INSPECTION REPORT OF MOTORCYCLE FBL 3505D**

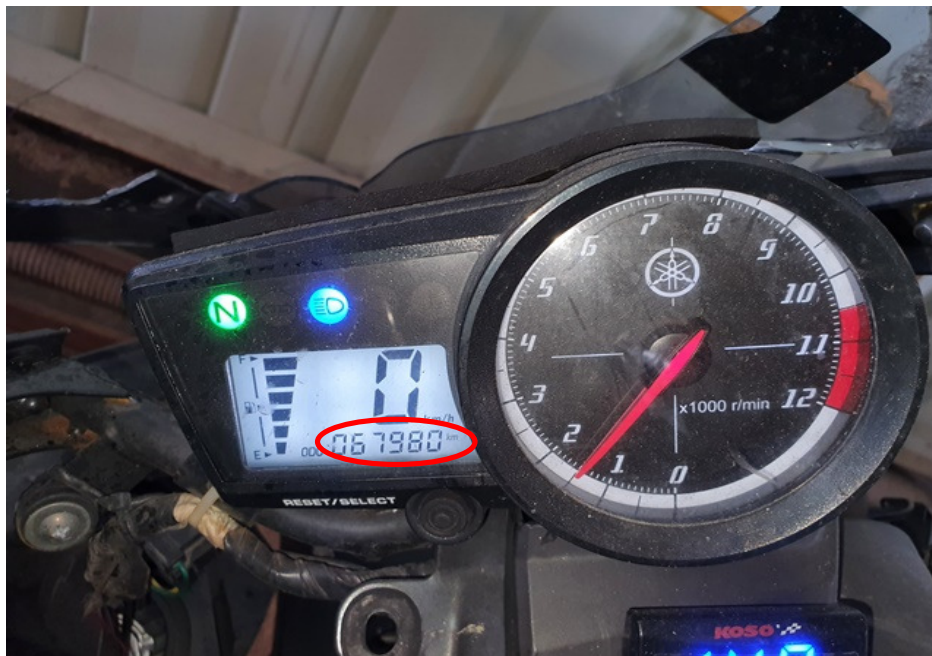
**Photo 1** shows the speedometer gauge of the Motorcycle where the mileage recorded at the time of our inspection was 67, 980km (circled).

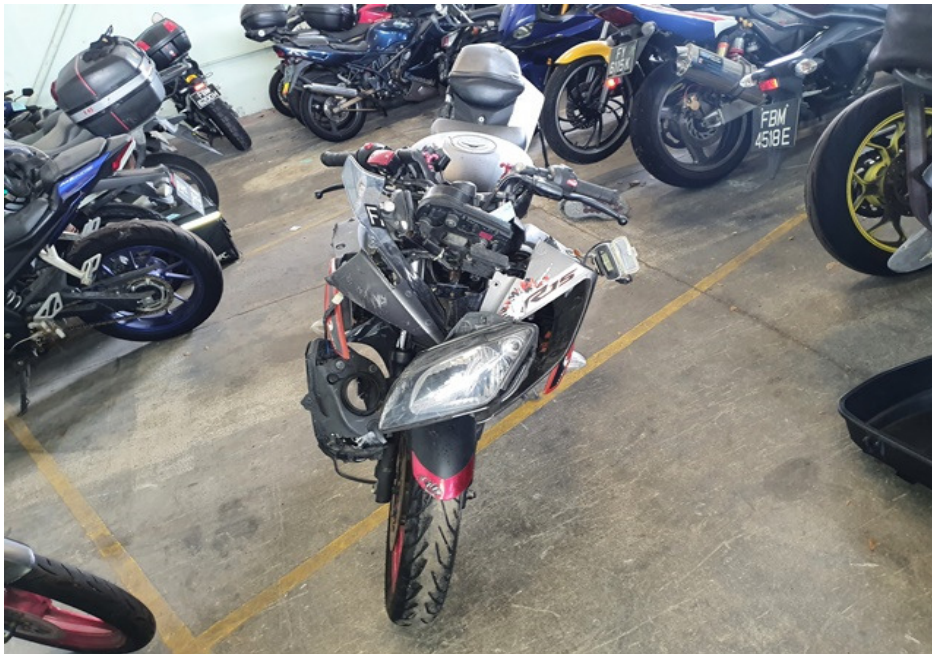
**Photo 3** shows a general view of the frontal portion of the Motorcycle at the time of our inspection. The Motorcycle was observed to have sustained damages all around.

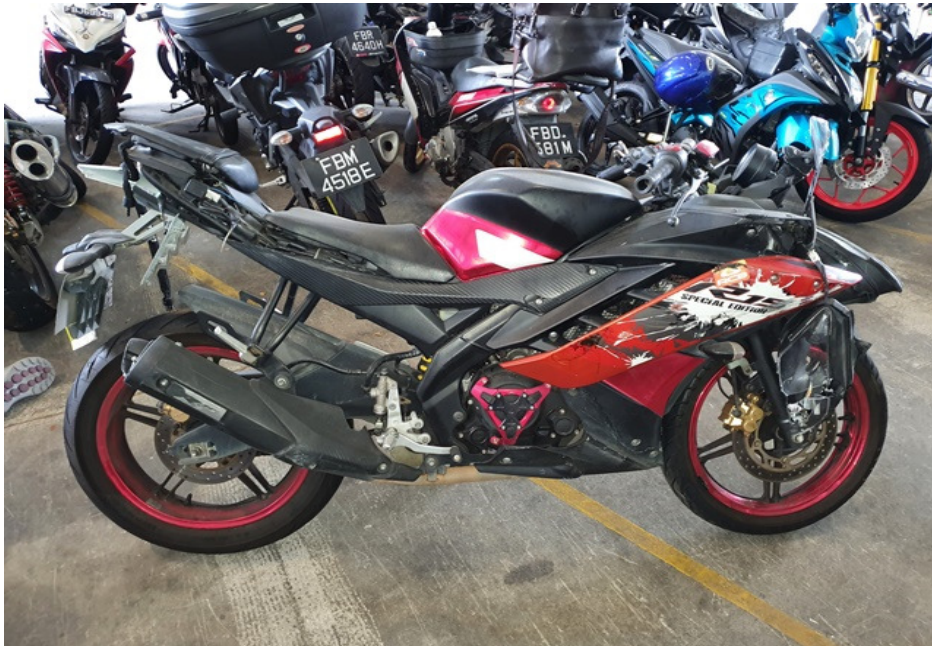
**Photo 4** shows a general view of the right body of the Motorcycle at the time of our inspection. The Motorcycle was observed to have sustained damages all around. Amongst the body parts that were found to have been damaged include its front mudguard, head cowl, headlight assembly, side cowlings, handlebar ends, front brake lever, clutch lever, rear brake pedal, right front footrest, right rear side cover, exhaust muffler heat shield and tail light assembly, amongst others.

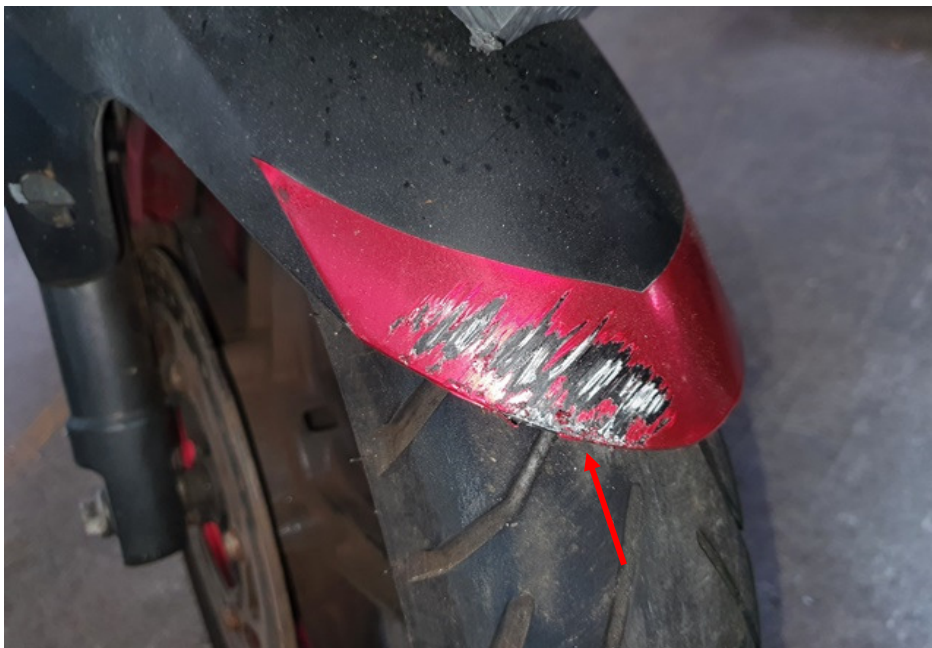
**Photo 5** shows a closer view of the front mudguard (arrowed) which was amongst the body parts at the front body of the Motorcycle that had sustained damage as a result of the accident.

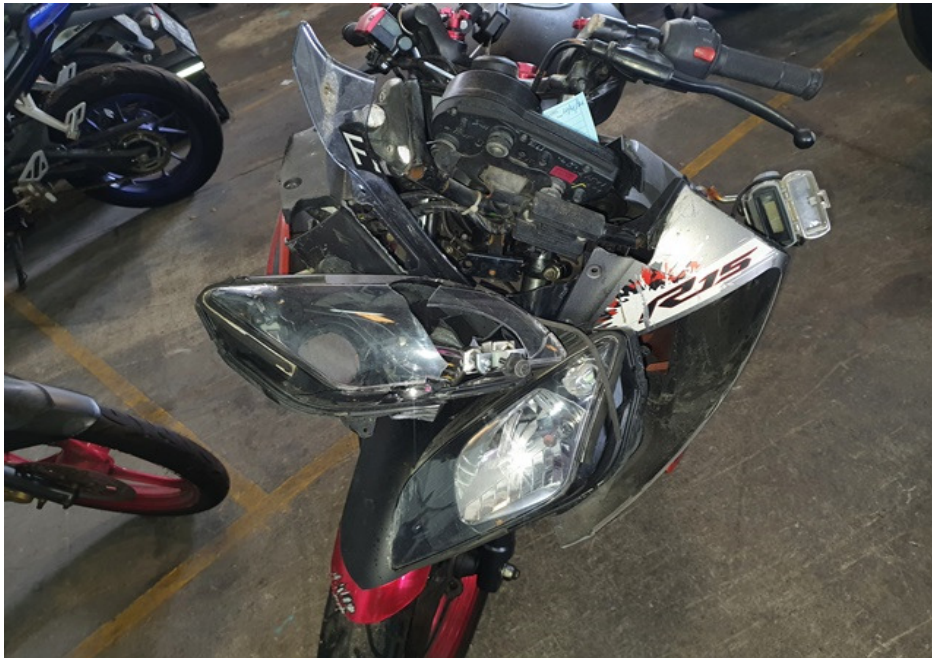
**Photo 6** shows a close up view of the head cowl and headlight assembly which was amongst the body parts of the Motorcycle that had sustained damage as a result of the accident.

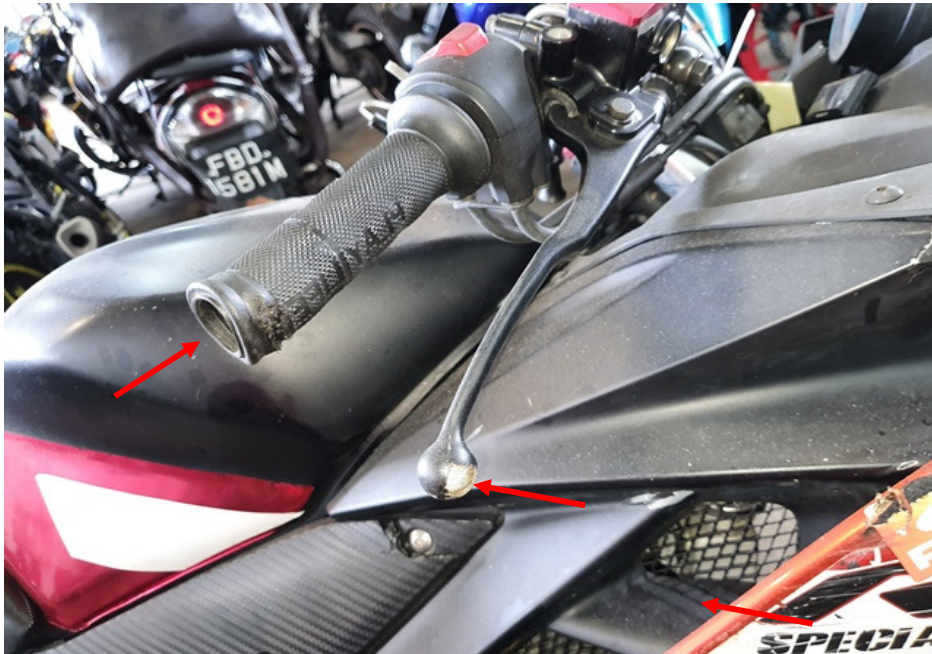
**Photo 7** shows a closer view of right handlebar end and front brake lever (arrowed) which were amongst the body parts at the front body of the Motorcycle that had sustained damage as a result of the accident.

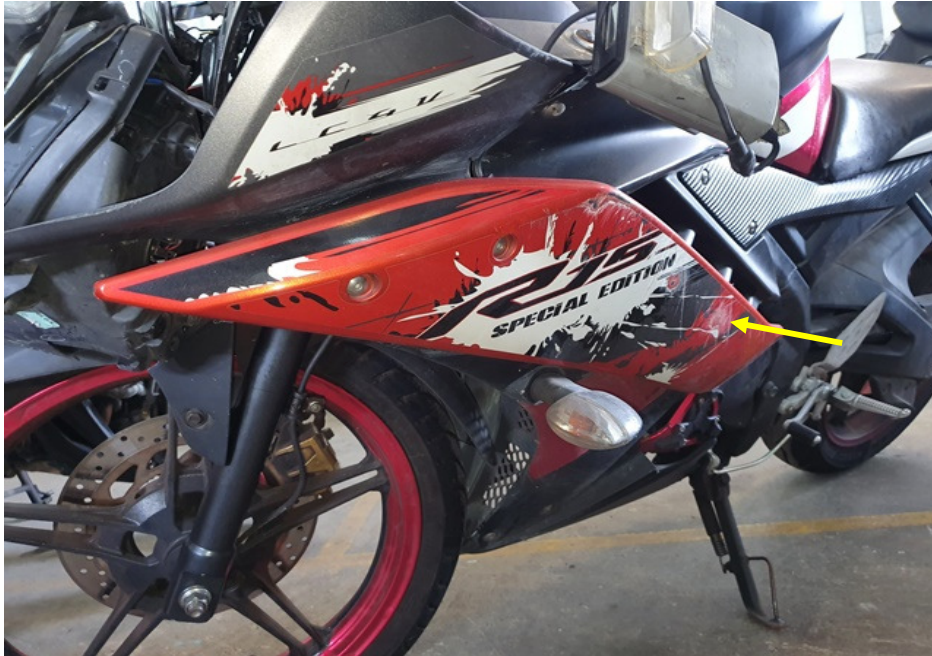
**Photo 8** shows a closer view of the left cowling of the Motorcycle that had sustained damages of grazing nature as a result of the accident (arrowed).

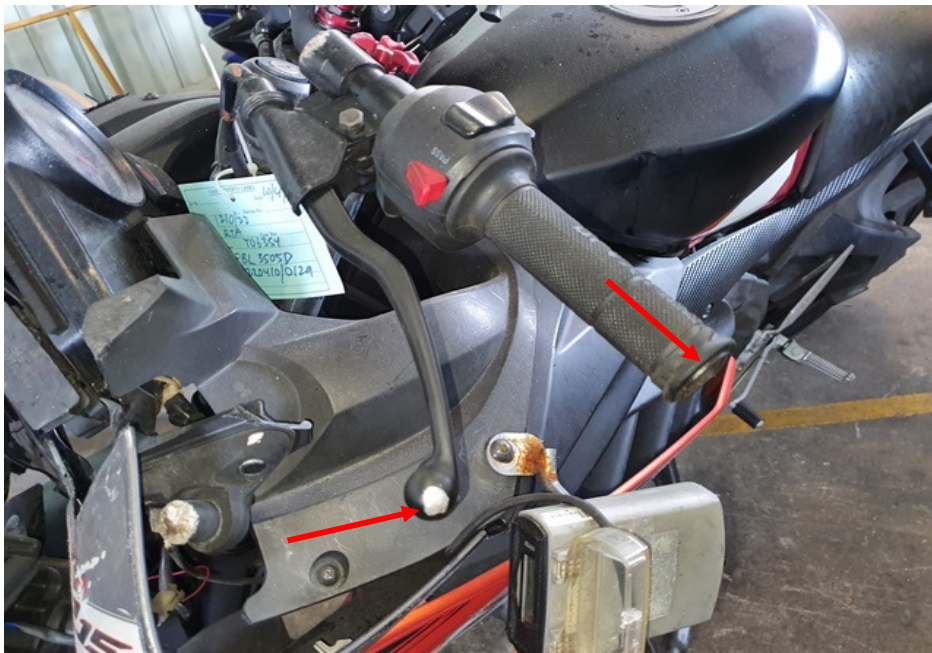
**Photo 9** shows a closer view of the left handlebar end and clutch lever (arrowed) which were amongst the body parts of the Motorcycle that had sustained damage as a result of the accident.

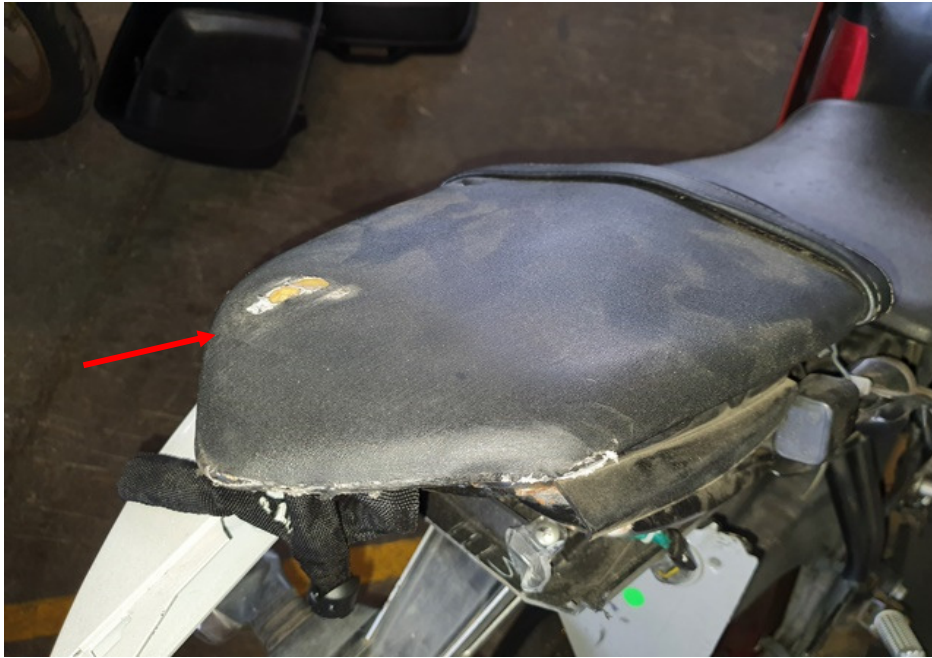
**Photo 10** shows a closer view of the deformed pillion seat of the Motorcycle as a result of the accident (arrowed).

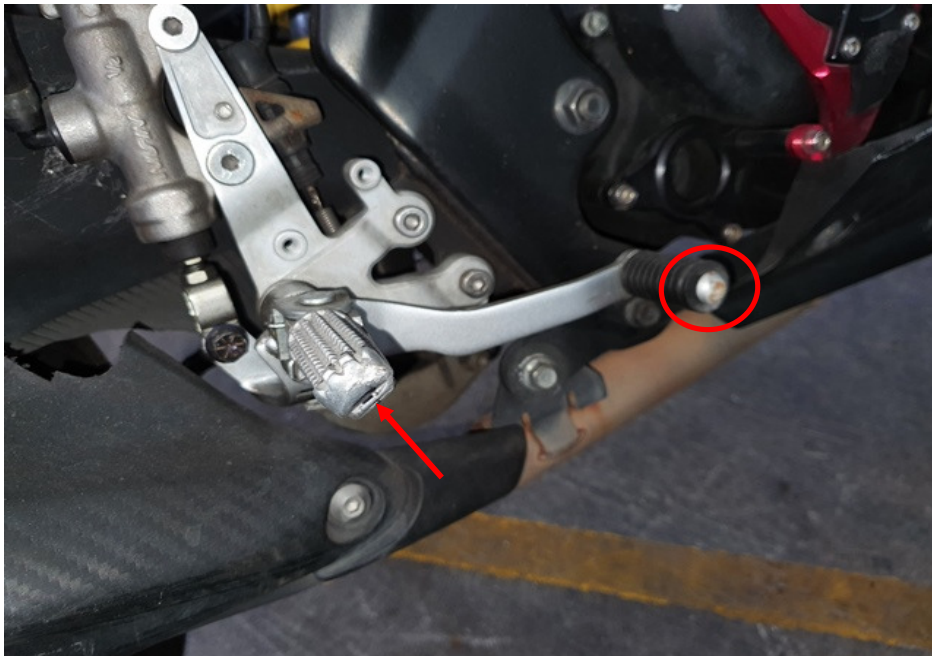
**Photo 11** shows a closer view of the rear brake pedal (circled) and right front footrest (arrowed) which were amongst the body parts of the Motorcycle that had sustained damage as a result of the accident

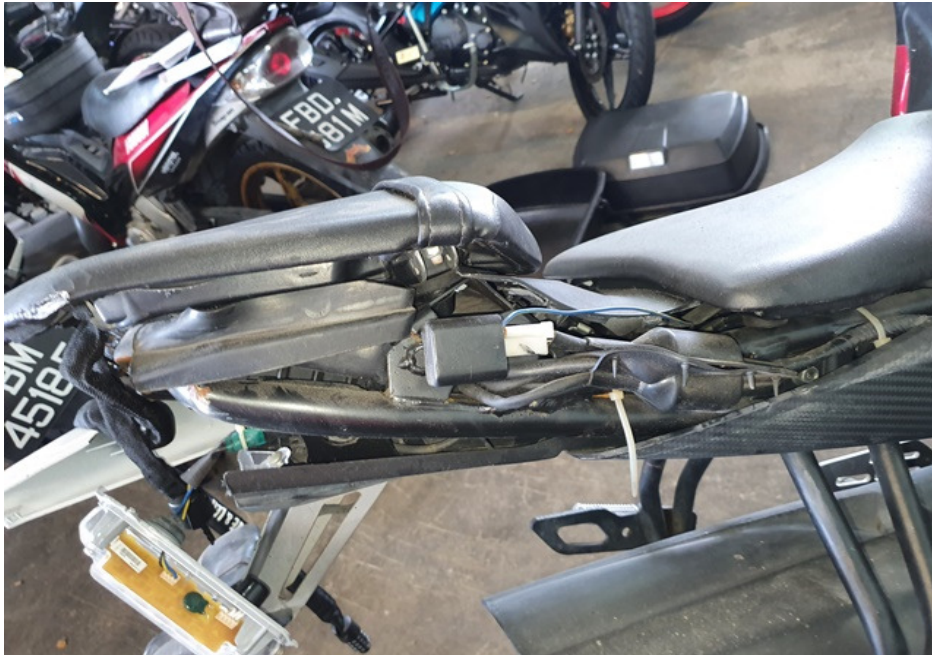
**Photo 12** shows the missing right rear side cover of the Motorcycle as a result of the accident.

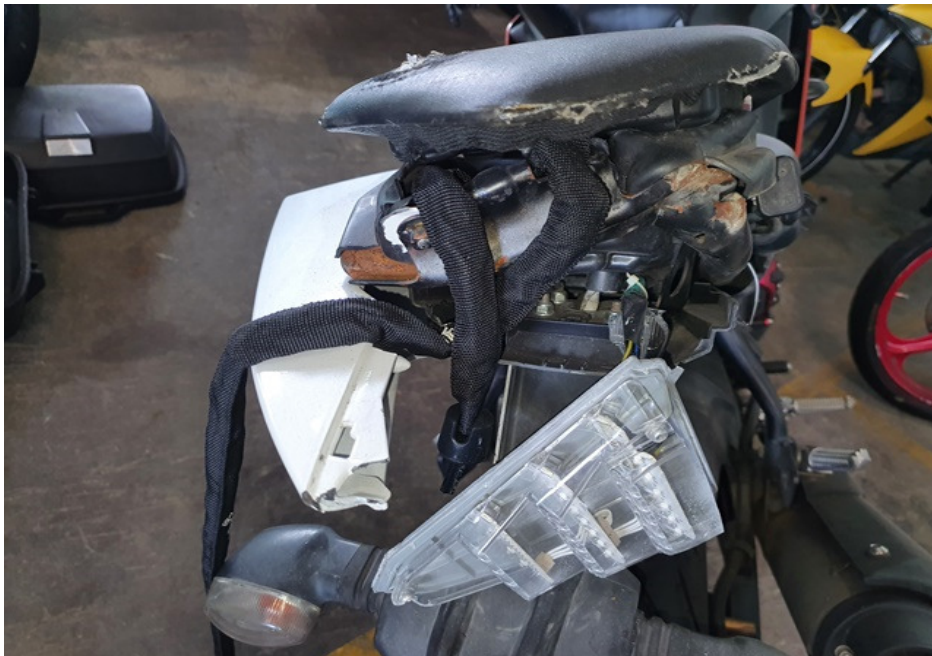
**Photo 13** shows a closer view of the tail light assembly of the Motorcycle as a result of the accident.

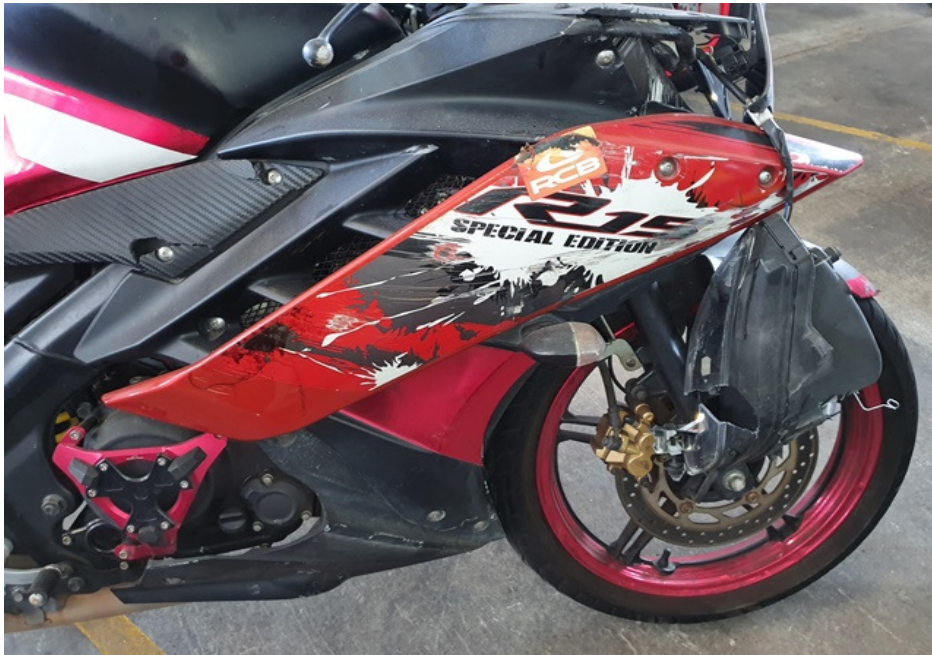
**Photo 14** shows a closer view of the right cowling of the Motorcycle that had sustained damages of grazing nature as a result of the accident.

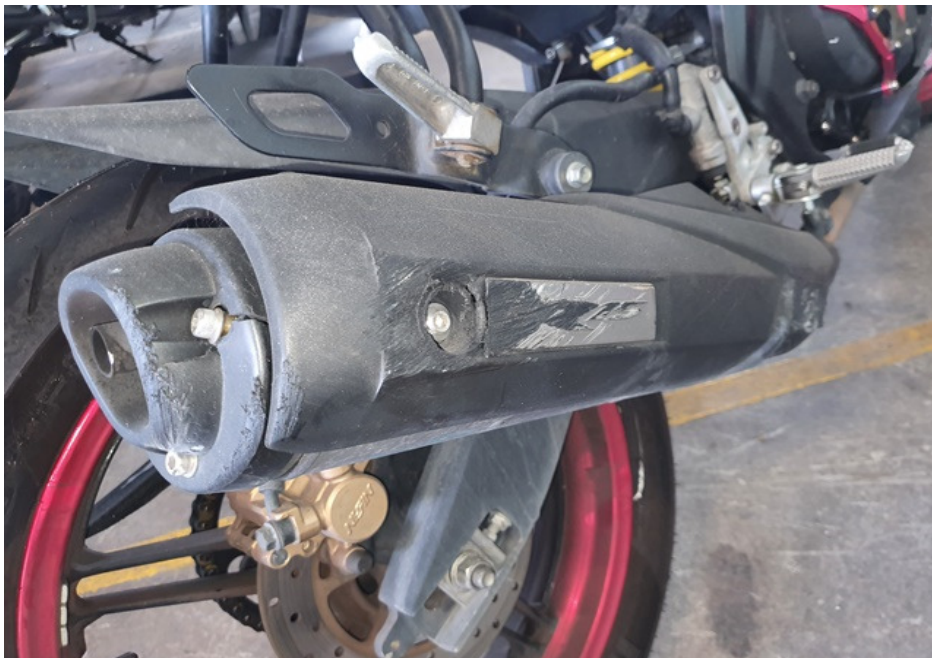
**Photo 15** shows a closer view of the exhaust muffler heat shield of the Motorcycle that had sustained damages of grazing nature as a result of the accident.

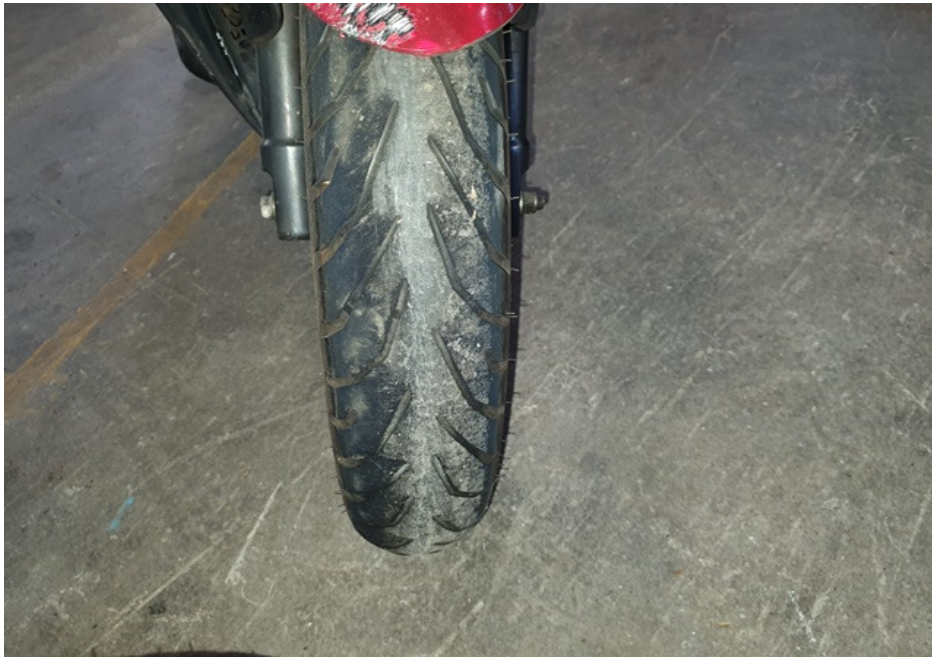
**Photo 16** shows the condition of the Motorcycle's front tyre. The front tyre was observed to be in serviceable condition with remaining tread depth of approximately 3mm. There was no tear, burst mark(s) and/or punctured hole(s) on the sidewalls as well as across the tread of the front tyre.

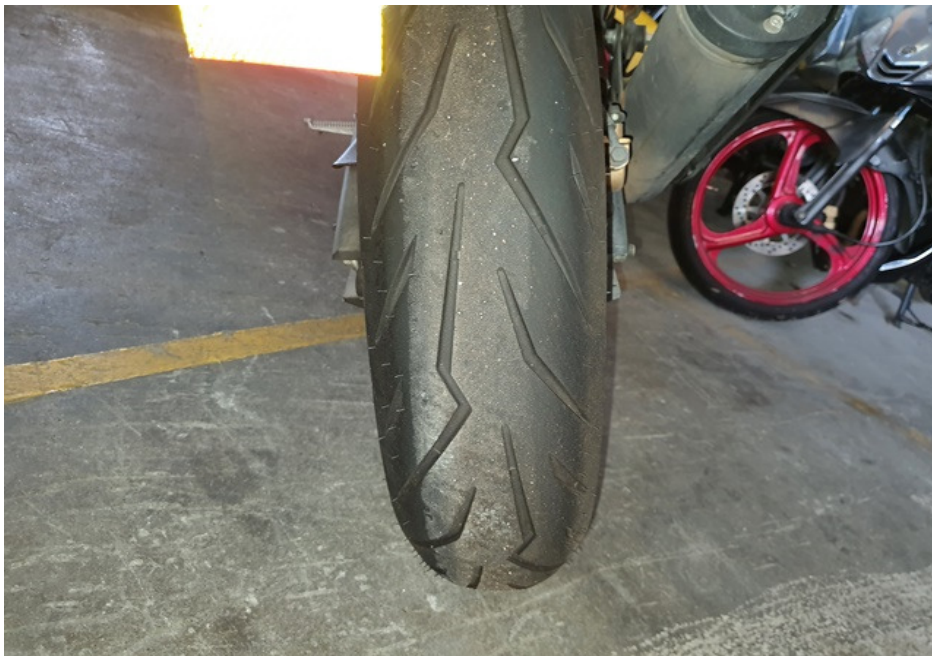
**Photo 17** shows the condition of the Motorcycle's rear tyre. The rear tyre was observed to be in serviceable condition with remaining tread depth of approximately 3mm. The tyre was also observed to be sufficiently inflated for vehicular operation. We did not observe any tear, burst mark(s) and/or punctured hole(s) on the sidewalls as well as across the tread of the rear tyre.

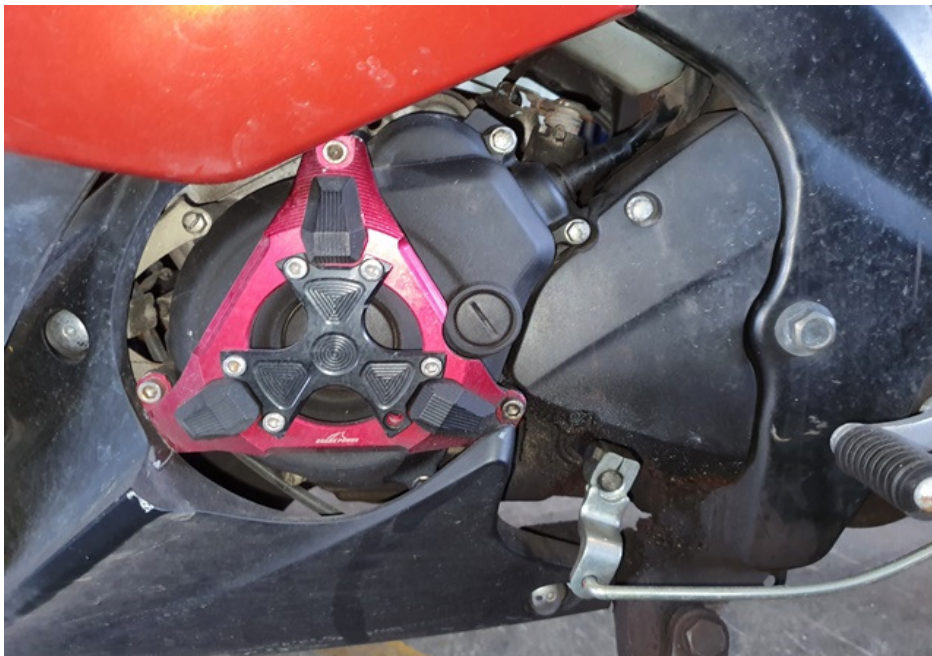
**Photo 18** shows the left side of the engine of the Motorcycle at the time of our inspection. The various engine related parts and components were found to be intact with no visible damage. There was also no sign(s) or indication(s) of fluid leak observed around the left engine area of the Motorcycle.

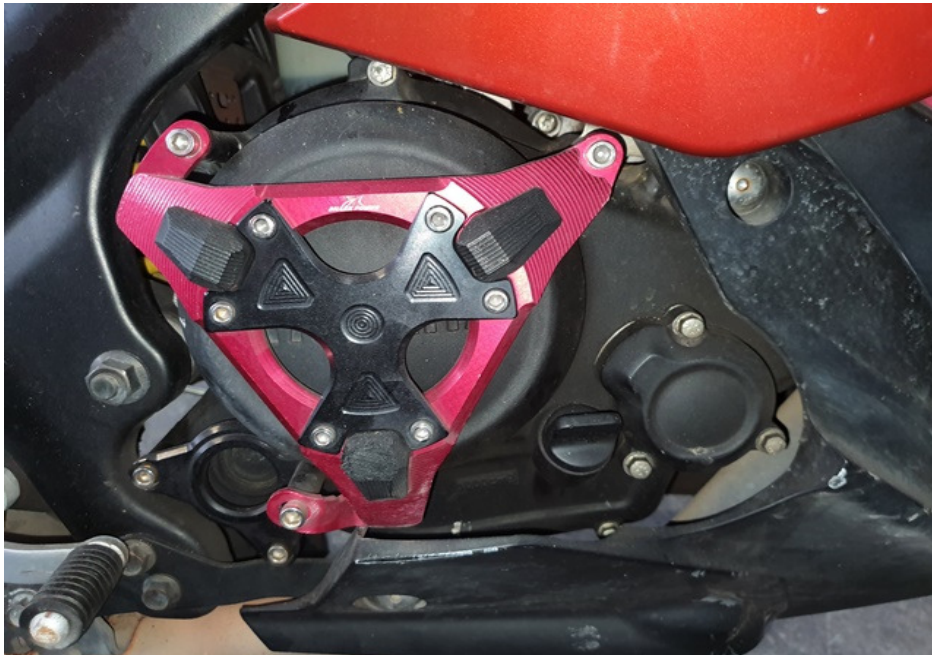
**Photo 19** shows the right side of the engine of the Motorcycle at the time of our inspection. The various engine related parts and components were found to be intact with no visible damage. There was also no sign(s) or indication(s) of fluid leak observed around the right engine area of the Motorcycle.

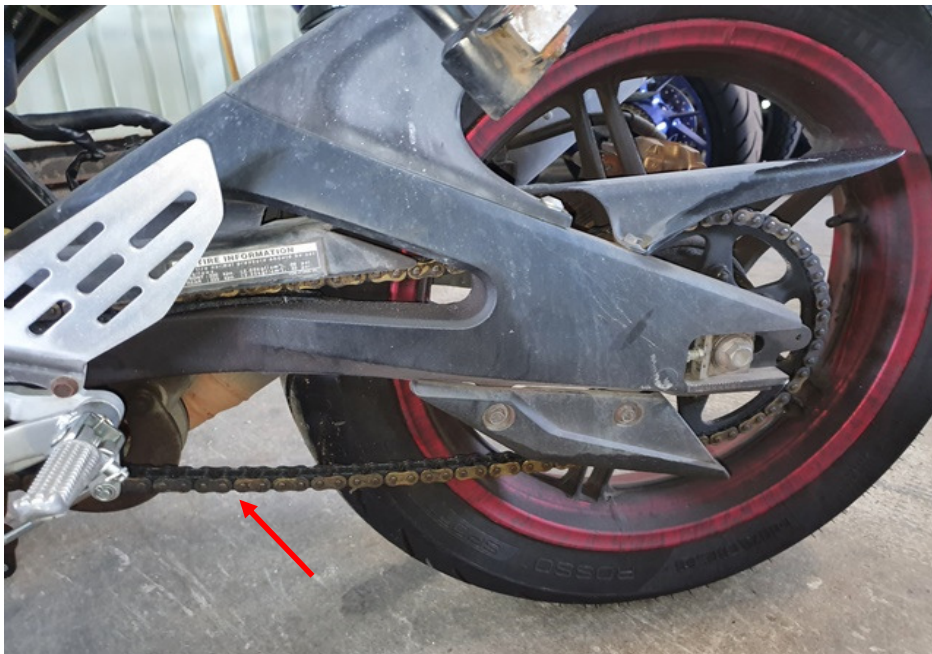
**Photo 20** shows the general view of the gear train (arrowed) of the Motorcycle, which was observed to be intact with no misalignment. It was also adequately lubricated for operating purposes.

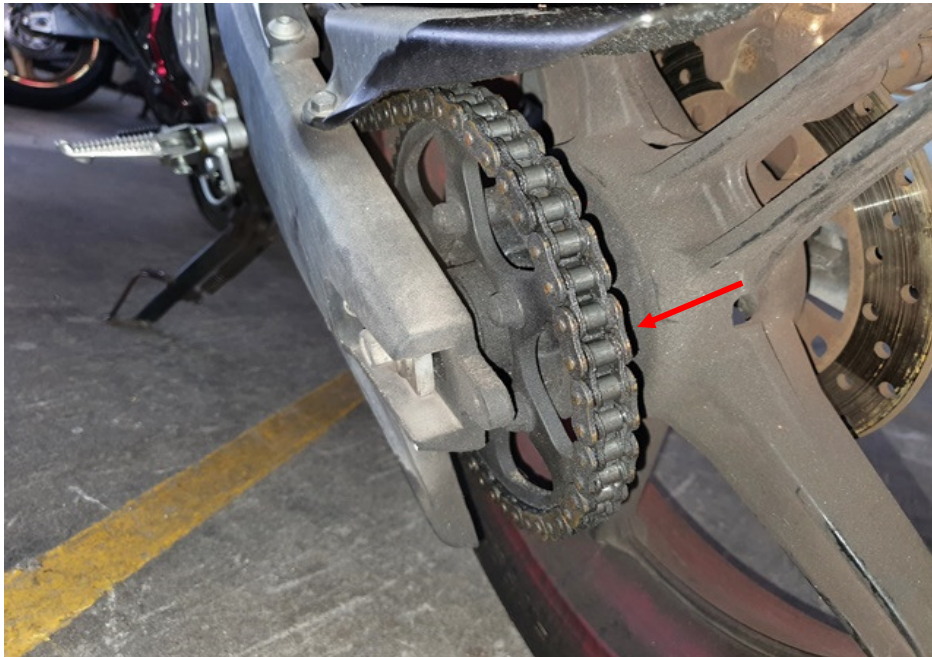
**Photo 21** shows a closer view of the gear train (arrowed) of the Motorcycle, which was observed to be intact with no misalignment. It was also adequately lubricated for operating purposes.

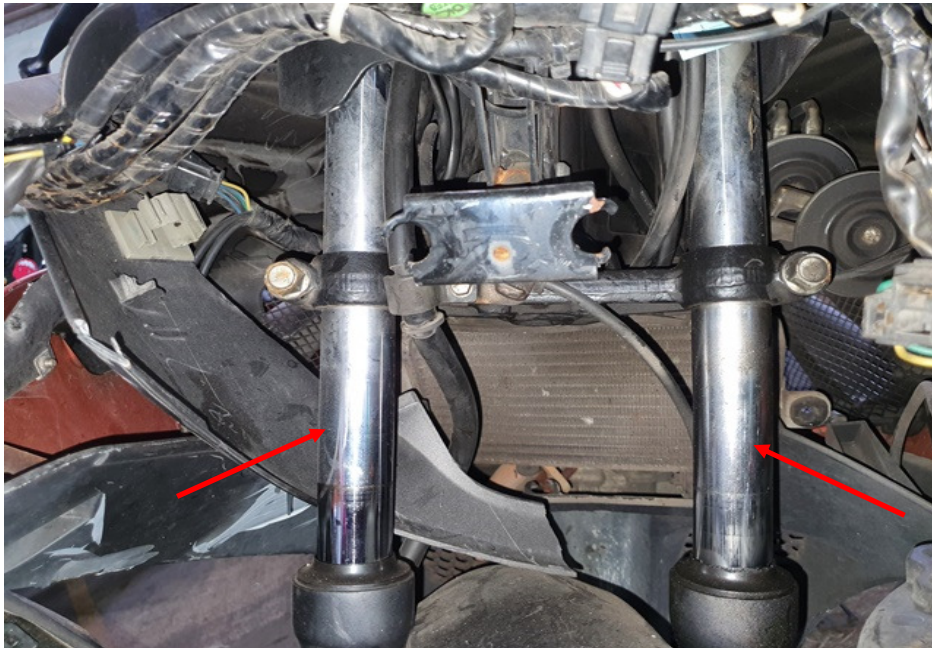
**Photo 22** shows the front fork (arrowed) of the Motorcycle. The front fork and fork bracket of the Motorcycle were both found to be intact and undamaged. Turning the Motorcycle's handle bar towards the left and right did not produce any abnormal free play and/or resistance. The steering system of the Motorcycle was in serviceable condition at the time of our inspection.

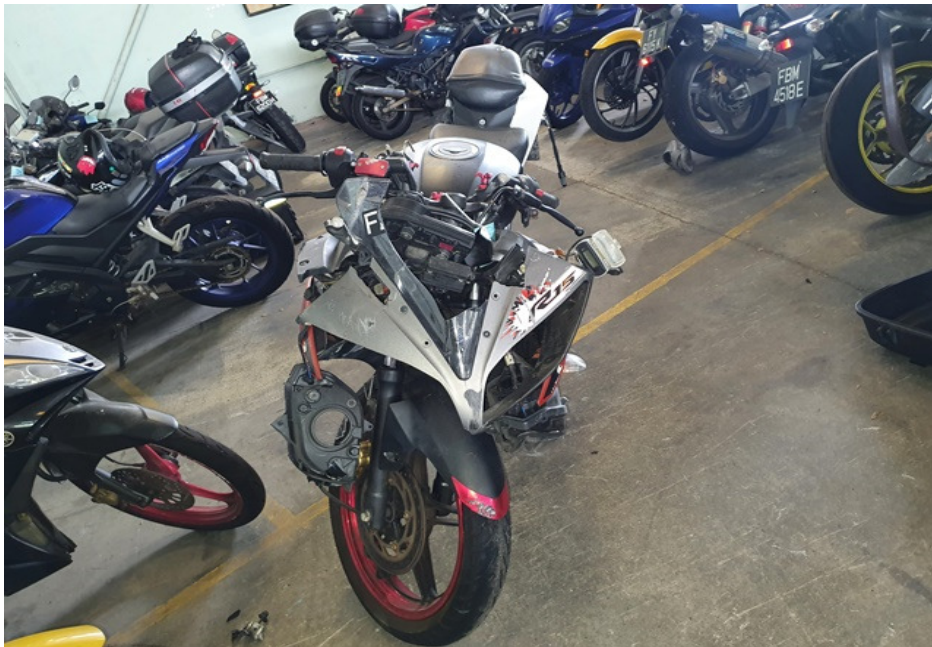
**Photo 23** shows the front wheel of the Motorcycle turned towards its full left. Turning the Motorcycle's handle bar towards the left and right did not produce any abnormal free play and/or resistance. This would indicate that the steering system of the Motorcycle was in serviceable condition at the time of our inspection.

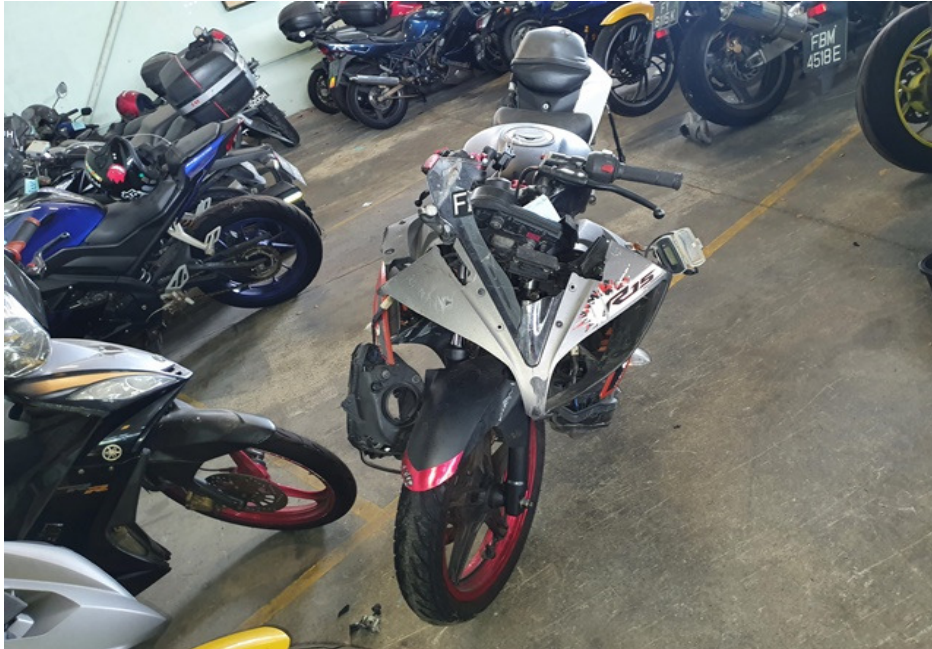
**Photo 24** shows the front wheel of the Motorcycle turned towards its full right. Turning the Motorcycle's handle bar towards the left and right did not produce any abnormal free play and/or resistance. This would indicate that the steering system of the Motorcycle was in serviceable condition at the time of our inspection.

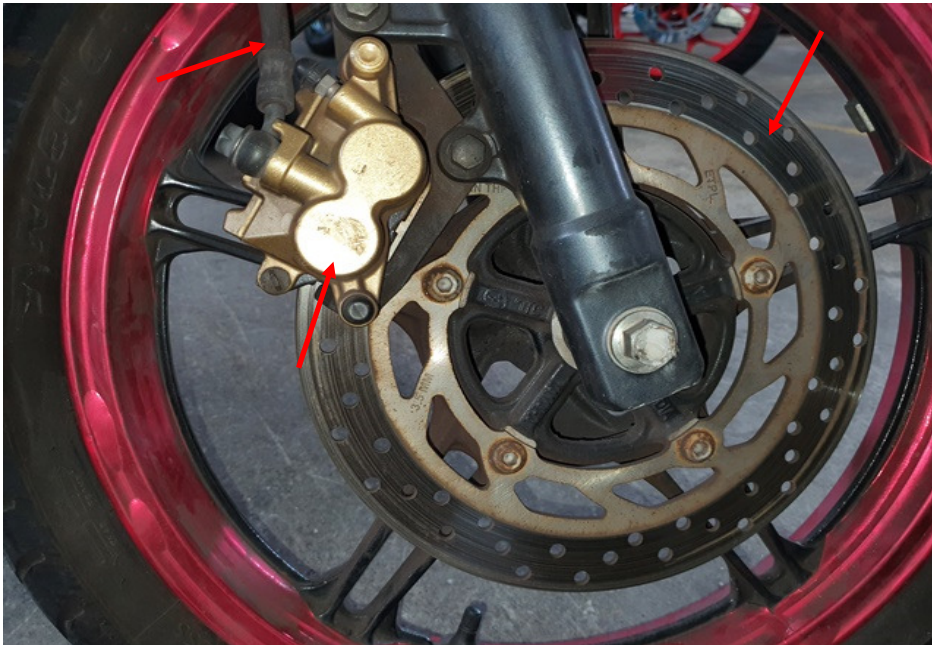
**Photo 25** shows a close up view of the front brake caliper, front brake disc and front brake hose (arrowed) of the Motorcycle, which are all part of the components in the hydraulic front brake system of the Motorcycle. Our visual checks of these various components had revealed all to be intact with no visible damage. No leakage of brake fluid was also observed.

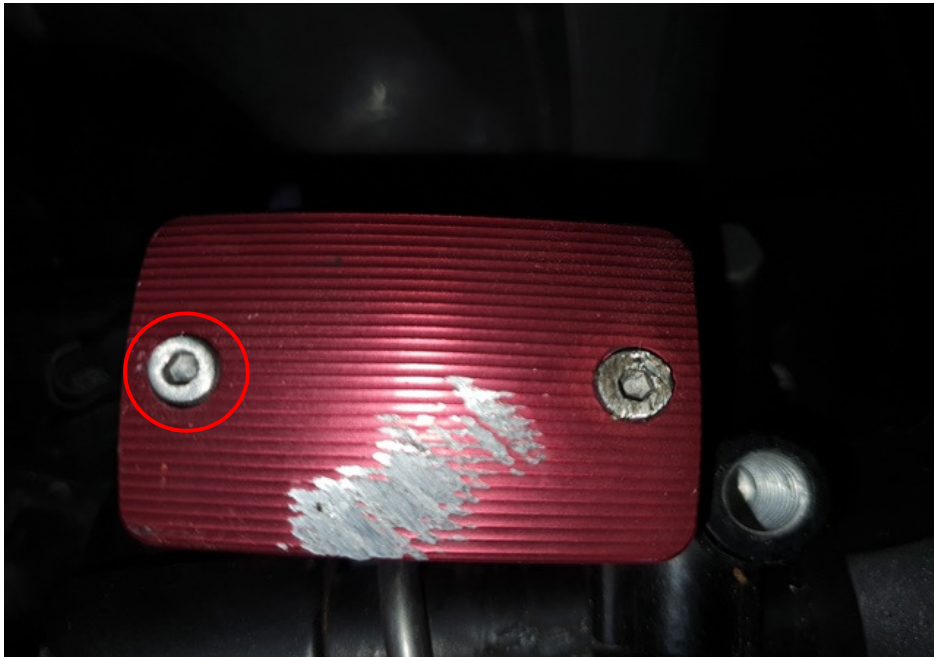
14. The brake fluid for the rear brake was found to be slightly contaminated. However it was observed not to be of sufficient level for operational purposes. We were unable remove the front brake reservoir cover to examine whether the front brake fluid was without contamination due to a worn out screw. However the front brake fluid was observed to be of sufficient level for operational purposes.

**Photo 26** shows the brake fluid reservoir cover for the front brake of the Motorcycle. We were unable to examine whether the front brake fluid was without contamination due to the worn out screw (circled).

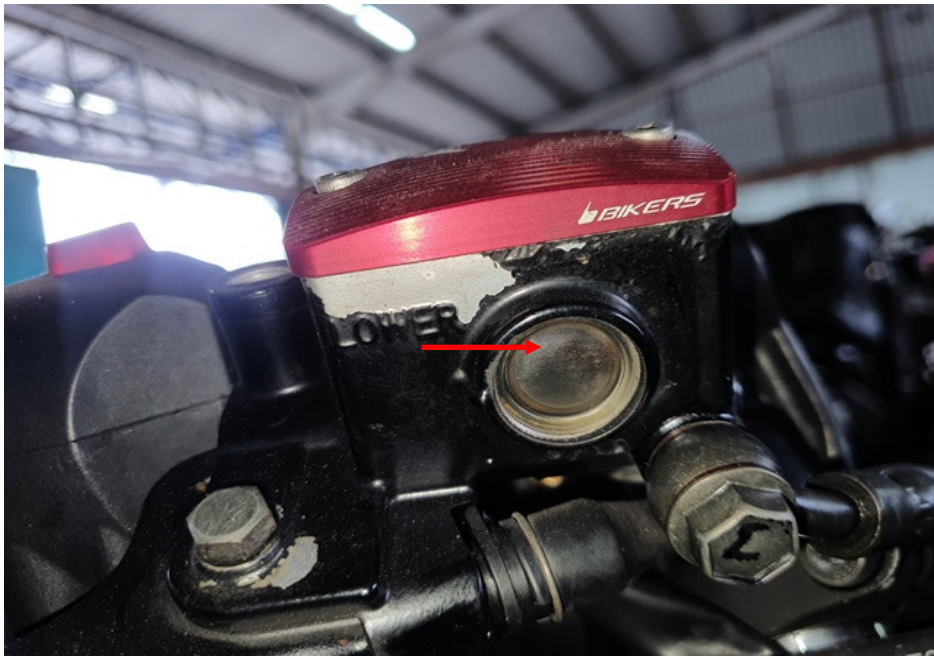
**Photo 27** shows a close up view of the brake fluid reservoir for the front brake of the Motorcycle. The brake fluid was observed to be of sufficient level for operational purposes (arrowed).

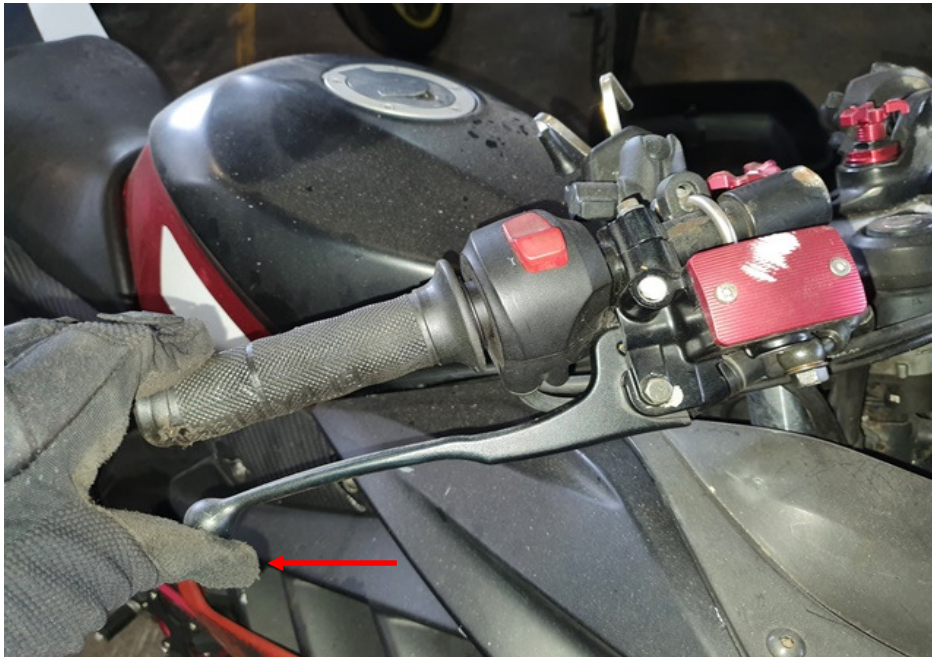
15. Static brake tests conducted on the Motorcycle had appear to indicate that the braking system of the Motorcycle was in serviceable condition. There was some resistance felt (spongy like feel) upon pressing the brake lever and upon stepping on the brake pedal. This would indicate that there was no leakage of pressure/vacuum in the brake system.

**Photo 28** shows the front brake lever being depressed. There was some resistance felt (spongy like feel) upon pressing the front brake lever (arrowed). This would indicate that there is no leakage of pressure/vacuum in the front brake system.

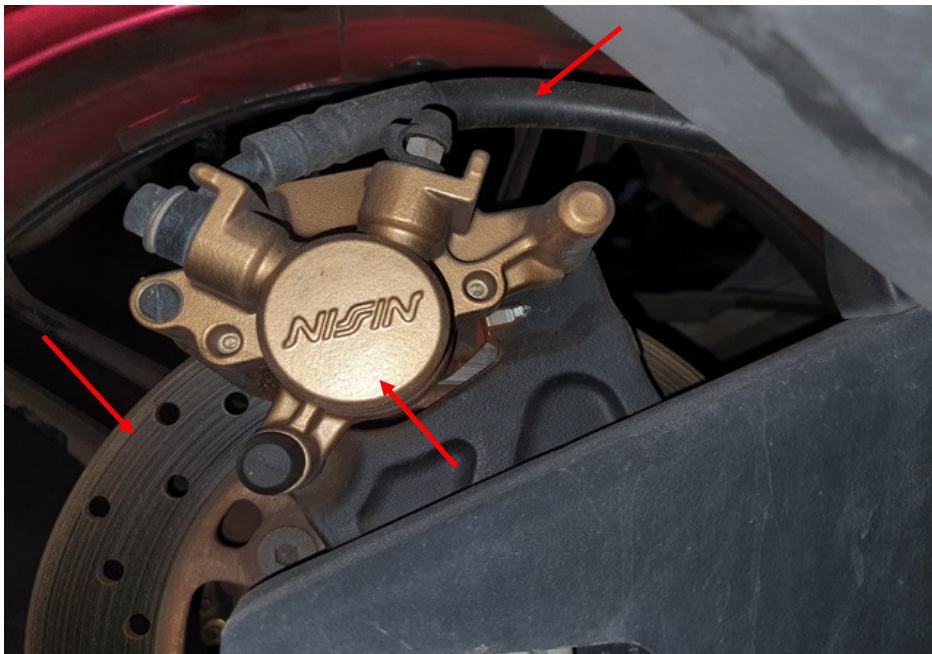
**Photo 29** shows a close up view of the rear brake caliper, rear brake disc and rear brake hose (arrowed) of the Motorcycle, which are all part of the components in the hydraulic rear brake system of the Motorcycle. Our visual checks of these various components had revealed all to be intact with no visible damage. No leakage of brake fluid was also observed.

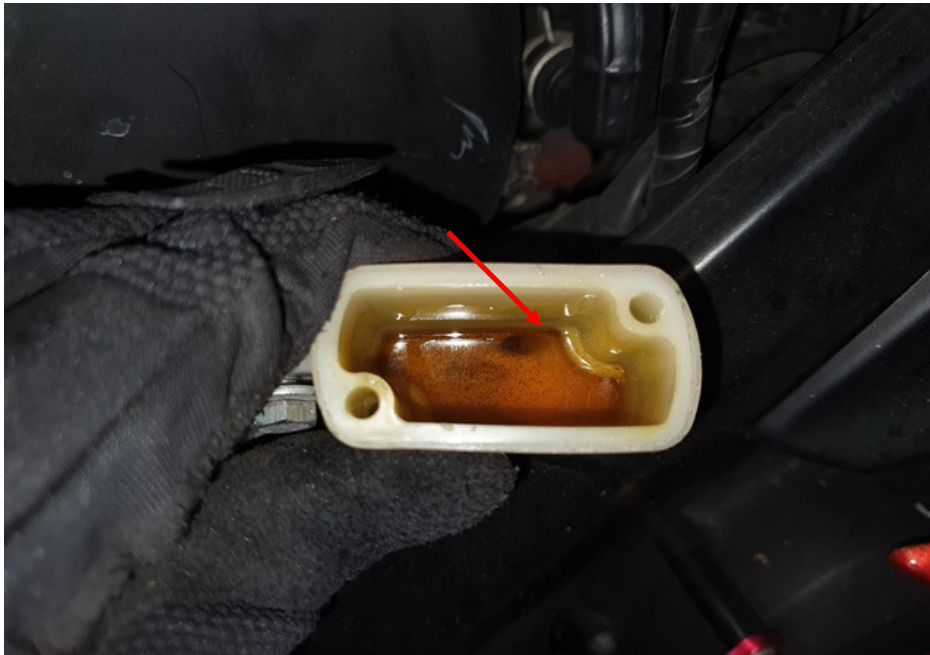
**Photo 30** shows a close up view of the brake fluid reservoir for the rear brake of the Motorcycle. The brake fluid for the rear brake was found to be slightly contaminated. However it was observed not to be of sufficient level for operational purposes (arrowed).
