Your Ref: TP/IP/04869/2022
Our Ref : CI/TPD22005253/N

Fatal Accident Investigation Team

INSPECTION REPORT OF MOTORCYCLE FBT 7887H

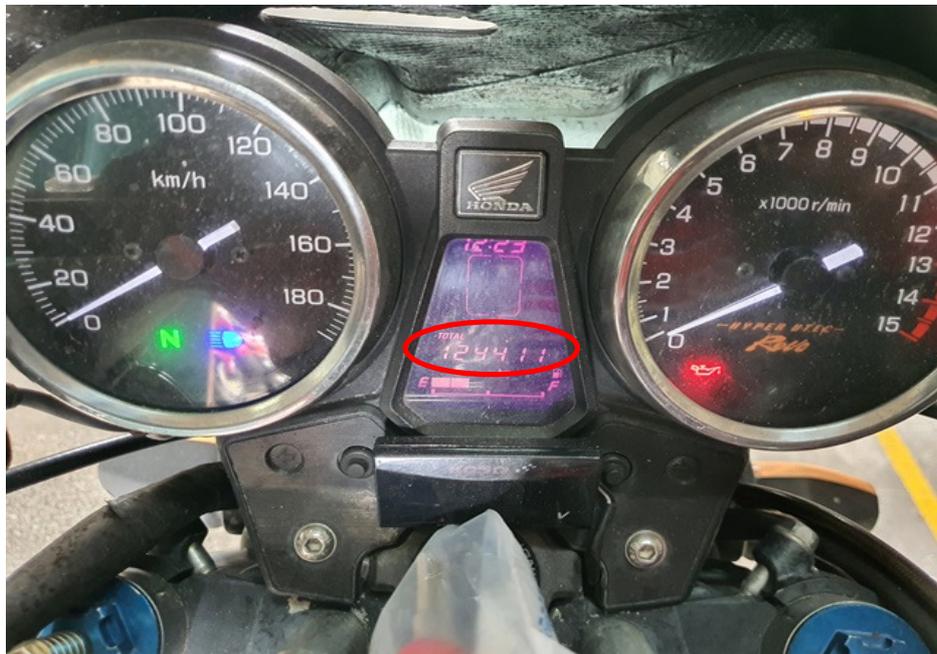
Photo 1 shows the speedometer gauge of the Motorcycle where the mileage recorded at the time of our inspection was 124, 411km (circled).

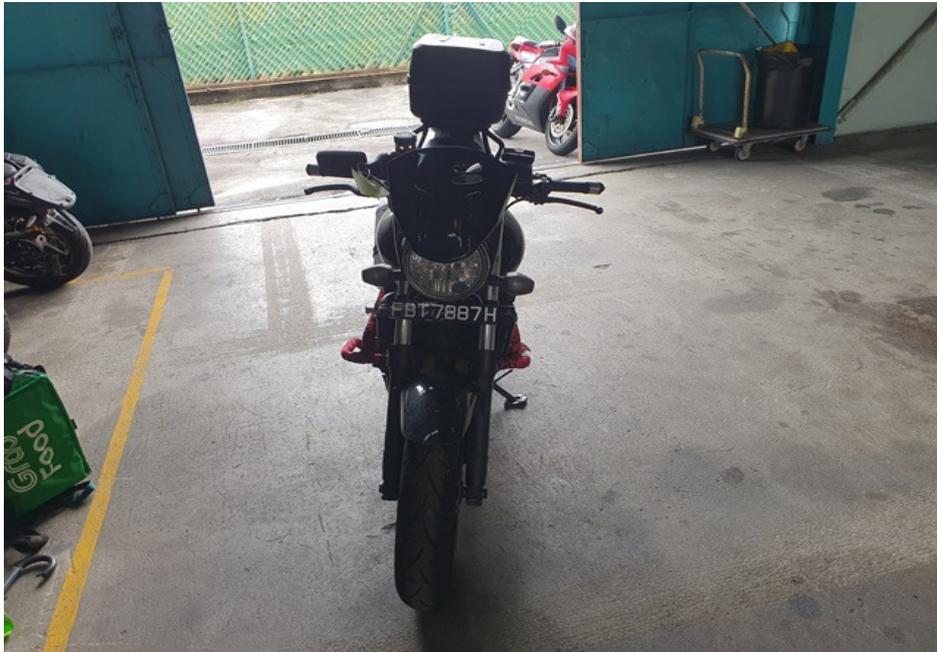
Photo 2 shows a general view of the frontal portion of the Motorcycle at the time of our inspection. The Motorcycle was observed to have sustained damages all around.

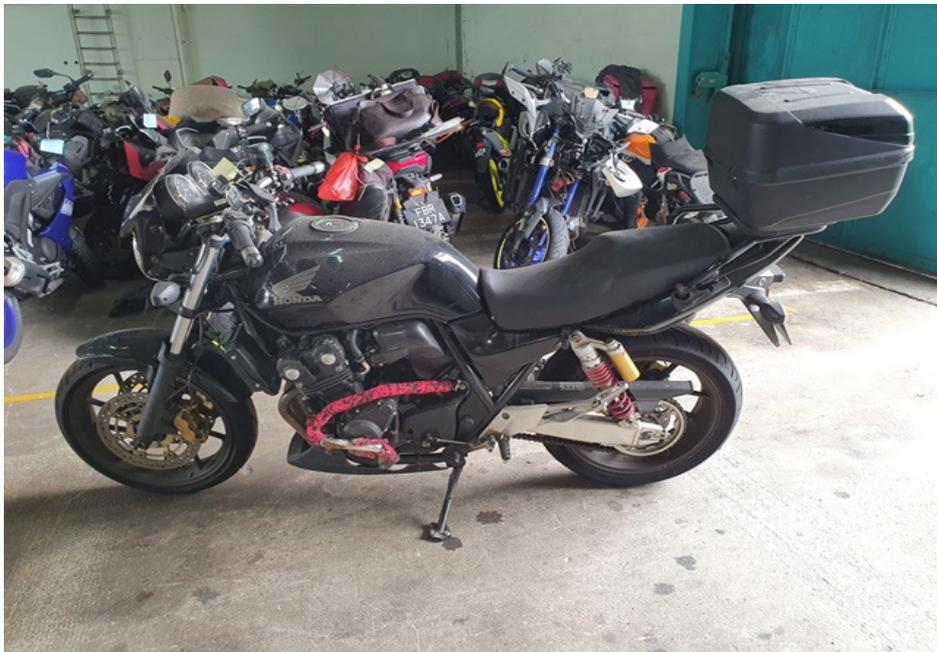
4. The mileage of the Motorcycle at the time of our inspection was 124, 411km.
5. The Motorcycle was observed to have sustained damages all around. The body parts that were found to have been damaged include its head cowling, front mudguard, handlebar ends, right side mirror, front brake lever, clutch lever, left engine crashbar, left front footrest and top box, amongst others.

Photo 3 shows a general view of the left front body of the Motorcycle at the time of our inspection. The Motorcycle was observed to have sustained damages all around. The body parts that were found to have been damaged include its head cowlings, front mudguard, handlebar ends, right side mirror, front brake lever, clutch lever, left engine crashbar, left front footrest and top box, amongst others.

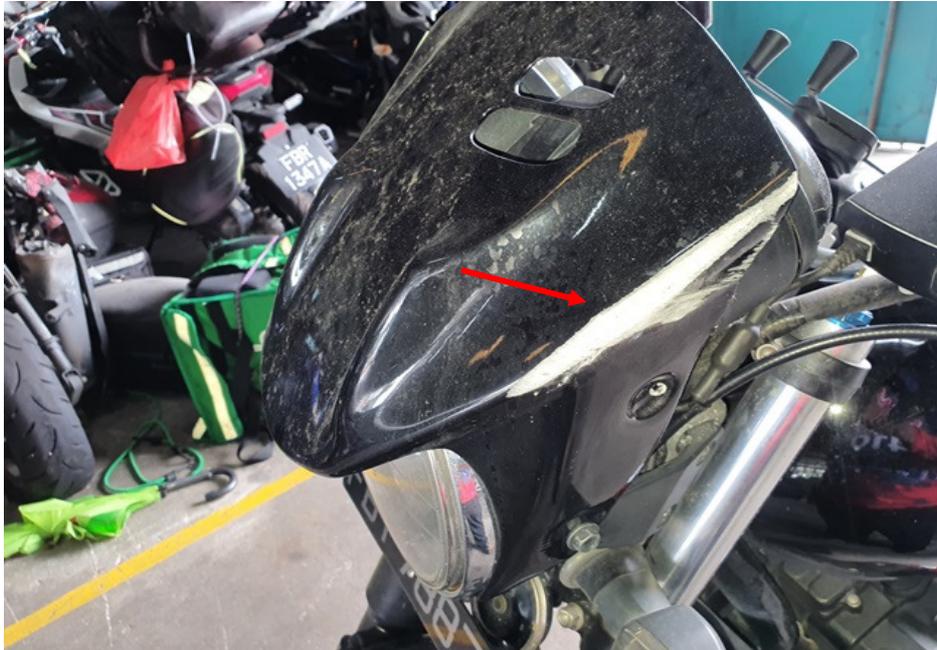
Photo 4 shows a closer view of the grazed head cowling (arrowed) of the Motorcycle as a result of the accident.

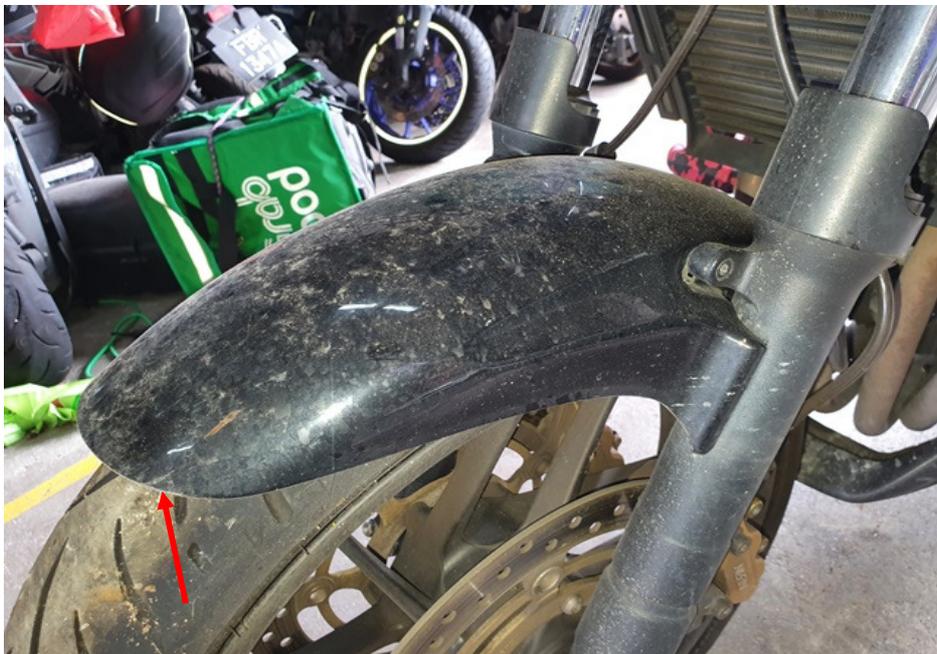
Photo 5 shows a closer view of the front mudguard which was amongst the body parts at the front body of the Motorcycle that had sustained damage as a result of the accident (arrowed).

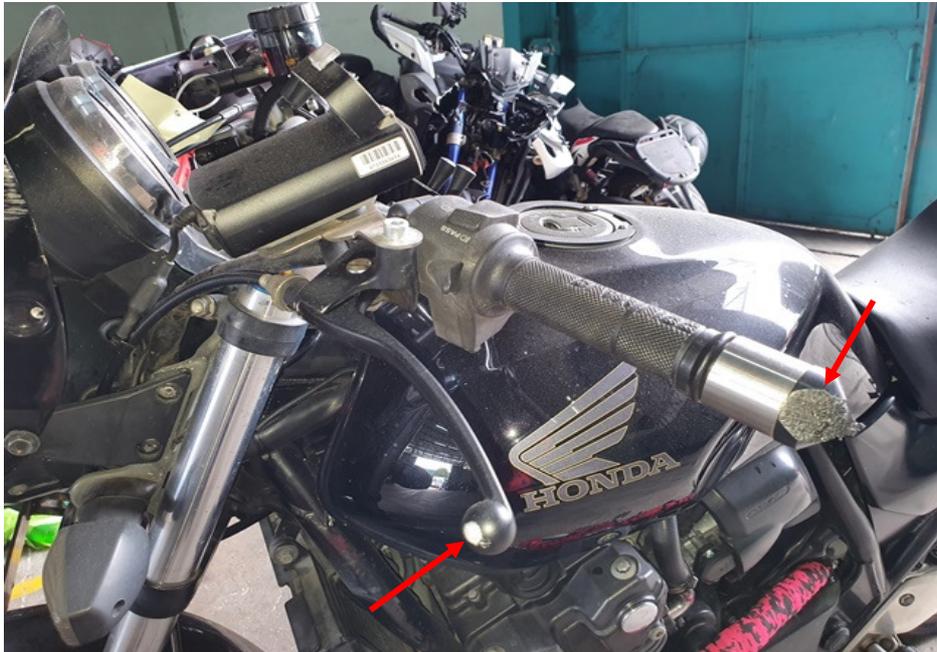
Photo 6 shows a closer view of the clutch lever and left handlebar end (arrowed) which were amongst the body parts at the front body of the Motorcycle that had sustained damage as a result of the accident.

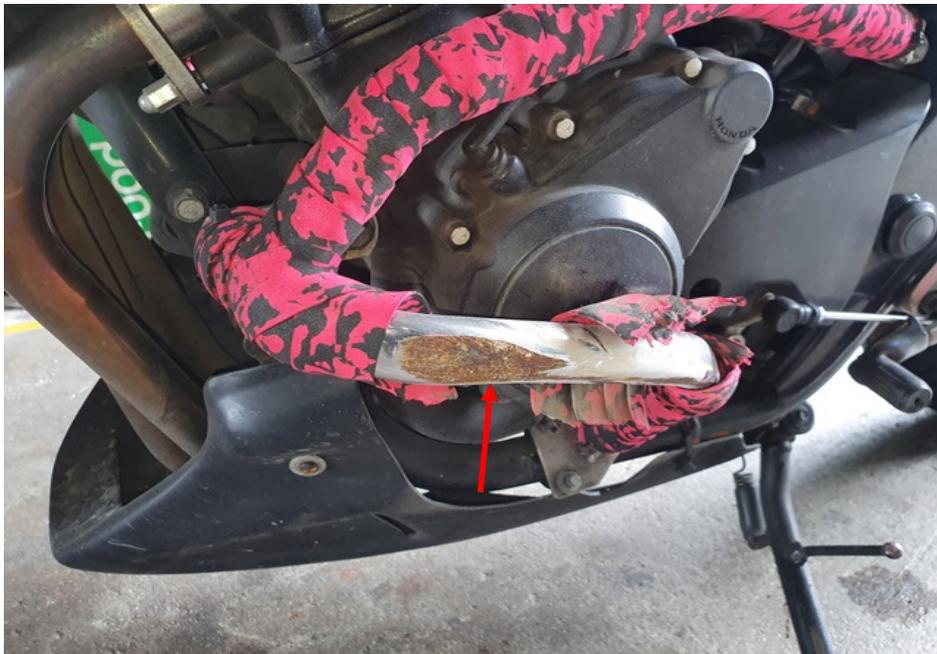
Photo 7 shows the grazed left engine crashbar of the Motorcycle as a result of the accident (arrowed).

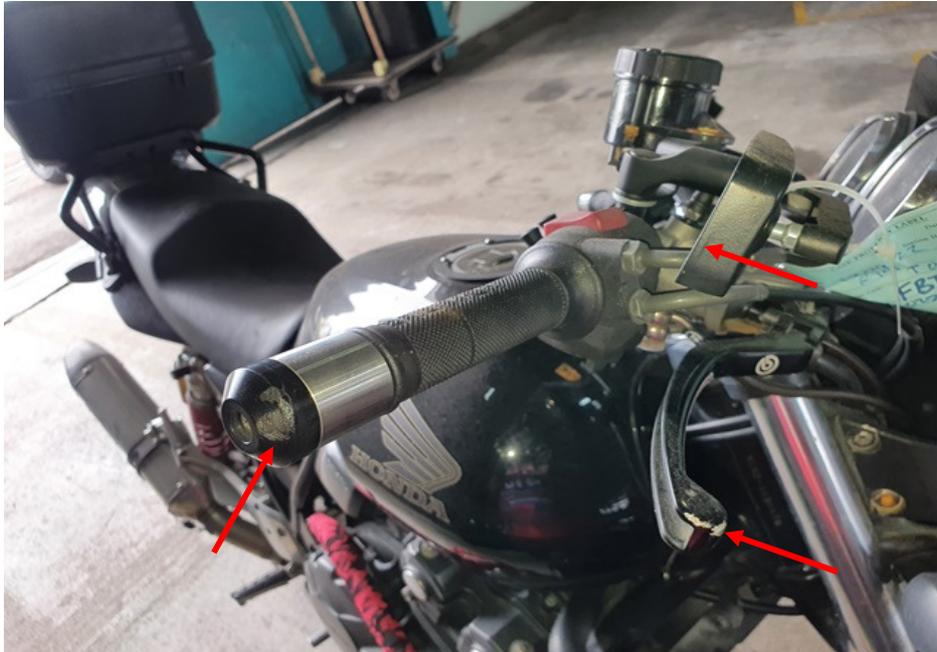
Photo 8 shows a closer view of the front brake lever, right side mirror and right handlebar end (arrowed) which were amongst the body parts at the front body of the Motorcycle that had sustained damage as a result of the accident.

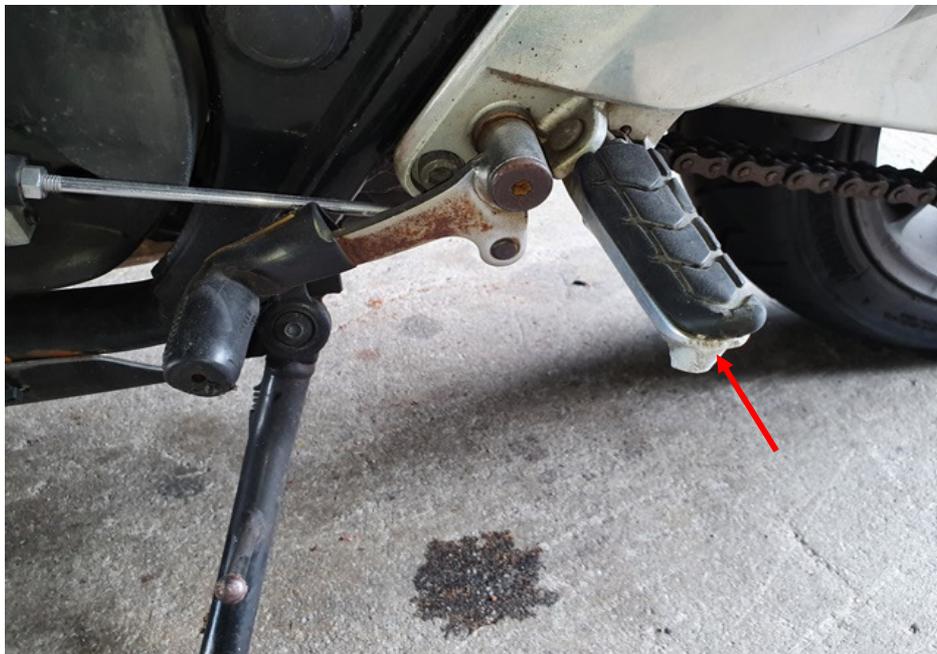
Photo 9 shows a closer view of the left front footrest (arrowed) which was amongst the body parts of the Motorcycle that had sustained damage as a result of the accident.

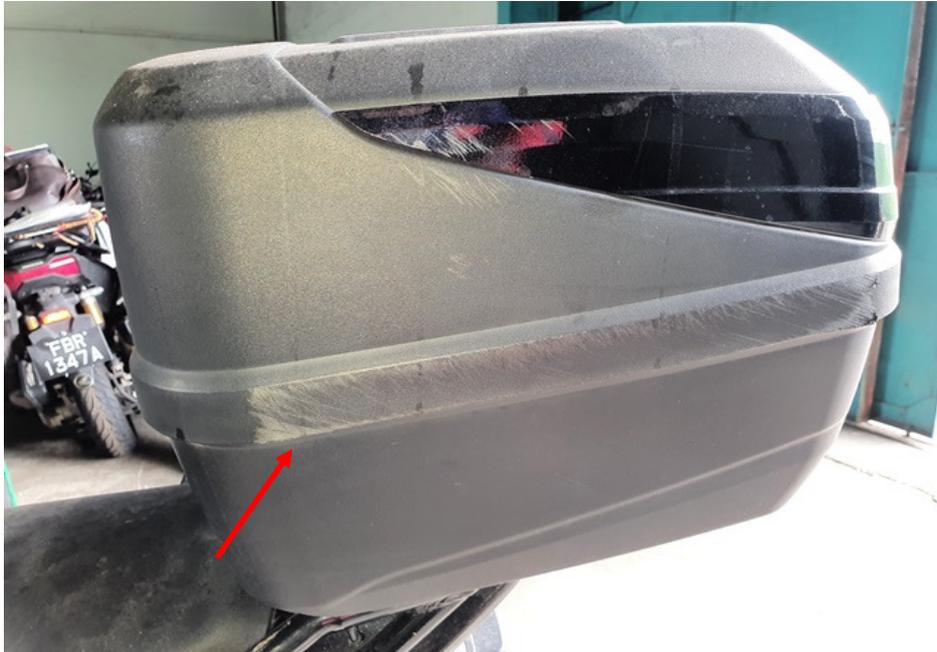
Photo 10 shows the grazed top box (arrowed) of the Motorcycle as a result of the accident.

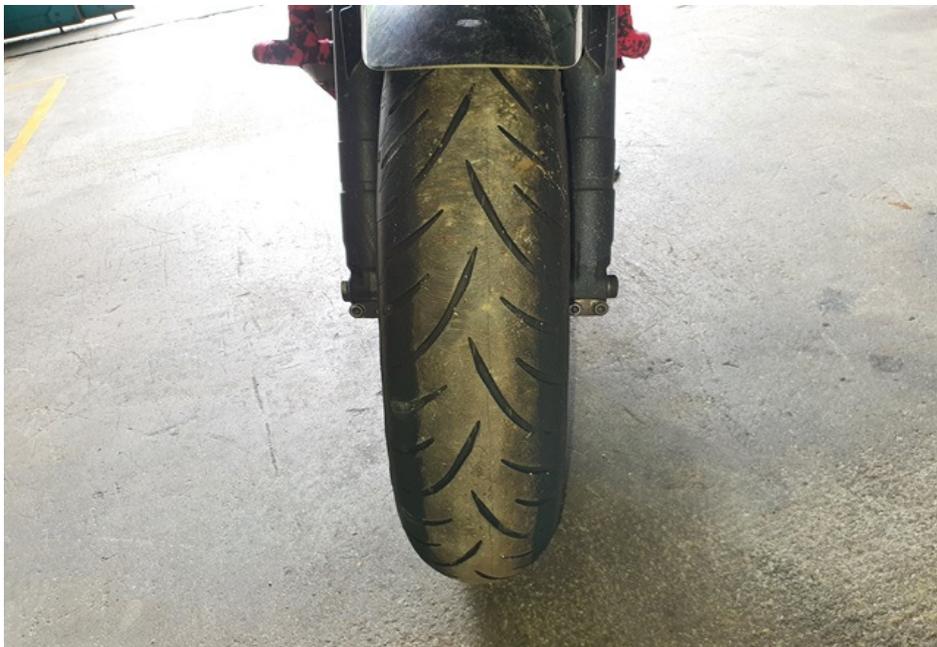
Photo 11 shows the front tyre of the Motorcycle at the time of our inspection. The front tyre was observed to be in serviceable condition with remaining tread depth of approximately 3mm. The pattern of the tread was also clearly visible. There was no tear, burst mark(s) and/or punctured hole(s) on the sidewalls as well as across the tread of the front tyre.

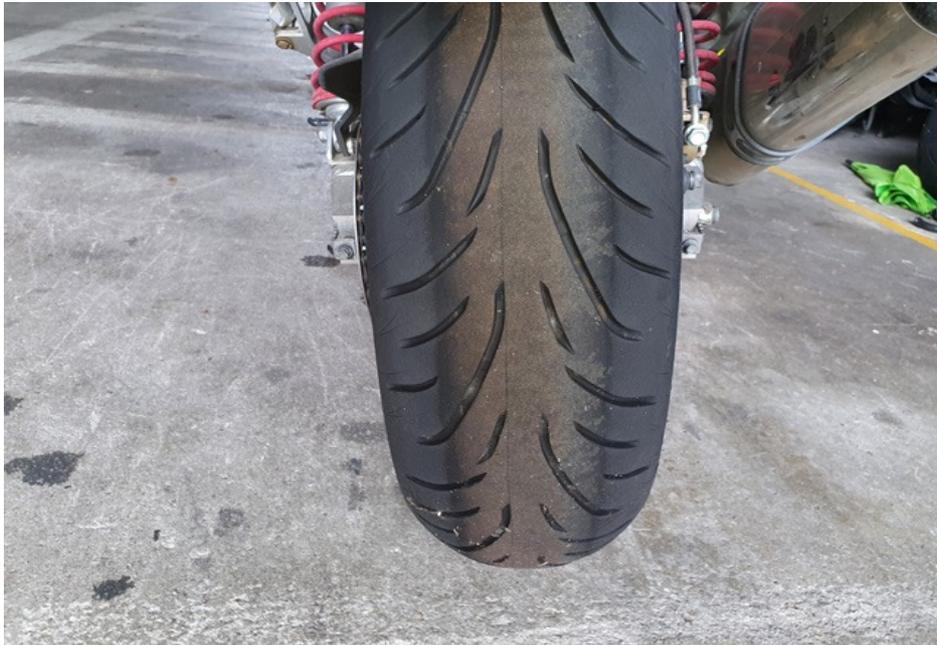
Photo 12 shows the condition of the Motorcycle's rear tyre. The rear tyre was observed to be in serviceable condition with remaining tread depth of approximately 4mm. The tyre was also observed to be sufficiently inflated for vehicular operation. We did not observe any tear, burst mark(s) and/or punctured hole(s) on the sidewalls as well as across the tread of the rear tyre.

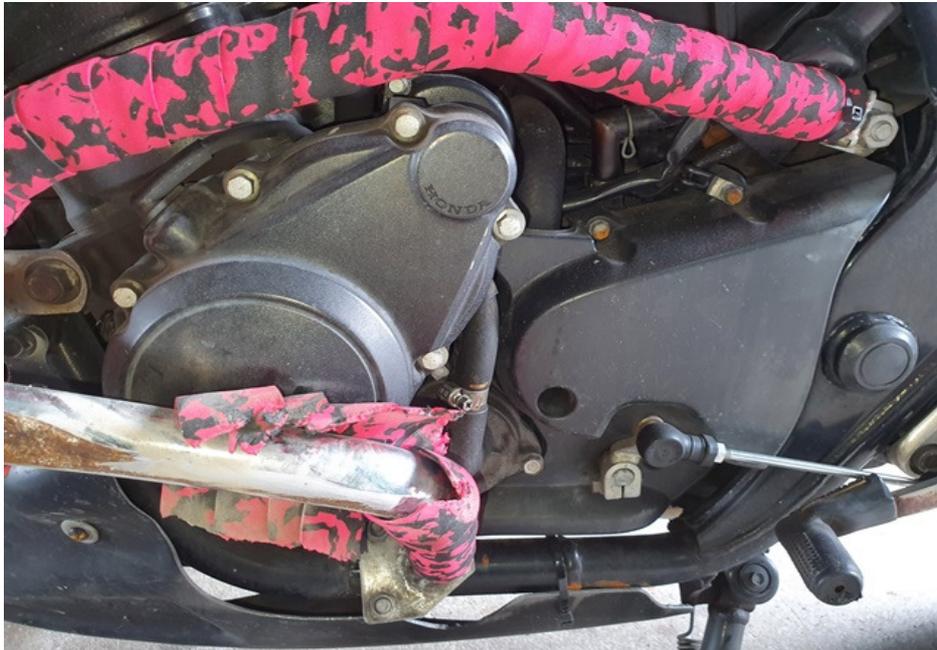
Photo 13 shows the left side of the engine of the Motorcycle at the time of our inspection. The various engine related parts and components were found to be intact with no visible damage. There was also no sign(s) or indication(s) of fluid leak observed around the left engine area of the Motorcycle.

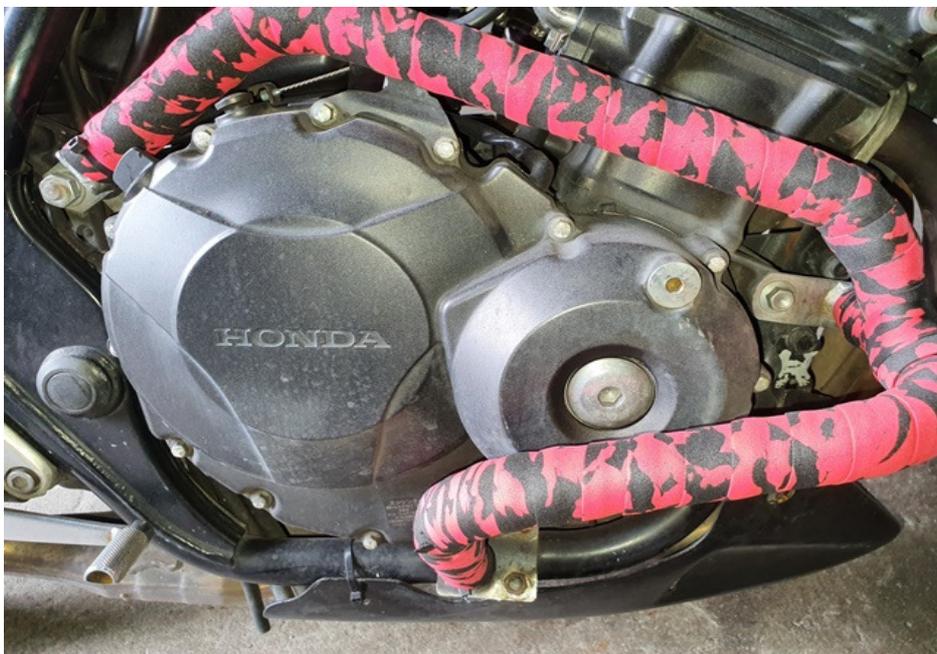
Photo 14 shows the right side of the engine of the Motorcycle at the time of our inspection. The various engine related parts and components were found to be intact with no visible damage. There was also no sign(s) or indication(s) of fluid leak observed around the right engine area of the Motorcycle.

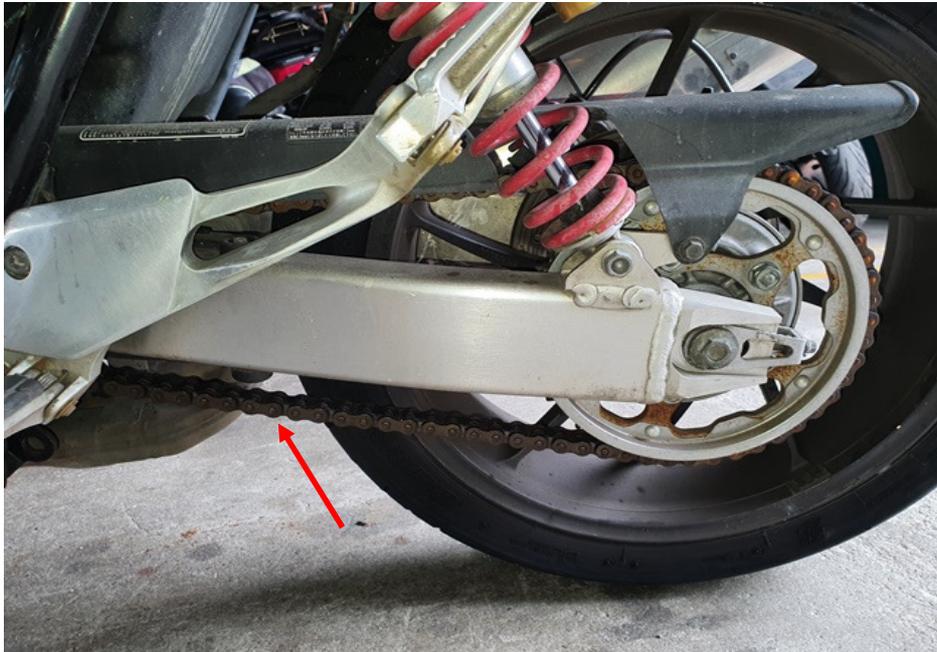
Photo 15 shows the general view of the gear train (arrowed) of the Motorcycle, which was observed to be intact with no misalignment. It was also adequately lubricated for operating purposes.

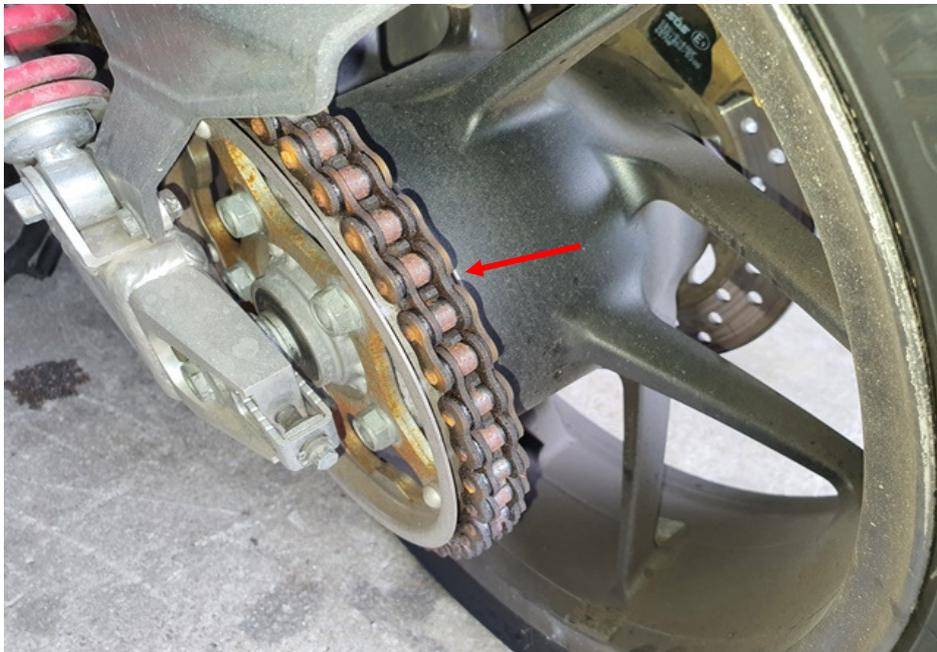
Photo 16 shows a closer view of the gear train (arrowed) of the Motorcycle, which was observed to be intact with no misalignment. It was also adequately lubricated for operating purposes.

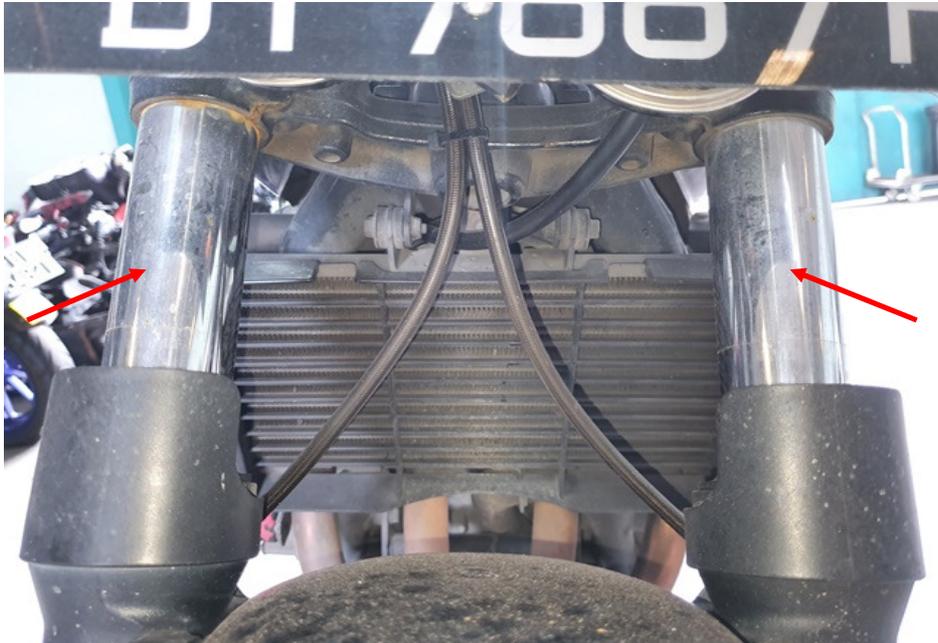
Photo 17 shows the front fork (arrowed) of the Motorcycle. The front fork and fork bracket of the Motorcycle were both found to be intact and undamaged. Turning the Motorcycle's handle bar towards the left and right did not produce any abnormal free play and/or resistance. The steering system of the Motorcycle was in serviceable condition at the time of our inspection.

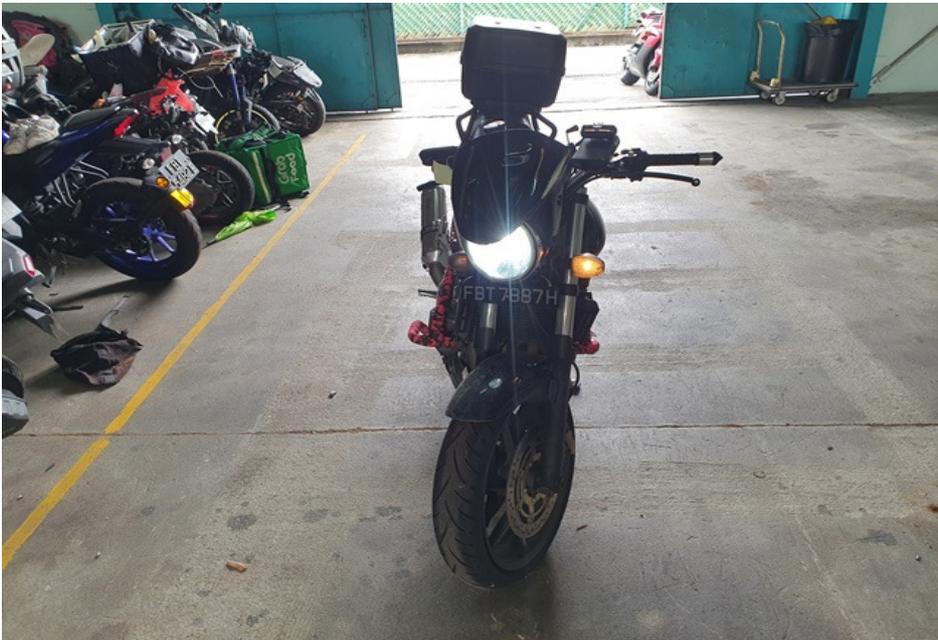
Photo 18 shows the front wheel of the Motorcycle turned towards its full right. Turning the Motorcycle's handle bar towards the left and right did not produce any abnormal free play and/or resistance. This would indicate that the steering system of the Motorcycle was in serviceable condition at the time of our inspection.

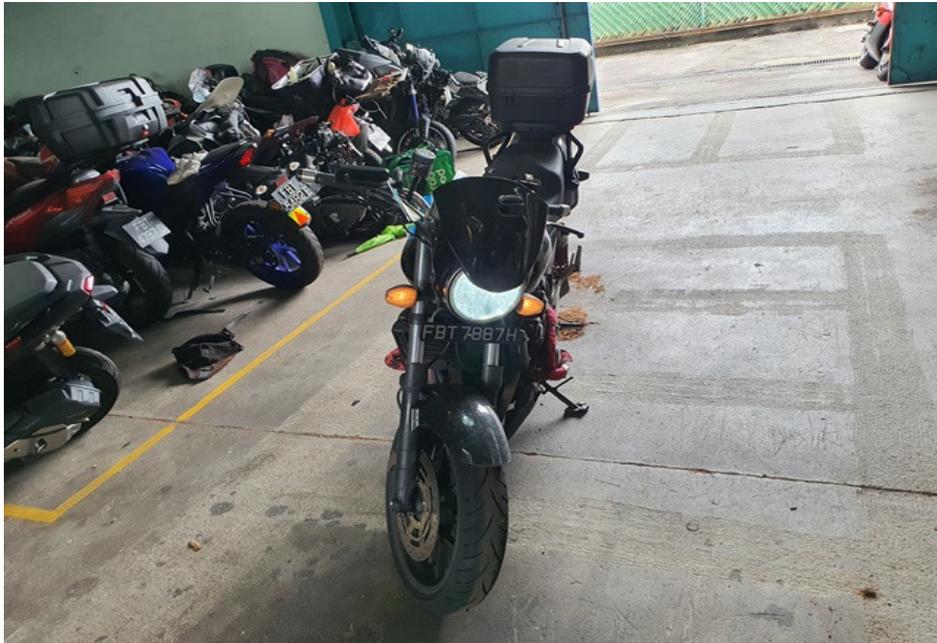
Photo 19 shows the front wheel of the Motorcycle turned towards its full left. Turning the Motorcycle's handle bar towards the left and right did not produce any abnormal free play and/or resistance. This would indicate that the steering system of the Motorcycle was in serviceable condition at the time of our inspection.

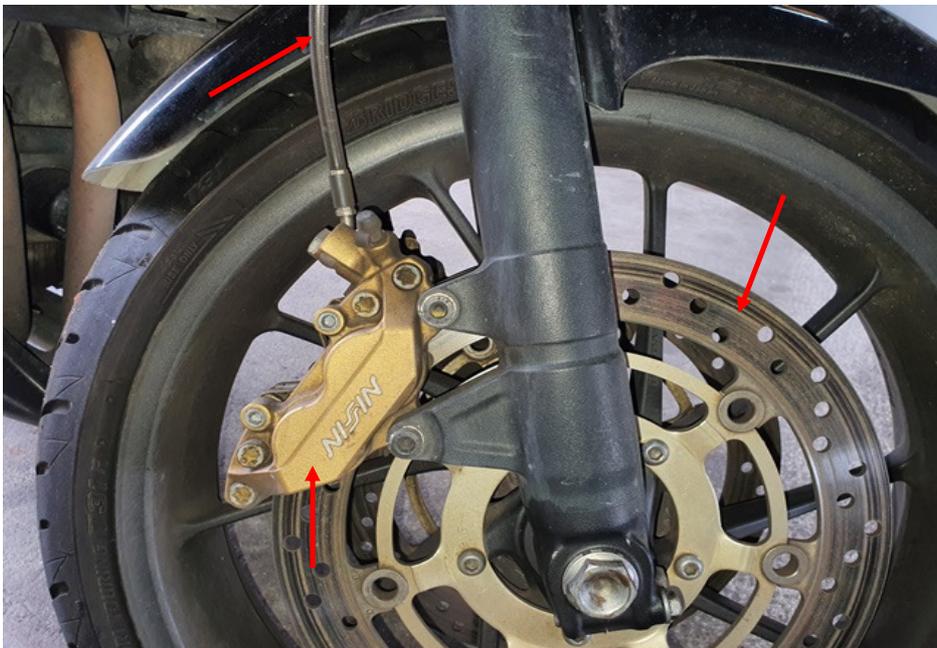
Photo 20 shows a close up view of the front brake caliper, front brake disc and front brake hose (arrowed) at the right side of the Motorcycle's front wheel, which are all part of the components in the hydraulic front brake system of the Motorcycle. Our visual checks of these various components had revealed all to be intact with no visible damage. No leakage of brake fluid was also observed.

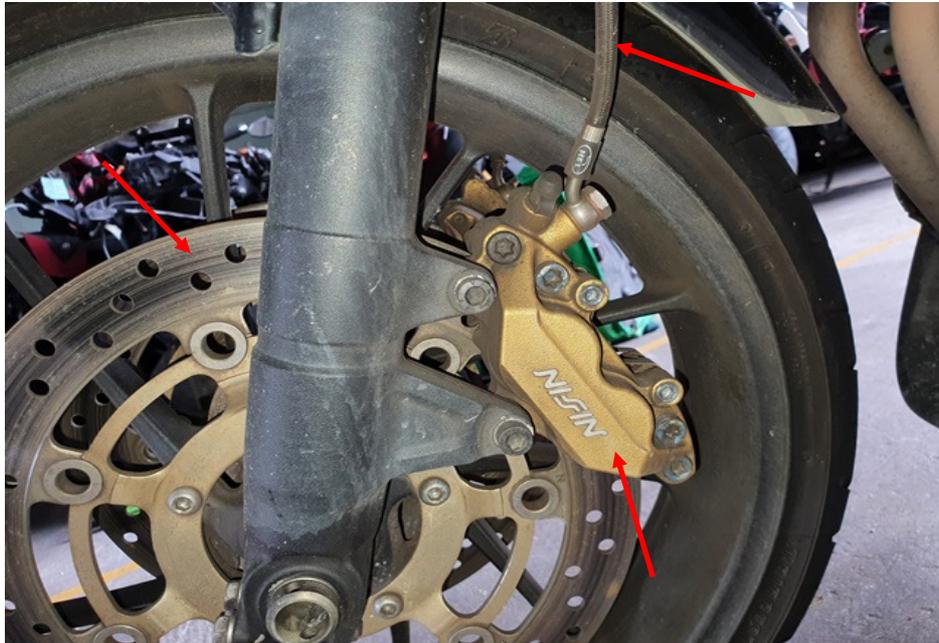
Photo 21 shows a close up view of the front brake caliper, front brake disc and front brake hose (arrowed) at the left side of the Motorcycle's front wheel, which are all part of the components in the hydraulic front brake system of the Motorcycle. Our visual checks of these various components had revealed all to be intact with no visible damage. No leakage of brake fluid was also observed.

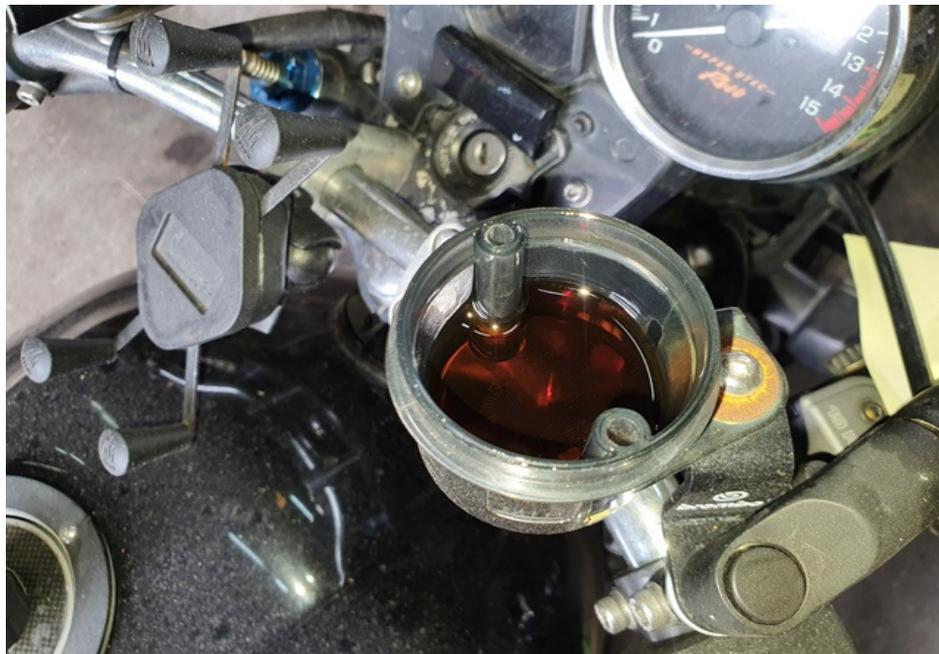
Photo 22 shows the brake fluid reservoir for the front brake of the Motorcycle. The brake fluid was observed to be of sufficient level for operational purposes and without contamination.

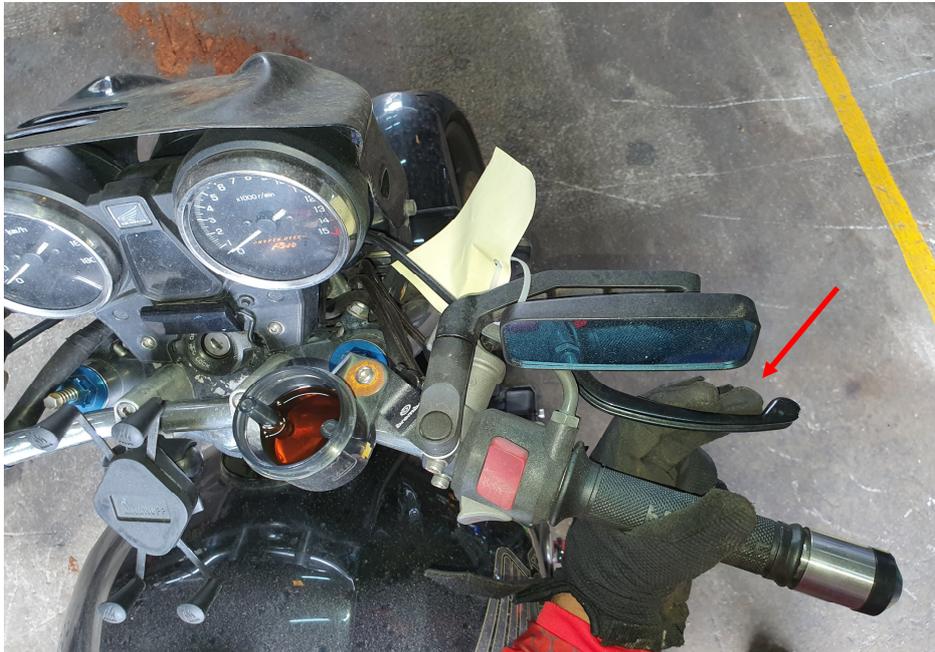
Photo 23 shows the front brake lever being depressed. There was some resistance felt (spongy like feel) upon pressing the front brake lever (arrowed). This would indicate that there is no leakage of pressure/vacuum in the brake system.

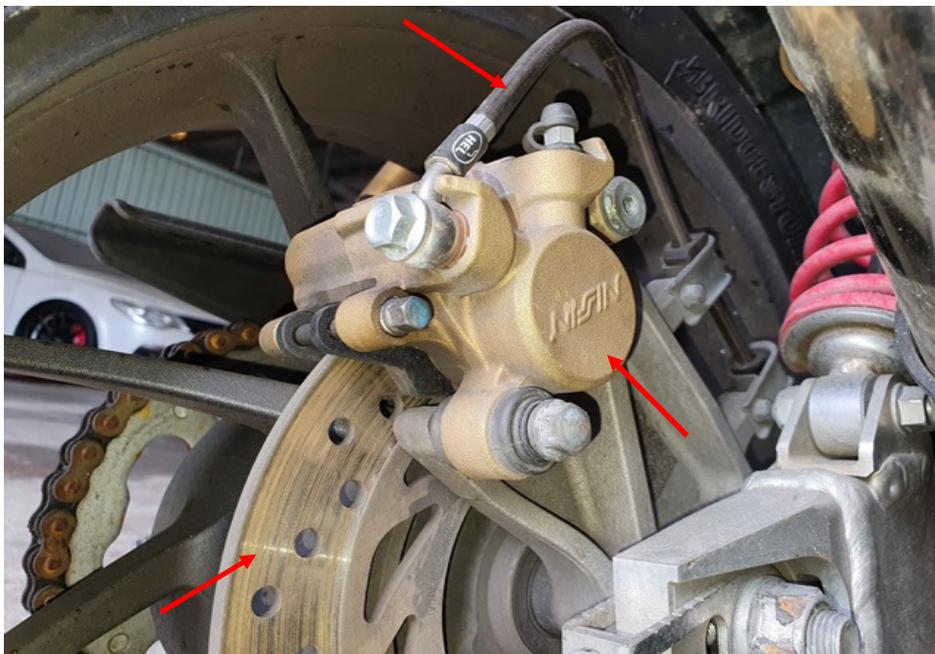
Photo 24 shows a close up view of the rear brake caliper, rear brake disc and rear brake hose (arrowed) of the Motorcycle, which are all part of the components in the hydraulic rear brake system of the Motorcycle. Our visual checks of these various components had revealed all to be intact with no visible damage. No leakage of brake fluid was also observed.

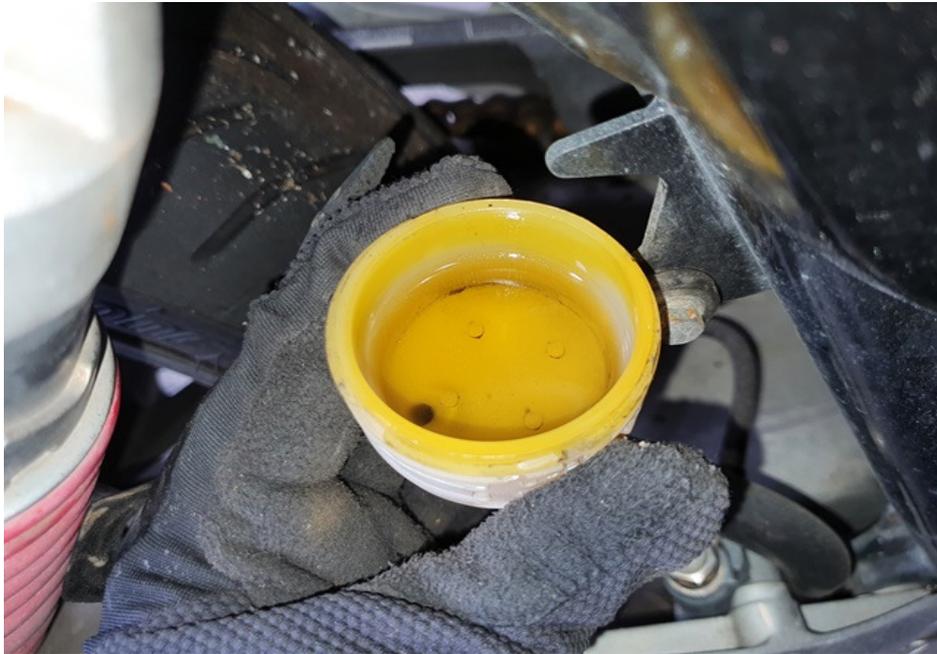
Photo 25 shows the brake fluid reservoir for the rear brake of the Motorcycle. The brake fluid was observed to be of sufficient level for operational purposes and without contamination.
