Your Ref: TP/IP/04869/2022  
Our Ref : CI/TPD22005254/N

**Fatal Accident Investigation Team**

**INSPECTION REPORT OF BICYCLE (DARK BLUE) - TRAFFIC POLICE  
POUND REPORT NO. 0722/22**

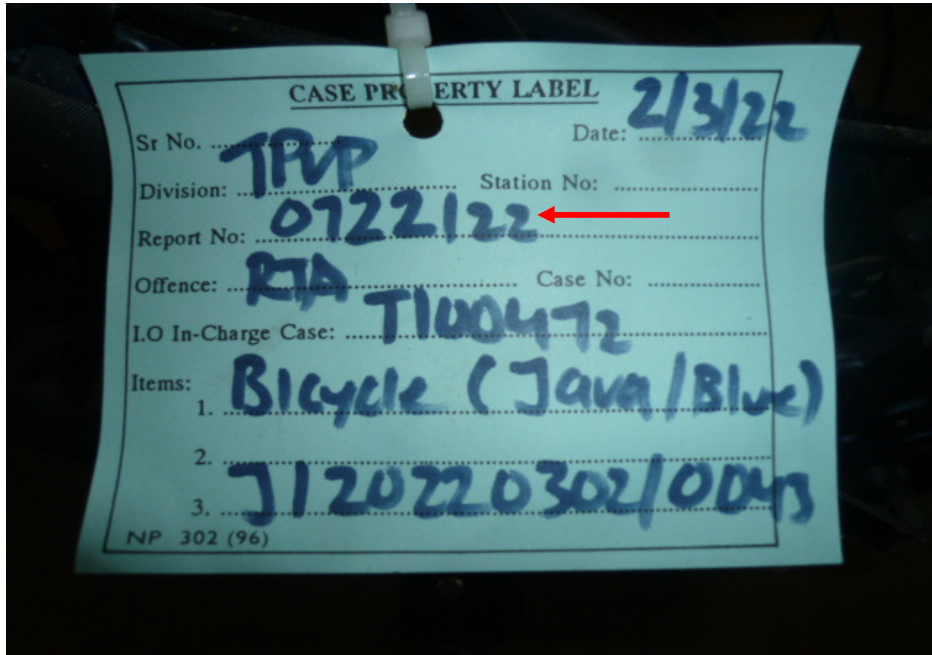
**Photo 1** shows the identification of the Bicycle with reference to Traffic Police Pound Report No. 0722/22 (arrowed).

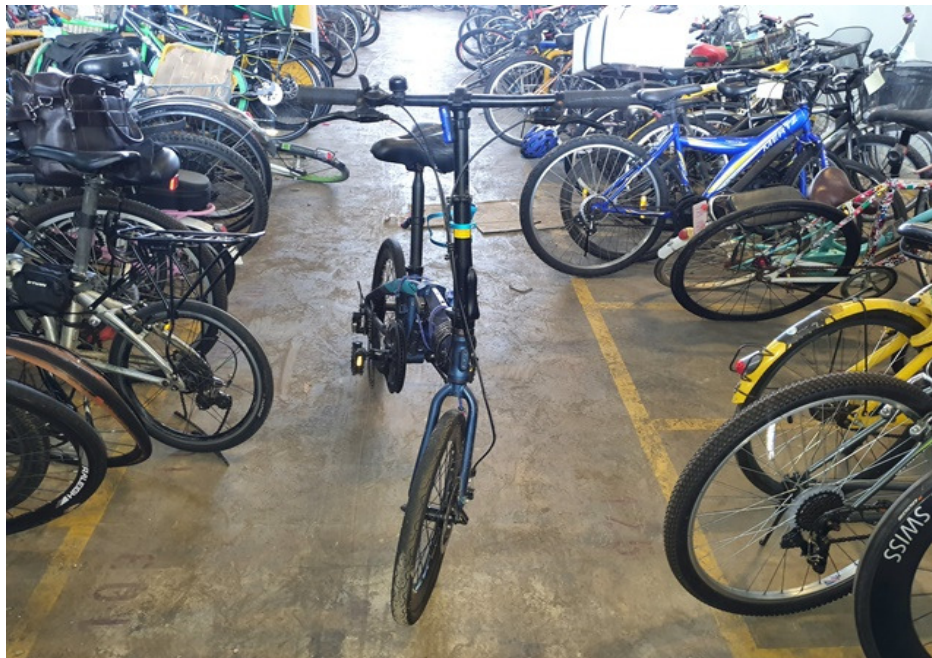
**Photo 2** shows the frontal portion of the Bicycle at the time of our inspection. The Bicycle had sustained damages all around.

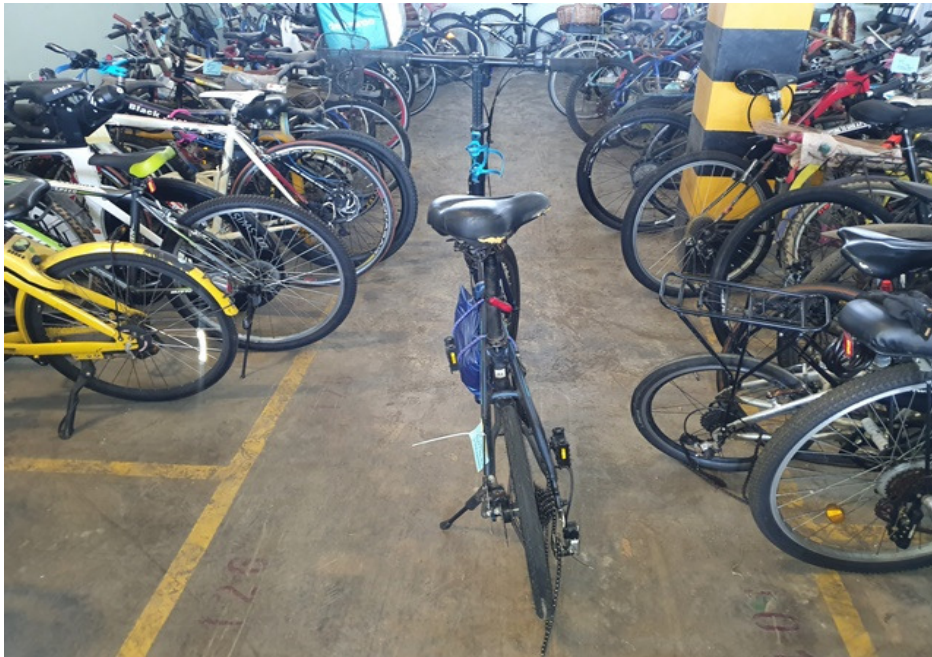
**Photo 3** shows the rear portion of the Bicycle at the time of our inspection. The Bicycle had sustained damages all around.

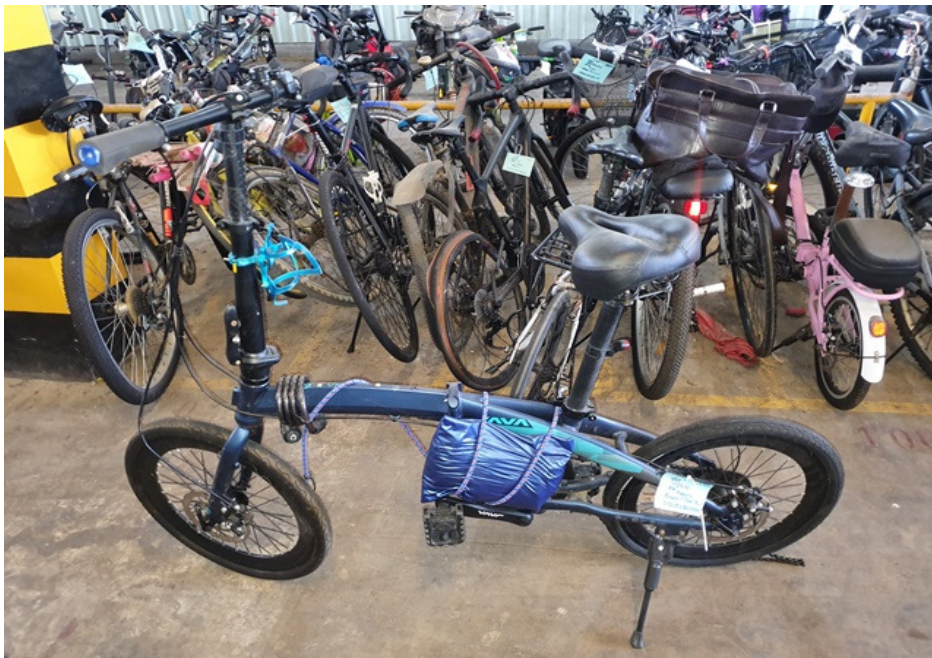
**Photo 4** shows the left body of the Bicycle at the time of our inspection. The Bicycle had sustained damages all around. The body parts that were found to have been damaged include its left hand brake lever, right hand brake lever, handlebar grips, sub frame, bottle holder and right pedal, amongst others as a result of the accident.

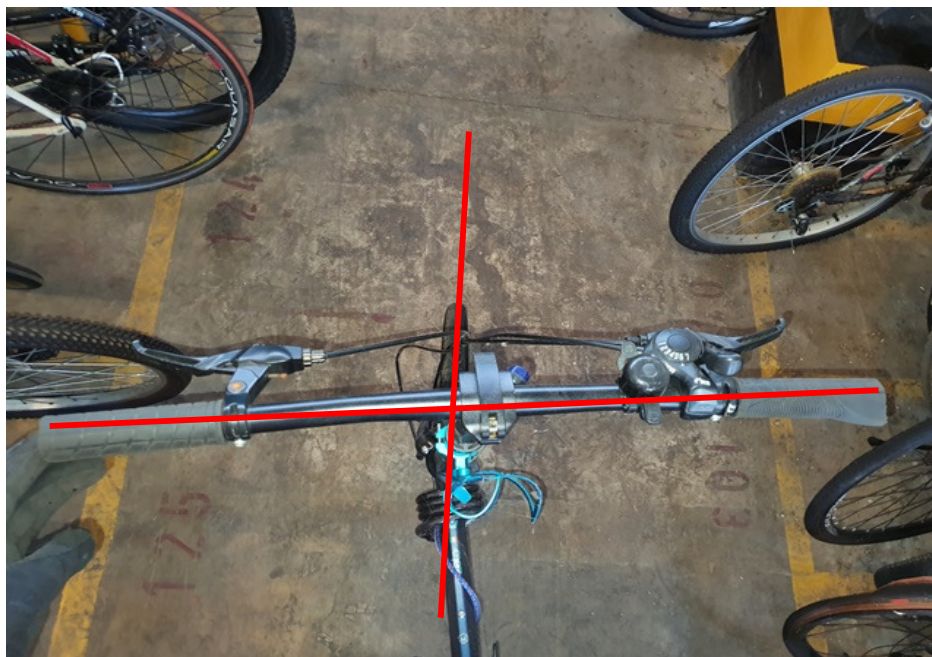
**Photo 5** shows the frontal portion of the Bicycle (top view) at the time of our inspection. There was a misalignment of the handlebar & front tyre observed.

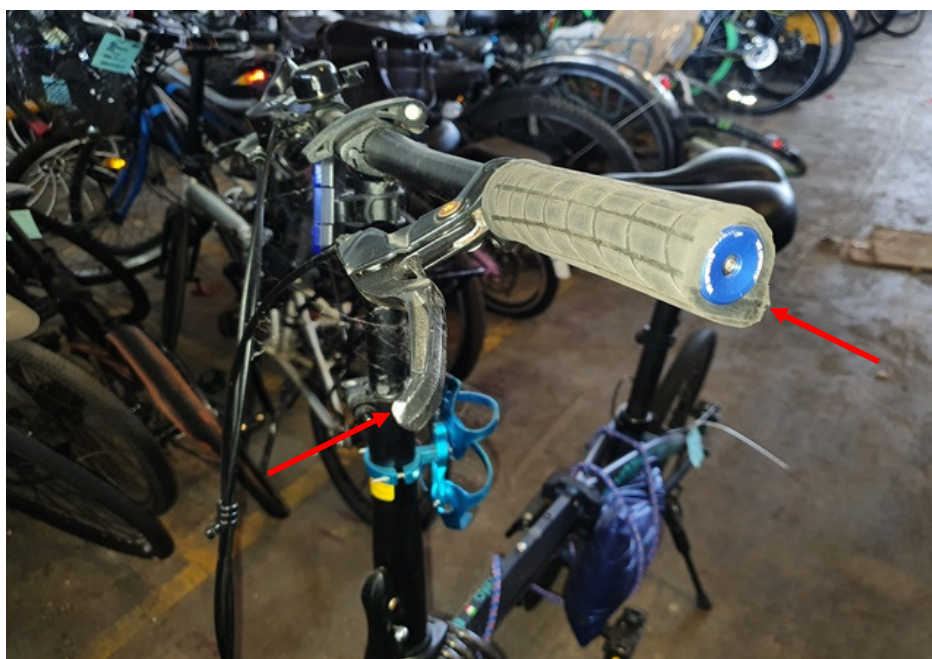
**Photo 6** shows the damages of grazing nature on the left hand brake lever and left handlebar grip of the Bicycle at the time of our inspection (arrowed).

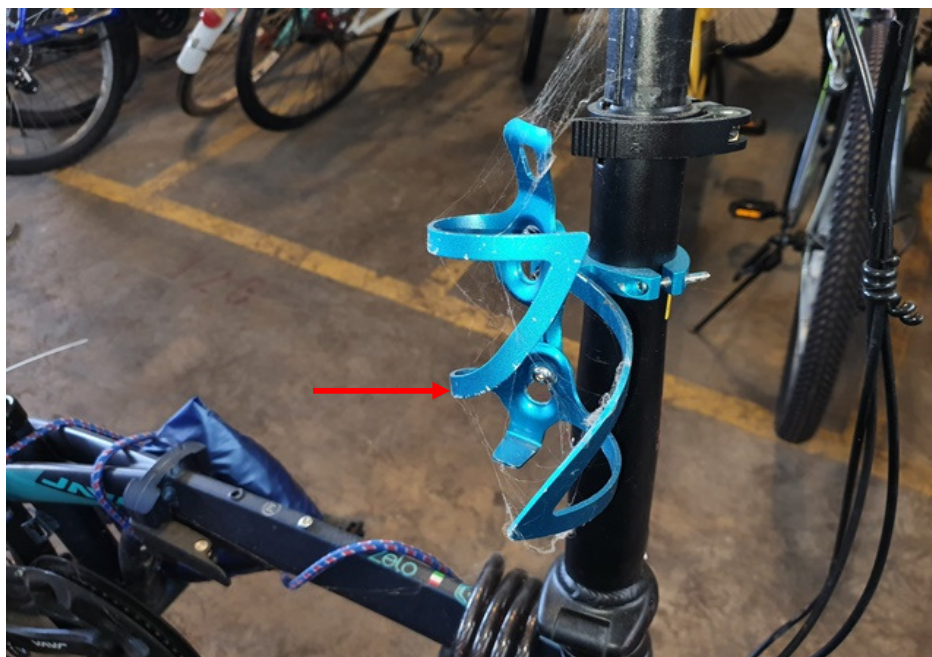
**Photo 7** shows the deformed bottle holder (arrowed) of the Bicycle as a result of the accident.

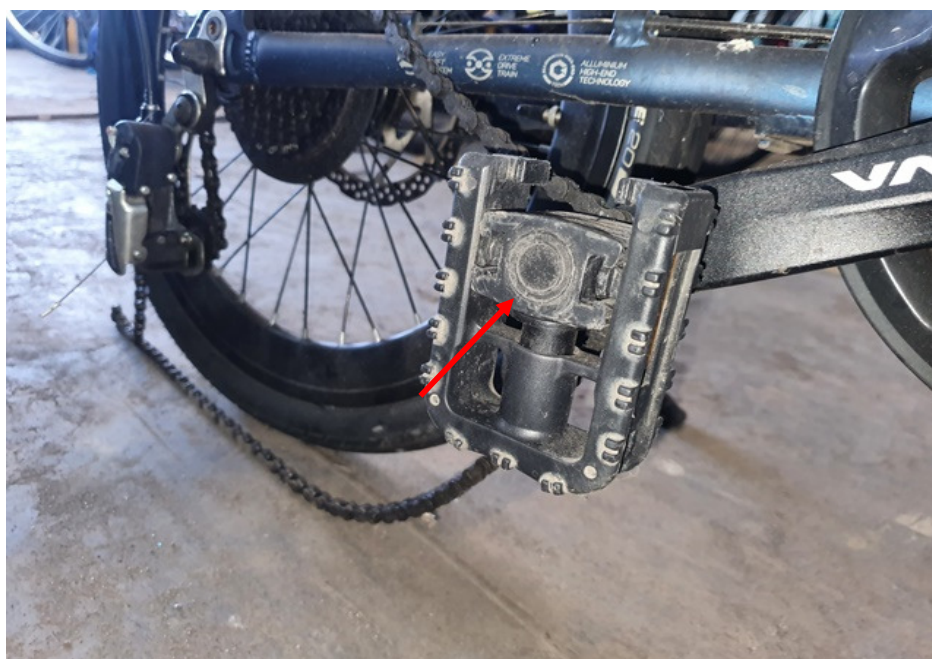
**Photo 8** shows the grazed right pedal of the Bicycle at the time of our inspection (arrowed).

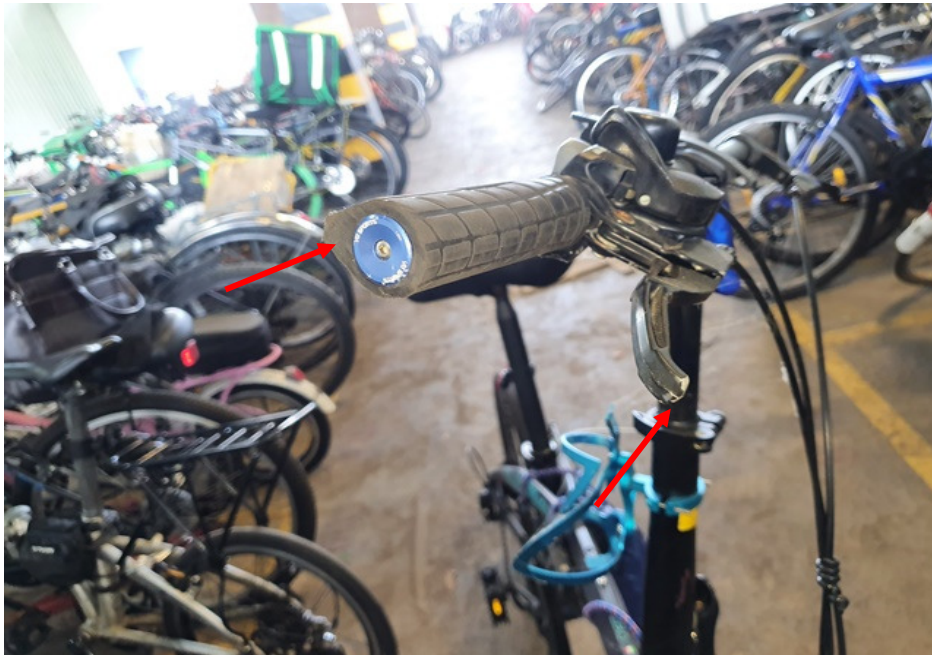
**Photo 9** shows the damages of grazing nature on the right hand brake lever and right handlebar grip of the Bicycle at the time of our inspection (arrowed).

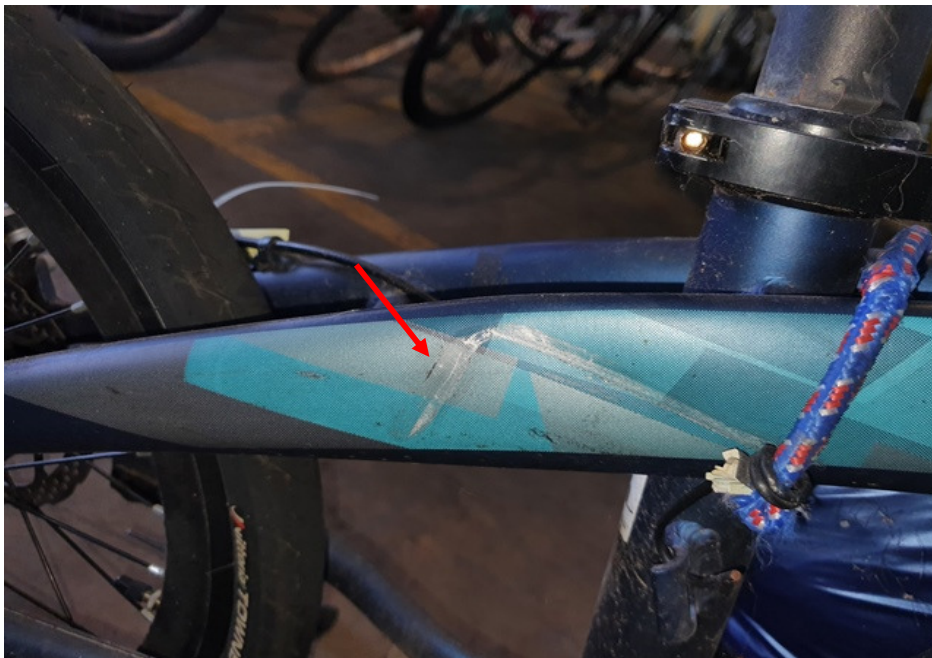
**Photo 10** shows a close-up view of the deformed sub frame of the Bicycle as a result of the accident (arrowed).

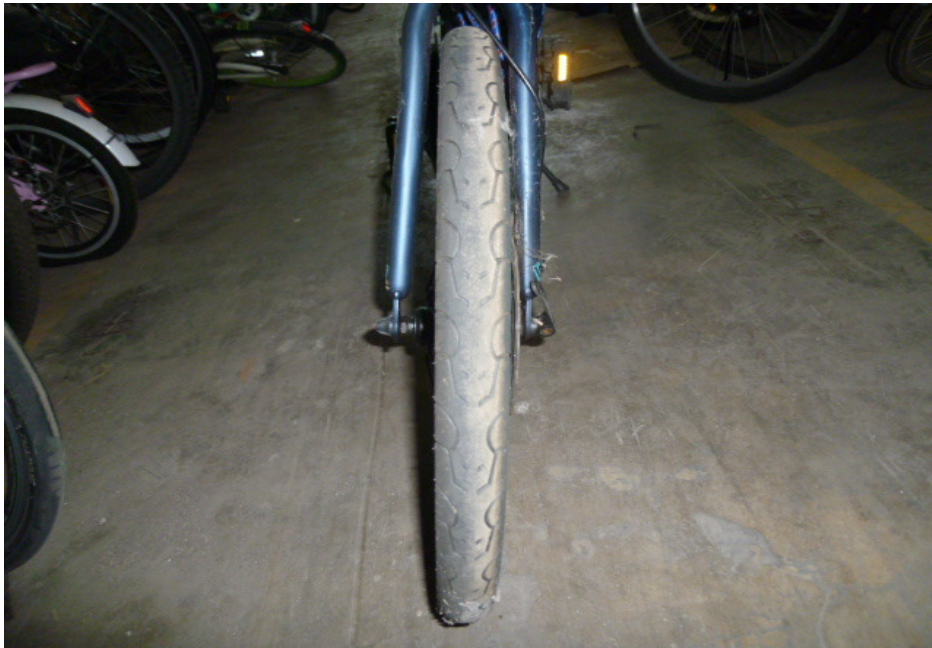
**Photo 11** shows the front tyre of the Bicycle. The front tyre was observed to be in serviceable condition with remaining tread depth of approximately 3mm. There was no tear, burst mark(s) and/or punctured hole(s) on the sidewalls as well as across the tread of the front tyre. The front tyre was also observed to be sufficiently inflated for vehicular operation.

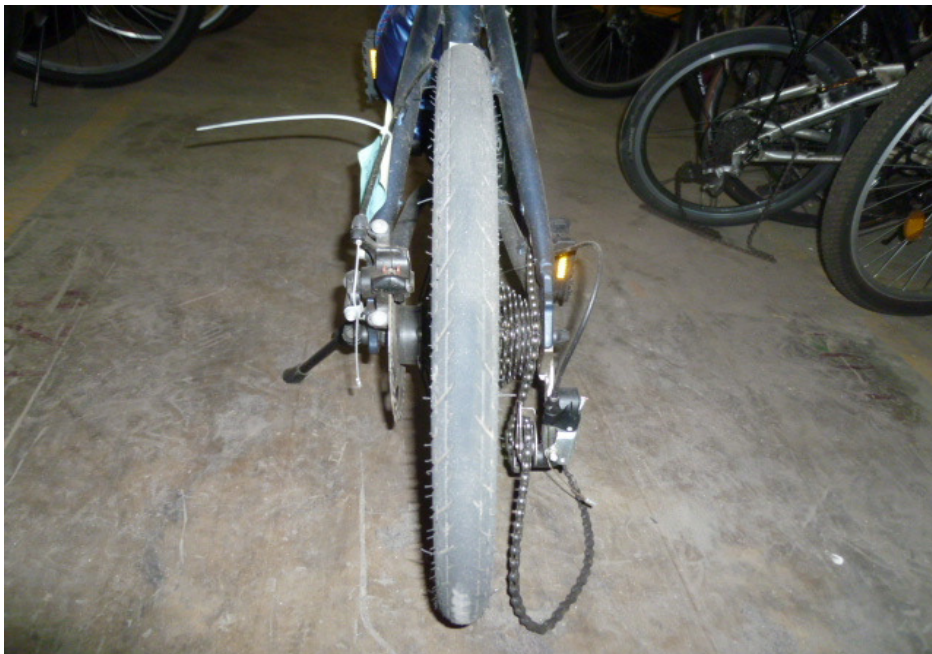
**Photo 12** shows the rear tyre of the Bicycle. The rear tyre was observed to be in serviceable condition with remaining tread depth of approximately 3mm. The pattern of the tread was clearly visible. There was no tear, burst mark(s) and/or punctured hole(s) on the sidewalls as well as across the tread of the rear tyre. The rear tyre was also observed to be sufficiently inflated for vehicular operation.

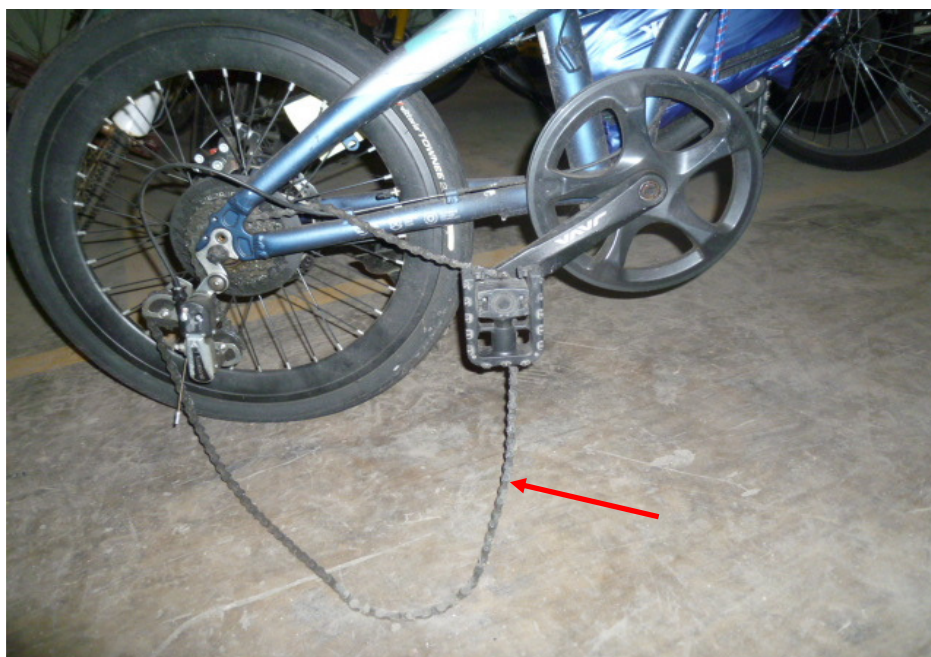
7. The gear train of the Bicycle was found to be severely damaged as a result of the accident. The chain was also observed to be dislodged from the gear train most likely as a result of the accident. No free play tension test can be conducted due to the extensive damages. See photos 13 & 14 below.

**Photo 13** shows the general view of the gear train of the Bicycle which was found to be severely damaged as a result of the accident. The chain was also observed to be dislodged from the gear train most likely as a result of the accident (arrowed).

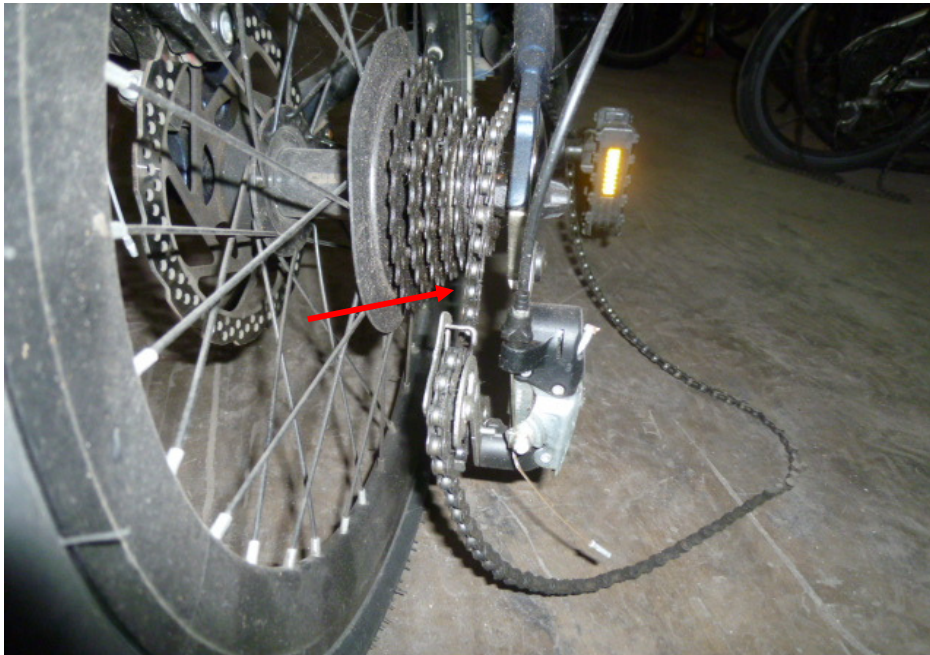
**Photo 14** shows a close up view of the gear train of the Bicycle, which was observed to have sustained severe damages as a result of the accident (arrowed). No free play tension test can be conducted due to the extensive damages.

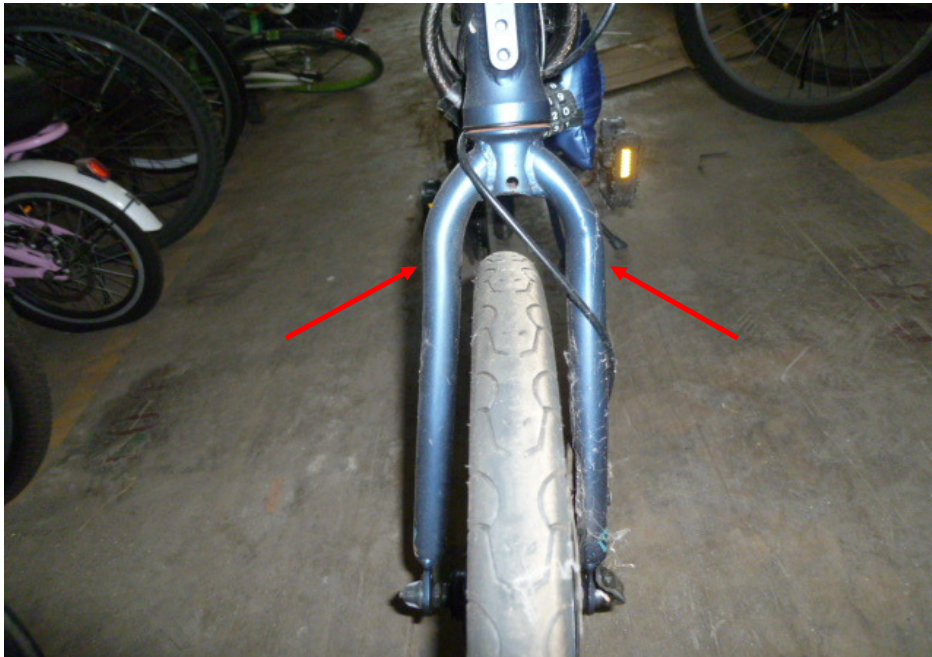
**Photo 15** shows the front fork assembly (arrowed) of the Bicycle. The front forks and fork bracket of the Bicycle were both found to be intact and undamaged. Turning the Bicycle's handle bar towards the left and right did not produce any abnormal free play. The steering system of the Bicycle was in serviceable condition at the time of our inspection.

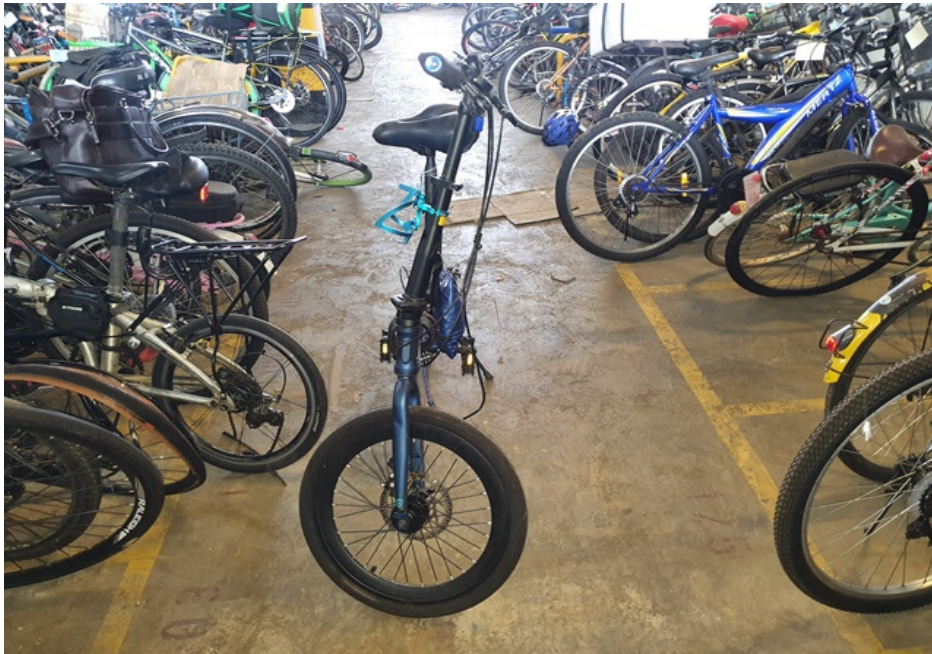
**Photo 16** shows the front wheel of the Bicycle turned towards its full left. Turning the Bicycle's handle bar towards the left did not produce any abnormal free play and/or resistance. This would indicate that the steering system of the Bicycle was in serviceable condition at the time of our inspection.

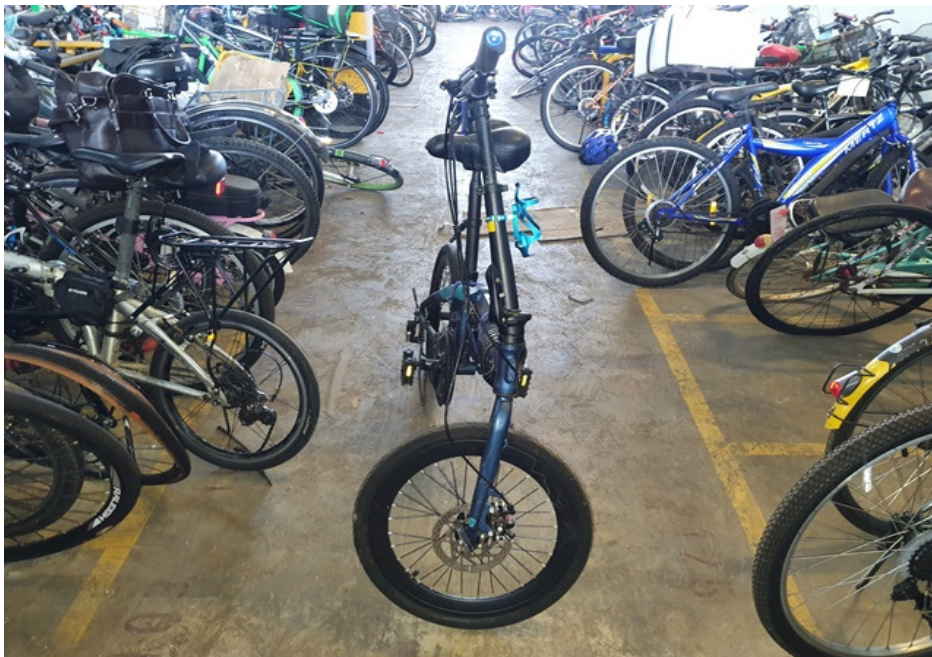
**Photo 17** shows the front wheel of the Bicycle turned towards its full right. Turning the Bicycle's handle bar towards the right did not produce any abnormal free play and/or resistance. This would indicate that the steering system of the Bicycle was in serviceable condition at the time of our inspection.

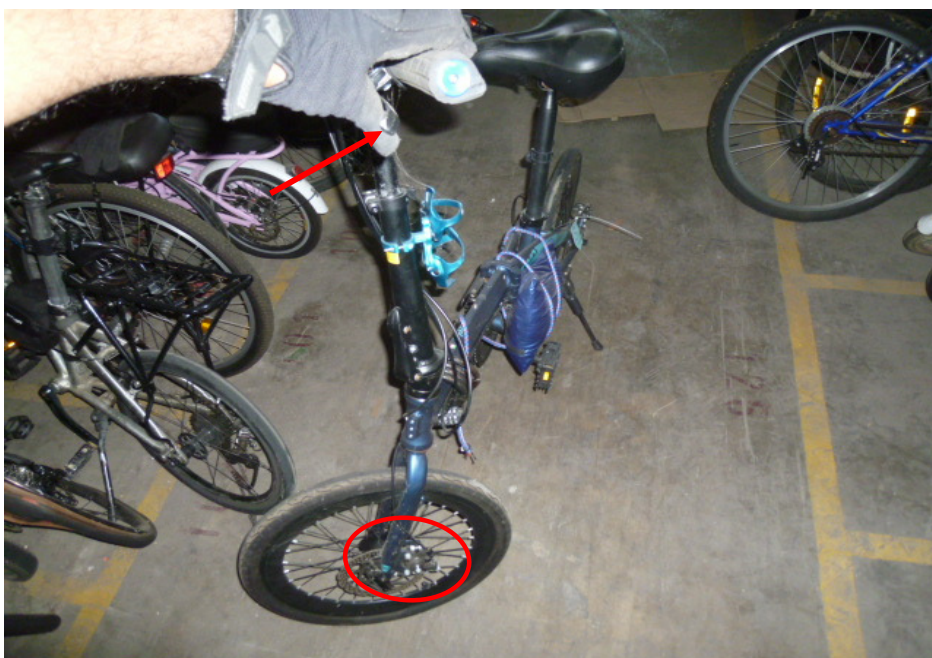
10. A static brake test was conducted on the front brake of the Bicycle. There was some resistance felt upon pressing the left hand brake lever. This was further confirmed by looking at the front brake pads while we pressed the left hand brake lever. It shows that the front brake pads responded to the gripping action. The front brake pads pressed against the front brake disc. This had appeared to indicate that the front brake of the Bicycle was in serviceable condition.

**Photo 18** shows a static brake test conducted on the Bicycle's front brake. There was some resistance felt upon pressing the left hand brake lever (arrowed). It also shows that the front brake pads responded to the gripping action (circled) after depressing the left hand brake lever.

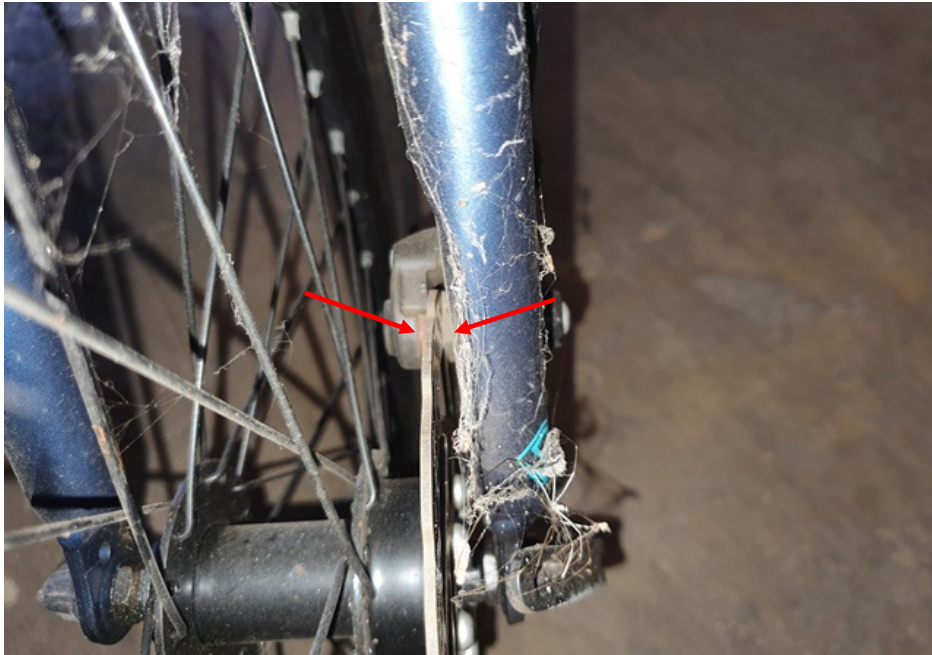
**Photo 19** shows a close up view of the front brake pads responding to the gripping action. The front brake pads pressed against the front brake disc (arrowed) upon depressing the left hand brake lever. This had appeared to indicate that the front brake of the Bicycle was in serviceable condition.

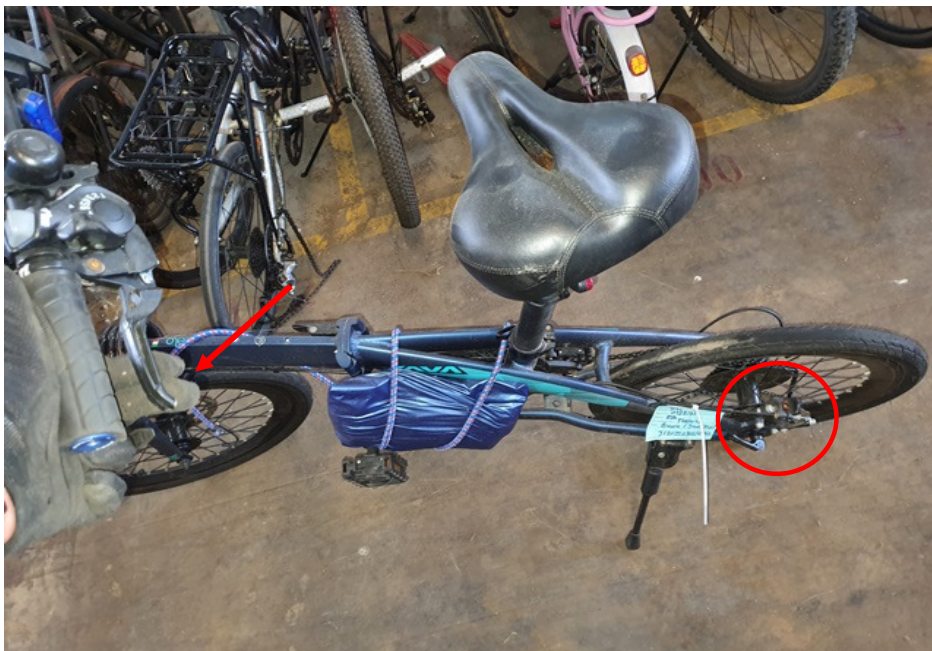
11. A static brake test was conducted on the rear brake of the Bicycle. There was some resistance felt upon pressing the right hand brake lever. This was further confirmed by looking at the rear brake pads while we pressed the right hand brake lever. It shows that the rear brake pads responded to the gripping action. The rear brake pads pressed against the rear brake disc. This had appeared to indicate that the rear brake of the Bicycle was in serviceable condition.

**Photo 20** shows a static brake test conducted on the Bicycle's rear brake. There was some resistance felt upon pressing the right hand brake lever (arrowed). It also shows that the rear brake pads responded to the gripping action (circled) after depressing the right hand brake lever.

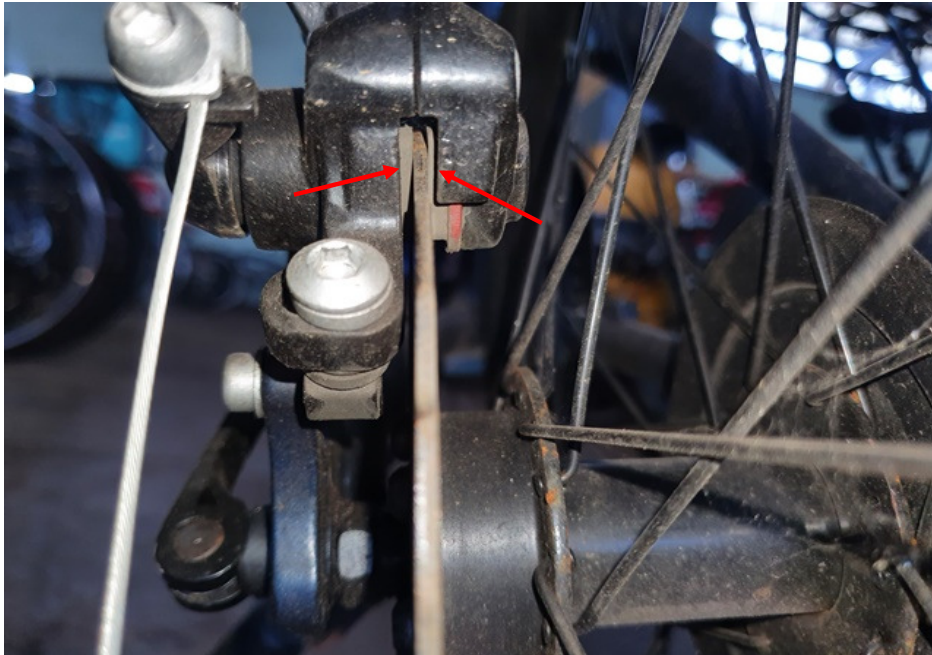
**Photo 21** shows a close up view of the rear brake pads responding to the gripping action. The rear brake pads pressed against the rear brake disc (arrowed) upon depressing the right hand brake lever. This had appeared to indicate that the rear brake of the Bicycle was in serviceable condition.
