Your Ref: TP/IP/08326/2022  
Our Ref : CI/TPD22005255/N

**Fatal Accident Investigation Team**

**INSPECTION REPORT OF MOTORCYCLE JSF 2515**

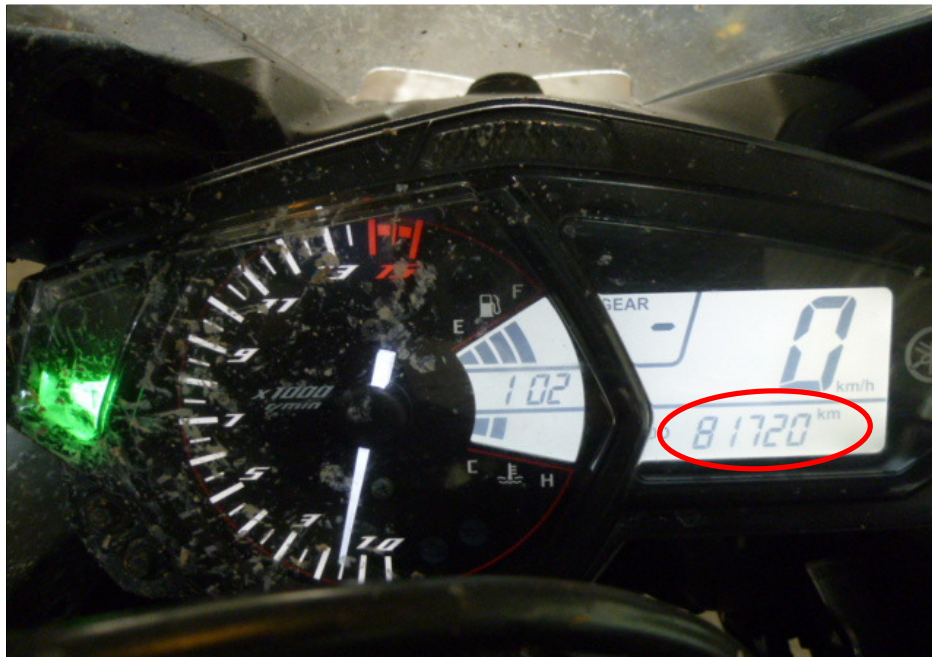
**Photo 1** shows the speedometer gauge of the Motorcycle. The mileage of the Motorcycle at the time of our inspection was 81, 720km (circled).

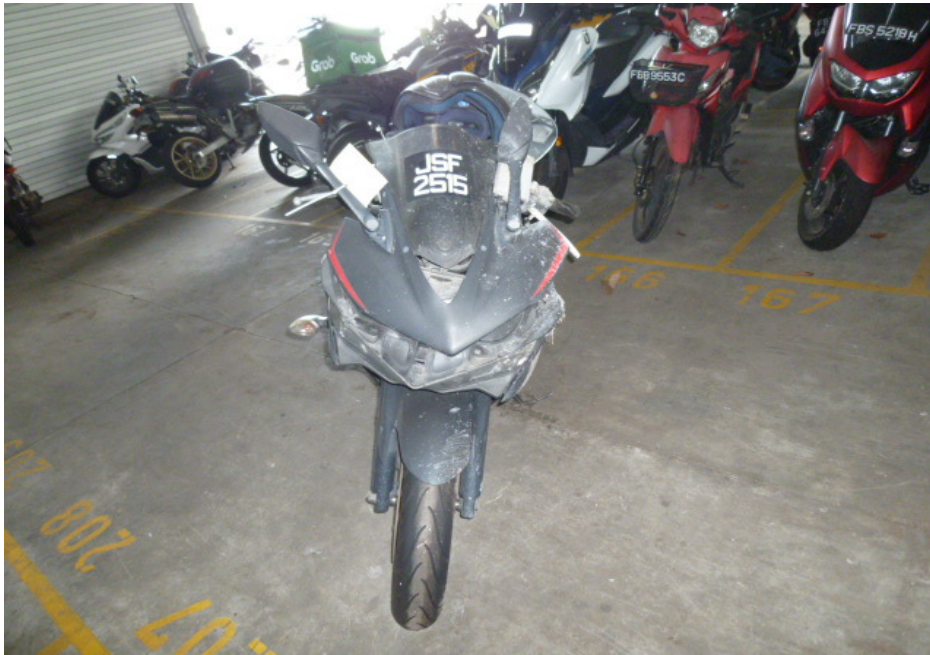
**Photo 2** shows a general view of the frontal portion of the Motorcycle at the time of our inspection. The Motorcycle was observed to have sustained damages all around.

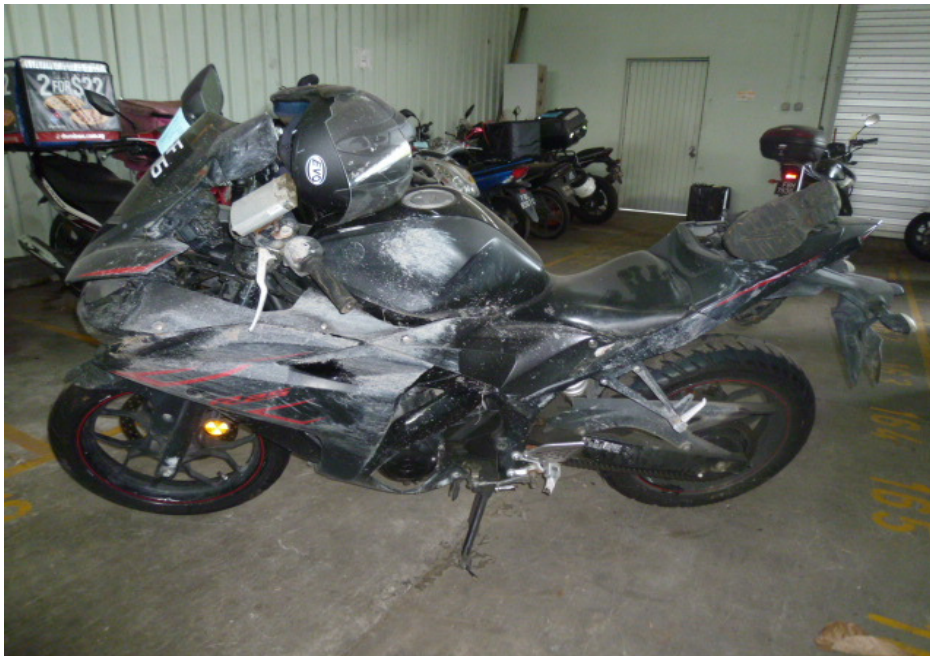
**Photo 3** shows a general view of the left body of the Motorcycle at the time of our inspection. The Motorcycle was observed to have sustained damages all around.

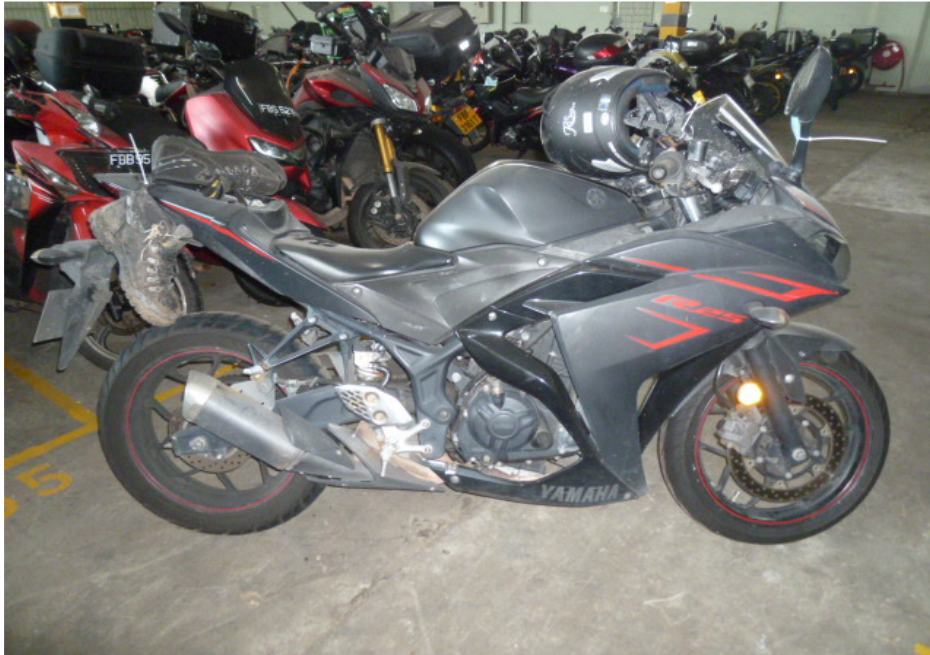
**Photo 4** shows a general view of the right body of the Motorcycle at the time of our inspection. The Motorcycle was observed to have sustained damages all around. The body parts that were found to have been damaged include its front cowling, front mudguard, front wheel axle nut, side cowlings, left side mirror, clutch lever, left handlebar end, petrol tank, gear shift pedal, left front footrest, rear side covers and left rear signal lamp, amongst others.

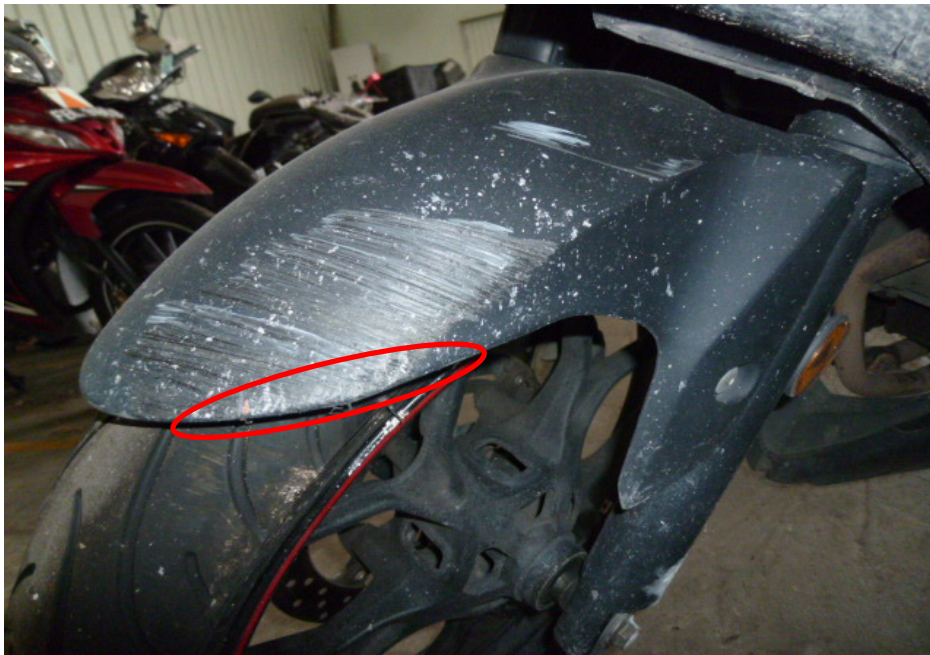
**Photo 5** shows a closer view of the front mudguard (circled) which was amongst the body parts of the Motorcycle that had sustained damage as a result of the accident.

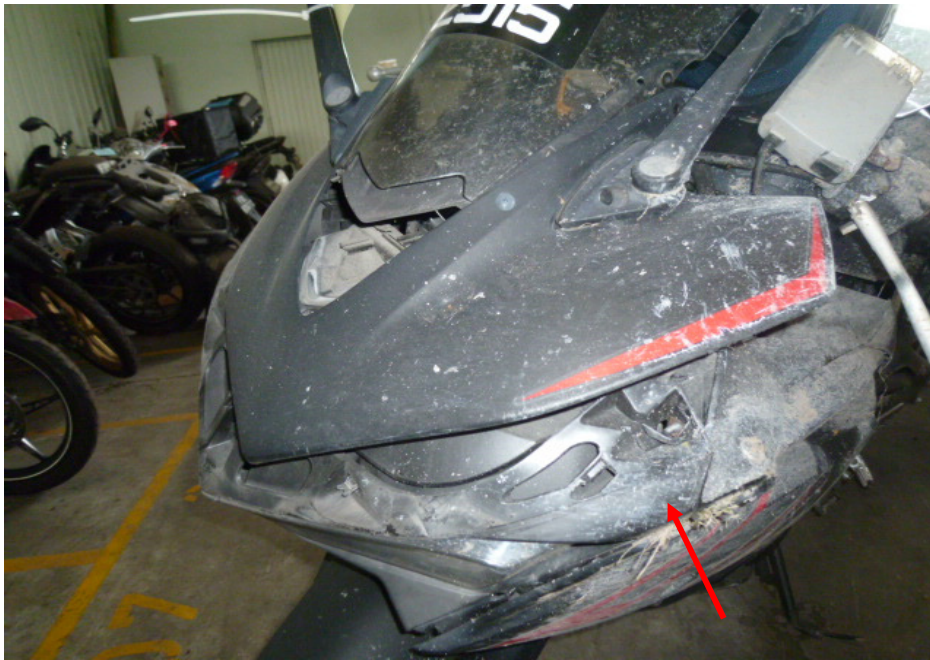
**Photo 6** shows the front cowling (arrowed), which were amongst the body parts of the Motorcycle that had sustained damage as a result of the accident.

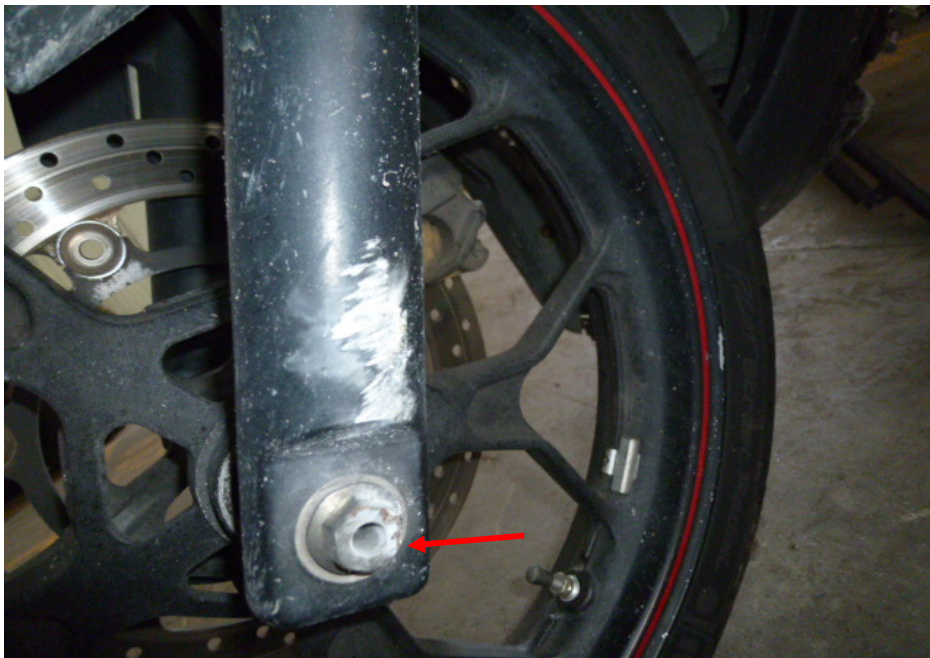
**Photo 7** shows a closer view of the grazed front wheel axle nut (arrowed) of the Motorcycle as a result of the accident.

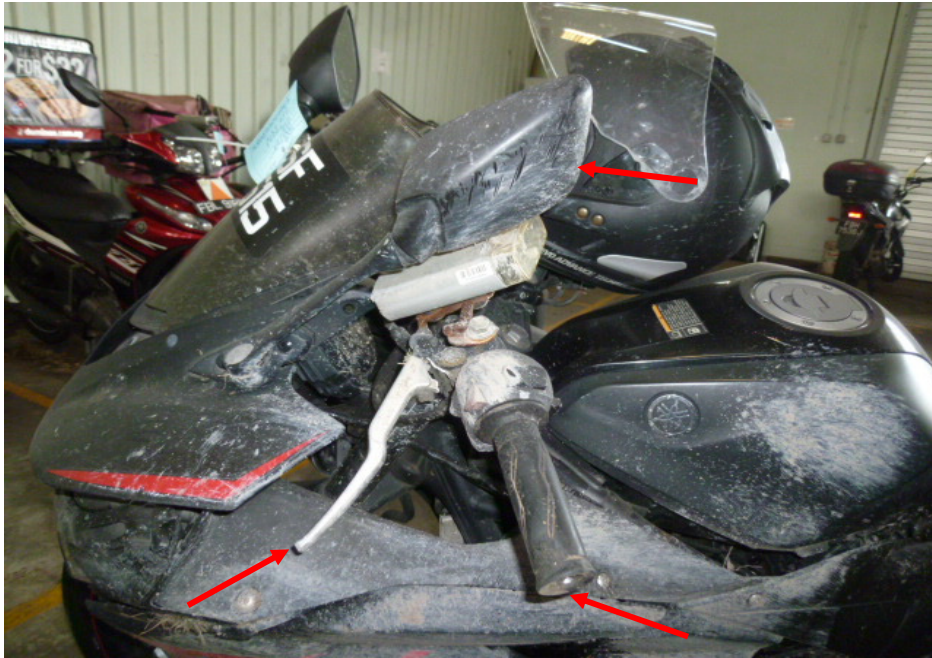
**Photo 8** shows the left handlebar end, clutch lever and left side mirror (arrowed), which were amongst the body parts of the Motorcycle that had sustained damage as a result of the accident.

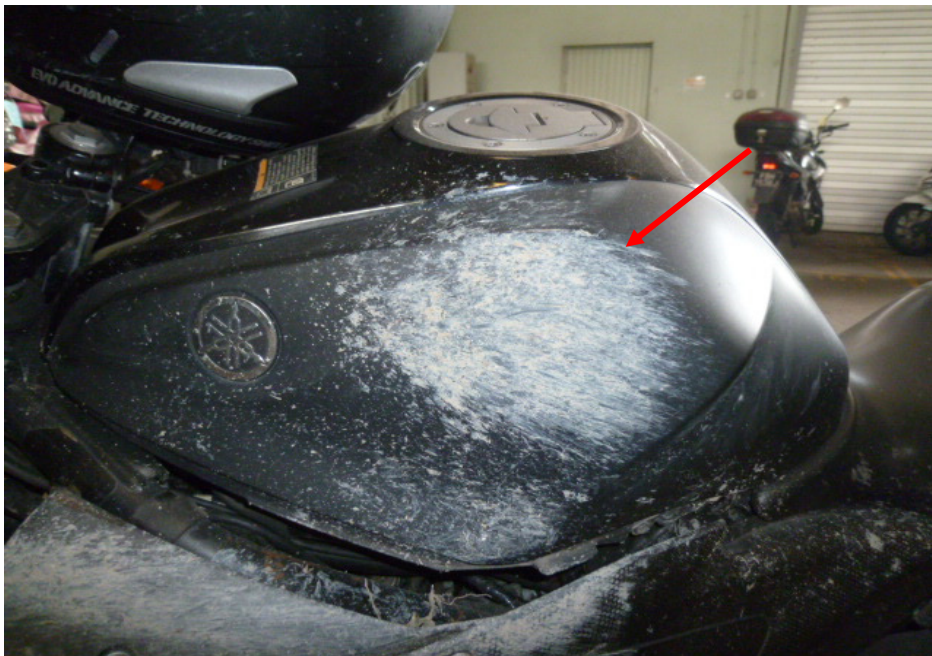
**Photo 9** shows a closer view of the grazed petrol tank of the Motorcycle as a result of the accident (arrowed).

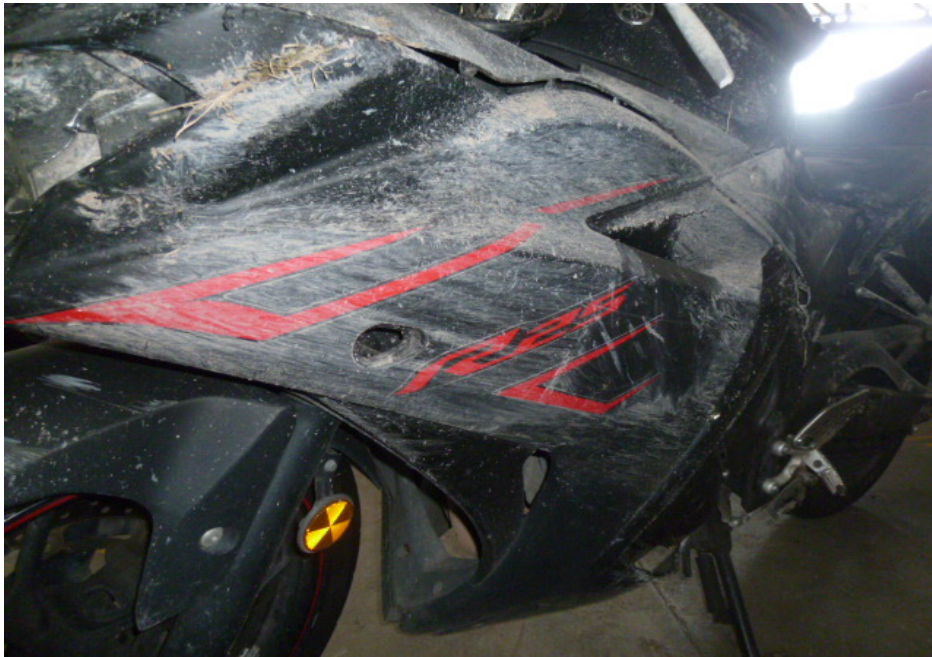
**Photo 10** shows a closer view of the left cowling which was amongst the body parts of the Motorcycle that had sustained damage as a result of the accident.

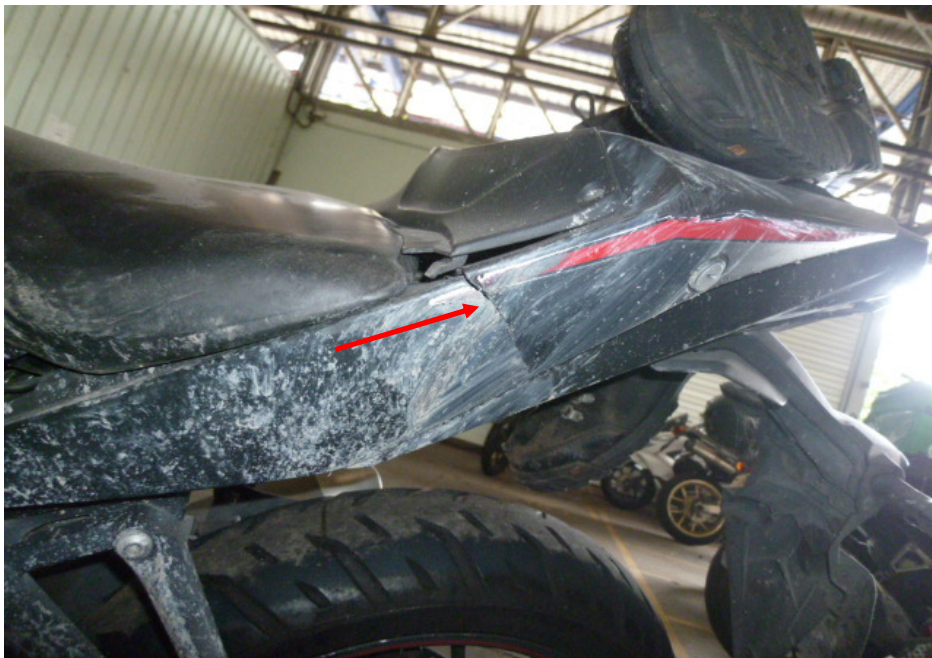
**Photo 11** shows a closer view of the cracked left rear side cover of the Motorcycle as a result of the accident (arrowed).

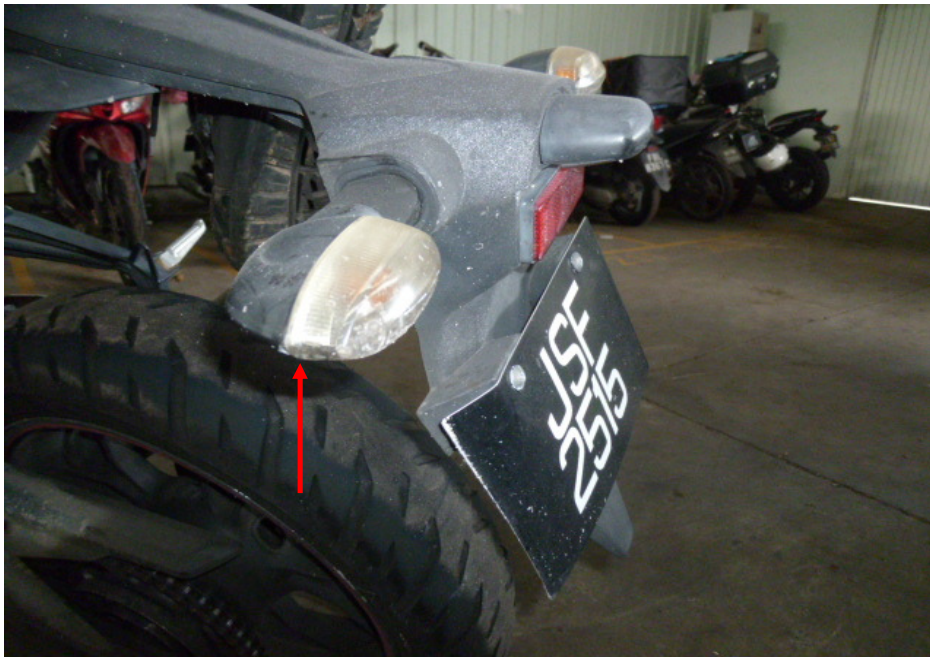
**Photo 12** shows a closer view of the grazed left rear signal lamp (arrowed) of the Motorcycle as a result of the accident.

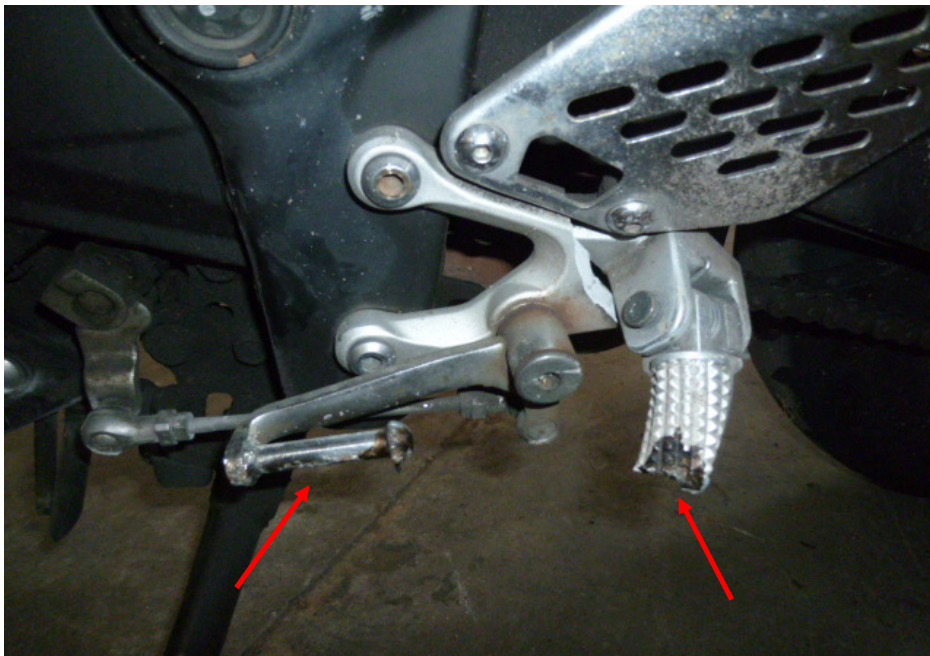
**Photo 13** shows the gear shift pedal and left front footrest of the Motorcycle that had sustained damage as a result of the accident (arrowed).

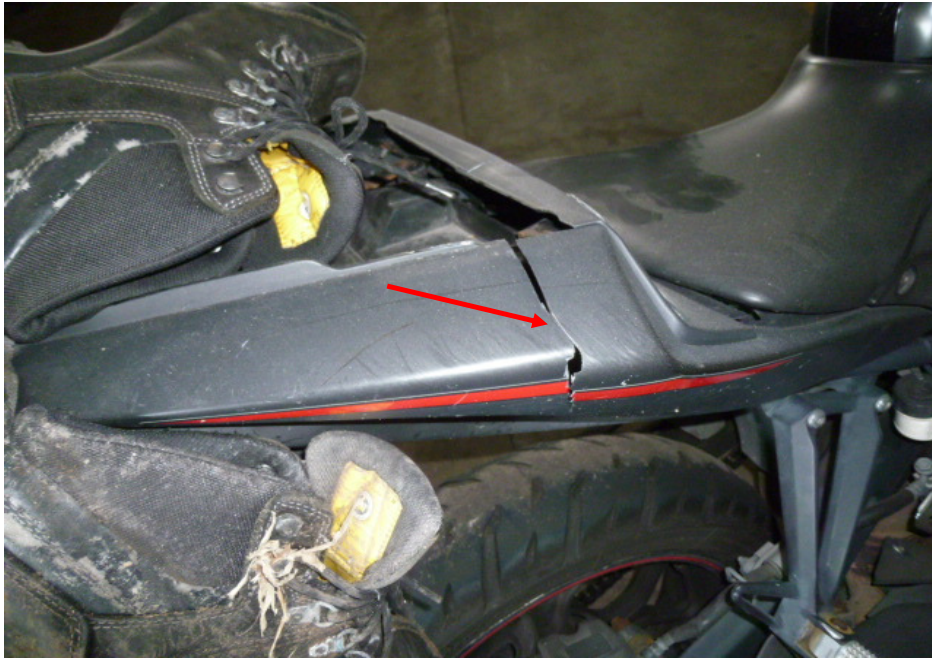
**Photo 14** shows a closer view of the cracked right rear side cover of the Motorcycle as a result of the accident (arrowed).

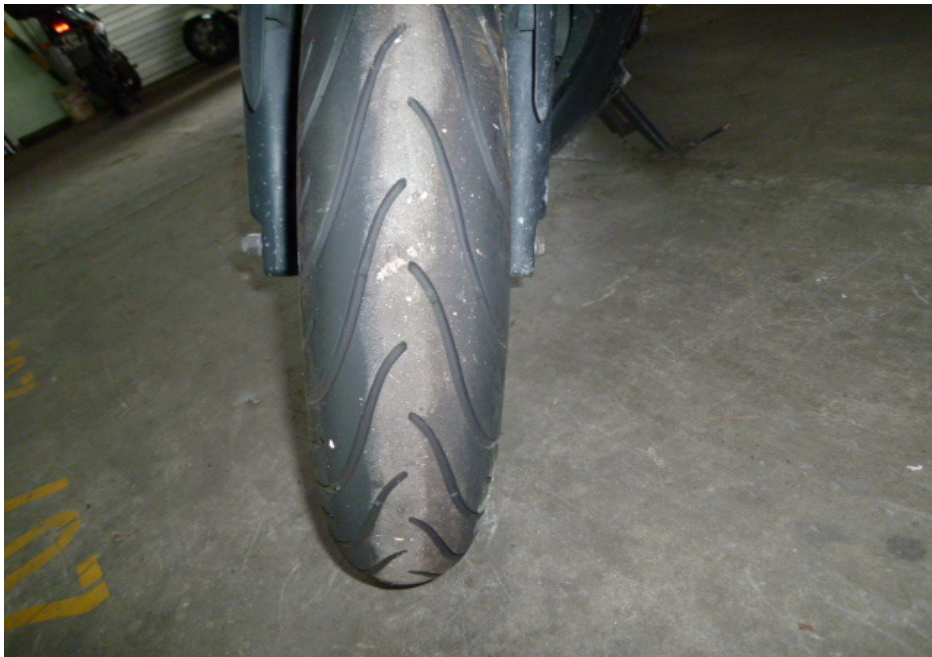
**Photo 15** shows the front tyre of the Motorcycle at the time of our inspection. The front tyre was observed to be in serviceable condition with remaining tread depth of approximately 4mm. The pattern of the tread was also clearly visible. There was no tear, burst mark(s) and/or punctured hole(s) on the sidewalls as well as across the tread of the front tyre.

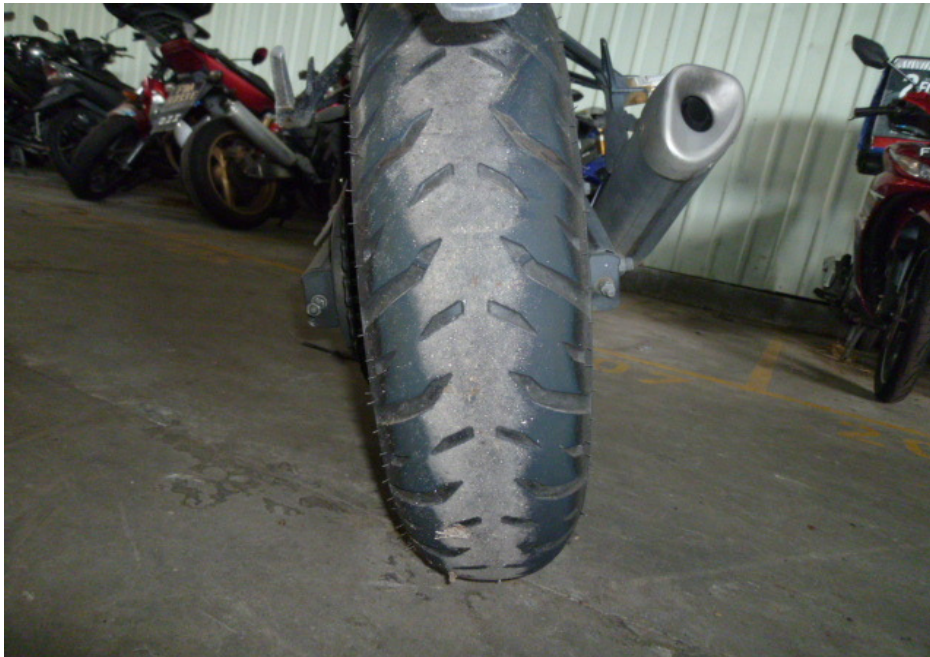
**Photo 16** shows the condition of the Motorcycle's rear tyre. The rear tyre was observed to be in serviceable condition with remaining tread depth of approximately 3mm. The tyre was also observed to be sufficiently inflated for vehicular operation. We did not observe any tear, burst mark(s) and/or punctured hole(s) on the sidewalls as well as across the tread of the rear tyre.

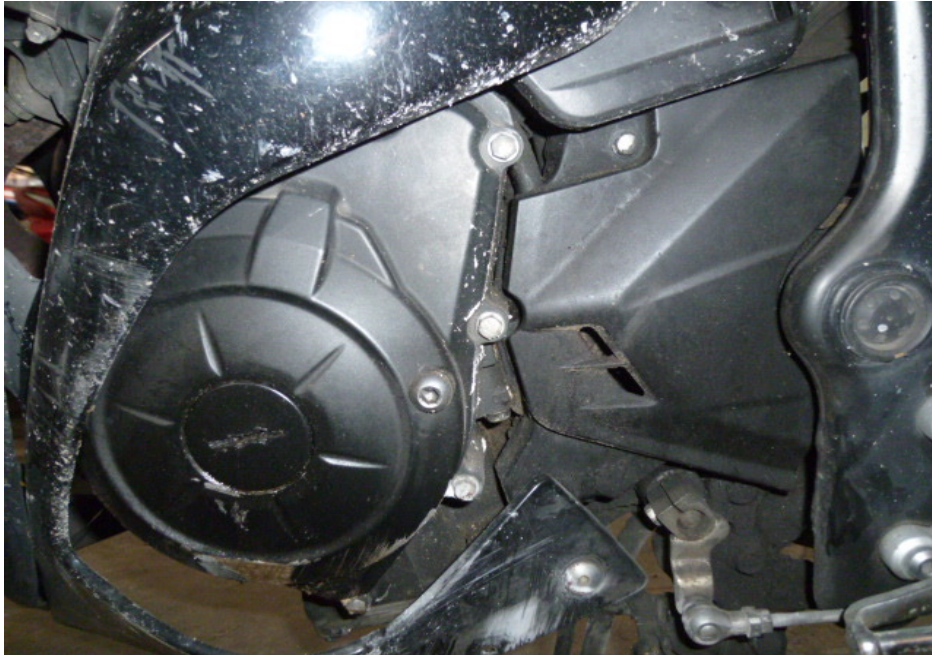
**Photo 17** shows the left side of the engine of the Motorcycle at the time of our inspection. The various engine related parts and components were found to be intact with no visible damage. There was also no sign(s) or indication(s) of fluid leak observed around the left engine area of the Motorcycle.

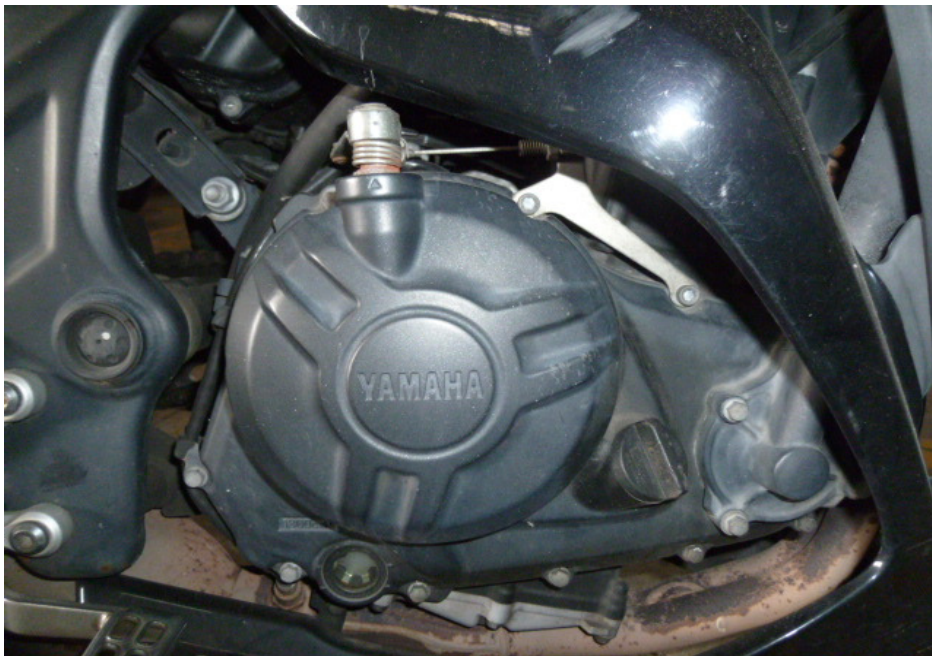
**Photo 18** shows the right side of the engine of the Motorcycle at the time of our inspection. The various engine related parts and components were found to be intact with no visible damage. There was also no sign(s) or indication(s) of fluid leak observed around the right engine area of the Motorcycle.

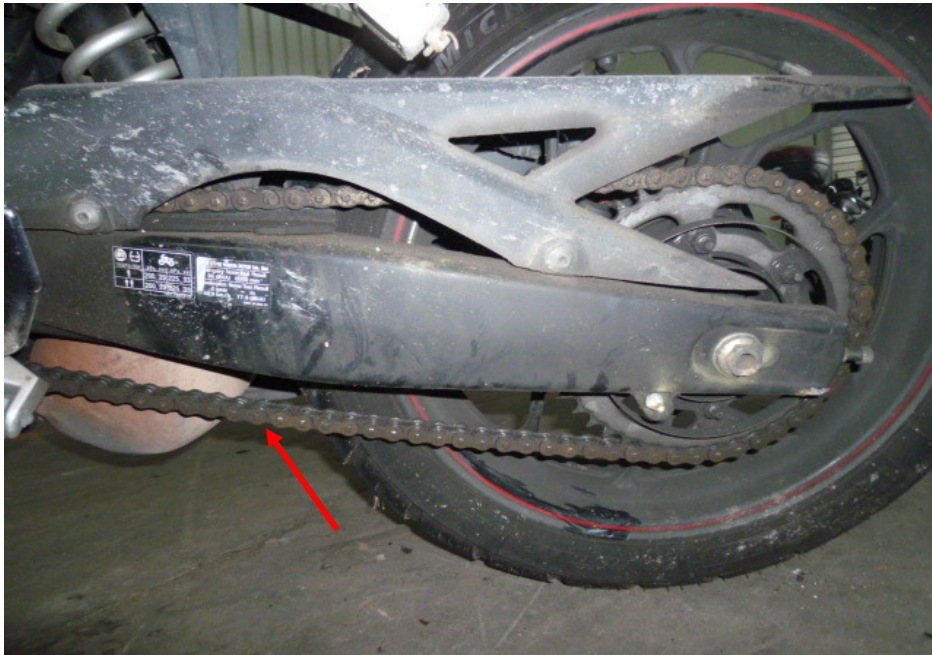
**Photo 19** shows the general view of the gear train (arrowed) of the Motorcycle, which was observed to be intact with no misalignment. It was also adequately lubricated for operating purposes.

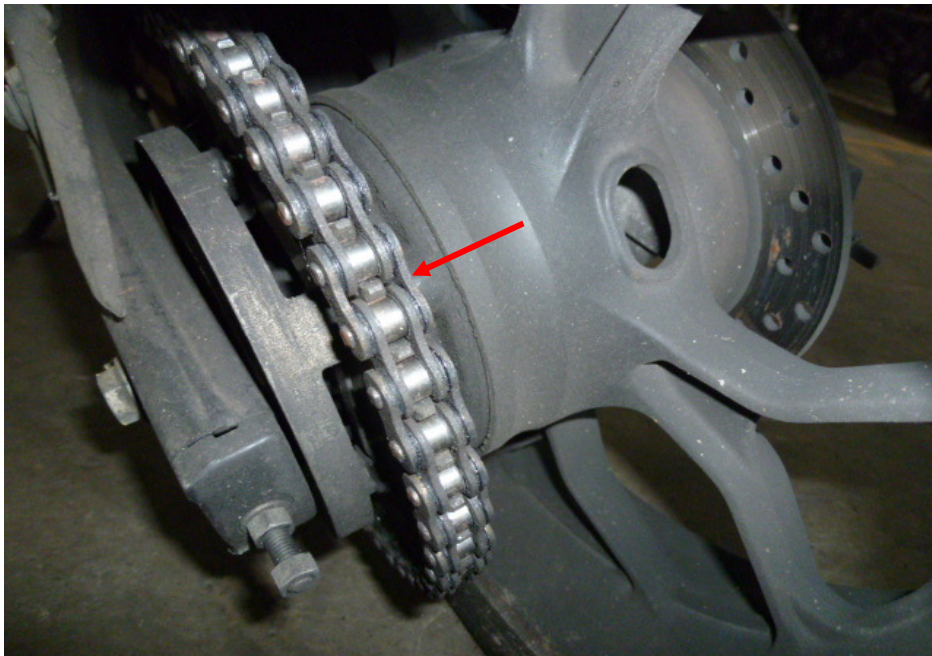
**Photo 20** shows a closer view of the gear train (arrowed) of the Motorcycle, which was observed to be intact with no misalignment. It was also adequately lubricated for operating purposes.

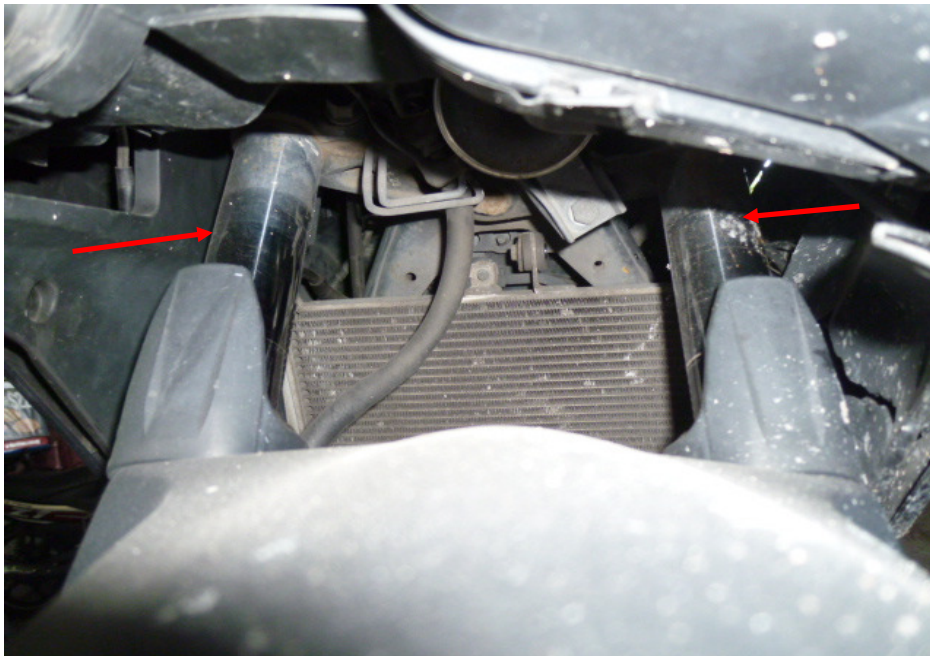
**Photo 21** shows the front forks (arrowed) of the Motorcycle. The front forks and fork bracket of the Motorcycle were both found to be intact and undamaged. Turning the Motorcycle's handle bar towards the left and right did not produce any abnormal free play. The steering system of the Motorcycle was in serviceable condition at the time of our inspection.

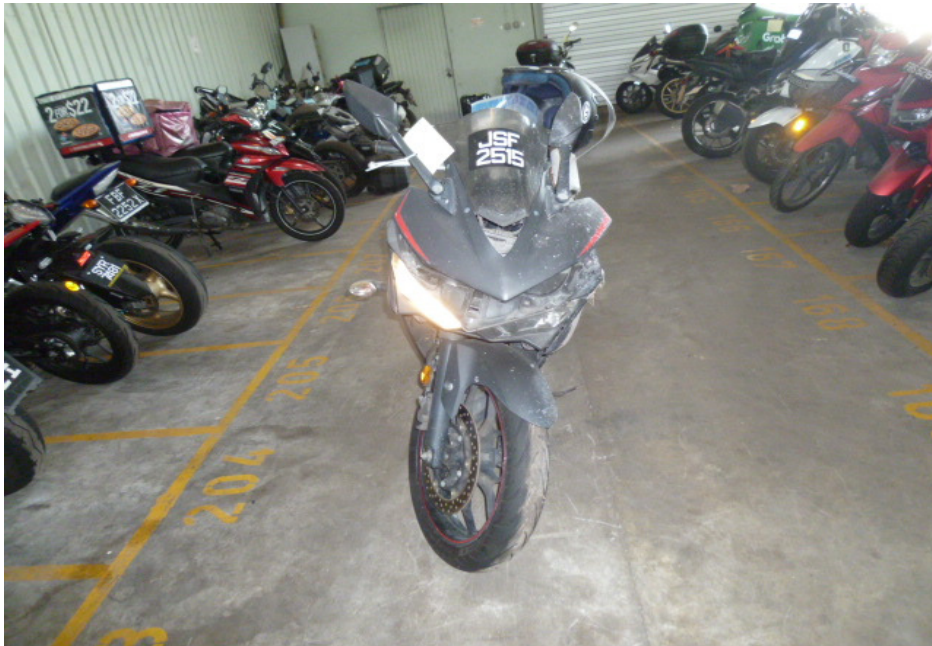
**Photo 22** shows the front wheel of the Motorcycle turned towards its full left. Turning the Motorcycle's handle bar towards the left did not produce any abnormal free play and/or resistance. This would indicate that the steering system of the Motorcycle was in serviceable condition at the time of our inspection.

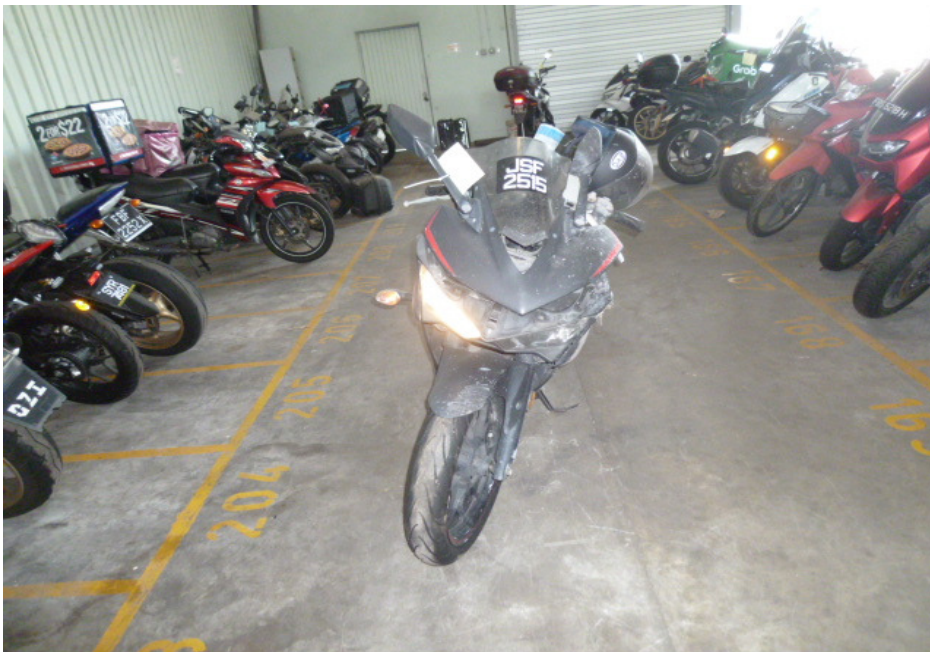
**Photo 23** shows the front wheel of the Motorcycle turned towards its full right. Turning the Motorcycle's handle bar towards the right did not produce any abnormal free play and/or resistance. This would indicate that the steering system of the Motorcycle was in serviceable condition at the time of our inspection.

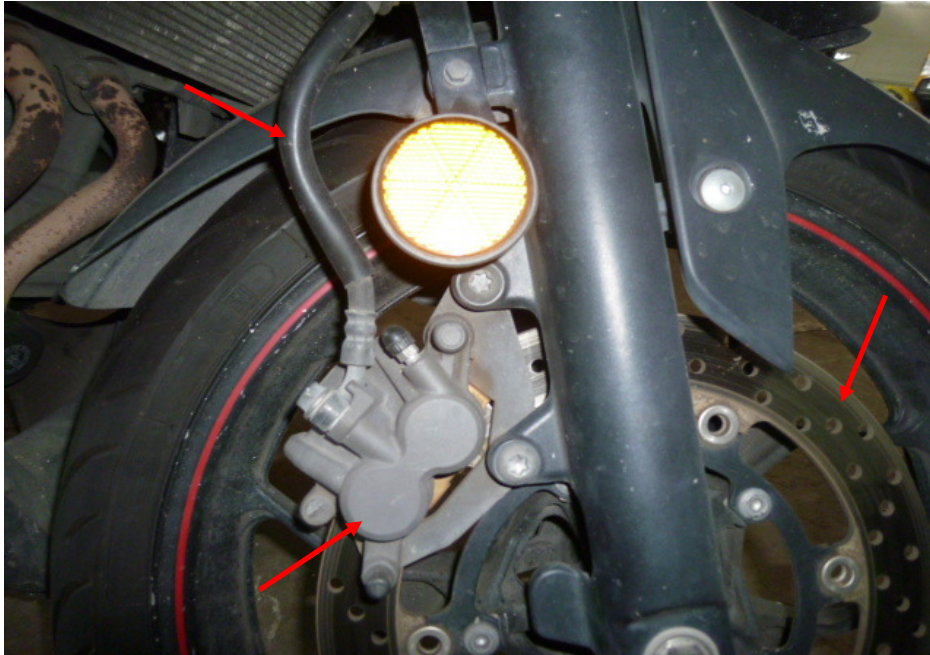
**Photo 24** shows a close up view of the front brake caliper, front brake disc and front brake hose (arrowed) of the Motorcycle, which are all part of the components in the hydraulic front brake system of the Motorcycle. Our visual checks of these various components had revealed all to be intact with no visible damage. No leakage of brake fluid was also observed.

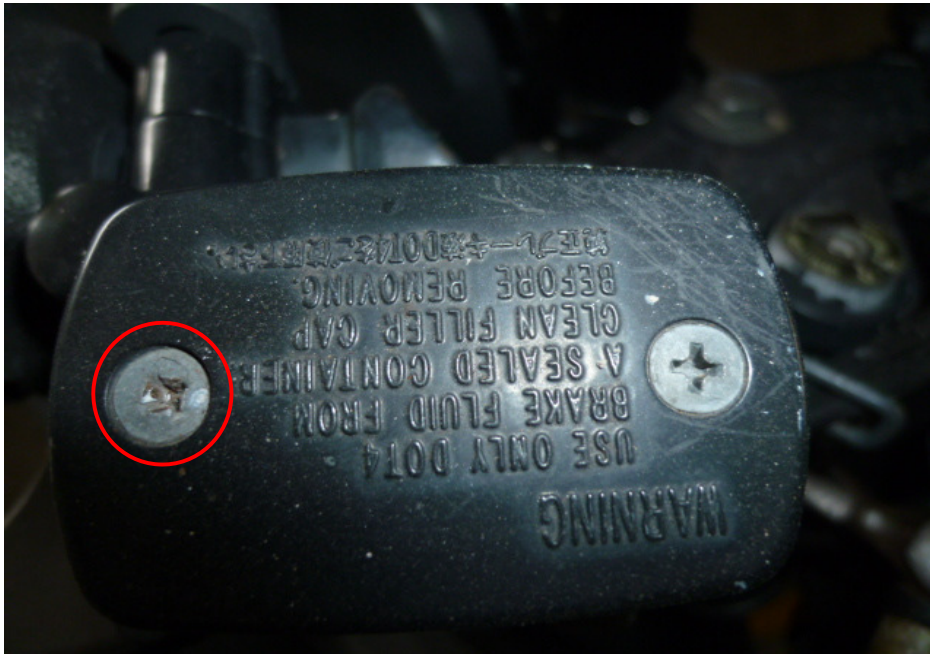
14. We were unable remove the front brake reservoir cover to examine whether the front brake fluid was without contamination due to a worn out screw. However the front brake fluid was observed to be of sufficient level for operational purposes. The brake fluid for the rear brake was found to be of sufficient level for operational purposes. However it was found to be slightly contaminated.

**Photo 25** shows the brake fluid reservoir cover for the front brake of the Motorcycle. We were unable to examine whether the front brake fluid was without contamination due to the worn out screw (circled).

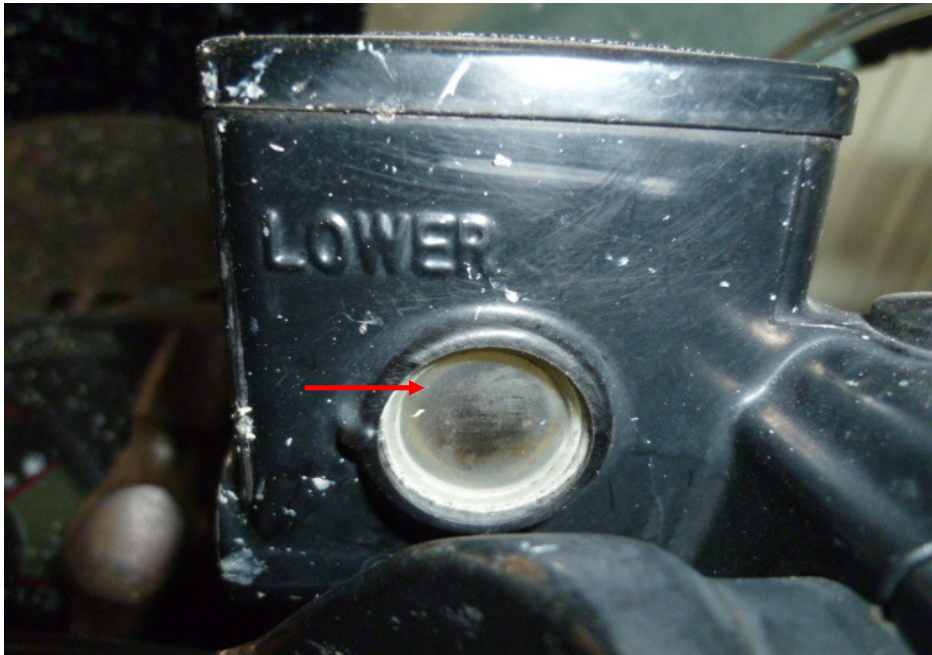
**Photo 26** shows a close up view of the brake fluid reservoir for the front brake of the Motorcycle. The brake fluid was observed to be of sufficient level for operational purposes (arrowed).

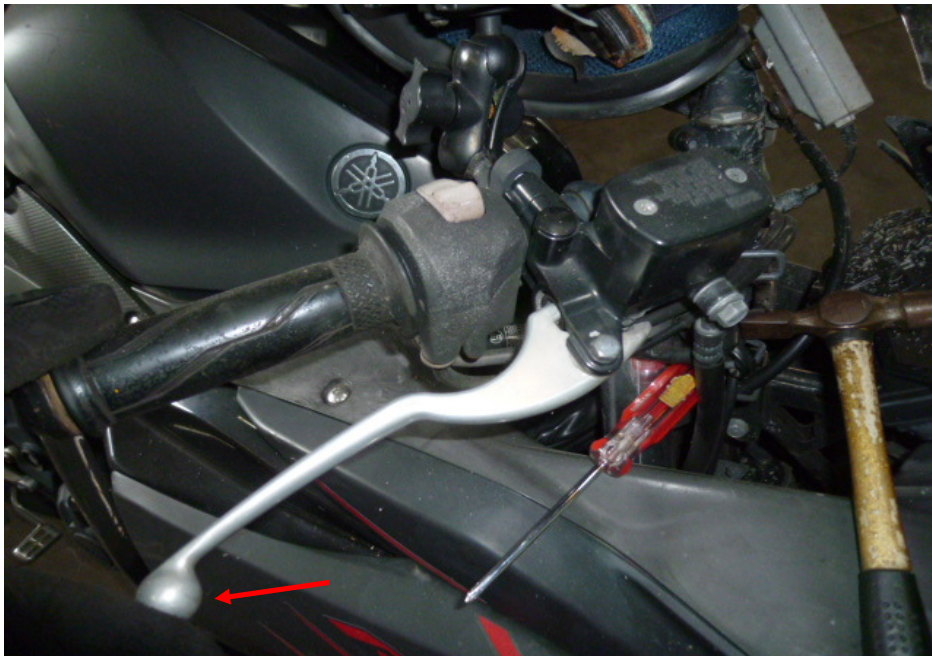
15. Static brake tests conducted on the Motorcycle had appear to indicate that the front braking system of the Motorcycle was in serviceable condition. There was some resistance felt (spongy like feel) upon pressing the brake lever. This would indicate that there was no leakage of pressure/vacuum in the front brake system.

**Photo 27** shows the front brake lever being depressed. There was some resistance felt (spongy like feel) upon pressing the front brake lever (arrowed). This would indicate that there is no leakage of pressure/vacuum in the front brake system.

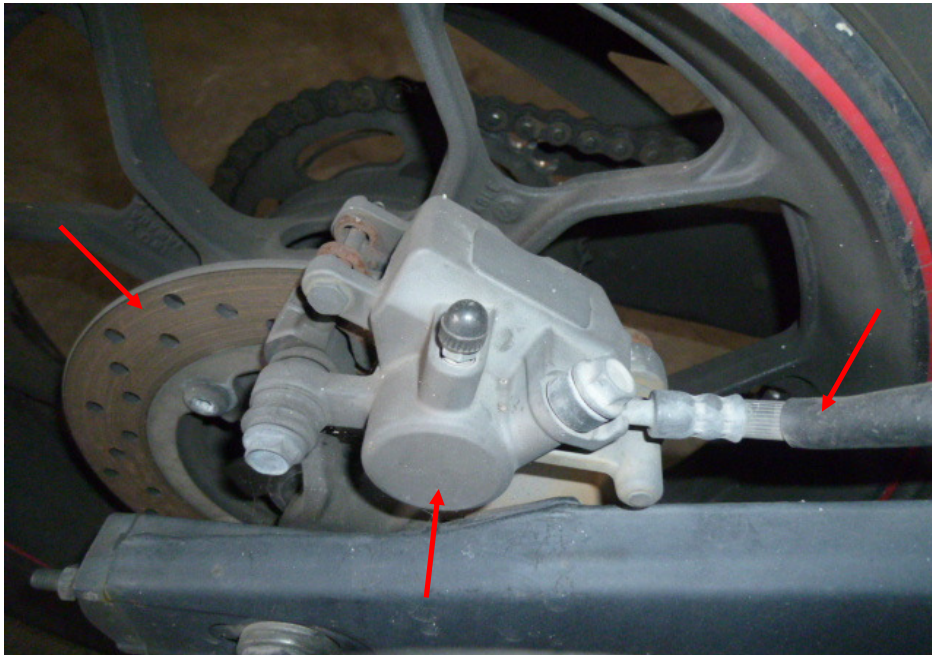
**Photo 28** shows a close up view of the rear brake caliper, rear brake disc and rear brake hose (arrowed) of the Motorcycle, which are all part of the components in the hydraulic rear brake system of the Motorcycle. Our visual checks of these various components had revealed all to be intact with no visible damage. No leakage of brake fluid was also observed.

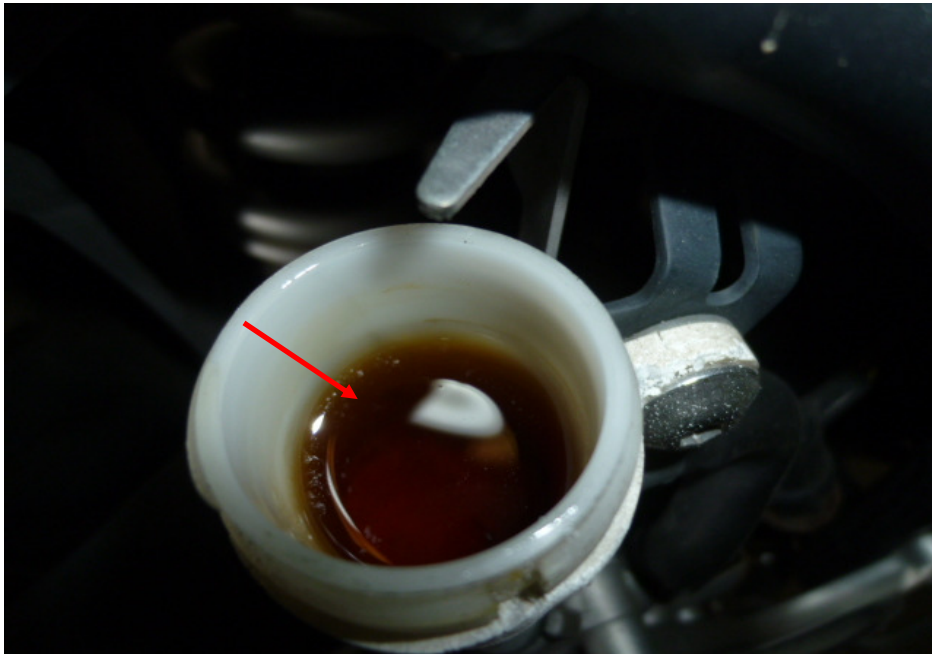
**Photo 29** shows a close up view of the brake fluid reservoir for the rear brake of the Motorcycle. The rear brake fluid was observed to be of sufficient level for operational purposes. However it was found to be slightly contaminated (arrowed).
