Your Ref: TP/IP/08326/2022
Our Ref : CI/TPD22005259/N

Fatal Accident Investigation Team

INSPECTION REPORT OF MOTORCYCLE FBH 6542Y

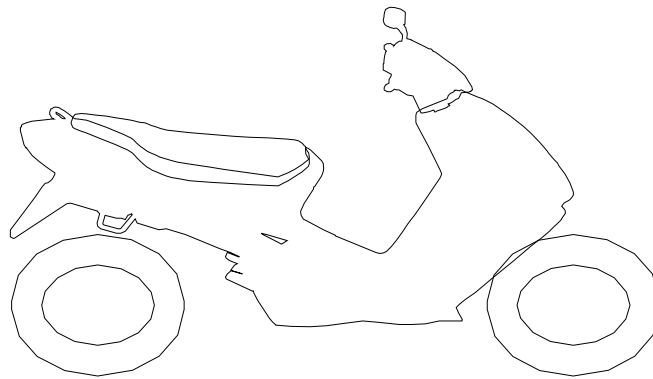
Bridgestone 160/60 - 17 (4mm)

Bridgestone 120/70 - 17 (3mm)
Cut / Deflated

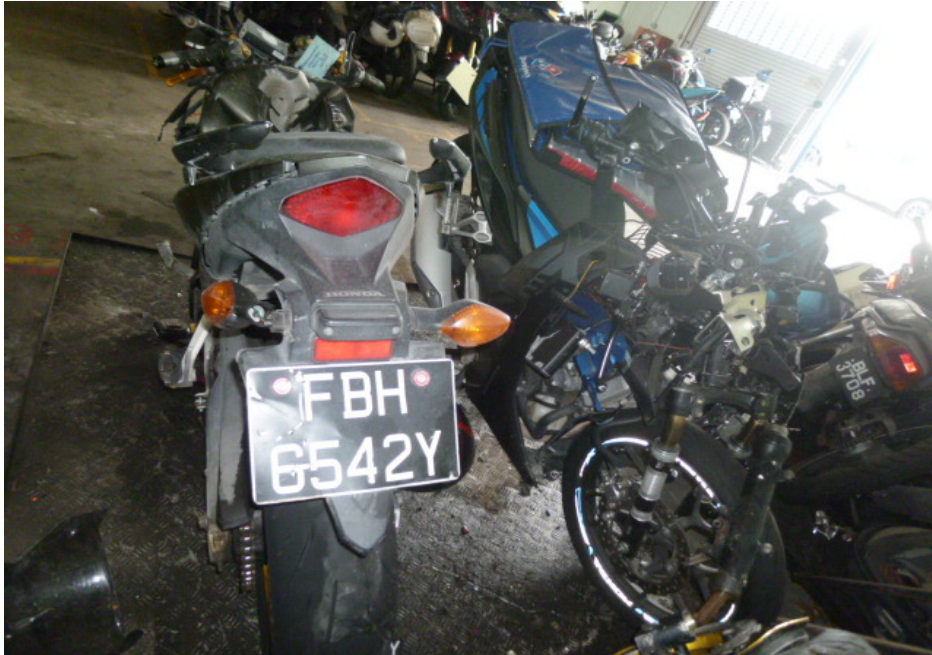
Photo 1 shows a general view of the rear body of the Motorcycle at the time of our inspection. The Motorcycle was observed to have sustained damages all around.

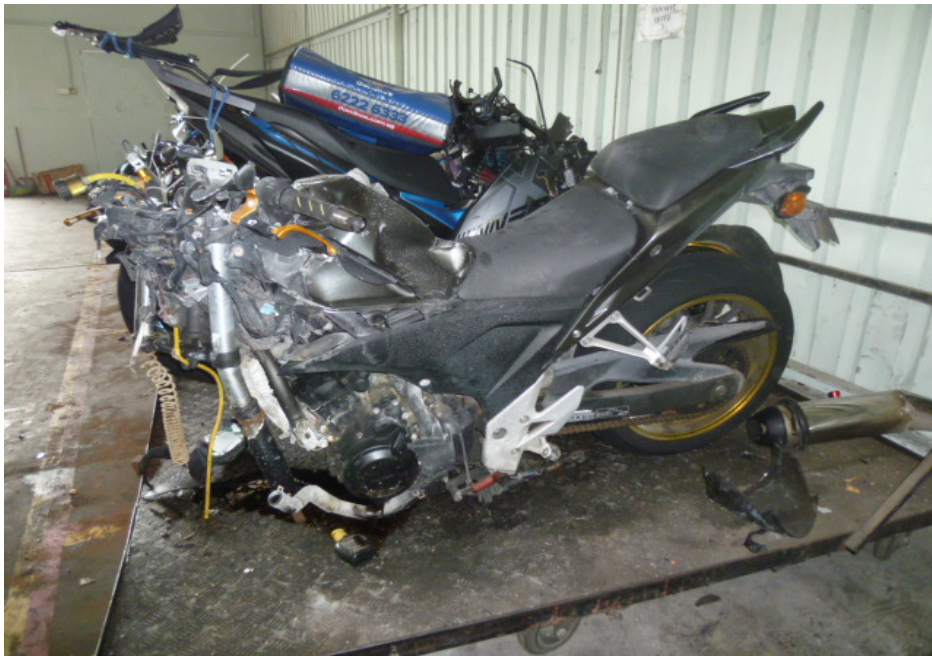
Photo 2 shows a general view of the left body of the Motorcycle at the time of our inspection. The Motorcycle was observed to have sustained damages all around.

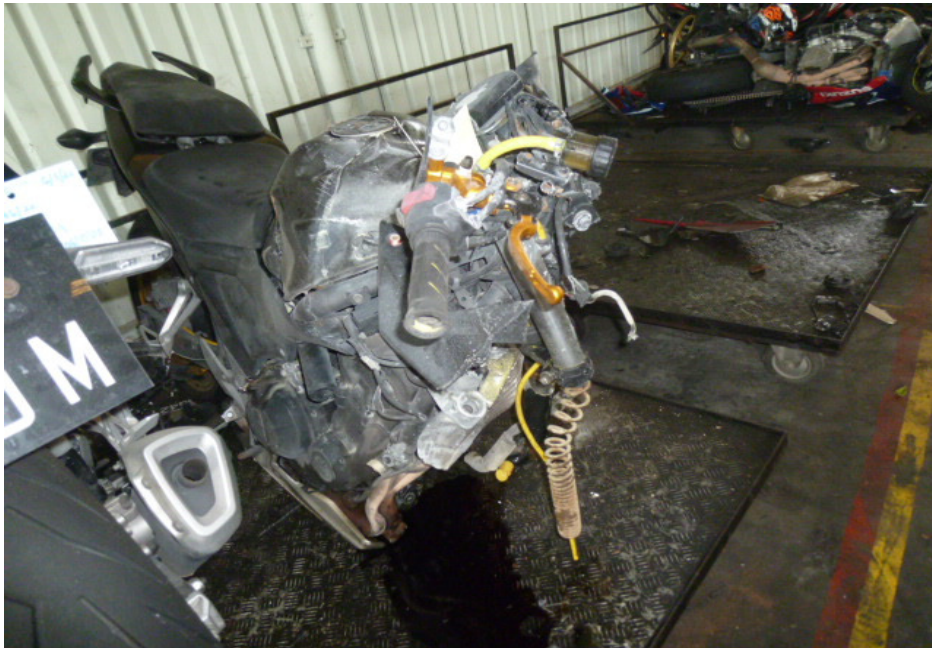
Photo 3 shows a general view of the right front body of the Motorcycle at the time of our inspection. The Motorcycle was observed to have sustained damages all around.

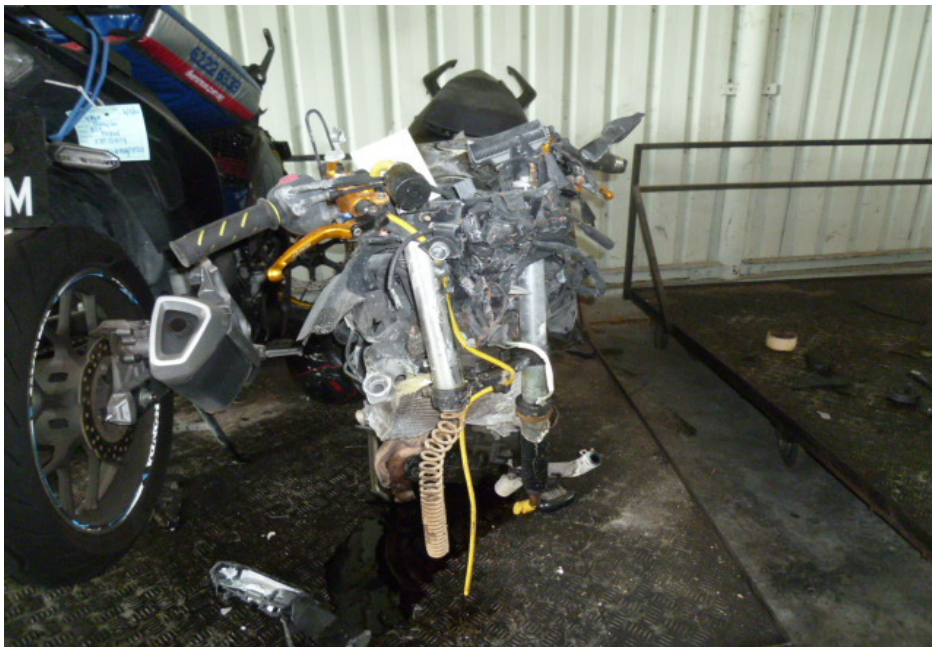
Photo 4 shows a general view of the frontal portion of the Motorcycle at the time of our inspection. The Motorcycle was observed to have sustained damages all around. The body parts that were found to have been damaged include its speedometer gauge, headlight assembly, side cowlings, handlebar, side mirrors, clutch lever, front brake lever, handlebar ends, radiator, exhaust headers, petrol tank, gear shift pedal, left front footrest, left rear side cover, left pillion grab rail and exhaust muffler, amongst others.

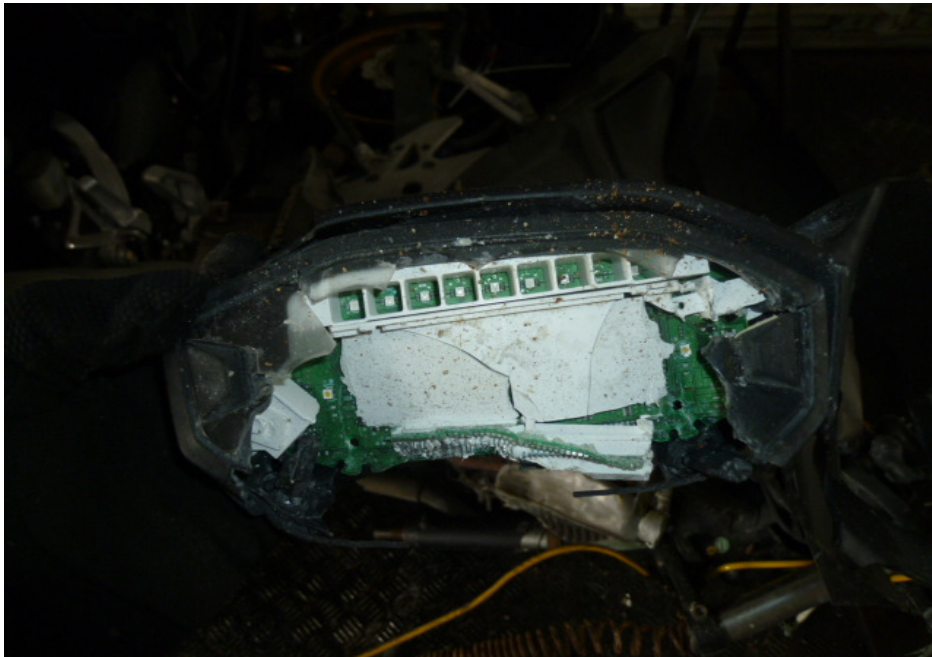
Photo 5 shows a closer view of the damaged speedometer gauge of the Motorcycle. The mileage of the Motorcycle at the time of our inspection was not recorded due to the damage sustained to the speedometer display screen as a result of the accident.

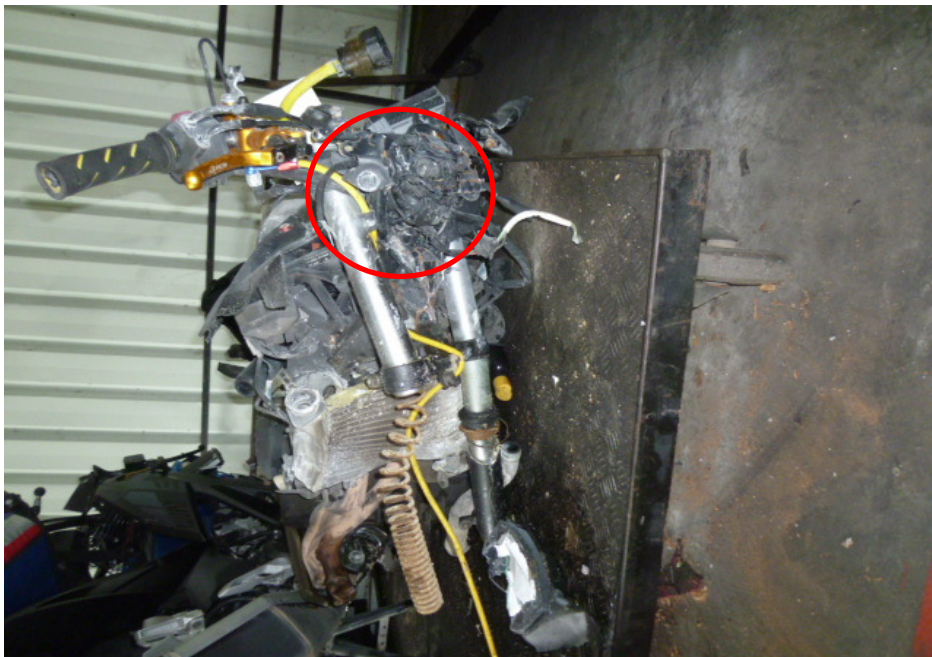
Photo 6 shows a closer view of the headlight assembly (circled) which was amongst the body parts at the front body of the Motorcycle that had sustained damage as a result of the accident.

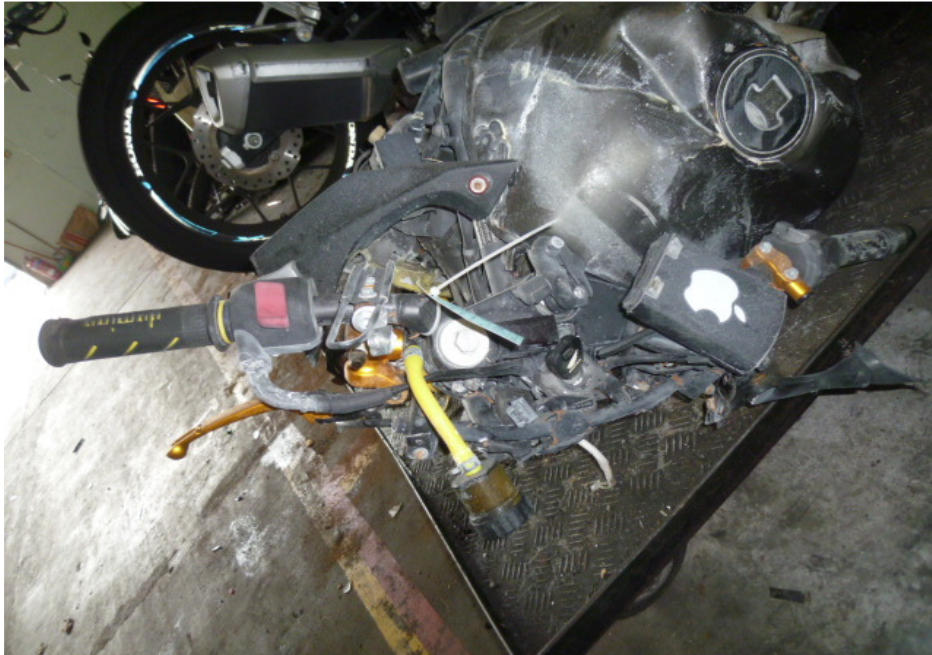
Photo 7 shows a close up view of the side mirrors, clutch lever, front brake lever, handlebar and handlebar ends of the Motorcycle. These parts were amongst the body parts of the Motorcycle which were damaged as a result of the accident.

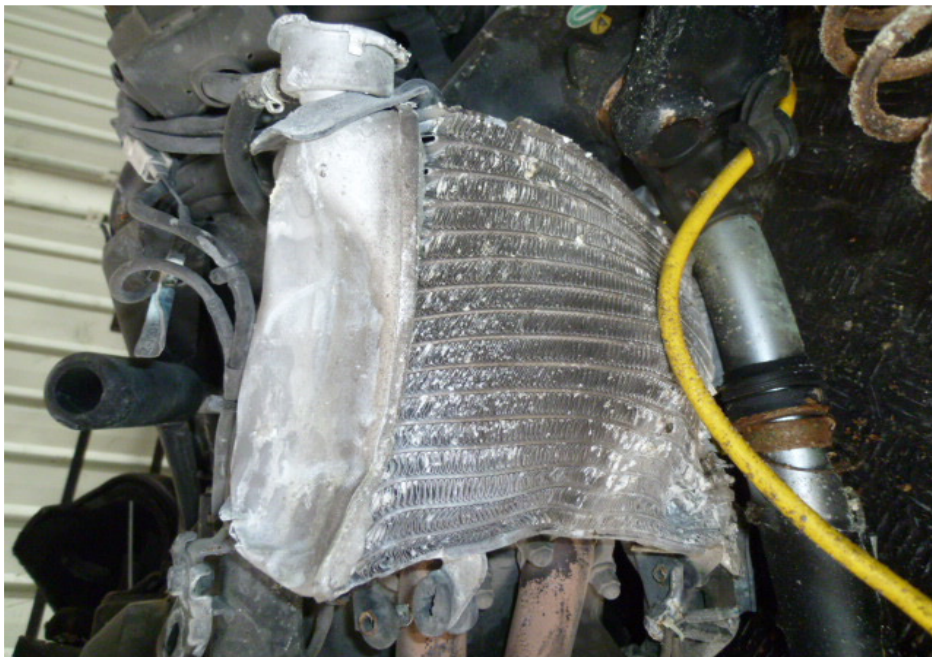
Photo 8 shows the deformed radiator of the Motorcycle as a result of the accident.

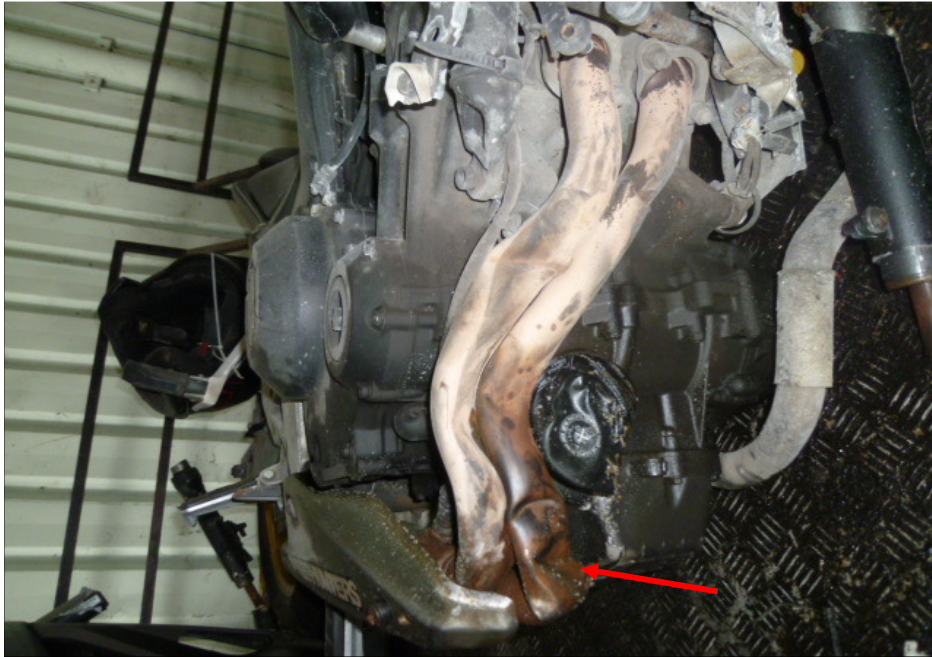
Photo 9 shows a closer view of the exhaust headers (arrowed) which was amongst the body parts at the front body of the Motorcycle that had sustained damage as a result of the accident.

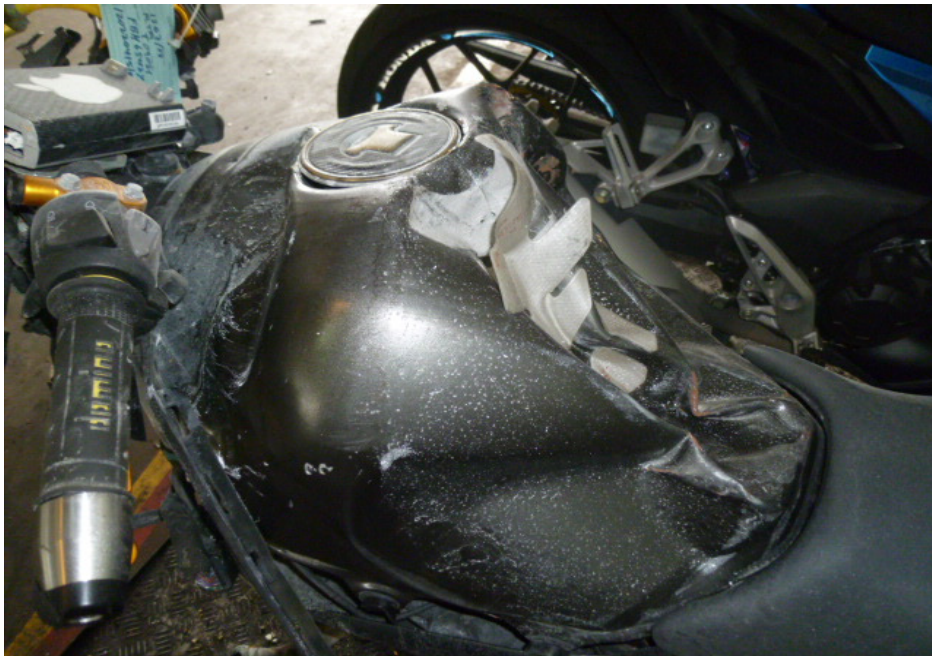
Photo 10 shows a closer view of the petrol tank, which was amongst the body parts of the Motorcycle that had sustained damage as a result of the accident.

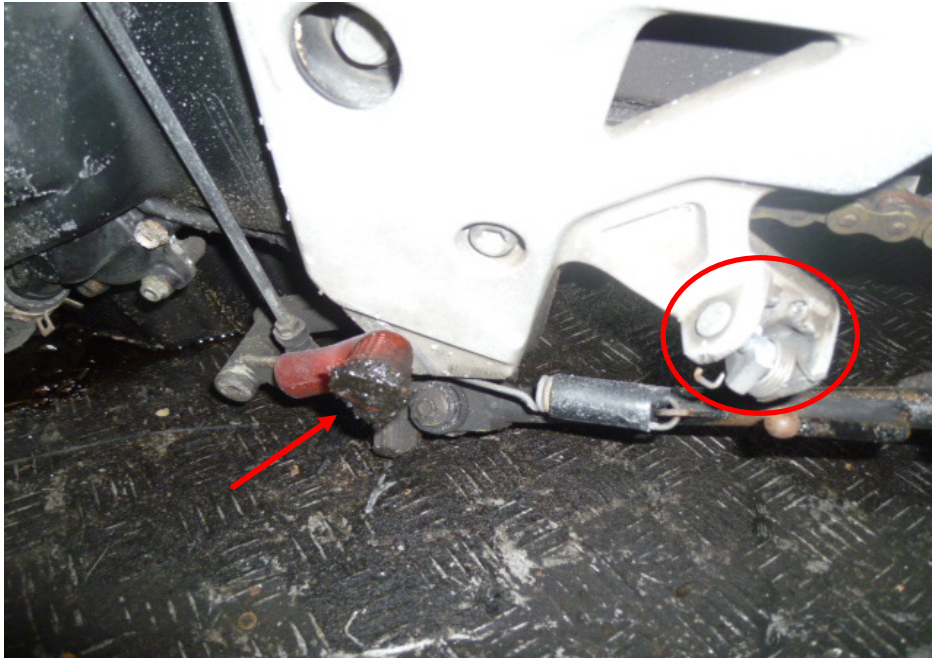
Photo 11 shows a closer view of the gear shift pedal (arrowed) and left front footrest (circled) which was amongst the body parts of the Motorcycle that had sustained damage as a result of the accident.

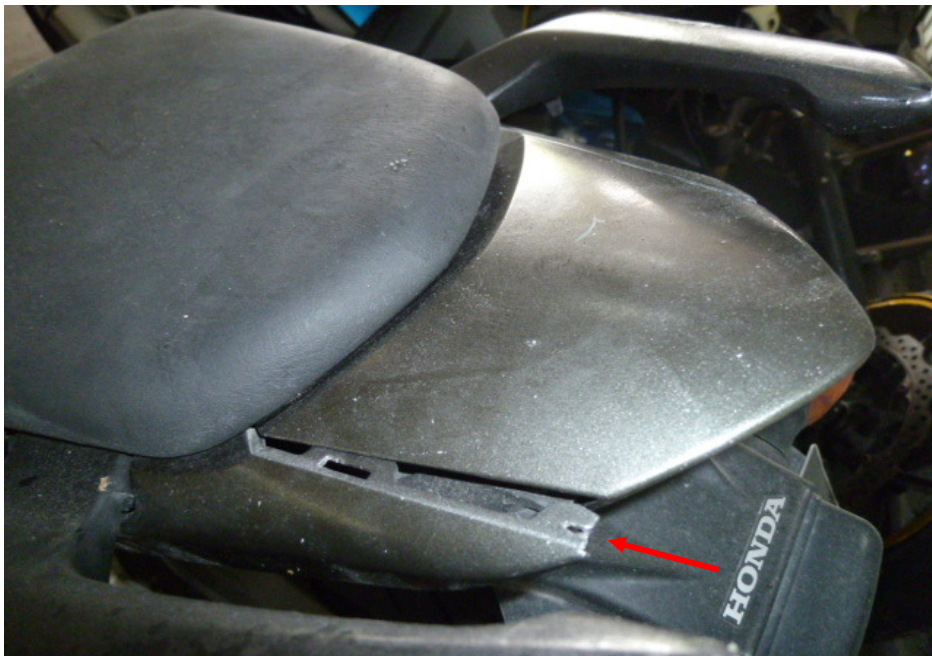
Photo 12 shows a closer view of the left rear side cover (arrowed) which was amongst the body parts of the Motorcycle that had sustained damage as a result of the accident.

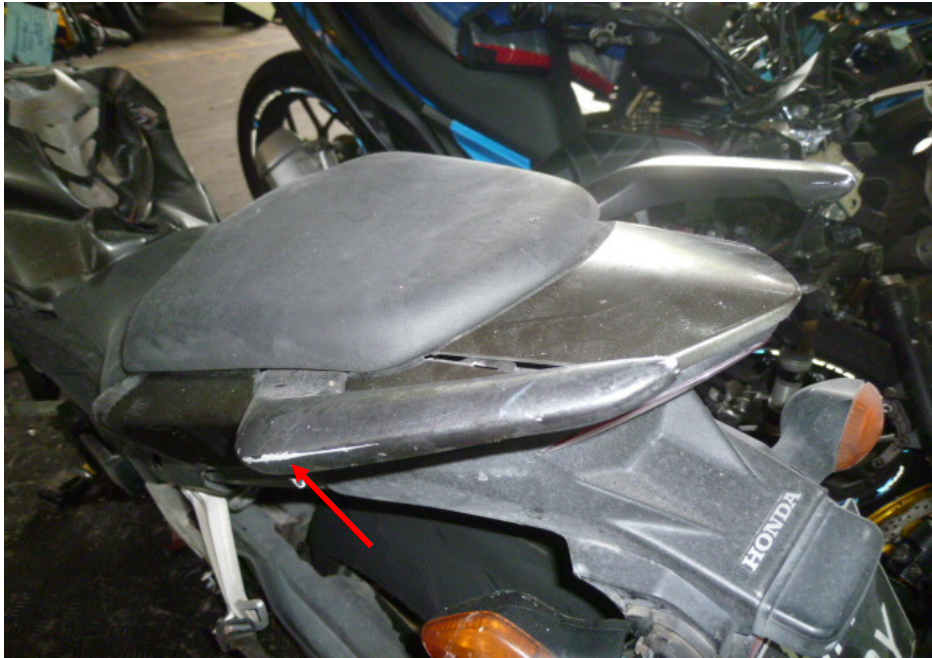
Photo 13 shows the left pillion grab rail (arrowed) which was amongst the body parts of the Motorcycle that had sustained damage as a result of the accident.

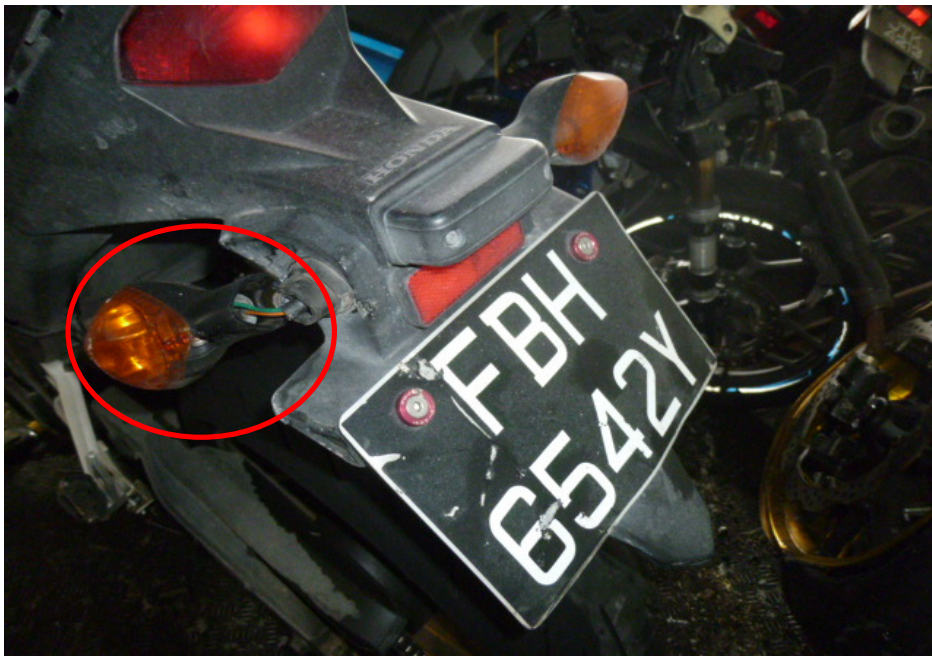
Photo 14 shows the left rear signal lamp (circled) which was amongst the body parts of the Motorcycle that had sustained damage as a result of the accident.

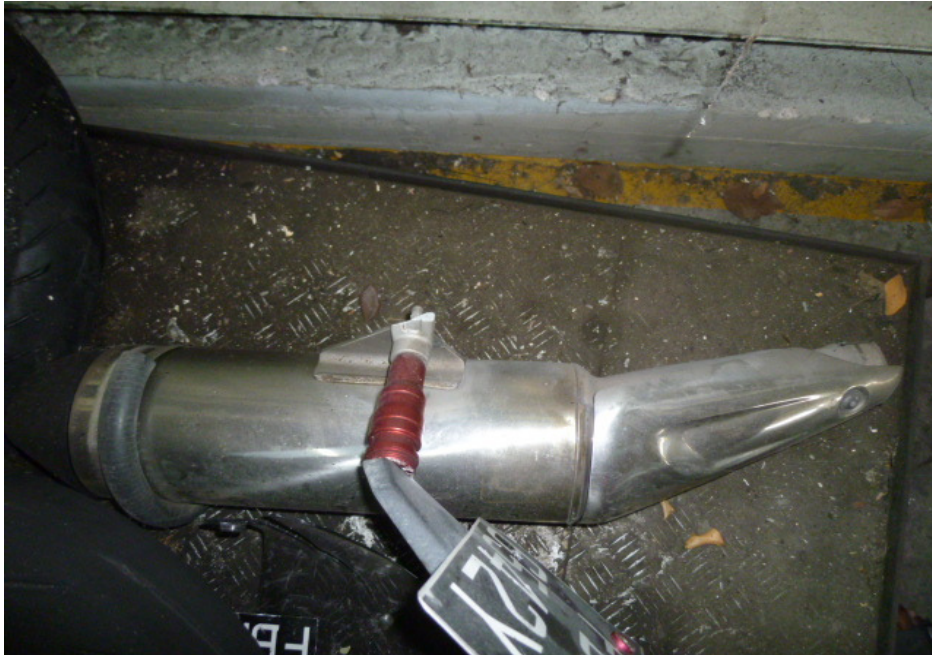
Photo 15 shows the dislodged exhaust muffler of the Motorcycle as a result of the accident.

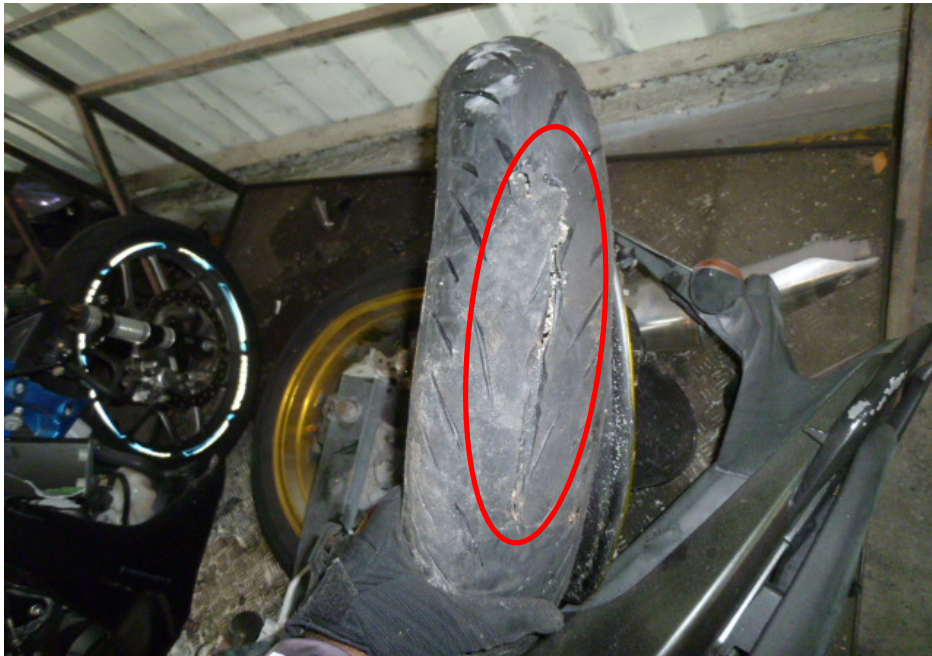
Photo 16 shows the condition of the Motorcycle's front tyre. The front tyre was observed to be in serviceable condition with remaining tread depth of approximately 4mm. However the tyre was observed to be deflated. We also observed a tear on the front tyre as a result of the accident (circled).

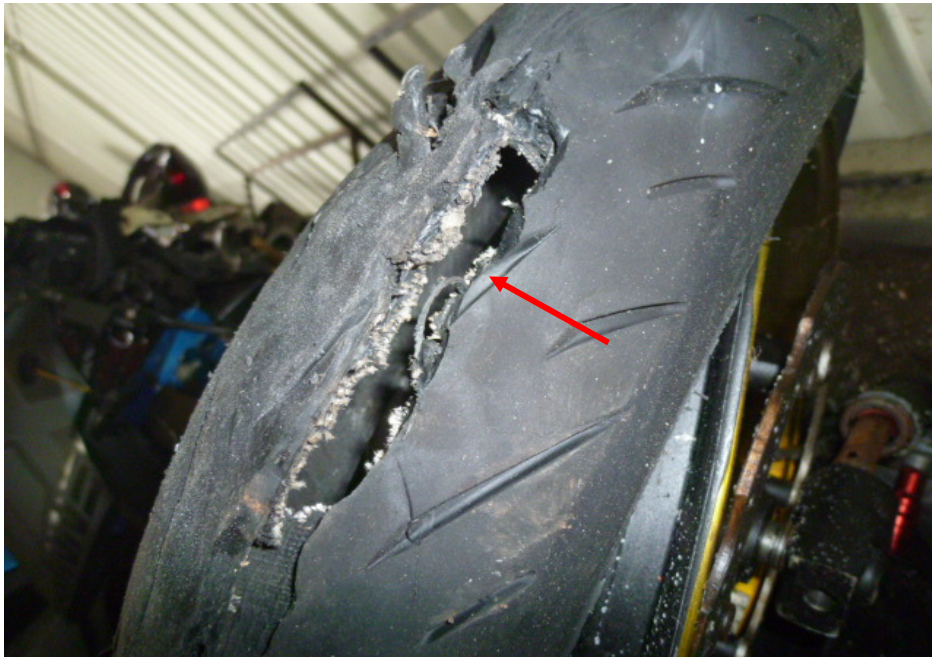
Photo 17 shows a closer view of the tear on the front tyre as a result of the accident (arrowed).

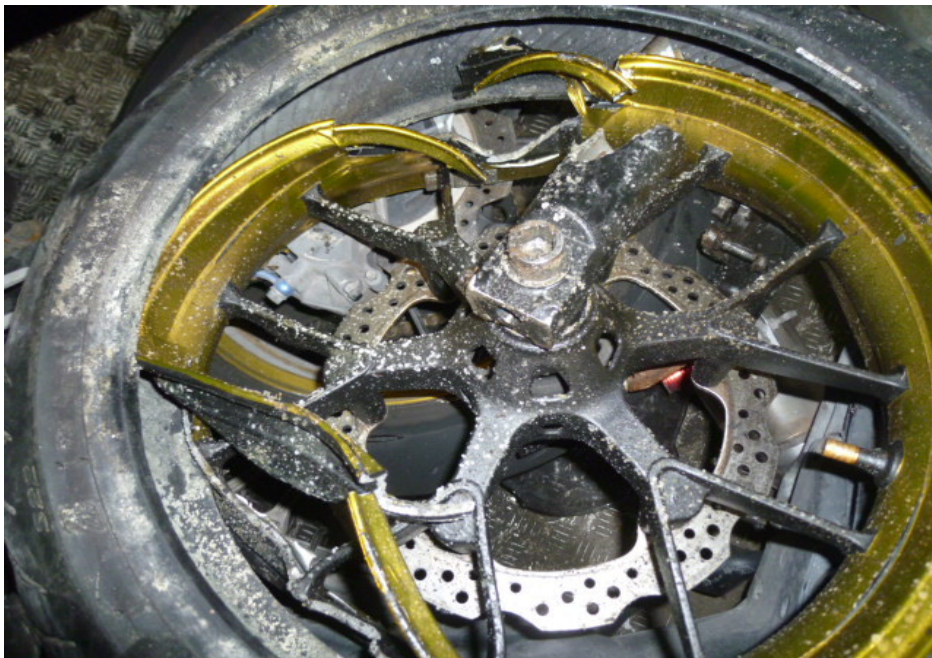
Photo 18 shows the broken front wheel rim of the Motorcycle at the time of our inspection.

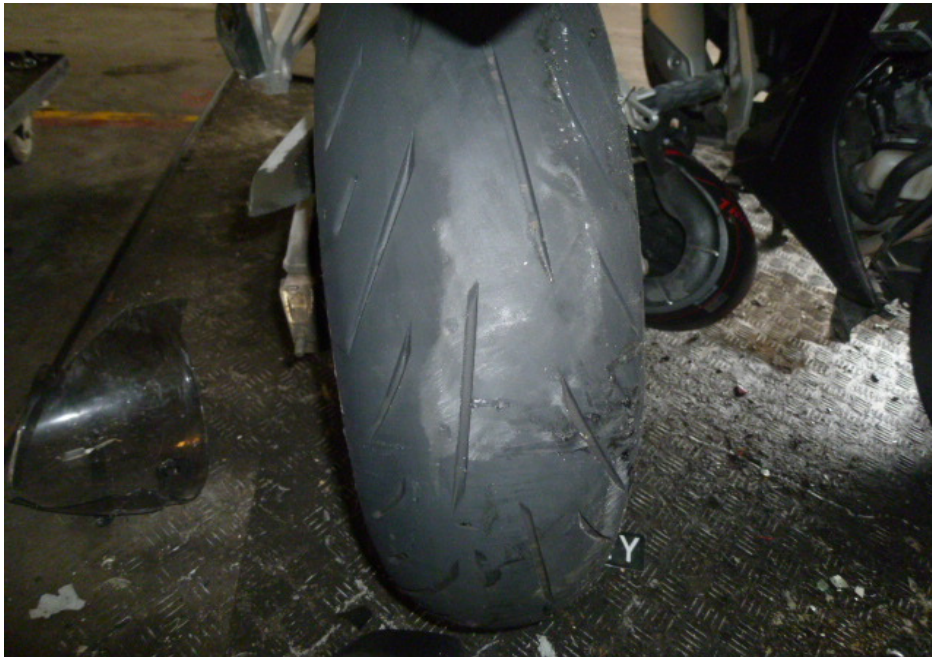
Photo 19 shows the condition of the Motorcycle's rear tyre. The rear tyre was observed to be in serviceable condition with remaining tread depth of approximately 4mm. The tyre was also observed to be sufficiently inflated for vehicular operation. We did not observe any tear, burst mark(s) and/or punctured hole(s) on the sidewalls as well as across the tread of the rear tyre.

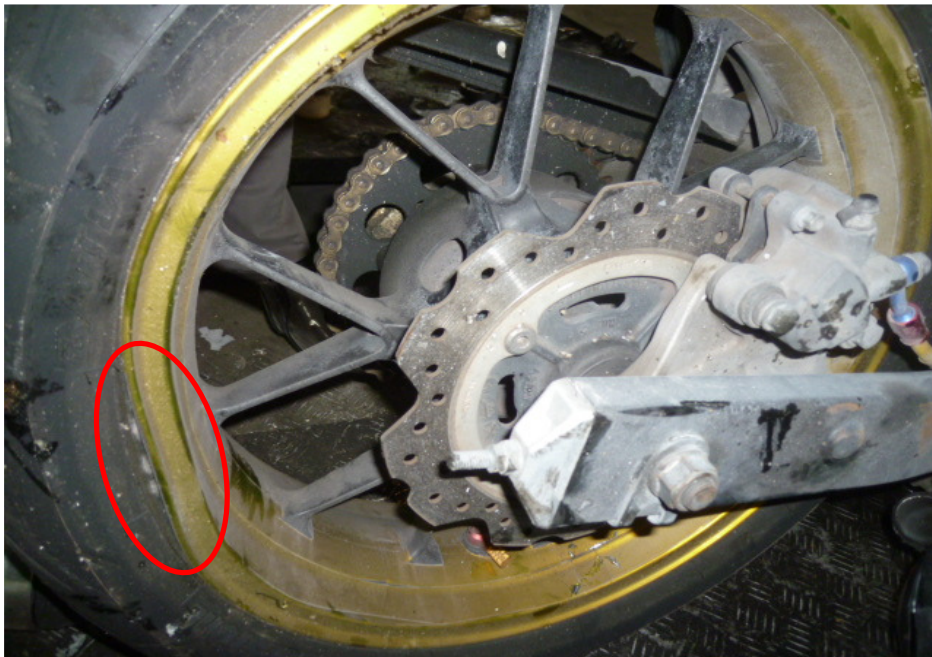
Photo 20 shows the bent rear wheel rim (circled) of the Motorcycle at the time of our inspection.

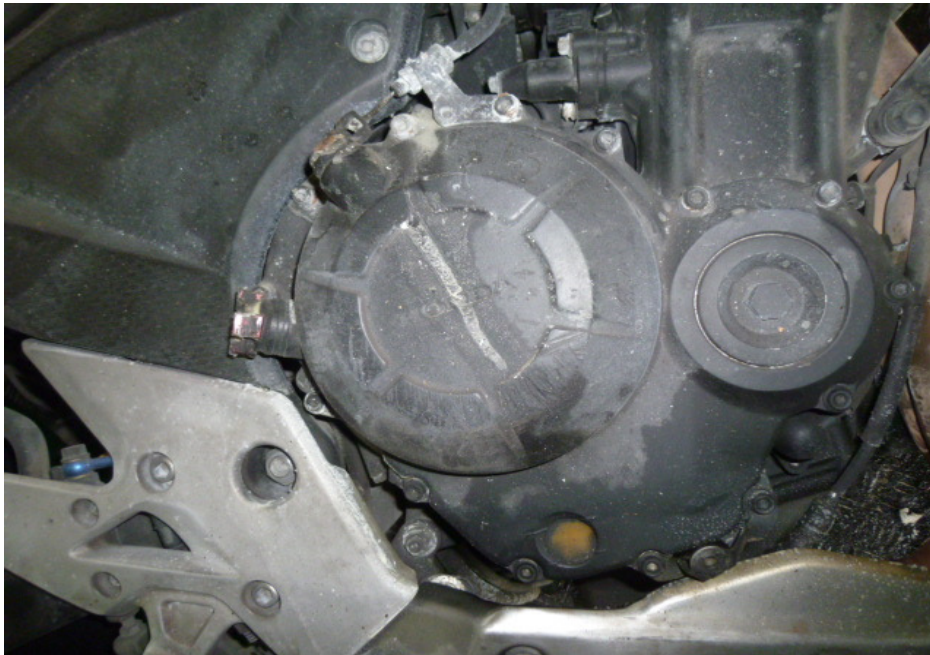
Photo 21 shows the right side of the engine of the Motorcycle at the time of our inspection. The various engine related parts and components were found to be intact with no visible damage. There was also no sign(s) or indication(s) of fluid leak observed around the right engine area of the Motorcycle.

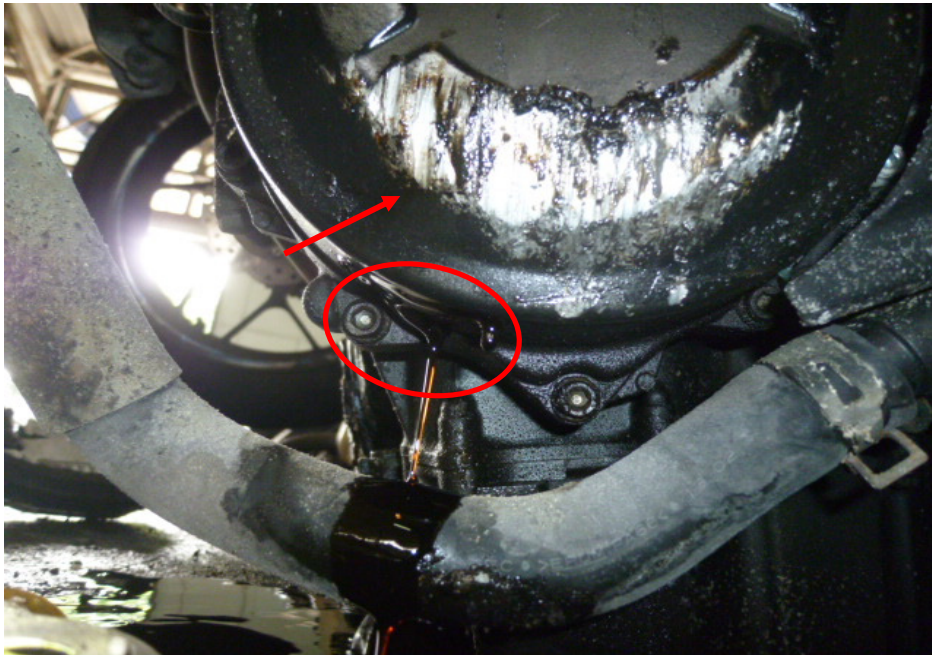
Photo 22 shows the left side of the engine of the Motorcycle at the time of our inspection. The various left engine components had sustained damage of grazing nature as a result of the accident (arrowed). Wet fluid stains were observed on the underside of the damaged left engine cover of the Motorcycle (circled).

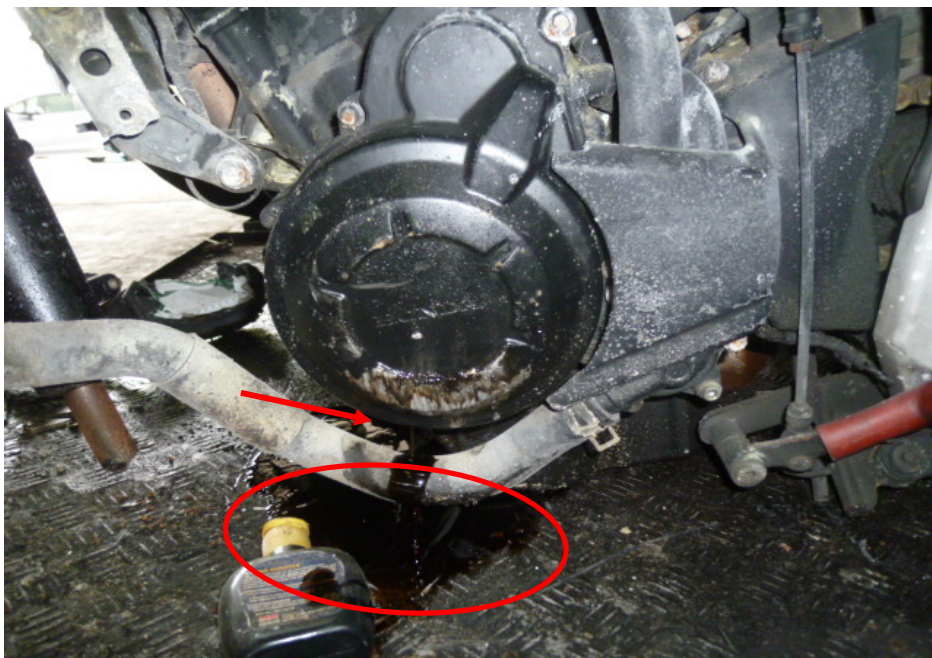
Photo 23 shows wet fluid stains observed on the ground (circled) directly below the damaged left engine cover of the Motorcycle (arrowed), indicating that a fluid leak had occurred as a result of the accident.

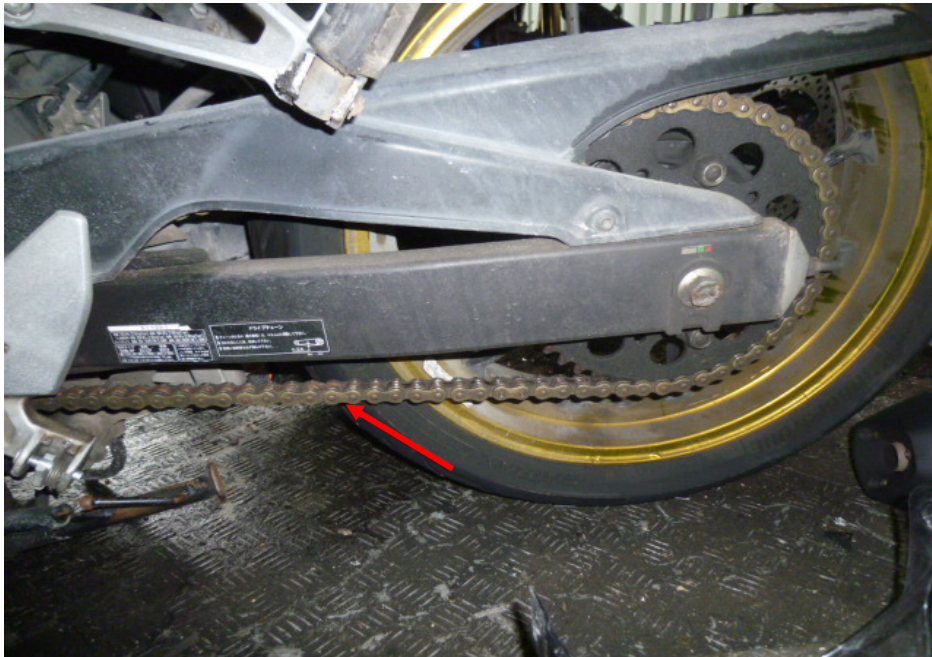
Photo 24 shows the general view of the gear train (arrowed) of the Motorcycle, which was observed to be intact with no misalignment. It was also adequately lubricated for operating purposes.

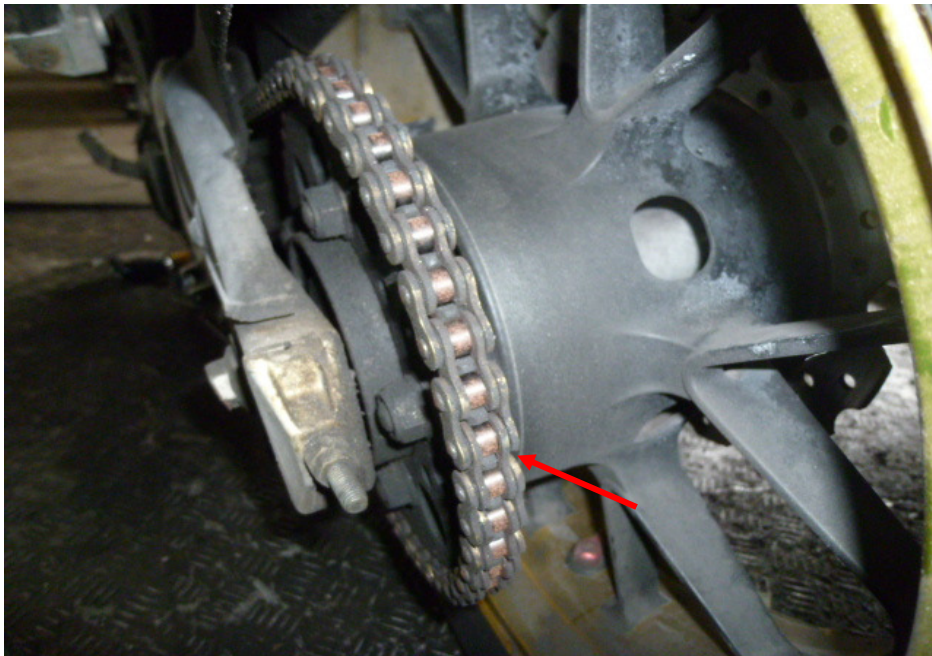
Photo 25 shows a closer view of the gear train (arrowed) of the Motorcycle, which was observed to be intact with no misalignment. It was also adequately lubricated for operating purposes.

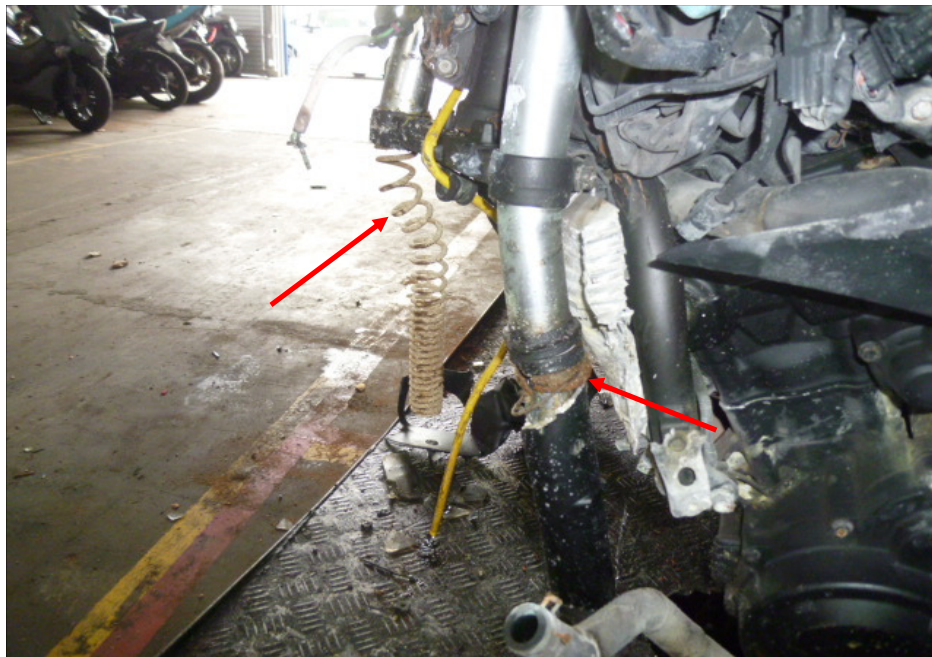
12. For this case, we were not able to conduct any test(s) on the steering system of the Motorcycle due to the damage of its front forks. The front forks were found to be broken as a result of the accident.

Photo 26 shows the front forks of the Motorcycle. The front forks (arrowed) were observed to be broken as a result of the accident. We were hence not able to conduct any tests on the steering system of the Motorcycle.

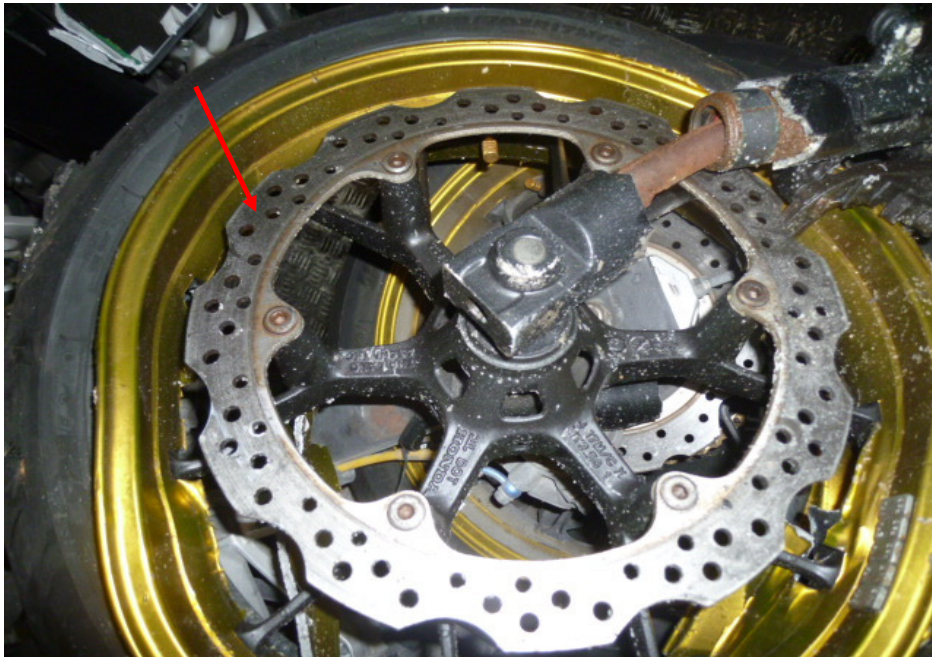
15. Our visual examination of the various components in the Motorcycle's front braking system like the brake disc, brake caliper, brake lever and brake hose revealed only the front brake disc and brake lever to be intact and without damage. The front brake caliper and front brake hose were observed to be missing as a result of the accident. There was also leakage of brake fluid observed along the front brake hose. This was from the respective front brake fluid reservoir to the front brake caliper of the Motorcycle. The brake fluid for the front brake was found to be of sufficient level for operating purposes and without any contamination.

Photo 27 shows a close up view of the front brake caliper, front brake disc and front brake hose of the Motorcycle's front wheel, which are all part of the components in the hydraulic front brake system of the Motorcycle. The front brake caliper and front brake hose were observed to be missing upon our inspection. Our visual checks of the front brake disc (arrowed) had revealed it to be intact with no visible damage. No leakage of brake fluid was also observed.

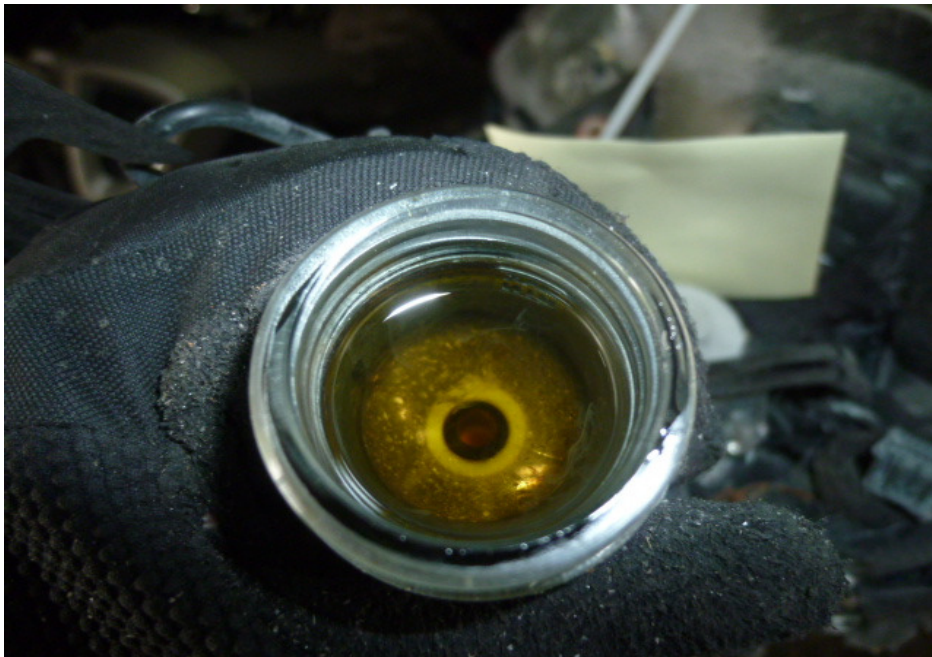
Photo 28 shows the brake fluid reservoir for the front brake of the Motorcycle. The brake fluid was observed to be of sufficient level for operational purposes and without contamination.

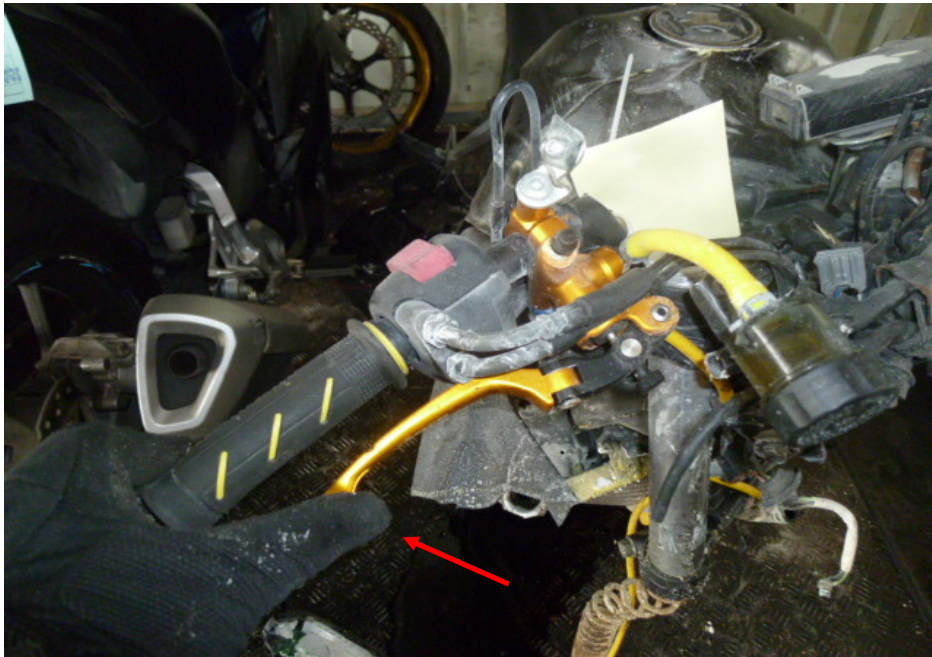
16. Static brake tests conducted on the front braking system of the Motorcycle had appear to indicate that the front braking system of the Motorcycle was not in serviceable condition. There was no resistance felt (spongy like feel) upon pressing the brake lever. This would indicate that there was a leakage of pressure/vacuum in the front brake system. Upon closer examination, we observed that the front brake hose of the Motorcycle was cut. Brake fluid was also found to be leaking from the cut front brake hose.

Photo 29 shows the front brake lever being depressed. There was no resistance felt (spongy like feel) upon pressing the front brake lever (arrowed). This would indicate that there is leakage of pressure/vacuum in the front brake system. Upon closer examination, we observed that the front brake hose of the Motorcycle was cut.

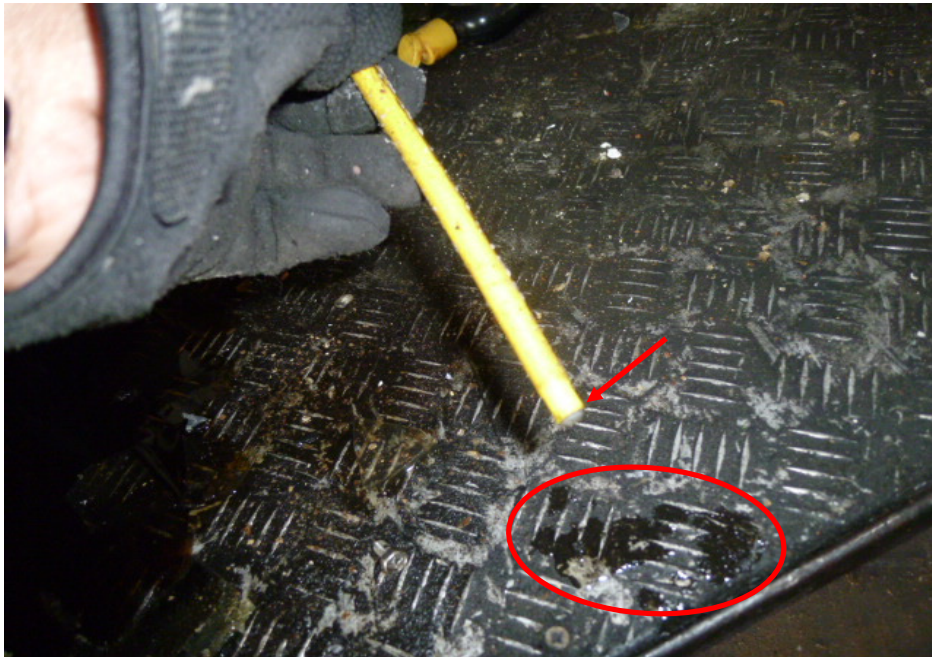
Photo 30 shows the front brake hose for the front brake of the Motorcycle. The front brake hose was observed to be cut as a result of the accident (arrowed). Brake fluid was also found to be leaking from the cut front brake hose (circled).

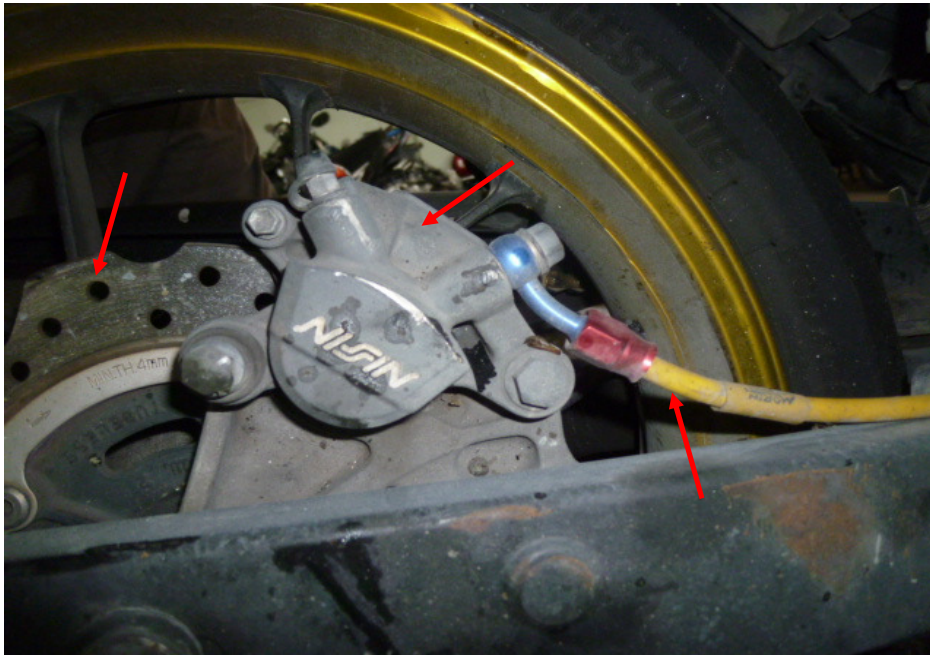
14. Our visual examination of the various components in the Motorcycle's rear braking system like the brake disc, brake caliper, brake foot pedal and brake hose revealed all to be intact and without damage. There was also no leakage of brake fluid observed along the rear brake hose. This was from the respective brake fluid reservoir to the rear brake caliper of the Motorcycle. We were unable remove the rear brake reservoir cover to examine whether the rear brake fluid was without contamination due to a worn out screw. However the rear brake fluid was observed to be of sufficient level for operational purposes.

Photo 31 shows a close up view of the rear brake caliper, rear brake disc and rear brake hose (arrowed) of the Motorcycle, which are all part of the components in the hydraulic rear brake system of the Motorcycle. Our visual checks of these various components had revealed all to be intact with no visible damage. No leakage of brake fluid was also observed.

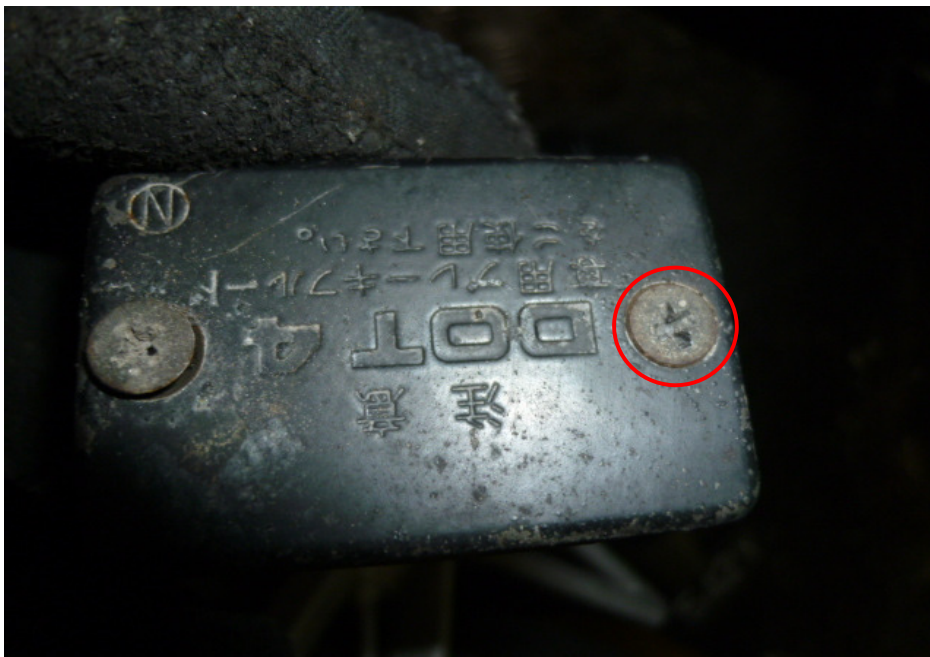
Photo 32 shows the brake fluid reservoir cover for the rear brake of the Motorcycle. We were unable to examine whether the rear brake fluid was without contamination due to the worn out screw (circled). However the rear brake fluid was observed to be of sufficient level for operational purposes.
