Your Ref: TP/IP/03871/2022  
Our Ref : CI/TPD22005260/N

**Fatal Accident Investigation Team**

**INSPECTION REPORT OF MOTORCYCLE FBQ 8087J**

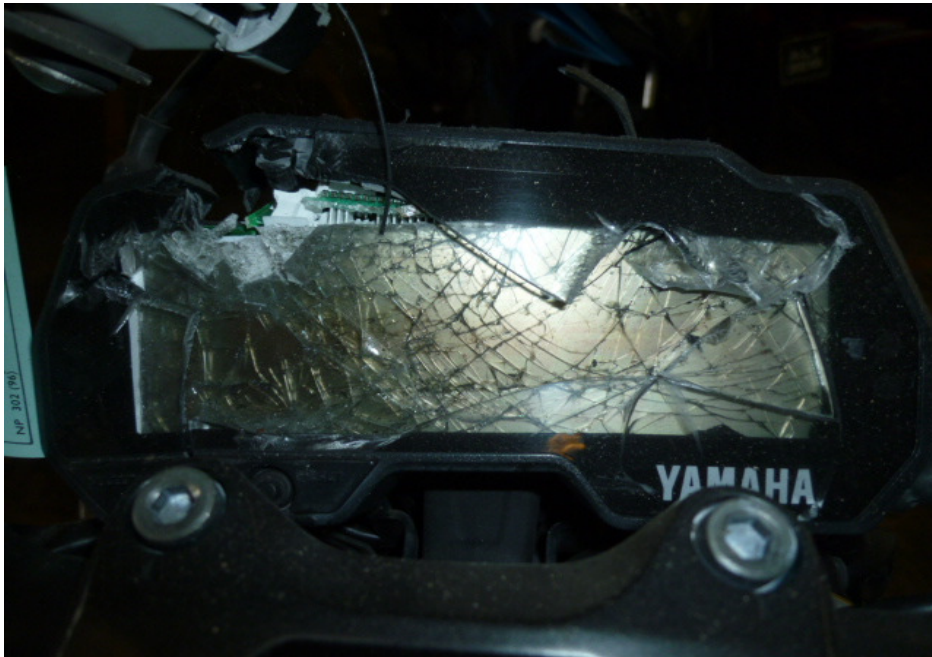
4. The mileage of the Motorcycle could not be recorded at the time of our inspection due to the damages sustained to the speedometer gauge.
5. The Motorcycle was observed to have sustained damages all around. The body parts that were found to have been damaged include its front cowling, front mudguard, side cowlings, side mirrors, front brake lever, clutch lever, petrol tank, rear side covers and exhaust muffler heat shield, amongst others.

**Photo 1** shows the damaged speedometer gauge of the Motorcycle as a result of the accident. Hence the mileage of the Motorcycle could not be recorded at the time of our inspection.

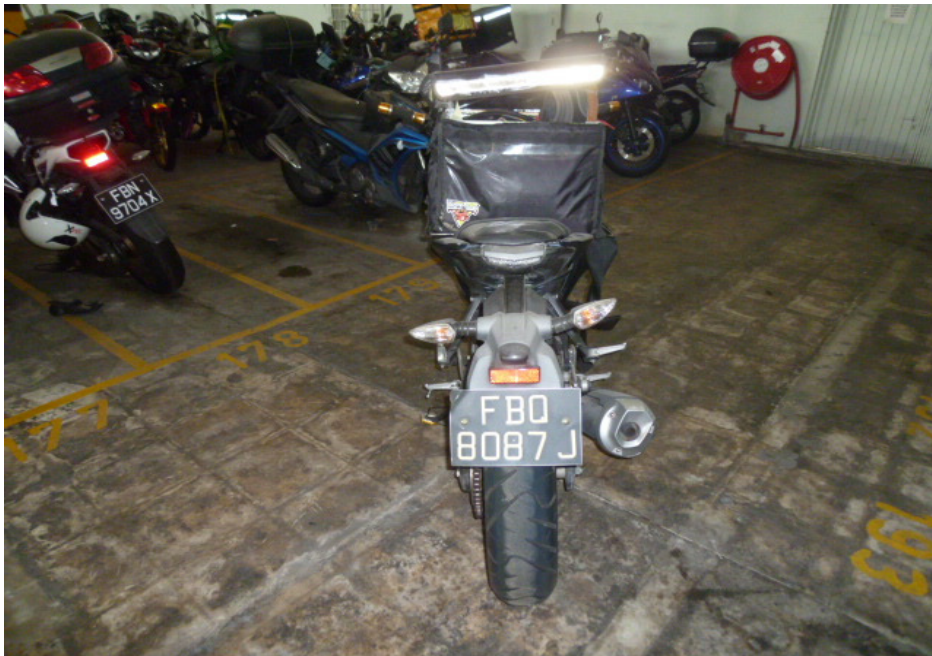
**Photo 2** shows a general view of the rear portion of the Motorcycle at the time of our inspection. The Motorcycle was observed to have sustained damages all around.

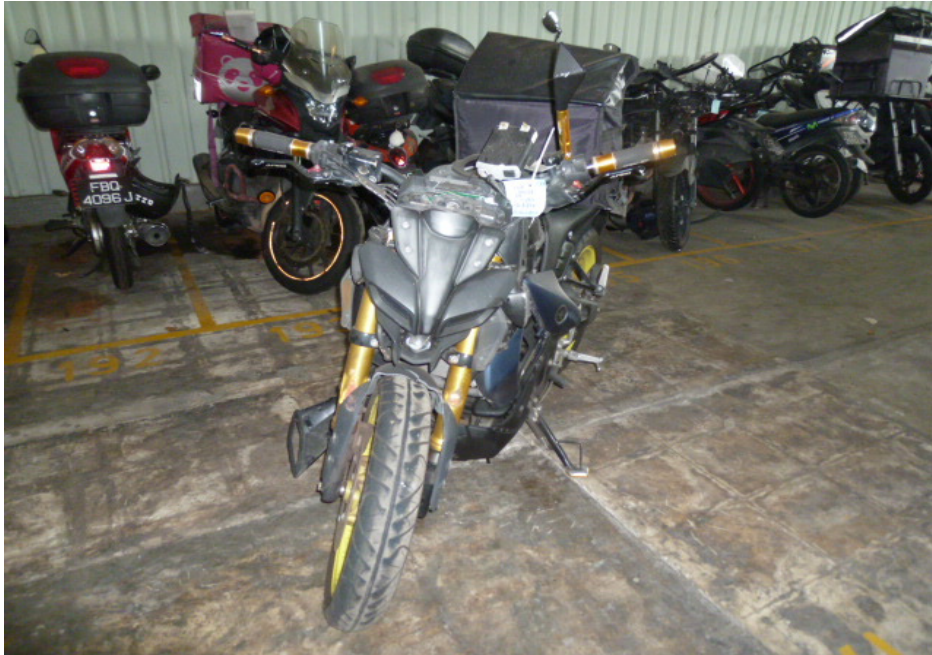
**Photo 3** shows a general view of the frontal portion of the Motorcycle at the time of our inspection. The Motorcycle was observed to have sustained damages all around.

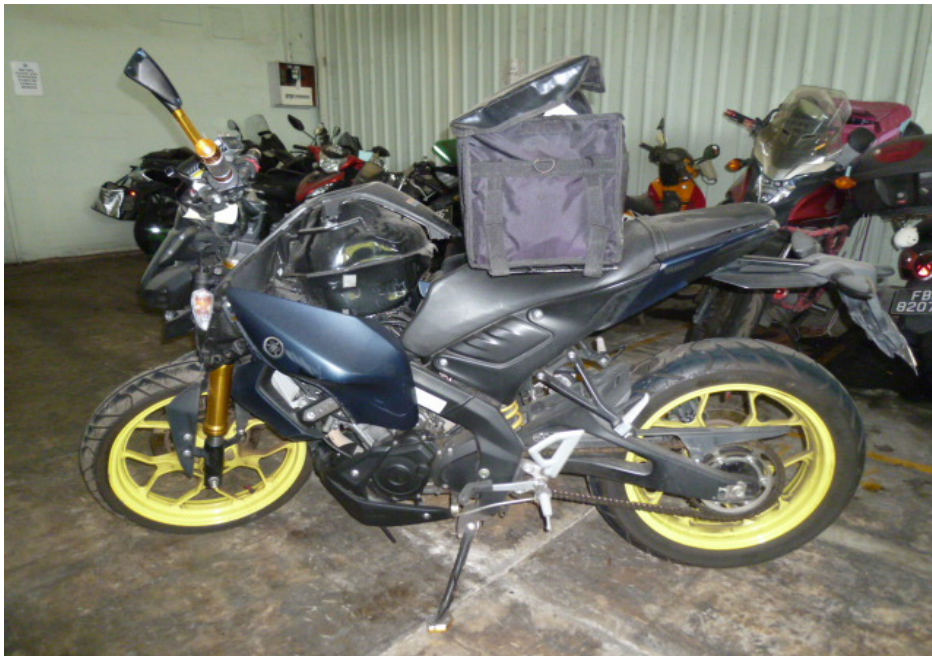
**Photo 4** shows a general view of the left body of the Motorcycle at the time of our inspection. The Motorcycle was observed to have sustained damages all around.

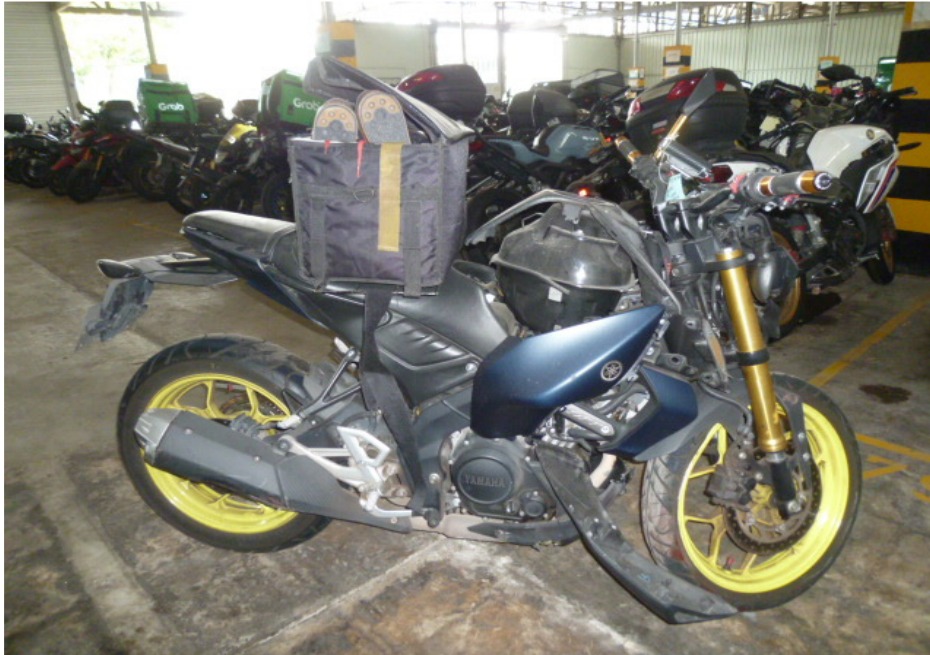
**Photo 5** shows a general view of the right body of the Motorcycle at the time of our inspection. The Motorcycle was observed to have sustained damages all around. The body parts that were found to have been damaged include its front cowlings, front mudguard, side cowlings, right side mirror, front brake lever, right handlebar end, petrol tank, gear shift pedal, left front footrest, left rear side cover, right rear signal lamp and exhaust muffler heat shield, amongst others.

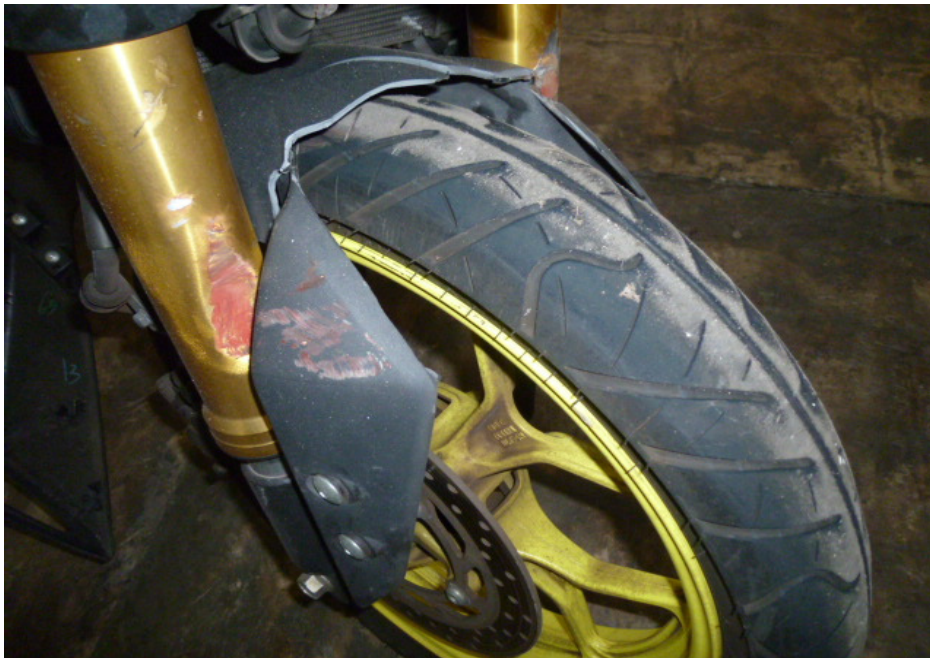
**Photo 6** shows a closer view of the cracked front mudguard which was amongst the body parts of the Motorcycle that had sustained damage as a result of the accident.

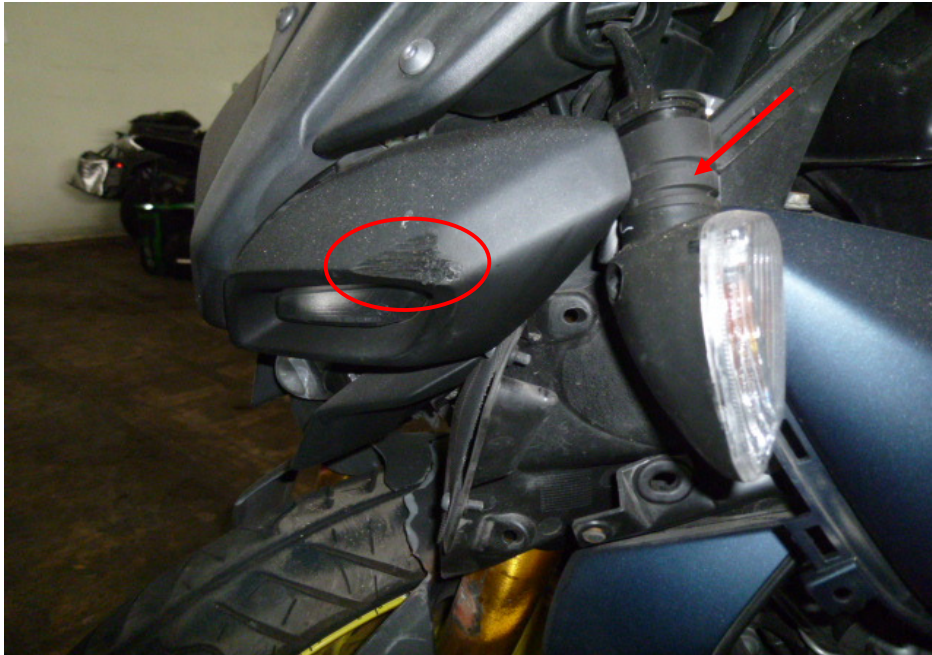
**Photo 7** shows the grazed front cowling (circled) and broken left front signal lamp (arrowed), which were amongst the body parts of the Motorcycle that had sustained damage as a result of the accident.

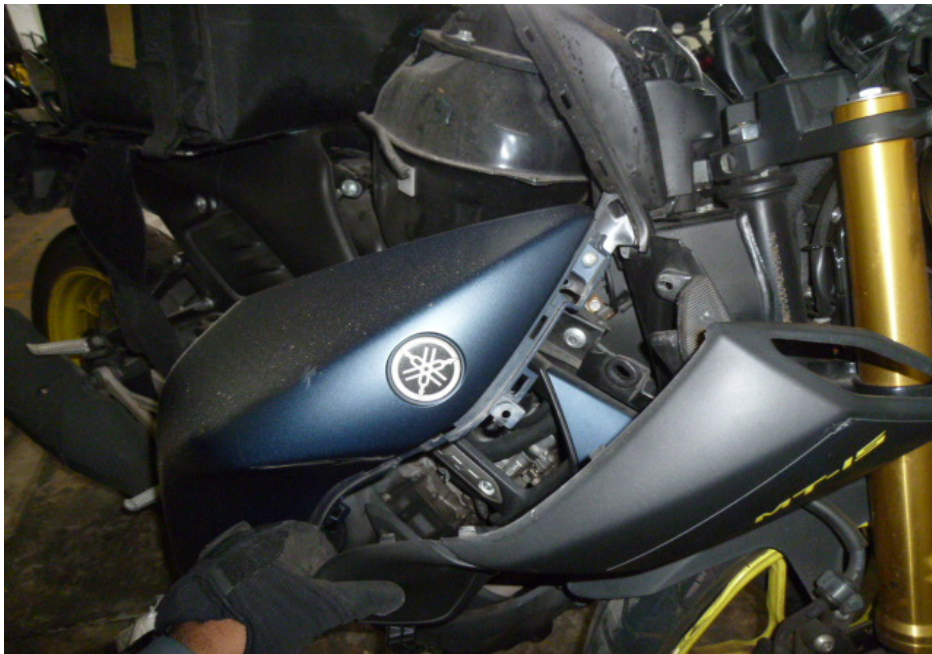
**Photo 8** shows a closer view of the cracked right cowling which was amongst the body parts of the Motorcycle that had sustained damage as a result of the accident.

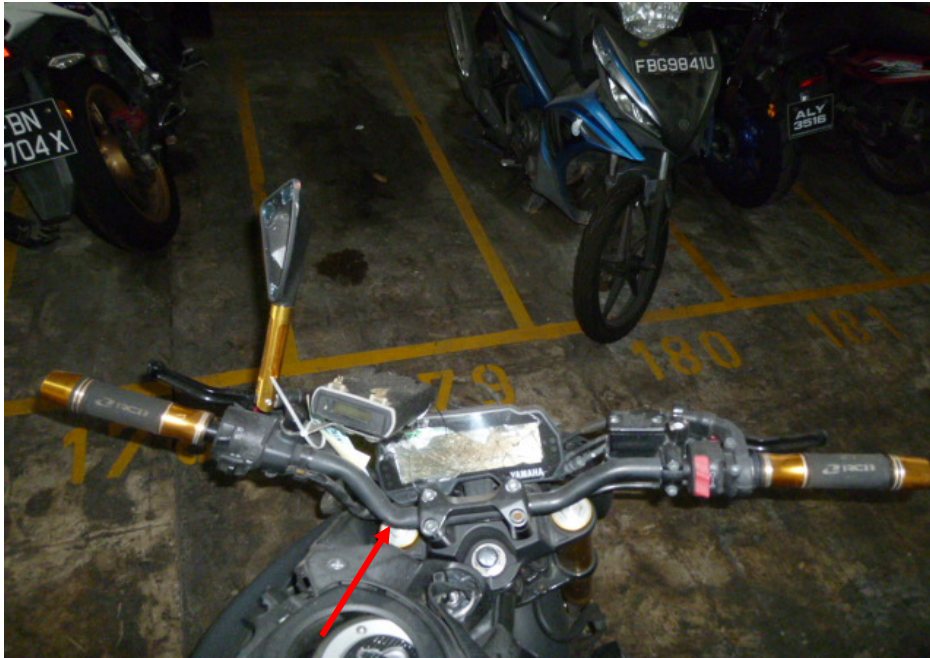
**Photo 9** shows a closer view of the bent handlebar of the Motorcycle as a result of the accident (arrowed).

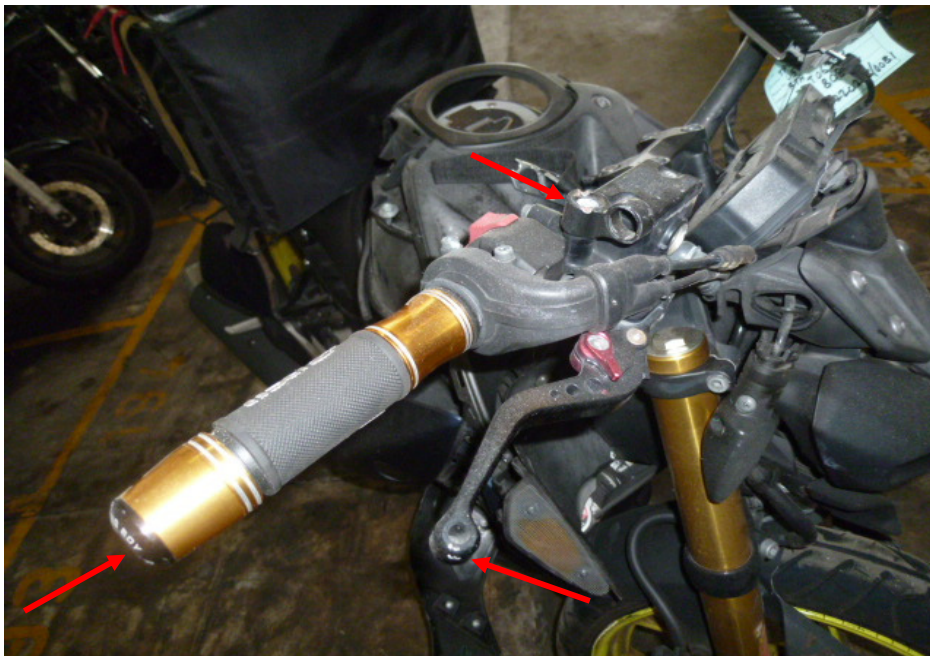
**Photo 10** shows the right handlebar end, front brake lever and right side mirror (arrowed), which were amongst the body parts of the Motorcycle that had sustained damage as a result of the accident.

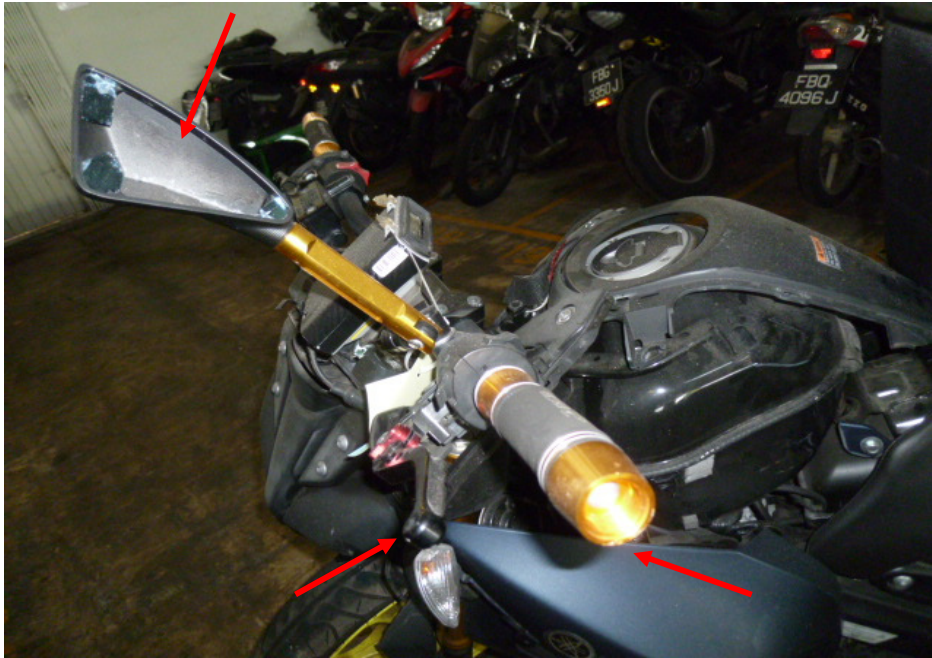
**Photo 11** shows the left handlebar end, clutch brake lever and left side mirror (arrowed), which were amongst the body parts of the Motorcycle that had sustained damage as a result of the accident.

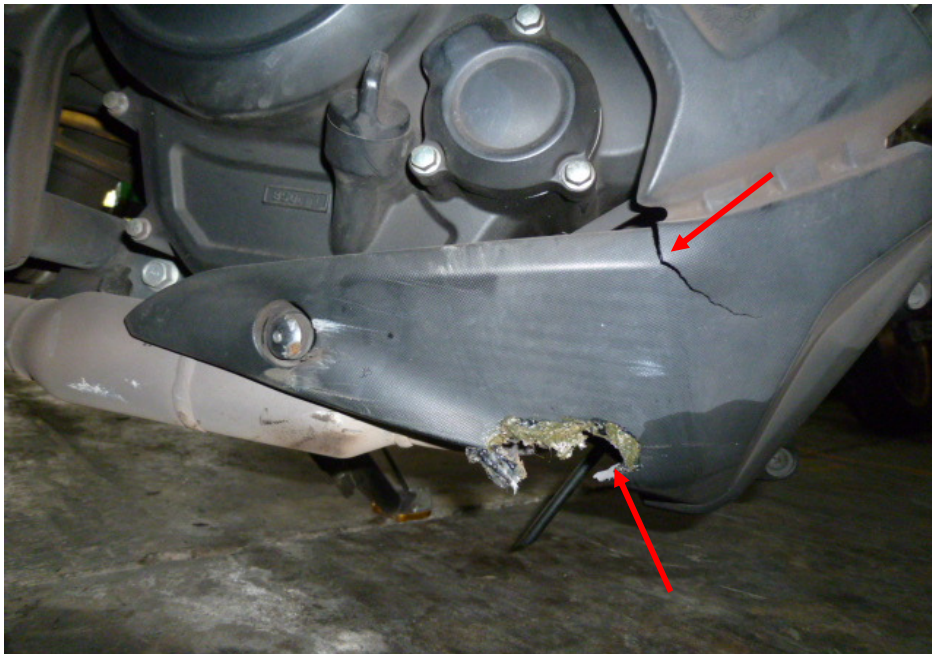
**Photo 12** shows a closer view of the cracked belly pan (arrowed) which was amongst the body parts of the Motorcycle that had sustained damage as a result of the accident.

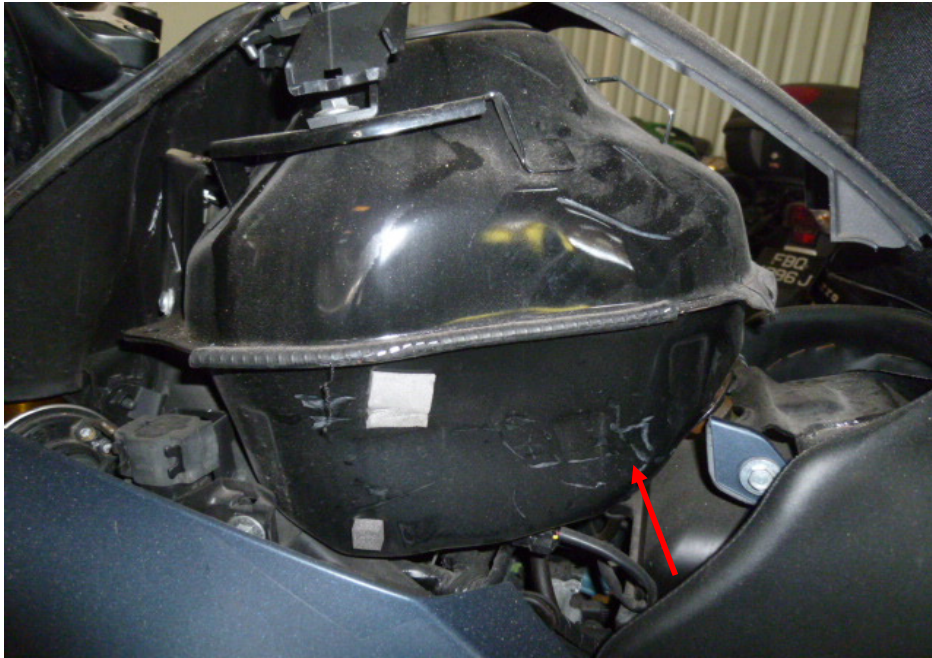
**Photo 13** shows a closer view of the dented petrol tank of the Motorcycle as a result of the accident (arrowed).

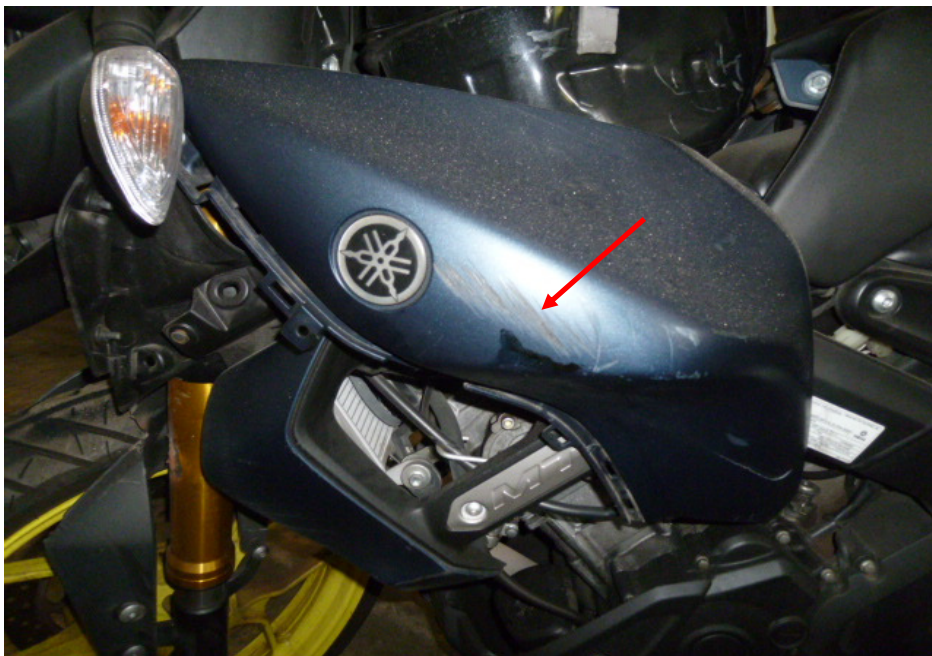
**Photo 14** shows a closer view of the grazed left cowling of the Motorcycle as a result of the accident (arrowed).

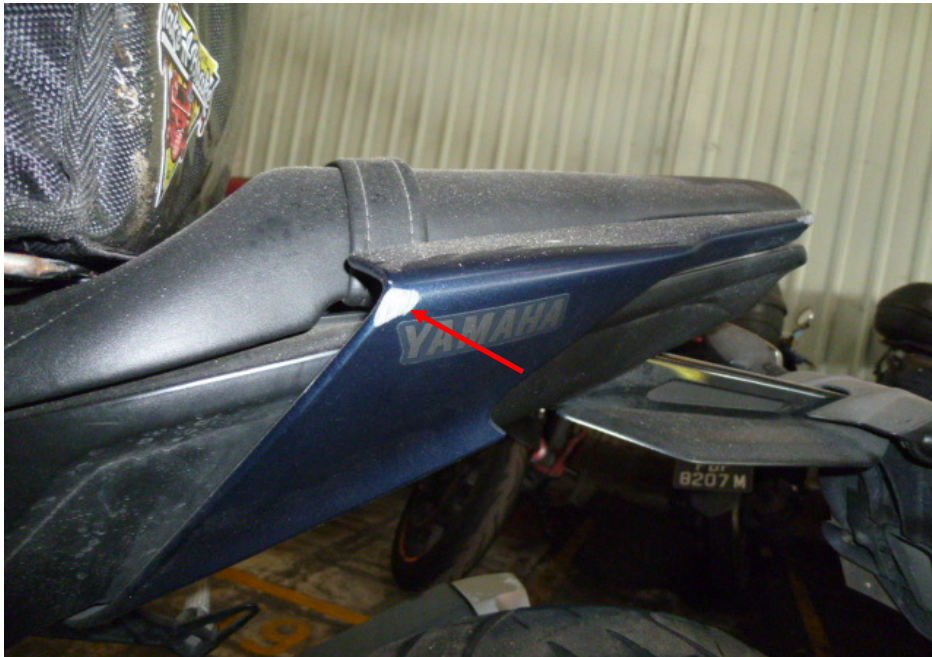
**Photo 15** shows a closer view of the grazed left rear side cover of the Motorcycle as a result of the accident (arrowed).

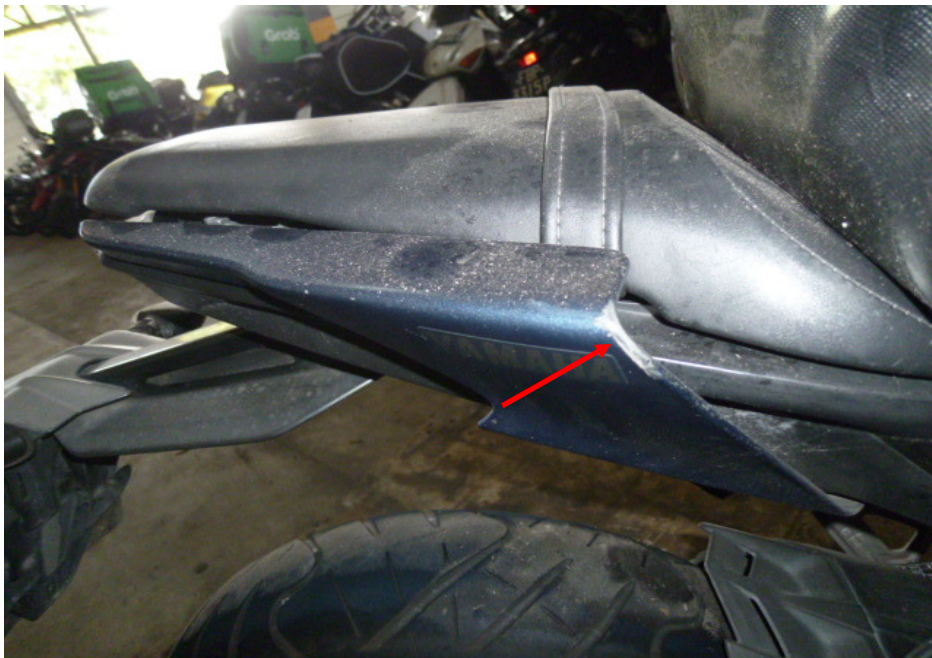
**Photo 16** shows a closer view of the grazed right rear side cover of the Motorcycle as a result of the accident (arrowed).

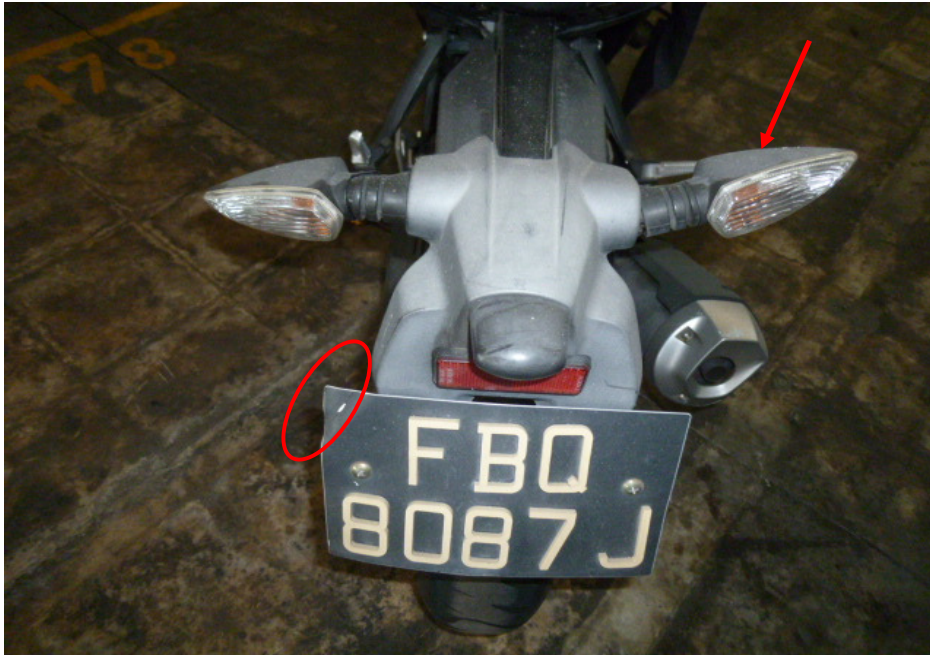
**Photo 17** shows a closer view of the deformed right rear signal lamp (arrowed) and dented rear number plate (circled) of the Motorcycle as a result of the accident.

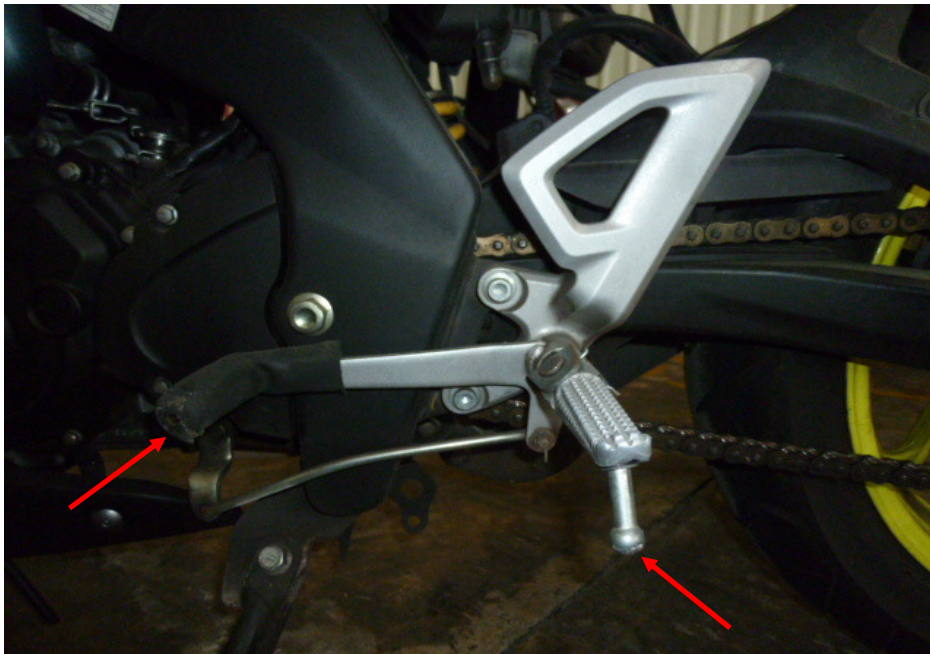
**Photo 18** shows the gear shift pedal and left front footrest of the Motorcycle that had sustained damage as a result of the accident (arrowed).

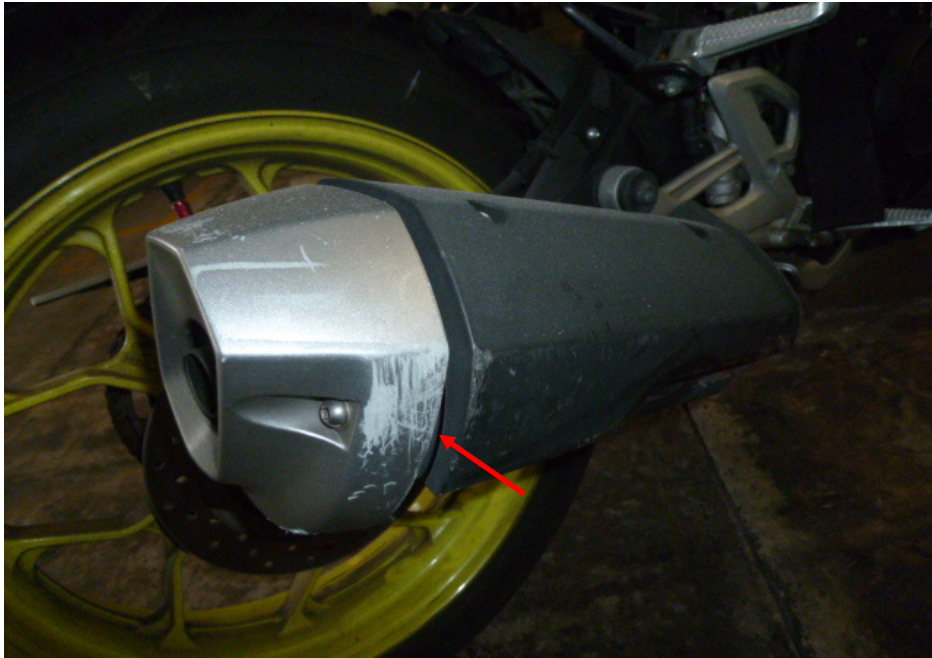
**Photo 19** shows the grazed exhaust muffler heat shield of the Motorcycle as a result of the accident (arrowed).

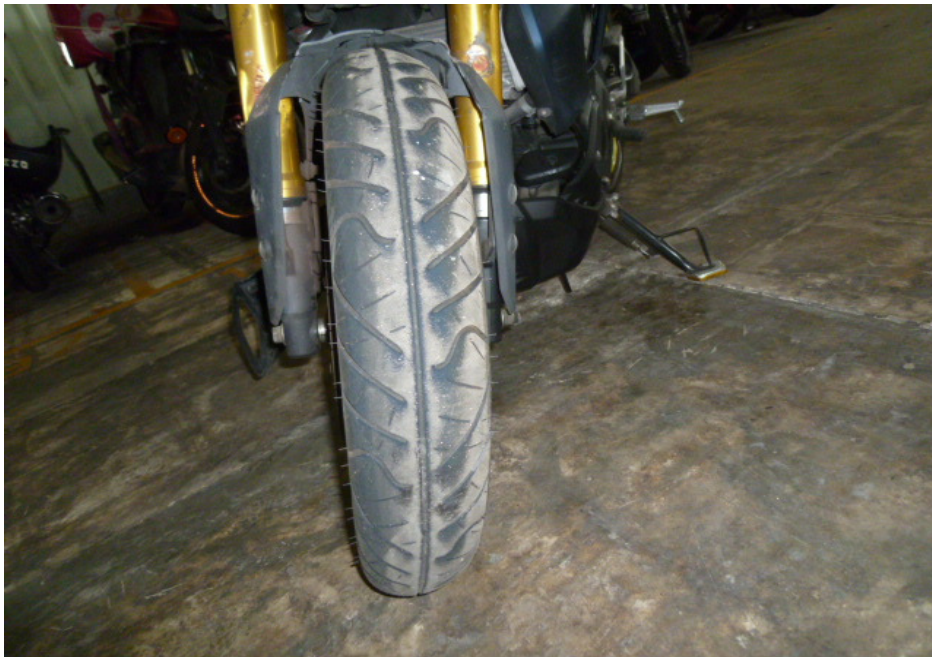
**Photo 20** shows the condition of the Motorcycle's front tyre. The front tyre was observed to be in serviceable condition with remaining tread depth of approximately 3mm. There was no tear, burst mark(s) and/or punctured hole(s) on the sidewalls as well as across the tread of the front tyre. However the front tyre was observed to be deflated.

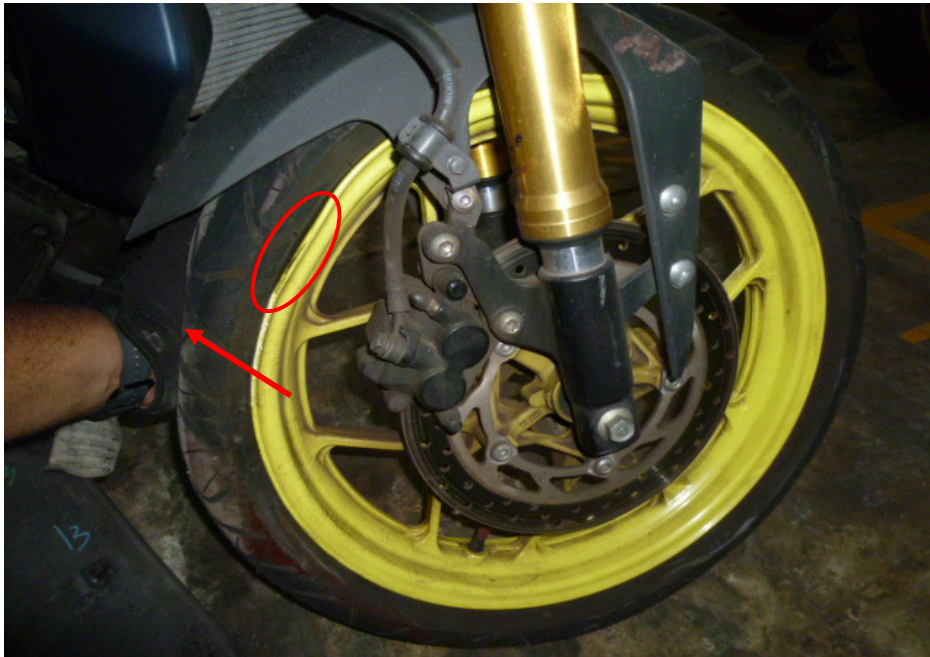
8. The 2 tyres were wrapped around alloy wheel rims. At the time of our inspection, we did not observe any visible damage on the rear wheel rim of the Motorcycle. However we did observe that the front wheel rim was bent. See photos 1 – 22 below.

**Photo 21** shows the bent front wheel rim (circled) and deflated front tyre (arrowed) of the Motorcycle at the time of our inspection.

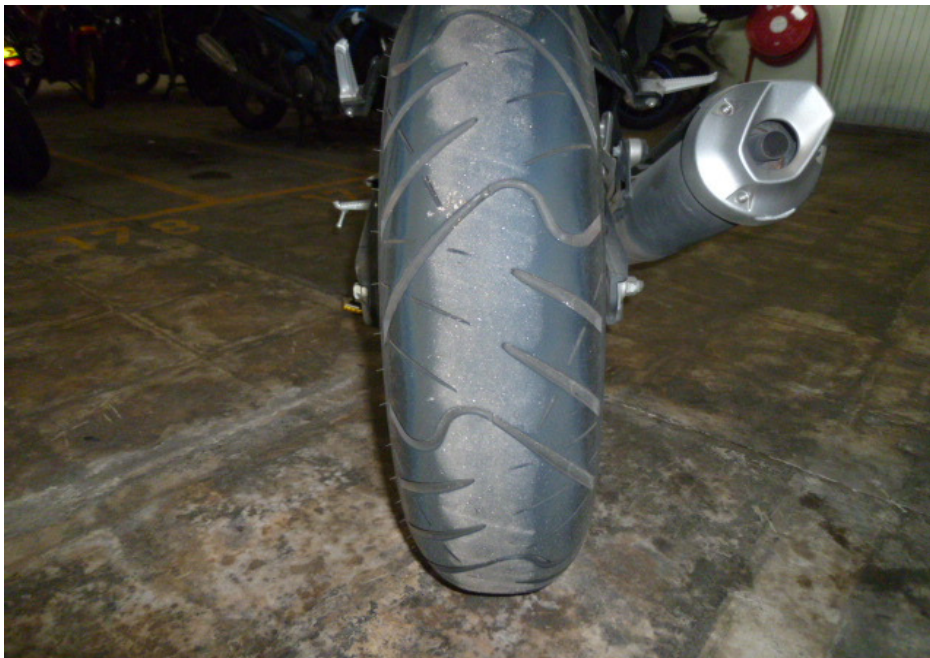
**Photo 22** shows the condition of the Motorcycle's rear tyre. The rear tyre was observed to be in serviceable condition with remaining tread depth of approximately 4mm. The tyre was also observed to be sufficiently inflated for vehicular operation. We did not observe any tear, burst mark(s) and/or punctured hole(s) on the sidewalls as well as across the tread of the rear tyre.

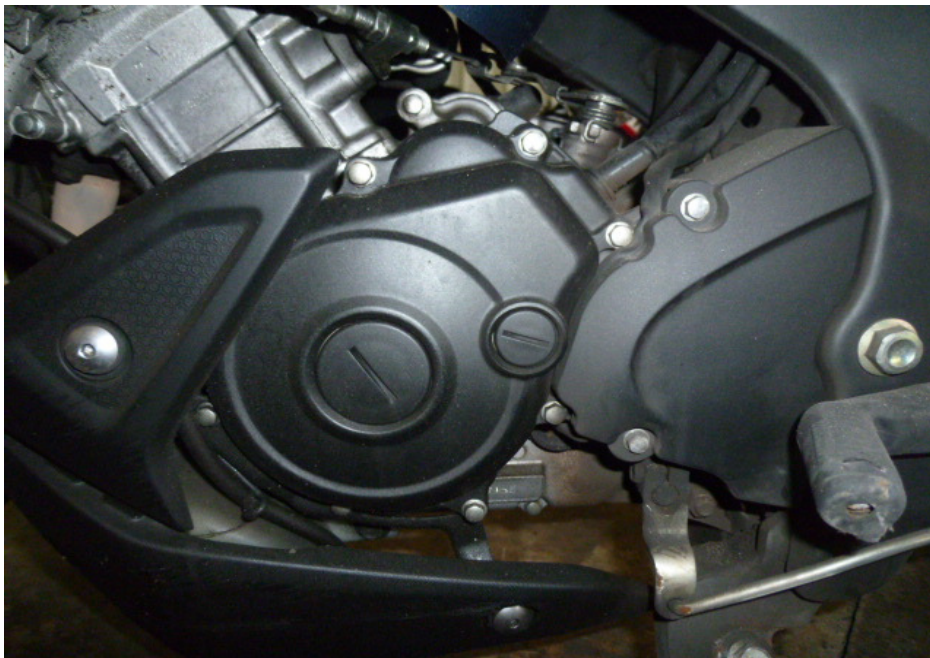
**Photo 23** shows the left side of the engine of the Motorcycle at the time of our inspection. The various engine related parts and components were found to be intact with no visible damage. There was also no sign(s) or indication(s) of fluid leak observed around the left engine area of the Motorcycle.

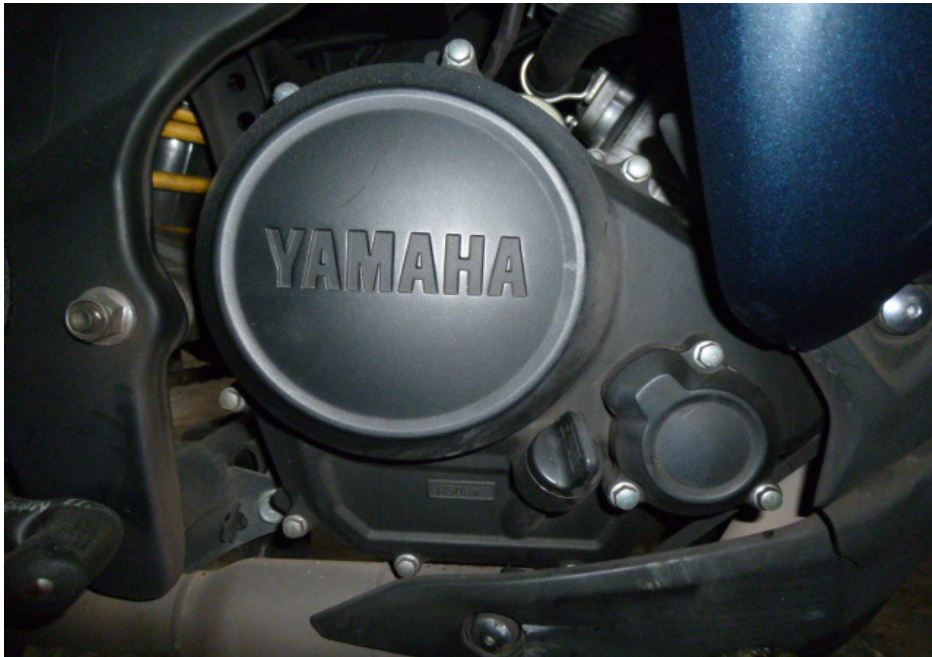
**Photo 24** shows the right side of the engine of the Motorcycle at the time of our inspection. The various engine related parts and components were found to be intact with no visible damage. There was also no sign(s) or indication(s) of fluid leak observed around the right engine area of the Motorcycle.

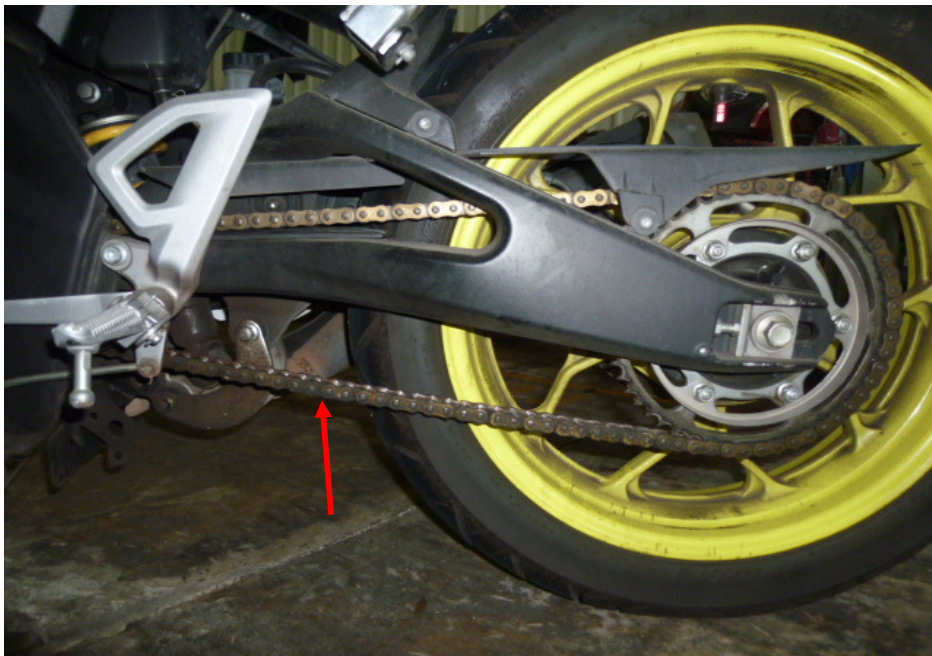
**Photo 25** shows the general view of the gear chain (arrowed) of the Motorcycle, which was observed to be intact with no misalignment. It was also adequately lubricated for operating purposes.

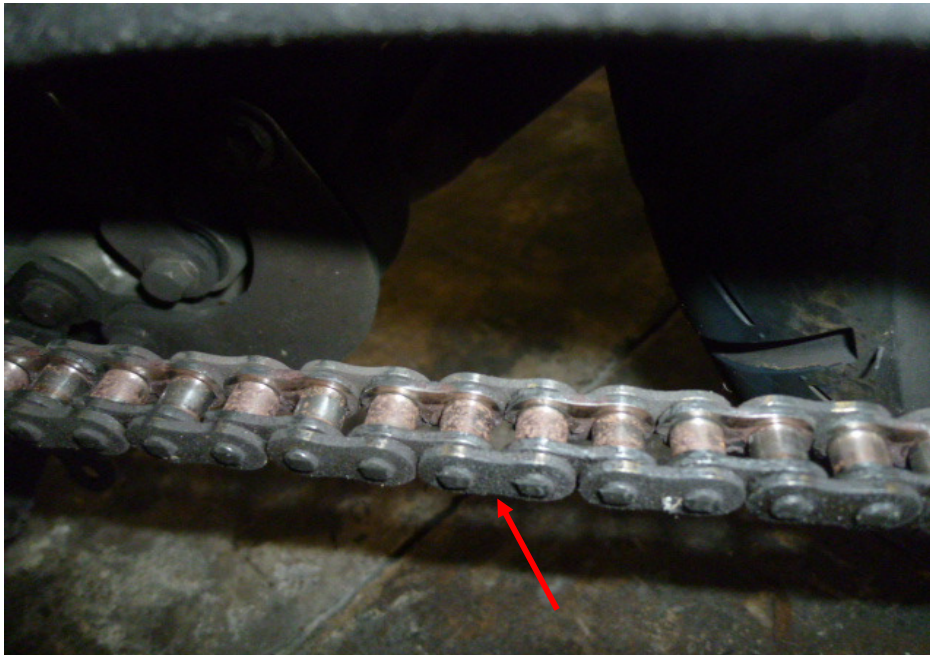
**Photo 26** shows a closer view of the gear chain (arrowed) of the Motorcycle, which was observed to be intact with no misalignment. It was also adequately lubricated for operating purposes.

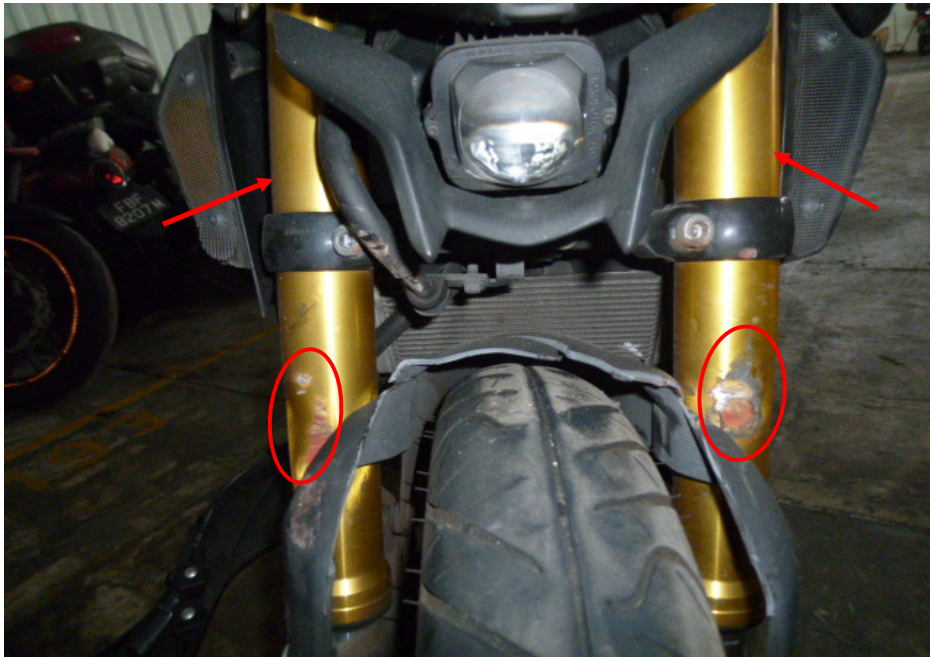
11. Our checks on the various steering components of the Motorcycle revealed that its steering system was in serviceable condition. Its front fork assembly was found to be intact. However the front forks had sustained damages of grazing nature as a result of the accident. Turning the handle bar towards the left and right also did not produce any abnormal free play and/or resistance.

**Photo 27** shows the front forks (arrowed) of the Motorcycle. The front forks and fork bracket of the Motorcycle were both found to be intact. However the front forks had sustained damages of grazing nature as a result of the accident (circled). Turning the Motorcycle's handle bar towards the left and right did not produce any abnormal free play. The steering system of the Motorcycle was in serviceable condition at the time of our inspection.

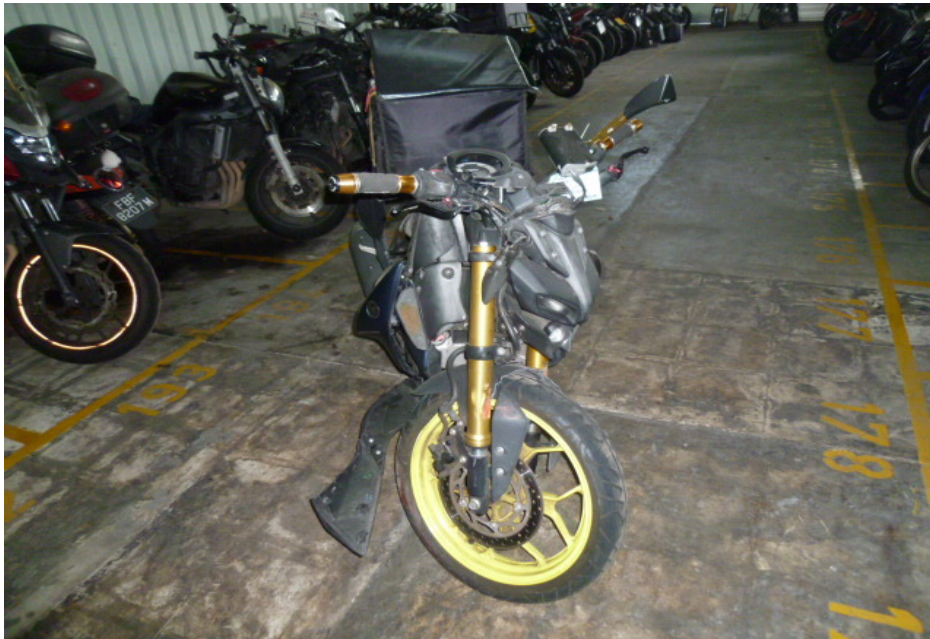
**Photo 28** shows the front wheel of the Motorcycle turned towards its full left. Turning the Motorcycle's handle bar towards the left did not produce any abnormal free play and/or resistance. This would indicate that the steering system of the Motorcycle was in serviceable condition at the time of our inspection.

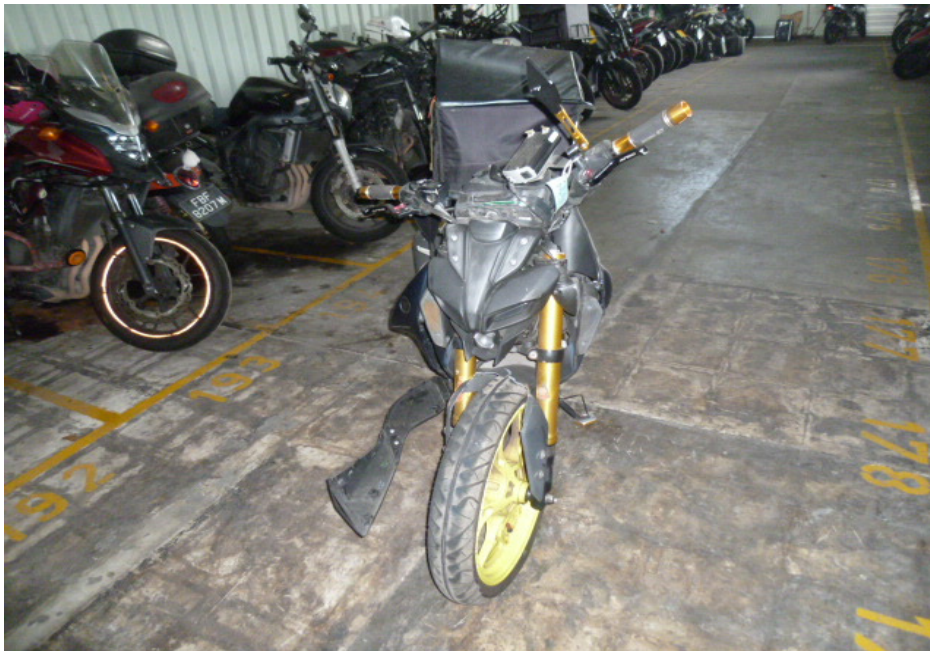
**Photo 29** shows the front wheel of the Motorcycle turned towards its full right. Turning the Motorcycle's handle bar towards the right did not produce any abnormal free play and/or resistance. This would indicate that the steering system of the Motorcycle was in serviceable condition at the time of our inspection.

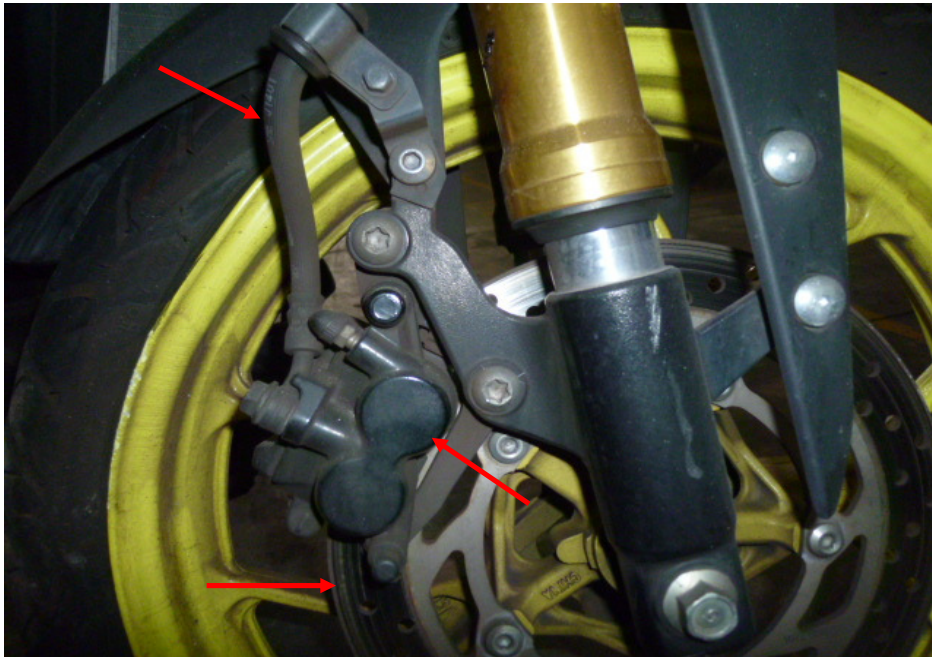
**Photo 30** shows a close up view of the front brake caliper, front brake disc and front brake hose (arrowed) of the Motorcycle, which are all part of the components in the hydraulic front brake system of the Motorcycle. Our visual checks of these various components had revealed all to be intact with no visible damage. No leakage of brake fluid was also observed.

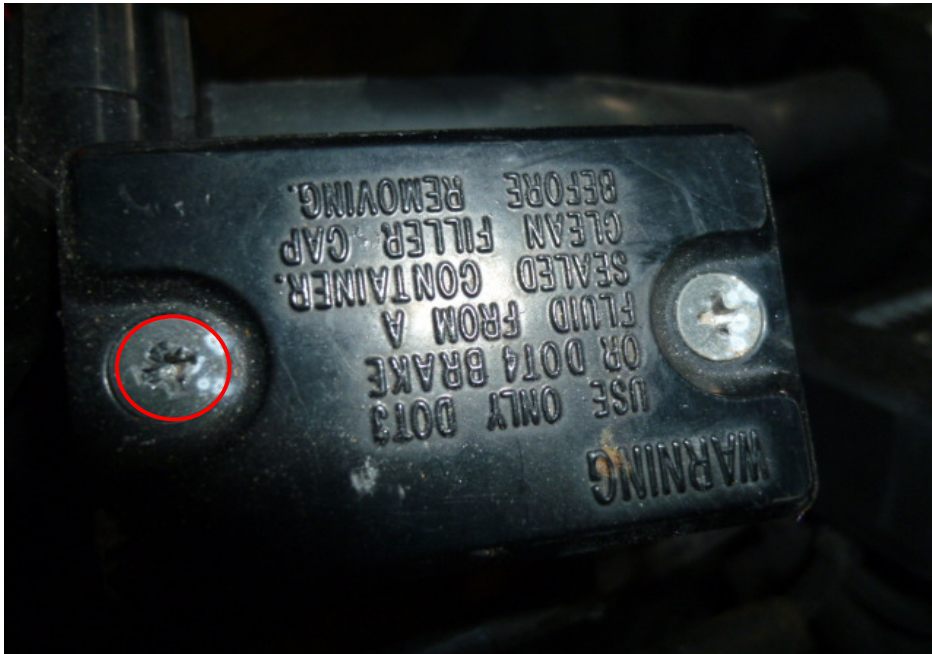
14. We were unable remove the front brake reservoir cover to examine whether the front brake fluid was without contamination due to a worn out screw. However the front brake fluid was observed to be of sufficient level for operational purposes.

**Photo 31** shows the brake fluid reservoir cover for the front brake of the Motorcycle. We were unable to examine whether the front brake fluid was without contamination due to the worn out screw (circled).

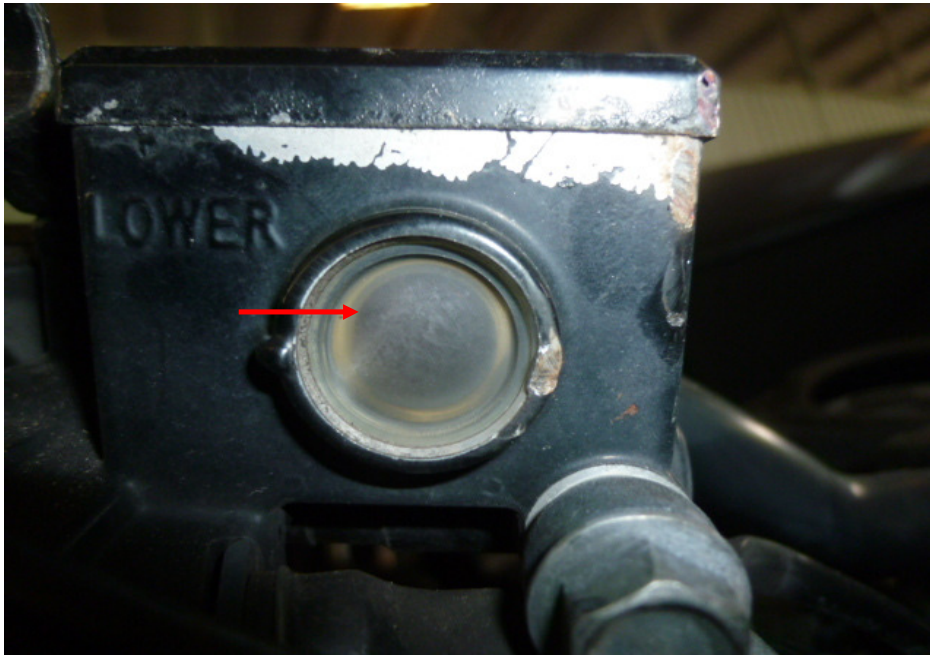
**Photo 32** shows a close up view of the brake fluid reservoir for the front brake of the Motorcycle. The brake fluid was observed to be of sufficient level for operational purposes (arrowed).

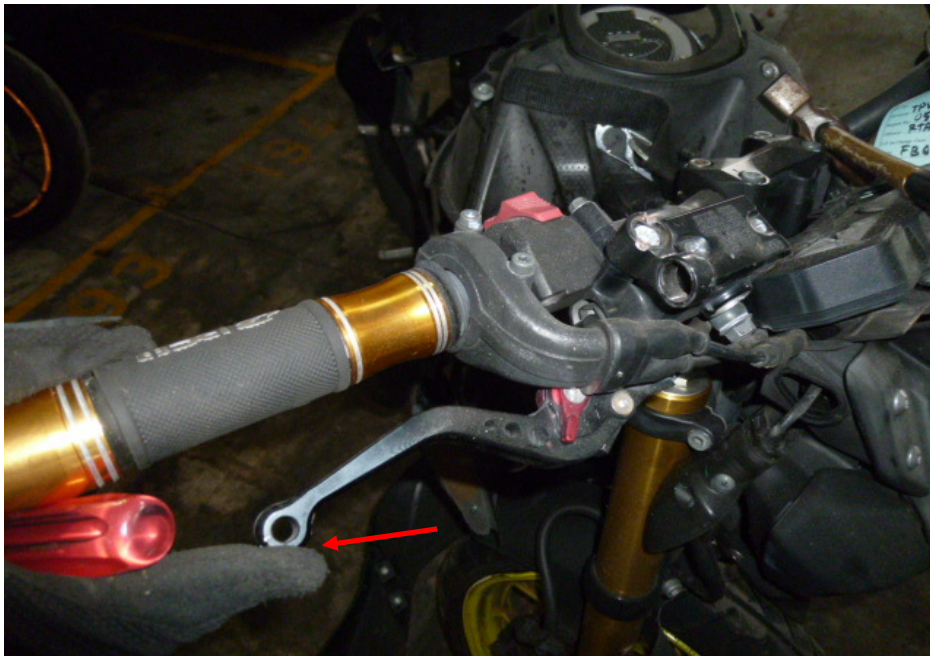
16. Static brake tests conducted on the Motorcycle had appear to indicate that the front braking system of the Motorcycle was in serviceable condition. There was some resistance felt (spongy like feel) upon pressing the brake lever. This would indicate that there was no leakage of pressure/vacuum in the front brake system.

**Photo 33** shows the front brake lever being depressed. There was some resistance felt (spongy like feel) upon pressing the front brake lever (arrowed). This would indicate that there is no leakage of pressure/vacuum in the front brake system.
