Your Ref: TP/IP/03871/2022  
Our Ref : CI/TPD22005260/N

**Fatal Accident Investigation Team**

**INSPECTION REPORT OF MOTORCYCLE FBQ 8087J**

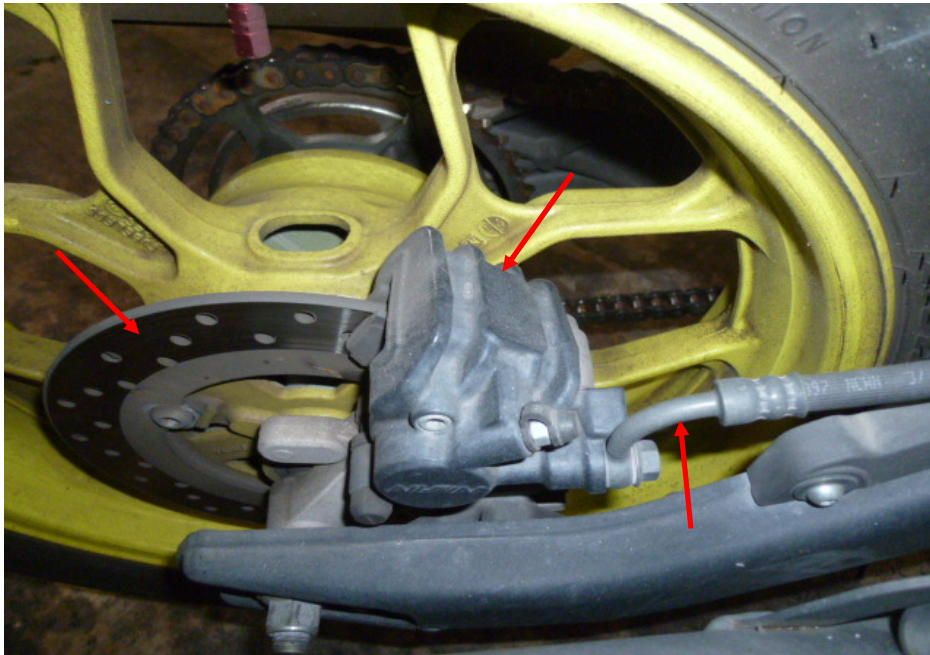
**Photo 34** shows a close up view of the rear brake caliper, rear brake disc and rear brake hose (arrowed) of the Motorcycle, which are all part of the components in the hydraulic rear brake system of the Motorcycle. Our visual checks of these various components had revealed all to be intact with no visible damage. No leakage of brake fluid was also observed.

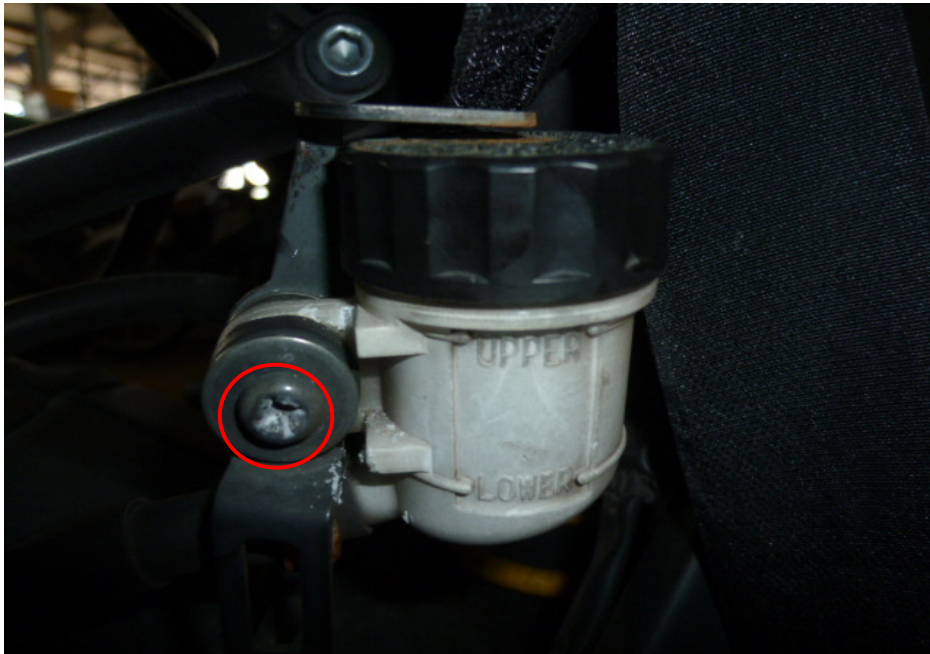
15. We were unable remove the rear brake reservoir cover to examine whether the front brake fluid was of sufficient level for operational purposes and without contamination due to a worn out screw.

**Photo 35** shows the brake fluid reservoir cover for the rear brake of the Motorcycle. We were unable to examine whether the front brake fluid was of sufficient level for operational purposes and without contamination due to the worn out screw (circled).
