Your Ref: TP/IP/09555/2022
Our Ref : CI/TPD22005261/N

18 August 2022

Fatal Accident Investigation Team

INSPECTION REPORT OF MOTORCYCLE JSP 2711

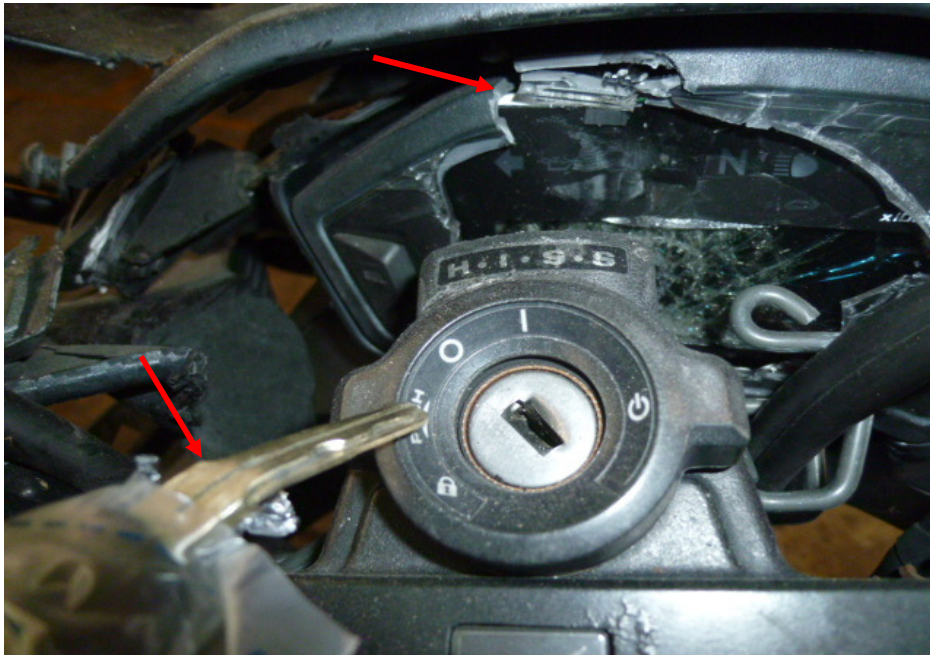
4. The mileage of the Motorcycle could not be recorded at the time of our inspection due to a bent ignition key as well as damages sustained to the speedometer gauge.
5. The Motorcycle was observed to have sustained damages all around. The body parts that were found to have been damaged include its speedometer gauge, head cowlings, front mudguard, side cowlings, right handlebar end, right side mirror, front brake lever, petrol tank, radiator, rear brake pedal, right front footrest, right rear side cover, exhaust muffler heat shield and exhaust muffler, amongst others.

Photo 1 shows the bent ignition key and broken speedometer gauge of the Motorcycle as a result of the accident (arrowed). The mileage of the Motorcycle could not be recorded at the time of our inspection.

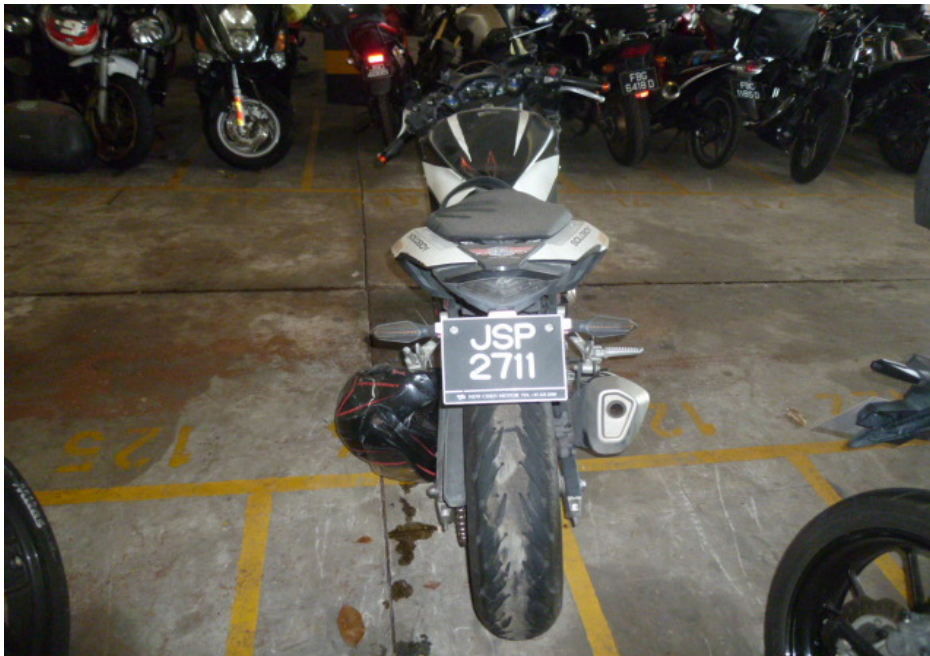
Photo 2 shows a general view of the rear portion of the Motorcycle at the time of our inspection. The Motorcycle was observed to have sustained damages all around.

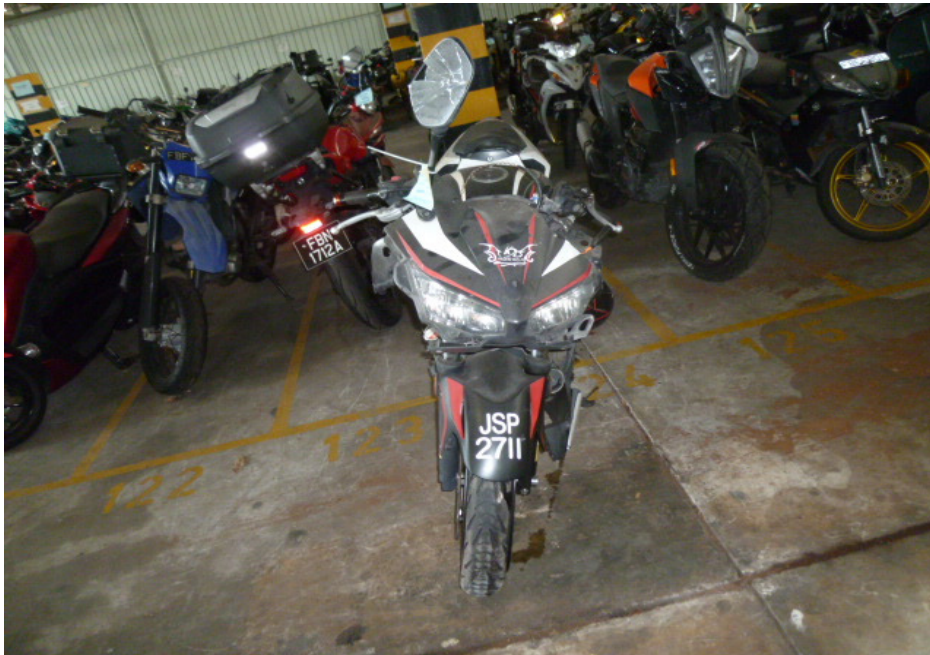
Photo 3 shows a general view of the frontal portion of the Motorcycle at the time of our inspection. The Motorcycle was observed to have sustained damages all around.

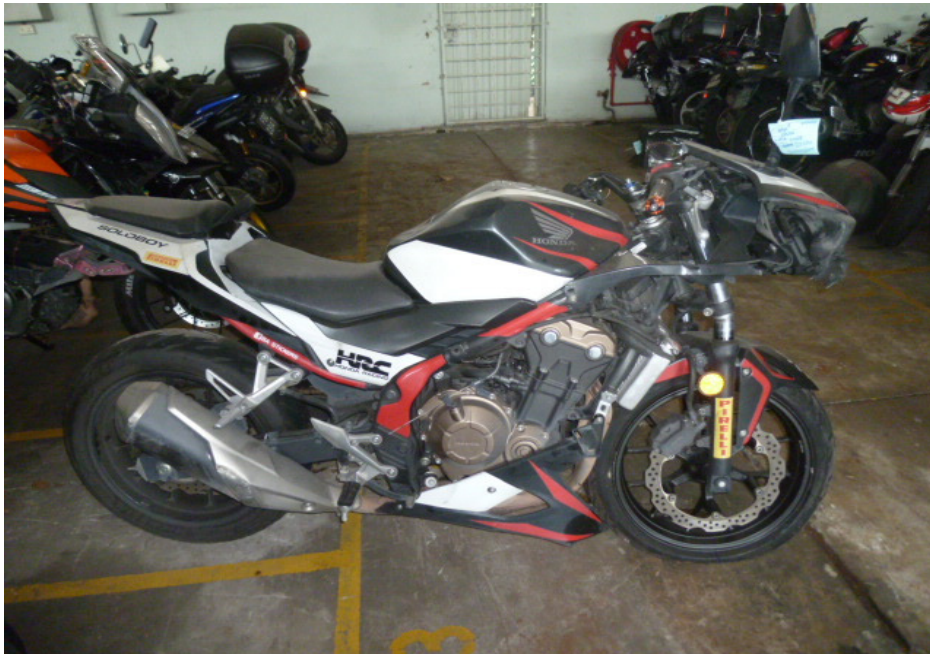
Photo 4 shows a general view of the right body of the Motorcycle at the time of our inspection. The Motorcycle was observed to have sustained damages all around. The body parts that were found to have been damaged include its speedometer gauge, head cowl, front mudguard, side cowlings, right handlebar end, right side mirror, front brake lever, petrol tank, radiator, rear brake pedal, right front footrest, right rear side cover, exhaust muffler heat shield and exhaust muffler, amongst others.

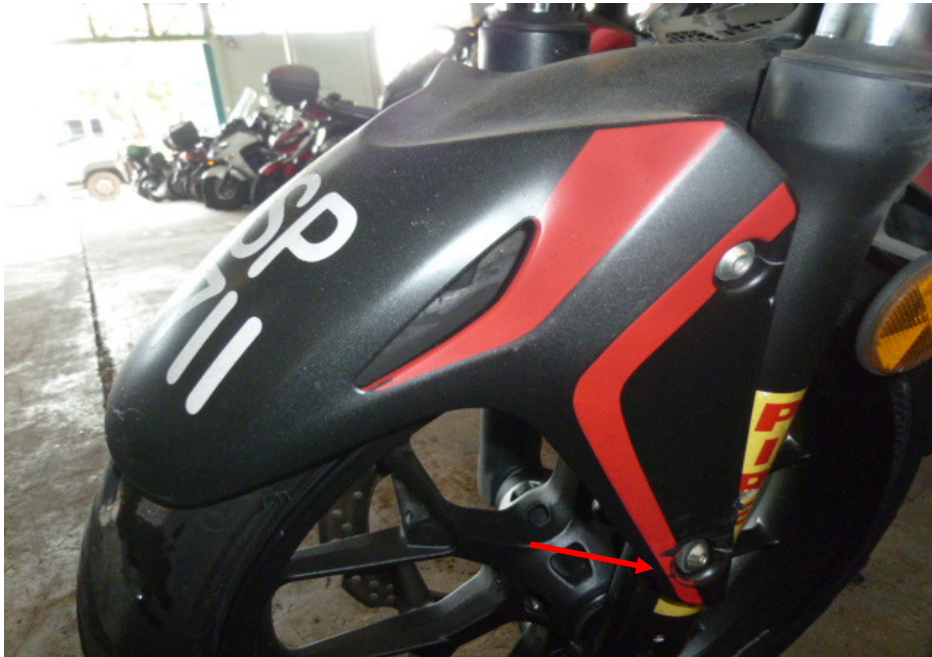
Photo 5 shows a closer view of the front mudguard (arrowed) which was amongst the body parts of the Motorcycle that had sustained damage as a result of the accident.

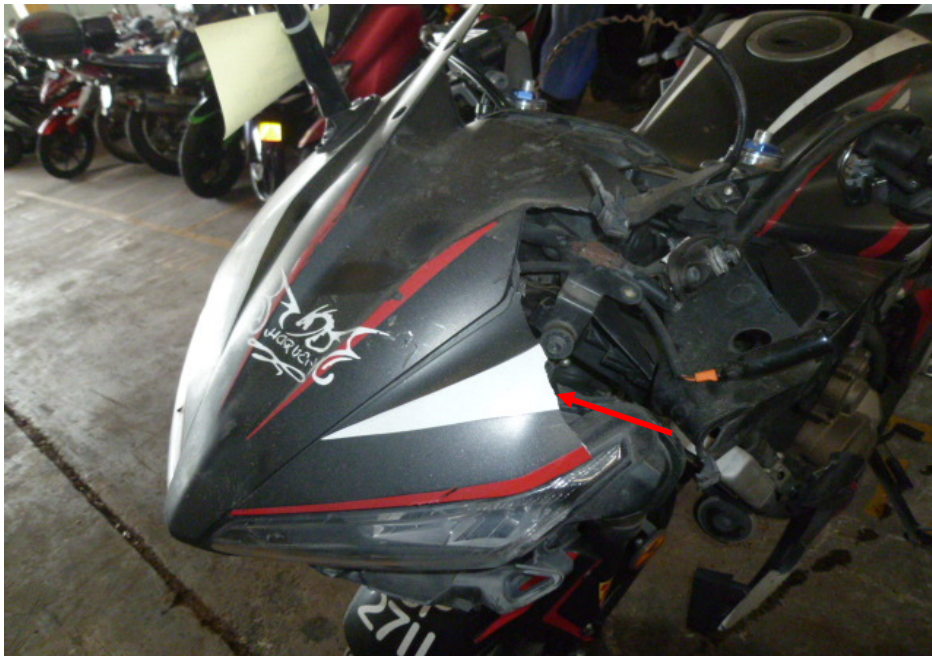
Photo 6 shows the cracked head cowl (arrowed) of the Motorcycle as a result of the accident.

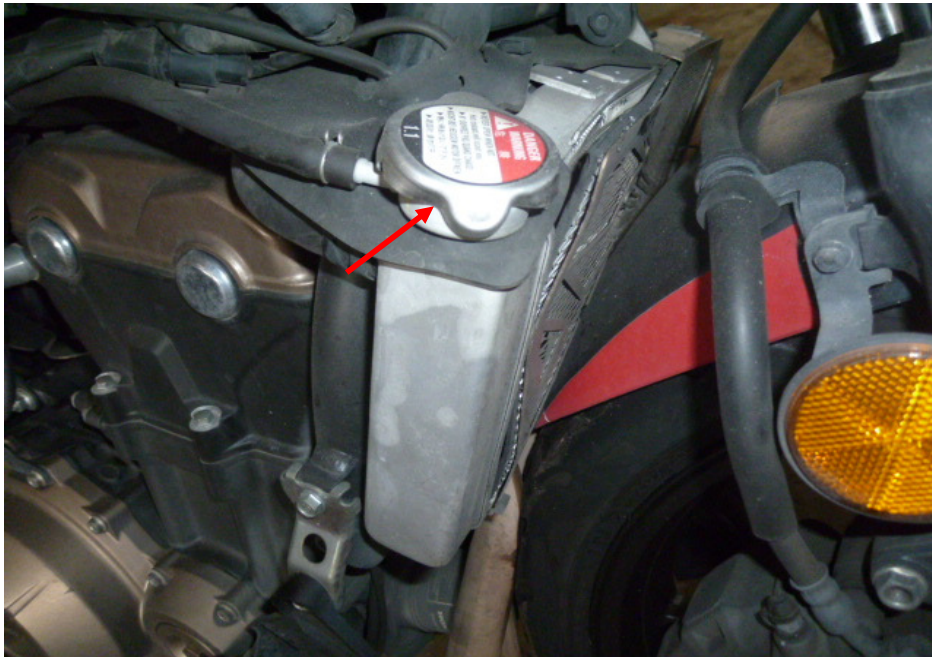
Photo 7 shows a closer view of the deformed radiator (arrowed) of the Motorcycle as a result of the accident.

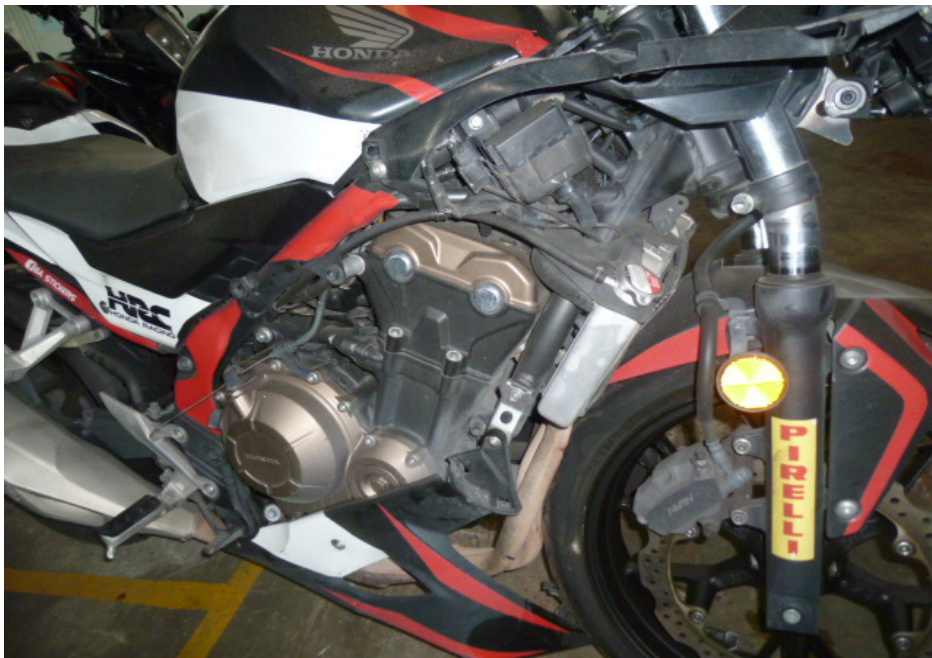
Photo 8 shows a closer view of the missing right cowling of the Motorcycle as a result of the accident.

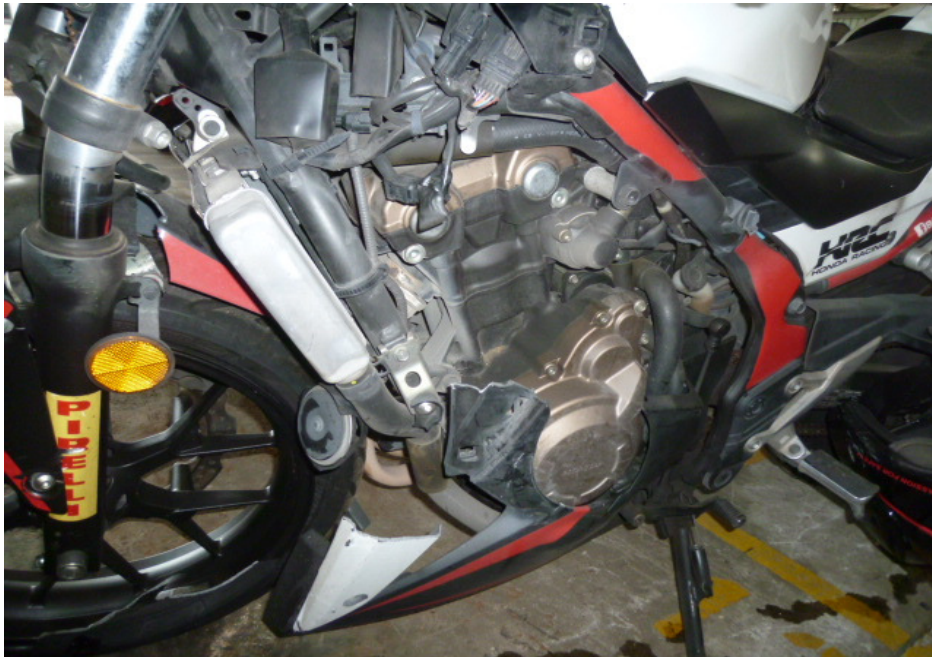
Photo 9 shows a closer view of the missing left cowling of the Motorcycle as a result of the accident.

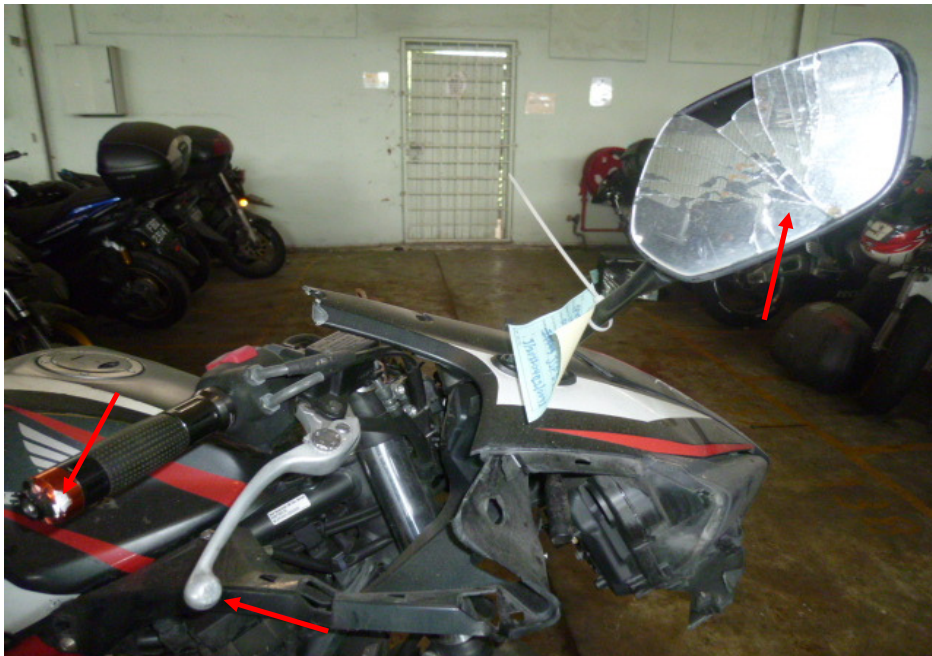
Photo 10 shows the right handlebar end, front brake lever and right side mirror (arrowed), which were amongst the body parts of the Motorcycle that had sustained damage as a result of the accident.

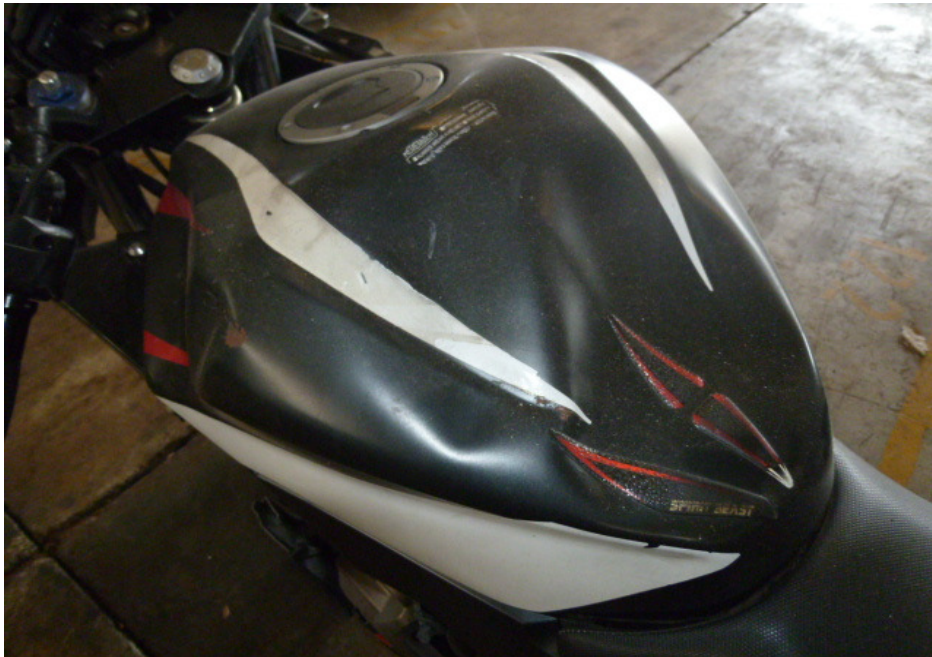
Photo 11 shows a closer view of the dented petrol tank of the Motorcycle as a result of the accident.

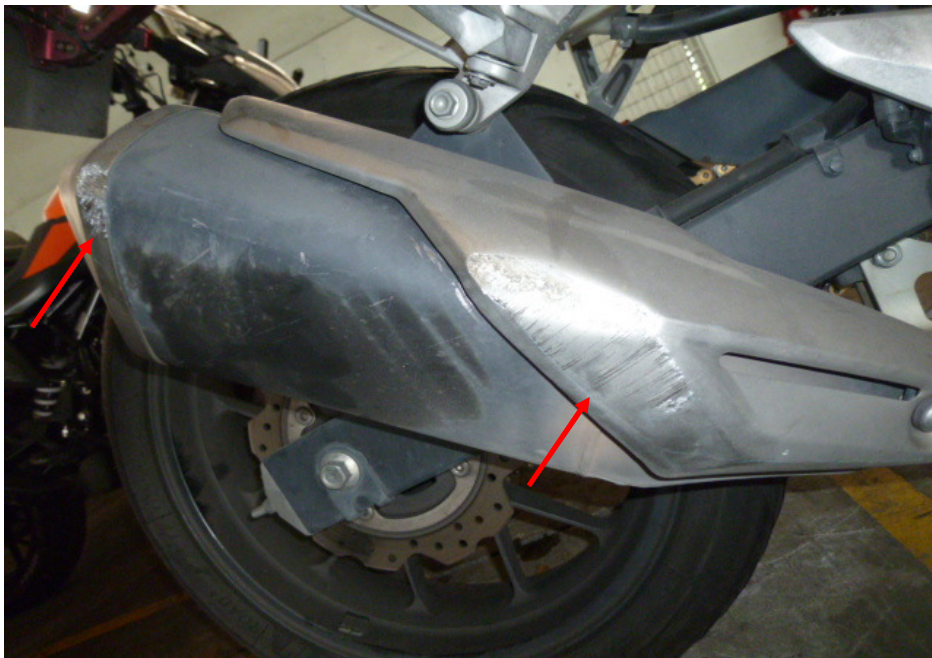
Photo 12 shows a closer view of the grazed exhaust muffler heat shield and exhaust muffler (arrowed) of the Motorcycle as a result of the accident.

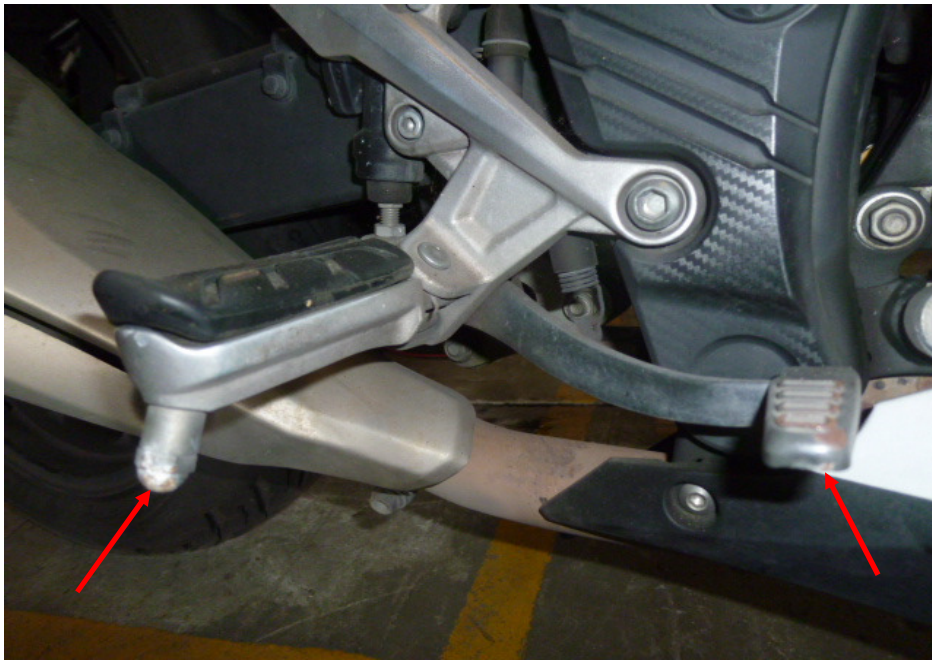
Photo 13 shows the rear brake pedal and right front footrest of the Motorcycle that had sustained damage as a result of the accident (arrowed).

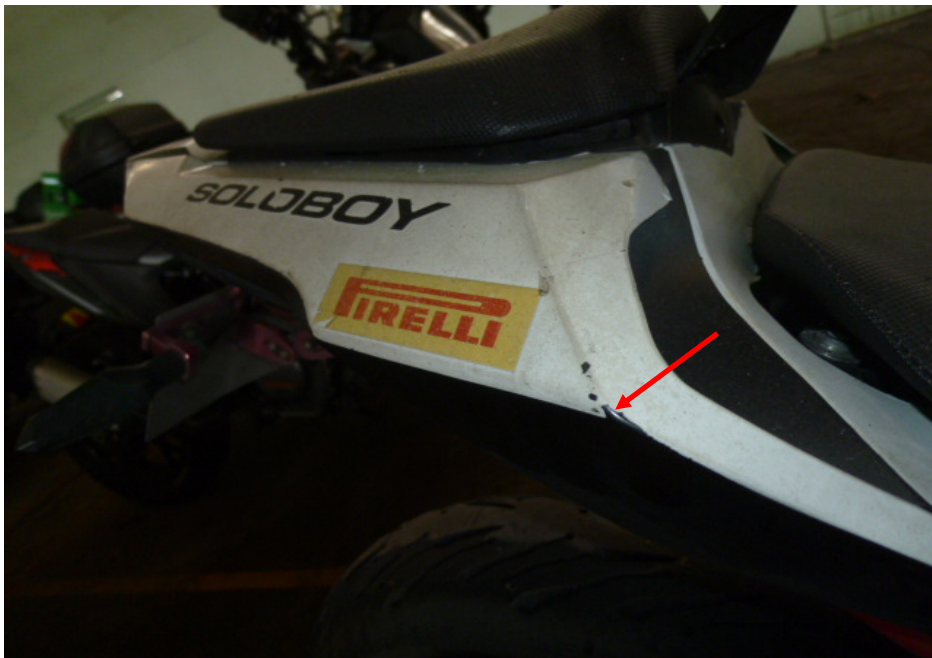
Photo 14 shows a closer view of the grazed right rear side cover of the Motorcycle as a result of the accident (arrowed).

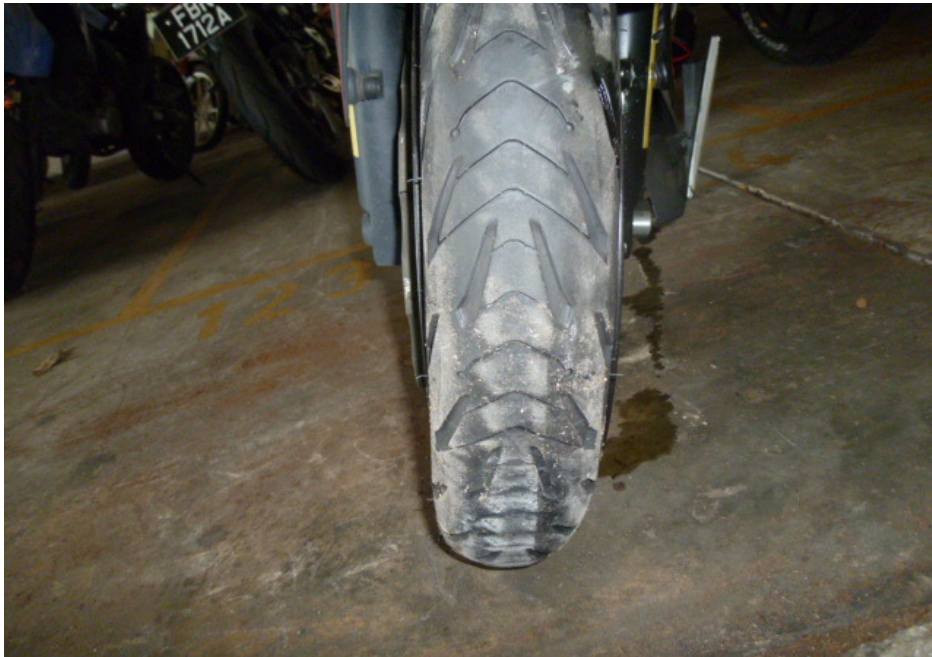
Photo 15 shows the condition of the Motorcycle's front tyre. The front tyre was observed to be in serviceable condition with remaining tread depth of approximately 3mm. There was no tear, burst mark(s) and/or punctured hole(s) on the sidewalls as well as across the tread of the front tyre. However the front tyre was observed to be deflated.

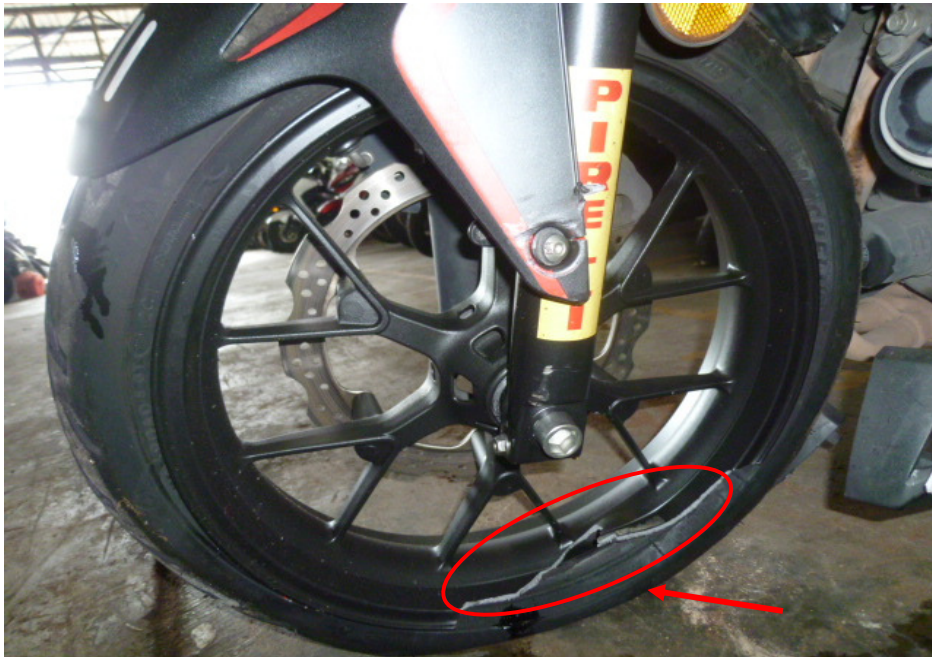
8. The 2 tyres were wrapped around alloy wheel rims. At the time of our inspection, we did not observe any visible damage on the rear wheel rim of the Motorcycle. However we did observe that the front wheel rim was broken. See photos 1 - 17 below.

Photo 16 shows the broken front wheel rim (circled) and deflated front tyre (arrowed) of the Motorcycle at the time of our inspection.

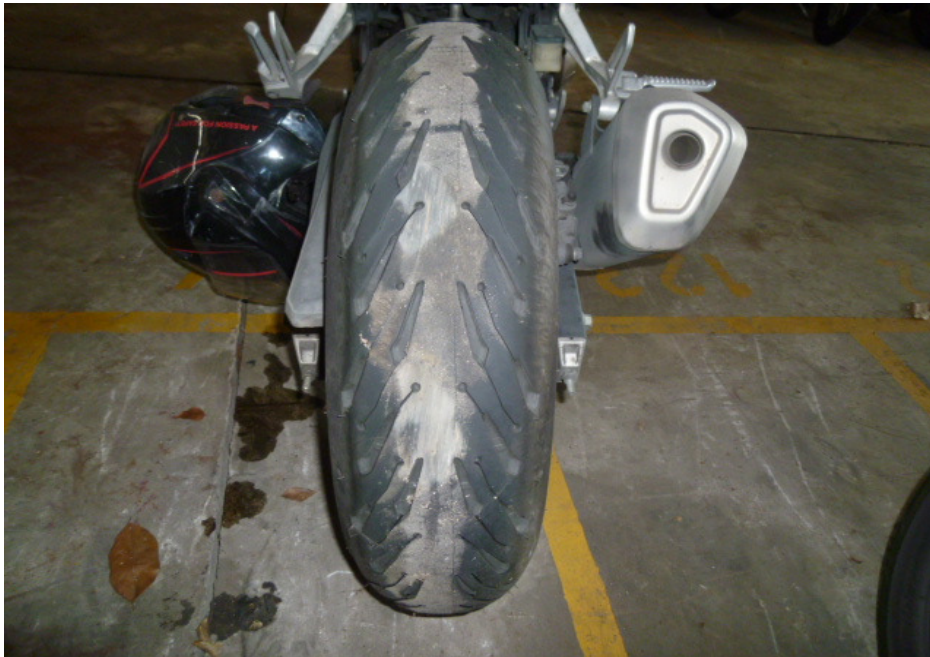
Photo 17 shows the condition of the Motorcycle's rear tyre. The rear tyre was observed to be in serviceable condition with remaining tread depth of approximately 4mm. The tyre was also observed to be sufficiently inflated for vehicular operation. We did not observe any tear, burst mark(s) and/or punctured hole(s) on the sidewalls as well as across the tread of the rear tyre.

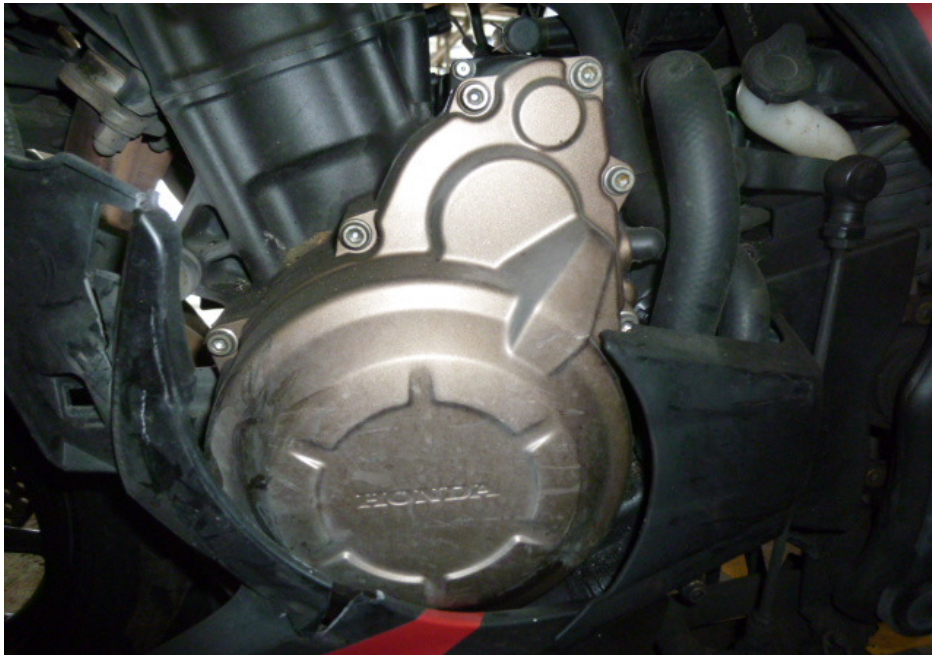
Photo 18 shows the left side of the engine of the Motorcycle at the time of our inspection. The various engine related parts and components were found to be intact with no visible damage. There was also no sign(s) or indication(s) of fluid leak observed around the left engine area of the Motorcycle.

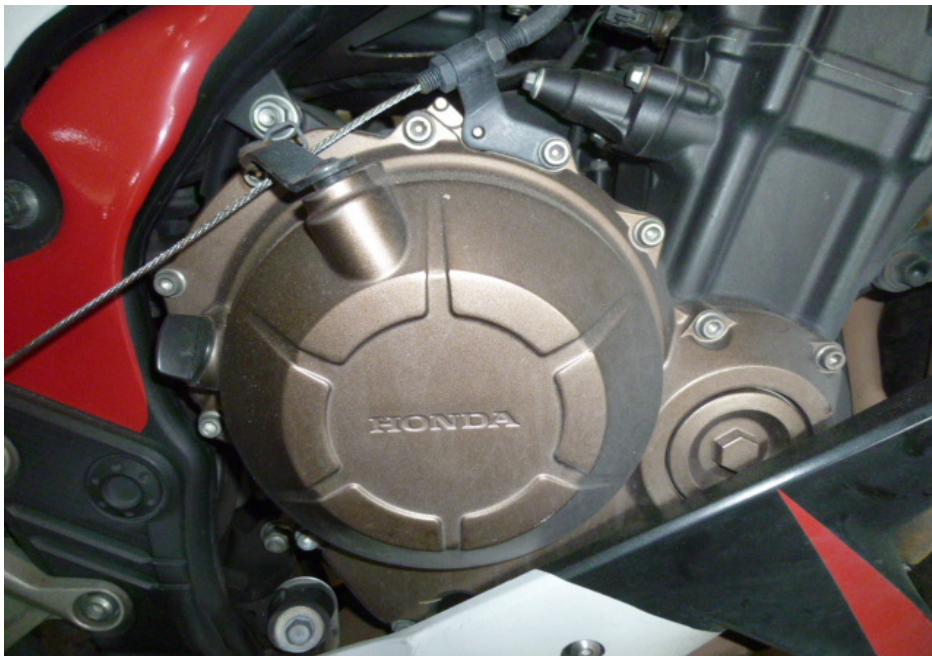
Photo 19 shows the right side of the engine of the Motorcycle at the time of our inspection. The various engine related parts and components were found to be intact with no visible damage. There was also no sign(s) or indication(s) of fluid leak observed around the right engine area of the Motorcycle.

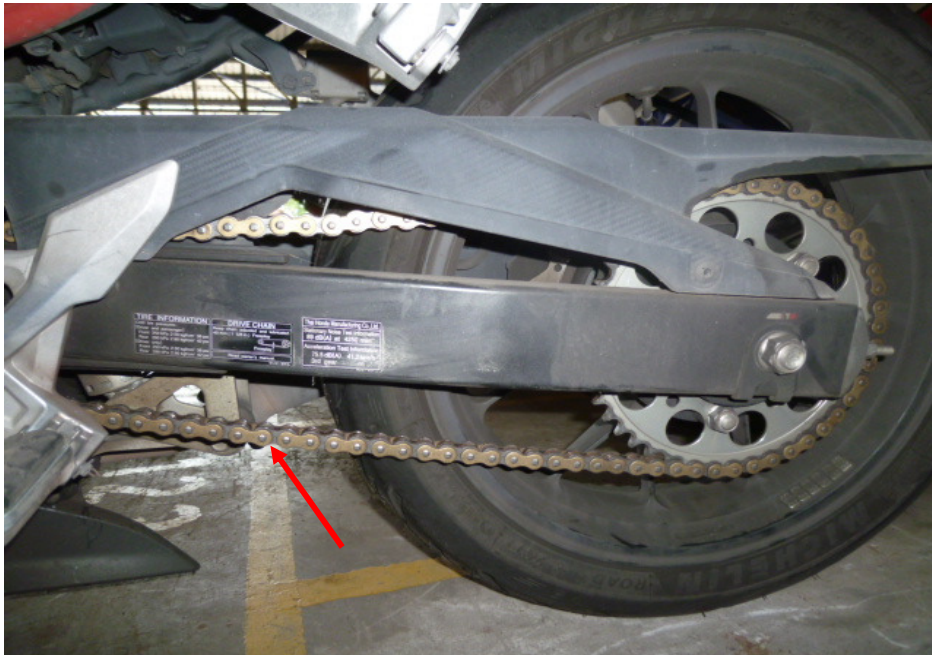
Photo 20 shows the general view of the gear train (arrowed) of the Motorcycle, which was observed to be intact with no misalignment. It was also adequately lubricated for operating purposes.

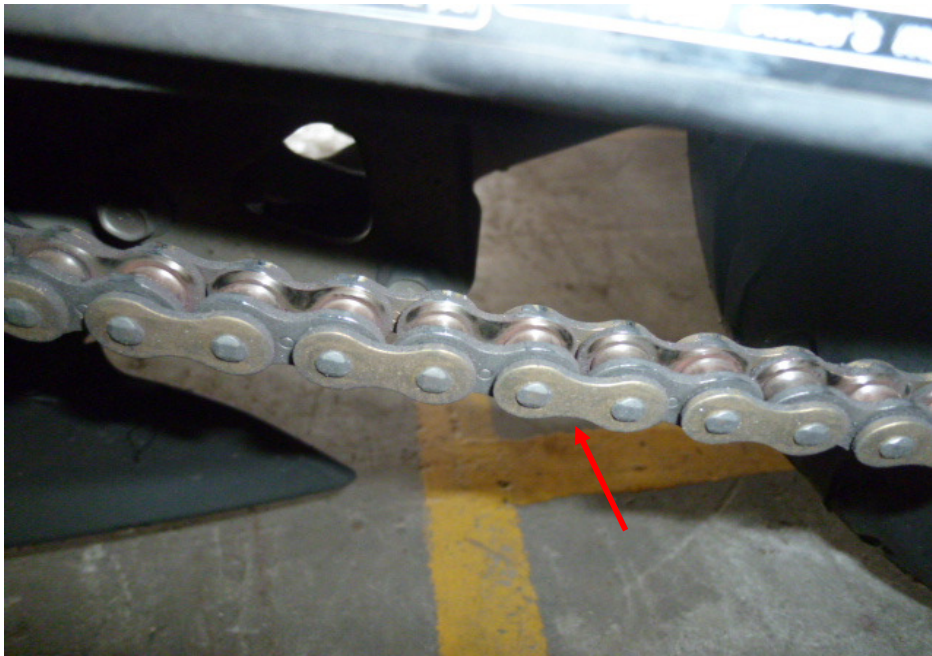
Photo 21 shows a closer view of the gear train (arrowed) of the Motorcycle, which was observed to be intact with no misalignment. It was also adequately lubricated for operating purposes.

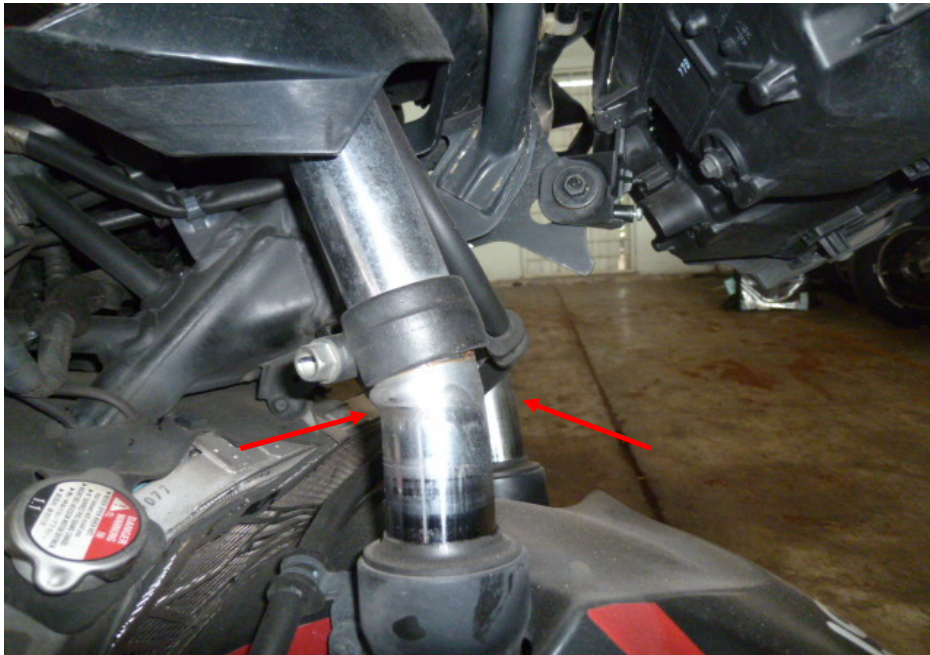
11. For this case, we were not able to conduct any test(s) on the steering system of the Motorcycle due to the damage of its front forks. The front forks were found to be bent inwards as a result of the accident.

15. For this case, we were not able to carry out any operational tests to the steering system and braking system of the Motorcycle due to the damage of its front fork assembly, which had rendered the Motorcycle immobile for the operational tests. We were not able to push the Motorcycle manually forward and backward, simulating movement of the Motorcycle, for the operational tests. See photos 22 – 27 below.

Photo 22 shows the front forks of the Motorcycle. The front forks were observed to be bent inwards as a result of the accident. We were hence not able to conduct any tests on the steering system of the Motorcycle.

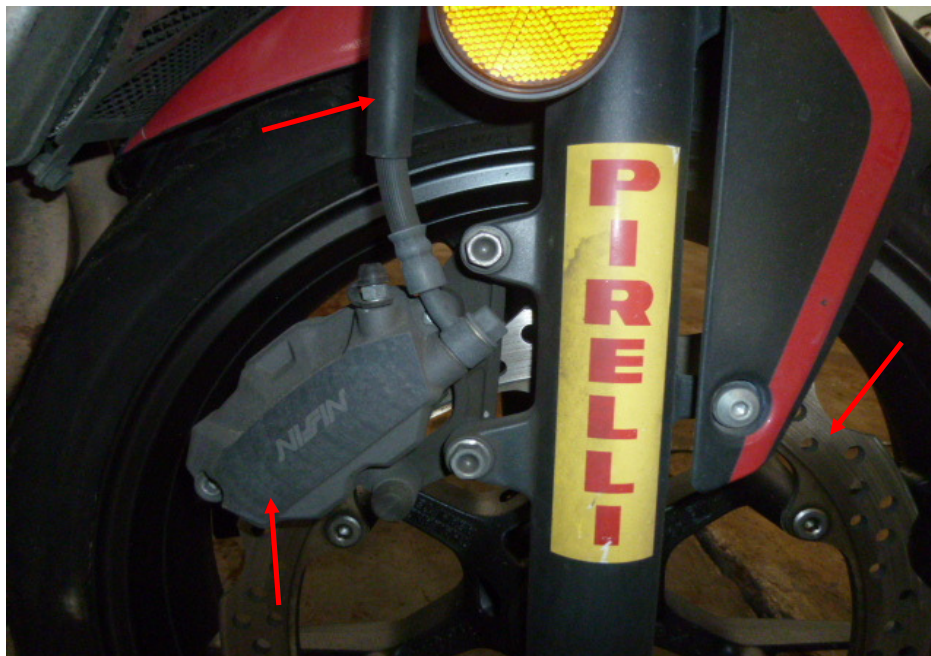
Photo 23 shows a close up view of the front brake caliper, front brake disc and front brake hose (arrowed) of the Motorcycle, which are all part of the components in the hydraulic front brake system of the Motorcycle. Our visual checks of these various components had revealed all to be intact with no visible damage. No leakage of brake fluid was also observed.

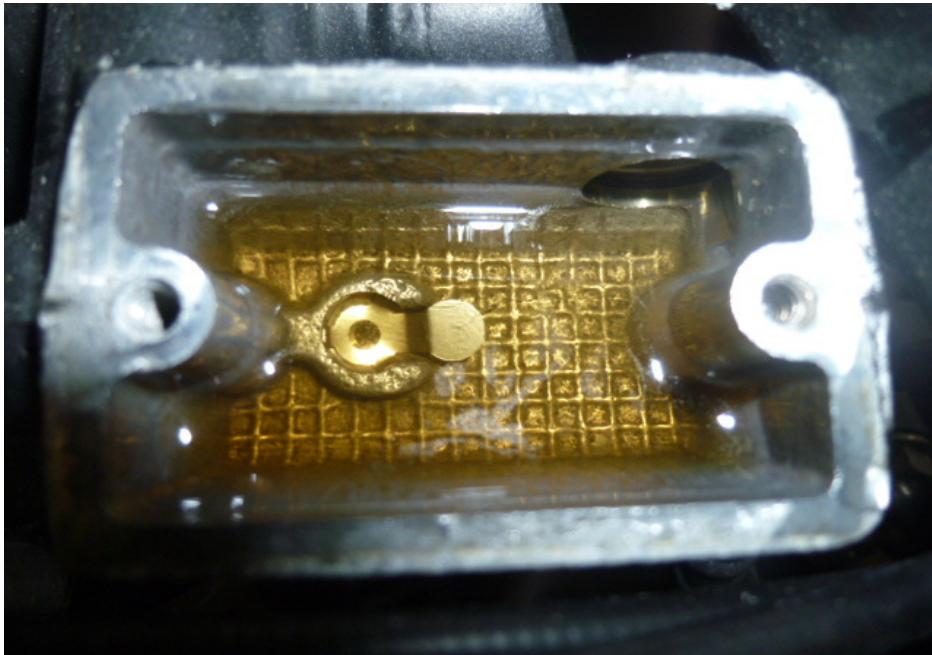
Photo 24 shows the brake fluid reservoir for the front brake of the Motorcycle. The brake fluid was observed to be of sufficient level for operational purposes and without any contamination.

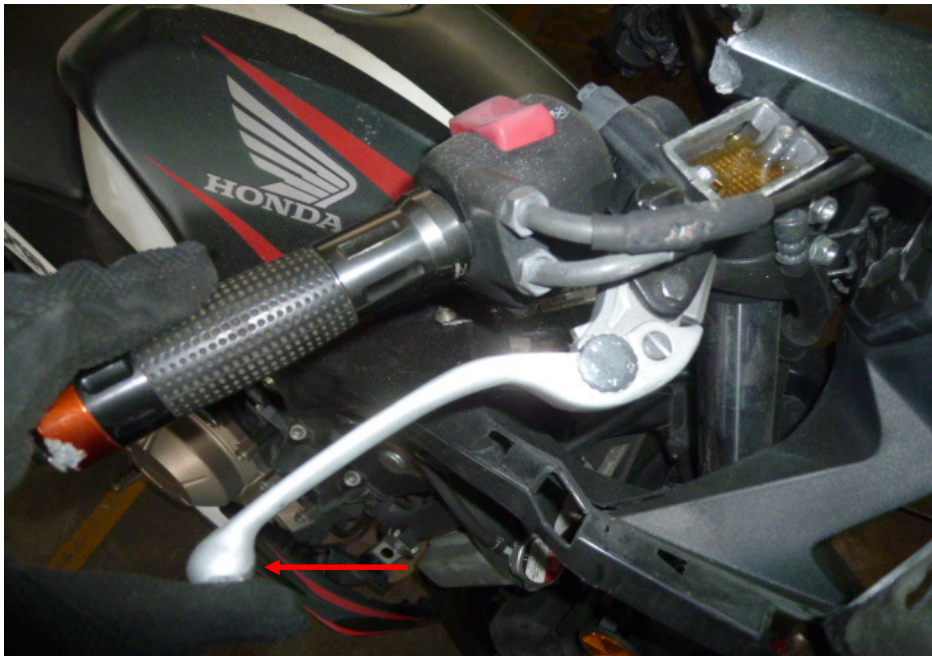
14. Static brake tests conducted on the Motorcycle had appear to indicate that the braking system of the Motorcycle was in serviceable condition. There was some resistance felt (spongy like feel) upon pressing the brake lever and upon stepping on the brake pedal. This would indicate that there was no leakage of pressure/vacuum in the brake system.

Photo 25 shows the front brake lever being depressed. There was some resistance felt (spongy like feel) upon pressing the front brake lever (arrowed). This would indicate that there is no leakage of pressure/vacuum in the front brake system.

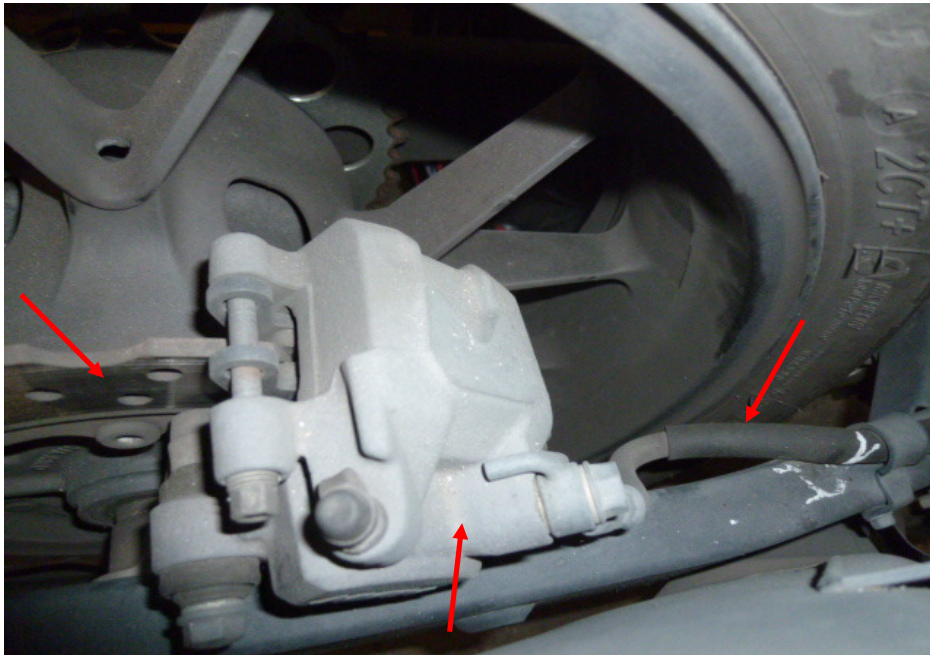
Photo 26 shows a close up view of the rear brake caliper, rear brake disc and rear brake hose (arrowed) of the Motorcycle, which are all part of the components in the hydraulic rear brake system of the Motorcycle. Our visual checks of these various components had revealed all to be intact with no visible damage. No leakage of brake fluid was also observed.

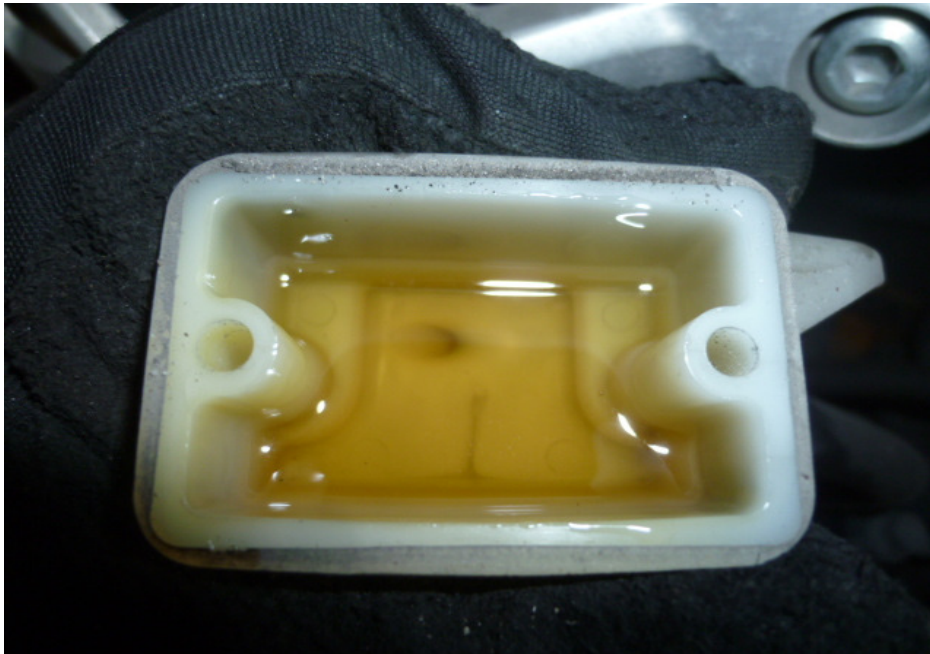
Photo 27 shows the brake fluid reservoir for the rear brake of the Motorcycle. The brake fluid was observed to be of sufficient level for operational purposes and without any contamination.
