Your Ref: TP/IP/08448/2022
Our Ref : CI/TPD22005262/N

5 July 2022

INSPECTION REPORT OF MOTORCYCLE FBH 7625K

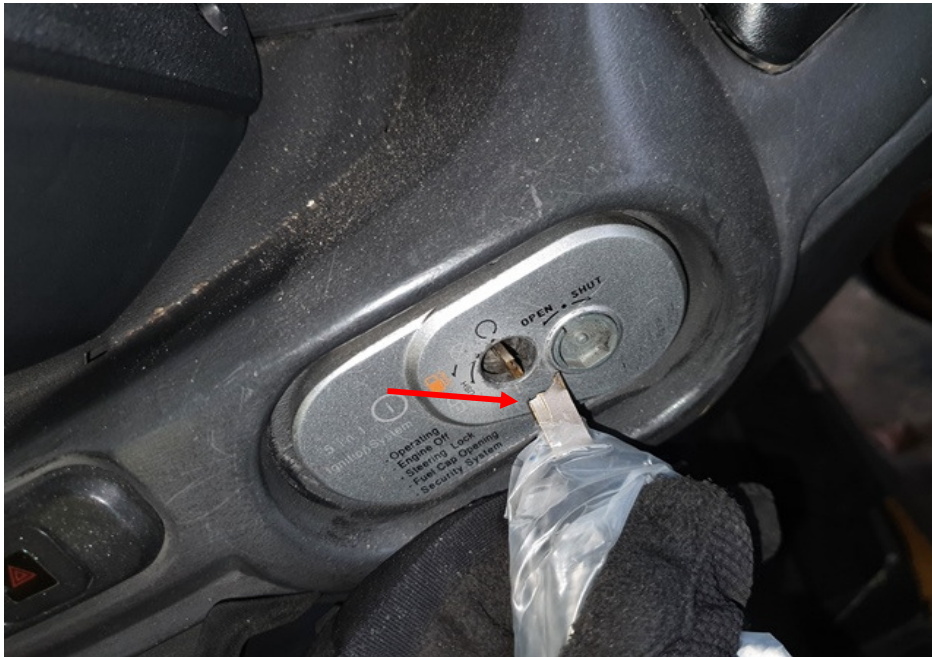
Photo 1 shows the ignition of the Motorcycle at the time of our inspection. The mileage of the Motorcycle could not be recorded at the time of our inspection due to a broken key (arrowed).

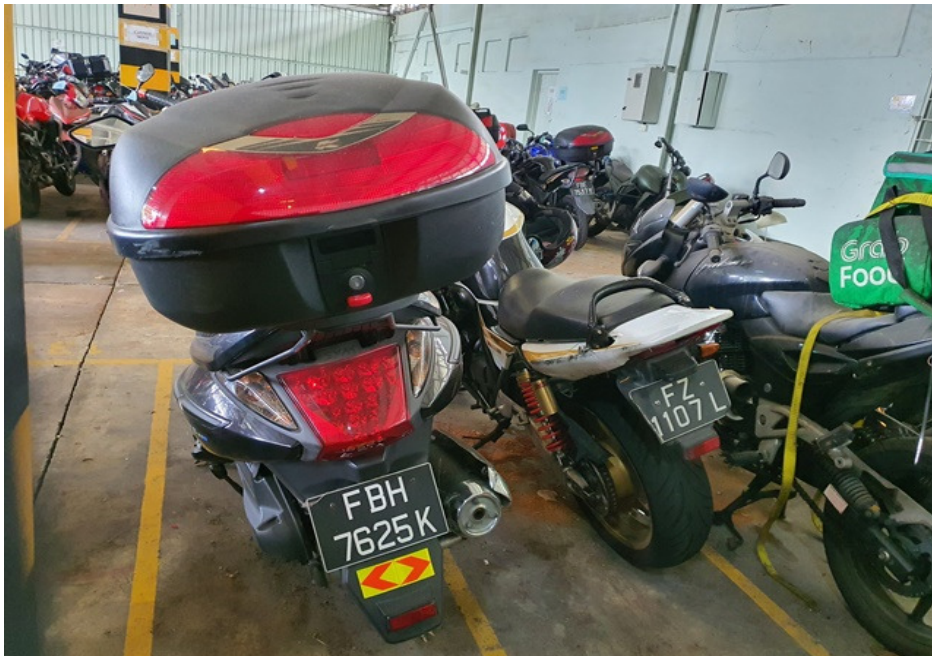
Photo 2 shows a general view of the rear portion of the Motorcycle at the time of our inspection. The Motorcycle was observed to have sustained damages all around.

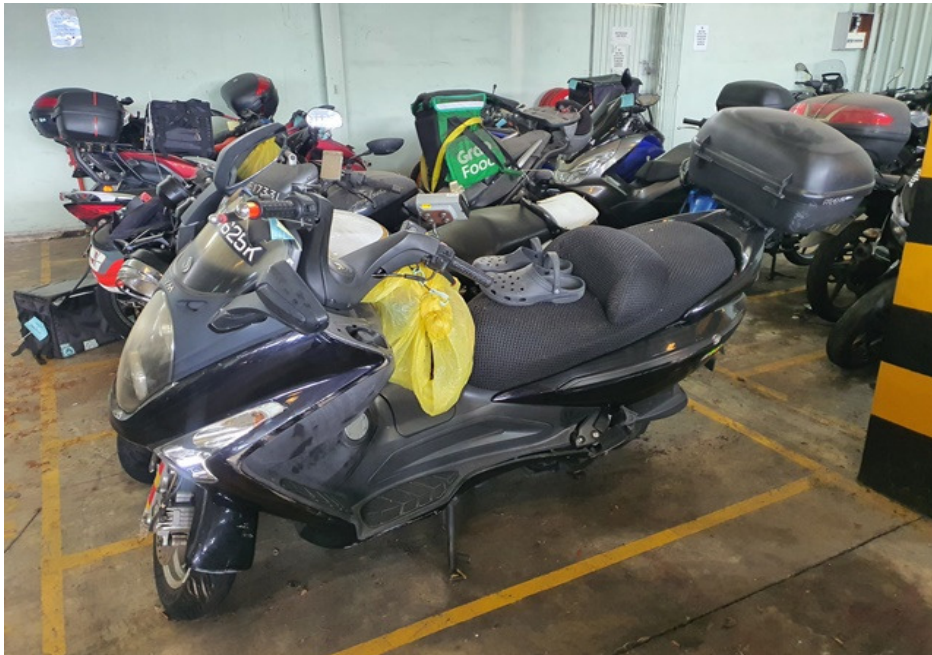
Photo 3 shows a general view of the left body of the Motorcycle at the time of our inspection. The Motorcycle was observed to have sustained damages all around.

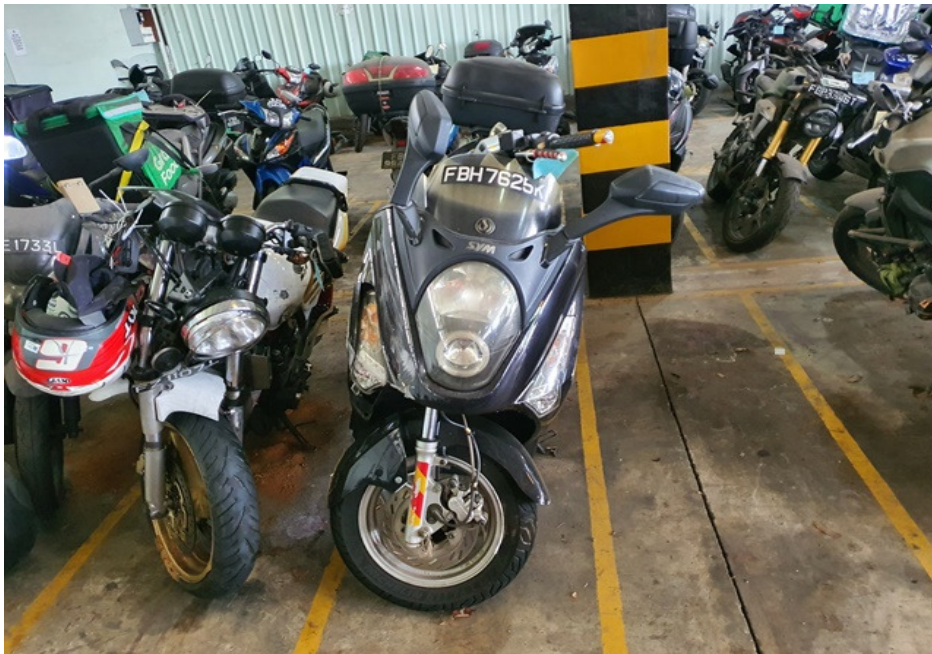
Photo 4 shows a general view of the frontal portion of the Motorcycle at the time of our inspection. The Motorcycle was observed to have sustained damages all around. The body parts that were found to have been damaged include its windshield, head cowl, front mudguard, fork assembly, side mirrors, side cowlings, lower side cowlings, left pillion step panel, rear side covers, top box and exhaust muffler heat shield, amongst others as a result of the accident.

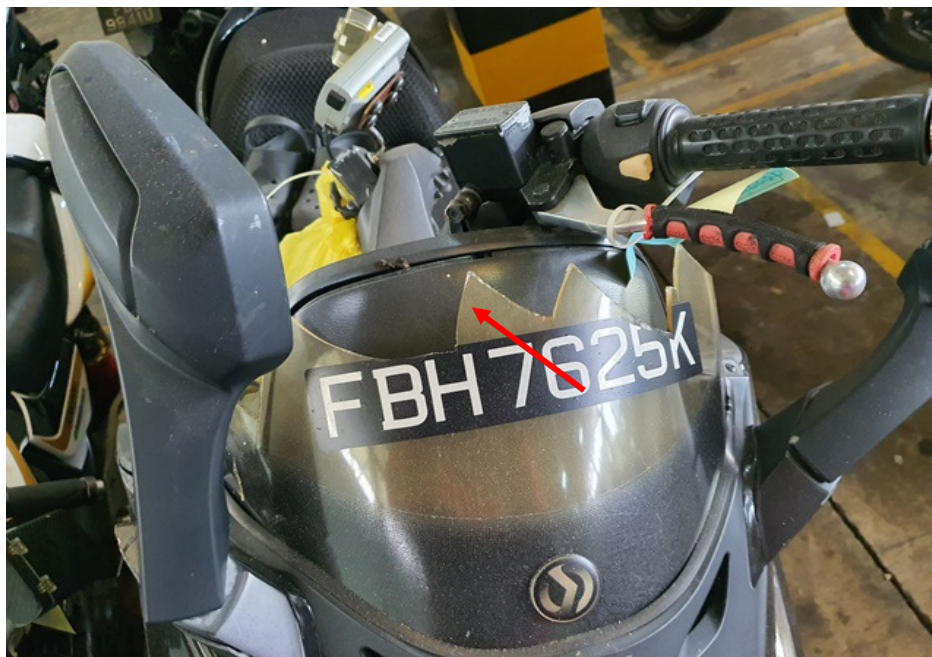
Photo 5 shows a closer view of the cracked windshield of the Motorcycle at the time of our inspection (arrowed).

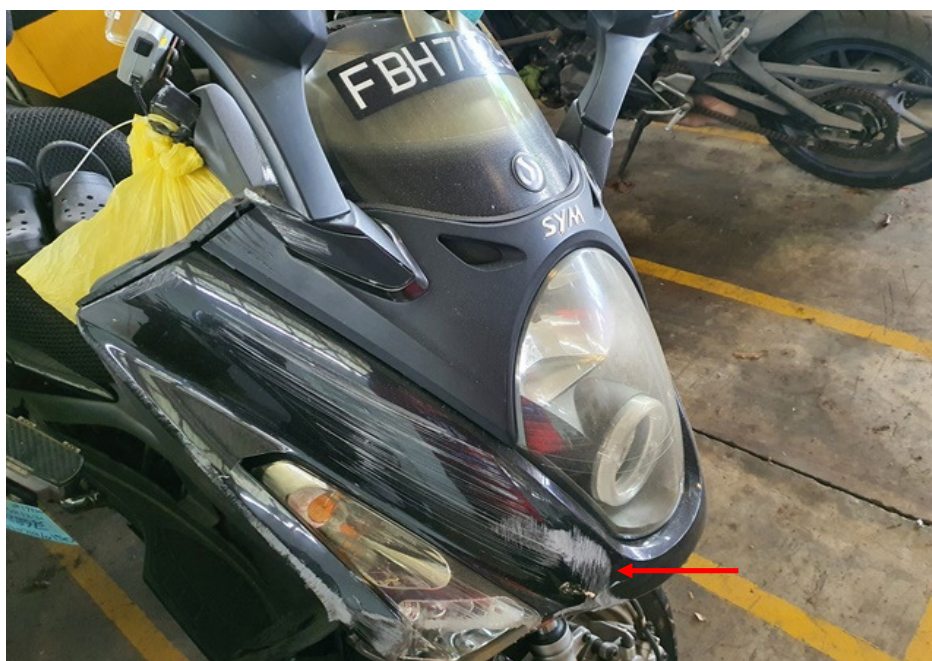
Photo 6 shows a closer view of the grazed head cowl of the Motorcycle as a result of the accident (arrowed).

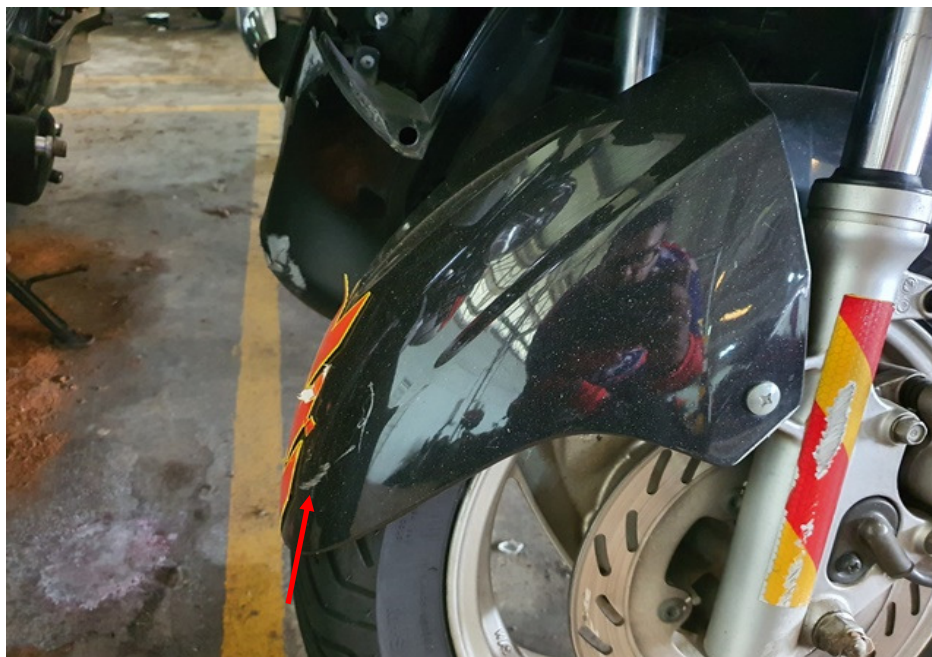
Photo 7 shows a closer view of the grazed front mudguard of the Motorcycle as a result of the accident (arrowed).

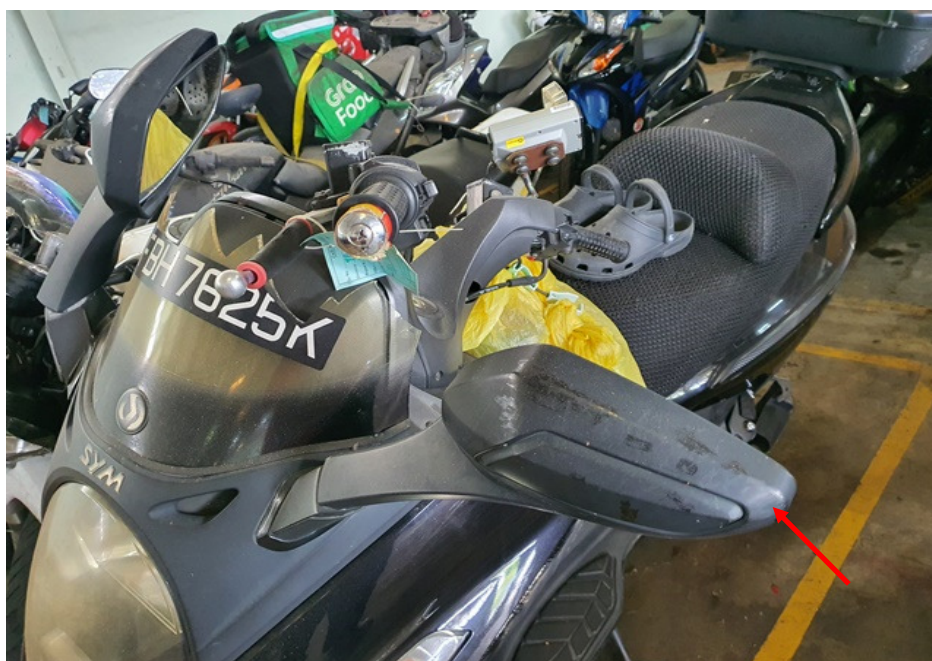
Photo 8 shows a closer view of the left side mirror of the Motorcycle which was observed to be damaged due to the accident (arrowed).

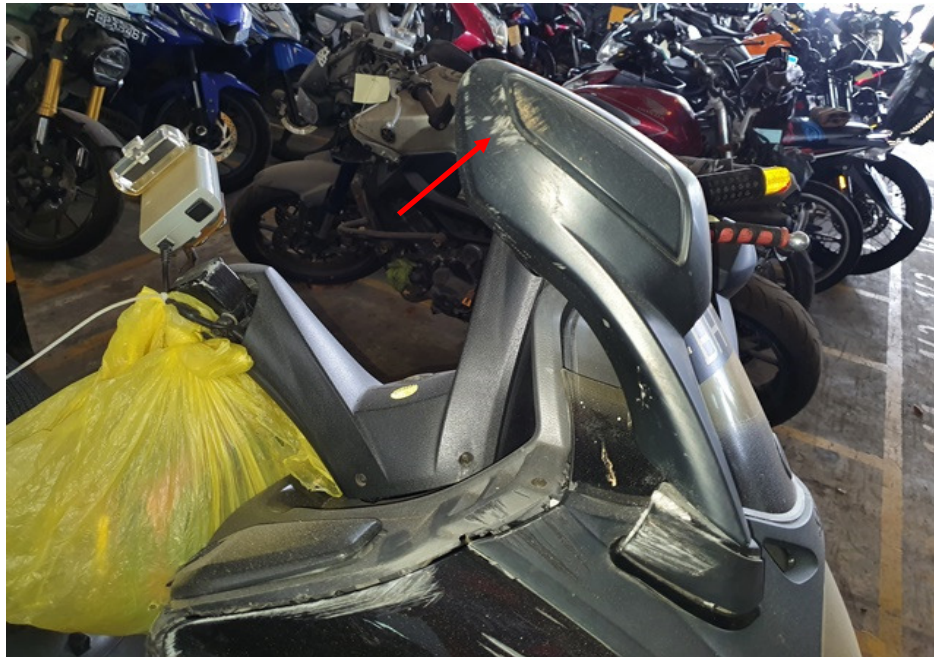
Photo 9 shows a closer view of the right side mirror of the Motorcycle which was observed to be damaged due to the accident (arrowed).

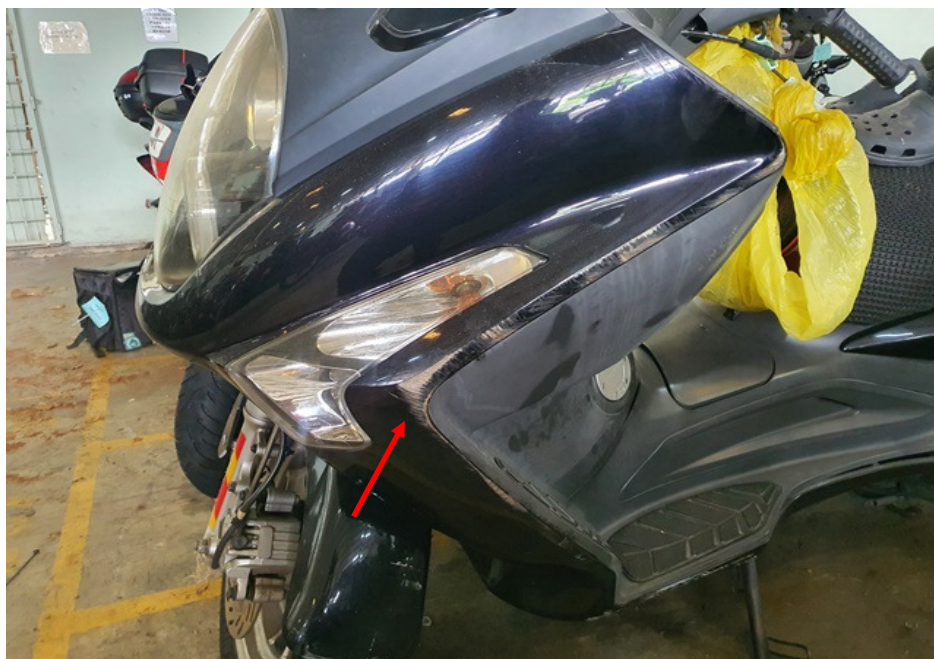
Photo 10 shows the grazed left side cowling of the Motorcycle as a result of the accident (arrowed).

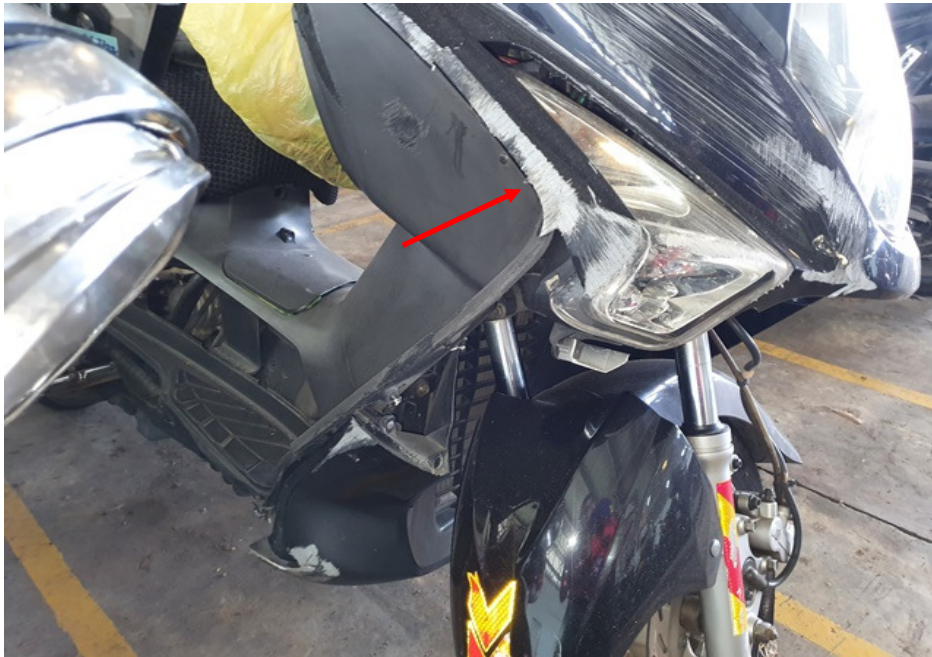
Photo 11 shows the grazed right side cowling of the Motorcycle as a result of the accident (arrowed).

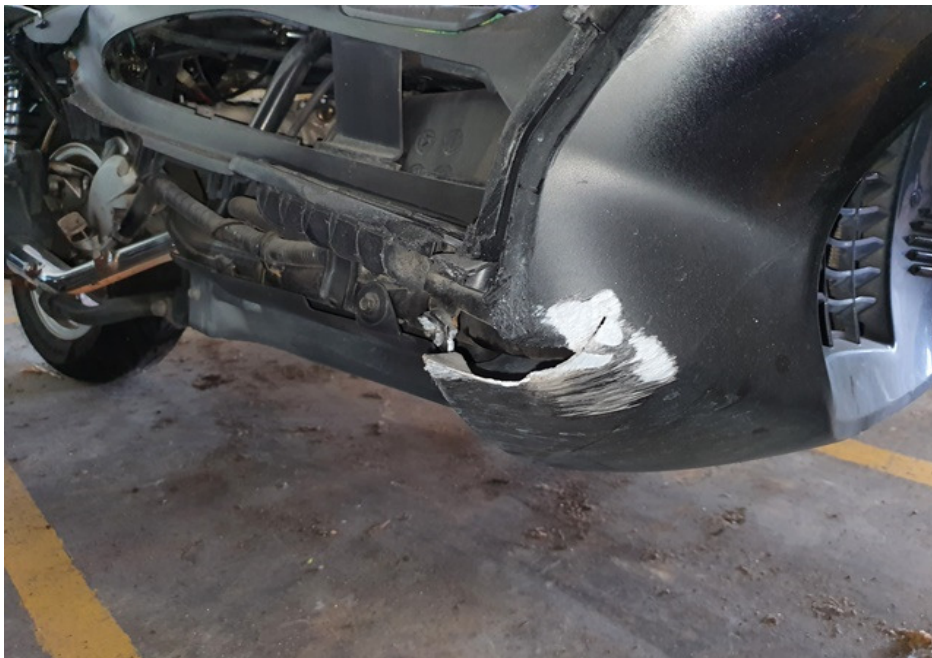
Photo 12 shows a close-up view of the cracked right lower side cowling of the Motorcycle as a result of the accident.

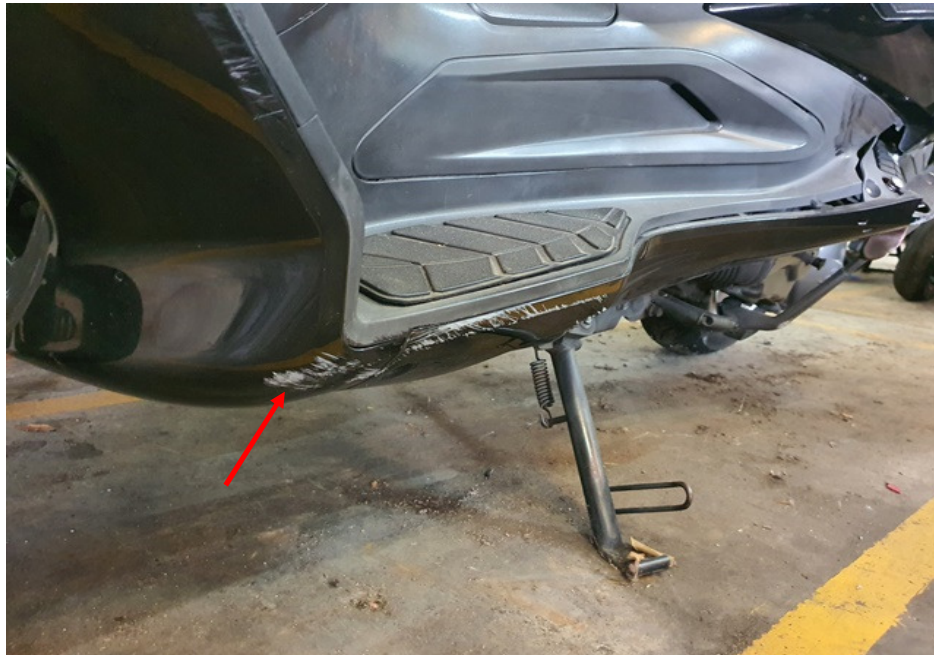
Photo 13 shows a close-up view of the grazed left lower side cowling of the Motorcycle as a result of the accident (arrowed).

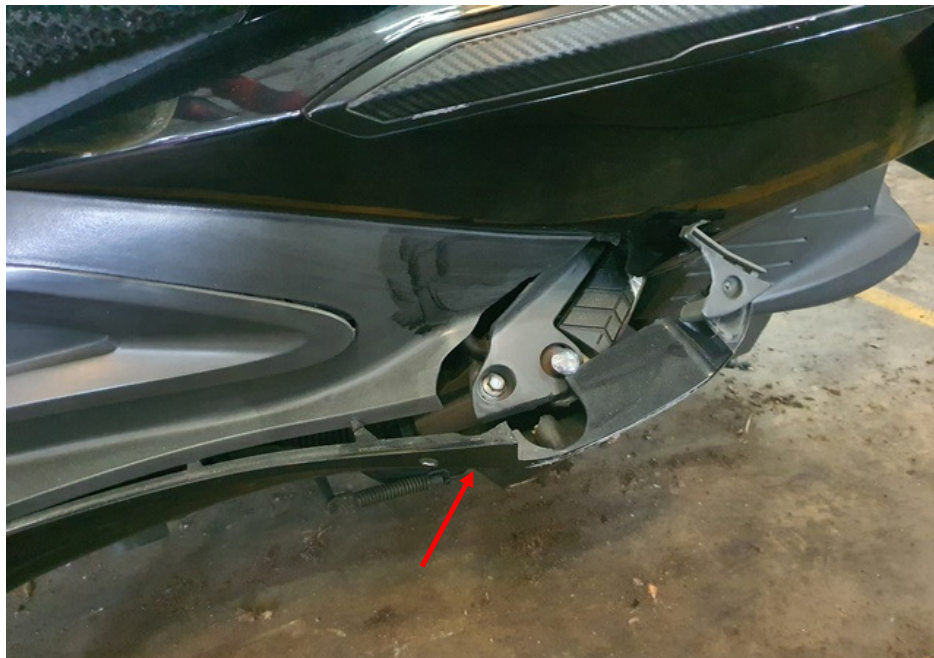
Photo 14 shows a general view of the cracked left pillion step panel of the Motorcycle as a result of the accident (arrowed).

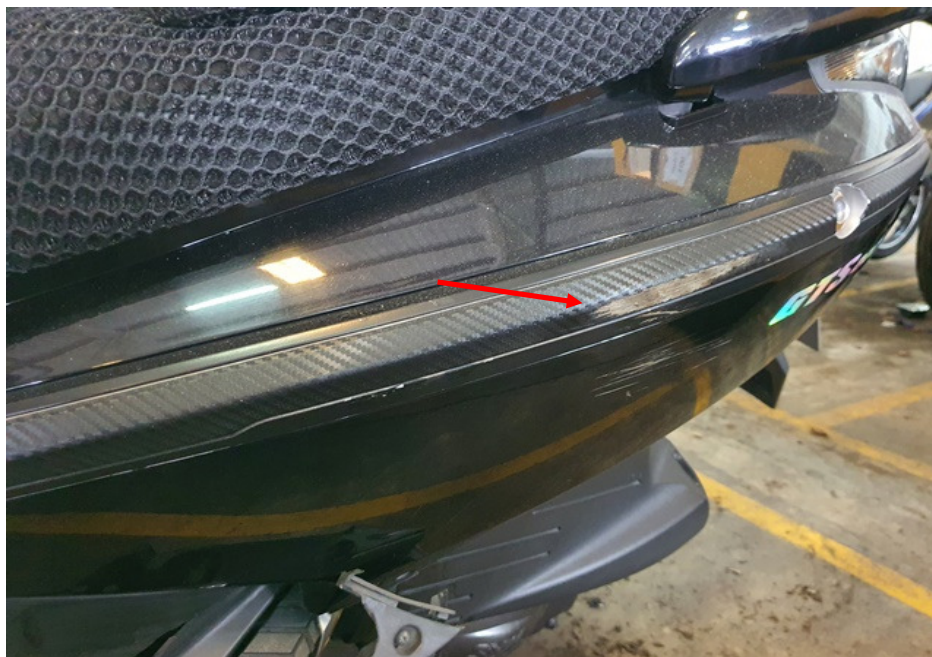
Photo 15 shows a close-up view of the grazed left rear side cover of the Motorcycle as a result of the accident (arrowed).

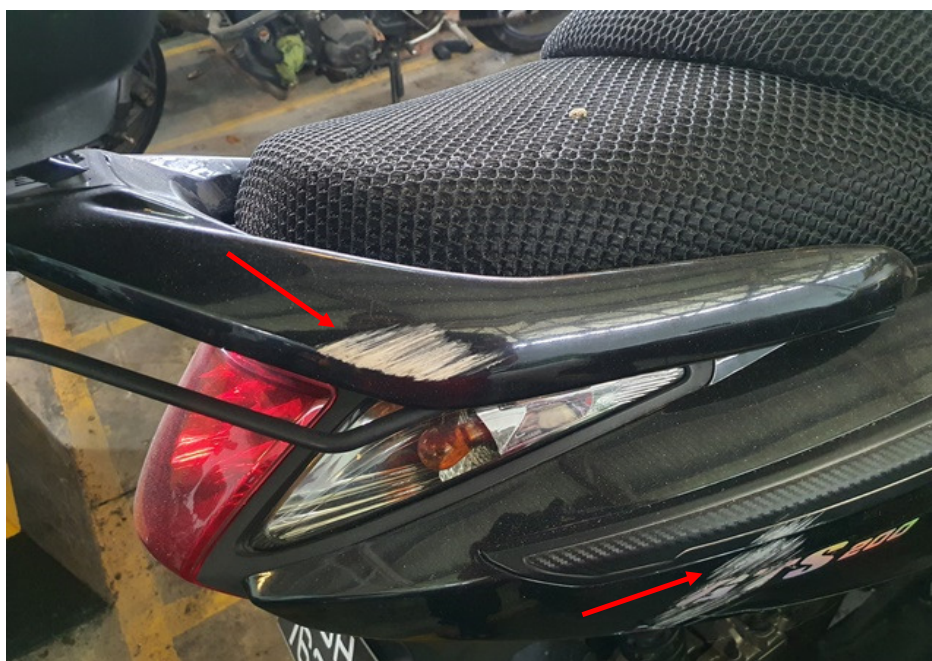
Photo 16 shows a close-up view of the grazed right rear side cover and right pillion grab rail of the Motorcycle as a result of the accident (arrowed).

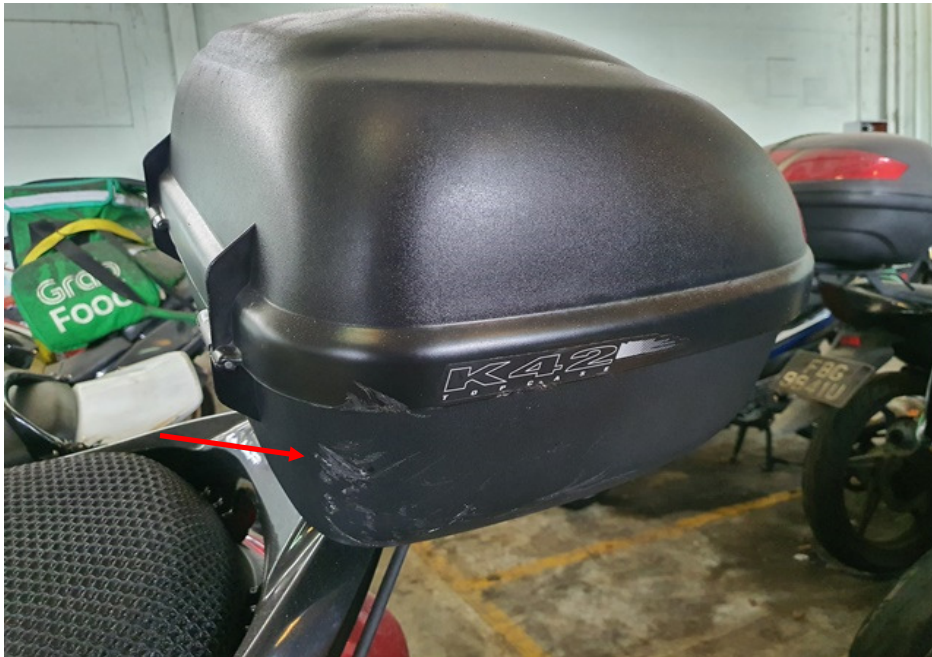
Photo 17 shows a close-up view of the grazed top box of the Motorcycle as a result of the accident (arrowed).

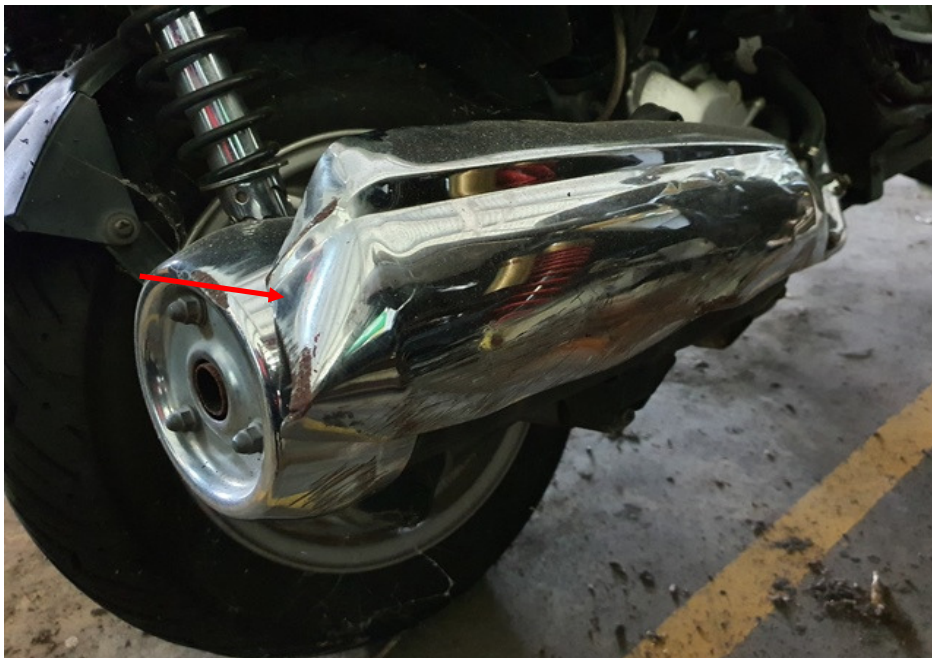
Photo 18 shows a close-up view of the dented exhaust muffler heat shield of the Motorcycle as a result of the accident (arrowed).

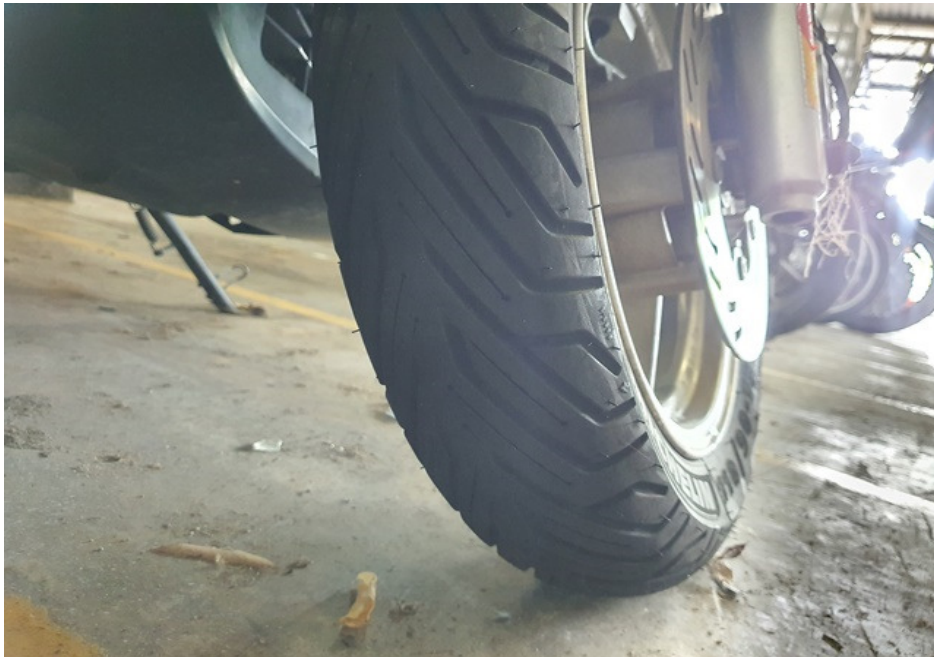
Photo 19 shows the condition of the Motorcycle's front tyre. The front tyre was observed to be in serviceable condition with remaining tread depth of approximately 4mm. There was no tear, burst mark(s) and/or punctured hole(s) on the sidewalls as well as across the tread of the front tyre.

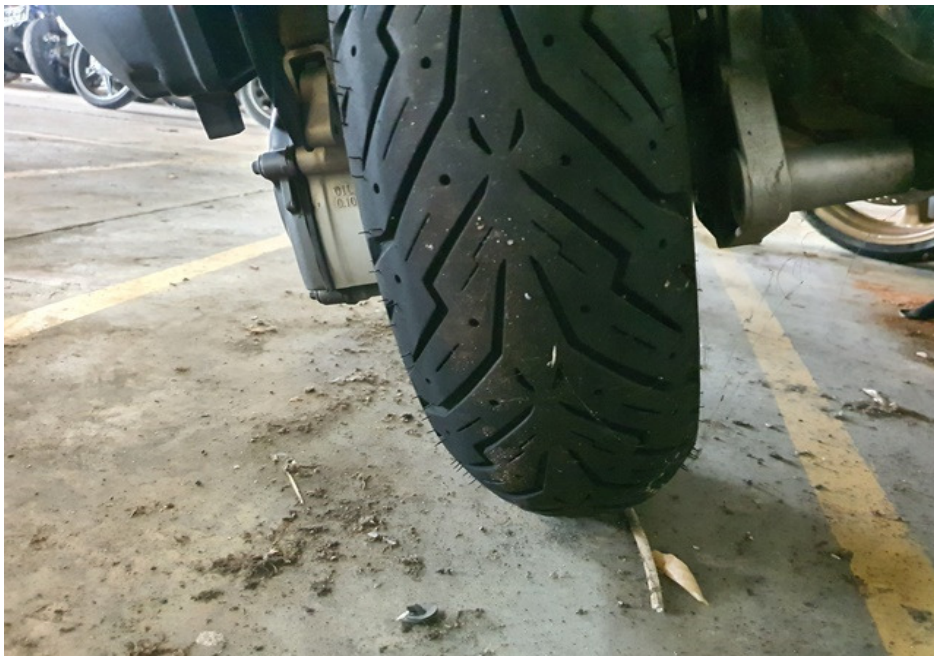
Photo 20 shows the condition of the Motorcycle's rear tyre. The rear tyre was observed to be in serviceable condition with remaining tread depth of approximately 4mm. The tyre was also observed to be sufficiently inflated for vehicular operation. We did not observe any tear, burst mark(s) and/or punctured hole(s) on the sidewalls as well as across the tread of the rear tyre.

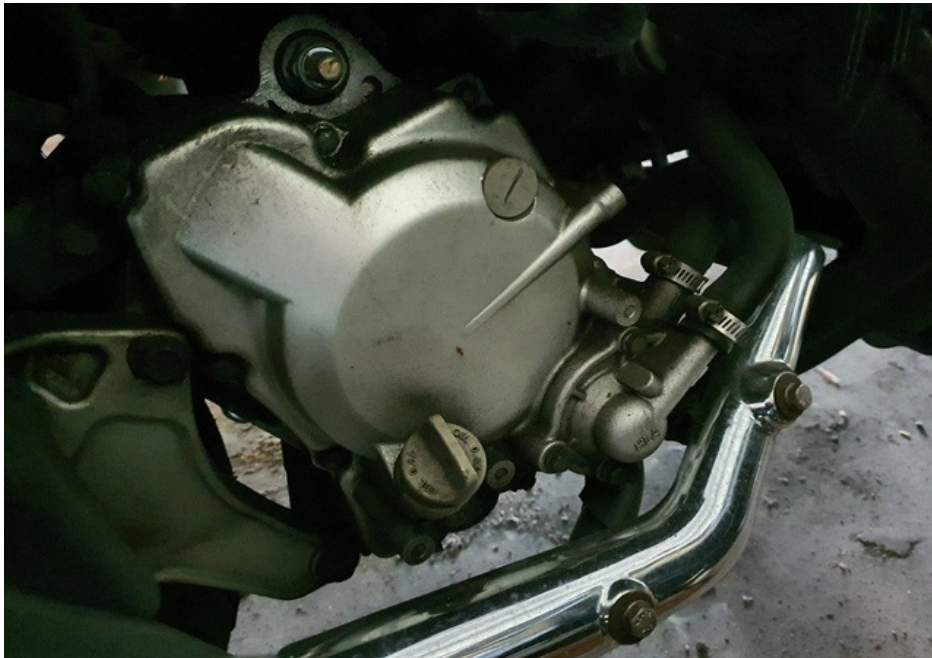
Photo 21 shows the right side of the engine of the Motorcycle at the time of our inspection. The various engine related parts and components were found to be intact with no visible damage. There was also no sign(s) or indication(s) of fluid leak observed around the right engine area of the Motorcycle.

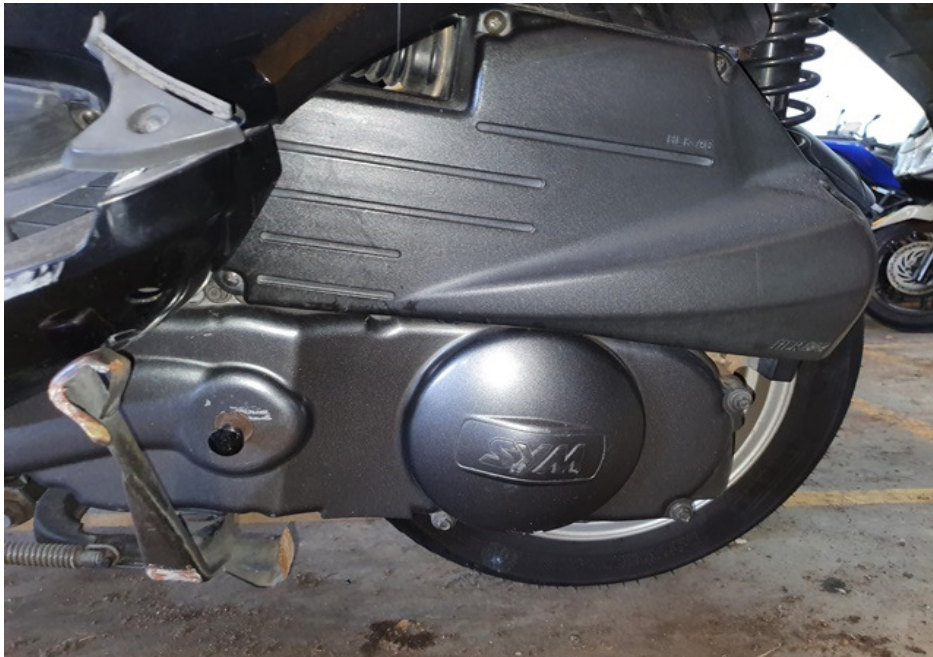
Photo 22 shows the drive train cover of the Motorcycle which was found to be intact without any misalignment.

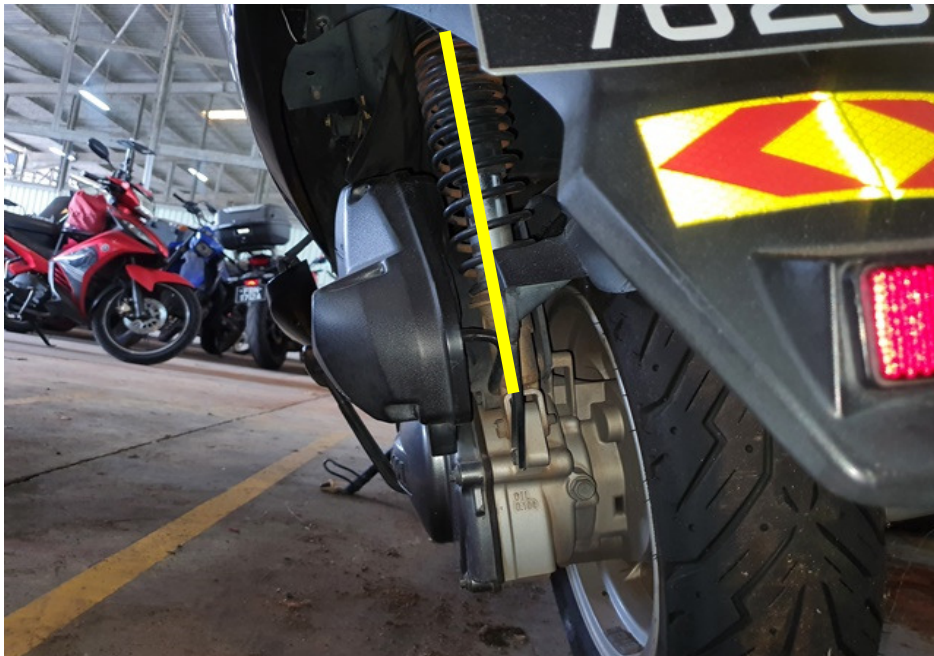
Photo 23 shows the left shock absorber of the Motorcycle which was found to be intact without any misalignment.

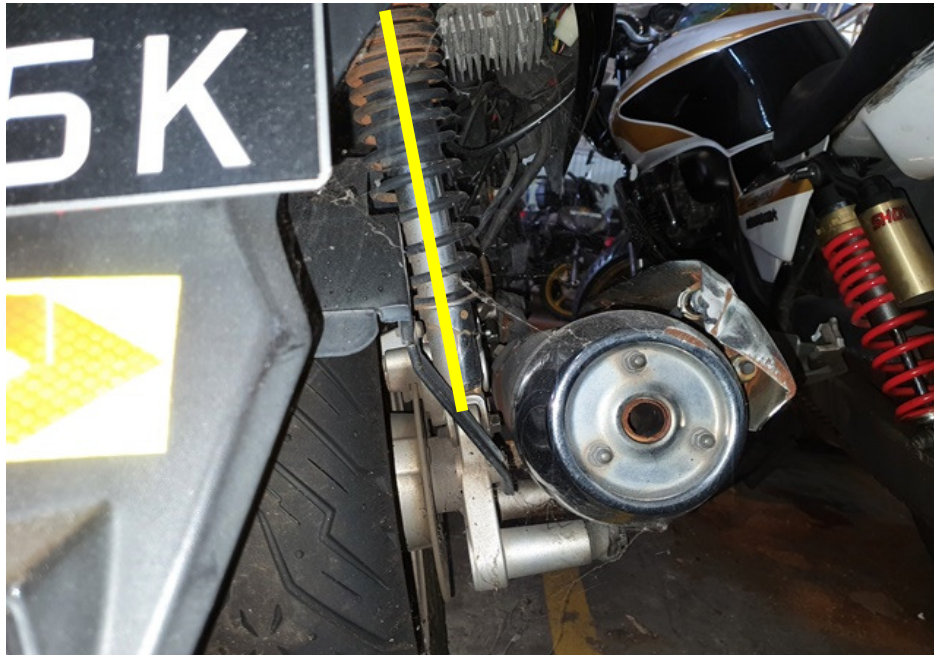
Photo 24 shows the right shock absorber of the Motorcycle which was found to be intact without any misalignment.

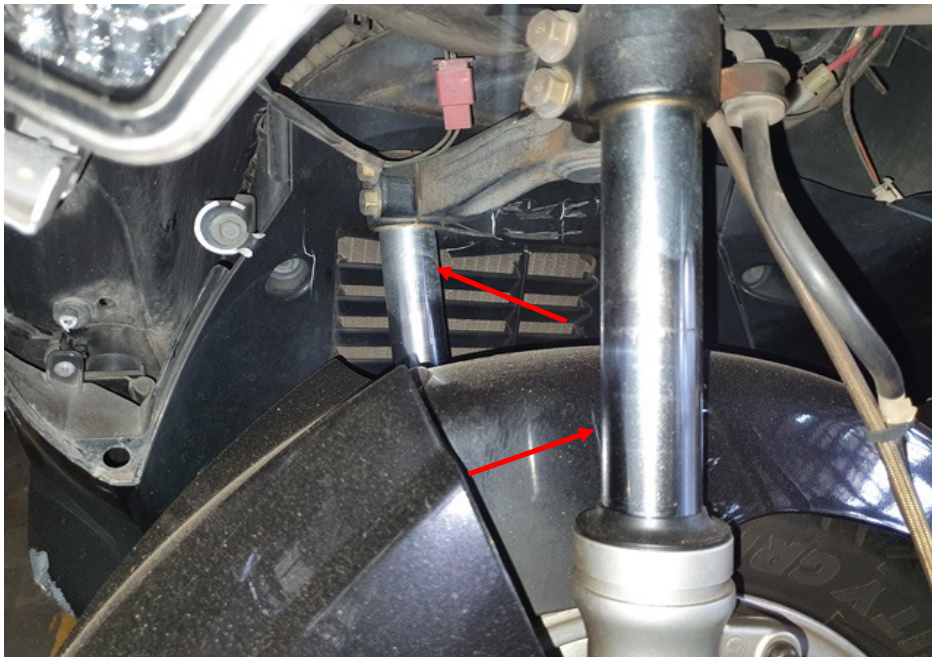
10. For this case, we were not able to conduct any test(s) on the steering system of the Motorcycle due to the damage of its front forks. The front forks were found to be bent as a result of the accident.

13. For this case, we were not able to carry out any operational tests to the steering system and front braking system of the Motorcycle due to the damage of its front forks, which had rendered the Motorcycle immobile for the operational tests. We were not able to push the Motorcycle manually forward and backward, simulating movement of the Motorcycle, for the operational tests. See photos 25 – 31 below.

Photo 25 shows the front forks of the Motorcycle. The front forks (arrowed) were observed to be bent as a result of the accident. We were hence not able to conduct any tests on the steering system of the Motorcycle.

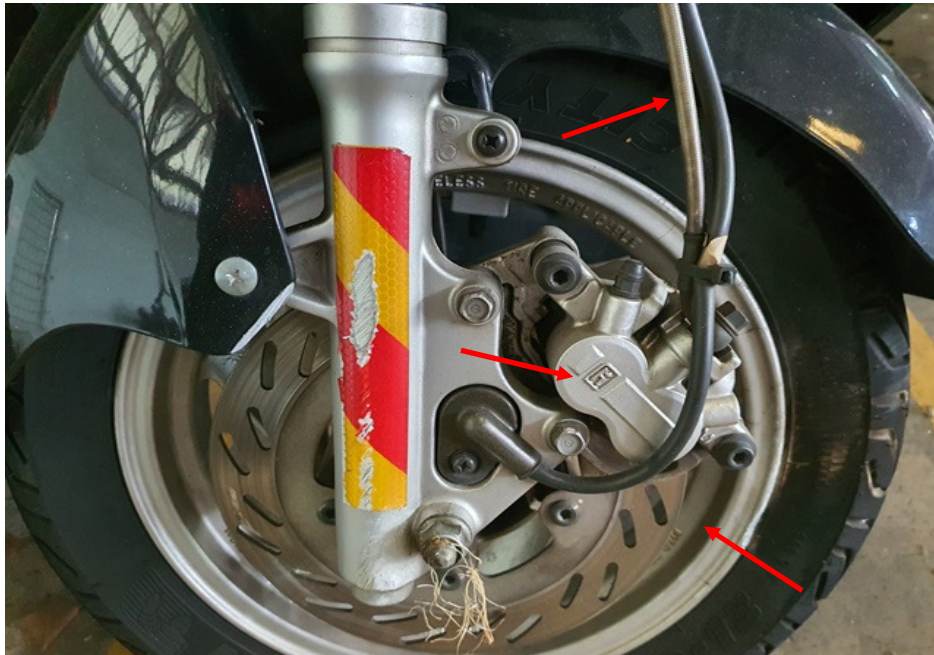
Photo 26 shows a close up view of the front brake caliper, front brake disc and front brake hose (arrowed) of the Motorcycle, which are all part of the components in the hydraulic front brake system of the Motorcycle. Our visual checks of these various components had revealed all to be intact with no visible damage. No leakage of brake fluid was also observed.

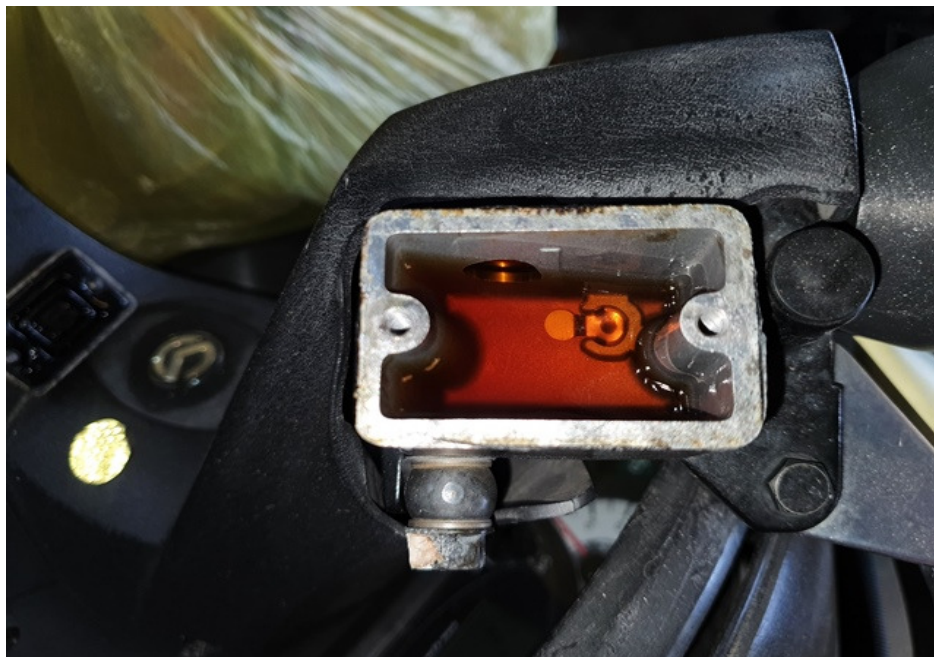
Photo 27 shows the brake fluid reservoir for the front brake of the Motorcycle. The brake fluid was observed to be of sufficient level for operational purposes and without contamination.

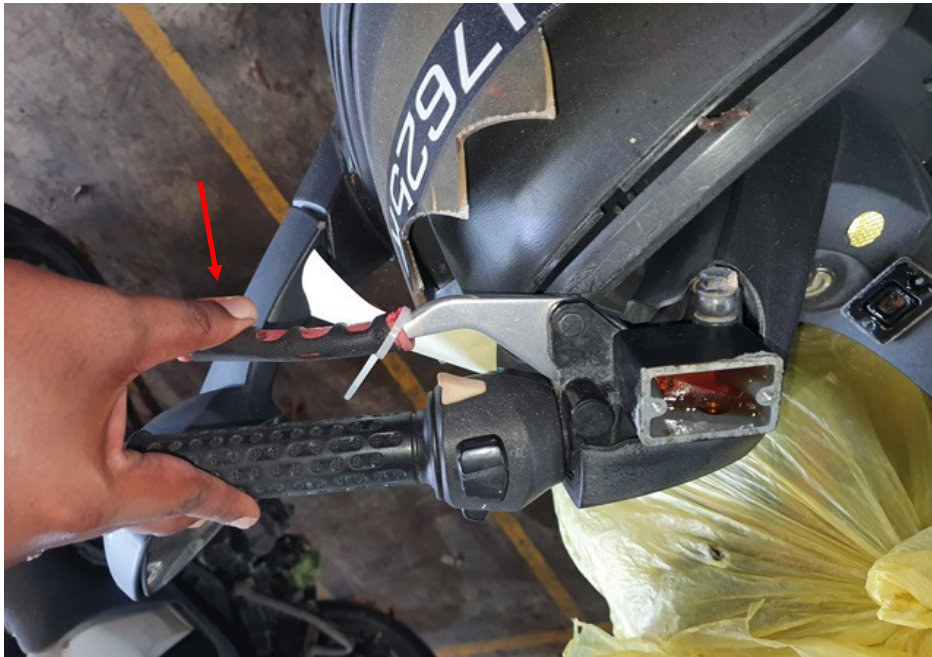
Photo 28 shows the front brake lever being depressed. There was some resistance felt (spongy like feel) upon pressing the front brake lever (arrowed). This would indicate that there is no leakage of pressure/vacuum in the brake system.

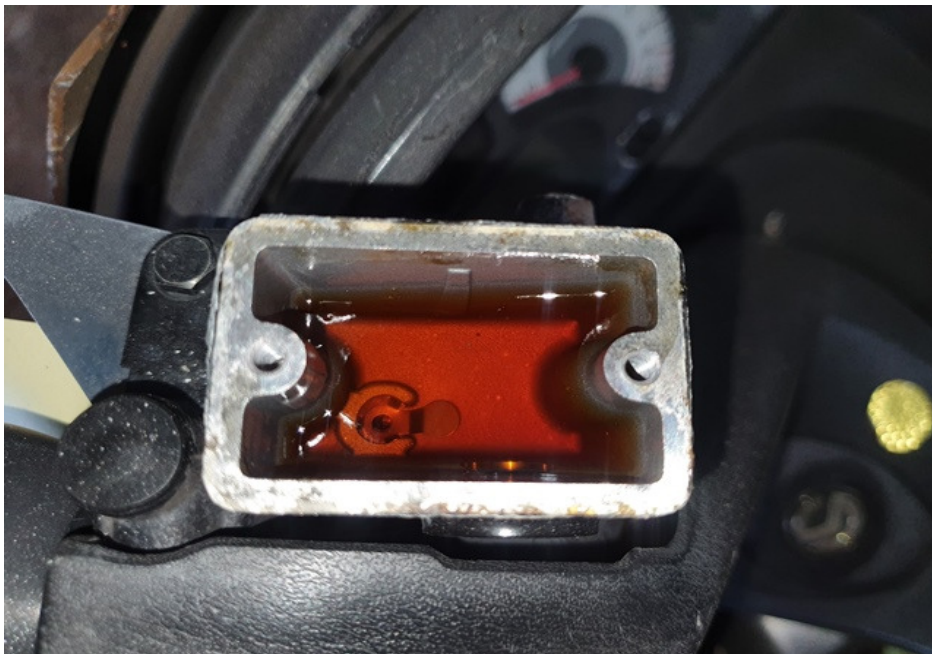
Photo 29 shows the brake fluid reservoir for the rear brake of the Motorcycle. The brake fluid was observed to be of sufficient level and without contamination for operational purposes.

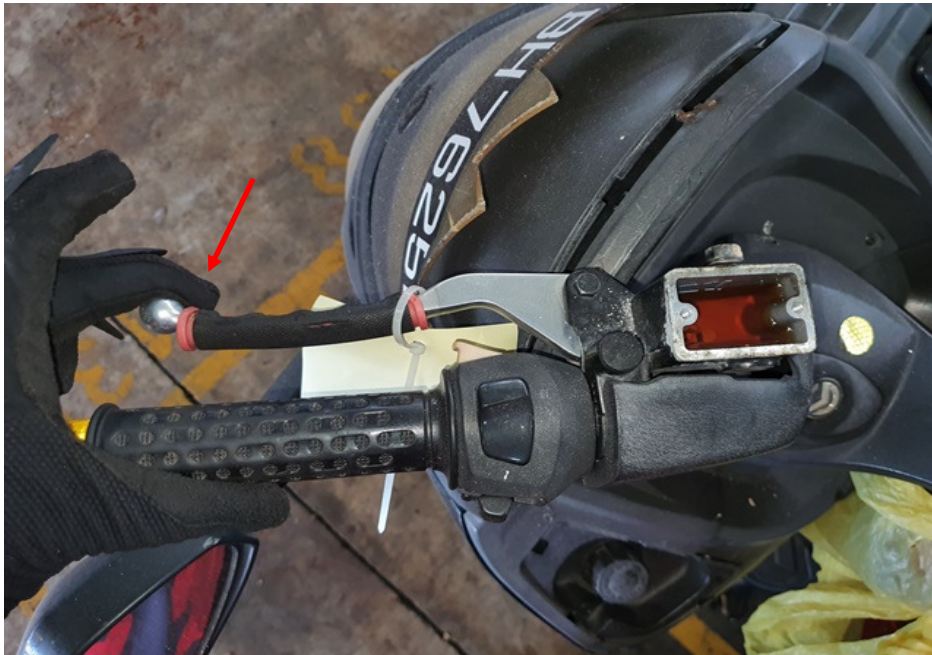
Photo 30 shows the rear brake lever being depressed. There was some resistance felt (spongy like feel) upon pressing the front brake lever (arrowed). This would indicate that there is no leakage of pressure/vacuum in the brake system.

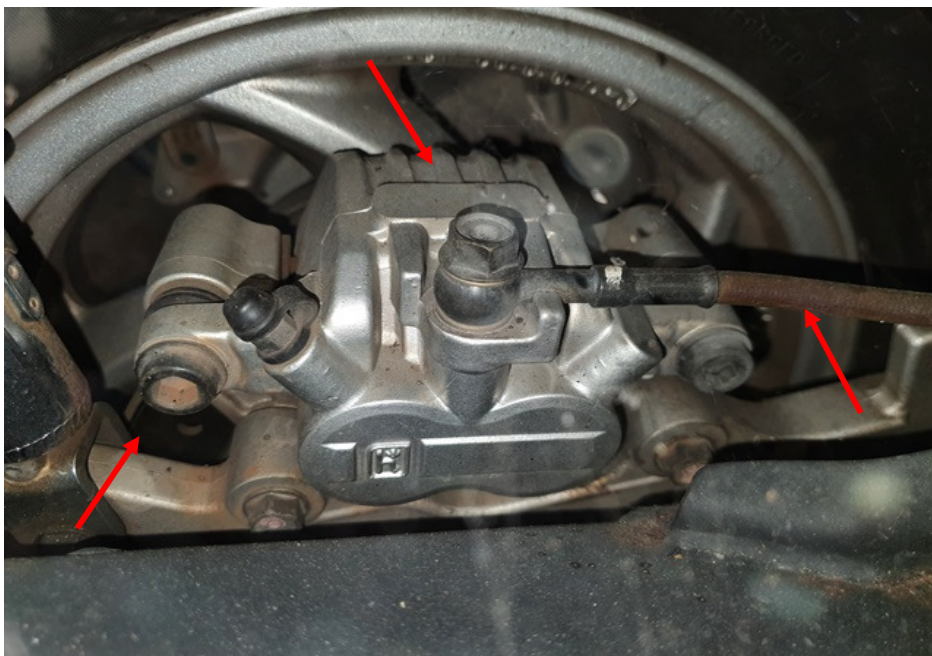
Photo 31 shows a close up view of the rear brake caliper, rear brake disc and rear brake hose (arrowed) of the Motorcycle, which are all part of the components in the hydraulic rear brake system of the Motorcycle. Our visual checks of these various components revealed all to be intact with no visible damage. No leakage of brake fluid was also observed.
