Your Ref: TP/IP/10841/2022  
Our Ref : CI/TPD22005265/N

**Fatal Accident Investigation Team**

**INSPECTION REPORT OF MOTORCYCLE FBT 1240M**

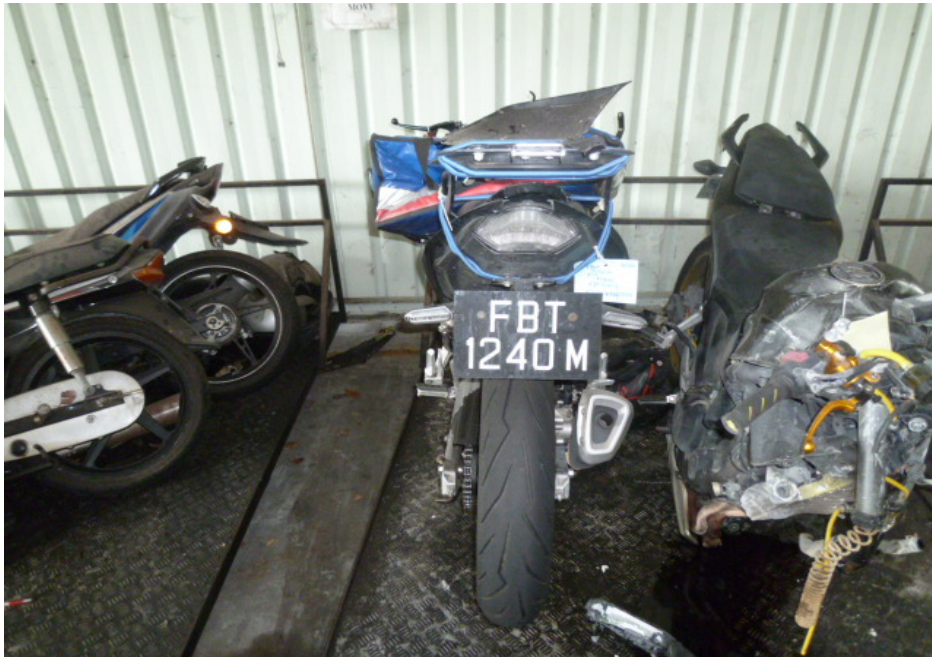
**Photo 1** shows a general view of the rear body of the Motorcycle at the time of our inspection. The Motorcycle was observed to have sustained damages all around.

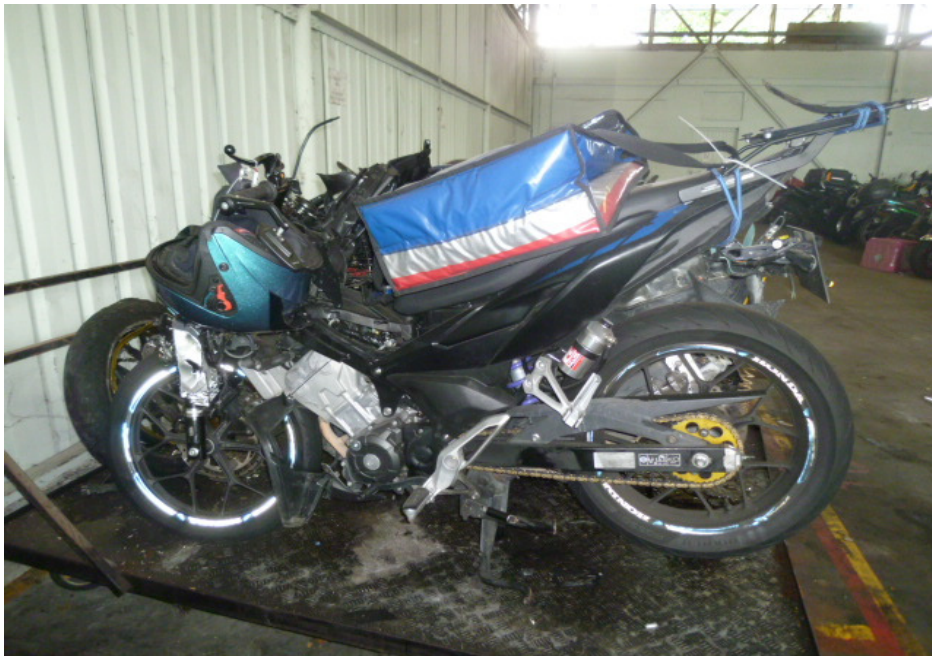
**Photo 2** shows a general view of the left body of the Motorcycle at the time of our inspection. The Motorcycle was observed to have sustained damages all around.

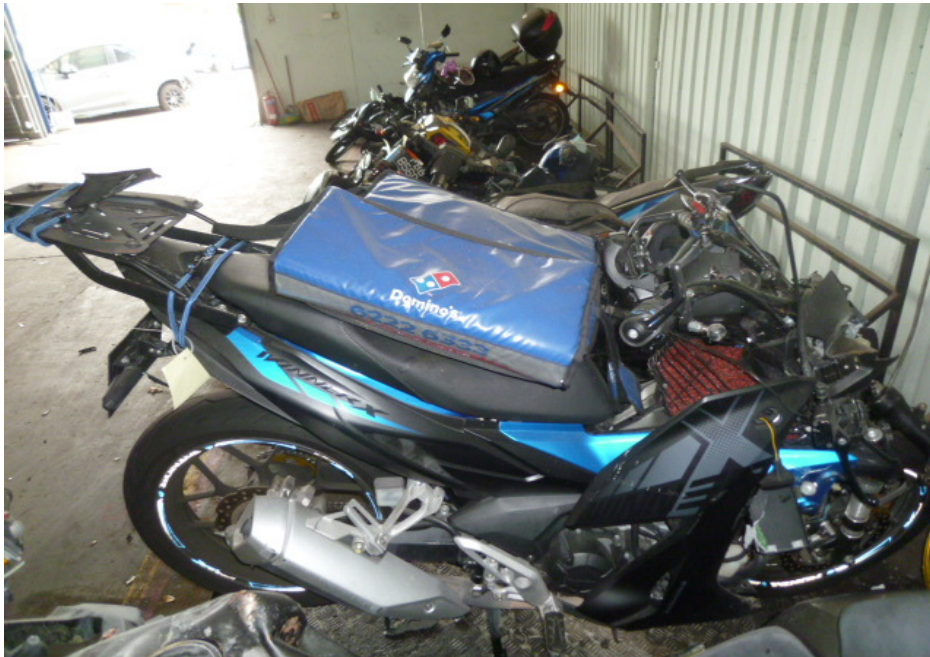
**Photo 3** shows a general view of the right body of the Motorcycle at the time of our inspection. The Motorcycle was observed to have sustained damages all around.

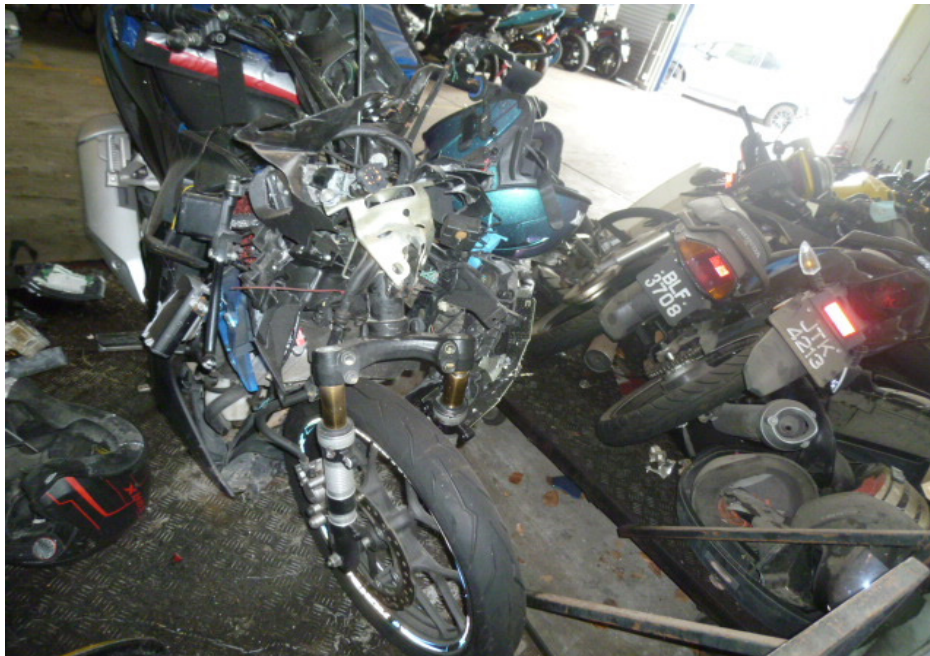
**Photo 4** shows a general view of the frontal portion of the Motorcycle at the time of our inspection. The Motorcycle was observed to have sustained damages all around. The body parts that were found to have been damaged include its speedometer gauge, headlight assembly, side cowlings, handlebar, side mirrors, clutch lever, front brake lever, handlebar ends, radiator, front basket, gear shift pedal, left front footrest, rear side covers and exhaust muffler, amongst others.

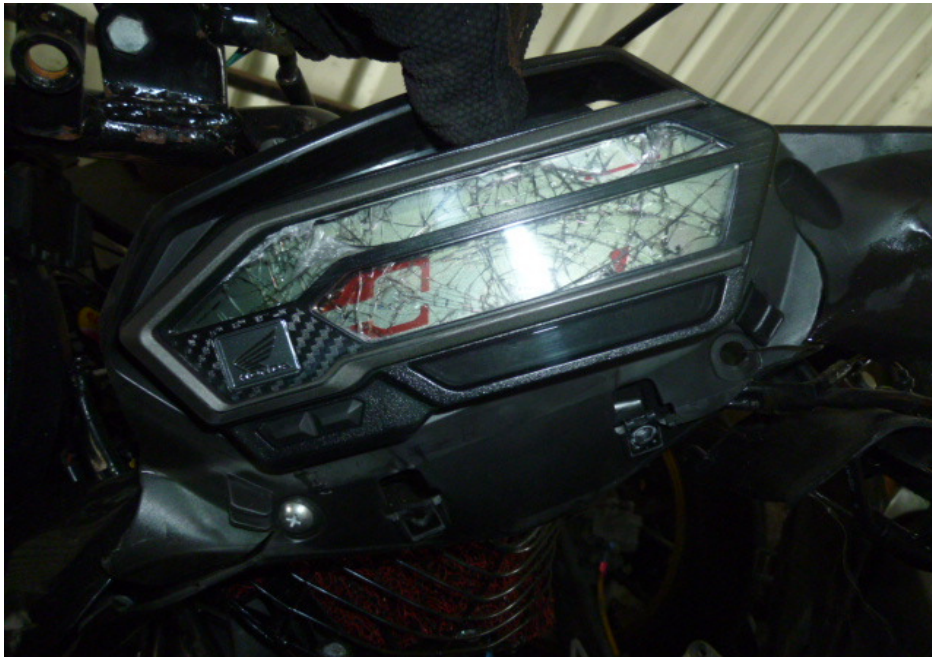
**Photo 5** shows a closer view of the damaged speedometer gauge of the Motorcycle. The mileage of the Motorcycle at the time of our inspection was not recorded due to the damage sustained to the speedometer display screen as a result of the accident.

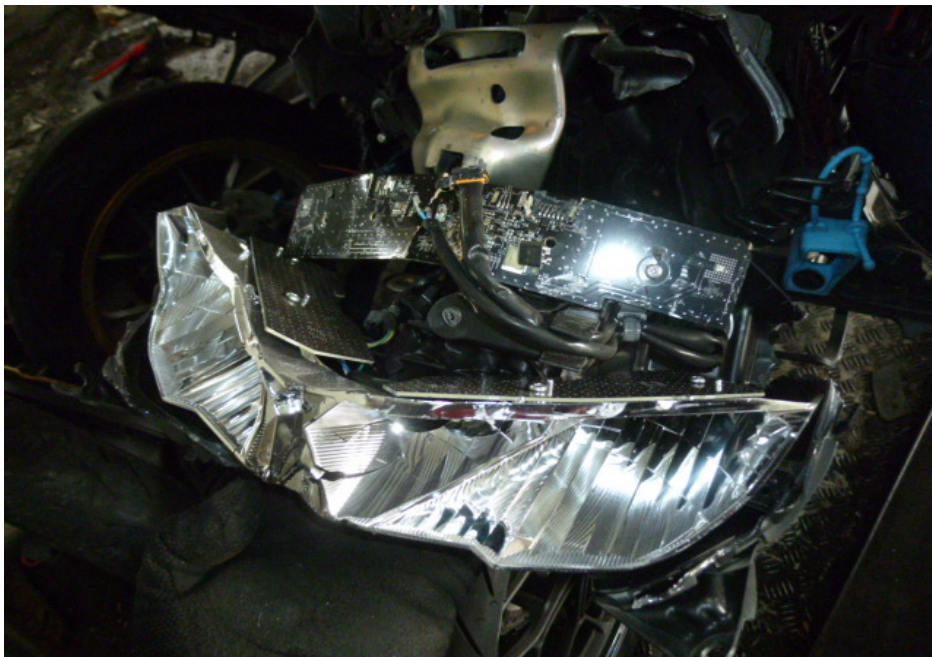
**Photo 6** shows a closer view of the headlight assembly which was amongst the body parts at the front body of the Motorcycle that had sustained damage as a result of the accident.

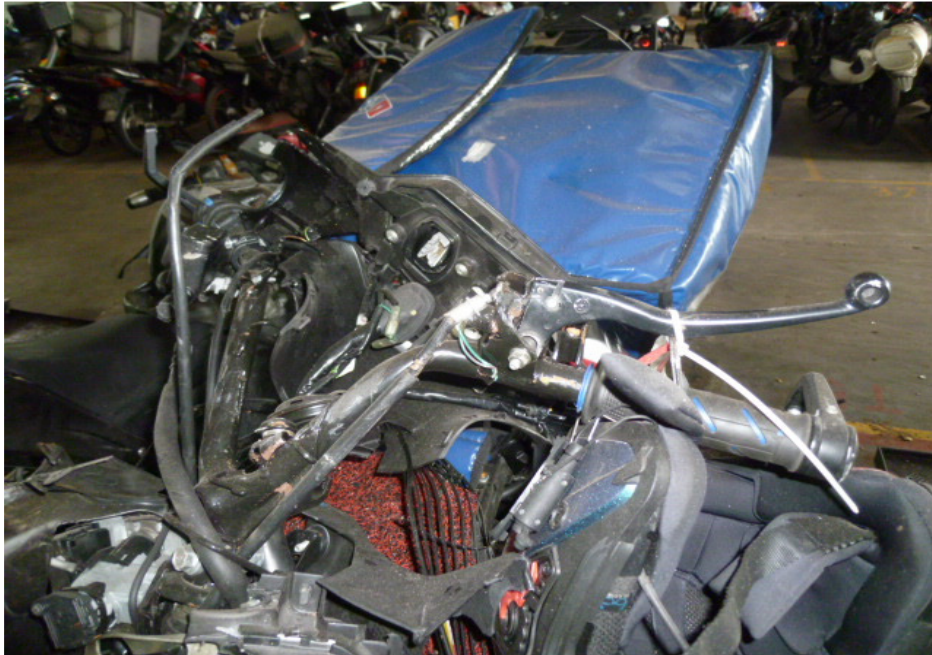
**Photo 7** shows a close up view of the side mirrors, clutch lever, front brake lever, handlebar and handlebar ends of the Motorcycle. These parts were amongst the body parts of the Motorcycle which were damaged as a result of the accident.

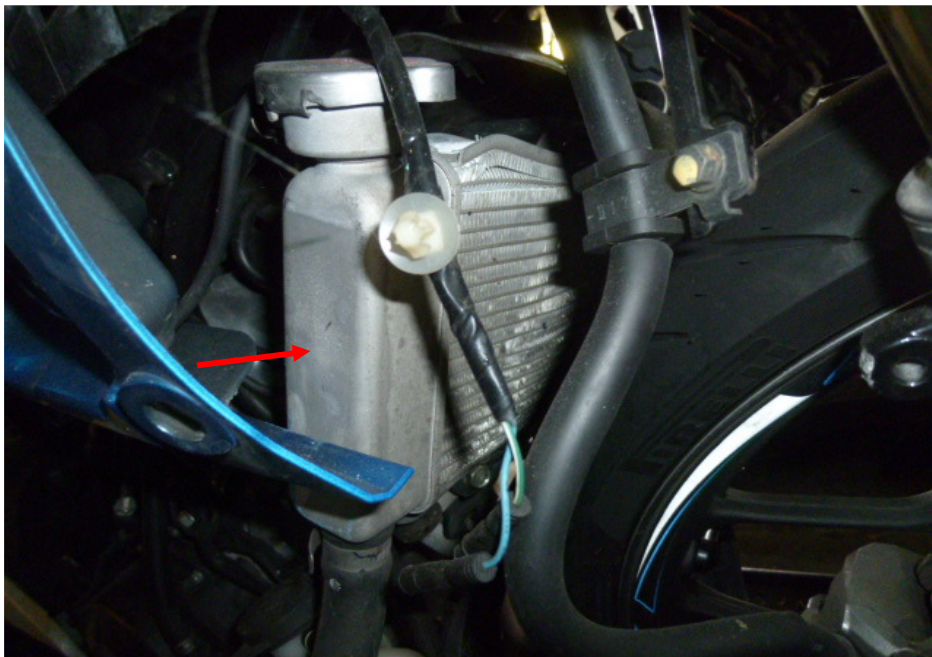
**Photo 8** shows the deformed radiator of the Motorcycle as a result of the accident (arrowed).

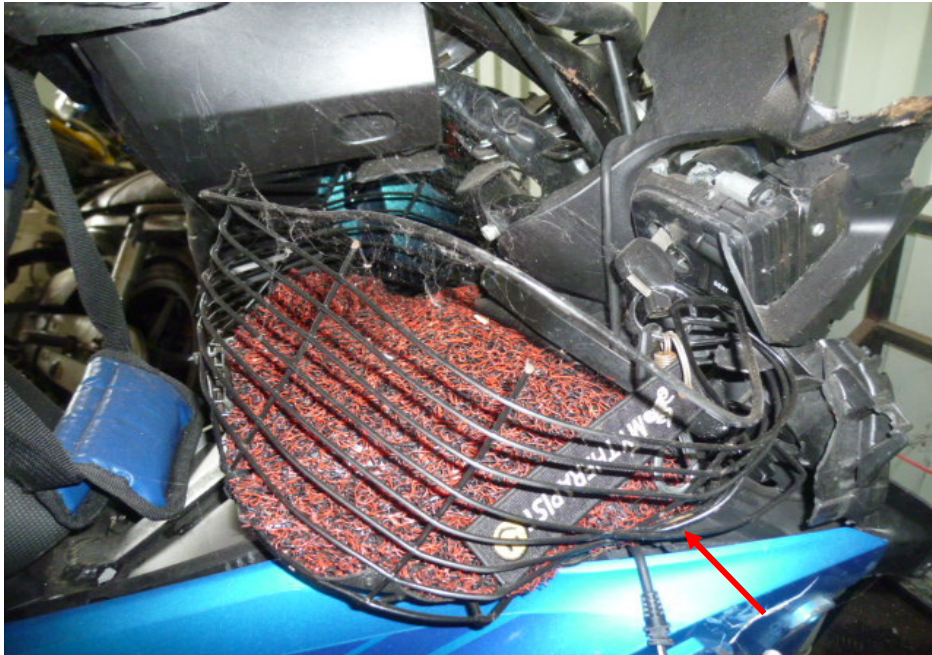
**Photo 9** shows the front basket (arrowed) which was amongst the body parts of the Motorcycle that had sustained damage as a result of the accident.

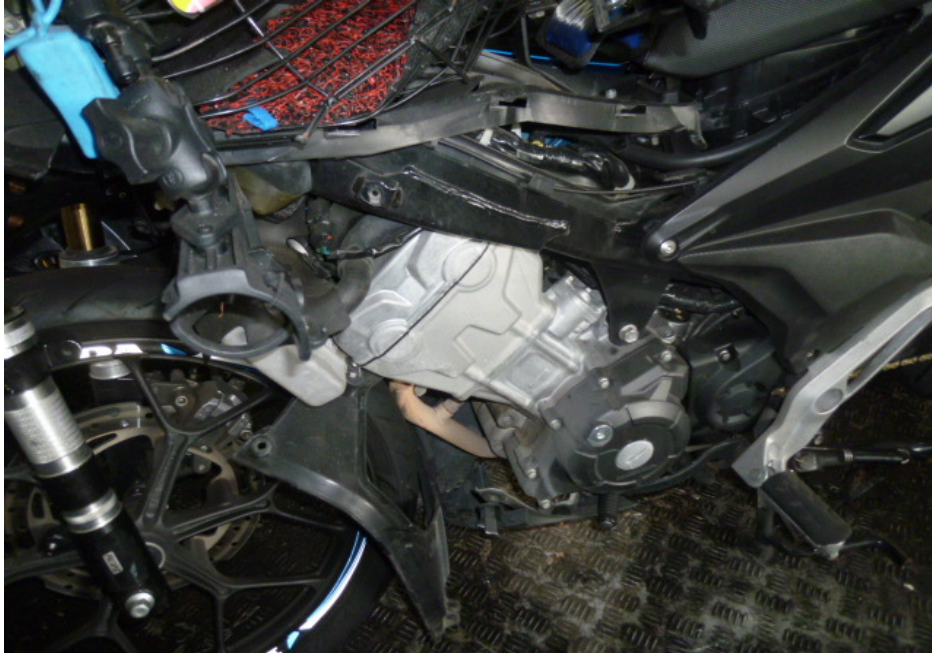
**Photo 10** shows the missing left cowling which was amongst the body of the Motorcycle that had sustained damage as a result of the accident.

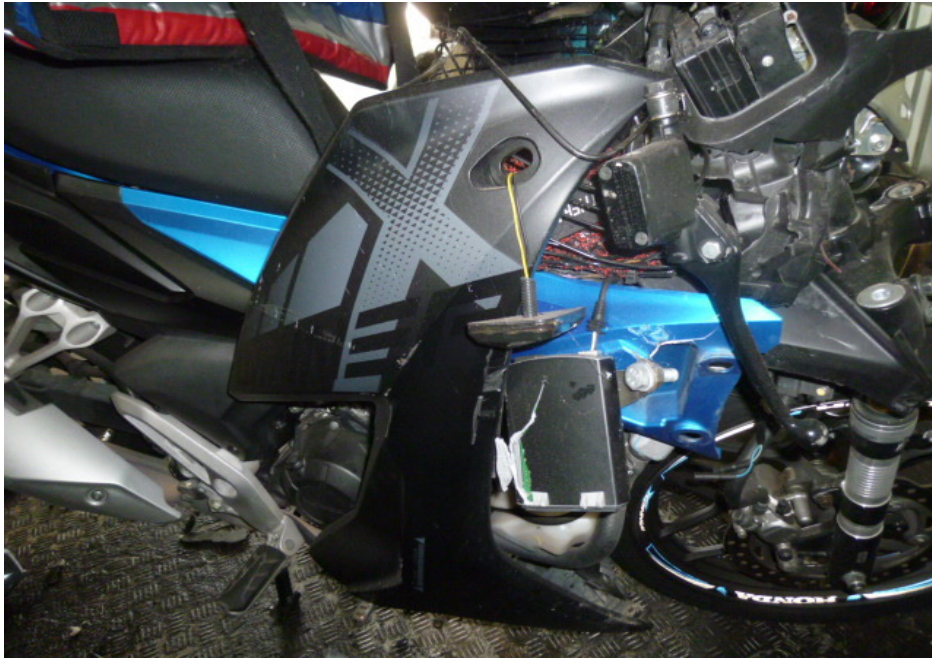
**Photo 11** shows the cracked right cowling which was amongst the body of the Motorcycle that had sustained damage as a result of the accident.

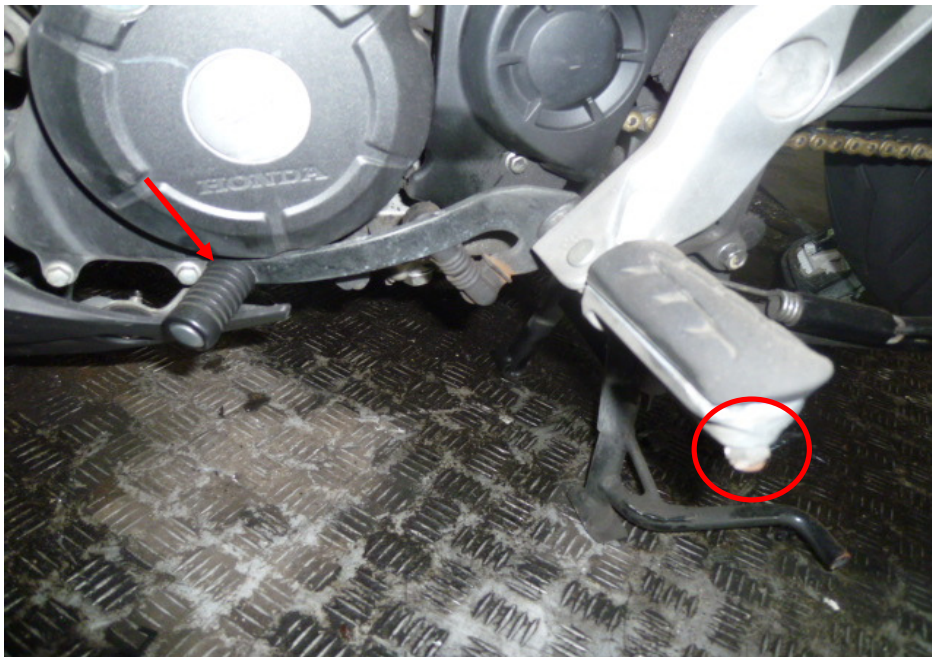
**Photo 12** shows a closer view of the gear shift pedal (arrowed) and left front footrest (circled) which was amongst the body parts of the Motorcycle that had sustained damage as a result of the accident.

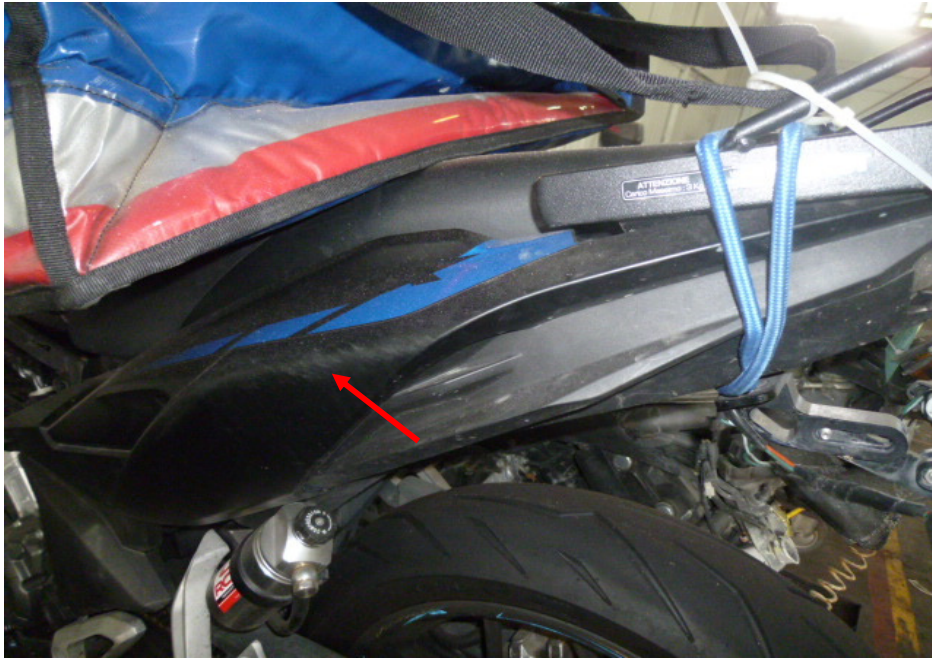
**Photo 13** shows a closer view of the grazed left rear side cover (arrowed) which was amongst the body parts of the Motorcycle that had sustained damage as a result of the accident.

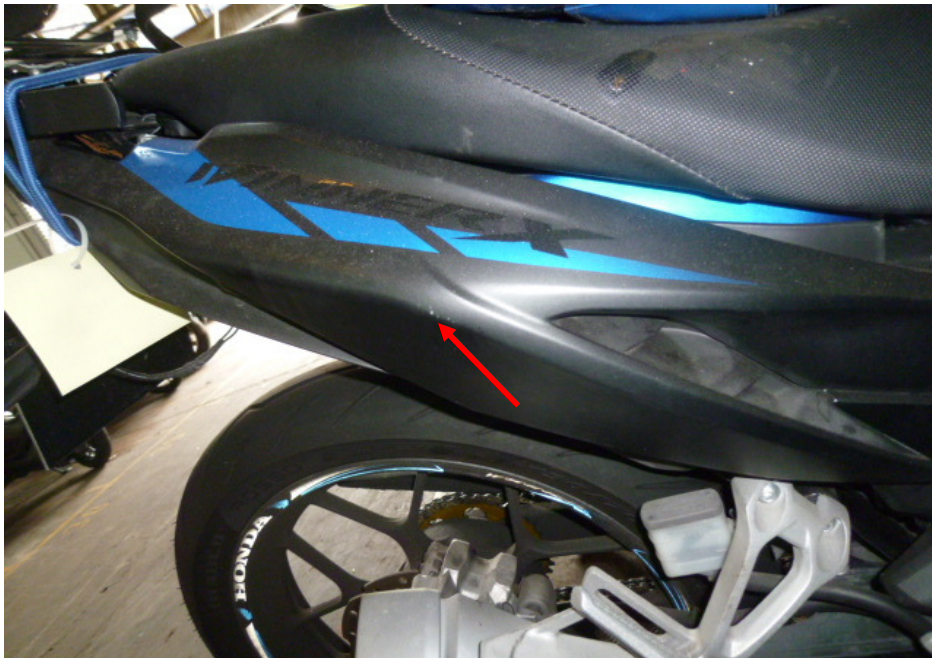
**Photo 14** shows a closer view of the grazed right rear side cover (arrowed) which was amongst the body parts of the Motorcycle that had sustained damage as a result of the accident.

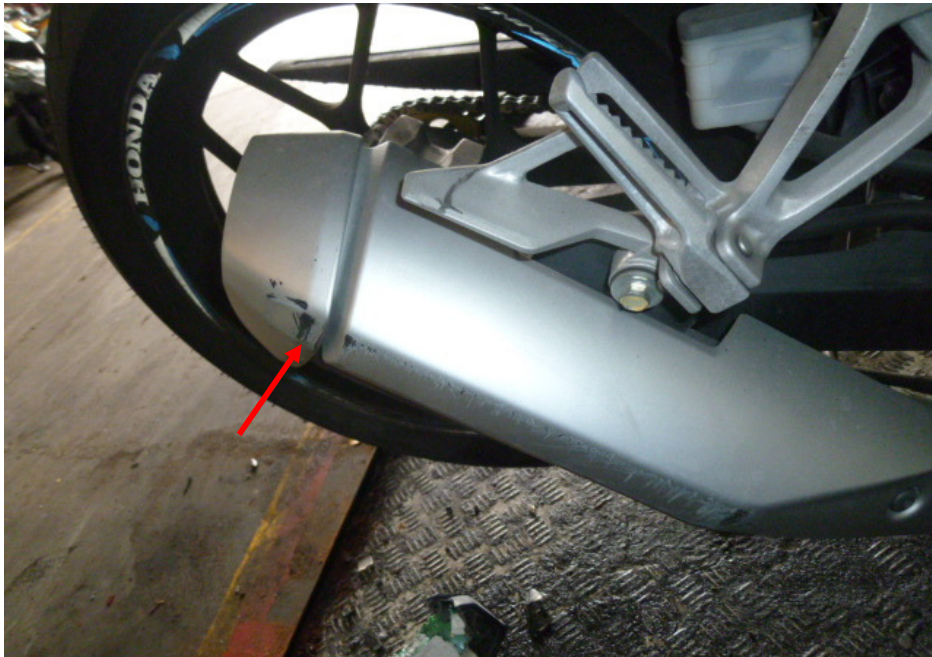
**Photo 15** shows the grazed exhaust muffler of the Motorcycle as a result of the accident (arrowed).

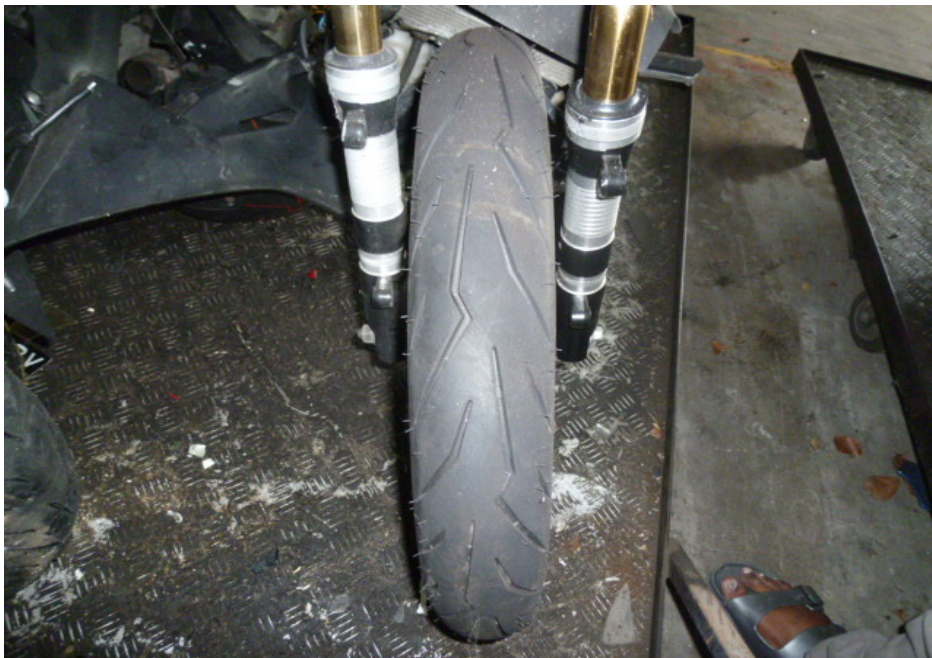
**Photo 16** shows the condition of the Motorcycle's front tyre. The front tyre was observed to be in serviceable condition with remaining tread depth of approximately 4mm. There was no tear, burst mark(s) and/or punctured hole(s) on the sidewalls as well as across the tread of the front tyre. However the front tyre was observed to be deflated.

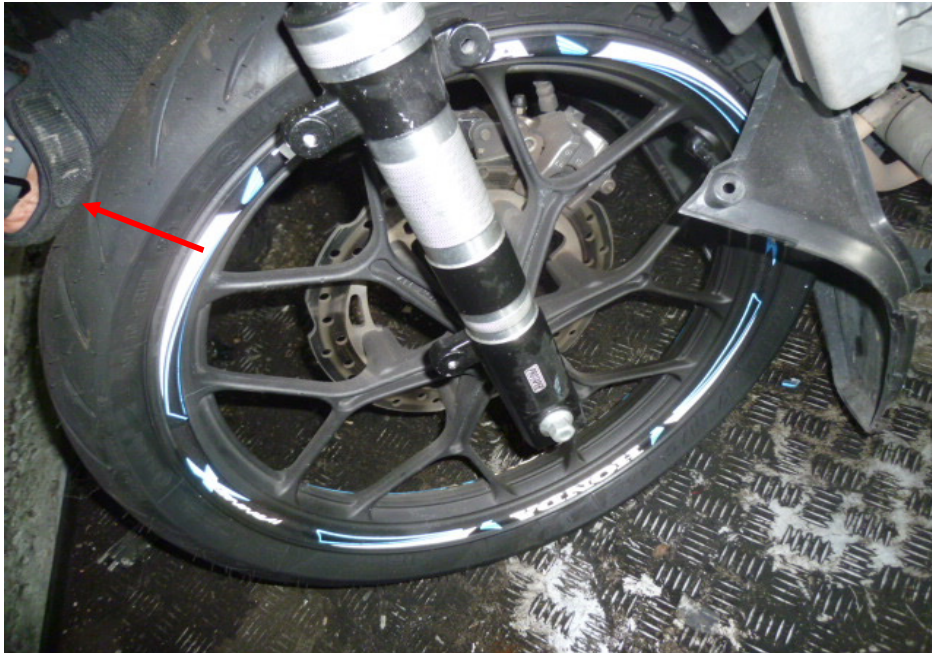
**Photo 17** shows the deflated front tyre (arrowed) of the Motorcycle at the time of our inspection.

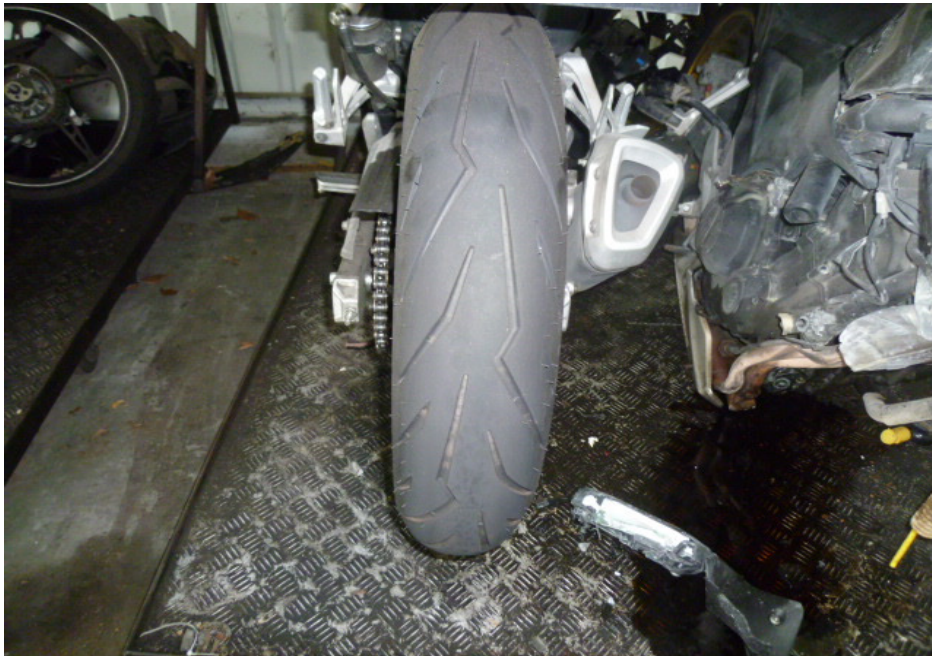
**Photo 18** shows the condition of the Motorcycle's rear tyre. The rear tyre was observed to be in serviceable condition with remaining tread depth of approximately 6mm. The tyre was also observed to be sufficiently inflated for vehicular operation. We did not observe any tear, burst mark(s) and/or punctured hole(s) on the sidewalls as well as across the tread of the rear tyre.

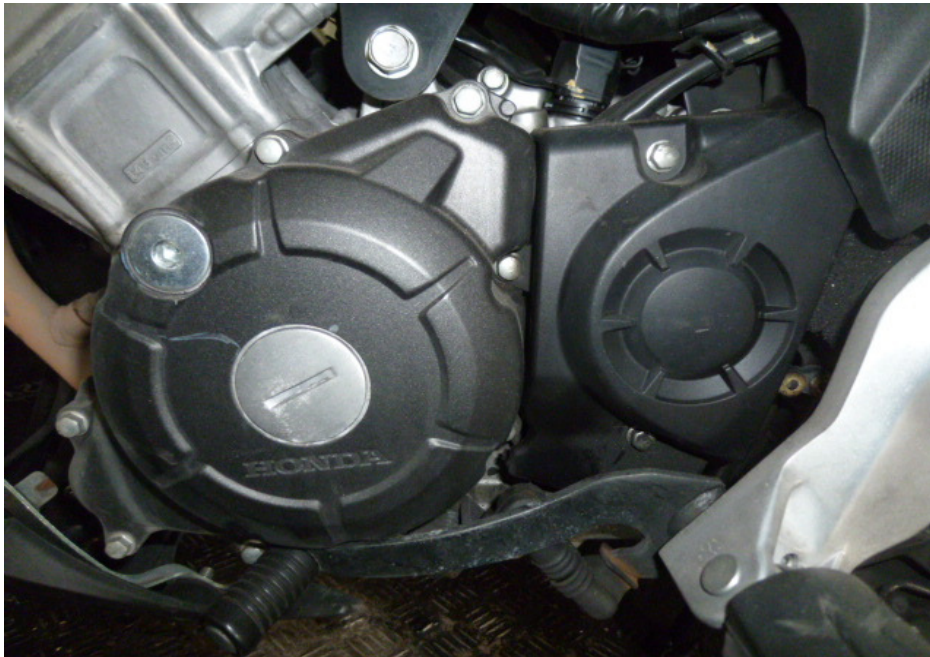
**Photo 19** shows the left side of the engine of the Motorcycle at the time of our inspection. The various engine related parts and components were found to be intact with no visible damage. There was also no sign(s) or indication(s) of fluid leak observed around the left engine area of the Motorcycle.

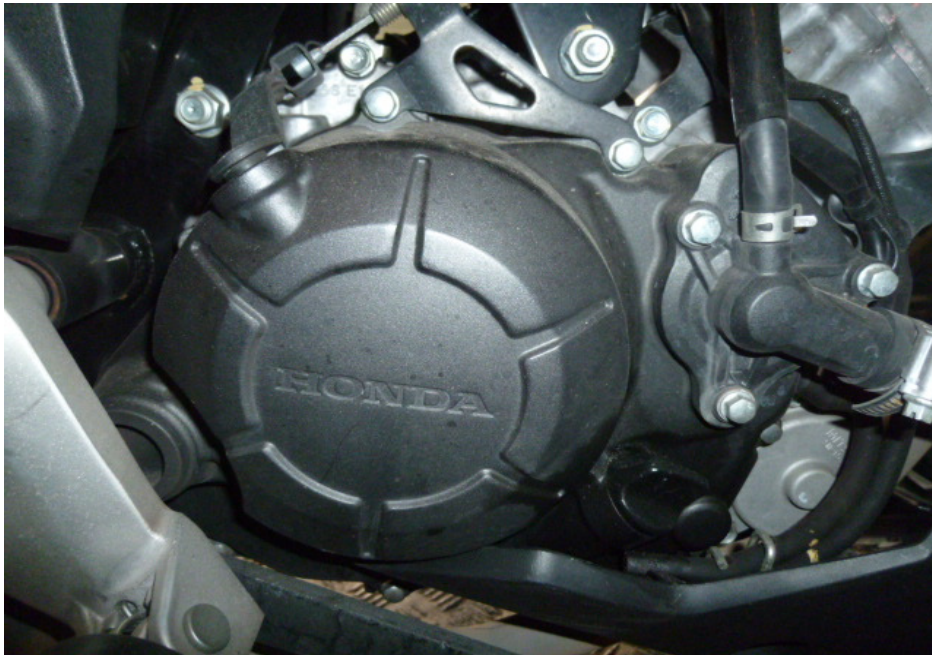
**Photo 20** shows the right side of the engine of the Motorcycle at the time of our inspection. The various engine related parts and components were found to be intact with no visible damage. There was also no sign(s) or indication(s) of fluid leak observed around the right engine area of the Motorcycle.

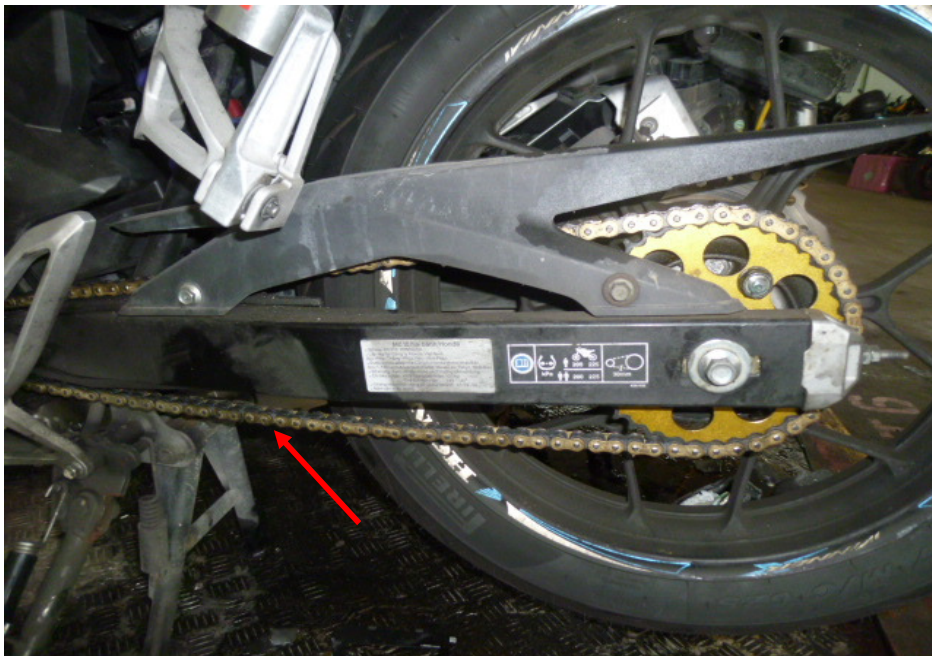
**Photo 21** shows the general view of the gear train (arrowed) of the Motorcycle, which was observed to be intact with no misalignment. It was also adequately lubricated for operating purposes.

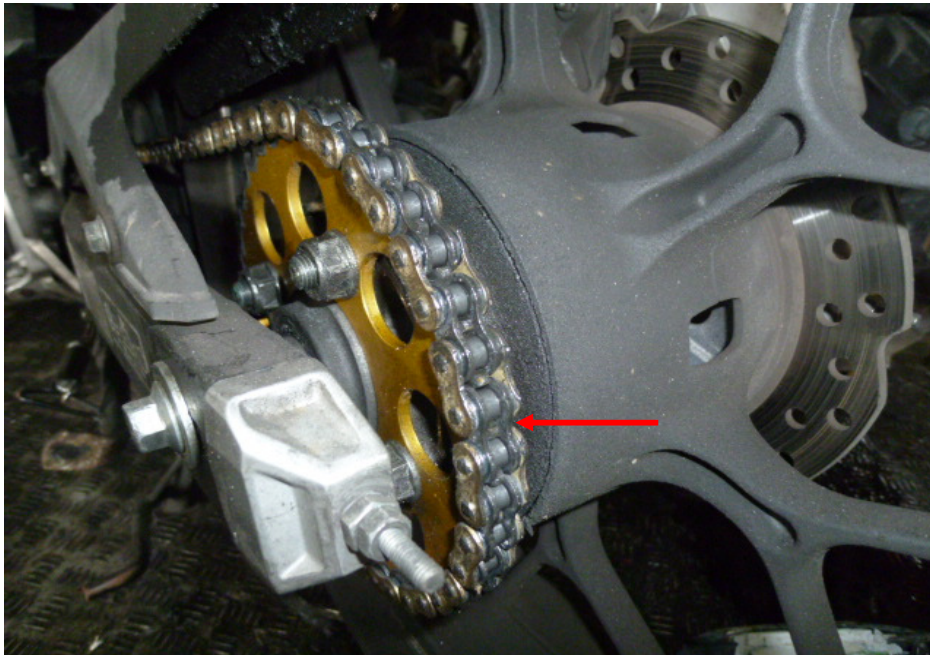
**Photo 22** shows a closer view of the gear train (arrowed) of the Motorcycle, which was observed to be intact with no misalignment. It was also adequately lubricated for operating purposes.

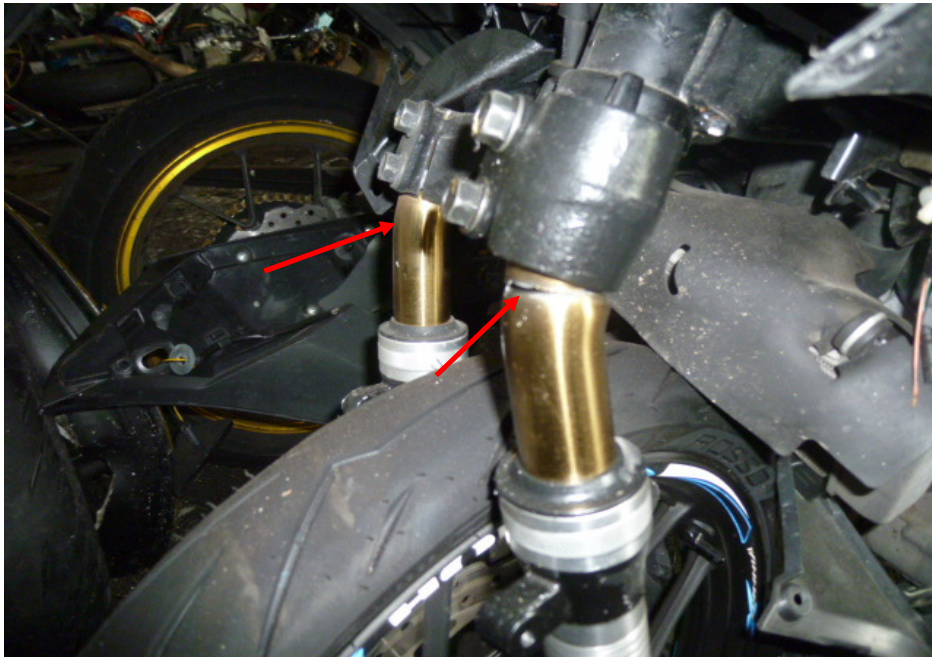
10. For this case, we were not able to conduct any test(s) on the steering system of the Motorcycle due to the damage of its front forks. The front forks were found to be broken as a result of the accident.

**Photo 23** shows the front forks of the Motorcycle. The front forks (arrowed) were observed to be broken as a result of the accident. We were hence not able to conduct any tests on the steering system of the Motorcycle.

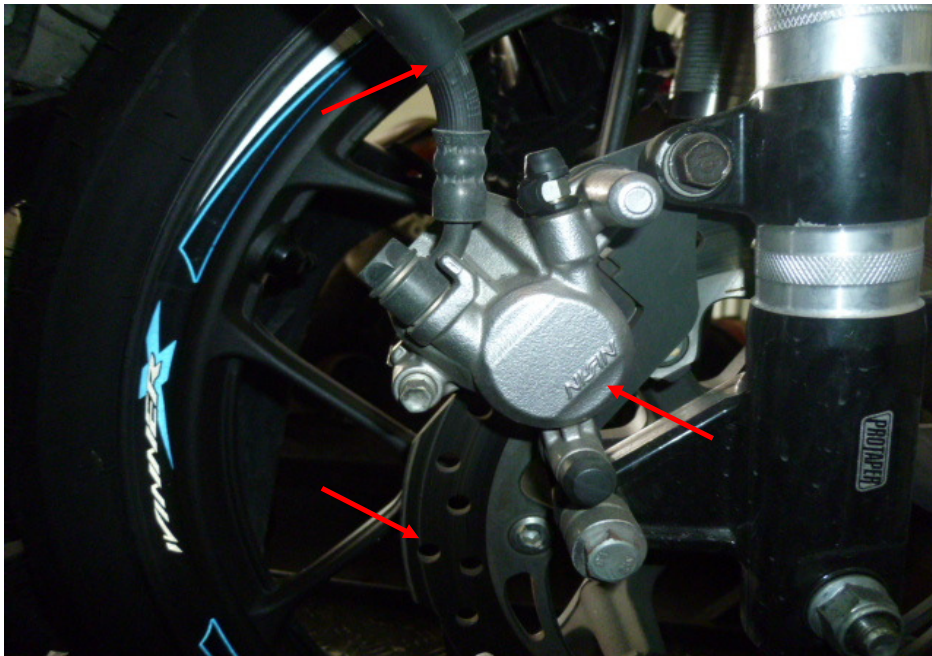
**Photo 24** shows a close up view of the front brake caliper, front brake disc and front brake hose (arrowed) of the Motorcycle, which are all part of the hydraulic front brake system of the Motorcycle. Our visual checks of these various components had revealed all to be intact with no visible damage. No leakage of brake fluid was also observed.

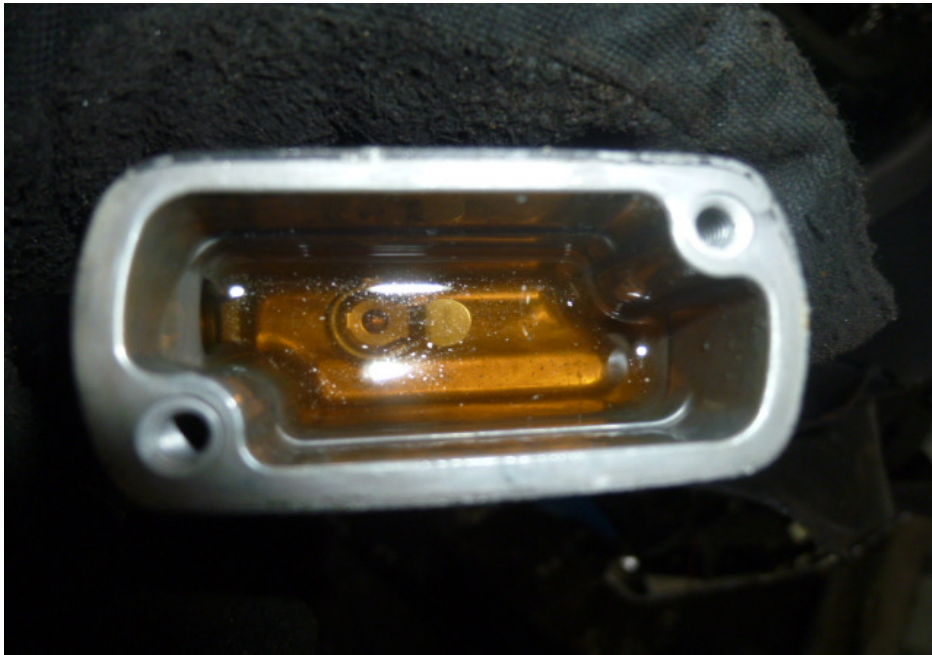
**Photo 25** shows the brake fluid reservoir for the front brake of the Motorcycle. The brake fluid was observed to be of sufficient level for operational purposes and without contamination.

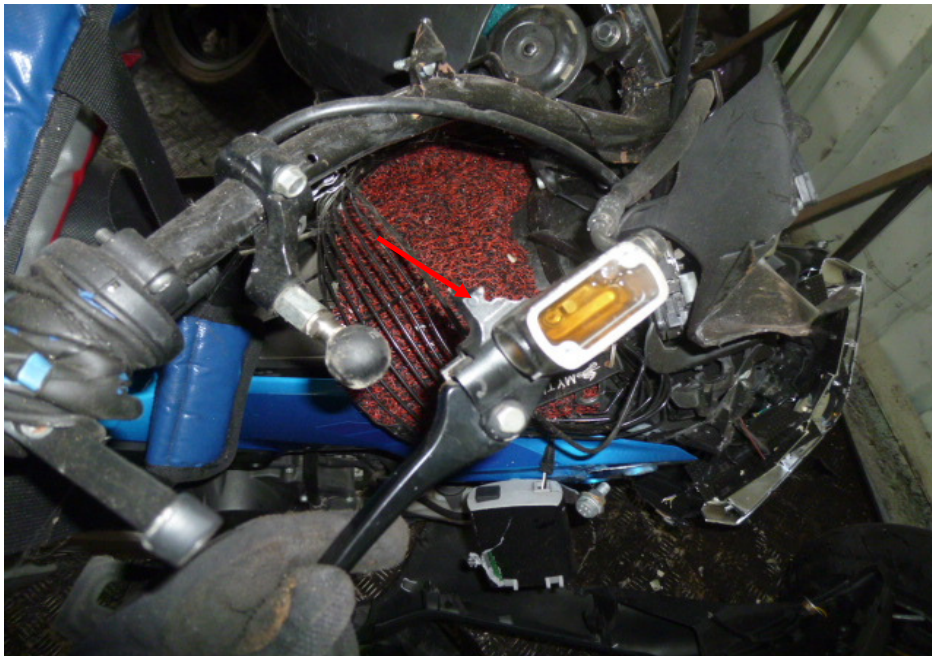
14. However we observed that part of the front brake master pump had broken off as a result of the accident. Hence static as well as operational brake tests could not be conducted on the Motorcycle front braking system. We were unable to determine if there was any leakage of pressure/vacuum in the front brake system.

**Photo 26** shows the front brake reservoir. We were unable to depress the front brake lever as part of front brake master pump had broken off as a result of the accident (arrowed). Hence we were unable to determine if there was any leakage of pressure/vacuum in the front brake system.

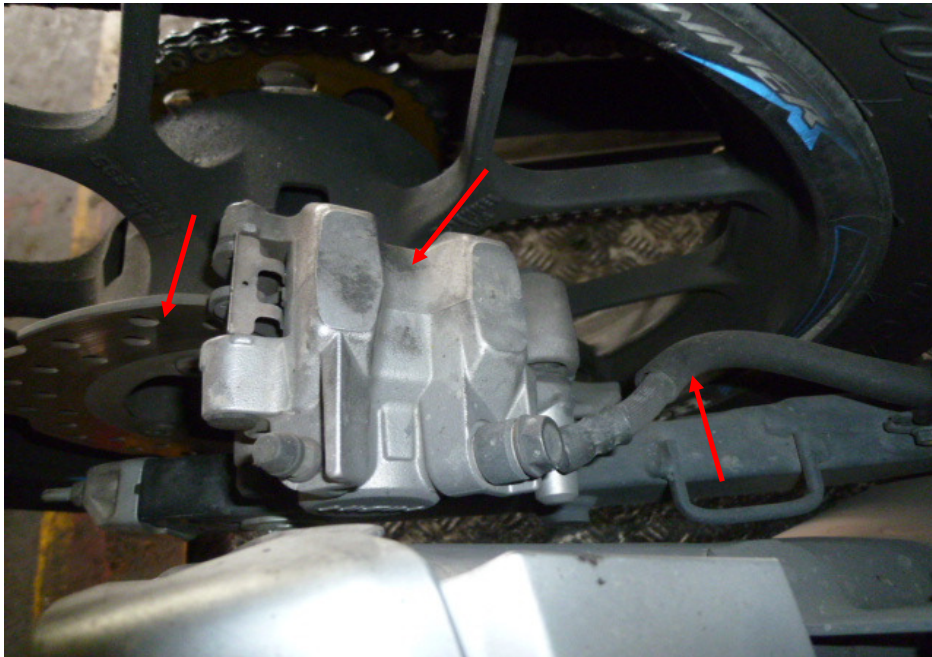
**Photo 27** shows a close up view of the rear brake caliper, rear brake disc and rear brake hose (arrowed) of the Motorcycle, which are all part of the components in the hydraulic rear brake system of the Motorcycle. Our visual checks of these various components had revealed all to be intact with no visible damage. No leakage of brake fluid was also observed.

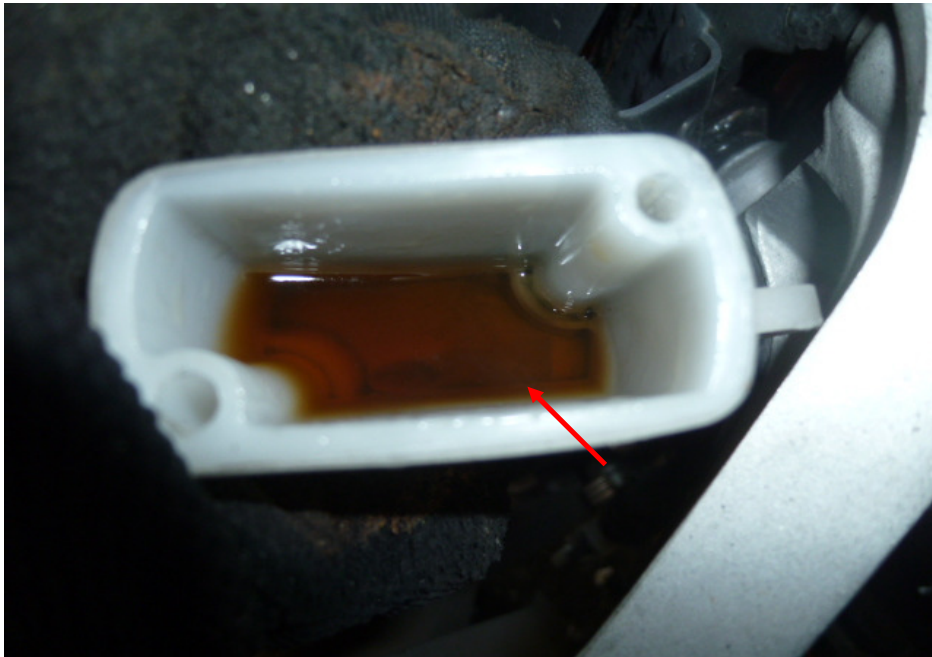
13. The brake fluid for the front brake was found to be of sufficient level for operating purposes and without any contamination. The brake fluid for the rear brake was observed to be of sufficient level for operational purposes. However the brake fluid for the rear brake was found to be slightly contaminated.

**Photo 28** shows a close up view of the brake fluid reservoir for the rear brake of the Motorcycle. The rear brake fluid was observed to be of sufficient level for operational purposes. However it was found to be slightly contaminated (arrowed).
