Your Ref: TP/IP/09095/2022
Our Ref : CI/TPD22005267/N

Fatal Accident Investigation Team

INSPECTION REPORT OF MOTORCYCLE FBJ 6994R

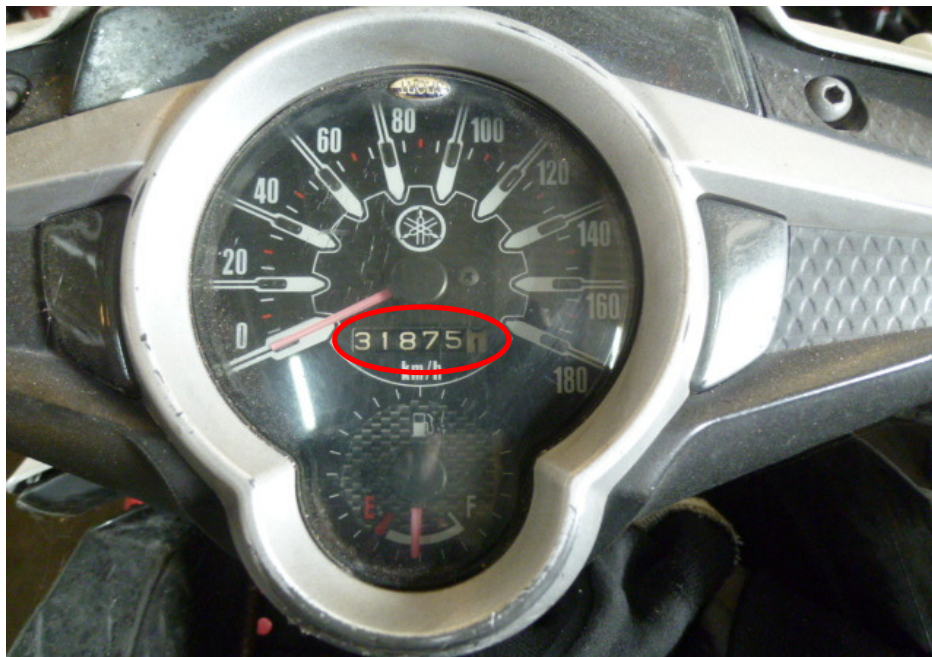
Photo 1 shows the speedometer gauge of the Motorcycle. The mileage of the Motorcycle at the time of our inspection was 31, 875km (circled).

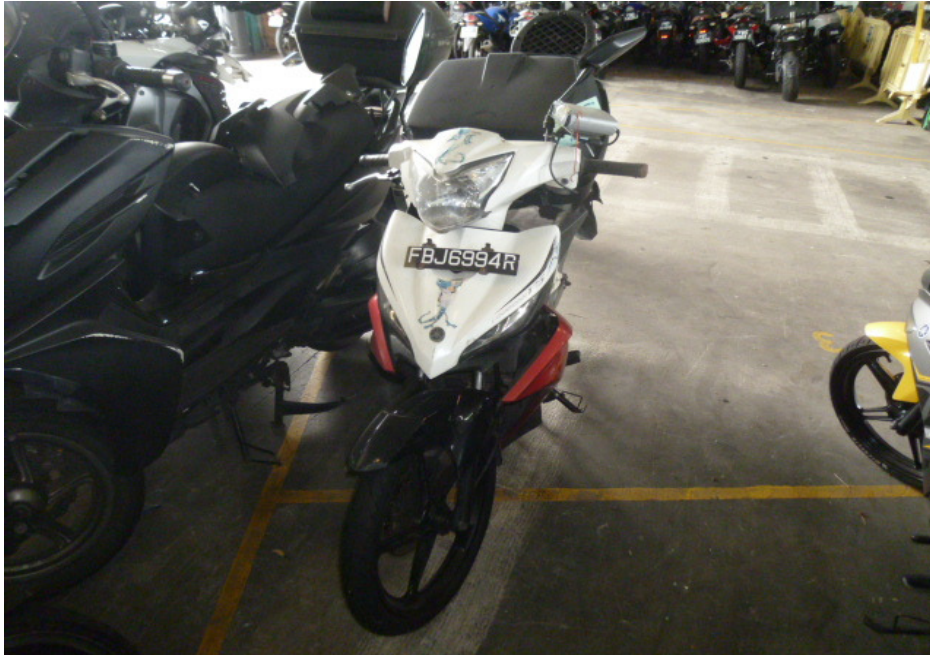
Photo 1 shows a general view of the frontal portion of the Motorcycle at the time of our inspection. The Motorcycle was observed to have sustained damages all around.

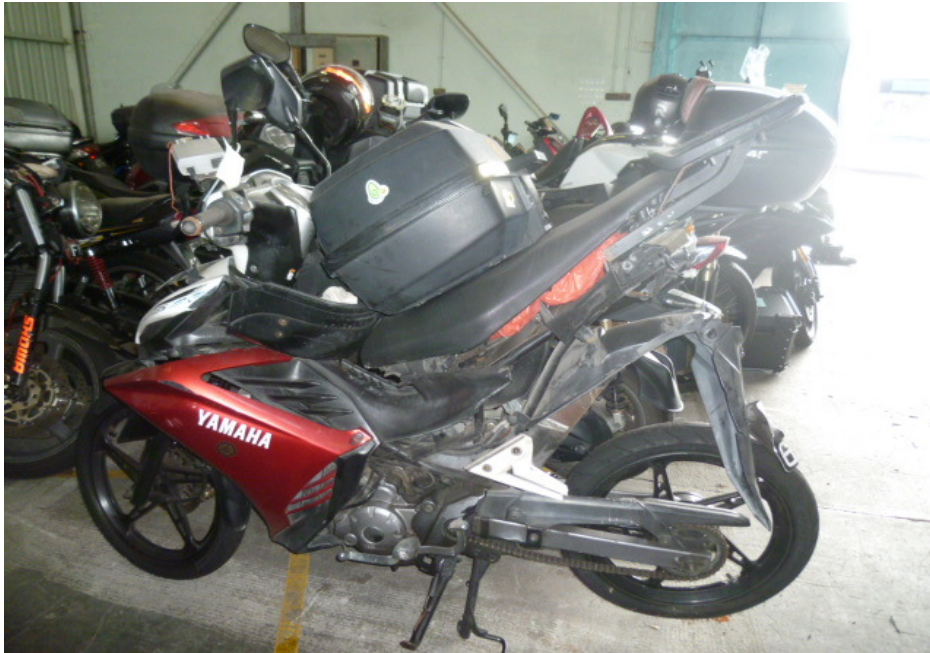
Photo 2 shows a general view of the left body of the Motorcycle at the time of our inspection. The Motorcycle was observed to have sustained damages all around.

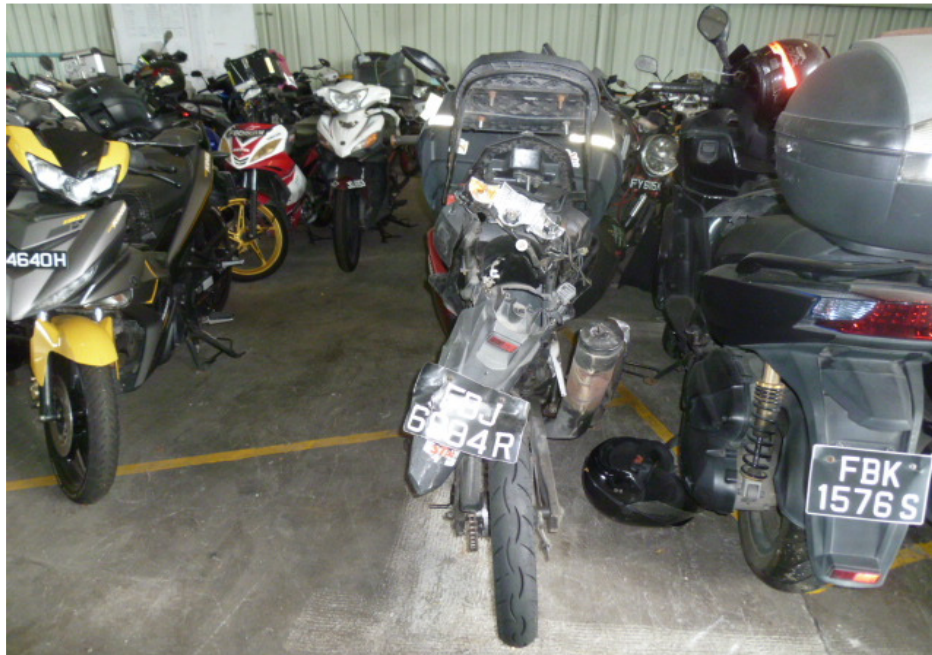
Photo 4 shows a general view of the rear portion of the Motorcycle at the time of our inspection. The Motorcycle was observed to have sustained damages all around. The body parts that were found to have been damaged include its headlight assembly, front cowling, front mudguard, centre cowling, left cowling, side mirrors, front brake lever, handlebar ends, gear shift pedal, rear brake pedal, left front footrest, right pillion foot peg bracket, rear side covers, exhaust muffler and tail light assembly, amongst others.

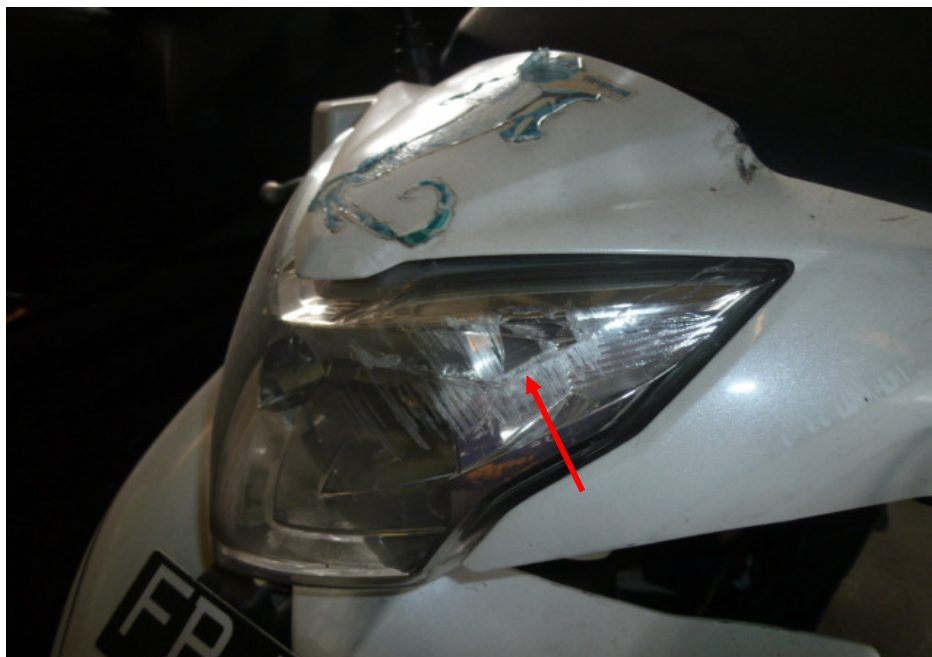
Photo 7 shows the headlight assembly (arrowed), which was amongst the body parts of the Motorcycle that had sustained damage as a result of the accident.

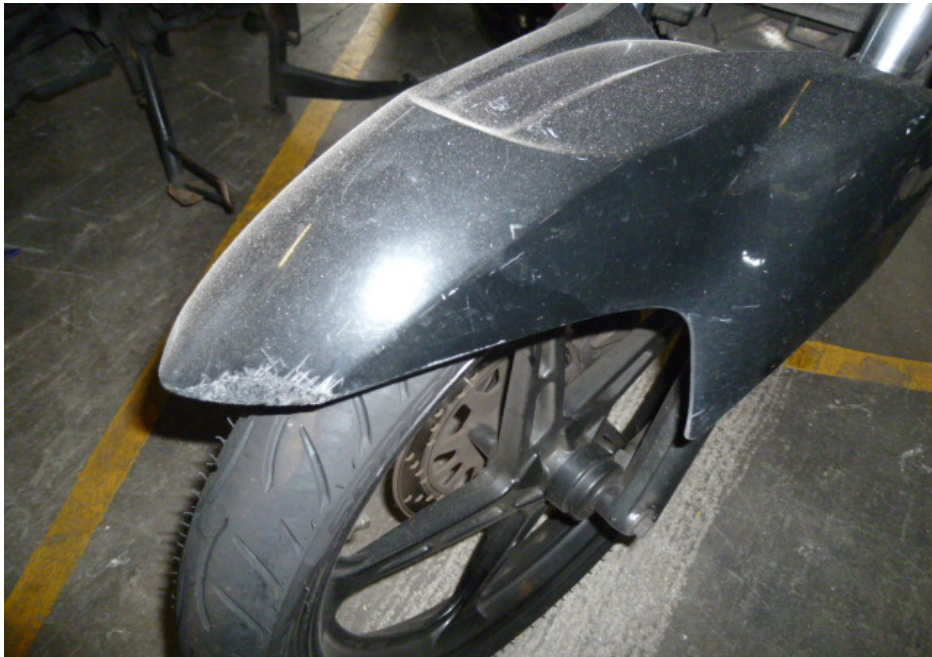
Photo 5 shows a closer view of the front mudguard which was amongst the body parts of the Motorcycle that had sustained damage as a result of the accident.

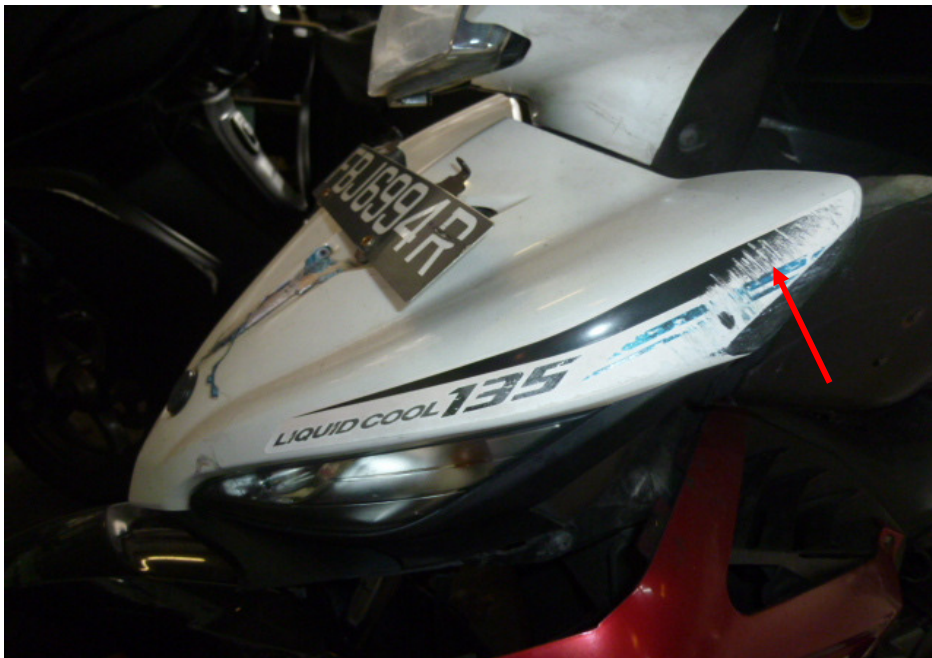
Photo 6 shows the front cowling (arrowed), which was amongst the body parts of the Motorcycle that had sustained damage as a result of the accident.

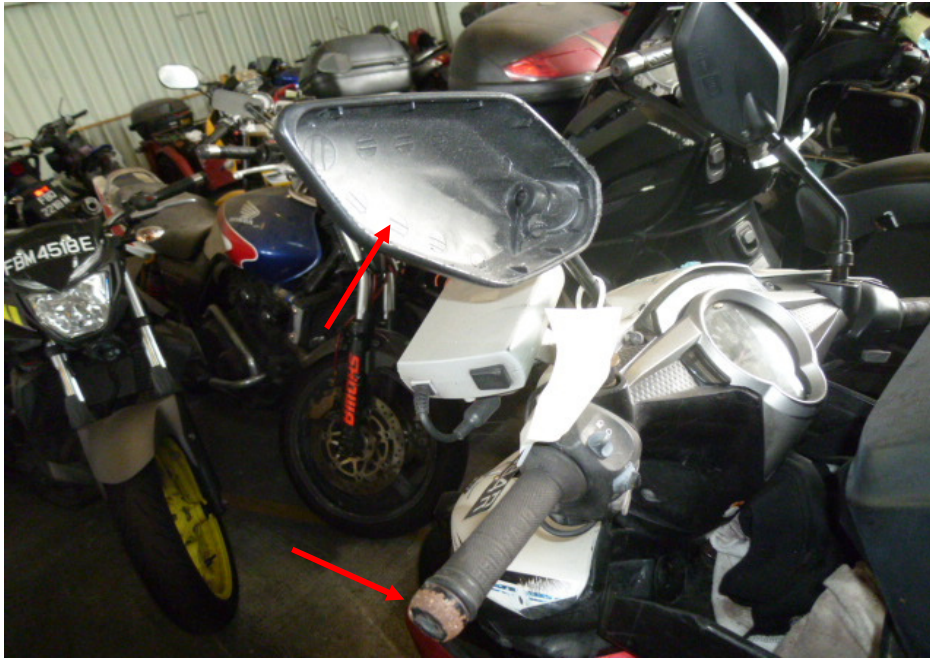
Photo 8 shows the left handlebar end and left side mirror (arrowed), which were amongst the body parts of the Motorcycle that had sustained damage as a result of the accident.

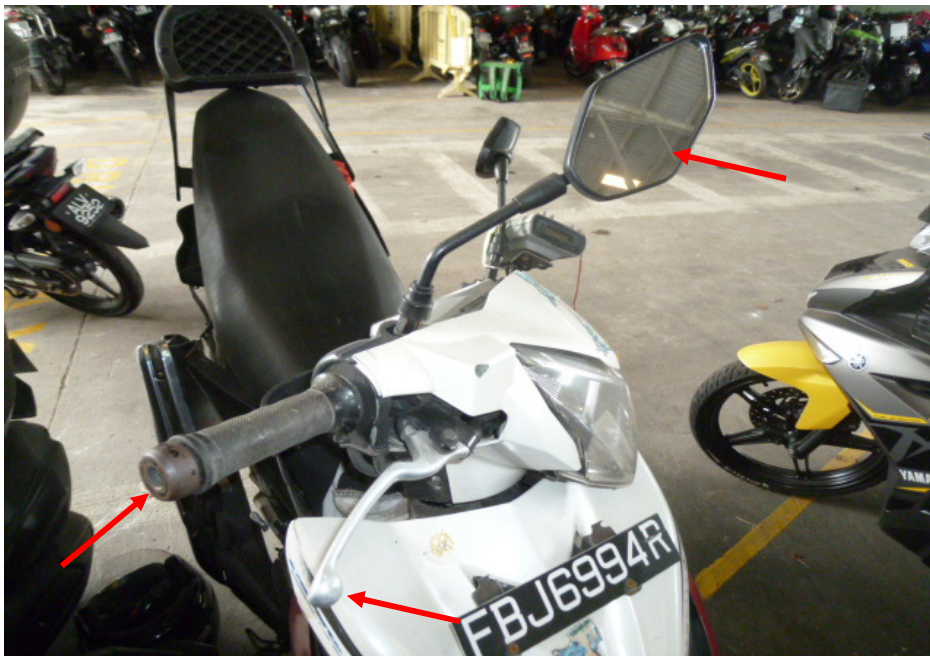
Photo 9 shows the right handlebar end, right side mirror and front brake lever (arrowed), which were amongst the body parts of the Motorcycle that had sustained damage as a result of the accident.

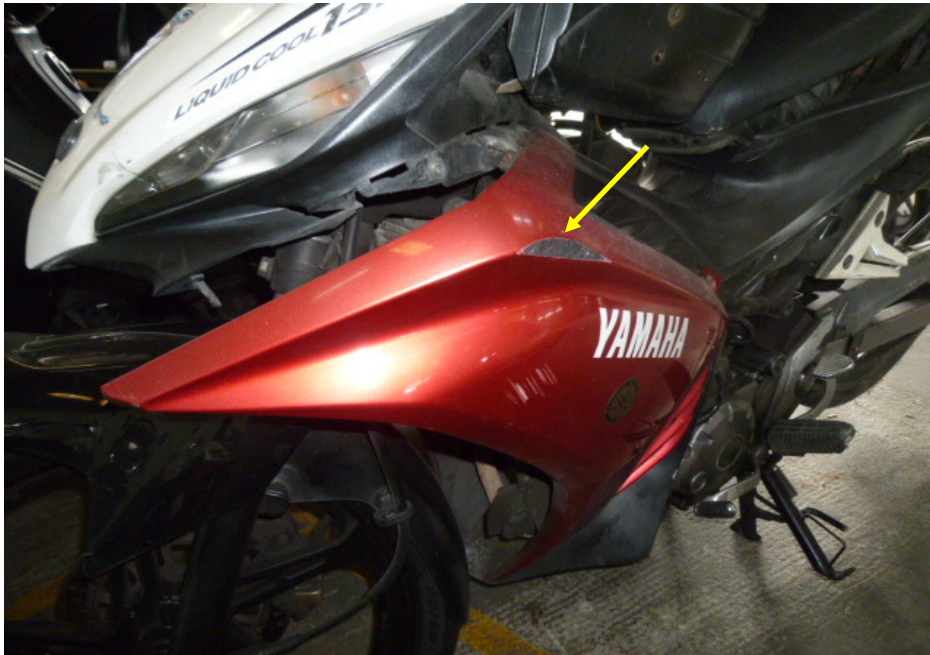
Photo 10 shows a closer view of the grazed left cowling of the Motorcycle as a result of the accident (arrowed).

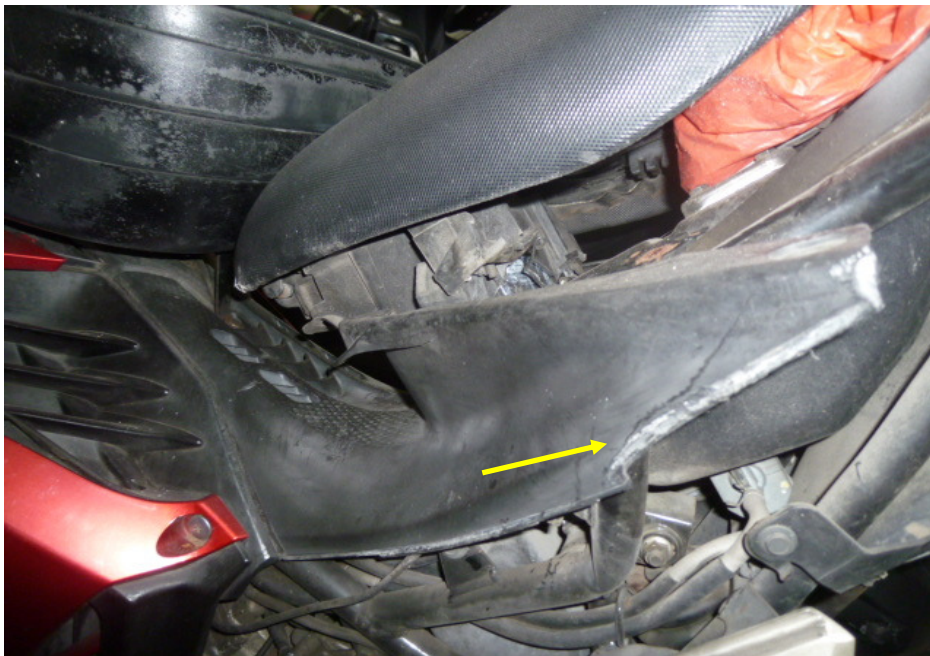
Photo 10 shows a closer view of the deformed centre cowling of the Motorcycle as a result of the accident (arrowed).

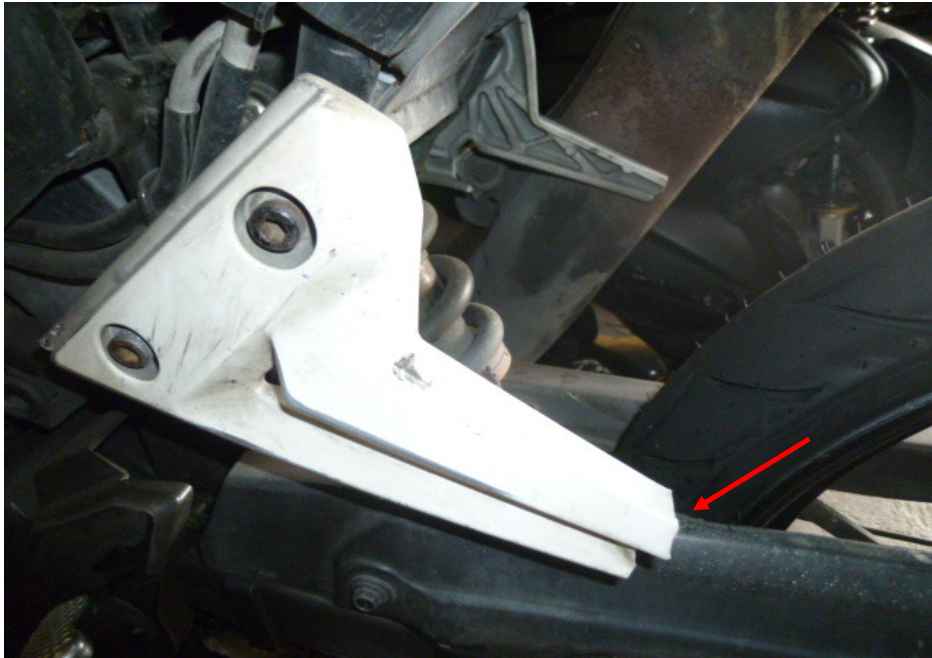
Photo 12 shows the broken left pillion foot peg bracket of the Motorcycle as a result of the accident (arrowed).

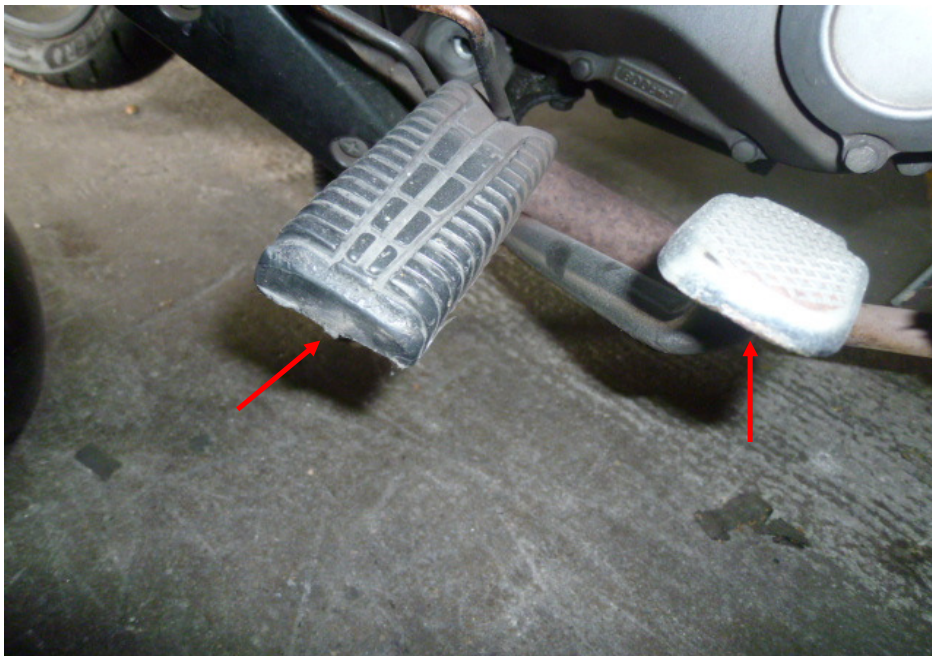
Photo 13 shows the rear brake pedal and right front footrest of the Motorcycle that had sustained damage as a result of the accident (arrowed).

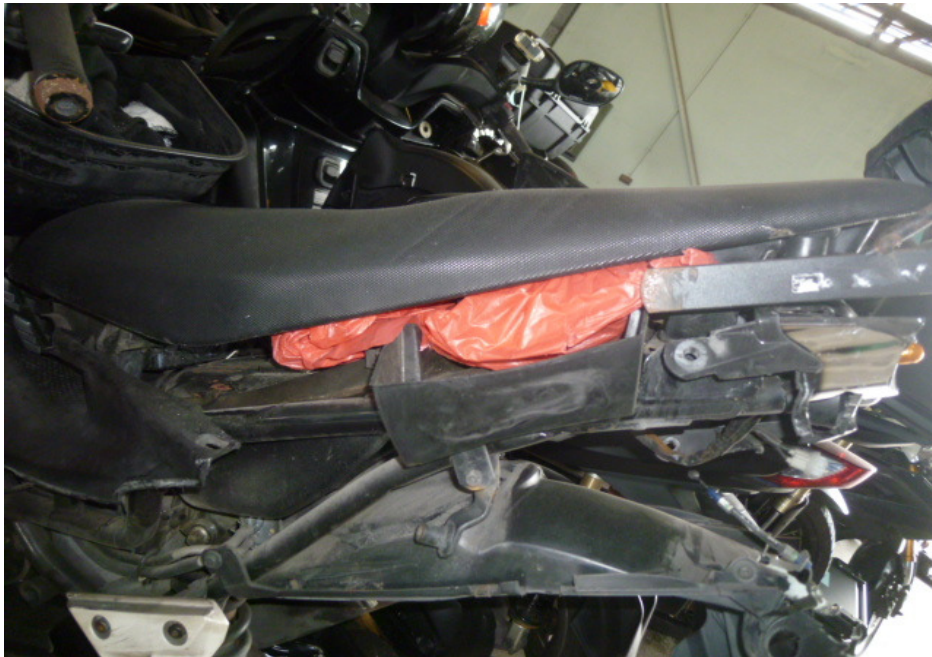
Photo 16 shows a closer view of the missing left rear side cover of the Motorcycle as a result of the accident.

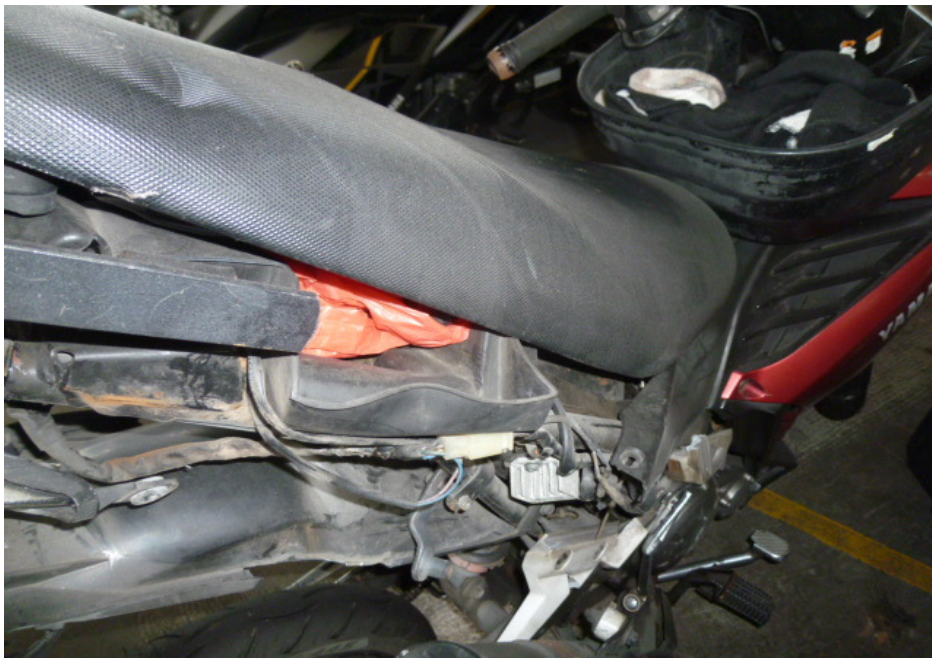
Photo 14 shows a closer view of the missing right rear side cover of the Motorcycle as a result of the accident.

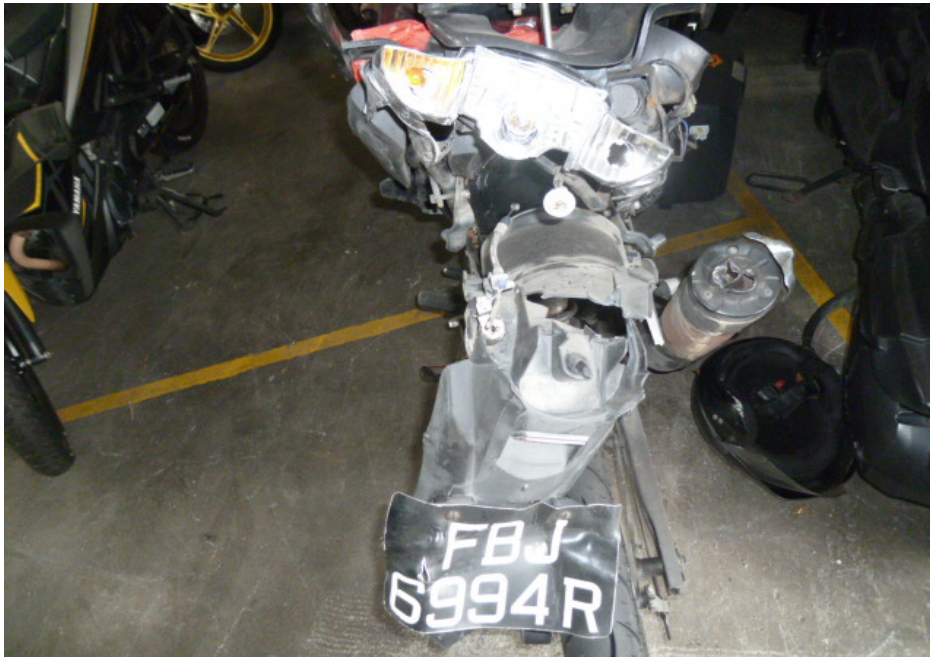
Photo 15 shows a closer view of the deformed tail light assembly of the Motorcycle as a result of the accident.

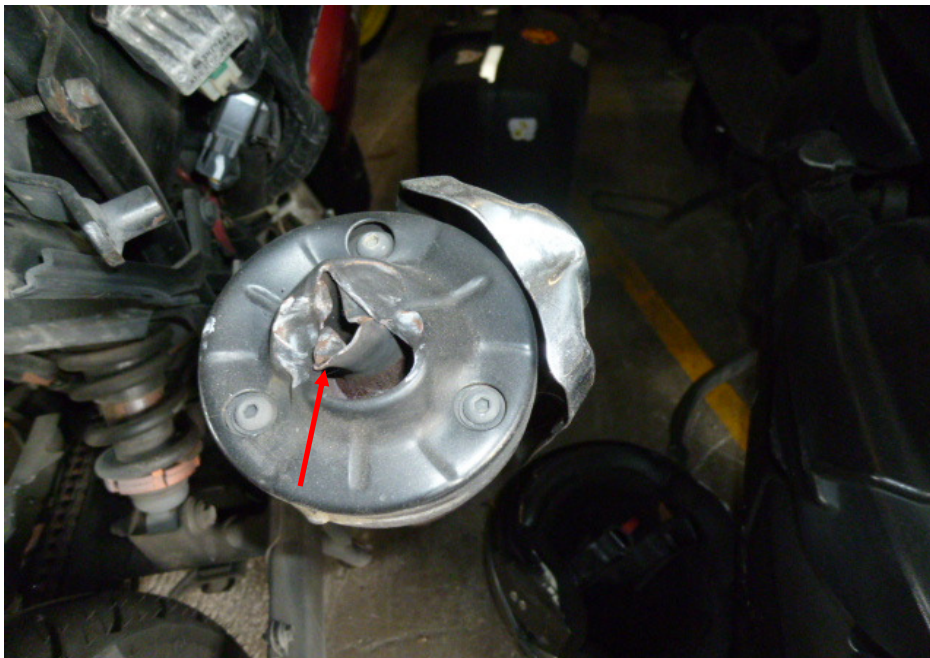
Photo 11 shows a closer view of the dented exhaust muffler of the Motorcycle as a result of the accident (arrowed).

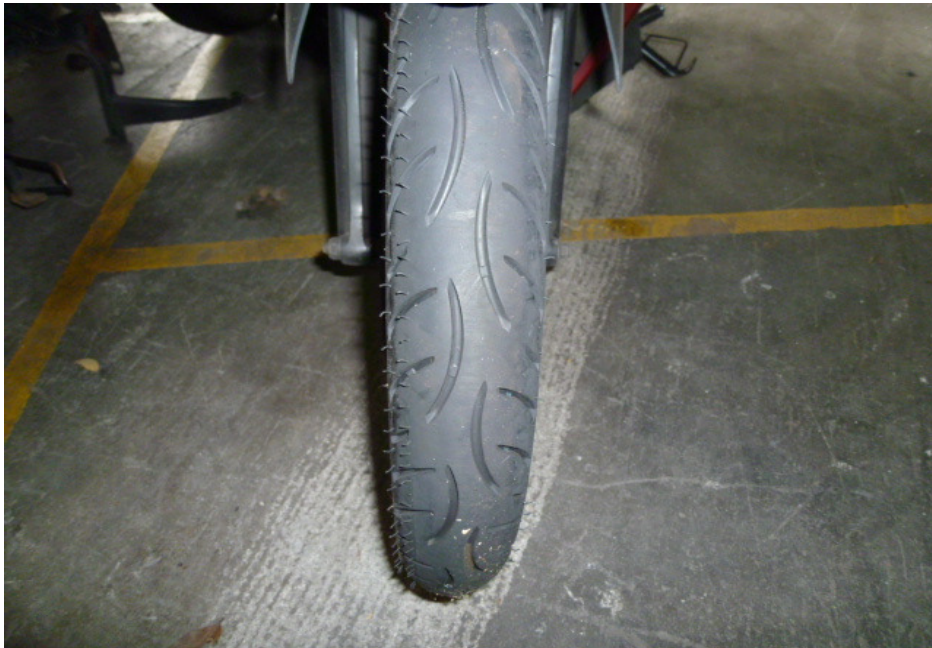
Photo 17 shows the front tyre of the Motorcycle at the time of our inspection. The front tyre was observed to be in serviceable condition with remaining tread depth of approximately 3mm. The pattern of the tread was also clearly visible. There was no tear, burst mark(s) and/or punctured hole(s) on the sidewalls as well as across the tread of the front tyre.

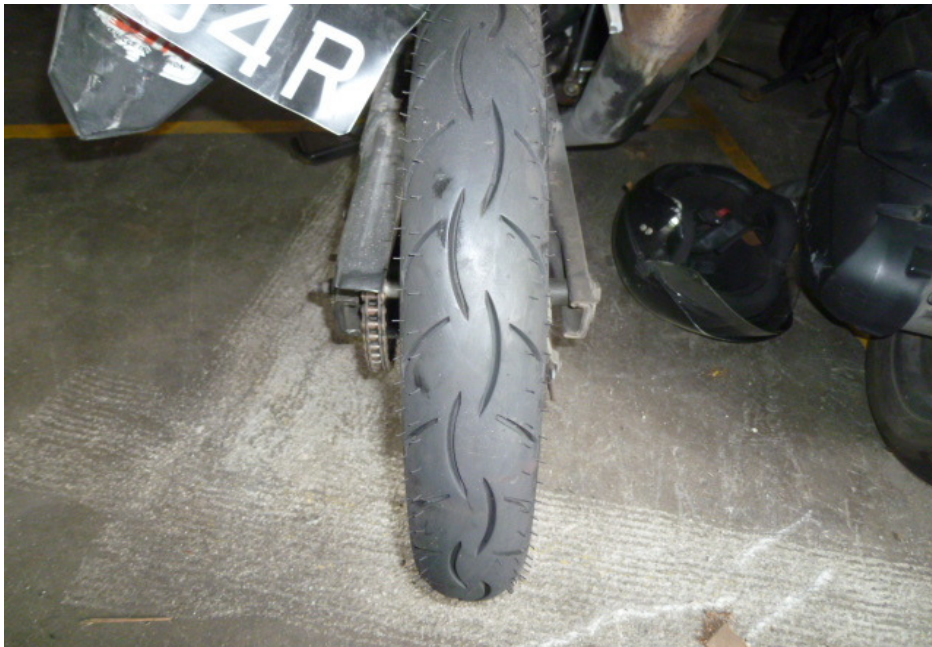
Photo 18 shows the condition of the Motorcycle's rear tyre. The rear tyre was observed to be in serviceable condition with remaining tread depth of approximately 5mm. There was no tear, burst mark(s) and/or punctured hole(s) on the sidewalls as well as across the tread of the rear tyre. However the rear tyre was observed to be deflated.

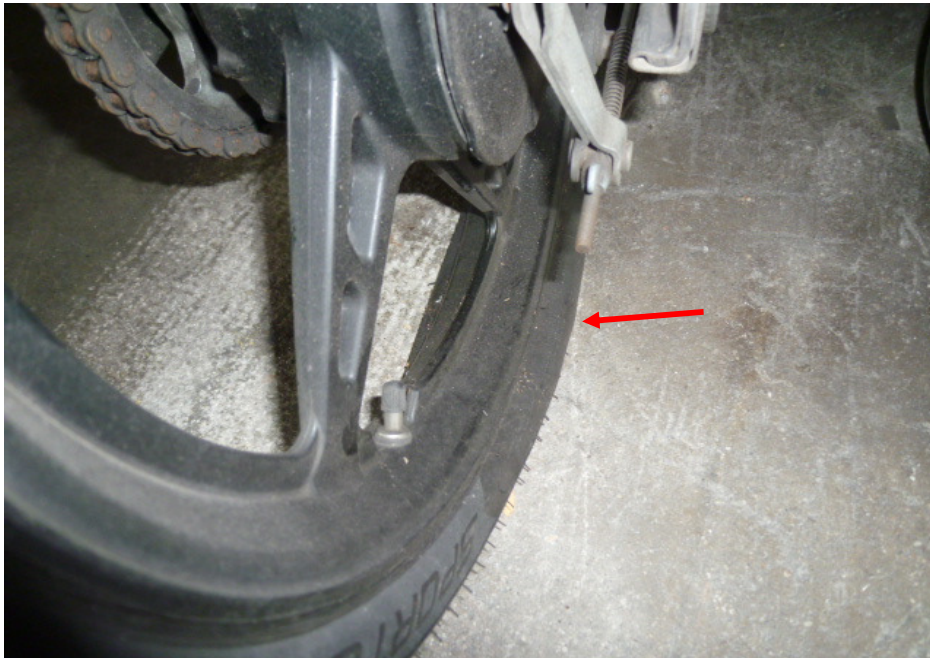
Photo 16 shows the deflated rear tyre (arrowed) of the Motorcycle at the time of our inspection.

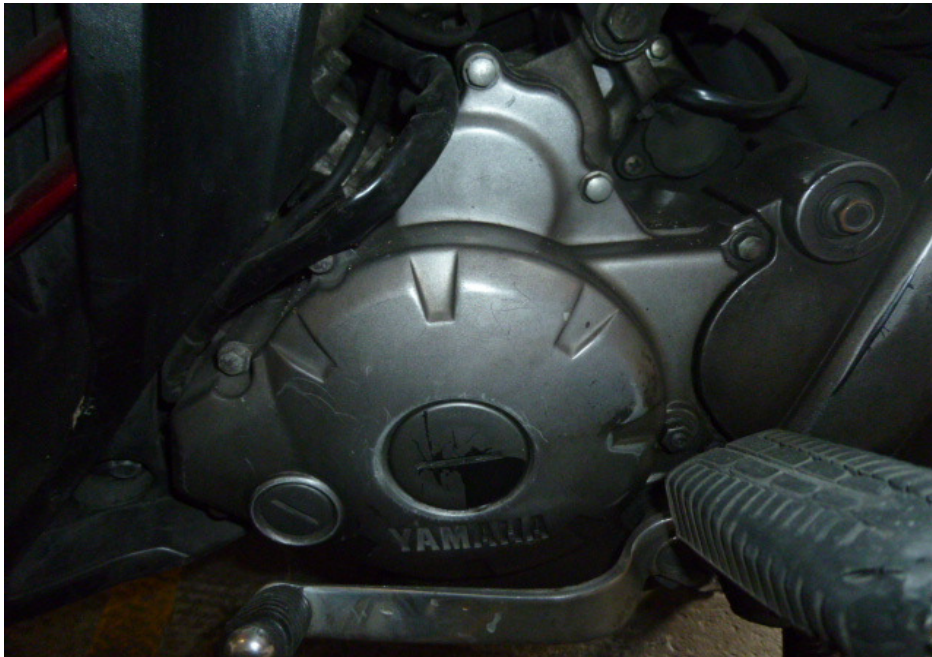
Photo 19 shows the left side of the engine of the Motorcycle at the time of our inspection. The various engine related parts and components were found to be intact with no visible damage. There was also no sign(s) or indication(s) of fluid leak observed around the left engine area of the Motorcycle.

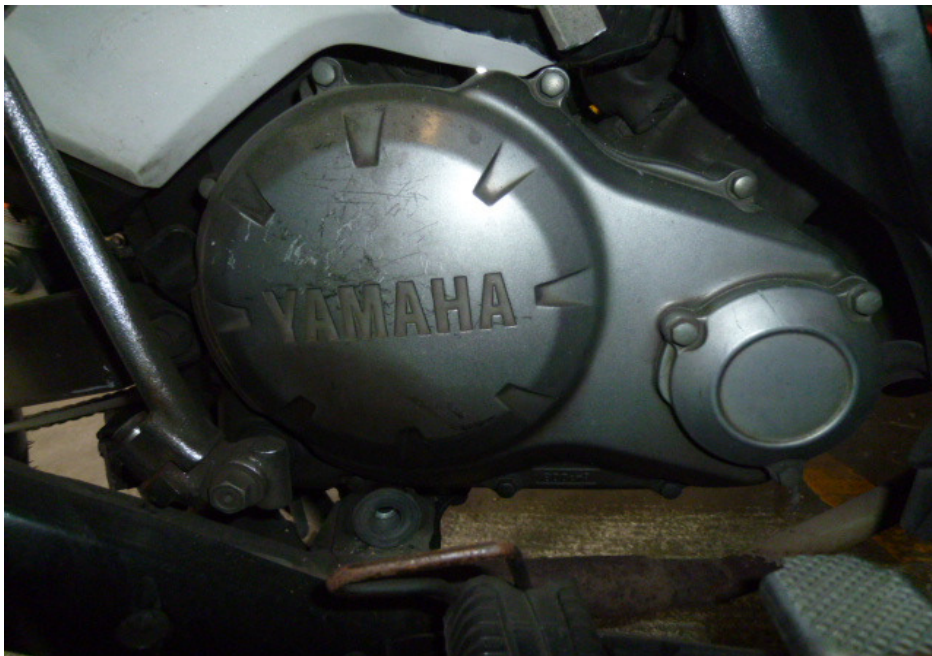
Photo 20 shows the right side of the engine of the Motorcycle at the time of our inspection. The various engine related parts and components were found to be intact with no visible damage. There was also no sign(s) or indication(s) of fluid leak observed around the right engine area of the Motorcycle.

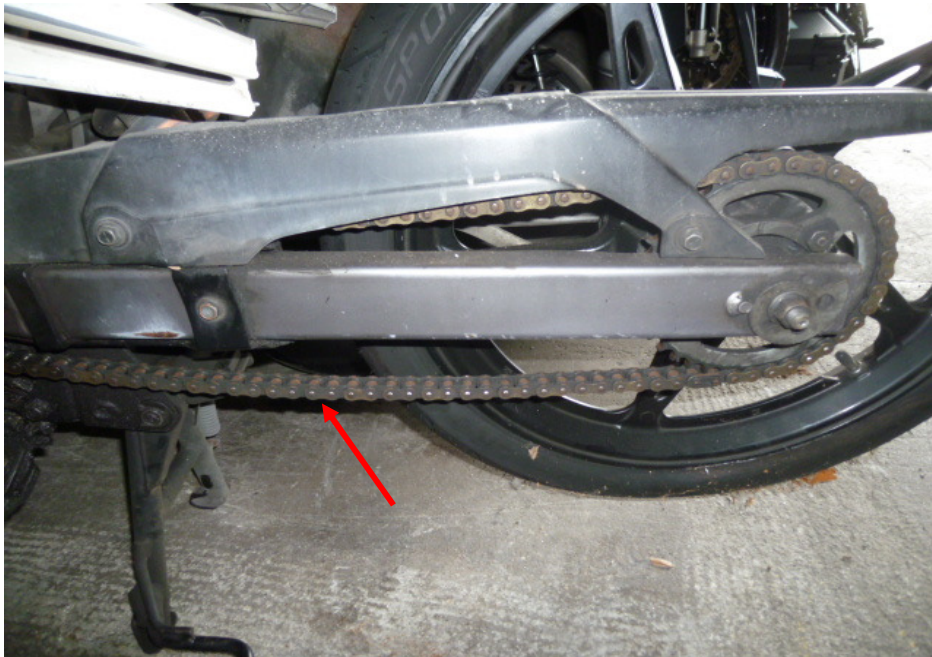
Photo 21 shows the general view of the gear train (arrowed) of the Motorcycle, which was observed to be intact with no misalignment. It was also adequately lubricated for operating purposes.

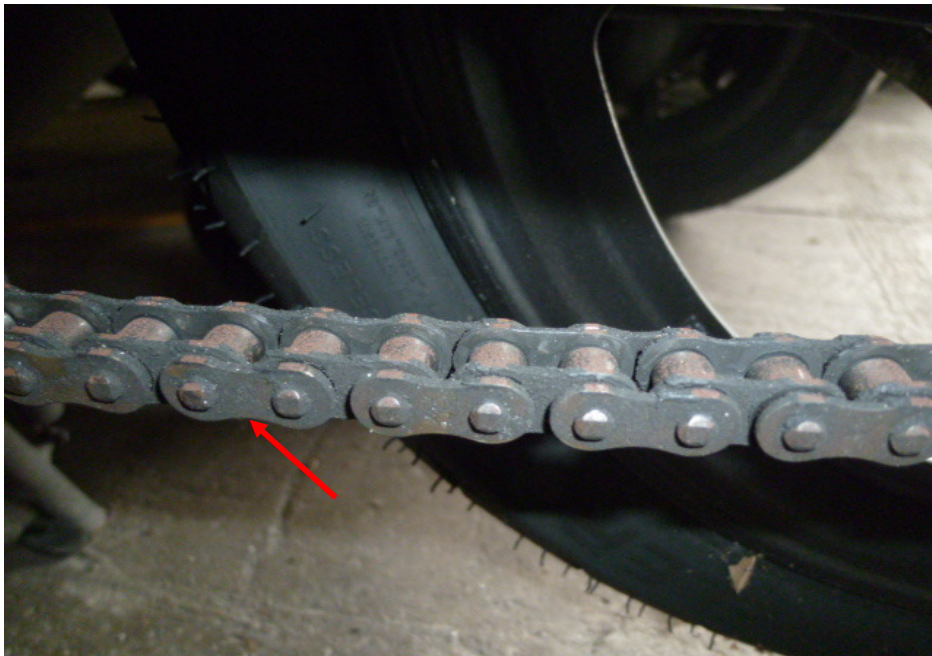
Photo 22 shows a closer view of the gear train (arrowed) of the Motorcycle, which was observed to be intact with no misalignment. It was also adequately lubricated for operating purposes.

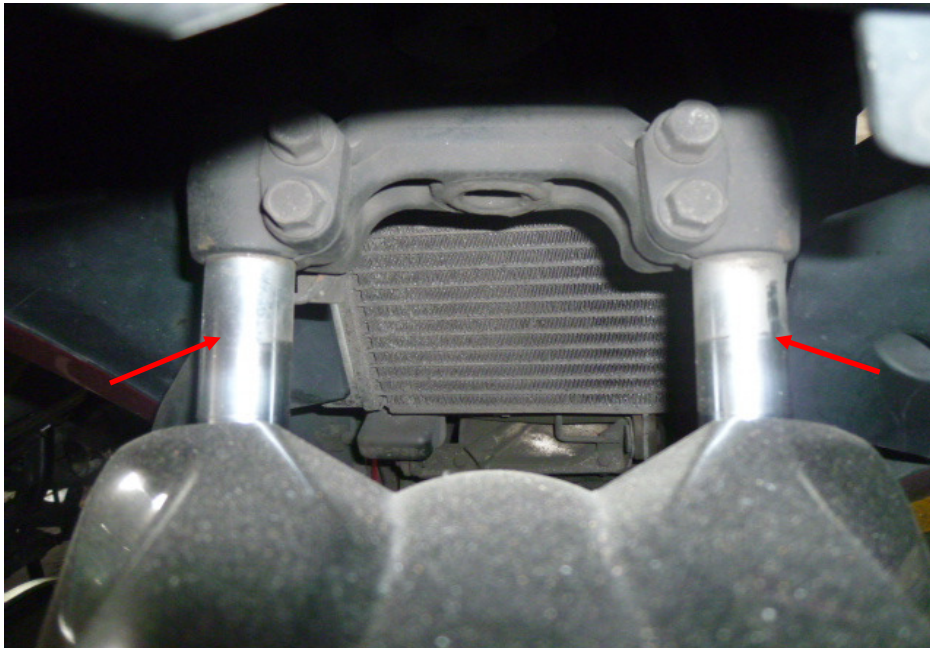
Photo 23 shows the front forks (arrowed) of the Motorcycle. The front forks and fork bracket of the Motorcycle were both found to be intact and undamaged. Turning the Motorcycle's handle bar towards the left and right did not produce any abnormal free play. The steering system of the Motorcycle was in serviceable condition at the time of our inspection.

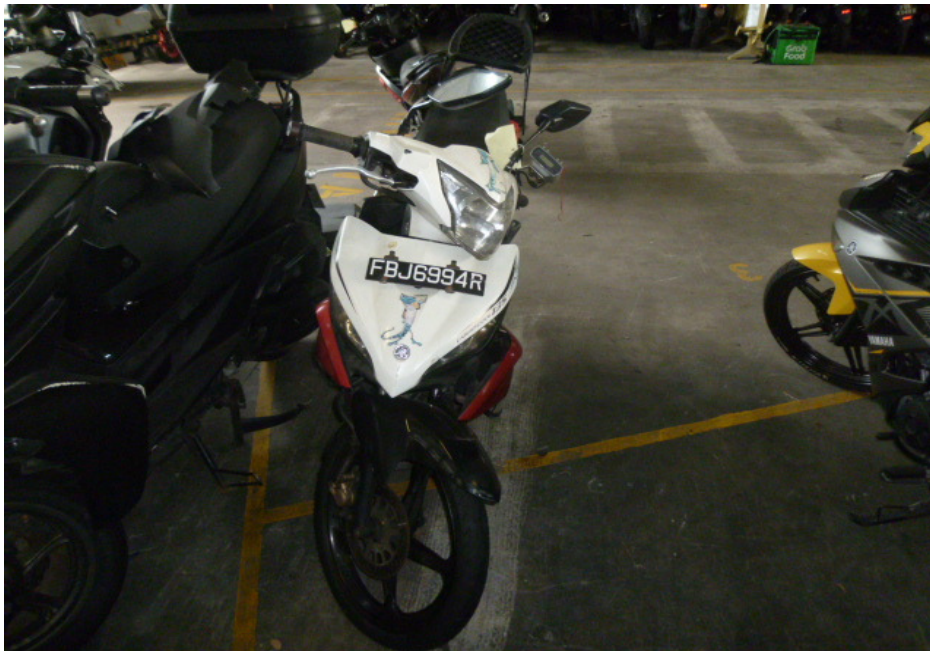
Photo 24 shows the front wheel of the Motorcycle turned towards its full left. Turning the Motorcycle's handle bar towards the left did not produce any abnormal free play and/or resistance. This would indicate that the steering system of the Motorcycle was in serviceable condition at the time of our inspection.

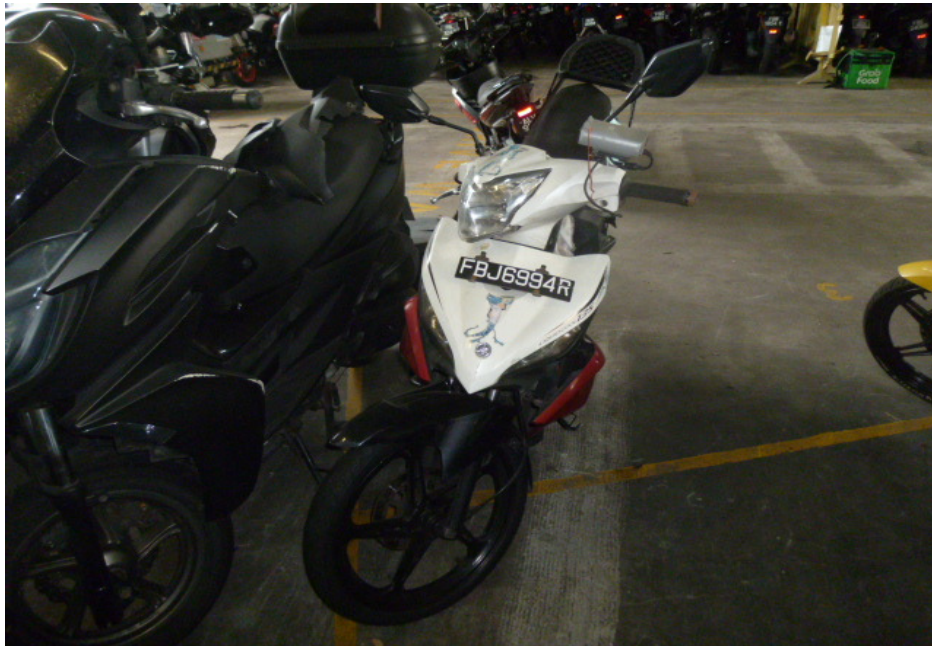
Photo 25 shows the front wheel of the Motorcycle turned towards its full right. Turning the Motorcycle's handle bar towards the right did not produce any abnormal free play and/or resistance. This would indicate that the steering system of the Motorcycle was in serviceable condition at the time of our inspection.

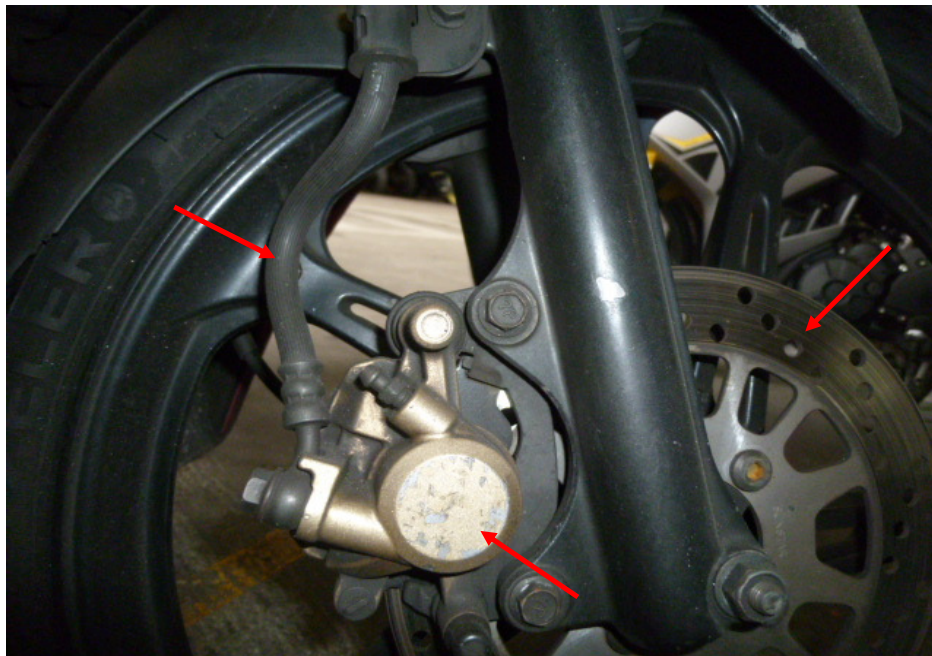
Photo 26 shows a close up view of the front brake caliper, front brake disc and front brake hose (arrowed) of the Motorcycle, which are all part of the components in the hydraulic front brake system of the Motorcycle. Our visual checks of these various components had revealed all to be intact with no visible damage. No leakage of brake fluid was also observed.

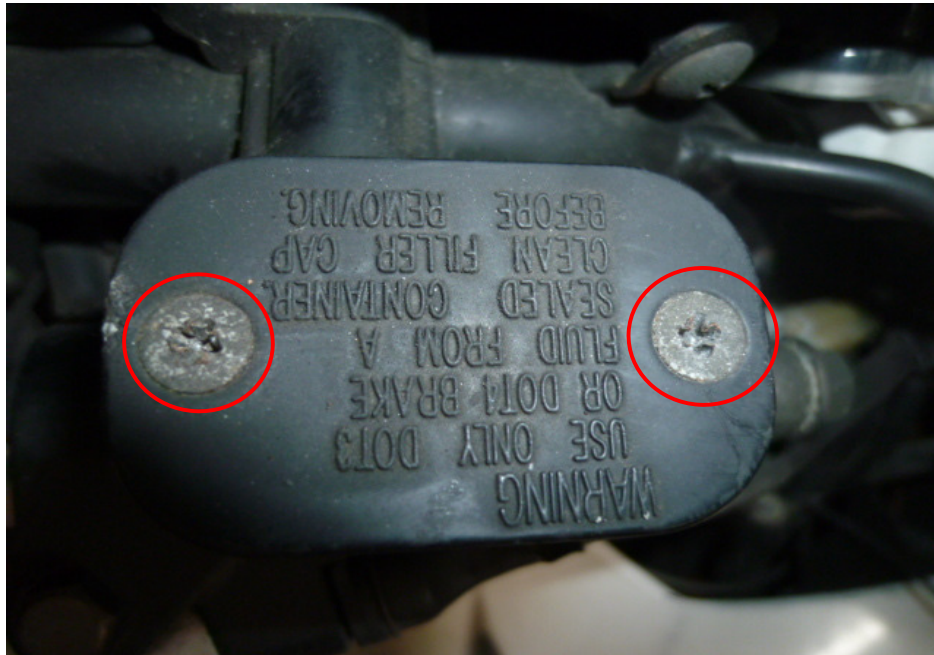
Photo 26 shows the brake fluid reservoir cover for the front brake of the Motorcycle. We were unable to examine whether the front brake fluid was without contamination due to worn out screws (circled).

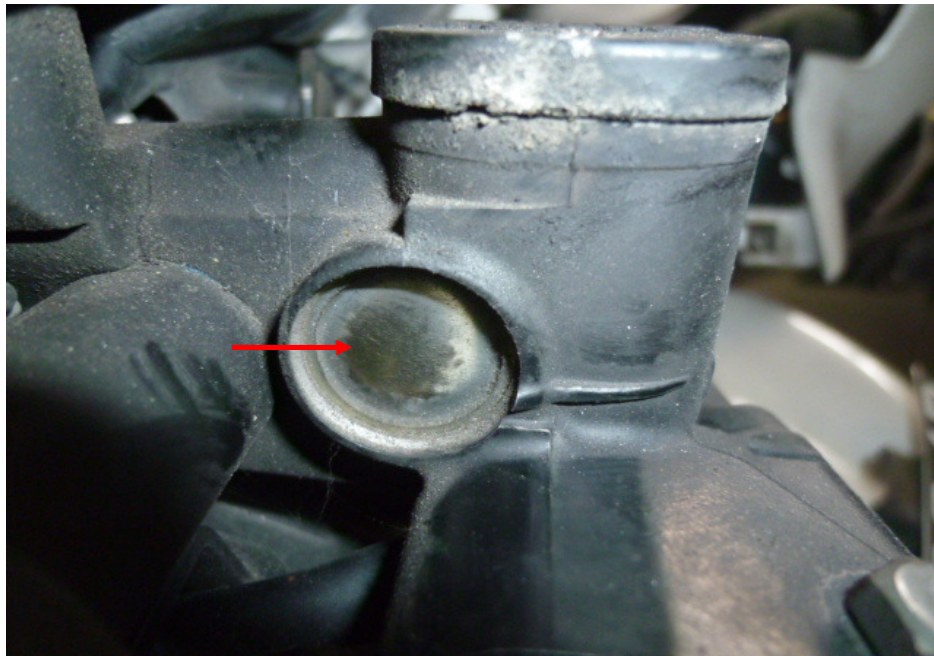
Photo 27 shows a close up view of the brake fluid reservoir for the front brake of the Motorcycle. The brake fluid was observed to be of sufficient level for operational purposes (arrowed).

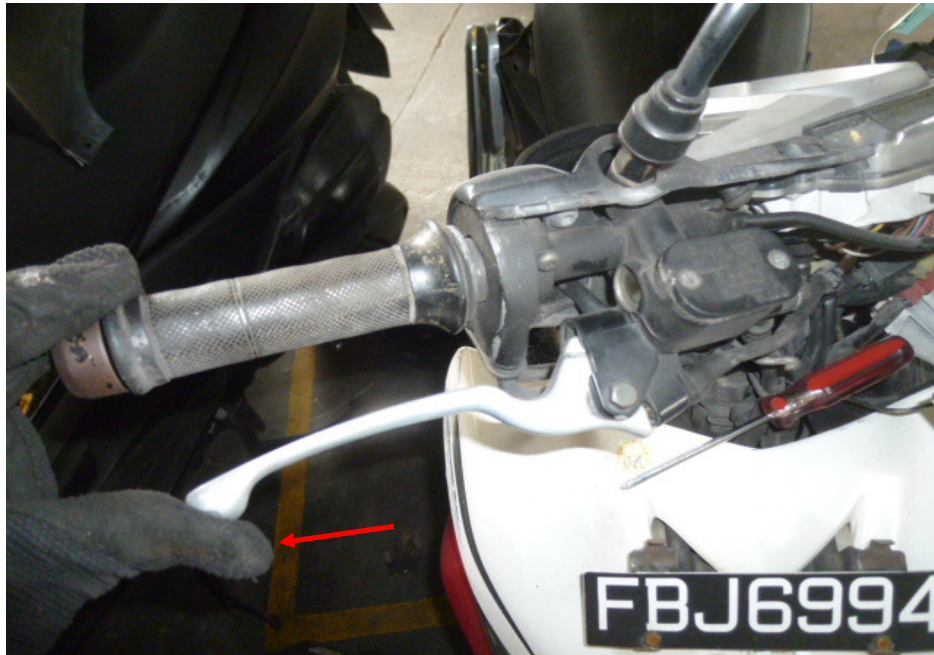
Photo 28 shows the front brake lever being depressed. There was some resistance felt (spongy like feel) upon pressing the front brake lever (arrowed). This would indicate that there is no leakage of pressure/vacuum in the brake system.

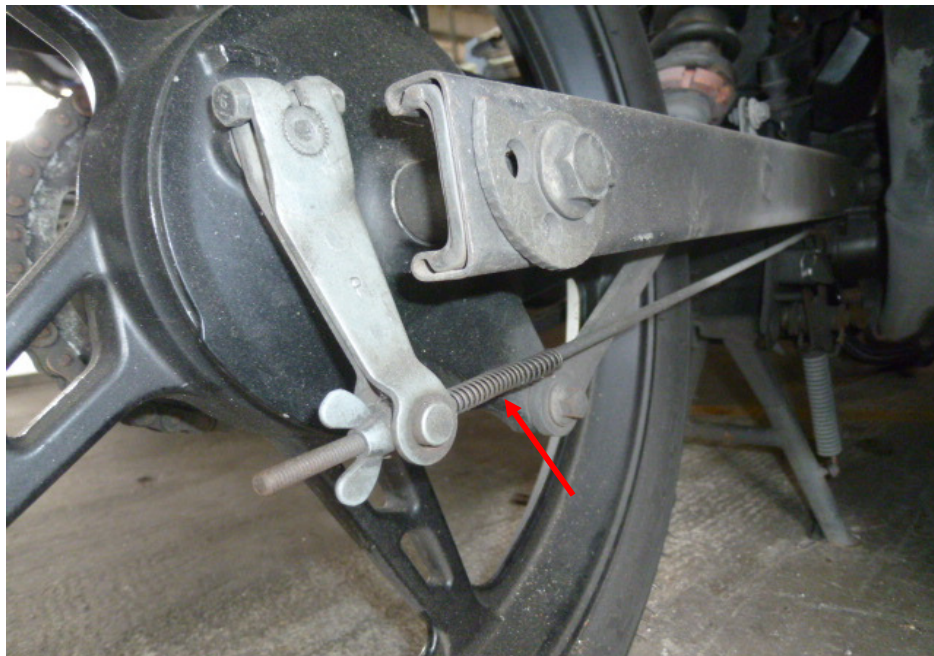
Photo 25 shows the rear wheel of the Motorcycle. The type of brake system for the rear wheel was of a mechanical type, controlled by the brake foot pedal of the Motorcycle. Our checks of the cable (arrowed), spring and drum which are all part of the components in the rear brake system of the Motorcycle reveal all to be intact and without damage.
