**INSPECTION REPORT OF MOTORCYCLE FBM 4518E**

1. We refer to your request dated 30 May 2022 to conduct a physical inspection of a motorcycle bearing registration number FBM 4518E (herein referred to as "**Motorcycle**"), which was involved in a fatal road traffic accident on 13 May 2022.
2. The purpose of this inspection is to primarily determine if there was any possible mechanical failure to the Motorcycle that may have contributed to the accident.
3. Following the request, we had carried out a physical inspection of the Motorcycle on 6 October 2022 at the premises of Traffic Police vehicle pound, 517 Airport Road Singapore 539942. We now set out below our observations and comments with respect to this inspection.

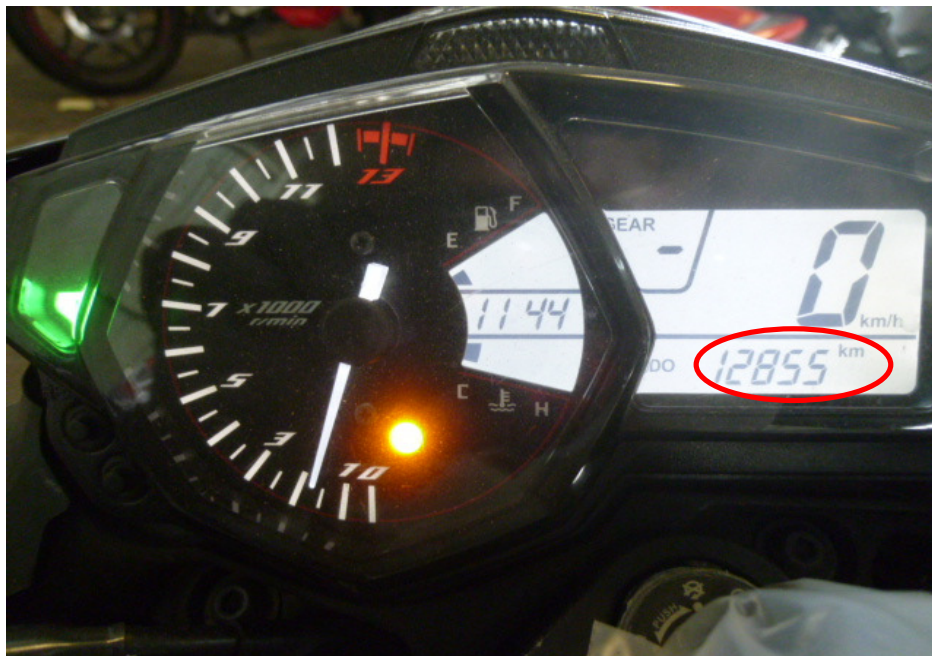
**Photo 1** shows the speedometer gauge of the Motorcycle where the mileage recorded at the time of our inspection was 12, 855km (circled).

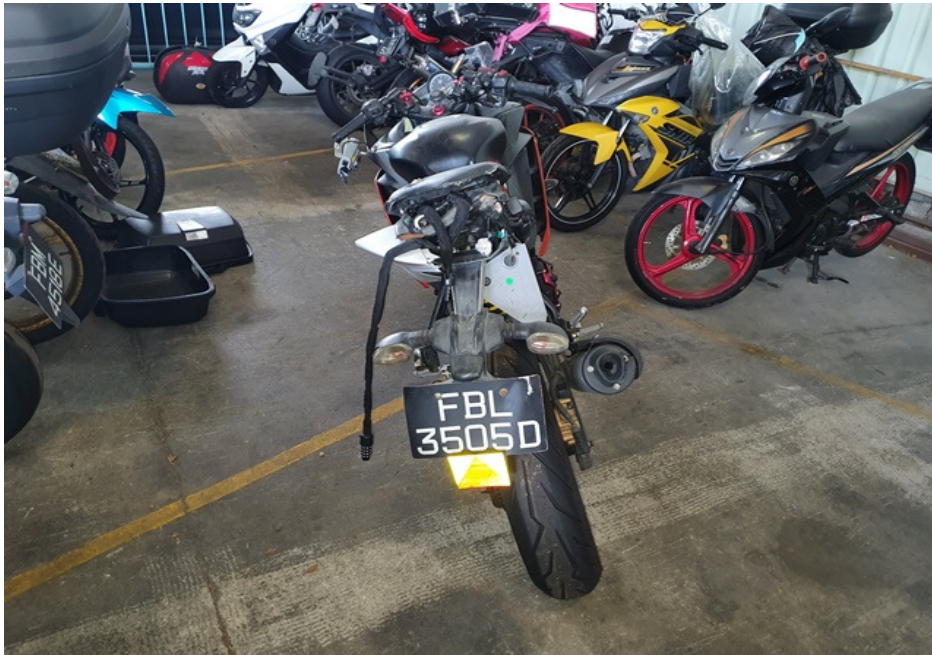
**Photo 2** shows a general view of the rear portion of the Motorcycle at the time of our inspection. The Motorcycle was observed to have sustained damages all around.

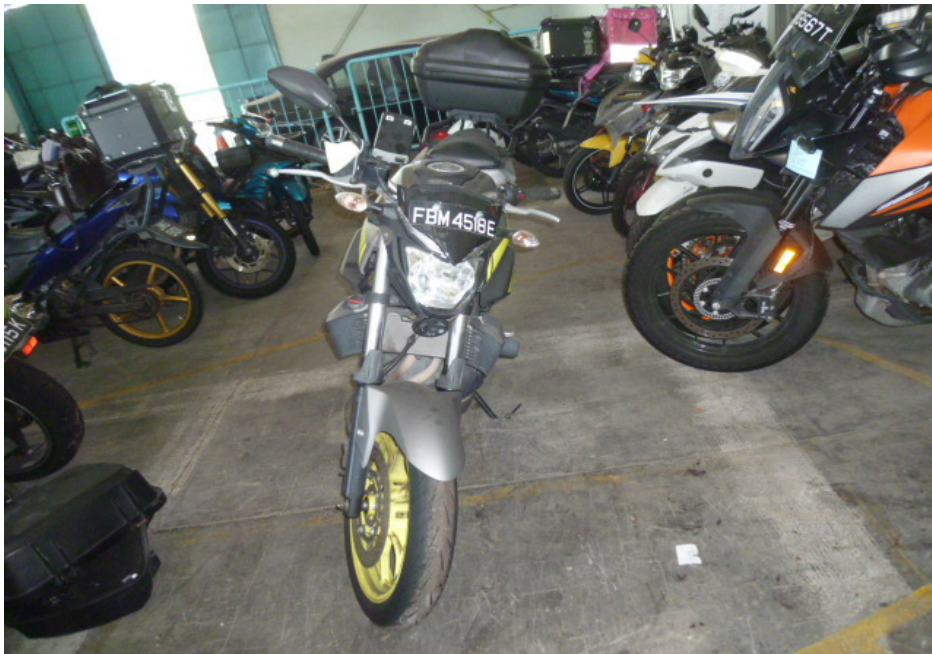
**Photo 3** shows a general view of the frontal portion of the Motorcycle at the time of our inspection. The Motorcycle was observed to have sustained damages all around.

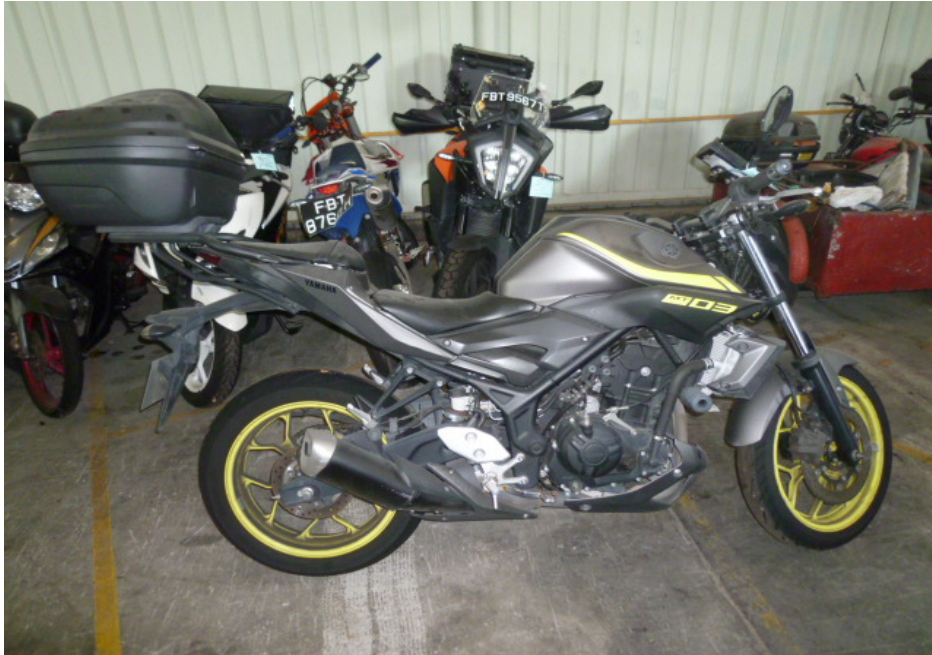
**Photo 4** shows a general view of the right body of the Motorcycle at the time of our inspection. The Motorcycle was observed to have sustained damages all around. Amongst the left side mirror, left frame slider, left handlebar end, clutch lever, left pillion foot peg, left rear side cover, left rear signal lamp, exhaust muffler and top box, amongst others.

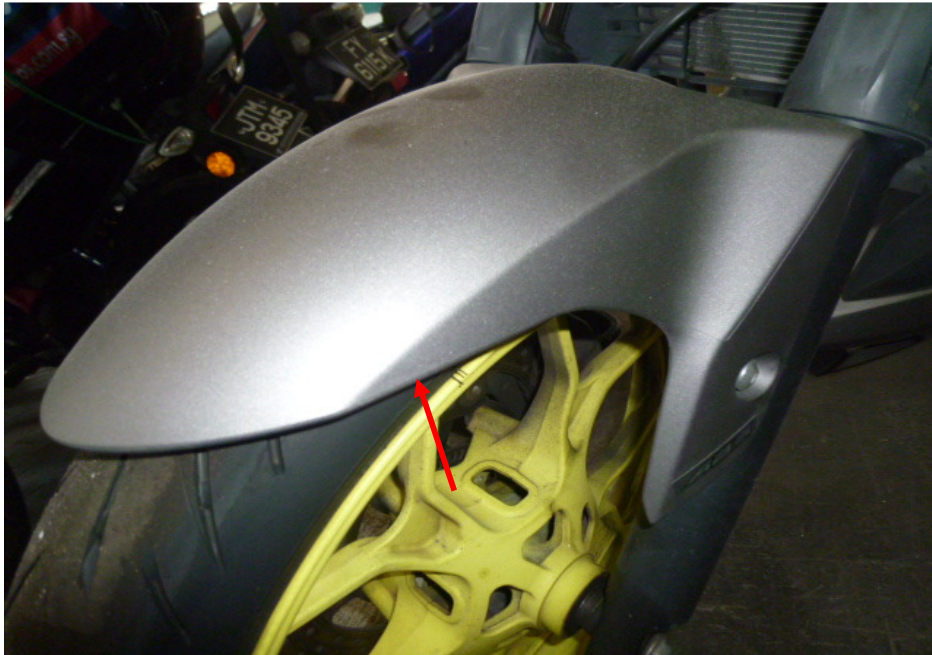
**Photo 5** shows a closer view of the front mudguard (arrowed) which was amongst the body parts at the front body of the Motorcycle that had sustained damage as a result of the accident.

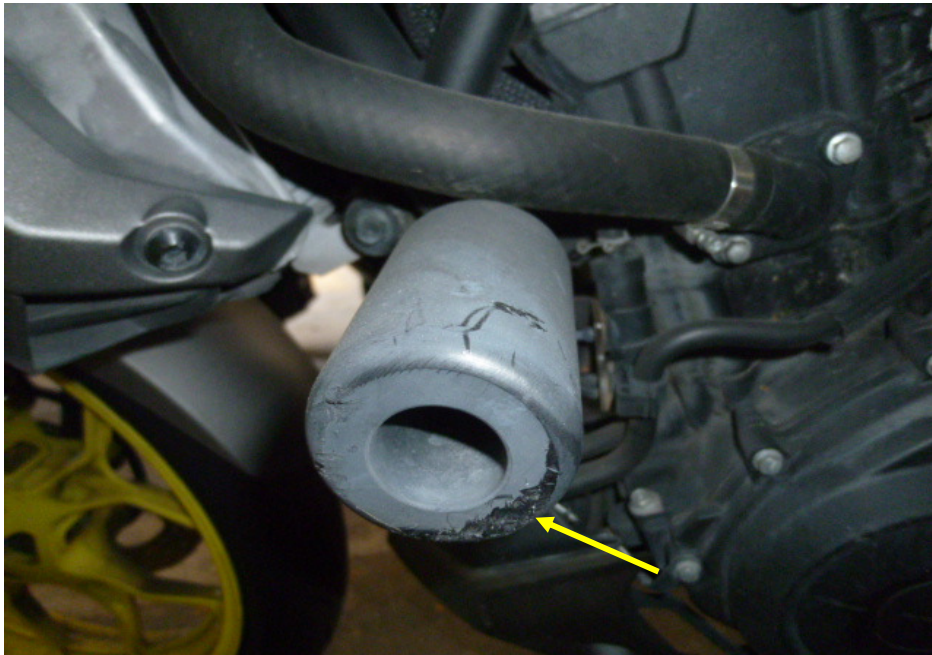
**Photo 6** shows a closer view of the left frame slider of the Motorcycle that had sustained damages of grazing nature as a result of the accident (arrowed).

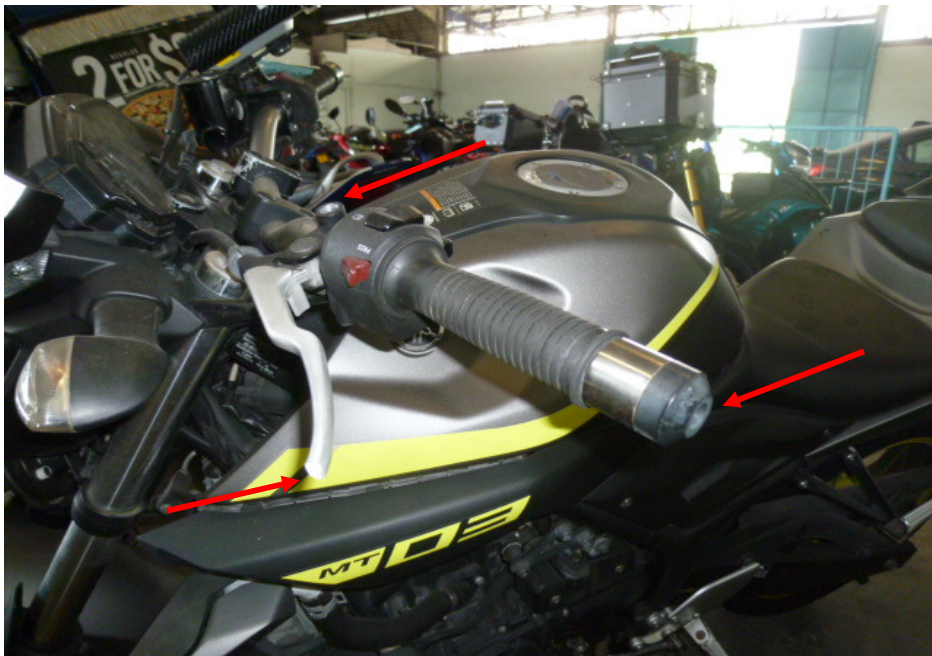
**Photo 7** shows a closer view of the left handlebar end, left side mirror and clutch lever (arrowed) which were amongst the body parts of the Motorcycle that had sustained damage as a result of the accident.

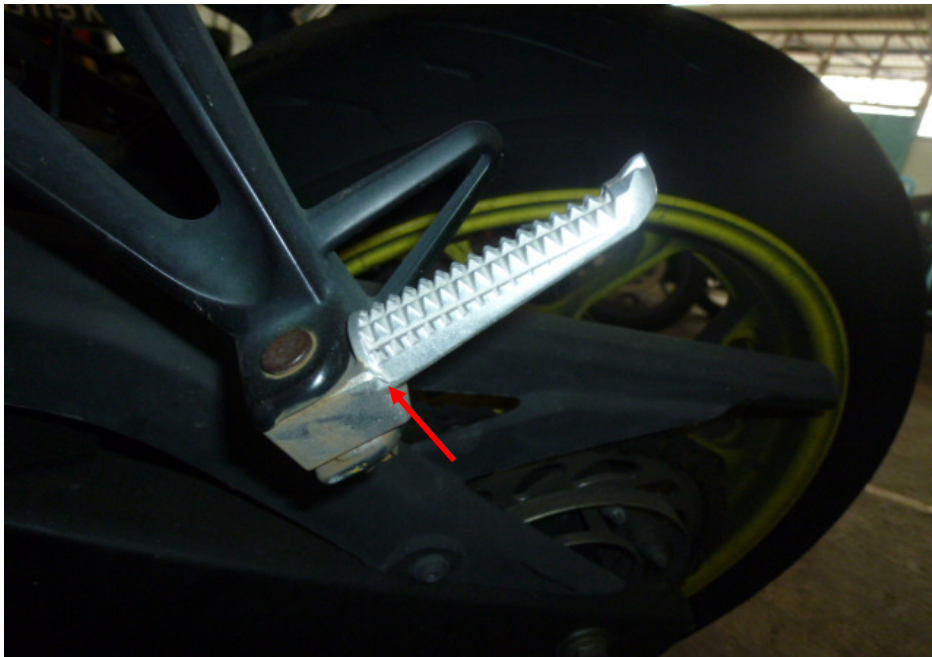
**Photo 8** shows a closer view of the left pillion foot peg (arrowed) which was amongst the body parts of the Motorcycle that had sustained damage as a result of the accident

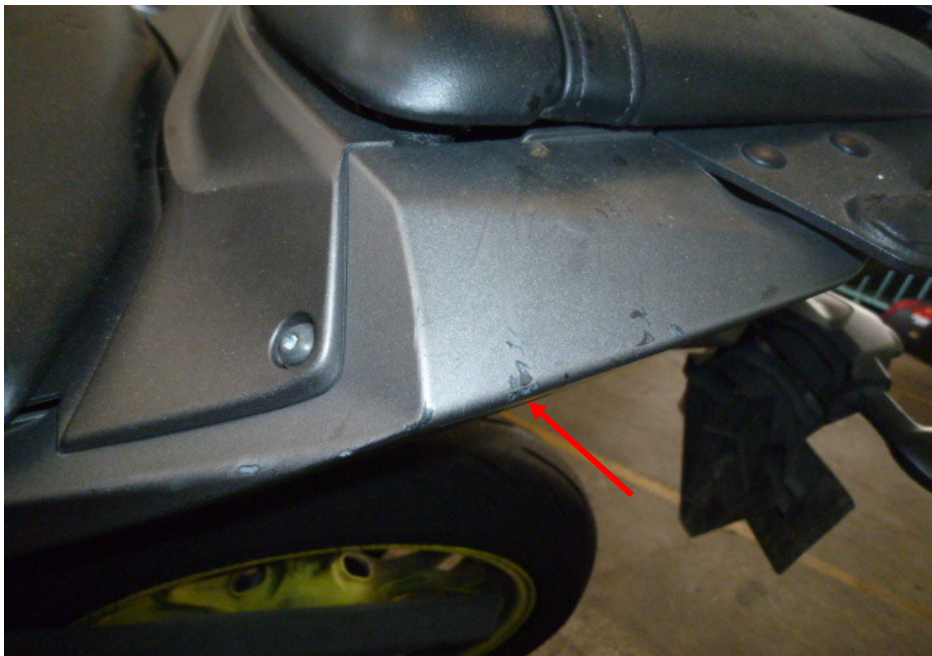
**Photo 9** shows a closer view of the left rear side cover of the Motorcycle that had sustained damages of grazing nature as a result of the accident (arrowed).

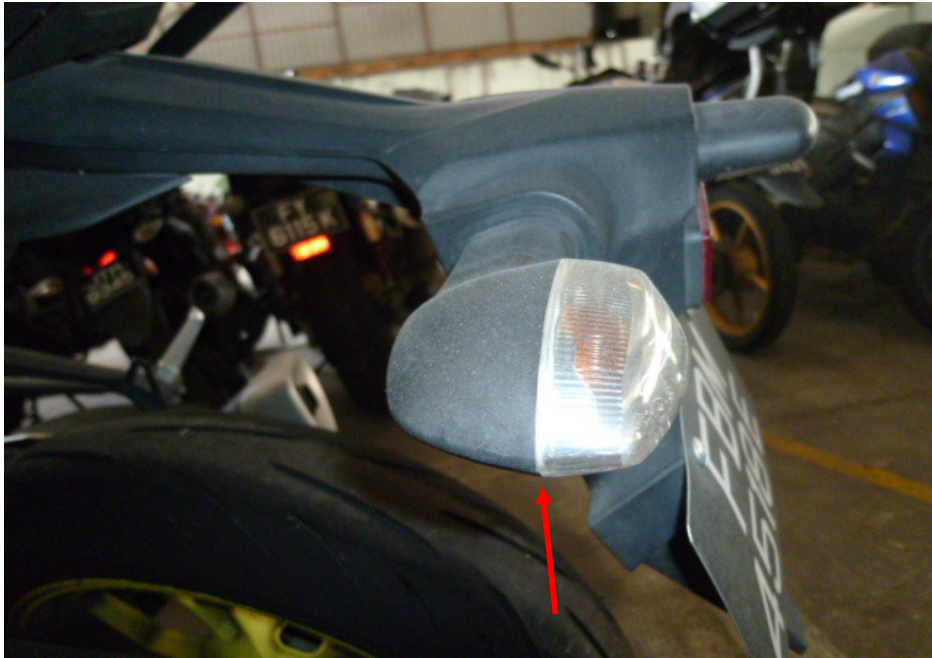
**Photo 10** shows a closer view of the grazed left rear signal lamp of the Motorcycle as a result of the accident (accident).

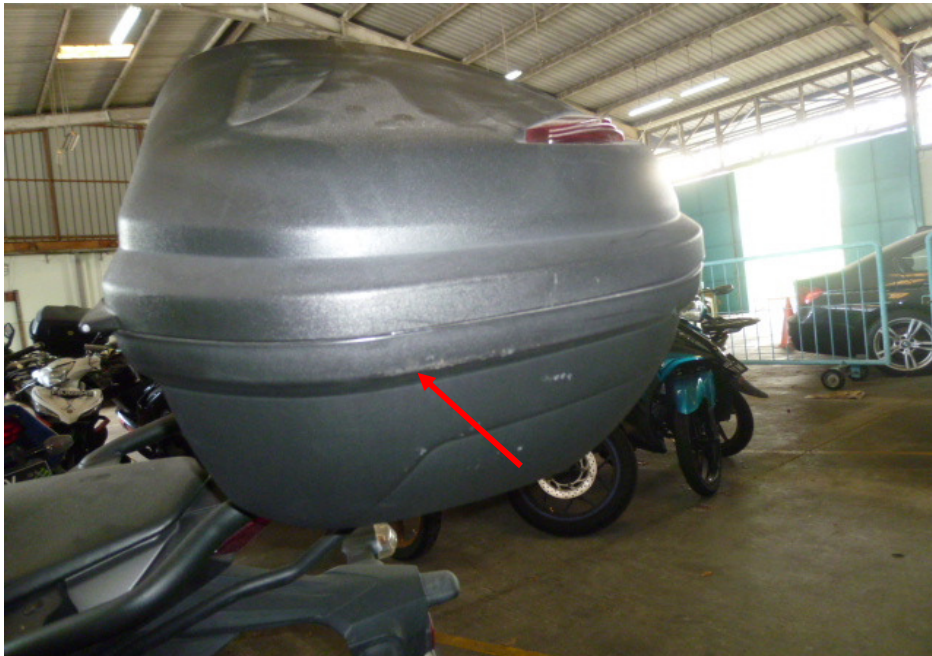
**Photo 11** shows a closer view of the top box of the Motorcycle that had sustained damages of grazing nature as a result of the accident (arrowed).

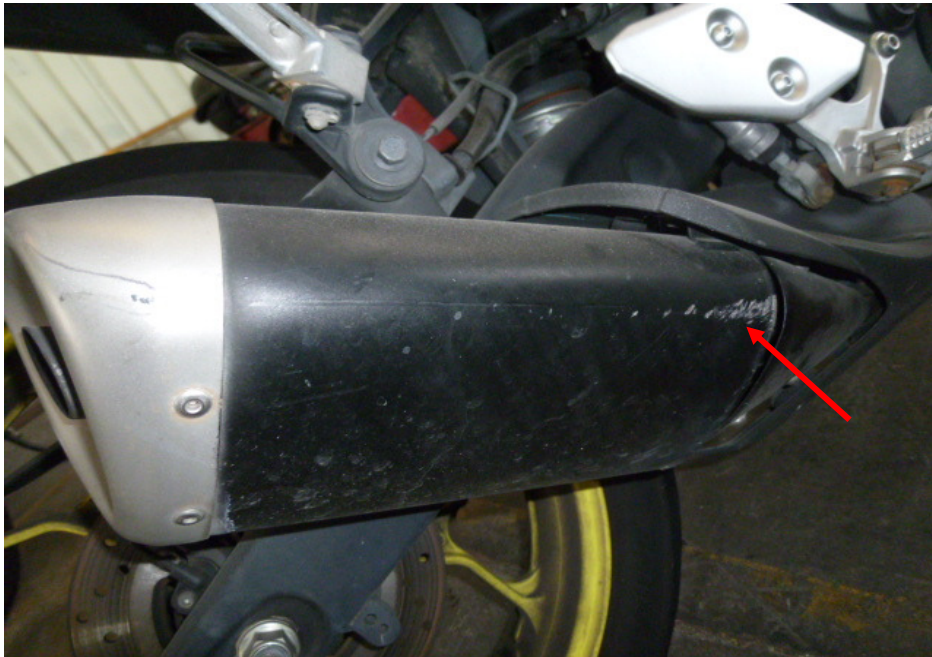
**Photo 12** shows a closer view of the exhaust muffler of the Motorcycle that had sustained damages of grazing nature as a result of the accident (arrowed).

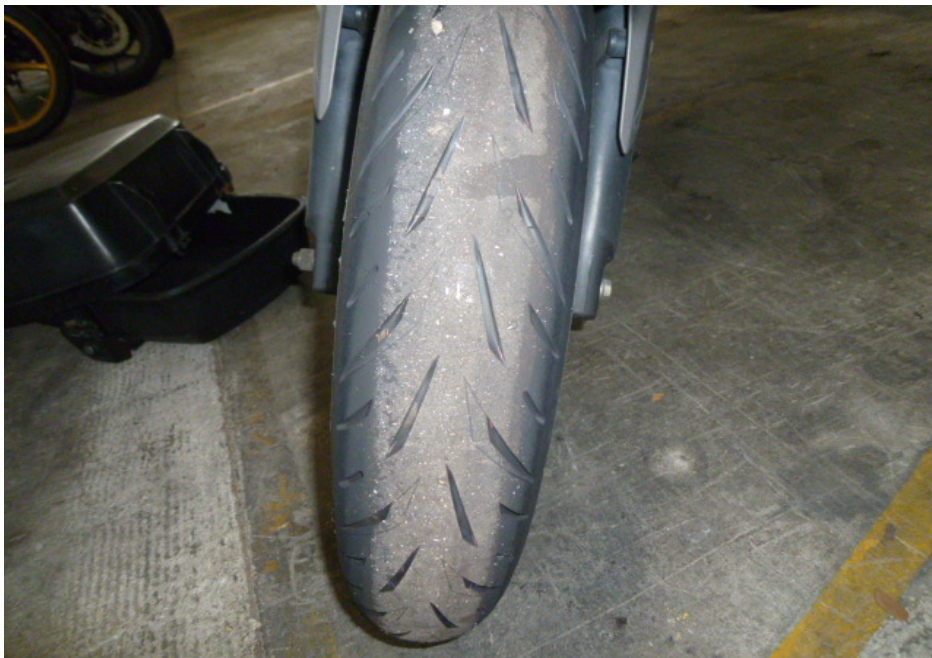
**Photo 13** shows the condition of the Motorcycle's front tyre. The front tyre was observed to be in serviceable condition with remaining tread depth of approximately 3mm. There was no tear, burst mark(s) and/or punctured hole(s) on the sidewalls as well as across the tread of the front tyre.

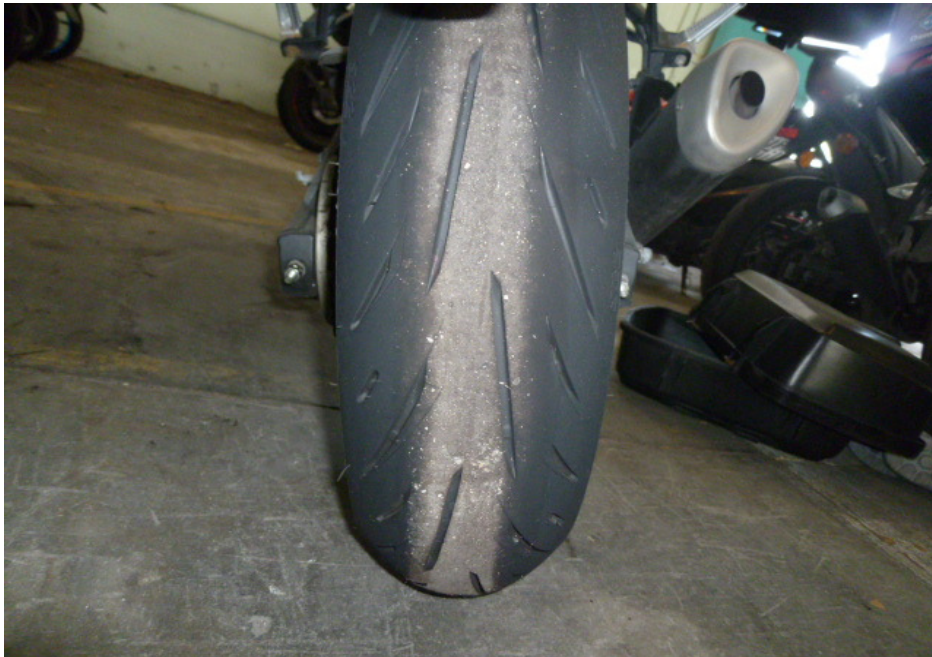
**Photo 14** shows the condition of the Motorcycle's rear tyre. The rear tyre was observed to be in serviceable condition with remaining tread depth of approximately 4mm. The tyre was also observed to be sufficiently inflated for vehicular operation. We did not observe any tear, burst mark(s) and/or punctured hole(s) on the sidewalls as well as across the tread of the rear tyre.

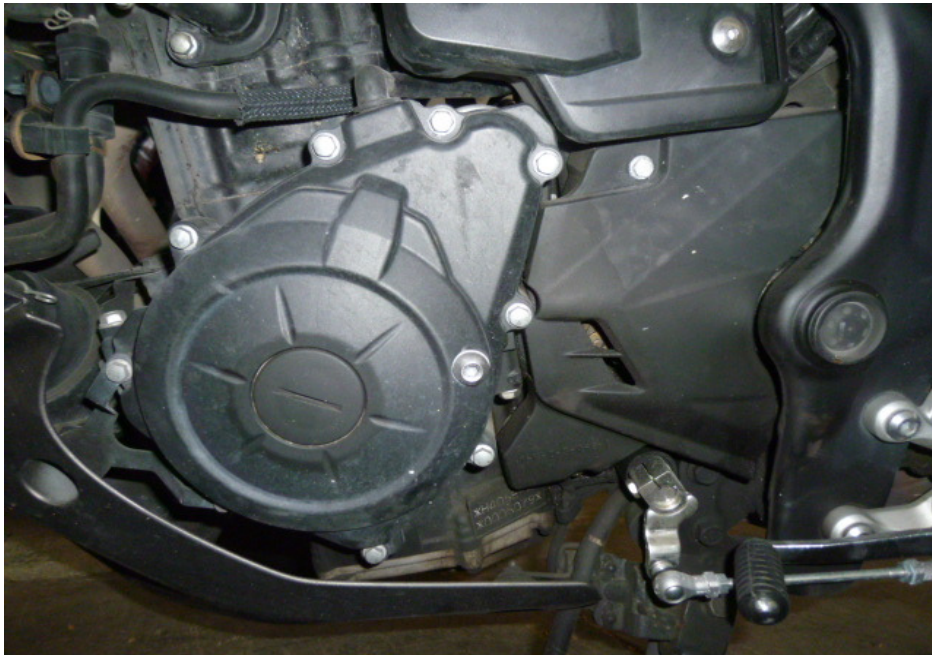
**Photo 15** shows the left side of the engine of the Motorcycle at the time of our inspection. The various engine related parts and components were found to be intact with no visible damage. There was also no sign(s) or indication(s) of fluid leak observed around the left engine area of the Motorcycle.

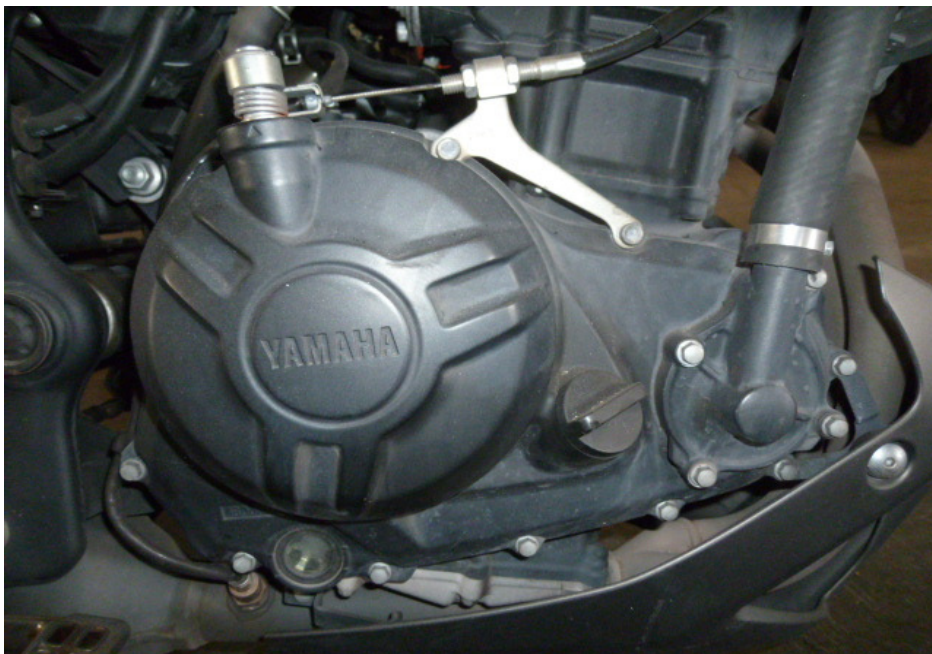
**Photo 16** shows the right side of the engine of the Motorcycle at the time of our inspection. The various engine related parts and components were found to be intact with no visible damage. There was also no sign(s) or indication(s) of fluid leak observed around the right engine area of the Motorcycle.

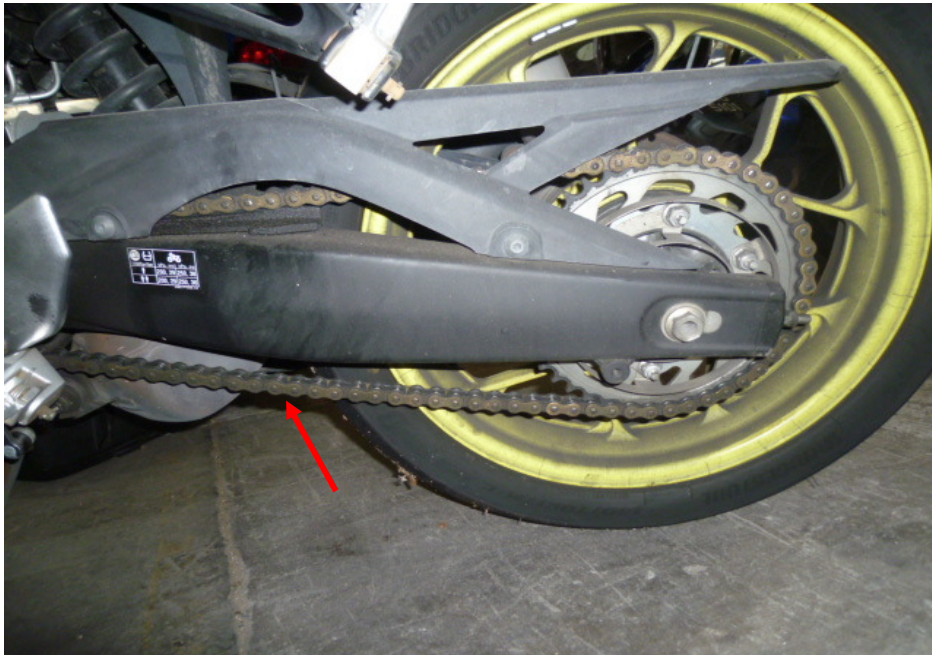
**Photo 17** shows the general view of the gear train (arrowed) of the Motorcycle, which was observed to be intact with no misalignment. It was also adequately lubricated for operating purposes.

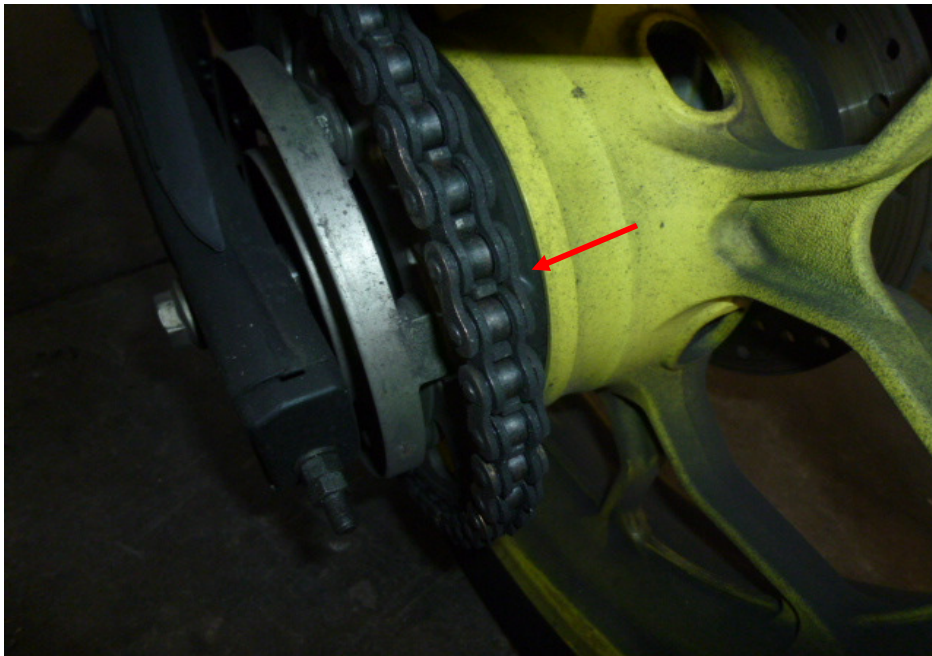
**Photo 18** shows a closer view of the gear train (arrowed) of the Motorcycle, which was observed to be intact with no misalignment. It was also adequately lubricated for operating purposes.

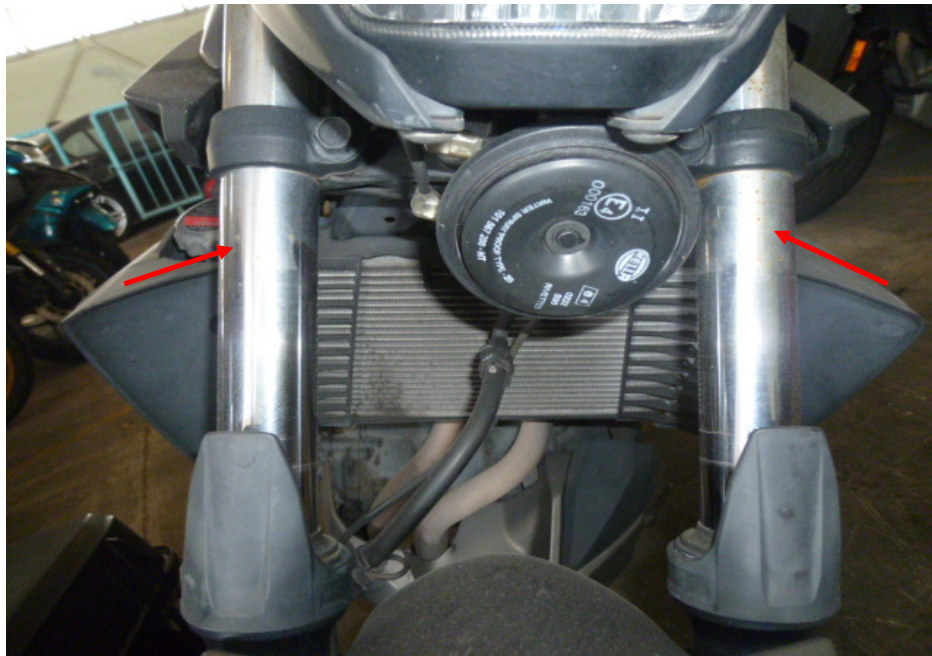
**Photo 19** shows the front forks (arrowed) of the Motorcycle. The front fork and fork bracket of the Motorcycle were both found to be intact and undamaged. Turning the Motorcycle's handle bar towards the left and right did not produce any abnormal free play and/or resistance. The steering system of the Motorcycle was in serviceable condition at the time of our inspection.

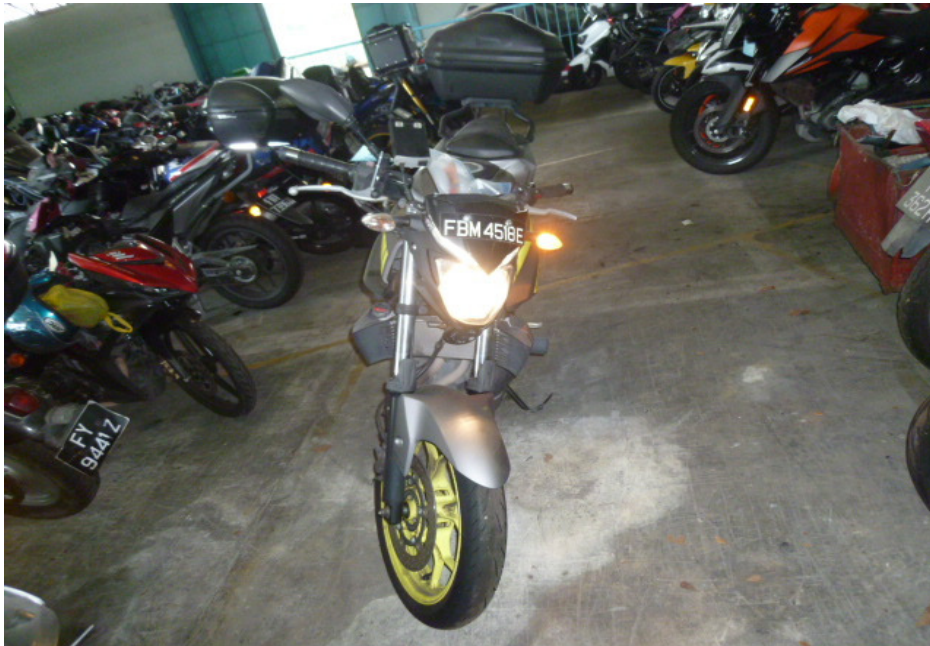
**Photo 20** shows the front wheel of the Motorcycle turned towards its full left. Turning the Motorcycle's handle bar towards the left and right did not produce any abnormal free play and/or resistance. This would indicate that the steering system of the Motorcycle was in serviceable condition at the time of our inspection.

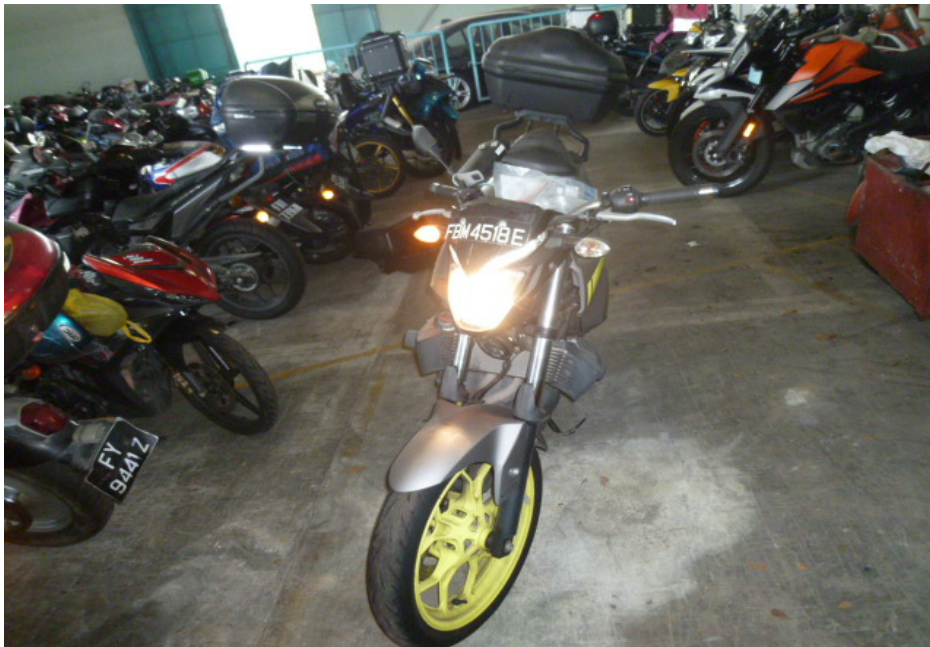
**Photo 21** shows the front wheel of the Motorcycle turned towards its full right. Turning the Motorcycle's handle bar towards the left and right did not produce any abnormal free play and/or resistance. This would indicate that the steering system of the Motorcycle was in serviceable condition at the time of our inspection.

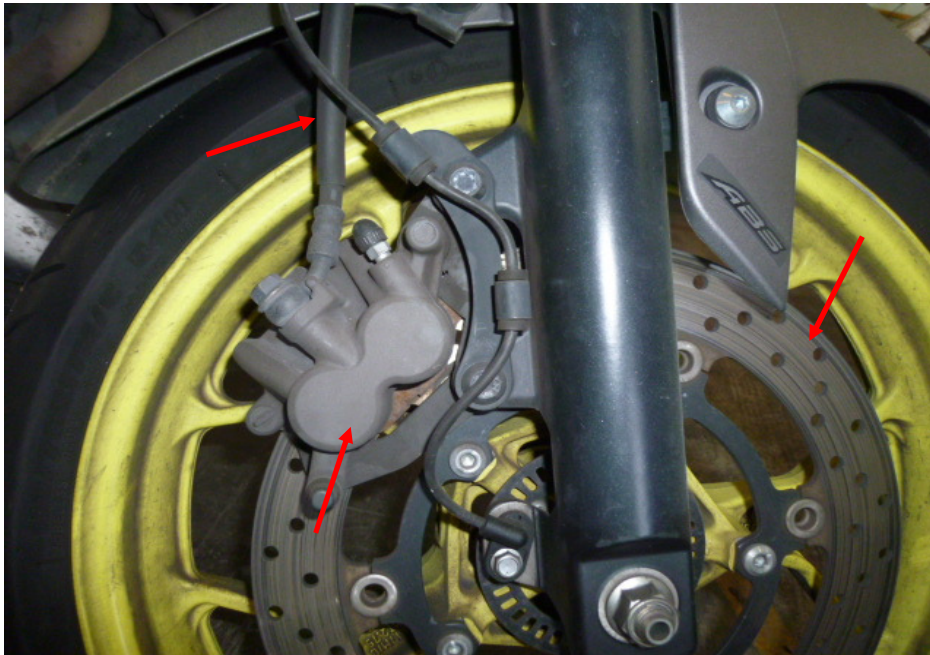
**Photo 22** shows a close up view of the front brake caliper, front brake disc and front brake hose (arrowed) of the Motorcycle, which are all part of the components in the hydraulic front brake system of the Motorcycle. Our visual checks of these various components had revealed all to be intact with no visible damage. No leakage of brake fluid was also observed.

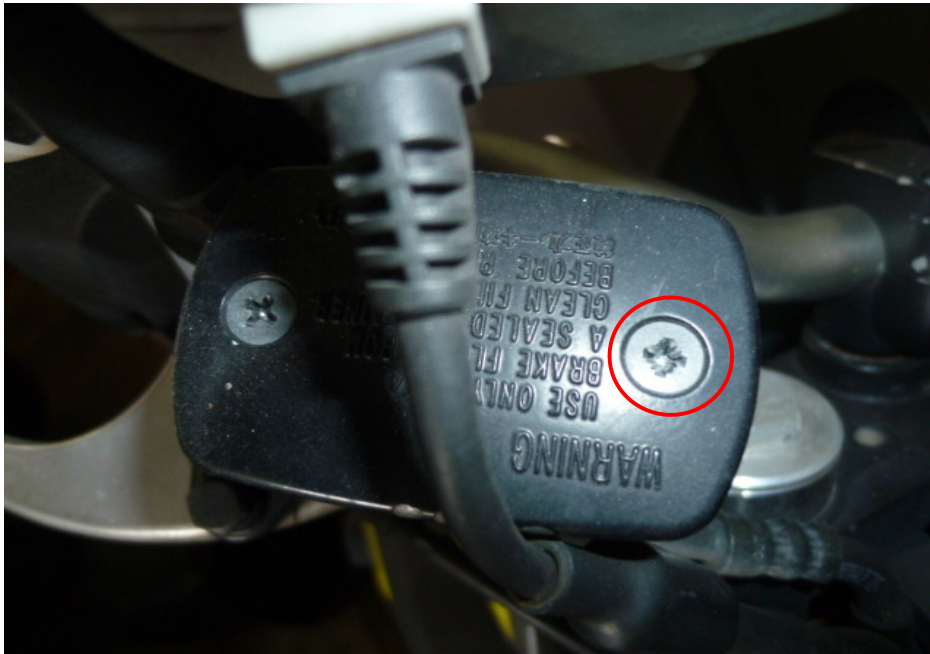
14. The brake fluid for the rear brake was observed to be of sufficient level for operational purposes. However it was found to be slightly contaminated. We were unable to remove the front brake reservoir cover to examine whether the front brake fluid was without contamination due to a worn out screw. However the front brake fluid was observed to be of sufficient level for operational purposes.

**Photo 23** shows the brake fluid reservoir cover for the front brake of the Motorcycle. We were unable to examine whether the front brake fluid was without contamination due to the worn out screw (circled).

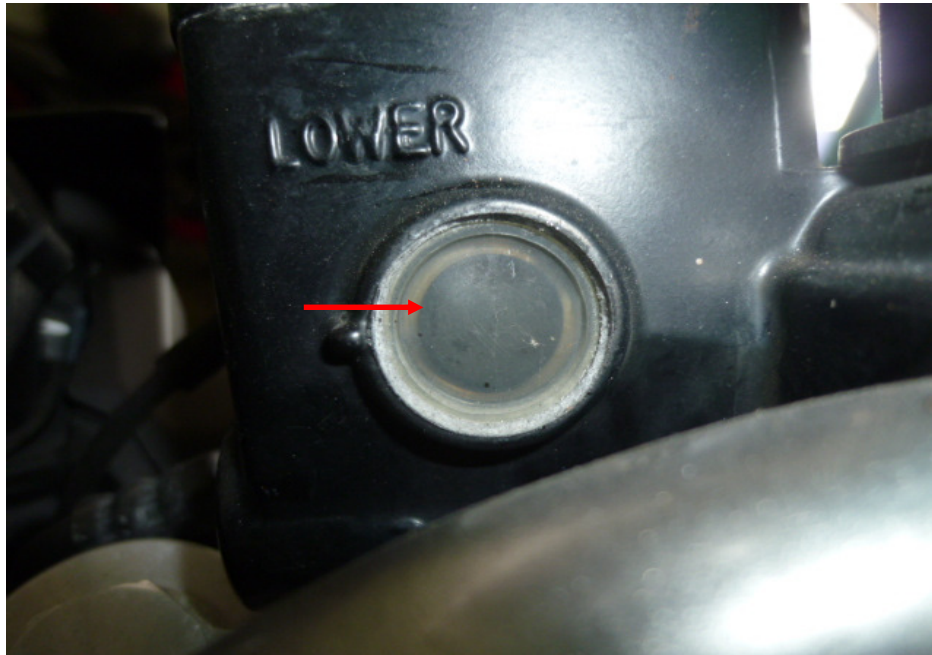
**Photo 24** shows a close up view of the brake fluid reservoir for the front brake of the Motorcycle. The brake fluid was observed to be of sufficient level for operational purposes (arrowed).

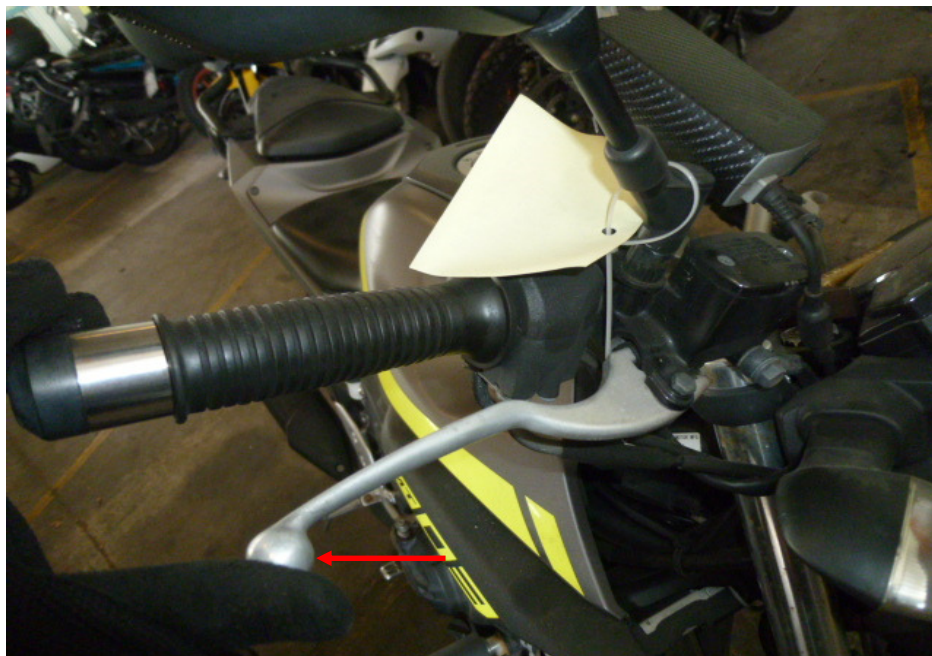
**Photo 25** shows the front brake lever being depressed. There was some resistance felt (spongy like feel) upon pressing the front brake lever (arrowed). This would indicate that there is no leakage of pressure/vacuum in the front brake system.

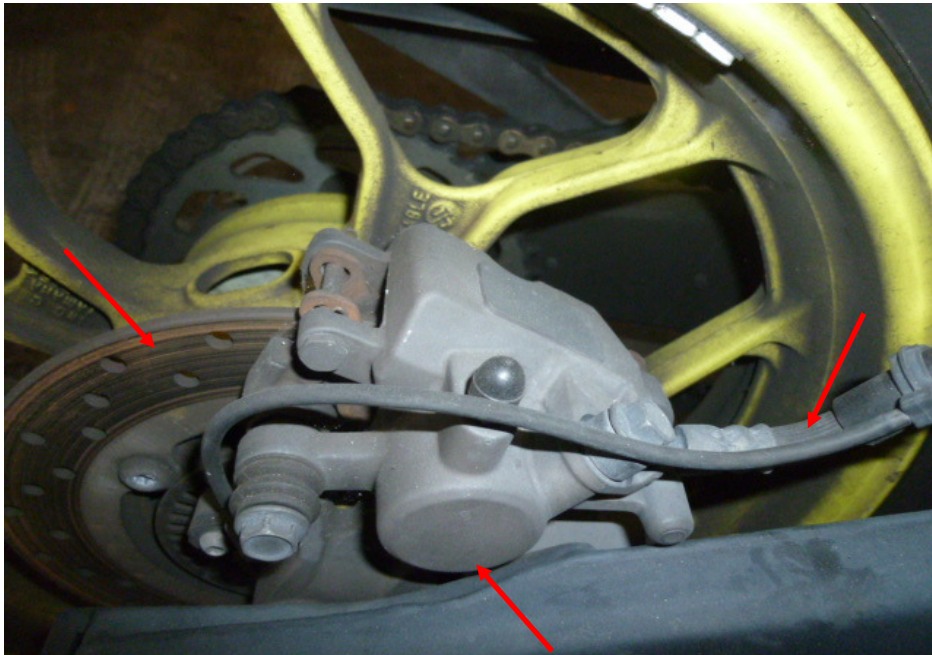
**Photo 26** shows a close up view of the rear brake caliper, rear brake disc and rear brake hose (arrowed) of the Motorcycle, which are all part of the components in the hydraulic rear brake system of the Motorcycle. Our visual checks of these various components had revealed all to be intact with no visible damage. No leakage of brake fluid was also observed.

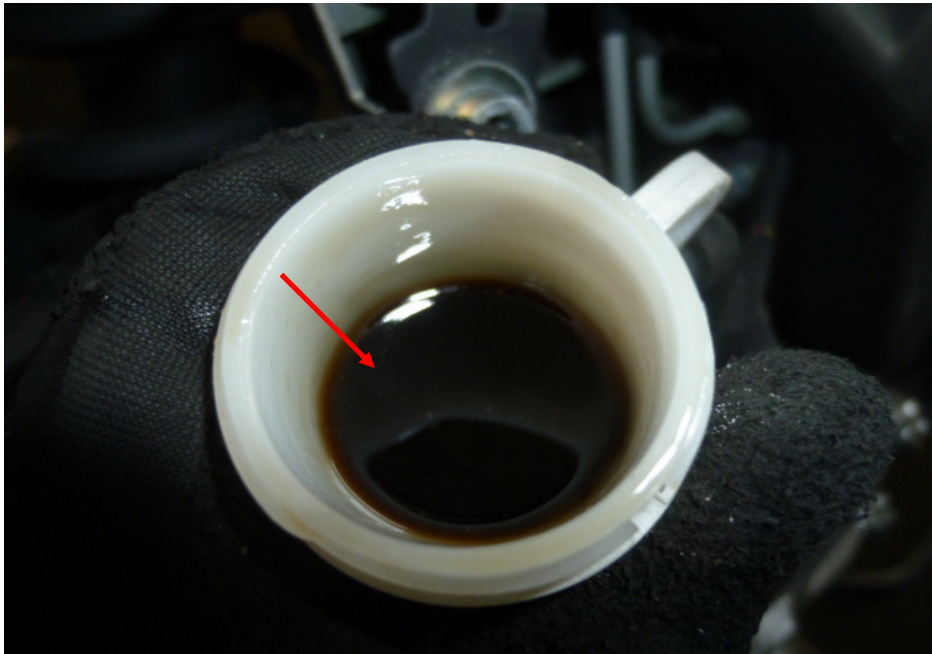
**Photo 27** shows a close up view of the brake fluid reservoir for the rear brake of the Motorcycle. The brake fluid for the rear brake was observed to be of sufficient level for operational purposes. However it was found to be slightly contaminated (arrowed).
