Your Ref: BMW 840i  
(chassis number WBAGV22050CG16963)  
Our Ref : CI/TP22005296/D

**INSPECTION REPORT OF AN UNREGISTERED BMW 840i MOTOR CAR  
WITH CHASSIS NUMBER WBAGV22050CG16963**

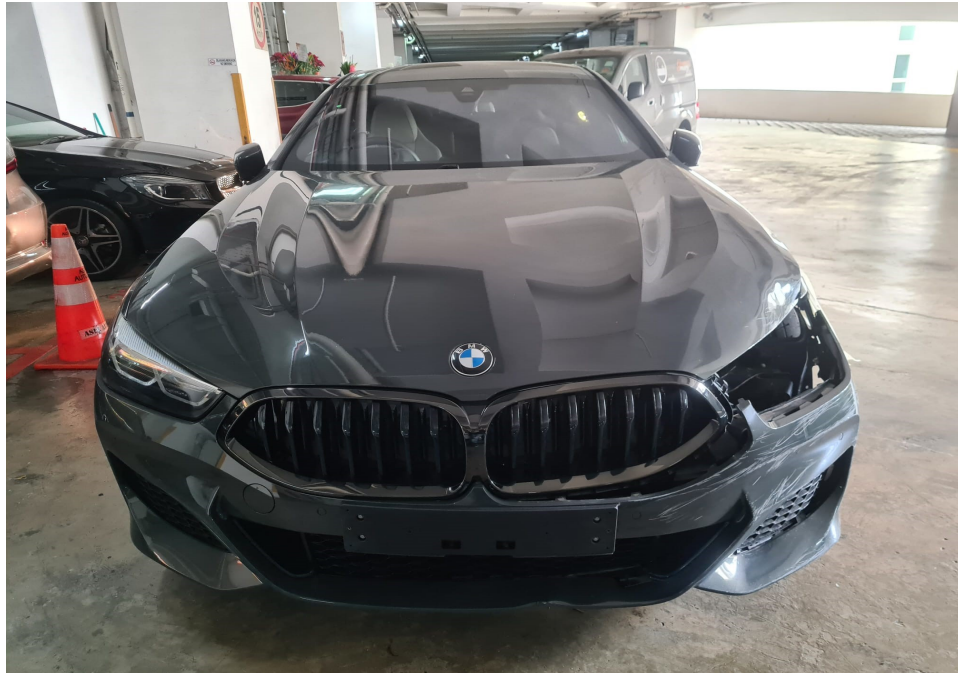
**Photo 1** shows the front body of the Motor Car (photograph provided to me). The photographs provided to me had showed damage to the front left portion of the Motor Car. Body parts damaged include the front bumper, front bumper left lower grille, front bumper centre lower grille, front left radiator grille, front left headlamp and front bonnet amongst others. The airbag(s) was not deployed as seen from the photographs that were provided to me.

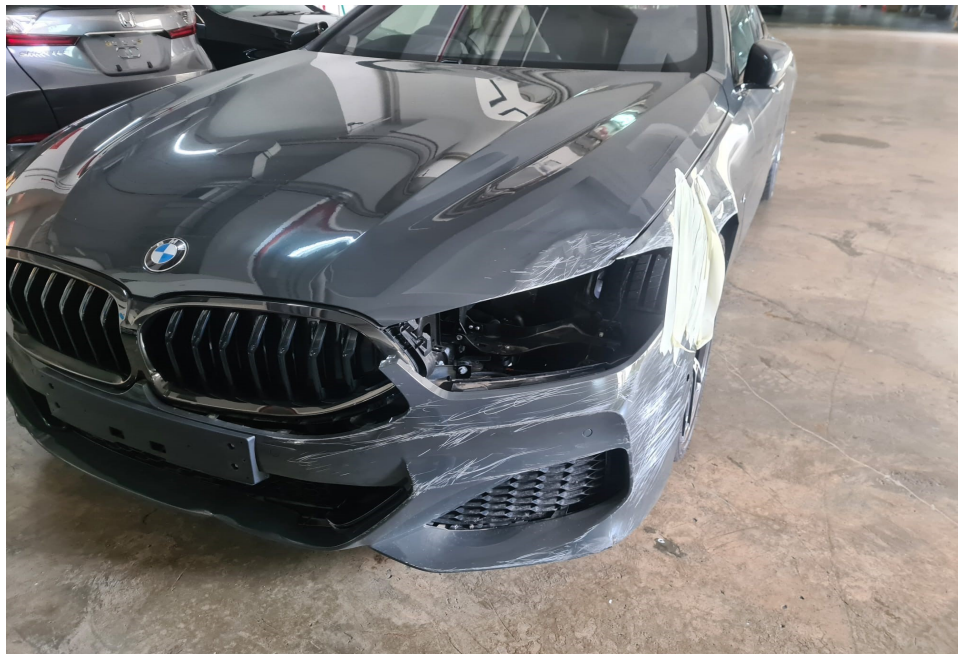
**Photo 2** shows another view of the damaged front left portion of the Motor Car (photograph provided to me). The front bumper, front bumper left lower grille, front left radiator grille, front bonnet, front left headlamp, front left fender and front left fender inner shield were amongst the body parts that were observed to have been damaged.

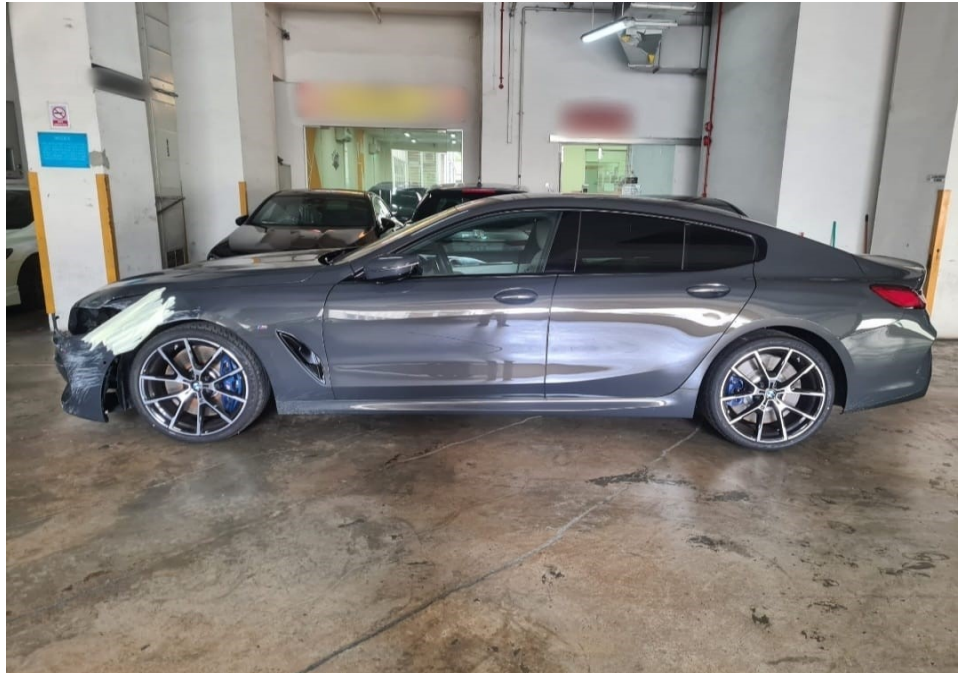
**Photo 3** shows the left side rear body of the Motor Car (photograph provided to me). The photographs provided to me had showed damage to the front left portion of the Motor Car. The front bumper, front left fender, front left headlamp and front bonnet were amongst the body parts that were observed to have been damaged. The airbag(s) was not deployed as seen from the photographs that were provided to me.

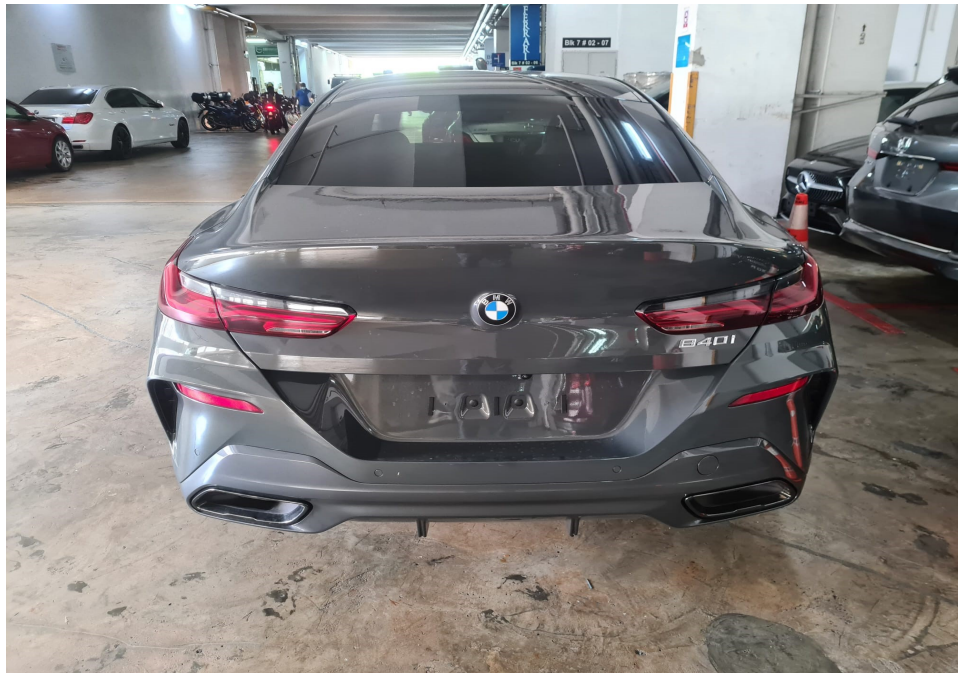
**Photo 4** shows the rear body of the Motor Car (photograph provided to me). Apart for the front left portion, there was no physical damage observed to other areas of the Motor Car.

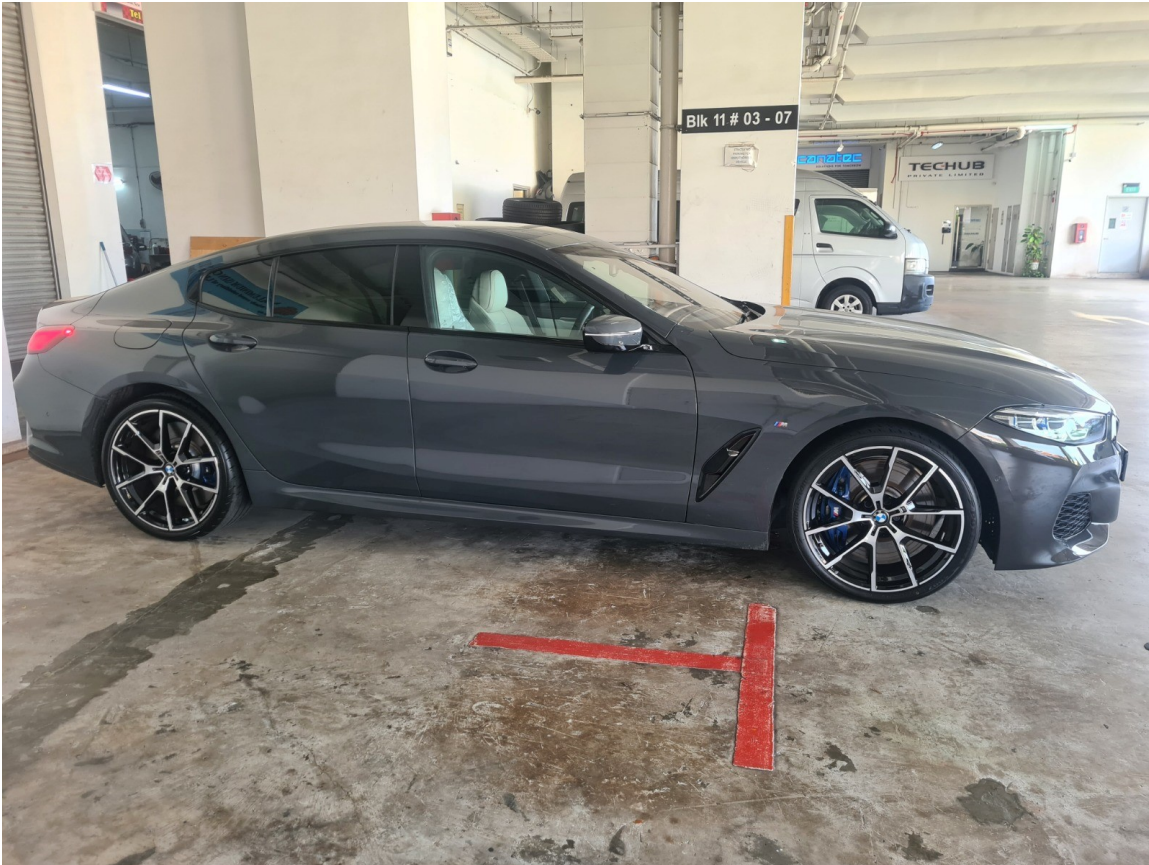
**Photo 5** shows the right side body of the Motor Car (photograph provided to me). Apart for the front left portion, there was no physical damage observed to other areas of the Motor Car. The airbag(s) was not deployed as seen from the photographs that were provided to me.

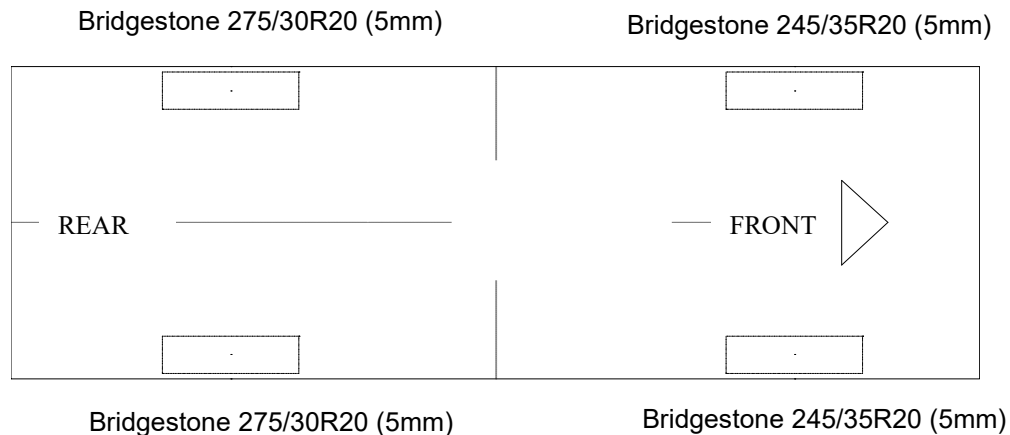
8. It was fitted with 20inch sport wheel rims that were wrapped with tyres that were observed to be of serviceable condition. The tyres were also sufficiently inflated for vehicular operation. The tyre brand, tyre size and approximate remaining tread depth of the 4 tyres of the Motor Car were recorded as follows: -

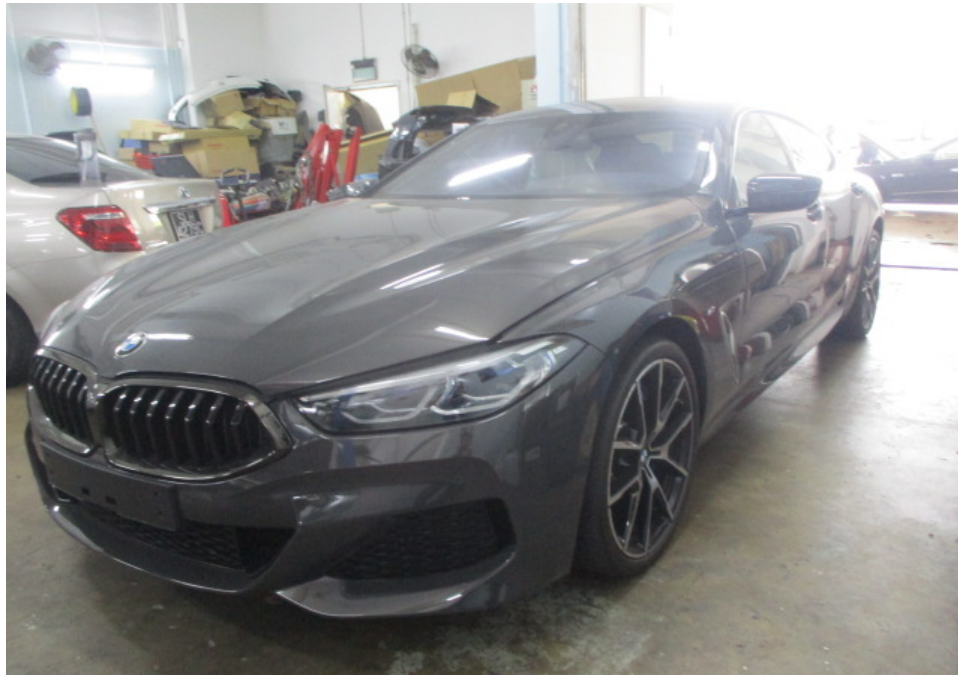
**Photo 6** shows a general view of the front left body of the Motor Car at the time of my inspection. The Motor Car was observed to be in a relatively good general condition with no loose exterior fittings observed. The body parts at the front left portion of the Motor Car were visually examined and it was observed that the repair/restoration works carried out to the damaged area of the Motor Car (refer to photograph 1 - 3 above) were reasonably adequate and in order.

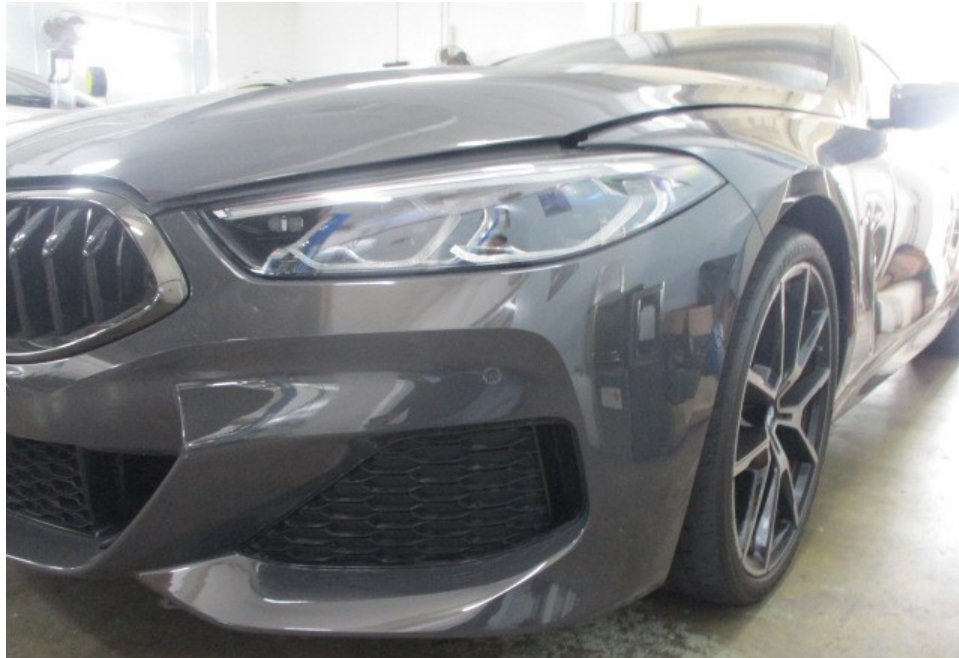
**Photo 7** shows a closer view of the Motor Car's front bumper, front bumper left lower grille, front left headlamp and front bonnet at the time of my inspection. The body parts at the front left portion of the Motor Car were visually examined and it was observed that the repair/restoration works carried out to the damaged area of the Motor Car (refer to photograph 1 - 3 above) were reasonably adequate and in order.

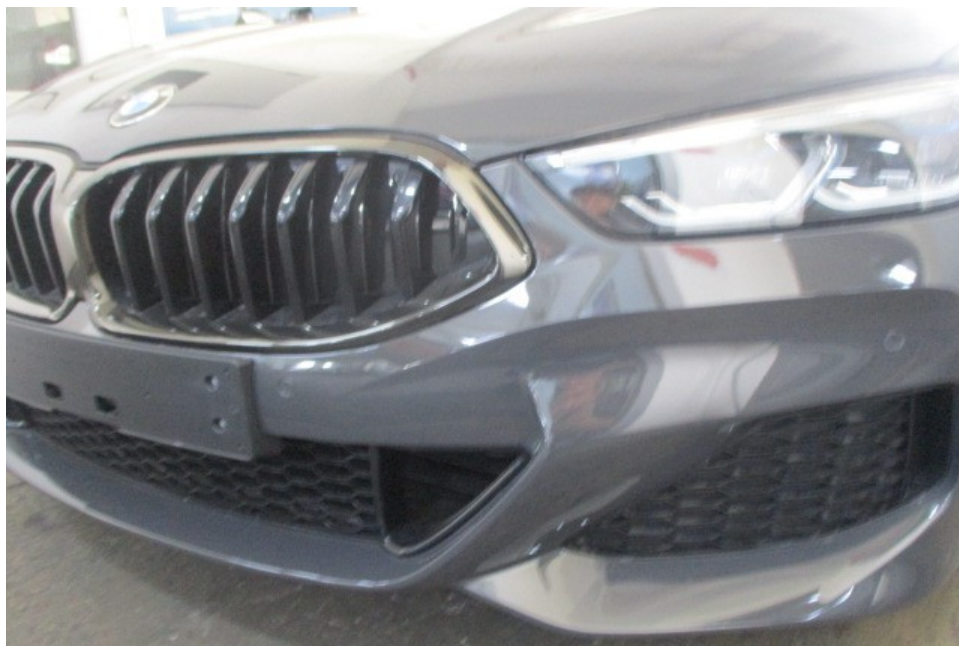
**Photo 8** shows a closer view of the Motor Car's front bumper, front bumper left lower grille, front bumper centre lower grille and front left radiator grille at the time of my inspection. The body parts at the front left portion of the Motor Car were visually examined and it was observed that the repair/restoration works carried out to the damaged area of the Motor Car (refer to photograph 1 - 3 above) were reasonably adequate and in order.

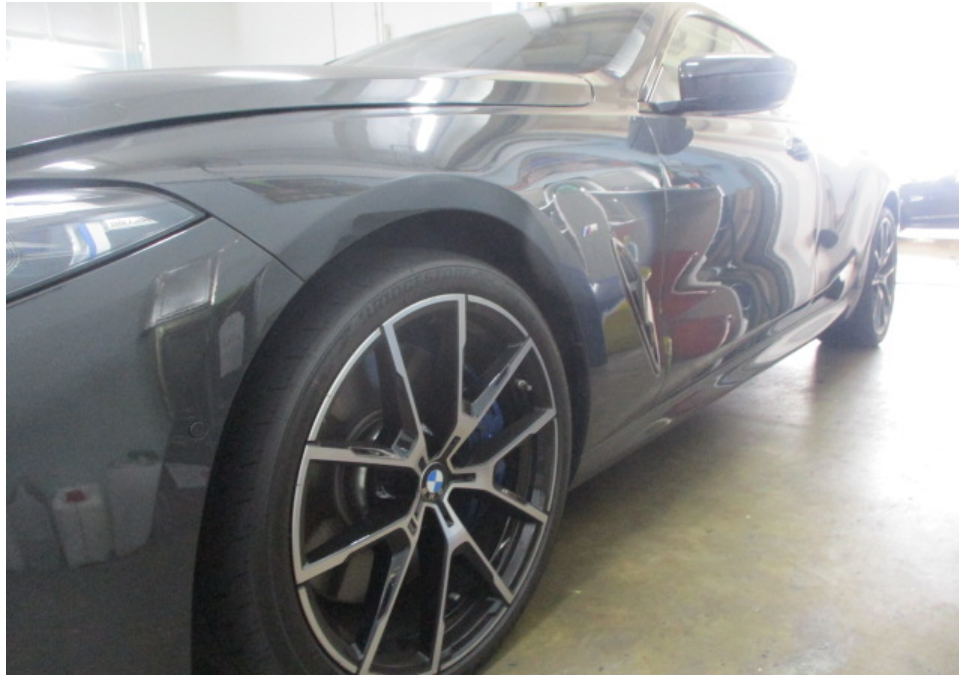
**Photo 9** shows a closer view of the Motor Car's front left fender, front left wheel rim and front bonnet at the time of my inspection. The body parts at the front left portion of the Motor Car were visually examined and it was observed that the repair/restoration works carried out to the damaged area of the Motor Car (refer to photograph 1 - 3 above) were reasonably adequate and in order.

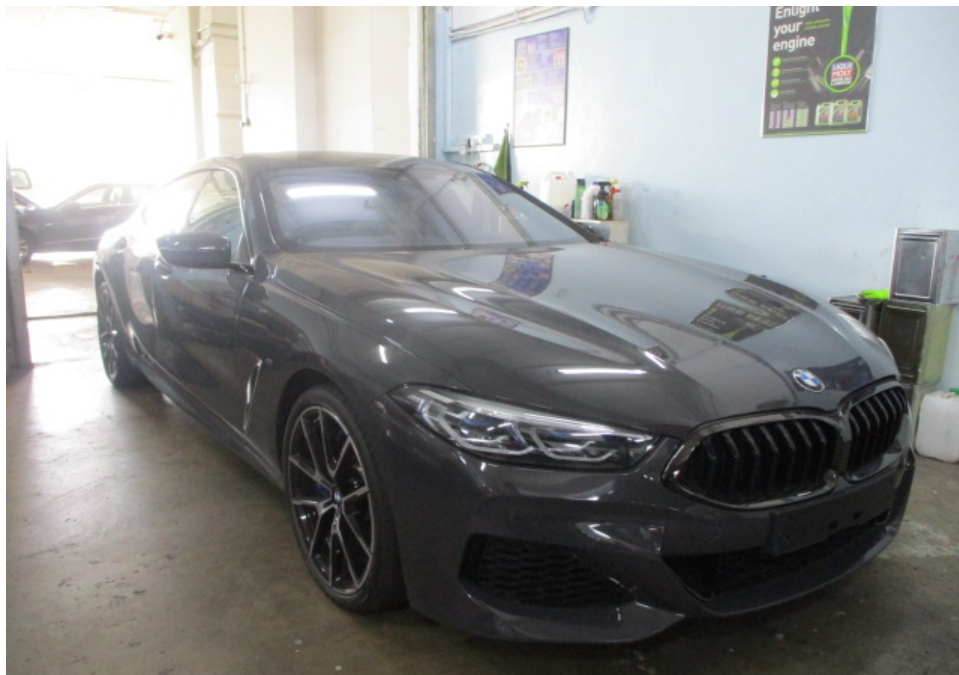
**Photo 10** shows a general view of the front right body of the Motor Car at the time of my inspection. The Motor Car was observed to be in a relatively good general condition with no loose exterior fittings observed. The mileage of the Motor Car recorded at the time of my inspection was 2,752km.

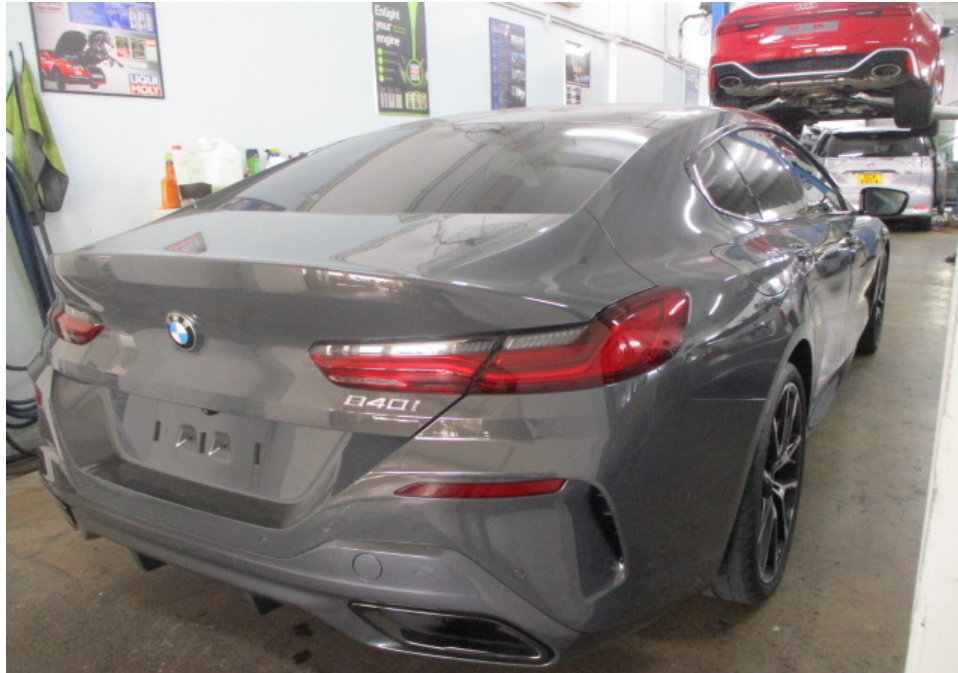
**Photo 11** shows a general view of the rear right body of the Motor Car at the time of my inspection. The Motor Car was observed to be in a relatively good general condition with no loose exterior fittings observed. The mileage of the Motor Car recorded at the time of my inspection was 2,752km.

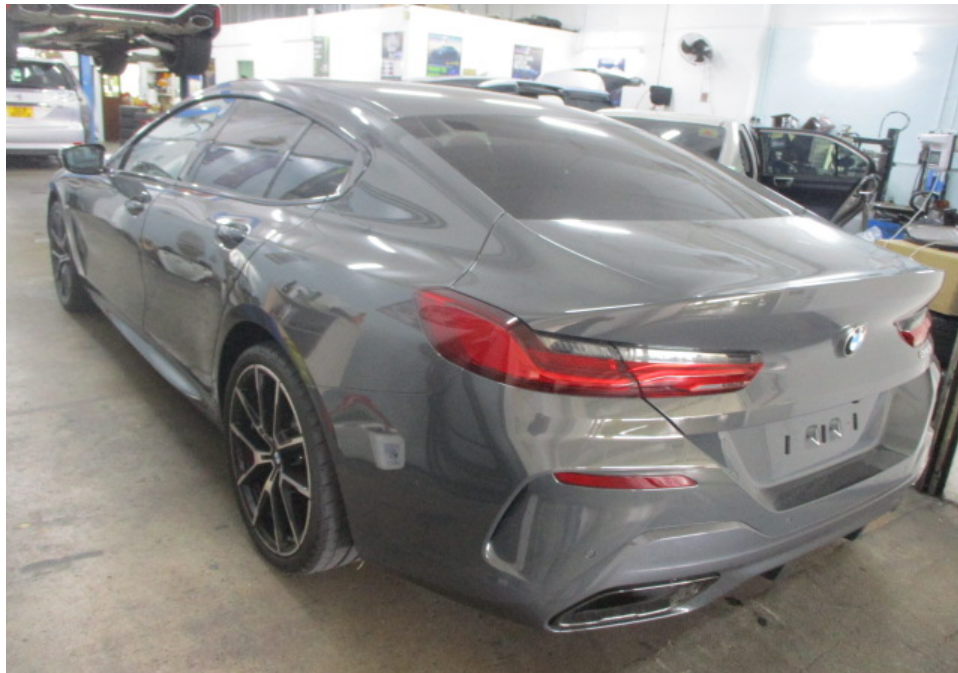
**Photo 12** shows a general view of the rear left body of the Motor Car at the time of my inspection. The Motor Car was observed to be in a relatively good general condition with no loose exterior fittings observed. The mileage of the Motor Car recorded at the time of my inspection was 2,752km.

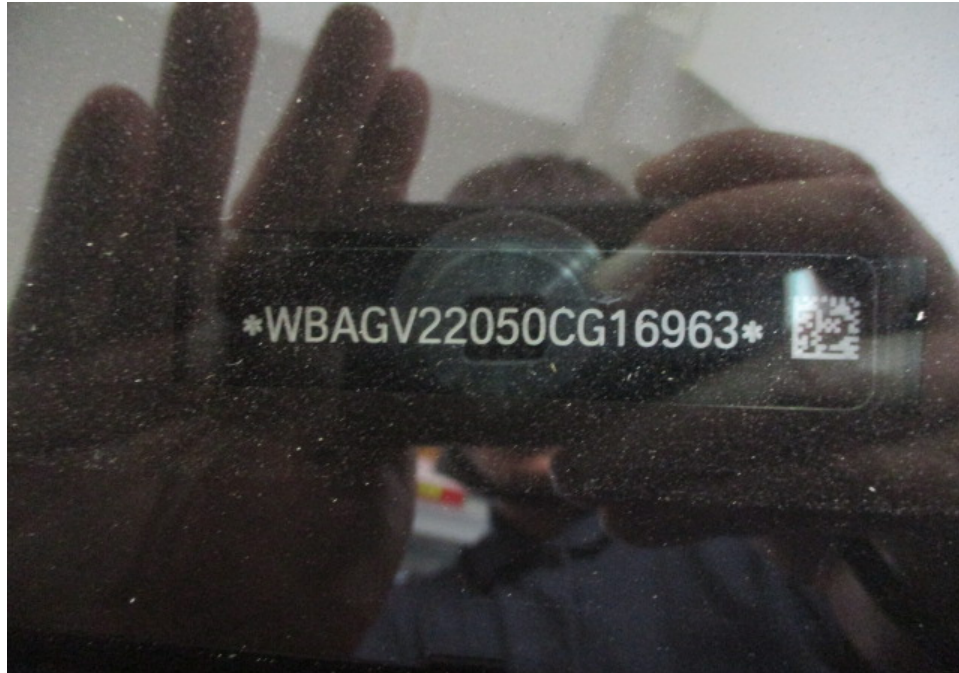
**Photo 13** shows the chassis number of the Motor Car. The chassis number recorded was WBAGV22050CG16963.

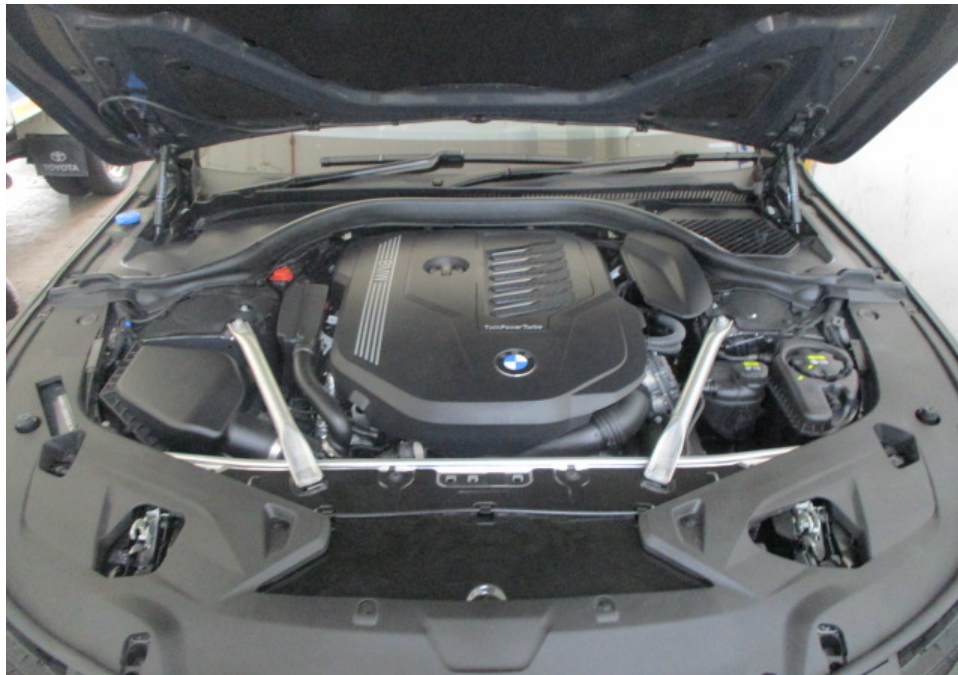
**Photo 14** shows a general view of the engine compartment of the Motor Car at the time of my inspection. The various parts and components inside the engine compartment were all observed to be intact and properly fitted. There was also no sign(s) or indication(s) of fluid leak and/or fluid stain found inside the engine compartment.

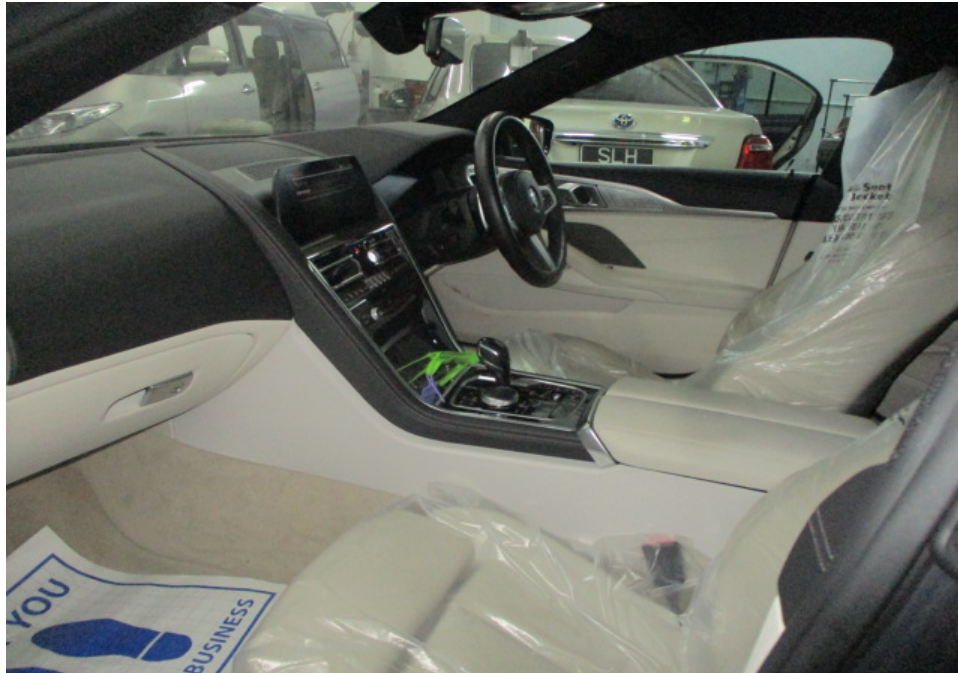
**Photo 15** shows the interior compartment of the Motor Car at the time of my inspection. The various parts and components, trims, carpet, and upholstery inside the interior compartment were all observed to be intact and properly fitted.

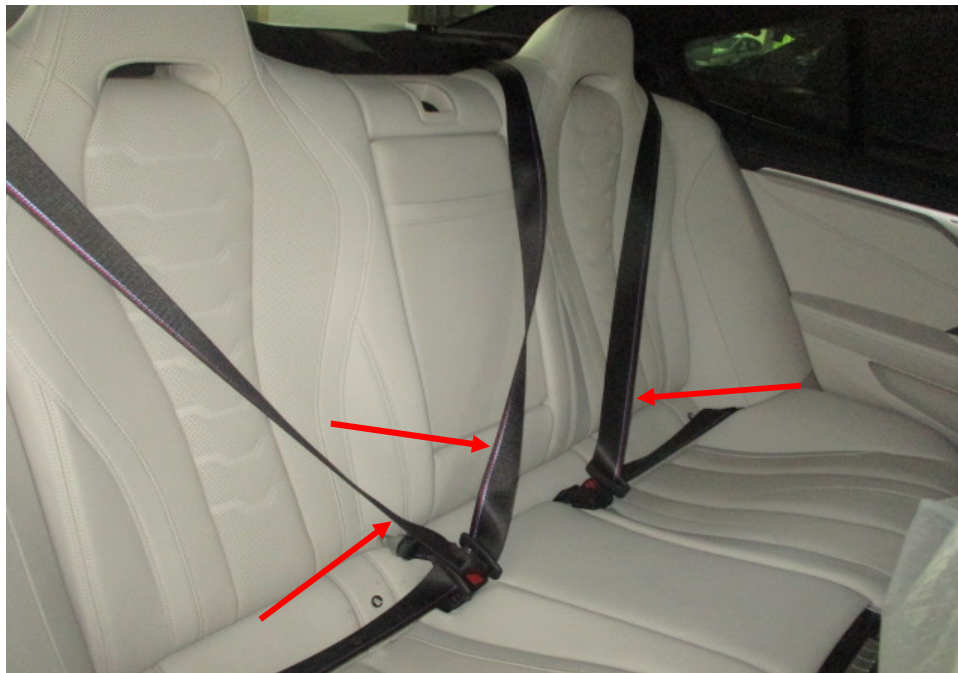
**Photo 16** shows the rear seats of the Motor Car. All the seats of the Motor Car were secured via seat rails to the floorboard. They were also fitted with a retractable seat belt reel and a pre-tensioner. The seat belts (arrowed) were tested and were able to be fastened into the respective pre-tensions that were fitted on the side of each individual seat.

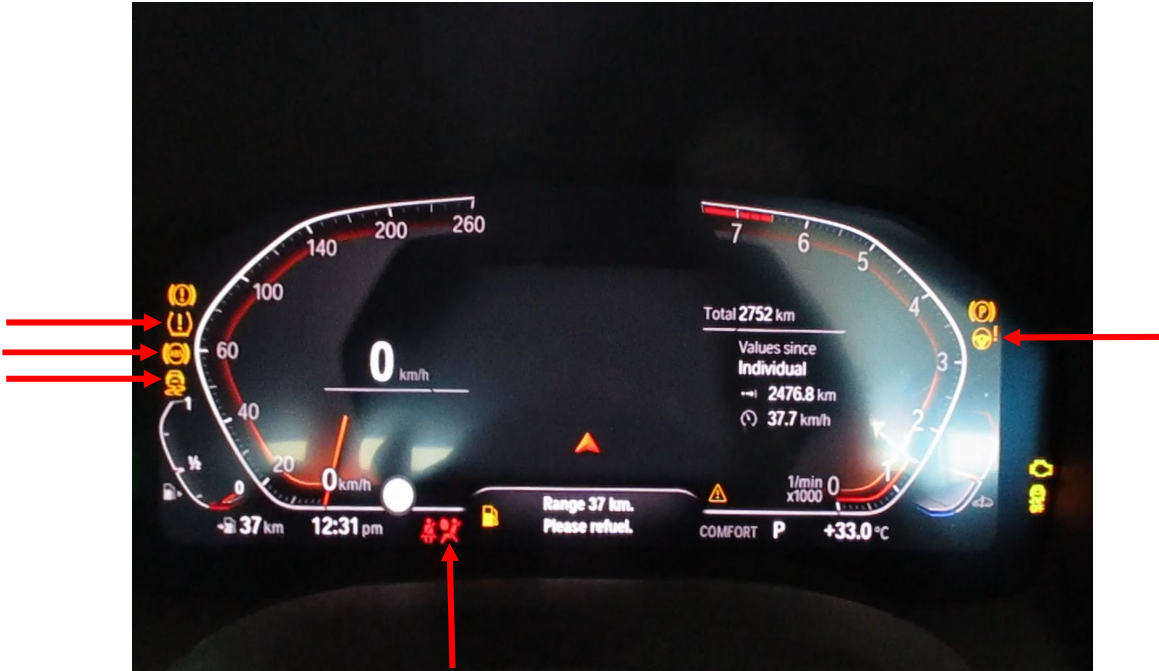
**Photo 17** shows the warning lights for the various electronic safety features appearing on the instrument panel of the Motor Car during its self-test when the engine is cranked, in particular the ABS, SRS, IAS, TPM and DSC lights (arrowed).

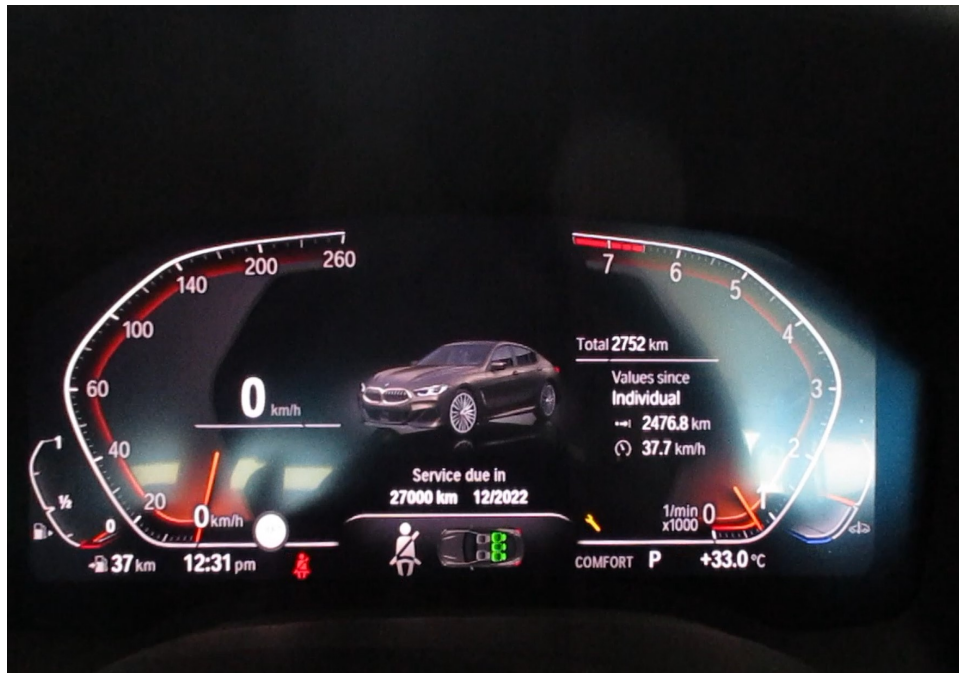
**Photo 18** shows the respective warning lights no longer illuminated, indicating that there is no fault detected to the ABS, SRS, IAS, TPM and DSC systems of the Motor Car during the self-test. These electronic systems were hence in working condition at the time of my inspection.

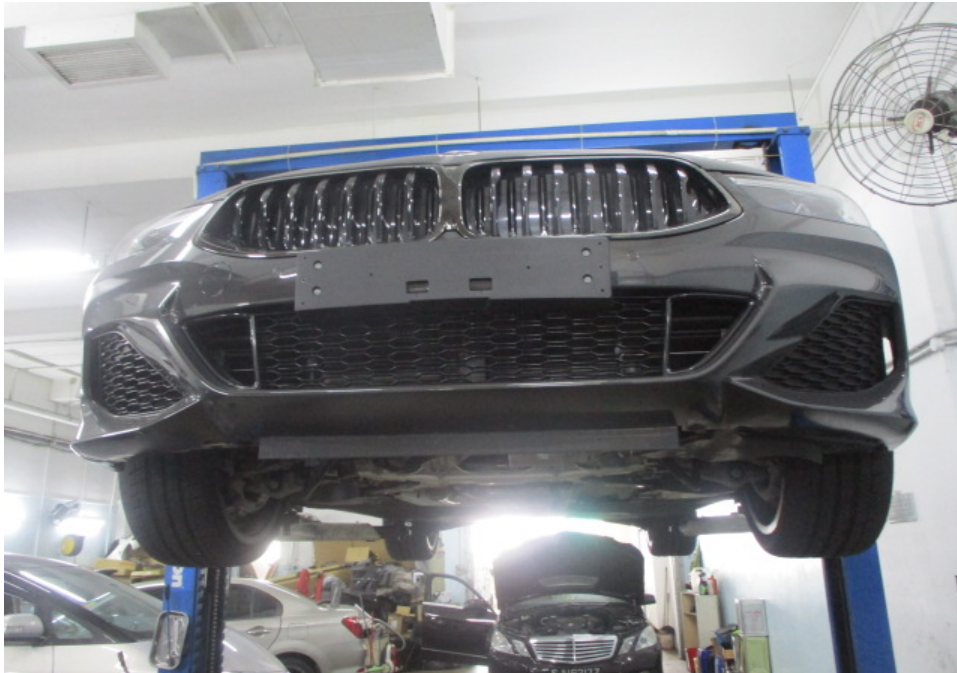
**Photo 19** shows the Motor Car hoisted up for checks on its undercarriage. There was no sign(s) or indication(s) of fluid leakage and/or fluid stain(s) on the underside of the Motor Car. The undercarriage components of the Motor Car were also all observed to be intact and secured in an appropriate manner.

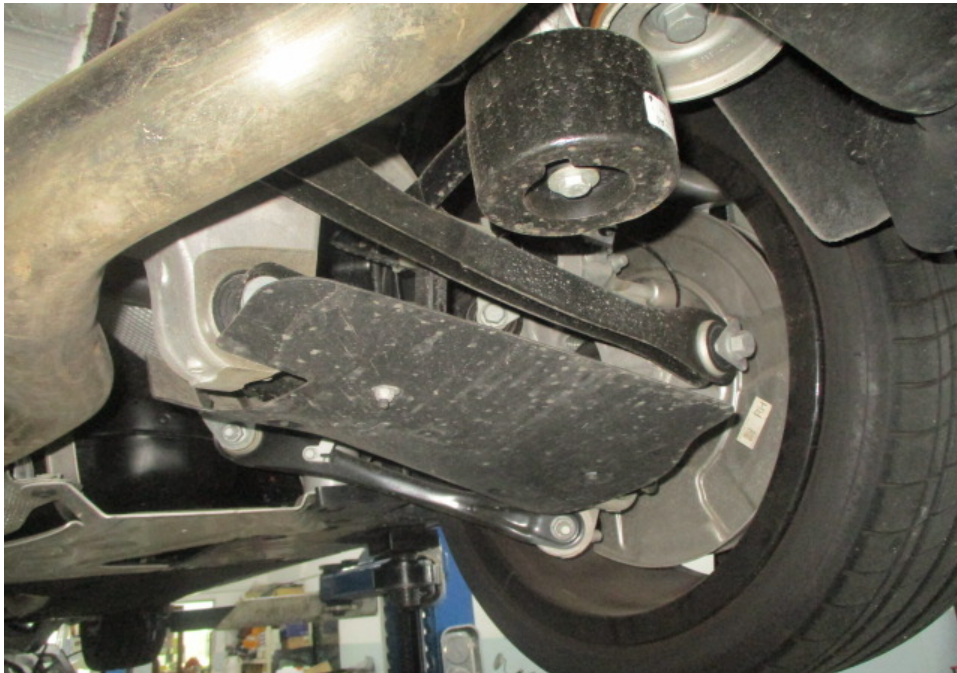
**Photo 20** shows a general view of the control arms and linkages at the rear right wheel of the Motor Car. I did not observe any fluid leak and/or fluid stain on the underside of the Motor Car. All of the Motor Car's undercarriage components were observed to be intact and secured in an appropriate manner.

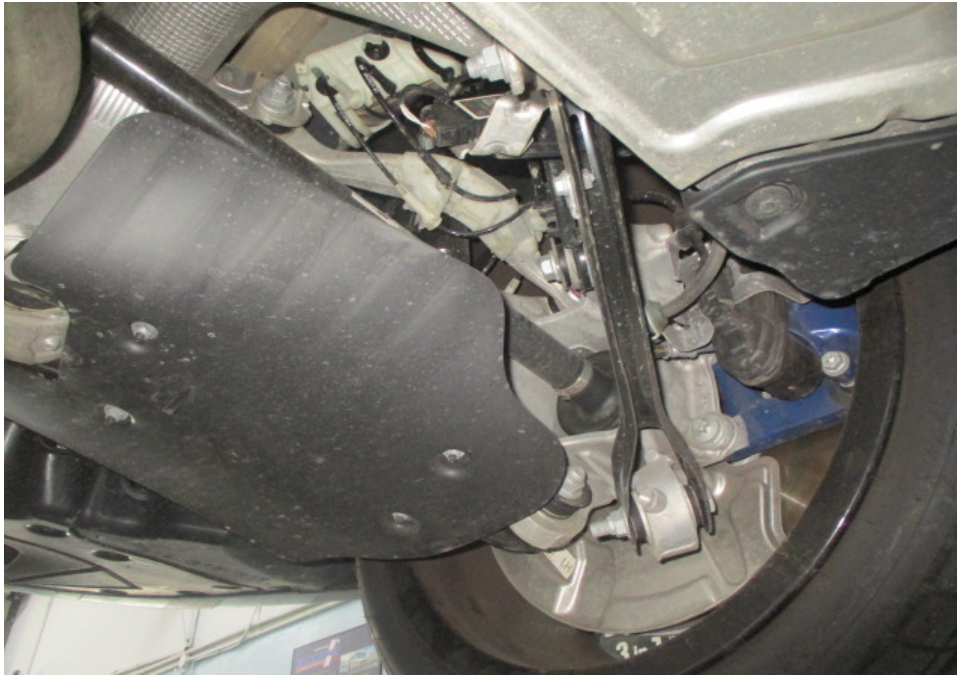
**Photo 21** shows a general view of the control arms and linkages at the rear left wheel of the Motor Car. I did not observe any fluid leak and/or fluid stain on the underside of the Motor Car. All of the Motor Car's undercarriage components were observed to be intact and secured in an appropriate manner.

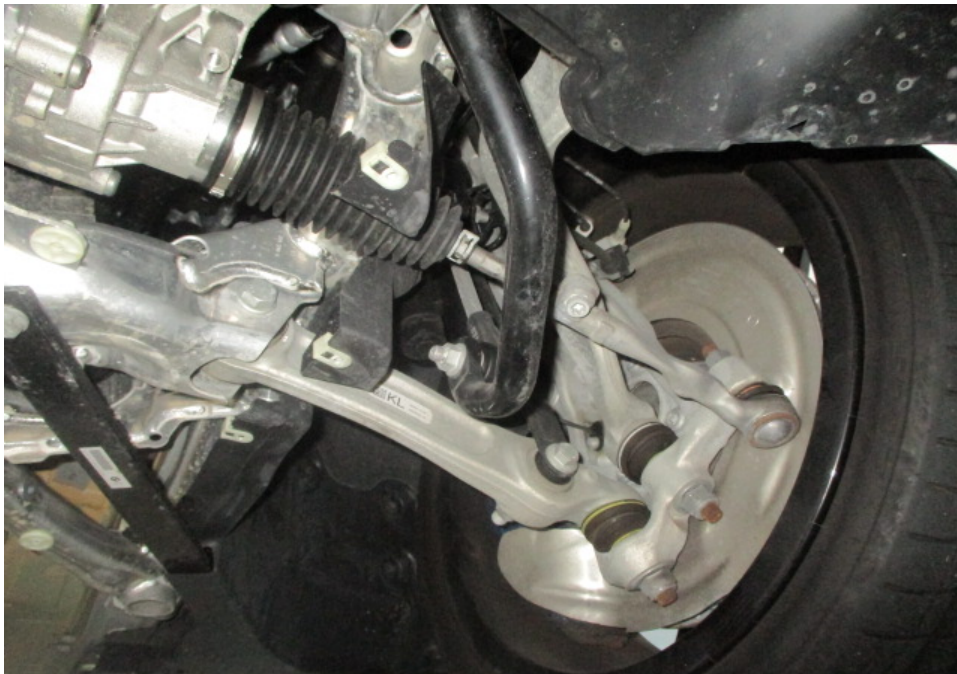
**Photo 22** shows the various undercarriage components at the front left wheel of the Motor Car. The mechanical components, control arms and linkages were all found to be intact and secured in an appropriate manner.

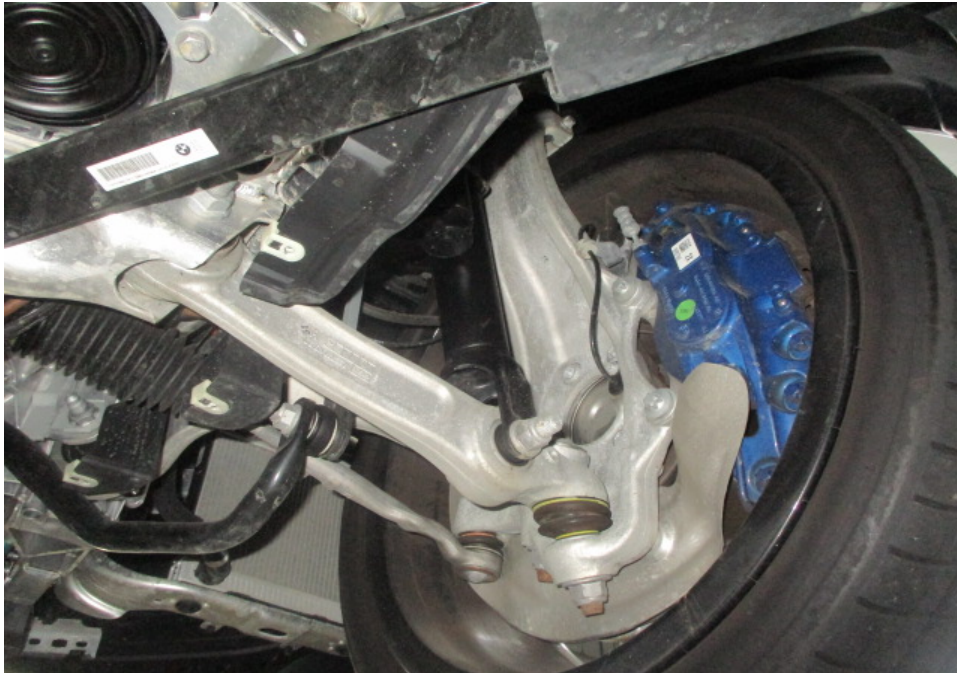
**Photo 23** shows the various undercarriage components at the front right wheel of the Motor Car. The mechanical components, control arms and linkages were all found to be intact and secured in an appropriate manner. I also did not observe any fluid leak and/or fluid stain on the underside of the Motor Car.

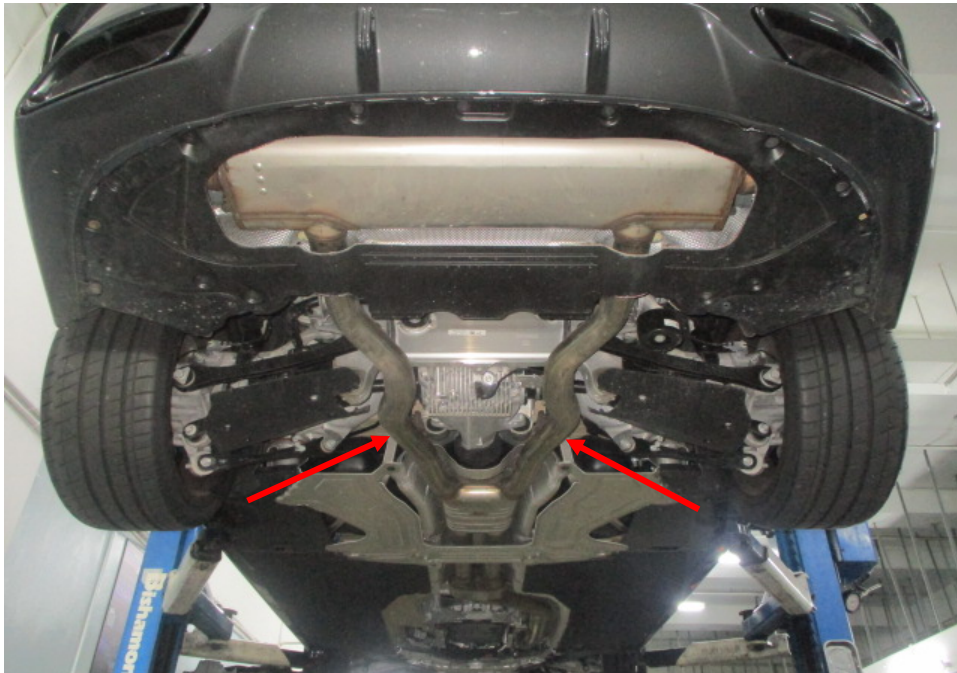
**Photo 24** shows the rear section of the Motor Car's exhaust system. My examination of the Motor Car's exhaust system revealed no sign(s) or indication(s) of any cut or weld marks along its exhaust pipes (arrowed), on its rear muffler, on its centre resonator boxes and on its catalytic converter.

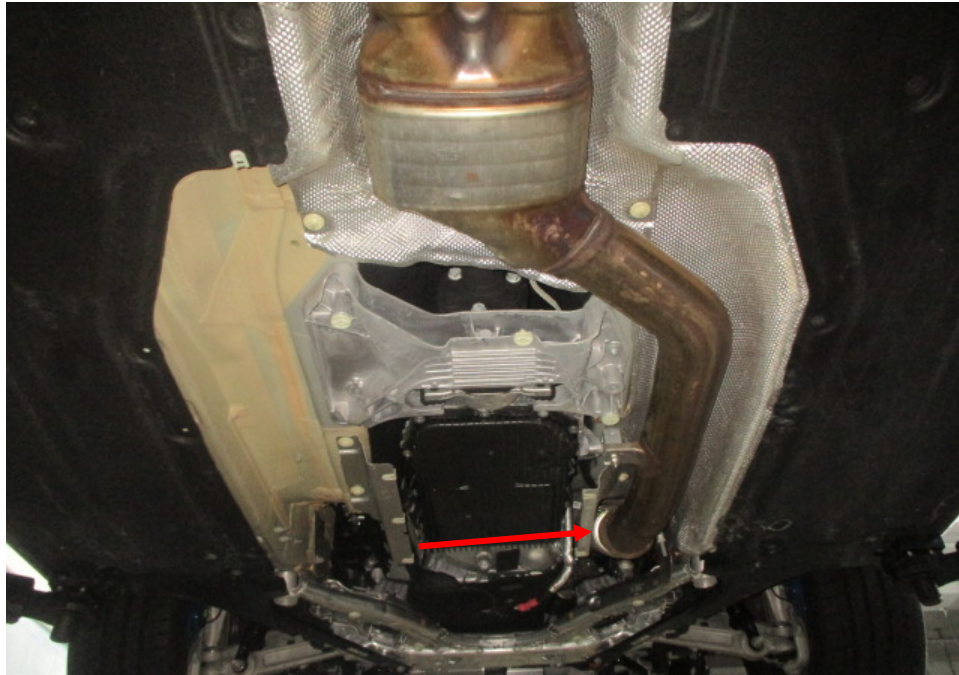
**Photo 25** shows the front section of the Motor Car's exhaust system. My examination of the Motor Car's exhaust system revealed no sign(s) or indication(s) of any cut or weld marks along its exhaust pipes, on its rear muffler, on its centre resonator boxes and on its catalytic converter (arrowed).

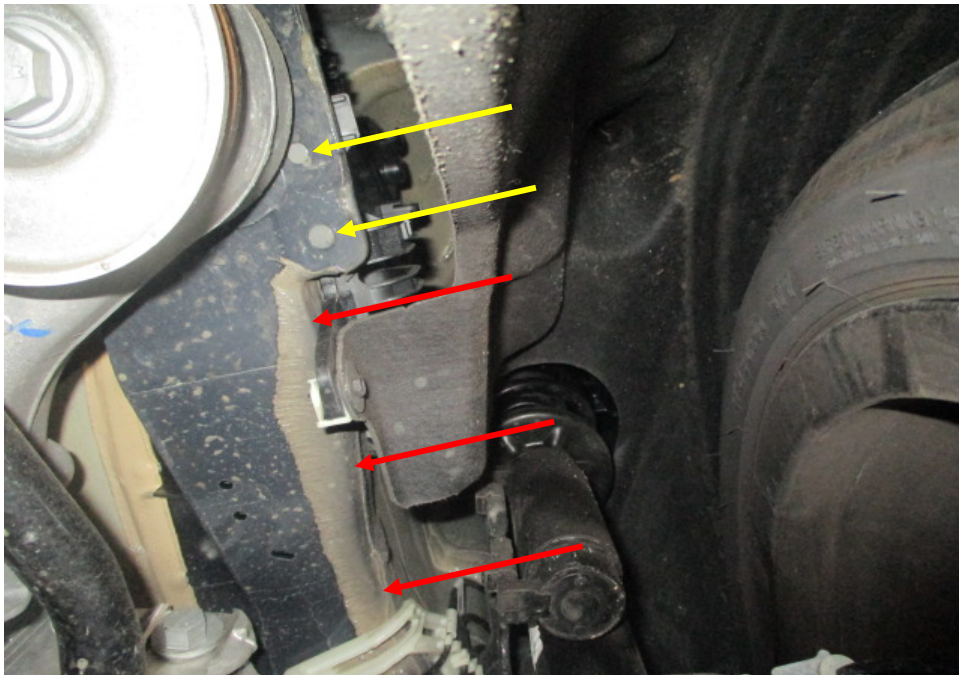
**Photo 26** shows the chassis/structural body at the underside rear right of the Motor Car. I did not find any weld marks other than original spot weld marks (yellow arrow) on the chassis/structural body of the Motor Car. The original factory sealant (red arrow) at the joints along the chassis/structural body was untouched, indicating no work was done on the chassis/structural body of the Motor Car and that the chassis/structural body was originally fitted.

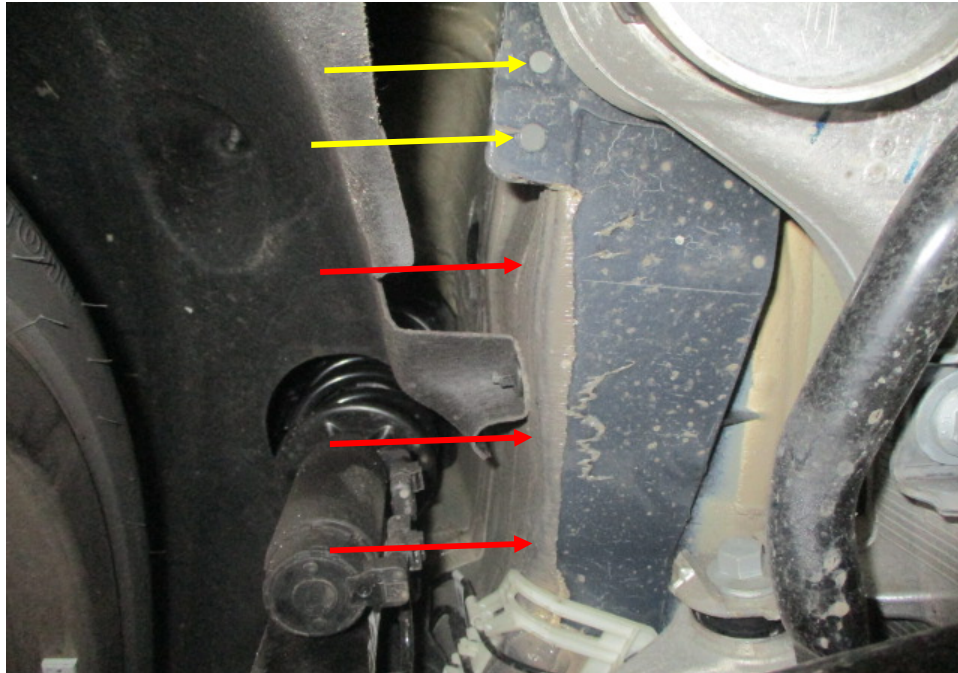
**Photo 27** shows the chassis/structural body at the underside rear left of the Motor Car. I did not find any weld marks other than original spot weld marks (yellow arrow) on the chassis/structural body of the Motor Car. The original factory sealant (red arrow) at the joints along the chassis/structural body was untouched, indicating no work was done on the chassis/structural body of the Motor Car and that the chassis/structural body was originally fitted.

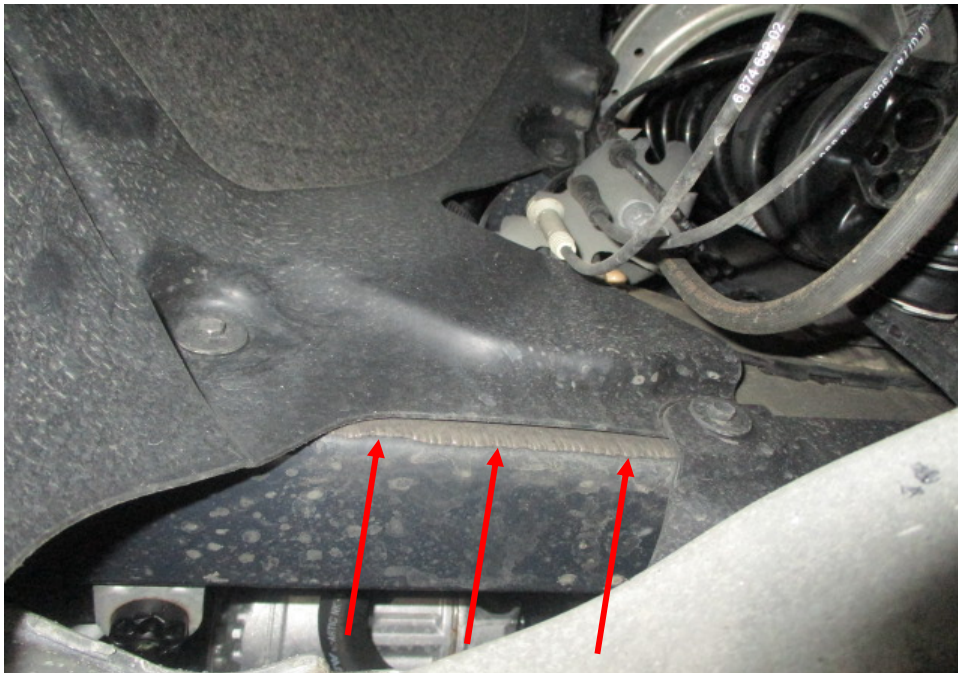
**Photo 28** shows the chassis/structural body at the underside front left of the Motor Car. The original factory sealant (arrowed) at the joints along the chassis/structural body was observed to be untouched. In general, I had found no work was carried out on the chassis/structural body of the Motor Car. The chassis/structural body of the Motor Car was originally fitted.

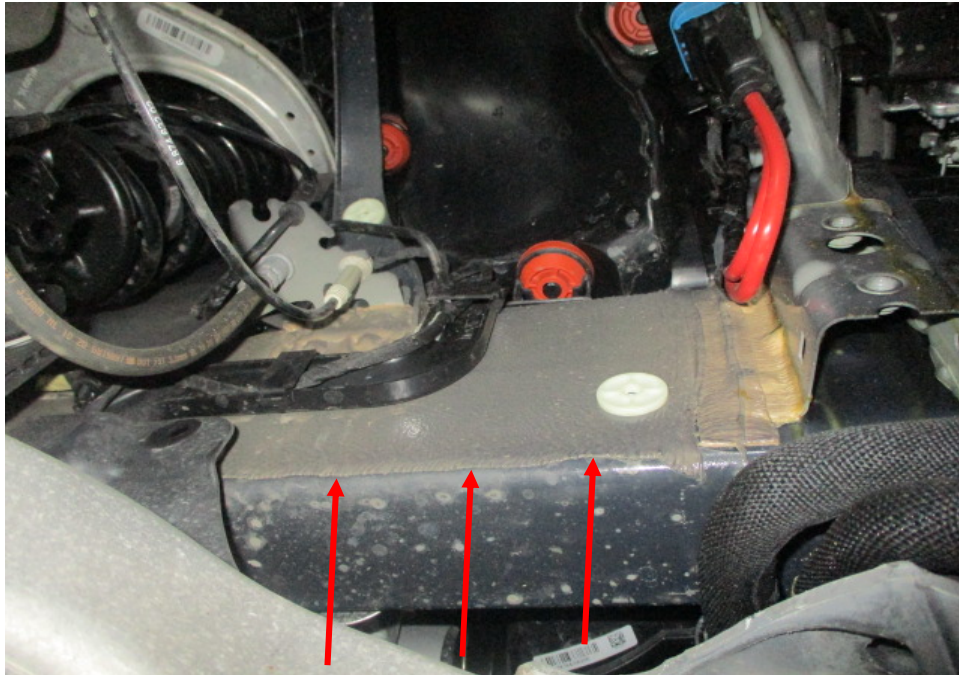
**Photo 29** shows the chassis/structural body at the underside front right of the Motor Car. The original factory sealant (arrowed) at the joints along the chassis/structural body was observed to be untouched. In general, I had found no work was carried out on the chassis/structural body of the Motor Car. The chassis/structural body of the Motor Car was originally fitted.
