Your Ref: BMW 840i  
(chassis number WBAGV22050CG16963)  
Our Ref : CI/TP22005296/D

**INSPECTION REPORT OF AN UNREGISTERED BMW 840i MOTOR CAR  
WITH CHASSIS NUMBER WBAGV22050CG16963**

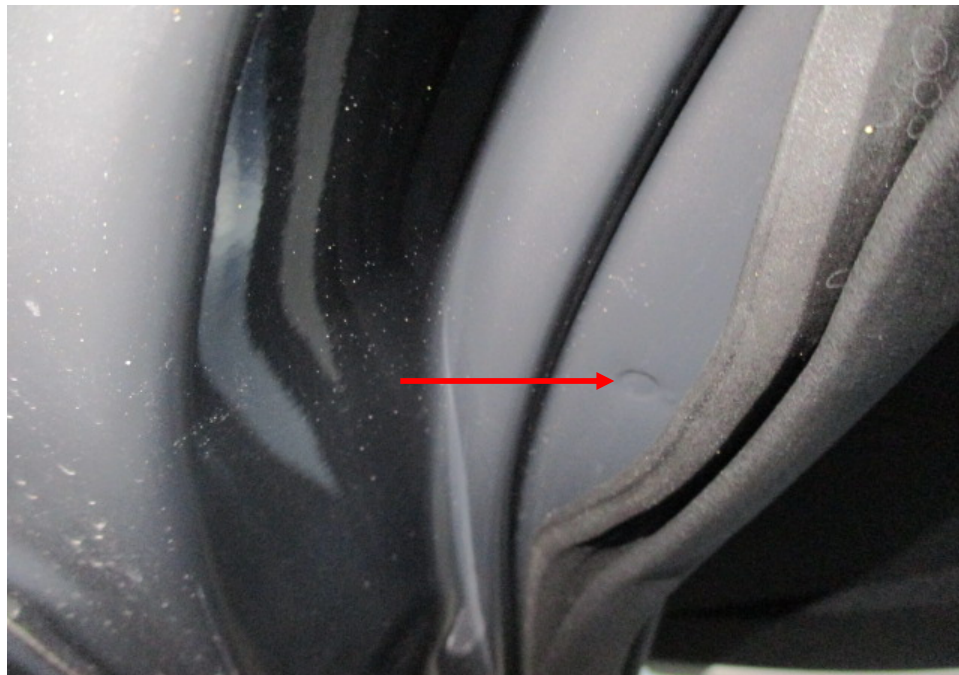
**Photo 30** shows the left side "A" pillar of the Motor Car. I did not find any weld marks other than original spot weld marks (arrowed) on the left side "A" pillar of the Motor Car which, indicates that there was no re-welding works carried out. In general, I had found all the non-detachable body panels of the Motor Car to be originally fitted at the time of my inspection.

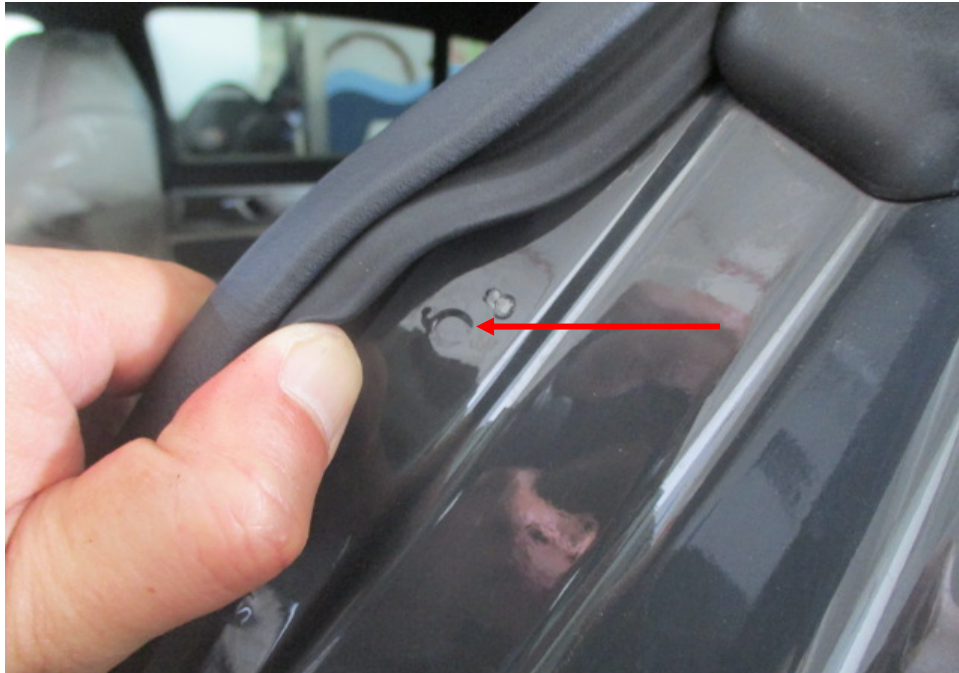
**Photo 31** shows the left side "C" pillar of the Motor Car. I did not find any weld marks other than original spot weld marks (arrowed) on the left side "C" pillar of the Motor Car which, indicates that there was no re-welding works carried out. In general, I had found all the non-detachable body panels of the Motor Car to be originally fitted at the time of my inspection.

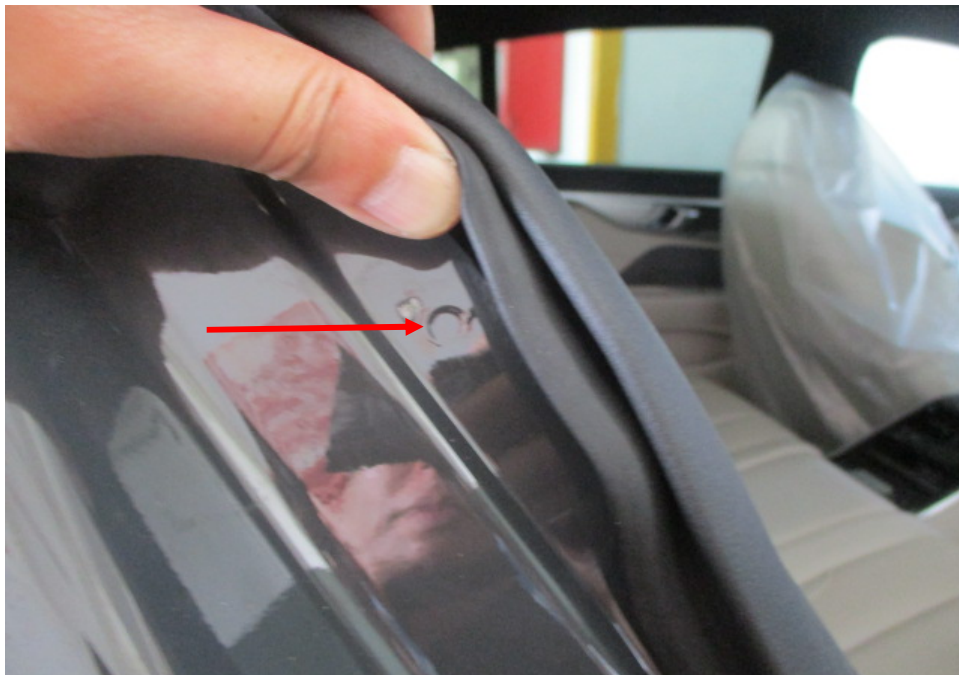
**Photo 32** shows the right side "C" pillar of the Motor Car. I did not find any weld marks other than original spot weld marks (arrowed) on the right side "C" pillar of the Motor Car which, indicates that there was no re-welding works carried out. In general, I had found all the non-detachable body panels of the Motor Car to be originally fitted at the time of my inspection.

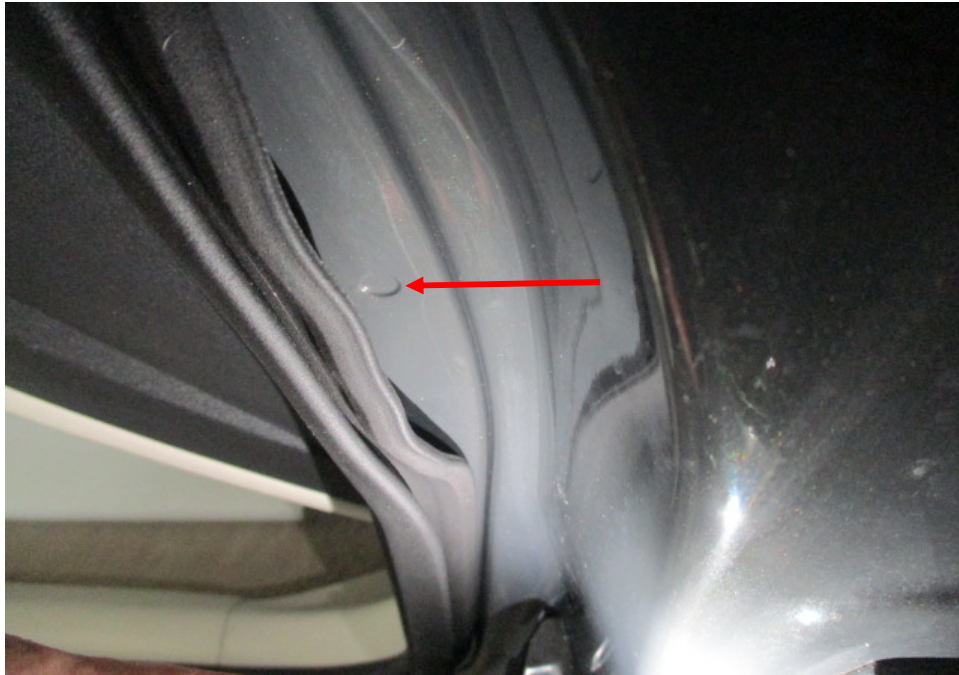
**Photo 33** shows the right side "A" pillar of the Motor Car. I did not find any weld marks other than original spot weld marks (arrowed) on the right side "A" pillar of the Motor Car which, indicates that there was no re-welding works carried out. In general, I had found all the non-detachable body panels of the Motor Car to be originally fitted at the time of my inspection.
