Our Ref : CI/TP22005579/N

10 June 2022

**TECHNICAL INVESTIGATION REPORT OF FIRE INCIDENT INVOLVING THE
INSURED VEHICLE GBG 9462E ON 18 MAY 2022**

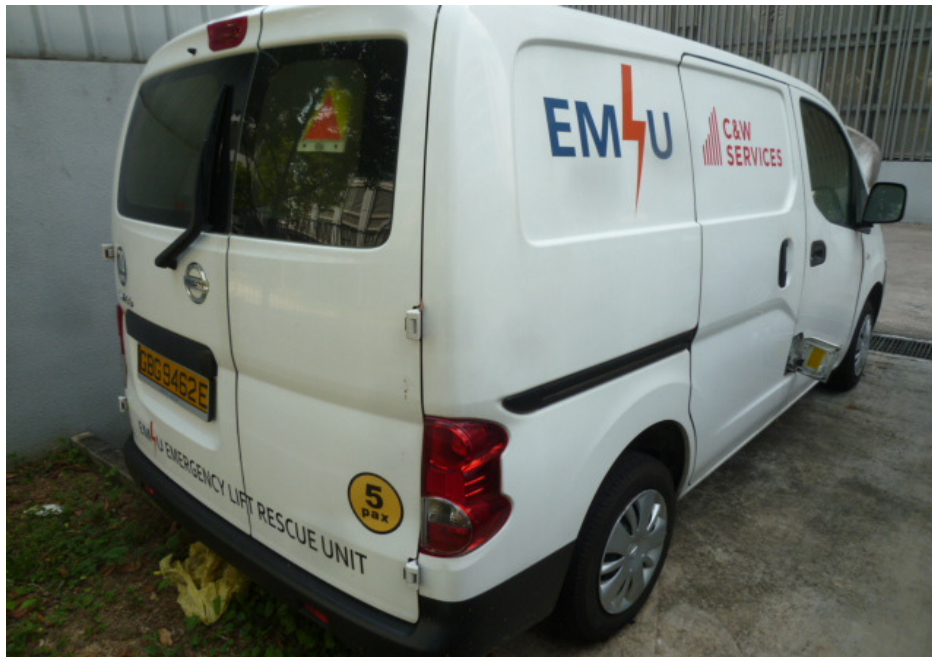
Photo 1 shows the general view of the right rear portion of the Insured Vehicle at the time of our inspection. The rear portion of the Insured Vehicle was relatively unaffected by the fire.

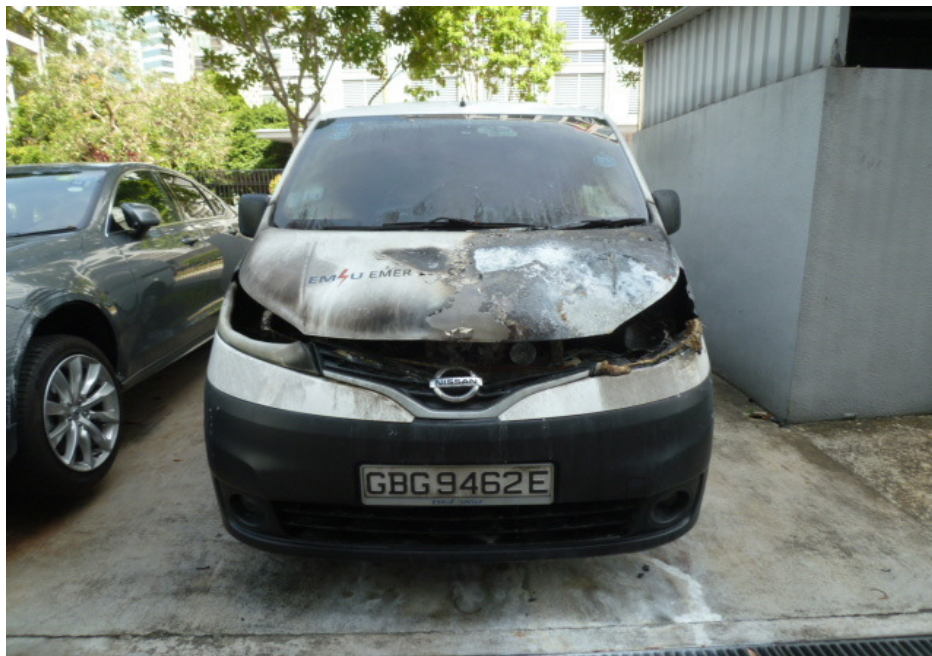
Photo 2 shows the general view of the frontal portion of the Insured Vehicle at the time of our inspection. The fire damage to the Insured Vehicle was confined to its frontal portion. The entire engine compartment of the Insured Vehicle was observed to be severely burnt while the interior compartment was observed to be seriously affected by the fire.

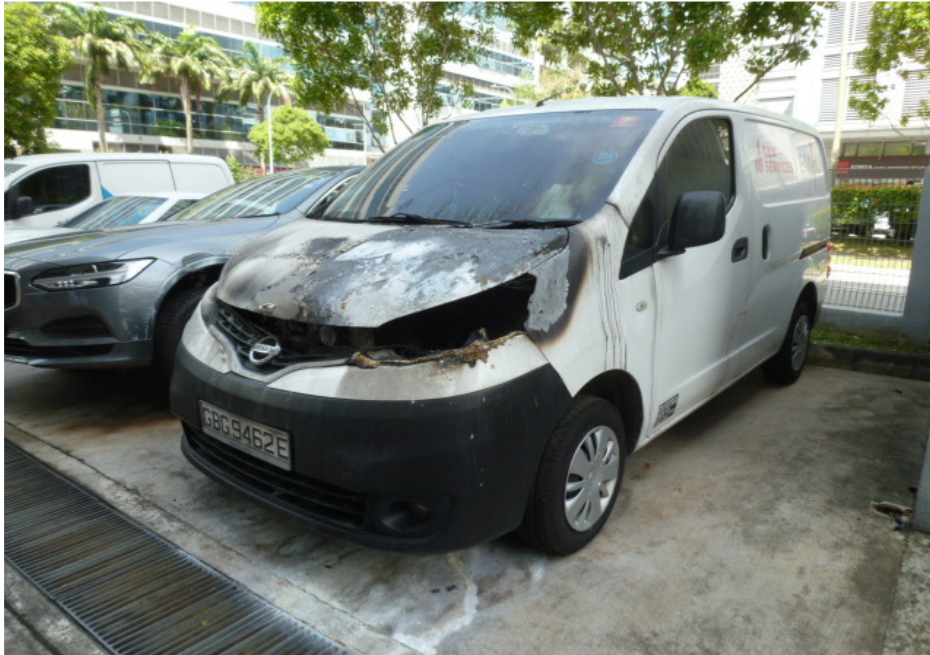
Photo 3 shows the closer view of the left front body of the Insured Vehicle at the time of our inspection. The fire damage to the Insured Vehicle was confined to its frontal portion. Its front bumper, front bonnet, front grille, front headlamps, front windscreen and front windscreen wipers were amongst the body parts that were found to have been affected by the fire.

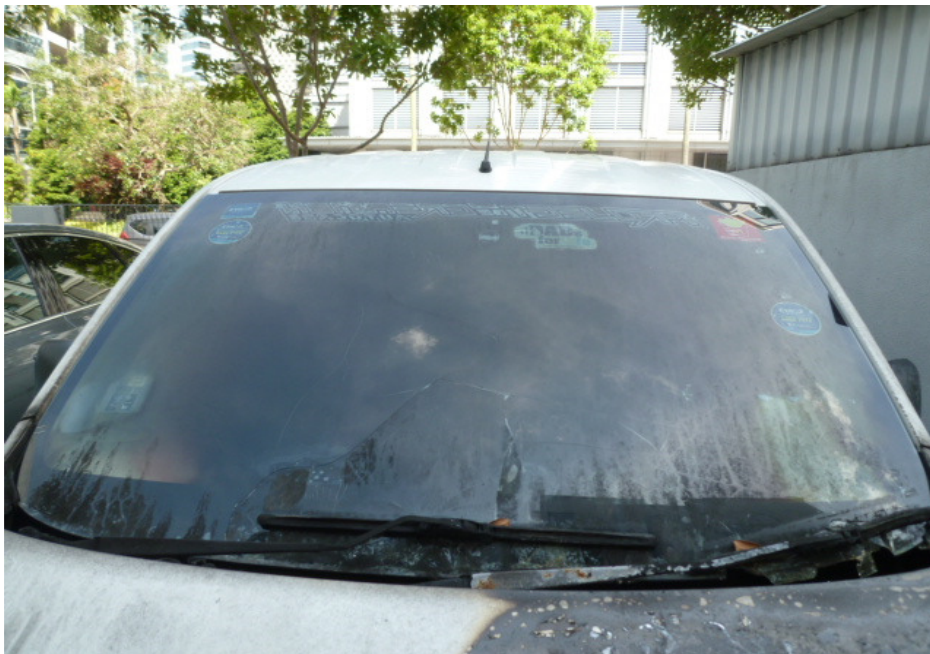
Photo 4 shows the general view of the front windscreen of the Insured Vehicle at the time of our inspection. The fire damage to the front windscreen was severe.

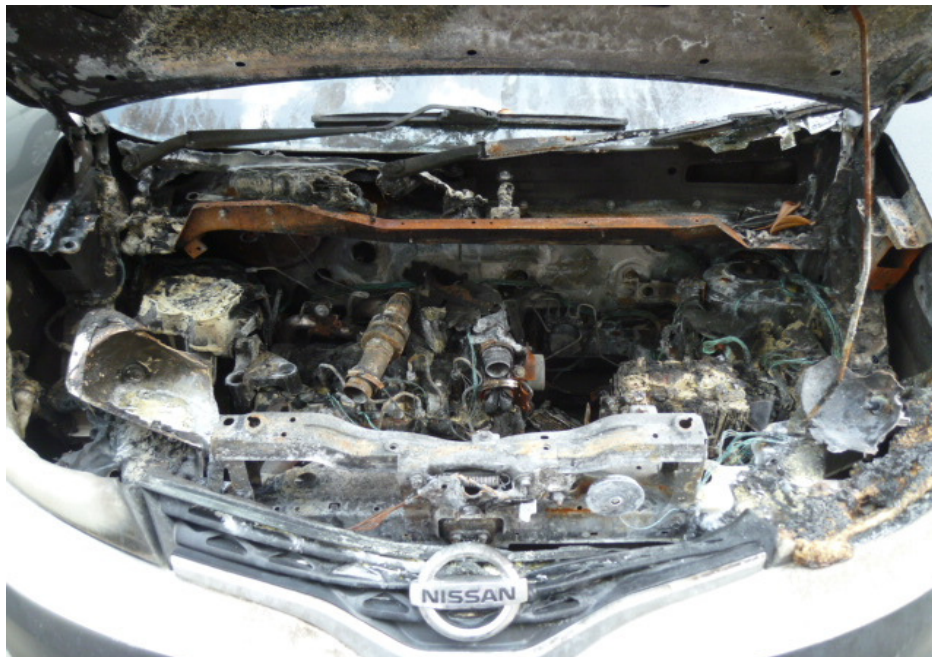
Photo 5 shows the engine compartment of the Insured Vehicle at the time of our inspection. The entire engine compartment of the Insured Vehicle was observed to be severely burnt. Most of the parts inside the engine compartment were found to be burnt and/or melted as a result of the fire.

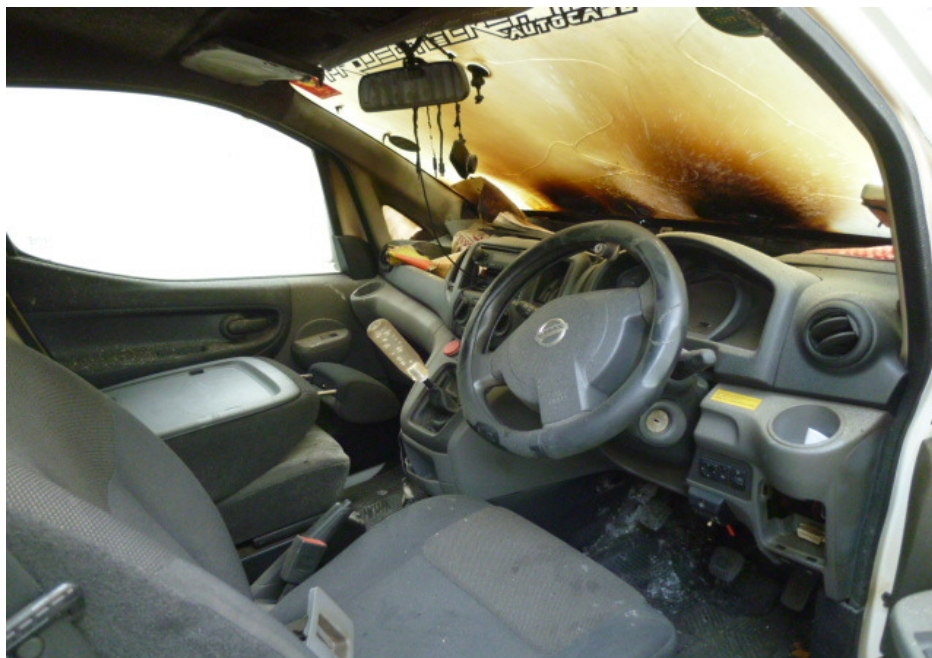
Photo 6 shows the interior compartment of the Insured Vehicle, which was seriously affected by the fire.

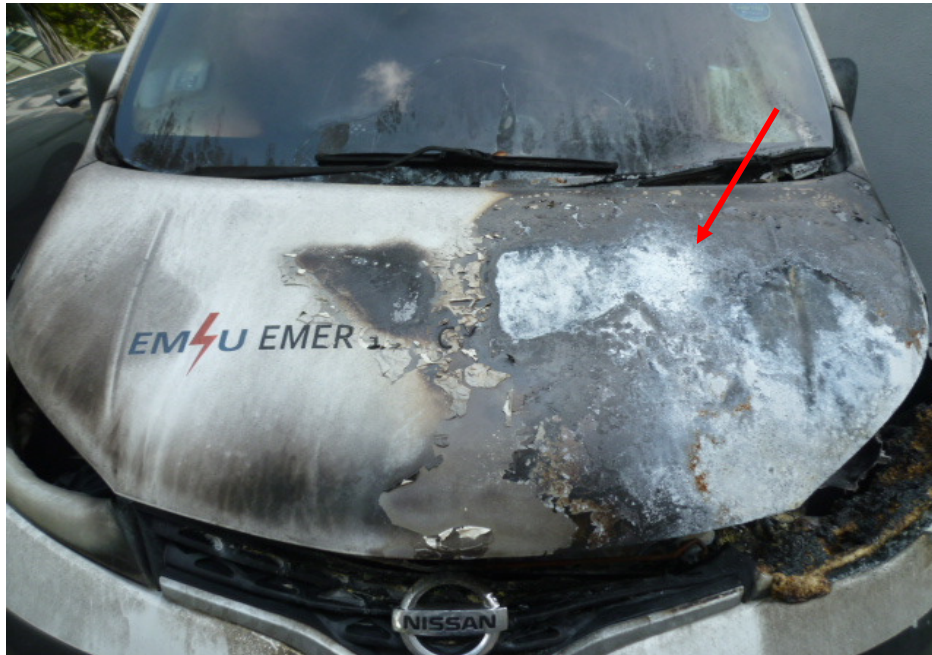
7. For this particular case, the fire appears to have originated within the engine compartment of the Insured Vehicle, somewhere around the left portion of the engine compartment. This can be determined due to the nature of the fire damage which was more extensive at the left portion, the burn pattern found on the left portion of the front bonnet of the Insured Vehicle and also the high heat intensity burn marks (whitish burn marks) as well as rust that had developed on the underside of the front bonnet, at the left portion.

Photo 7 shows the burn pattern that was found on the left portion of the front bonnet of the Insured Vehicle (arrowed). Such whitish burn marks are a result of exposure to prolonged heat intensity, which may indicate where the fire had started. Rust would also begin to develop on these areas soon after the fire.

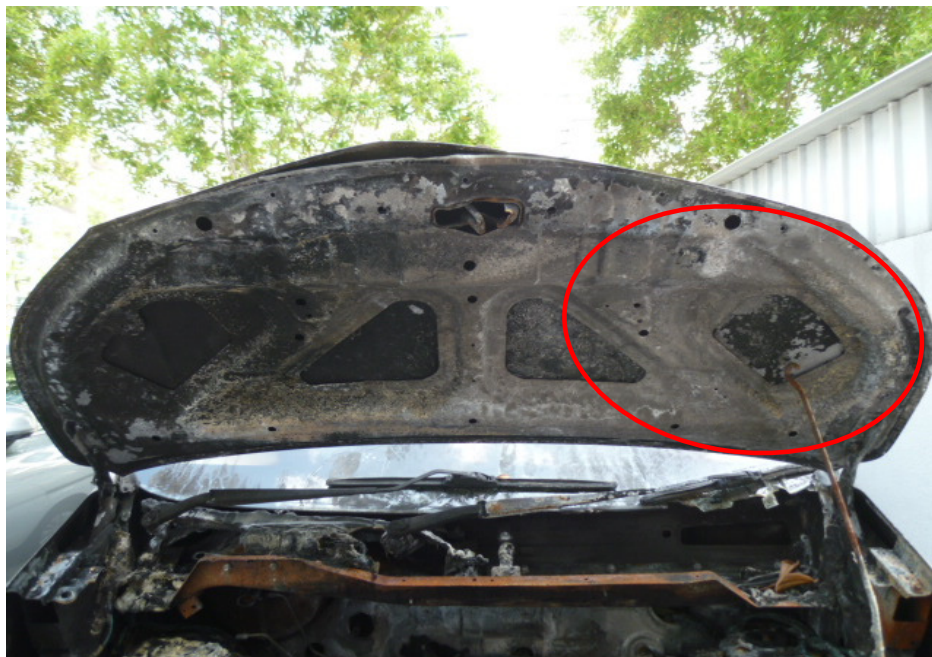
Photo 8 shows the whitish marks that were found on the underside of the front bonnet of the Insured Vehicle, at the left portion (circled). Such whitish burn marks are a result of exposure to prolonged heat intensity, which may indicate where the fire had started. Rust would also begin to develop on these areas soon after the fire.

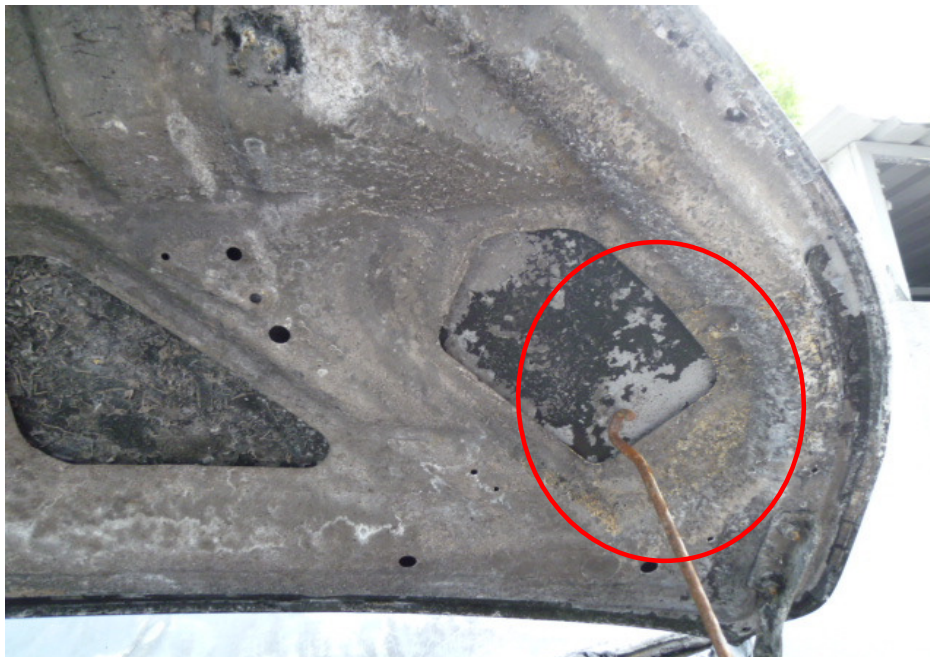
Photo 9 shows the rust that had developed on the underside of the front bonnet, around the left portion (circled). The development of rust is an indication that this area was subjected to prolonged exposure to high heat intensity, which had caused the steel/metal material of the front bonnet to be exposed to natural environmental condition. Hence the fire to the Insured Vehicle can be determined to have originated towards the left portion of the engine compartment.

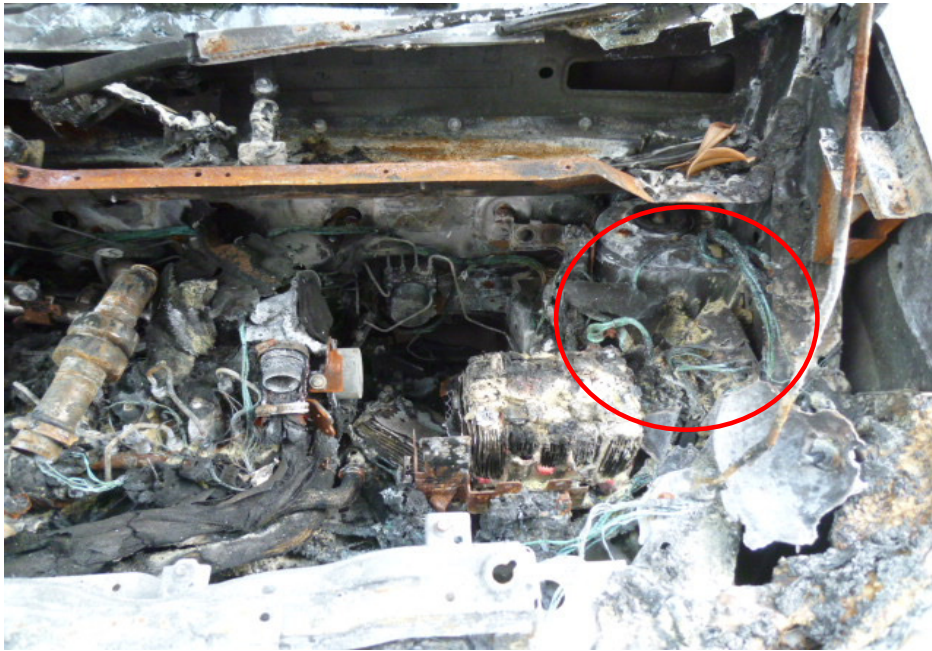
9. Upon closer examination of the left portion of the engine compartment, which was where the fire to the Insured Vehicle had likely started, we had found greenish residue on several burnt stretches of original factory fitted wirings around the left portion of the engine compartment. The presence of such greenish residue indicates internal heating of copper wires, a sign of an electrical short circuit occurring. The greenish residue is normally left behind from oxidation as a result of chemical reaction involving the copper wires. This physical evidence would then appear to suggest that the cause of fire to the Insured Vehicle could have possibly been due to electrical in nature. See photos 10 - 13 below.

Photo 10 shows the original factory fitted wirings around the left portion of the engine compartment, which is in the immediate vicinity where the fire to the Insured Vehicle had likely started. We had found greenish residue on several burnt stretches of these wirings (circled). The presence of such greenish residue indicates internal heating of copper wires, a sign of an electrical short circuit occurring. The greenish residue is normally left behind from oxidation as a result of chemical reaction involving the copper wires.

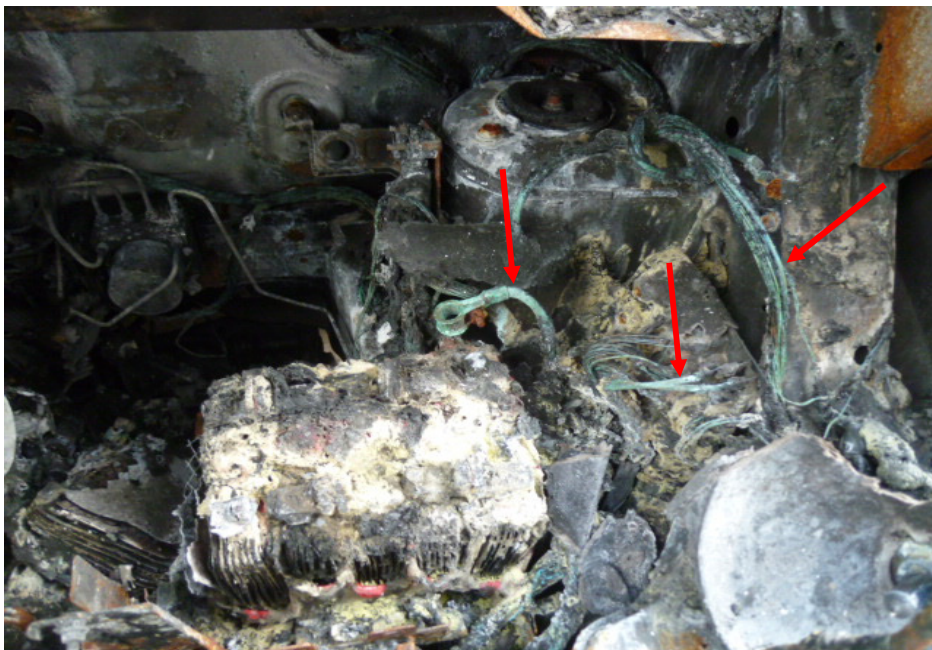
Photo 11 shows a closer view of the greenish residue found on some of the burnt stretches of original factory fitted wirings (arrowed). The presence of such greenish residue suggests occurrence of an electrical short circuit.

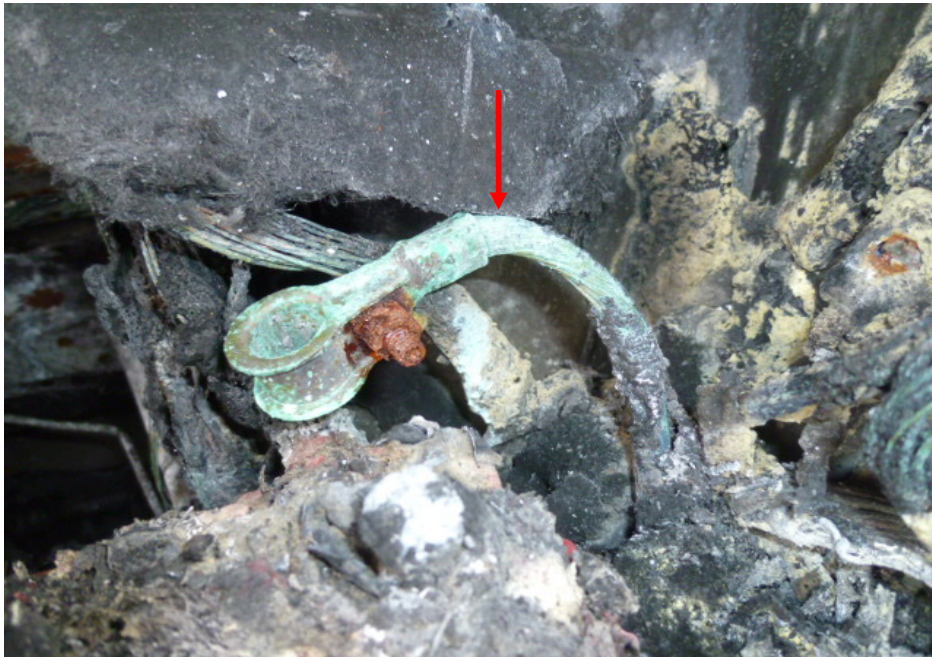
Photo 12 shows a close up view of the greenish residue found on some of the burnt stretches of original factory fitted wirings (arrowed). The presence of such greenish residue suggests occurrence of an electrical short circuit.

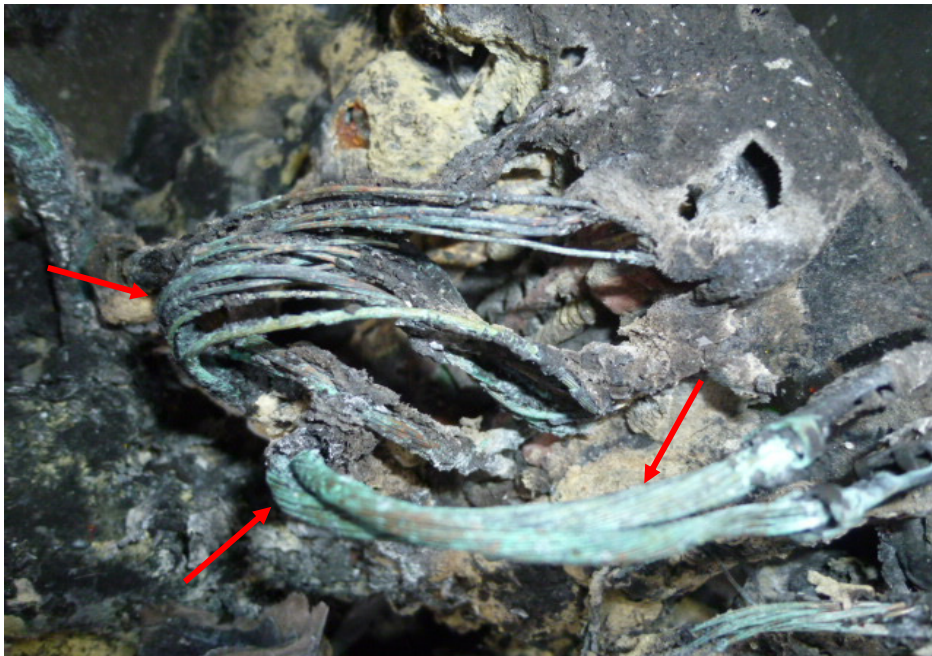
Photo 13 shows a close up view of the greenish residue found on some of the burnt stretches of original factory fitted wirings (arrowed). The presence of such greenish residue suggests occurrence of an electrical short circuit.

26. Having investigated and technically analysed the damages of burnt nature to the Insured Vehicle, we are of the view that the cause of fire to the Insured Vehicle was of electrical in nature. For this particular case, the fire had originated along the original factory fitted wirings inside the engine compartment, somewhere around the left portion of the engine compartment.
27. We did not find any evidence which had suggested that the cause of fire to the Insured Vehicle was due to poor maintenance and/or recurring electrical problem.
28. There were no modification(s) or additional electronic and/or electrical component(s) fitted on the Insured Vehicle at the time of our inspection of the Insured Vehicle.

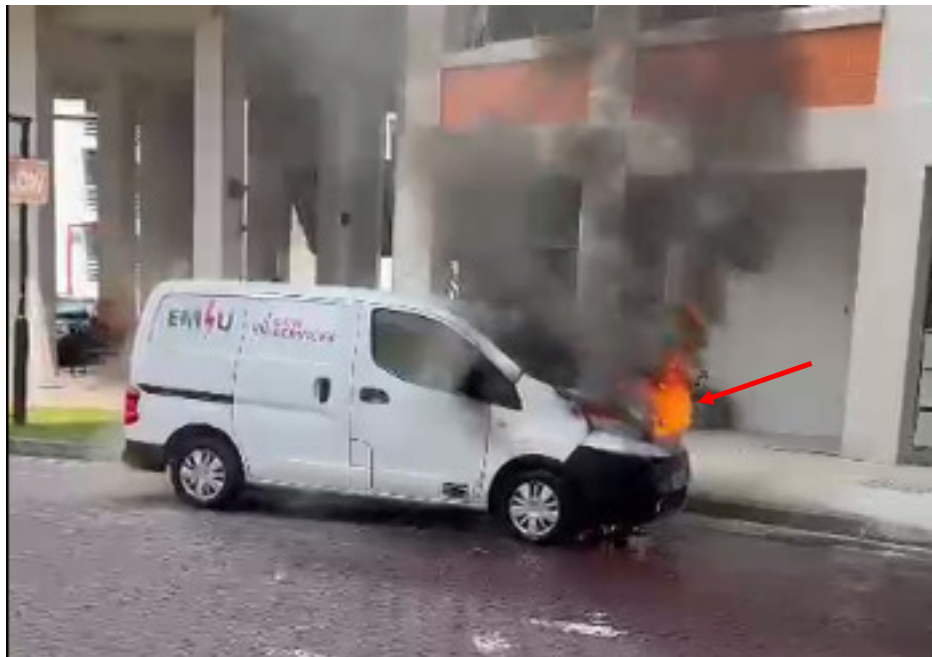
Photo 14 shows the Insured Vehicle on fire before the arrival of the SCDF. In general, the information that could be gathered from this photograph had corresponded to the events that were related to us by Mr Nur, which is the fire had started from the engine compartment of the Insured Vehicle (arrowed).

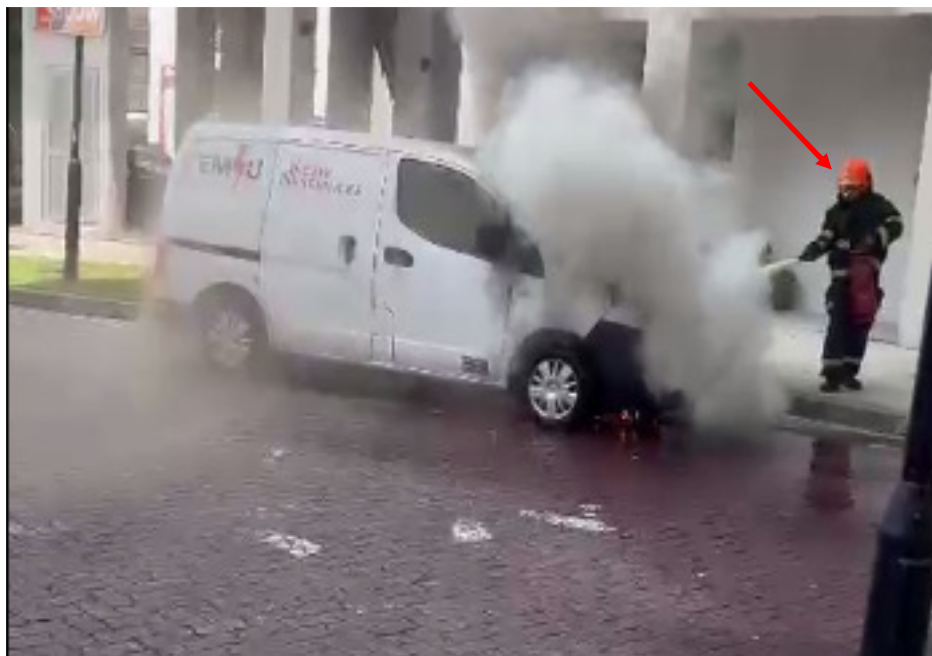
Photo 15 shows a firefighter putting out the fire on the Insured Vehicle (arrowed). In general, the information that could be gathered from this photograph had corresponded to the events that were related to us by Mr Nur, which is the SCDF were present at the incident location.

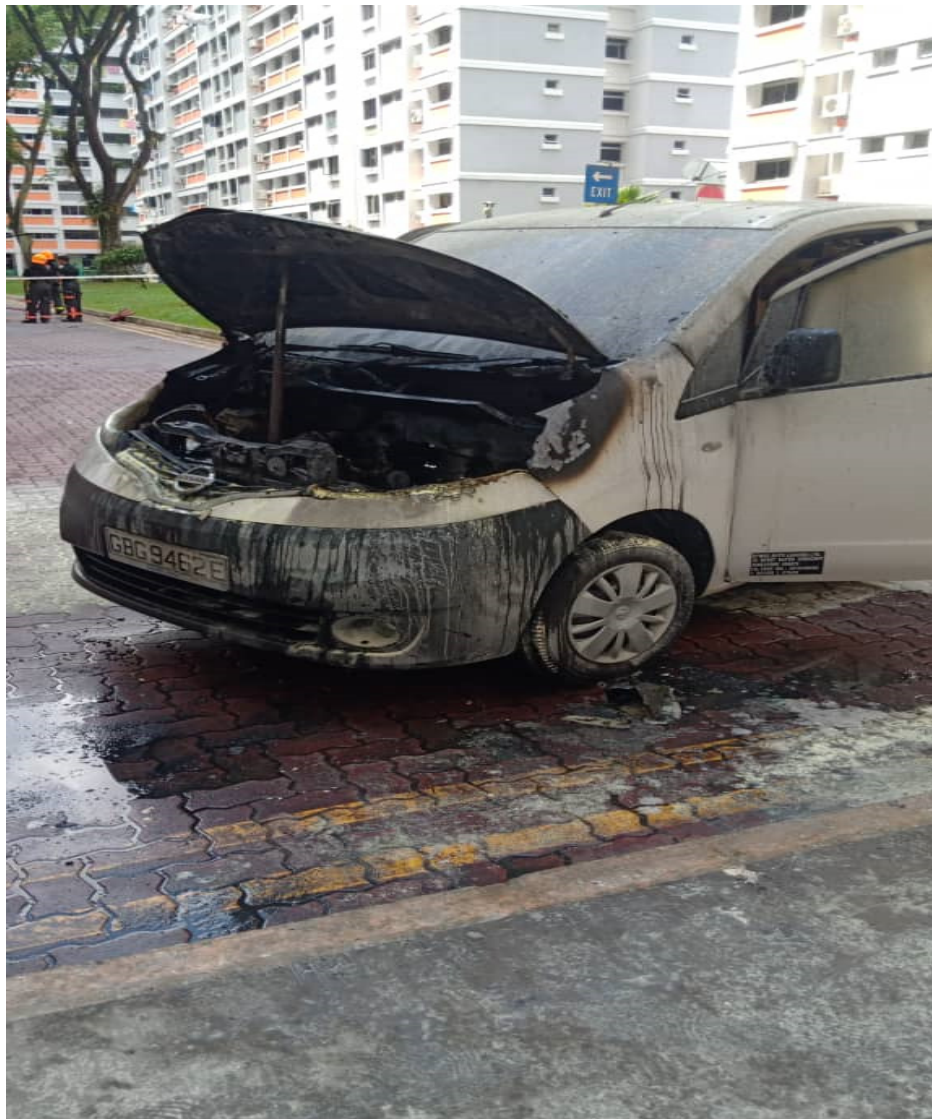
Photo 16 shows the Insured Vehicle after the fire had been extinguished.
