## LKK Auto Consultants Pte Ltd

| Affiliated to Federation Internationale Des Experts En Automobile | | | | |
|---|---|---|---|--|
| <b>1. Policy Particulars :- THIRD PARTY CLAIM</b> | | | | |

## ADJUSTMENT ON REPAIR COST FOR VEHICLE NO. SHC 4500L

PHOTOGRAPHS FOR VEHICLE NO. SHC 4500L

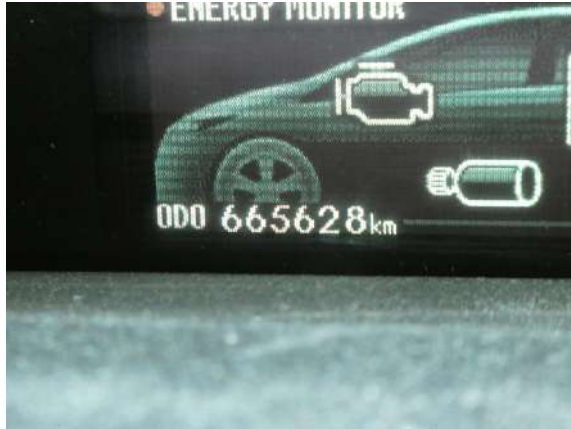
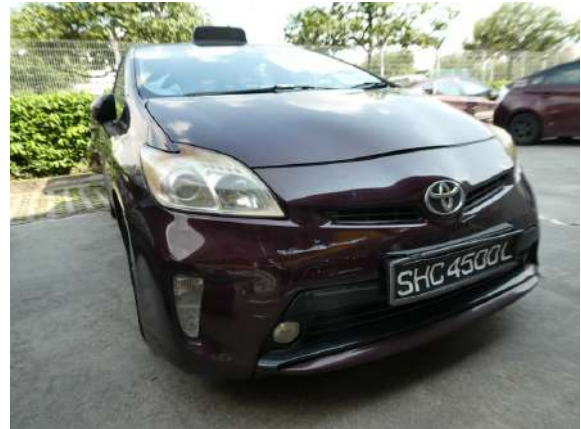
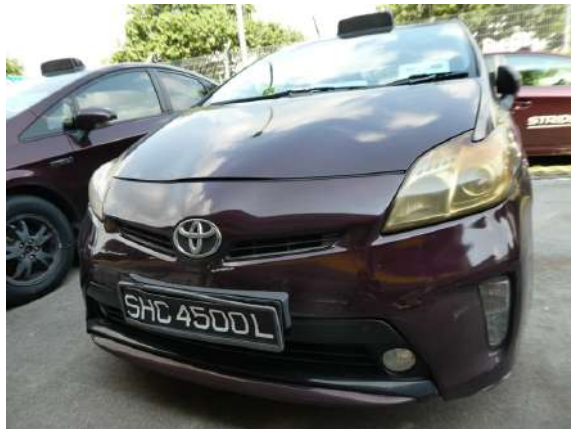
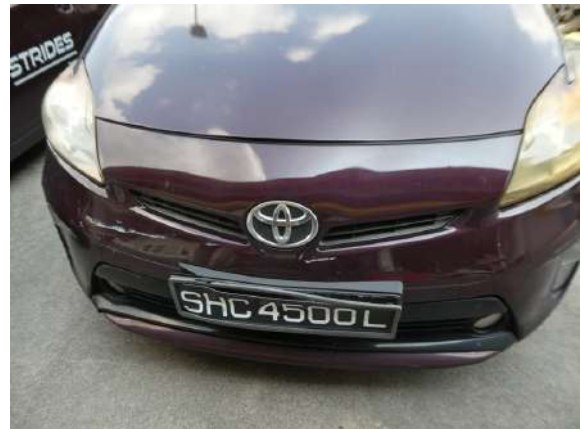
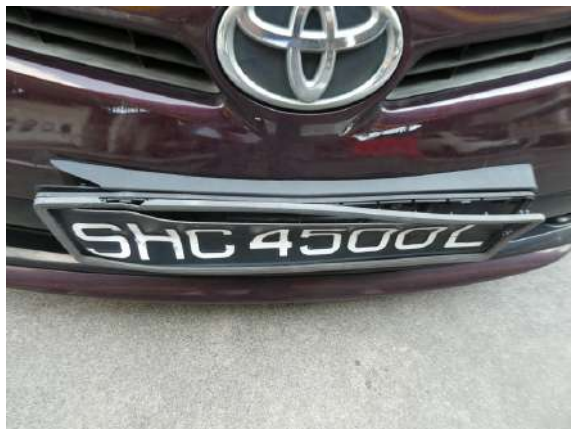
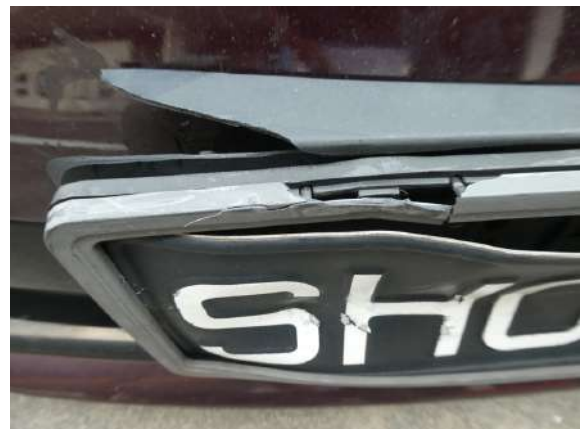
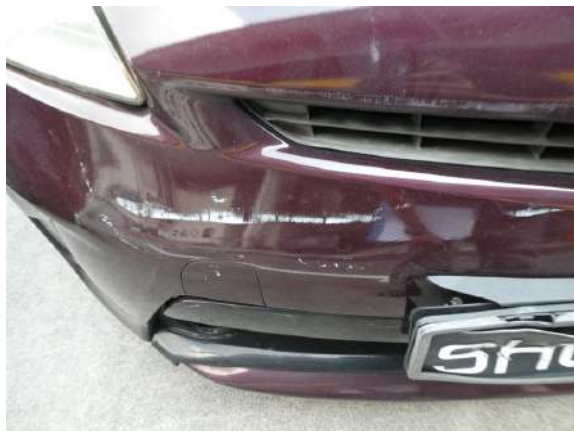
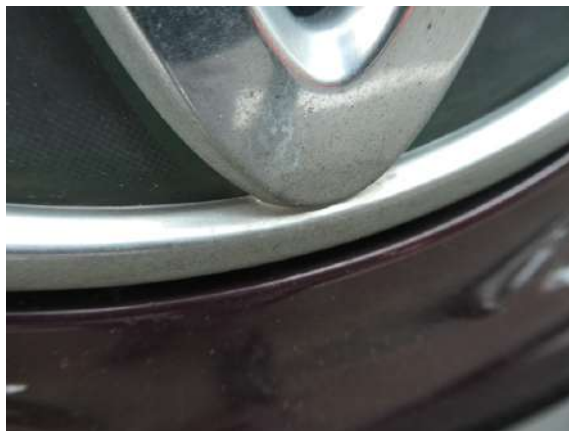
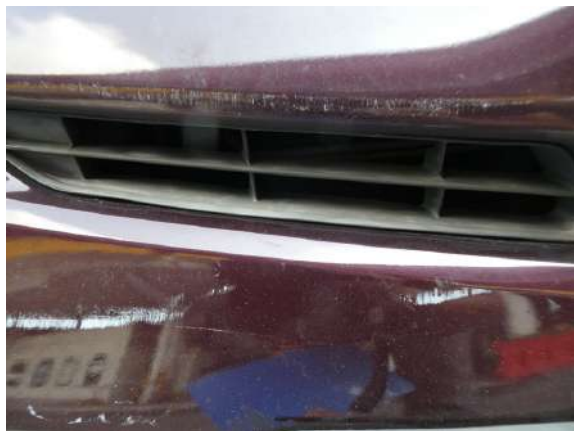
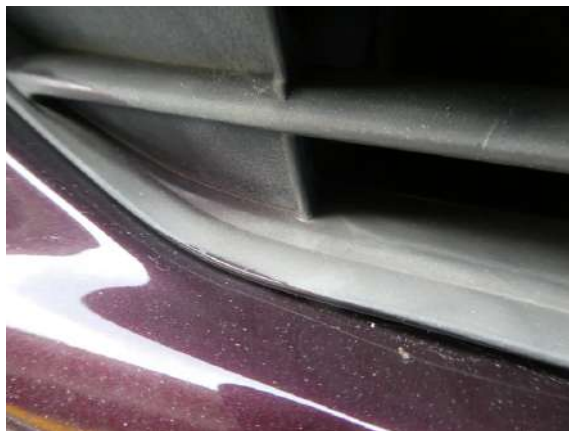
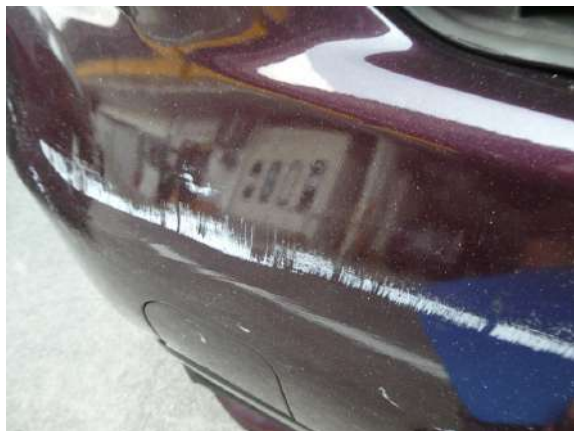
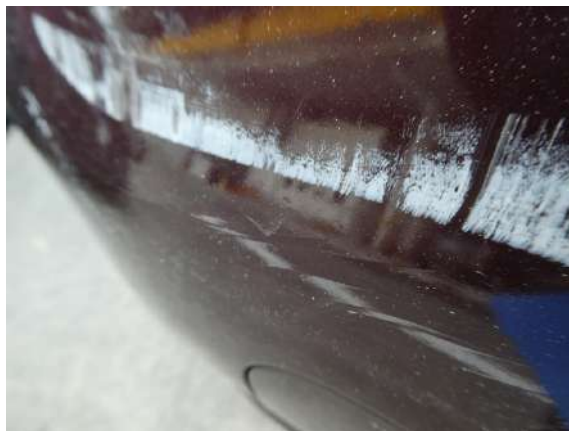
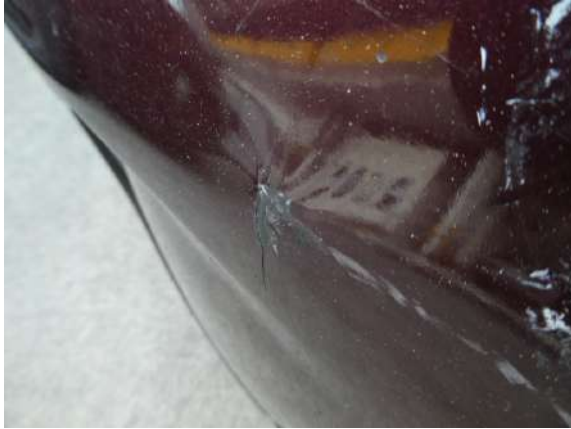
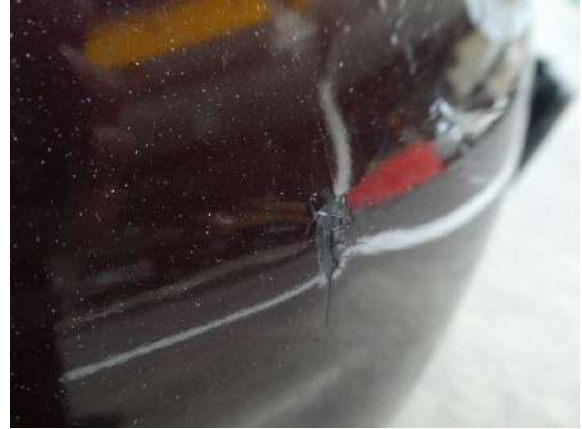
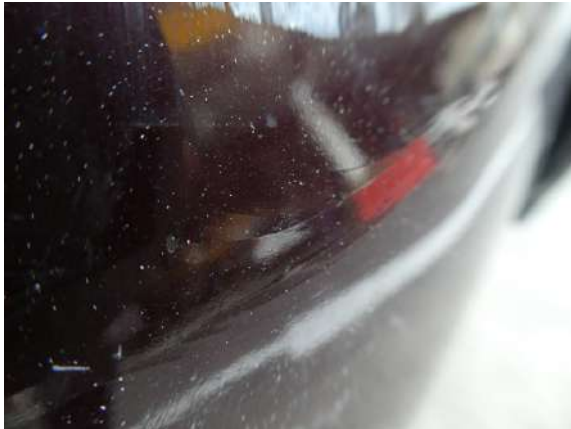
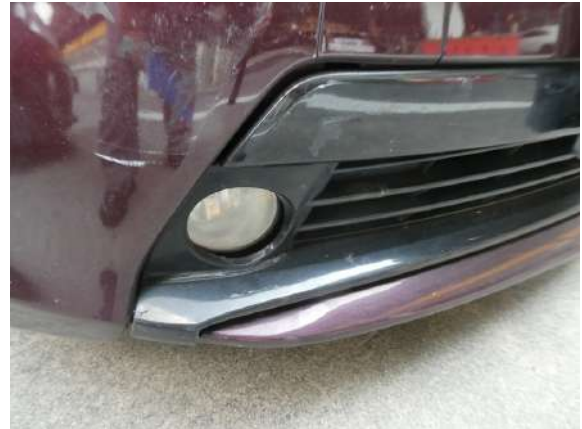
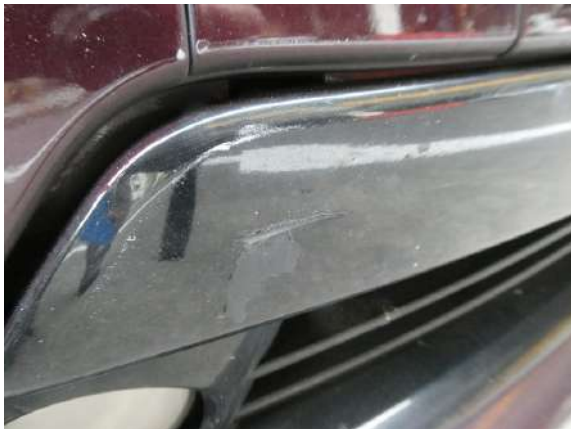
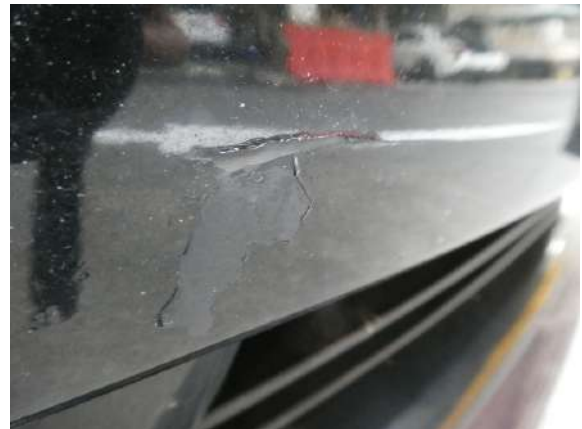
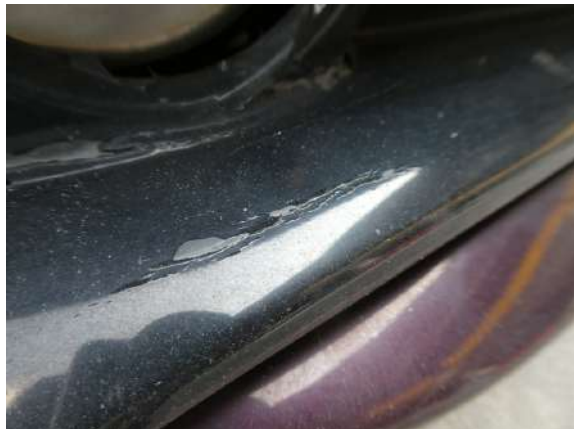
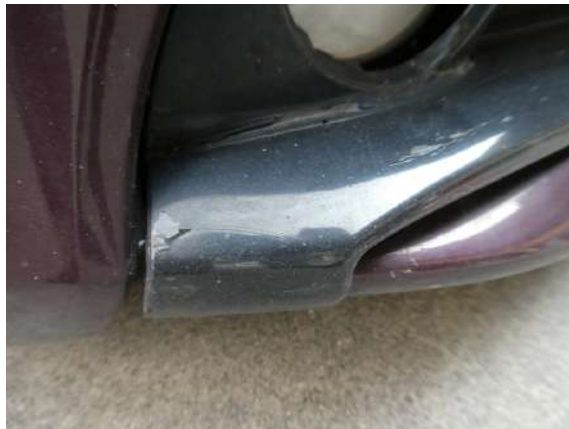
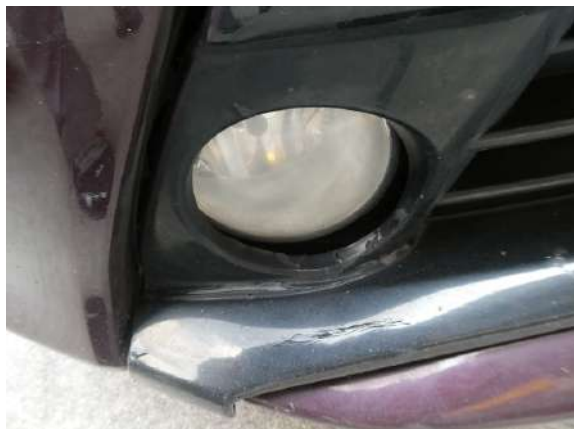
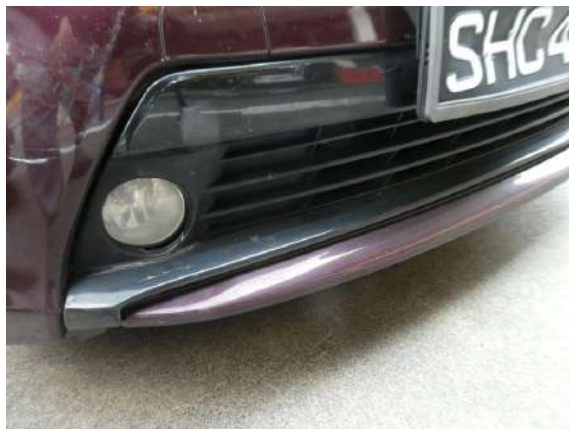
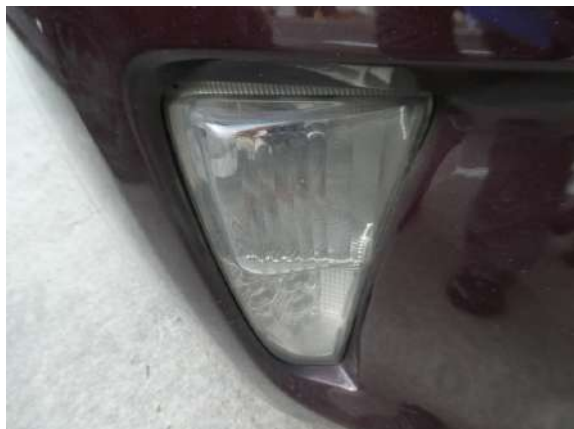
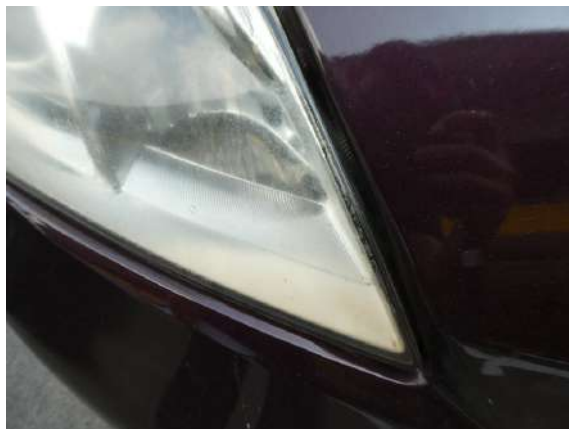
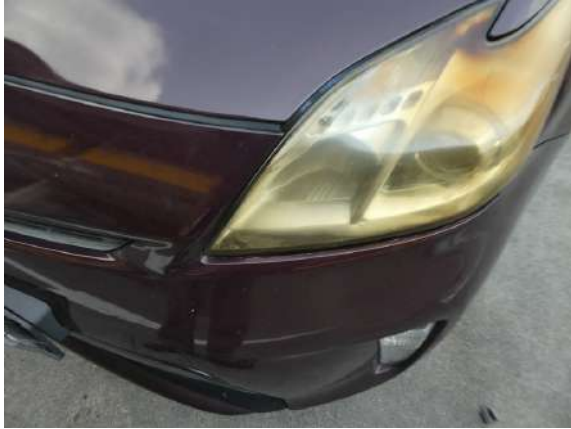
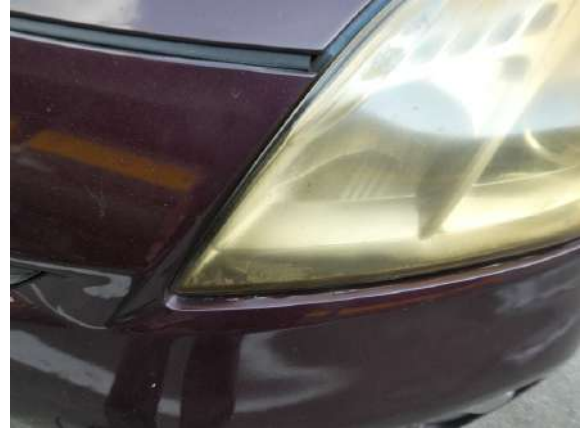
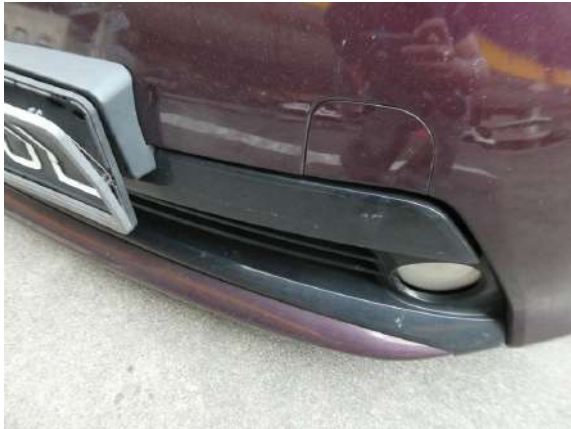
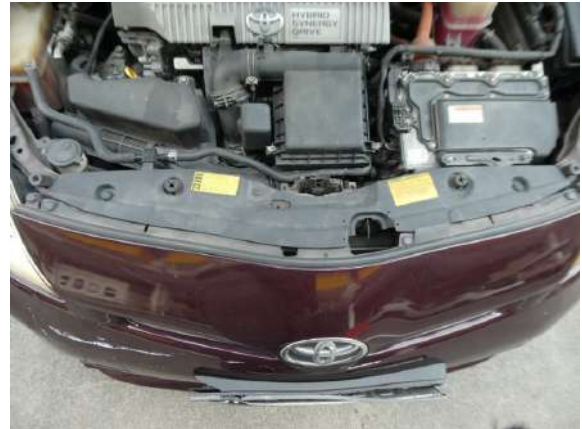
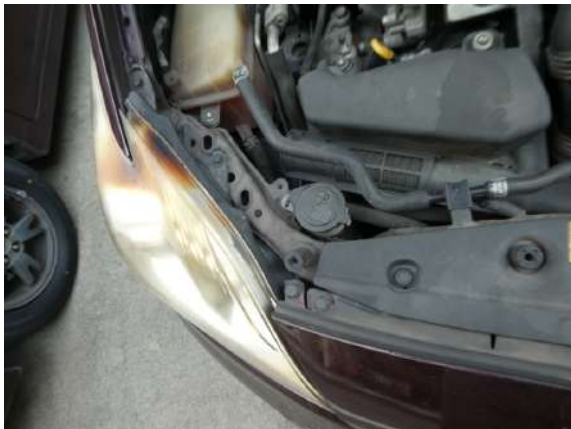
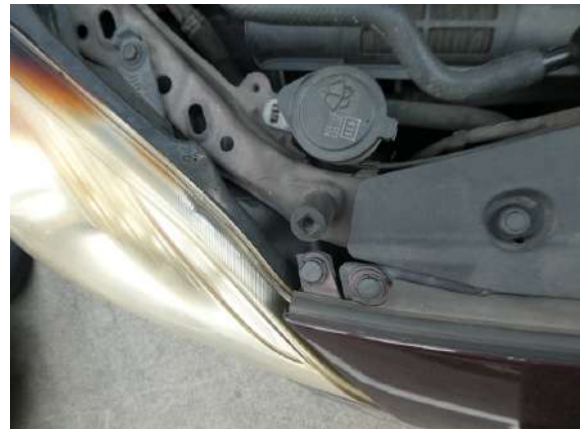
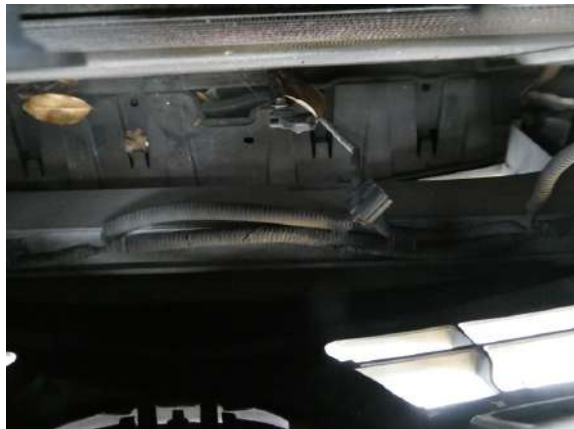
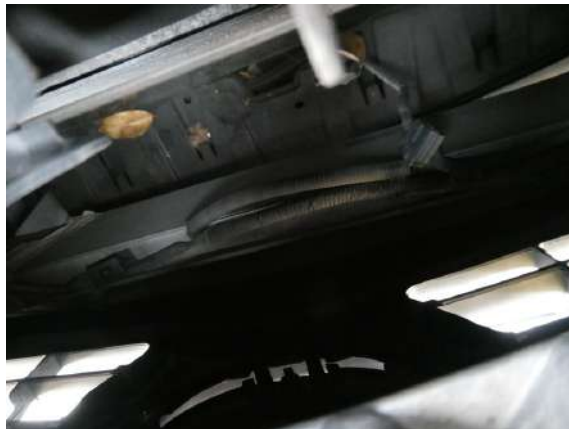
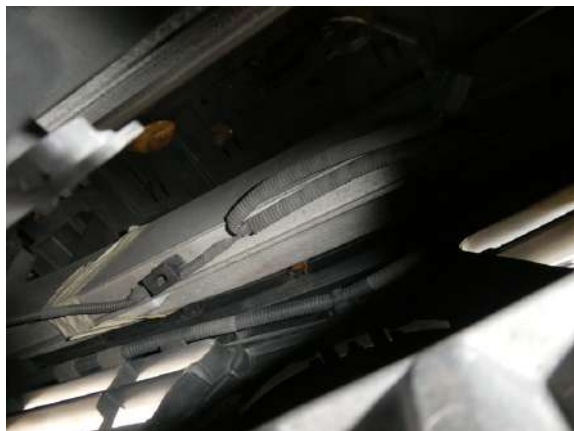
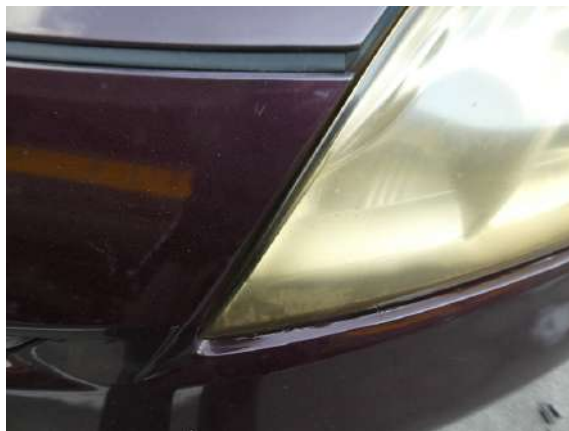
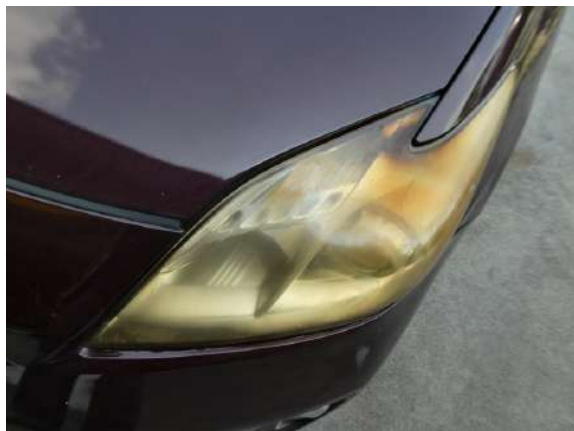
INSPECTION

| Affiliated to Federation Internationale Des Experts En Automobile | | | | |
|---|---|---|---|--|
| THE VEHICLE SUSTAINED DAMAGES AT THE FRONT PORTION.<br>DAMAGES SEE DETAILS. | | | | |
