Your Ref: Maserati Levante  
(chassis number ZN6XU61C00X349385)  
Our Ref : CI/TP22005667/D

11 June 2022

**INSPECTION REPORT OF AN UNREGISTERED MASERATI LEVANTE  
MOTOR CAR WITH CHASSIS NUMBER ZN6XU61C00X349385**

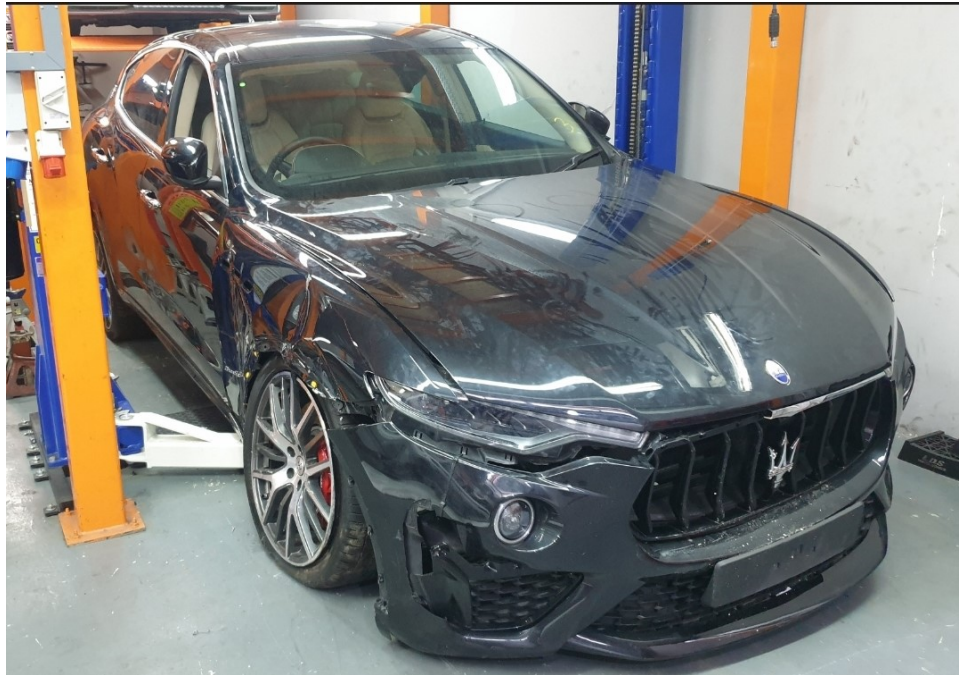
3. The photographs provided to me had showed damage at the front right portion of the Motor Car. Body parts damaged include the front bumper, front bumper right lower grille, front radiator grille, front bonnet, front right headlamp, front right fender, front right fender wheel arc garnish, front right wheel rim and front right tyre amongst others.
4. The Motor Car's front right wheel was also observed to be tilted inwards, indicating damage to the undercarriage parts at the Motor Car's front right wheel. The front right knuckle arm, front right lower arm, front right shock absorber and front right steering tie rod are amongst the undercarriage parts that may possible be damaged.
5. No physical damage was observed to other areas of the Motor Car. The Motor Car's airbag(s) was not deployed as seen from the photographs that were provided to me. See photo 1 – 4 below.

**Photo 1** shows the front right body of the Motor Car (photograph provided to me). The Motor Car was observed to have sustained damage at its front right portion. The front bumper, front bumper right lower grille, front radiator grille, front bonnet, front right headlamp, front right fender, front right fender wheel arc garnish, front right wheel rim and front right tyre were amongst the body parts that were observed to have been damaged. The Motor Car's front right wheel was also observed to be tilted inwards indicating damage to the undercarriage parts at the Motor Car's front right wheel.

23. The body parts at the front right portion of the Motor Car, as well as the undercarriage parts at the front right wheel of the Motor Car were visually examined and it was noted that the repair/restoration works carried out to the damaged area of the Motor Car (refer to photograph 1 above) were reasonably adequate and in order.

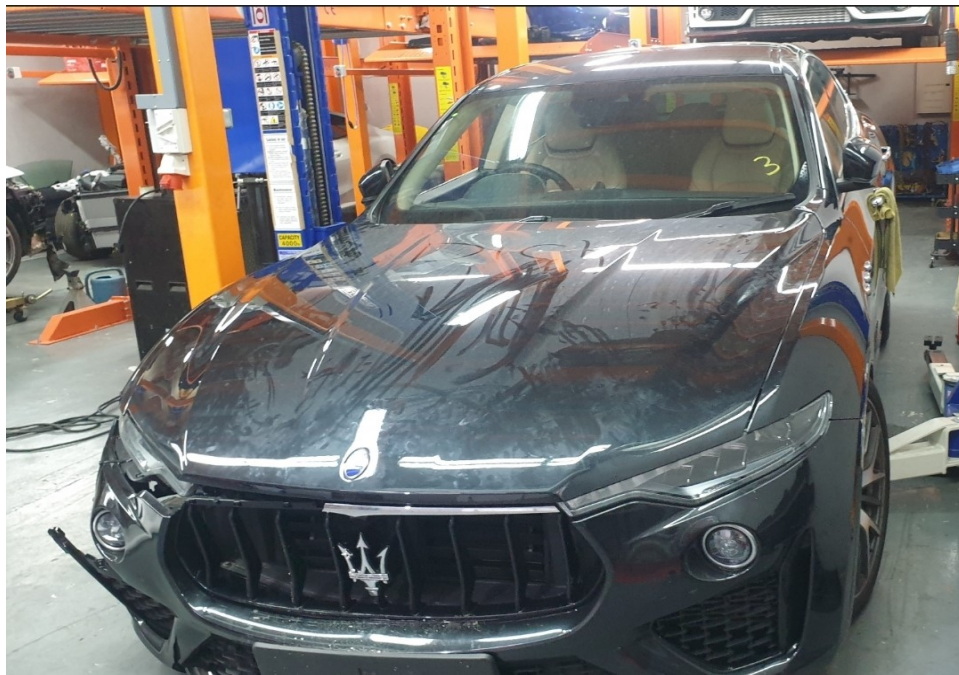
**Photo 2** shows the front left body of the Motor Car (photograph provided to me). Apart for the front right portion, there was no physical damage observed to other areas of the Motor Car. The airbag(s) was also not deployed.

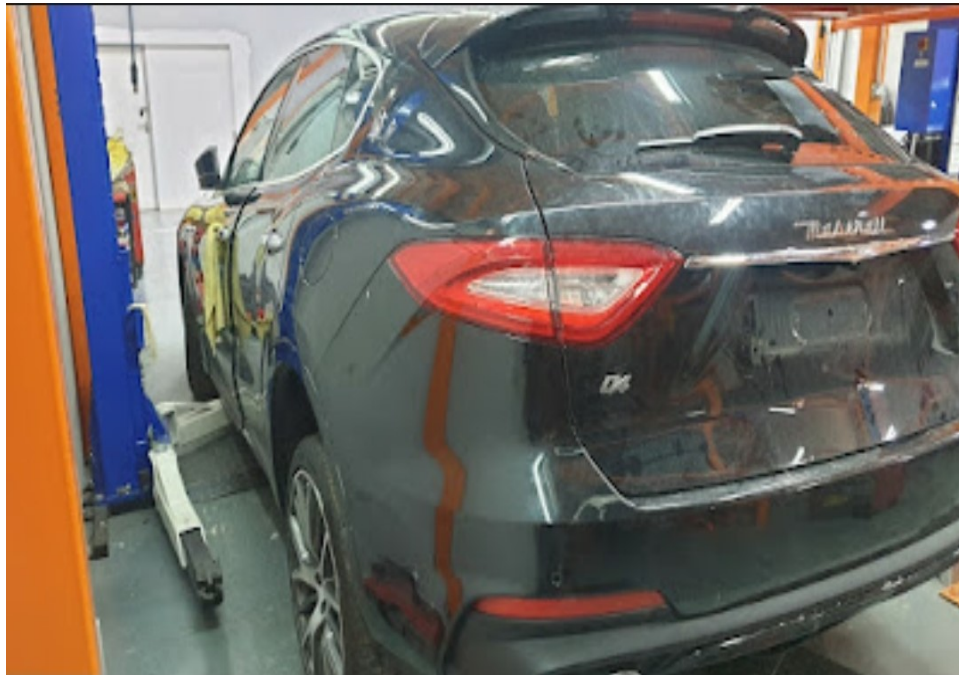
**Photo 3** shows the rear left body of the Motor Car (photograph provided to me). Apart for the front right portion, there was no physical damage observed to other areas of the Motor Car.

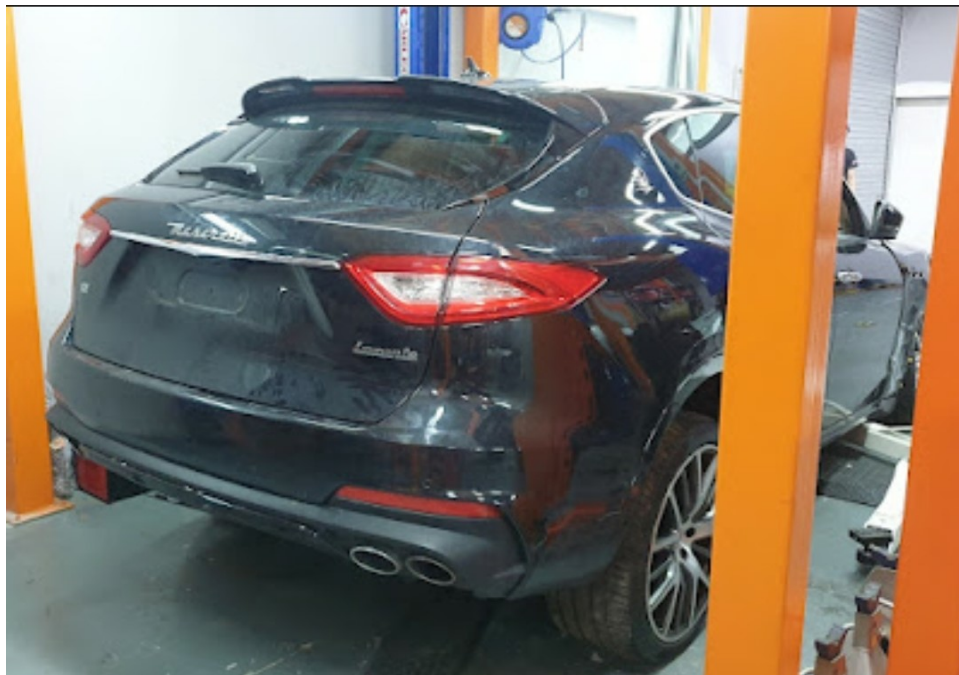
**Photo 4** shows the rear right body of the Motor Car (photograph provided to me). Apart for the front right portion, there was no physical damage observed to other areas of the Motor Car.

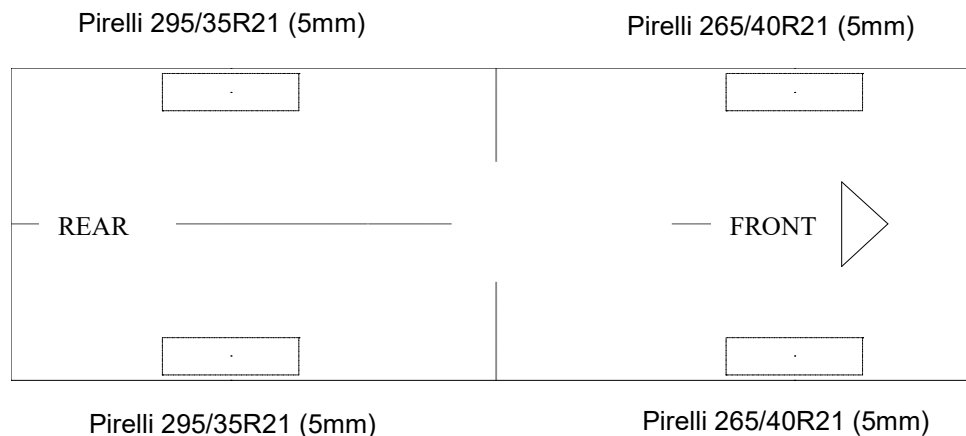
9. It was fitted with 21inch sport wheel rims that were wrapped with tyres that were observed to be of serviceable condition. The tyres were also sufficiently inflated for vehicular operation. The tyre brand, tyre size and approximate remaining tread depth of the 4 tyres of the Motor Car were recorded as follows: -

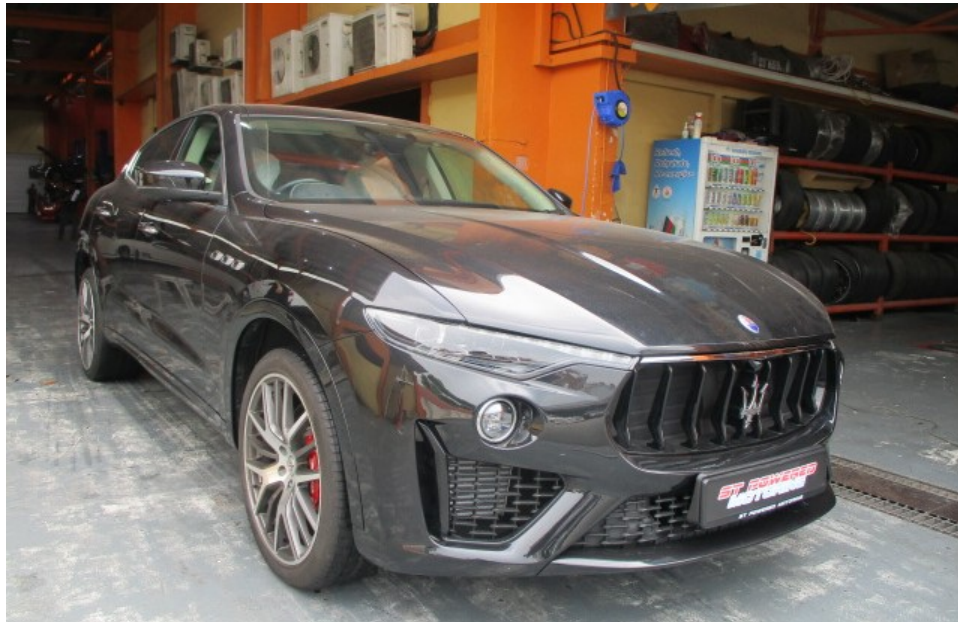
**Photo 5** shows a general view of the front right body of the Motor Car at the time of my inspection. The Motor Car was observed to be in a relatively good general condition with no loose exterior fittings observed. The body parts at the front right portion of the Motor Car were visually examined and it was observed that the repair/restoration works carried out to the damaged area of the Motor Car (refer to photograph 1 above) were reasonably adequate and in order.

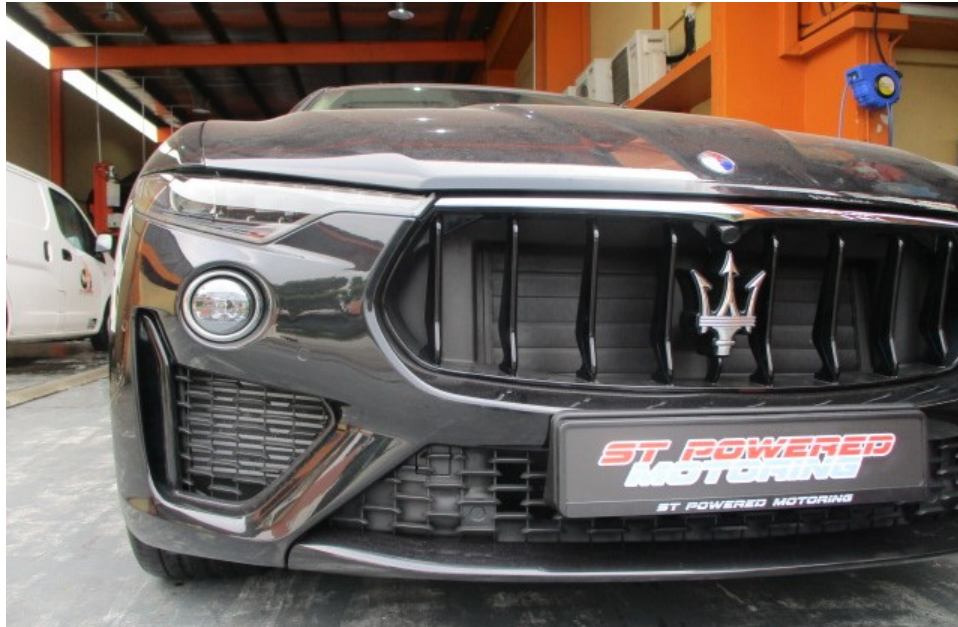
**Photo 6** shows a closer view of the Motor Car's front radiator grille, front bumper, front bumper right lower grille, front right fog light and front right headlamp at the time of my inspection. The body parts at the front right portion of the Motor Car were visually examined and it was observed that the repair/restoration works carried out to the damaged area of the Motor Car (refer to photograph 1 above) were reasonably adequate and in order.

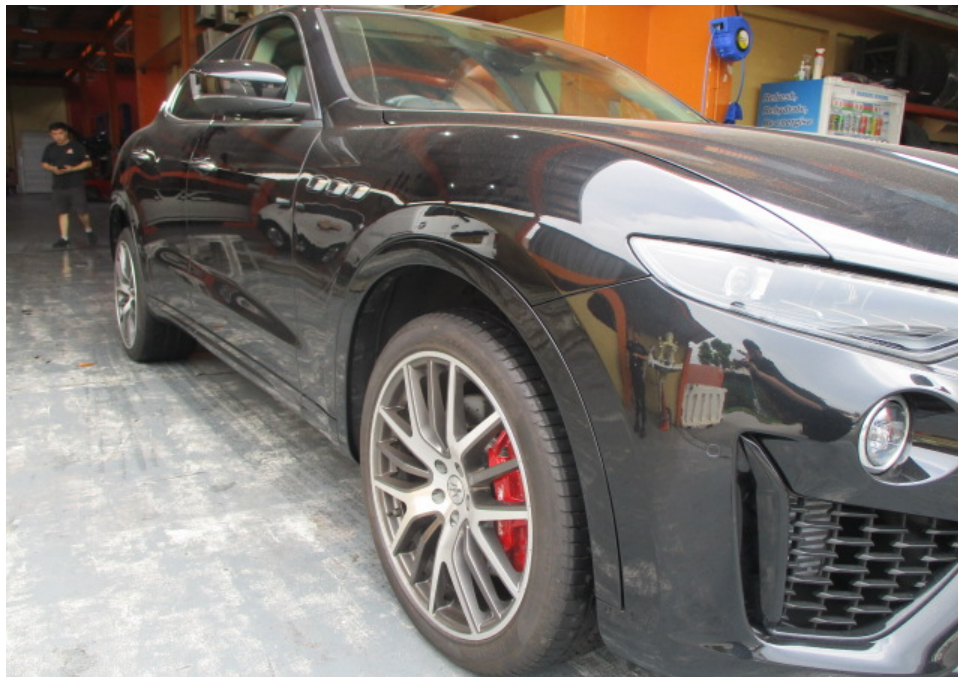
**Photo 7** shows a closer view of the Motor Car's front bonnet, front right headlamp, front right fender, front right fender wheel arc garnish, front right wheel rim and front right tyre. The body parts at the front right portion of the Motor Car were visually examined and it was observed that the repair/restoration works carried out to the damaged area of the Motor Car (refer to photograph 1 above) were reasonably adequate and in order.

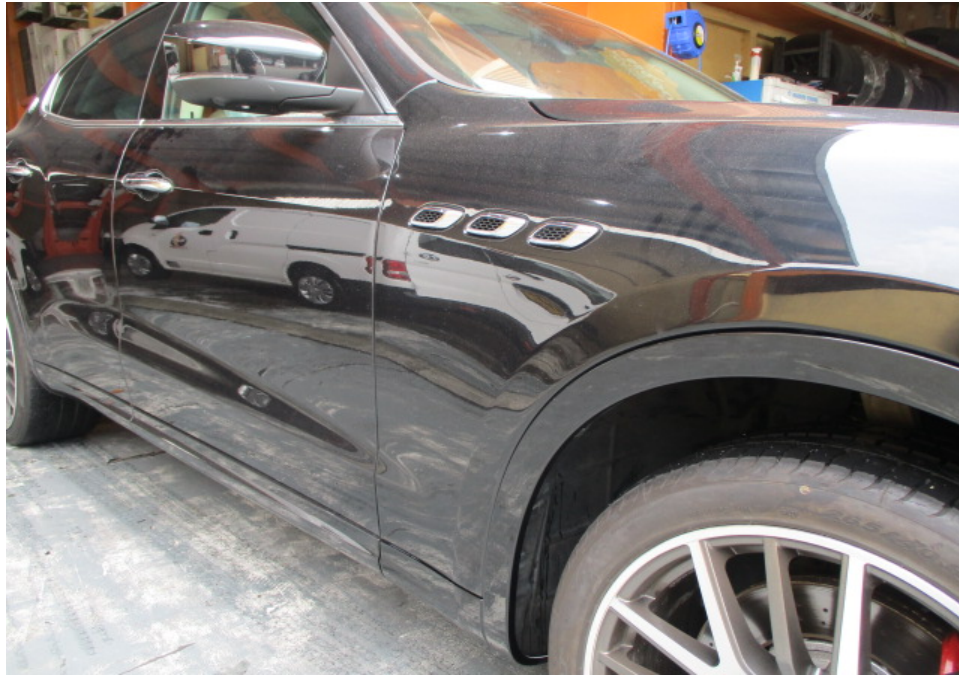
**Photo 8** shows a closer view of the Motor Car's front right fender, front right fender wheel arc garnish and front right door at the time of my inspection. The body parts at the front right portion of the Motor Car were visually examined and it was observed that the repair/restoration works carried out to the damaged area of the Motor Car (refer to photograph 1 above) were reasonably adequate and in order.

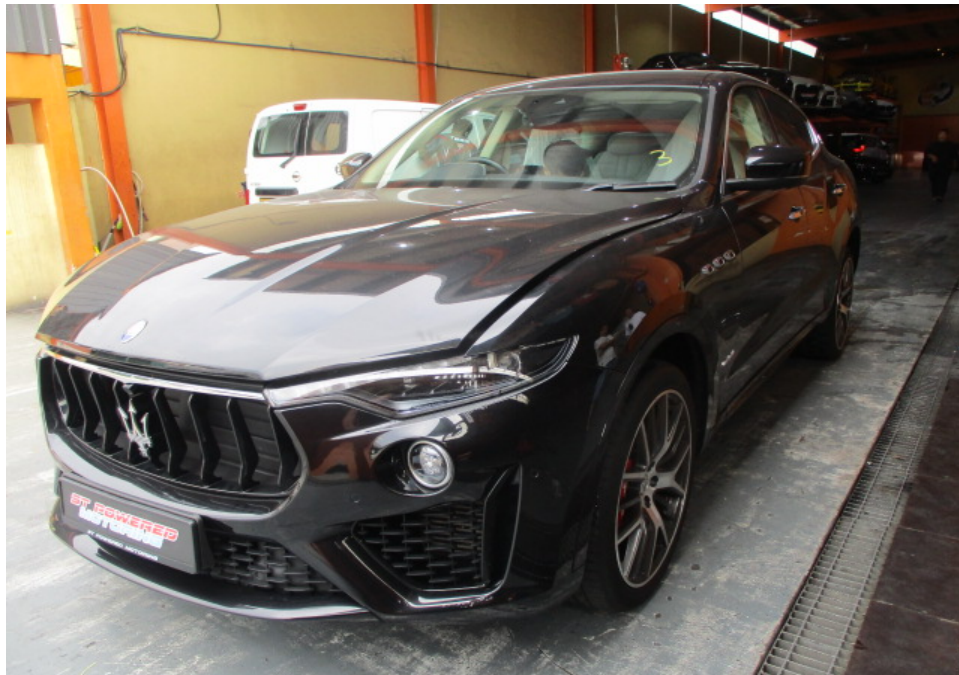
**Photo 9** shows a general view of the front left body of the Motor Car at the time of my inspection. The Motor Car was observed to be in a relatively good general condition with no loose exterior fittings observed. The mileage of the Motor Car recorded at the time of my inspection was 8,304km.

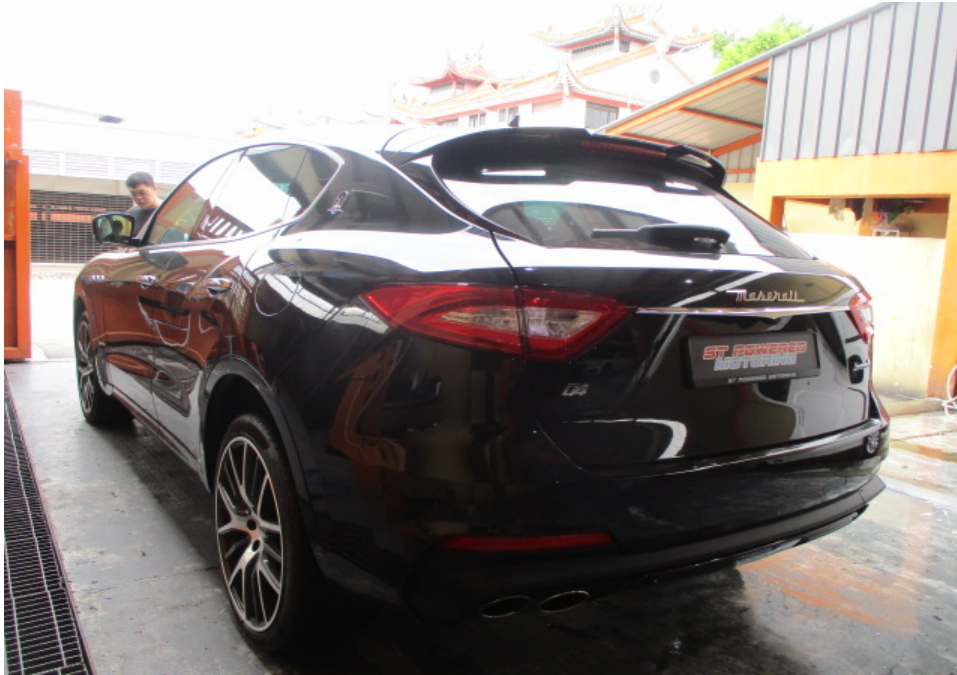
**Photo 10** shows a general view of the rear left body of the Motor Car at the time of my inspection. The Motor Car was observed to be in a relatively good general condition with no loose exterior fittings observed. The mileage of the Motor Car recorded at the time of my inspection was 8,304km.

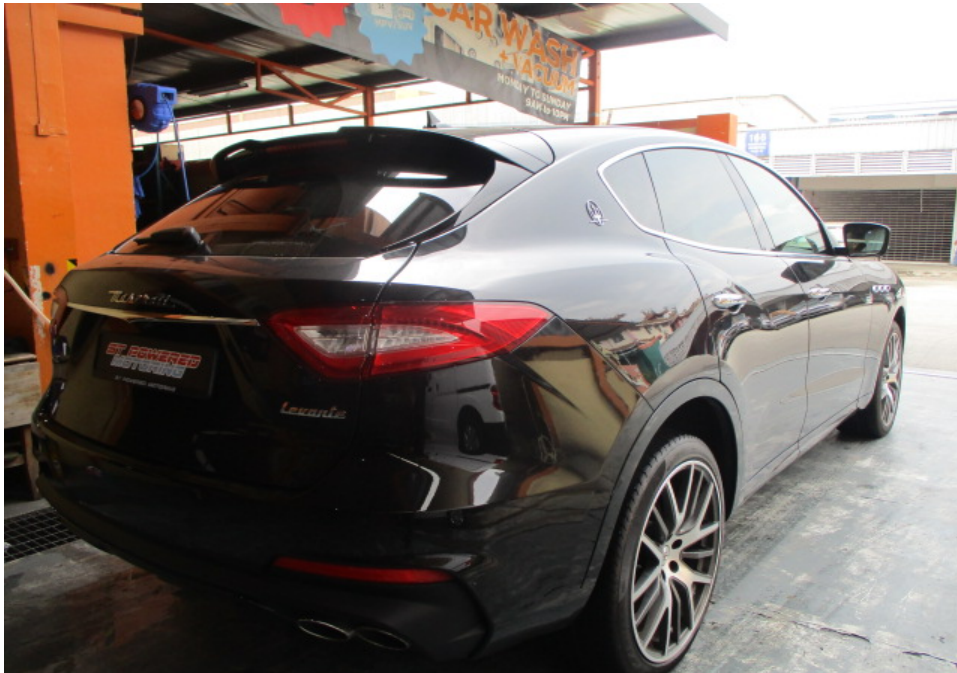
**Photo 11** shows a general view of the rear right body of the Motor Car at the time of my inspection. The Motor Car was observed to be in a relatively good general condition with no loose exterior fittings observed. The mileage of the Motor Car recorded at the time of my inspection was 8,304km.

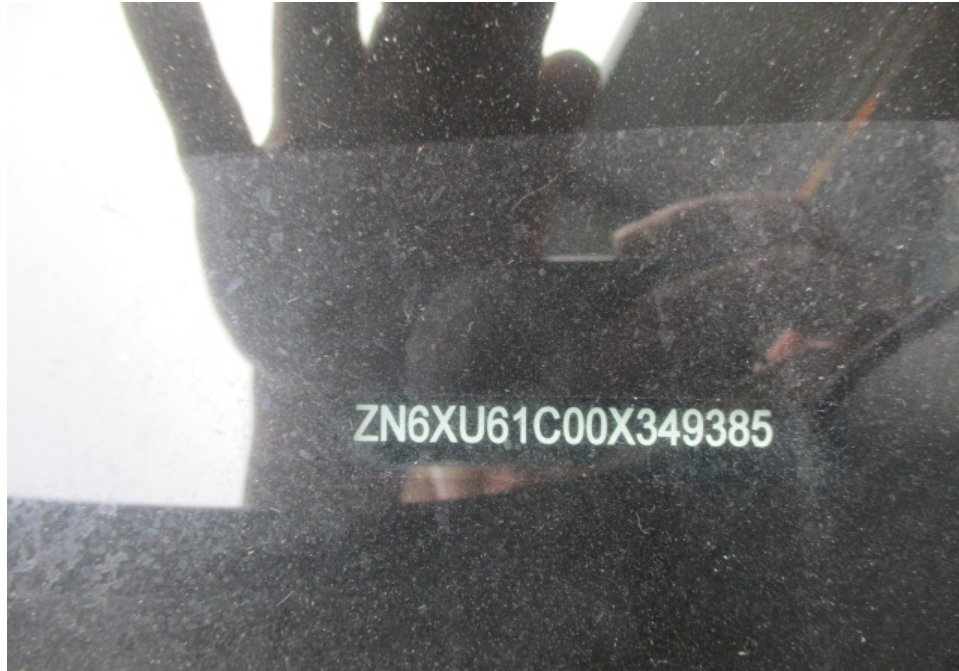
**Photo 12** shows the chassis number of the Motor Car. The chassis number recorded was ZN6XU61C00X349385.

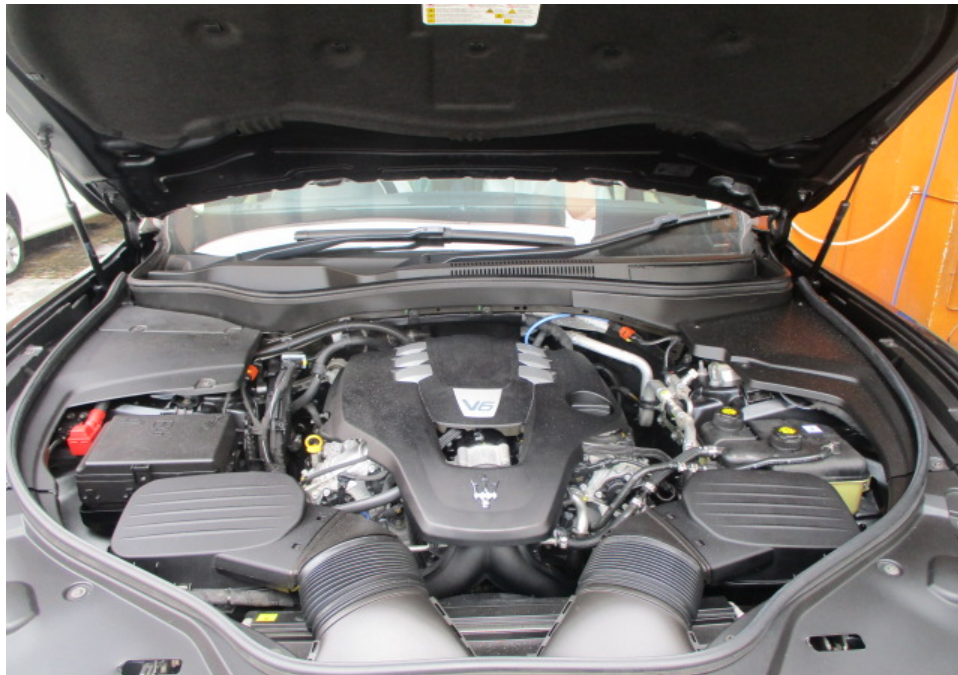
**Photo 13** shows a general view of the engine compartment of the Motor Car at the time of my inspection. The various parts and components inside the engine compartment were all observed to be intact and properly fitted. There was also no sign(s) or indication(s) of fluid leak and/or fluid stain found inside the engine compartment.

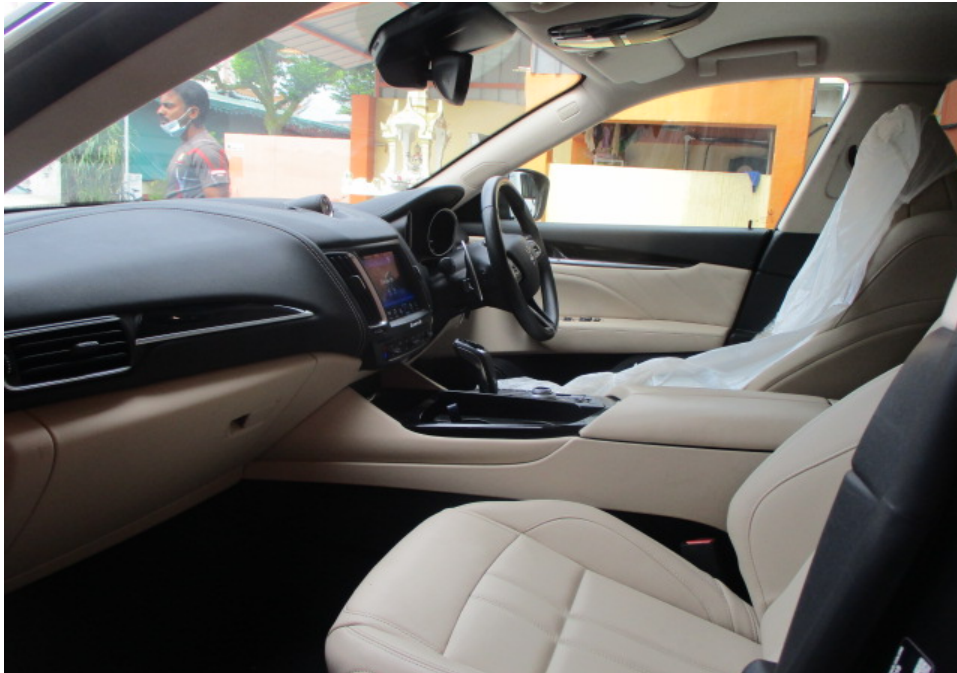
**Photo 14** shows the interior compartment of the Motor Car at the time of my inspection. The various parts and components, trims, carpet, and upholstery inside the interior compartment were all observed to be intact and properly fitted.

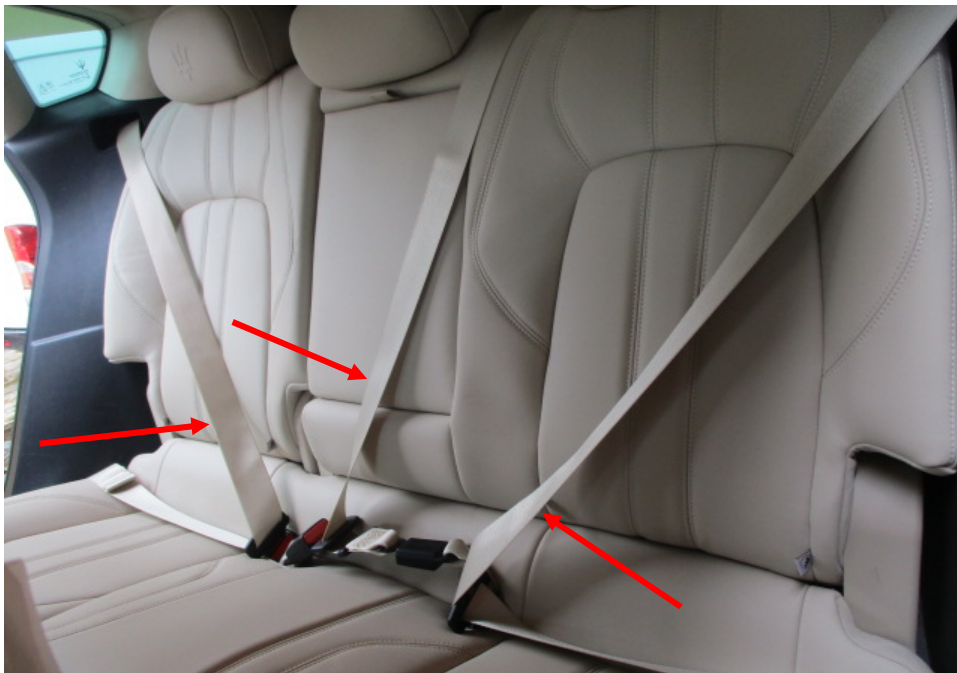
**Photo 15** shows the rear seats of the Motor Car. All the seats of the Motor Car were secured via seat rails to the floorboard. They were also fitted with a retractable seat belt reel and a pre-tensioner. The seat belts (arrowed) were tested and were able to be fastened into the respective pre-tensions that were fitted on the side of each individual seat.

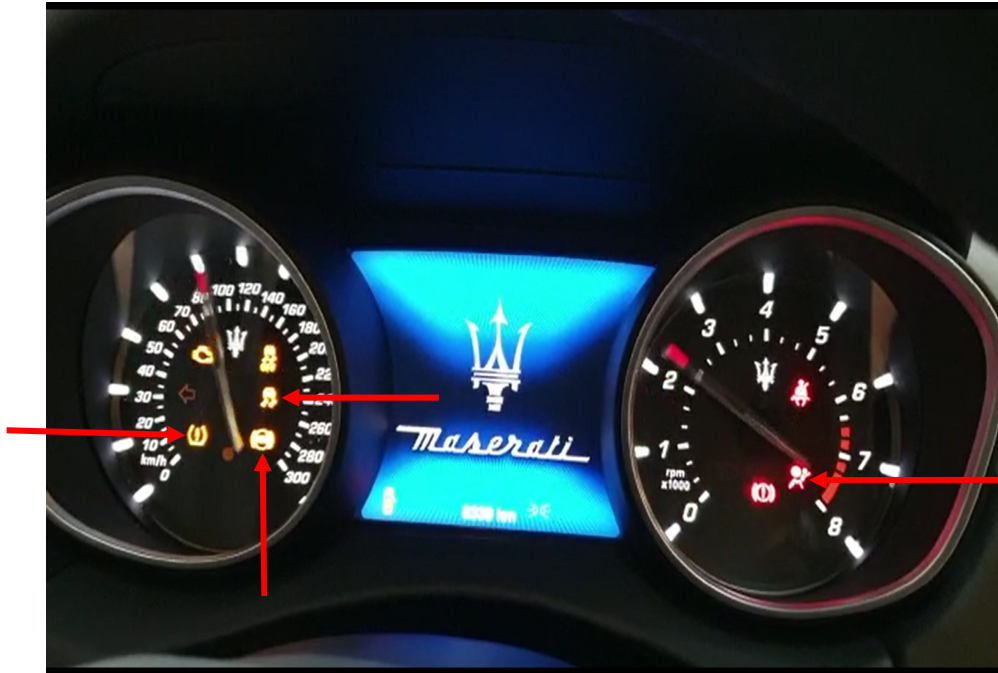
**Photo 16** shows the warning lights for the various electronic safety features appearing on the instrument panel of the Motor Car during its self-test when the engine is cranked, in particular the ABS, SRS, TPM and TCS lights (arrowed).

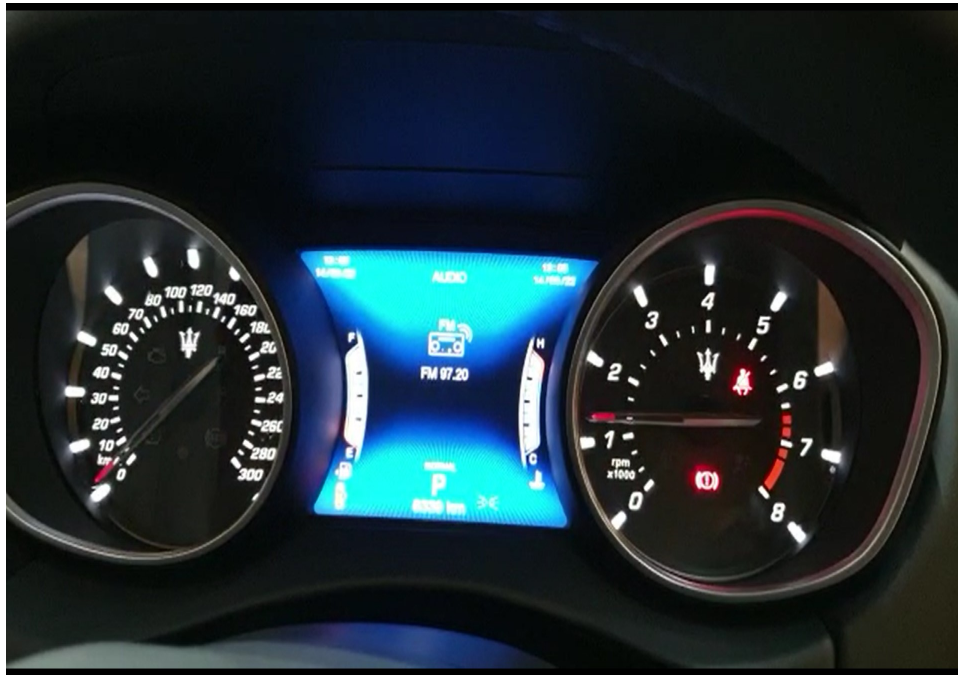
**Photo 17** shows the respective warning lights no longer illuminated, indicating that there is no fault detected to the ABS, SRS, TPM and TCS lights systems of the Motor Car during the self-test. These electronic systems were hence in working condition at the time of my inspection.

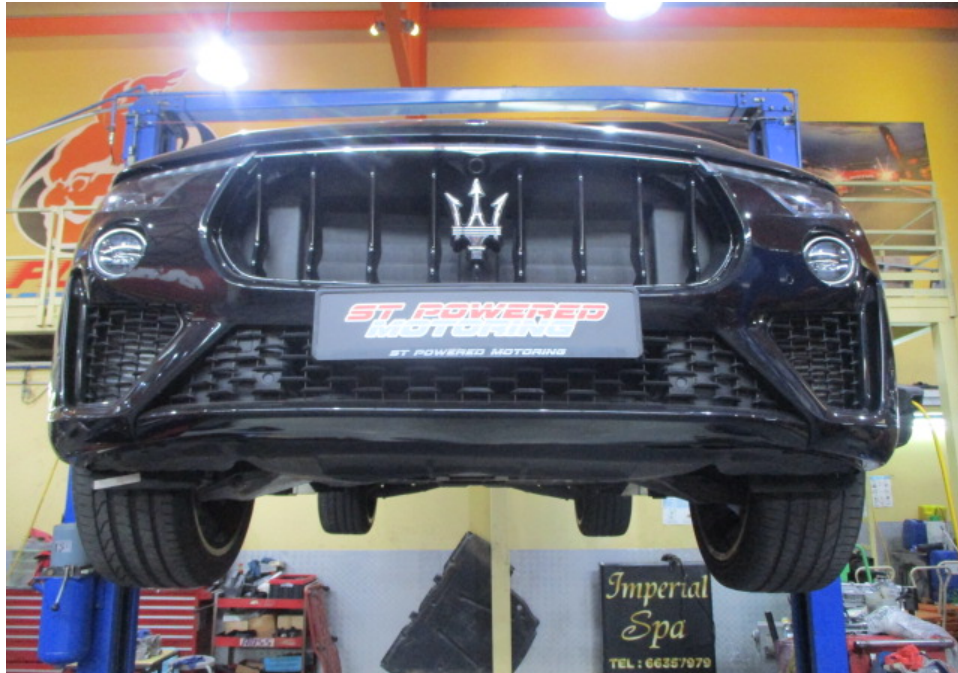
**Photo 18** shows the Motor Car hoisted up for checks on its undercarriage. There was no sign(s) or indication(s) of fluid leakage and/or fluid stain(s) on the underside of the Motor Car. The undercarriage components of the Motor Car were also all observed to be intact and secured in an appropriate manner.

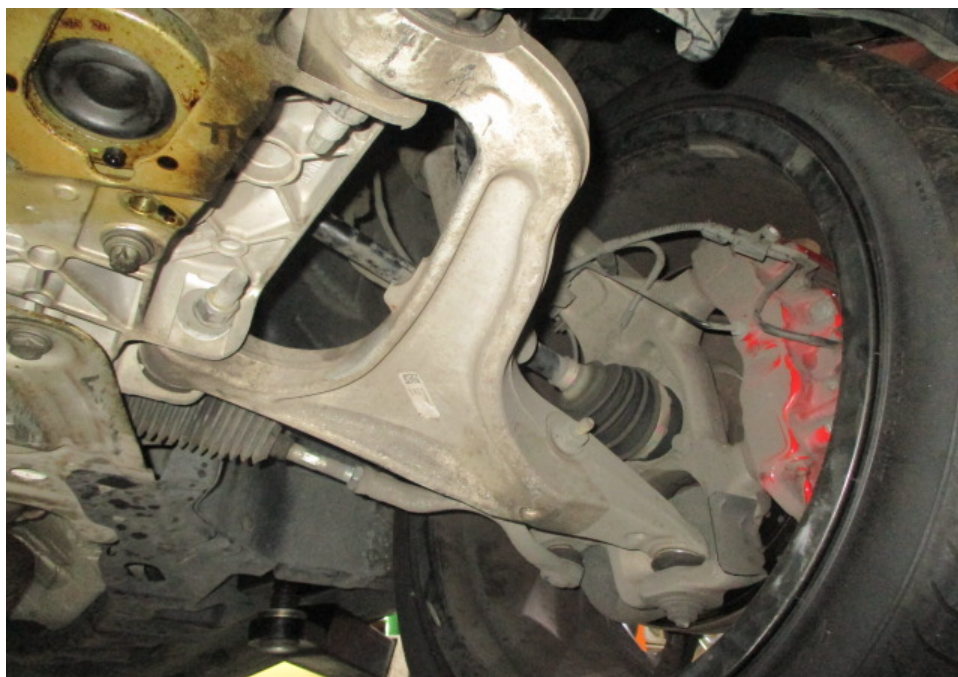
**Photo 19** shows the various undercarriage components at the front left wheel of the Motor Car. The mechanical components, control arms and linkages were all found to be intact and secured in an appropriate manner.

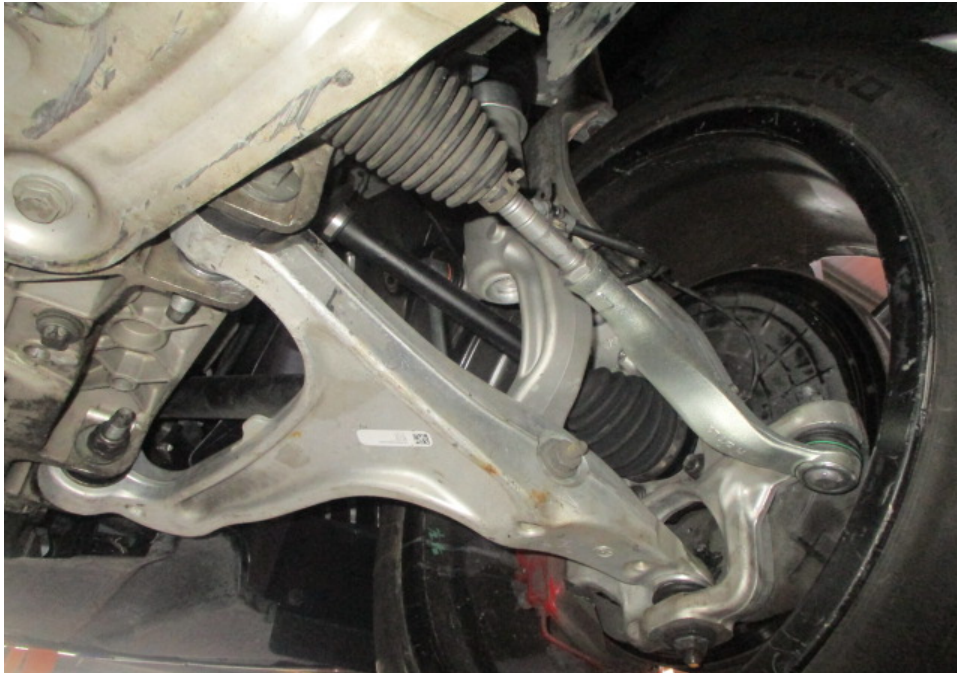
**Photo 20** shows the various undercarriage components at the front right wheel of the Motor Car. The mechanical components, control arms and linkages were all found to be intact and secured in an appropriate manner. I also did not observe any fluid leak and/or fluid stain on the underside of the Motor Car.

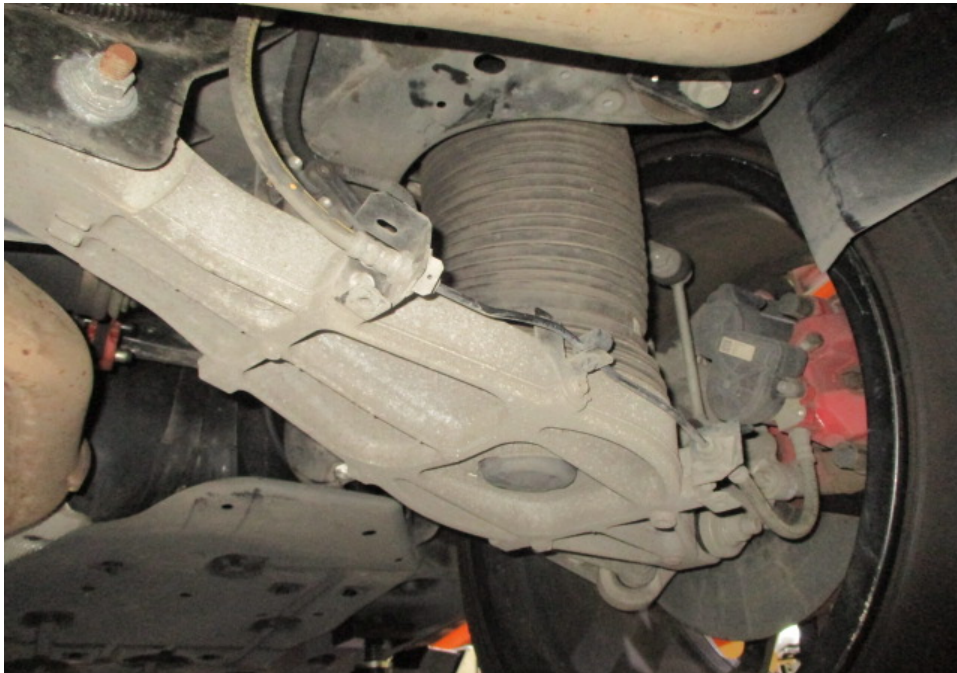
**Photo 21** shows a general view of the control arms and linkages at the rear right wheel of the Motor Car. I did not observe any fluid leak and/or fluid stain on the underside of the Motor Car. All of the Motor Car's undercarriage components were observed to be intact and secured in an appropriate manner.

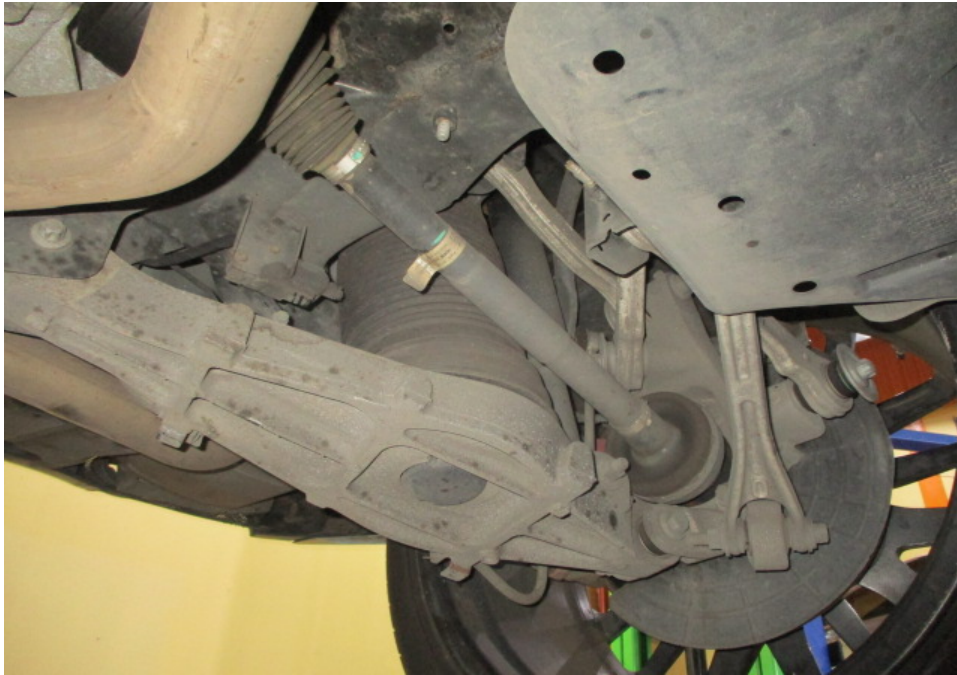
**Photo 22** shows a general view of the control arms and linkages at the rear left wheel of the Motor Car. I did not observe any fluid leak and/or fluid stain on the underside of the Motor Car. All of the Motor Car's undercarriage components were observed to be intact and secured in an appropriate manner.

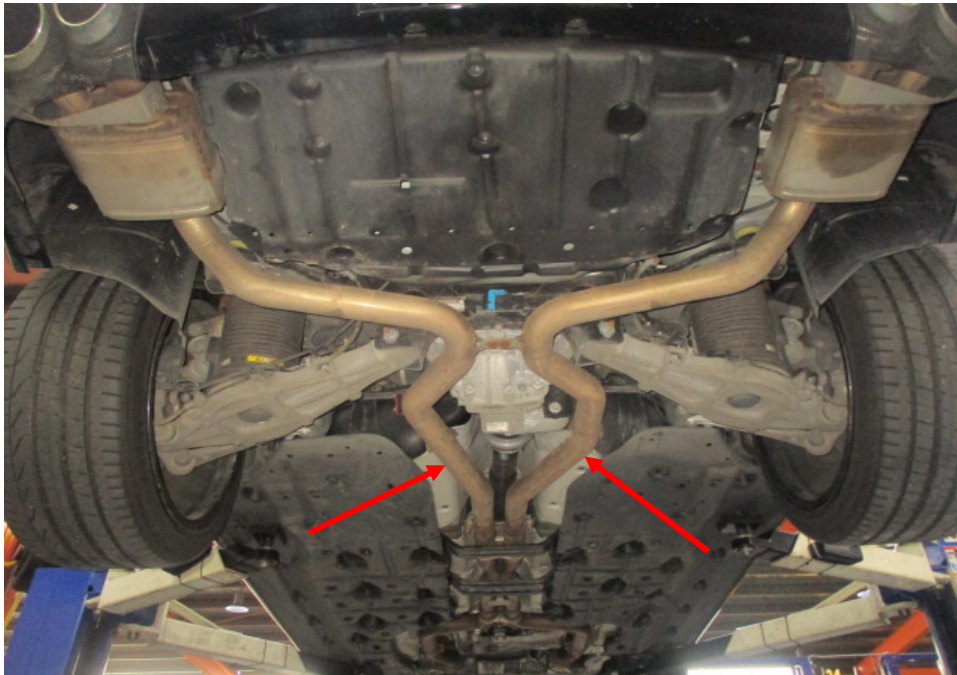
**Photo 23** shows the rear section of the Motor Car's exhaust system. My examination of the Motor Car's exhaust system revealed no sign(s) or indication(s) of any cut or weld marks along its exhaust pipes (arrowed), on its rear mufflers, on its centre resonator box and on its catalytic converters.

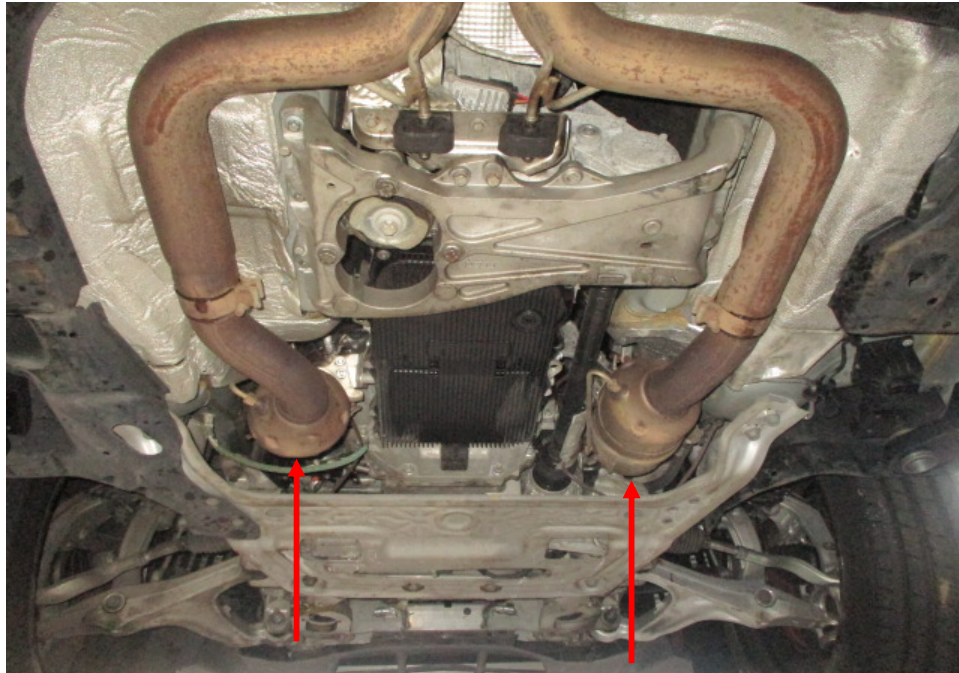
**Photo 24** shows the front section of the Motor Car's exhaust system. My examination of the Motor Car's exhaust system revealed no sign(s) or indication(s) of any cut or weld marks along its exhaust pipes, on its rear mufflers, on its centre resonator box and on its catalytic converters (arrowed).

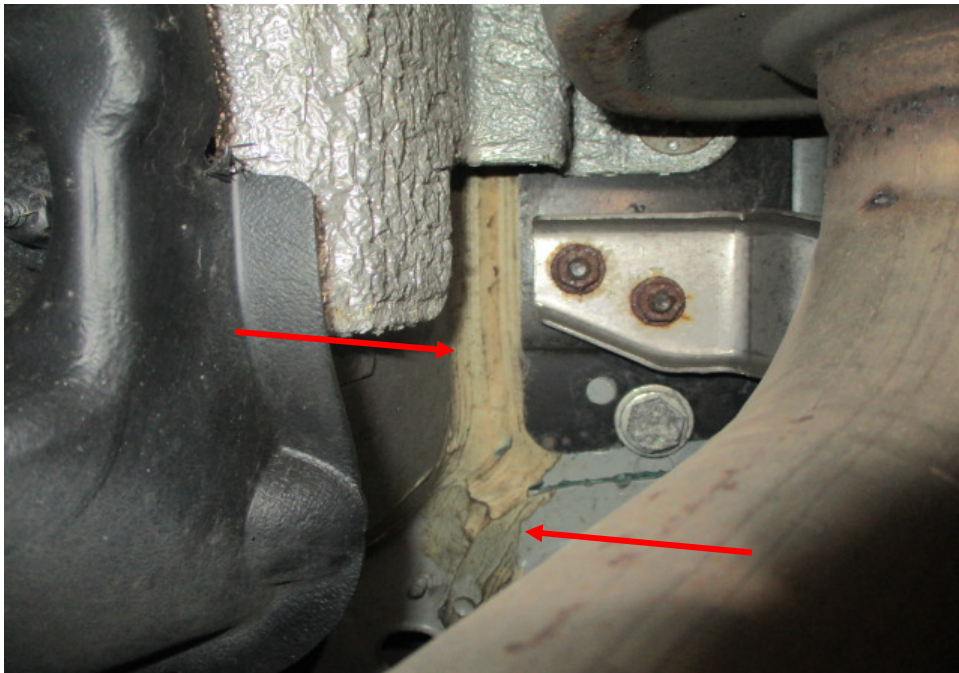
**Photo 25** shows the chassis/structural body at the underside rear right of the Motor Car. I did not find any weld marks other than original spot weld marks on the chassis/structural body of the Motor Car. The original factory sealant (arrowed) at the joints along the chassis/structural body was untouched, indicating no work was done on the chassis/structural body of the Motor Car and that the chassis/structural body was originally fitted.

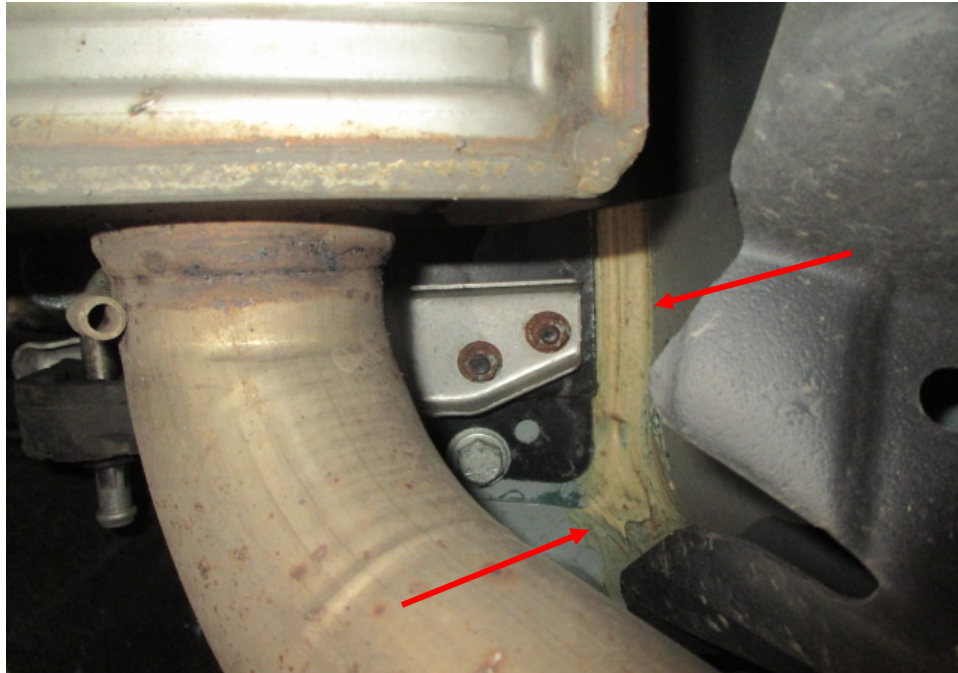
**Photo 26** shows the chassis/structural body at the underside rear left of the Motor Car. The original factory sealant (arrowed) at the joints along the chassis/structural body was observed to be untouched. In general, I had found no work was carried out on the chassis/structural body of the Motor Car. The chassis/structural body of the Motor Car was originally fitted.

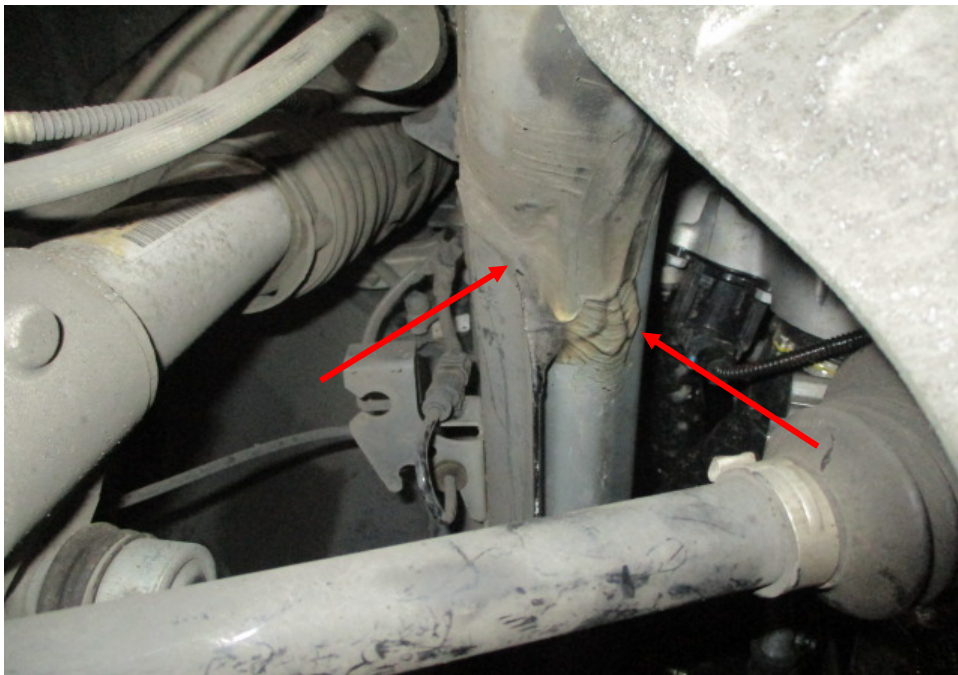
**Photo 27** shows the chassis/structural body at the underside front left of the Motor Car. I did not find any weld marks other than original spot weld marks on the chassis/structural body of the Motor Car. The original factory sealant (arrowed) at the joints along the chassis/structural body was untouched, indicating no work was done on the chassis/structural body of the Motor Car and that the chassis/structural body was originally fitted.

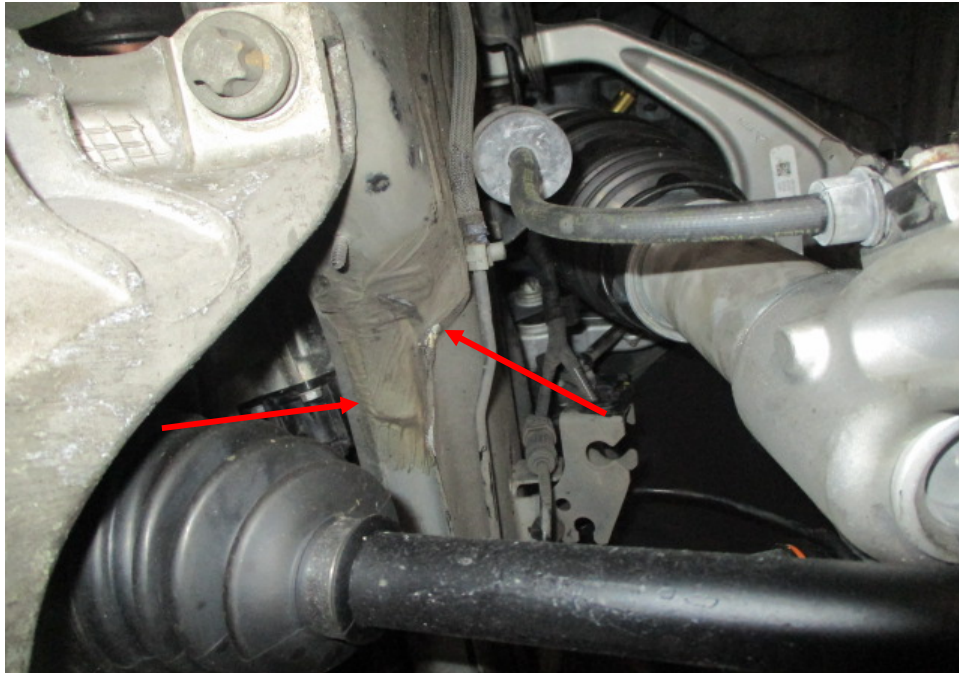
**Photo 28** shows the chassis/structural body at the underside front right of the Motor Car. The original factory sealant (arrowed) at the joints along the chassis/structural body was observed to be untouched. In general, I had found no work was carried out on the chassis/structural body of the Motor Car. The chassis/structural body of the Motor Car was originally fitted.

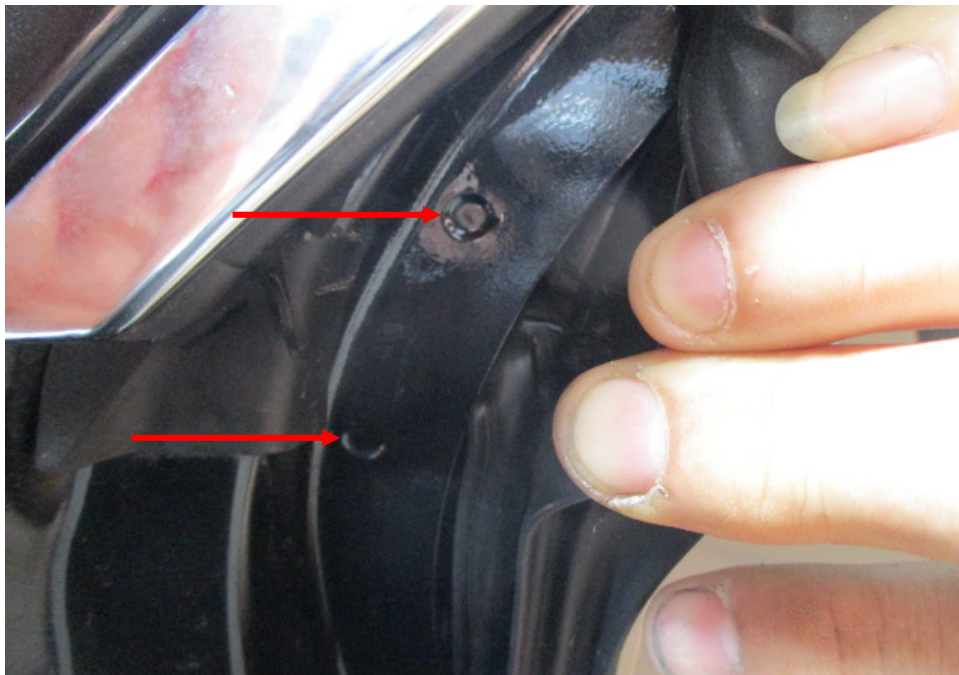
**Photo 29** shows the left side "A" pillar of the Motor Car. I did not find any weld marks other than original spot weld marks (arrowed) on the left side "A" pillar of the Motor Car which, indicates that there was no re-welding works carried out. In general, I had found all the non-detachable body panels of the Motor Car to be originally fitted at the time of my inspection, except for the rear left body panel.

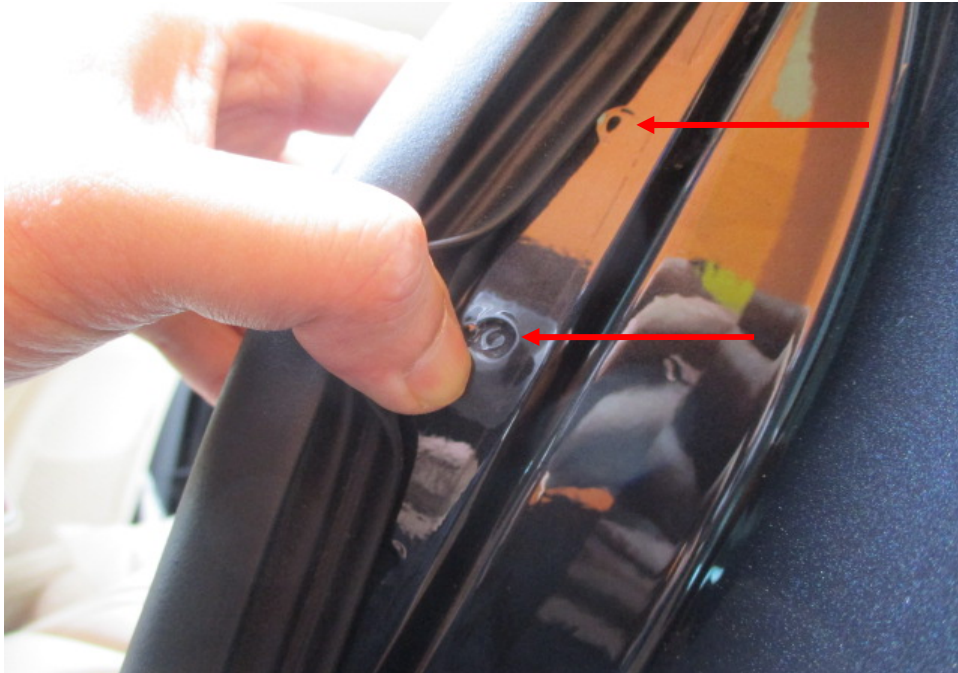
**Photo 30** shows the left side “C” pillar of the Motor Car. I did not find any weld marks other than original spot weld marks (arrowed) on the left side “C” pillar of the Motor Car, which indicates that there was no re-welding works carried out. In general, I had found all the non-detachable body panels of the Motor Car to be originally fitted at the time of my inspection, except for the rear left body panel.
