Your Ref: Maserati Levante  
(chassis number ZN6XU61C00X349385)  
Our Ref : CI/TP22005667/D

11 June 2022

**INSPECTION REPORT OF AN UNREGISTERED MASERATI LEVANTE  
MOTOR CAR WITH CHASSIS NUMBER ZN6XU61C00X349385**

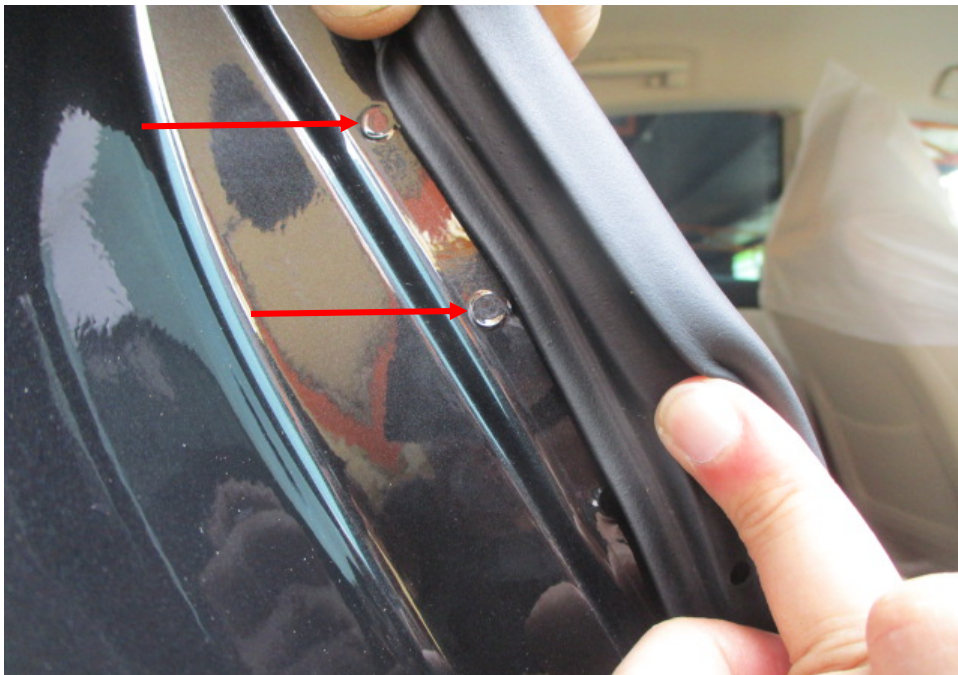
**Photo 31** shows the right side “C” pillar of the Motor Car. I did not find any weld marks other than original spot weld marks (arrowed) on the right side “C” pillar of the Motor Car, which indicates that there was no re-welding works carried out. In general, I had found all the non-detachable body panels of the Motor Car to be originally fitted at the time of my inspection, except for the rear left body panel

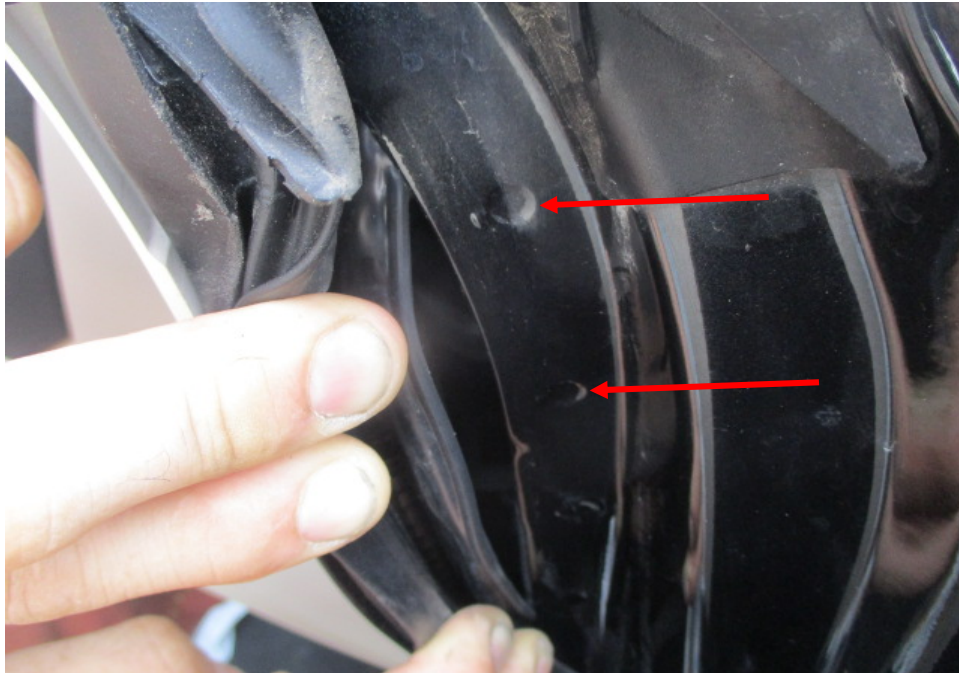
**Photo 32** shows the right side "A" pillar of the Motor Car. I did not find any weld marks other than original spot weld marks (arrowed) on the right side "A" pillar of the Motor Car, which indicates that there was no re-welding works carried out. In general, I had found all the non-detachable body panels of the Motor Car to be originally fitted at the time of my inspection, except for the rear left body panel.
