Our Reference : KAAS/TA/6035/8480/TP/07.20
Date : 08 August 2020

VEHICLE APPRAISAL REPORT

Name of Workshop : Apex Motoring
Place of inspection : 25 Kaki Bukit Road 4 #01-55, Synergy @ Kaki Bukit, Singapore 417800
Date of Assignment : 30 July 2020
Date of Accident : 27 July 2020
Date of Inspection : 30 July 2020

Registration No.	: SMH 8480Z	Chassis Frame No.	: GB7-1086395
Make / Model	: Honda Freed Hybrid 1.5G (A)	Engine No. (Logcard)	: LEB5624179
Year of Manufacture/Reg	: 2019	Odometer Reading	: 138,026 KM
Colour	: Silver		
Class / Type	: MPV

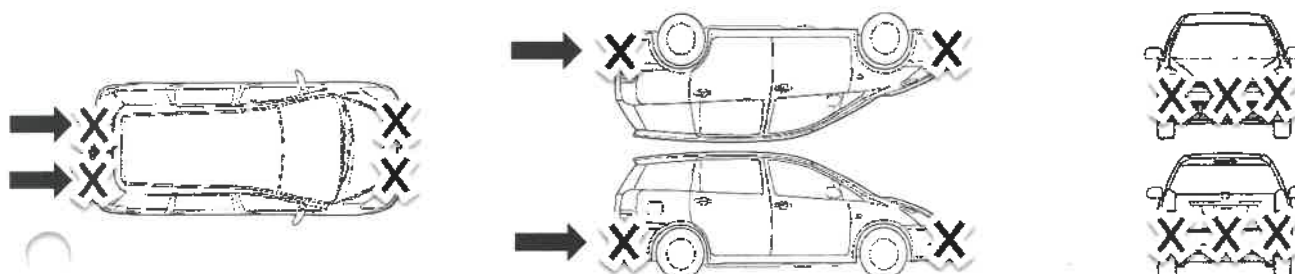
Damages sustained were consistent with the subject vehicle being involved in a collision with another vehicle and the impact was delivered

Squarely to the Rear

portion of the vehicle.

The general area of damages is at the **Front and Rear portion**
(Please refer to the parts list and photographs as attached for more information)
