VEHICLE DAMAGE ASSESSMENT REPORT

JP/S2/22/2838/SCM

Ref No	: 2022/04037	Date of Report	: 17/5/2022
Claim Type	: Third Party	Date of Request	: 26/4/2022
Third party vehicle	: SLN5560B	Date of Accident	: 25/4/2022
Insured Vehicle	:	Date of Inspection	: 26/4/2022
Your Reference No	:

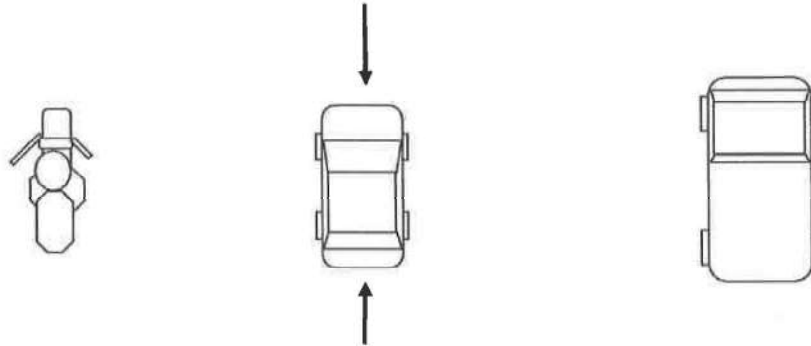
At the time of inspection, this vehicle sustained damages to the **Front and Rear Portion**.

Front bumper, bonnet support panel dented. Front grille holder torn, headlamp base crack. Rear bumper, tailgate, rear end dented etc.

We have not authorised repair. Under normal circumstances, estimated **10** working days are required to repair the vehicle.
