# Precise Appraiser Pte Ltd

## VEHICLE DAMAGE ASSESSMENT REPORT

Ref No	: 2022/04037	Date of Report	: 17/5/2022
Claim Type	: Third Party	Date of Request	: 26/4/2022
Third party vehicle	: SLN5560B	Date of Accident	: 25/4/2022
Insured Vehicle	:	Date of Inspection	: 26/4/2022
Your Reference No	:

Vehicle Number : SLN5560B

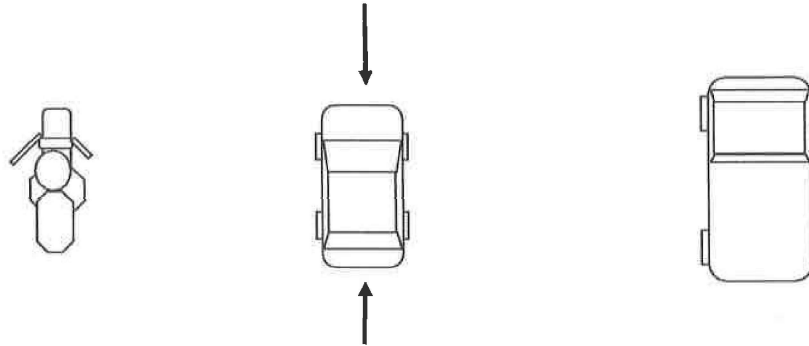
At the time of inspection, this vehicle sustained damages to the **Front and Rear Portion**.

Front bumper, bonnet support panel dented. Front grille holder torn, headlamp base crack. Rear bumper, tailgate, rear end dented etc.
