Your Ref: Porsche 911 Carrera S Cabriolet
(chassis number WP0ZZZ99ZLS260338)
Our Ref : CI/TP22005804/D

**INSPECTION REPORT OF AN UNREGISTERED PORSCHE 911 CARRERA S
CABRIOLET MOTOR CAR WITH CHASSIS NUMBER WP0ZZZ99ZLS260338**

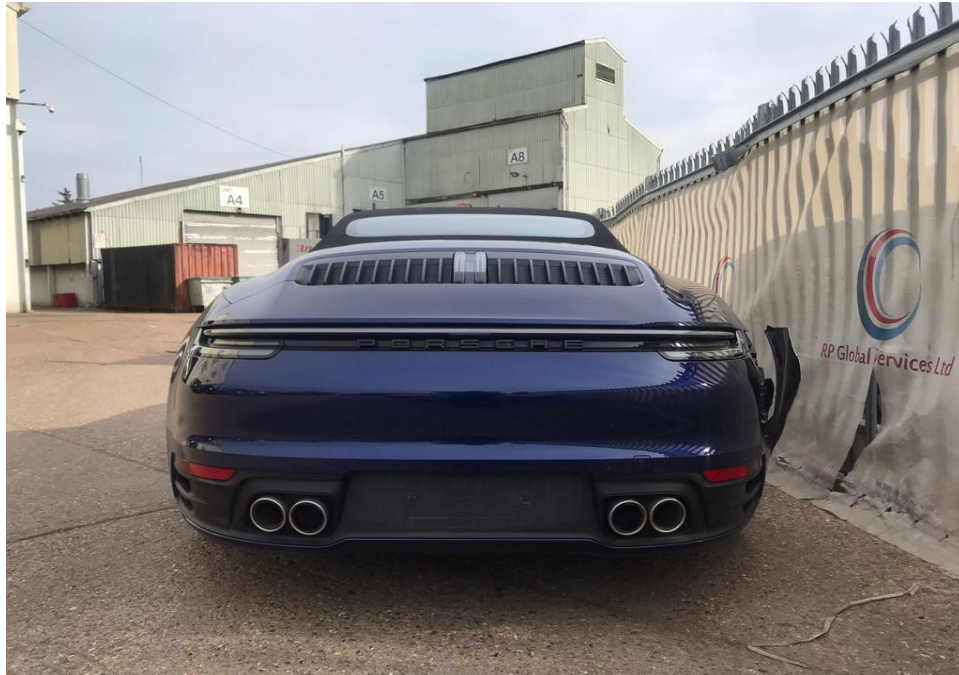
Photo 1 shows the rear body of the Motor Car (photograph provided to me). The Motor Car was observed to have sustained damage at its rear right portion. The rear bumper, rear bumper right lower grille, rear bumper right reflector, rear bumper right bracket, rear right taillamp, rear right body panel and rear right wheel rim were amongst the body parts that were observed to have been damaged (refer to photograph 2 & 3 below).

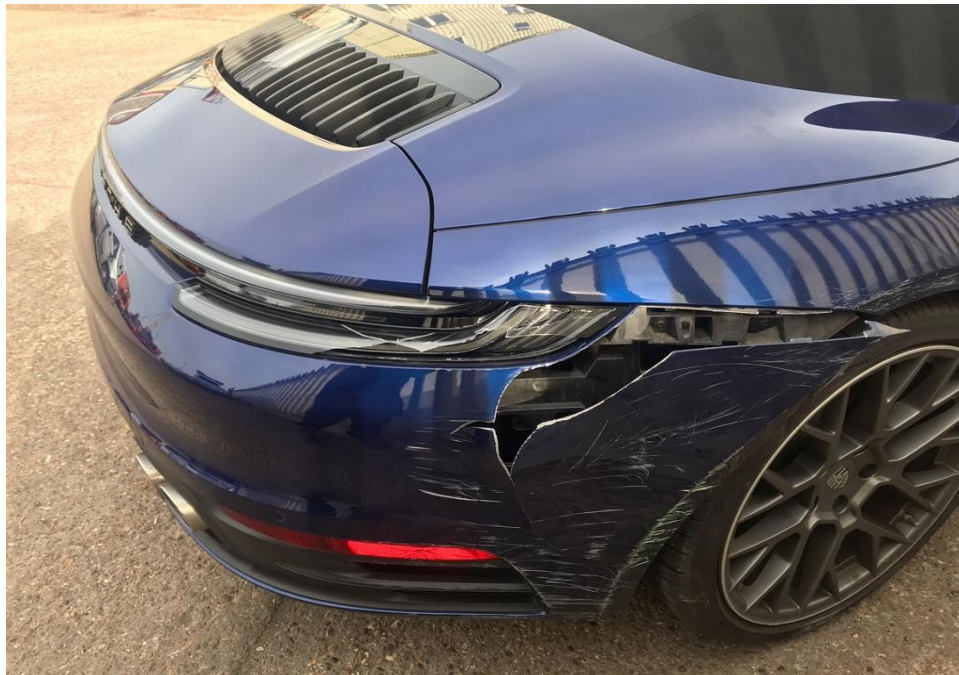
Photo 2 shows the damaged rear right body of the Motor Car (photograph provided to me). The photographs provided to me had showed damage to the Motor Car's rear bumper, rear bumper right lower grille, rear bumper right reflector, rear bumper right bracket, rear right taillamp and rear right body panel amongst others.

23. The body parts at the rear right portion of the Motor Car were visually examined and it was noted that the repair/restoration works carried out to the damaged area of the Motor Car (refer to photograph 2 & 3 above) were reasonably adequate and in order.

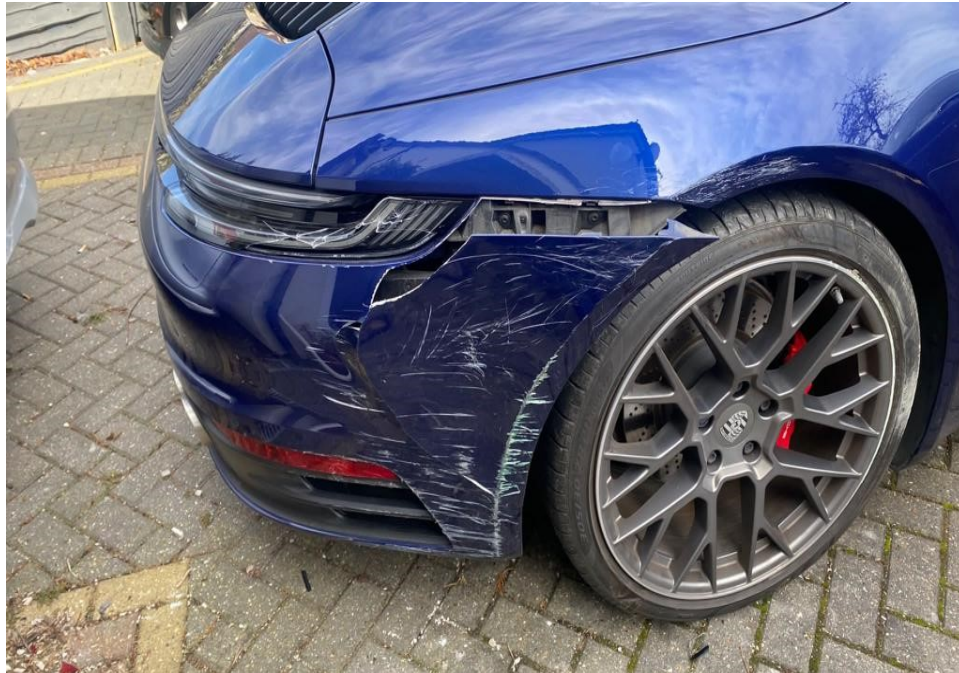
Photo 3 shows another view of the damaged rear right portion of the Motor Car (photograph provided to me). The rear bumper, rear bumper right lower grille, rear bumper right reflector, rear bumper right bracket, rear right taillamp, rear right body panel and rear right wheel rim were amongst the body parts that were observed to have been damaged.

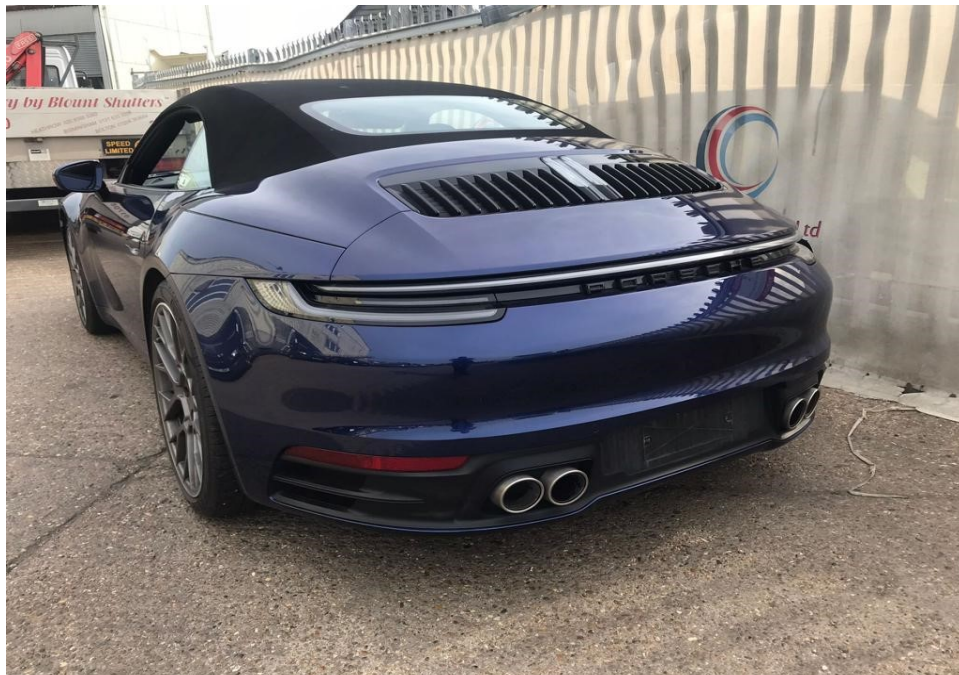
Photo 4 shows the rear left body of the Motor Car (photograph provided to me). Apart for the rear right portion, there was no physical damage observed to other areas of the Motor Car. The airbag(s) of the Motor Car was not deployed as seen from the photographs that were provided.

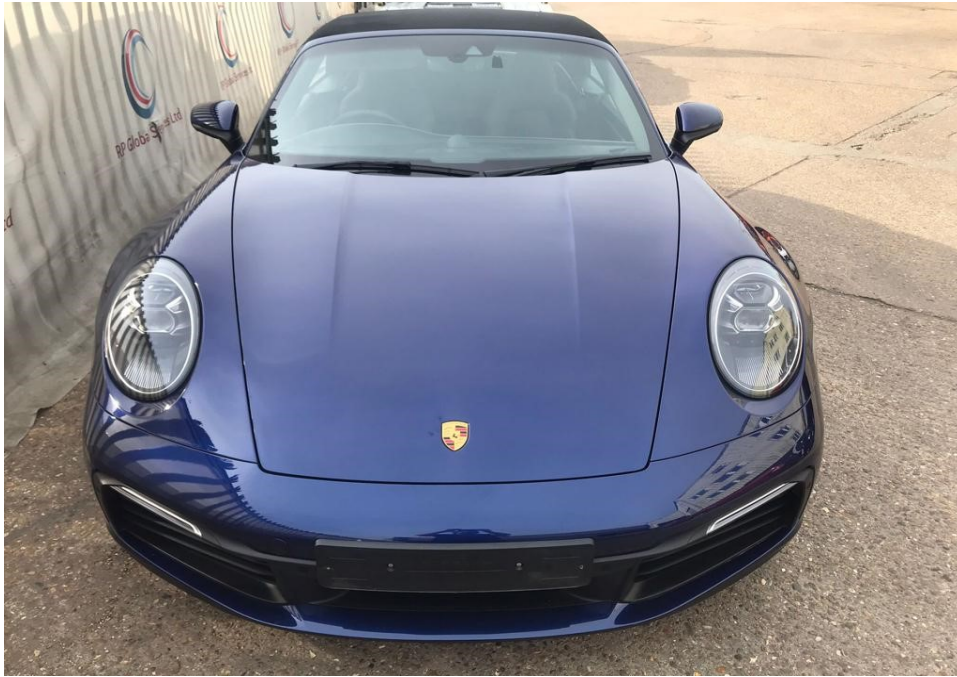
Photo 5 shows the frontal body of the Motor Car (photograph provided to me). Apart for the rear right portion, there was no physical damage observed to other areas of the Motor Car. The airbag(s) of the Motor Car was not deployed as seen from the photographs that were provided.

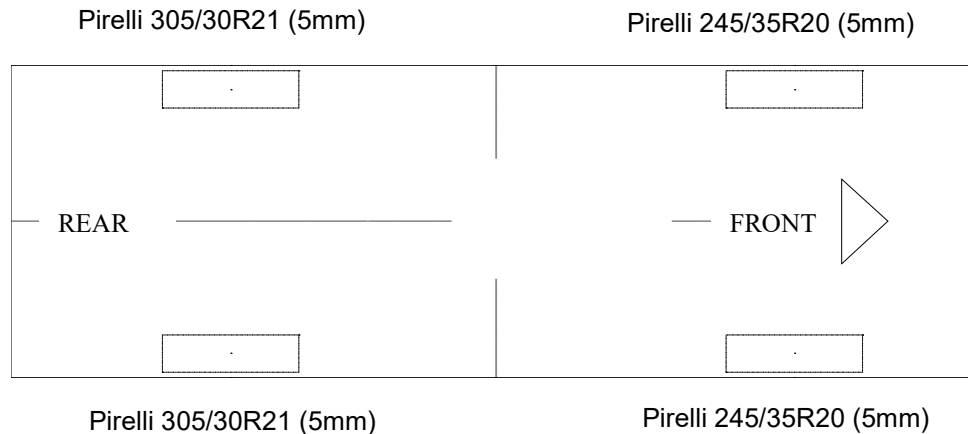
9. It was fitted with 20inch (front) and 21inch (rear) sport wheel rims that were wrapped with tyres that were observed to be of serviceable condition. The tyres were also sufficiently inflated for vehicular operation. The tyre brand, tyre size and approximate remaining tread depth of the 4 tyres of the Motor Car were recorded as follows: -

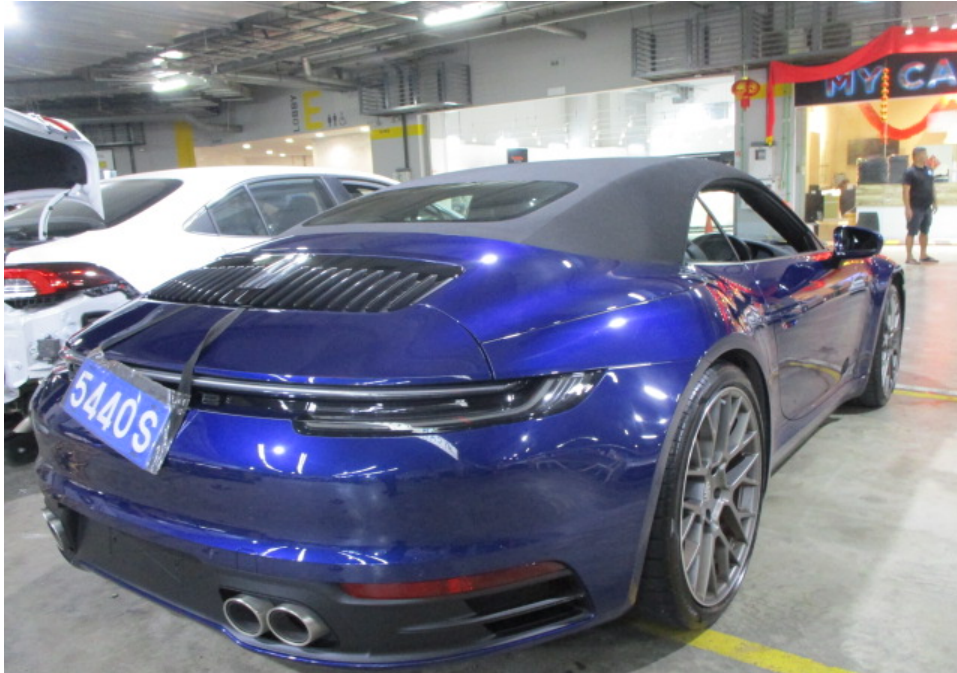
Photo 6 shows a general view of the rear right body of the Motor Car at the time of my inspection. The Motor Car was observed to be in a relatively good general condition with no loose exterior fittings observed. The body parts at the rear right portion of the Motor Car were visually examined and it was observed that the repair/restoration works carried out to the damaged area of the Motor Car (refer to photograph 2 & 3 above) were reasonably adequate and in order.

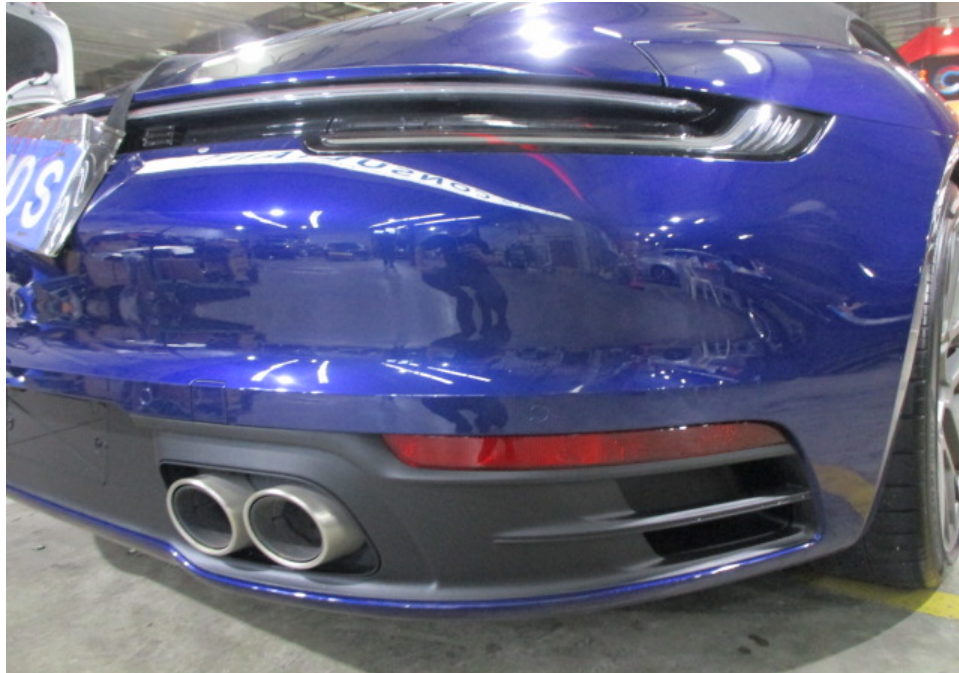
Photo 7 shows a closer view of the Motor Car's rear bumper, rear bumper right lower grille and rear bumper right reflector. The body parts at the rear right portion of the Motor Car were visually examined and it was observed that the repair/restoration works carried out to the damaged area of the Motor Car (refer to photograph 2 & 3 above) were reasonably adequate and in order.

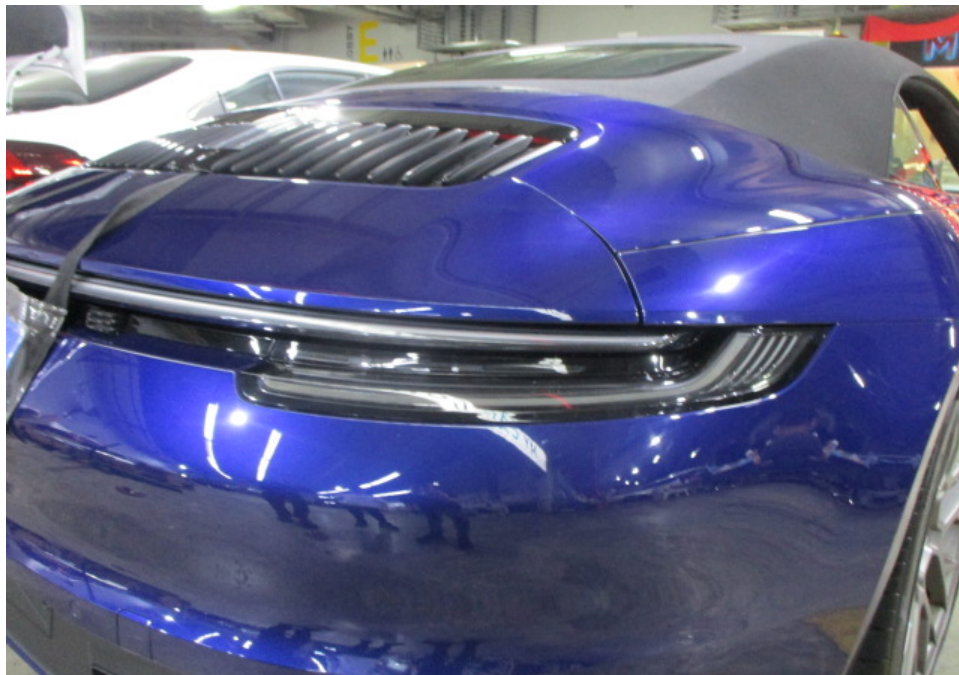
Photo 8 shows a closer view of the Motor Car's rear bumper, rear right taillamp and rear top panel. The body parts at the rear right portion of the Motor Car were visually examined and it was observed that the repair/restoration works carried out to the damaged area of the Motor Car (refer to photograph 2 & 3 above) were reasonably adequate and in order.

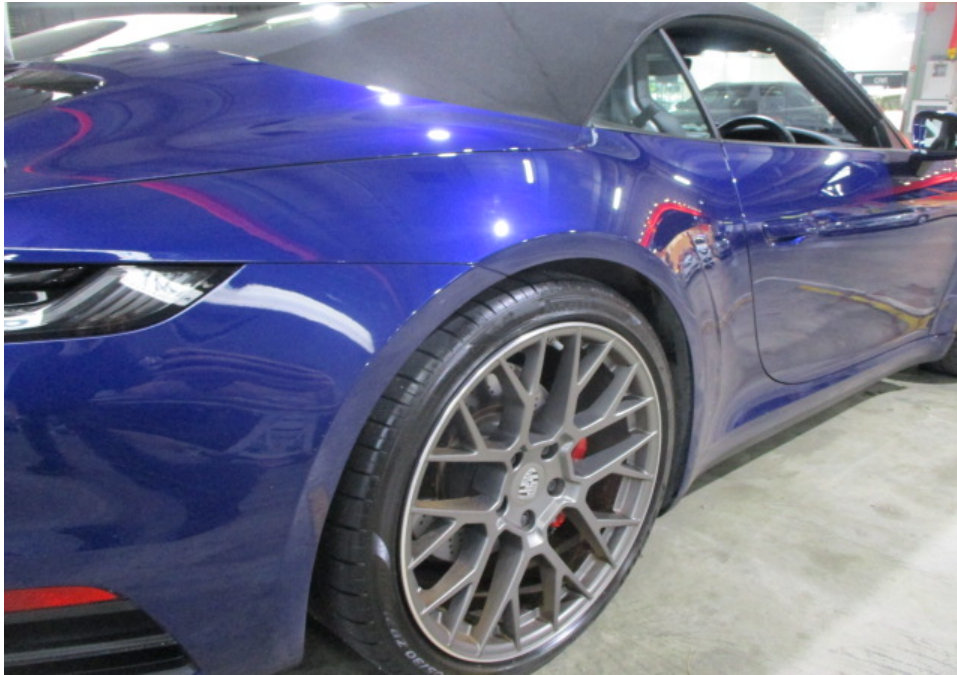
Photo 9 shows a closer view of the Motor Car's rear bumper, rear right body panel and rear right wheel rim. The body parts at the rear right portion of the Motor Car were visually examined and it was observed that the repair/restoration works carried out to the damaged area of the Motor Car (refer to photograph 2 & 3 above) were reasonably adequate and in order.

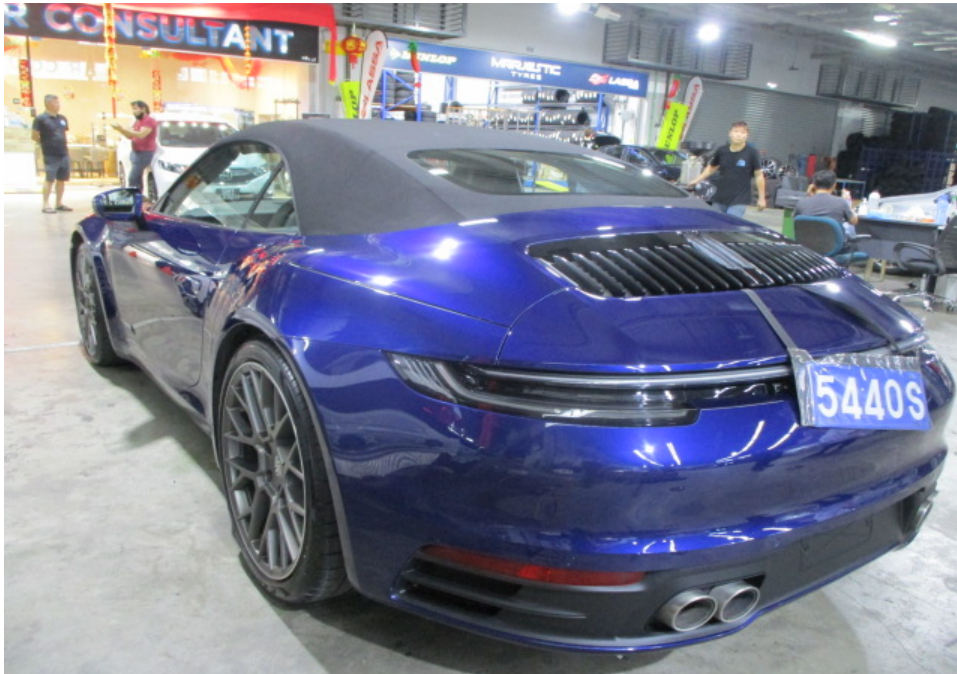
Photo 10 shows a general view of the rear left body of the Motor Car at the time of my inspection. The Motor Car was observed to be in a relatively good general condition with no loose exterior fittings observed. The mileage of the Motor Car recorded at the time of my inspection was 21,658km.

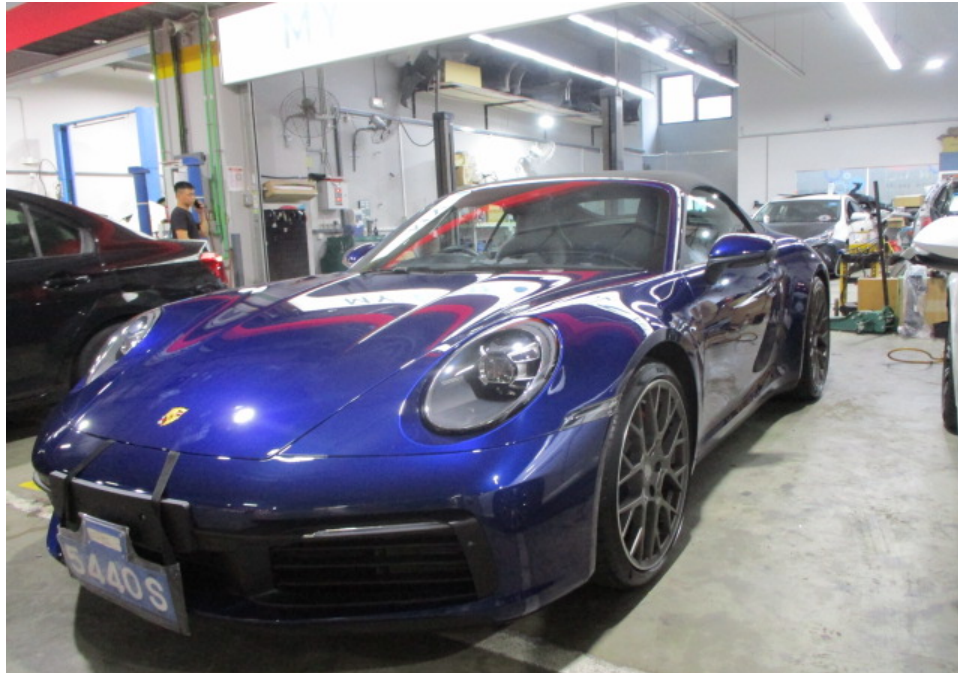
Photo 11 shows a general view of the front left body of the Motor Car at the time of my inspection. The Motor Car was observed to be in a relatively good general condition with no loose exterior fittings observed. The mileage of the Motor Car recorded at the time of my inspection was 21,658km.

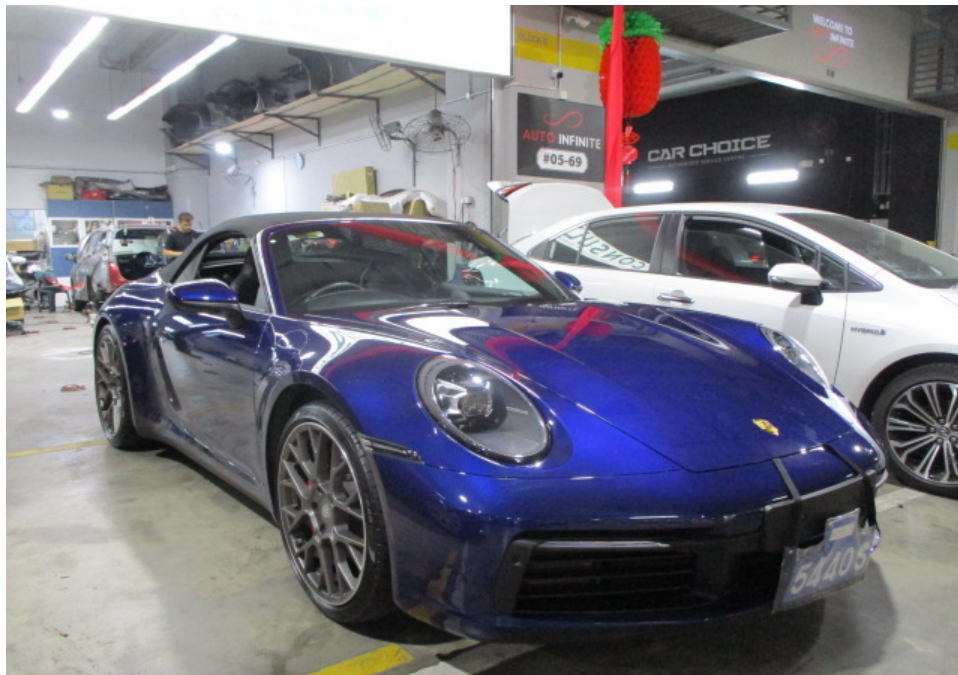
Photo 12 shows a general view of the front right body of the Motor Car at the time of my inspection. The Motor Car was observed to be in a relatively good general condition with no loose exterior fittings observed. The mileage of the Motor Car recorded at the time of my inspection was 21,658km.

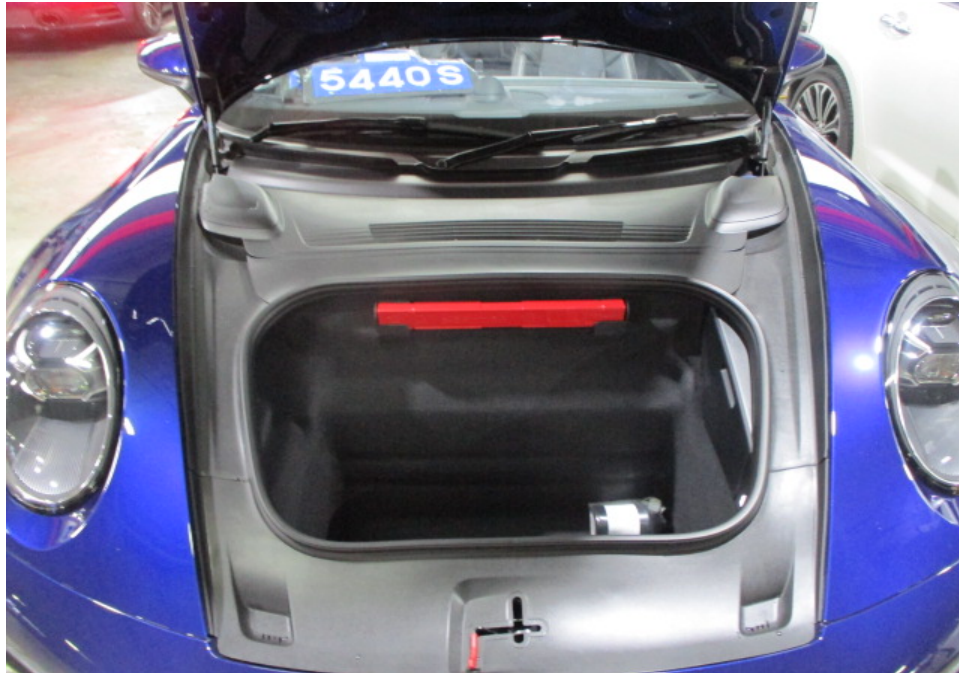
Photo 13 shows a general view of the Motor Car's front bonnet compartment at the time of my inspection. All inner trims, garnishes and upholstery etc were observed to be properly fitted.

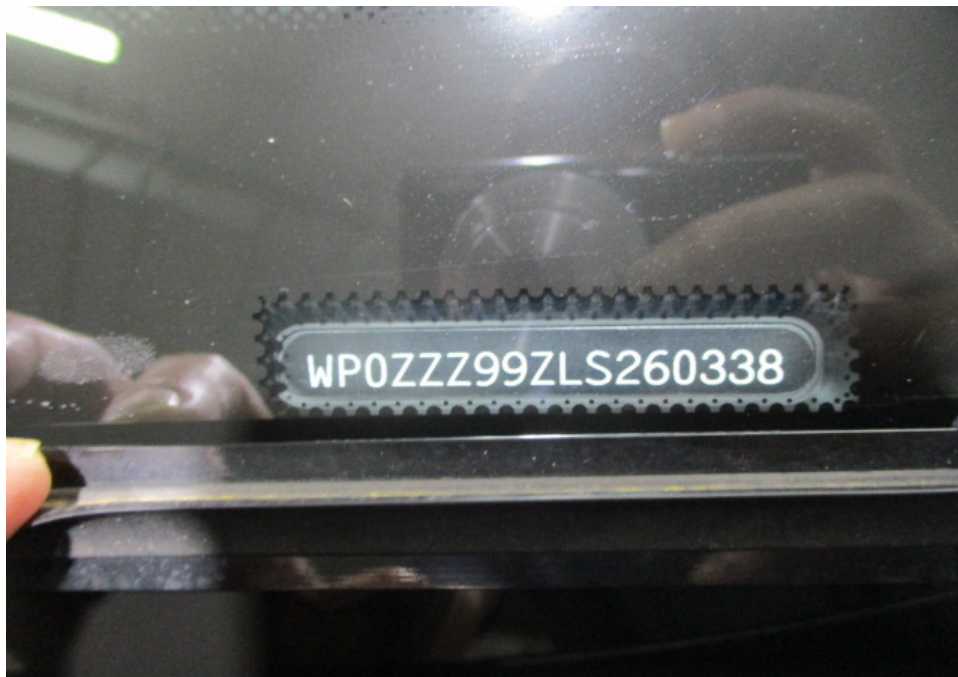
Photo 14 shows the chassis number of the Motor Car. The chassis number recorded was WP0ZZZ99ZLS260338.

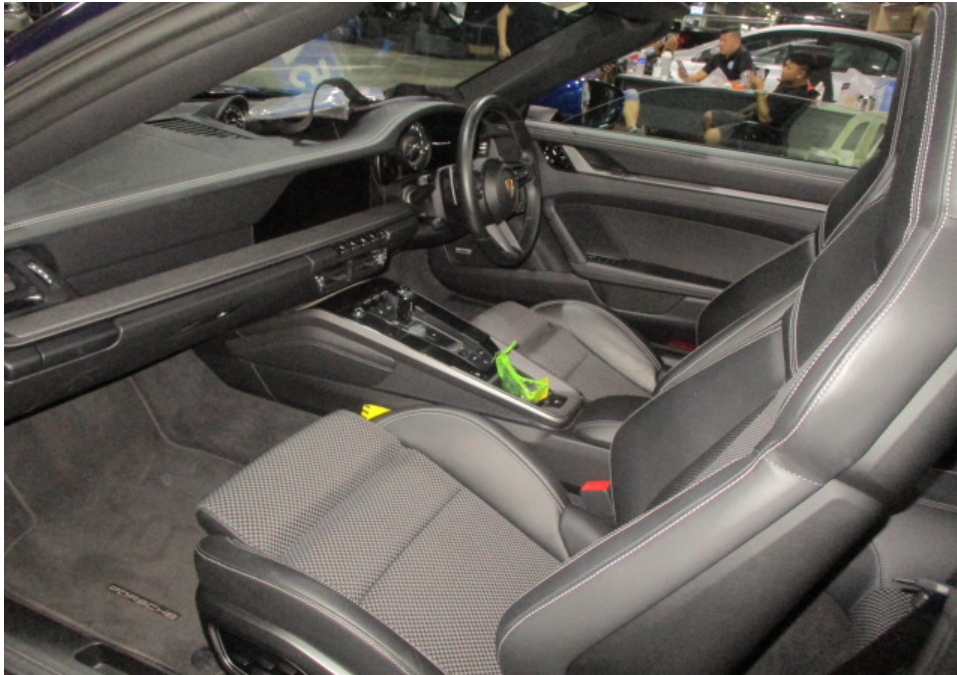
Photo 15 shows the interior compartment of the Motor Car at the time of my inspection. The various parts and components, trims, carpet, and upholstery inside the interior compartment were all observed to be intact and properly fitted.

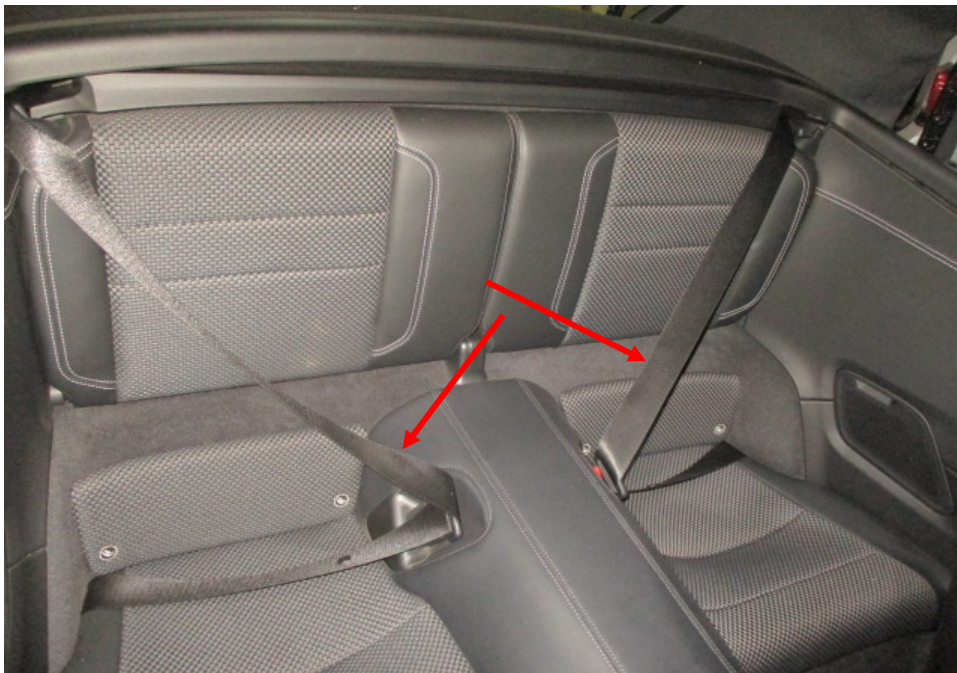
Photo 16 shows the rear seats of the Motor Car. All the seats of the Motor Car were secured via seat rails to the floorboard. They were also fitted with a retractable seat belt reel and a pre-tensioner. The seat belts (arrowed) were tested and were able to be fastened into the respective pre-tensions that were fitted on the side of each individual seat.

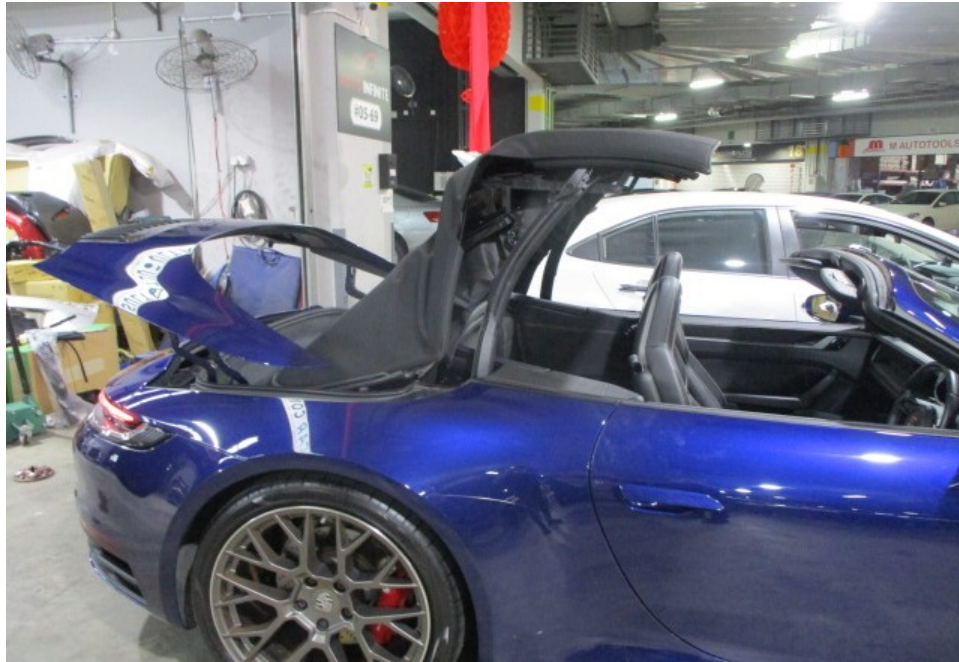
Photo 17 shows the Motor Car's soft top roof being tested. It was observed that as a safety feature, the soft top roof could only open and close when the Motor Car was in a stationary position. When opened, the soft top roof is completely folded into the rear compartment with no parts protruding out of the Motor Car's body. The soft top roof was also found adequately secured to the "A" pillar after closing.

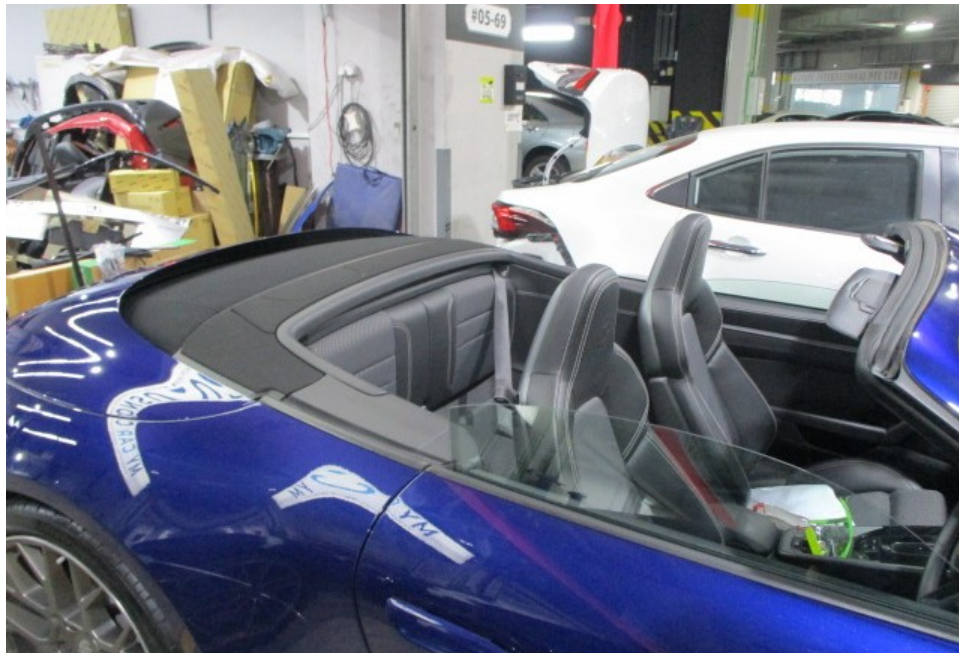
Photo 18 shows the Motor Car with its soft top roof completely folded. It was observed that as a safety feature, the soft top roof could only open and close when the Motor Car was in a stationary position. When opened, the soft top roof is completely folded into the rear compartment with no parts protruding out of the Motor Car's body. The soft top roof was also found adequately secured to the "A" pillar after closing.

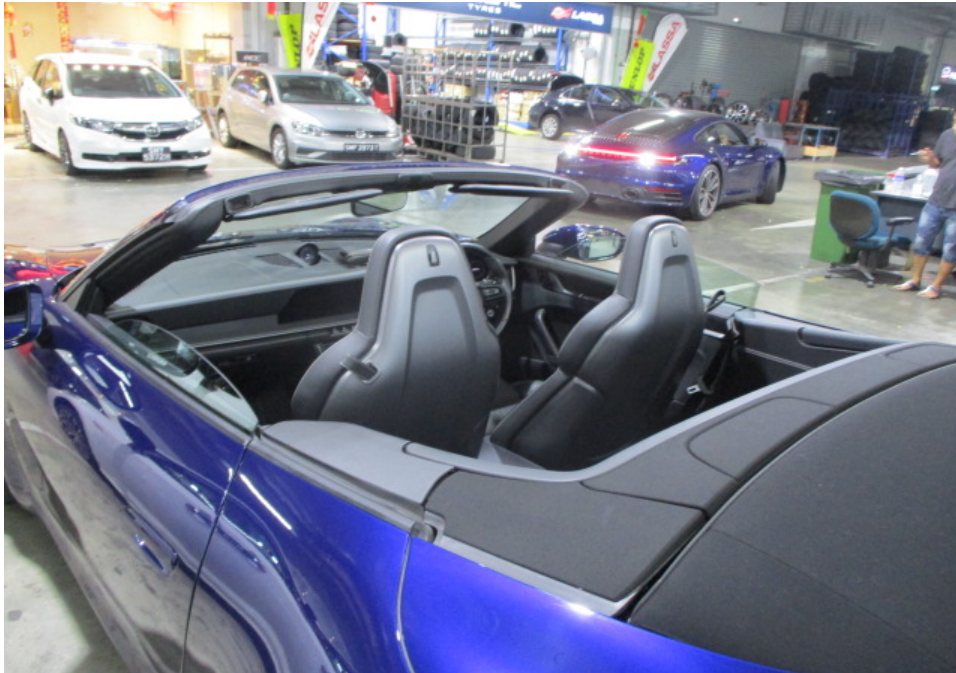
Photo 19 shows another view of the Motor Car with its soft top roof completely folded. It was observed that as a safety feature, the soft top roof could only open and close when the Motor Car was in a stationary position. When opened, the soft top roof is completely folded into the rear compartment with no parts protruding out of the Motor Car's body. The soft top roof was also found adequately secured to the "A" pillar after closing.

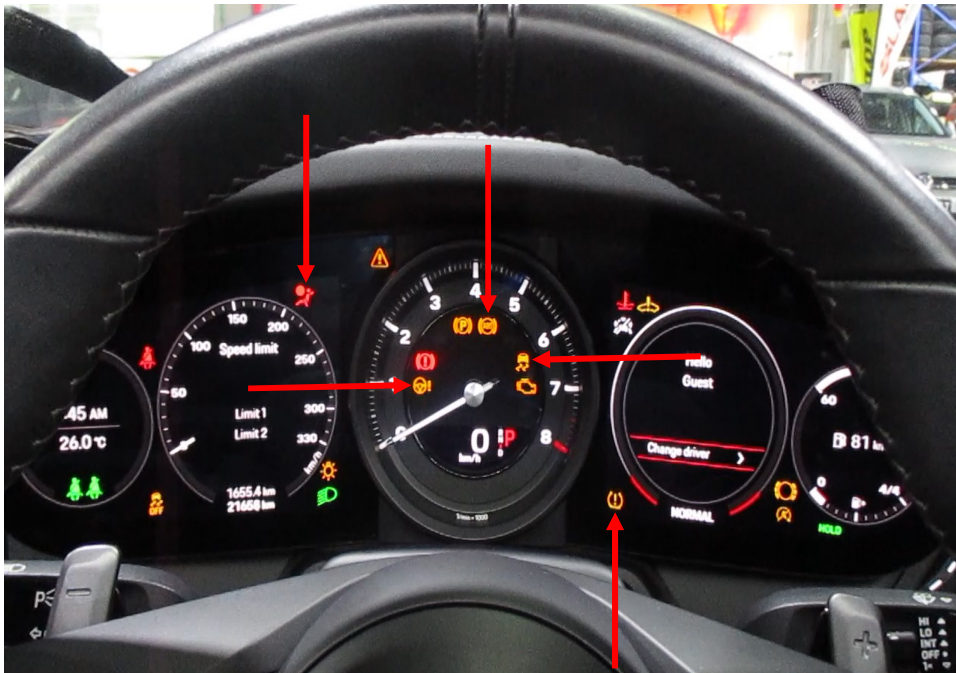
Photo 20 shows the warning lights for the various electronic safety features appearing on the instrument panel of the Motor Car during its self-test when the engine is cranked, in particular the ABS, SRS, EPS, TPM and TCS lights (arrowed).

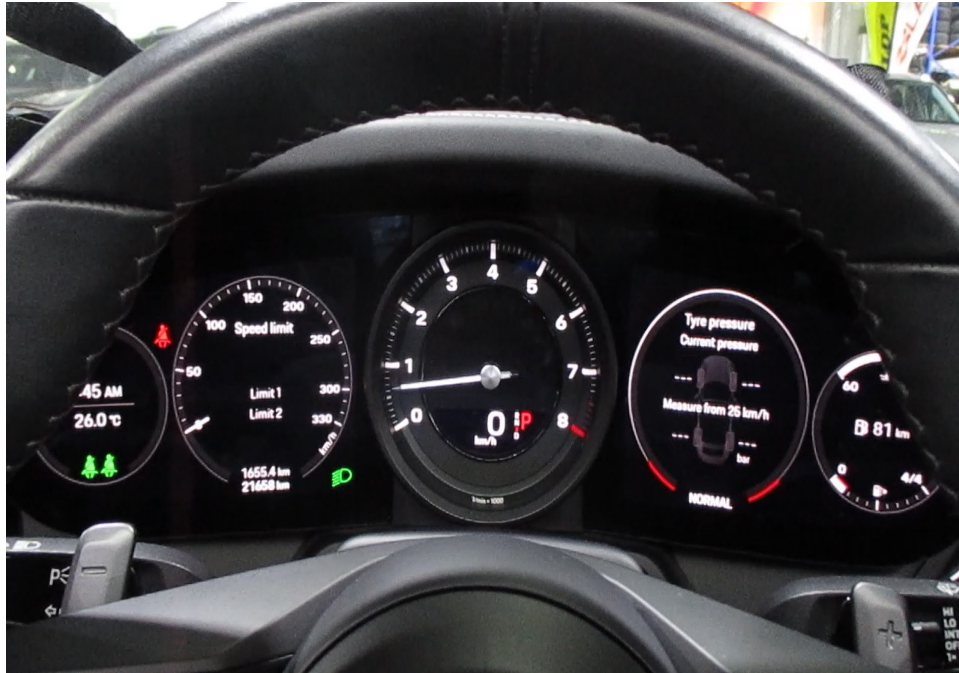
Photo 21 shows the respective warning lights no longer illuminated, indicating that there is no fault detected to the ABS, SRS, EPS, TPM and TCS systems of the Motor Car during the self-test. These electronic systems were hence in working condition at the time of my inspection.

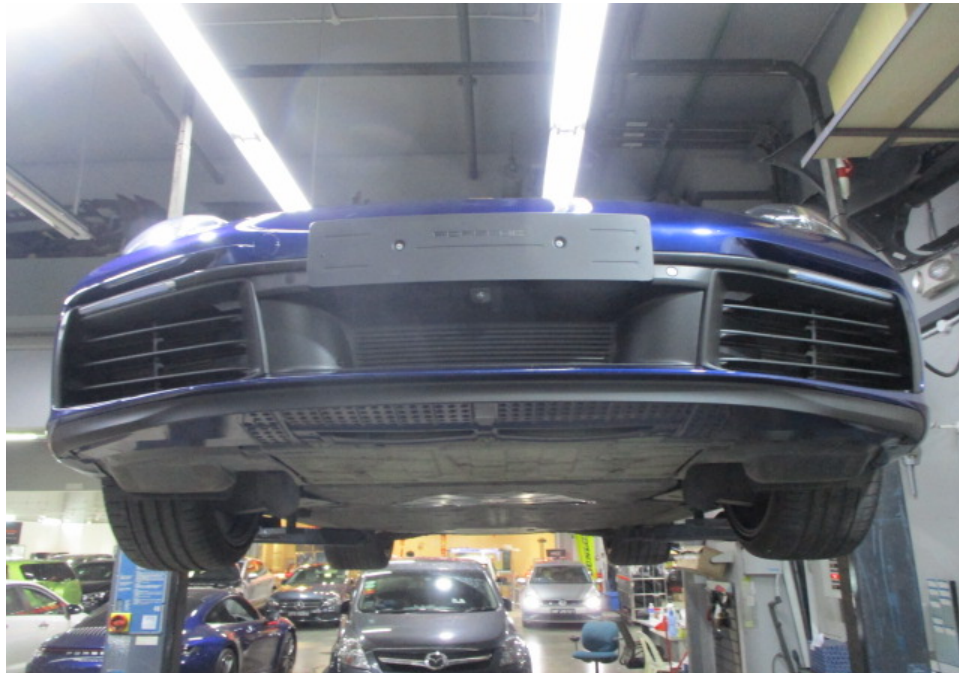
Photo 22 shows the Motor Car hoisted up for checks on its undercarriage. There was no sign(s) or indication(s) of fluid leakage and/or fluid stain(s) on the underside of the Motor Car. The undercarriage components of the Motor Car were also all observed to be intact and secured in an appropriate manner.

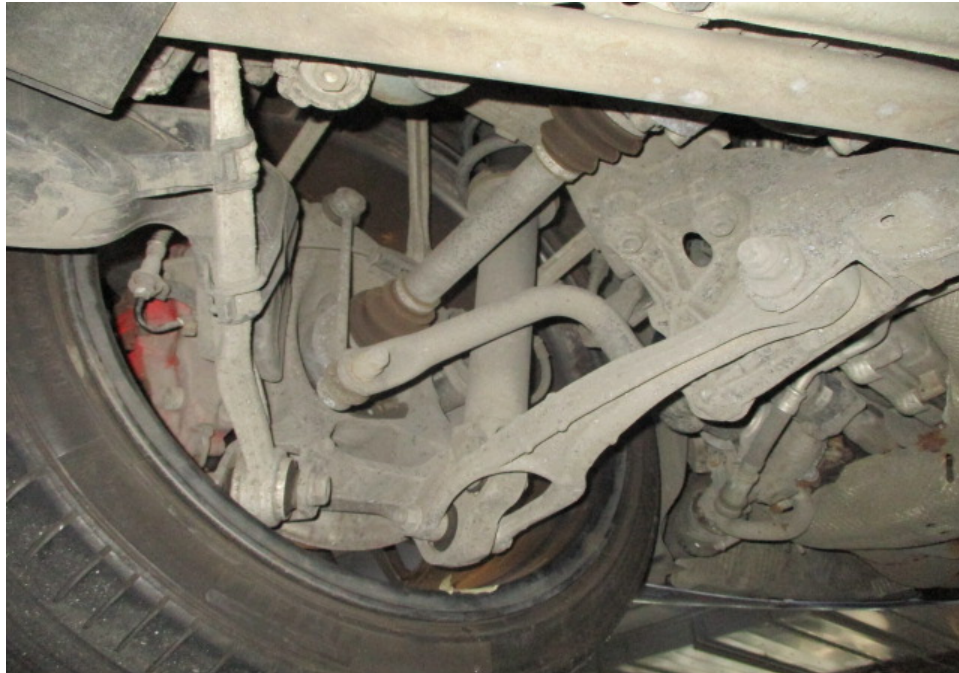
Photo 23 shows a general view of the control arms and linkages at the rear right wheel of the Motor Car. I did not observe any fluid leak and/or fluid stain on the underside of the Motor Car. All of the Motor Car's undercarriage components were observed to be intact and secured in an appropriate manner.

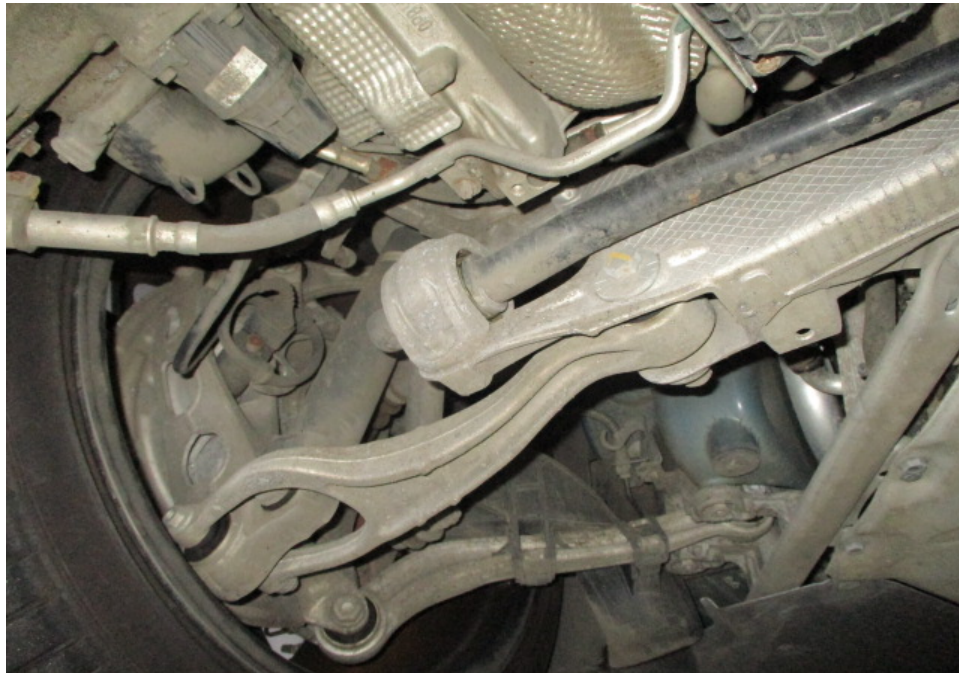
Photo 24 shows a general view of the control arms and linkages at the rear left wheel of the Motor Car. I did not observe any fluid leak and/or fluid stain on the underside of the Motor Car. All of the Motor Car's undercarriage components were observed to be intact and secured in an appropriate manner.

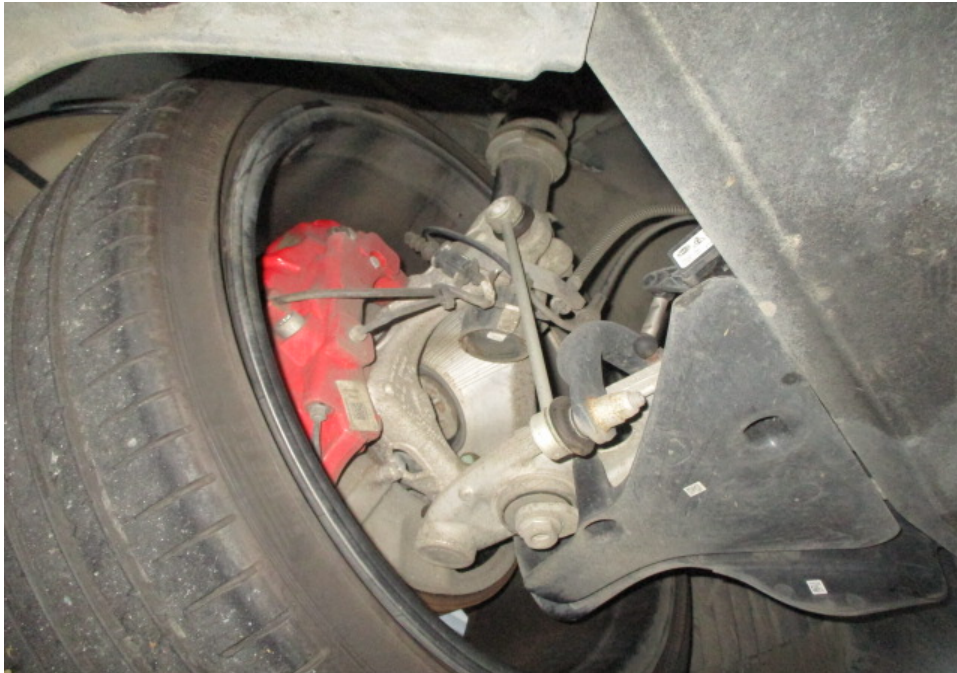
Photo 25 shows the various undercarriage components at the front left wheel of the Motor Car. The mechanical components, control arms and linkages were all found to be intact and secured in an appropriate manner.

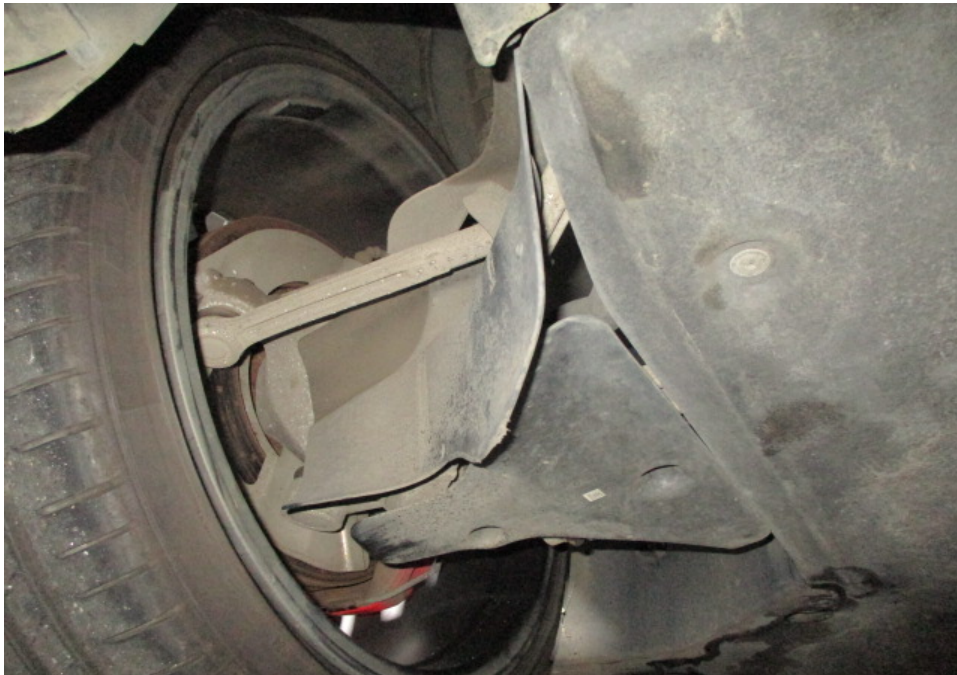
Photo 26 shows the various undercarriage components at the front right wheel of the Motor Car. The mechanical components, control arms and linkages were all found to be intact and secured in an appropriate manner. I also did not observe any fluid leak and/or fluid stain on the underside of the Motor Car.

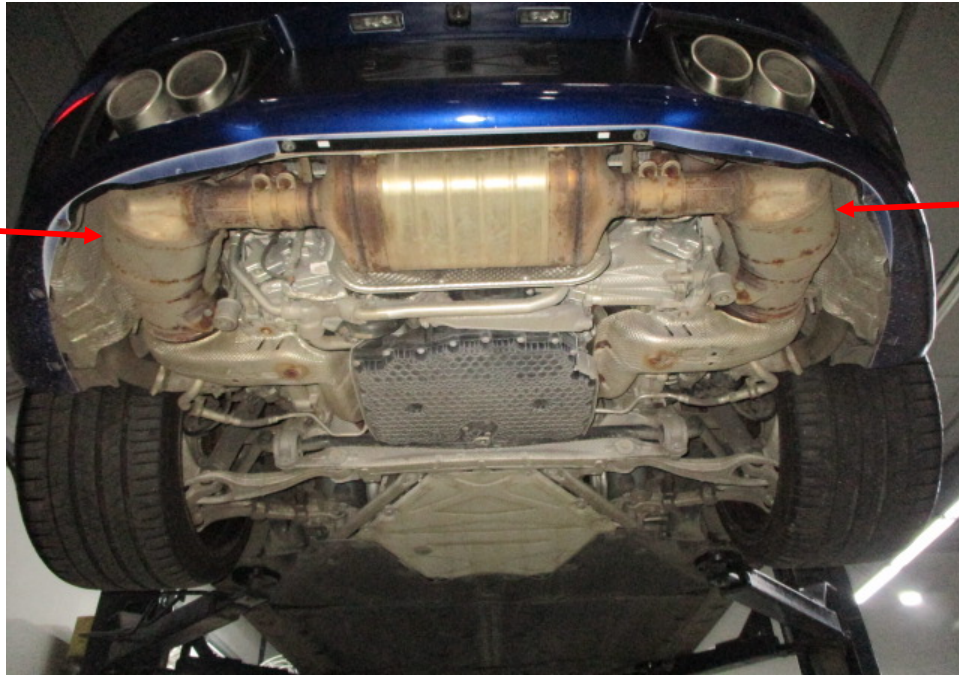
Photo 27 shows the Motor Car's exhaust system. My examination of the Motor Car's exhaust system revealed no sign(s) or indication(s) of any cut or weld marks along its exhaust pipes, on its catalytic converters (arrowed) and on its rear muffler.

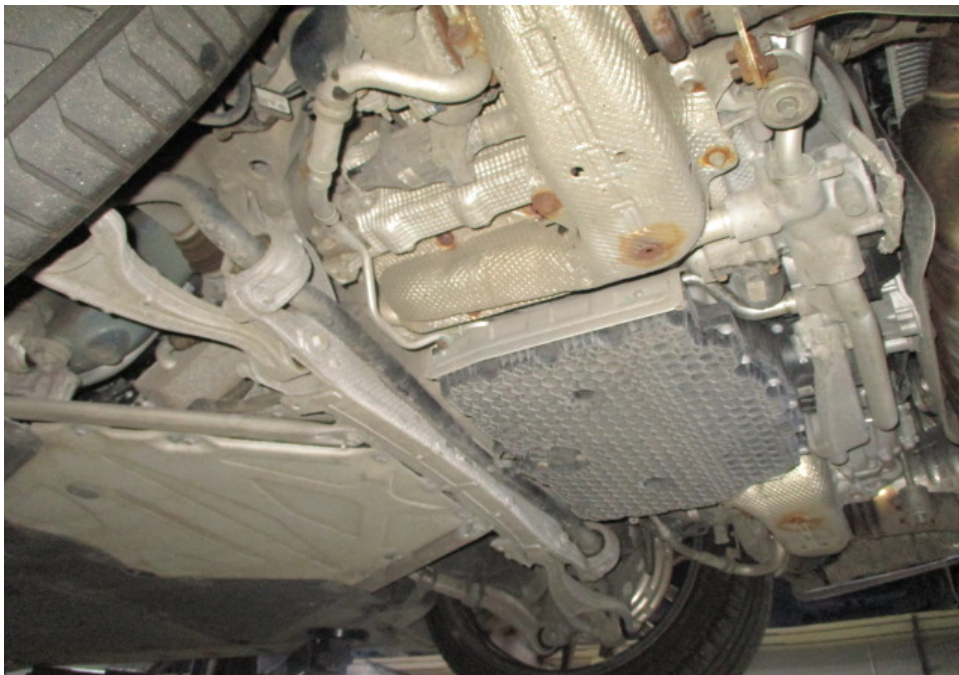
Photo 28 shows a general view of the Motor Car's engine compartment. The engine compartment was at the rear underside of the Motor Car. The various parts and components within the engine compartment were all observed to be intact and properly fitted. There was also no sign(s) or indication(s) of fluid leak and/or fluid stain found inside the engine compartment.

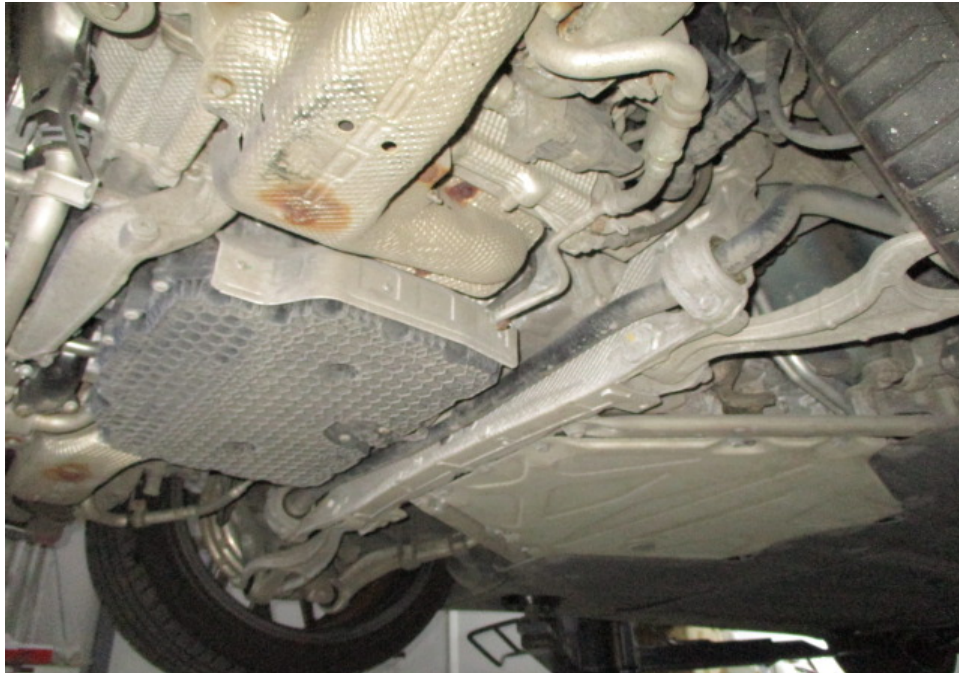
Photo 29 shows another view of the Motor Car's engine compartment. The engine compartment was at the rear underside of the Motor Car. The various parts and components within the engine compartment were all observed to be intact and properly fitted. There was also no sign(s) or indication(s) of fluid leak and/or fluid stain found inside the engine compartment.

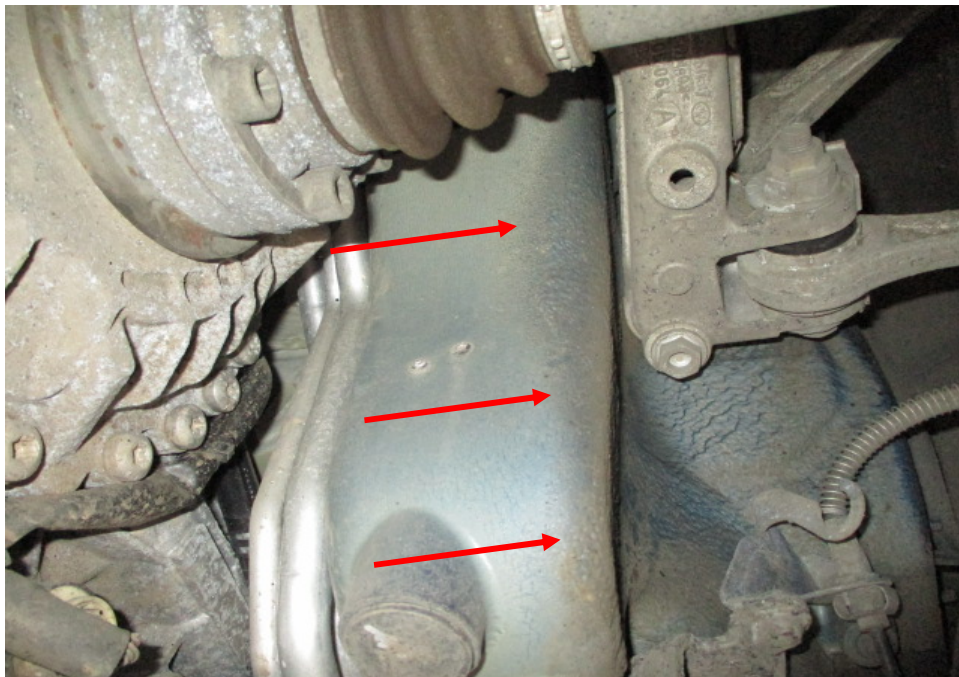
Photo 30 shows the chassis/structural body at the underside rear right of the Motor Car. I did not find any weld marks other than original spot weld marks on the chassis/structural body of the Motor Car. The original factory sealant (arrowed) at the joints along the chassis/structural body was untouched, indicating no work was done on the chassis/structural body of the Motor Car and that the chassis/structural body was originally fitted.
