Your Ref: Porsche 911 Carrera S Cabriolet
(chassis number WP0ZZZ99ZLS260338)
Our Ref : CI/TP22005804/D

**INSPECTION REPORT OF AN UNREGISTERED PORSCHE 911 CARRERA S
CABRIOLET MOTOR CAR WITH CHASSIS NUMBER WP0ZZZ99ZLS260338**

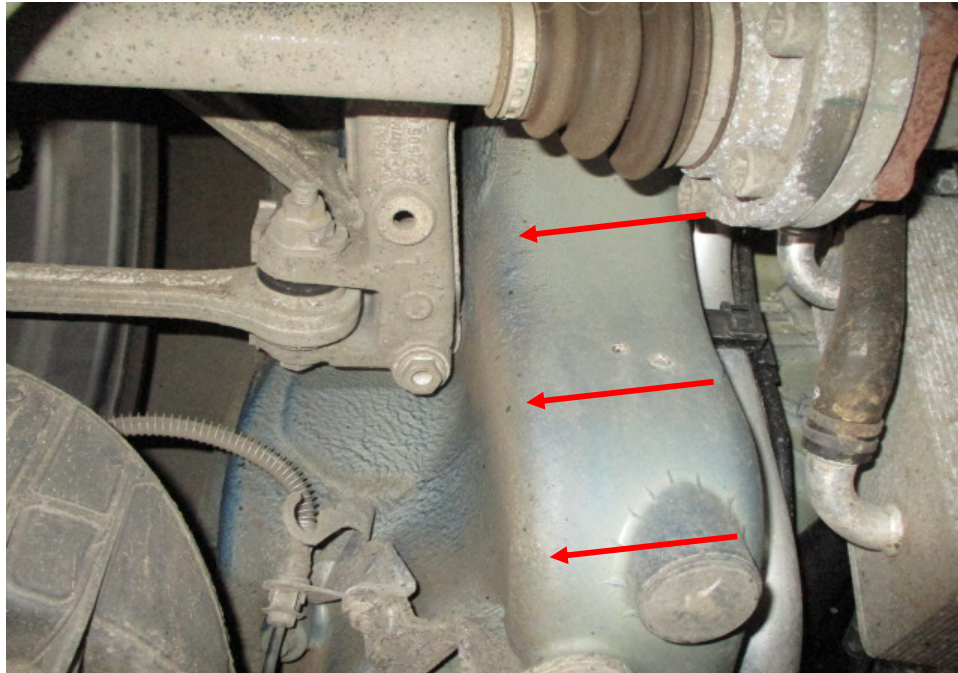
Photo 31 shows the chassis/structural body at the underside rear left of the Motor Car. The original factory sealant (arrowed) at the joints along the chassis/structural body was observed to be untouched. In general, I had found no work was carried out on the chassis/structural body of the Motor Car. The chassis/structural body of the Motor Car was originally fitted.

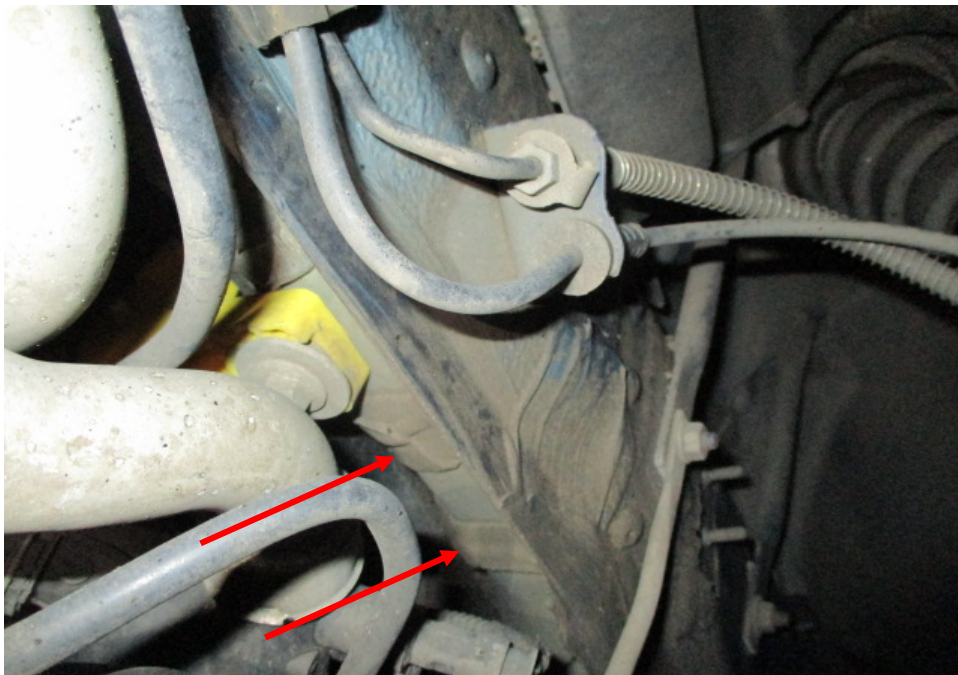
Photo 32 shows the chassis/structural body at the underside front left of the Motor Car. I did not find any weld marks other than original spot weld marks on the chassis/structural body of the Motor Car. The original factory sealant (arrowed) at the joints along the chassis/structural body was untouched, indicating no work was done on the chassis/structural body of the Motor Car and that the chassis/structural body was originally fitted.

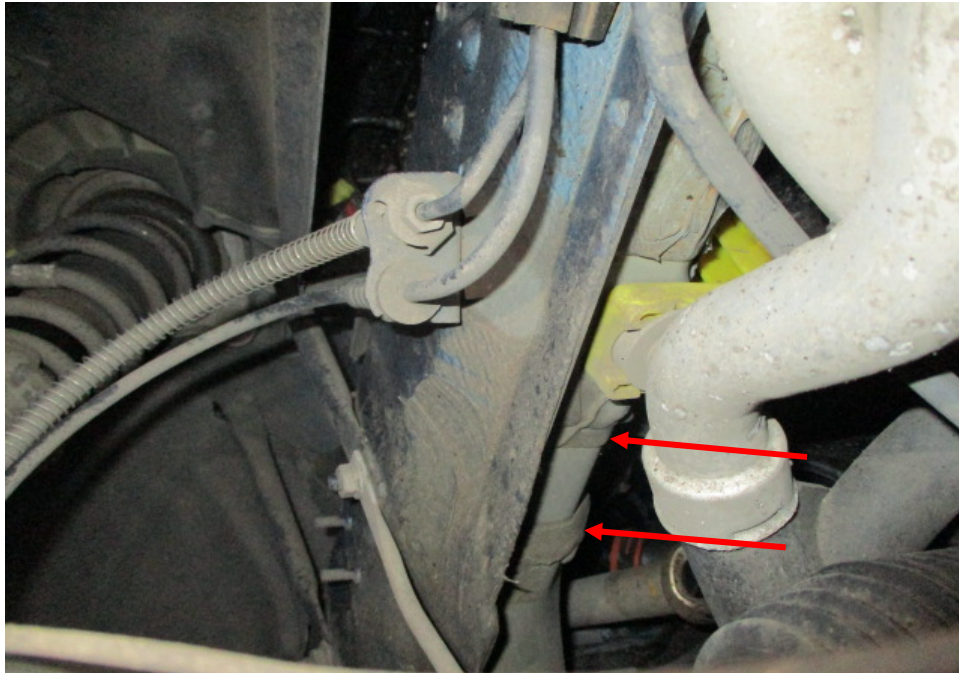
Photo 33 shows the chassis/structural body at the underside front right of the Motor Car. The original factory sealant (arrowed) at the joints along the chassis/structural body was observed to be untouched. In general, I had found no work was carried out on the chassis/structural body of the Motor Car. The chassis/structural body of the Motor Car was originally fitted.
