ST Appraisal Services

DAMAGED VEHICLE (SLC 9229 R) INSPECTION REPORT (WITHOUT PREJUDICE)

Registration No	: SLC 9229 R	Mileage	: 79718 Km
Make & Model	: KIA FORTE K3 1.6A EX	Engine No	: G4FGGH612127
Date of Registration	: 30 th May 2016	Chassis No.	: KNAFX411MG5596214
Colour	: Red	Engine Capacity.	: 1,591 c.c.

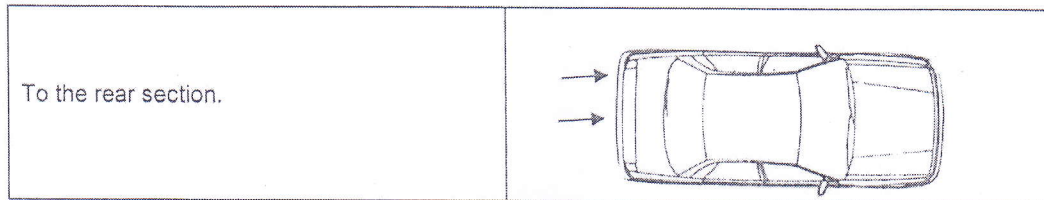
(E) Point of Impact

The impact of the collision has damaged/affected the boot lid, boot lid lamps, rear bumper, rear end panel, tail lamp and etc.

Our adjusted cost of lump sum repair is **\$7,100.00** and an estimated **6** days is required to repair the vehicle. Please refer to the Annex for a detailed account of the cost estimates
