Our Ref : TP / FMP SLC9229R/ 04.24/22

DAMAGED VEHICLE (SLC 9229 R) INSPECTION REPORT (WITHOUT PREJUDICE)

Registration No	: SLC 9229 R	Mileage	: 79718 Km
Make & Model	: KIA FORTE K3 1.6A EX	Engine No	: G4FGGH612127
Date of Registration	: 30 th May 2016	Chassis No.	: KNAFX411MG5596214
Colour	: Red	Engine Capacity.	: 1,591 c.c.

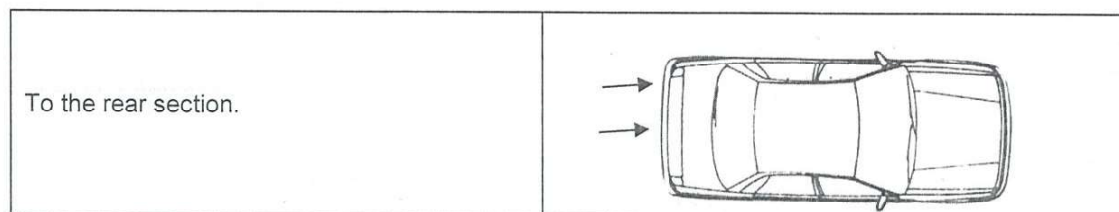
(E) Point of Impact

The impact of the collision has damaged/affected the boot lid, boot lid lamps, rear bumper, rear end panel, tail lamp and etc.
