Type of Survey: Third Party
Make/Model: Toyota Hiace
Reg No: GBL 1775D

Vehicle Accident/Damage Inspection Report

Our Reference:	2206/MEC/1006	Date:	4 Jul 2022
Type of Survey:	Third Party	Accident Date:	9 Jun 2022
Claimant:	Absolute Wheels Leasing Pte Ltd	Inspection Date:	20 Jun 2022
Repairer:	The Mechanic 8 Kaki Bukit Ave 4 #02-47 Premier@KB Singapore (415875)

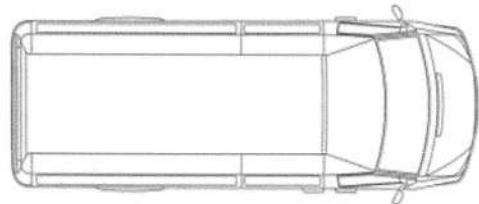
Square on the rear, in a direction from rear to front.

Damages to the vehicle sustained at the time of inspection is on the rear portion.
