Your Ref : G0079677
Our Ref : CI/SGL22005968/N

27 June 2022

**TECHNICAL INVESTIGATION REPORT OF FIRE INCIDENT INVOLVING THE
INSURED VEHICLE SJX 5861D ON 20 JUNE 2022**

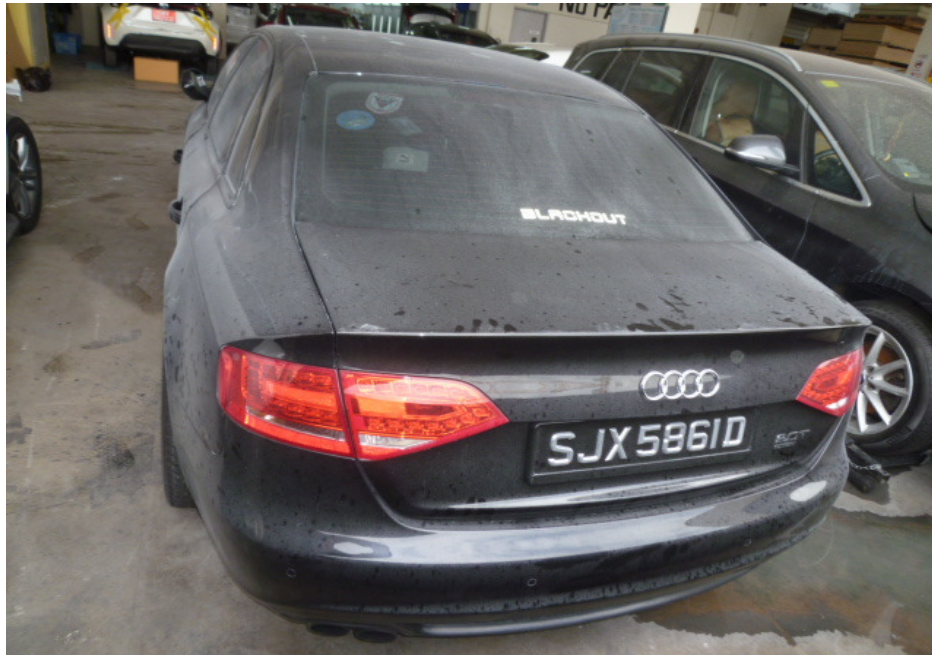
Photo 1 shows the general view of the rear portion of the Insured Vehicle at the time of our inspection. The rear portion of the Insured Vehicle was observed to be unaffected by the fire.

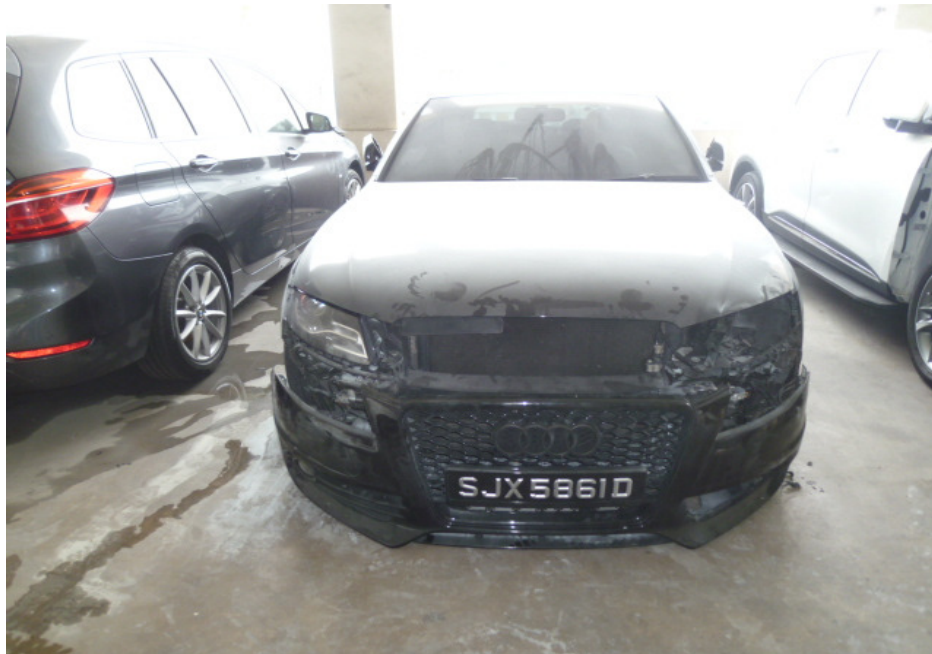
Photo 2 shows the general view of the frontal portion of the Insured Vehicle at the time of our inspection. The exterior body of the Insured Vehicle had sustained visible fire damage. This included its front bumper, front bonnet, left front headlamp and left front fog lamp.

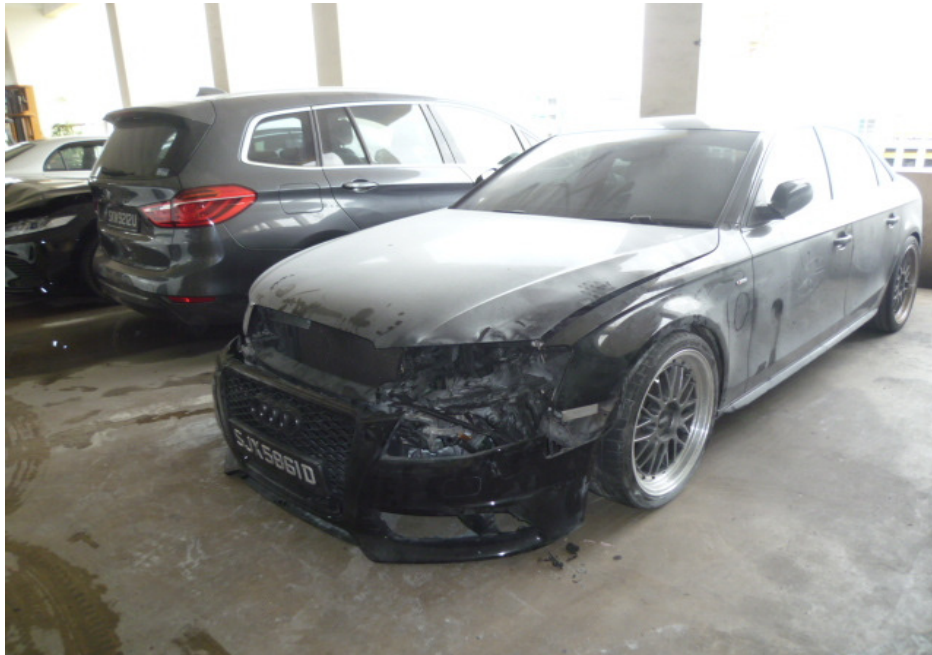
Photo 3 shows a closer view of the left front body of the Insured Vehicle at the time of our inspection. The exterior body of the Insured Vehicle had sustained visible fire damage. This included its front bumper, front bonnet, left front headlamp and left front fog lamp.

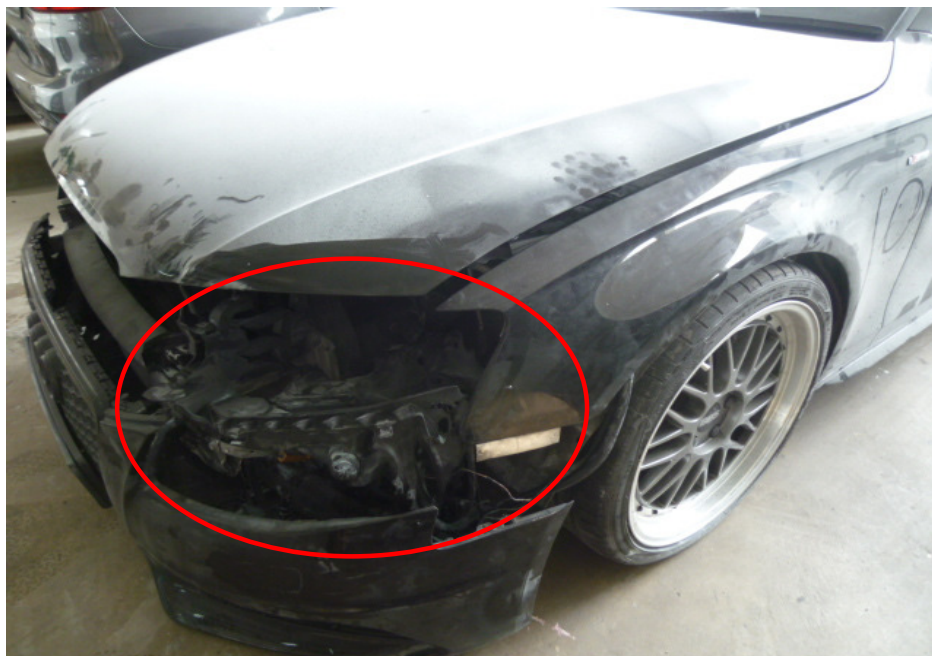
Photo 4 shows a closer view of the left front body of the Insured Vehicle at the time of our inspection. The exterior body of the Insured Vehicle had sustained visible fire damage. This included its front bumper, front bonnet, left front headlamp and left front fog lamp (circled).

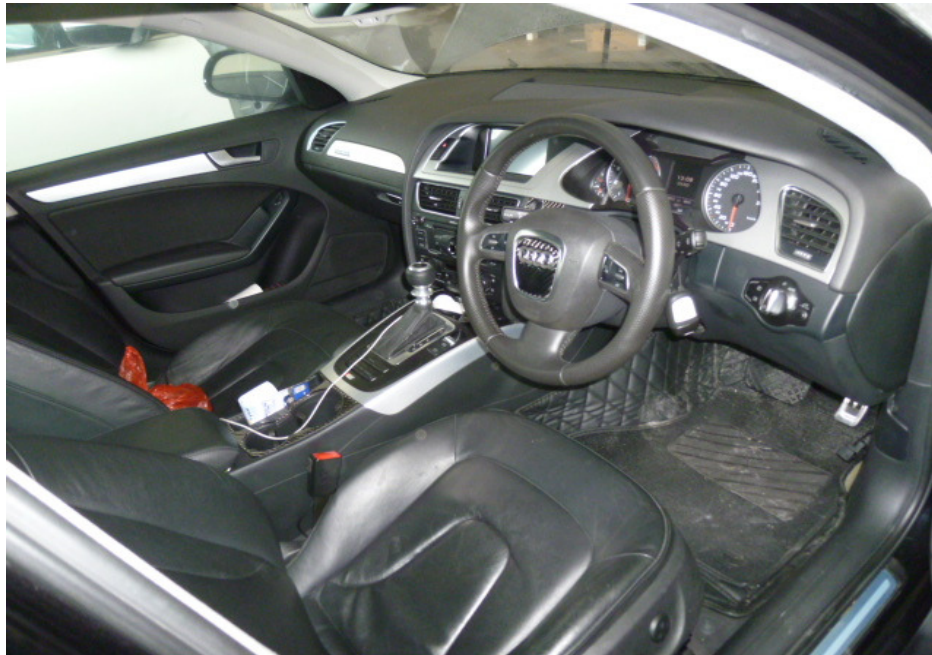
Photo 5 shows the interior compartment of the Insured Vehicle at the time of our inspection. The interior compartment of the Insured Vehicle was relatively unaffected by the fire.

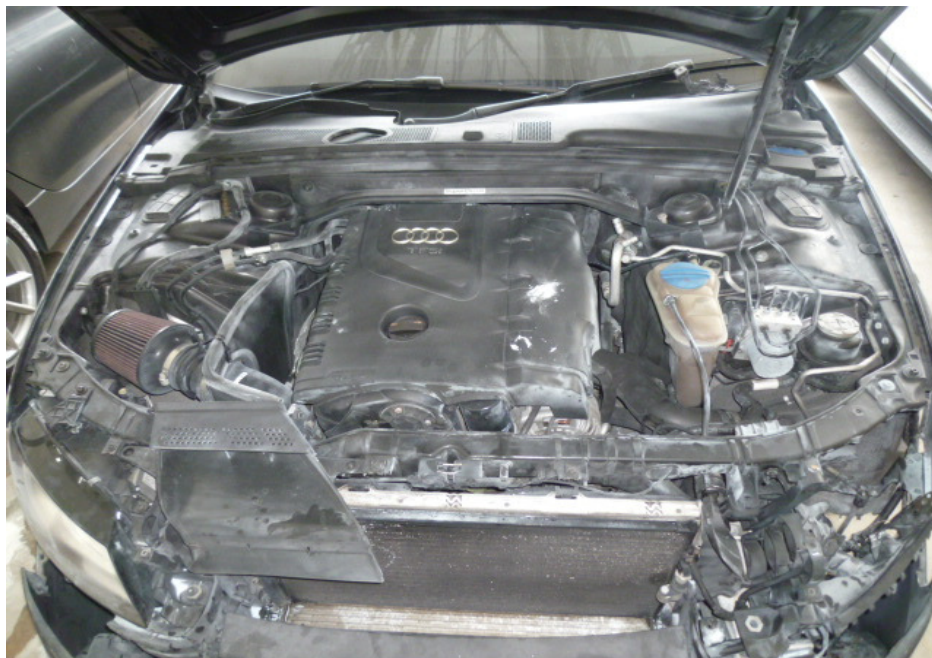
Photo 6 shows the general view of the engine compartment of the Insured Vehicle at the time of our inspection. The fire damage was confined to its interior compartment. The engine compartment of the Insured Vehicle was observed to be relatively unaffected by the fire.

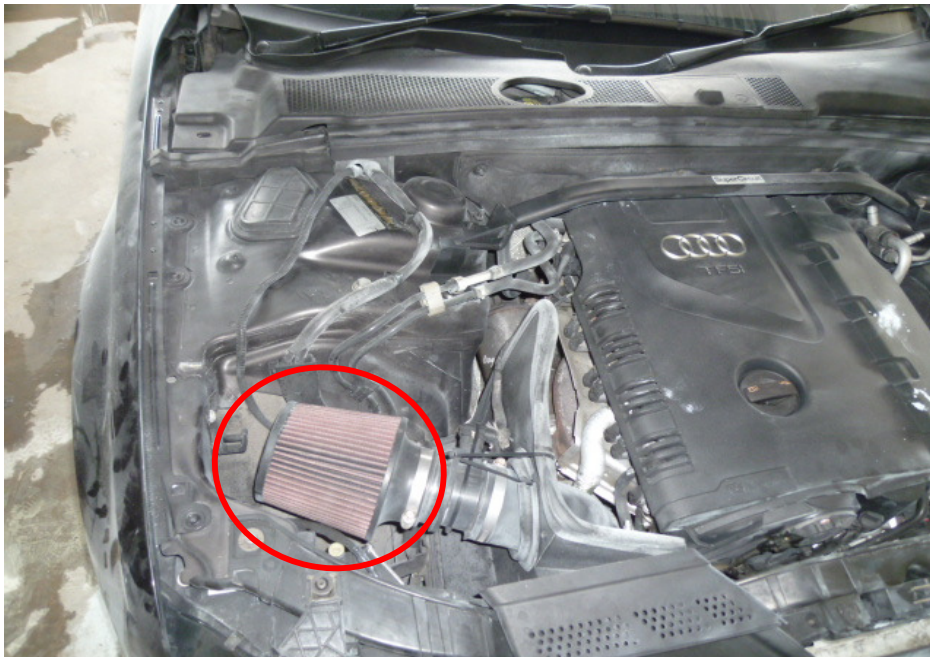
Photo 7 shows a close up view of the non- standard open- pod air filter fitted onto the Insured Vehicle upon our inspection (circled).

32. Although the non- standard open- pod air filter, aftermarket engine strut bar and aftermarket alloy rims fitted on the Insured Vehicle were not the standard type for the Insured Vehicle, we are of the view that these parts did not cause and/or contribute to the fire incident.

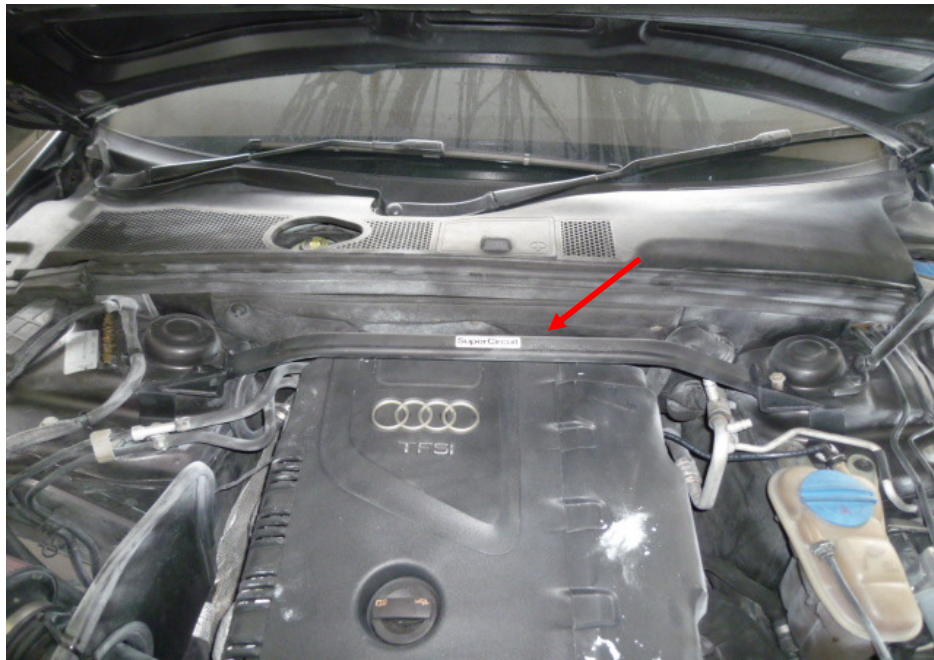
Photo 8 shows the aftermarket engine strut bar fitted on the Insured Vehicle (arrowed).

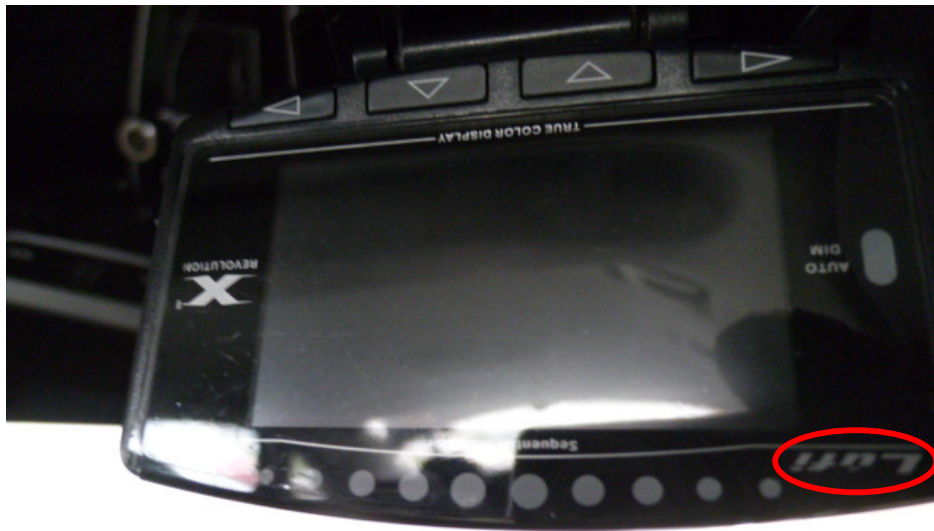
Photo 9 shows the aftermarket on-board diagnostic (OBD) gauge additionally fitted onto the Insured Vehicle upon our inspection. The brand of the OBD gauge was 'LUFU' (circled).

30. We are further of the view that the additionally fitted electrical/electronic components found on the Insured Vehicle could not have possibly caused overloading to the electrical system of the Insured Vehicle considering that the installation was carried out a few years prior to the fire incident.

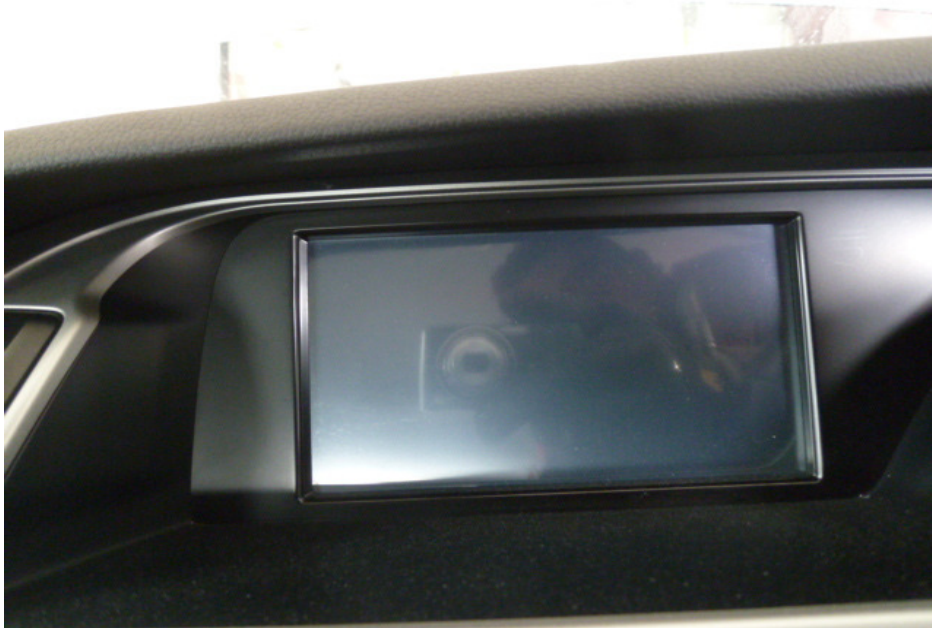
Photo 10 shows the aftermarket in-car DVD player that was fitted at the centre portion of the front dashboard of the Insured Vehicle.

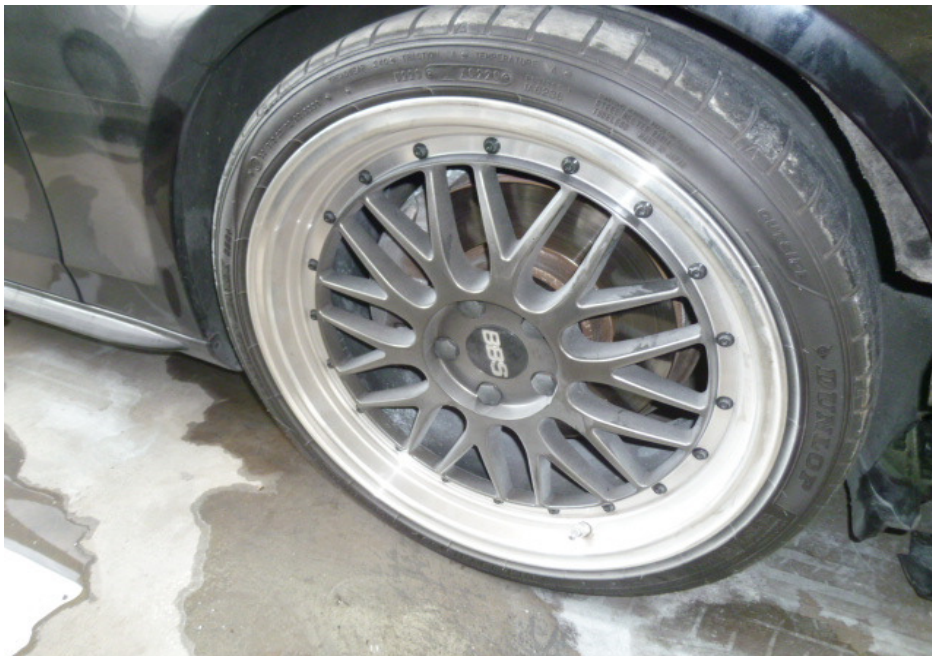
Photo 11 shows the non-standard rim found to be fitted on the Insured Vehicle at the time of our inspection. The 19- inch alloy rims fitted on the Insured Vehicle were not the standard type for the Insured Vehicle.

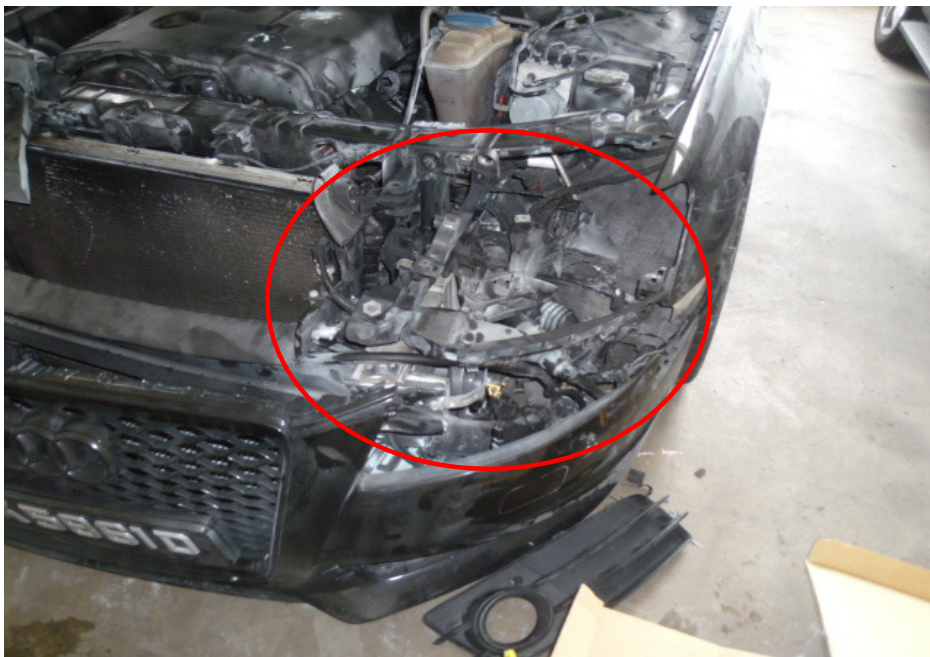
8. For this particular case, the fire appears to have originated from the left front portion of the Insured Vehicle, somewhere around the left front fog lamp. The heat intensity caused several plastic components which included the left front headlamp, left front fog lamp and left front fog lamp cover to melt. See photos 12 - 16 below.

Photo 12 shows the burn pattern and the nature of fire damage on the left front portion of the Insured Vehicle. The heat intensity caused several plastic components which included the left front headlamp, left front fog lamp and left front fog lamp cover to melt (circled).

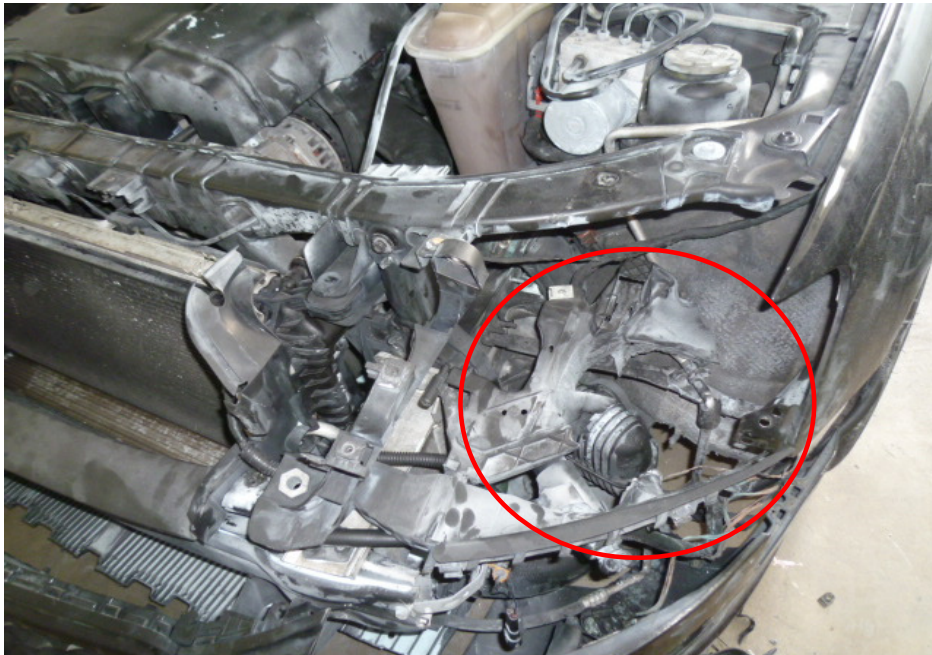
Photo 13 shows a closer view of the burn pattern and the nature of fire damage on the left front portion of the Insured Vehicle. The heat intensity caused several plastic components which included the left front headlamp, left front fog lamp and left front fog lamp cover to melt (circled).

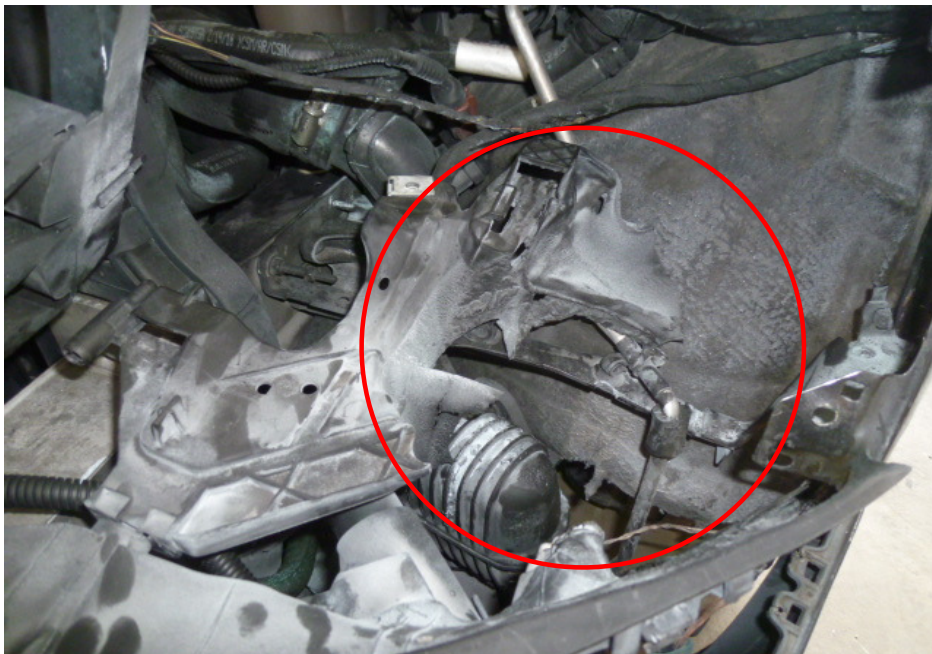
Photo 14 shows a close up view of the several plastic components around the left front portion of the Insured Vehicle which had partially melted due to the heat intensity caused by the fire (circled).

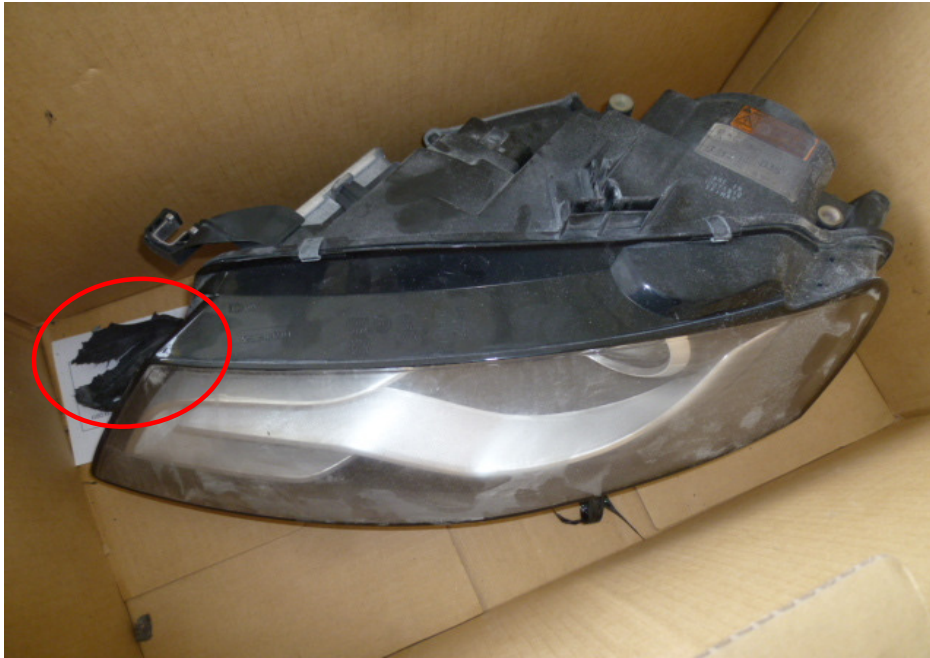
Photo 15 shows a closer view of the left front headlamp of the Insured Vehicle which had partially melted due to the heat intensity caused by the fire (circled).

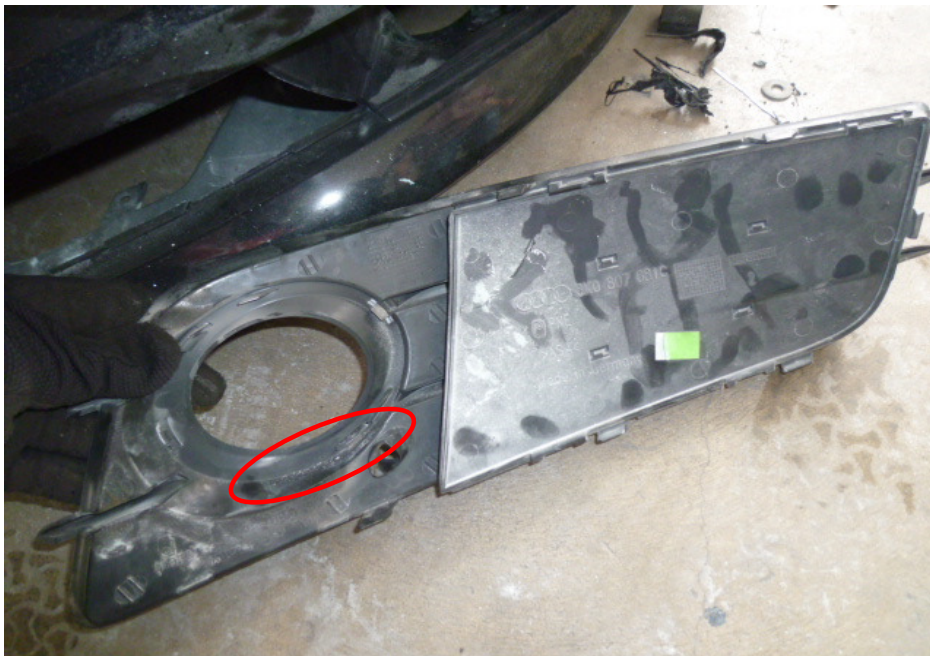
Photo 16 shows a closer view of the left front fog lamp cover of the Insured Vehicle which had partially melted due to the heat intensity caused by the fire (circled).

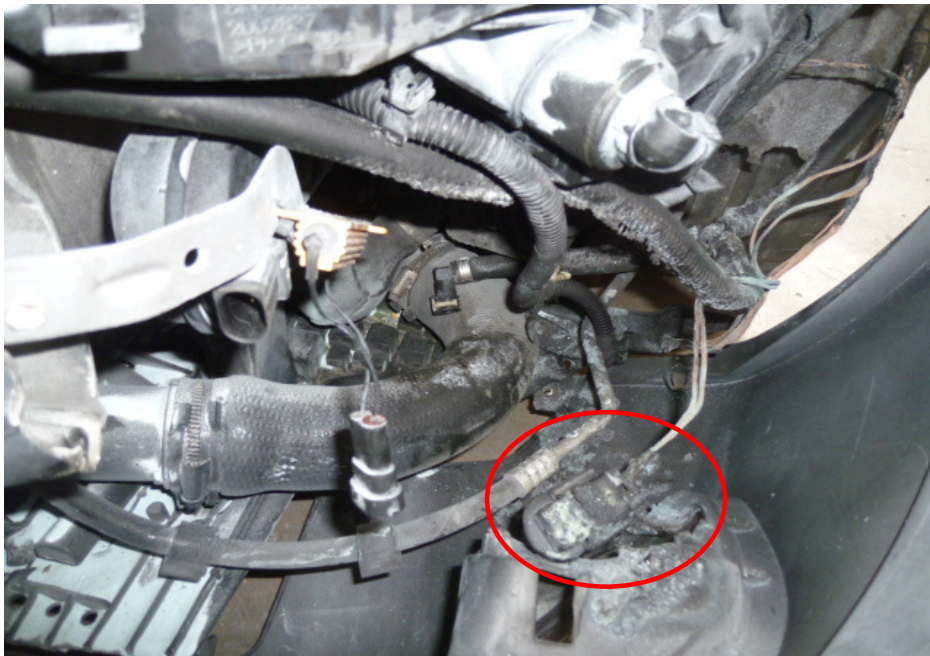
9. Upon closer examination of the left front fog lamp which was where the fire to the Insured Vehicle had likely started, we had found several stretches of wirings with greenish residue. These wirings were original factory fitted wirings leading from the left front fog lamp bulb socket of the Insured Vehicle. The presence of greenish residue indicates internal heating of copper wires, a sign of an electrical short circuit occurring. The greenish residue is normally left behind from oxidation as a result of chemical reaction involving the copper wires. This physical evidence would appear to suggest that the cause of fire to the Insured Vehicle could have possibly been due to electrical in nature. See photos 17 – 21 below.

Photo 17 shows the wirings around the left front fog lamp which is near to the vicinity where the fire to the Insured Vehicle had likely started. We observed greenish residue on the wirings leading from the left front fog lamp bulb socket of the Insured Vehicle (circled). The presence of greenish residue indicates internal heating of copper wires, a sign of an electrical short circuit occurring. The greenish residue is normally left behind from oxidation as a result of chemical reaction involving the copper wires.

25. The possibility of the fire being due to electrical in nature would then seem more likely given that engine overheating and external factors would both seem unlikely. The fire being due to electrical in nature is also supported by the burnt wirings found in the left front portion of the Insured Vehicle, which was earlier discussed in paragraph 9 above.

27. Having investigated and technically analysed the damages of burnt nature to the Insured Vehicle, we are of the view that the cause of fire to the Insured Vehicle was of electrical in nature. For this particular case, the fire had originated along the wirings inside the engine compartment, leading from the left front fog lamp bulb socket of the Insured Vehicle. The wirings were original factory wirings of the Insured Vehicle.
28. We did not find any evidence which had suggested that the cause of fire to the Insured Vehicle was due to poor maintenance and/or recurring electrical problem.
29. We found the Insured Vehicle to be fitted with additional electrical/electronic components which included an aftermarket on-board diagnostic (OBD) gauge and an aftermarket in-car DVD player. The abovementioned electrical/electronic components do not require prior approval from LTA.

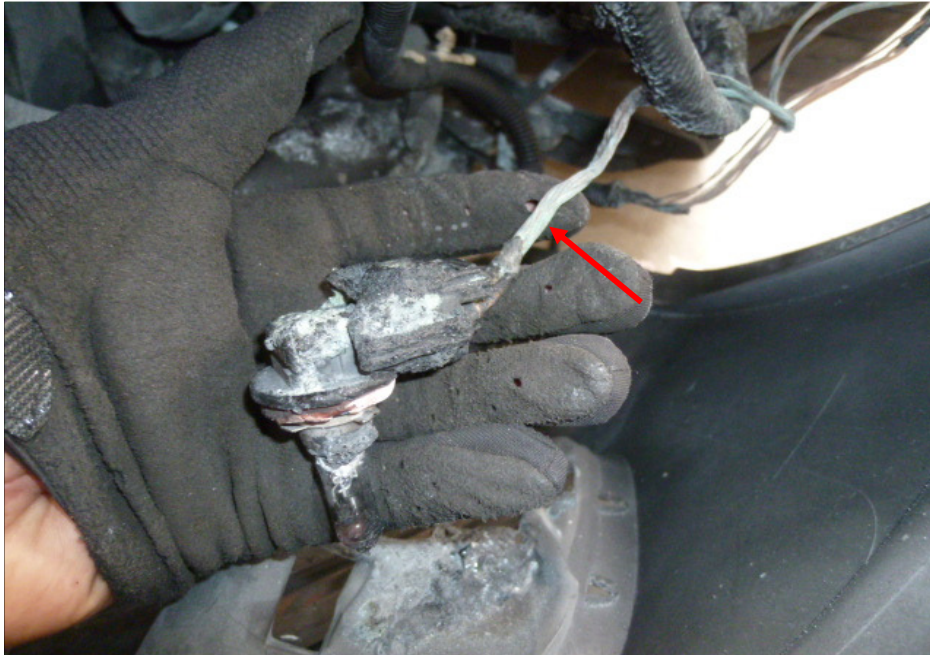
Photo 18 shows a closer view the greenish residue on the wirings leading from the left front fog lamp bulb socket of the Insured Vehicle (arrowed). The presence of such greenish residue suggests occurrence of an electrical short circuit.

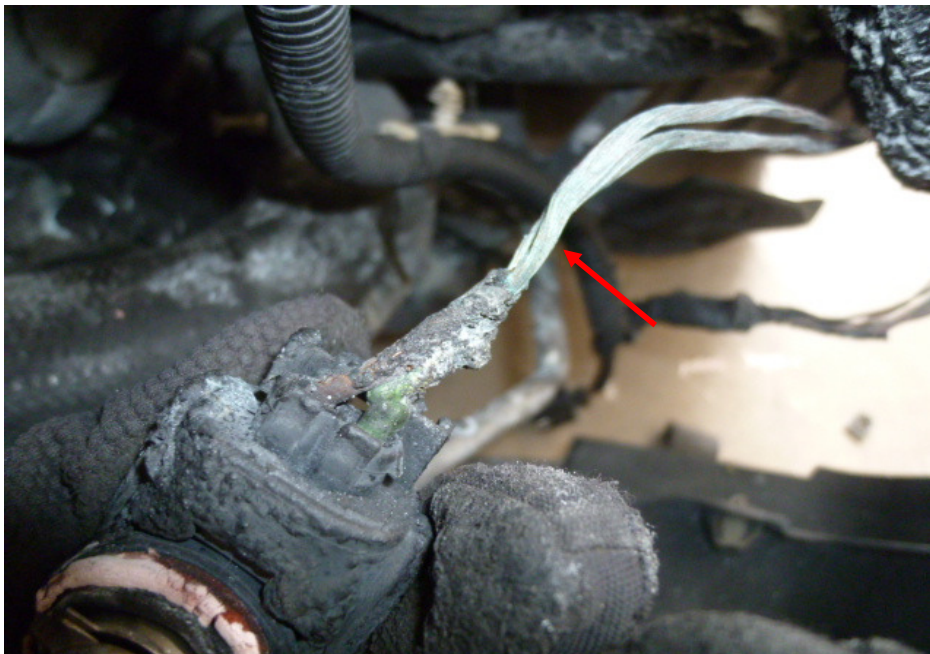
Photo 19 shows a closer view the greenish residue on the wirings leading from the left front fog lamp bulb socket of the Insured Vehicle (arrowed). The presence of such greenish residue suggests occurrence of an electrical short circuit.

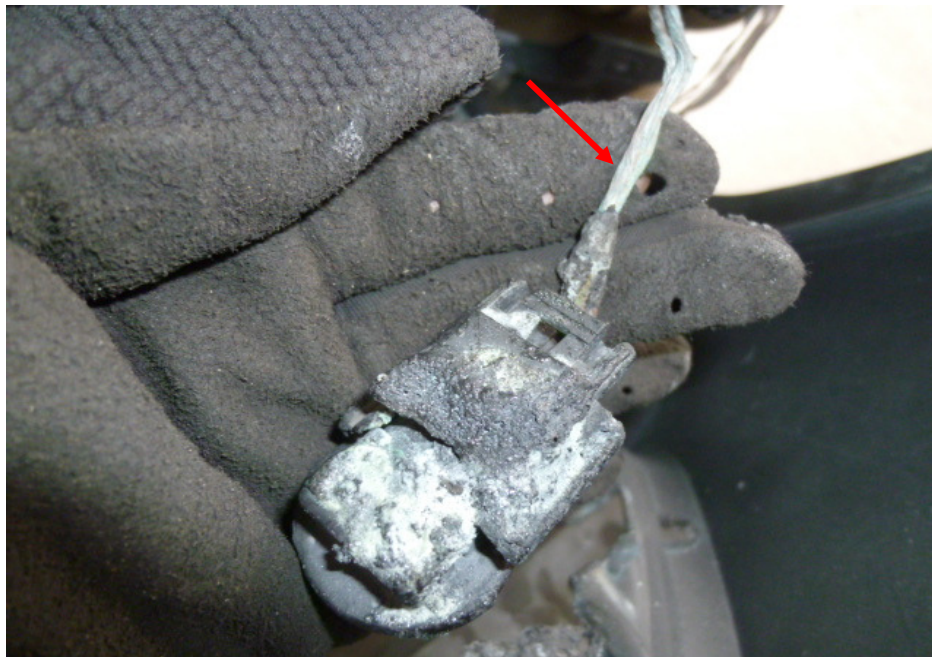
Photo 20 shows a close up view of the greenish residue on the wirings leading from the left front fog lamp bulb socket of the Insured Vehicle (arrowed). The presence of such greenish residue suggests occurrence of an electrical short circuit.

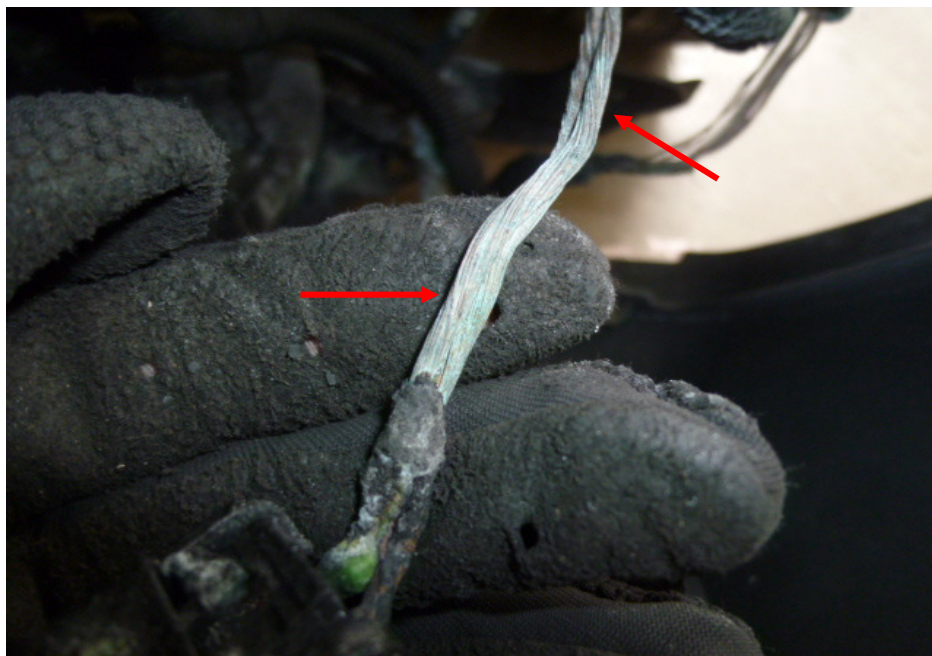
Photo 21 shows a close up view of the greenish residue on the wirings leading from the left front fog lamp bulb socket of the Insured Vehicle (arrowed). The presence of such greenish residue suggests occurrence of an electrical short circuit.

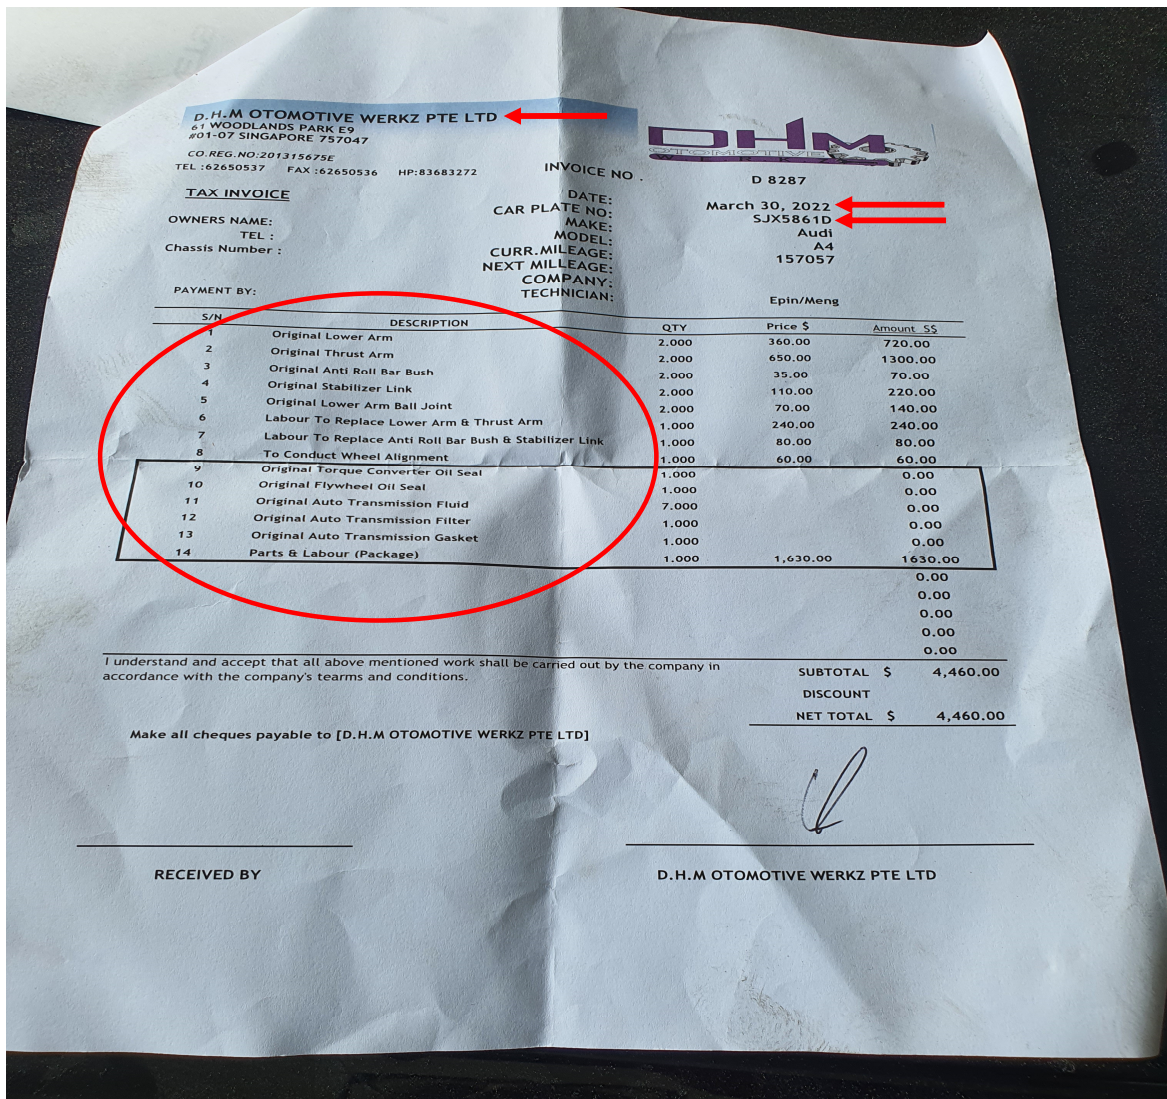
Invoice 2 shows the latest repairs done on the Insured Vehicle at DHM on 30 March 2022 (arrowed). The repair package had included changing of the lower arm, anti roll bar bush, stabilizer link, lower arm ball joint, torque converter oil seal, flywheel oil seal, automatic transmission fluid (ATF), ATF filter and auto transmission gasket (circled).

22. Based on the vehicle service record invoices provided, we are of the opinion that it is unlikely that the fire could have been caused by poor maintenance of the Insured Vehicle.

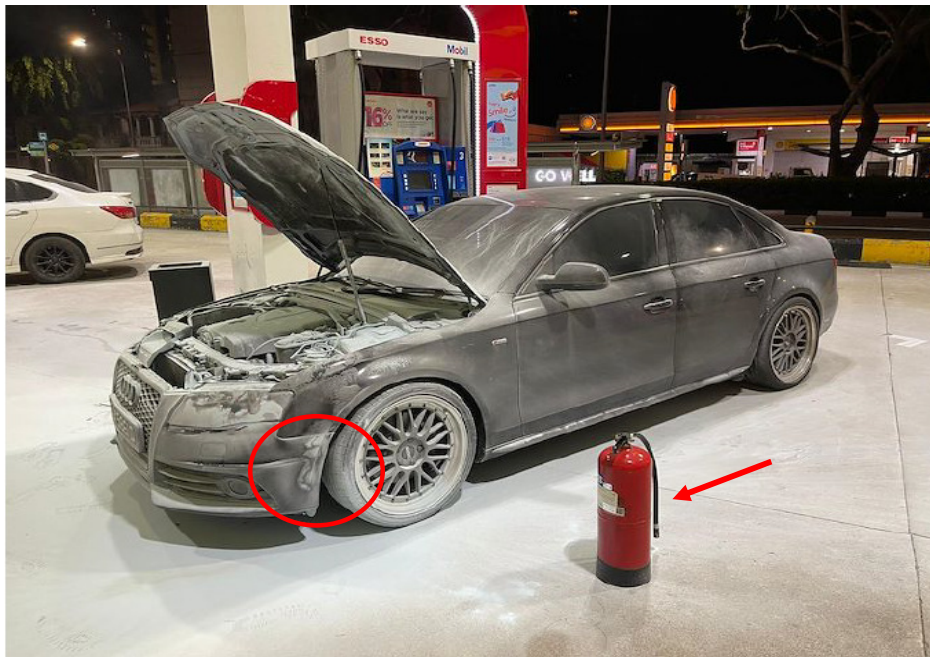
Photo 22 shows the Insured Vehicle at the incident location after the fire was extinguished. In general, the information that could be gathered from this photograph had corresponded to the events that were related to us by Mr Saifuddin, which is the burn pattern observed is an indication that the fire had started from the left front portion of the Insured Vehicle (circled) and that Mr Saifuddin had put out the fire himself with a fire extinguisher retrieved from the petrol station (arrowed).

24. The possibility of the fire being due to external factors (foreign material(s) stuck on hot surfaces, arson and sabotage amongst others) would also seem unlikely given that our examination of the available incident scene photograph did not reveal any unusual material(s)/object(s) found on the ground near where the Insured Vehicle was positioned. The location of where the Insured Vehicle was positioned was also observed to be not at a secluded location.
