Your Ref: C02998
Our Ref : CI/III22006055/P

**TECHNICAL INVESTIGATION REPORT OF WARRARTY CLAIM INVOLVING
THE INSURED VEHICLE SKL 3399L ON 16th June 2022**

Vehicle Registration No.	: SKL 3399L
Make / Model	: TOYOTA APLHARD 3.5 SC AUTO
Chassis No	: GGH30-0028603
Year of Registration	: JUNE 2022
Mileage	: 116,067KM

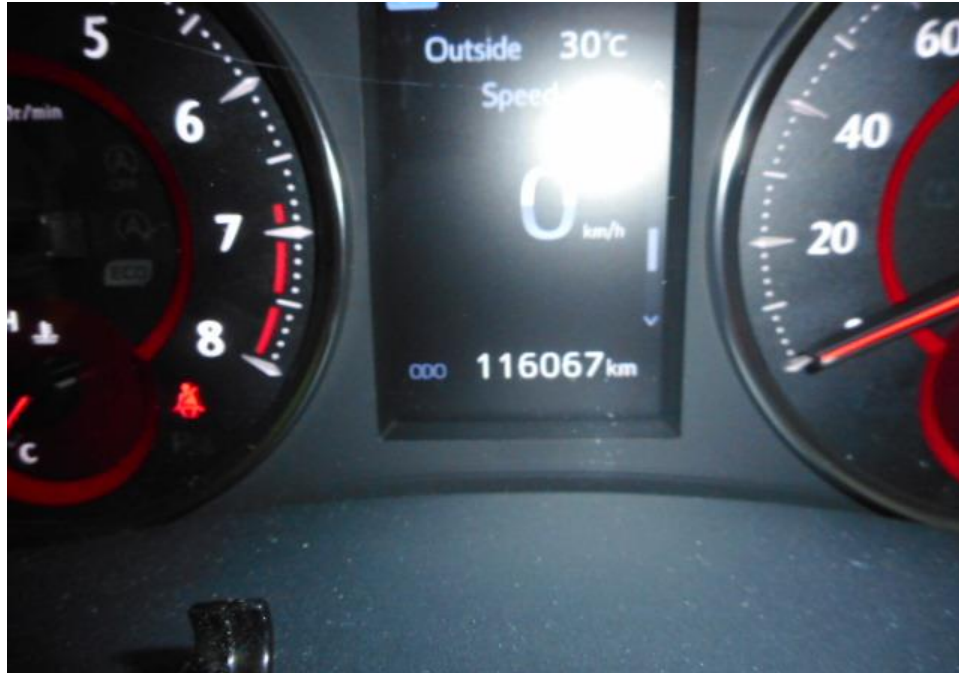
Photo 1 shows the mileage of the Insured Vehicle recorded at the time inspection at 116,067KM

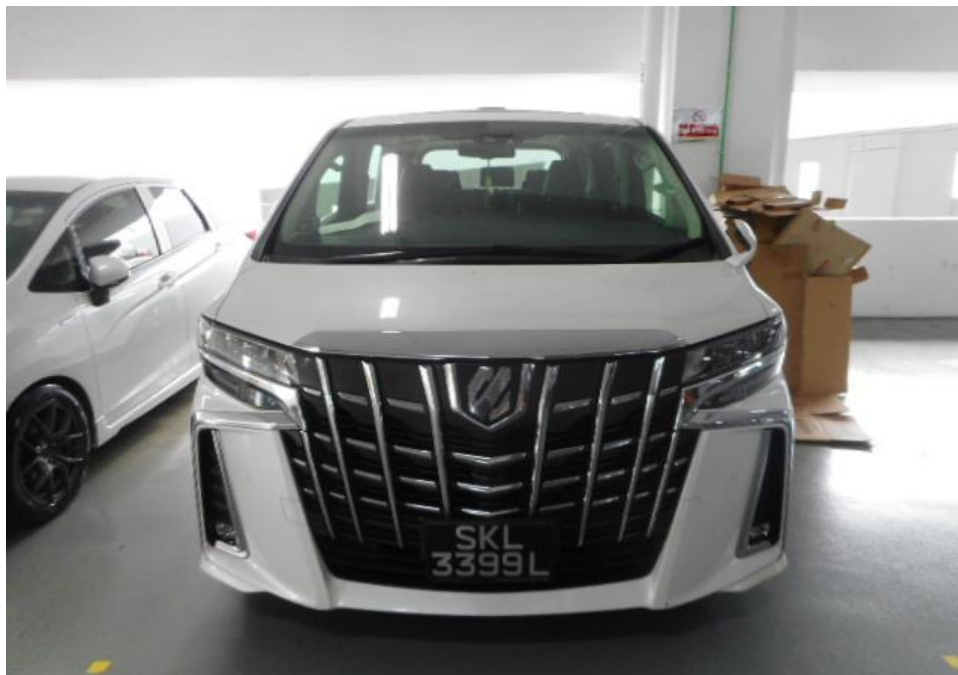
Photo 2 shows the general view of the front portion of the Insured Vehicle at the time of our inspection. The Insured Vehicle is observed to be unaffected by any signs of accident.

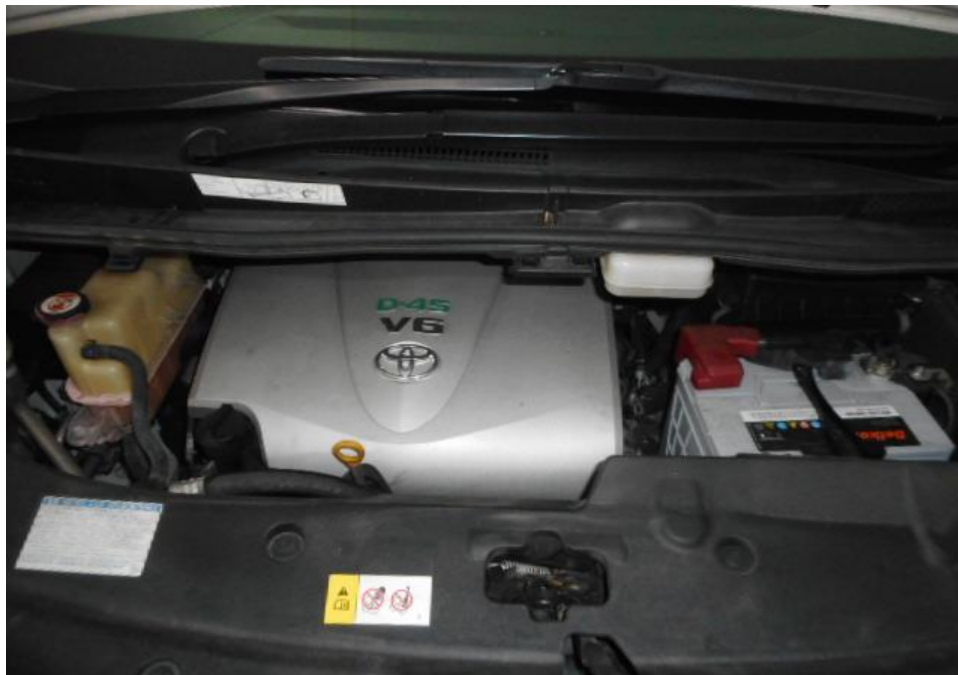
Photo 3 shows the general view of the engine portion of the Insured Vehicle at the time of our inspection. The engine compartment is observed to be unaffected by any signs of accident.

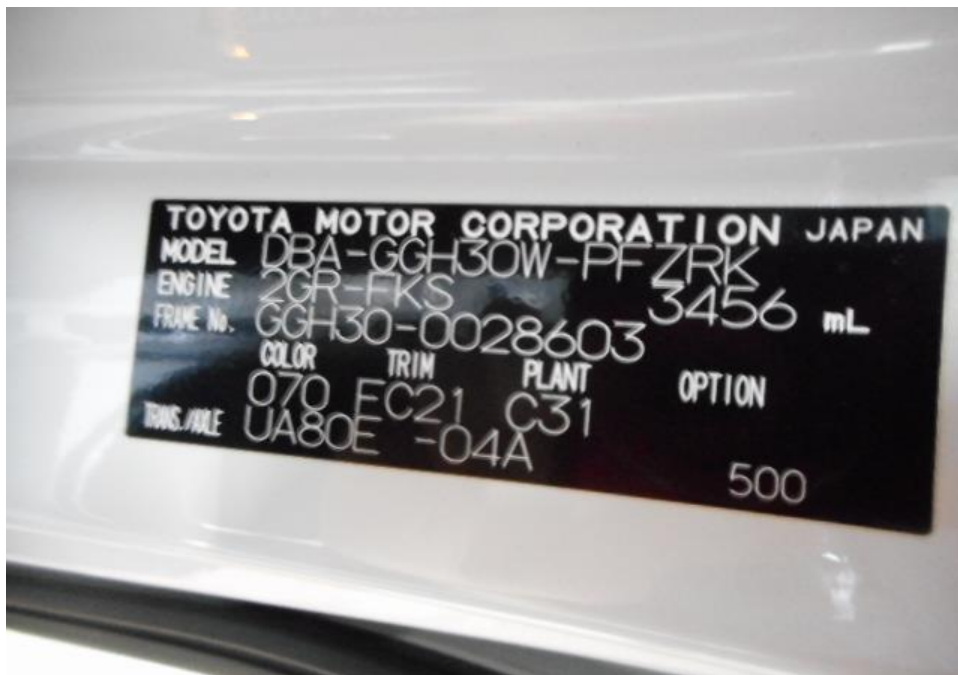
Photo 4 shows the chassis number of the Insured Vehicle at the time of our inspection.

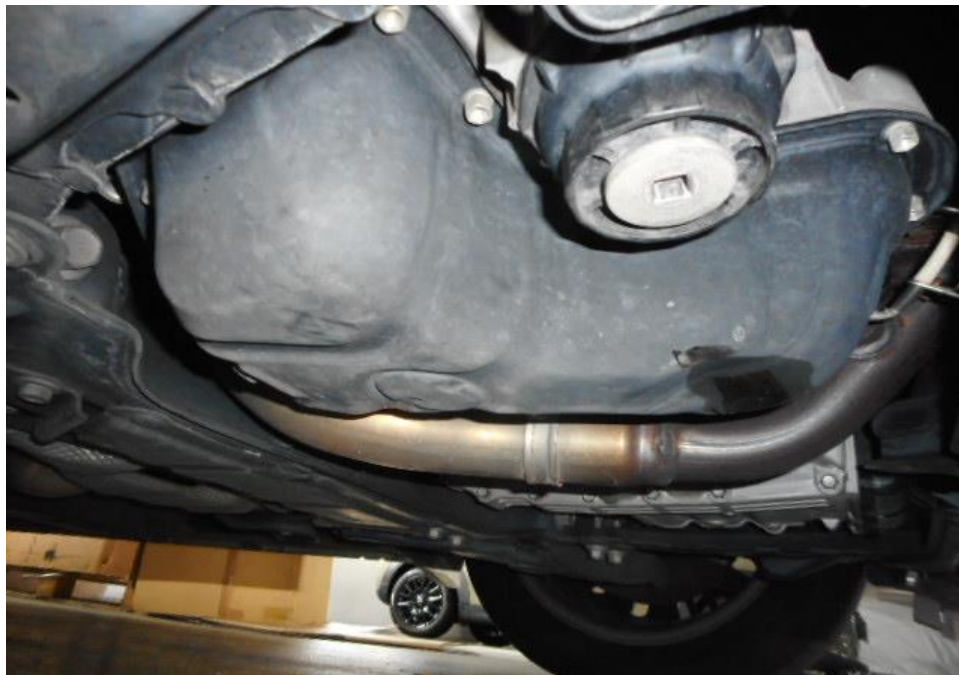
Photo 5 shows the general view of the engine and gearbox underside portion of the Insured Vehicle at the time of our inspection. The engine and transmission underside compartment is observed to be unaffected and by any signs of accident.

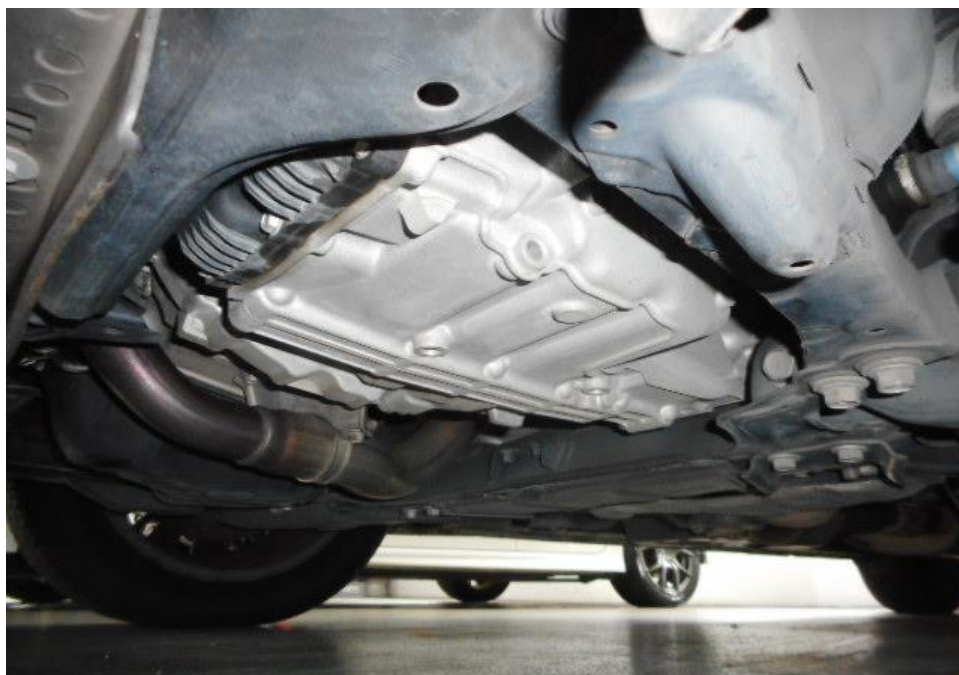
Photo 6 shows the general view of the gearbox underside portion of the Insured Vehicle at the time of our inspection. The gearbox unit was is observed unaffected and by any signs of accident.

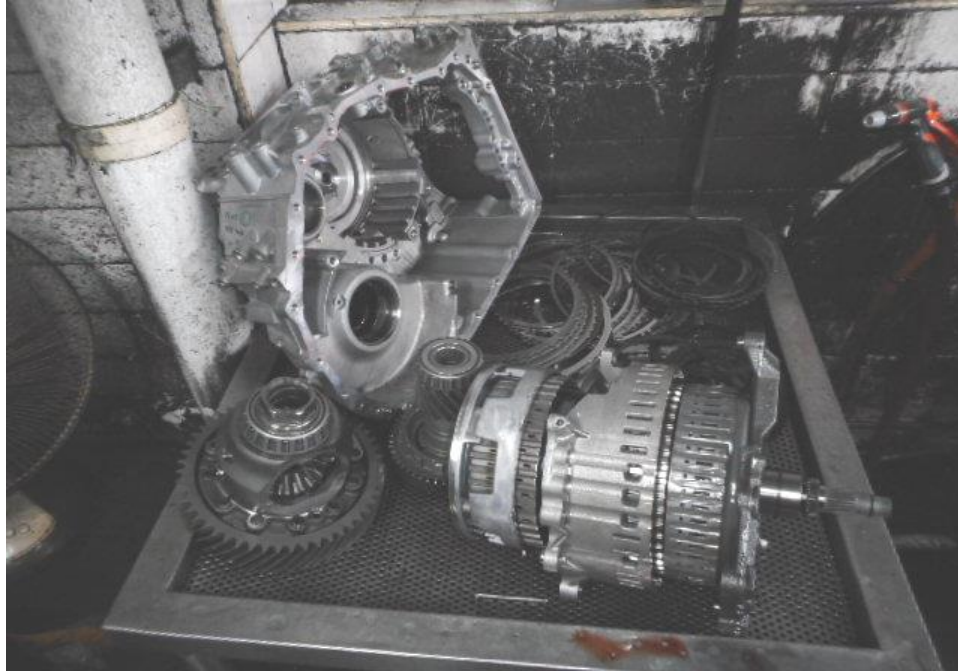
Photo 7 shows the general view of inside the gearbox unit of the Insured Vehicle at the time of our inspection. The components in the gearbox unit is observed to be unaffected and by any signs of accident.

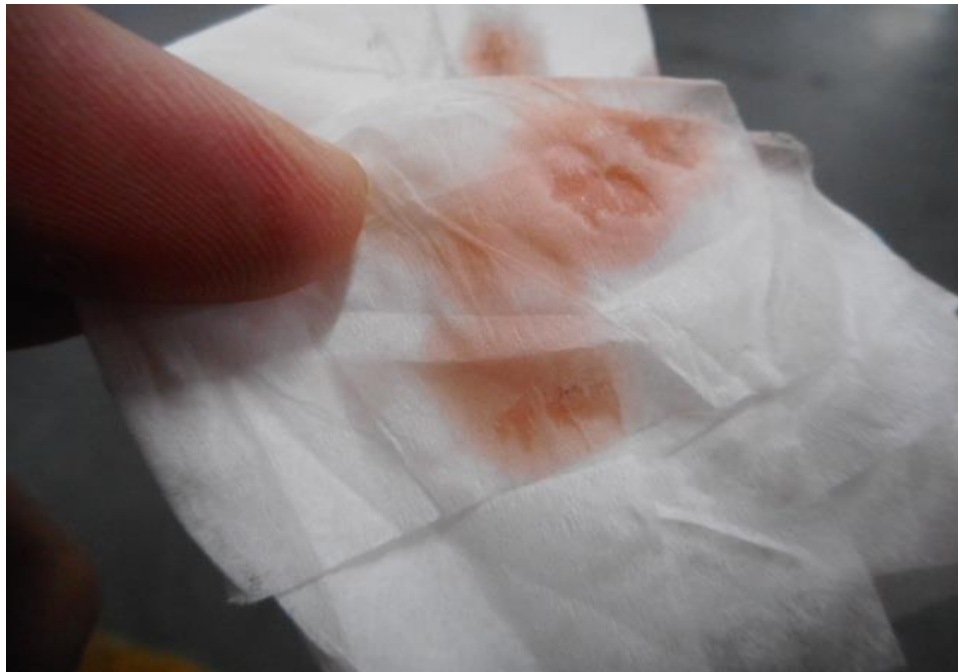
Photo 8 shows the close up view of the gearbox fluid of the Insured Vehicle at the time of our inspection. We observed that gearbox fluid was observed to be without any visible contamination.

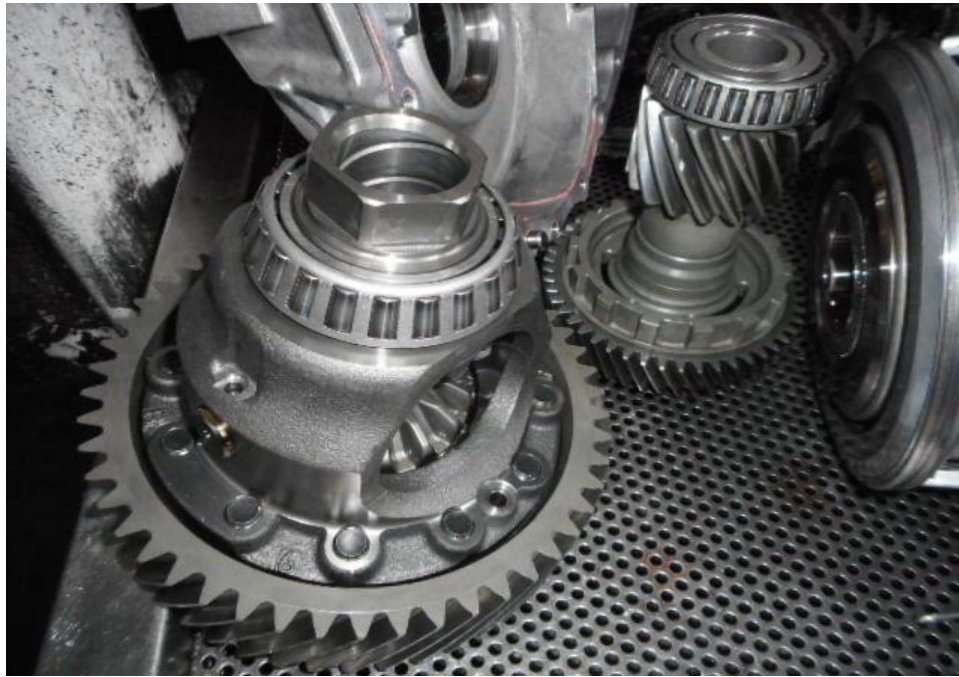
Photo 9 shows the general view of the gearbox unit of the Insured Vehicle at the time of our inspection. We observed that the gears was observed to be intact.

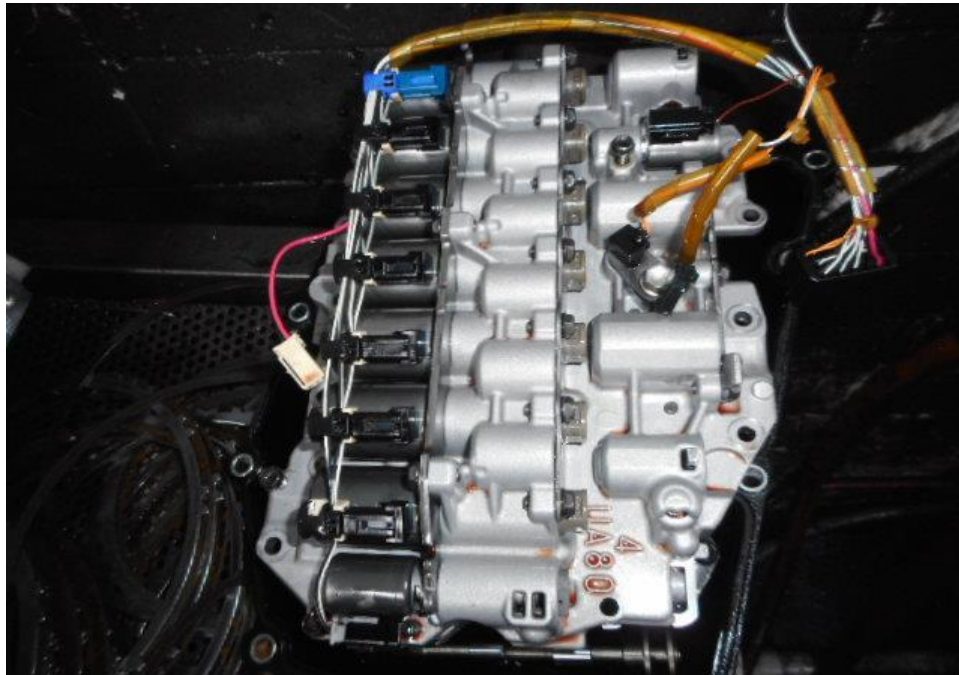
Photo 10 shows the general view of the gearbox unit of the Insured Vehicle at the time of our inspection. We observed that the valve body was observed to be intact.

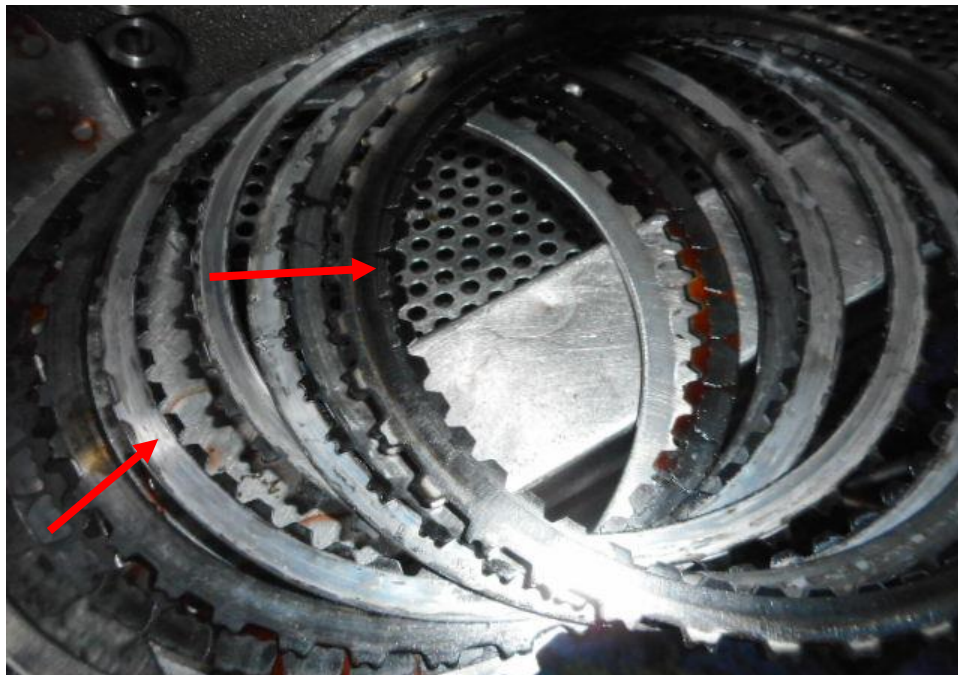
6. Upon dismantling the gearbox unit they have found damages to the clutch packs in the gearbox of the Insured Vehicle and agreed that the complained problem is from these components in the gearbox unit See photos 7 – 14 below.

Photo 11 the general view of inside the gearbox unit of the Insured Vehicle at the time of our inspection. The clutch packs (arrowed) component in the gearbox unit is observed to be damaged with scratches and friction burnt marks on the surface on the clutch packs linings, this is the cause for the complained problems of the vehicle being unable to move despite shifting into gear on the Insured Vehicle.

8. We did not find any evidence which had suggested that the cause of abnormalities to the Insured Vehicle was due to poor maintenance and/or recurring problem.
9. Our investigations had also revealed that at the time of writing this report, there is no manufacturer recall to similar make and model vehicle as the Insured Vehicle that may possibly be related to this incident on the gearbox unit.
10. The recommendation to overhaul the Auto gearbox unit and replace the clutch set at \$6,826.60 is justifiable as all the relevant checks has been conducted.

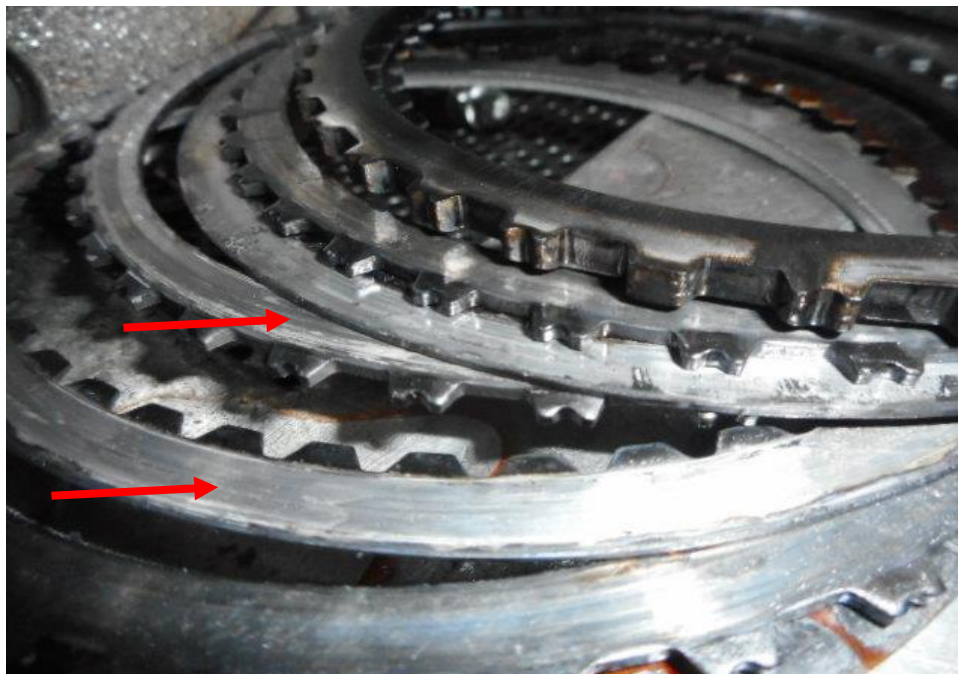
Photo 12 the close up view of inside the gearbox unit of the Insured Vehicle at the time of our inspection. The clutch packs (arrowed) component in the gearbox unit is observed to be damaged with scratches and friction burnt marks on the surface on the clutch packs linings, this is the cause for the complained problems of the vehicle being unable to move despite shifting into gear on the Insured Vehicle.

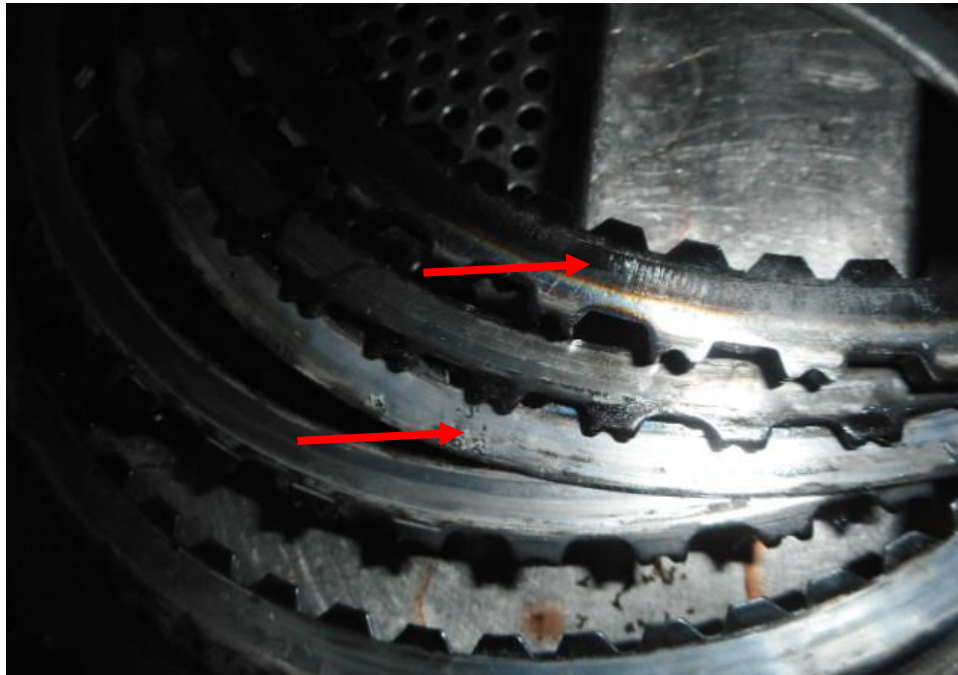
Photo 13 the close up view of inside the gearbox unit of the Insured Vehicle at the time of our inspection. The clutch packs (arrowed) component in the gearbox unit is observed to be damaged with scratches and friction burnt marks on the surface on the clutch packs linings, this is the cause for the complained problems of the vehicle being unable to move despite shifting into gear on the Insured Vehicle.

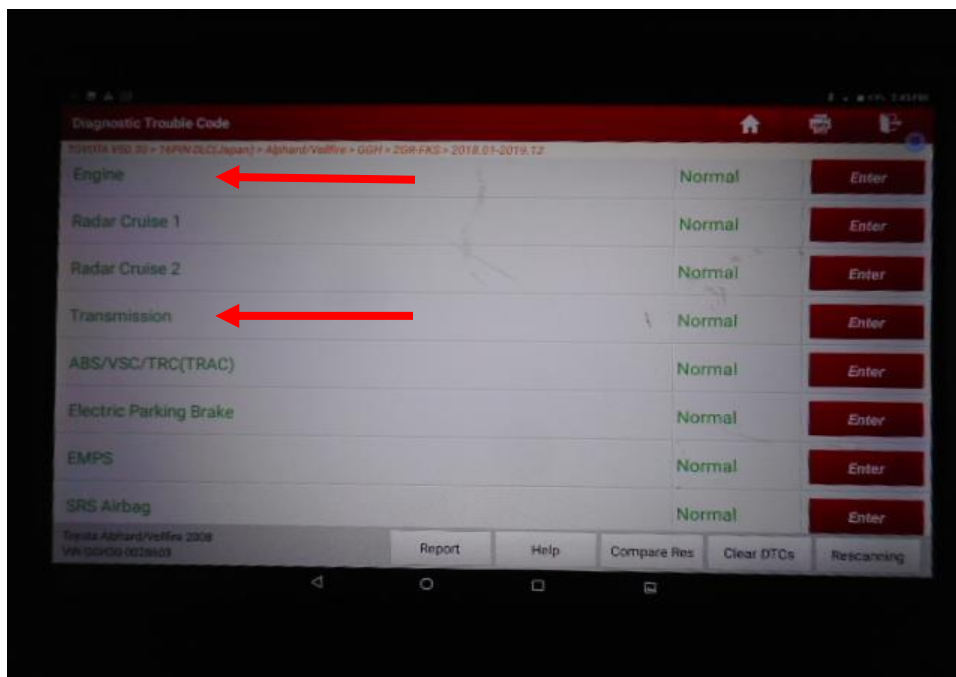
Photo 14 shows the conducted OBD diagnosis report of the Insured Vehicle at the time of our inspection. There was no electronic error on engine and gearbox/transmission system of the Insured Vehicle (arrowed).
