LKK Auto Consultants Pte Ltd

Vehicle No. SNE 5044Z
Insured Veh. XE 2963Y
Claim No. 22/22/22/VC00/025969
Policy No. Z/22VC00/113278
Accident Date 24/06/2022
Inspection Date 05/07/2022

ADJUSTMENT ON REPAIR COST FOR VEHICLE NO. SNE 5044Z

PHOTOGRAPHS FOR VEHICLE NO. SNE 5044Z

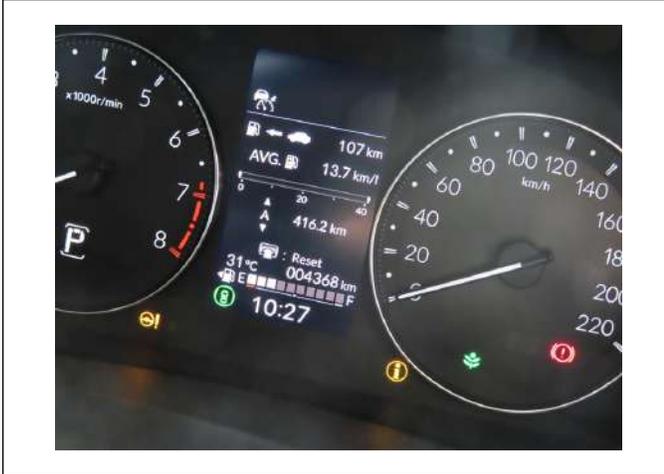
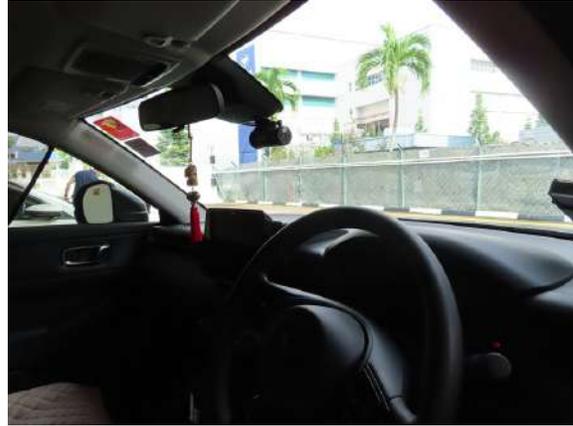
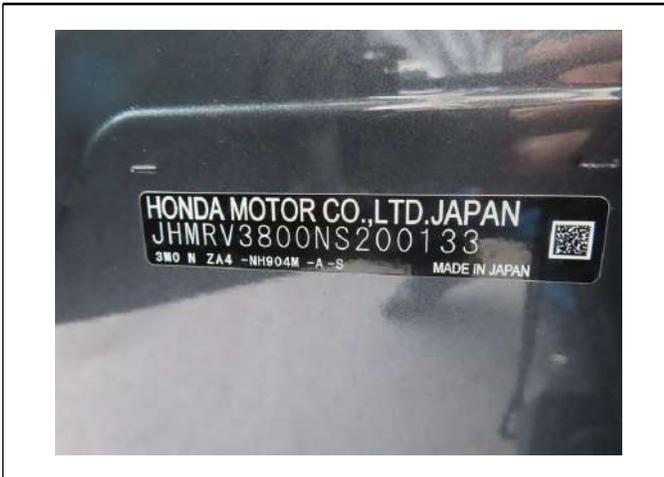
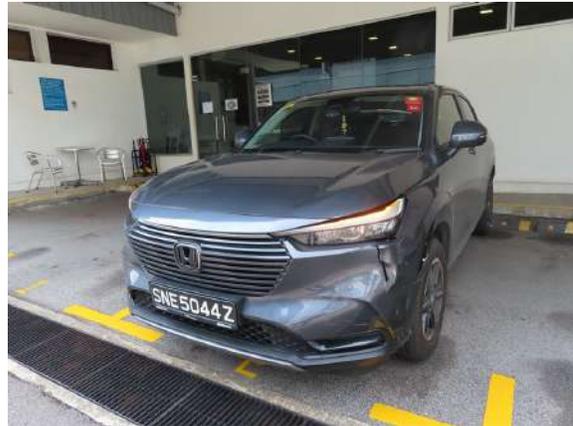
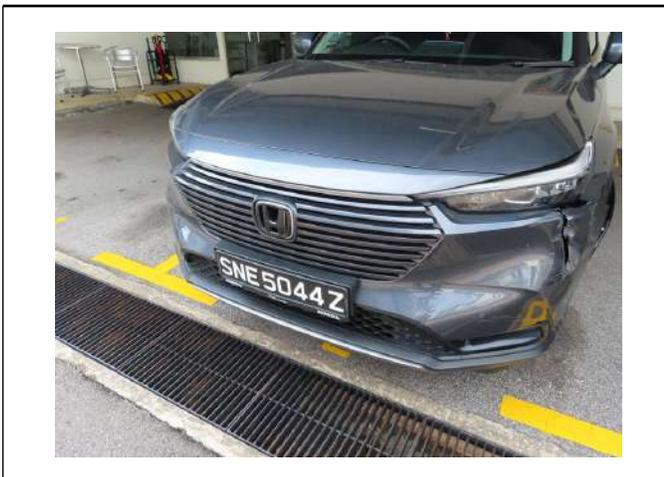
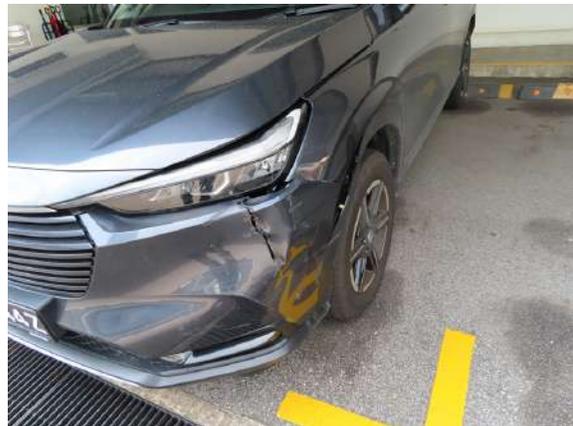
INSPECTION

THE VEHICLE SUSTAINED DAMAGES AT THE FRONT N/S PORTION.
DAMAGES SEE DETAILS.
