Your Ref: MTS2022D0003130/DT
Our Ref : CI/III22006146/P

**TECHNICAL INVESTIGATION REPORT OF WARRANTY CLAIM INVOLVING
THE INSURED VEHICLE SJW 757K ON 27th June 2022**

Vehicle Registration No.	: SJW 757K
Make / Model	: PORSCHE CAYENNE
Chassis No	: WP1ZZZ9YZLDA59192
Year of Registration	: APR 2020
Mileage	: 41,034KM

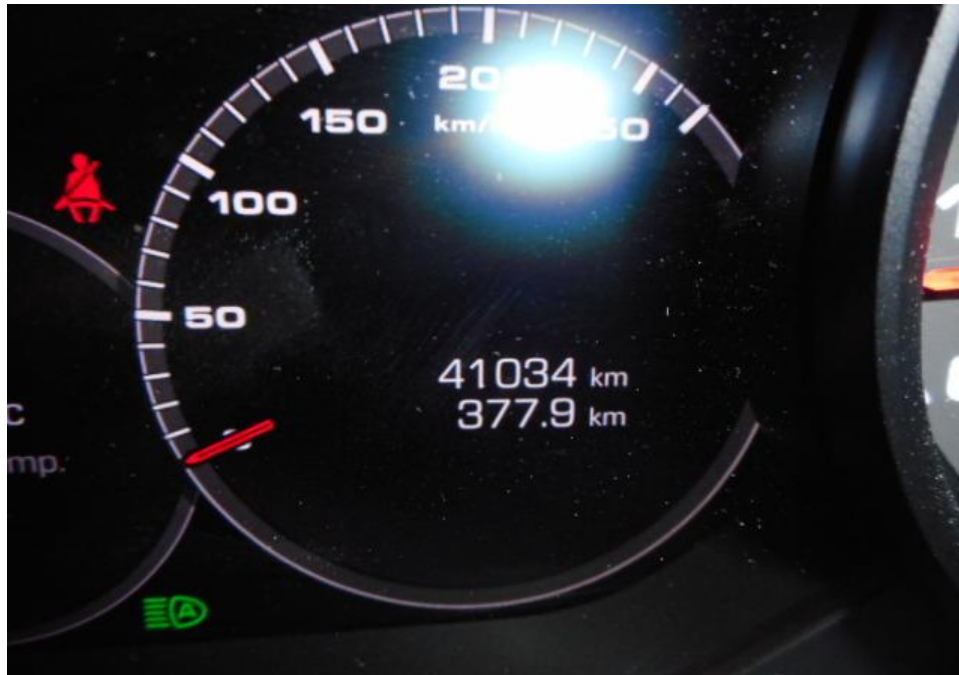
Photo 1 shows the mileage of the Insured Vehicle recorded at the time inspection at 41,034KM

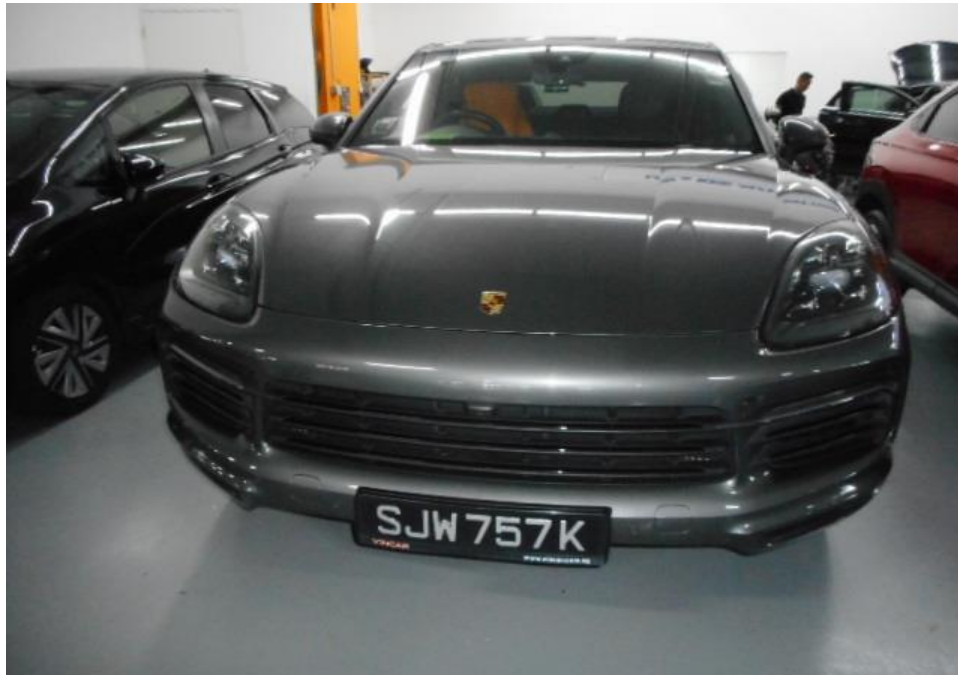
Photo 2 shows the general view of the front portion of the Insured Vehicle at the time of our inspection. The Insured Vehicle is observed to be unaffected by any signs of accident.

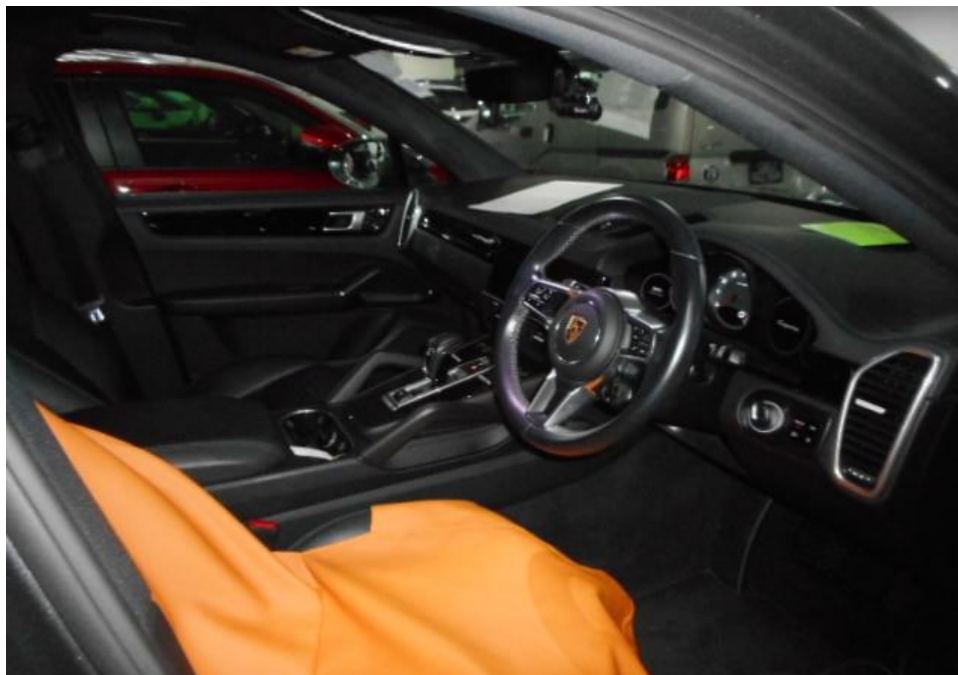
Photo 3 shows the general view of the interior portion of the Insured Vehicle at the time of our inspection. The Insured Vehicle's interior is observed to be unaffected by any signs of accident.

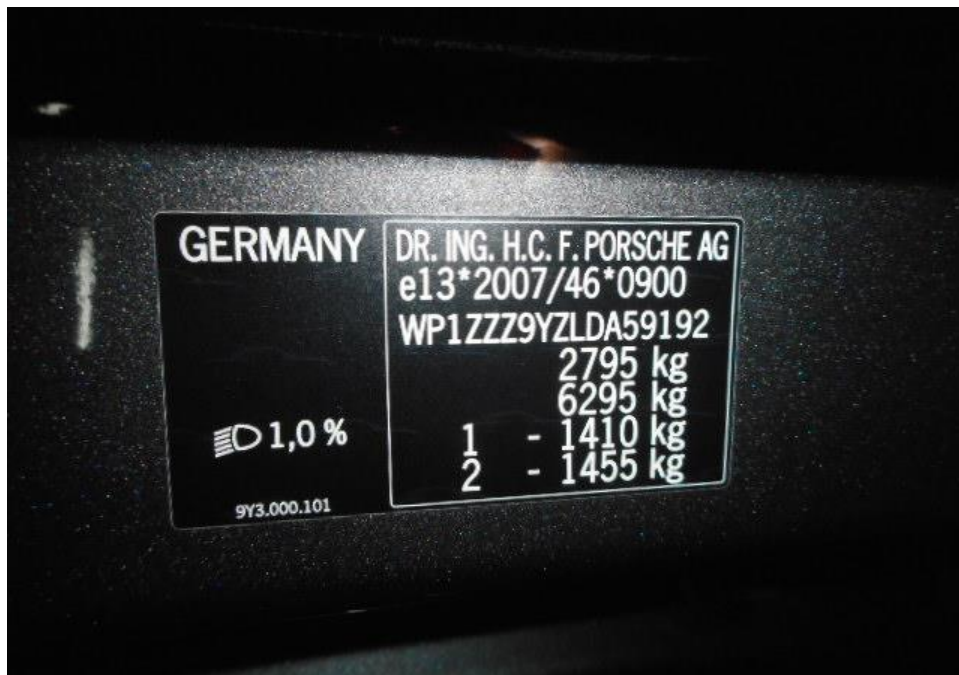
Photo 4 shows the chassis number of the Insured Vehicle at the time of our inspection.

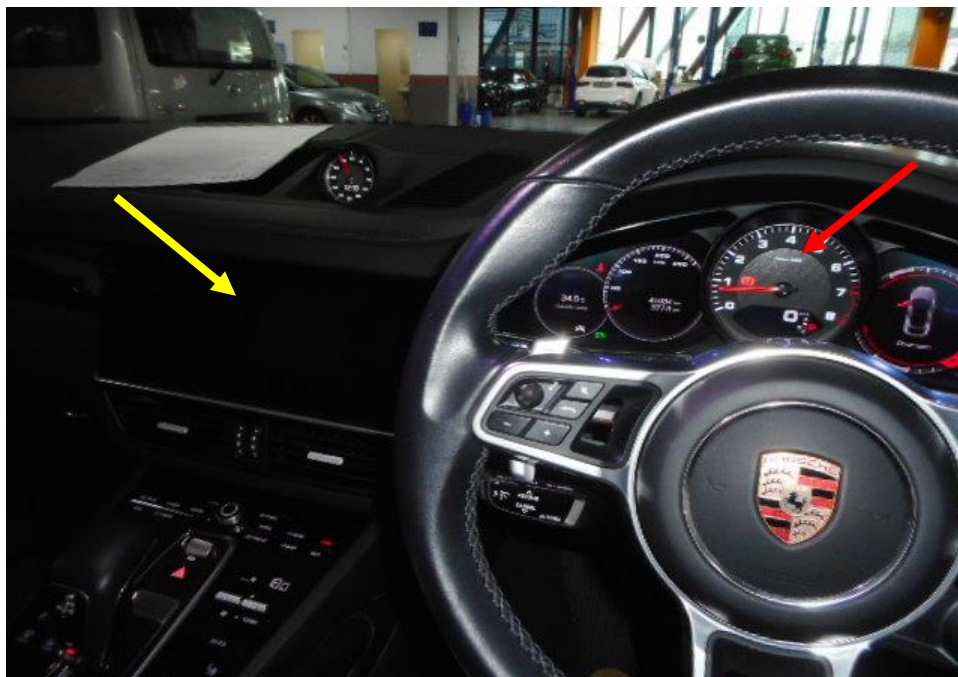
5. The complaint on the Insured Vehicle was noted be that the centre digital instrument display would not turn on. There is a recommendation by the workshop to replace the Infotainment head unit module. The vehicle was observed to be unaffected by any signs of accident.

Photo 5 shows the close up view of the vehicle instrument portion of the Insured Vehicle at the time of our inspection. The driver's instrument display (red arrowed) would remained on after the vehicle's engine is turned on as compared to the centre display panel which did not turn on at all (yellow arrow).

8. We did not find any evidence which had suggested that the cause of abnormalities to the Insured Vehicle was due to poor maintenance and/or recurring problem.
9. The recommendation to replace the Infotainment control module, capped at \$3,000 for claims is justifiable as all the relevant checks has been conducted.

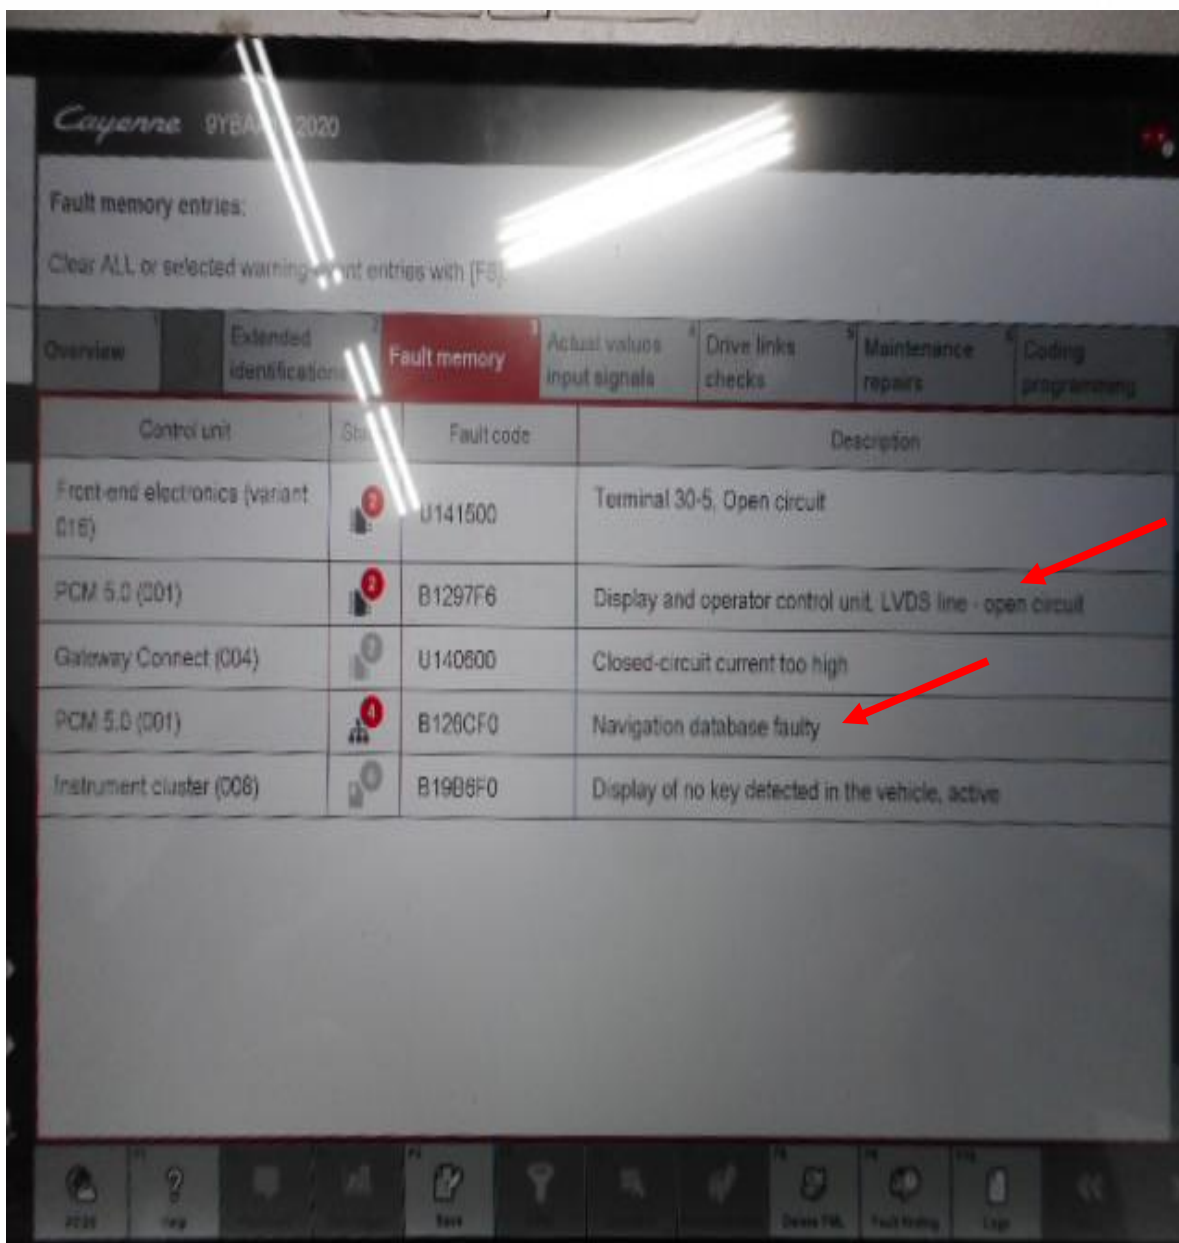
Photo 6 shows the conducted ECU diagnosis of the Insured Vehicle at the time of our inspection. There was a few electronic error which all pointed to the centre infotainment head unit cluster (arrowed) on the Insured Vehicle.
