Your Ref: TP/IP/14469/2022
Our Ref : CI/TPD22006179/P

15th November 2022

MECHANICAL INSPECTION REPORT OF PRIME MOVER, XD 4847S

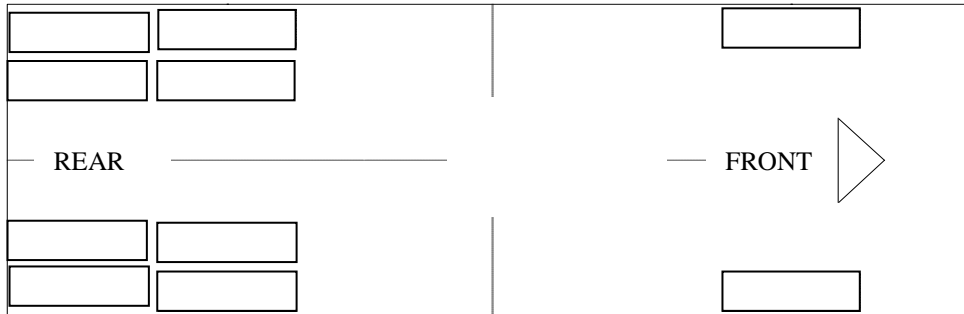
Prime Mover

Ling Long 295/80 R22.5 (5.3mm)

Ceirul 295/80 R22.5 (13.7mm)

Ling Long 295/80 R22.5 (9.1mm)

Annaite 295/80 R22.5 (5mm)

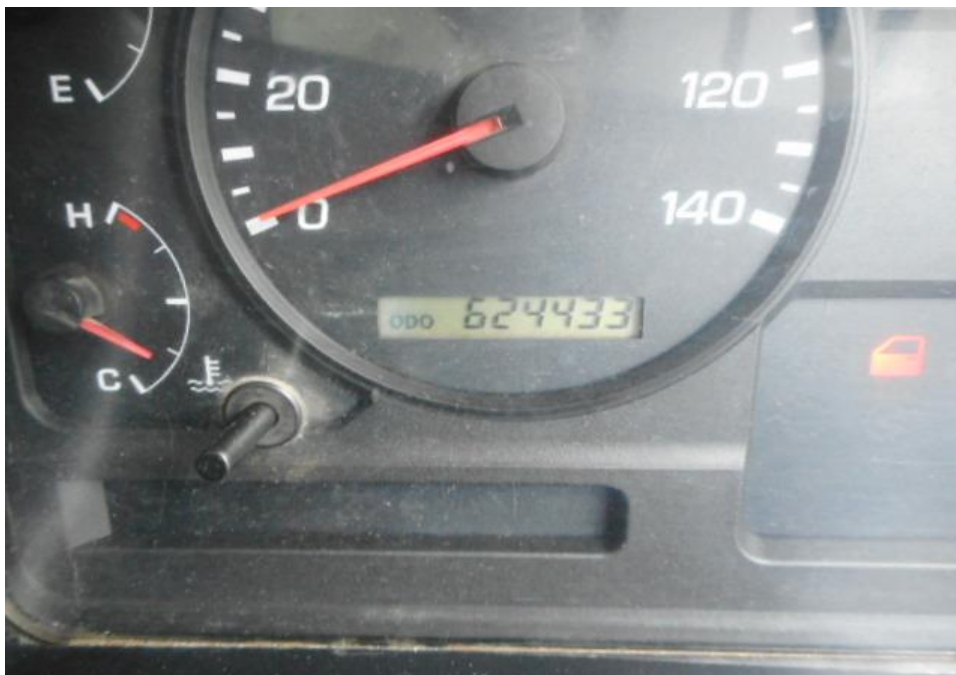
Photo 1 shows a general view of the instrument cluster of the Prime Mover at the time of my inspection. The mileage of the Prime Mover was 624,433km

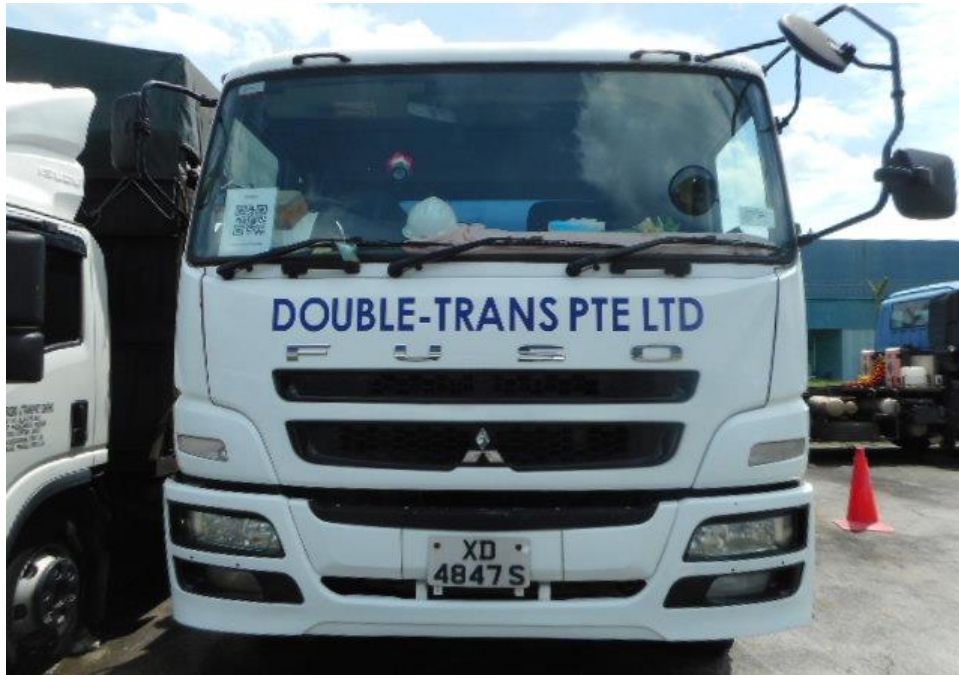
Photo 2 shows a general view of the front body of the Prime Mover at the time of my inspection. The Prime Mover was observed to be intact and unaffected by the accident.

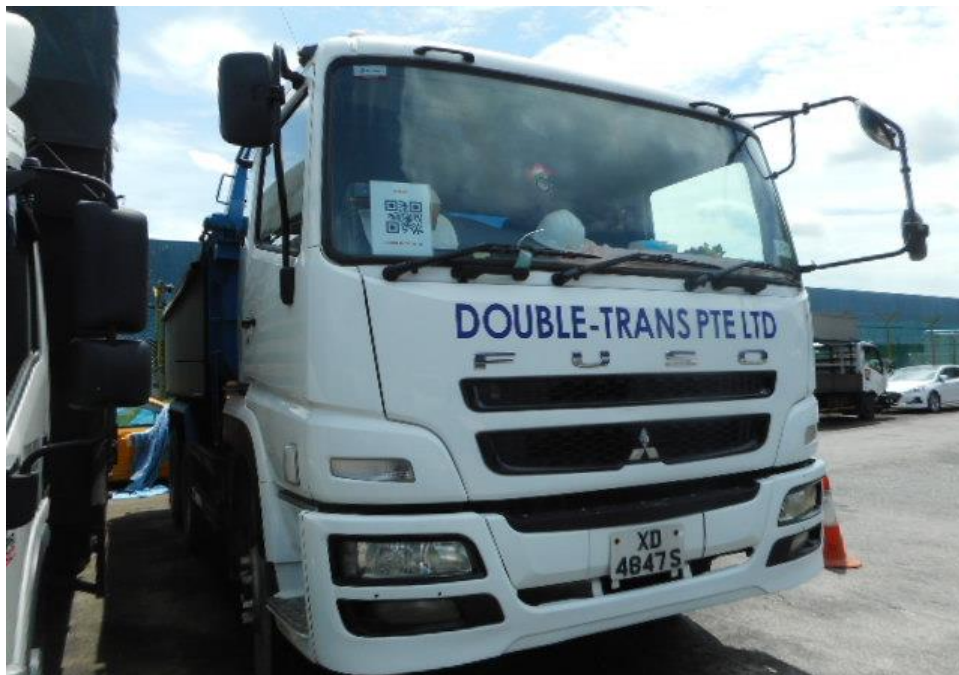
Photo 3 shows a general view of the front right body of the Prime Mover at the time of my inspection. The Prime Mover was observed to be intact and unaffected by the accident.

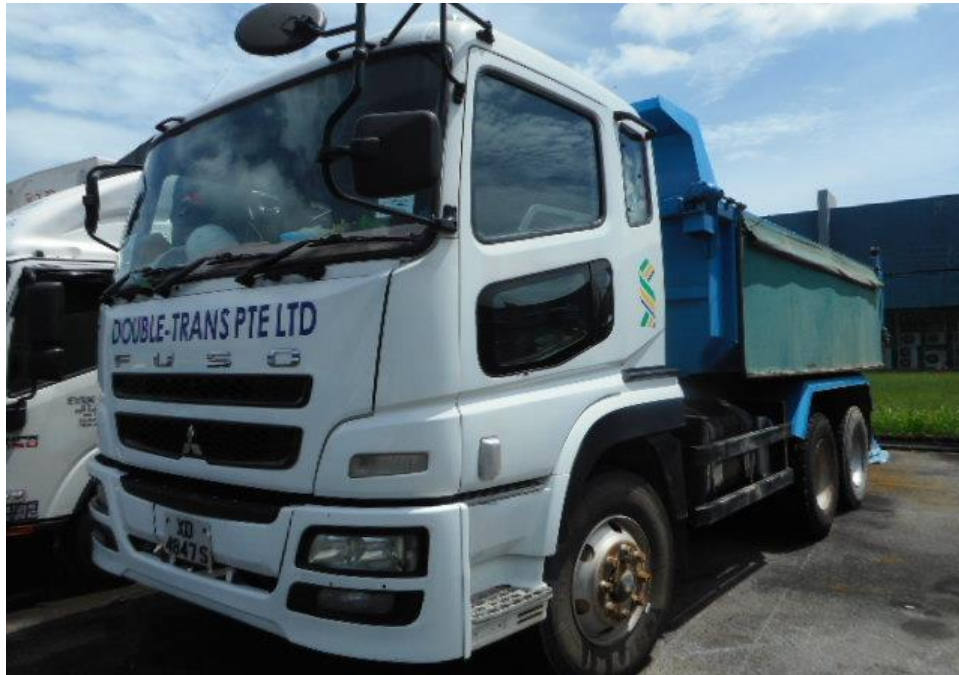
Photo 4 shows a general view of the front left body of the Prime Mover at the time of my inspection. The Prime Mover was observed to be intact and unaffected by the accident.

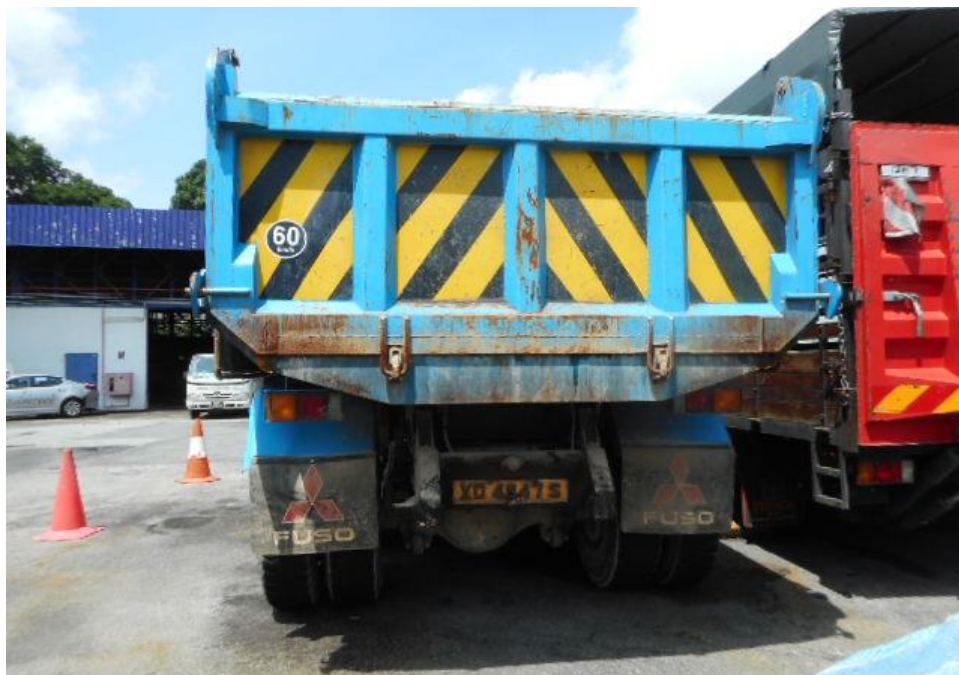
Photo 5 shows a general view of the Prime Mover's rear body at the time of my inspection. The Prime Mover was observed to be intact and unaffected by the accident.

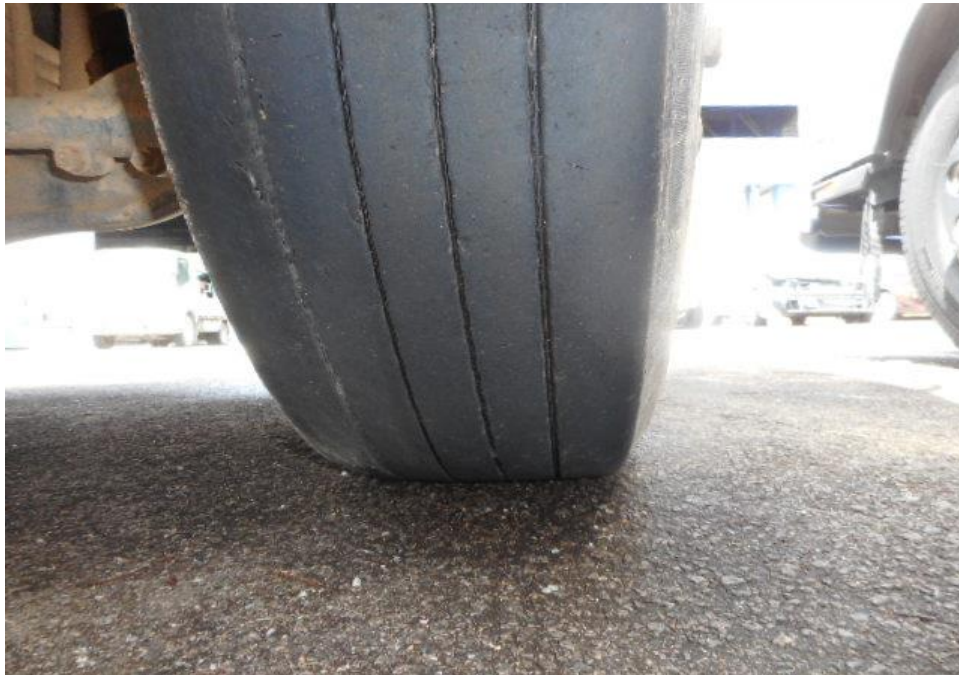
Photo 6 shows the condition of the front right tyre of the Prime Mover, which was observed to be in serviceable condition with remaining tread depth of approximately 5mm. The tyre, which was wrapped around standard steel wheel rim, was also observed to be sufficiently inflated for vehicular operation. There was no tear, cut or burst mark(s) on the outer and the inner sidewalls as well as across the tread of the 6 tyres that were fitted on the Prime Mover.

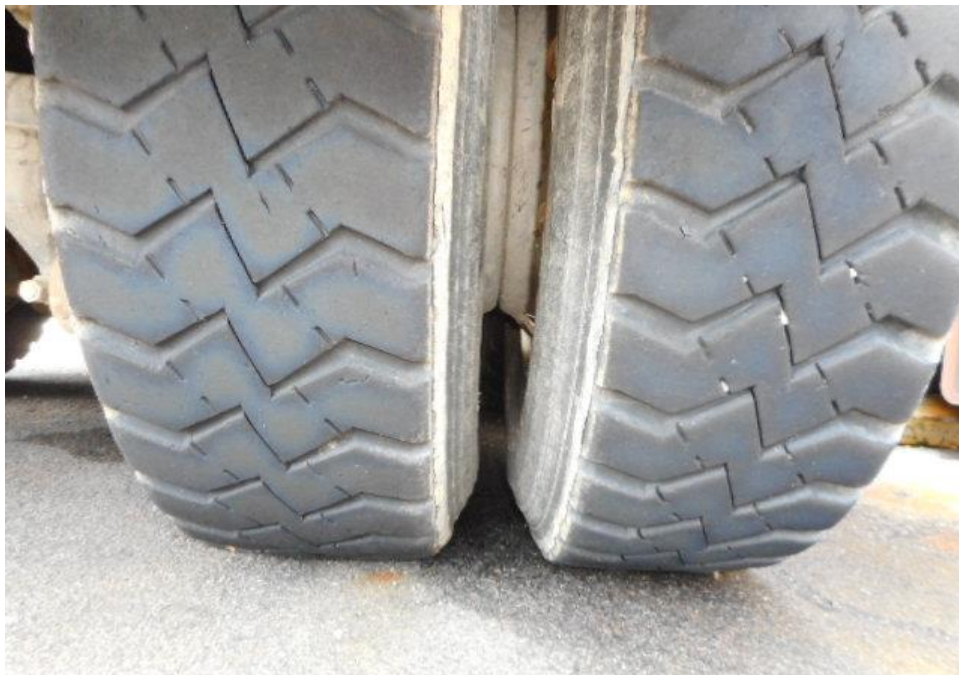
Photo 7 shows the condition of the rear right tyre of the Prime Mover, which was observed to be in serviceable condition with remaining tread depth of approximately 9.1mm. The tyre, which was wrapped around standard steel wheel rim, was also observed to be sufficiently inflated for vehicular operation.

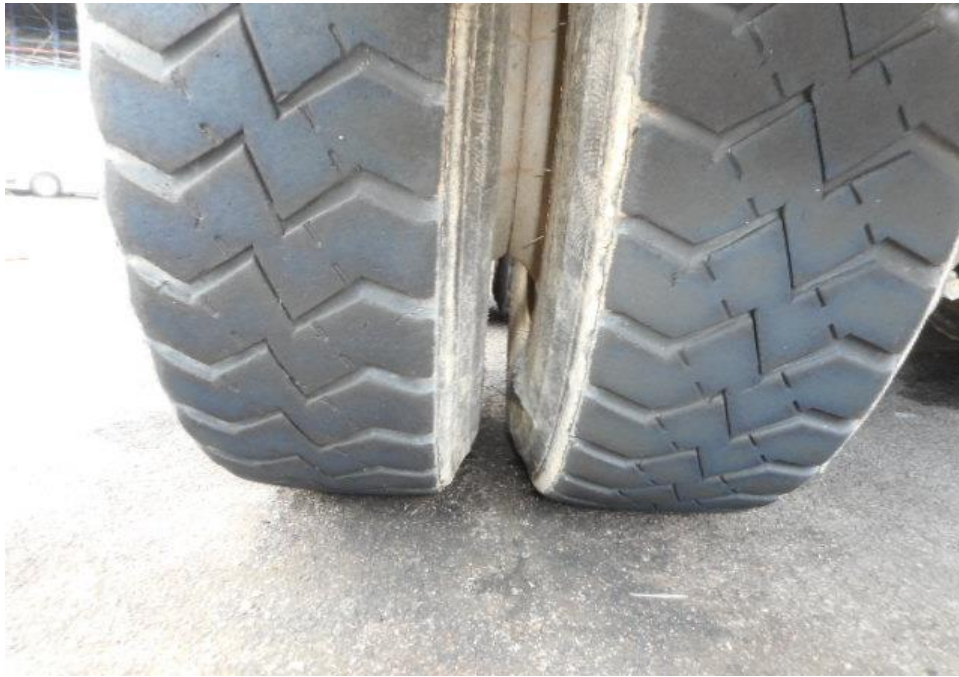
Photo 8 shows the condition of the rear left tyres of the Prime Mover, which was observed to be in serviceable condition with remaining tread depth of approximately 5.3mm. The tyres, which were wrapped around standard steel wheel rim, were also observed to be sufficiently inflated for vehicular operation. There was also no damage found on all 6 steel wheel rims of the Prime Mover.

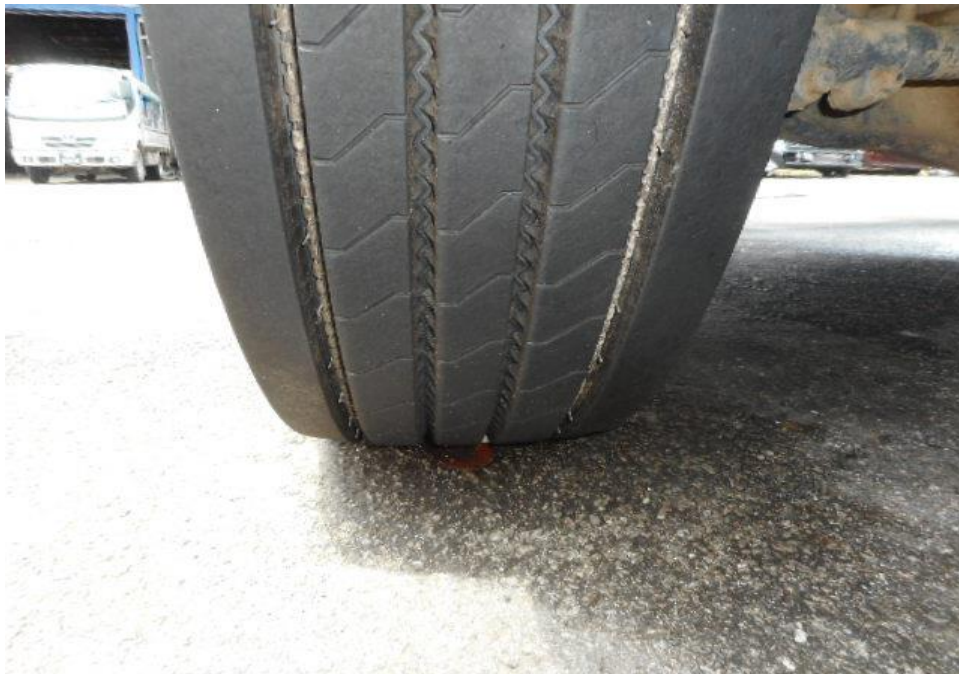
Photo 9 shows the condition of the front left tyres of the Prime Mover, which were observed to be in serviceable condition with remaining tread depth of approximately 13.7mm. There was also no tear, cut or burst mark(s) on the outer and the inner sidewalls as well as across the tread of the 6 tyres that were fitted on the Prime Mover.

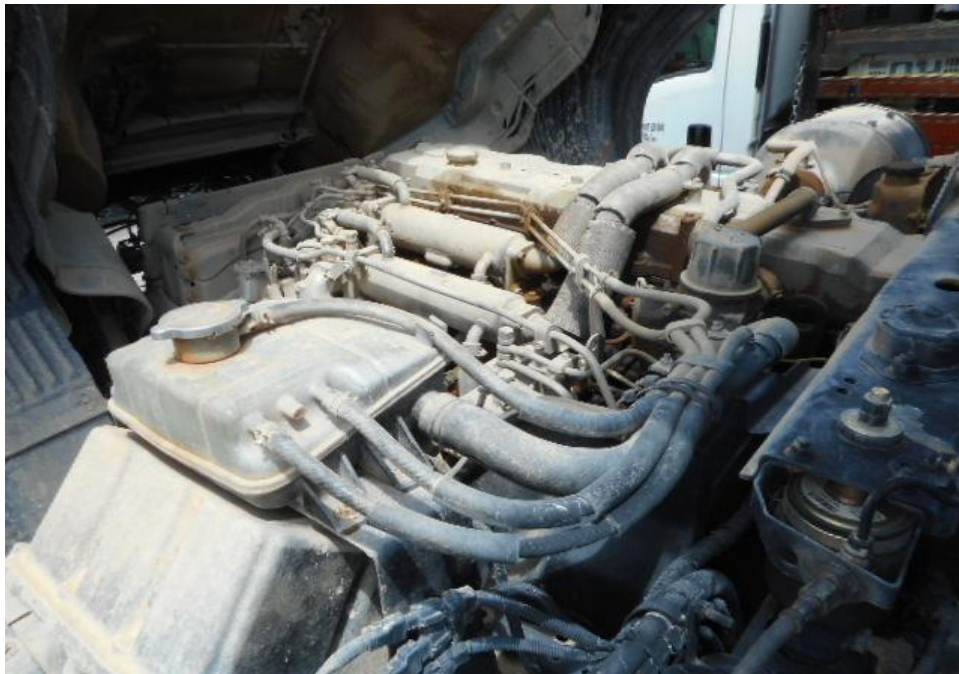
Photo 10 shows a general view of the Prime Mover's engine compartment, which was accessed by lifting the front cabin of the Prime Mover. The various parts and components inside the engine compartment were unaffected by the accident. There was also no sign(s) or indication(s) of fresh fluid leakage and/or fluid stain within the engine compartment

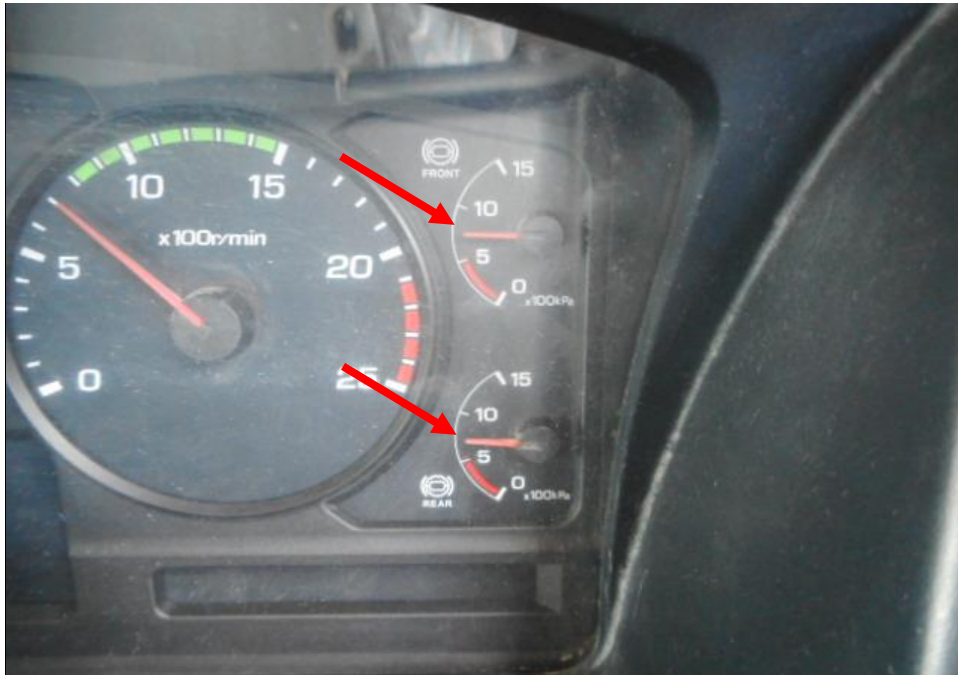
Photo 11 shows the air in the air brake cylinders of the Prime Mover at the time of my inspection. The air in the cylinder was observed to be of sufficient level & serviceable at the time of the accident.

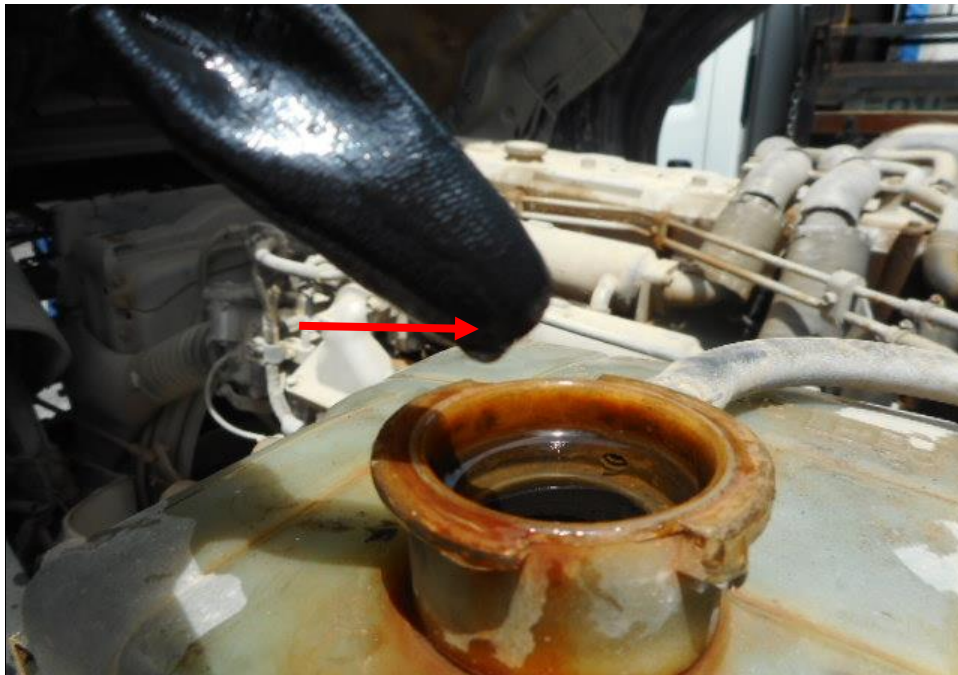
Photo 12 shows the engine coolant reservoir of the Prime Mover at the time of my inspection. The engine coolant was observed to be of sufficient level (arrowed) and without any visible contamination.

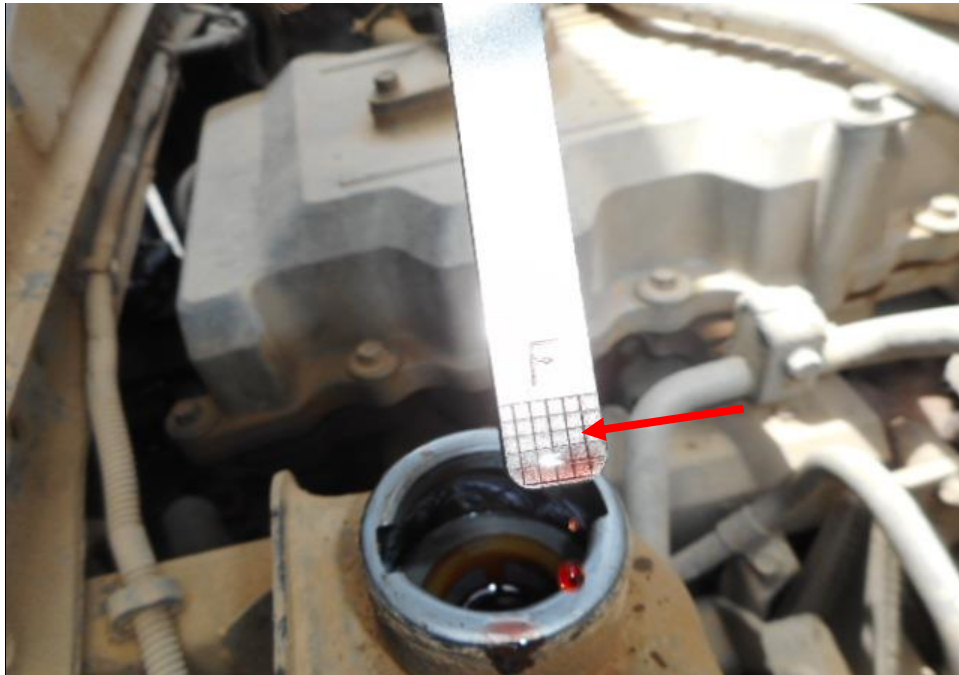
Photo 13 shows the power steering fluid reservoir of the Prime Mover at the time of my inspection. The power steering fluid was observed to be of sufficient level (arrowed) and without any visible contamination.

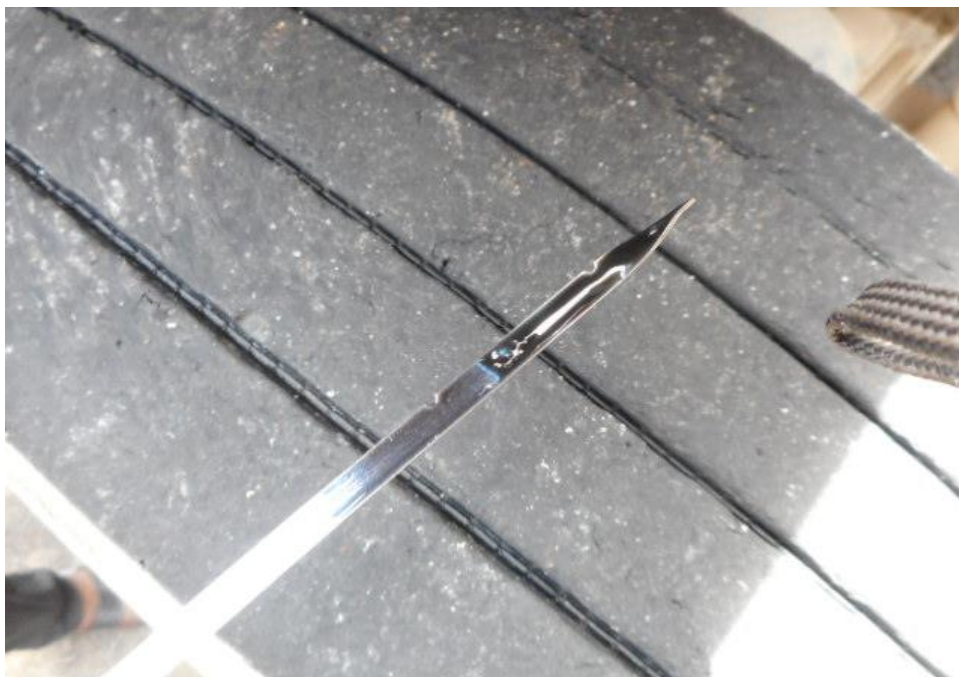
Photo 14 shows the engine oil dip stick of the Prime Mover at the time of my inspection. The engine oil was observed to be of insufficient level at the time of our inspection.

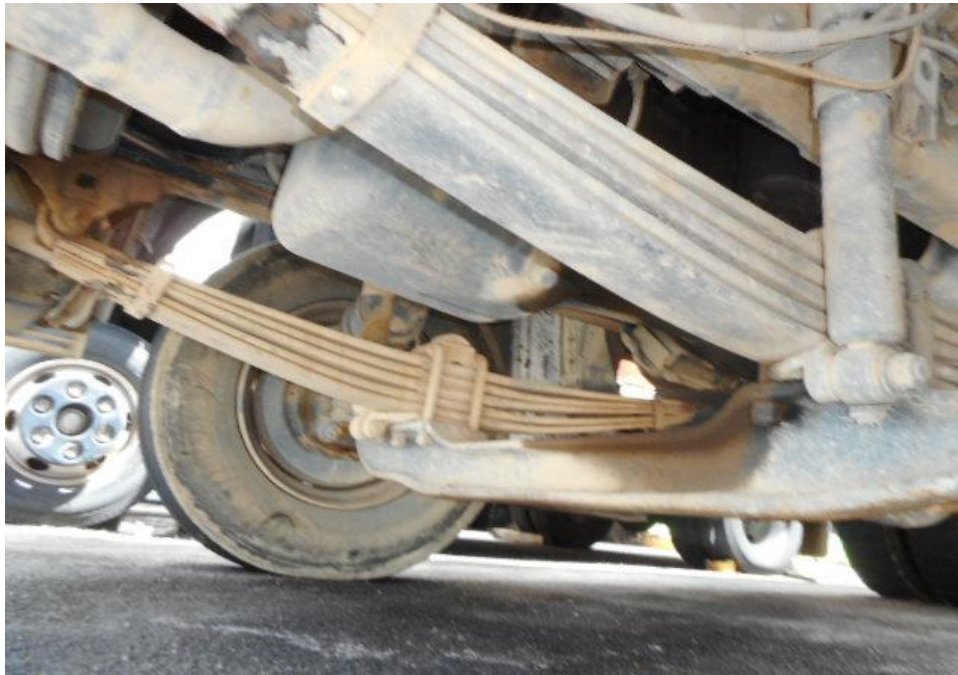
Photo 15 shows the undercarriage of the Prime Mover, at the area where the engine housing located. I did not find any sign(s) or indication(s) of fluid leak, however old fluid stain(s) was observed on the underside of the Prime Mover.

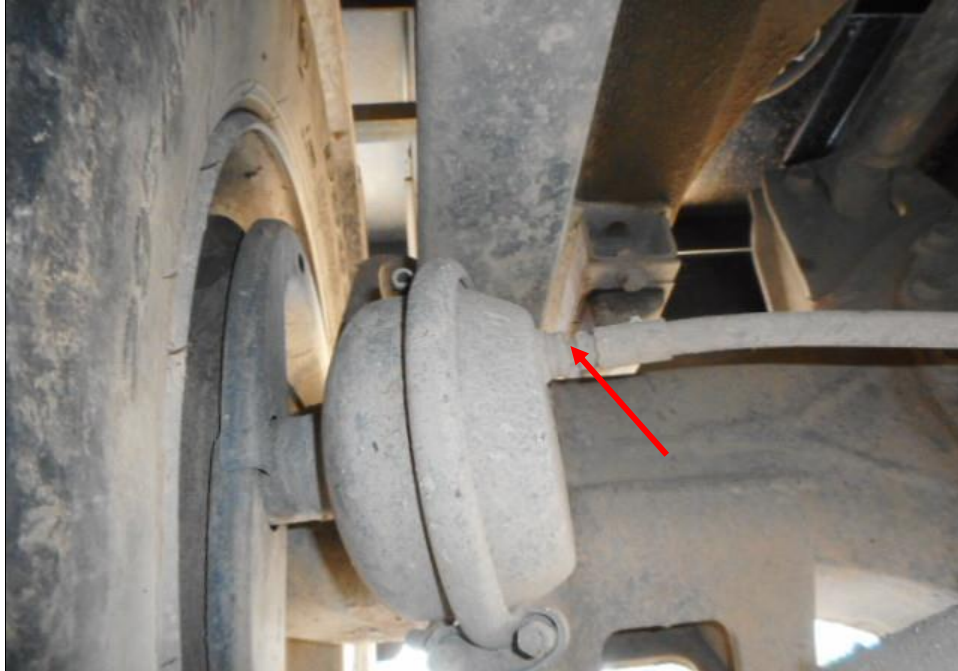
Photo 16 shows the brake pipe (arrowed) at the rear right wheel of the Prime Mover. I did not observe any leakage of brake fluid at the time of my inspection of the Prime Mover. My static tests of the Prime Mover's braking system, along with my visual examination of the various mechanical components in the braking system, had indicated that there was no internal leakage of pressure/vacuum. Hence the braking system of the Prime Mover was likely to be in serviceable condition at the material time of accident.

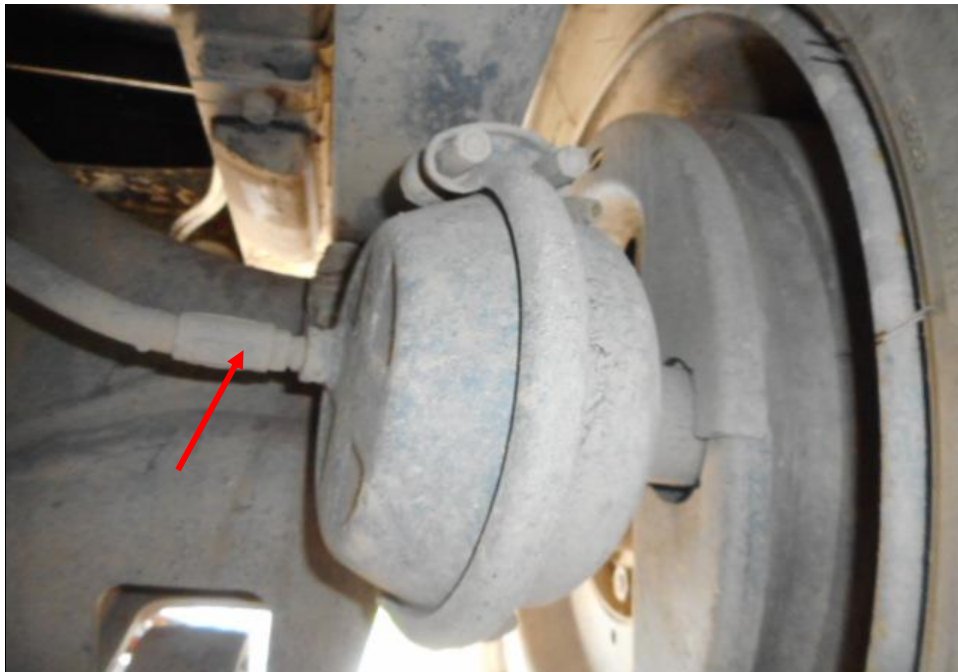
Photo 17 shows the brake pipe (arrowed) at the rear left wheel of the Prime Mover. I did not observe any leakage of brake fluid at the time of my inspection of the Prime Mover. My static tests of the Prime Mover's braking system, along with my visual examination of the various mechanical components in the braking system, had indicated that there was no internal leakage of pressure/vacuum. Hence the braking system of the Prime Mover was likely to be in serviceable condition at the material time of accident.

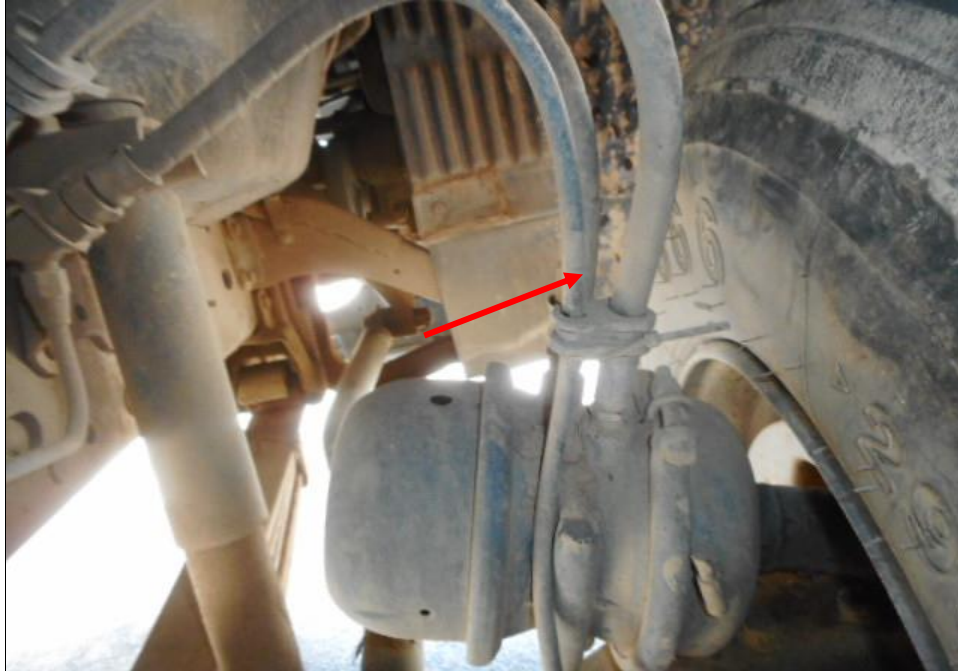
Photo 18 shows the brake pipe (arrowed) at the front right wheel of the Prime Mover. I did not observe any leakage of brake fluid at the time of my inspection of the Prime Mover. My static tests of the Prime Mover's braking system, along with my visual examination of the various mechanical components in the braking system, had indicated that there was no internal leakage of pressure/vacuum. Hence the braking system of the Prime Mover was likely to be in serviceable condition at the material time of accident.

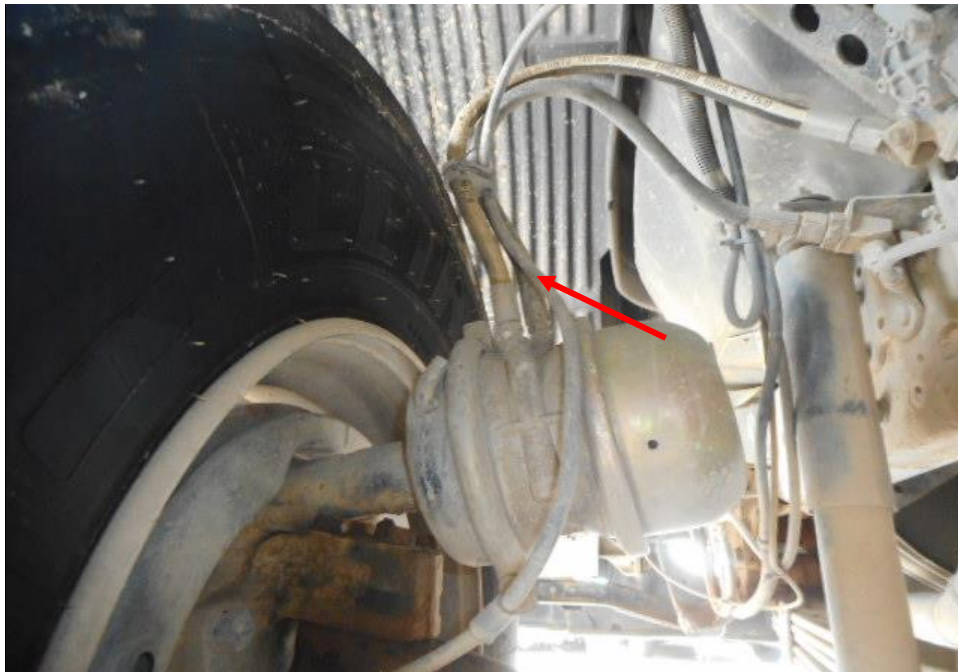
Photo 19 shows the brake pipe (arrowed) at the front left wheel of the Prime Mover. I did not observe any leakage of brake fluid at the time of my inspection of the Prime Mover. My static tests of the Prime Mover's braking system, along with my visual examination of the various mechanical components in the braking system had indicated that there was no internal leakage of pressure/vacuum. Hence the braking system of the Prime Mover was likely to be in serviceable condition at the material time of accident.

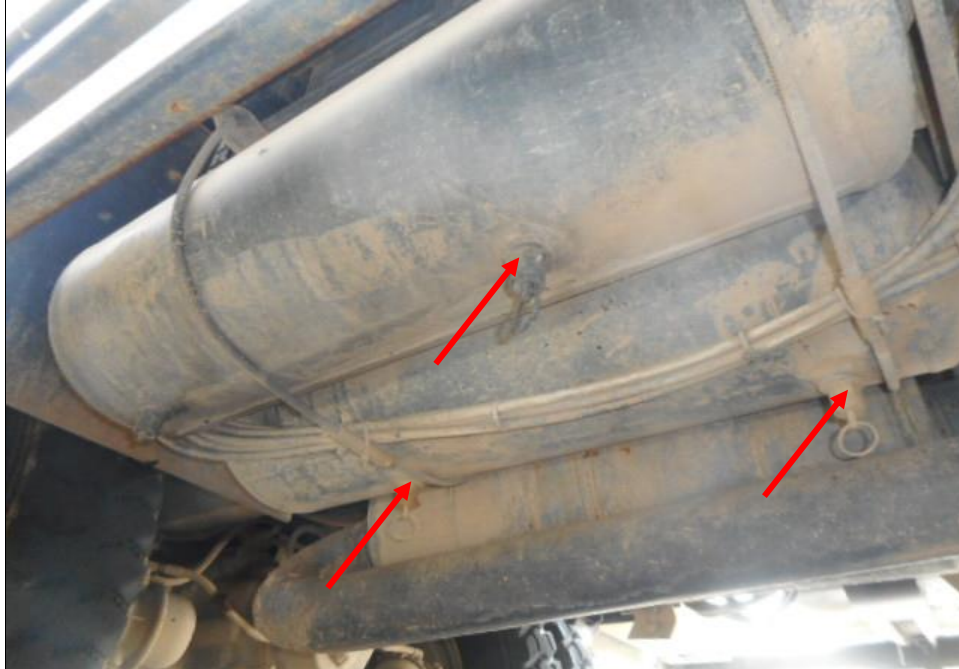
Photo 20 shows the air brake cylinders (arrowed) at the undercarriage of the Prime Mover. I did not observe any leakage of air brake fluid at the time of my inspection of the Prime Mover. My static tests of the Prime Mover's braking system, along with my visual examination of the various mechanical components in the braking system had indicated that there was no internal leakage of pressure/vacuum. Hence the braking system of the Prime Mover was likely to be in serviceable condition at the material time of accident.

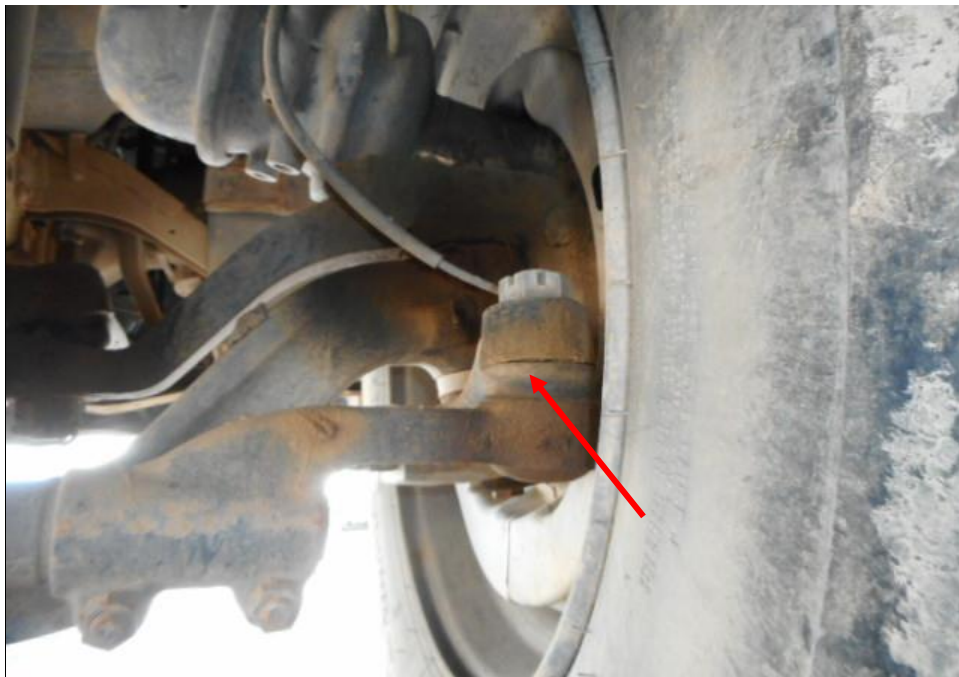
Photo 21 shows the various undercarriage components at the front right wheel of the Prime Mover, in particular the steering tie rod end (arrowed). The various steering components were all found to be intact, suggesting that the steering system of the Prime Mover was likely to be in serviceable condition at the material time of accident. There was also no sign of fluid stain(s) observed on the various undercarriage components.

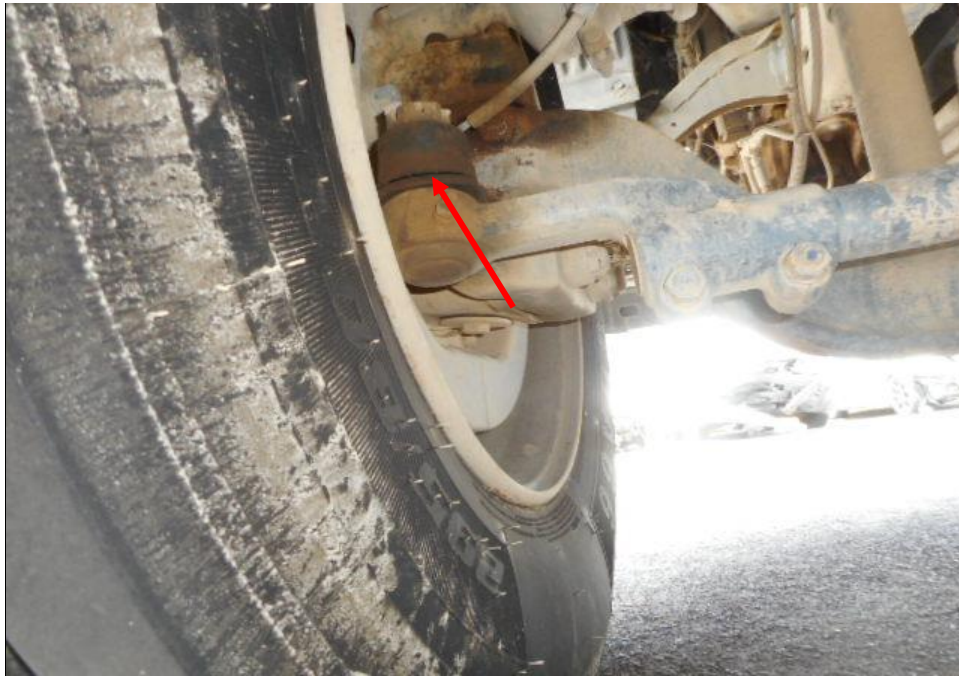
Photo 22 shows the various undercarriage components at the front left wheel of the Prime Mover, in particular the steering tie rod end (arrowed). The various undercarriage components of the Prime Mover were all found to be intact without any visible damage. There was also no sign of fluid stain(s) observed on the various undercarriage components.

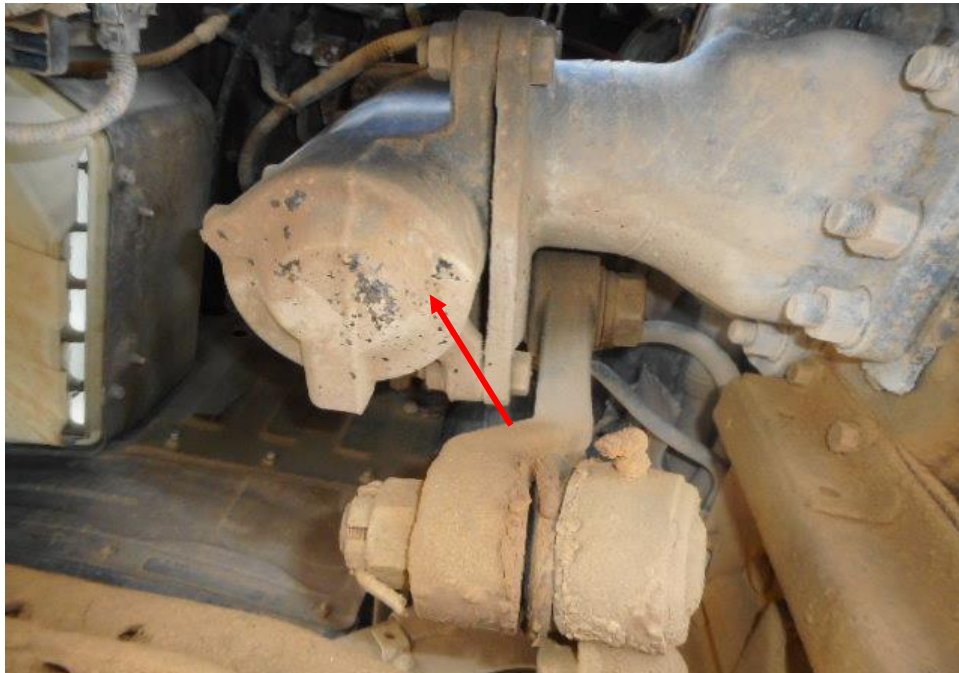
Photo 23 shows the steering box component (arrowed) at the undercarriage of the Prime Mover was found to be intact without any visible damage. There was also no sign of fluid stain(s) observed on the various undercarriage components.

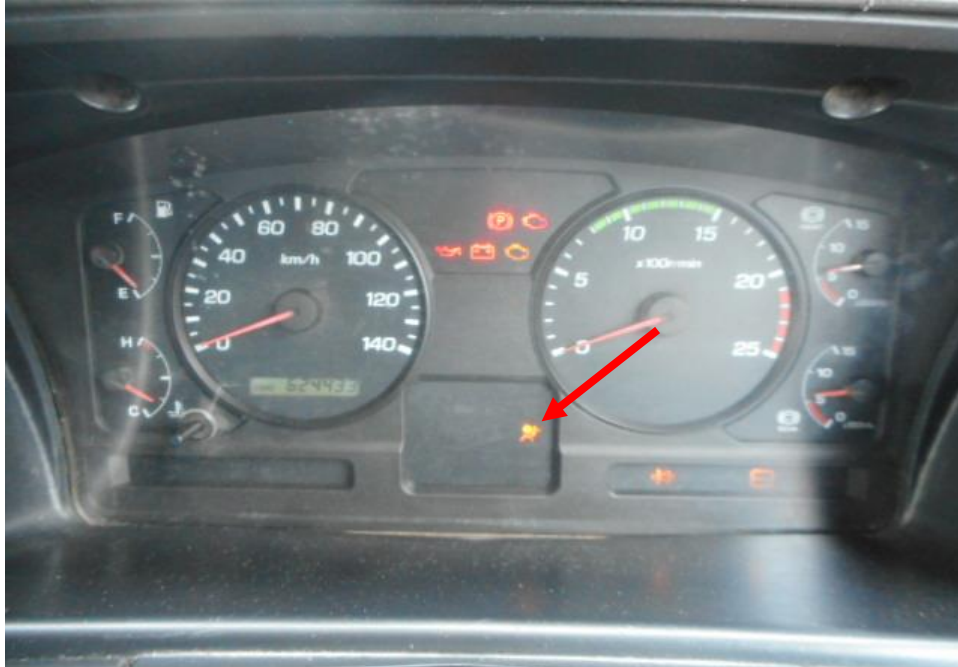
Photo 25 shows the warning light for Supplemental Restraint System (SRS) (arrowed) appearing on the instrument panel of the Prime Mover during the self-test of its various electronic operating systems when its engine was cranked.

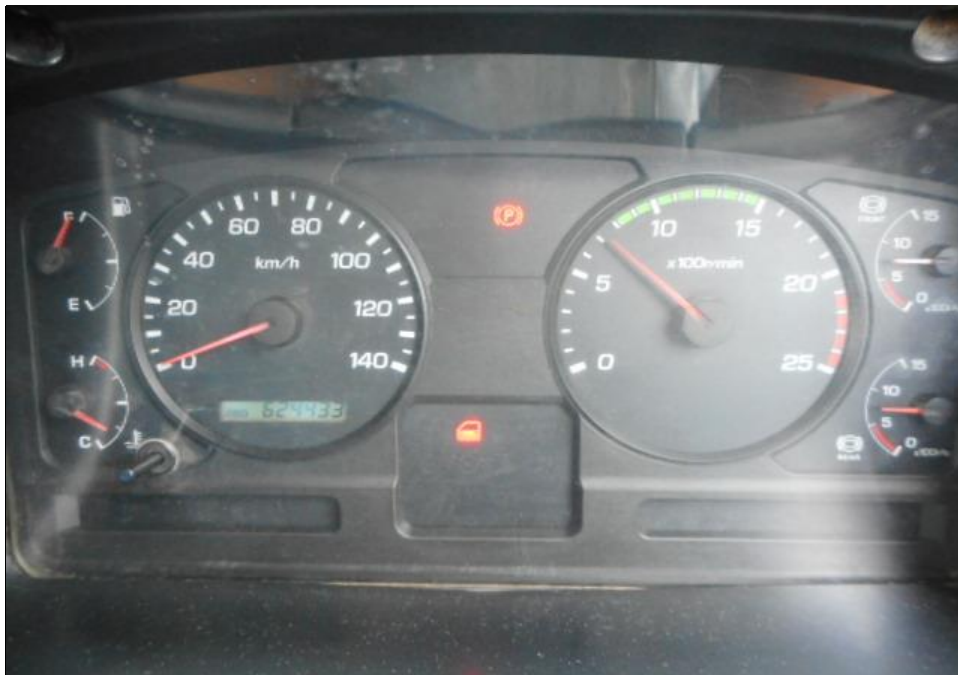
Photo 26 shows the Supplemental Restraint System (SRS) warning lights had went off on the instrument panel of the Prime Mover after the engine was cranked. This would suggest that there was no abnormality to the electronic operating system of the Prime Mover, like the SRS, and etc.
