You're Ref: TP/IP/12302/2022  
Our Ref: CI/TPD22006181/P

6<sup>th</sup> July 2022

**MECHANICAL INSPECTION REPORT OF MOTOR CAR SJN 5560A**

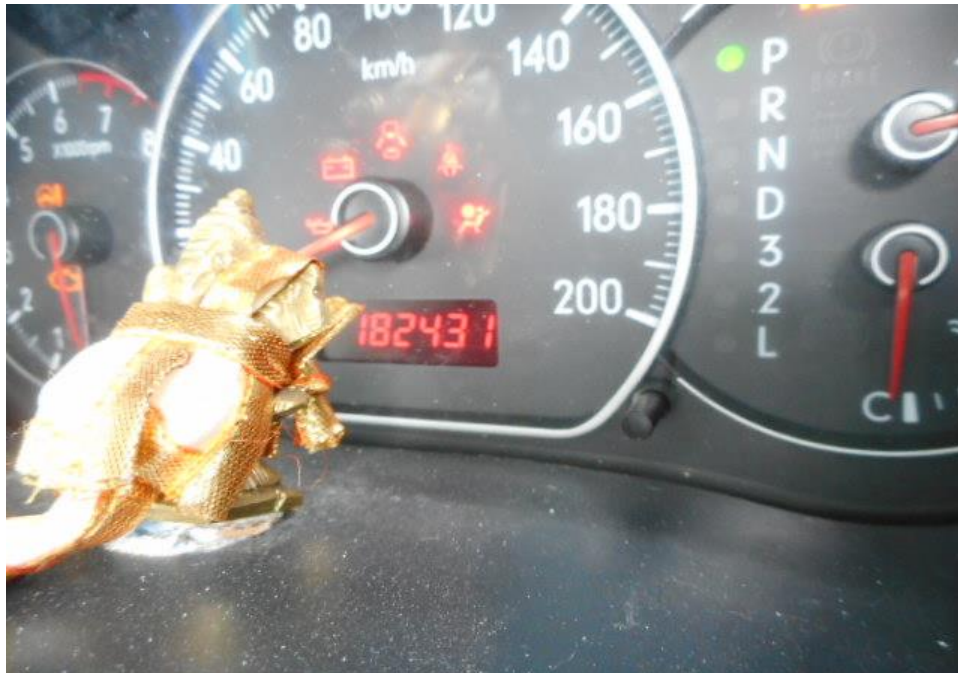
**Photo 1** shows the mileage of the Motor Car at the time of my inspection. The mileage observed was 182,431km.

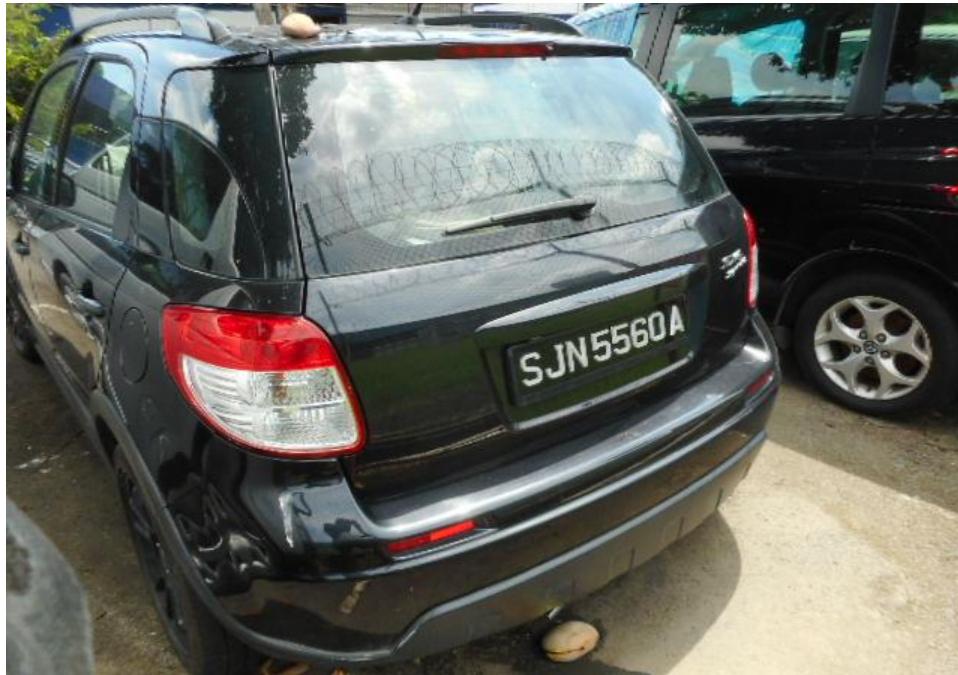
**Photo 2** shows the general view of the Motor Car's rear body at the time of my inspection. The rear portion of the Motor Car was observed to have been unaffected by the accident.

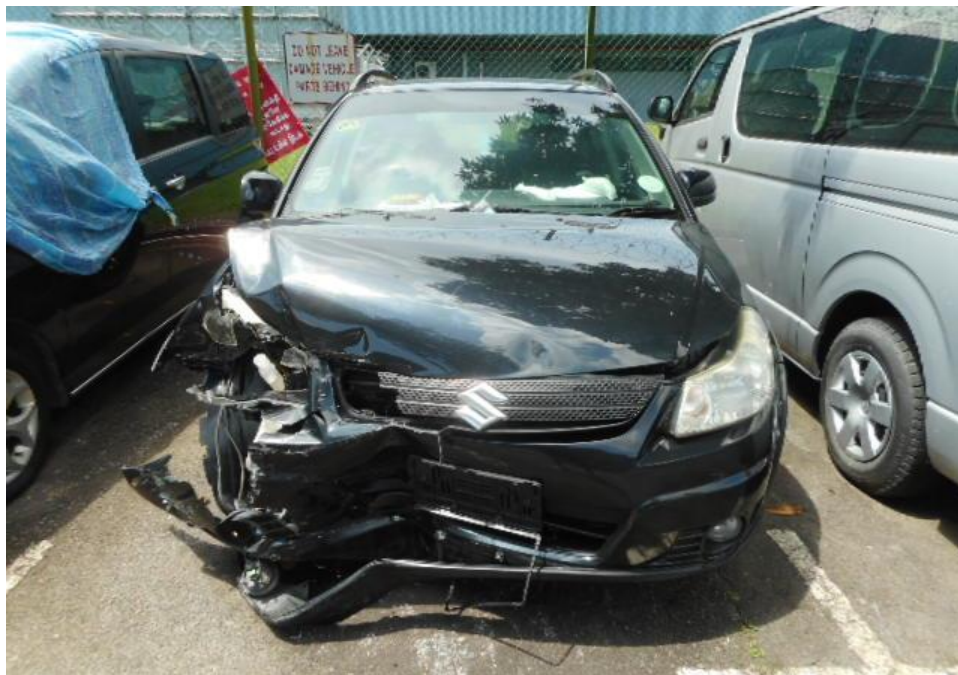
**Photo 3** shows a general view of the Motor Car's front body at the time of my inspection. The front portion observed to have sustained damage. Its front bonnet, front right fender, front right headlamp and its front bumper was the body parts as well as its various engine components were also damaged as a result of the accident. The airbag of the Supplemental Restraint System (SRS) was activated as a result of the accident.

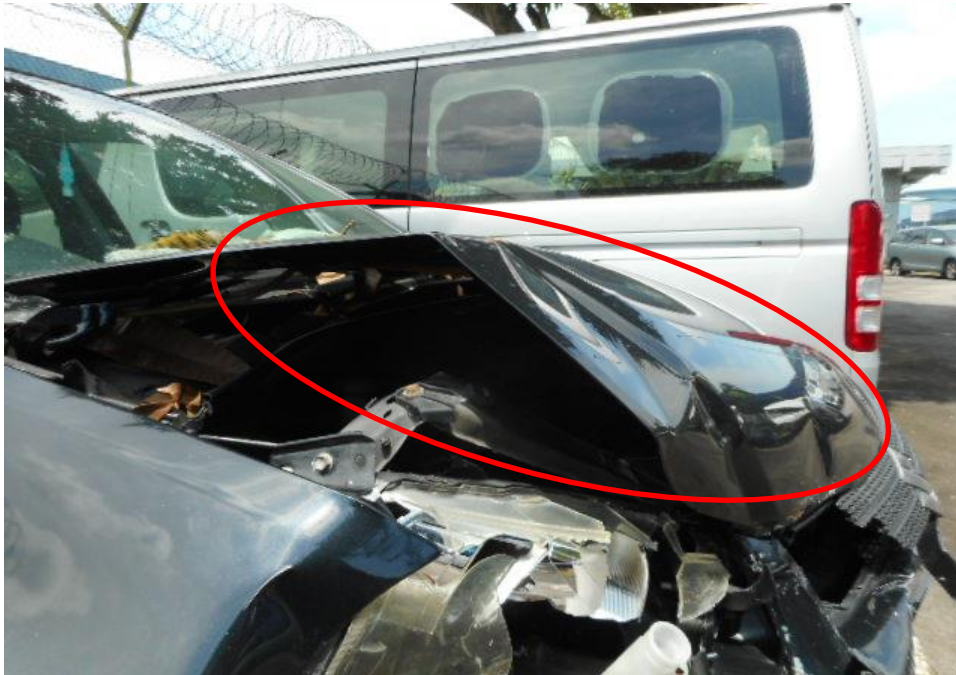
**Photo 4** shows a close up view of the Motor Car's front body at the time of my inspection. The Motor Car was observed to have sustained damage at its front portion. Its front bonnet (circled) was the body part that were damaged as a result of the accident.

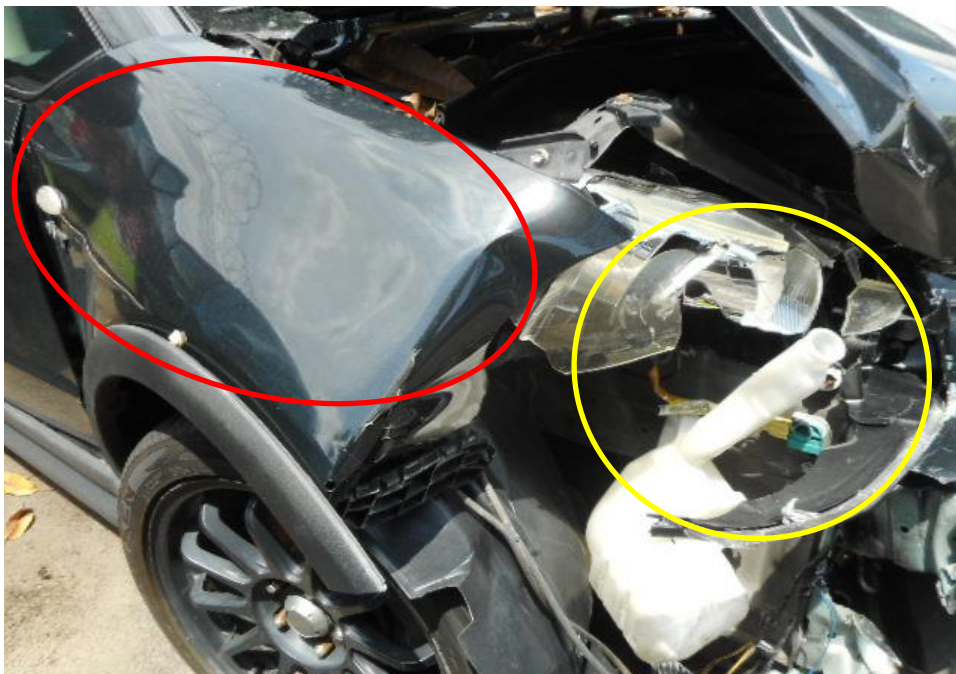
**Photo 5** shows a close up view of the Motor Car's front body at the time of my inspection. The Motor Car was observed to have sustained damage at its front portion. Its front right fender (red circle) and front right headlamp (yellow circle) was the body part that were damaged as a result of the accident.

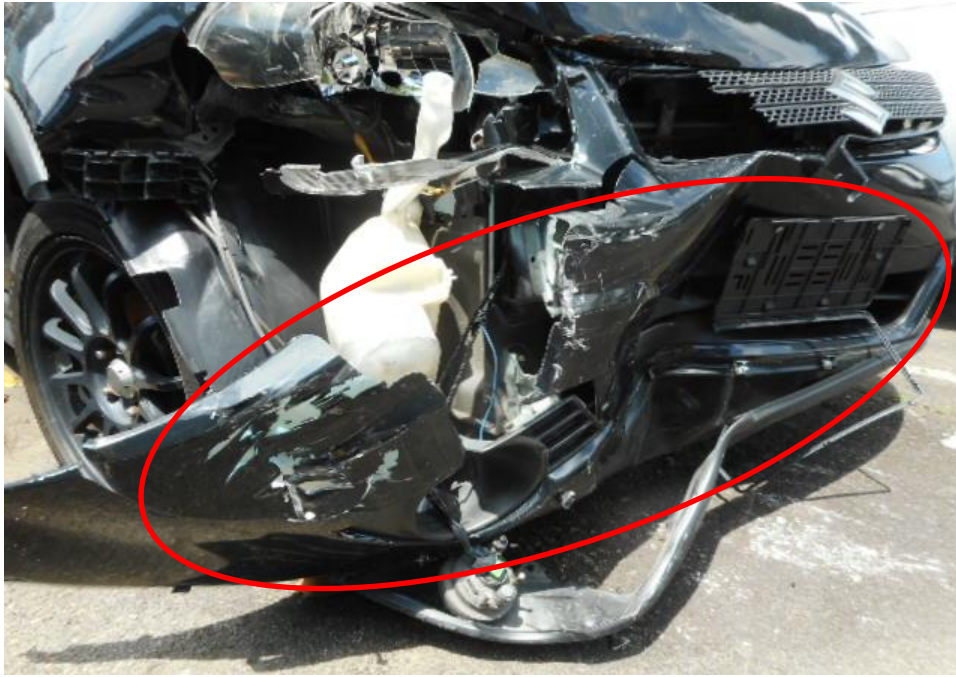
**Photo 6** shows a close up view of the Motor Car's front body at the time of my inspection. The Motor Car was observed to have sustained damage at its front portion. Its front bumper (circled) was the body part that were damaged as a result of the accident.

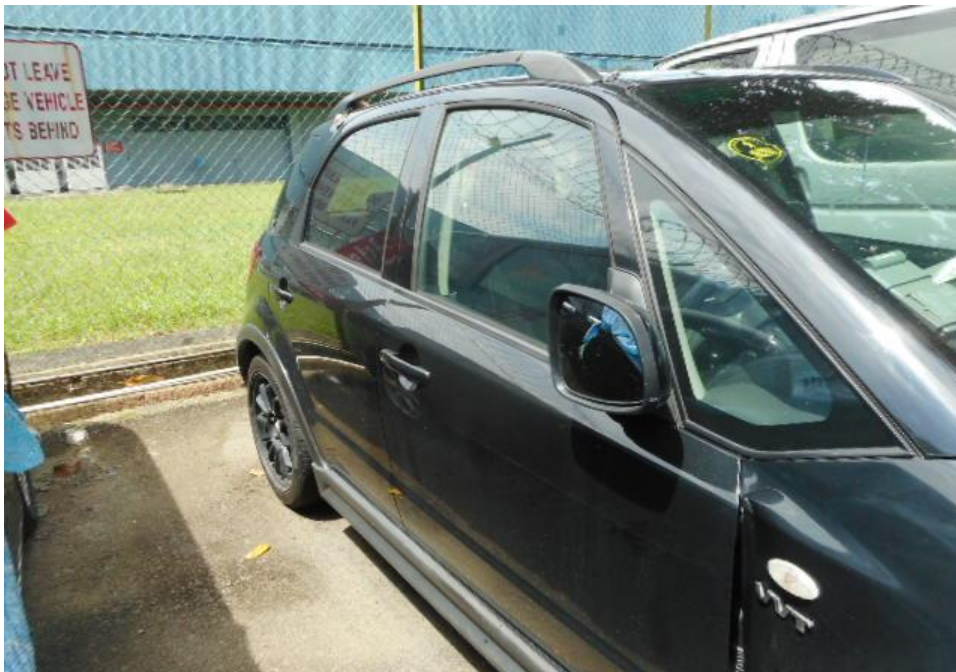
**Photo 7** shows a general view of the Motor Car's right body at the time of my inspection. The right portion of the Motor Car was observed to have been unaffected by the accident.

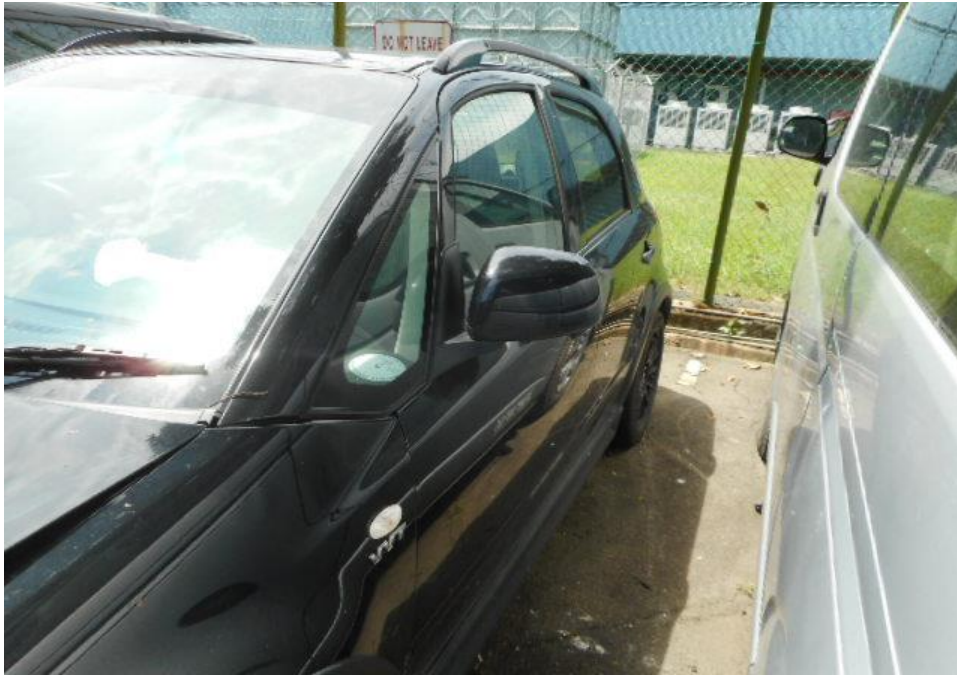
**Photo 8** shows a general view of the Motor Car's left body at the time of my inspection. The right portion of the Motor Car was observed to have been unaffected by the accident.

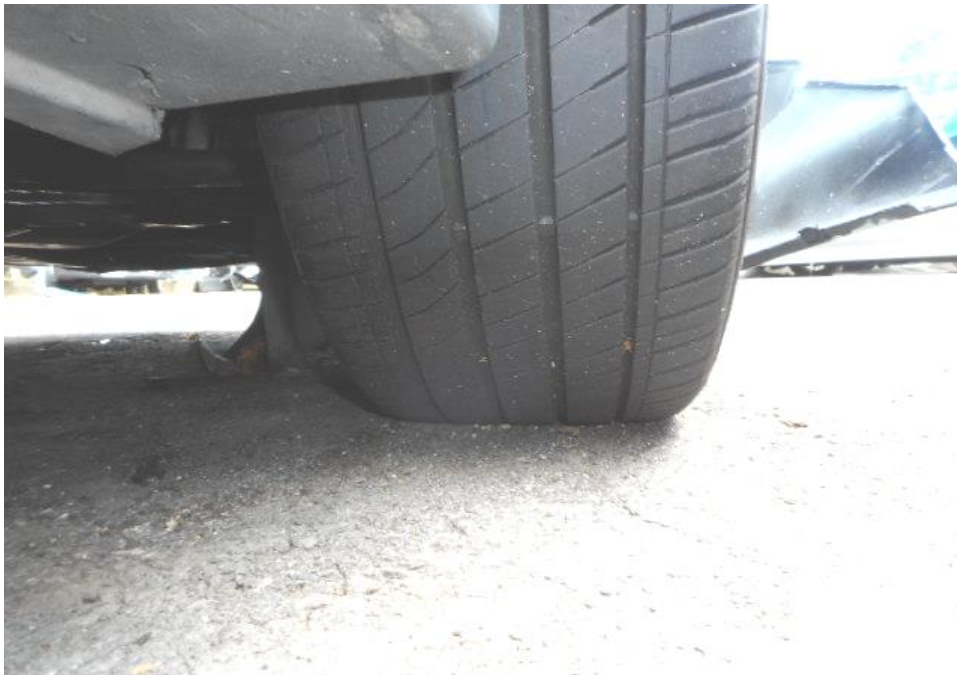
**Photo 9** shows the condition of the front right tyre of the Motor Car, which was observed to be in serviceable condition with remaining tread depth of approximately 5.3mm. The tyre was sufficiently inflated for vehicular operation with no tear, cut or burst mark(s) on the outer and the inner sidewalls as well as across the tread. The 4 tyres of the Motor Car were wrapped around standard steel wheel rims without any damage.

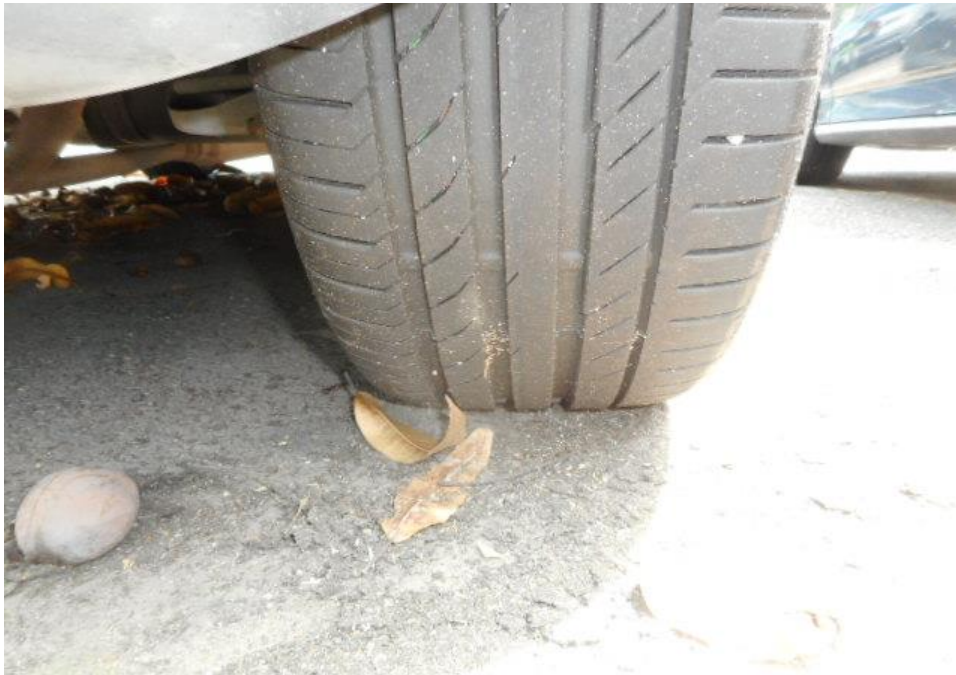
**Photo 10** shows the condition of the rear right tyre of the Motor Car, which was observed to be in serviceable condition with remaining tread depth of approximately 6.4mm. The tyre was also observed to be sufficiently inflated for vehicular operation with no tear, cut or burst mark(s).

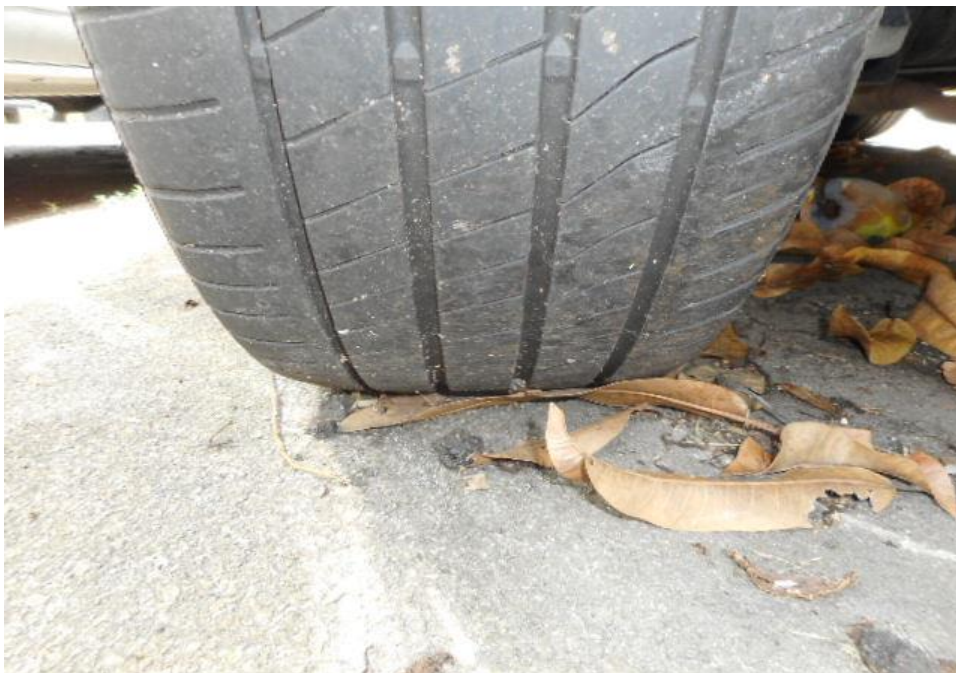
**Photo 11** shows the condition of the rear left tyre of the Motor Car, which was observed to be in serviceable condition with remaining tread depth of approximately 4.7mm. The tyre, which was wrapped around steel wheel rim, was also observed to be sufficiently inflated for vehicular operation. The 4 tyres of the Motor Car were wrapped around standard steel wheel rims.

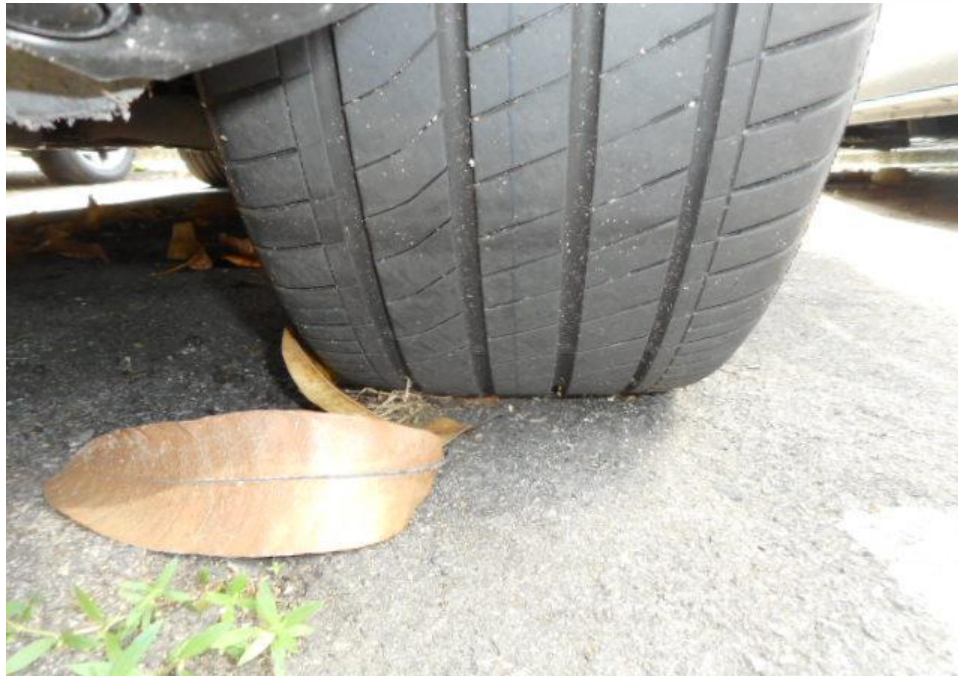
**Photo 12** shows the condition of the front left tyre of the Motor Car, which was observed to be in serviceable condition with remaining tread depth of approximately 5.1mm. There was also no tear, cut or burst mark(s) on the outer and the inner sidewalls as well as across the tread of the Motor Car's 4 tyres.

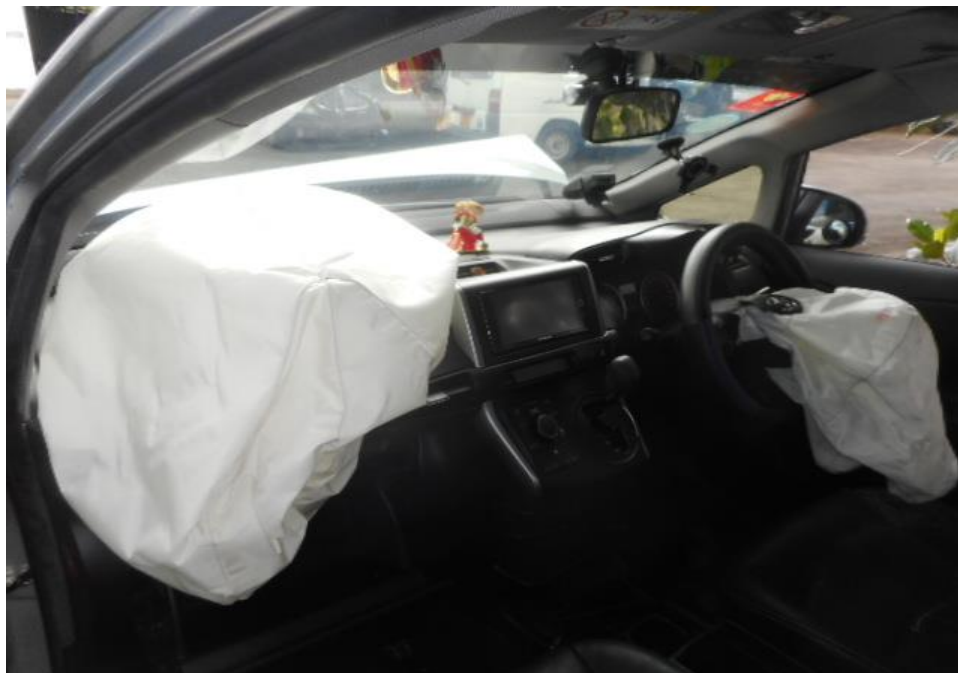
**Photo 13** shows the deployment of the Supplemental Restraint System (SRS) airbag in the Motor Car as a result of the accident.

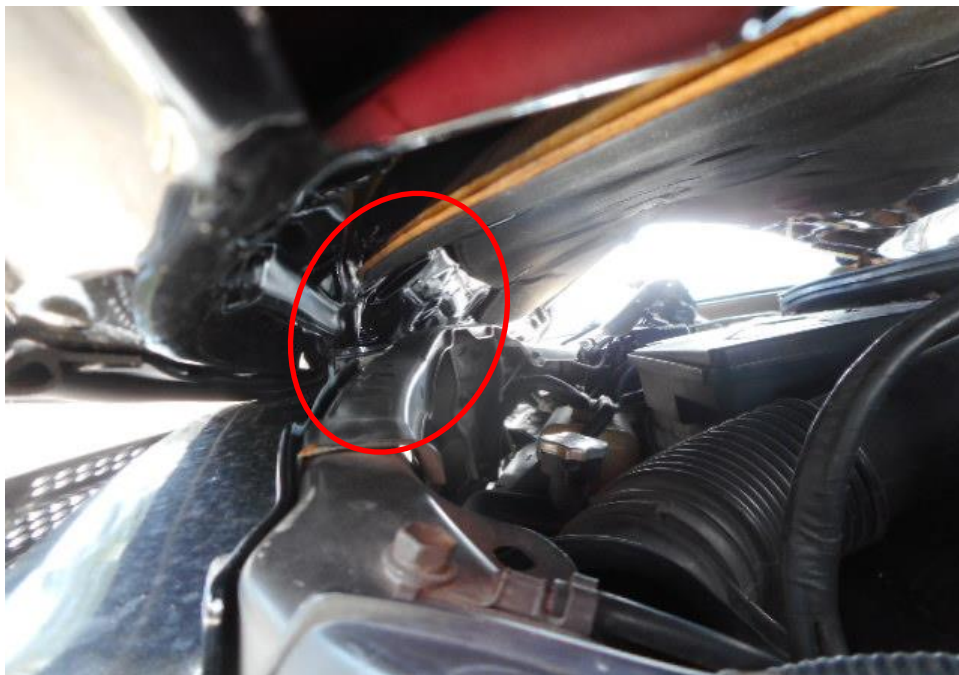
8. We were unable to raise the front bonnet of the Motor car to conduct the examination of the Motor Car's engine compartment because the damage caused by the accident had resulted in the damages to the lock mechanism of the bonnet and the structure of the engine compartment. (Unable to open).
9. However, we were able to examine the brake fluid and its brake fluid reservoir were found to be of sufficient level for operating purposes. Visually, there was also no contamination found to these fluids.
10. My subsequent checks on the underside of the Motor Car also revealed no sign(s) or indication(s) of fluid leak and/or fluid stain(s). Visually, the various undercarriage components of the Motor Car were all observed to be intact and without any visible damage. See photo 14 – 16 below.

**Photo 14** shows a close up view of the damaged front bonnet lock mechanism (circled) and the structure of the engine compartment of the Motor Car at the time of my inspection resulting it unable to open a result of the accident. (Unable to open)

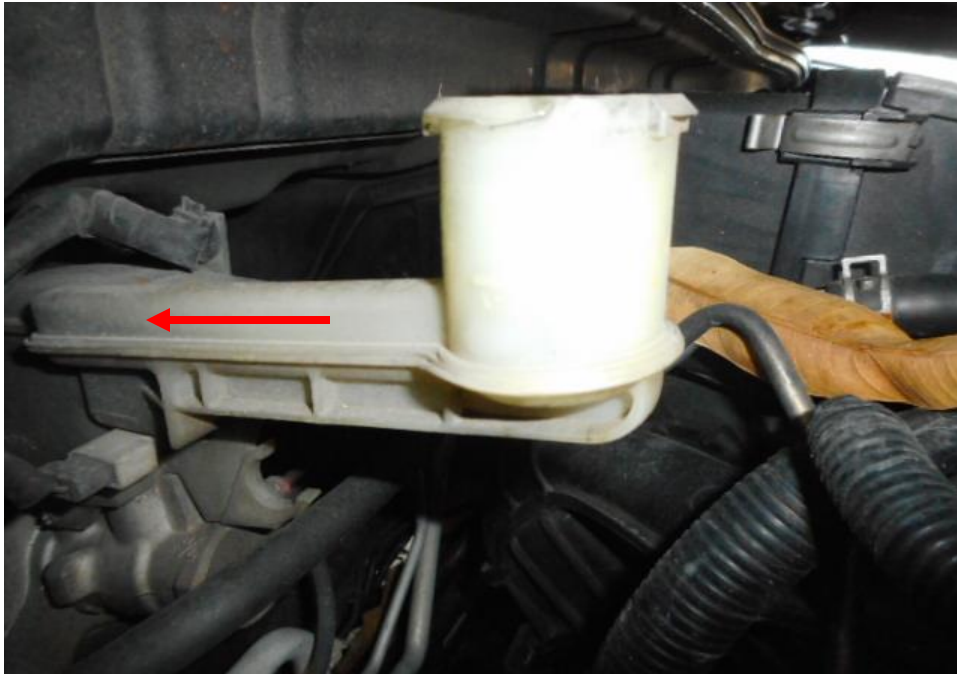
**Photo 15** shows the brake fluid reservoir of the Motor Car at the time of my inspection. The brake fluid was observed to be of sufficient level (arrowed) and without any visible contamination.

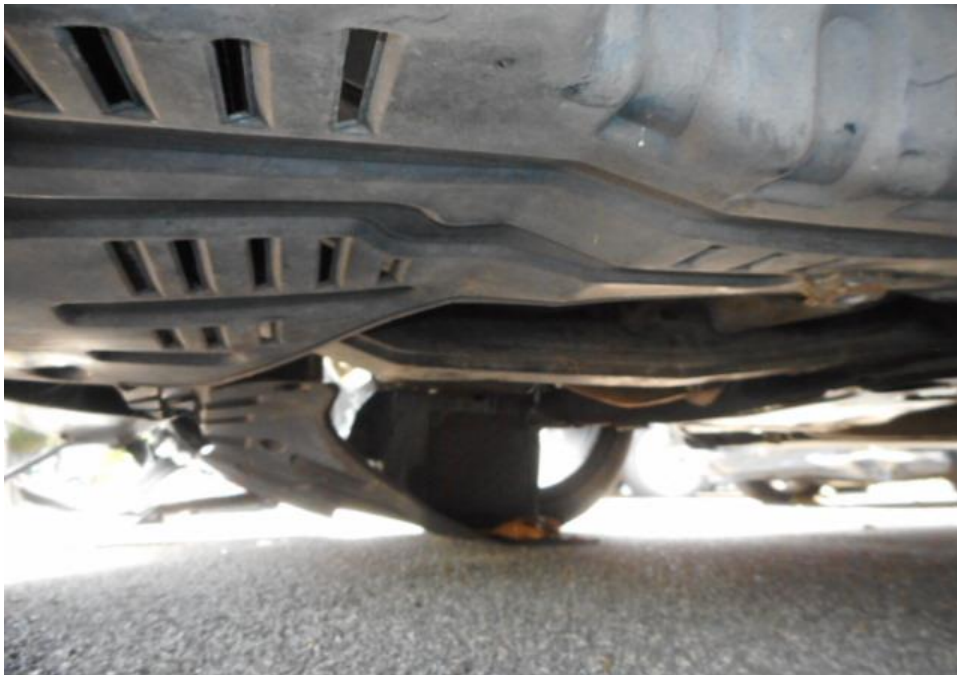
**Photo 16** shows the undercarriage of the Motor Car, at the area where the engine housing and transmission housing are located. I did not find any sign(s) or indication(s) of fluid leak and/or fluid stain(s) on the underside of the Motor Car.

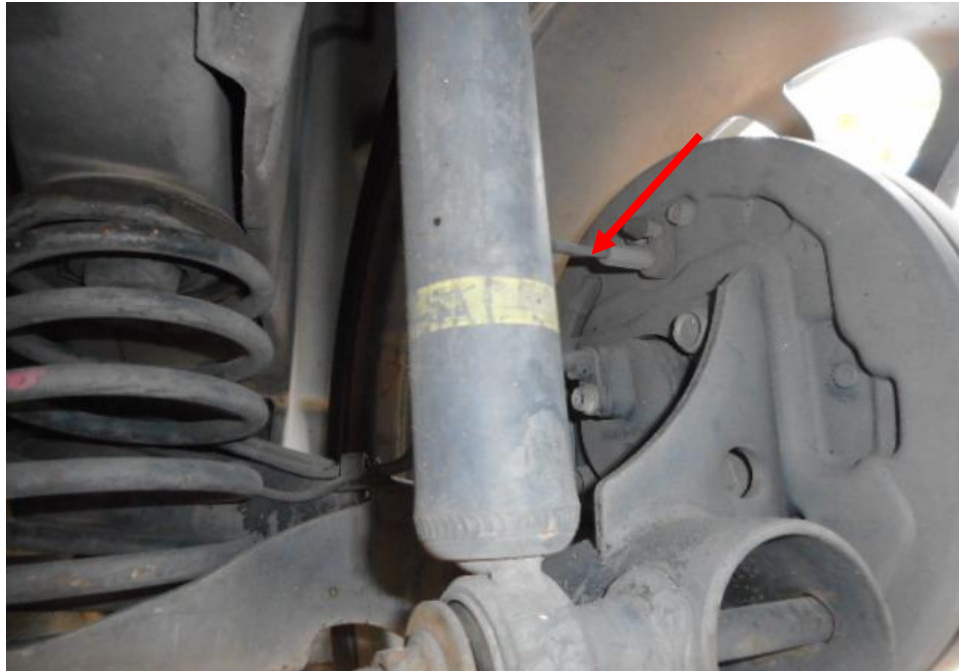
**Photo 17** shows the brake hose/pipe (arrowed) at the rear right wheel of the Motor Car. No leakage of brake fluid was observed. Visual examination of the various components of the braking system like the drum brake, brake booster, brake pedal etc. had revealed all to be intact and without visible damage.

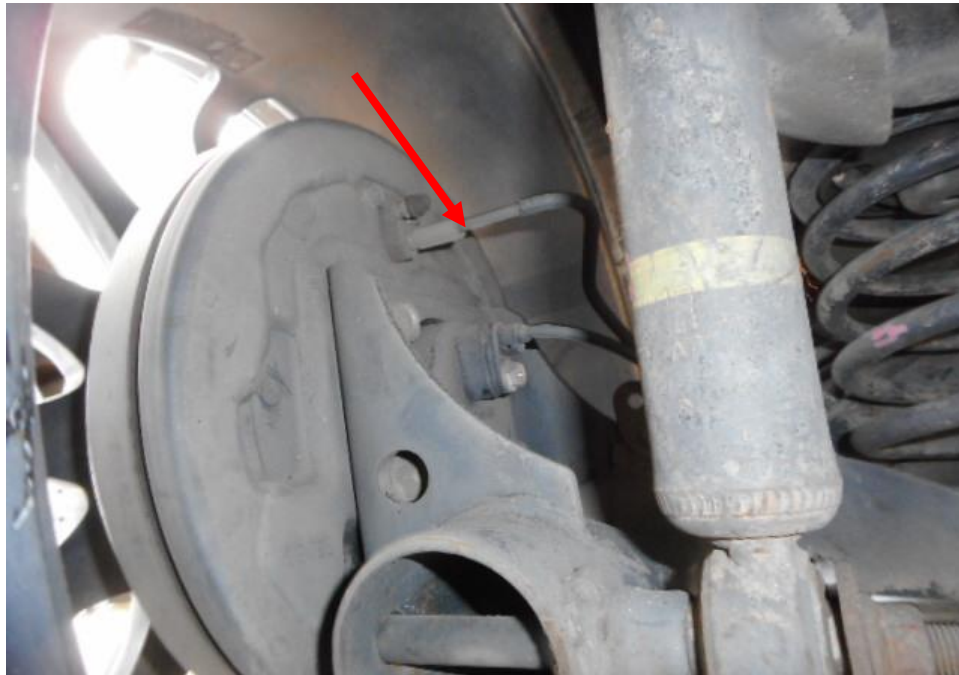
**Photo 18** shows the brake hose/pipe (arrowed) at the rear left wheel of the Motor Car. I did not observe any leakage of brake fluid at the time of my inspection of the Motor Car. Static tests of the Motor Car's braking system had indicated that there was no internal leakage of pressure/vacuum. The undercarriage components of the Motor Car were also all found to be intact and without any visible damage.

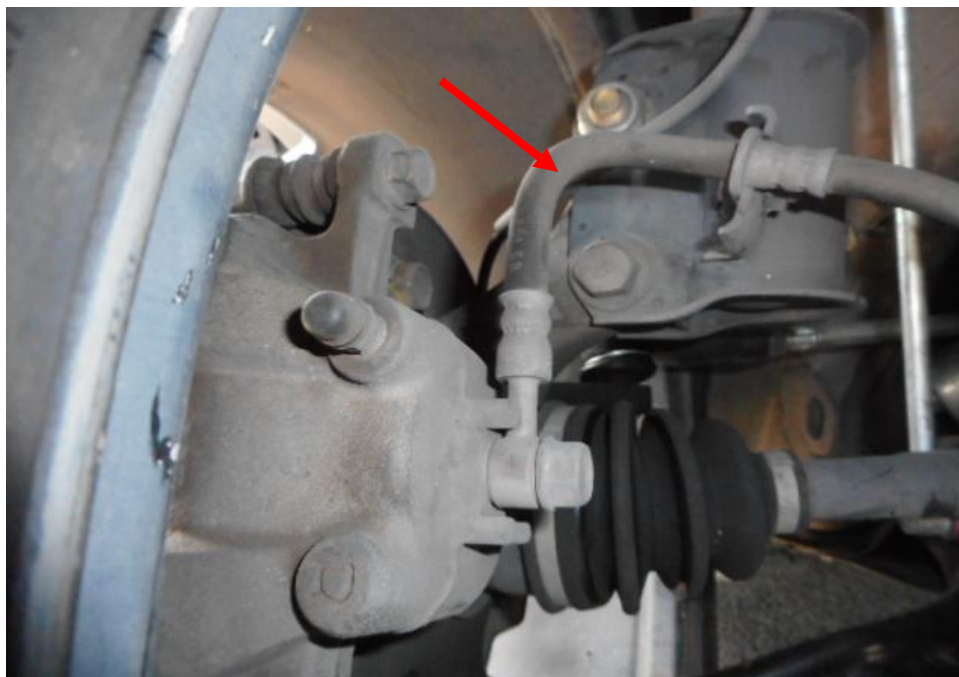
**Photo 19** shows the brake hose/pipe (arrowed) at the front right wheel of the Motor Car. I did not observe any leakage of brake fluid at the time of my inspection of the Motor Car. Static tests of the Motor Car's braking system had indicated that there was no internal leakage of pressure/vacuum.

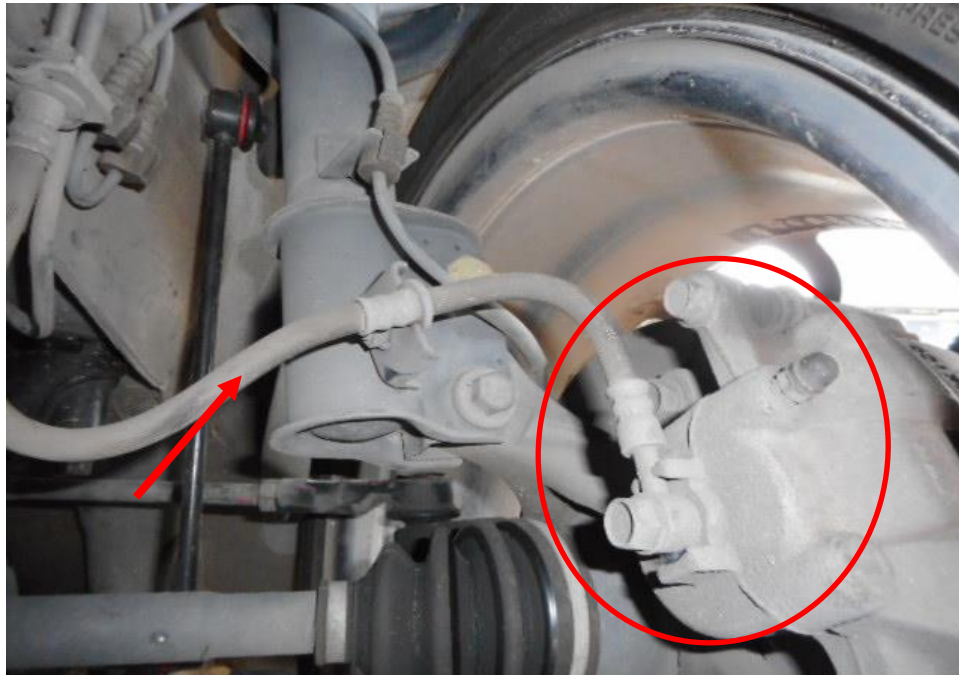
**Photo 20** shows the brake hose/pipe (arrowed) at the front left wheel of the Motor Car. No leakage of brake fluid was observed. Visual examination of the various components of the braking system like the brake caliper (circled), brake booster, brake pedal etc had revealed all to be intact and without visible damage.

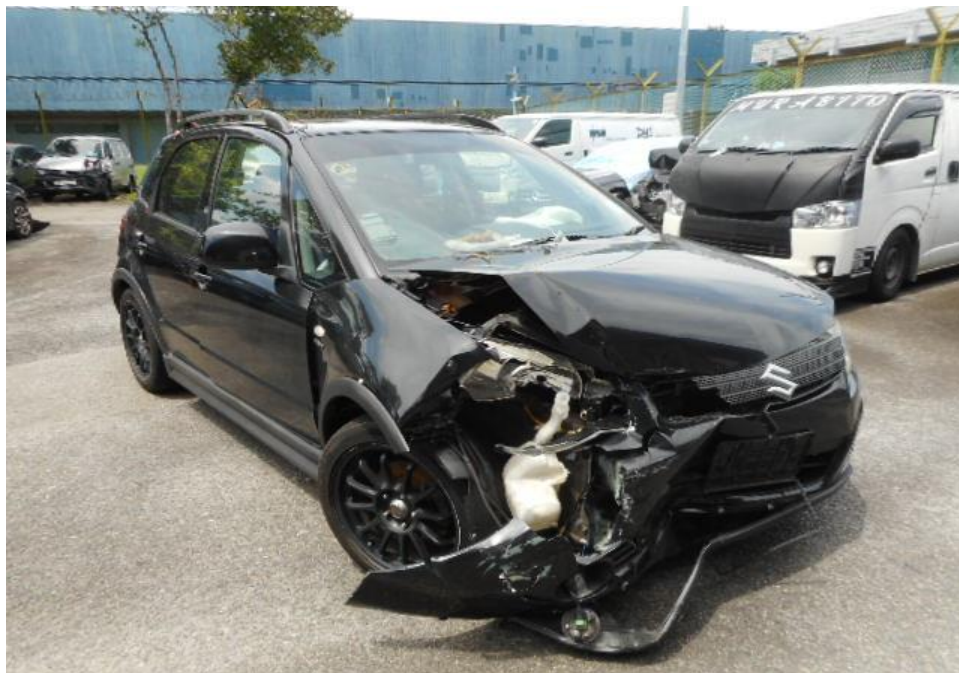
**Photo 21** shows the front right wheel of the Motor Car turned to its full left. During my steering system test, I did not experience any abnormal free play and/or resistance when I had turned the steering wheel towards the left and right. This would suggest that the steering system of the Motor Car was likely to be in serviceable condition at the material time of accident.

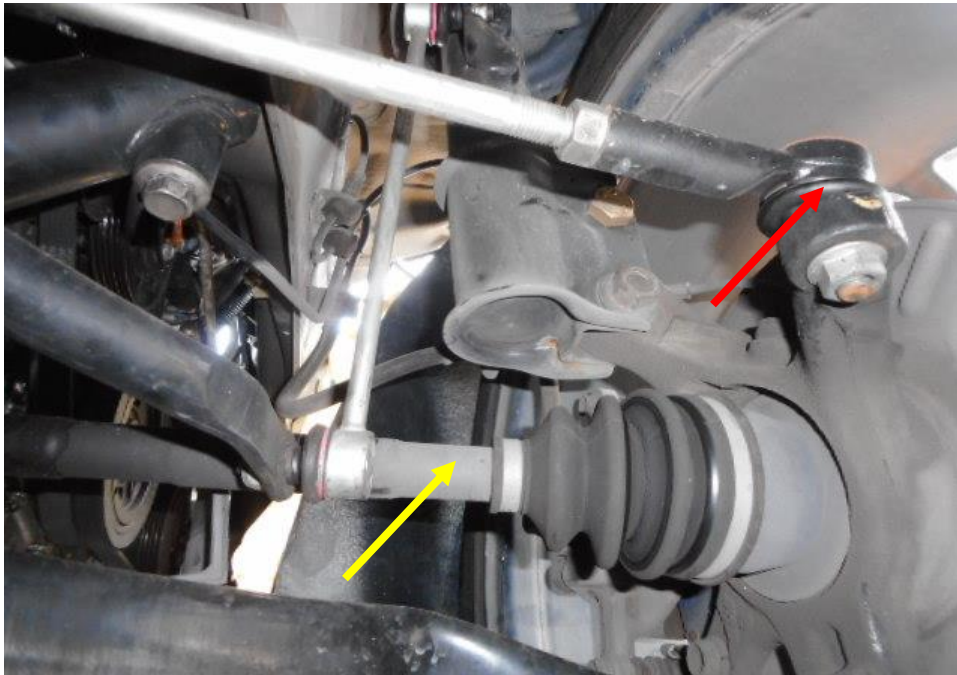
**Photo 22** shows the various undercarriage components at the front right wheel of the Motor Car, in particular the steering tie rod (red arrow) and the driveshaft (yellow arrow). The various steering components were all found to be intact, suggesting that the steering system of the Motor Car was likely to be in serviceable condition at the material time of accident. There was also no sign of fluid stain observed on the various undercarriage components at the front right wheel of the Motor Car.

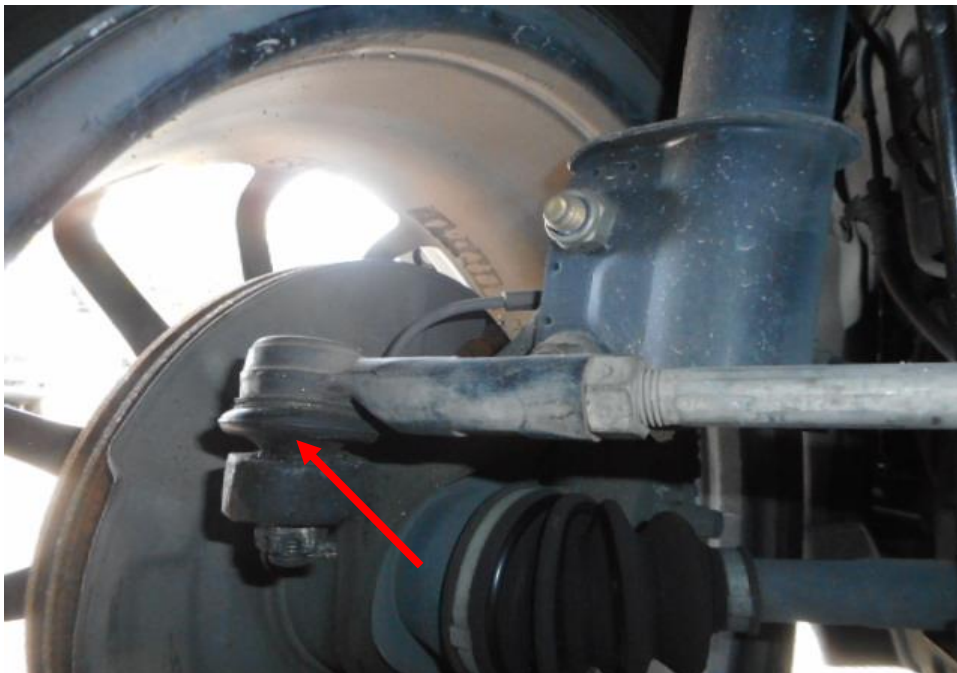
**Photo 23** shows the various undercarriage components at the front left wheel of the Motor Car, in particular the steering tie rod end (arrowed). The various undercarriage components of the Motor Car were all found to be intact without any visible damage. There was also no sign of fluid stain(s) observed on the various undercarriage components.

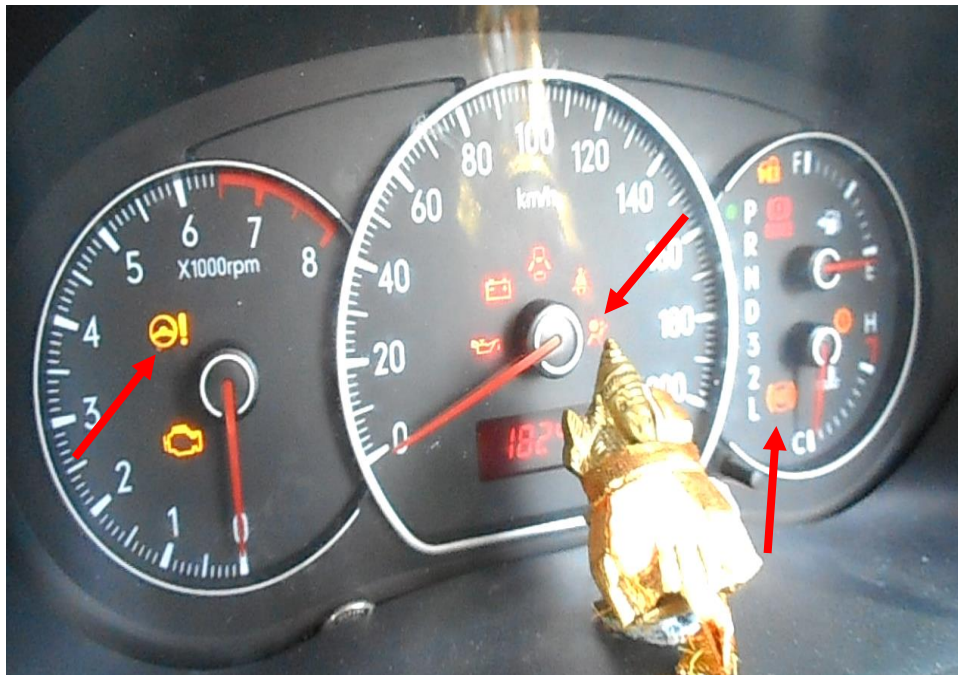
**Photo 24** shows the warning light for Anti-Lock Brake System (ABS), Traction Control System (TCS), Electronic Power Steering System (EPS) and Supplemental Restraint System (SRS) (arrowed) appearing on the instrument panel of the Motor Car during the self-test of its various electronic operating systems when its engine was cranked.

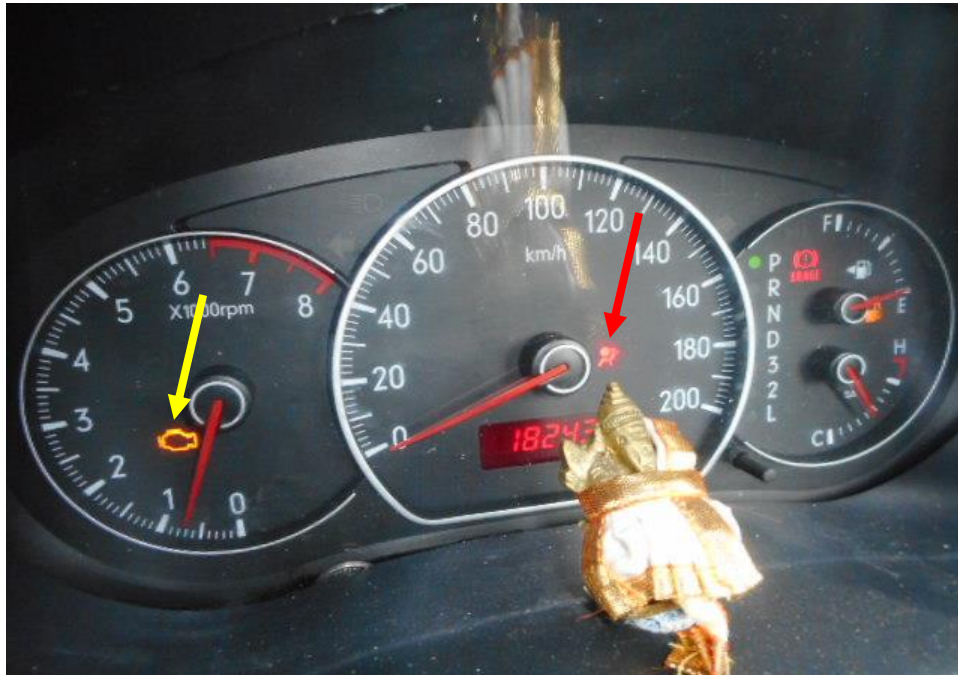
14. The Supplemental Restraint System (SRS) warning light remained illuminated up due to the deployment of the airbag as a result of the accident.
15. We also further observed that the engine light remained illuminated up and we did a diagnostic system test to the Motor Car's electronic system and observed a stored fault code stating a faulty O2 sensor (Oxygen Sensor) which is located on the engine exhaust piping. See photo 24 - 26 below.

**Photo 25** shows the Supplemental Restraint System (SRS) (red arrow) light remained illuminated on due to the deployment of the airbag as a result of the accident after the engine was cranked and we also observed the engine warning light remained illuminated up and this was due to an faulty O2 Sensor (Oxygen Sensor) (yellow arrow) on the engine exhaust piping. However, there was no abnormality to the other electronic operating system of the Motor Car, like the ABS, EPS and TCS etc.

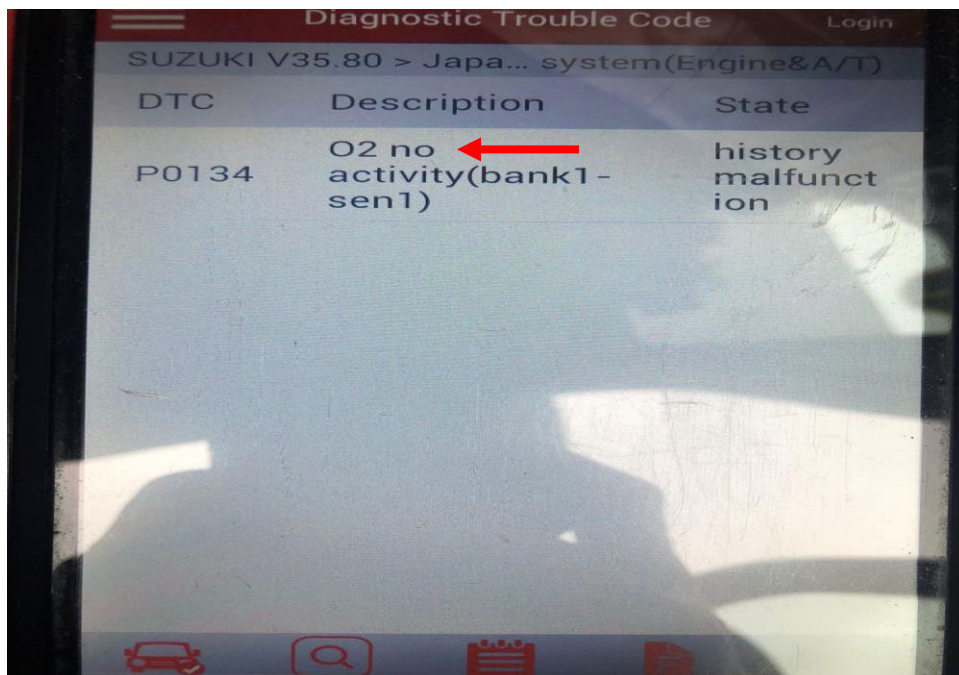
**Photo 26** shows the fault code of the faulty O2 Sensor (Oxygen Sensor) of the engine exhaust piping (arrowed).

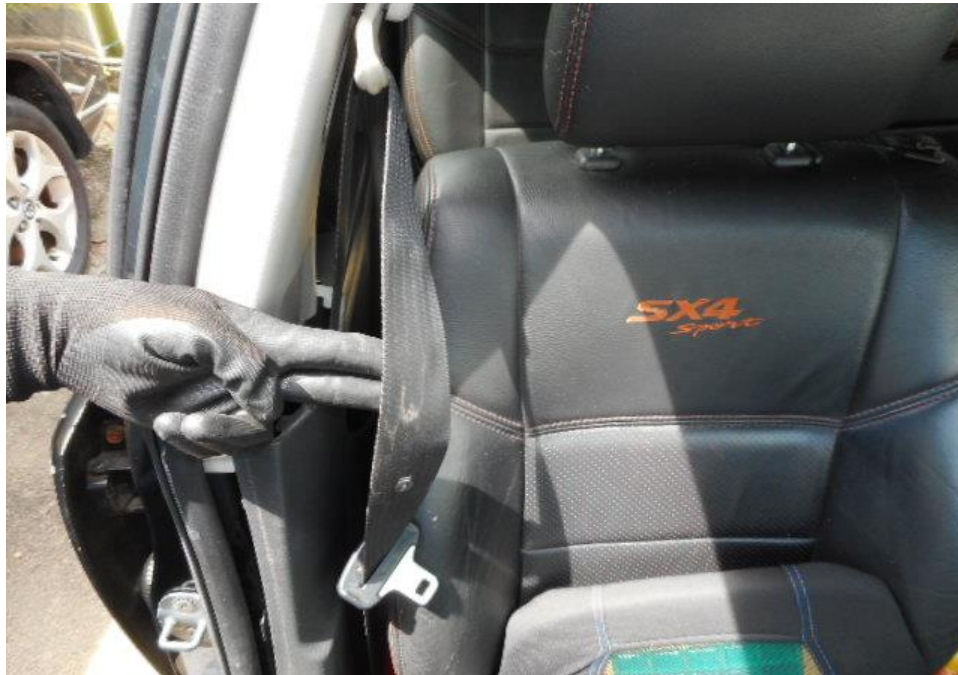
**Photo 27** shows that the seat belt on the right seat was not worn at the material time of accident as the safety pre-tensioners was activated at the moment of impact and caused the seat belt to be locked into the last position.

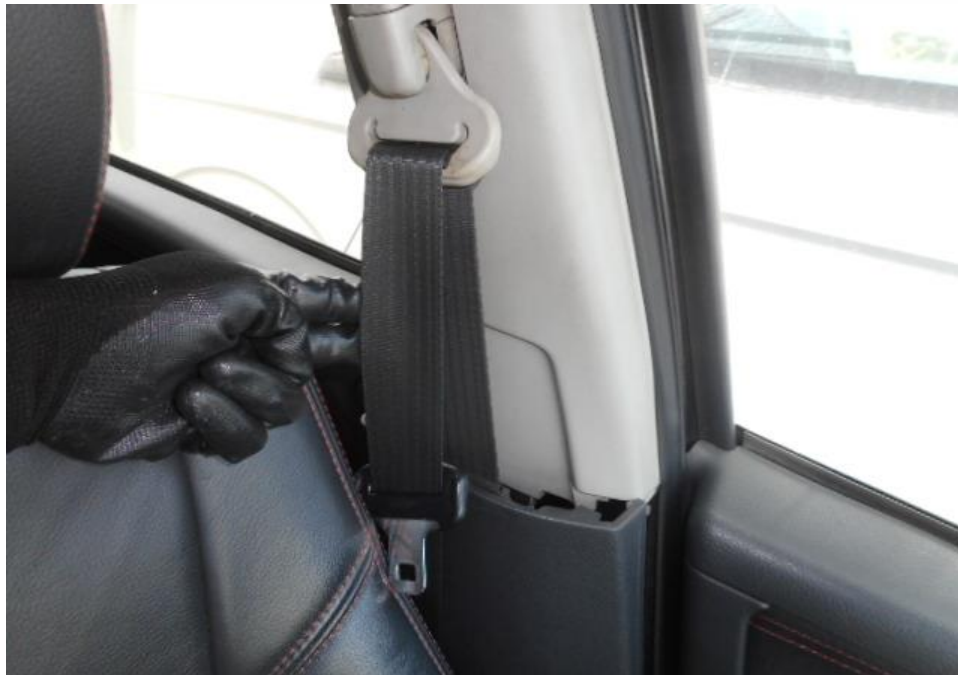
**Photo 28** shows that the seat belt on the left seat was not worn at the material time of accident as the safety pre-tensioners was activated at the moment of impact and caused the seat belt to be locked into the last position.
