Your Ref: TP/IP/15610/2022
Our Ref: CI/TPD22006183/P

Fatal Accident Investigation Team

MECHANICAL INSPECTION REPORT OF MOTOR BUS SMB 3609K

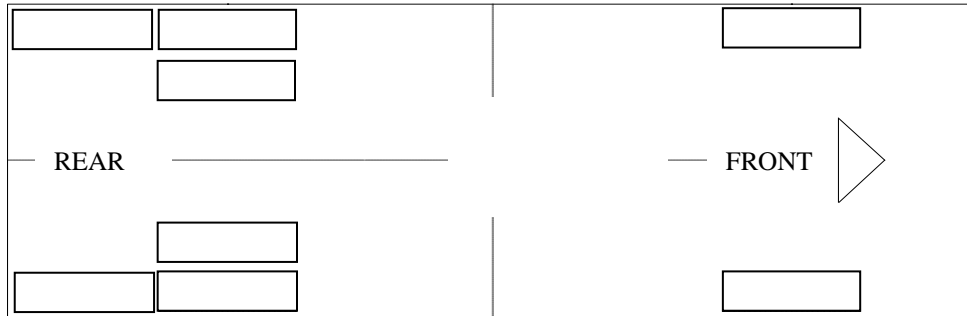
6. The 2 front tyres and 6 rear tyres of the Motor Bus were observed to be in serviceable condition and sufficiently inflated for vehicular operation. I did not find any tear, cut or burst mark(s) on the outer and the inner sidewalls as well as across the tread of the 8 tyres. The tyre brand, tyre size and remaining tread depth of the 8 tyres of the Motor Bus were recorded as follows:-

Firenze 305/70R22.5 (11.9mm)

Firenze 305/70R22.5 (8.7mm)

Firenze 305/70R22.5 (12.7mm)

Firenze 305/70R22.5 (11.3mm)

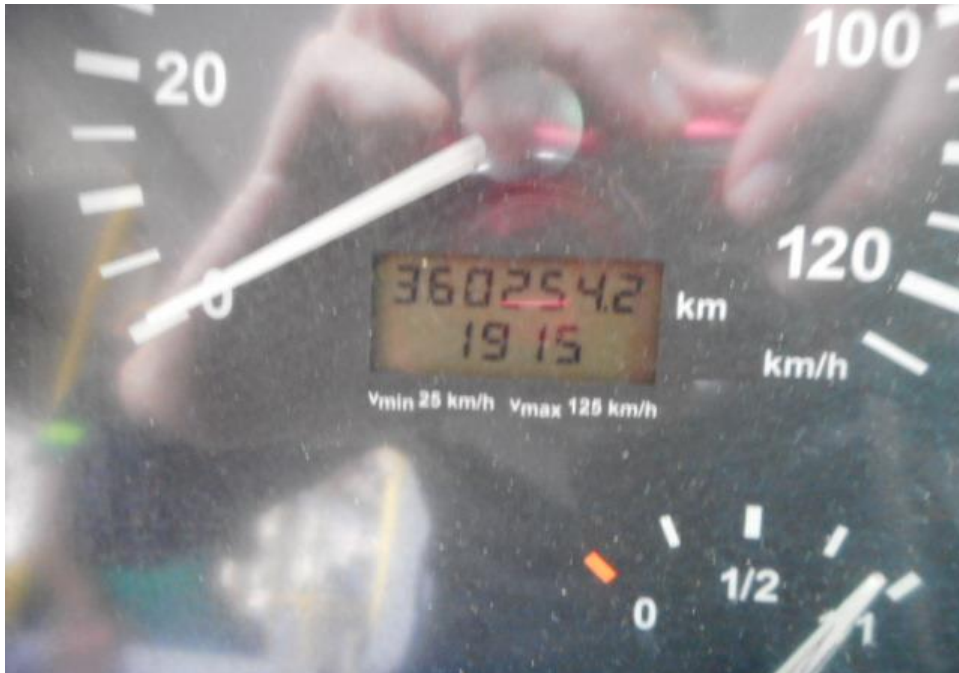
4. The mileage of the Motor Bus at the time of my inspection was 360,254km.
5. There was no visible damage observed on Motor Bus at the time of my inspection.

Photo 1 shows a general view of the instrument cluster of the Motor Bus at the time of my inspection. The mileage of the Motor Bus was 360,254km

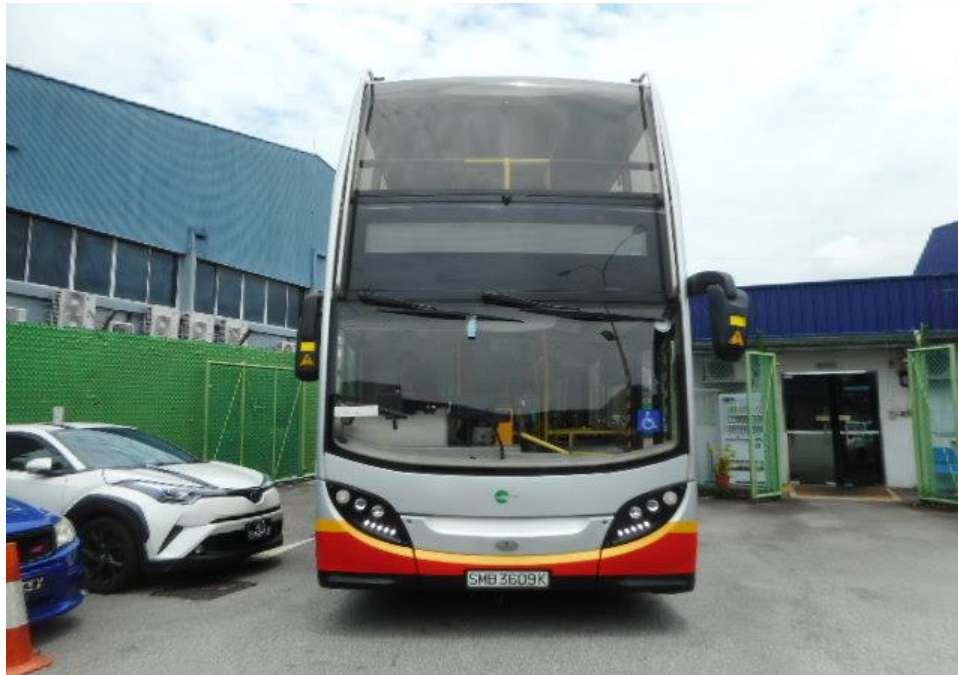
Photo 2 shows a general view of the front body of the Motor Bus at the time of my inspection. The Motor Bus was observed to be intact and unaffected by the accident.

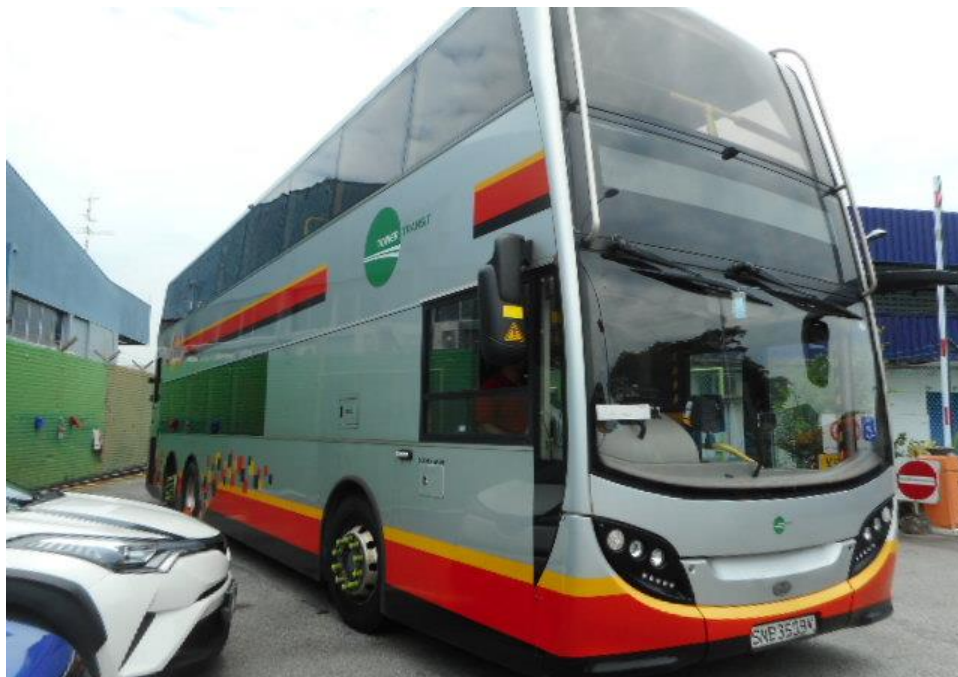
Photo 3 shows a general view of the right body of the Motor Bus at the time of my inspection. The Motor Bus was observed to be intact and unaffected by the accident.

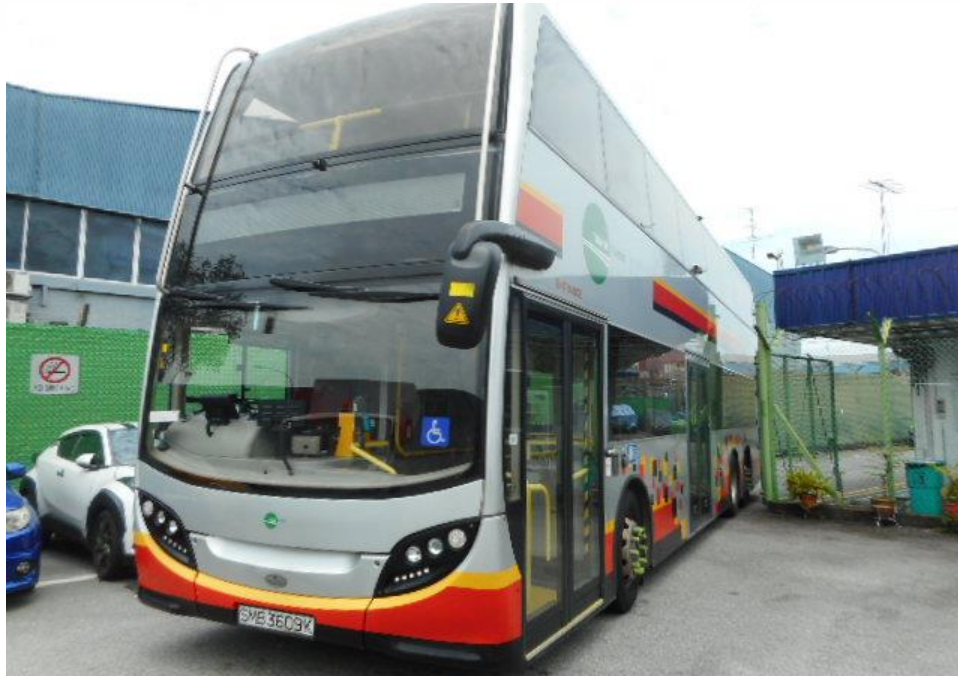
Photo 4 shows a general view of the left body of the Motor Bus at the time of my inspection. The Motor Bus was observed to be intact and unaffected by the accident.

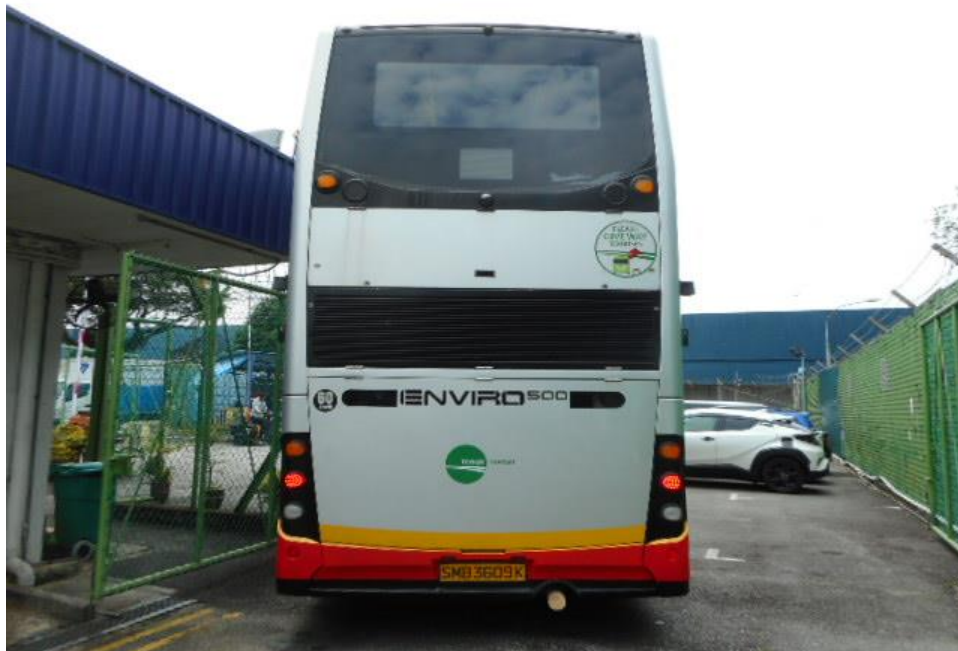
Photo 5 shows a general view of the rear body of the Motor Bus at the time of my inspection. The Motor Bus was observed to be intact and unaffected by the accident.

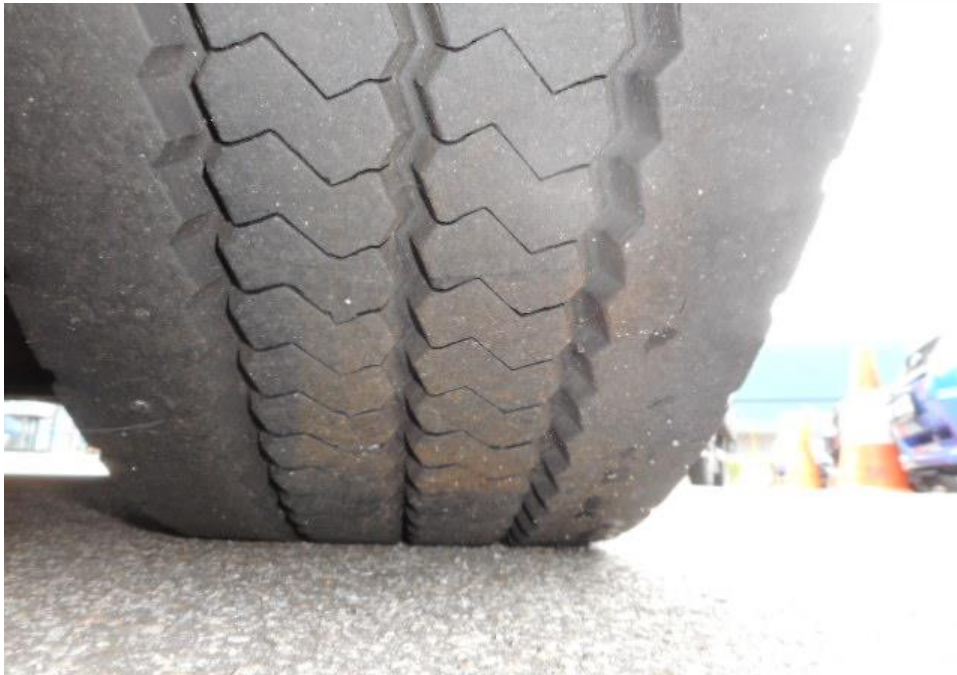
Photo 6 shows the condition of the front right tyre of the Motor Bus, which was observed to be in serviceable condition with remaining tread depth of approximately 11.3mm. The tyre, which was wrapped around standard steel wheel rim, was also observed to be sufficiently inflated for vehicular operation. There was no tear, cut or burst mark(s) on the outer and the inner sidewalls as well as across the tread of the 8 tyres that were fitted on the Motor Bus.

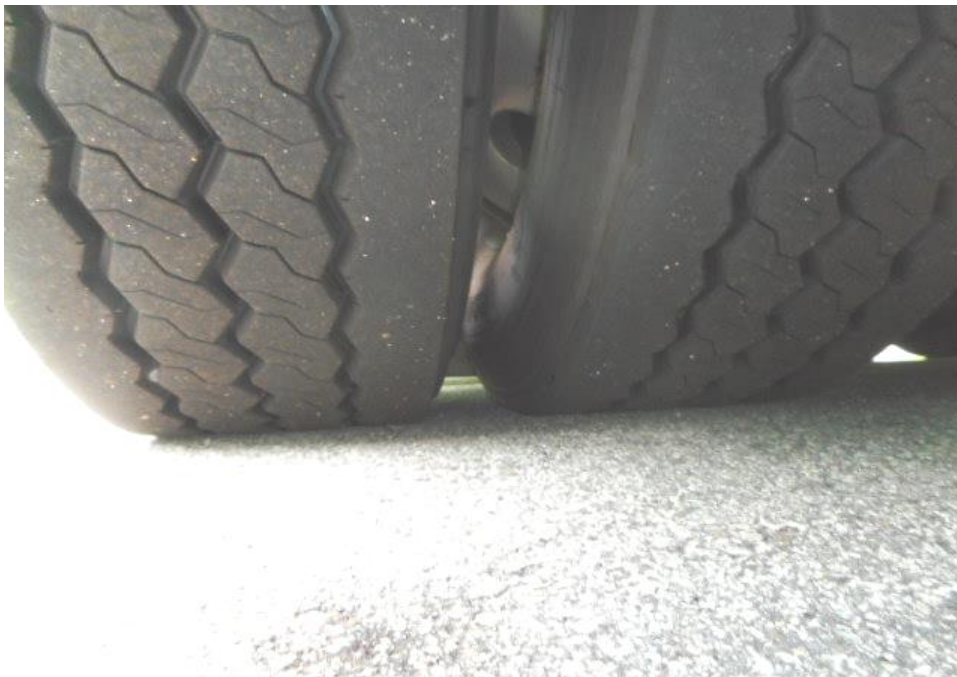
Photo 7 shows the condition of the rear right tyre of the Motor Bus, which was observed to be in serviceable condition with remaining tread depth of approximately 12.7mm. The tyre, which was wrapped around standard steel wheel rim, was also observed to be sufficiently inflated for vehicular operation.

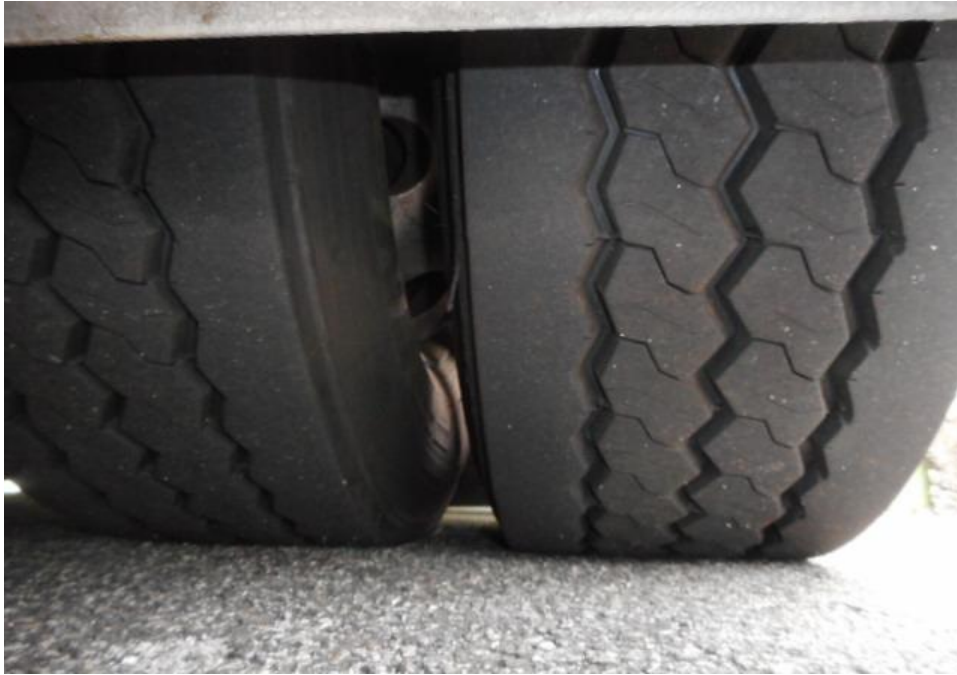
Photo 8 shows the condition of the rear left tyres of the Motor Bus, which was observed to be in serviceable condition with remaining tread depth of approximately 11.9mm. The tyres, which were wrapped around standard steel wheel rim, were also observed to be sufficiently inflated for vehicular operation. There was also no damage found on all 8 steel wheel rims of the Motor Bus.

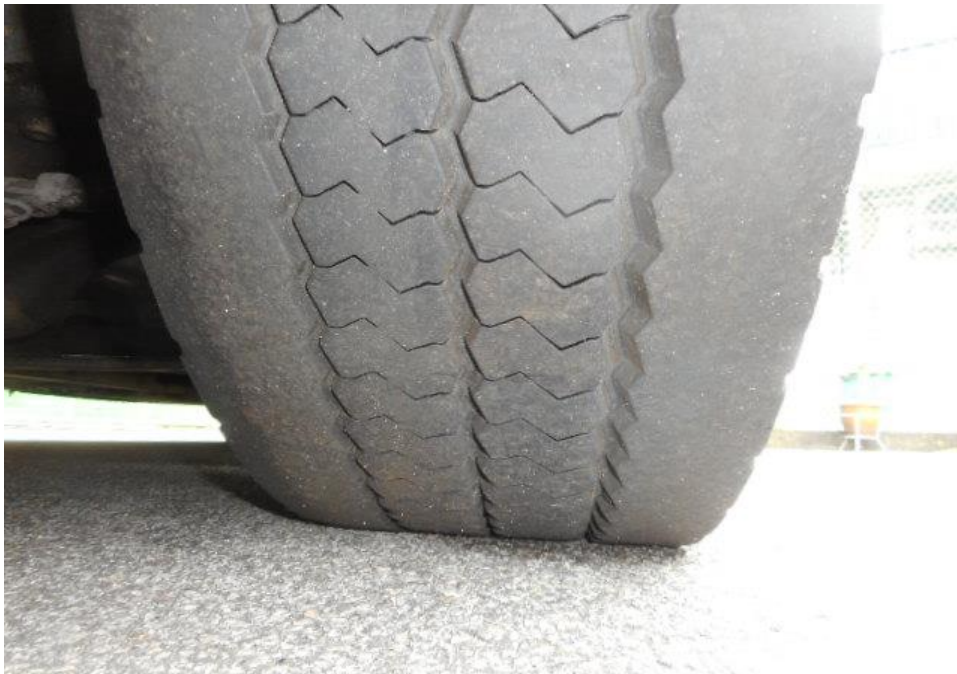
Photo 9 shows the condition of the front left tyres of the Motor Bus, which were observed to be in serviceable condition with remaining tread depth of approximately 8.7mm. There was also no tear, cut or burst mark(s) on the outer and the inner sidewalls as well as across the tread of the 8 tyres that were fitted on the Motor Bus.

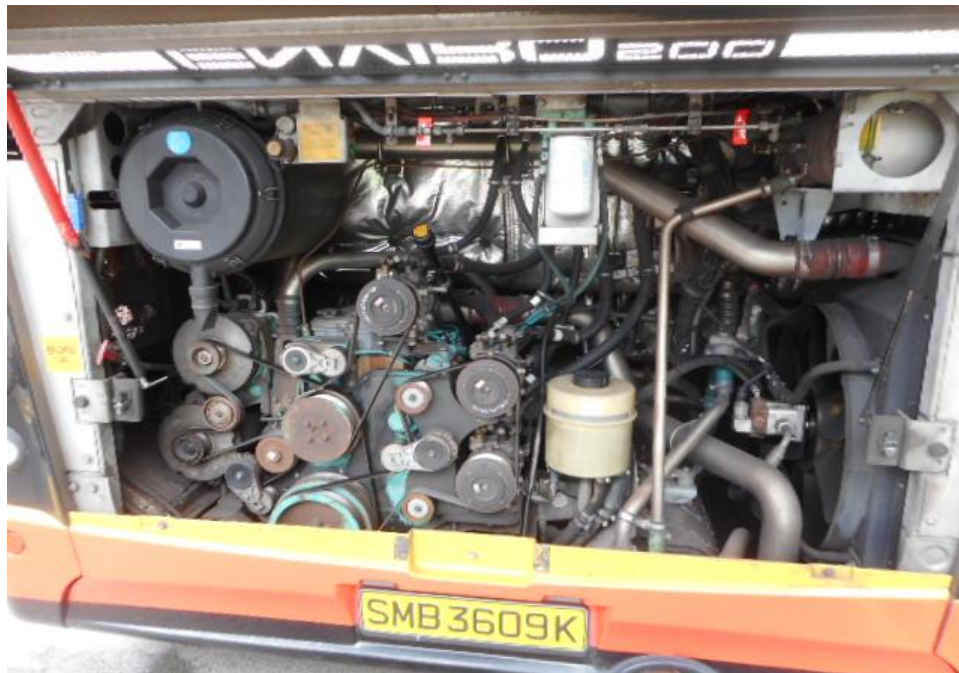
Photo 10 shows a general view of the Motor Bus's engine compartment, which was accessed by lifting the rear of the Motor Bus. The various parts and components inside the engine compartment were unaffected by the accident. There was also no sign(s) or indication(s) of fresh fluid leakage and/or fluid stain within the engine compartment

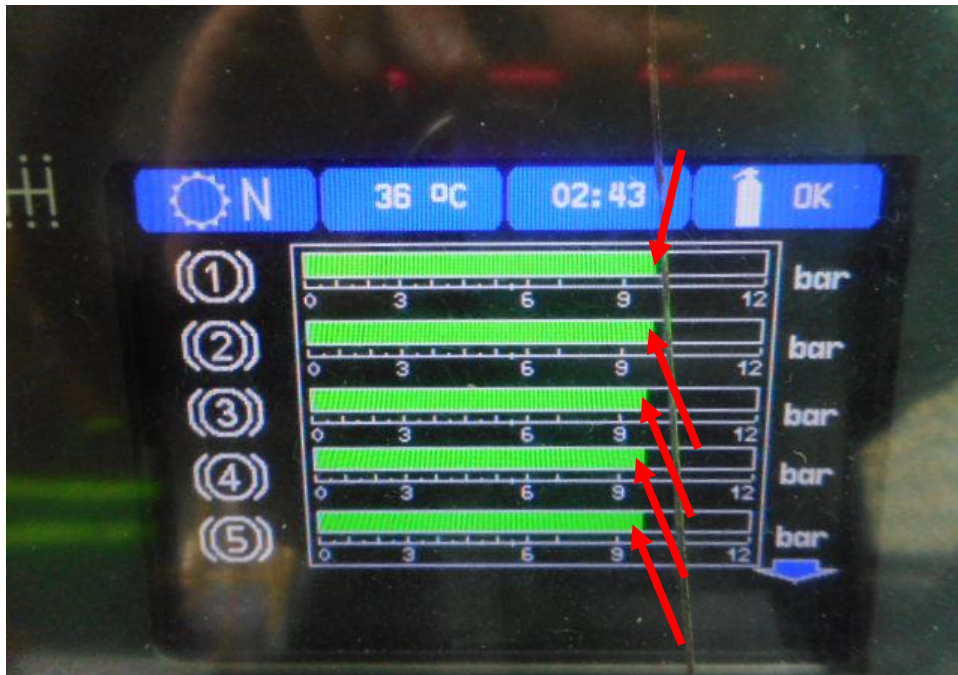
Photo 11 shows the air in the air brake cylinder of the Motor Bus at the time of my inspection. The air in the cylinder was observed to be of sufficient level & serviceable at the time of the accident.

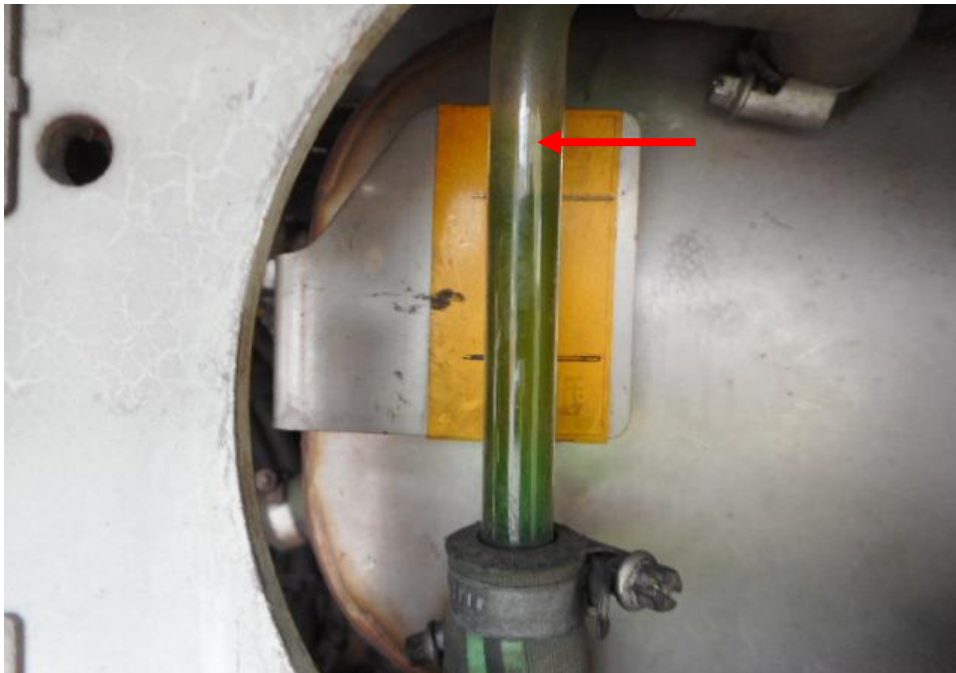
Photo 12 shows the engine coolant reservoir of the Motor Bus at the time of my inspection. The engine coolant was observed to be of sufficient level (arrowed) and without any visible contamination.

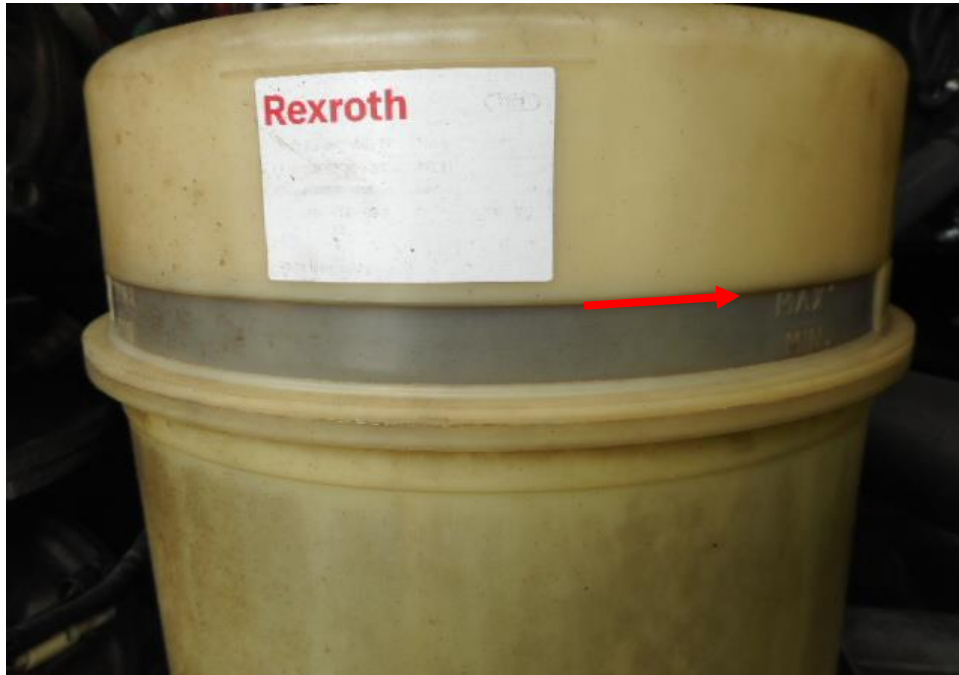
Photo 13 shows the power steering fluid reservoir of the Motor Bus at the time of my inspection. The power steering fluid was observed to be of sufficient level and without any visible contamination.

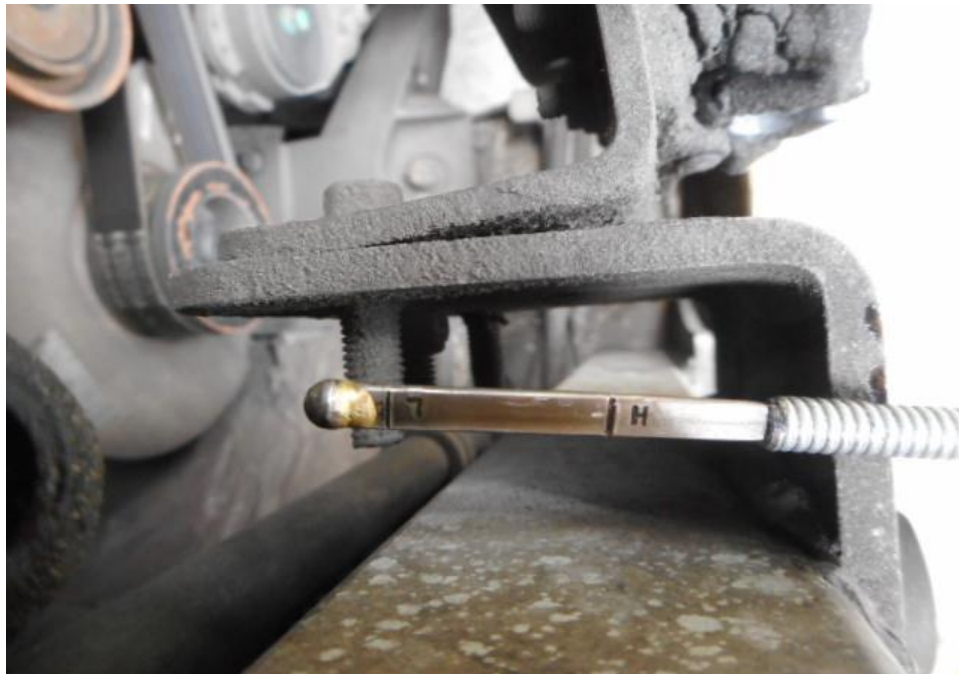
Photo 14 shows the engine oil dip stick system of the Motor Bus at the time of my inspection. The engine oil was observed to be sufficient for operation and without any visible contamination.

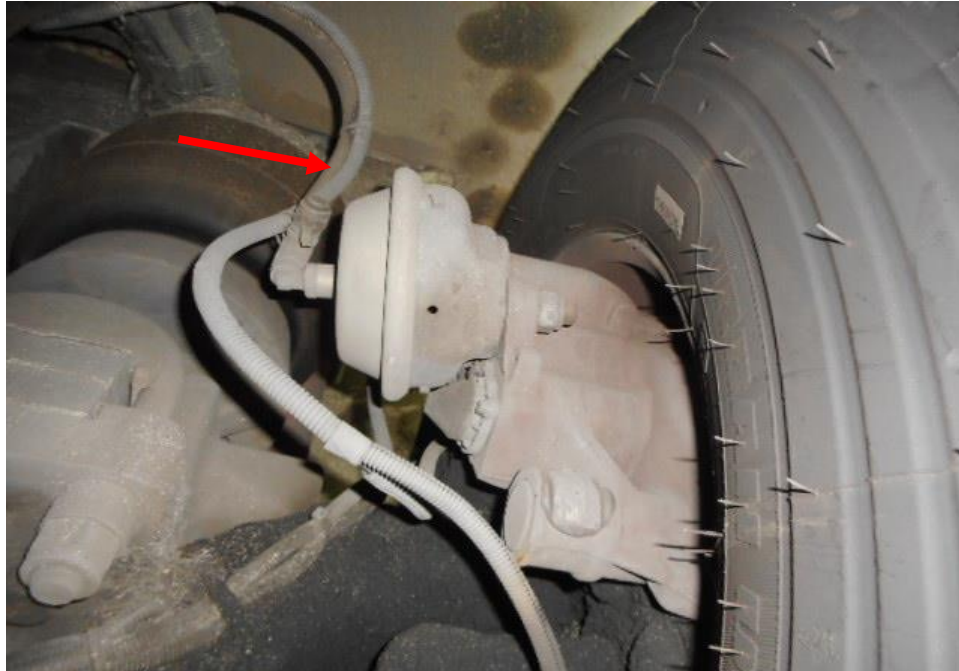
Photo 15 shows the brake pipe (arrowed) at the rear right wheel of the Motor Bus. I did not observe any leakage of brake fluid at the time of my inspection of the Motor Bus. My static tests of the Motor Bus's braking system, along with my visual examination of the various mechanical components in the braking system, had indicated that there was no internal leakage of pressure/vacuum. Hence the braking system of the Motor Bus was likely to be in serviceable condition at the material time of accident.

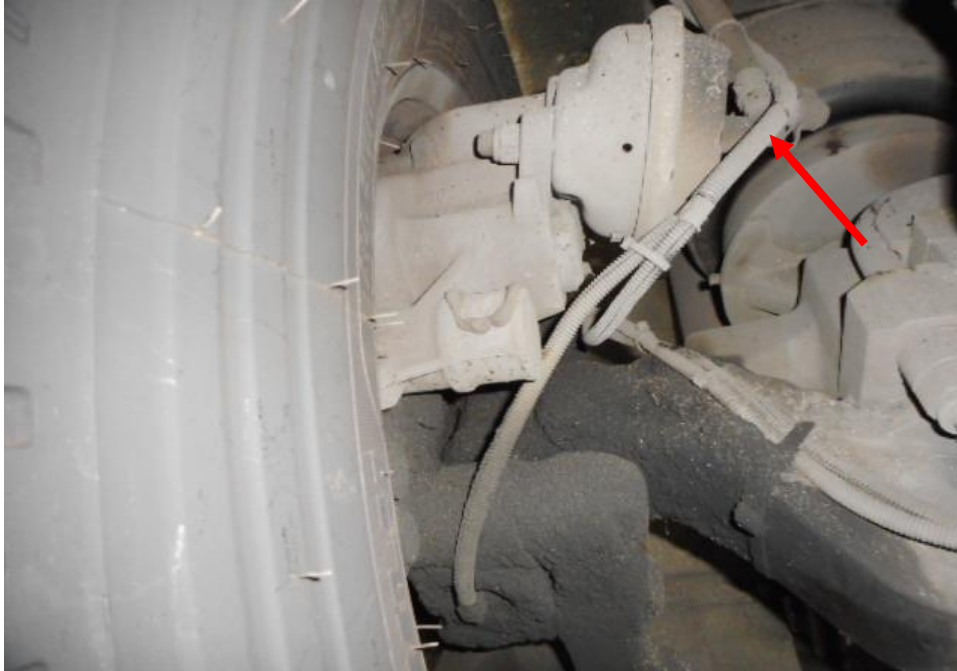
Photo 16 shows the brake pipe (arrowed) at the rear left wheel of the Motor Bus. I did not observe any leakage of brake fluid at the time of my inspection of the Motor Bus. My static tests of the Motor Bus's braking system, along with my visual examination of the various mechanical components in the braking system, had indicated that there was no internal leakage of pressure/vacuum. Hence the braking system of the Motor Bus was likely to be in serviceable condition at the material time of accident.

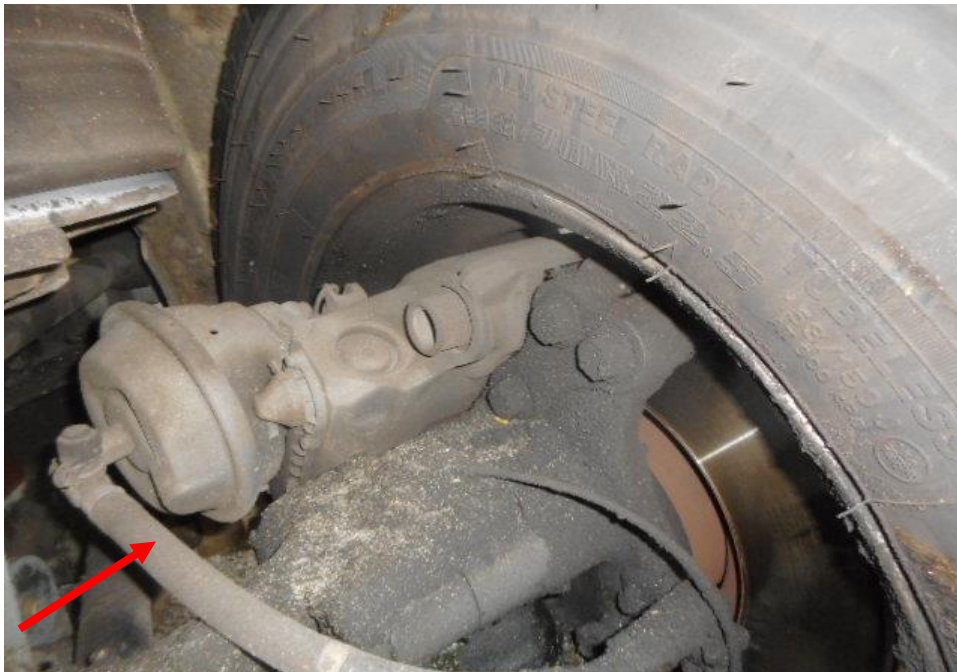
Photo 17 shows the brake pipe (arrowed) at the front right wheel of the Motor Bus. I did not observe any leakage of brake fluid at the time of my inspection of the Motor Bus. My static tests of the Motor Bus's braking system, along with my visual examination of the various mechanical components in the braking system, had indicated that there was no internal leakage of pressure/vacuum. Hence the braking system of the Motor Bus was likely to be in serviceable condition at the material time of accident.

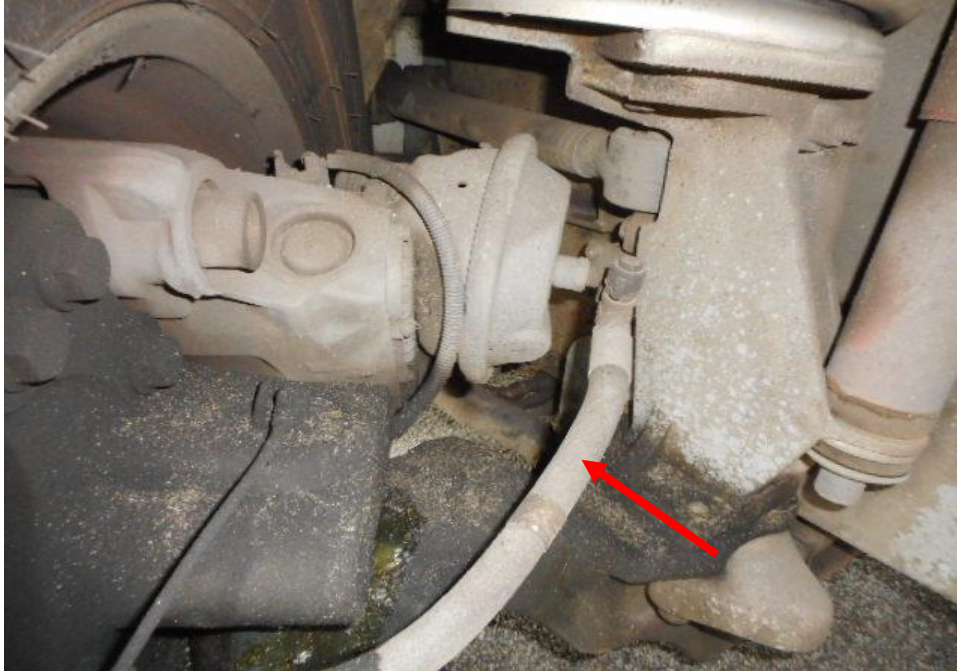
Photo 18 shows the brake pipe (arrowed) at the front left wheel of the Motor Bus. I did not observe any leakage of brake fluid at the time of my inspection of the Motor Bus. My static tests of the Motor Bus's braking system, along with my visual examination of the various mechanical components in the braking system had indicated that there was no internal leakage of pressure/vacuum. Hence the braking system of the Motor Bus was likely to be in serviceable condition at the material time of accident.

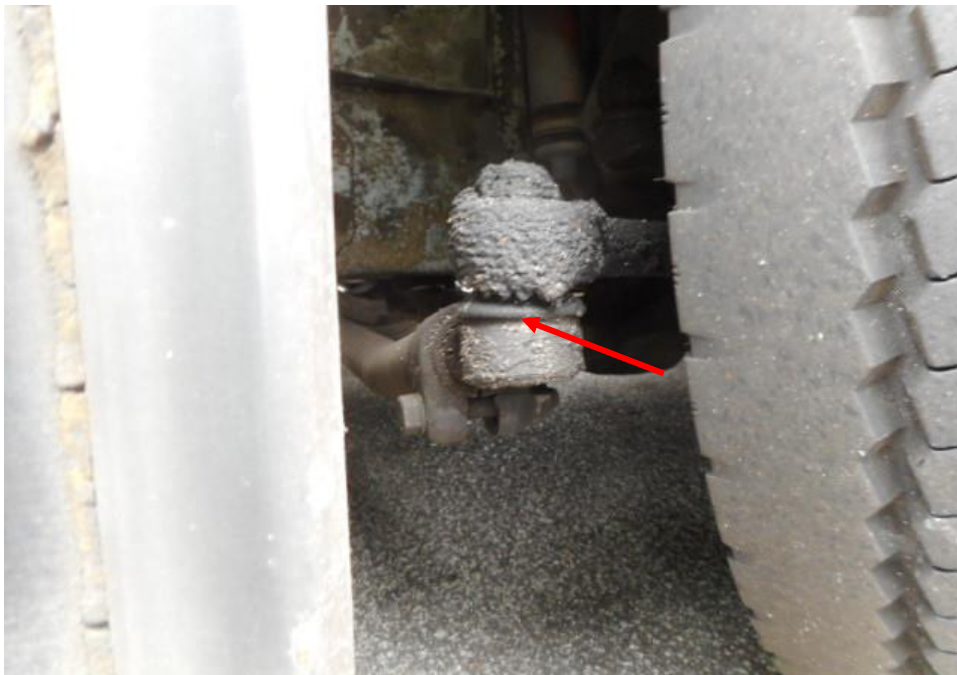
Photo 19 shows the various undercarriage components at the front right wheel of the Motor Bus, in particular the steering tie rod end (arrowed). The various steering components were all found to be intact, suggesting that the steering system of the Motor Bus was likely to be in serviceable condition at the material time of accident. There was also no sign of fluid stain(s) observed on the various undercarriage components.

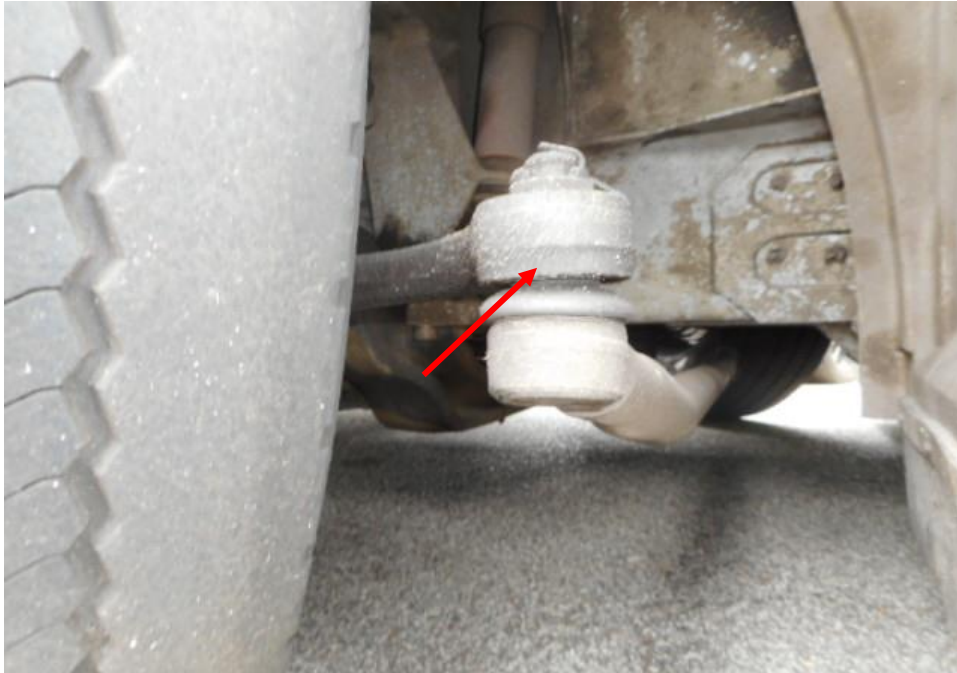
Photo 20 shows the various undercarriage components at the front left wheel of the Motor Bus, in particular the steering tie rod end (arrowed). The various undercarriage components of the Motor Bus were all found to be intact without any visible damage. There was also no sign of fluid stain(s) observed on the various undercarriage components.

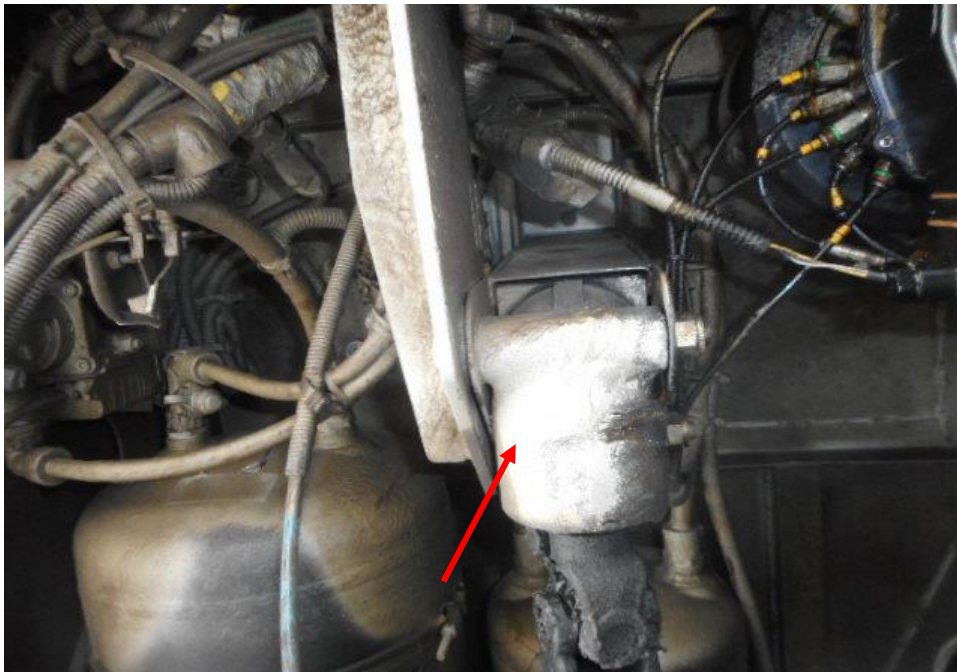
Photo 21 shows the steering box component (arrowed) at the undercarriage of the Motor Bus was found to be intact without any visible damage. There was also no sign of fluid stain(s) observed on the various undercarriage components.

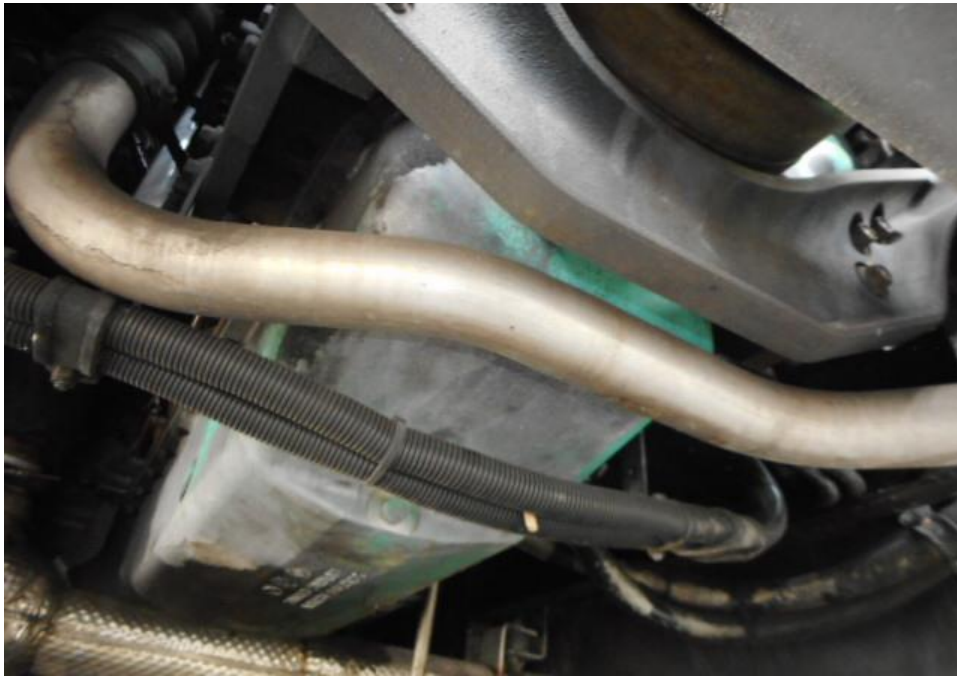
Photo 22 shows the undercarriage of the Motor Bus, at the area where the engine housing and transmission housing are located. I did not find any sign(s) or indication(s) of fluid leak and/or fluid stain(s) on the underside of the Motor Bus.

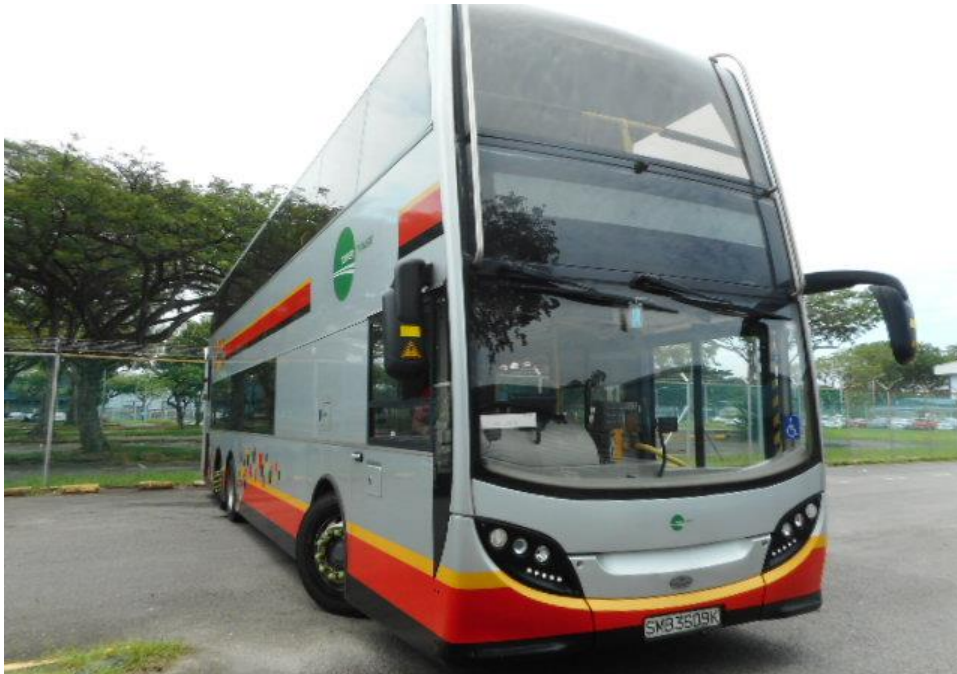
Photo 23 shows the front right wheel of the Motor Bus turned to its full left. During my steering system test, I did not experience any abnormal free play and/or resistance when I had turned the steering wheel towards full left and full right. This would suggest that the steering system of the Motor Bus was likely to be in serviceable condition at the material time of accident.

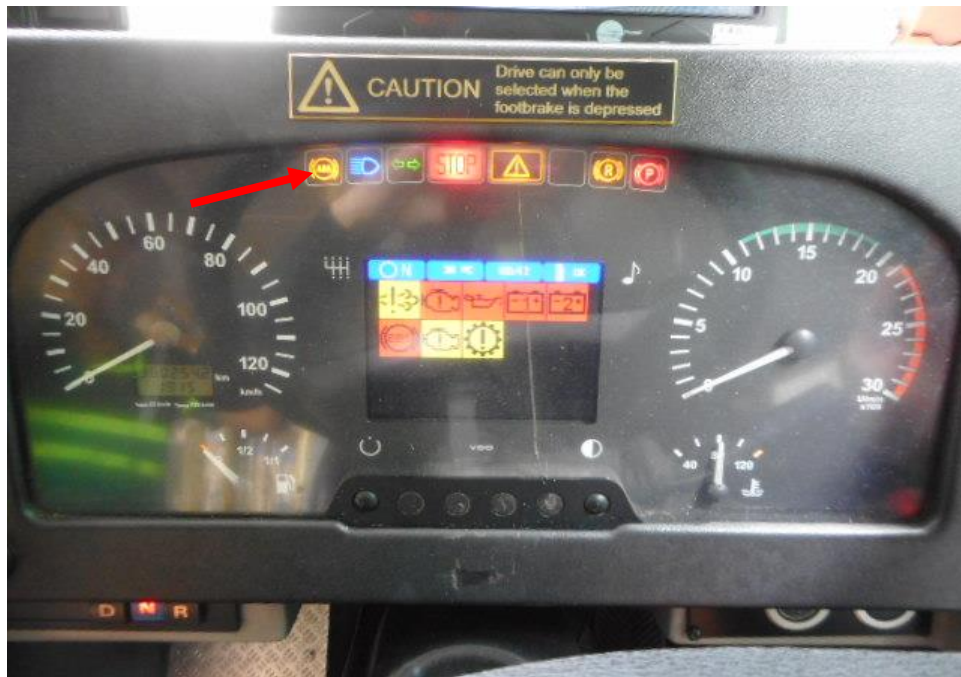
13. The Motor Bus automatic self-test of the functionality of its electronic operating systems like the Anti-Lock Braking System (ABS) during cranking of the engine. The Anti-Lock Braking System (ABS) had remained illuminated on however, during our operational test drive the system were in working condition and without abnormality. See photo 24 & 25 below.

Photo 24 shows the warning light for Anti-Lock Braking System (ABS) appearing on the instrument panel of the Motor Bus during the self-test of its various electronic operating systems when its engine was cranked.

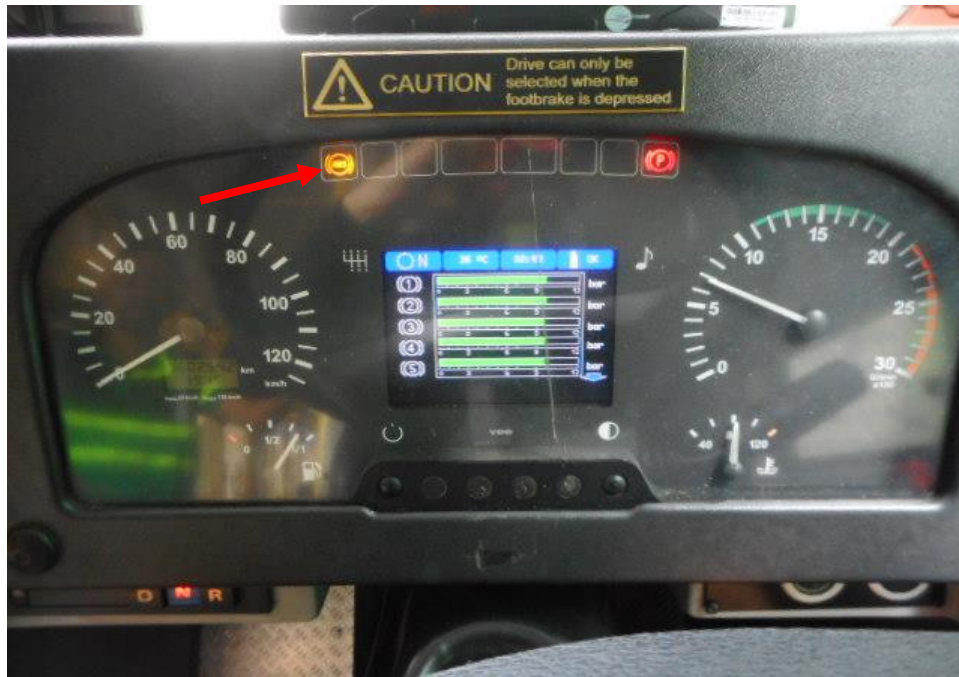
Photo 25 shows the Anti-Lock Braking System (arrowed) warning lights remained illuminated on the instrument panel of the Motor Bus after the engine was cranked, however during our operational test drive the system were in working condition and without abnormality.
