You're Ref: TP/IP/15610/2022  
Our Ref: CI/TPD22006184/P

**Fatal Accident Investigation Team**

**MECHANICAL INSPECTION REPORT OF MOTOR CAR SMR 5215R**

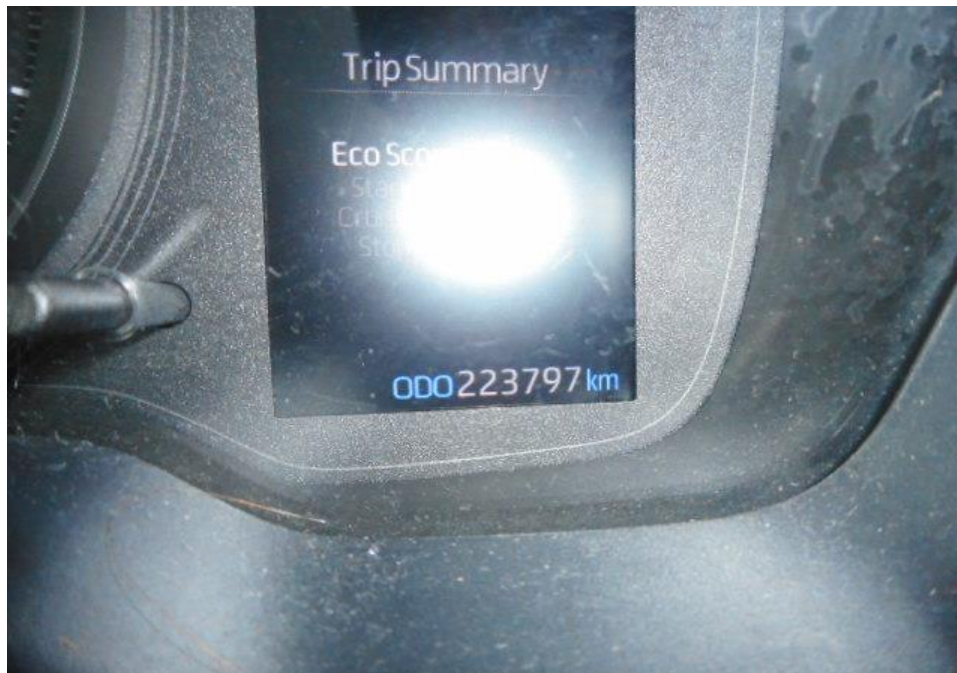
**Photo 1** shows the mileage of the Motor Car at the time of my inspection. The mileage observed was 223,797km.

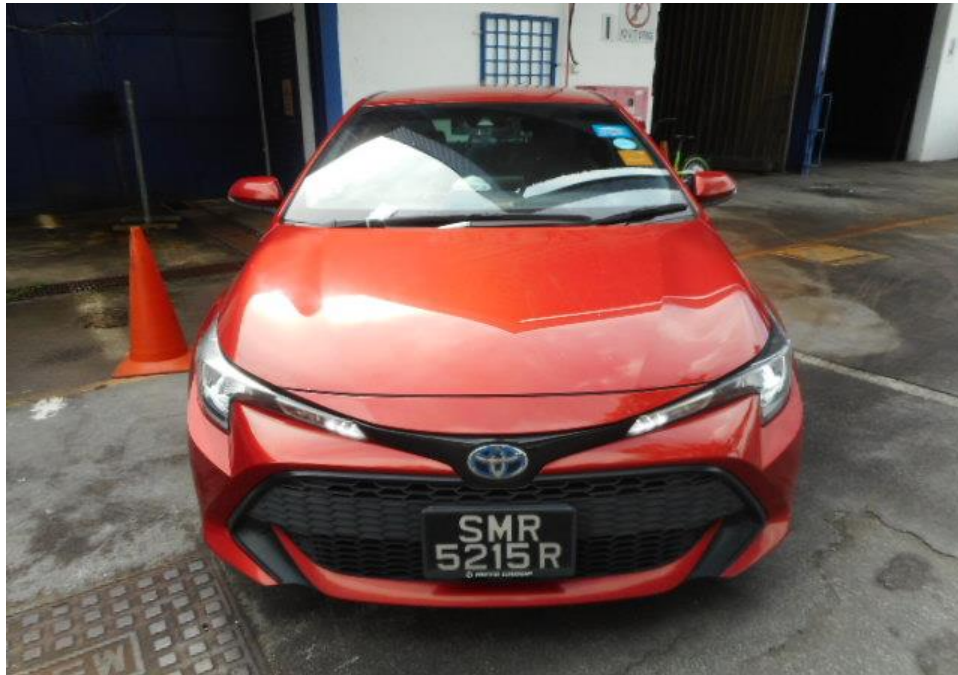
**Photo 2** shows a general view of the Motor Car's front body at the time of my inspection. The front portion of the Motor Car was observed to have sustained damage. The front bumper was the body part that were damaged as a result of the accident.

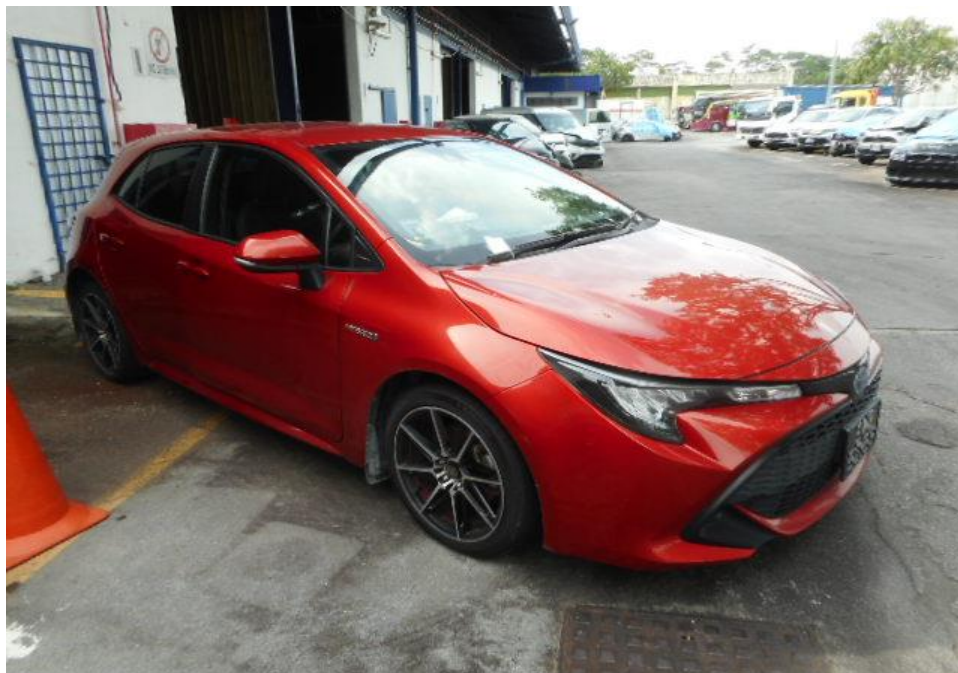
**Photo 3** shows a general view of the Motor Car's right body at the time of my inspection. The right portion of the Motor Car was observed to have been unaffected by the accident.

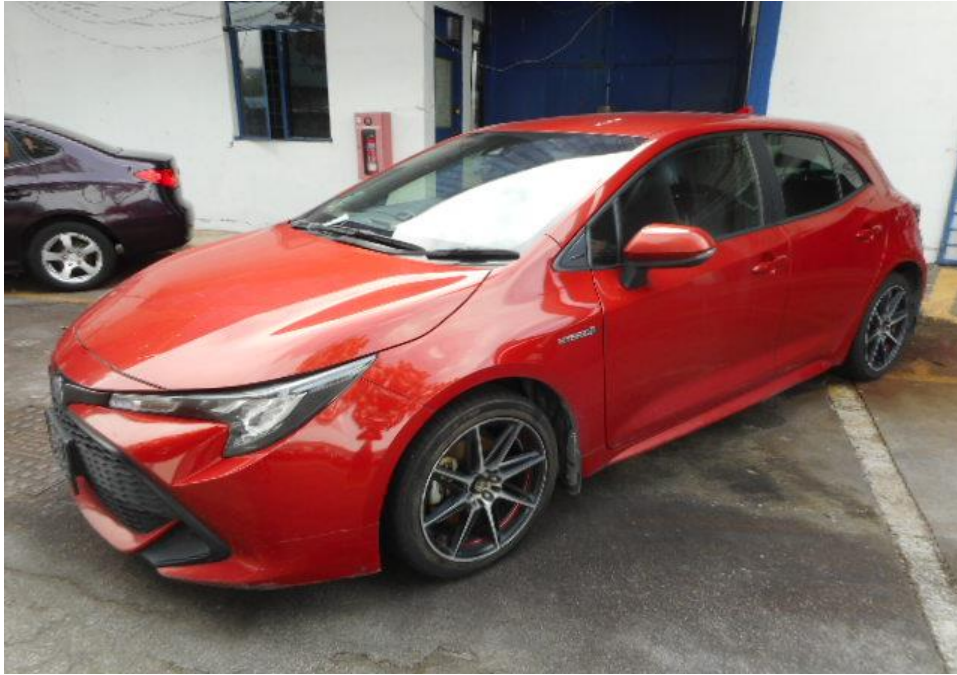
**Photo 4** shows a general view of the Motor Car's left body at the time of my inspection. The left portion of the Motor Car was observed to have been unaffected by the accident.

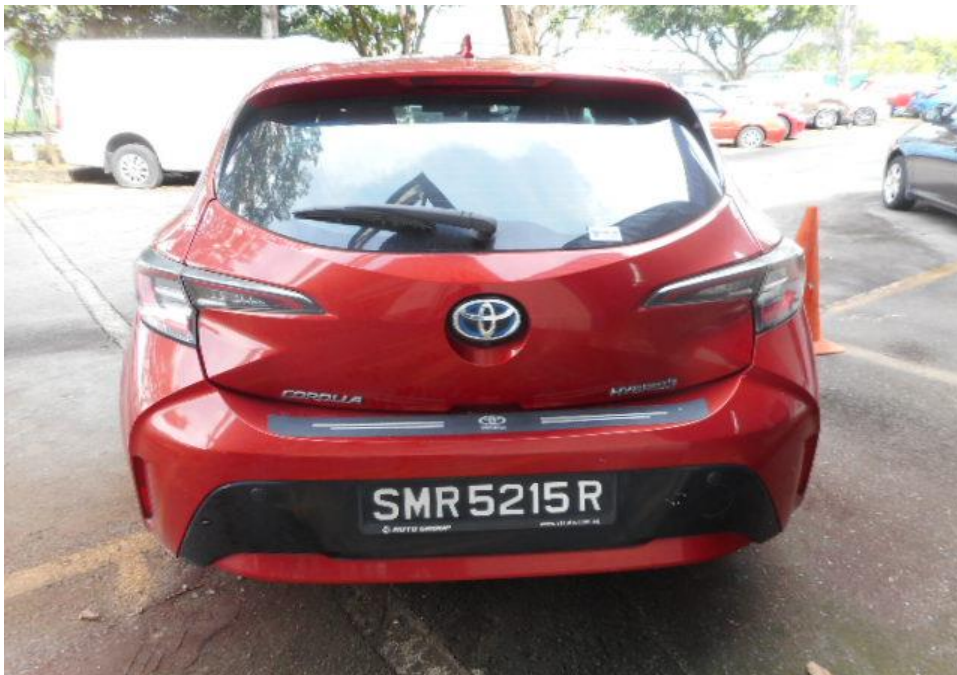
**Photo 5** shows the general view of the Motor Car's rear body at the time of my inspection. The Motor Car rear was observed to be unaffected by the accident.

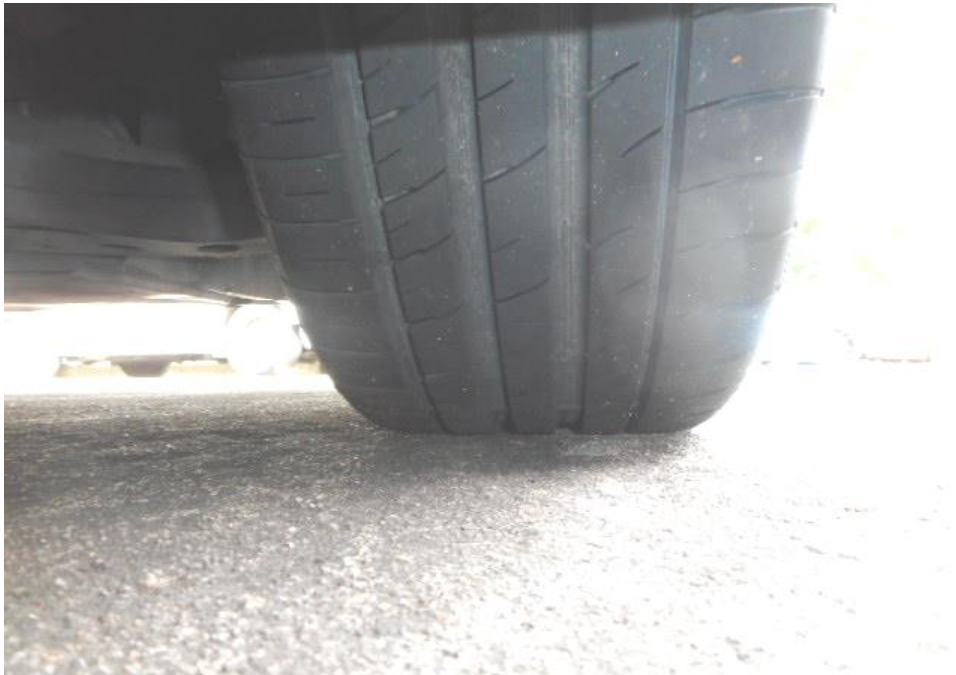
**Photo 6** shows the condition of the front right tyre of the Motor Car, which was observed to be in serviceable condition with remaining tread depth of approximately 5.4mm. The tyre was sufficiently inflated for vehicular operation with no tear, cut or burst mark(s) on the outer and the inner sidewalls as well as across the tread. The 4 tyres of the Motor Car were wrapped around standard steel wheel rims without any damage.

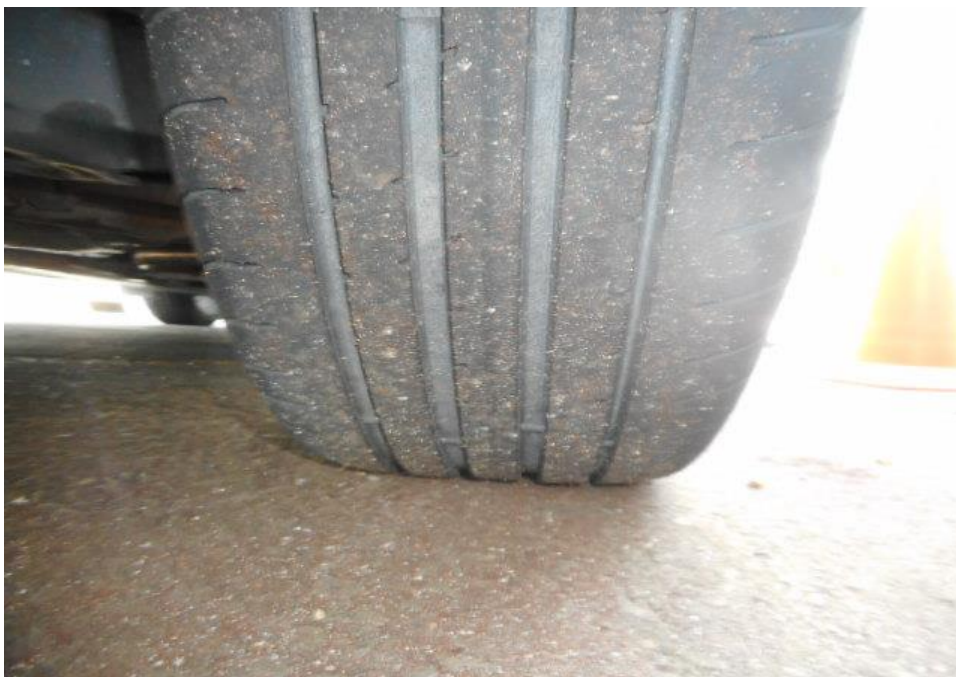
**Photo 7** shows the condition of the rear right tyre of the Motor Car, which was observed to be in serviceable condition with remaining tread depth of approximately 5mm. The tyre was also observed to be sufficiently inflated for vehicular operation with no tear, cut or burst mark(s).

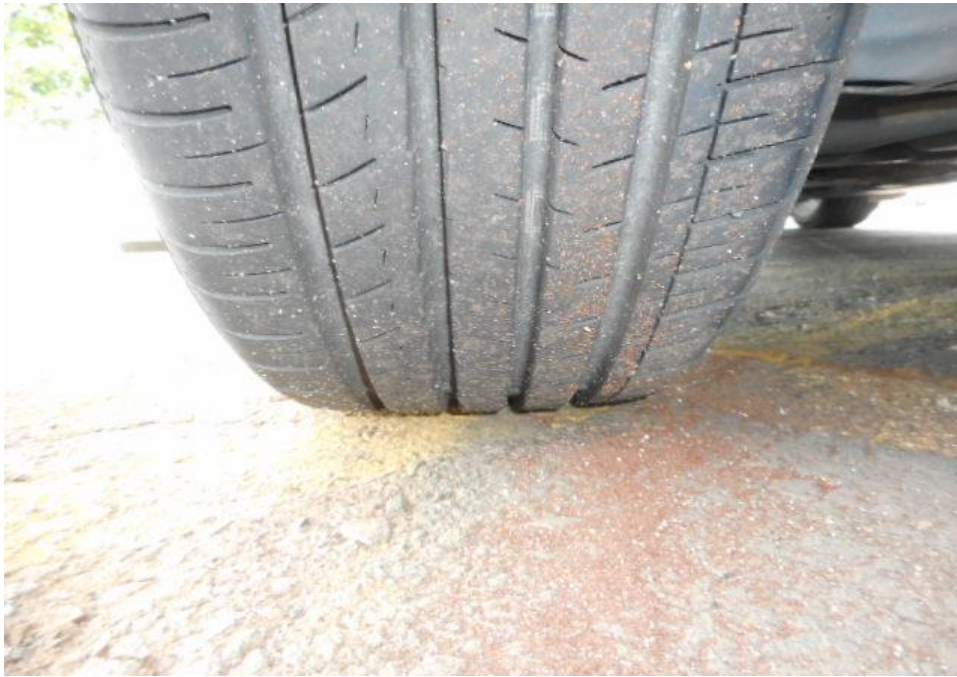
**Photo 8** shows the condition of the rear left tyre of the Motor Car, which was observed to be in serviceable condition with remaining tread depth of approximately 6.5mm. The tyre, which was wrapped around steel wheel rim, was also observed to be sufficiently inflated for vehicular operation. The 4 tyres of the Motor Car were wrapped around standard steel wheel rims.

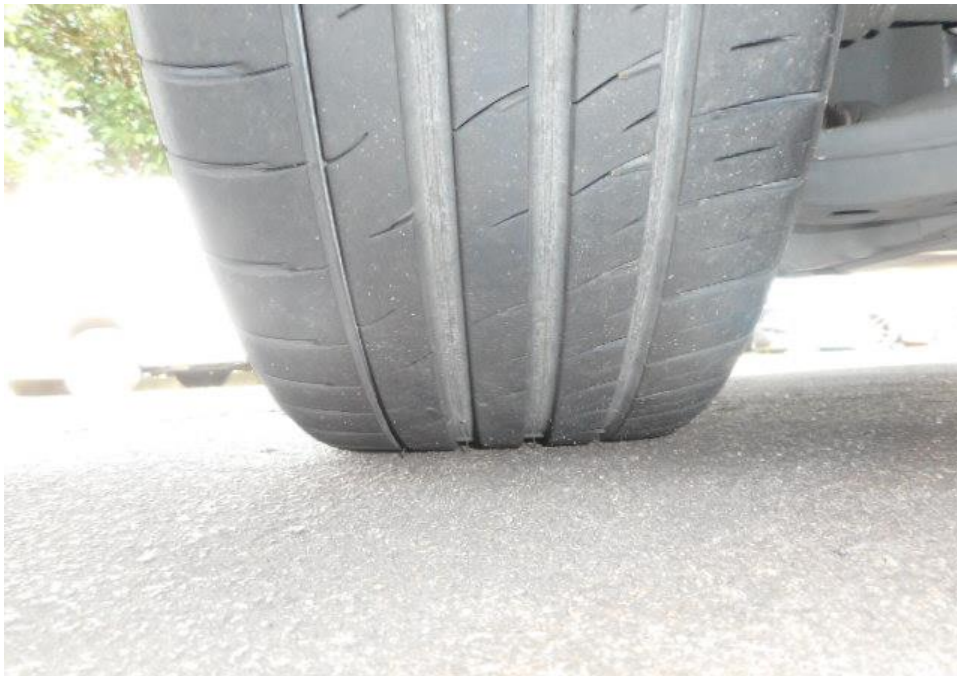
**Photo 9** shows the condition of the front left tyre of the Motor Car, which was observed to be in serviceable condition with remaining tread depth of approximately 5.1mm. There was also no tear, cut or burst mark(s) on the outer and the inner sidewalls as well as across the tread of the Motor Car's 4 tyres.

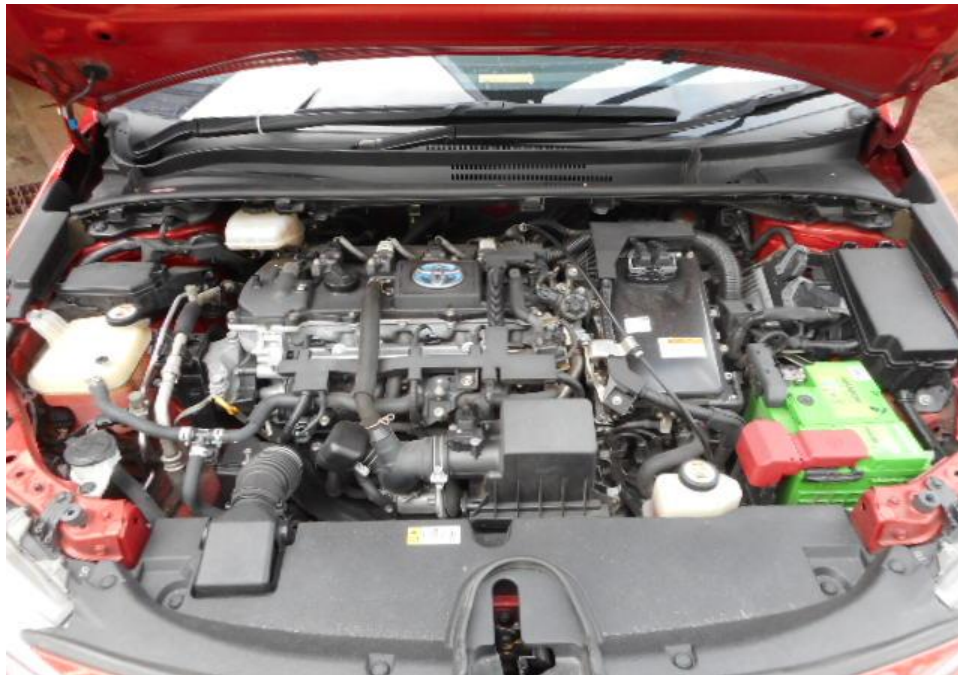
**Photo 10** shows a general view of the Motor Car's engine compartment. The various parts and components inside the engine compartment were unaffected by the accident. There was also no sign(s) or indication(s) of fluid leakage and/or fluid stain within the engine compartment.

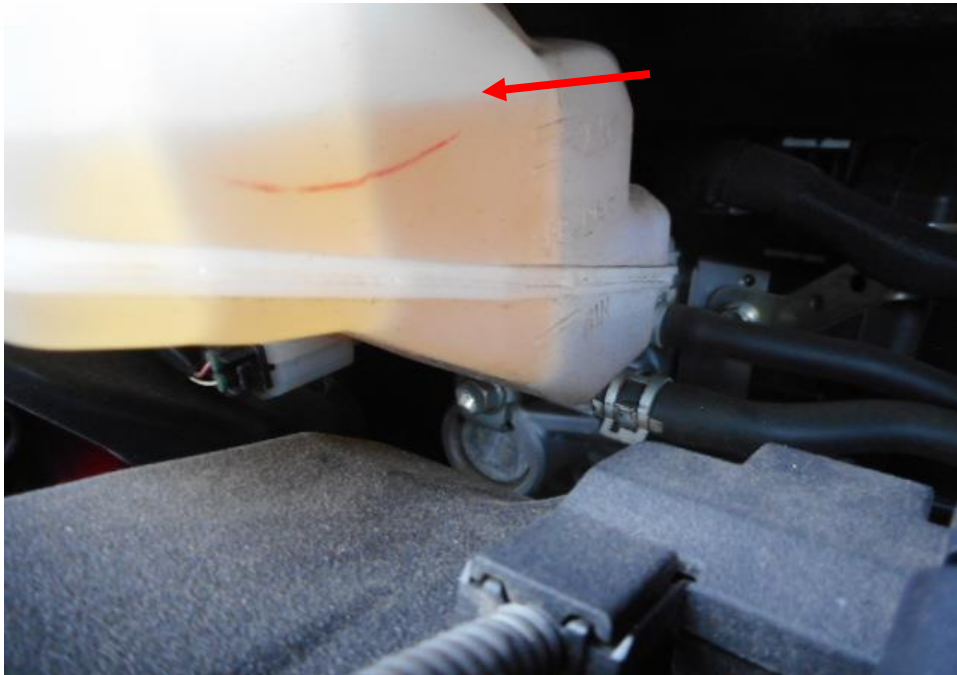
**Photo 11** shows the brake fluid reservoir of the Motor Car at the time of my inspection. The brake fluid was observed to be of sufficient level (arrowed) and without any visible contamination.

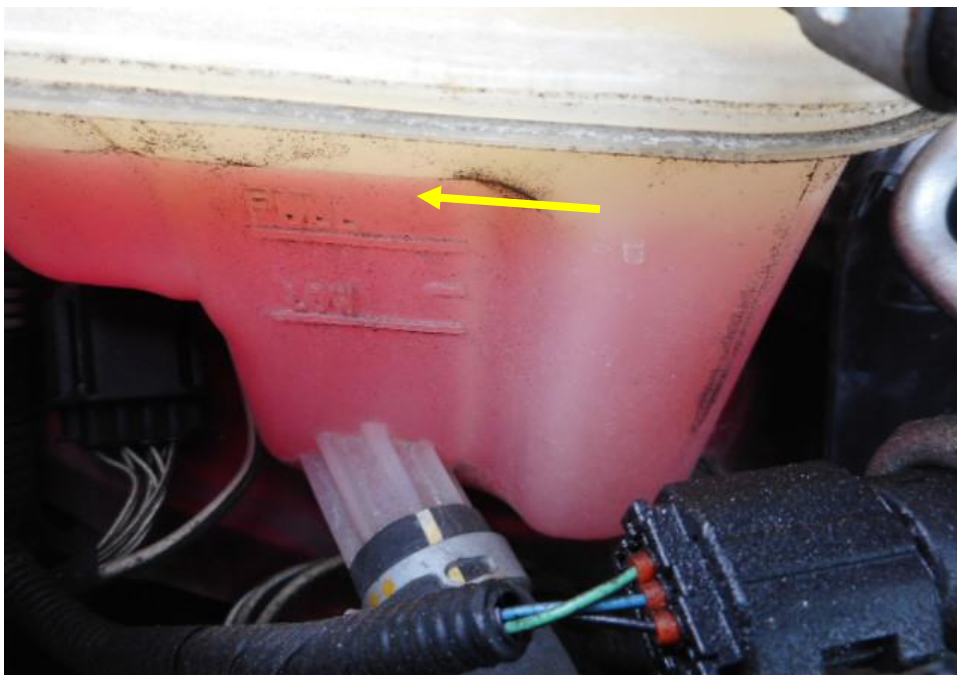
**Photo 12** shows checks being carried out to the engine coolant of the Motor Car at the time of my inspection. The engine coolant was observed to be of sufficient level (arrowed) and without any visible contamination.

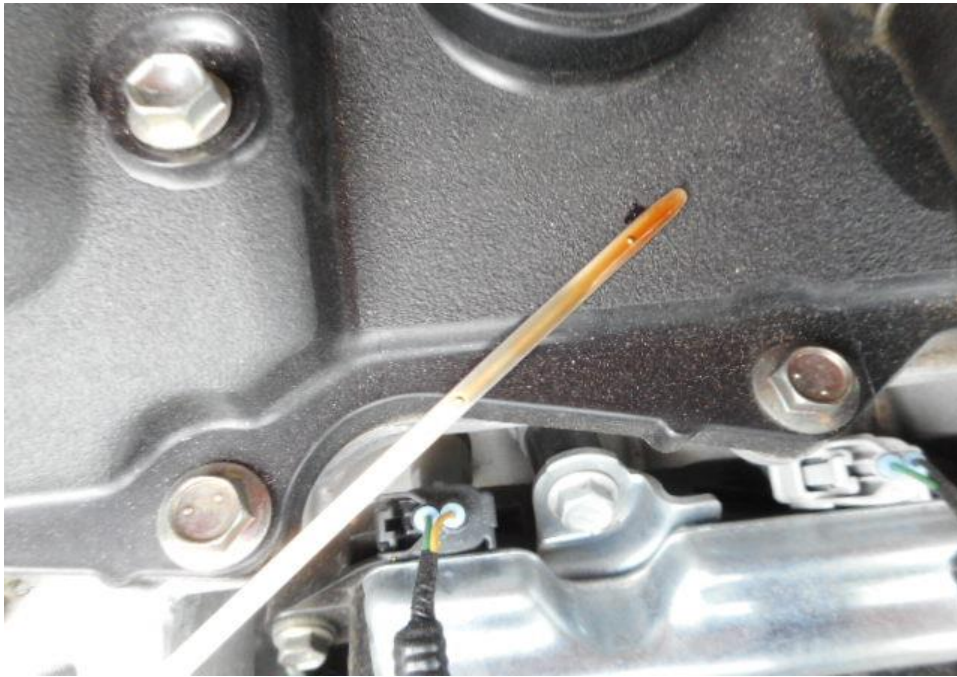
**Photo 13** shows the engine oil dip stick of the Motor Car at the time of my inspection. The engine oil was observed to be of sufficient level and without any visible contamination.

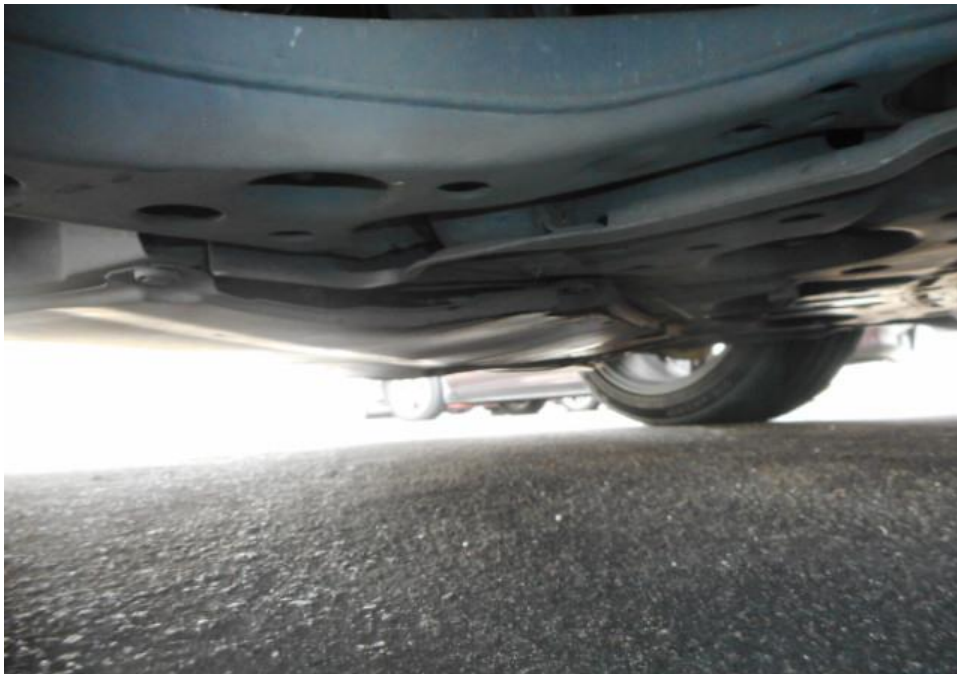
**Photo 14** shows the undercarriage of the Motor Car, at the area where the engine housing and transmission housing are located. I did not find any sign(s) or indication(s) of fluid leak and/or fluid stain(s) on the underside of the Motor Car.

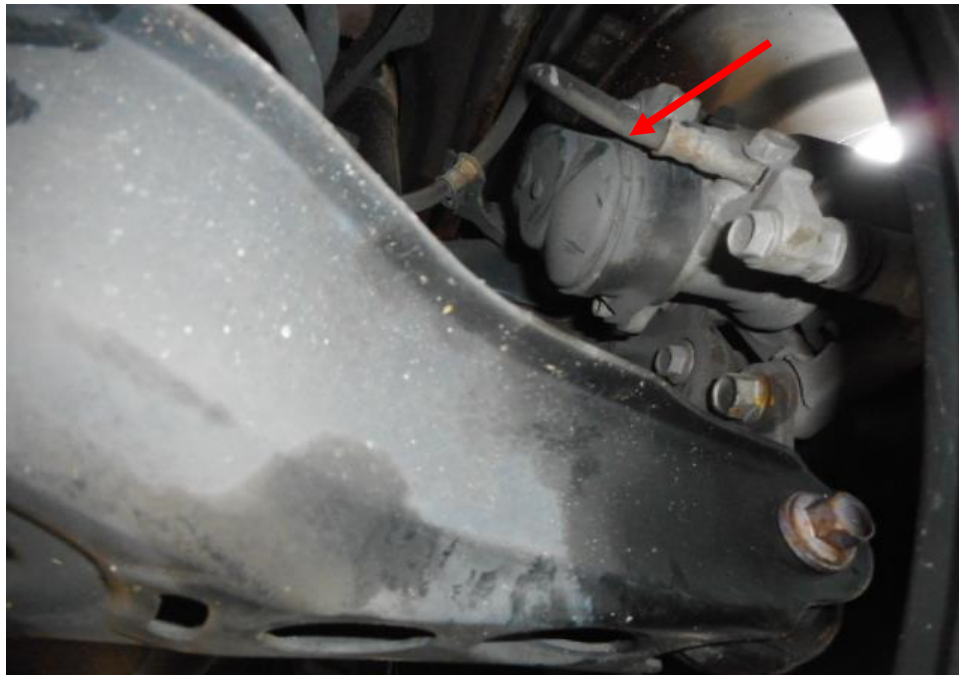
**Photo 15** shows the brake hose/pipe (arrowed) at the rear right wheel of the Motor Car. No leakage of brake fluid was observed. Visual examination of the various components of the braking system like the drum brake, brake booster, brake pedal etc. had revealed all to be intact and without visible damage.

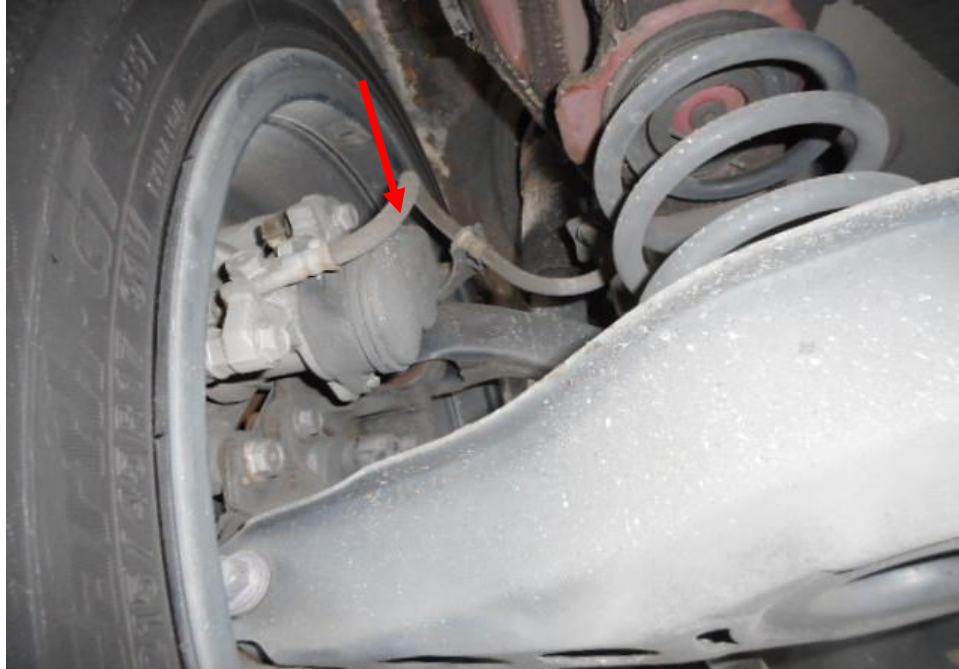
**Photo 16** shows the brake hose/pipe (arrowed) at the rear left wheel of the Motor Car. I did not observe any leakage of brake fluid at the time of my inspection of the Motor Car. Static tests of the Motor Car's braking system had indicated that there was no internal leakage of pressure/vacuum. The undercarriage components of the Motor Car were also all found to be intact and without any visible damage.

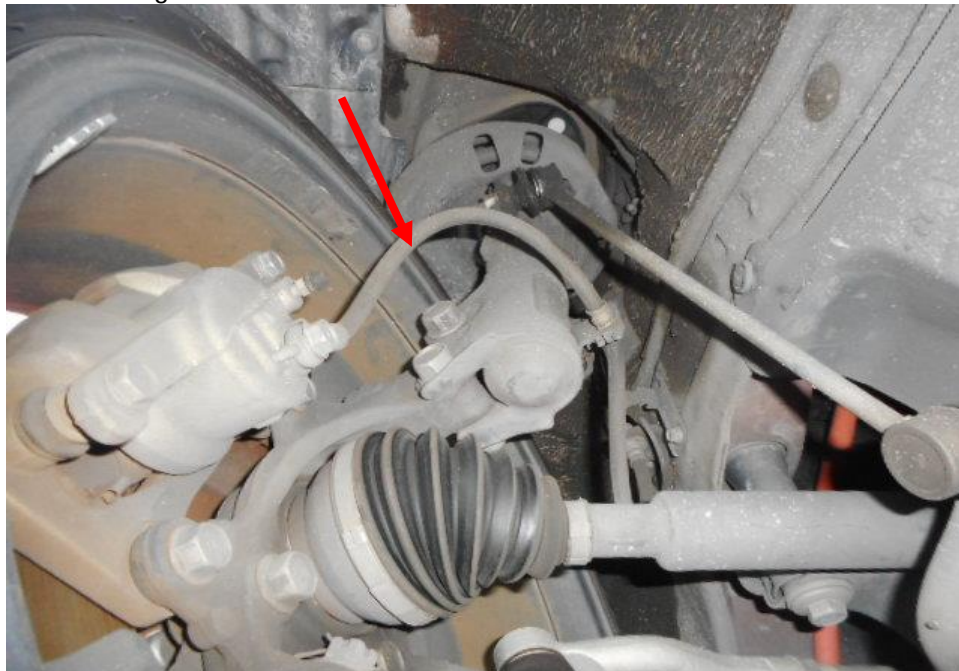
**Photo 17** shows the brake hose/pipe (arrowed) at the front right wheel of the Motor Car. I did not observe any leakage of brake fluid at the time of my inspection of the Motor Car. Static tests of the Motor Car's braking system had indicated that there was no internal leakage of pressure/vacuum. The undercarriage components of the Motor Car were also all found to be intact and without any visible damage.

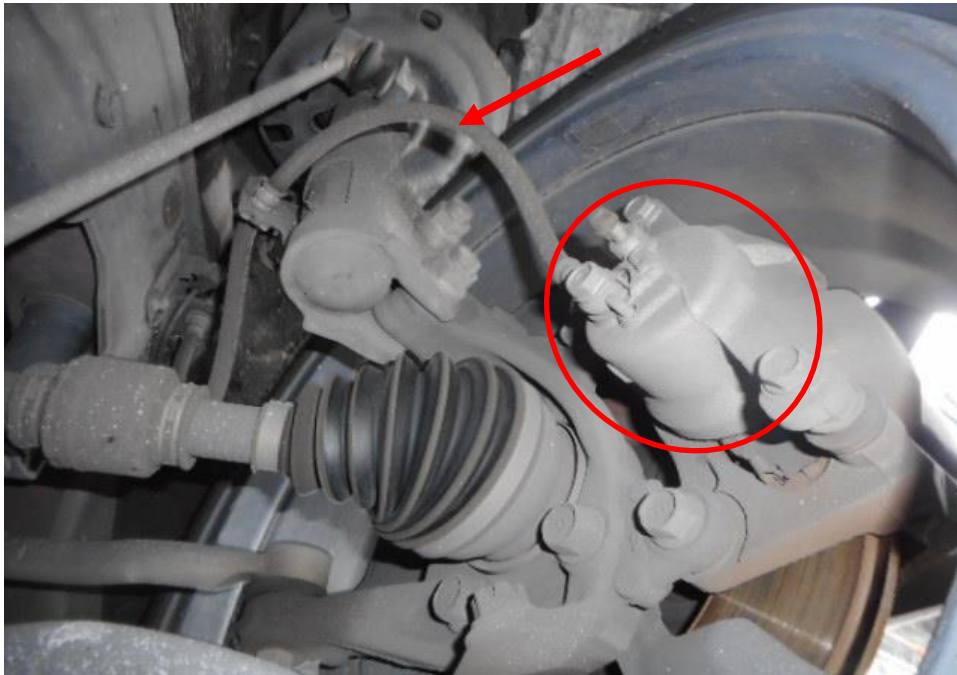
**Photo 18** shows the brake hose/pipe (arrowed) at the front left wheel of the Motor Car. No leakage of brake fluid was observed. Visual examination of the various components of the braking system like the brake caliper (circled), brake booster, brake pedal etc had revealed all to be intact and without visible damage.

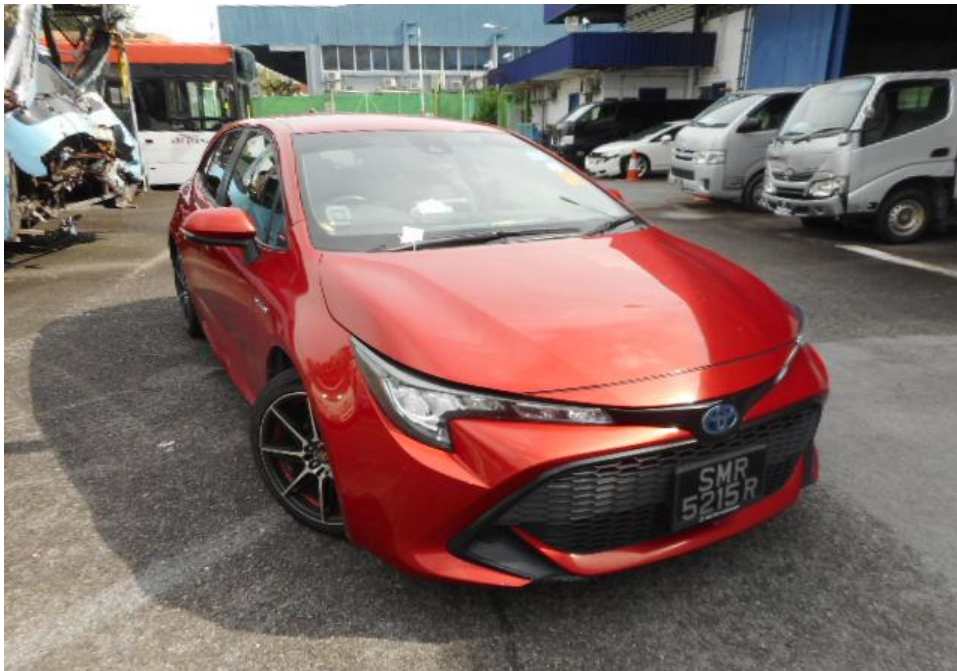
**Photo 19** shows the front right wheel of the Motor Car turned to its full left. During my steering system test, I did not experience any abnormal free play and/or resistance when I had turned the steering wheel towards the left and right. This would suggest that the steering system of the Motor Car was likely to be in serviceable condition at the material time of accident.

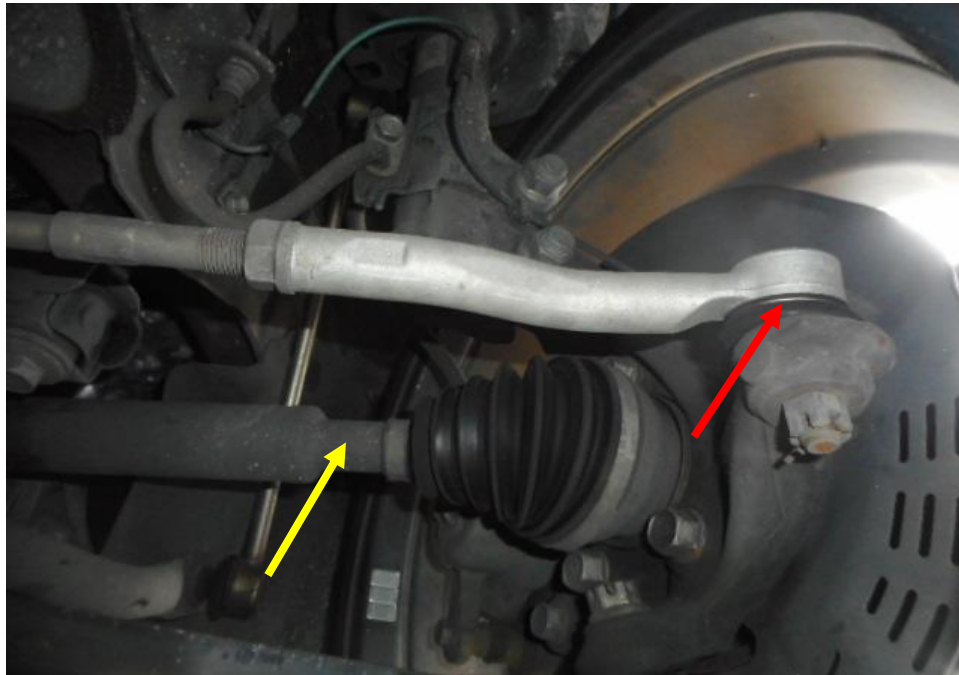
**Photo 20** shows the various undercarriage components at the front right wheel of the Motor Car, in particular the steering tie rod (red arrow) and drive shaft (yellow arrow). The various steering components were all found to be intact, suggesting that the steering system of the Motor Car was likely to be in serviceable condition at the material time of accident. There was also no sign of fluid stain observed on the various undercarriage components at the front right wheel of the Motor Car.

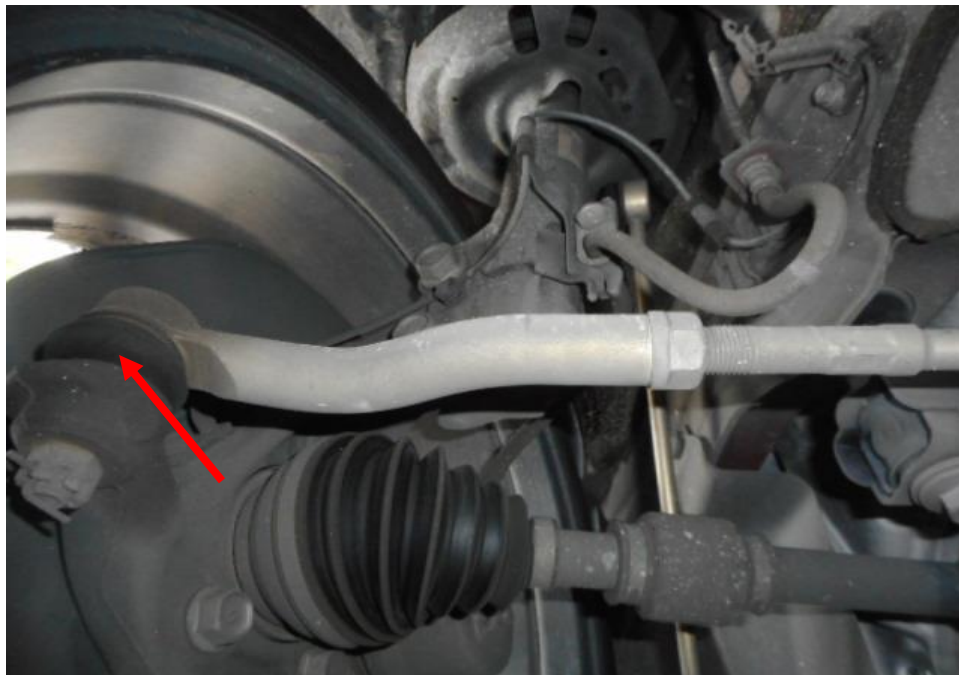
**Photo 21** shows the various undercarriage components at the front left wheel of the Motor Car, which had included the steering tie rod (arrowed). The various undercarriage components of the Motor Car were all found to be intact without any visible damage.

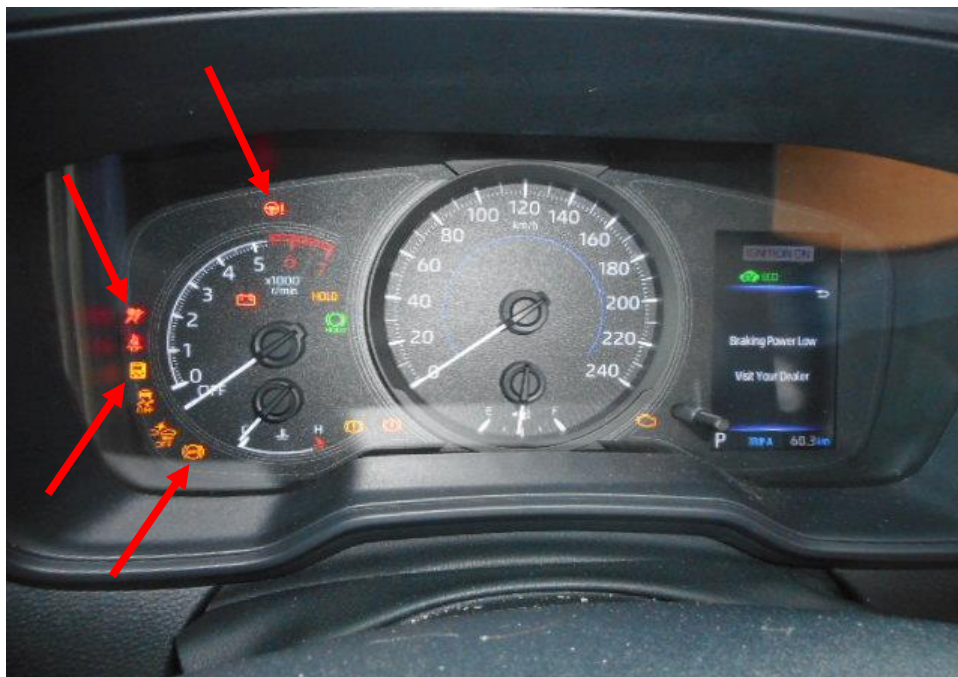
**Photo 22** shows the warning light for Anti-Lock Brake System (ABS) and Power Steering System (EPS), Supplemental Restraint System (SRS) and Traction Control (TC) (arrowed) appearing on the instrument panel of the Motor Car during the self-test of its various electronic operating systems when its engine was cranked.

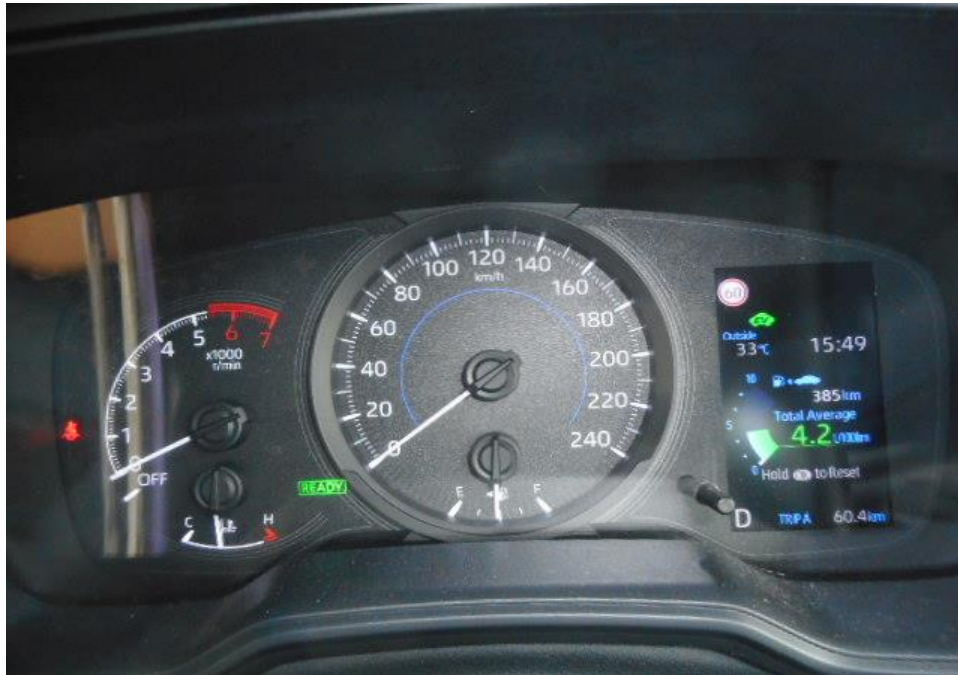
**Photo 23** shows no warning lights illuminated on the instrument panel of the Motor Car after the engine was cranked. This would suggest that there was no abnormality to the electronic operating system of the Motor Car, like the ABS, EPS, SRS, and TC etc.
