You're Ref: TP/IP/15610/2022  
Our Ref: CI/TPD22006185/P

**Fatal Accident Investigation Team**

**MECHANICAL INSPECTION REPORT OF MOTOR TAXI SHD 5501Y**

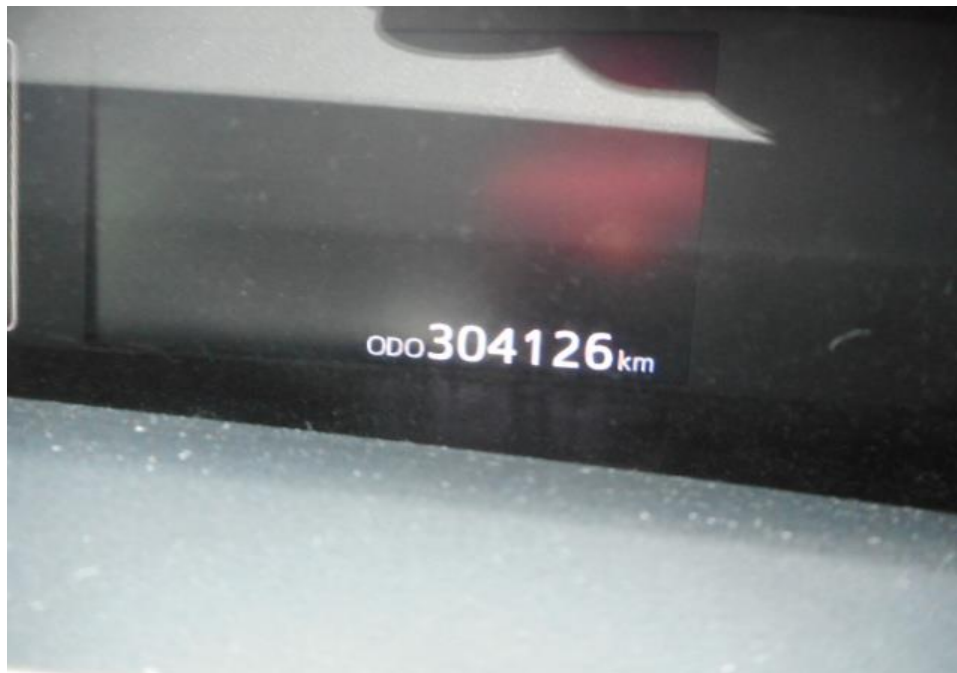
**Photo 1** shows the mileage of the Motor Taxi at the time of my inspection. The mileage observed was 304,126km.

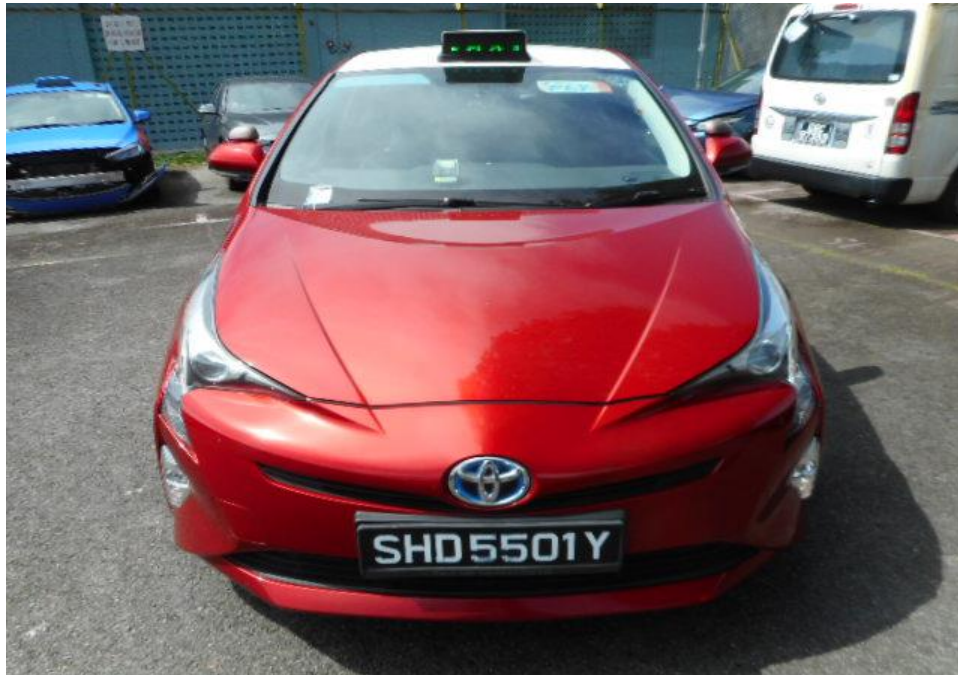
**Photo 2** shows a general view of the Motor Taxi's front body at the time of my inspection. The front portion of the Motor Taxi was observed to have sustained damage. The front bumper was the body part that were damaged as a result of the accident.

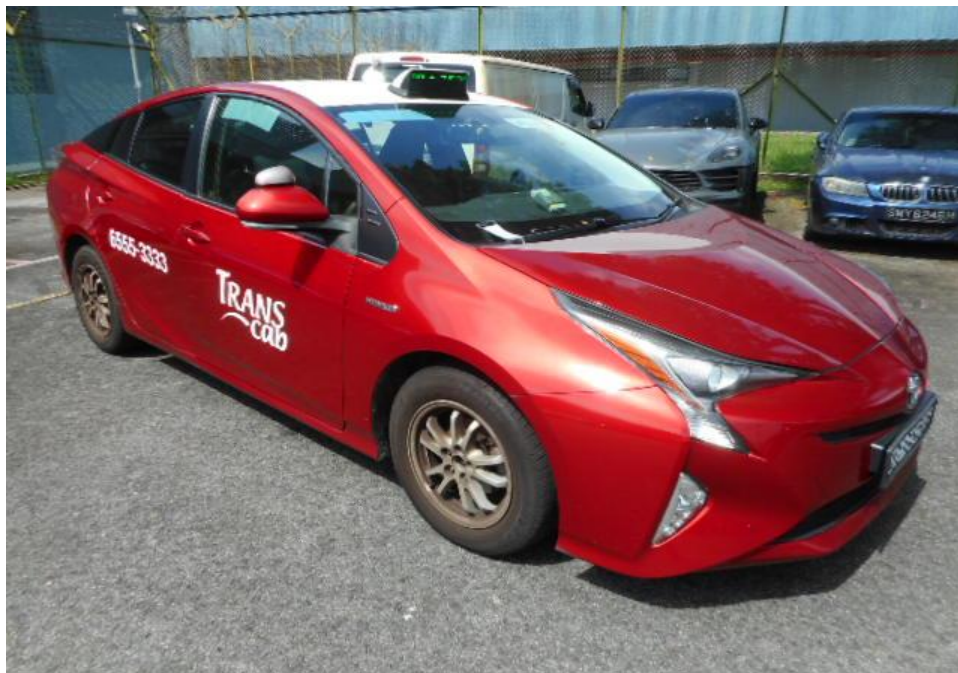
**Photo 3** shows a general view of the Motor Taxi's right body at the time of my inspection. The right portion of the Motor Taxi was observed to have been unaffected by the accident.

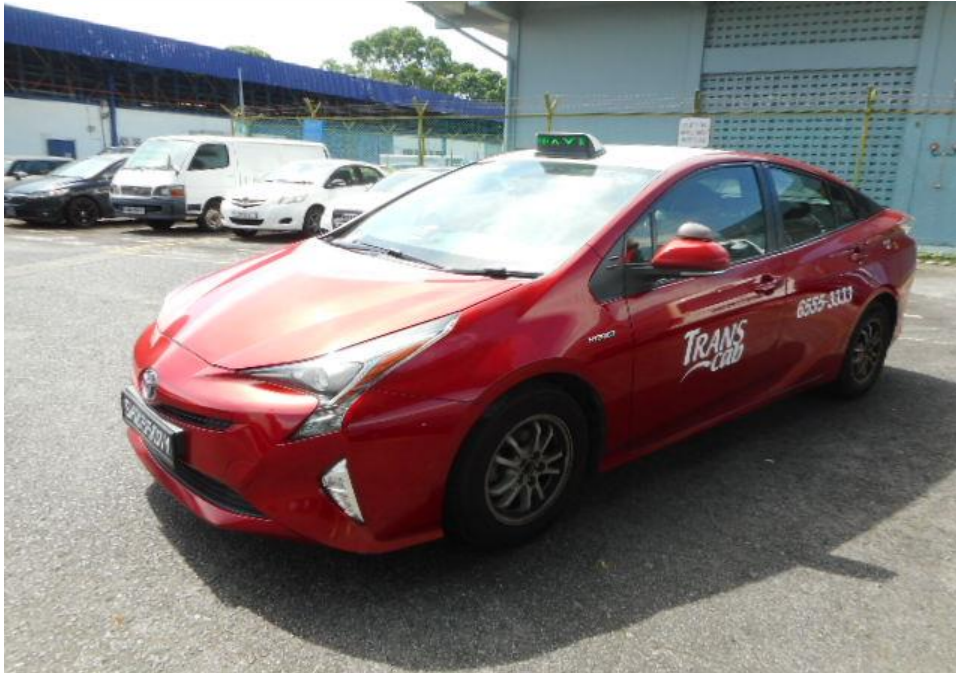
**Photo 4** shows a general view of the Motor Taxi's left body at the time of my inspection. The left portion of the Motor Taxi was observed to have been unaffected by the accident.

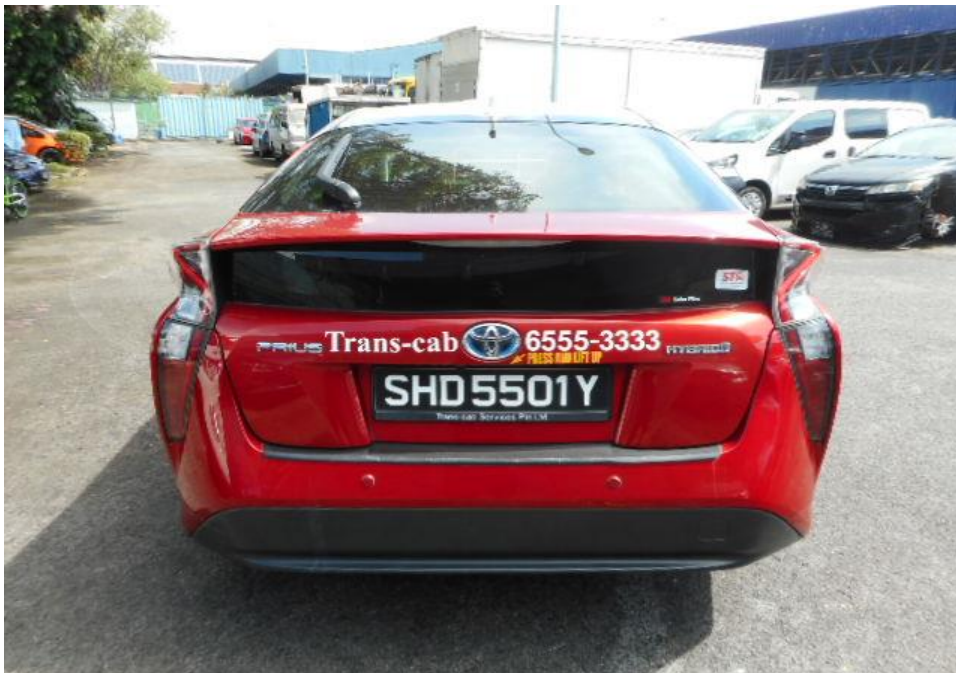
**Photo 5** shows the general view of the Motor Taxi's rear body at the time of my inspection. The Motor Taxi rear was observed to be unaffected by the accident.

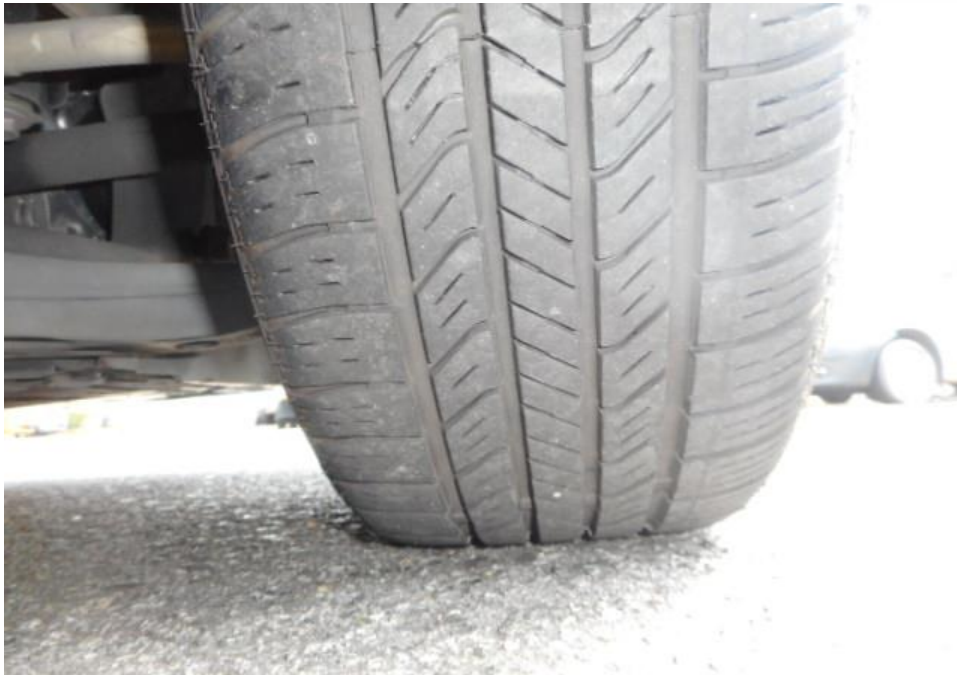
**Photo 6** shows the condition of the front right tyre of the Motor Taxi, which was observed to be in serviceable condition with remaining tread depth of approximately 5.5mm. The tyre was sufficiently inflated for vehicular operation with no tear, cut or burst mark(s) on the outer and the inner sidewalls as well as across the tread. The 4 tyres of the Motor Taxi were wrapped around standard steel wheel rims without any damage.

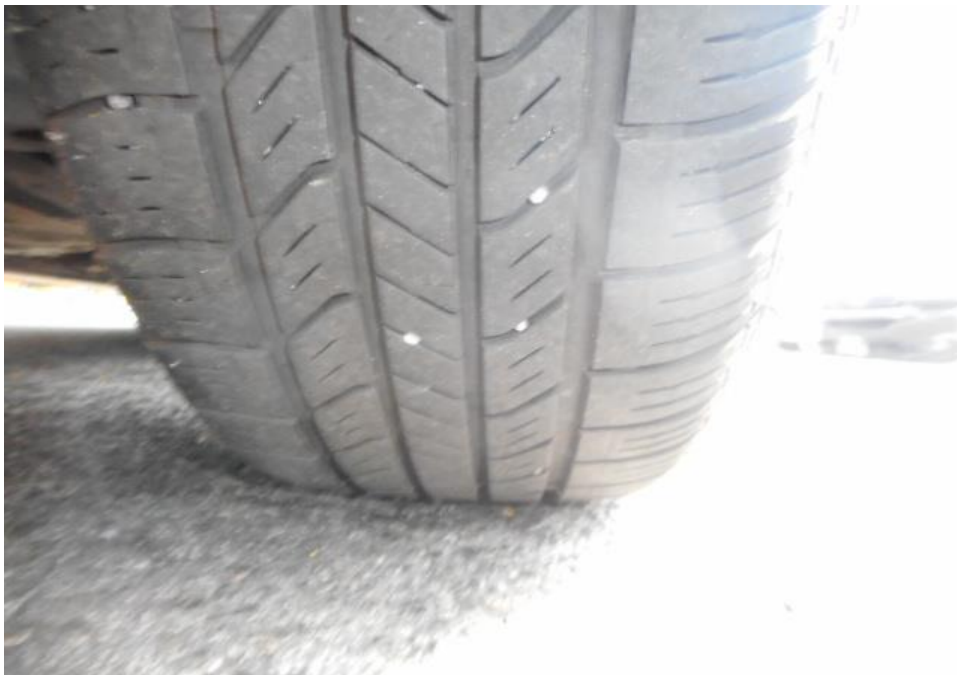
**Photo 7** shows the condition of the rear right tyre of the Motor Taxi, which was observed to be in serviceable condition with remaining tread depth of approximately 5.4mm. The tyre was also observed to be sufficiently inflated for vehicular operation with no tear, cut or burst mark(s).

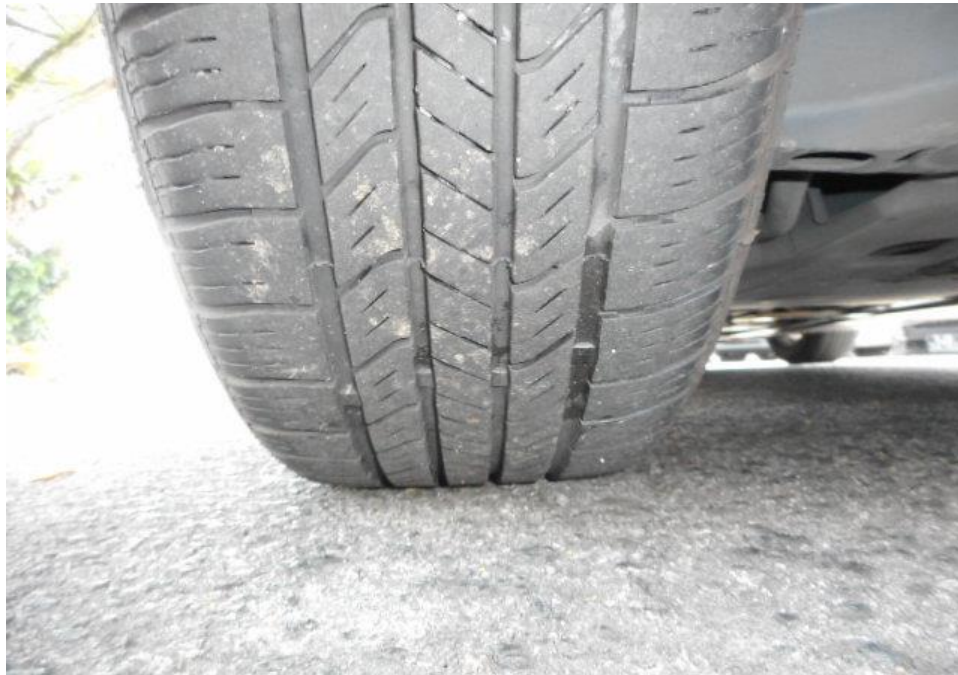
**Photo 8** shows the condition of the rear left tyre of the Motor Taxi, which was observed to be in serviceable condition with remaining tread depth of approximately 5.1mm. The tyre, which was wrapped around steel wheel rim, was also observed to be sufficiently inflated for vehicular operation. The 4 tyres of the Motor Taxi were wrapped around standard steel wheel rims.

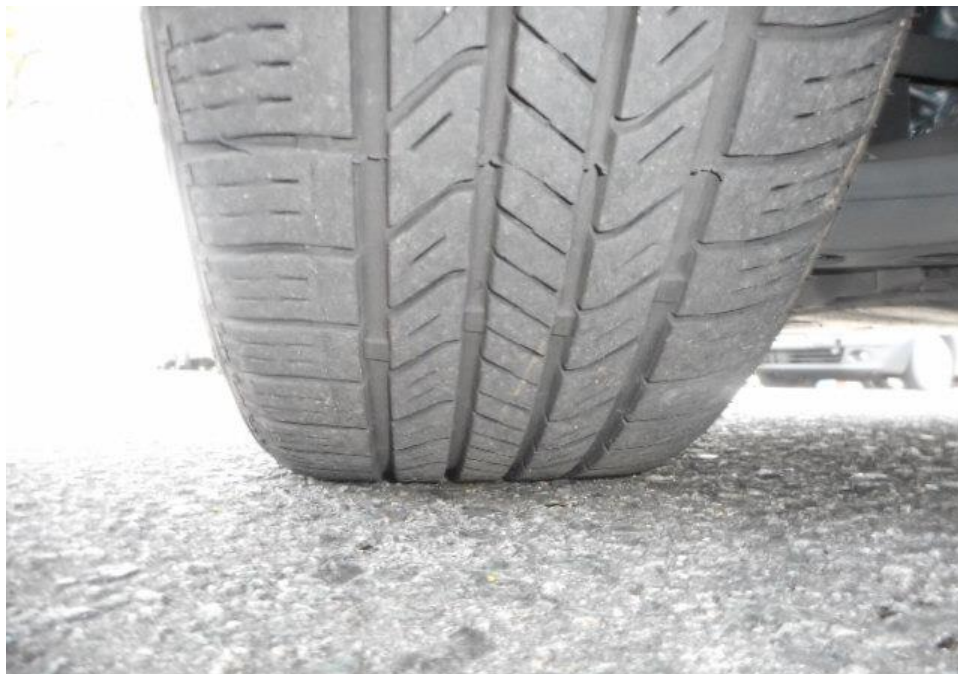
**Photo 9** shows the condition of the front left tyre of the Motor Taxi, which was observed to be in serviceable condition with remaining tread depth of approximately 5.2mm. There was also no tear, cut or burst mark(s) on the outer and the inner sidewalls as well as across the tread of the Motor Taxi's 4 tyres.

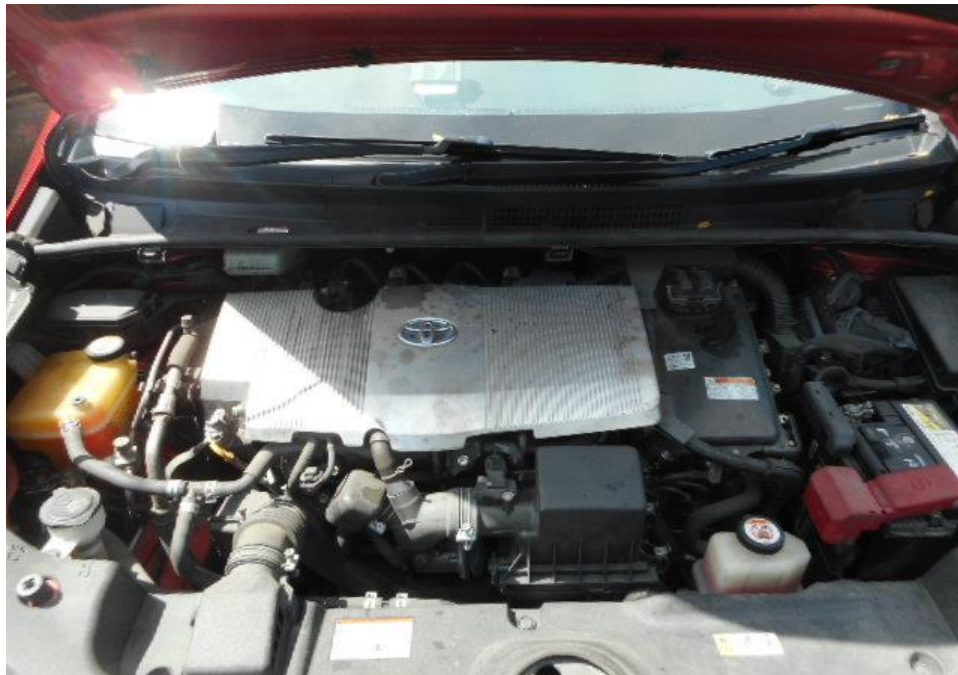
**Photo 10** shows a general view of the Motor Taxi's engine compartment. The various parts and components inside the engine compartment were unaffected by the accident. There was also no sign(s) or indication(s) of fluid leakage and/or fluid stain within the engine compartment.

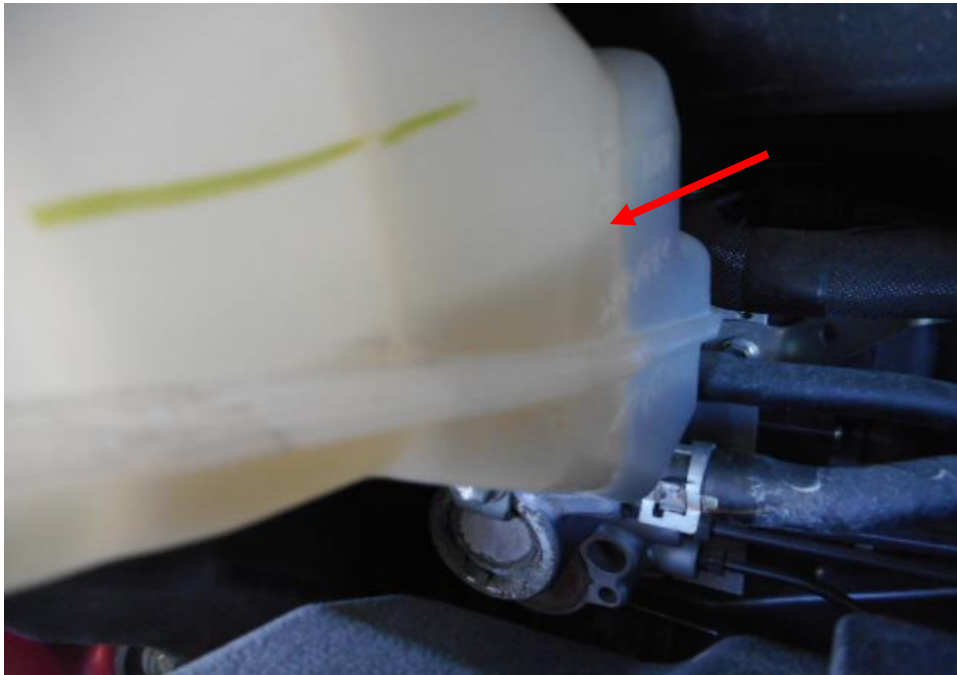
**Photo 11** shows the brake fluid reservoir of the Motor Taxi at the time of my inspection. The brake fluid was observed to be of sufficient level (arrowed) and without any visible contamination.

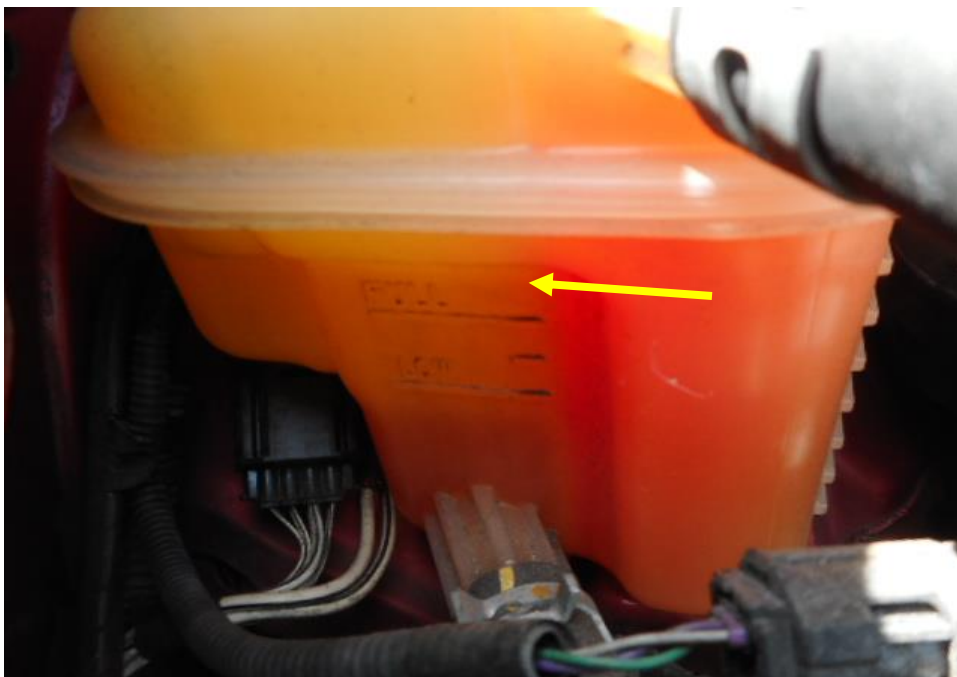
**Photo 12** shows checks being carried out to the engine coolant of the Motor Taxi at the time of my inspection. The engine coolant was observed to be of sufficient level (arrowed) and without any visible contamination.

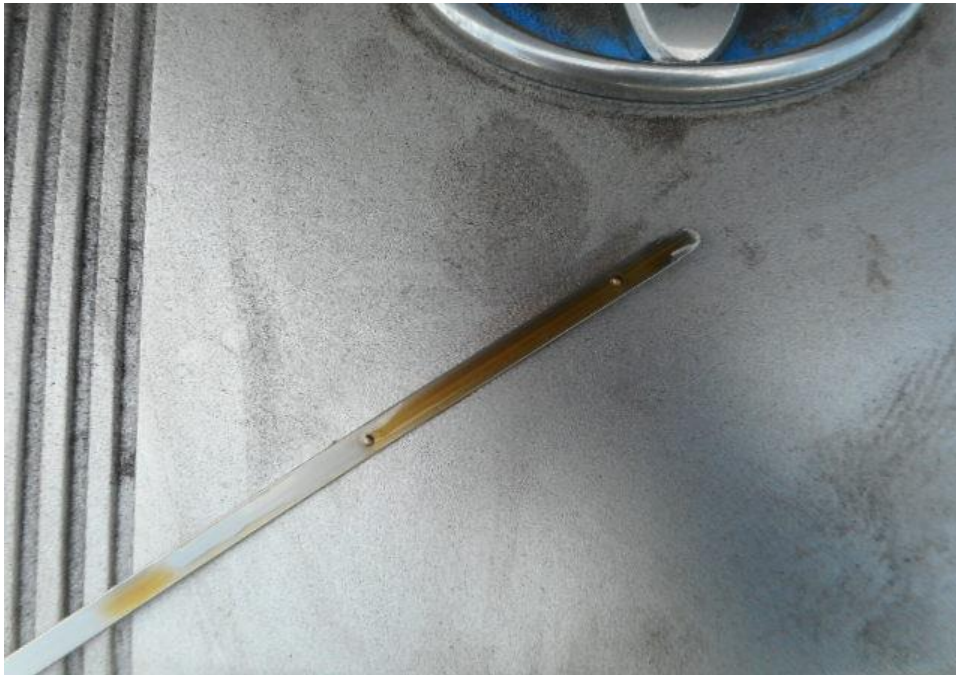
**Photo 13** shows the engine oil dip stick of the Motor Taxi at the time of my inspection. The engine oil was observed to be of sufficient level and without any visible contamination.

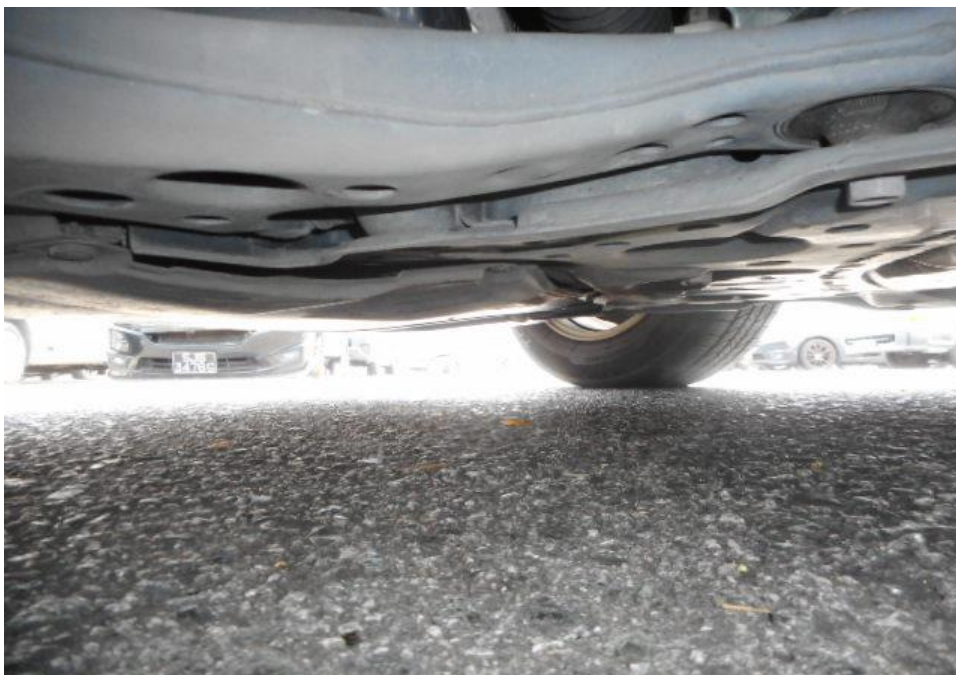
**Photo 14** shows the undercarriage of the Motor Taxi, at the area where the engine housing and transmission housing are located. I did not find any sign(s) or indication(s) of fluid leak and/or fluid stain(s) on the underside of the Motor Taxi.

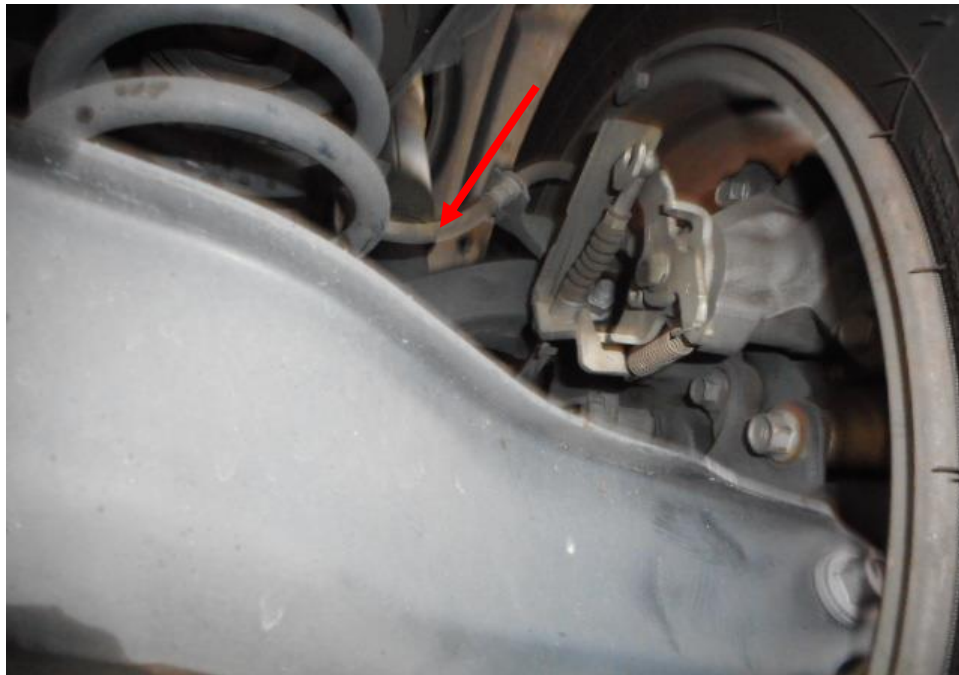
**Photo 15** shows the brake hose/pipe (arrowed) at the rear right wheel of the Motor Taxi. No leakage of brake fluid was observed. Visual examination of the various components of the braking system like the drum brake, brake booster, brake pedal etc. had revealed all to be intact and without visible damage.

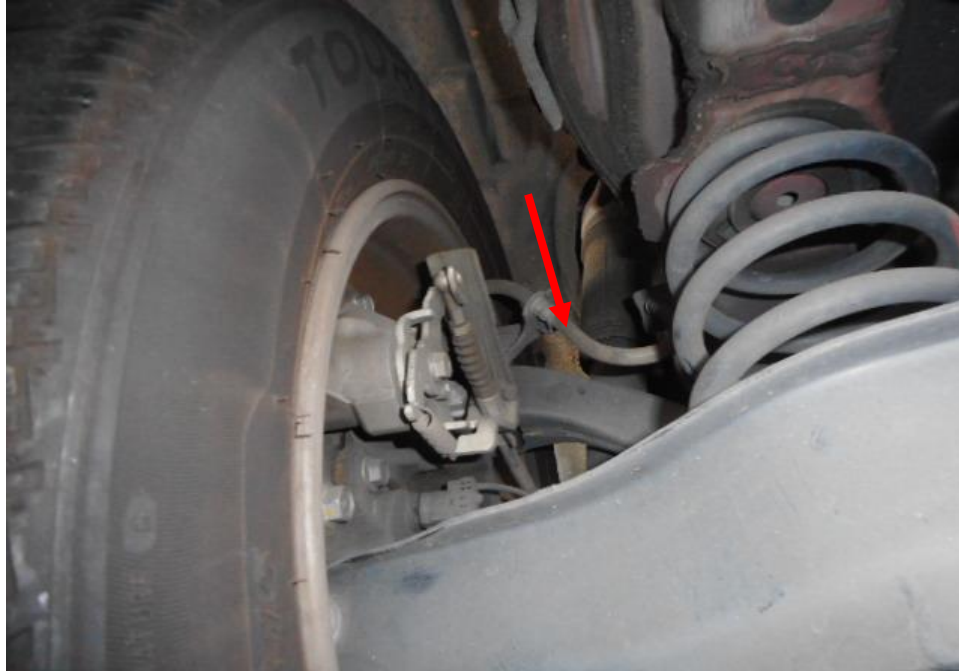
**Photo 16** shows the brake hose/pipe (arrowed) at the rear left wheel of the Motor Taxi. I did not observe any leakage of brake fluid at the time of my inspection of the Motor Taxi. Static tests of the Motor Taxi's braking system had indicated that there was no internal leakage of pressure/vacuum. The undercarriage components of the Motor Taxi were also all found to be intact and without any visible damage.

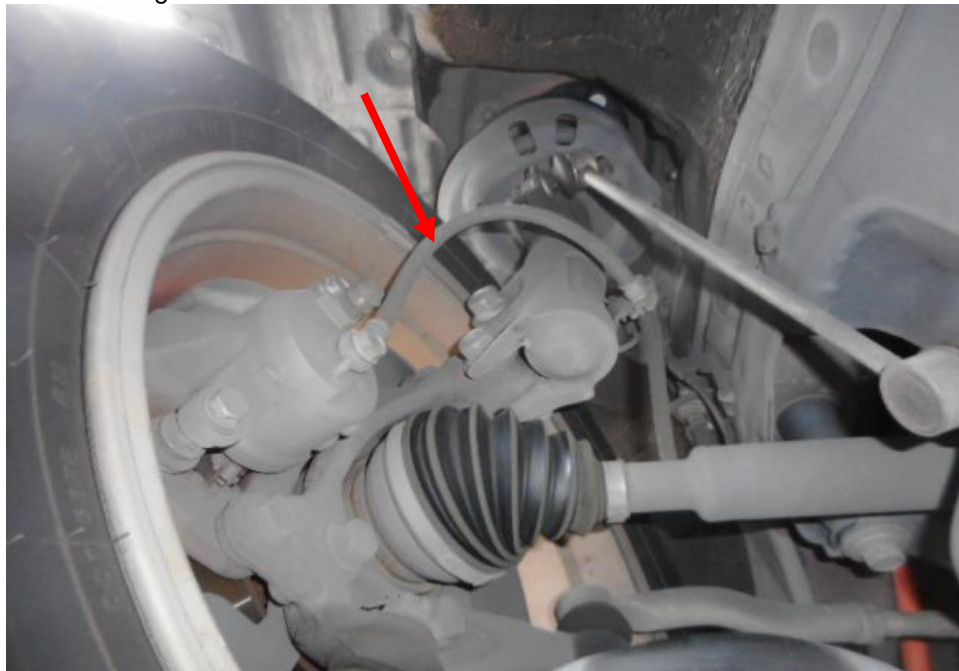
**Photo 17** shows the brake hose/pipe (arrowed) at the front right wheel of the Motor Taxi. I did not observe any leakage of brake fluid at the time of my inspection of the Motor Taxi. Static tests of the Motor Taxi's braking system had indicated that there was no internal leakage of pressure/vacuum. The undercarriage components of the Motor Taxi were also all found to be intact and without any visible damage.

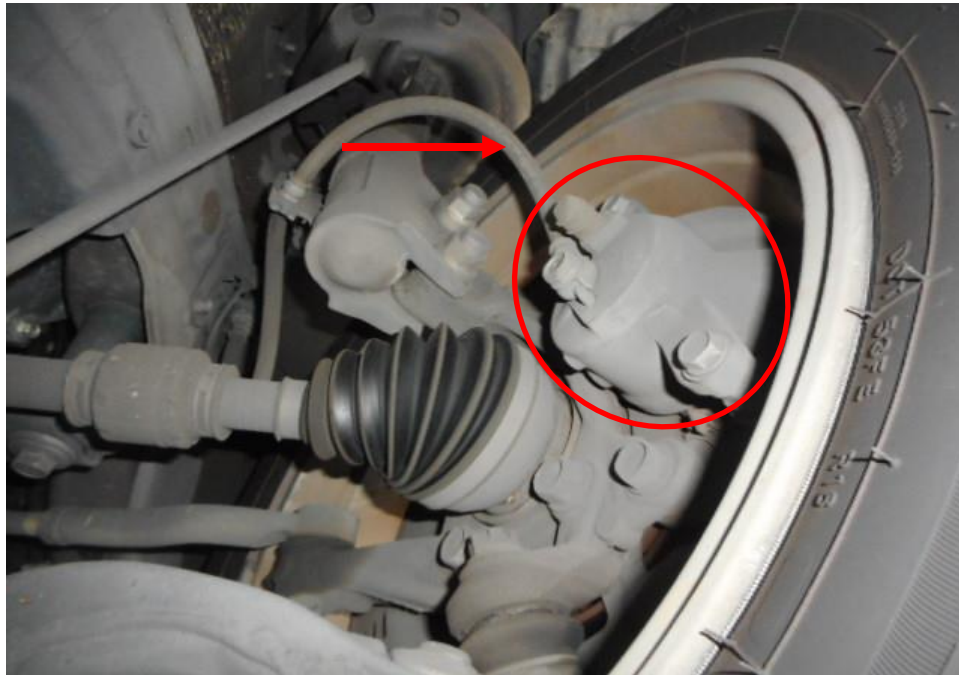
**Photo 18** shows the brake hose/pipe (arrowed) at the front left wheel of the Motor Taxi. No leakage of brake fluid was observed. Visual examination of the various components of the braking system like the brake caliper (circled), brake booster, brake pedal etc had revealed all to be intact and without visible damage.

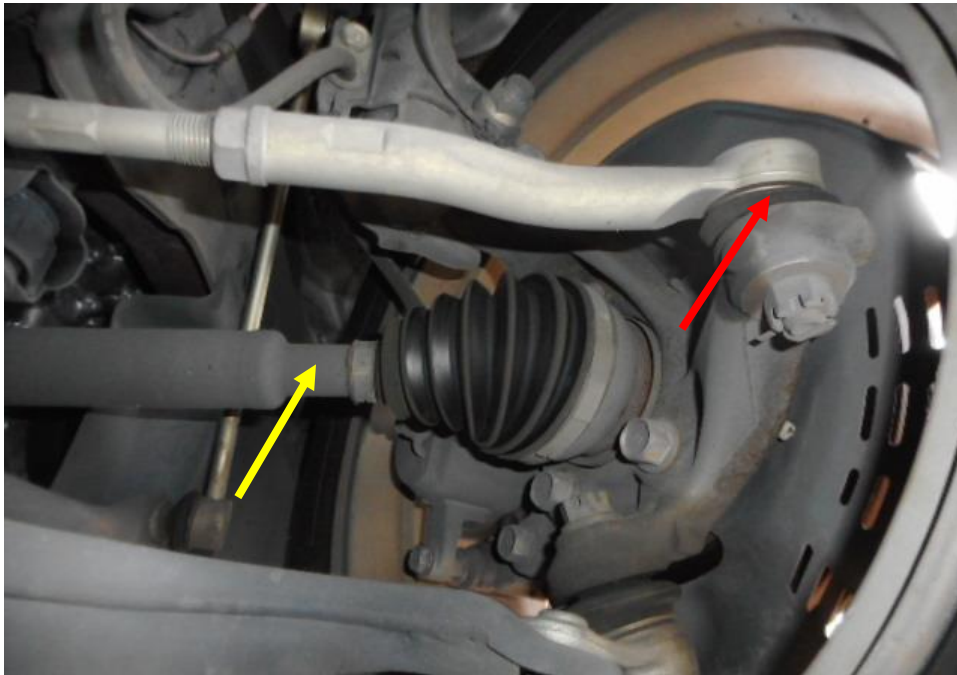
**Photo 20** shows the various undercarriage components at the front right wheel of the Motor Taxi, in particular the steering tie rod (red arrow) and drive shaft (yellow arrow). The various steering components were all found to be intact, suggesting that the steering system of the Motor Taxi was likely to be in serviceable condition at the material time of accident. There was also no sign of fluid stain observed on the various undercarriage components at the front right wheel of the Motor Taxi.

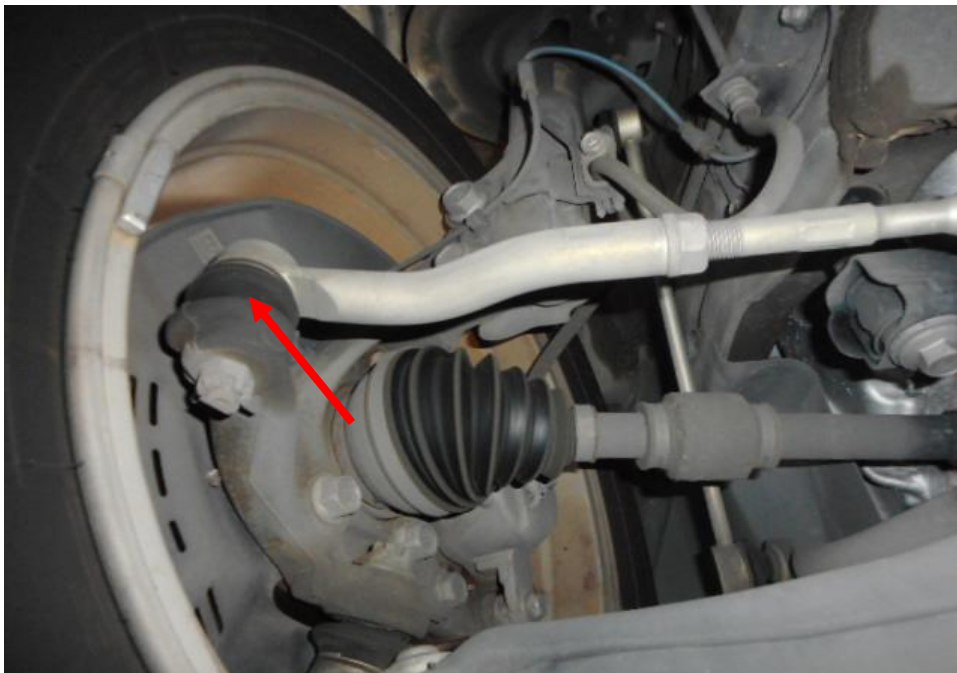
**Photo 21** shows the various undercarriage components at the front left wheel of the Motor Taxi, which had included the steering tie rod (arrowed). The various undercarriage components of the Motor Taxi were all found to be intact without any visible damage.

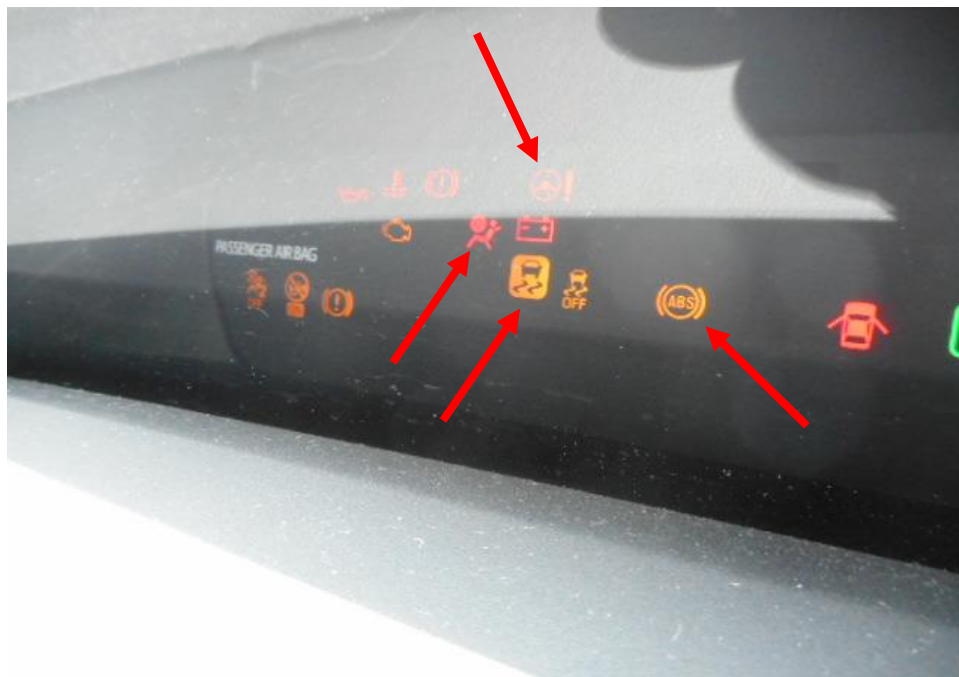
**Photo 22** shows the warning light for Anti-Lock Brake System (ABS) and Power Steering System (EPS), Supplemental Restraint System (SRS) and Traction Control (TC) (arrowed) appearing on the instrument panel of the Motor Taxi during the self-test of its various electronic operating systems when its engine was cranked.

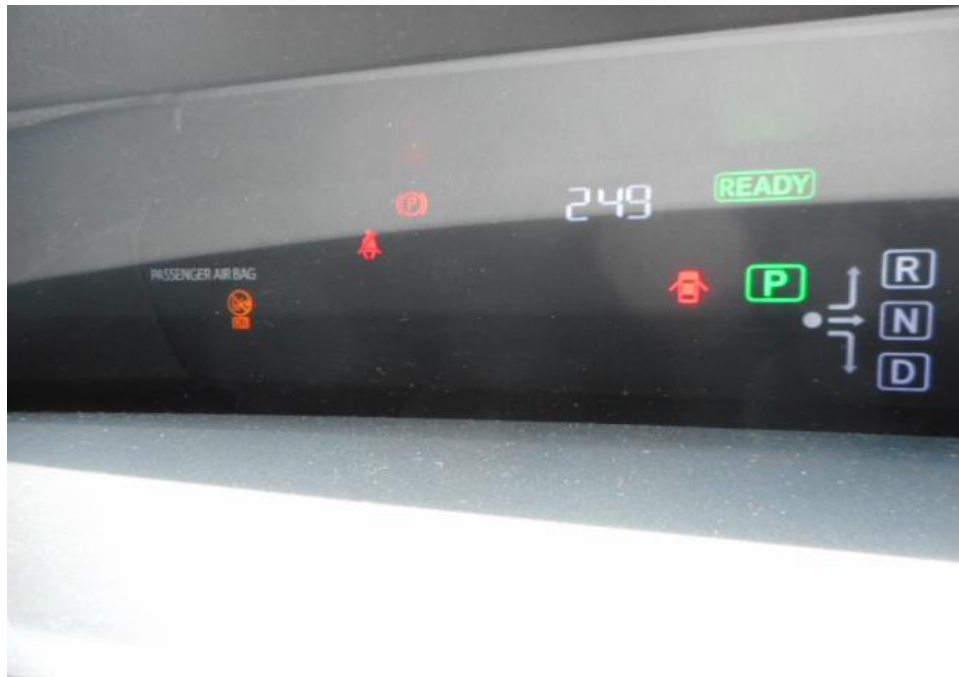
**Photo 23** shows no warning lights illuminated on the instrument panel of the Motor Taxi after the engine was cranked. This would suggest that there was no abnormality to the electronic operating system of the Motor Taxi, like the ABS, EPS, SRS, and TC etc.
