PRECISION APPRAISAL SERVICES

AUTOMOBILE INSPECTION REPORT

VEHICLE REGISTRATION NO. : SJJ 7663 U

VEHICLE REGN NO : SJJ 7663 U
 OUR REFERENCE : PAS/AFS/220238/TP
 INSPECTION REPORT DATE : 30-Jul-22

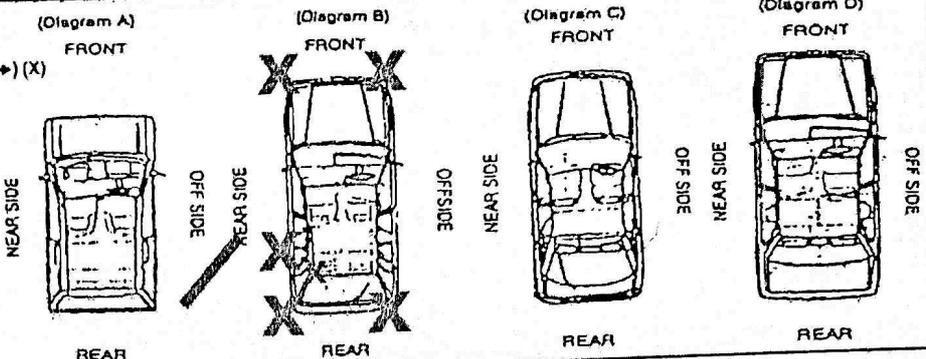
POINT OF IMPACT

Direction of impact/damage marked (→) (X)

The vehicle sustained impact on its Front & Rear Portion. (see Diagram B)

Parts damaged were : **The front bumper and grille, front n/s fender and headlamp panel, aircon condenser, rear bumper and panel, bootlid, both rear fenders and chassis, n/s taillamp lower panel and rooftop panel were dented.**
