AUTOMOBILE INSPECTION REPORT

Assigned By : As above
Accident Date : 29 June 2022
Assignment Date : 30 June 2022
Inspection Date : 30 June 2022
Our Reference No. : PAS/AFS/220238/TP

Registration No.	: SJJ 7663 U	Mileage	: 176549	Km/h
Make/Model	: HONDA STREAM 1.8X A	Radio/Cassette	: Fitted	
Yr of Manuf/Regn	: 30 Sep 2015	CD Disc Player	: Fitted	
Carrying Capacity	: 7Seater	Air Conditioner	: Fitted	
Chassis No.	: RN61070284	Clock	: Fitted	
Engine No.	: R18A1777771	Seat Belt	: Fitted	
Colour	: Metallic White	Wing Mirror	: Fitted	
Class	: Passenger (Private Hire - Station Wagon)	Other Accessories	: Fitted

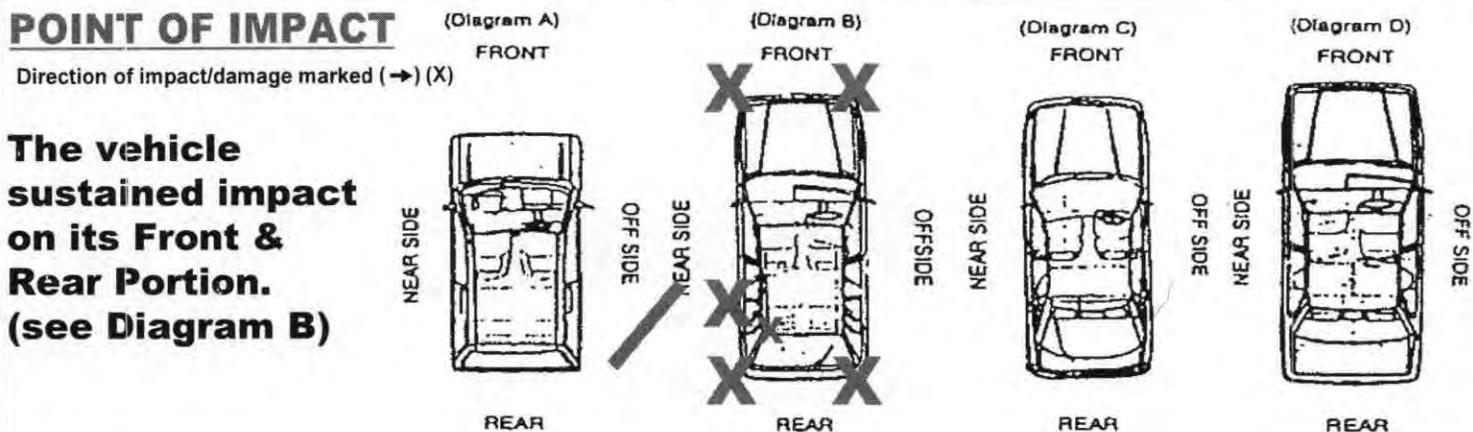
POINT OF IMPACT

The vehicle sustained impact on its Front & Rear Portion. (see Diagram B)

Parts damaged were : **The front bumper and grille, front n/s fender and headlamp panel, aircon condenser, rear bumper and panel, bootlid, both rear fenders and chassis, n/s taillamp lower panel and rooftop panel were dented.**
