# **VEHICLE INSPECTION REPORT**

Report No.: PAS/TP/0160522

: SKT318Z

: Audi Q5 Sport 2.0 TFSI Quattro S Tror Mileage (km)

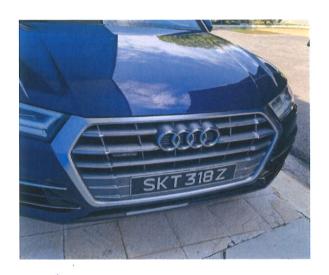
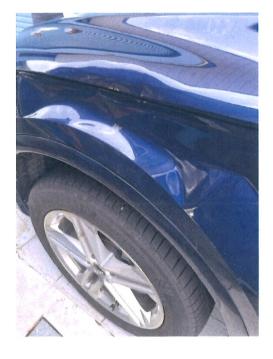
The vehicle sustained Left Hand Front portion damages during the accident on 18/04/2022. The Left Hand Front roadwheel was also affected.

It was report that the vehicle has been parked and subsequently hit by a lorry while reversing.

From the evidence of 9 pieces accident scene photographs and 4 pieces photos of video footage captured from the vehicle SKT318Z dashcam (*provided by the owner*), damages appeared consistent with the Police Report made.
