Your Ref: Porsche Cayenne
(chassis number WP1ZZZ9YZLDA02651)
Our Ref : CI/TP22006328/D

**INSPECTION REPORT OF AN UNREGISTERED PORSCHE CAYENNE
MOTOR CAR WITH CHASSIS NUMBER WP1ZZZ9YZLDA02651**

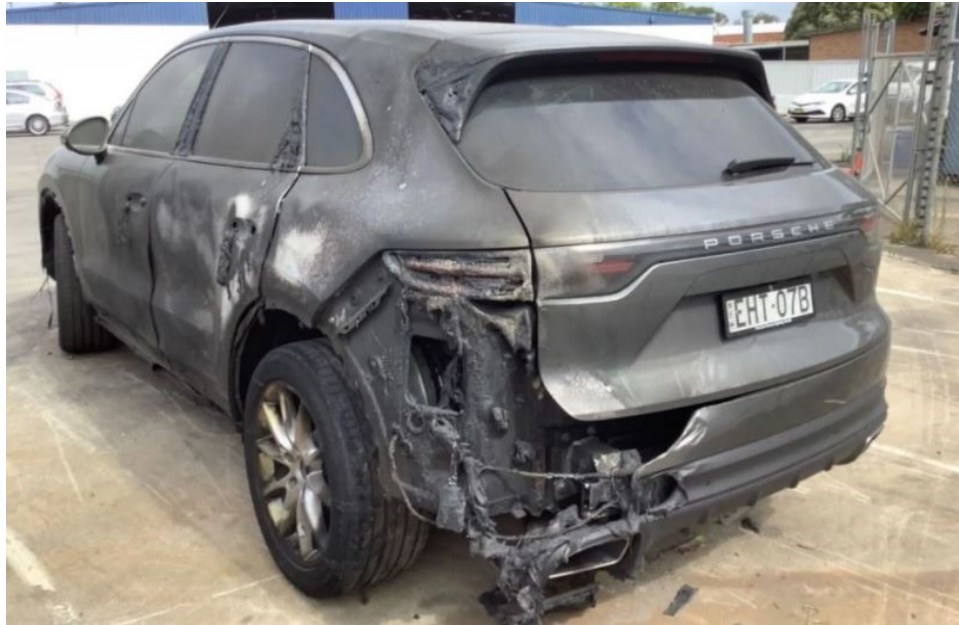
Photo 1 shows the rear left body of the Motor Car (photograph provided to me). The photographs provided to me had showed damage of burnt and/or smoke/heat nature to the exterior body parts along the left side portion of the Motor Car. The rear bumper, rear bumper lower cover, rear bumper left reflector, rear bootlid, rear left bootlid lamp, rear bootlid spoiler, rear left taillamp, rear left fender, rear left door and rear left door outer handle were amongst the exterior body parts that had sustained burnt and/or smoke/heat damage.

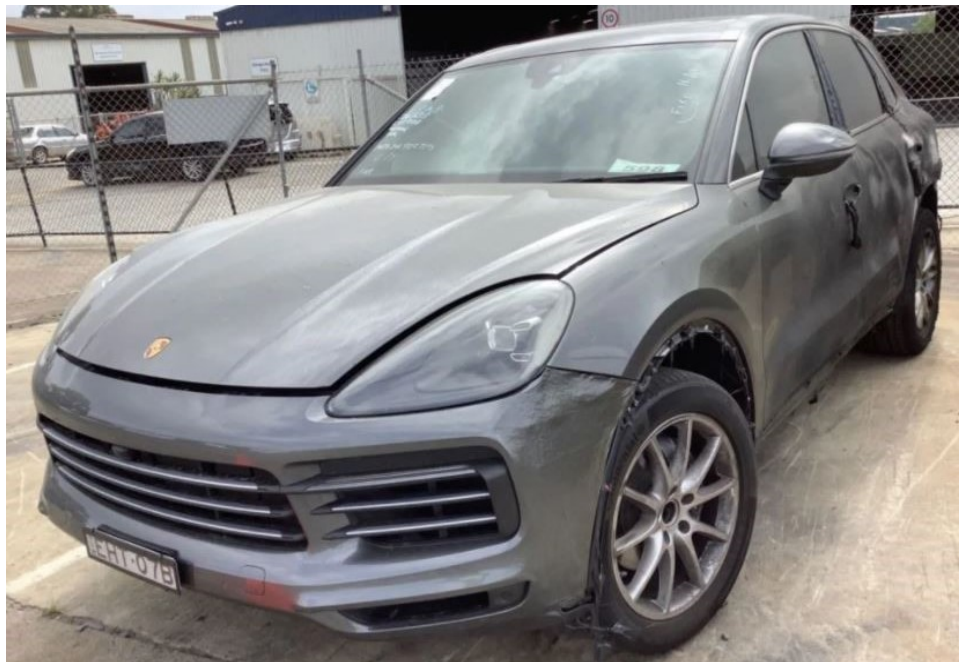
Photo 2 shows the front left body of the Motor Car (photograph provided to me). The photographs provided to me had showed damage of burnt and/or smoke/heat nature to the exterior body parts along the left side portion of the Motor Car. The front bumper, front left fender, front left fender wheel arc garnish, front left door and front left door outer handle were amongst the exterior body parts that had sustained burnt and/or smoke/heat damage.

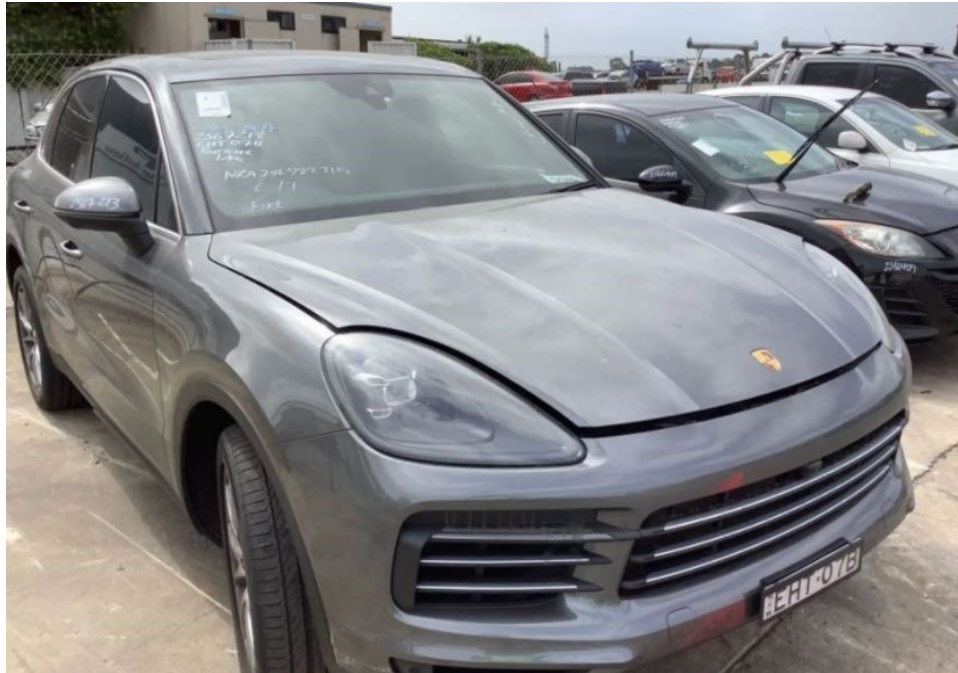
Photo 3 shows the front right body of the Motor Car (photograph provided to me). Apart for the left side portion, there was no physical damage observed to other areas of the Motor Car. The airbag(s) appears to be not deployed as seen from the photographs that were provided to me.

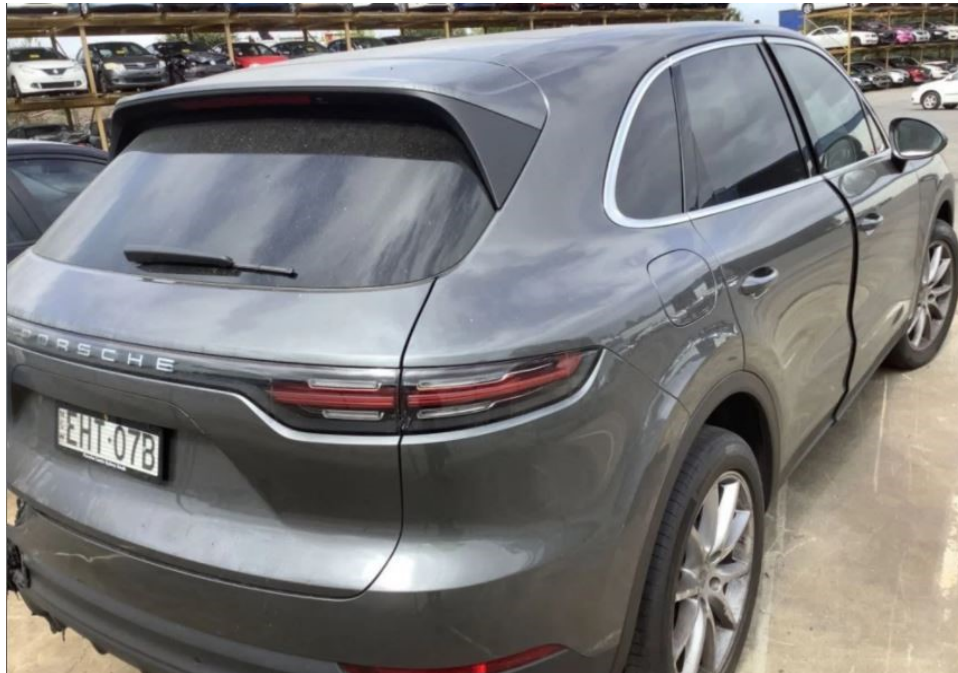
Photo 4 shows the rear right body of the Motor Car (photograph provided to me). Apart for the left side portion, there was no physical damage observed to other areas of the Motor Car. The airbag(s) appears to be not deployed as seen from the photographs that were provided to me.

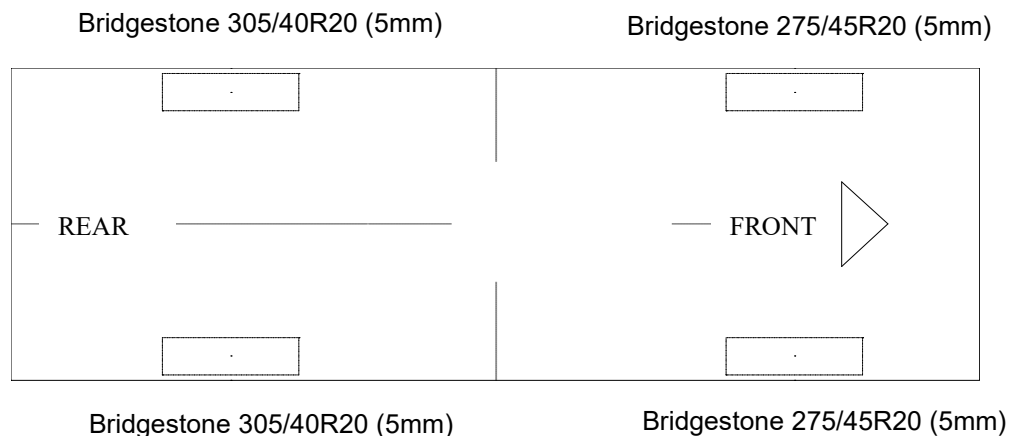
8. It was fitted with 20inch sport wheel rims that were wrapped with tyres that were observed to be of serviceable condition. The tyres were also sufficiently inflated for vehicular operation. The tyre brand, tyre size and approximate remaining tread depth of the 4 tyres of the Motor Car were recorded as follows: -

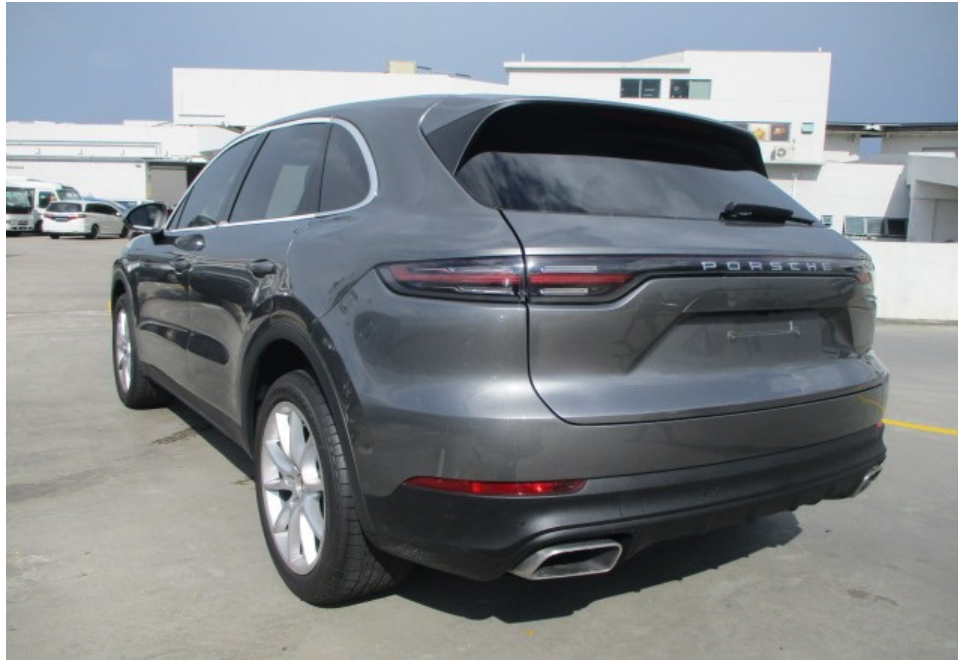
22. The body parts along the left side portion of the Motor Car were visually examined and it was noted that the repair/restoration works carried out to the damaged area of the Motor Car (refer to photograph 1 & 2 above) were reasonably adequate and in order.

Photo 5 shows a general view of the rear left body of the Motor Car at the time of my inspection. The Motor Car was observed to be in a relatively good general condition with no loose exterior fittings observed. The body parts along the left side portion of the Motor Car were visually examined and it was observed that the repair/restoration works carried out to the damaged area of the Motor Car (refer to photograph 1 & 2 above) were reasonably adequate and in order.

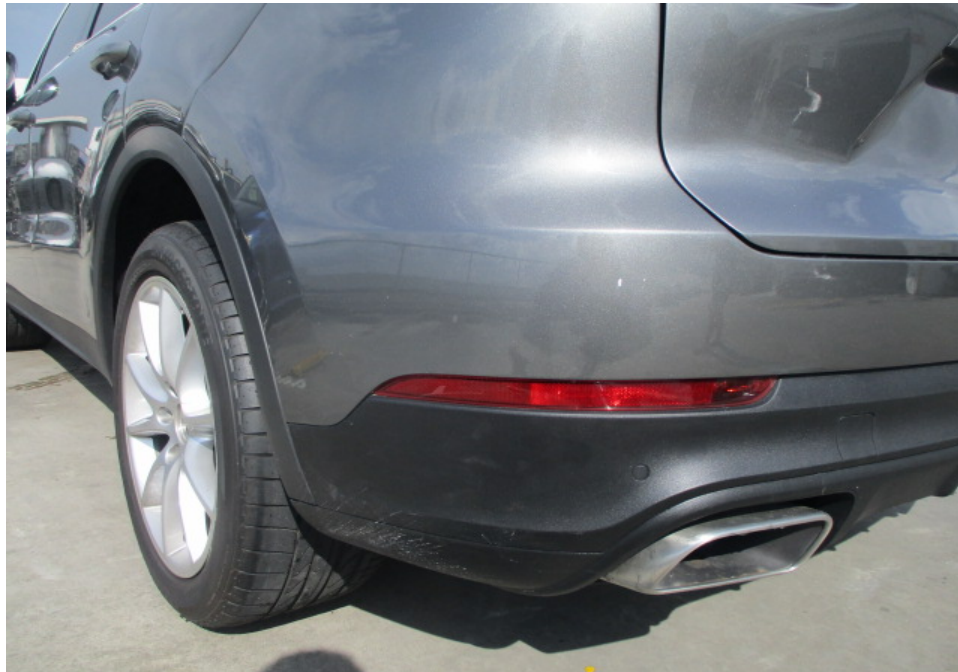
Photo 6 shows a closer view of the Motor Car's rear bumper, rear bumper lower cover, rear bumper lower garnish and rear bumper left reflector. The body parts along the left side portion of the Motor Car were visually examined and it was observed that the repair/restoration works carried out to the damaged area of the Motor Car (refer to photograph 1 above) were reasonably adequate and in order.

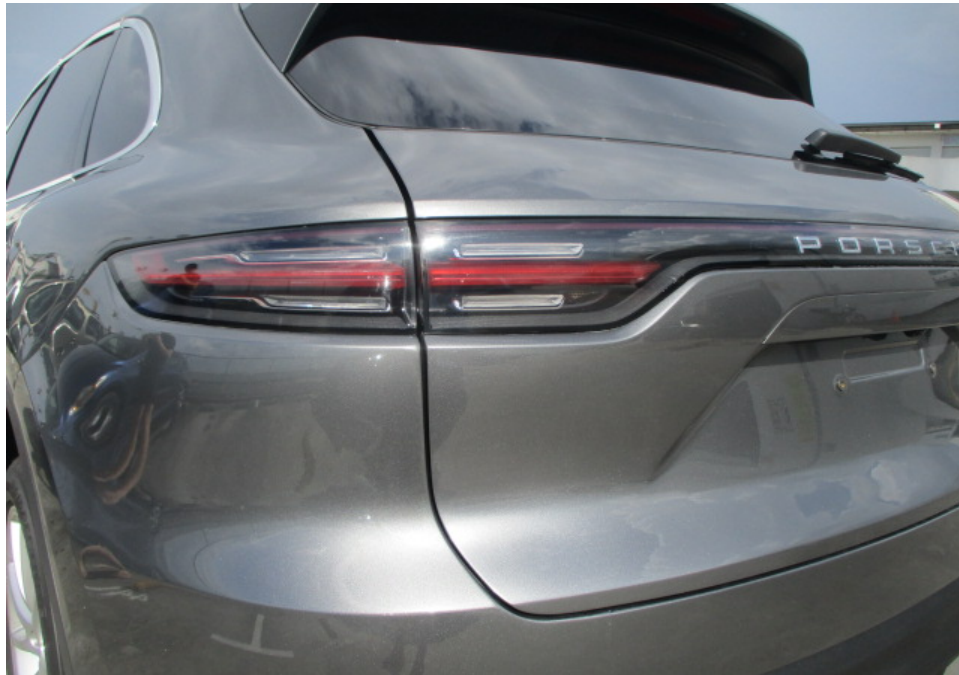
Photo 7 shows a closer view of the Motor Car's rear bumper, rear bootlid, rear left bootlid lamp and rear left taillamp. The body parts along the left side portion of the Motor Car were visually examined and it was observed that the repair/restoration works carried out to the damaged area of the Motor Car (refer to photograph 1 above) were reasonably adequate and in order.

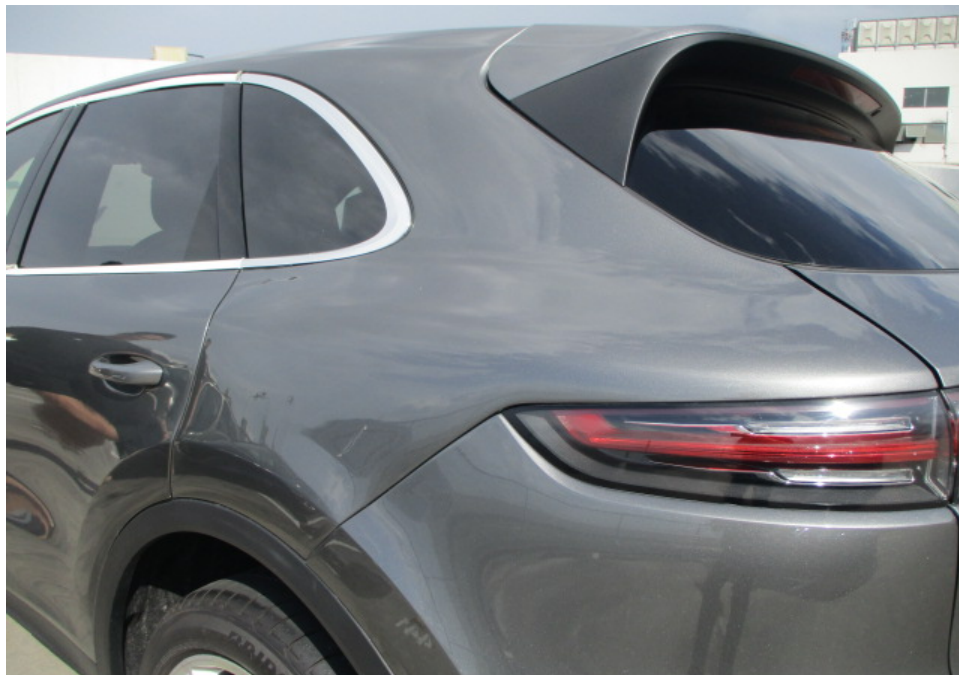
Photo 8 shows a closer view of the Motor Car's rear bootlid spoiler, rear left taillamp, rear left fender, rear left fender wheel arc garnish and rear left quarter glass chrome moulding. The body parts along the left side portion of the Motor Car were visually examined and it was observed that the repair/restoration works carried out to the damaged area of the Motor Car (refer to photograph 1 above) were reasonably adequate and in order.

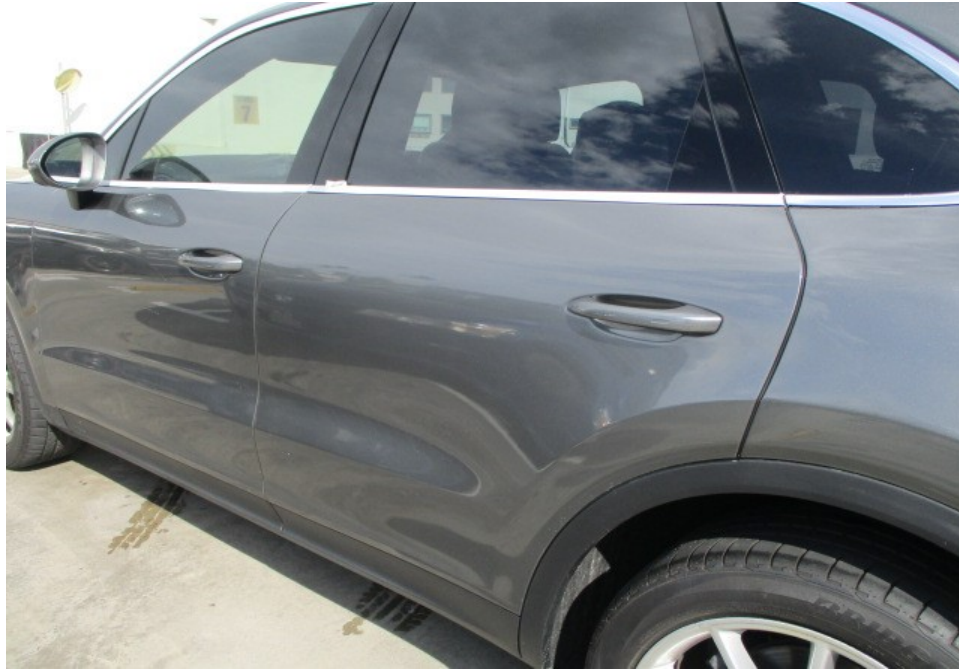
Photo 9 shows a closer view of the Motor Car's rear left door, rear left door outer handle, front left door, front left door outer handle and left side rocker panel garnish. The body parts along the left side portion of the Motor Car were visually examined and it was observed that the repair/restoration works carried out to the damaged area of the Motor Car (refer to photograph 1 above) were reasonably adequate and in order.

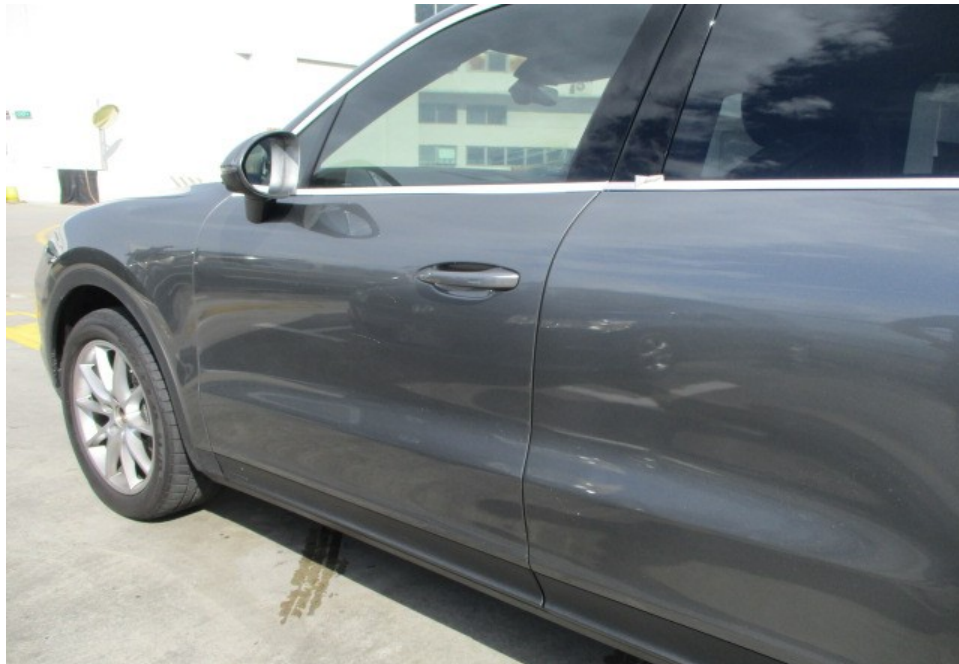
Photo 10 shows a closer view of the Motor Car's front left door, front left door outer handle and front left door top chrome moulding. The body parts along the left side portion of the Motor Car were visually examined and it was observed that the repair/restoration works carried out to the damaged area of the Motor Car (refer to photograph 1 above) were reasonably adequate and in order.

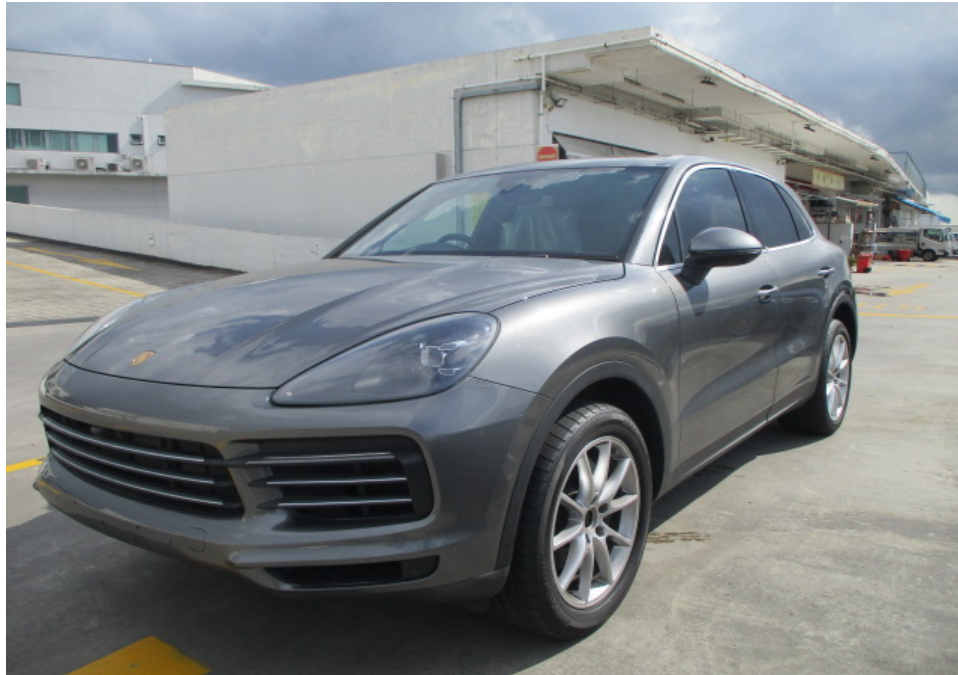
Photo 11 shows a general view of the front left body of the Motor Car at the time of my inspection. The Motor Car was observed to be in a relatively good general condition with no loose exterior fittings observed. The body parts along the left side portion of the Motor Car were visually examined and it was observed that the repair/restoration works carried out to the damaged area of the Motor Car (refer to photograph 1 & 2 above) were reasonably adequate and in order.

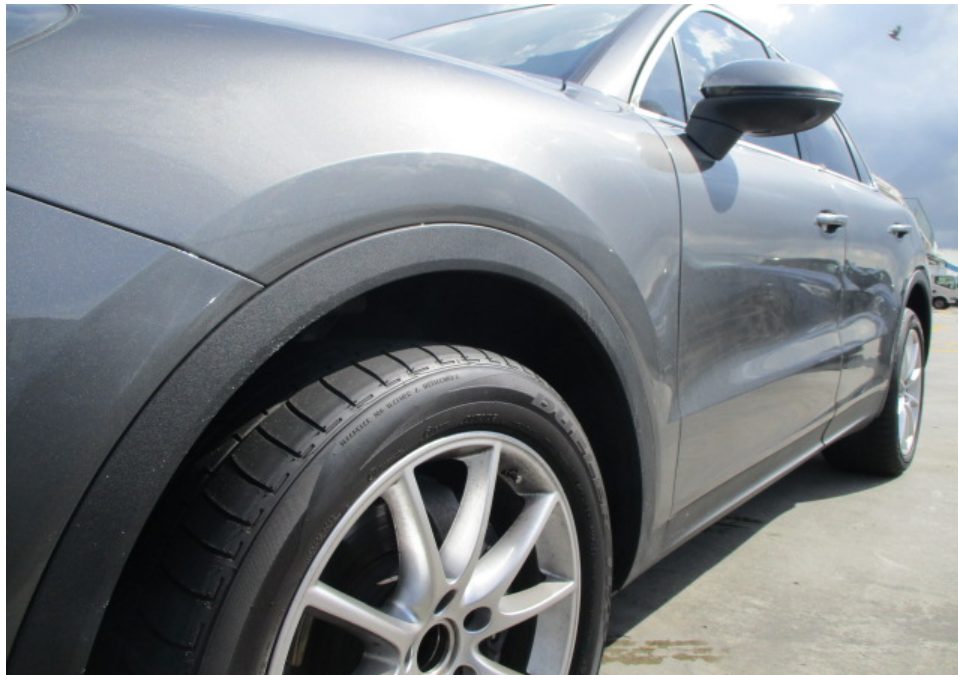
Photo 12 shows a closer view of the Motor Car's front bumper, front left fender and front left fender wheel arc garnish. The body parts along the left side portion of the Motor Car were visually examined and it was observed that the repair/restoration works carried out to the damaged area of the Motor Car (refer to photograph 2 above) were reasonably adequate and in order.

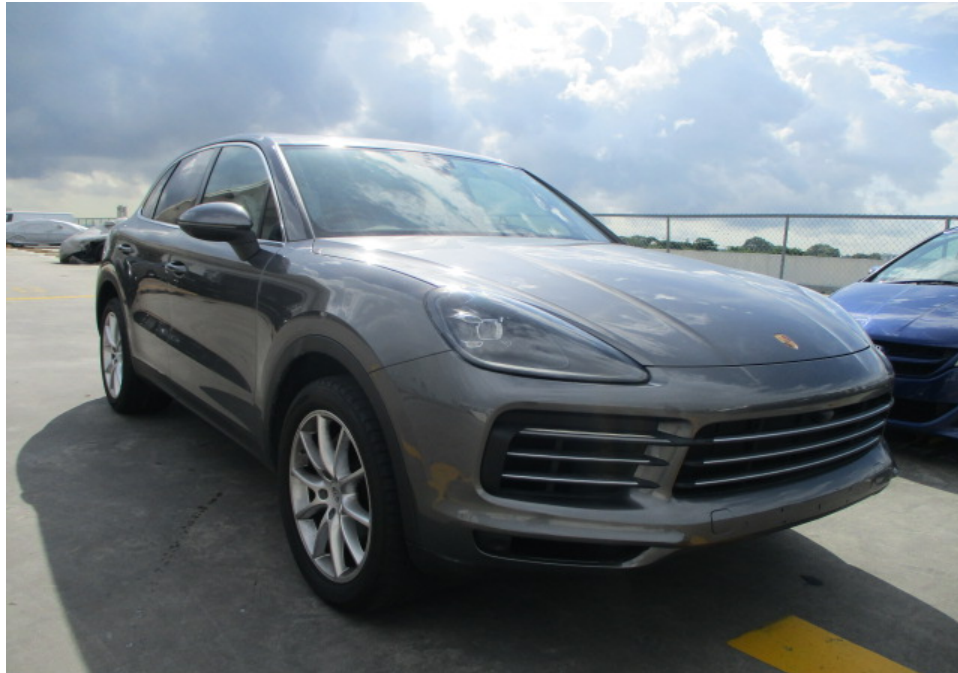
Photo 13 shows a general view of the front right body of the Motor Car at the time of my inspection. The Motor Car was observed to be in a relatively good general condition with no loose exterior fittings observed. The mileage of the Motor Car recorded at the time of my inspection was 6,614km.

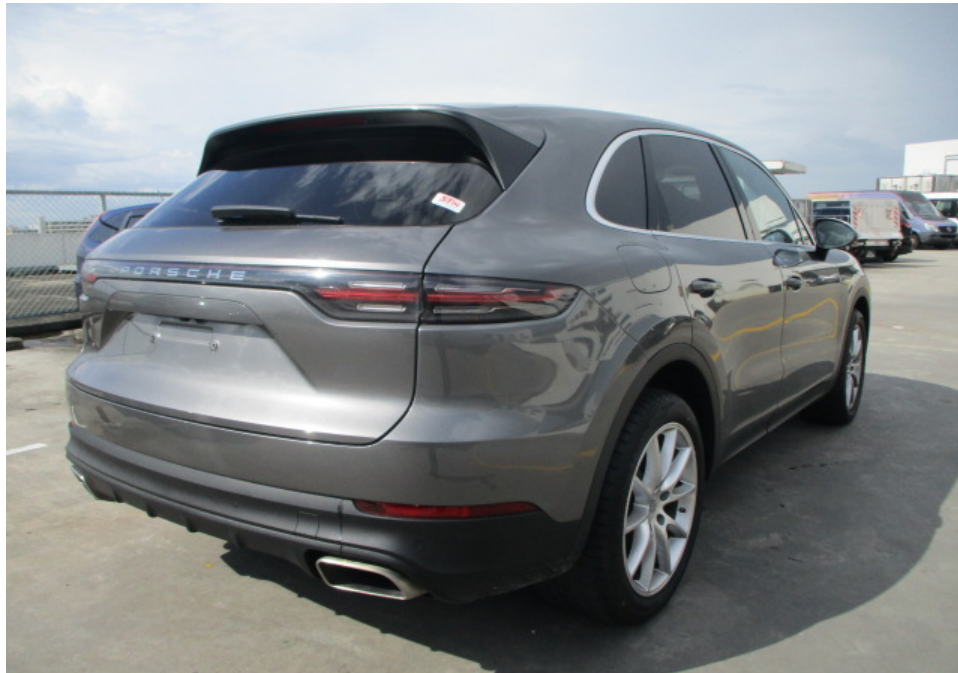
Photo 14 shows a general view of the rear right body of the Motor Car at the time of my inspection. The Motor Car was observed to be in a relatively good general condition with no loose exterior fittings observed. The mileage of the Motor Car recorded at the time of my inspection was 6,614km.

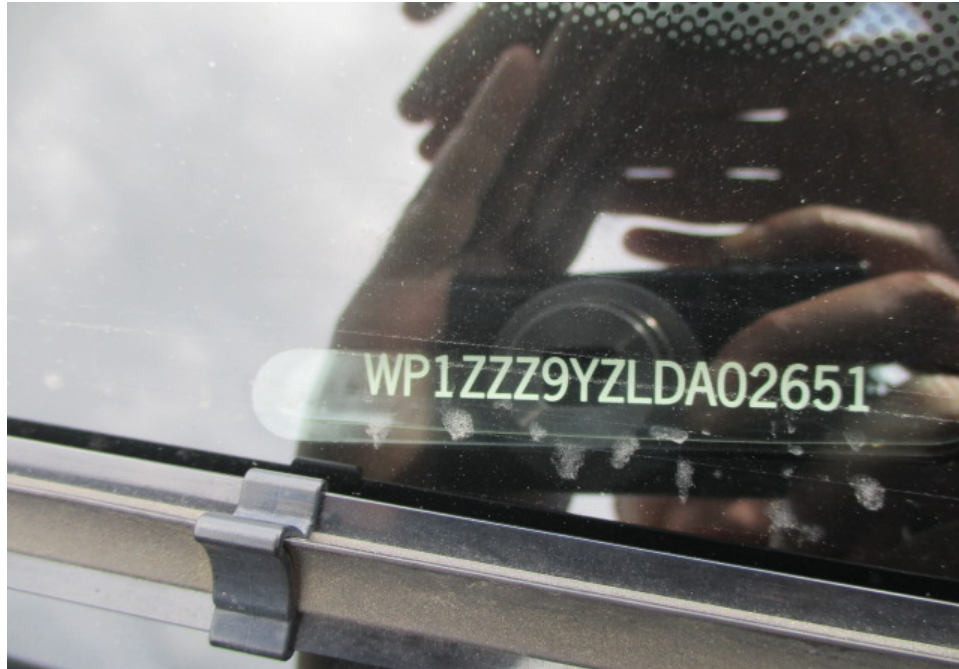
Photo 15 shows the chassis number of the Motor Car. The chassis number recorded was WP1ZZZ9YZLDA02651.

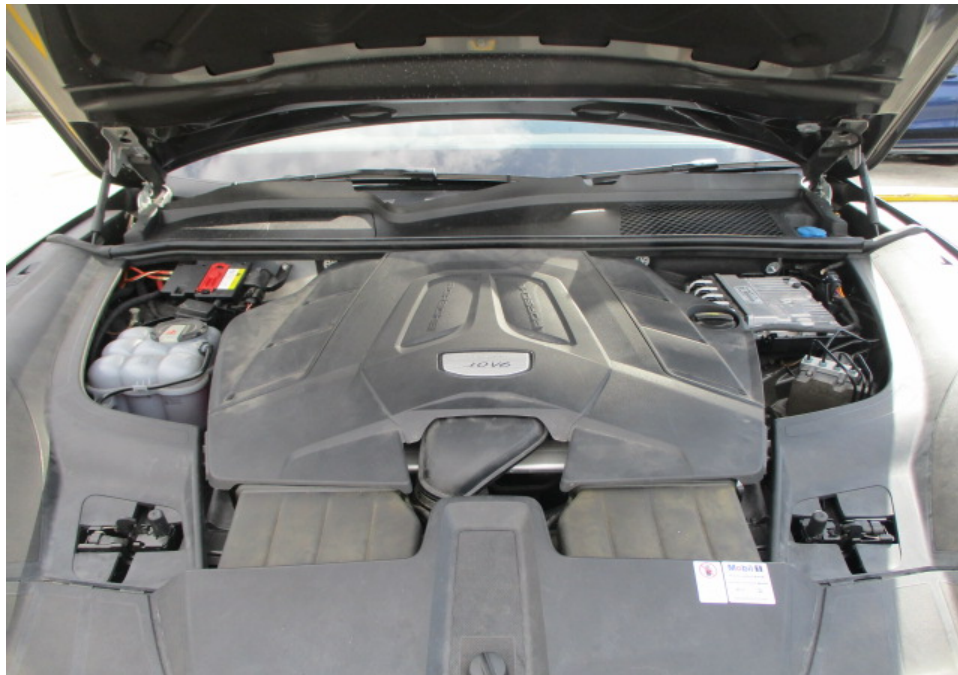
Photo 16 shows a general view of the engine compartment of the Motor Car at the time of my inspection. The various parts and components inside the engine compartment were all observed to be intact and properly fitted. There was also no sign(s) or indication(s) of fluid leak and/or fluid stain found inside the engine compartment.

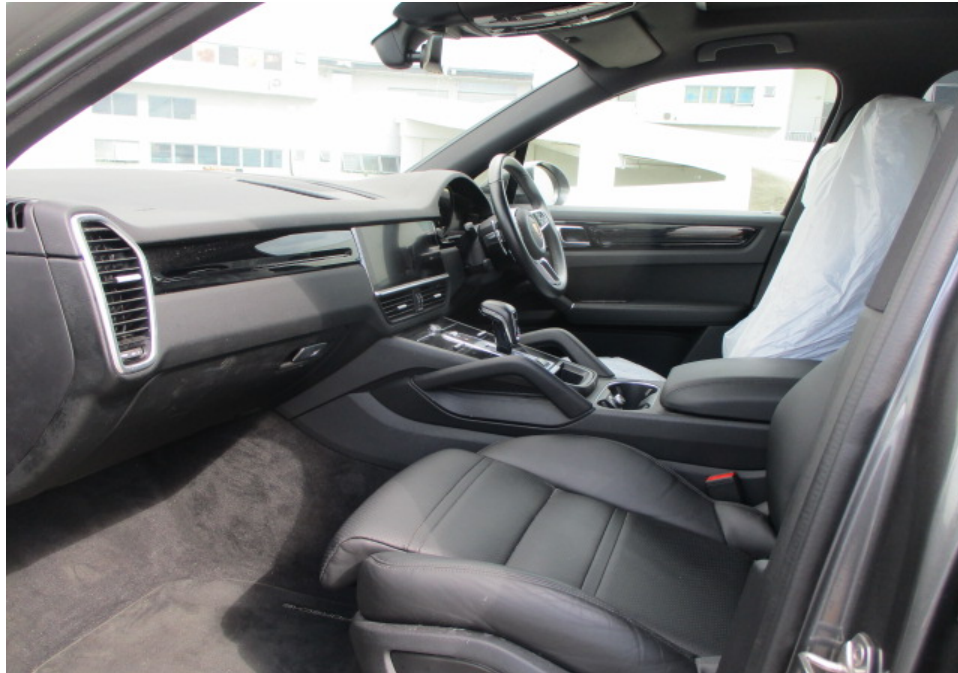
Photo 17 shows the interior compartment of the Motor Car at the time of my inspection. The various parts and components, trims, carpet, and upholstery inside the interior compartment were all observed to be intact and properly fitted.

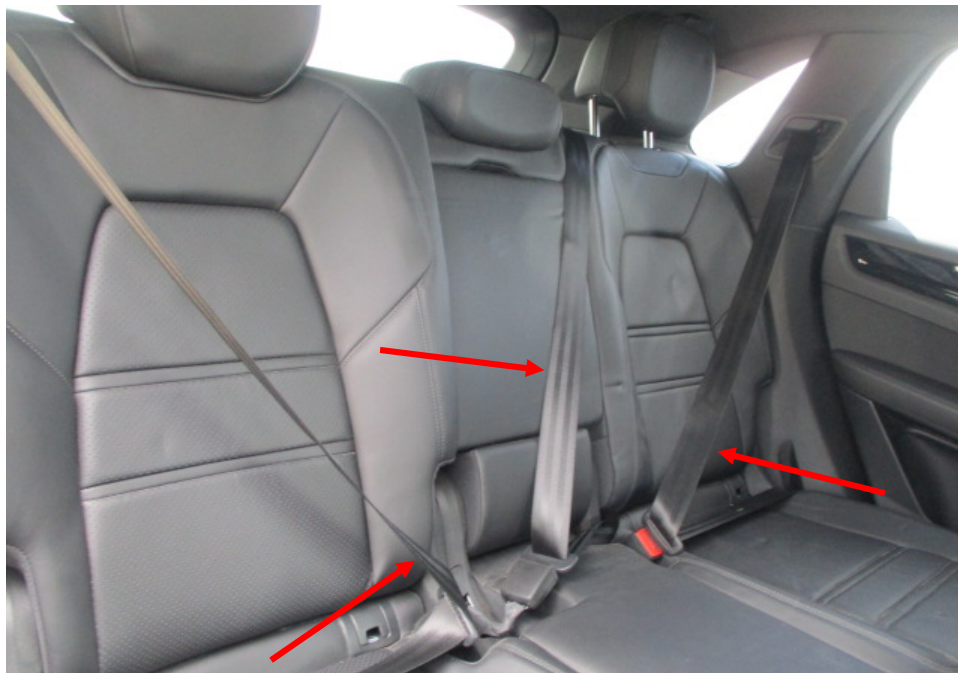
Photo 18 shows the rear seats of the Motor Car. All the seats of the Motor Car were secured via seat rails to the floorboard. They were also fitted with a retractable seat belt reel and a pre-tensioner. The seat belts (arrowed) were tested and were able to be fastened into the respective pre-tensions that were fitted on the side of each individual seat.

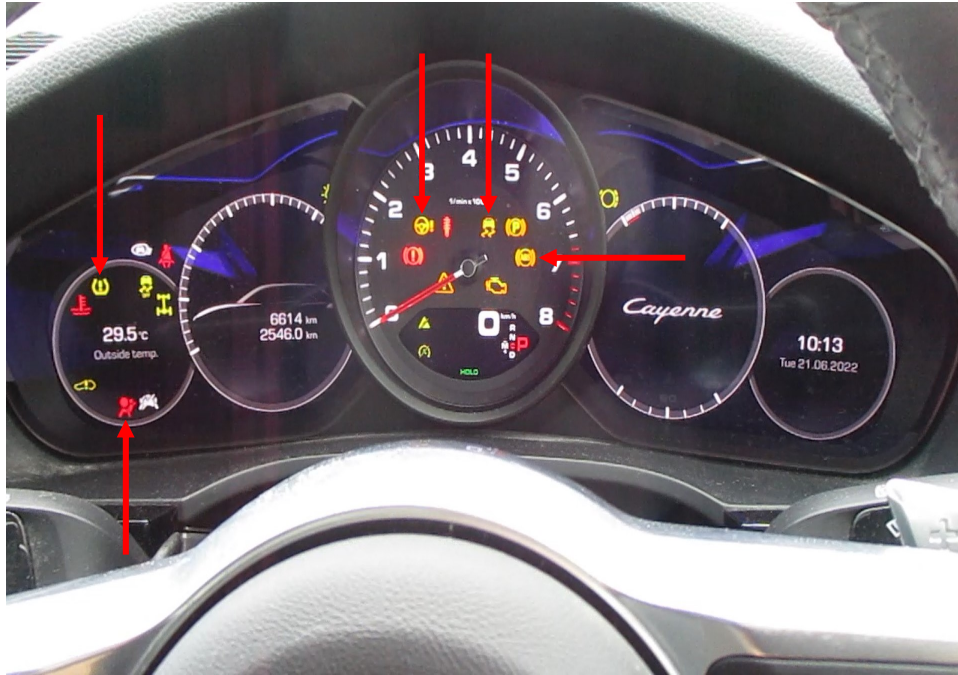
Photo 19 shows the warning lights for the various electronic safety features appearing on the instrument panel of the Motor Car during its self-test when the engine is cranked, in particular the ABS, SRS, EPS, TPM and TCS lights (arrowed).

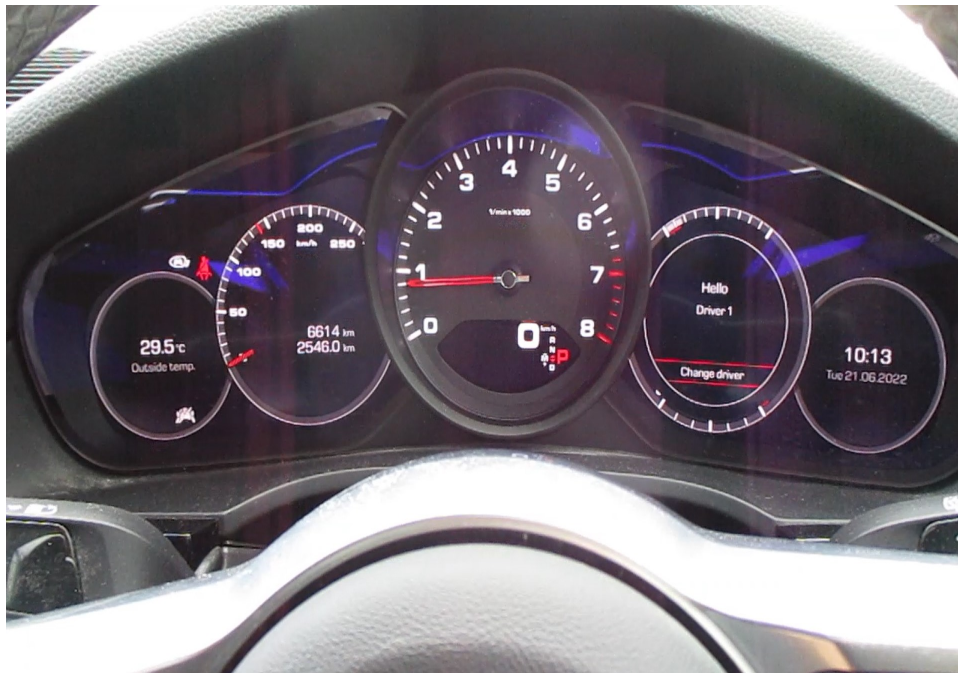
Photo 20 shows the respective warning lights no longer illuminated, indicating that there is no fault detected to the ABS, SRS, EPS, TPM and TCS systems of the Motor Car during the self-test. These electronic systems were hence in working condition at the time of my inspection.

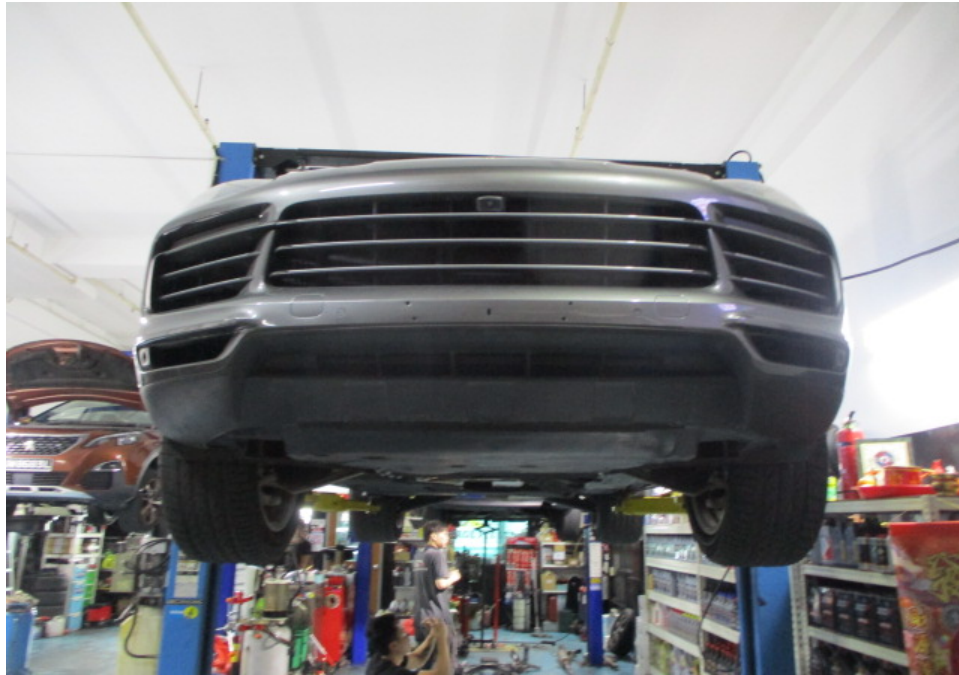
Photo 21 shows the Motor Car hoisted up for checks on its undercarriage. There was no sign(s) or indication(s) of fluid leakage and/or fluid stain(s) on the underside of the Motor Car. The undercarriage components of the Motor Car were also all observed to be intact and secured in an appropriate manner.

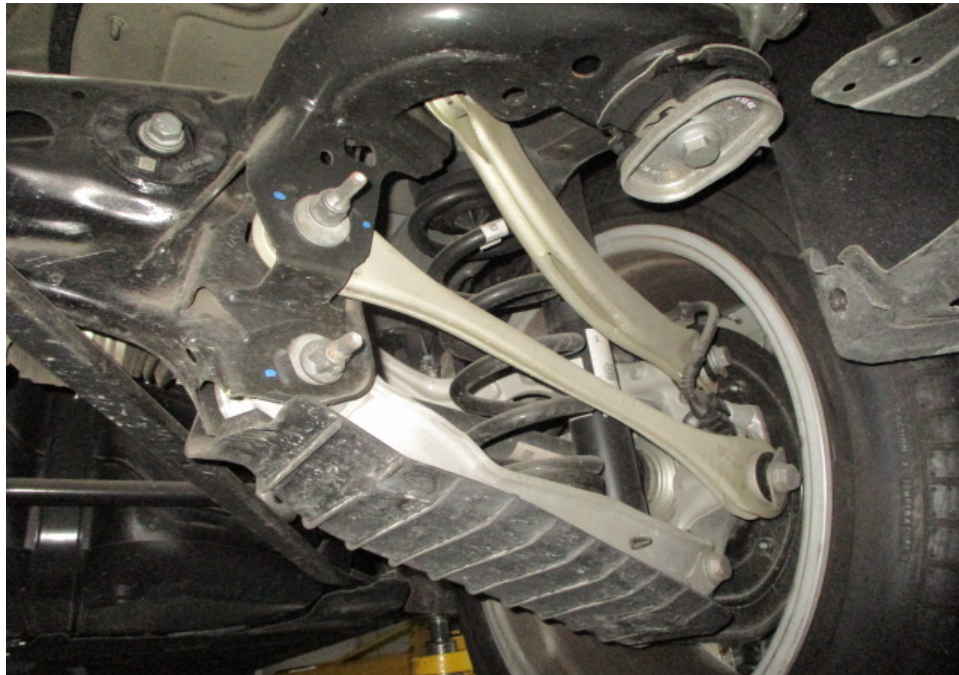
Photo 22 shows a general view of the control arms and linkages at the rear right wheel of the Motor Car. I did not observe any fluid leak and/or fluid stain on the underside of the Motor Car. All of the Motor Car's undercarriage components were observed to be intact and secured in an appropriate manner.

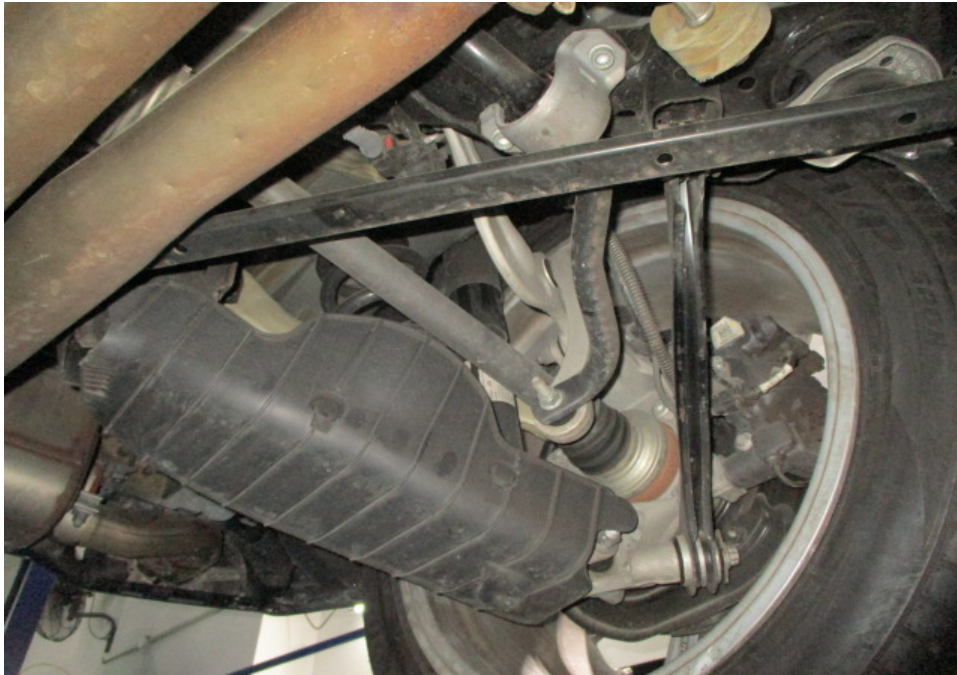
Photo 23 shows a general view of the control arms and linkages at the rear left wheel of the Motor Car. I did not observe any fluid leak and/or fluid stain on the underside of the Motor Car. All of the Motor Car's undercarriage components were observed to be intact and secured in an appropriate manner.

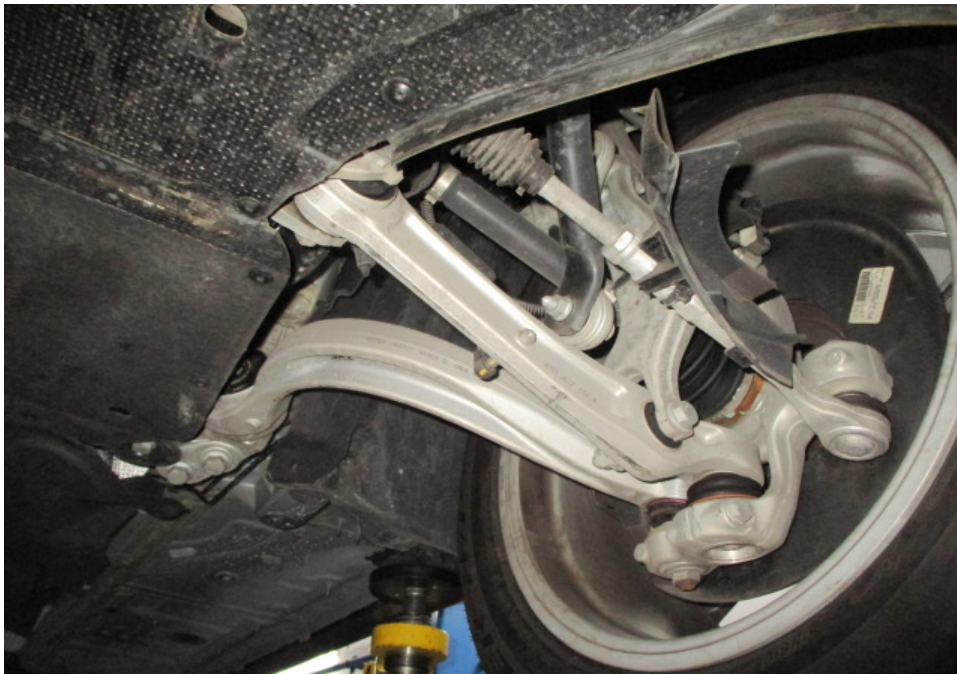
Photo 24 shows the various undercarriage components at the front left wheel of the Motor Car. The mechanical components, control arms and linkages were all found to be intact and secured in an appropriate manner.

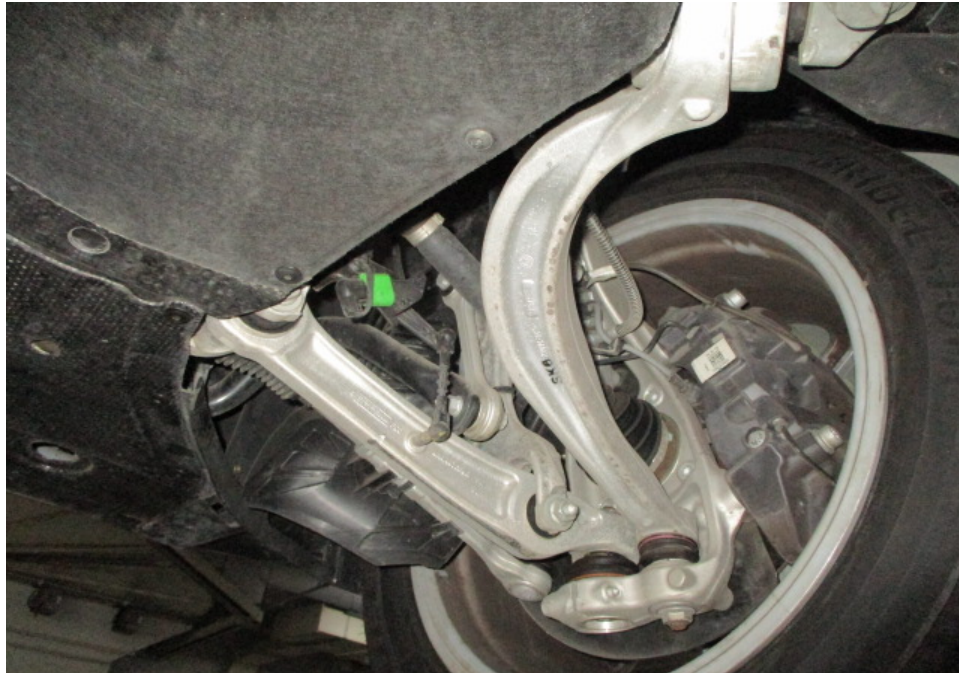
Photo 25 shows the various undercarriage components at the front right wheel of the Motor Car. The mechanical components, control arms and linkages were all found to be intact and secured in an appropriate manner. I also did not observe any fluid leak and/or fluid stain on the underside of the Motor Car.

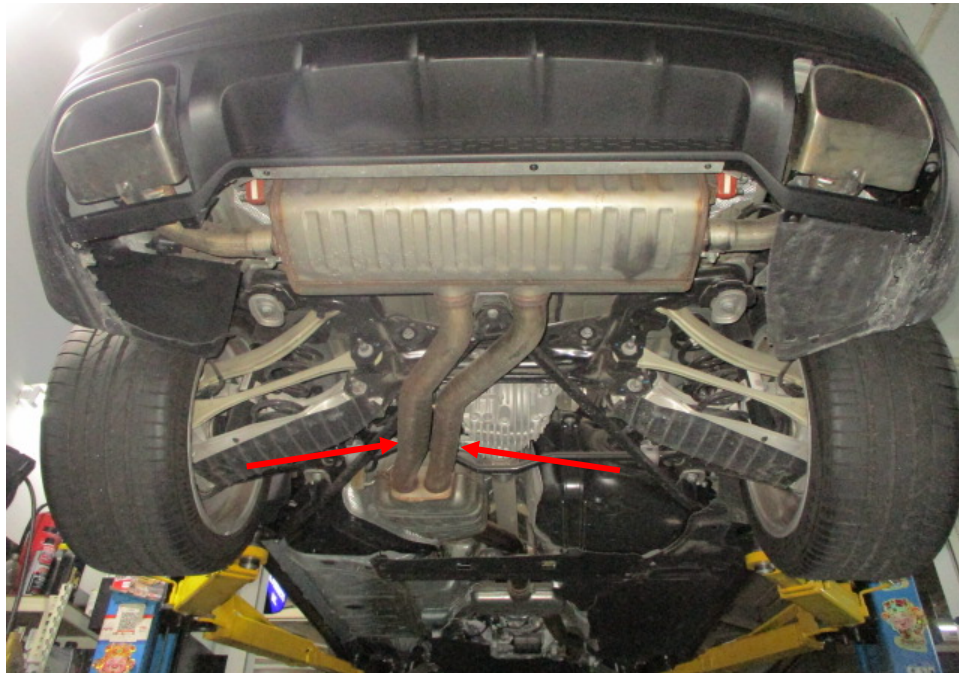
Photo 26 shows the rear section of the Motor Car's exhaust system. My examination of the Motor Car's exhaust system revealed no sign(s) or indication(s) of any cut or weld marks along its exhaust pipes (arrowed), on its rear muffler, on its centre resonator boxes and on its catalytic converter.

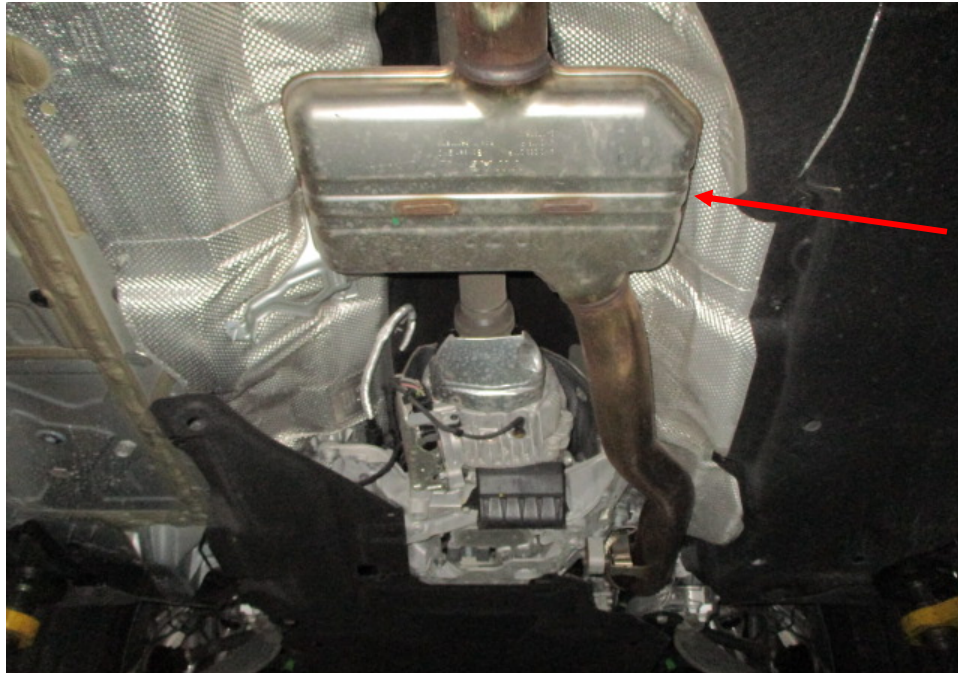
Photo 27 shows the front section of the Motor Car's exhaust system. My examination of the Motor Car's exhaust system revealed no sign(s) or indication(s) of any cut or weld marks along its exhaust pipes, on its rear mufflers, on its centre resonator boxes (arrowed) and on its catalytic converter.

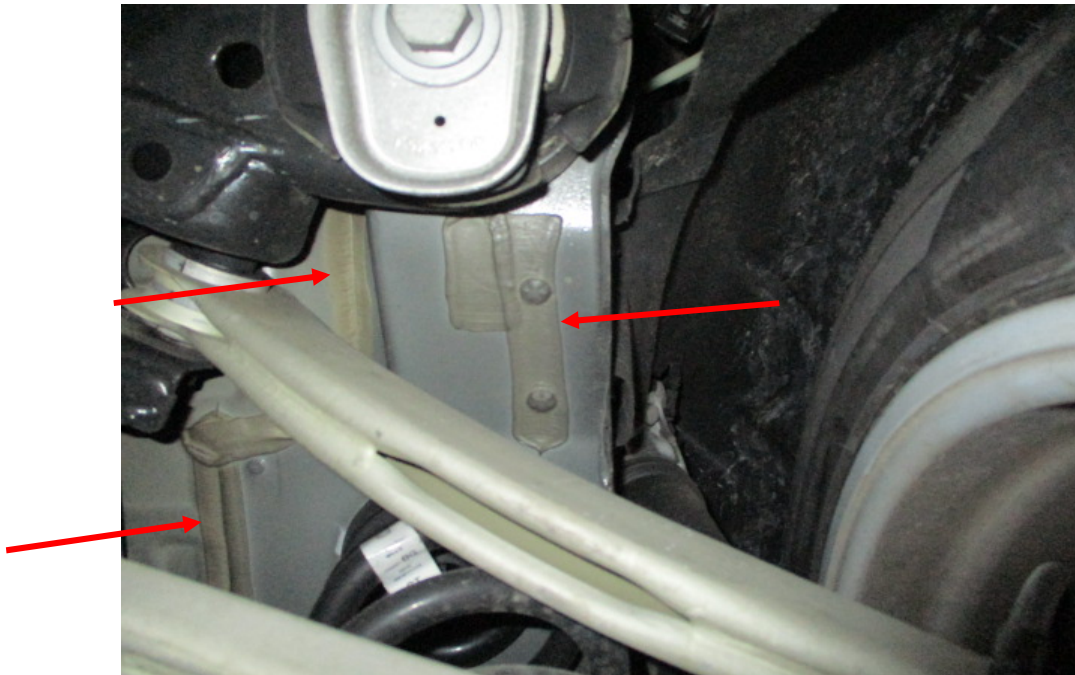
Photo 28 shows the chassis/structural body at the underside rear right of the Motor Car. I did not find any weld marks other than original spot weld marks on the chassis/structural body of the Motor Car. The original factory sealant (arrowed) at the joints along the chassis/structural body was untouched, indicating no work was done on the chassis/structural body of the Motor Car and that the chassis/structural body was originally fitted.

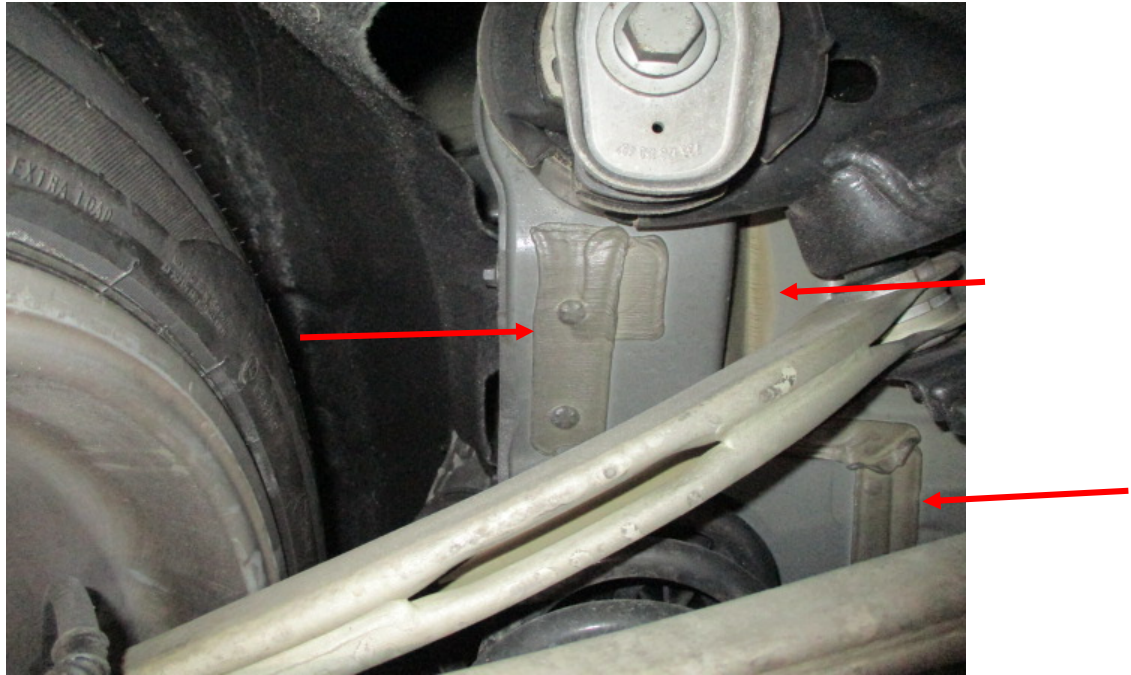
Photo 29 shows the chassis/structural body at the underside rear left of the Motor Car. I did not find any weld marks other than original spot weld marks on the chassis/structural body of the Motor Car. The original factory sealant (arrowed) at the joints along the chassis/structural body was untouched, indicating no work was done on the chassis/structural body of the Motor Car and that the chassis/structural body was originally fitted.

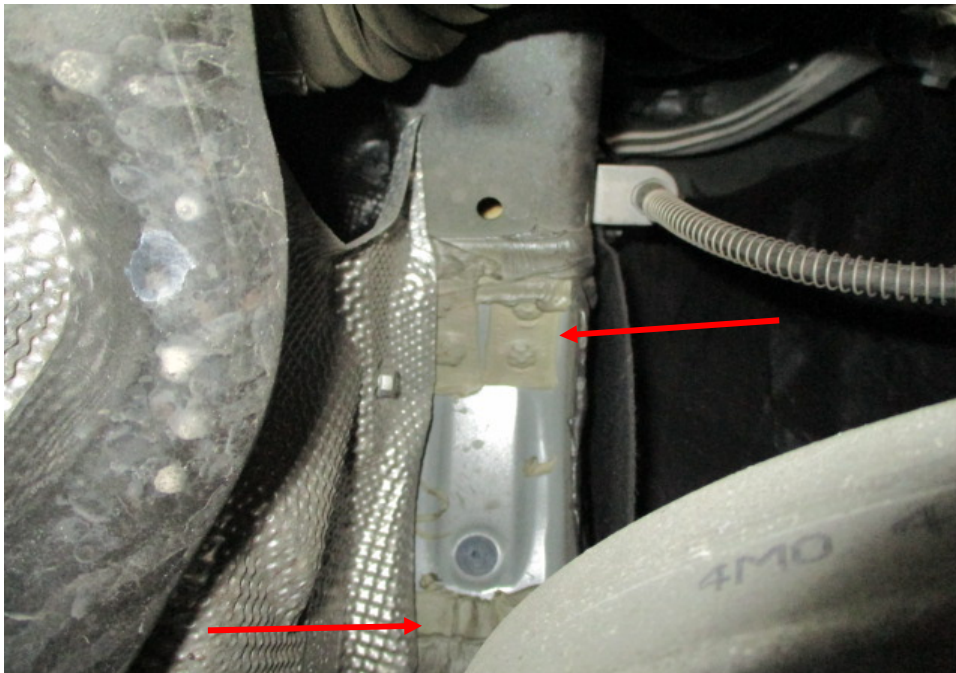
Photo 30 shows the chassis/structural body at the underside front left of the Motor Car. The original factory sealant (arrowed) at the joints along the chassis/structural body was observed to be untouched. In general, I had found no work was carried out on the chassis/structural body of the Motor Car. The chassis/structural body of the Motor Car was originally fitted.
