Your Ref: Porsche Cayenne
(chassis number WP1ZZZ9YZLDA02651)
Our Ref : CI/TP22006328/D

**INSPECTION REPORT OF AN UNREGISTERED PORSCHE CAYENNE
MOTOR CAR WITH CHASSIS NUMBER WP1ZZZ9YZLDA02651**

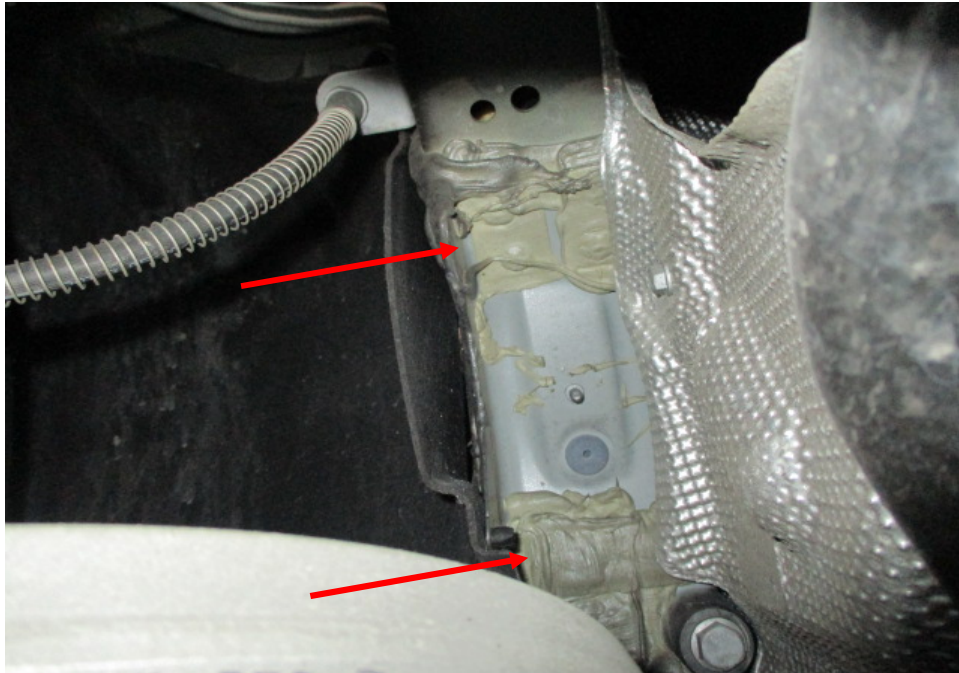
Photo 31 shows the chassis/structural body at the underside front right of the Motor Car. The original factory sealant (arrowed) at the joints along the chassis/structural body was observed to be untouched. In general, I had found no work was carried out on the chassis/structural body of the Motor Car. The chassis/structural body of the Motor Car was originally fitted.
