Your Ref: Porsche GT3 Coupe  
(chassis number WP0ZZZ99ZNS262574)  
Our Ref : CI/TP22006409/D

01 July 2022

**INSPECTION REPORT OF AN UNREGISTERED PORSCHE GT3 COUPE  
MOTOR CAR WITH CHASSIS NUMBER WP0ZZZ99ZNS262574**

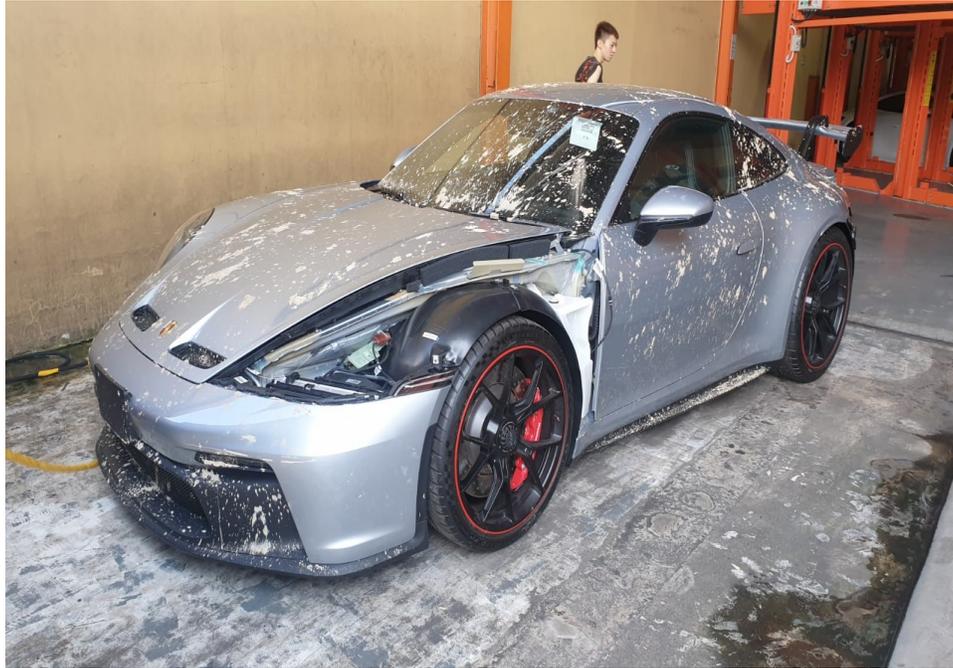
3. The photographs provided to me had showed the Motor Car's front left fender and front left headlamp missing/dislodged/damaged.
4. The Motor Car's rear bumper and all its related parts and attachments like the rear bumper lower cover, rear bumper sensors, rear bumper reflectors, rear number plate garnish and tow hook cover amongst others were also observed to be missing/dislodged/damaged.
5. The airbag(s) of the Motor Car was not deployed as seen from the photographs that were provided to me. See photo 1 – 4 below.

**Photo 1** shows the front left body of the Motor Car (photograph provided to me). The photographs provided to me had showed the Motor Car's front left fender and front left headlamp missing/dislodged/damaged.

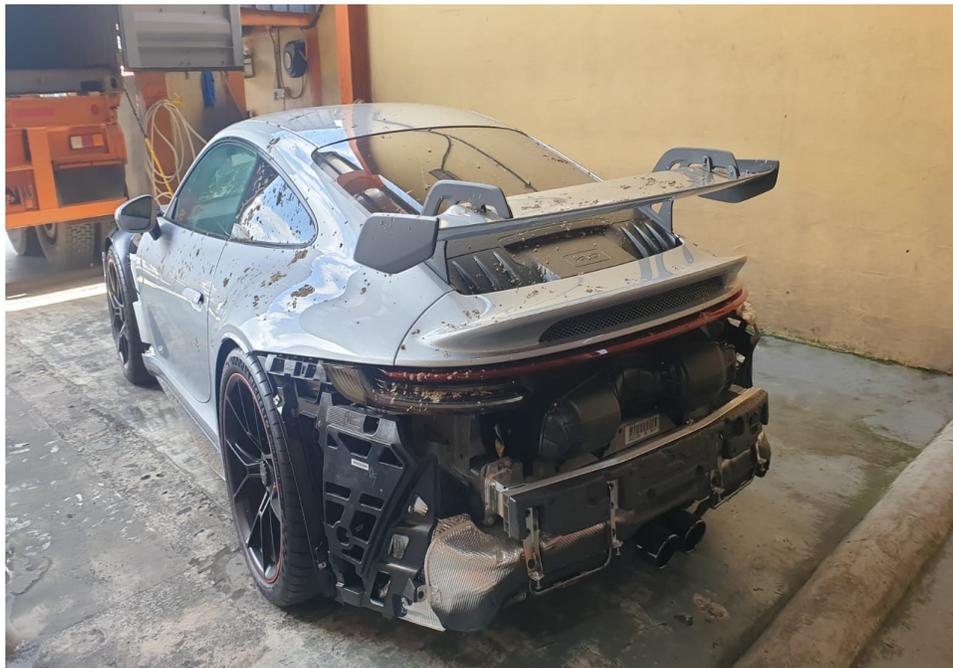
**Photo 2** shows the rear left body of the Motor Car (photograph provided to me). The Motor Car's rear bumper and all its related parts and attachments like the rear bumper lower cover, rear bumper sensors, rear bumper reflectors, rear

51 UBI AVE 1, #01-25 PAYA UBI INDUSTRIAL PARK, SINGAPORE 408933 TEL : (065) 62563561 FAX : (065) 67414108  
number plate garnish and tow hook cover amongst others were also observed to be missing/dislodged/damaged.

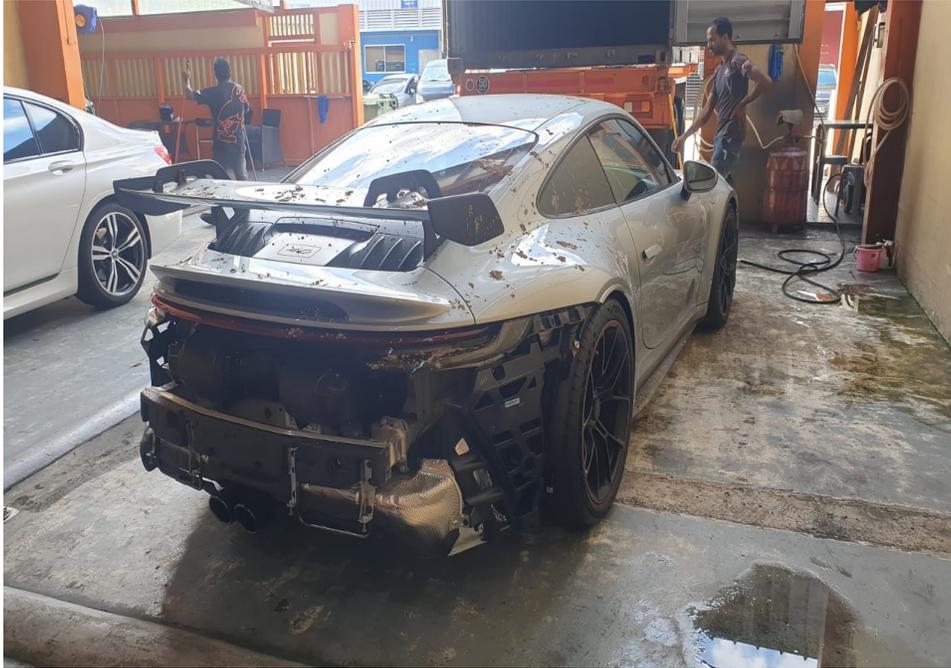
**Photo 3** shows the rear right body of the Motor Car (photograph provided to me). The Motor Car's rear bumper and all its related parts and attachments like the rear bumper lower cover, rear bumper sensors, rear bumper reflectors, rear number plate garnish and tow hook cover amongst others were also observed to be missing/dislodged/damaged.

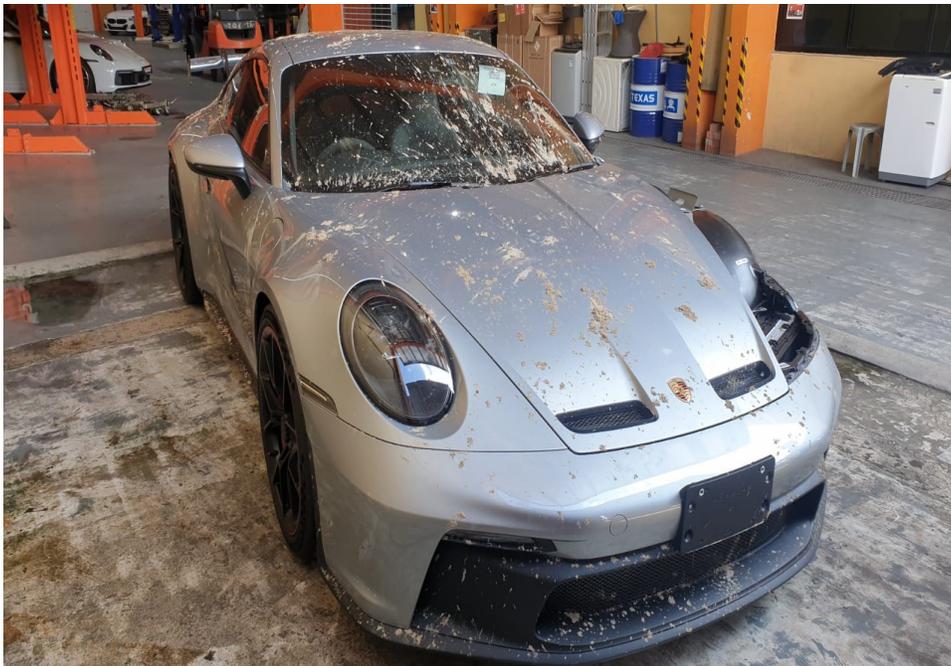
**Photo 4** shows the front right body of the Motor Car (photograph provided to me). No physical damage was observed to the right side portion of the Motor Car. The

51 UBI AVE 1, #01-25 PAYA UBI INDUSTRIAL PARK, SINGAPORE 408933 TEL : (065) 62563561 FAX : (065) 67414108  
airbag(s) was also not deployed as seen from the photographs that were provided to me.

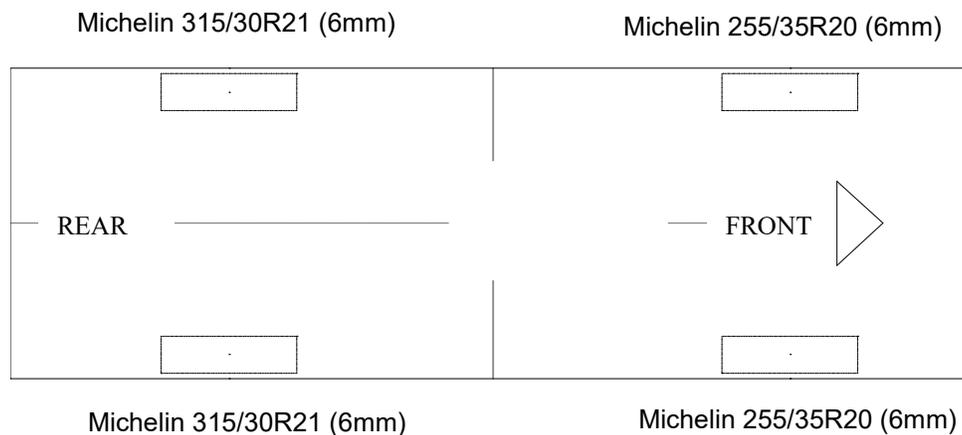
9. It was fitted with 20inch (front) and 21inch (rear) sport wheel rims that were wrapped with tyres that were observed to be of serviceable condition. The tyres were also sufficiently inflated for vehicular operation. The tyre brand, tyre size and approximate remaining tread depth of the 4 tyres of the Motor Car were recorded as follows: -

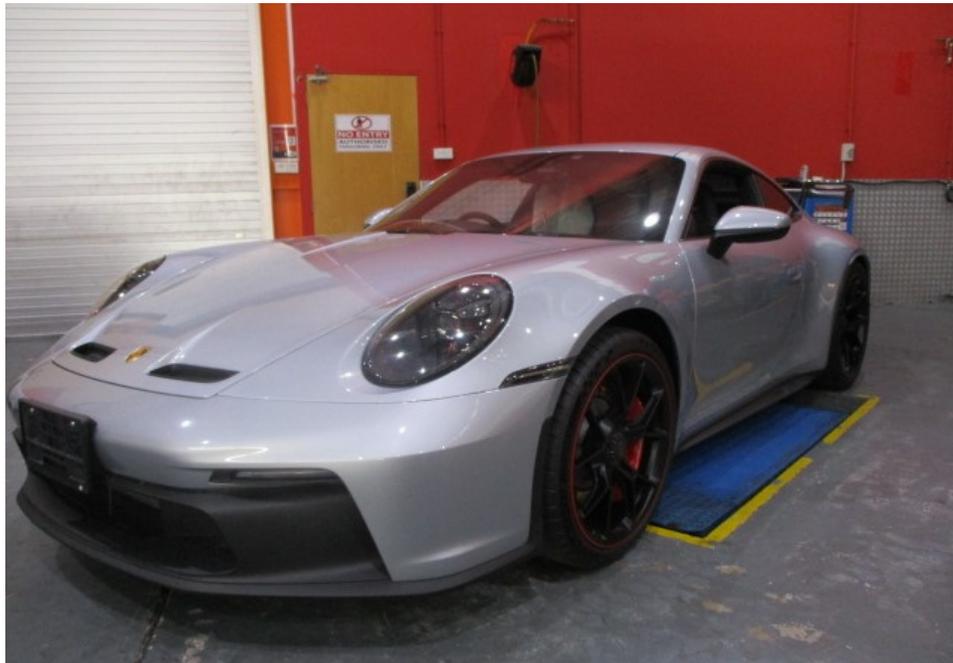
**Photo 5** shows a general view of the front left body of the Motor Car at the time of my inspection. The Motor Car was observed to be in a relatively good general condition with no loose exterior fittings observed. The body parts at the front left

51 UBI AVE 1, #01-25 PAYA UBI INDUSTRIAL PARK, SINGAPORE 408933 TEL : (065) 62563561 FAX : (065) 67414108  
portion of the Motor Car were visually examined and it was observed that the repair/restoration works carried out to the damaged area of the Motor Car (refer to photograph 1 above) were reasonably adequate and in order.

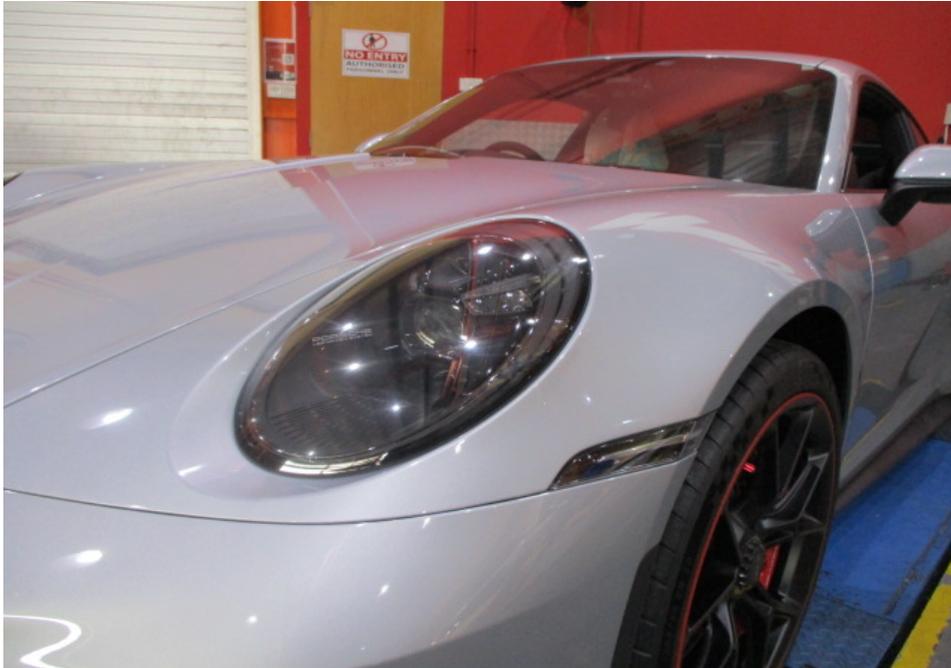
**Photo 6** shows a closer view of the Motor Car's front bumper, front left signal lamp, front left headlamp and front left fender. The body parts at the front left portion of the Motor Car were visually examined and it was observed that the repair/restoration works carried out to the damaged area of the Motor Car (refer to photograph 1 above) were reasonably adequate and in order.

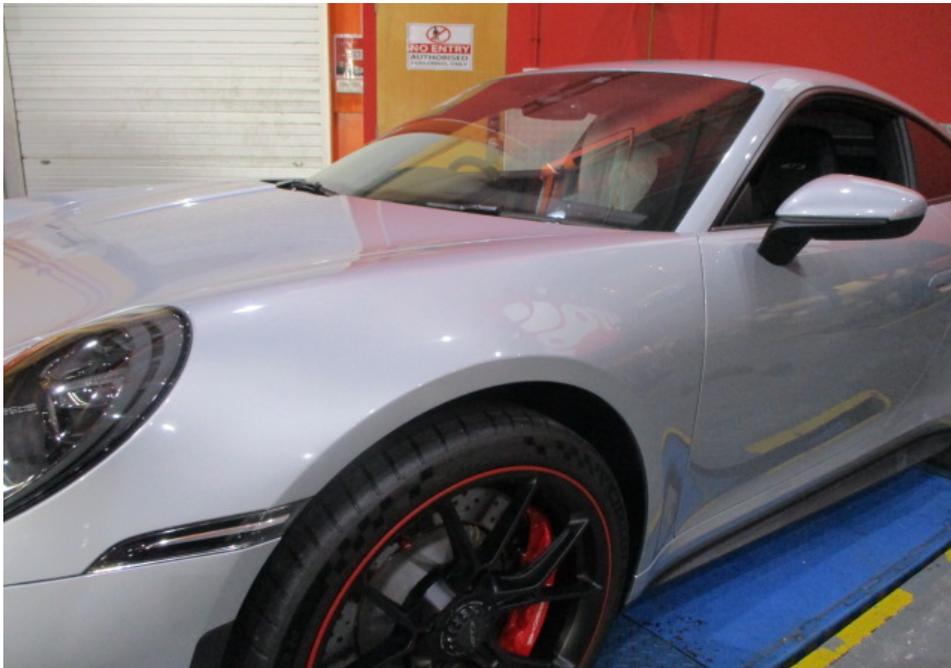
**Photo 7** shows a closer view of the Motor Car's front left fender, front left door, left wing mirror and front bonnet. The body parts at the front left portion of the

51 UBI AVE 1, #01-25 PAYA UBI INDUSTRIAL PARK, SINGAPORE 408933 TEL : (065) 62563561 FAX : (065) 67414108  
Motor Car were visually examined and it was observed that the repair/restoration works carried out to the damaged area of the Motor Car (refer to photograph 1 above) were reasonably adequate and in order.

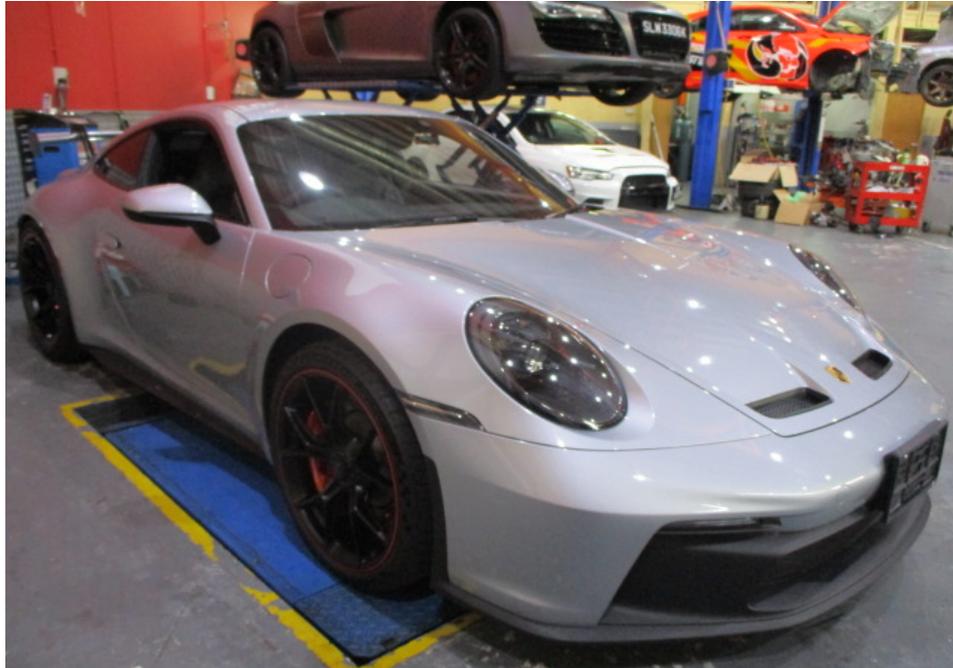
**Photo 8** shows a general view of the front right body of the Motor Car at the time of my inspection. The Motor Car was observed to be in a relatively good general condition with no loose exterior fittings observed. The mileage of the Motor Car recorded at the time of my inspection was 308km.

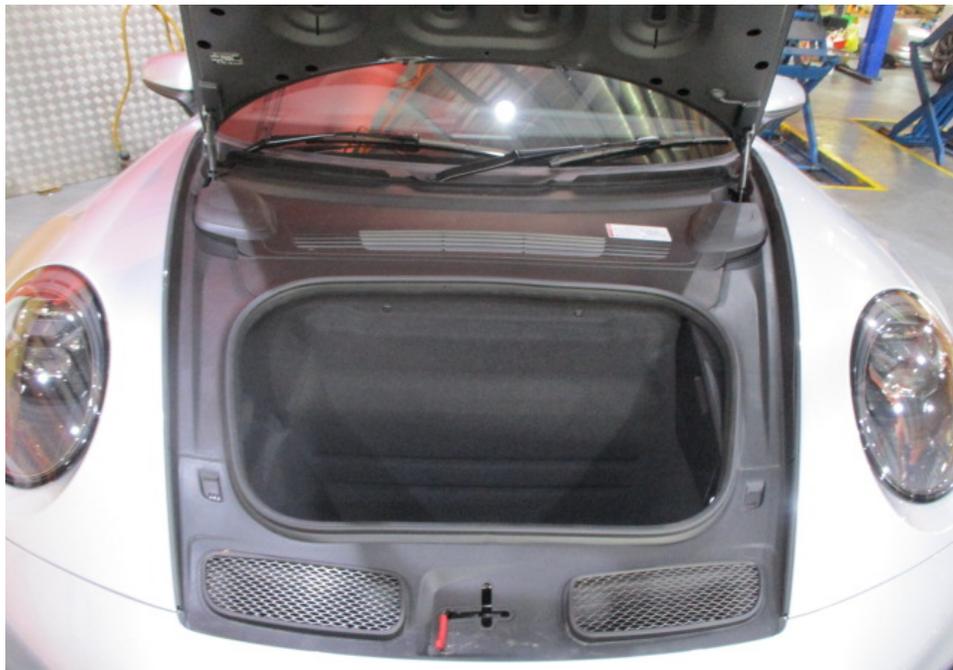
**Photo 9** shows a general view of the Motor Car's front bonnet compartment at the time of my inspection. All inner trims, garnishes and upholstery etc were observed to be properly fitted.

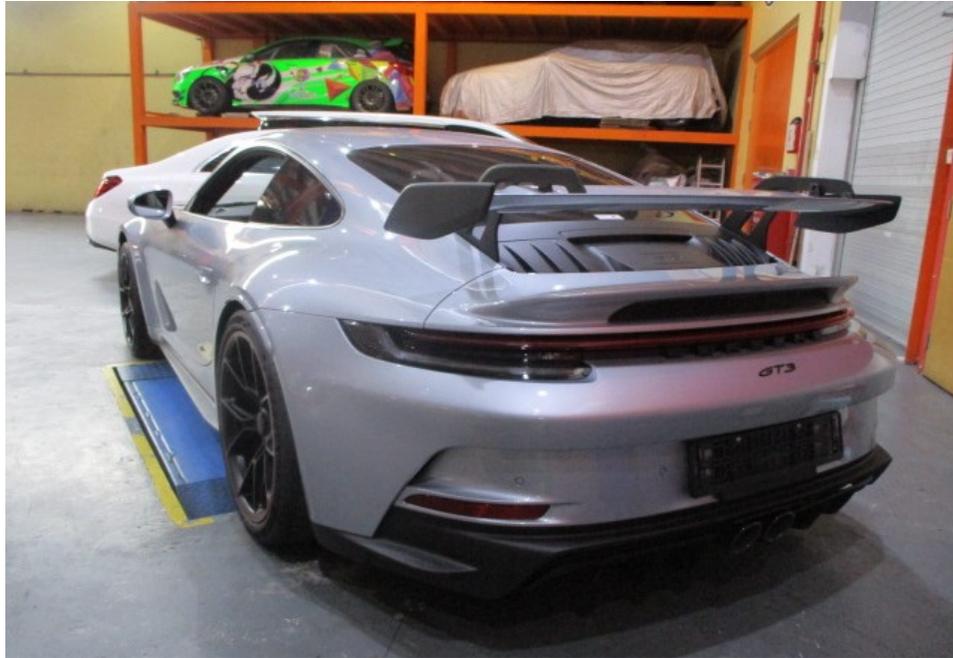
**Photo 10** shows a general view of the rear left body of the Motor Car at the time of my inspection. The Motor Car was observed to be in a relatively good general condition with no loose exterior fittings observed. The body parts at the rear portion of the Motor Car were visually examined and it was observed that the repair/restoration works carried out to the damaged area of the Motor Car (refer to photograph 2 & 3 above) were reasonably adequate and in order.

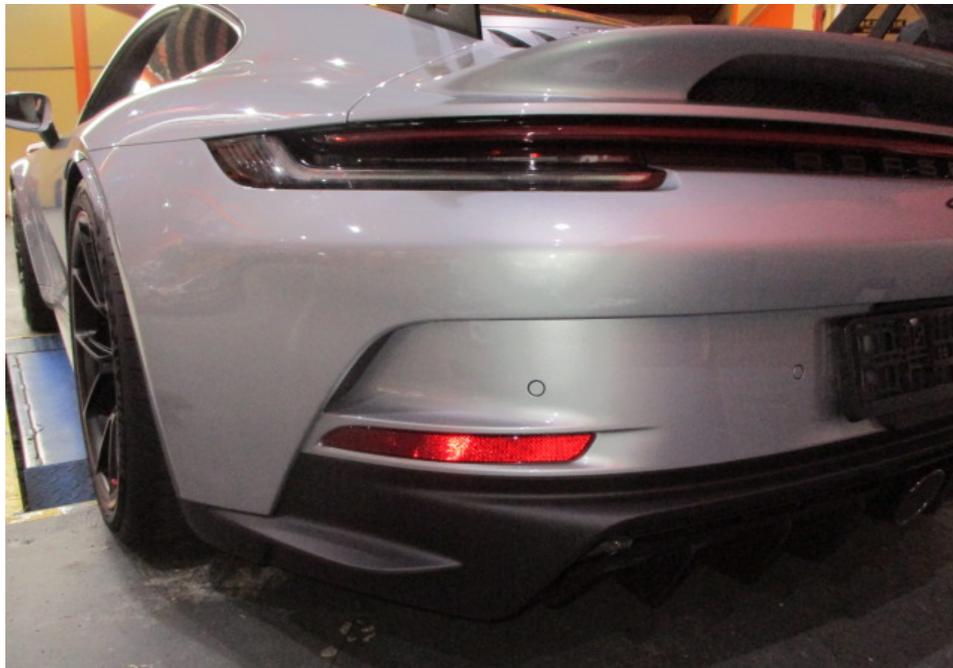
**Photo 11** shows a closer view of the Motor Car's rear bumper, rear bumper lower cover, rear bumper left reflector and rear left taillamp. The body parts at the

51 UBI AVE 1, #01-25 PAYA UBI INDUSTRIAL PARK, SINGAPORE 408933 TEL : (065) 62563561 FAX : (065) 67414108  
rear portion of the Motor Car were visually examined and it was observed that the repair/restoration works carried out to the damaged area of the Motor Car (refer to photograph 2 & 3 above) were reasonably adequate and in order.

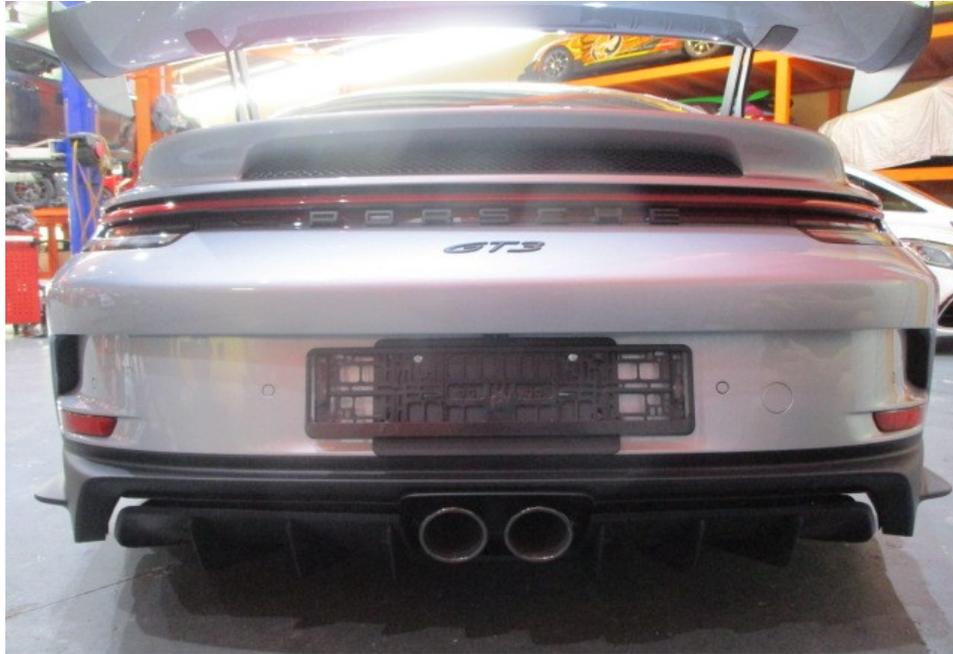
**Photo 12** shows a closer view of the Motor Car's rear bumper, rear bumper lower cover, rear bumper reflectors and rear bumper sensors. The body parts at the rear portion of the Motor Car were visually examined and it was observed that the repair/restoration works carried out to the damaged area of the Motor Car (refer to photograph 2 & 3 above) were reasonably adequate and in order.

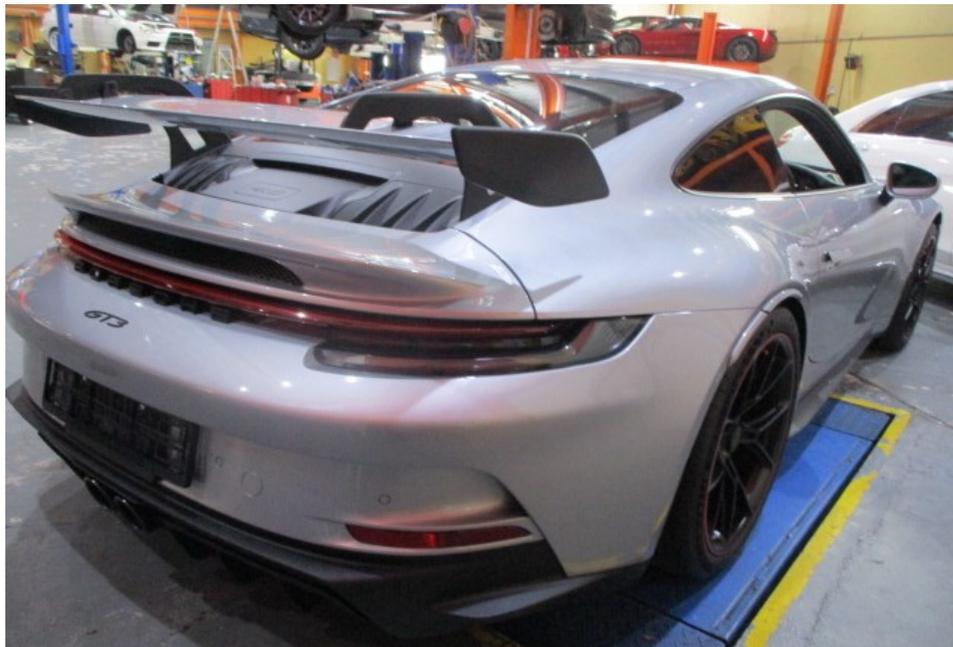
**Photo 13** shows a general view of the rear right body of the Motor Car at the time of my inspection. The Motor Car was observed to be in a relatively good general condition with no loose exterior fittings observed. The body parts at the rear portion of the Motor Car were visually examined and it was observed that

51 UBI AVE 1, #01-25 PAYA UBI INDUSTRIAL PARK, SINGAPORE 408933 TEL : (065) 62563561 FAX : (065) 67414108  
the repair/restoration works carried out to the damaged area of the Motor Car (refer to photograph 2 & 3 above) were reasonably adequate and in order.

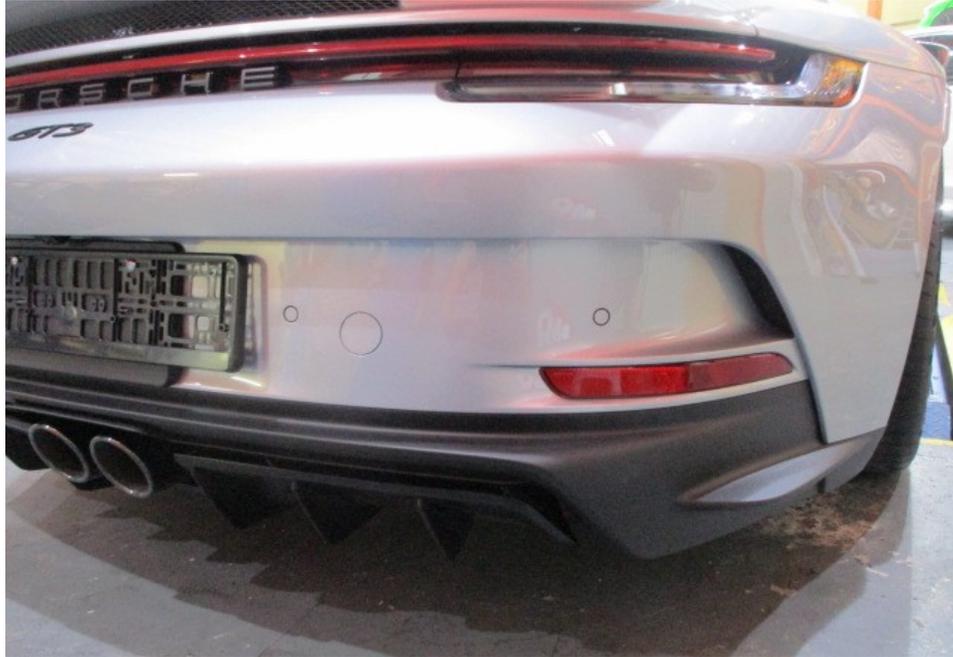
**Photo 14** shows a closer view of the Motor Car's rear bumper, rear bumper lower cover, rear bumper right reflector, rear bumper sensors and rear right taillamp. The body parts at the rear portion of the Motor Car were visually examined and it was observed that the repair/restoration works carried out to the damaged area of the Motor Car (refer to photograph 2 & 3 above) were reasonably adequate and in order.

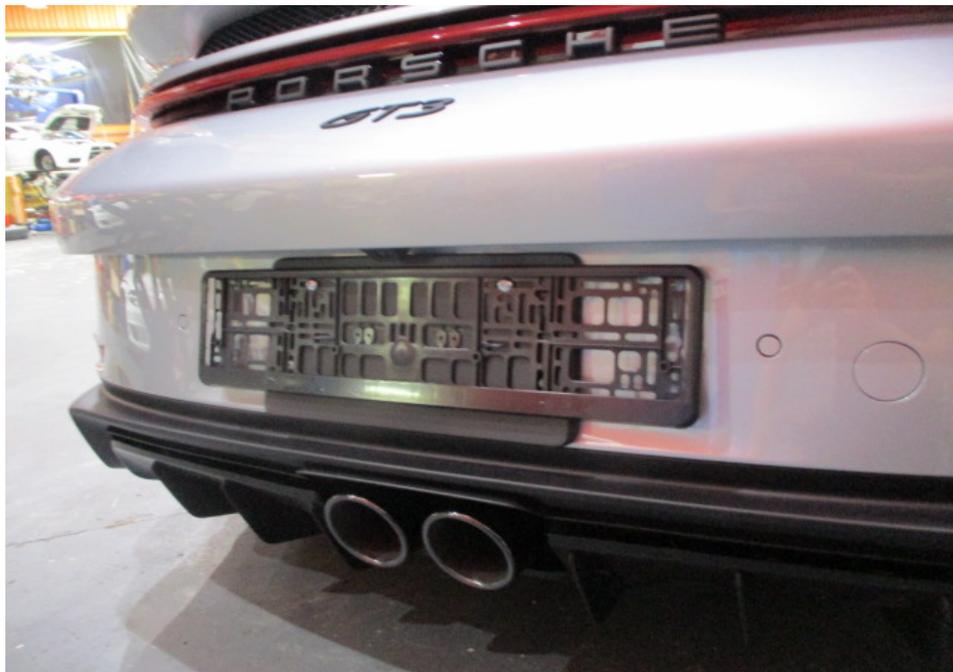
**Photo 15** shows a closer view of the Motor Car's rear bumper, rear bumper lower cover and rear number plate garnish. The body parts at the rear portion of the Motor Car were visually examined and it was observed that the

51 UBI AVE 1, #01-25 PAYA UBI INDUSTRIAL PARK, SINGAPORE 408933 TEL : (065) 62563561 FAX : (065) 67414108  
repair/restoration works carried out to the damaged area of the Motor Car (refer to photograph 2 & 3 above) were reasonably adequate and in order.

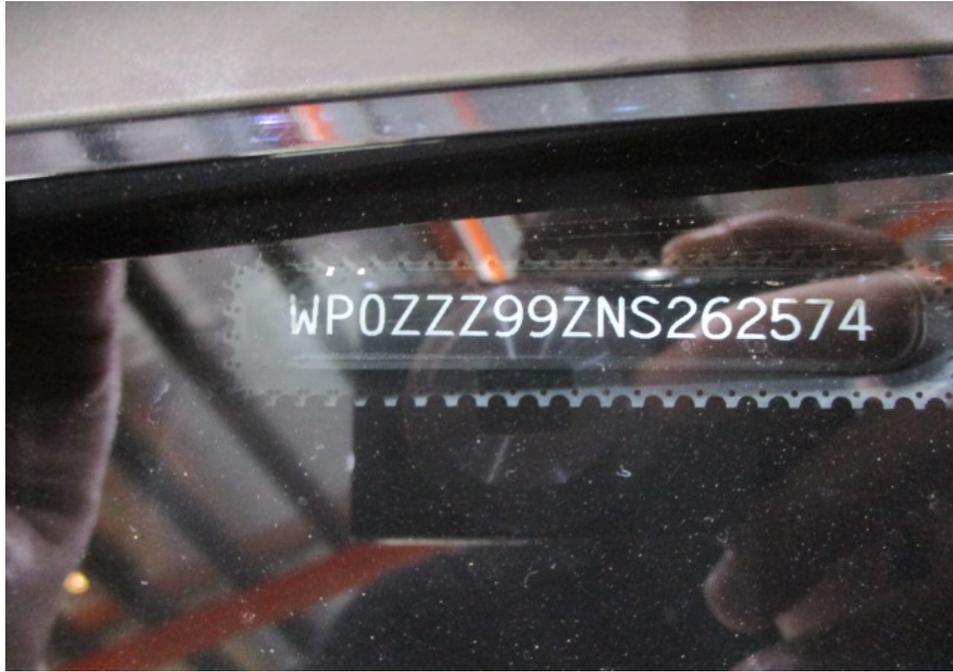
**Photo 16** shows the chassis number of the Motor Car. The chassis number recorded was WP0ZZZ99ZNS262574.

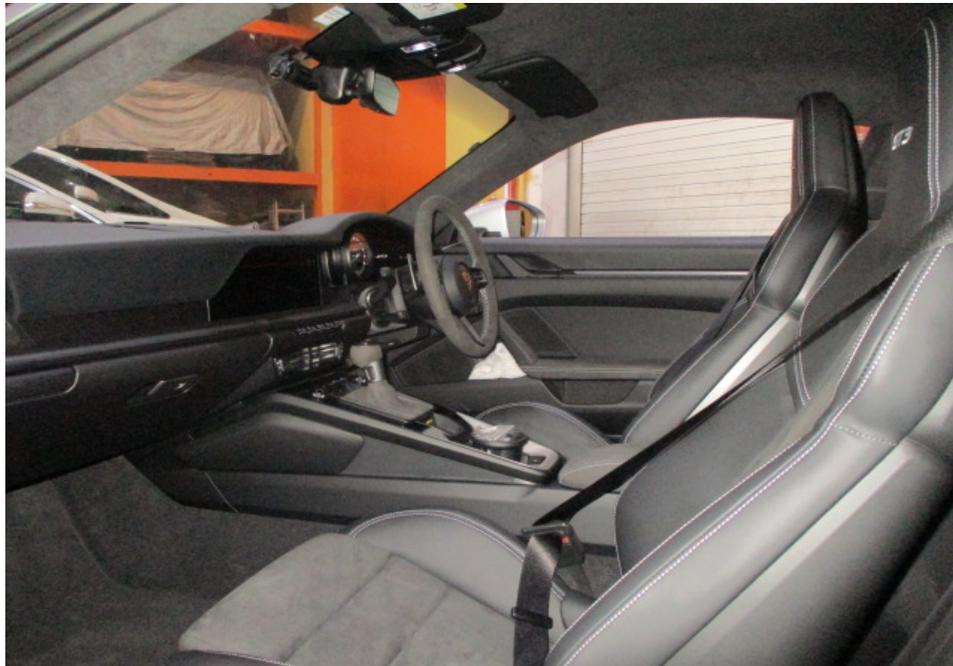
**Photo 17** shows the interior compartment of the Motor Car at the time of my inspection. The various parts and components, trims, carpet, and upholstery inside the interior compartment were all observed to be intact and properly fitted.

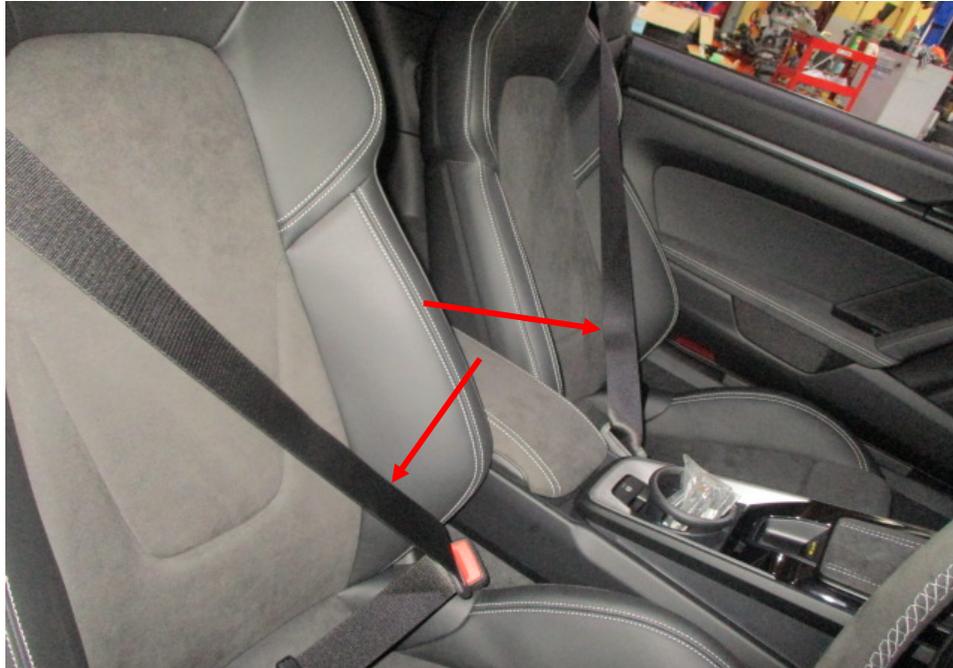
13. The seats of the Motor Car were found to be secured to the floorboard of the Motor Car via seat rails bolted onto the floorboard. Retractable seat belt reels and pre-tensioners were fitted on all seats of the Motor Car. The seat belts were tested and were able to be fastened securely into the respective pre-tensioners that were fixed to the side of all the seats.

**Photo 18** shows the seats of the Motor Car. All the seats of the Motor Car were secured via seat rails to the floorboard. They were also fitted with a retractable seat belt reel and a pre-tensioner. The seat belts (arrowed) were tested and were able to be fastened into the respective pre-tensions that were fitted on the side of each individual seat.

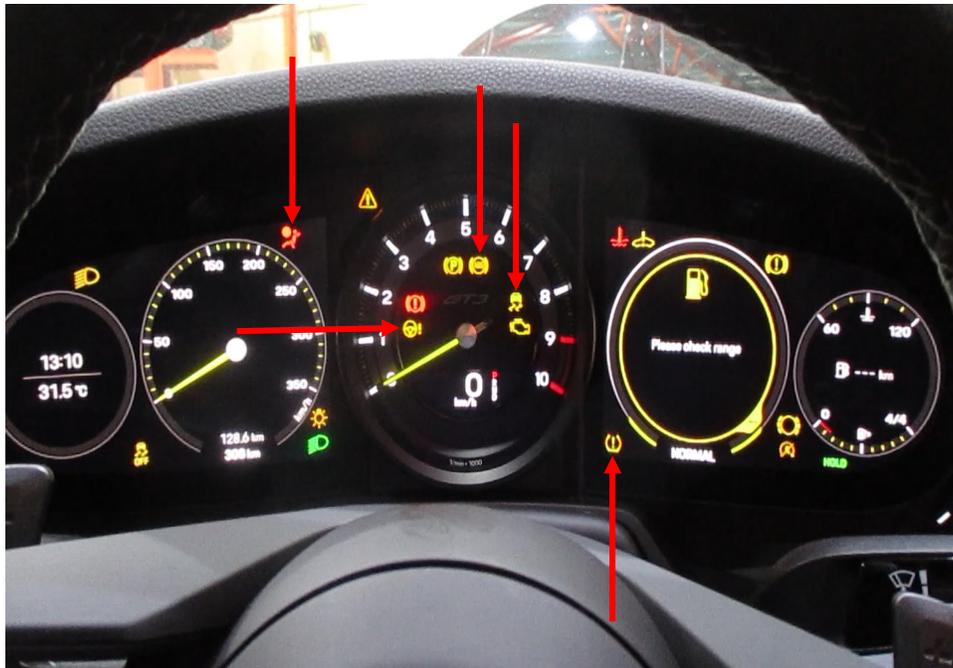
**Photo 19** shows the warning lights for the various electronic safety features appearing on the instrument panel of the Motor Car during its self-test when the engine is cranked, in particular the ABS, SRS, EPS, TPM and TCS lights (arrowed).

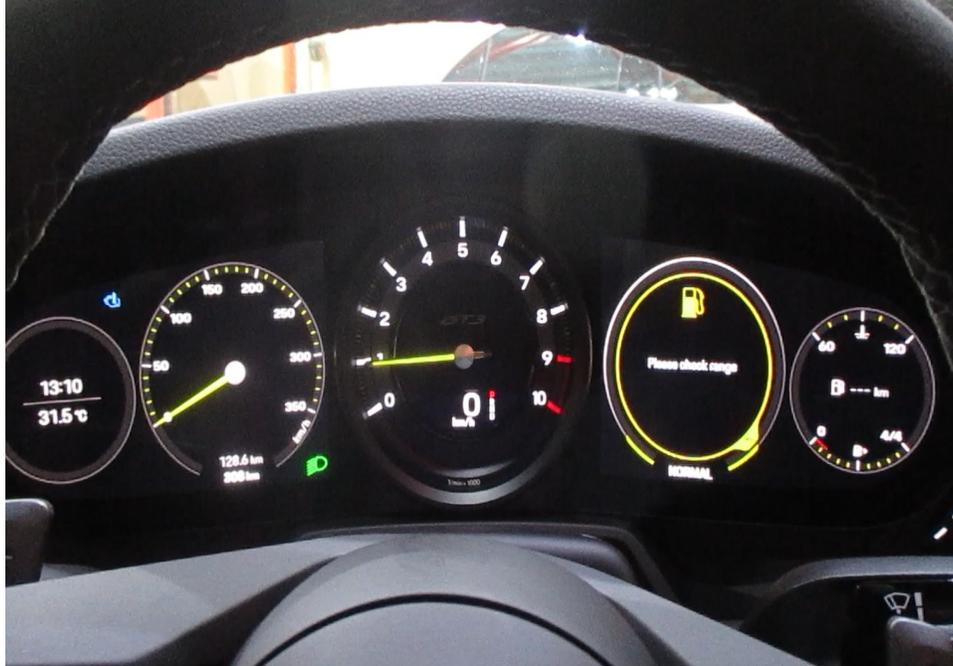
14. The Motor Car's automatic self-test of the functionality of its various electronic safety features like the Anti-Lock Brake System (ABS), Supplemental Restraint System (SRS), Electric Power Steering (EPS), Tyre Pressure Monitor (TPM) and Traction Control System (TCS) during cranking of the engine had indicated that these electronic systems were in working condition. This was determined from the respective warning lights disappearing from the instrument panel after the self-test.

**Photo 20** shows the respective warning lights no longer illuminated, indicating that there is no fault detected to the ABS, SRS, EPS, TPM and TCS systems of the Motor Car during the self-test. These electronic systems were hence in working condition at the time of my inspection.

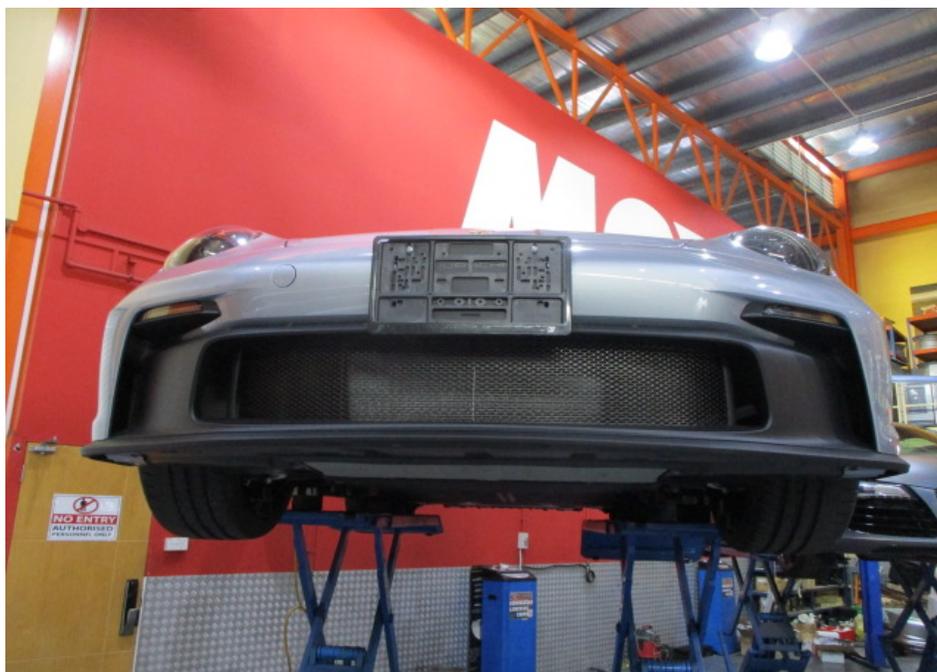
16. My checks on the underside of the Motor Car revealed no sign(s) or indication(s) of fluid leakage and/or fluid stain(s). The engine block and automatic transmission assembly were both secured properly. All undercarriage components of the Motor Car were also observed to be intact and secured in an appropriate manner.

**Photo 21** shows the Motor Car hoisted up for checks on its undercarriage. There was no sign(s) or indication(s) of fluid leakage and/or fluid stain(s) on the underside of the Motor Car. The undercarriage components of the Motor Car were also all observed to be intact and secured in an appropriate manner.

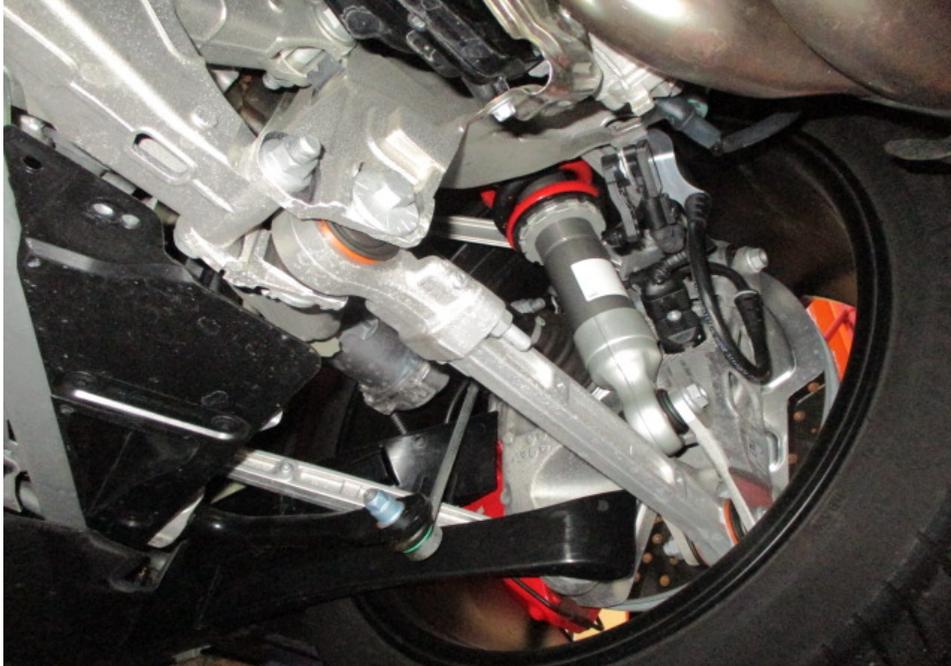
**Photo 22** shows a general view of the control arms and linkages at the rear right wheel of the Motor Car. I did not observe any fluid leak and/or fluid stain on the underside of the Motor Car. All of the Motor Car's undercarriage components were observed to be intact and secured in an appropriate manner.

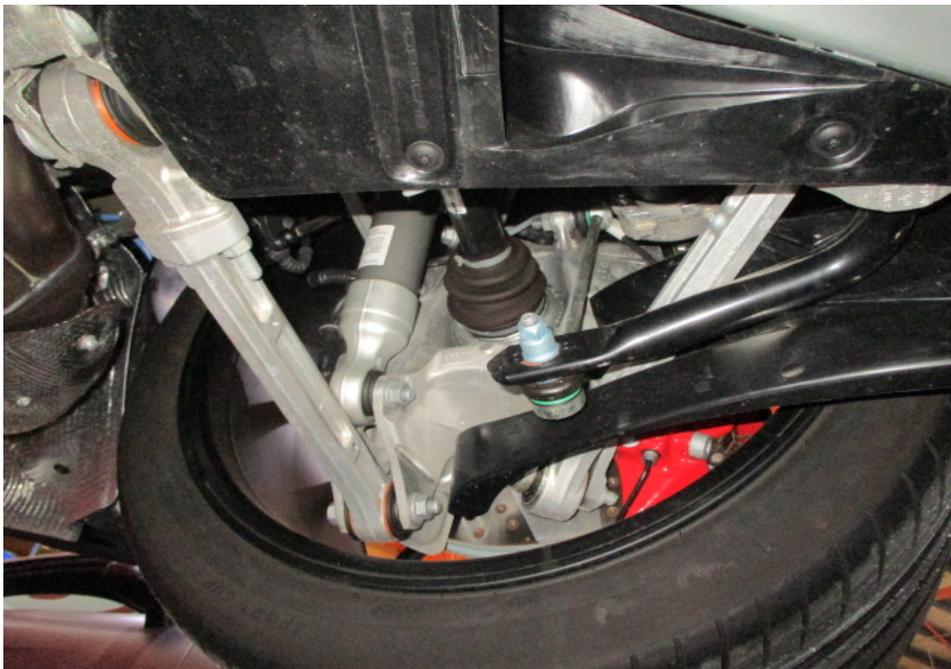
**Photo 23** shows a general view of the control arms and linkages at the rear left wheel of the Motor Car. I did not observe any fluid leak and/or fluid stain on the underside of the Motor Car. All of the Motor Car's undercarriage components were observed to be intact and secured in an appropriate manner.

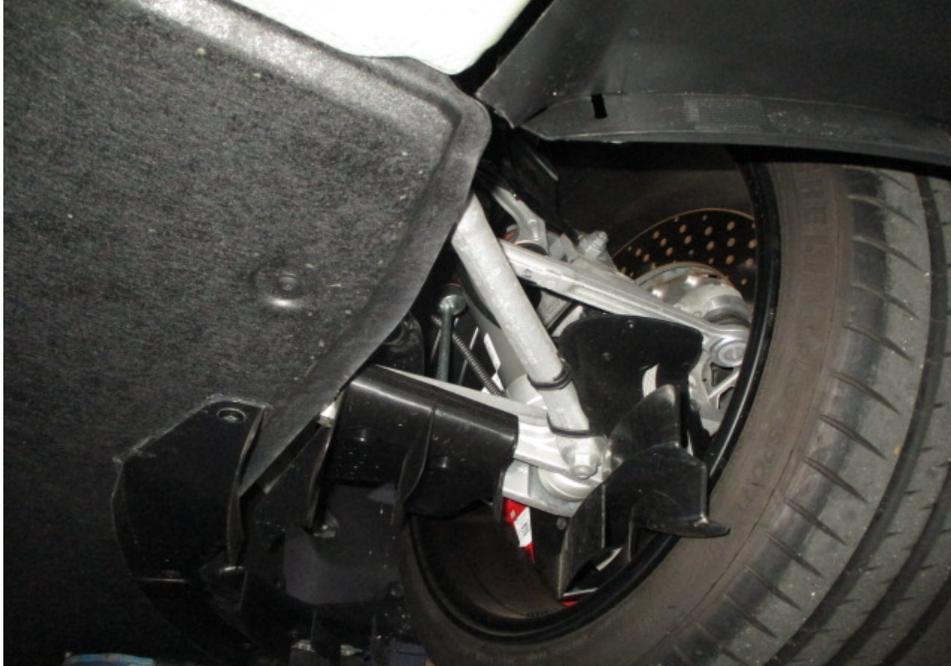
**Photo 24** shows the various undercarriage components at the front left wheel of the Motor Car. The mechanical components, control arms and linkages were all found to be intact and secured in an appropriate manner.

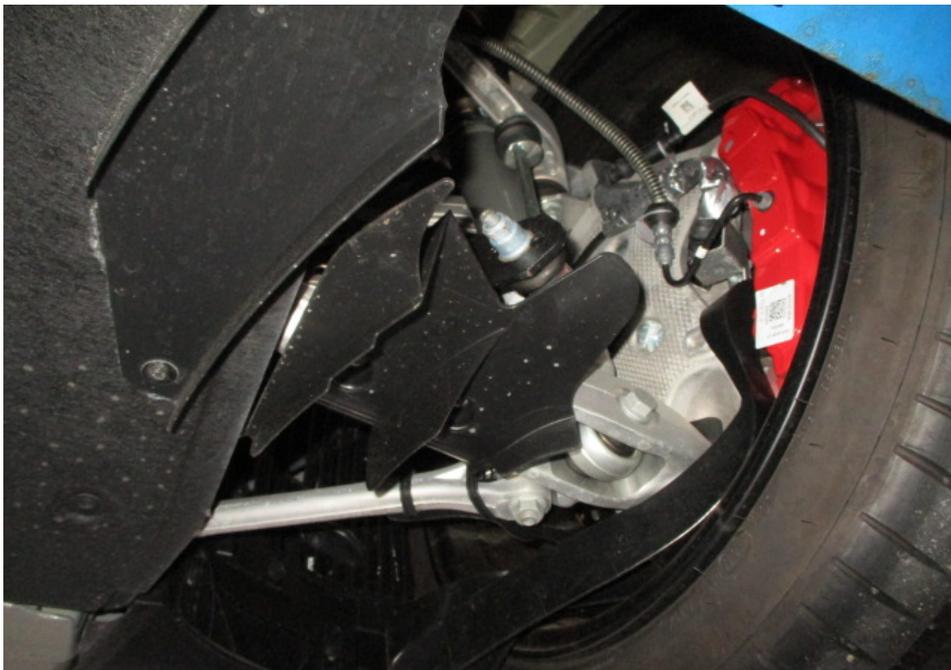
**Photo 25** shows the various undercarriage components at the front right wheel of the Motor Car. The mechanical components, control arms and linkages were all found to be intact and secured in an appropriate manner. I also did not observe any fluid leak and/or fluid stain on the underside of the Motor Car.

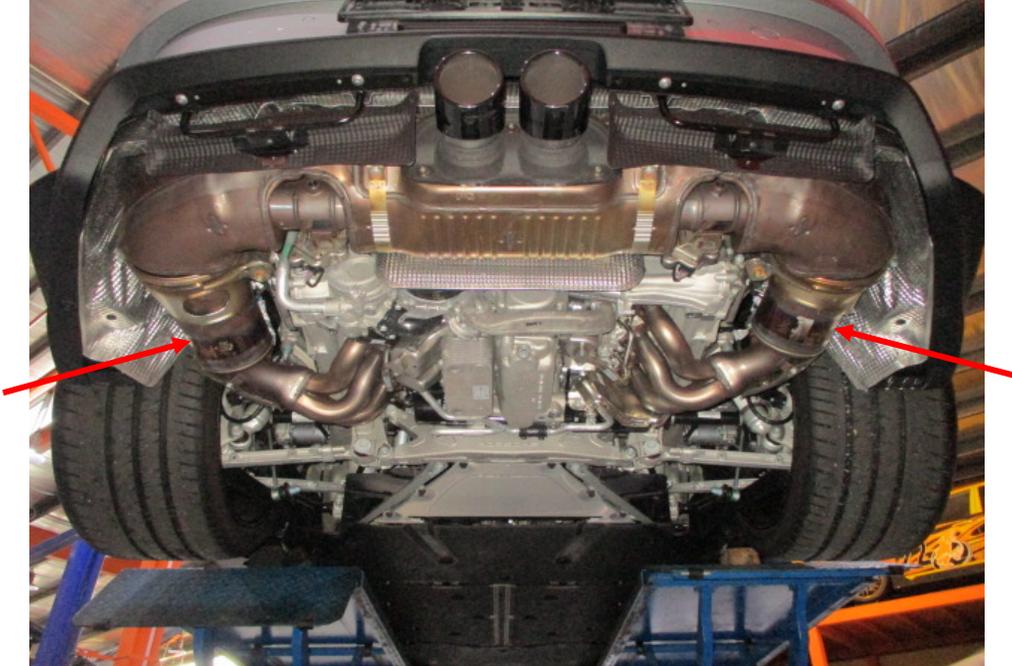
**Photo 26** shows the Motor Car's exhaust system. My examination of the Motor Car's exhaust system revealed no sign(s) or indication(s) of any cut or weld marks along its exhaust pipes, on its catalytic converters (arrowed) and on its rear muffler.

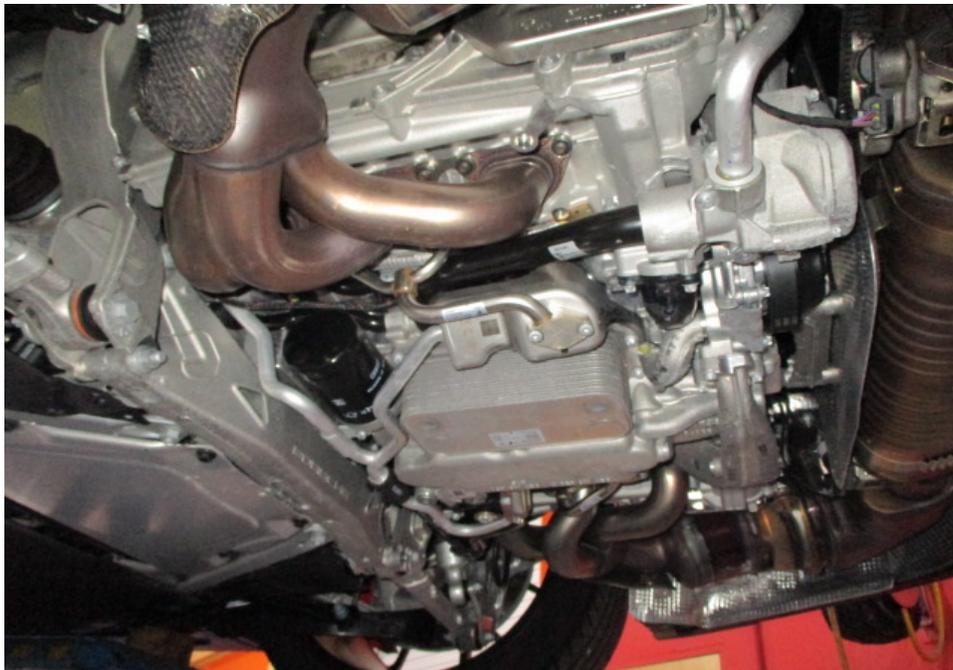
**Photo 27** shows a general view of the Motor Car's engine compartment. The engine compartment was at the rear underside of the Motor Car. The various parts and components inside the engine compartment were all observed to be intact and properly fitted. There was also no sign(s) or indication(s) of fluid leak and/or fluid stain found inside the engine compartment.

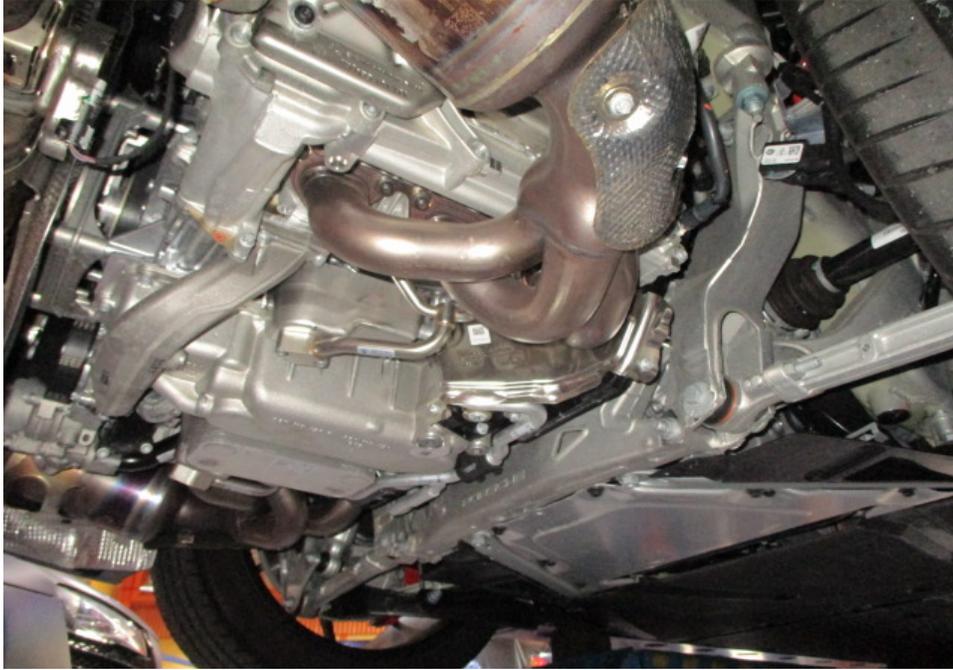
**Photo 28** shows another view of the Motor Car's engine compartment. The engine compartment was at the rear underside of the Motor Car. The various parts and components inside the engine compartment were all observed to be intact and properly fitted. There was also no sign(s) or indication(s) of fluid leak and/or fluid stain found inside the engine compartment.

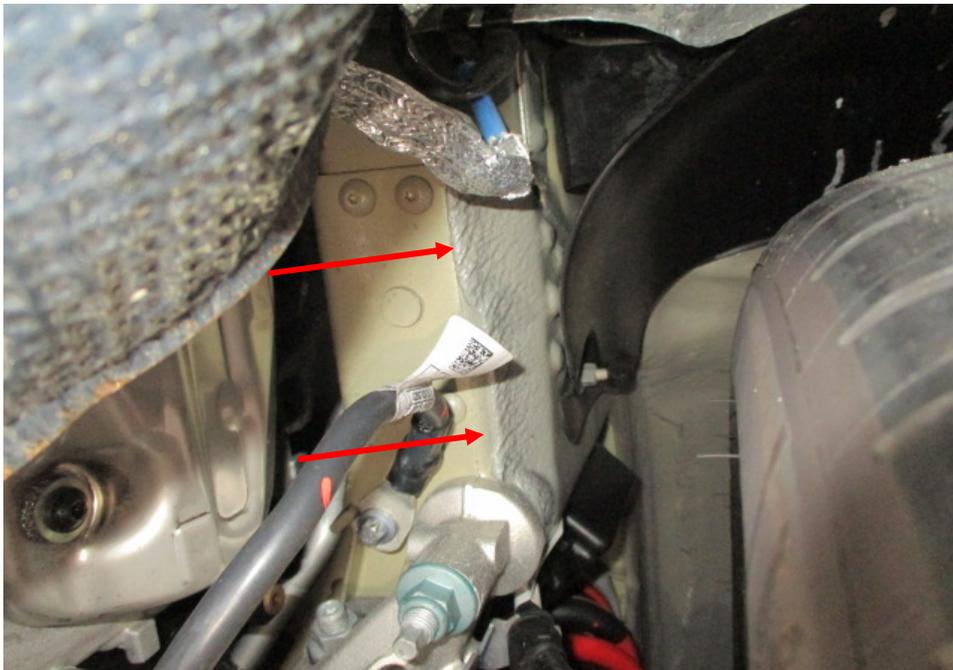
12. Visually, I did not find any weld marks, other than the original spot weld marks, on the chassis/structural body of the Motor Car. The original factory sealant at the joints along the chassis/structural body was also untouched, again indicating that no replacement of the chassis/structural body was carried out; and that the chassis/structural body was originally fitted.

**Photo 29** shows the chassis/structural body at the underside rear right of the Motor Car. I did not find any weld marks other than original spot weld marks on the chassis/structural body of the Motor Car. The original factory sealant (arrowed) at the joints along the chassis/structural body was untouched, indicating no work was done on the chassis/structural body of the Motor Car and that the chassis/structural body was originally fitted.
