Your Ref: Porsche GT3 Coupe  
(chassis number WP0ZZZ99ZNS262574)  
Our Ref : CI/TP22006409/D

01 July 2022

**INSPECTION REPORT OF AN UNREGISTERED PORSCHE GT3 COUPE  
MOTOR CAR WITH CHASSIS NUMBER WP0ZZZ99ZNS262574**

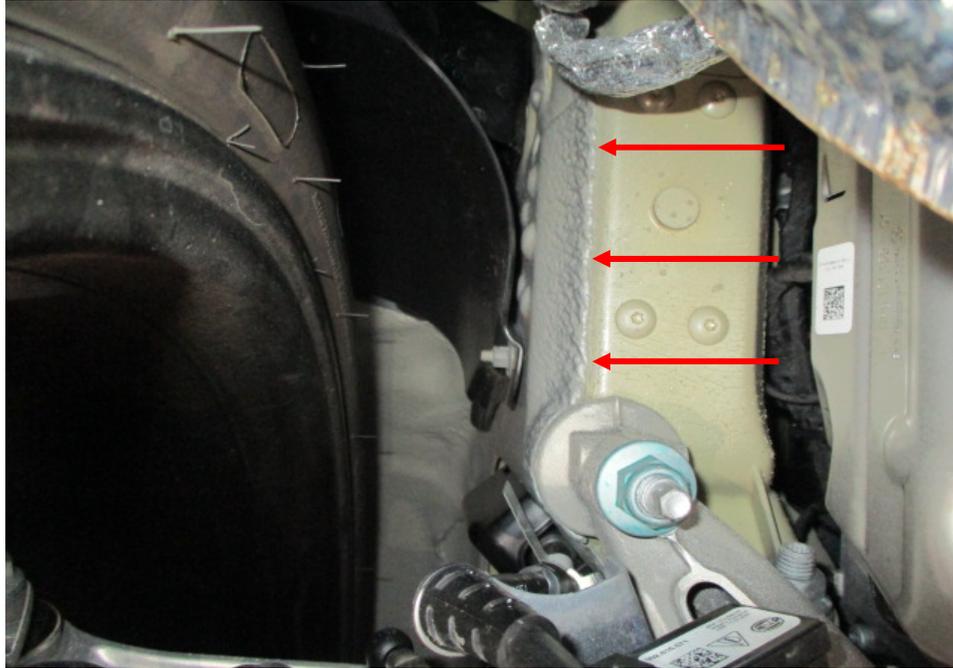
**Photo 30** shows the chassis/structural body at the underside rear left of the Motor Car. The original factory sealant (arrowed) at the joints along the chassis/structural body was observed to be untouched. In general, I had found no work was carried out on the chassis/structural body of the Motor Car. The chassis/structural body of the Motor Car was originally fitted.

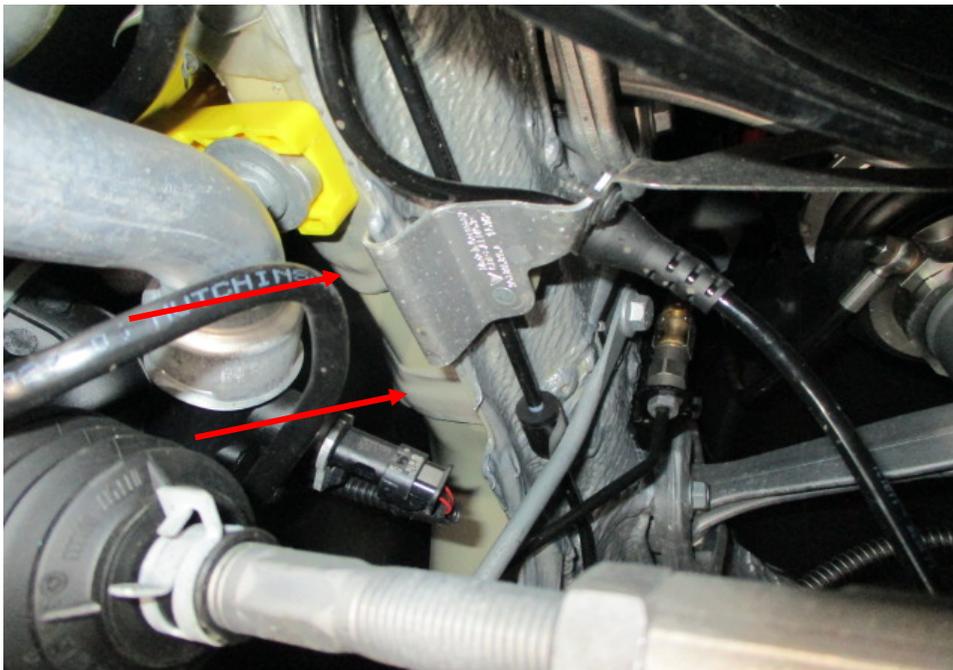
**Photo 31** shows the chassis/structural body at the underside front left of the Motor Car. I did not find any weld marks other than original spot weld marks on the chassis/structural body of the Motor Car. The original factory sealant (arrowed) at the joints along the chassis/structural body was untouched, indicating no work was done on the chassis/structural body of the Motor Car and that the chassis/structural body was originally fitted.

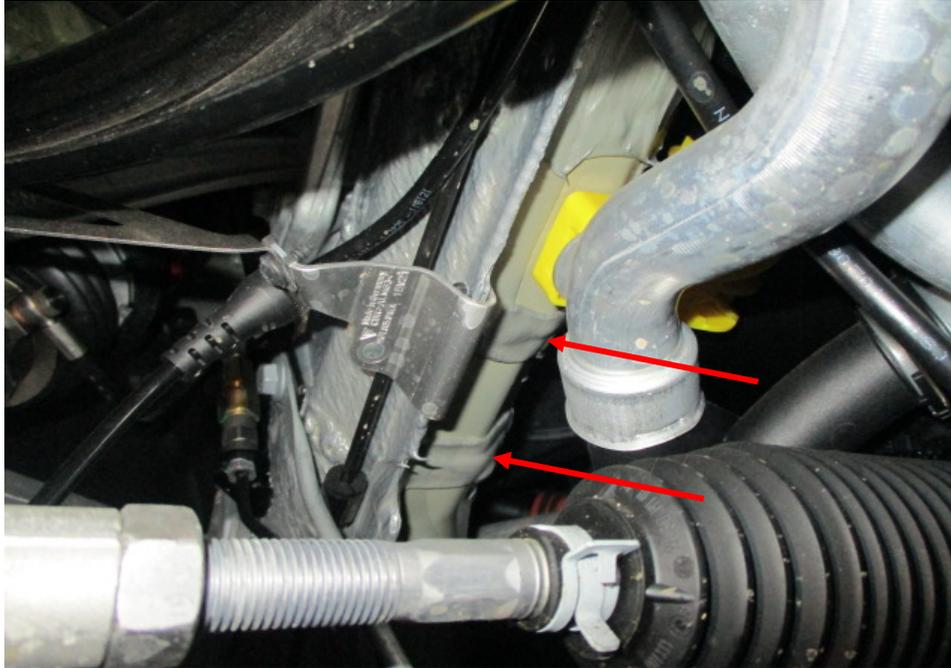
**Photo 32** shows the chassis/structural body at the underside front right of the Motor Car. The original factory sealant (arrowed) at the joints along the chassis/structural body was observed to be untouched. In general, I had found no work was carried out on the chassis/structural body of the Motor Car. The chassis/structural body of the Motor Car was originally fitted.
