Your Ref: CDMCG22001320
Our Ref : CS4/EGI22006462/P

**TECHNICAL INVESTIGATION REPORT OF FIRE INCIDENT INVOLVING THE
INSURED VEHICLE GBD 7178E ON 3rd July 2022**

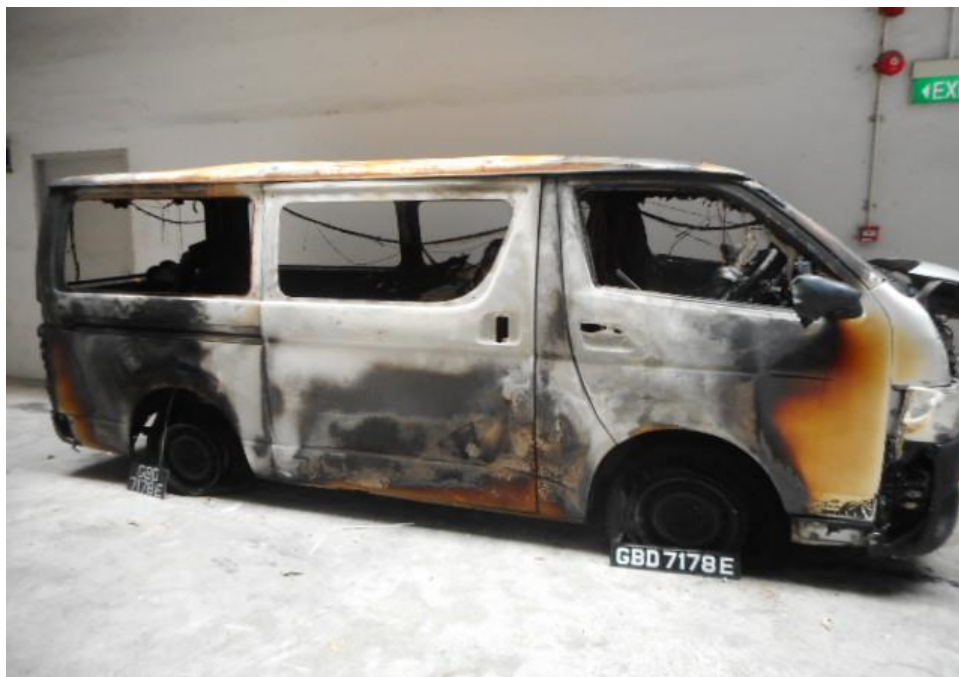
Photo 1 shows the right view of the Insured Vehicle at the time of our inspection. The right body panel of the Insured Vehicle had sustained heat and smoke damage by as a result of the fire.

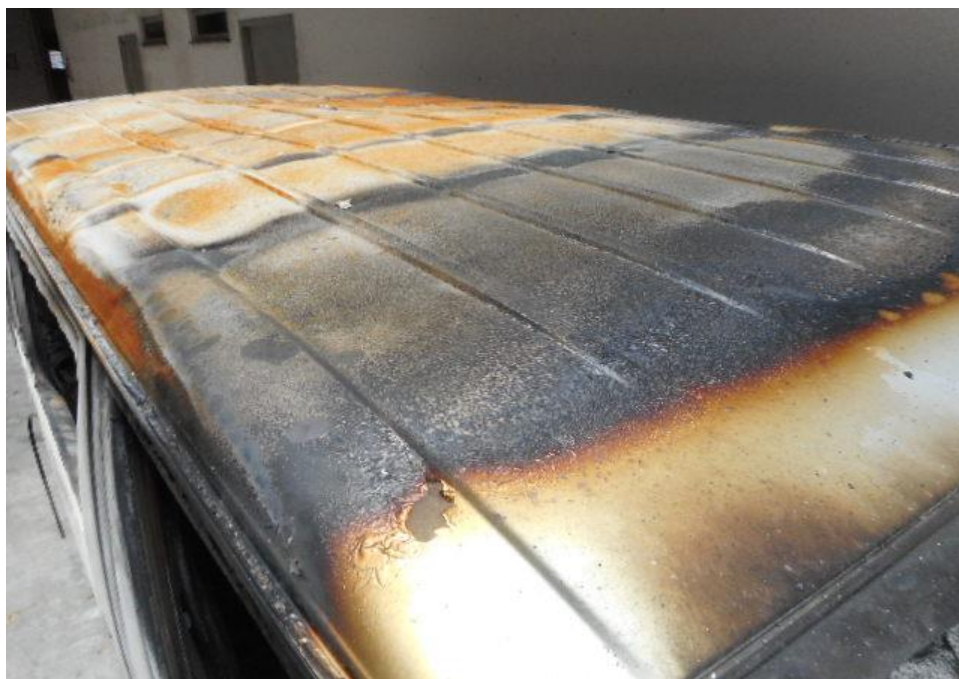
Photo 2 shows the top view of the Insured Vehicle at the time of our inspection. The roof top of the Insured Vehicle had sustained heat and smoke damage by as a result of the fire.

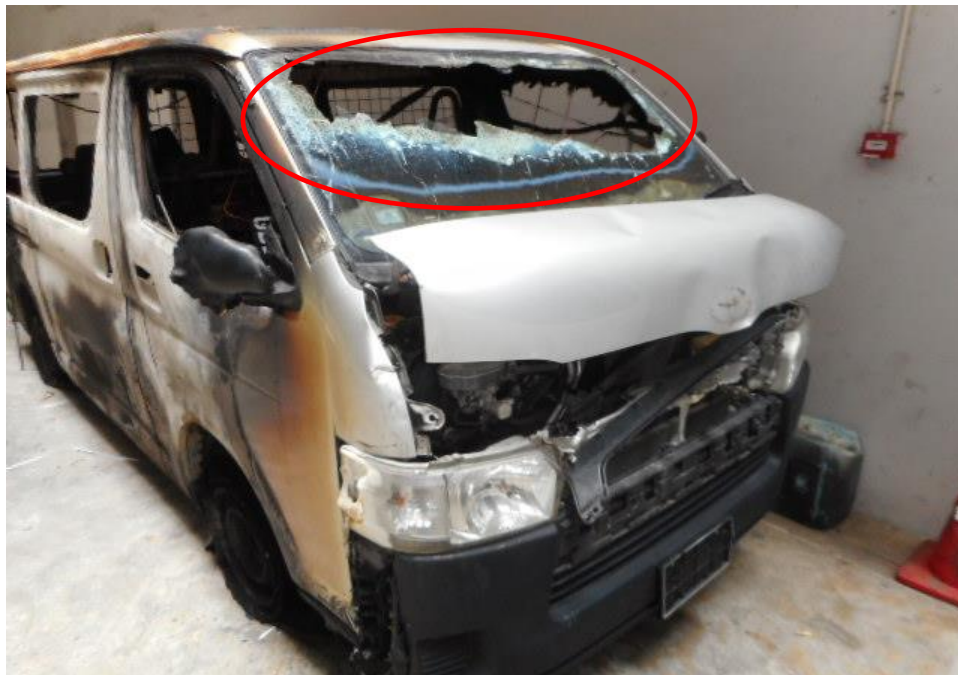
Photo 3 shows the front view of the Insured Vehicle at the time of our inspection. Only the front windscreen (circled) of the Insured Vehicle was damaged as a result of the fire. However, the front body portion of the Insured Vehicle was relatively unaffected by the fire.

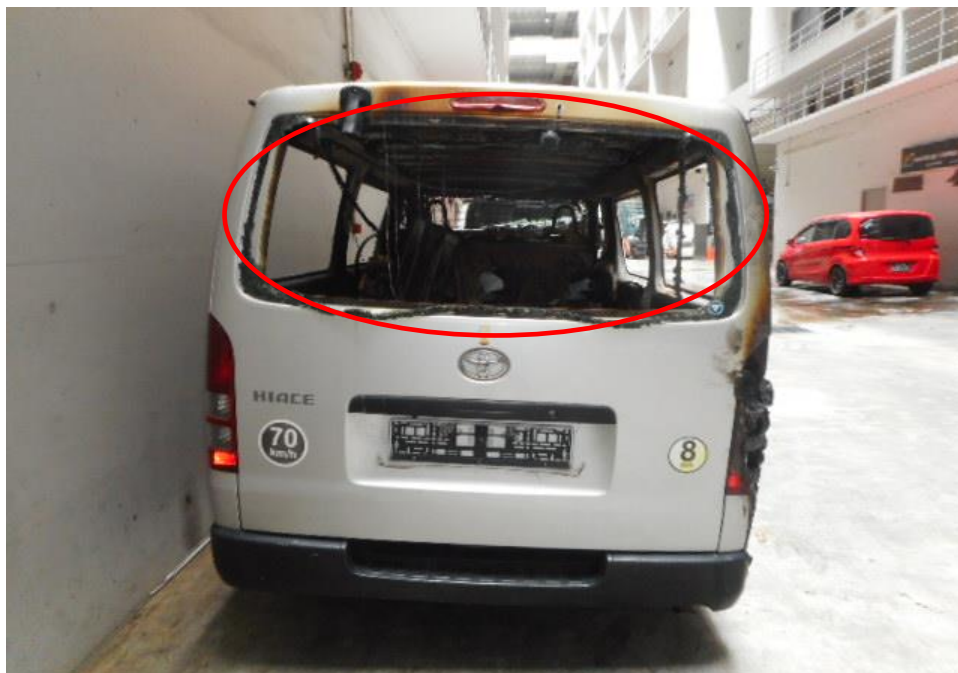
Photo 4 shows the rear view of the Insured Vehicle at the time of our inspection. Only the rear windscreen (circled) of the Insured Vehicle was damaged as a result of the fire. However, the rear body portion of the Insured Vehicle was relatively unaffected by the fire.

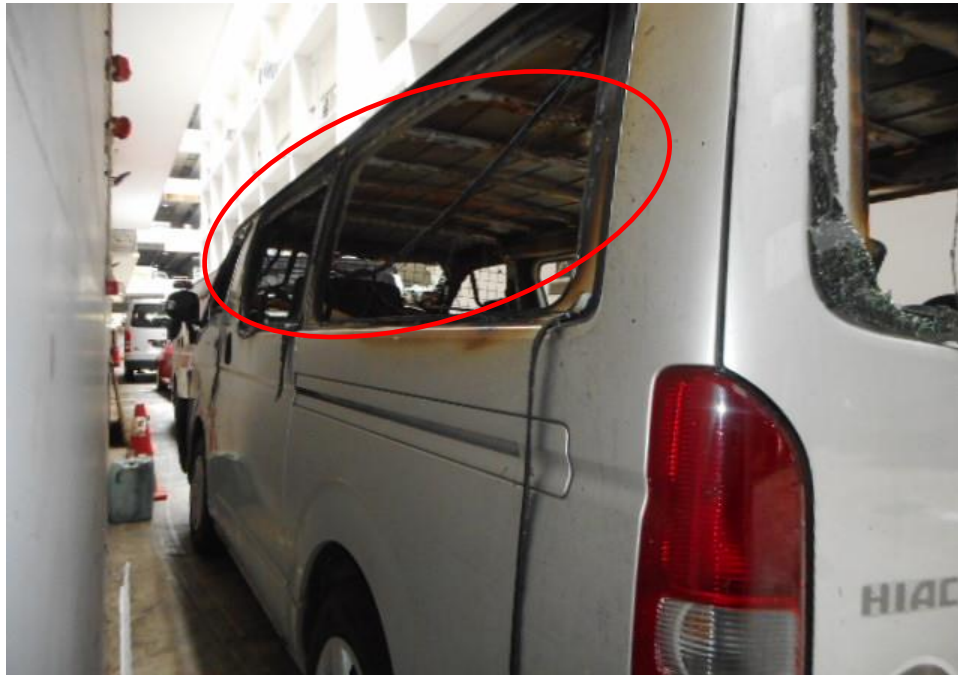
Photo 5 shows the up view of the right side of the Insured Vehicle at the time of our inspection. Only the rear windscreen (circled) of the Insured Vehicle was damaged as a result of the fire. However, the rear body portion of the Insured Vehicle was relatively unaffected by the fire.

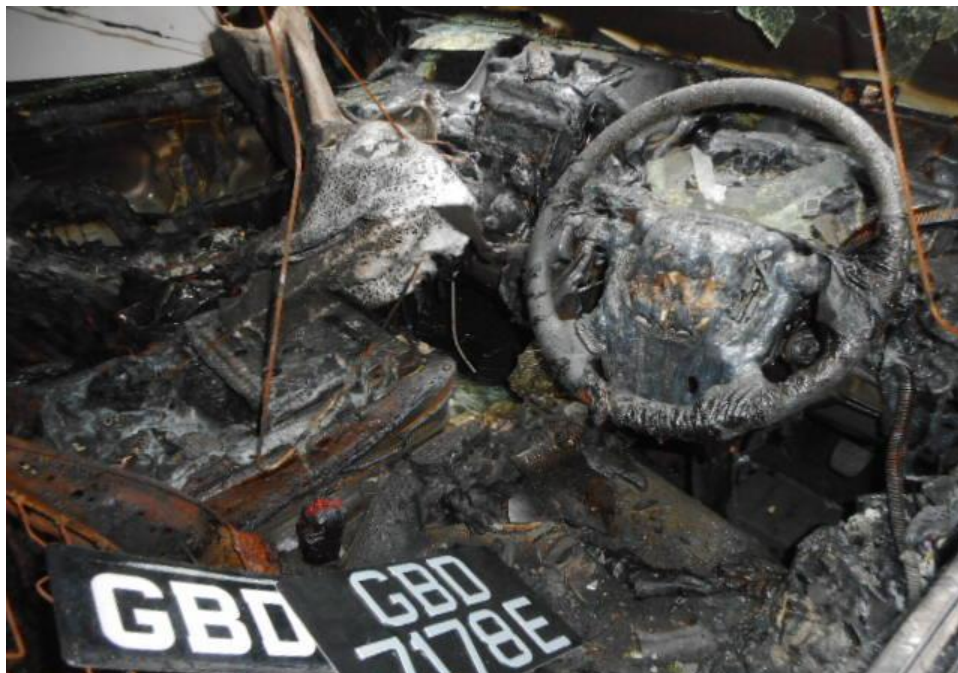
Photo 6 shows the general view of the interior compartment of the Insured Vehicle at the time of our inspection. Its interior compartment had suffered heat, smoke damage and melted as a result of the fire.

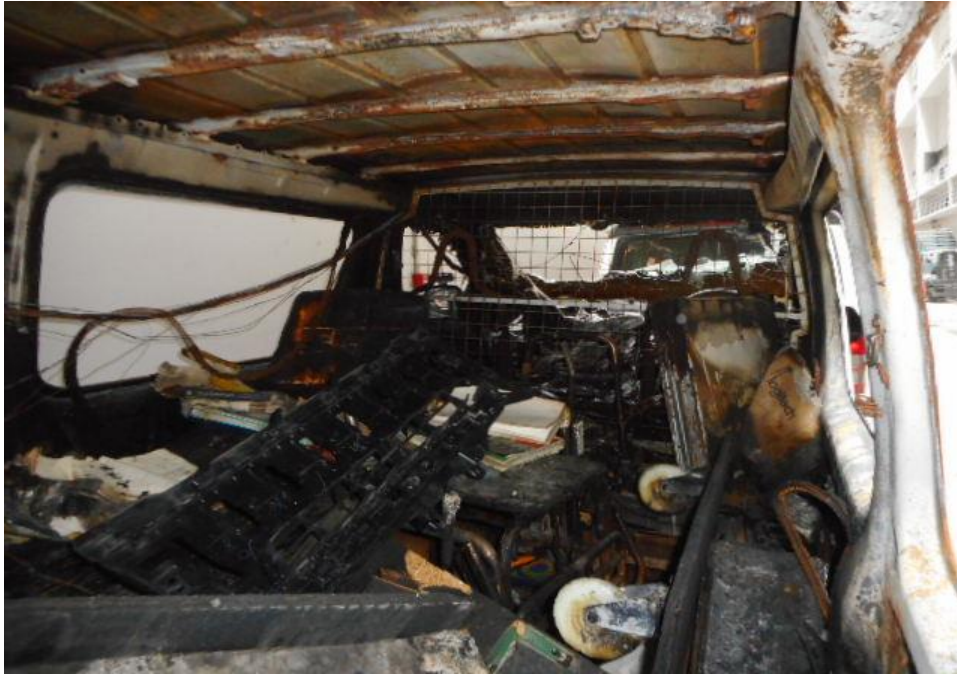
Photo 7 shows the general view of the interior compartment of the Insured Vehicle at the time of our inspection. Its interior compartment had suffered heat, smoke damage and melted as a result of the fire.

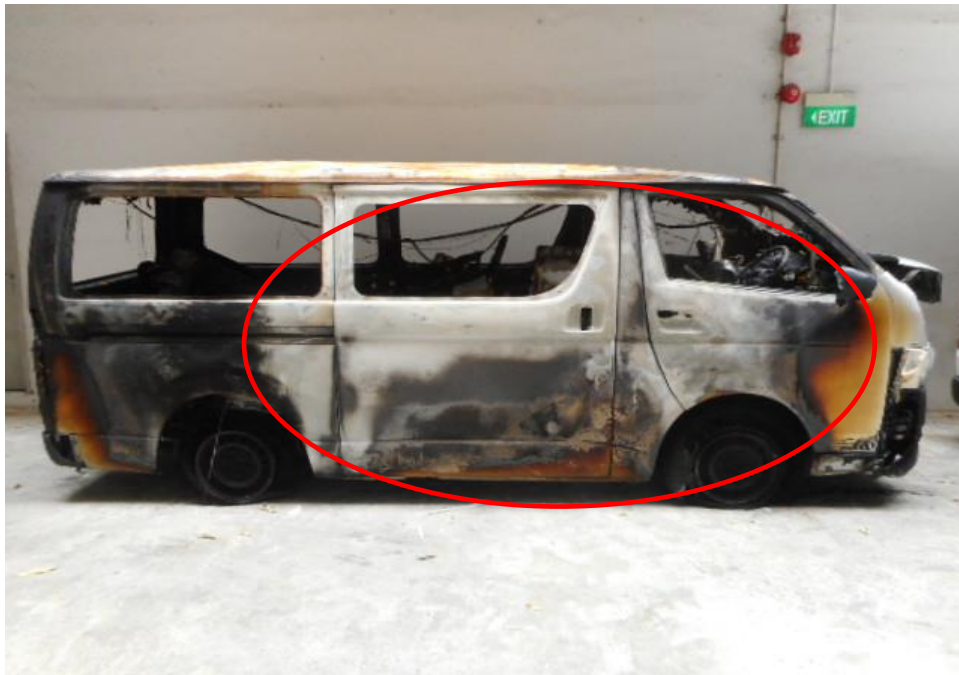
8. These whitish burn marks are a result of exposure to prolong heat intensity. Rust would normally start to develop around these areas soon after a fire as the prolonged exposure to high heat intensity usually causes the bare steel/metal material of the body parts to be exposed to natural environmental condition. The rust that had developed on the right portion, in the immediate vicinity of where these whitish burn marks were found, would also support our findings of where the fire had affected the Insured Vehicle.

Photo 8 shows the fire damage at the exterior portion of the right side of the Insured Vehicle. The high heat intensity burn marks (whitish burn marks) found on the exterior surface of its right side as well as rust that had also developed on (circled) this indicates that the fire to the Insured Vehicle had originated from the exterior of the Insured Vehicle.

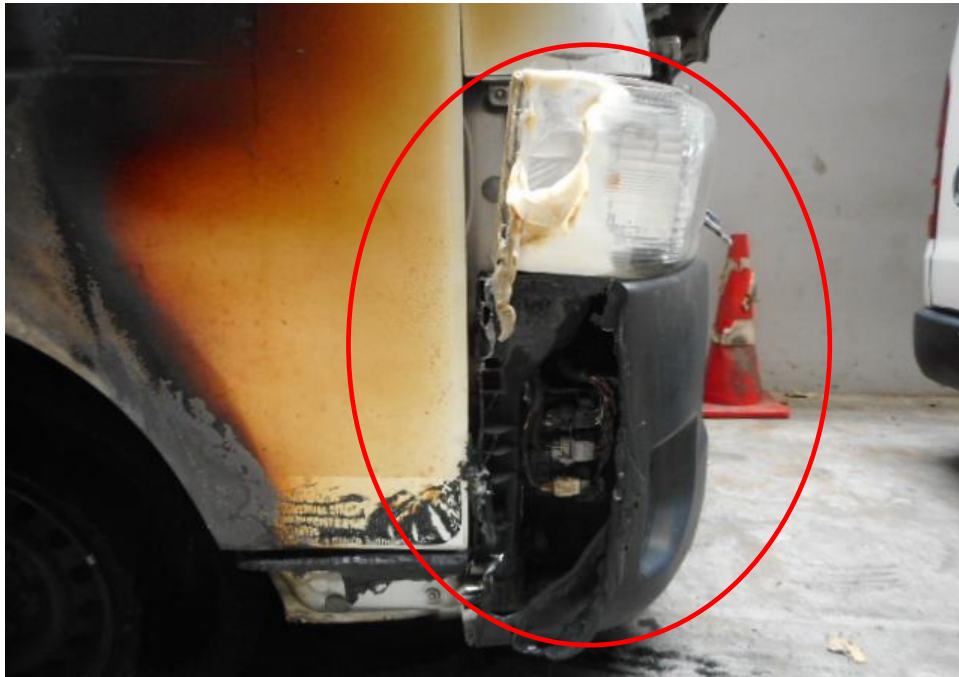
Photo 9 shows the fire damage at the front right headlamp and bumper portion of the Insured Vehicle. The front right headlamp and bumper had melted as a result of the fire as well as the high heat intensity burn marks (whitish burn marks) found on the exterior surface of its right side body panel as well as rust that had also developed on (circled) this indicates that the fire to the Insured Vehicle had originated from the exterior of the Insured Vehicle.

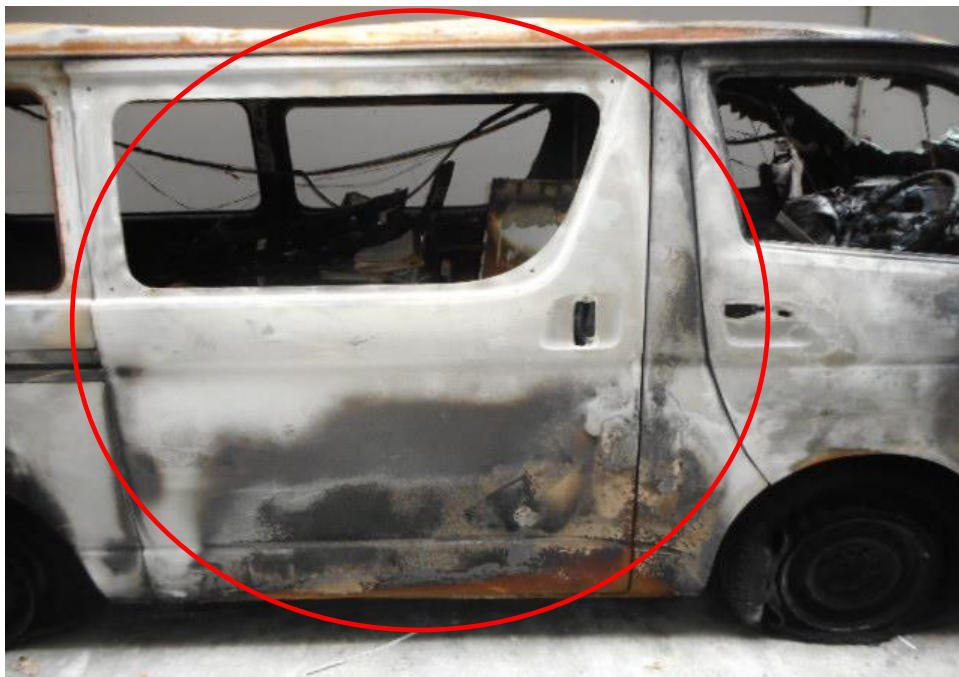
Photo 10 shows close up view of the fire damage at the exterior portion of the right side of the Insured Vehicle. The high heat intensity burn marks (whitish burn marks) found on the exterior surface of its right side as well as rust that had also developed on (circled) this indicates that the fire to the Insured Vehicle had originated from the exterior of the Insured Vehicle.

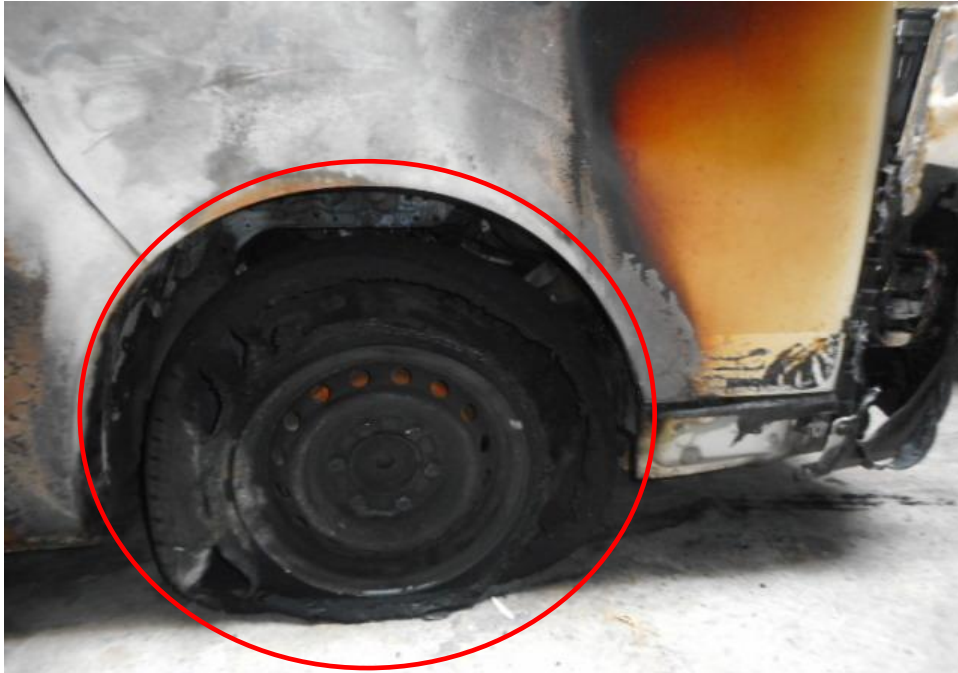
Photo 11 shows the fire damage at the front right wheel portion of the right side of the Insured Vehicle. The tyre and wheel rim had sustained fire damages to it. high heat intensity burn marks (whitish burn marks) found on the exterior surface of its right side as well as rust that had also developed on (circled) this indicates that the fire to the Insured Vehicle had originated from the exterior of the Insured Vehicle.

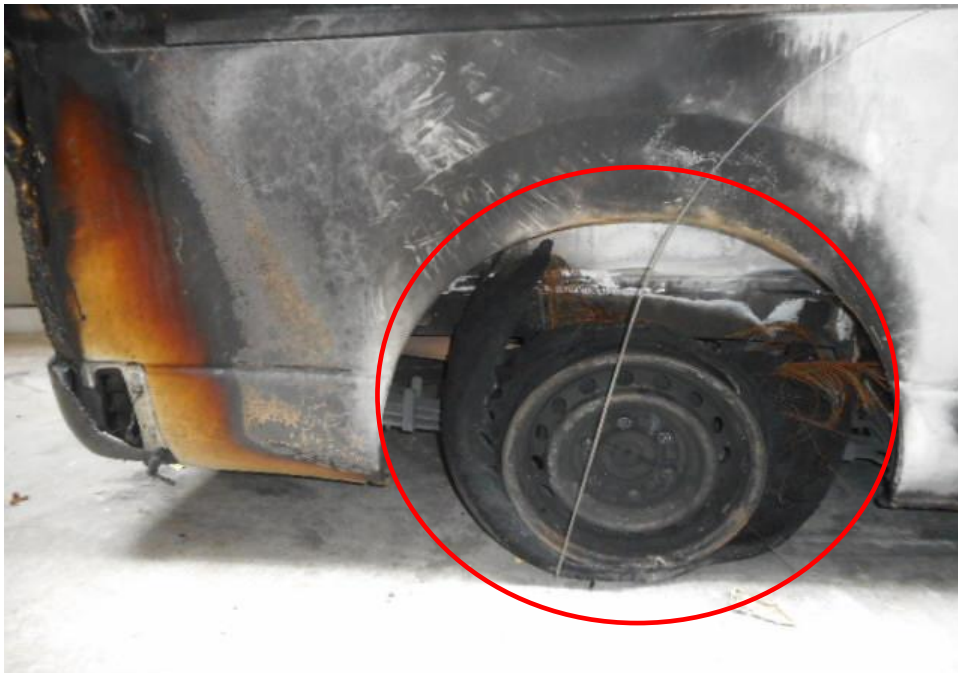
Photo 12 shows the fire damage at the rear right wheel portion of the right side of the Insured Vehicle. The tyre and wheel rim had sustained fire damages to it. high heat intensity burn marks (whitish burn marks) found on the exterior surface of its right side as well as rust that had also developed on (circled) this indicates that the fire to the Insured Vehicle had originated from the exterior of the Insured Vehicle.

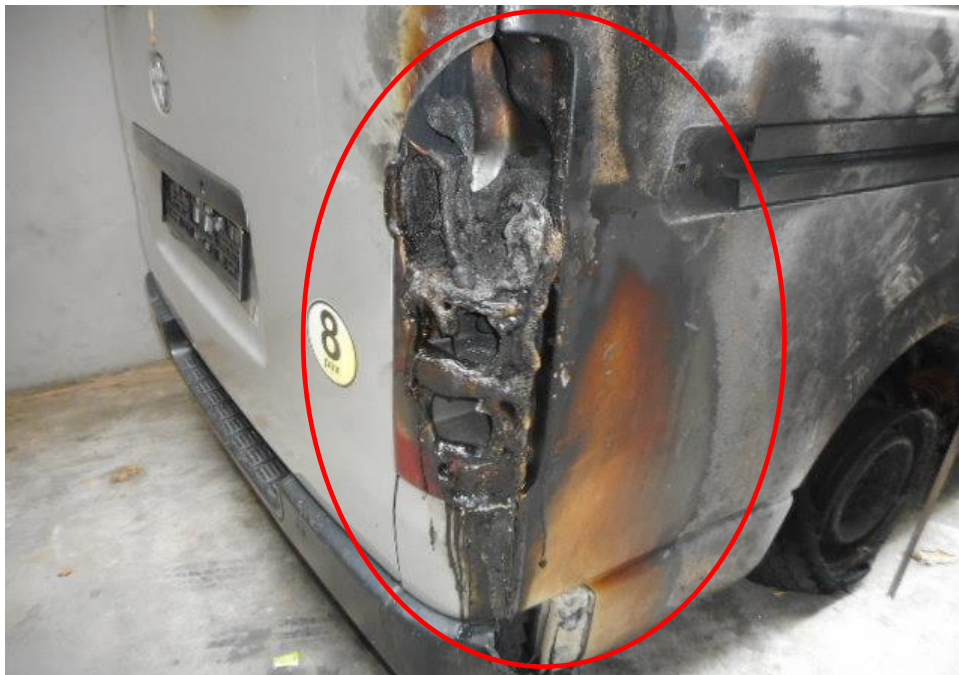
Photo 13 shows the fire damage at the rear right headlamp and bumper portion of the Insured Vehicle. The rear right headlamp and bumper had melted as a result of the fire as well as the high heat intensity burn marks (whitish burn marks) found on the exterior surface of its right side body panel as well as rust that had also developed on (circled) this indicates that the fire to the Insured Vehicle had originated from the exterior of the Insured Vehicle.

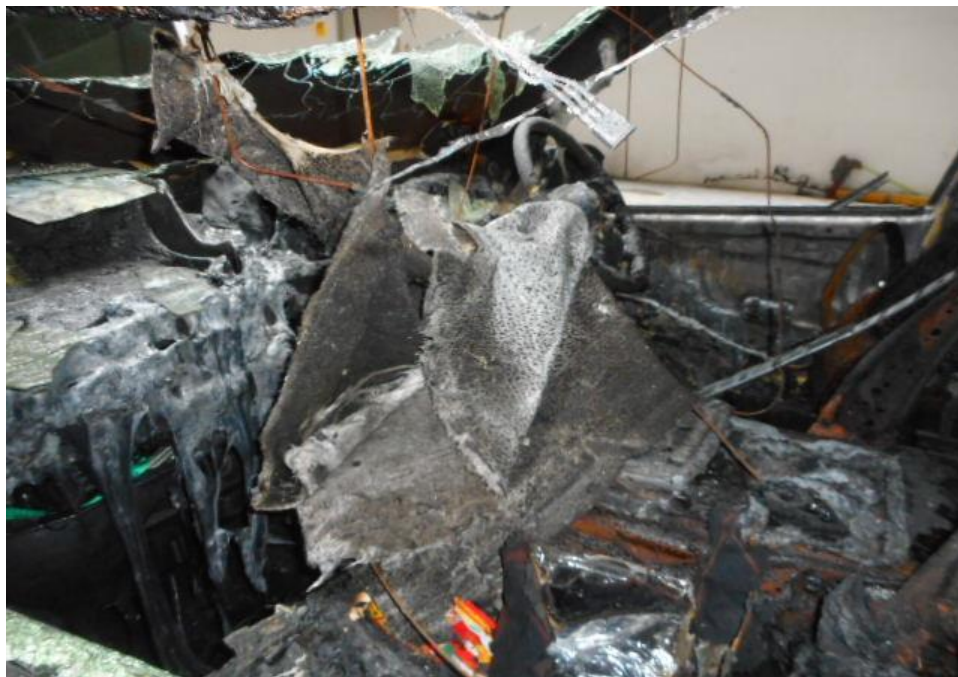
Photo 14 shows the general view of the interior compartment of the Insured Vehicle at the time of our inspection. Its interior compartment had suffered heat, smoke damage and melted as a result of the fire.

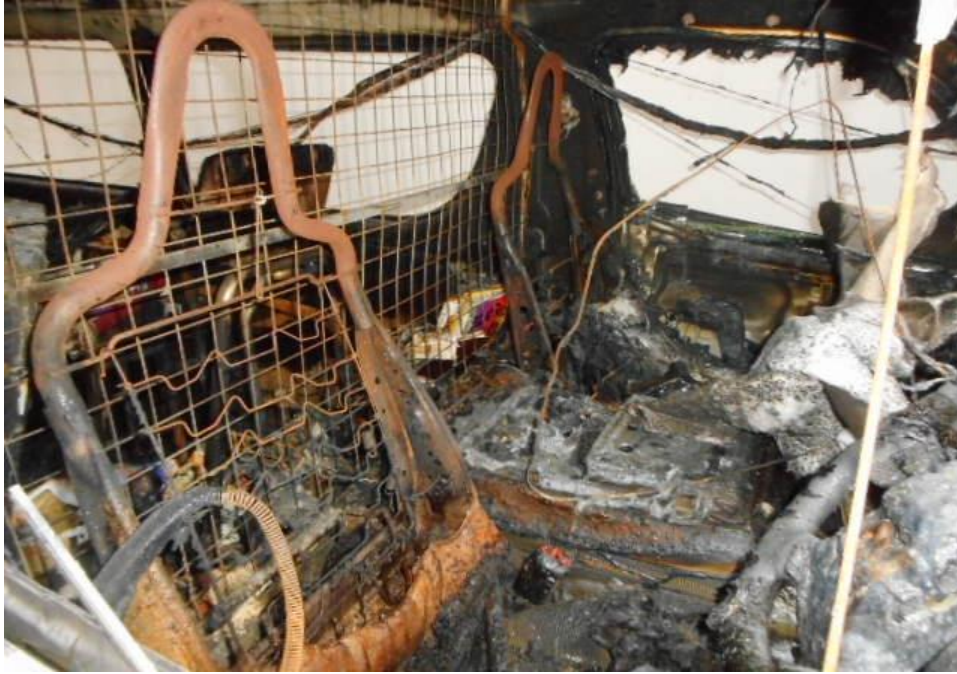
Photo 15 shows the close up view of the interior compartment of the Insured Vehicle at the time of our inspection. Its interior compartment had suffered heat, smoke damage and melted as a result of the fire.

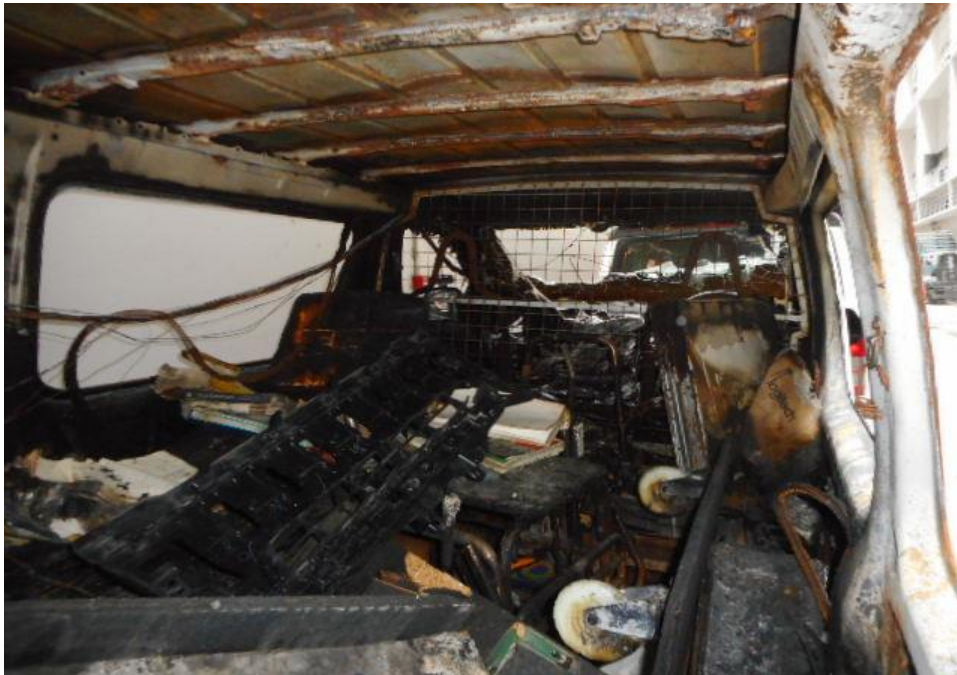
Photo 16 shows the close up view of the interior compartment of the Insured Vehicle at the time of our inspection. Its goods and materials in the Insured Vehicle were all damaged as a result of the fire.

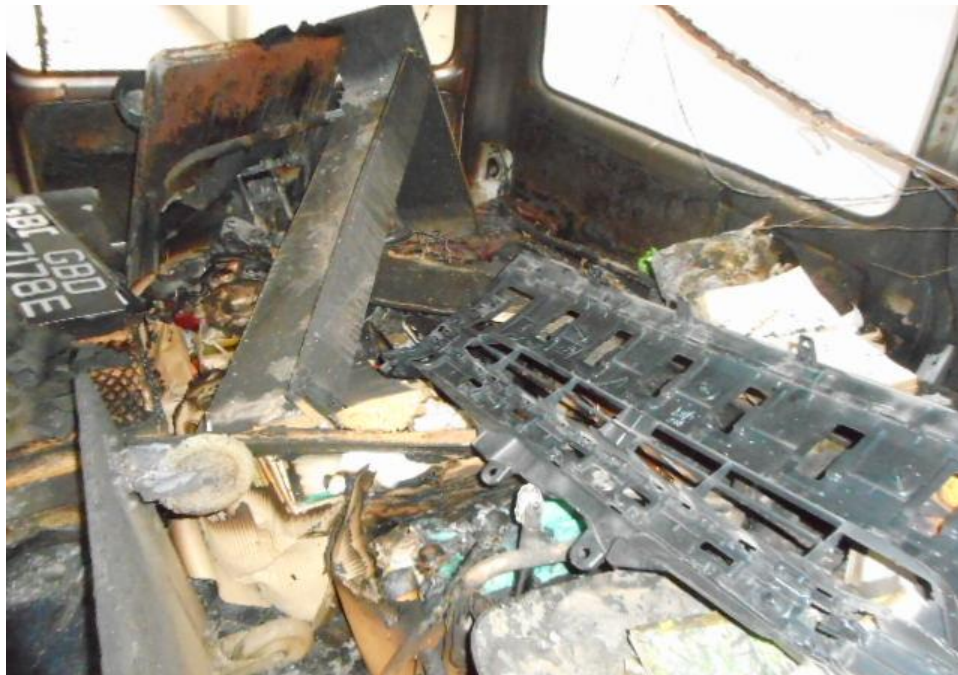
Photo 17 shows the close up view of the interior compartment of the Insured Vehicle at the time of our inspection. Its goods and materials in the Insured Vehicle were all damaged as a result of the fire.

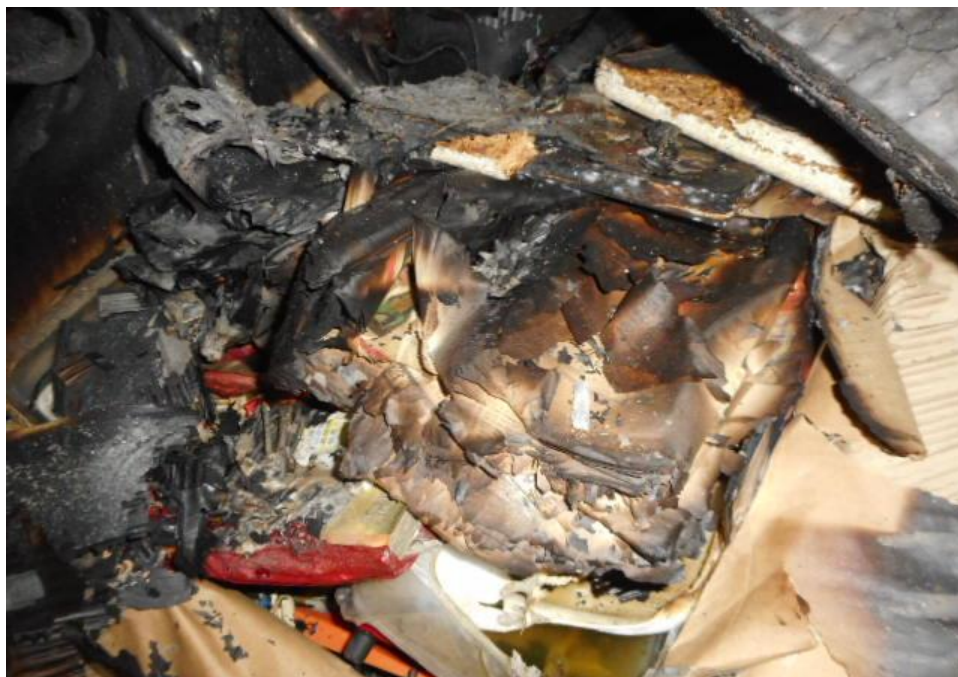
Photo 18 shows the close up view of the interior compartment of the Insured Vehicle at the time of our inspection. The Insured Vehicle was carrying combustible materials and that had resulted in the spread of the fire in the Insured Vehicle at the material time of incident.

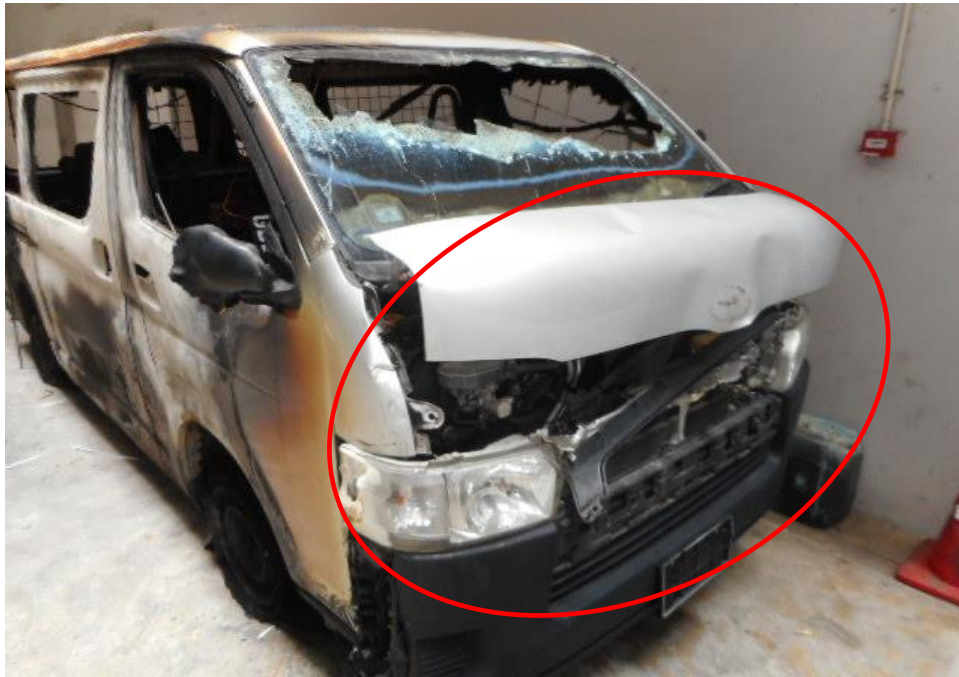
Photo 19 shows the front exterior portion of the Insured Vehicle. The front exterior portion of the Insured Vehicle was not affected by heat and smoke damage.

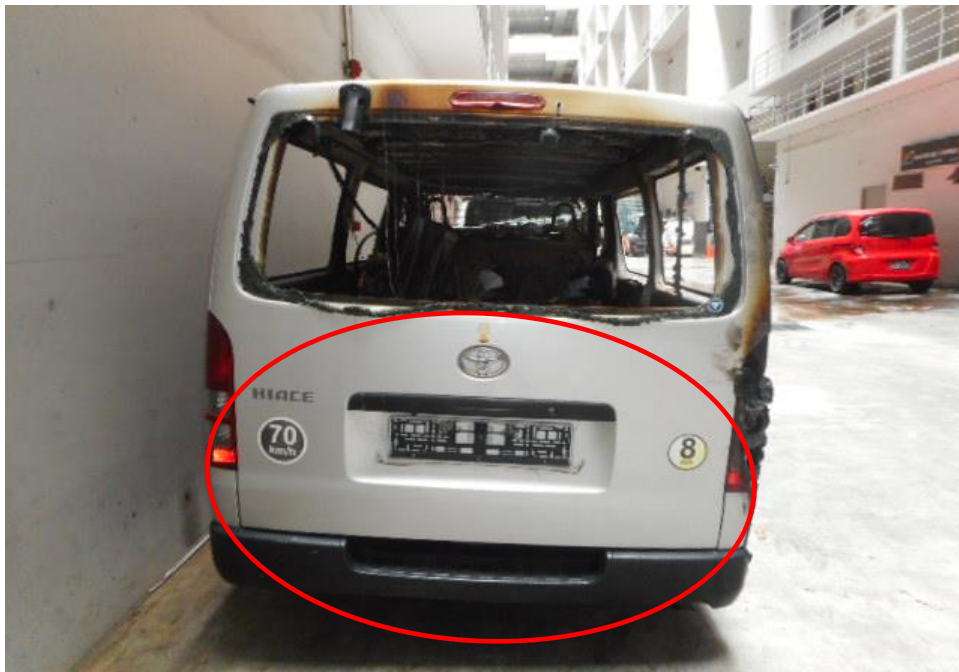
Photo 20 shows the rear exterior portion of the Insured Vehicle. The rear exterior portion of the Insured Vehicle was not affected by heat and smoke damage.

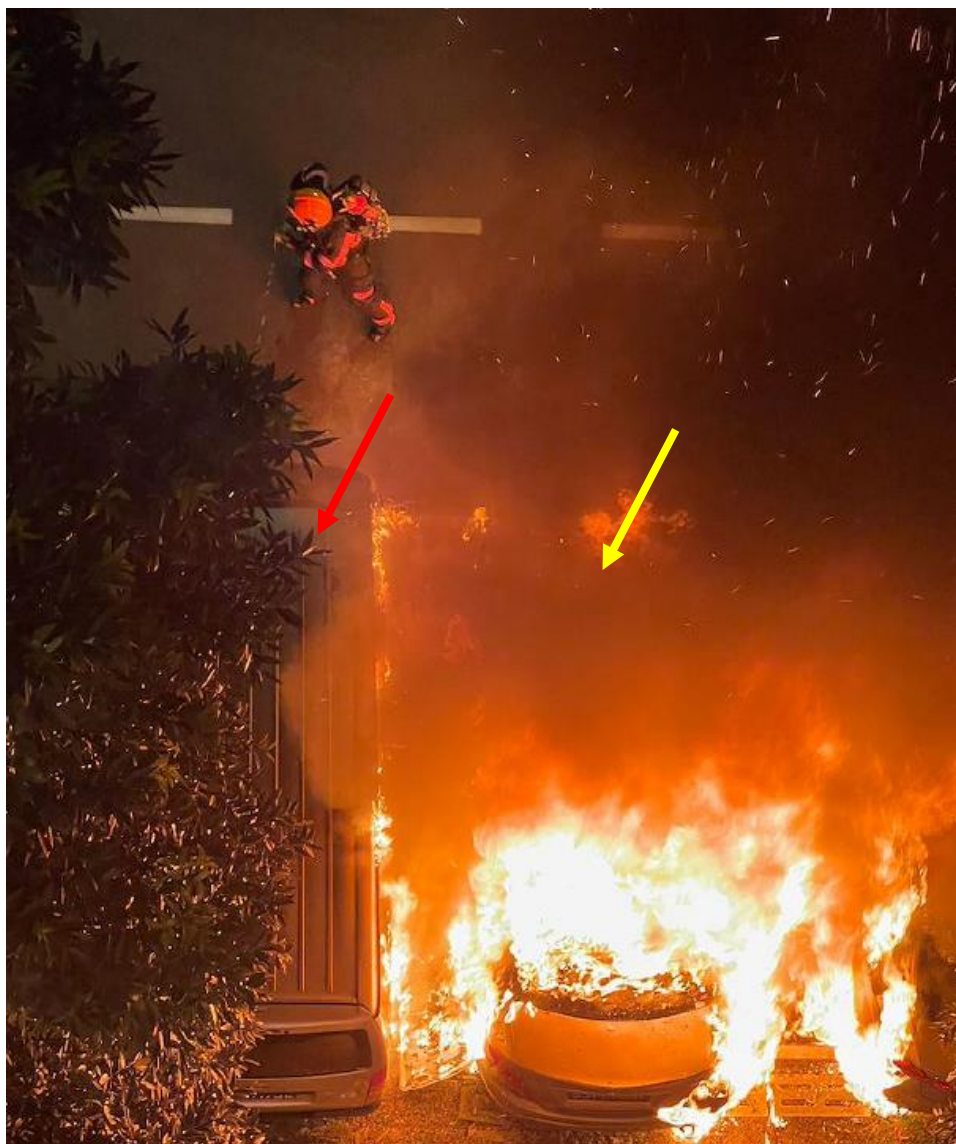
Photo 22 shows the Insured Vehicle on the left side (red arrowed) of the vehicle (yellow arrow) that was on fire at the parking lot when the fire had just started up, the fire observed to be spread from the vehicle beside the Insured Vehicle. In general, the information that could be gathered from this photograph had corresponded to the events that were related to us by Mr Foong, location when the fire broke out.

24. Having investigated and technically analysed the damages of burnt nature to the Insured Vehicle, we are of the view that the cause of fire damage to the Insured Vehicle was due to a fire that had started from a vehicle that was parked on the right side of the Insured Vehicle which spread onto the Insured Vehicle engulfing it. Refer to Photo 22.

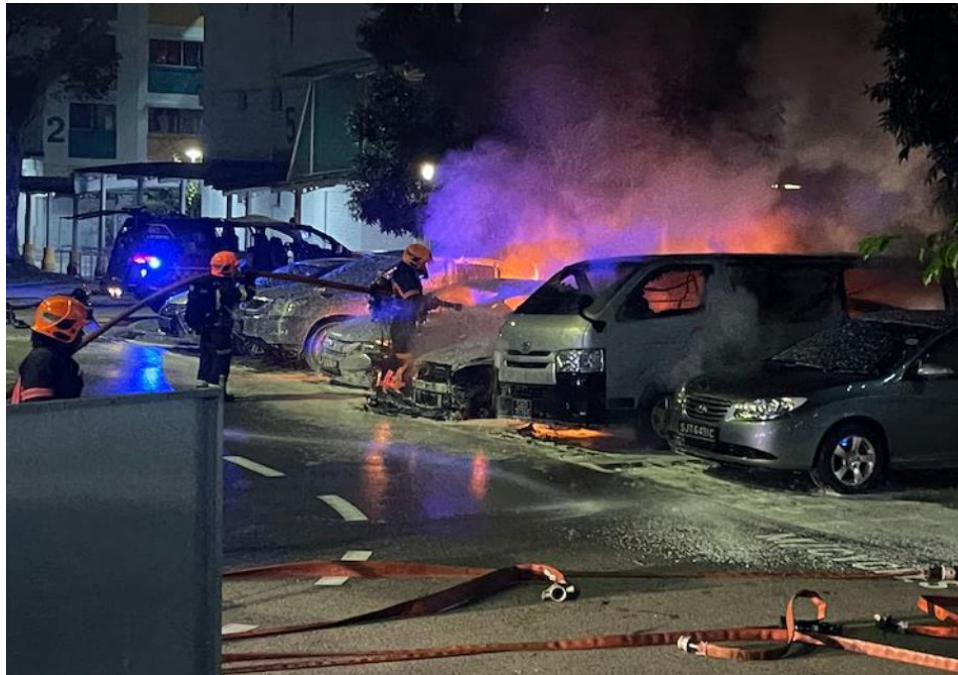
Photo 23 shows the SCDF officers on scene and putting out the fire on the vehicle on the right side on the Insured Vehicle first. In general, the information that could be gathered from this photograph had corresponded to the events that were related to us by Mr Foong, location when the fire broke out.

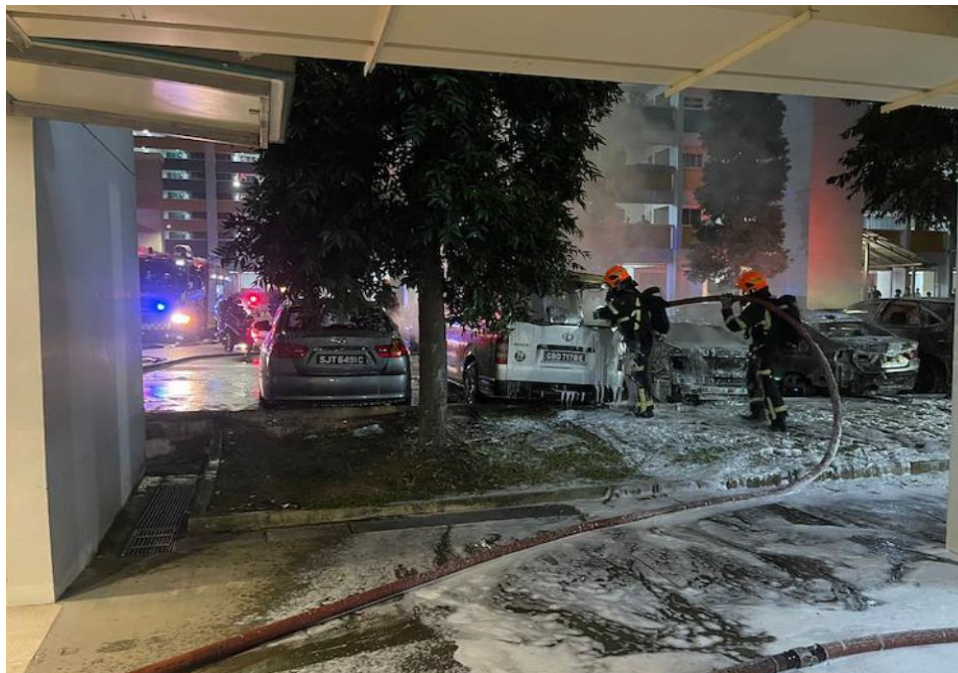
Photo 24 shows the SCDF officers on scene and putting out the fire on the Insured Vehicle which had spread from the vehicle on its right and onto it. In general, the information that could be gathered from this photograph had corresponded to the events that were related to us by Mr Foong, location when the fire broke out.

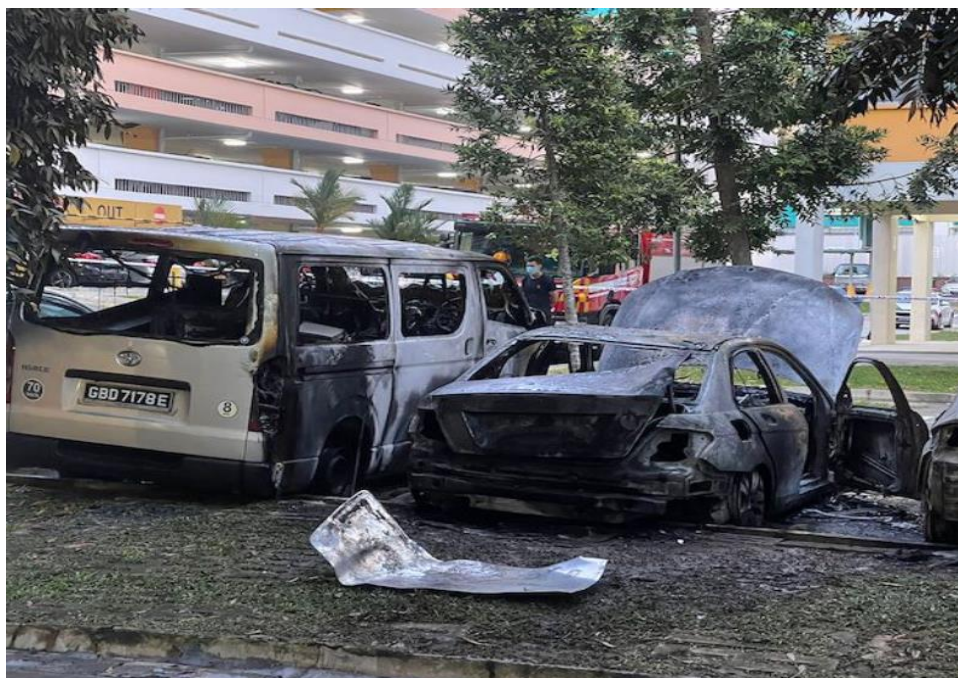
Photo 25 shows the exterior of the Insured Vehicle after the fire was put out. The high heat intensity burn marks (whitish burn marks) and rust that had development found on the right side exterior surface of the Insured Vehicle which was caused by the vehicle that was parked on the right side which had called fire. In general, the information that could be gathered from this photograph had corresponded to the events that were related to us by Mr Foong, location when the fire broke out.

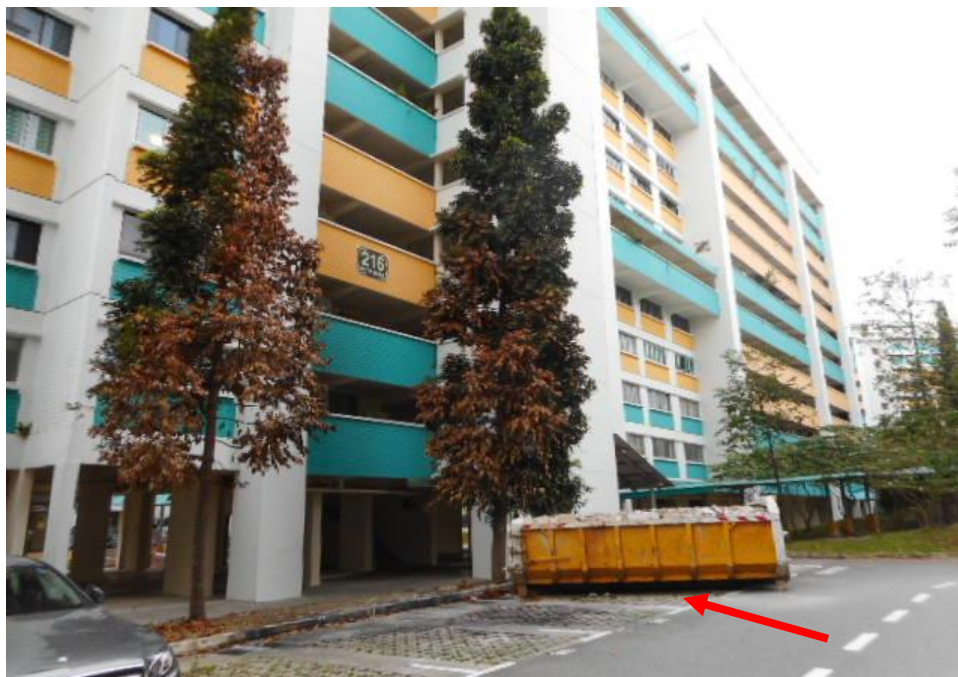
Photo 26 shows the general view of the location where the fire incident had occurred. The Insured Vehicle was positioned at carpark lot 350 (arrowed) at 216 Petir Road, Singapore 670216.

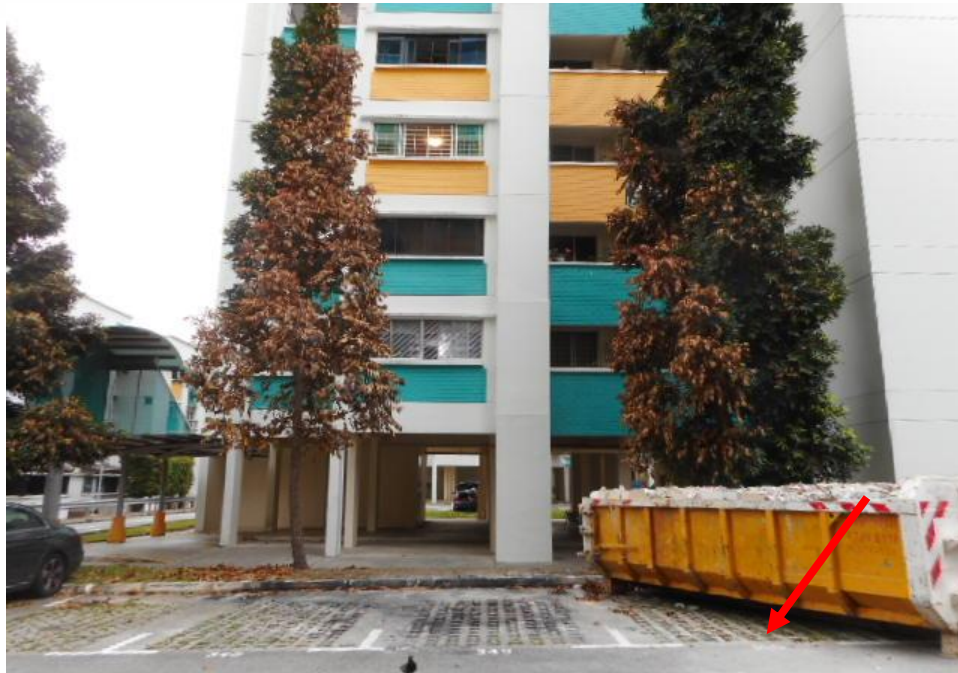
Photo 27 shows the general view of the location where the fire incident had occurred. The Insured Vehicle was positioned head out at the carpark lot 350 (arrowed) at block 216 Petir Road, Singapore 670216. From our observations, the trees and surroundings were affected by the fire.

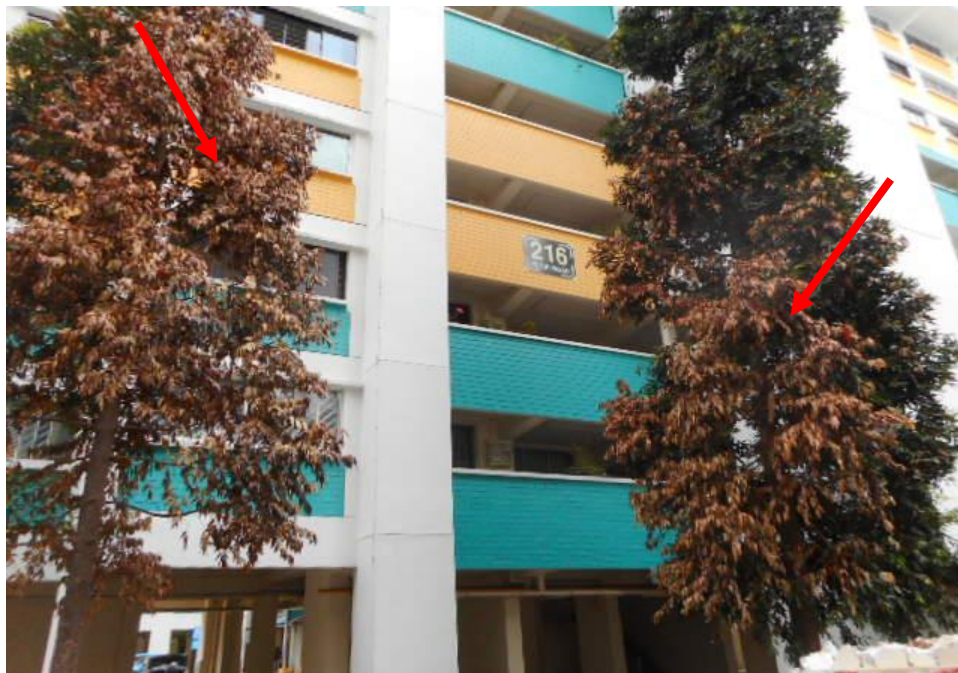
Photo 28 shows the close-up view of the location where the fire incident had occurred. The trees at the vicinity of where Insured Vehicle was also damaged as a result of the fire.

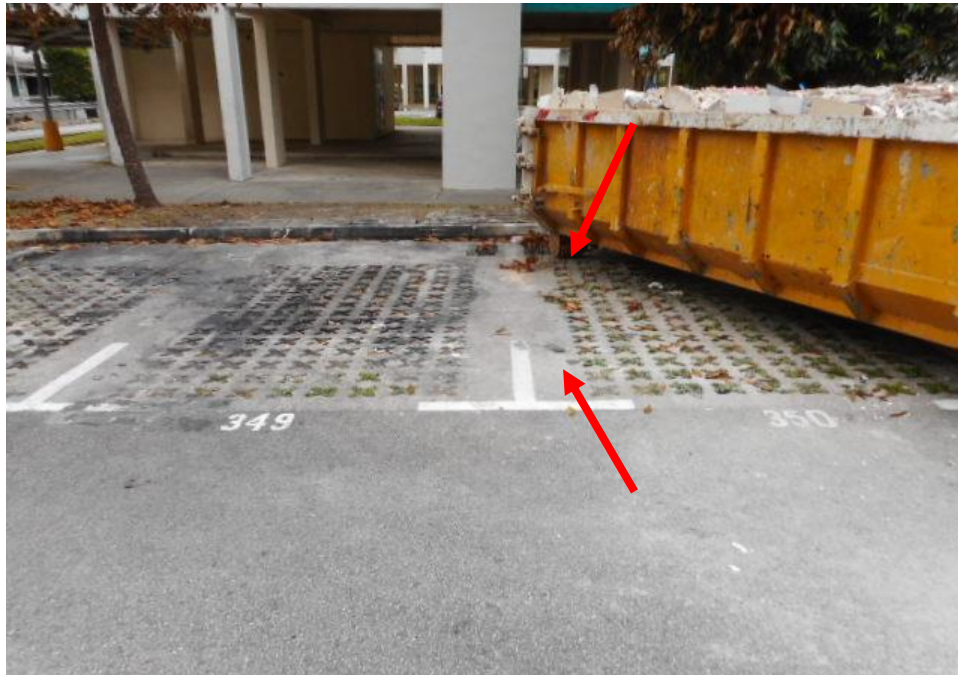
Photo 29 shows the general view of the carpark lot number 349 and 350 where the fire incident had occurred. The Insured Vehicle was parked at carpark lot 350 beside the vehicle that was on fire at carpark lot 349. From our observations, we observed two black residue spots on the ground which was from the right front and rear tyres of Insured Vehicle that had melted as a result of the fire. (arrowed)

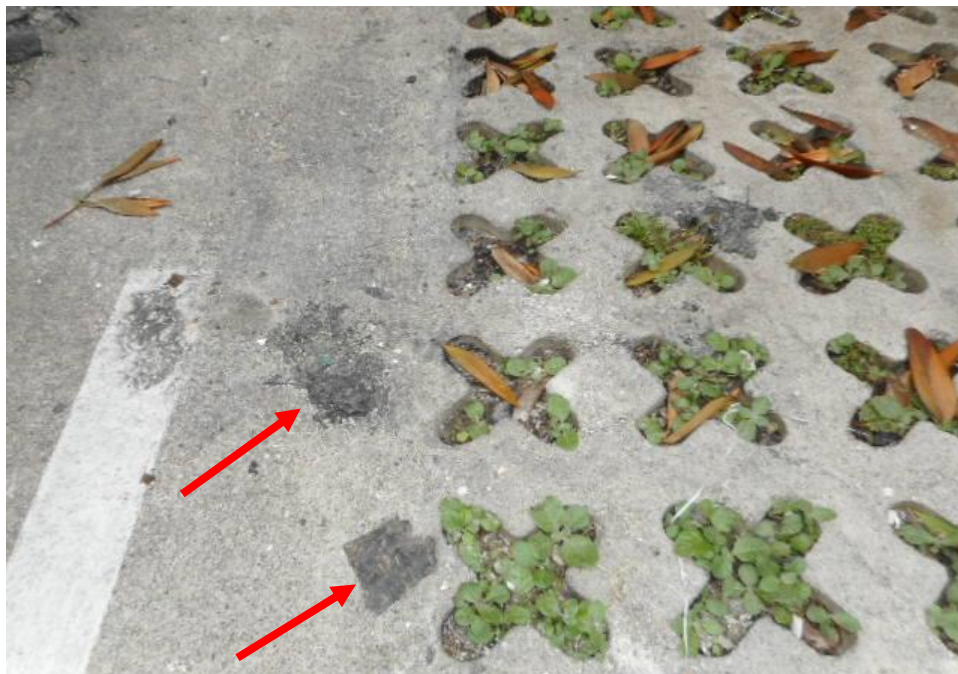
Photo 30 shows the general view of the carpark lot number 349 and 350 where the fire incident had occurred. The Insured Vehicle was parked at carpark lot 350 beside the vehicle that was on fire at carpark lot 349. From our observations, we observed two black residue spots on the ground which was from the right front and rear tyres of Insured Vehicle that had melted as a result of the fire. (arrowed)

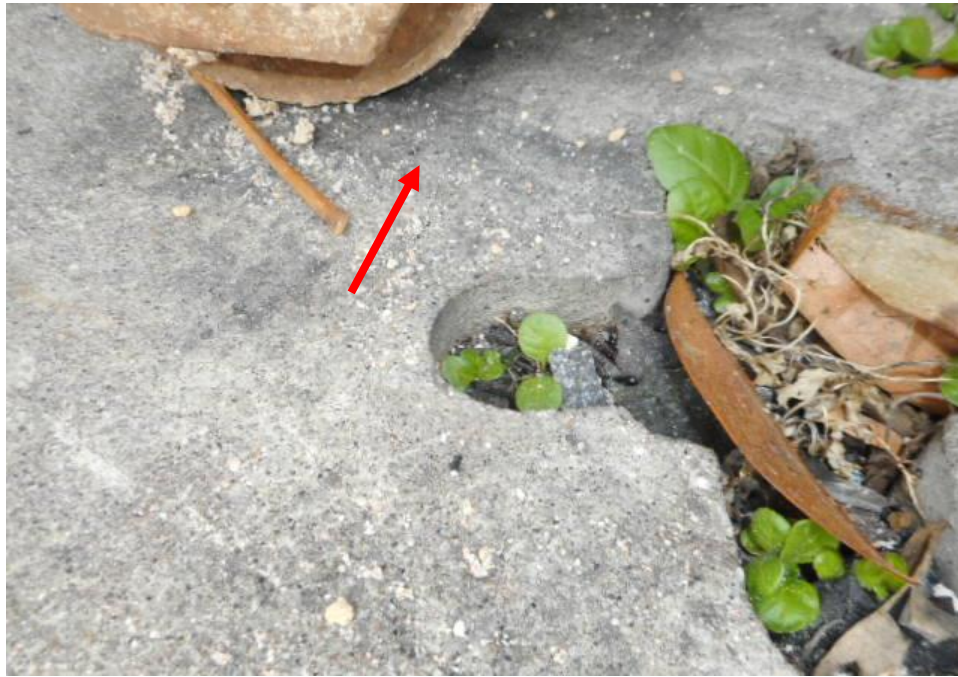
Photo 31 shows the general view of the carpark lot number 349 and 350 where the fire incident had occurred. The Insured Vehicle was parked at carpark lot 350 beside the vehicle that was on fire at carpark lot 349. From our observations, we observed two black residue spots on the ground which was from the right front and rear tyres of Insured Vehicle that had melted as a result of the fire. (arrowed)
