Affiliated to Federation Internationale Des Experts En Automobile				
CHINA TAIPING INSURANCE (S) PTE LTD 3 ANSON ROAD #16-00 SPRINGLEAF TOWERSINGAPORE 079909			Ref: CC6/CTI20007525/Krs3q2	
			Date: 20/09/2021	
			Code: CTI

ADJUSTMENT ON REPAIR COST FOR VEHICLE NO. SKR 380C

PHOTOGRAPHS FOR VEHICLE NO. SKR 380C

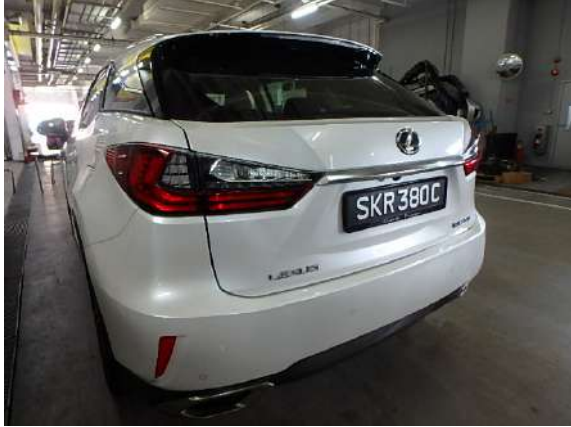
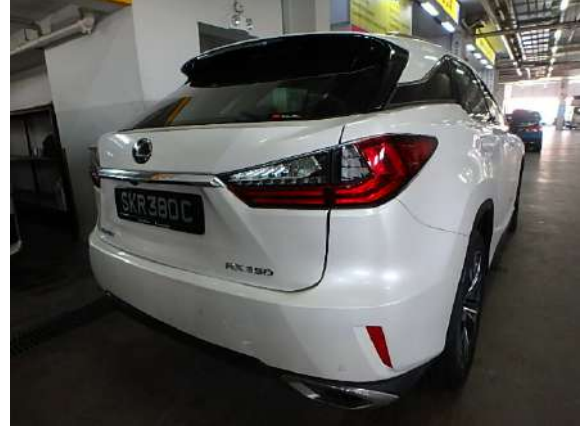
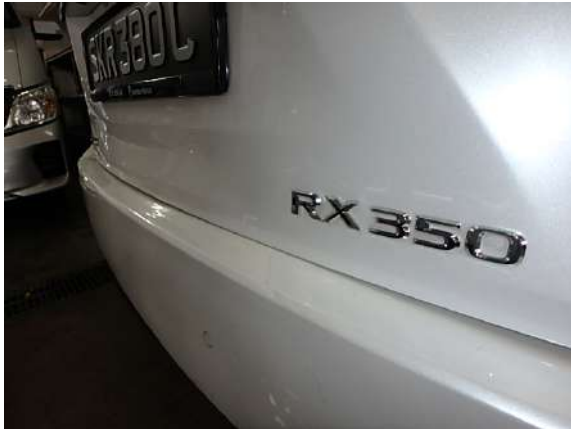
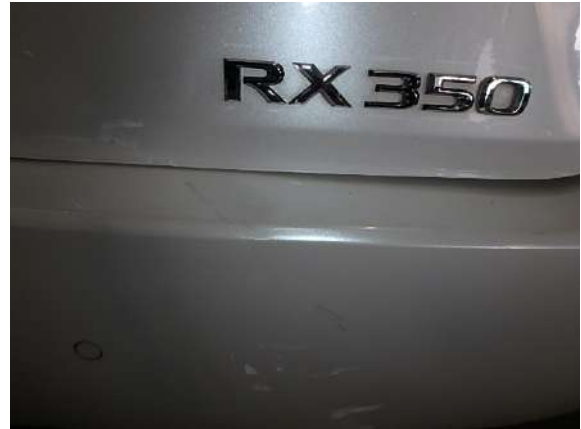
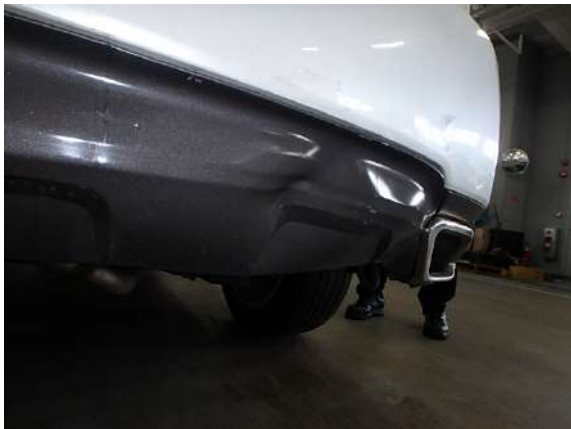
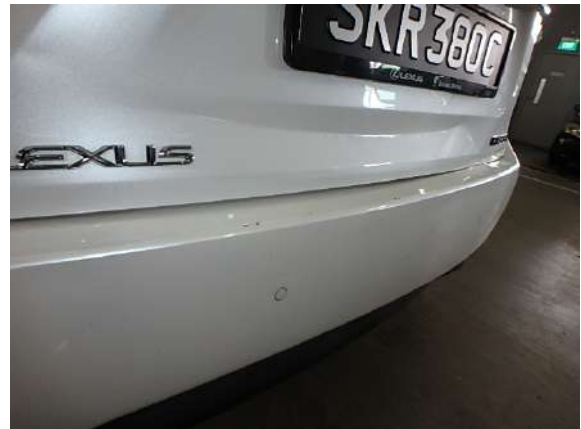
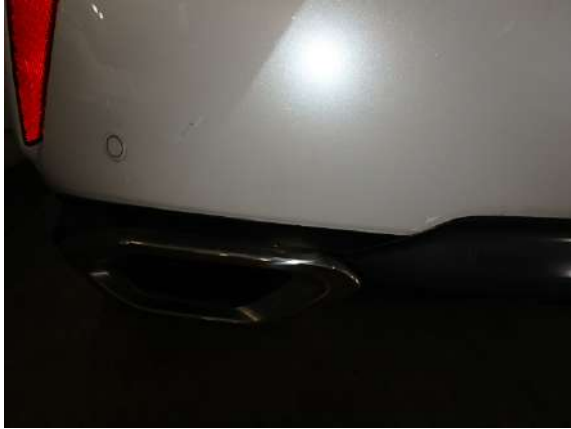
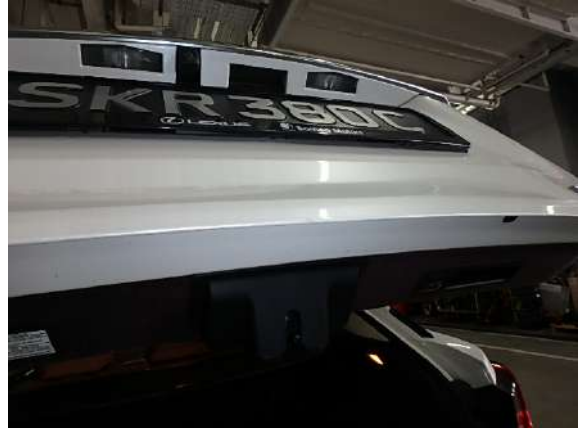
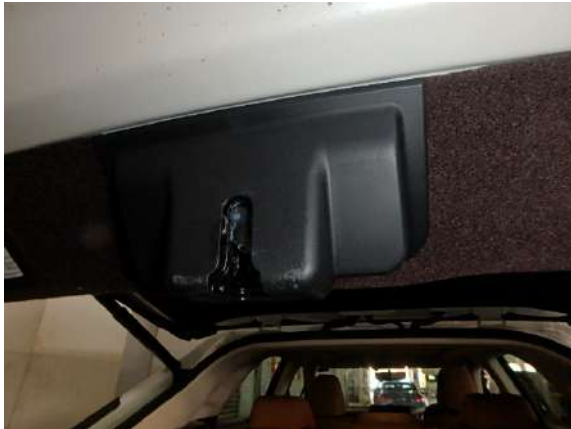
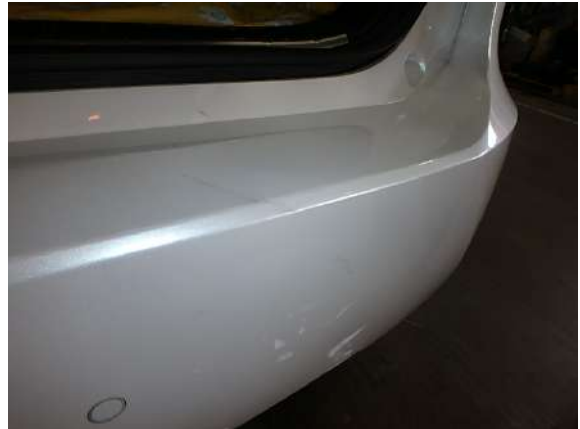
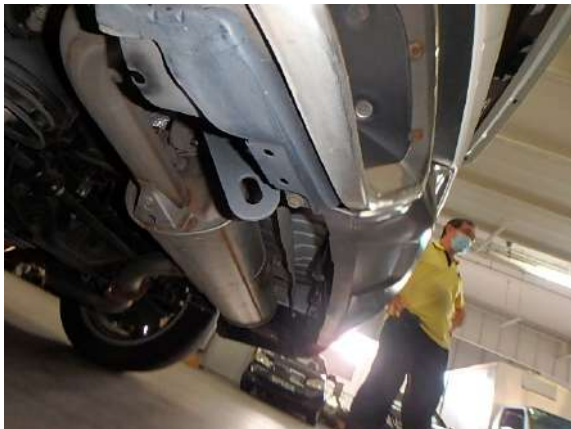
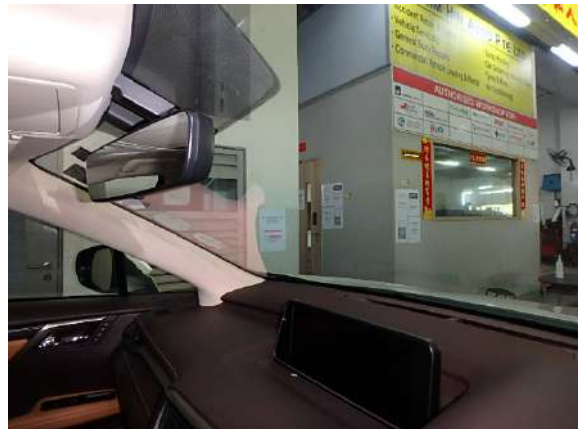
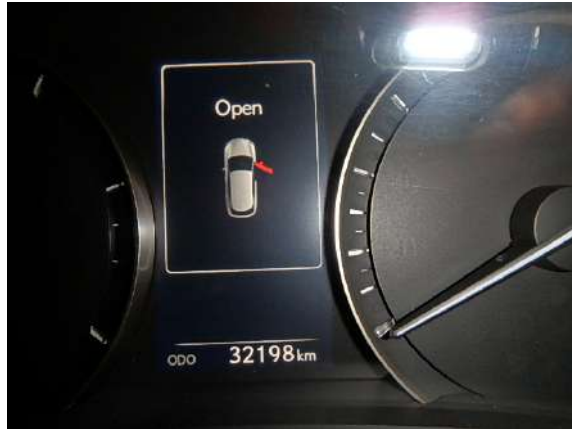
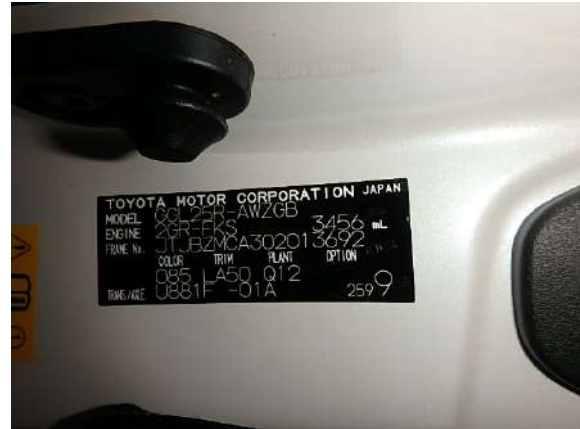
4. Description of Damages				
THE VEHICLE SUSTAINED DAMAGES AT THE REAR PORTION. DAMAGES SEE DETAILS.				
5. General Information				
Accident Date	16/07/2020	Inspection Date	20/07/2020	
Survey held at	K.KIM HIN AUTOMOTIVE PTE LTD 160 SIN MING DRIVE, #02-20 SIN MING AUTOCITY SINGAPORE 575722			
5a. Remarks				
A)THE INSPECTION WAS CONDUCTED ON A"WITHOUT PREJUDICE" BASIS. B)IN ACCORDANCE TO YOUR INSTRUCTIONS, WE HAVE NOT AUTHORISED REPAIRS.				
5b. Estimate Days of Repair				
ESTIMATED NORMAL PERIOD FOR REPAIR:			4 Working Days
